**Bridges with Premature Concrete Deterioration:
Fatigue Testing of Full-Scale, Prestressed
Concrete Box Girders Failing in Shear**

Research Report 1857-3

*STRUCTURAL ASSESSMENT OF IN-SERVICE BRIDGES
WITH PREMATURE CONCRETE DETERIORATION*

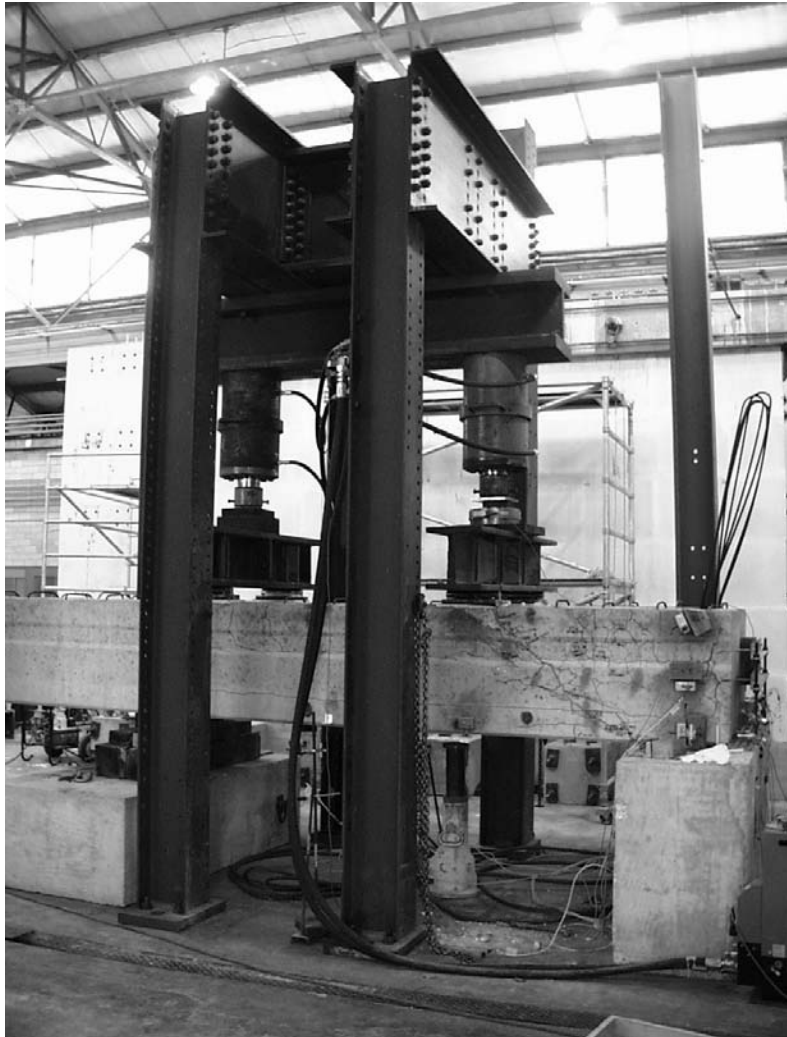
Figure 3.3 Loading setup for shear-dominated fatigue specimens

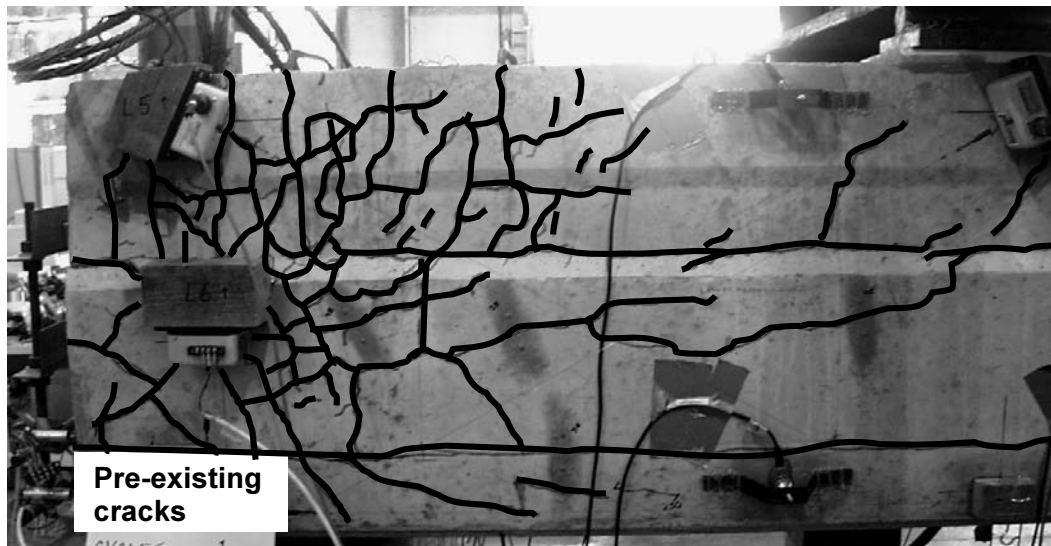
Figure 4.21 Pre-existing cracks in the east web of BG3S

The pre-existing cracks in the east and west webs of BG3S are shown in Figures 4.21 and 4.22.

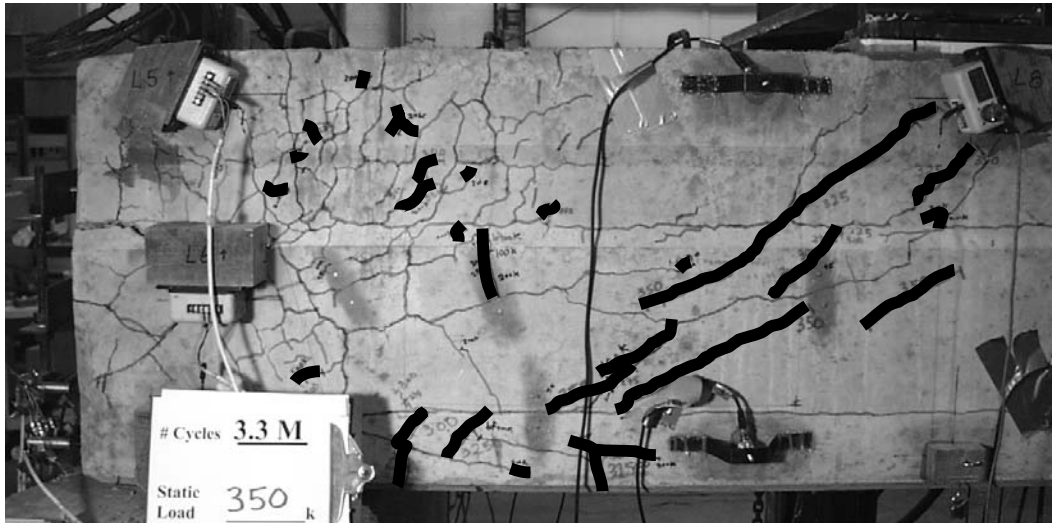
Figure 4.27 Shear-induced cracks in the east web of BG3S after 3,328,600 load cycles, and under a static load of 350 kips (1560 kN)

loading, cracking was audible, and the east web experienced worse cracking than the west web. At approximately 320 kips (1420 kN), one crack in the east web propagated through the bottom flange. During the loading increment from 325 kips (1450 kN) to 350 kips (1560 kN), there was again audible cracking, yet not as much as during the previous loading step. The additional cracking that formed during the stepped quasi-static loading is shown under a static load of 350 kips (1560 kN) in Figures 4.27 and 4.28.

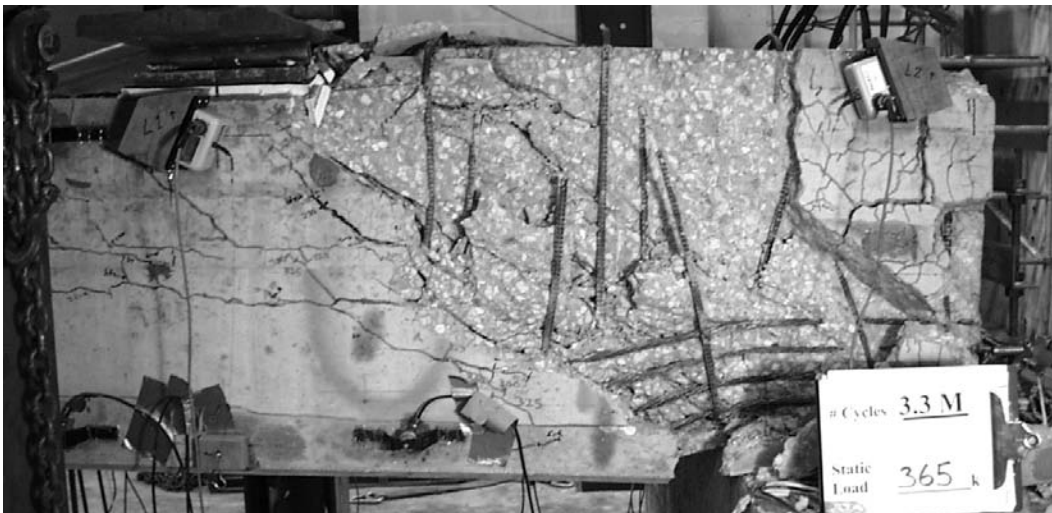
Figure 4.30 Failure of the west web of BG3S after 3,328,600 load cycles and a 365 kip (1620 kN) quasi-static load

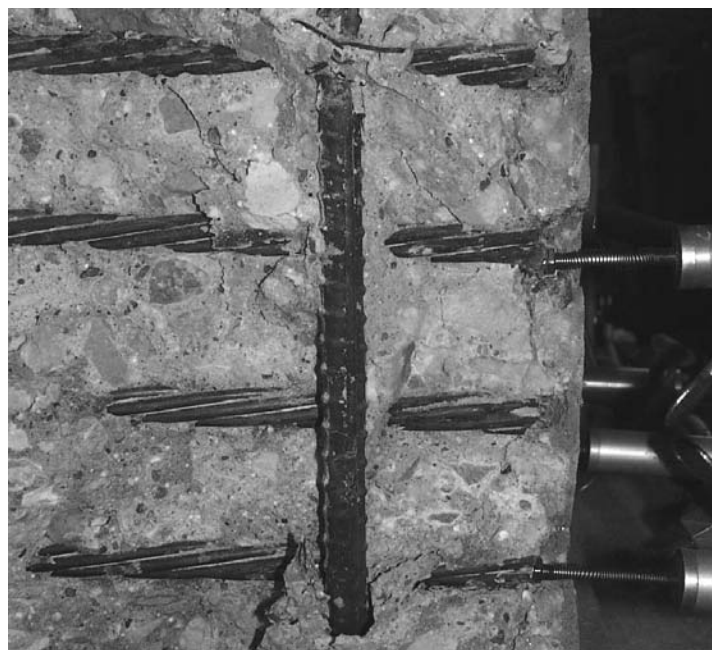
Figure 4.32 Slip of exterior prestressing strands after failure of BG3S

There was no significant slip of prestressing strands during the fatigue test. In the final moments of the quasi-static test to failure, however, as the concrete cover spalled off and the web concrete crushed, several interior prestressing strands and all of the strands nearest to the exterior surfaces of the webs slipped (Figure 4.32). The amount of slip was not measured accurately by the linear potentiometers because as the girder failed, the potentiometers slipped off of the ends of the prestressing strands. Slip was verified by visual inspection, and was manually measured to be between 0.125 in. (3 mm) and 0.25 in. (6 mm) for the interior strand, and approximately 0.5 inch (13 mm) for the exterior strand.

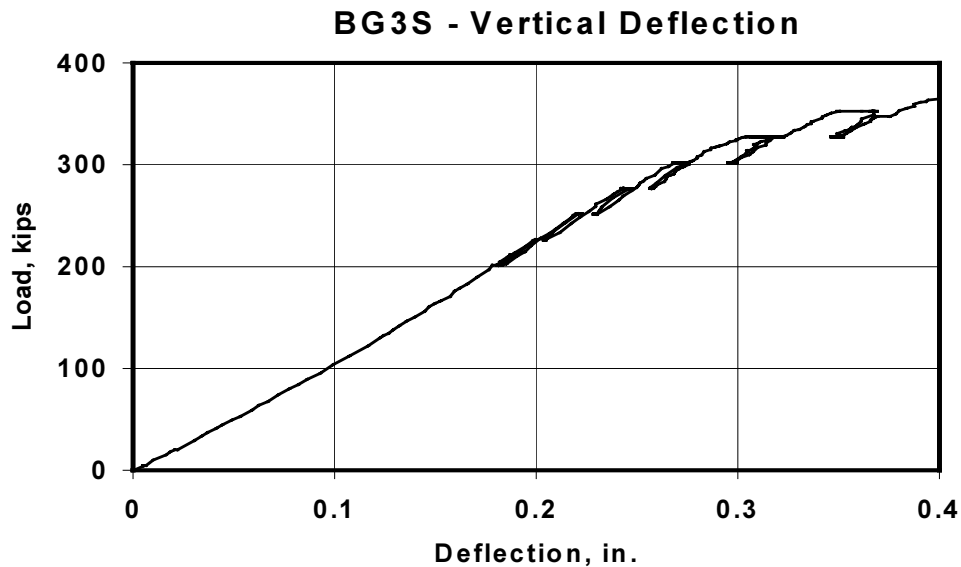
Figure 4.34 Quasi-static loading of BG3S to failure

The difference between the average deflection after one load cycle, and nearly 3.3 million cycles was only 0.006 in. (0.15 mm). Therefore, the change in vertical deflection with respect to the number of load cycles is very small. Vertical deflections were similarly measured during quasi-static loading to failure, and are plotted versus load (Figure 4.34).

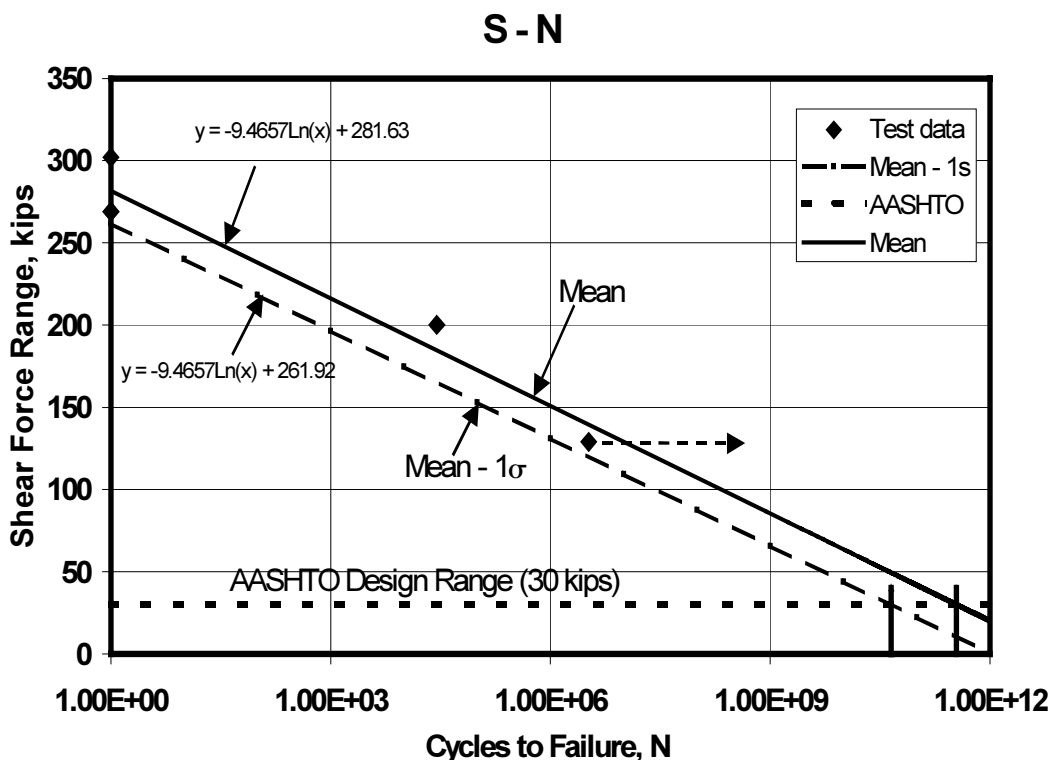
Figure 5.2 S-N curve for box girder test specimens

The data presented in Table 5.1 were analyzed by taking the logarithm of the number of cycles to failure (N), and performing a linear regression analysis. The best-fit line through the S-N data, calculated by least-squares regression, is shown in Figure 5.2. Although this S-N curve is based upon only five data points, the calculated reliability is acceptable, as indicated by an R^2 value of 0.94.
