BEHAVIOR OF POST-TENSIONED GIRDER ANCHORAGE ZONES

RESEARCH REPORT 208-2

PROJECT 3-5-77-208

CENTER FOR TRANSPORTATION RESEARCH

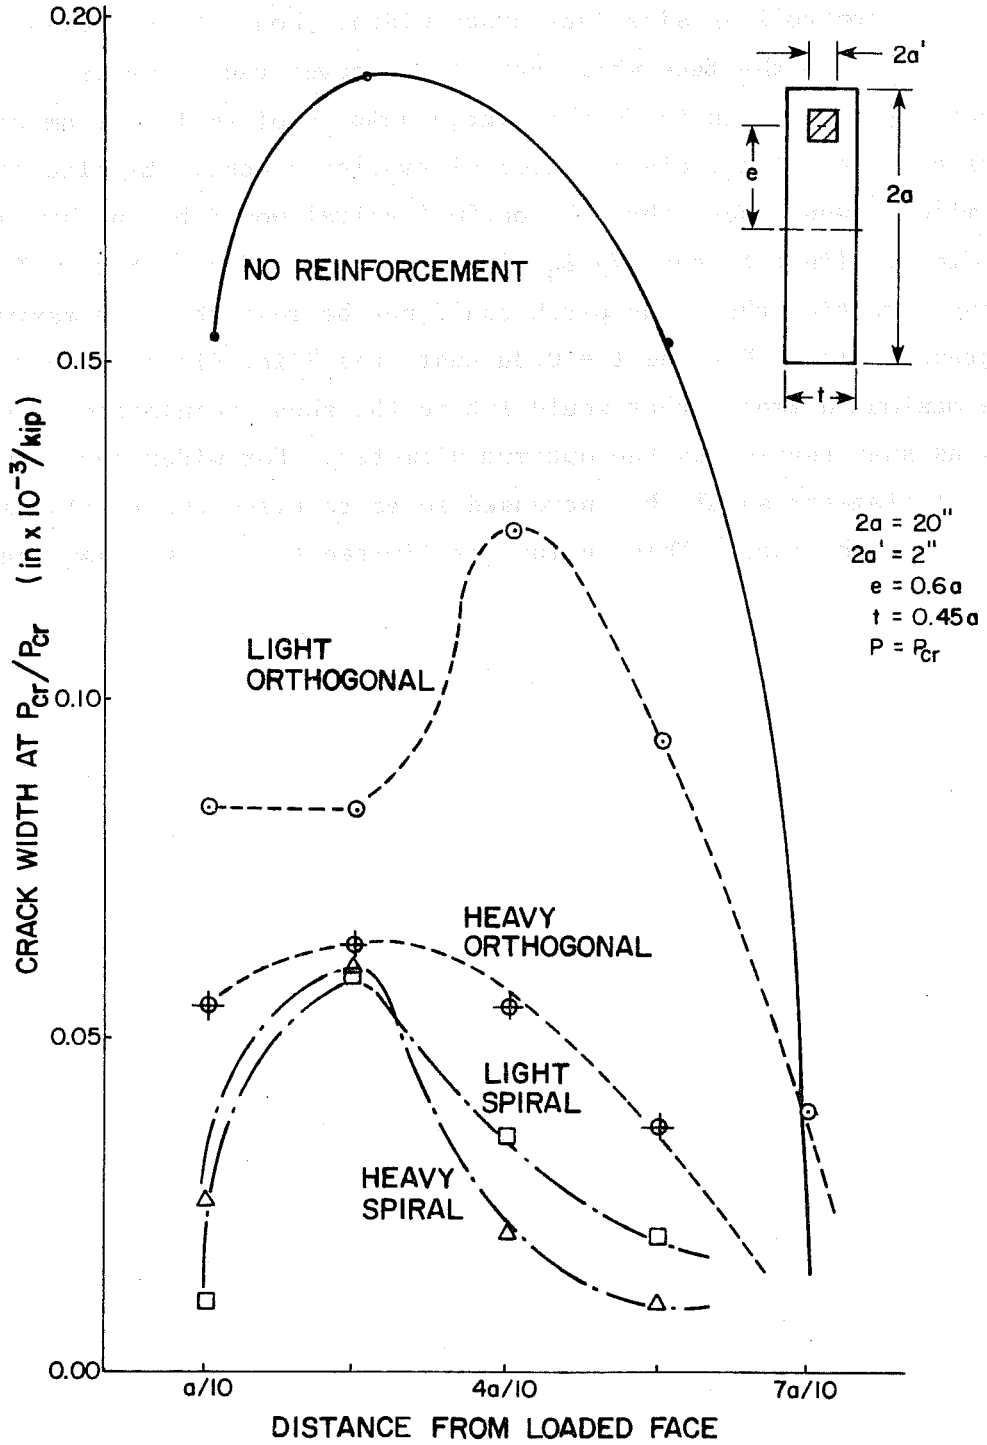
Fig. 2.38 Crack widths normalized to P_{cr} , $t = 0.45a$

Grid Line	Average Crack Width $\div P_{cr}$				t = 0.45a		all specimens	
	M2B-4	M4A-4	M4B-4	M5B-4	M5A-4			
1	0.154	0.083	0.054	0.025	0.01			
2	0.192	0.083	0.0625	0.06	0.06			
3	0.115	0.125	0.054	0.02	0.035			
4	0.154	0.104	0.036	0.01	0.02			
5	0.038	0.094						
6		0.031

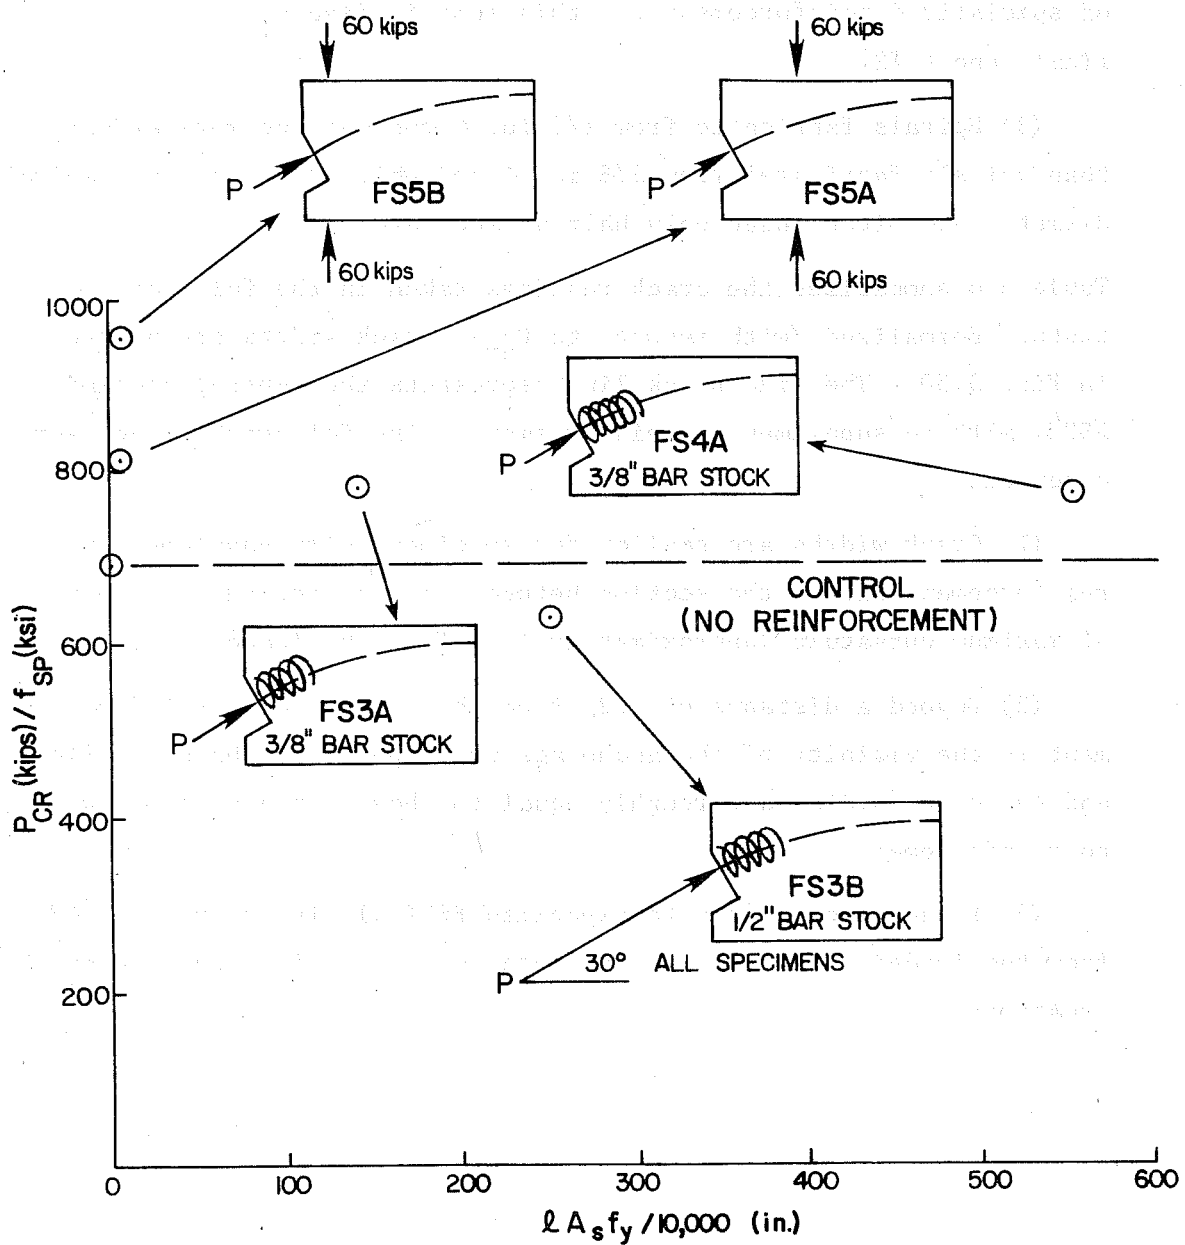
Fig. 3.49 Reinforcement efficiency

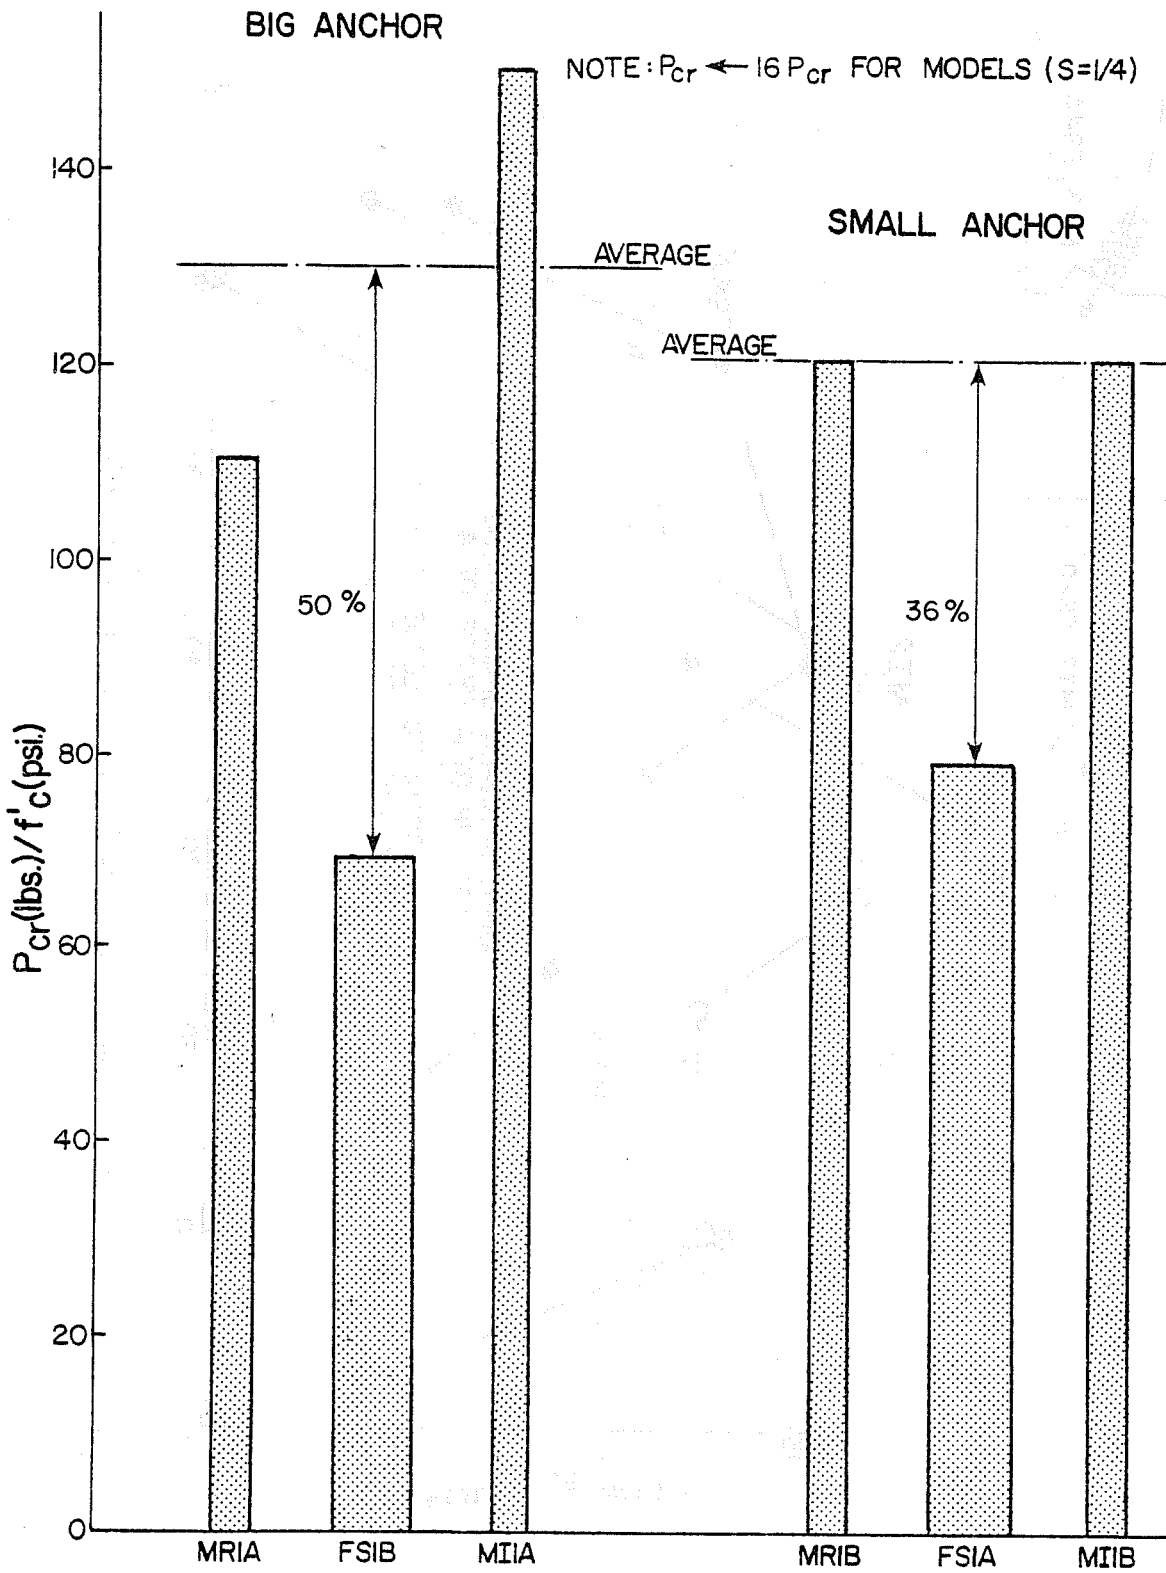
Fig. 4.32 Straight tendon specimens--cracking loads normalized with respect to f'_c

Figure 4.32 shows cracking loads normalized with respect to f'_c and the scale factor (for load $S^2 = 16$) for models and full-scale specimens. Differences of 50 percent for specimens with the standard commercial anchors, and 36 percent for specimens with the reduced anchors were observed from the model analysis. The important point to be made is that the compressive strength of the concrete is not an appropriate parameter for correlation of cracking loads between model and prototype, especially since the tensile strength (f_{sp} , indirect) of the microconcrete was found to be substantially greater
