SEISMIC STRENGTHENING OF A REINFORCED CONCRETE FRAME
USING STRUCTURAL STEEL BRACING

Report on a Research Project

Phil M. Ferguson Structural Engineering Laboratory
Department of Civil Engineering
BUREAU OF ENGINEERING RESEARCH
THE UNIVERSITY OF TEXAS AT AUSTIN

May 1986

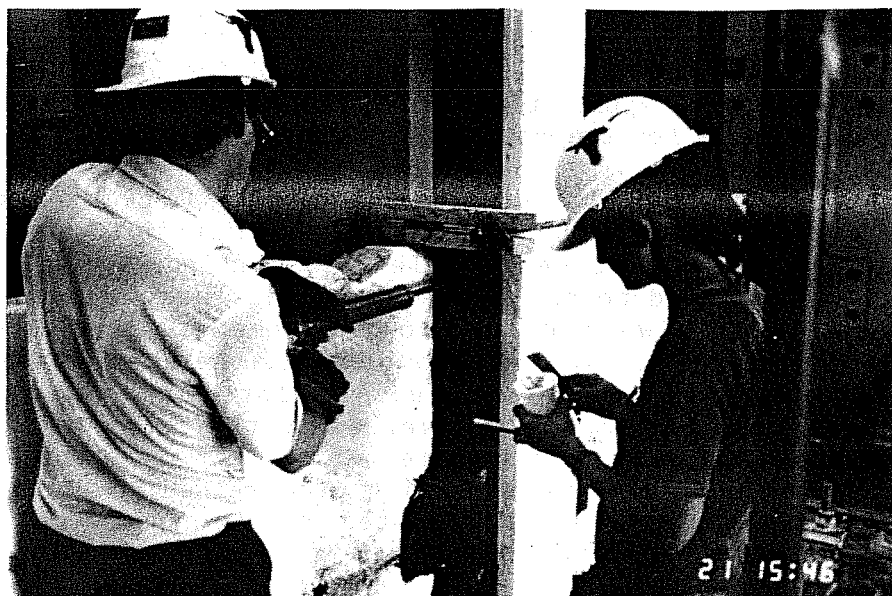
Fig. 3.23 Epoxy application procedure

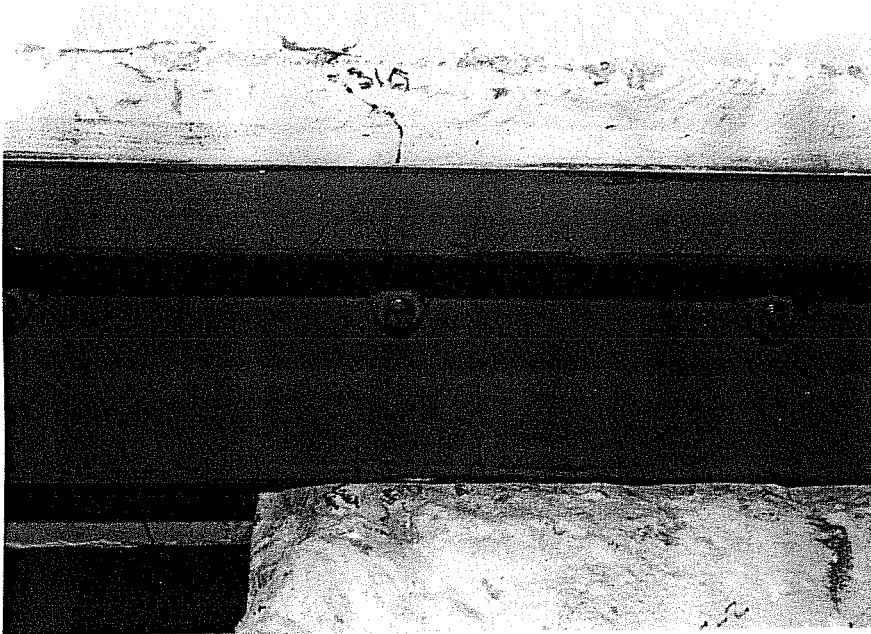
Fig. 4.11 Compression yield lines on channel

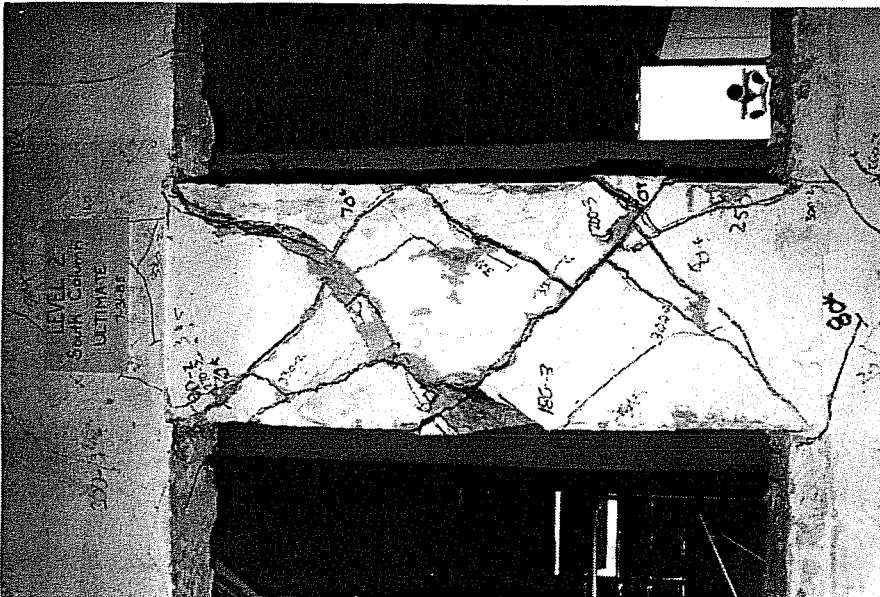
(b) North column

(a) South column

Fig. 4.15 Second level columns at ultimate
