**CRACK DETECTION IN NAVAL CRANE
SHAFTS USING ACOUSTIC EMISSION**

PHIL M. FERGUSON STRUCTURAL ENGINEERING LABORATORY
Department of Civil Engineering / Bureau of Engineering Research
The University of Texas at Austin

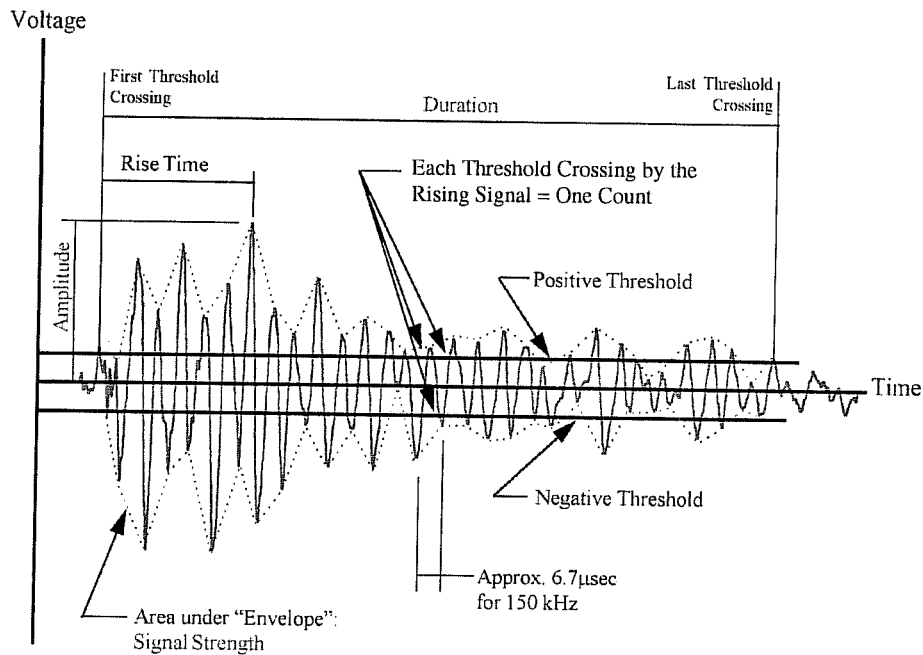
Figure 2.4: Typical AE signal - Voltage VS Time - Showing definitions of Amplitude, Duration, Threshold, counts, and Rise Time.

Figure 2.4 shows typical output from an AE sensor. When a stress wave strikes the face of the sensor, it causes the output signal to rise above a preset threshold. This signal is commonly referred to as a "hit". The threshold value will vary depending on the type of data required, and the circumstances of the test. It is used to selectively reject signals with amplitudes below the threshold which will not provide meaningful data, as they may be caused by spurious sources such as ambient, electronic, or electromagnetic noise.

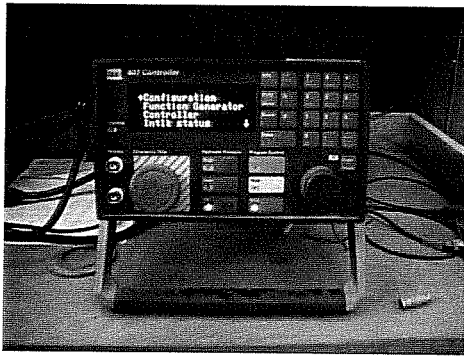
Figure 3.9: MTS Automated Controls Systems, as implemented

An automated control system consisting of an MTS 407 Programmable Electronic Controller and a MTS 293 Hydraulic Manifold was used in place of the hand pumps previously connected to the rams. These are shown in Figure 3.9. The controller and hydraulic system allowed for the load to be cycled at any given rate. The system was under load control, with feedback from load cells in the rams governing the amount of load applied. The electronic controller passed the load level through an output which was in turn used as a parametric input for the acoustic emission instrumentation.

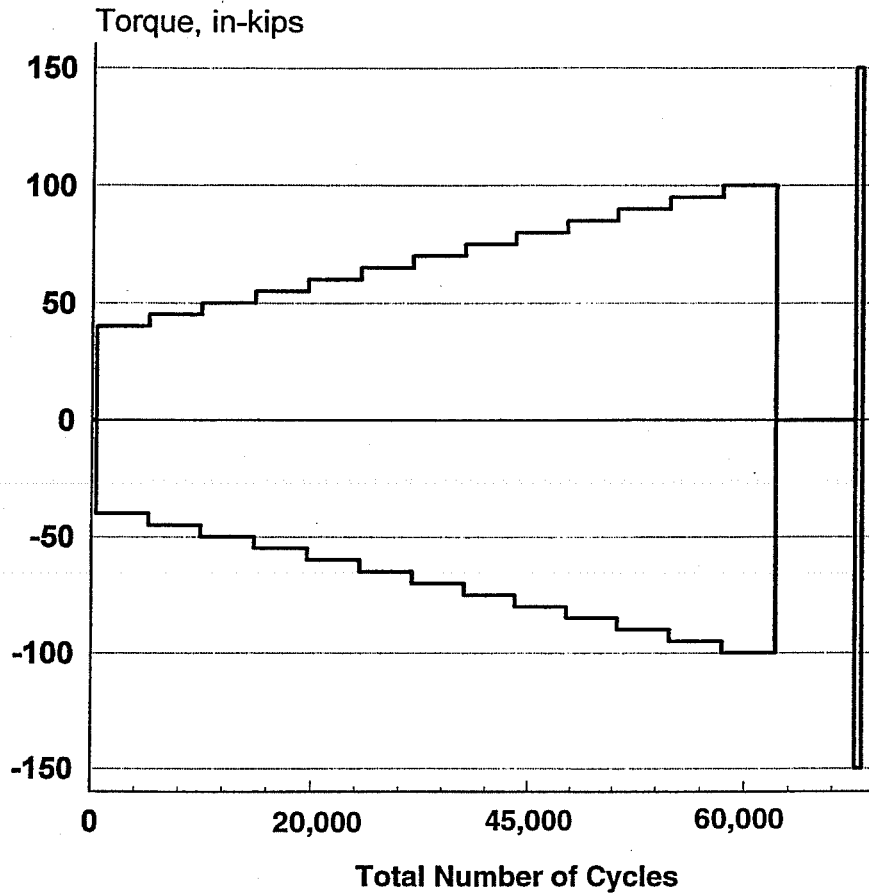
Figure 3.12: Loading Envelope used During Dynamic Testing Phase

Loading of the shaft consisted of 4,500 cycles at each load level starting at 40 in-kips working up to 100 in-kips in increments of 5 in-kips. A 10% overload was applied every 1,500 cycles. Additionally, a single overload cycle of 150 in-kips was applied at the end of the testing regime. The loading envelope is shown in Figure 3.12.

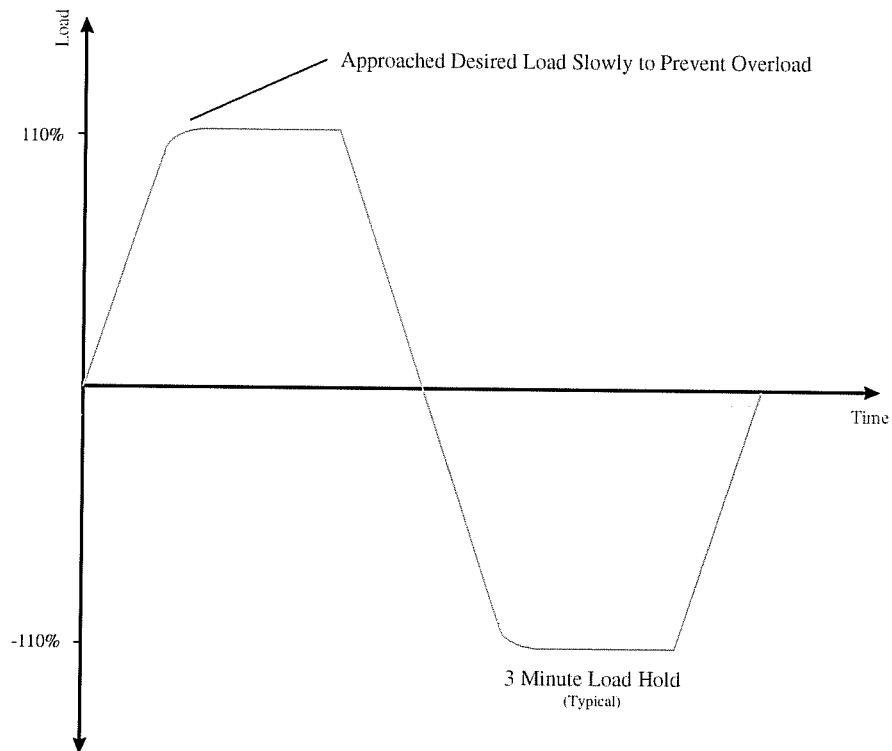
Figure 3.14: Load vs. Time for an Overload Cycle

Overloads of 10% of the fatigue load were manually applied every 1,500 cycles. The purpose of the overload was to obtain AE data from an overload of a growing crack. This provided data for the standardized test procedure and calibration of the acceptance criteria and intensity plots. The overload was applied by manually adjusting the set point of the rams using the control knob on the MTS 407 Digital Controller. As can be observed in Figure 3.12, the load is applied extremely rapidly when the automated square waveform is used. For the overload cycles it was felt that a slow application of the load was better suited to the purpose, as the Felicity effect and other load based parameters could be more accurately ascertained. Additionally, applying the load slowly further minimized the amount of frame borne background noise originating from the rapid movement of hydraulic fluid into and out of the rams, and the subsequent vibration in the stand. The slow loading rate is how the load is applied in the field tests, as well. Because of the higher load being used and the relatively small number of times the shaft was subjected to an overload at each fatigue load level a load hold of 90 seconds was used. An idealized Load vs. Time graph for the overload cycles is shown in Figure 3.14. AE monitoring was done throughout the entire cycle.

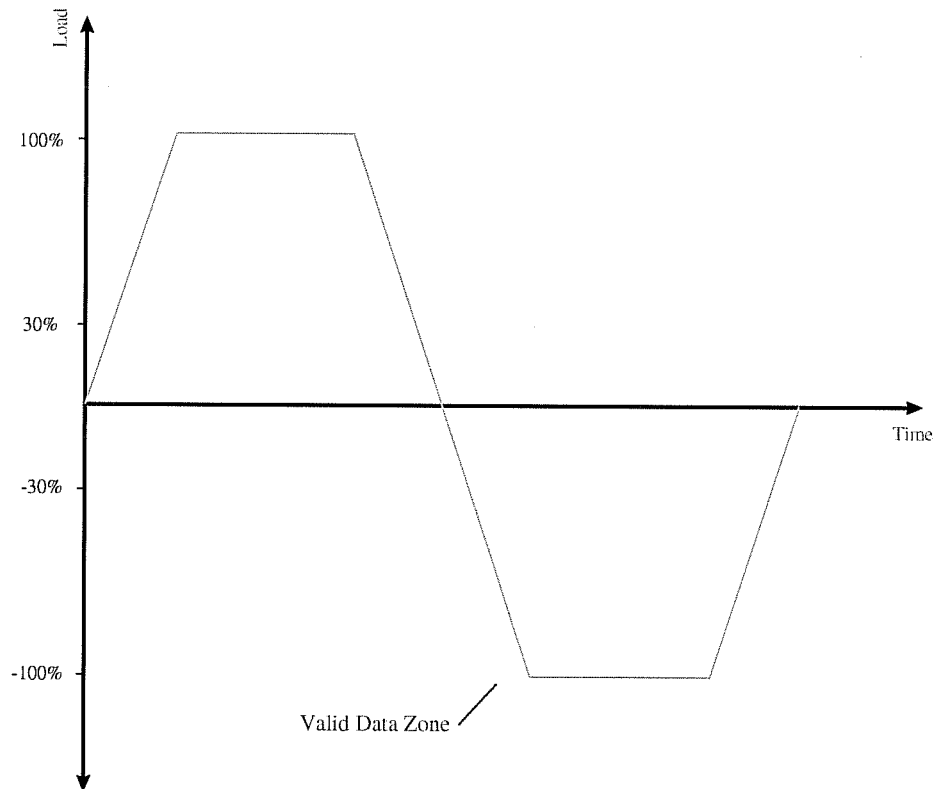
Figure 4.13: Values of Load for which Data was Accepted during Negative Overload Data Filtering

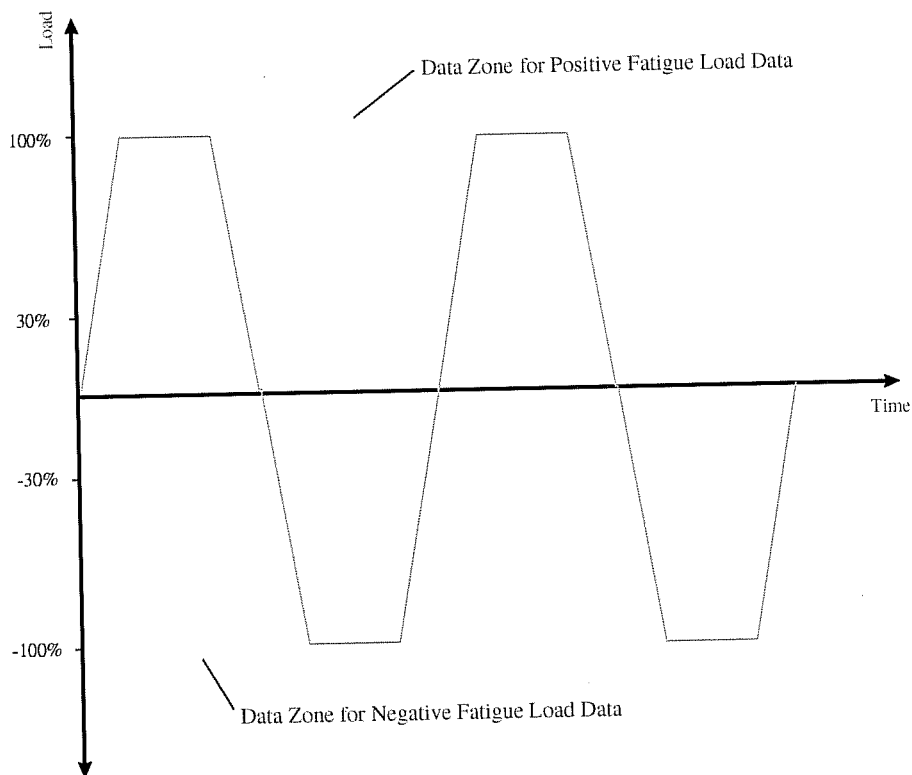
Figure 4.19: Data Zones for Positive and Negative Fatigue Load Data

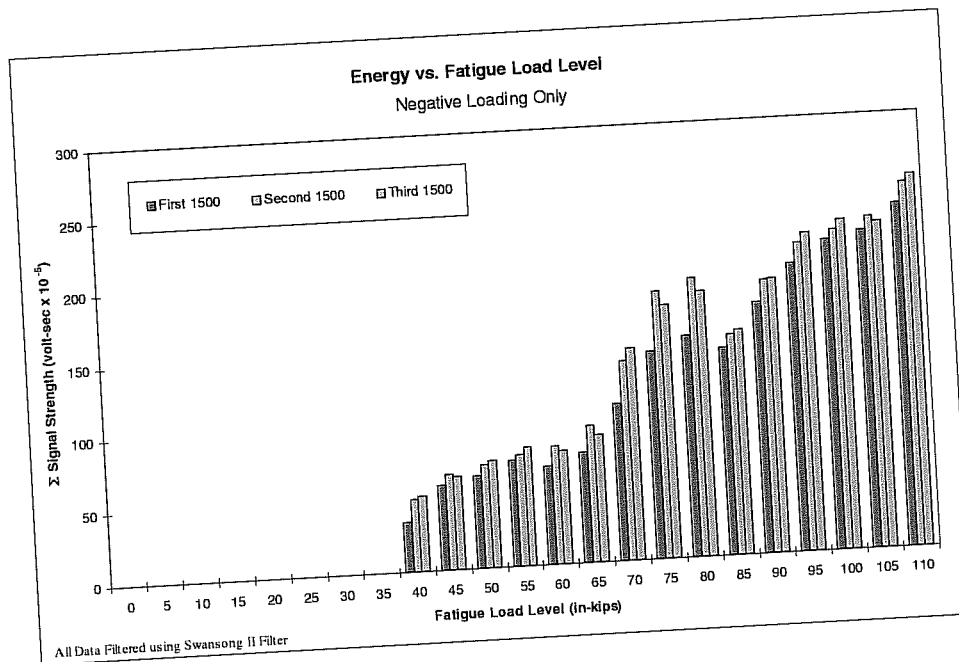
Figure 4.22: Signal Strength vs. Load Level for Negative Fatigue Loading

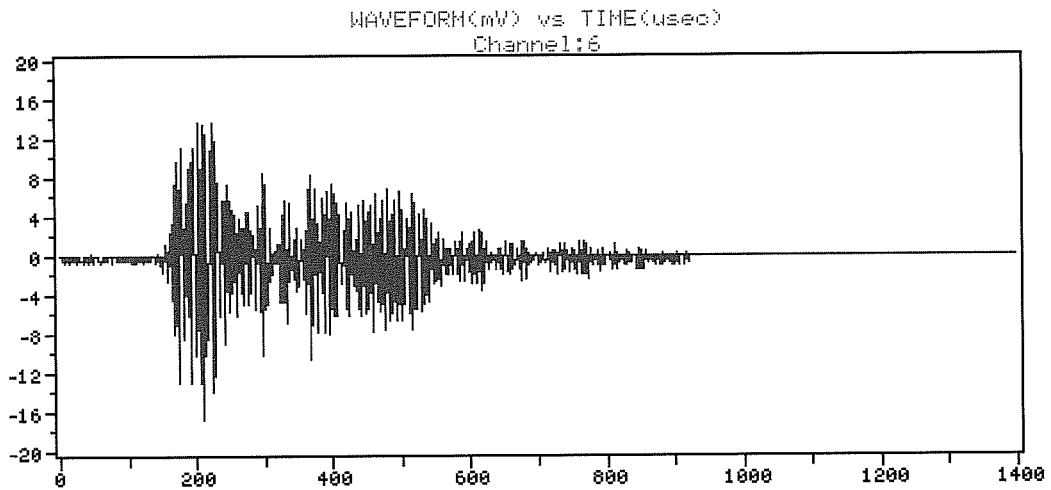
Figure 4.28: Dunnegan Cracker Waveform as Recorded by R15I Sensor
