# **LONG-TERM POST-TENSIONED COLUMN EXPOSURE TEST SPECIMENS: FINAL EVALUATION**

**Research Report 0-1405-8**

*DURABILITY DESIGN OF POST-TENSIONED  
BRIDGE SUBSTRUCTURE ELEMENTS*

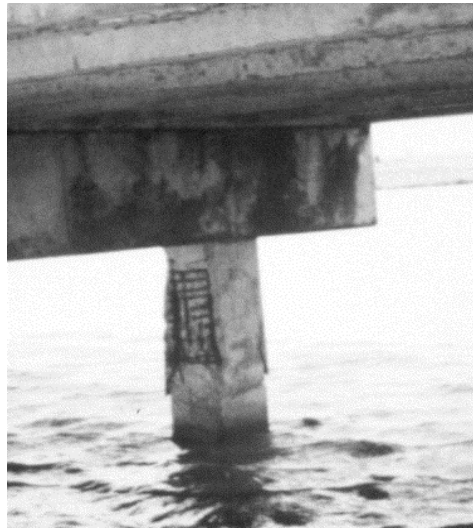
(a) *Deicing Chemical Exposure  
"Attack from Above"*

(b) *Coastal Saltwater Exposure  
"Attack from Below"*

**Figure 1.2 Typical Corrosion Damage in Bridge Substructures<sup>2</sup>**

Columns or piers in sea water are exposed to a very severe environment. This is especially the case for columns in the tidal zone (region between low and high tides) with periodic wetting and drying. In addition, above the high tide zone, the "wicking effect" (or capillary rise) may take place, which combined with periodic splashing, provide the conditions for aggressive chloride exposure (see Figure 1.1) and subsequent corrosion damage (see Figure 1.2).

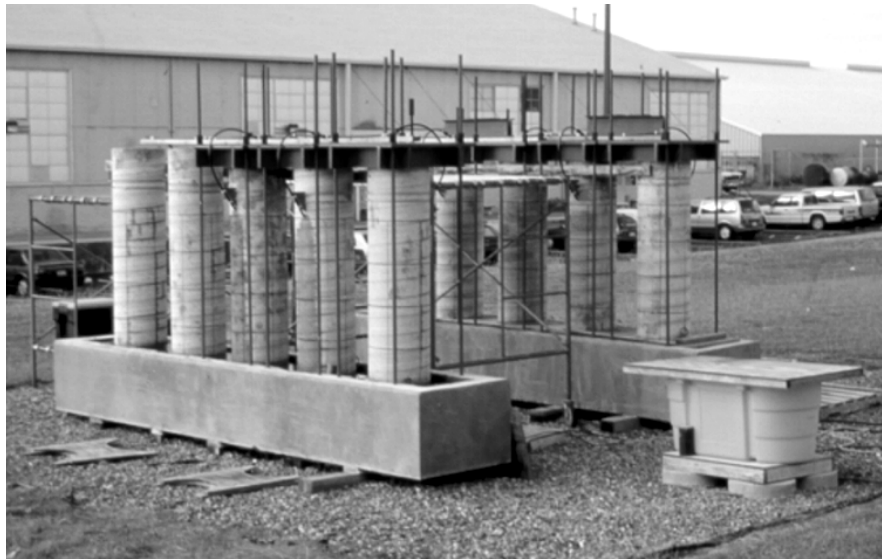
The dimensions of the reinforced concrete foundation (designed using a strut and tie model) were 15.33 ft long, 36 in. wide and 18 in. high, with a 6 x 6 in. curb along the perimeter of the top surface to contain ponded saltwater. Loading was applied on the columns using a stiffened loading plate on top of the column and four-one inch threaded prestressing bars. The forces in the bars were adjusted to apply the desired moment and axial force.

**Figure 2.9 Column Corrosion Test Setup<sup>2</sup>**

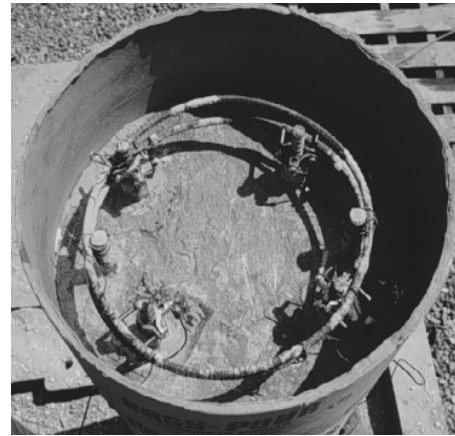
*PT Bars Protruding from Foundation Reinforcement, Ducts and Grout Tubes*

*Gasket Around Post-Tensioning Bar Top of Column Prior to Capping*

As shown in Figure 2.14, short lengths of post-tensioning bar were cast into the foundation to provide anchorage for the column post-tensioning bars. Shallow, square pockets were formed around each bar to accommodate rubber gaskets to seal the “dead end” of the post-tensioning ducts. The column post-tensioning bars were coupled to the protruding bars prior to placement of the ducts. Ground clamps were used to attach ground wires for measurements of potentials to the post-tensioning bar ends prior to capping.

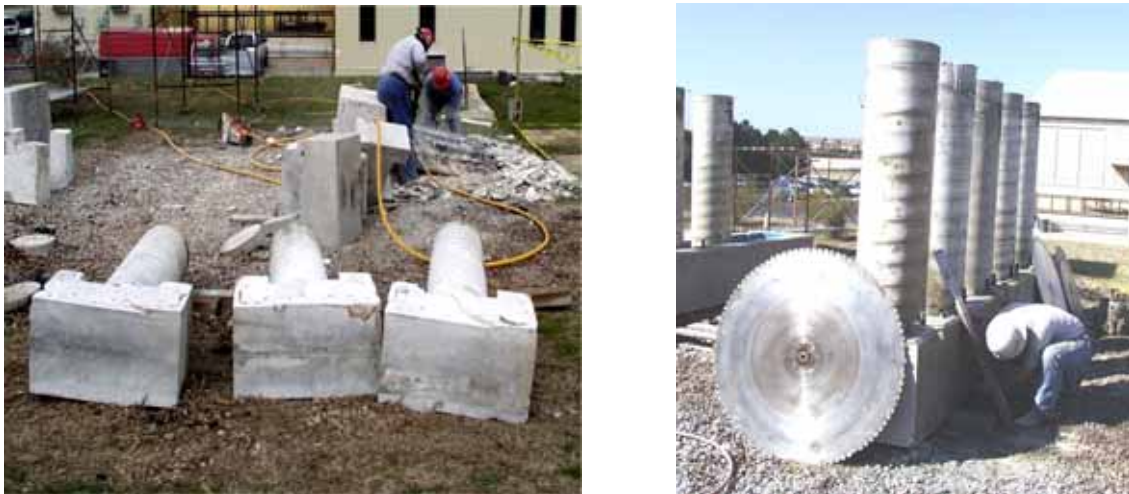
Figure 4.1 Saw Cutting of Column Foundation<sup>1</sup>

Prior to concrete removal, column specimens sharing the same foundation were separated by saw cutting as shown in Figure 4.1. Due to special saw cutting equipment requirements, saw cutting had to be contracted with an external concrete demolition company.

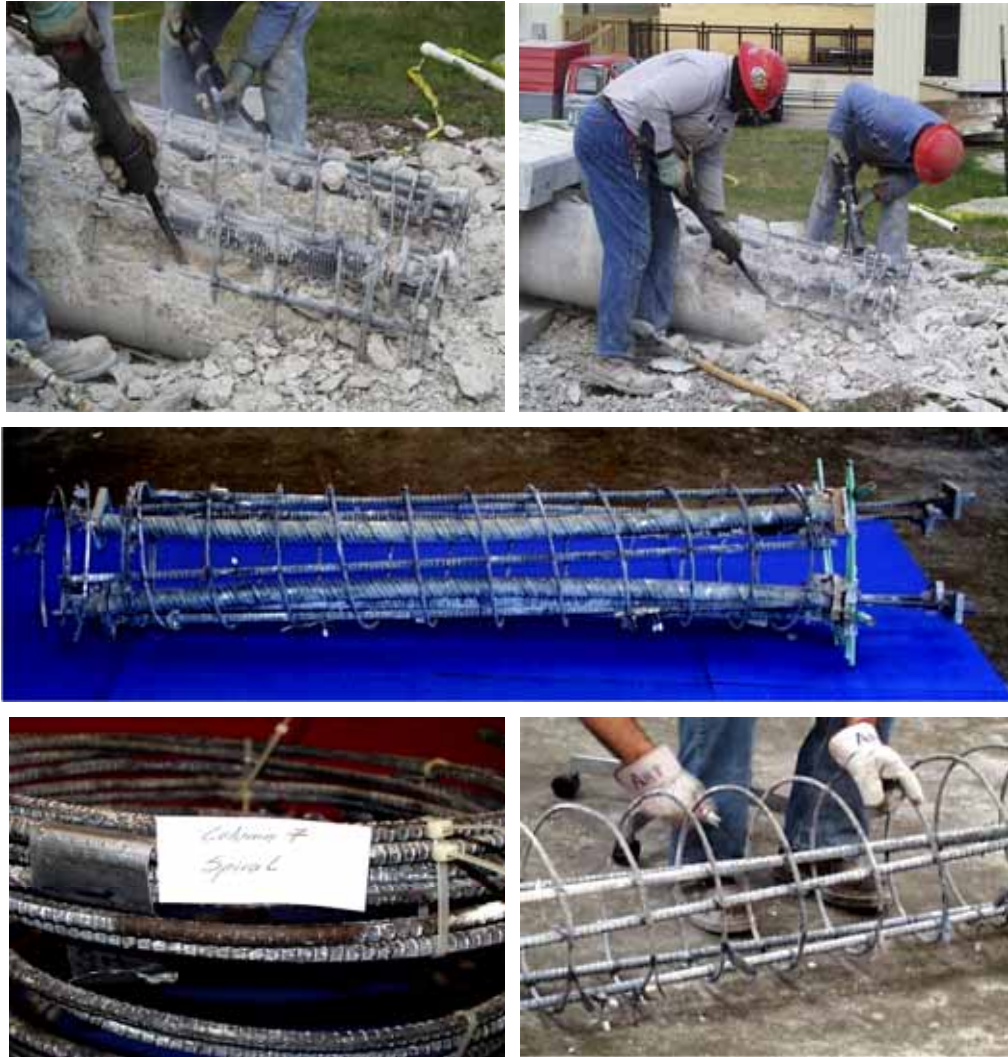
**Figure 4.2 Concrete Removal and Reinforcement Dismantling<sup>1</sup>**

All specimens (ten in total) were autopsied at the end of six and a half years of continuous exposure testing. After concrete was removed from each column, mild steel reinforcement, post-tensioning ducts and high-strength post-tensioning bars were carefully inspected and rated according to the corrosion rating scheme explained in the following section. During autopsy, ducts were cut open in half longitudinally, and grout samples were taken at different locations to investigate chloride ingress to the post-tensioning bar level. Anchorages and bar splices were also inspected for signs of corrosion in the areas exposed to concrete and at the crevices, where steel pieces in the post-tensioning system were in contact.

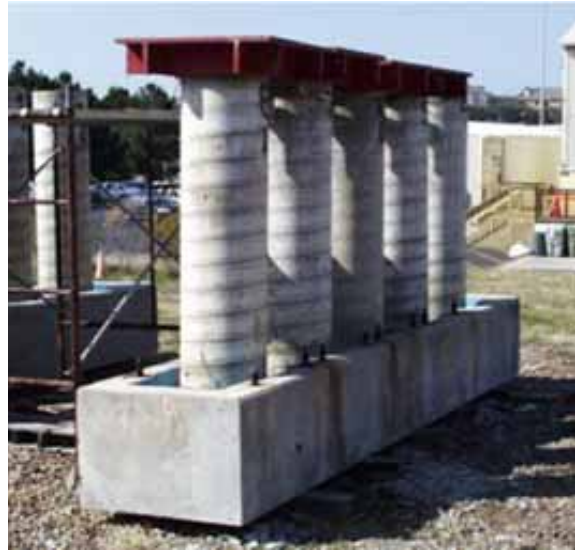
Tie down bars had uniform corrosion at the column base level, which stained the foundation, but no severe pitting was observed on these high-strength bars.

Figure 4.6 Specimen Condition at the End of Testing<sup>1</sup>

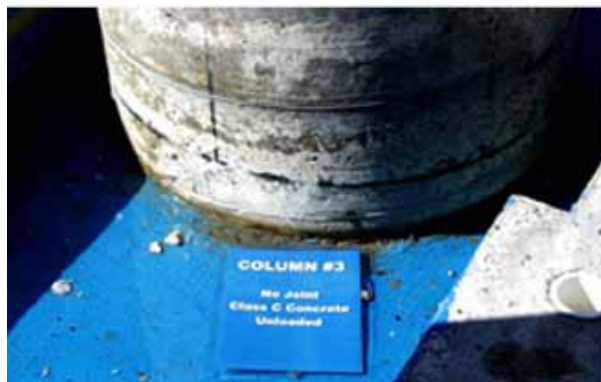
Figure 4.7 Condition of Specimen NJ-TC-N at the End of Testing<sup>1</sup>

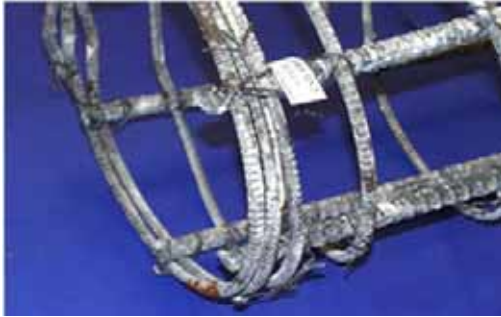
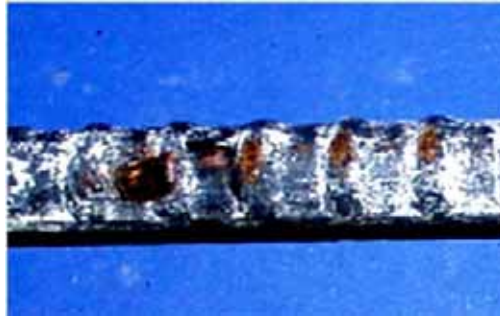
Reinforcing bars were in excellent condition. Only rebar #2 showed light corrosion in one of the two inch segments as shown in Figure 4.8.

Specimen	NJ-TC-N
Autopsy after 6.5 years	
Spiral	532
Rebar	2
Dowel	NA
Duct #1	NA
Duct #2	NA
Duct #3	NA
Duct #4	NA
PT-Bar	NA

*Complete Cage*

*Rebar #2*

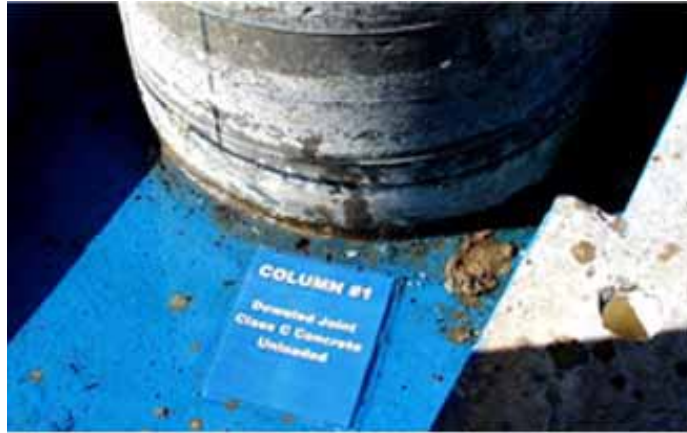
Specimen	DJ-TC-N
Autopsy after 6.5 years	
Spiral	595
Rebar	35
Dowel	2704
Duct #1	NA
Duct #2	NA
Duct #3	NA
Duct #4	NA
PT-Bar	NA

**Figure 4.9 Condition of Specimen DJ-TC-N at the End of Testing<sup>1</sup>**

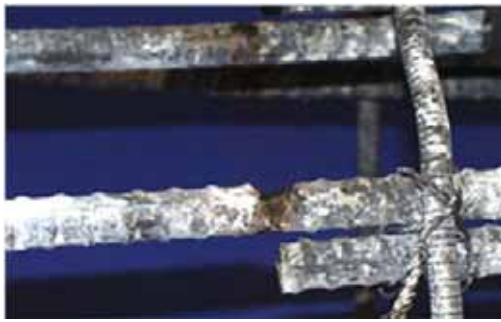
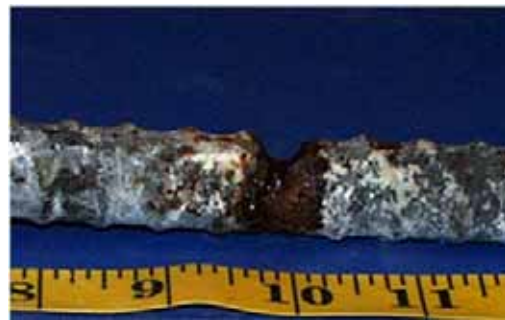
*Complete Cage*

*Rebar #3*

*Dowel #4*

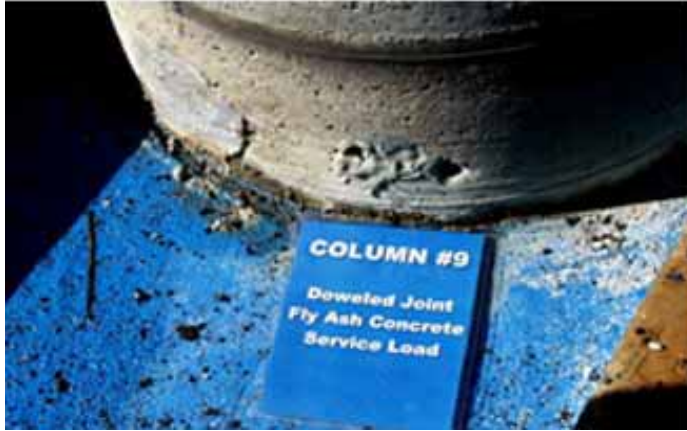
Spiral reinforcement had moderate corrosion in the North side (non-dripper side) at the four-inch level from the column base. Light corrosion was also concentrated in the spiral North side in the center four two-inch segments from the four-inch height up to a height of 30 inches.

**Figure 4.11 Condition of Specimen DJ-FA-S at the End of Testing<sup>1</sup>**

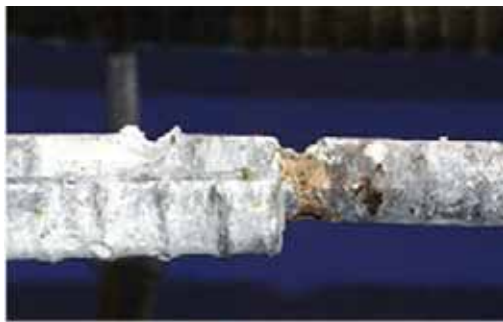
Dowels showed in general light to moderate corrosion in the two-inch segment at the column base (joint location). Dowel #1 showed the heaviest corrosion and area loss in this region, as shown in Figure 4.12.

*Complete Cage*

*Rebar #1*

*Dowel #1*

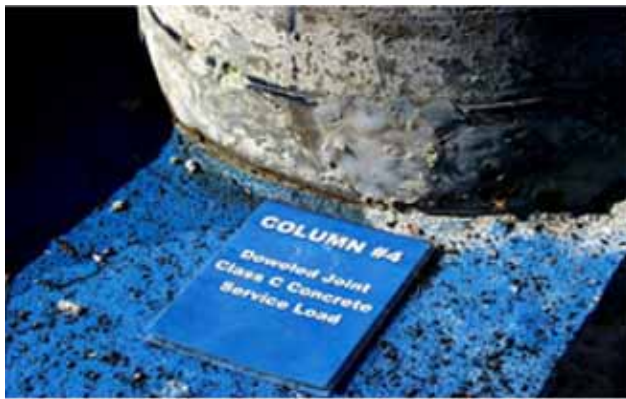
Specimen	DJ-TC-S
Autopsy after 6.5 years	
Spiral	458
Rebar	26
Dowel	86
Duct #1	NA
Duct #2	NA
Duct #3	NA
Duct #4	NA
PT-Bar	NA

**Figure 4.13 Condition of Specimen DJ-TC-S at the End of Testing<sup>1</sup>**

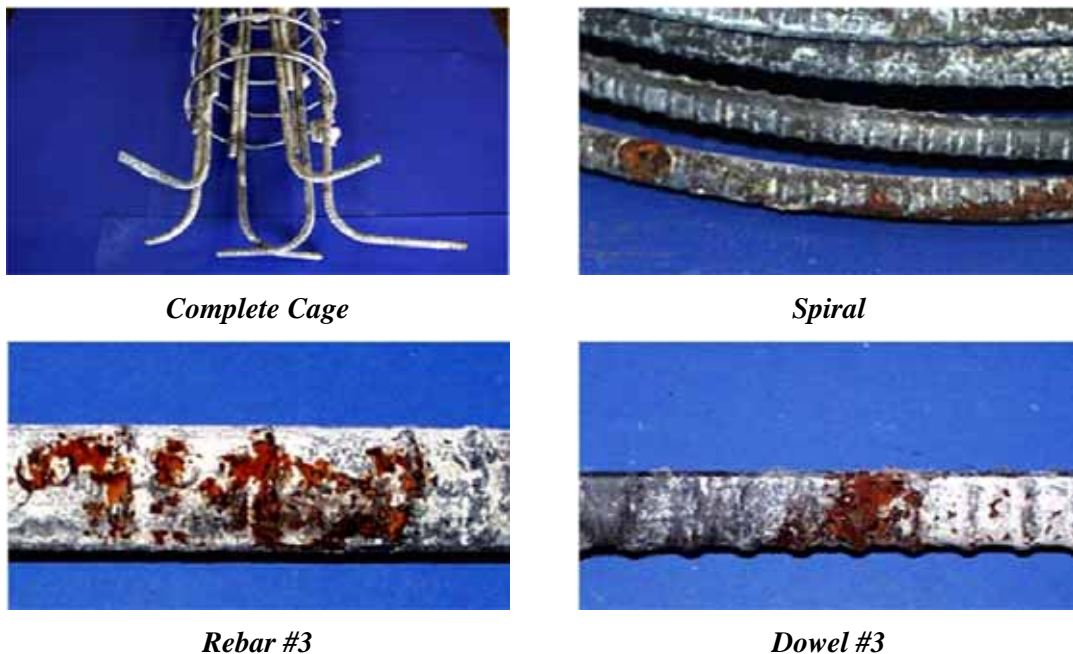
**Figure 4.14 Reinforcement Condition for Specimen DJ-TC-S<sup>1</sup>**

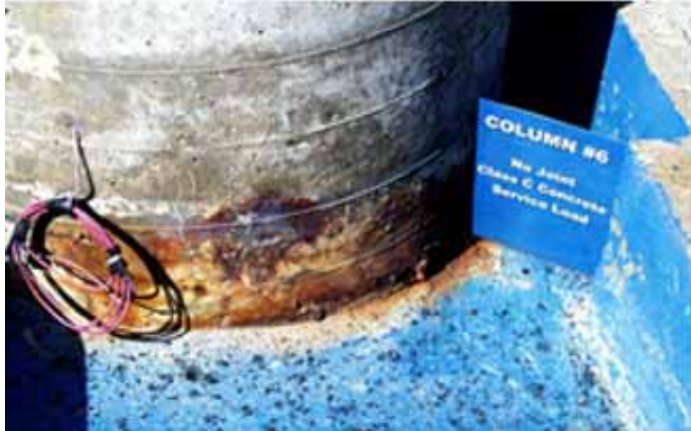
No signs of cracking or spalling were visible on the column surfaces. Rust stains extended the first 5 inches, from the column base, as shown in Figure 4.15. No other signs of corrosion were visible in the specimen.

Corrosion Rating:	
Specimen	NJ-TC-S
Autopsy after 6.5 years	
Spiral	10266
Rebar	32
Dowel	NA
Duct #1	NA
Duct #2	NA
Duct #3	NA
Duct #4	NA
PT-Bar	NA

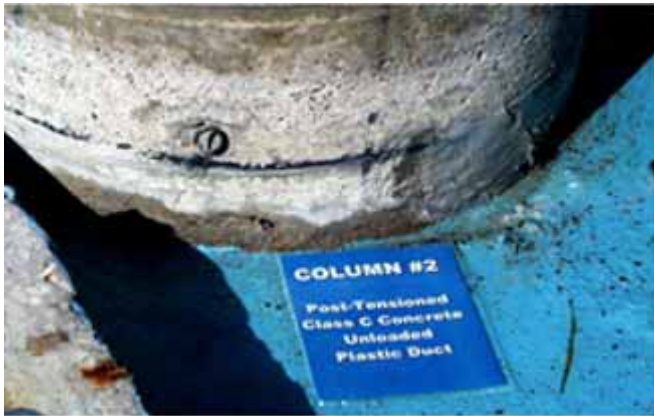
Figure 4.17 Condition of Specimen PT-TC-N-PD at the End of Testing<sup>1</sup>

Corrosion Rating:	
Specimen	PT-TC-N-PD
Autopsy after 6.5 years	
Spiral	351
Rebar	9
Dowel	NA
Duct #1	Plastic
Duct #2	Plastic
Duct #3	276
Duct #4	4
PT-Bar	673

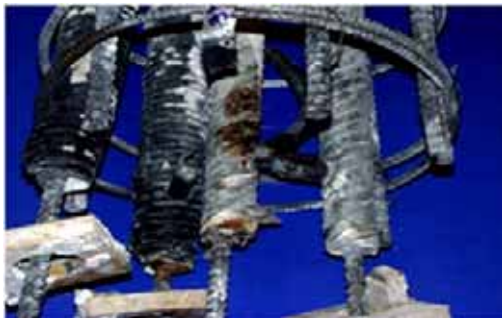
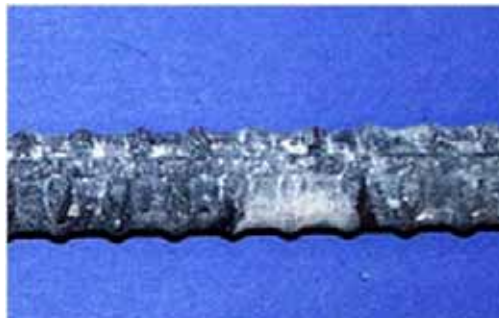
As shown in Figure 4.18, the spiral reinforcement showed light to moderate uniform corrosion in the first two steps (up to a height of nine inches). From this level to the top of the spiral (corresponding to the top of the column), the reinforcement only showed discoloration. Rebar corrosion was negligible.

*Complete Cage*

*Spiral*

*Rebar #1*

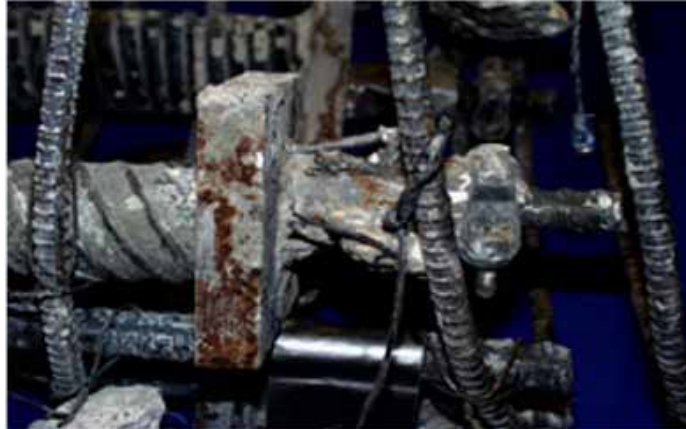
**Figure 4.19 PT Bar Top Anchorage Condition for Specimen PT-TC-N-PD<sup>1</sup>**

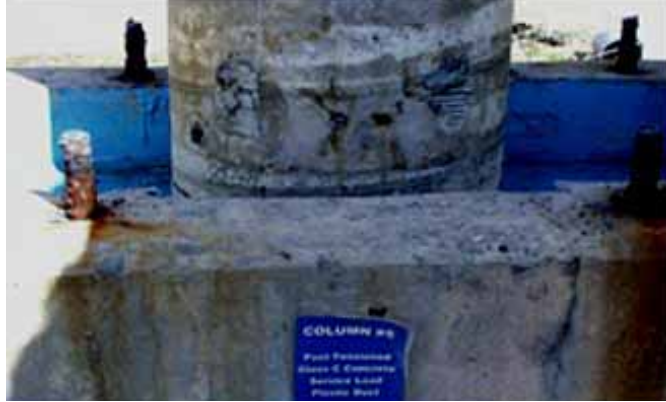
<b>Corrosion Rating:</b>	
Specimen	PT-TC-S-PD
Autopsy after 6.5 years	
Spiral	339
Rebar	3
Dowel	NA
Duct #1	Plastic
Duct #2	Plastic
Duct #3	312
Duct #4	1461
PT-Bar	146

Figure 4.21 Condition of Specimen PT-TC-S-PD at the End of Testing<sup>1</sup>

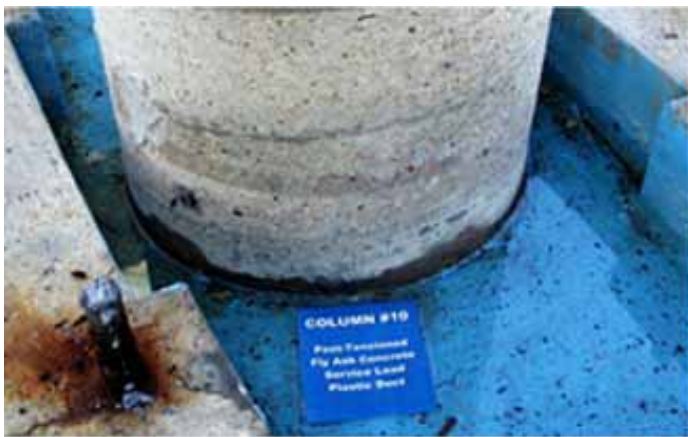
**Figure 4.24 Condition of Specimen PT-FA-S-PD at the End of Testing<sup>1</sup>**

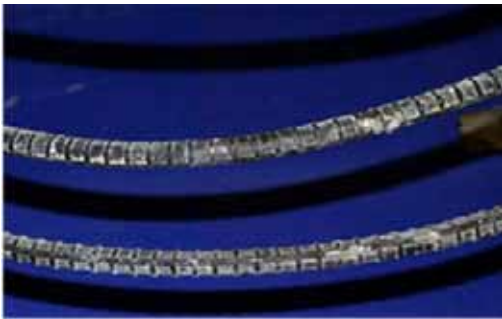
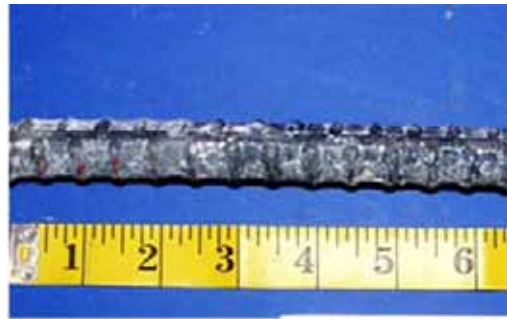
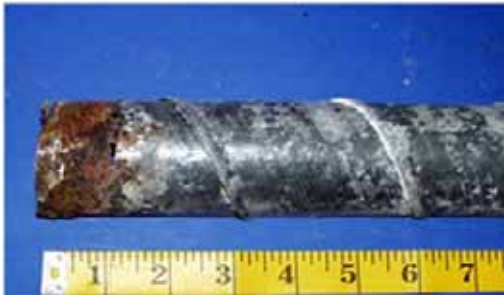
*Spiral*

*Rebar #3*

*Duct #4*

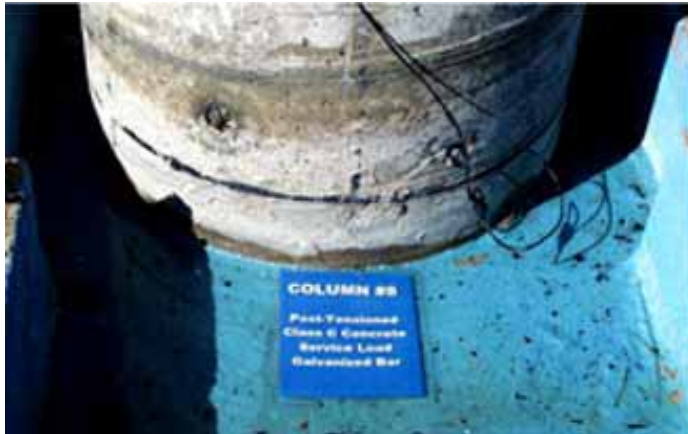
**Figure 4.30 Condition of Specimen PT-TC-S-GB at the End of Testing<sup>1</sup>**

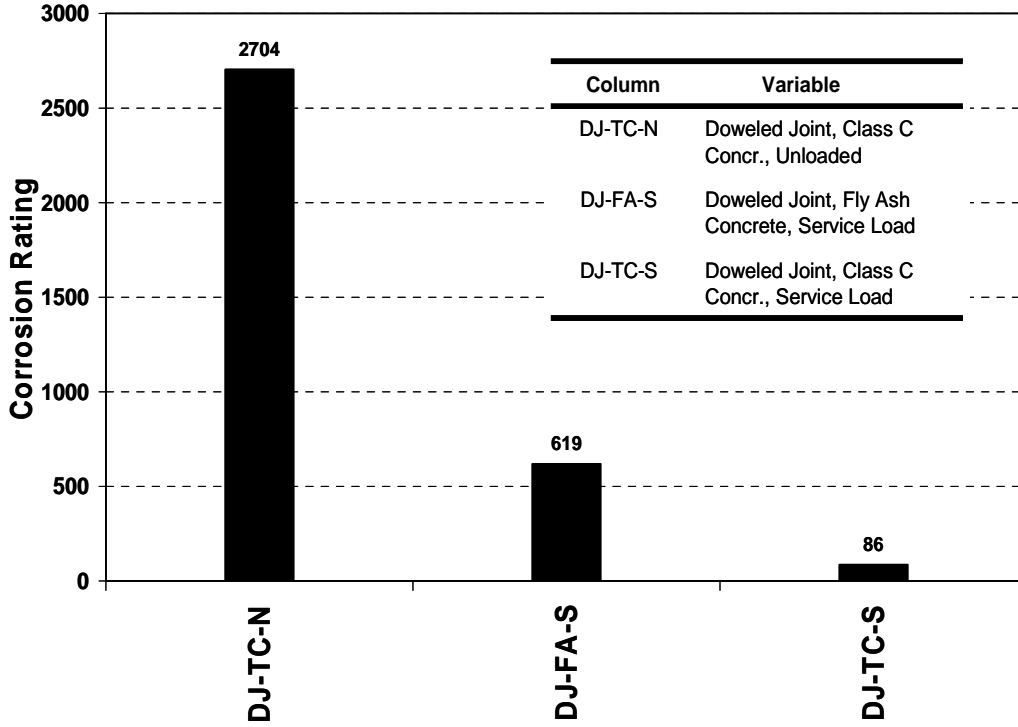
Figure 4.38 Total Dowel Corrosion Rating for All Specimens<sup>1</sup>

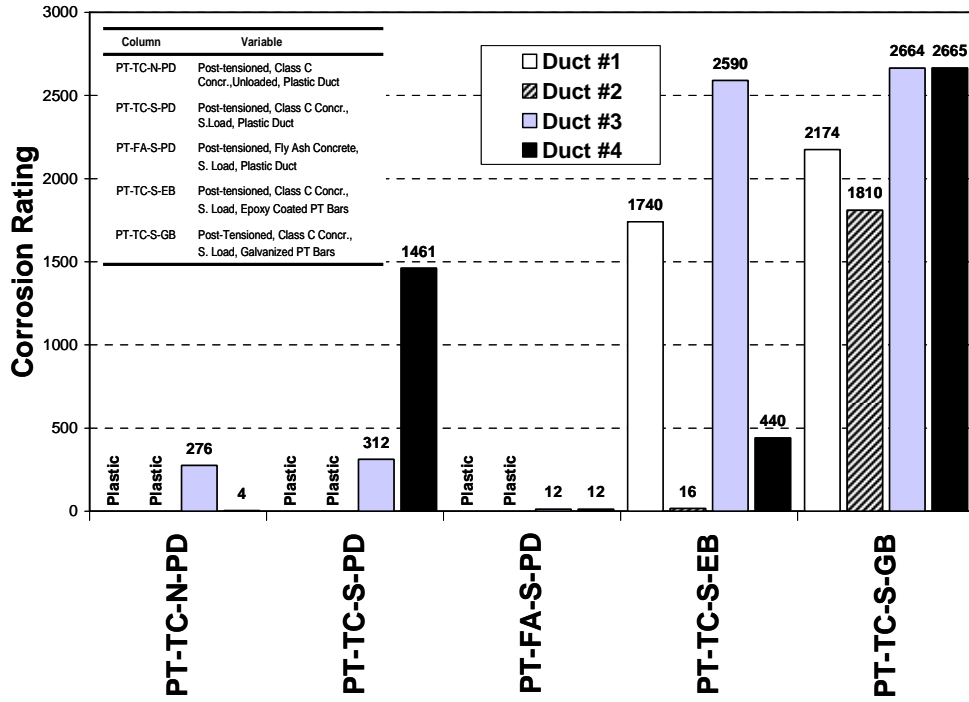
Figure 4.40 Total Duct Corrosion Rating for All Specimens<sup>1</sup>

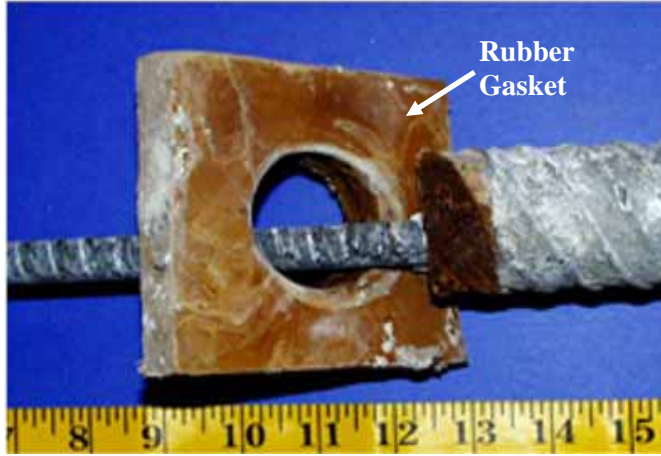
Figure 5.2 Duct Corrosion Found Inside Rubber Gaskets<sup>1</sup>
