**DETAILED EVALUATION OF PERFORMANCE FRP WRAPPED  
COLUMNS AND BEAMS  
IN A CORROSIVE ENVIRONMENT**

Research Report No. 0-1774-3

*“Effect of Wrapping Chloride Contaminated Structural Concrete  
with Multiple Layers of Glass Fiber/Composites and Resin”*

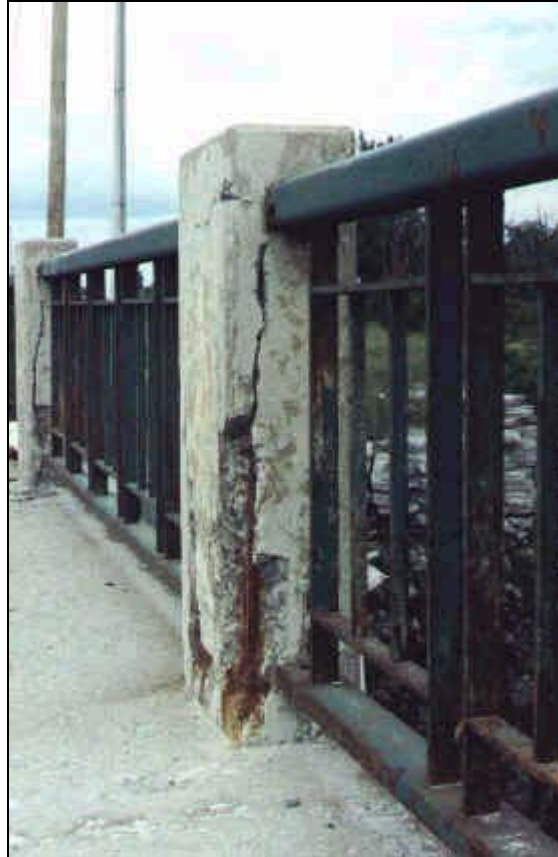
*Figure 1.1 Concrete degradation caused by rebar corrosion damage near Kingston, Ontario (Roberge 1999)*

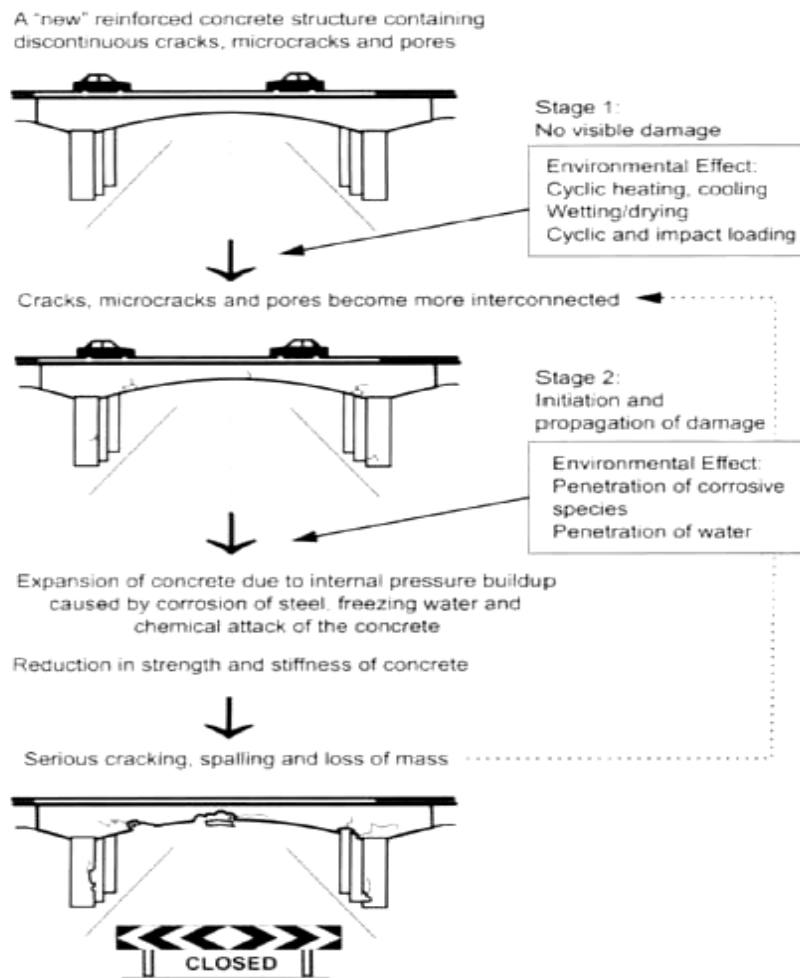
Figure 2.1 Concrete degradation processes resulting from environmental effects (from Roberge 1999)

Mehta argued that the development of a network of connected microcracks and other defects was a more serious factor in the development of corrosion. Concrete manufactured under high quality standards was initially considered to be impermeable, and interior pores and microcracks did not form interconnected paths extending to the exterior surface. However, the effects of continuous cyclic loading and environmental weathering result in the development and propagation of interconnected cracks. This network of defects, compounded by the inherent porosity, provides a route for transporting corrosive agents to the surface of the reinforcing steel beneath the layer of protective cover. A schematic of Mehta's model of environmental degradation is presented in Figure 2.1.

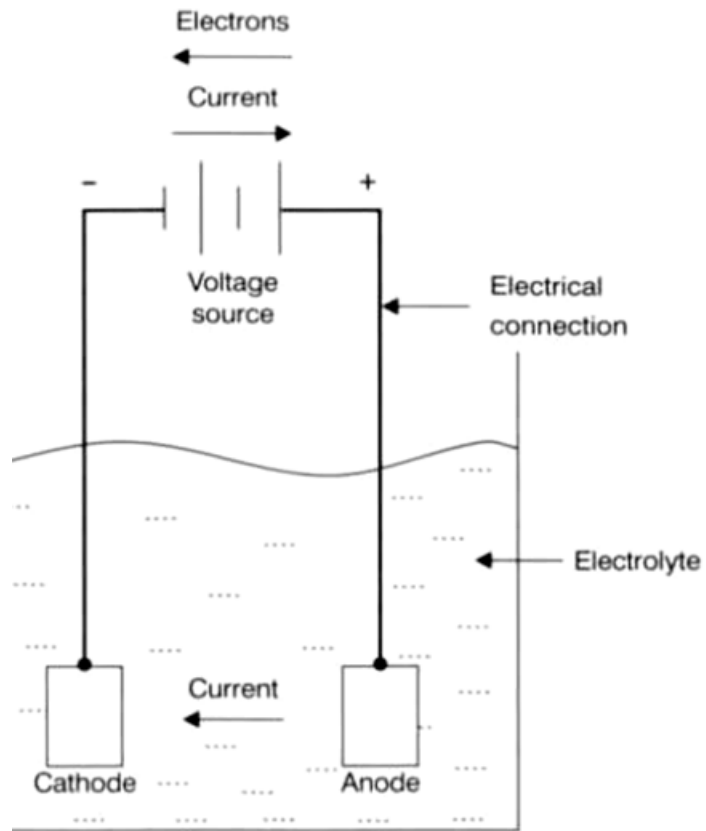
Figure 2.2 Schematic of an electrochemical corrosion cell with separate anode and cathode regions (Chess 1998)

An example of a common electrochemical reaction is presented in Figure 2.2. This corrosion system, also known as an electrochemical cell, is made up of separate and distinguishable anode and cathode regions. An example of such a system is an aluminum sheet with brass screws, where the aluminum constitutes the anode and the brass the cathode (Mattsson 1989).

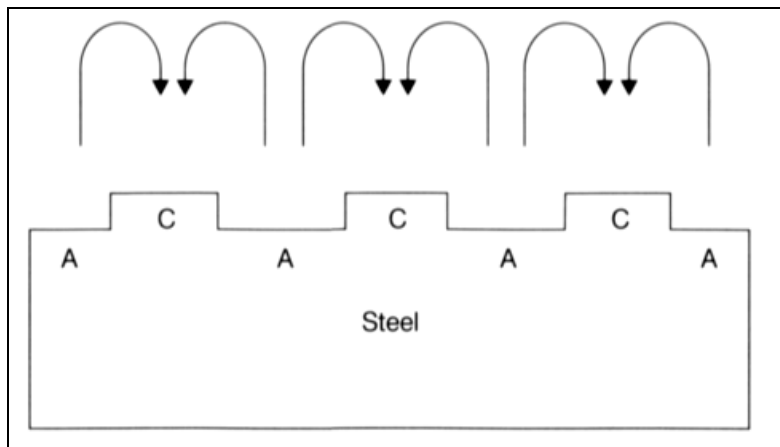
Figure 2.3 Schematic of electrochemical corrosion with continuous anode (A)/cathode (C) regions (Chess 1998)

Another example of an electrochemical reaction is presented in Figure 2.3. Here, the difference from the preceding example is that the corrosion cell would exist without distinguishable anode and cathode surfaces. Part of the metal surface forms the anode and part forms the cathode. In this case, the corrosion occurs at all the anode points giving the appearance of general or uniform corrosion.

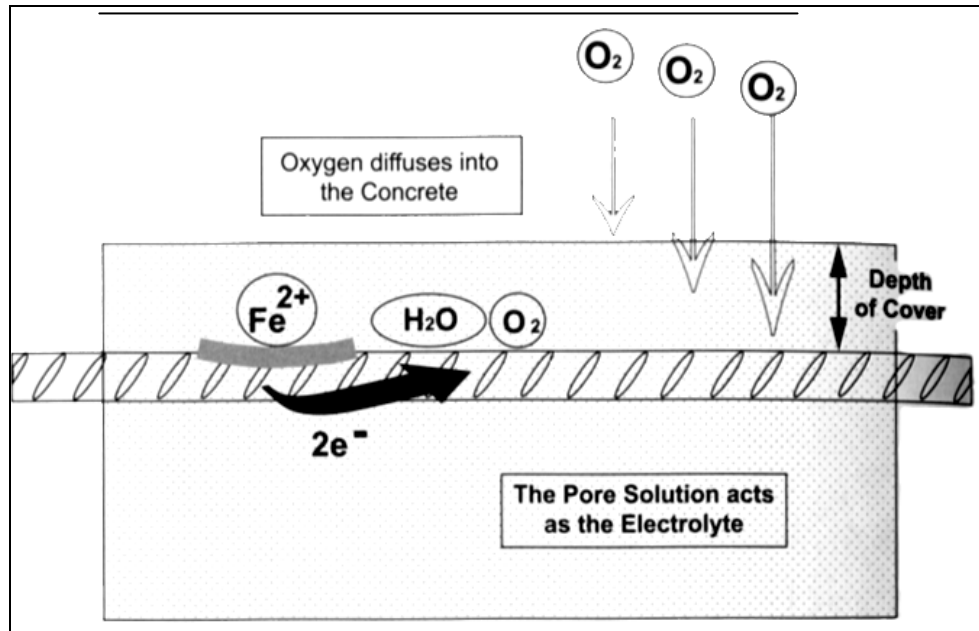
Figure 2.4 Illustration of electrochemical corrosion reactions in concrete (Roberge 1999)

Oxygen molecules are transported to the steel surface via porosity within the concrete microstructure and networked cracks within the cover material. The  $\text{Fe}^{2+}$  ions produced at the anodes combine with the  $\text{OH}^-$  ions from the cathodic reaction, producing a stable passive film. This procedure is outlined in Figure 2.4.

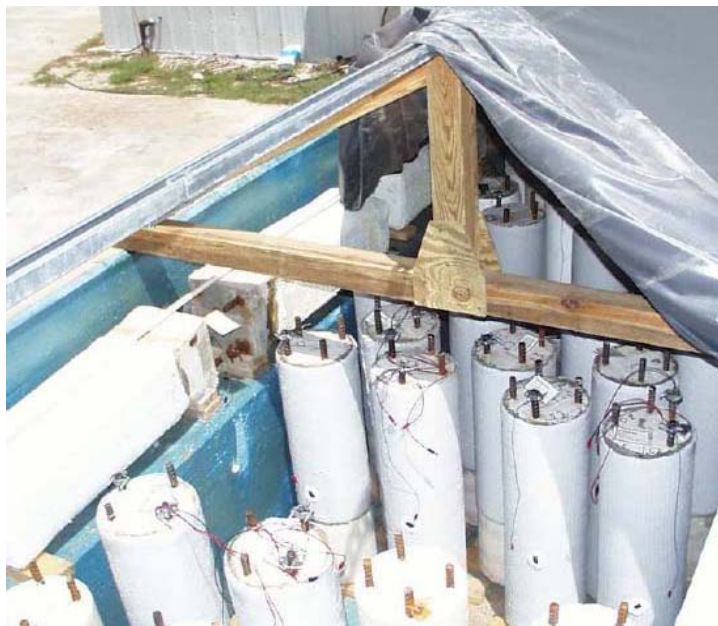
*Figure 3.1 The corrosion monitoring tank and several specimens under observation for TxDOT Project 0-1774*

The columns were arranged in a series of rows in the base of the tank, as shown in Figure 3.1. A 3.5% saline solution was introduced to the tank on a one-week cycle. During the wet period, the water level reached the lower one-foot of the columns. Following the one-week wet cycle, the tank was drained and remained dry for another two-week period.

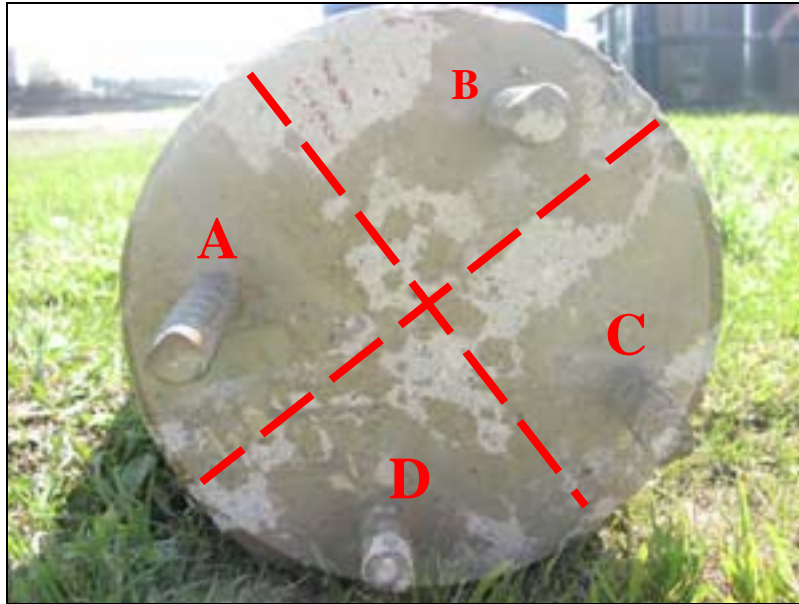
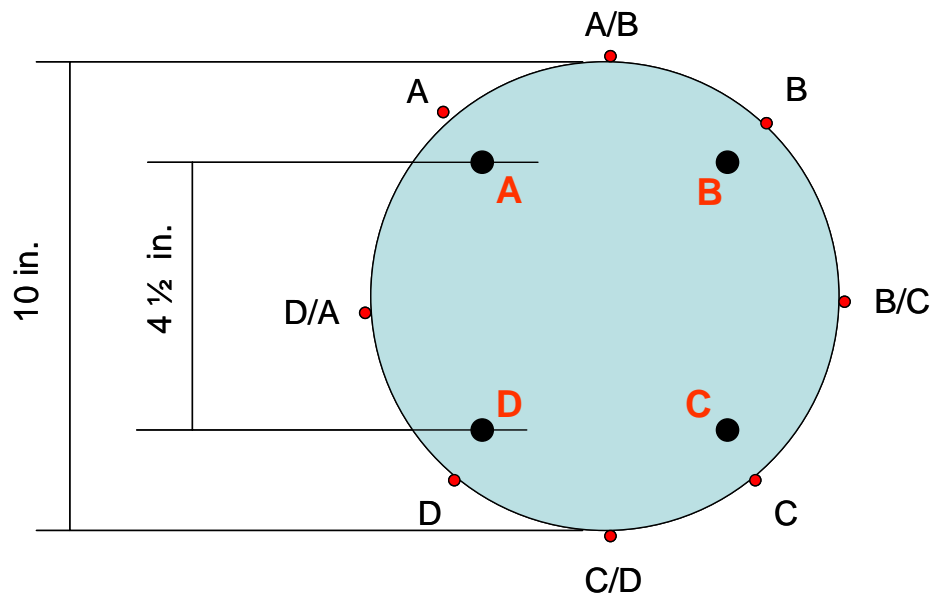
Figure 3.2 (A) Diagram of vertical labeling scheme for cylindrical specimens. (B) Lines along half-cell readings were taken for columns (36 readings @ 1 in. per line)

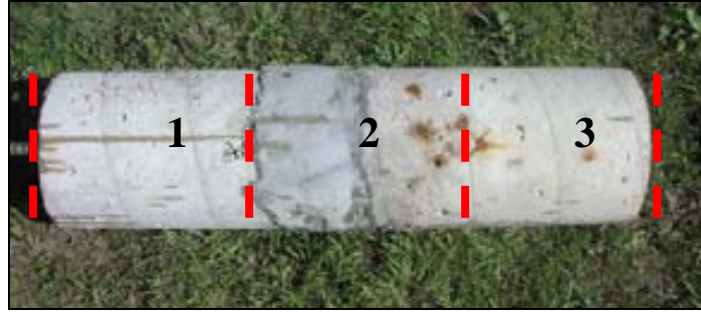
Figure 3.3 Diagram of horizontal labeling scheme  
Section 1 corresponds with the area nearest the exposed rebar

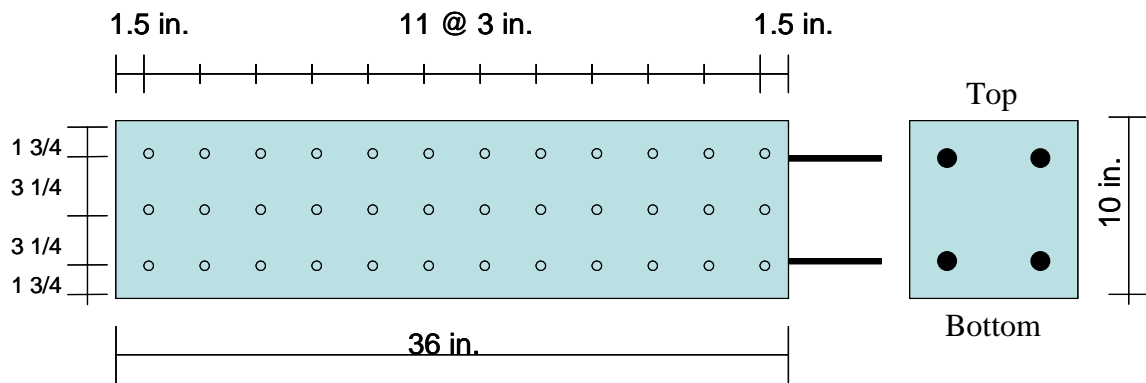
Figure 3.4 Lines along half-cell readings were taken for beams

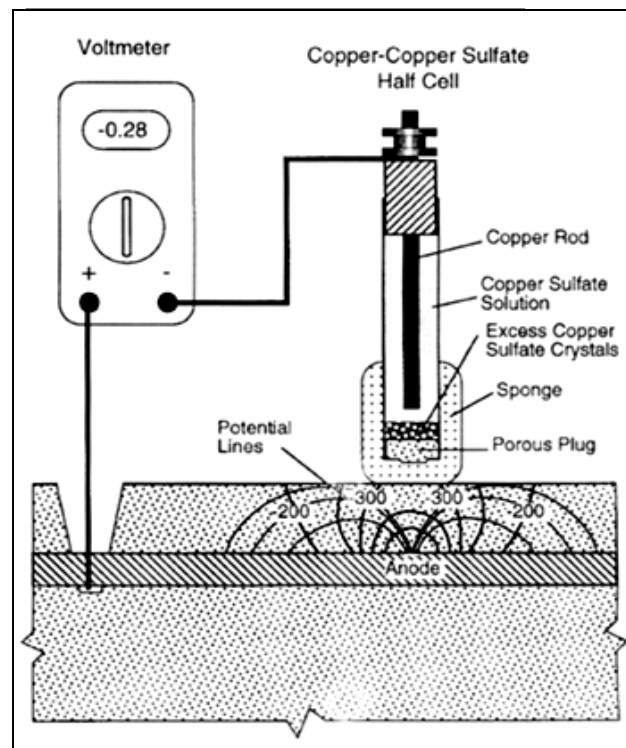
Figure 3.6 Half-Cell potential schematic as described in ASTM C 876

The standard test method for measuring this potential is given in ASTM C 876 and is presented in Figure 3.6. This setup includes a copper-copper sulfate half-cell, connecting wires, and a high-impedance voltmeter. The positive terminal is attached to the reinforcement and the negative terminal is attached to the half-cell.

When corrosion is occurring, free electrons in the bar would flow from the bar to the half-cell. This layout of this circuit is such that the voltmeter indicates negative voltage. The more negative the voltage, the higher the probability corrosion is taking place below the half-cell probe.

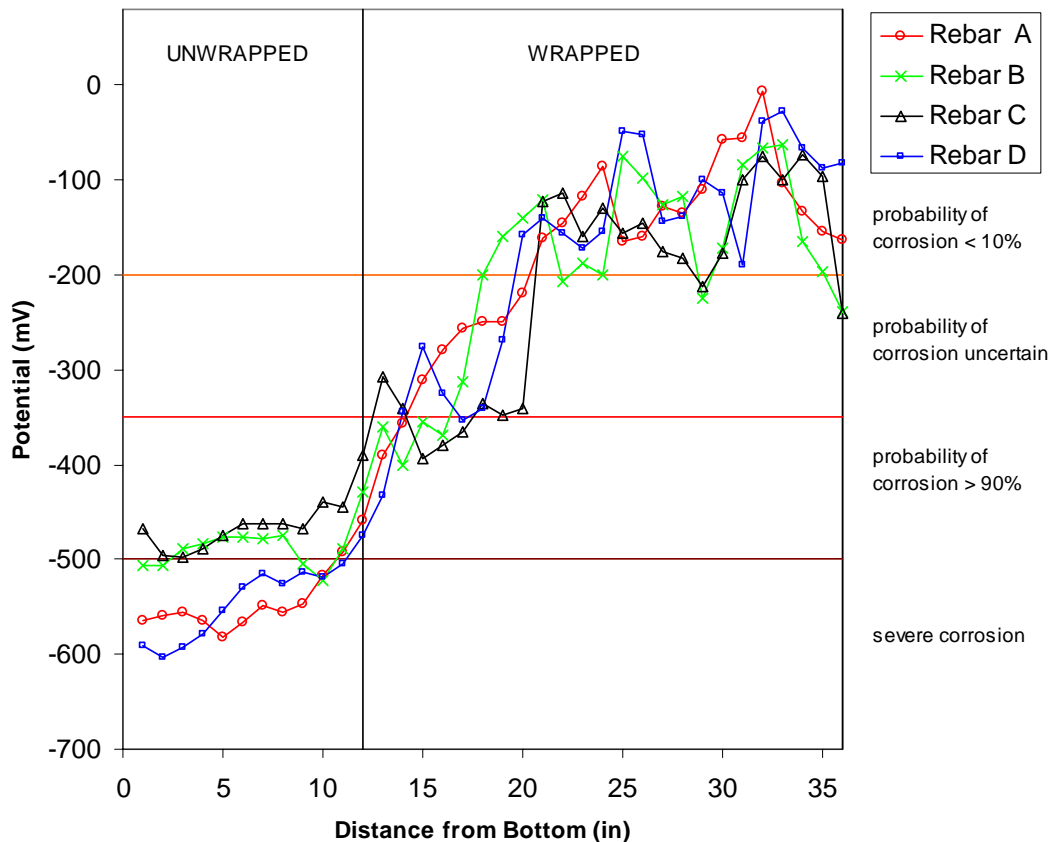
Figure 3.7 Example of half-cell profile analysis along length of cylinder

The reference probe was placed at one-inch intervals and the resulting potentials were plotted to generate a profile of potential readings along the entire length of reinforcing steel, such as that presented in Figure 3.7.

The profile created a visual representation of the location of probable corrosive activity and proved to be a useful tool in gauging the performance of each specimen.

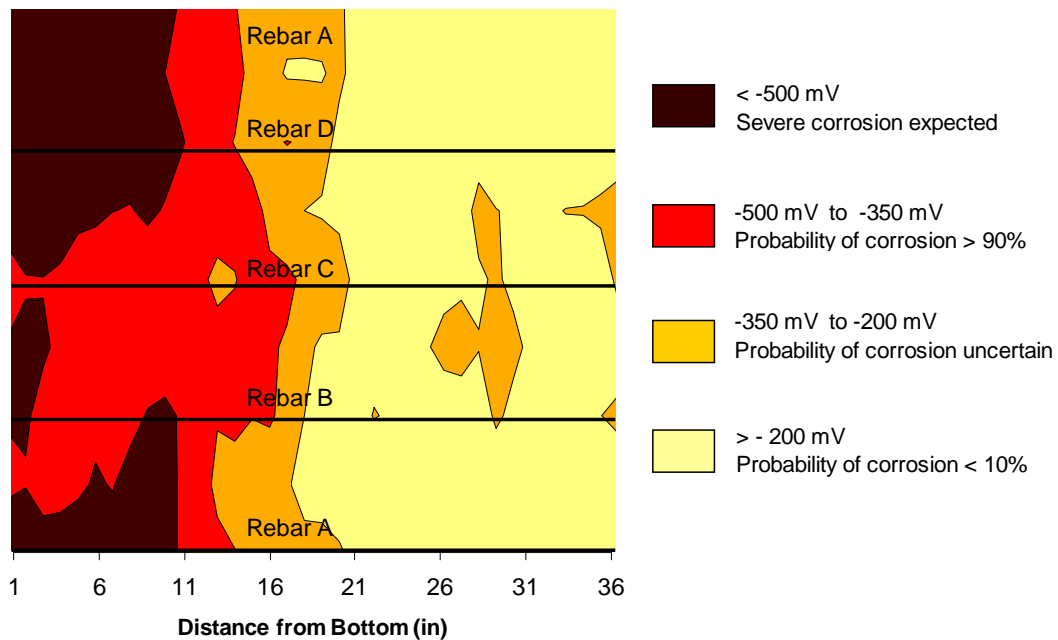
Figure 3.8 Example of half-cell potential contours over the specimen surface

To provide data for plotting contours of half-cell readings over the surface of the specimens, another series of readings were taken as a line midway between the longitudinal bars. All the half-cell potential readings were combined (readings at 8 points around the circumference of the specimen at 1-inch intervals over the 36-inch height or length of the specimen for a total of 288 readings) and used in a statistical analysis program MATLAB to generate equipotential contour maps for the surface of each specimen. By connecting points where the potential is equal, the graph indicated where corrosion was most likely taking place (Fig. 3.8).

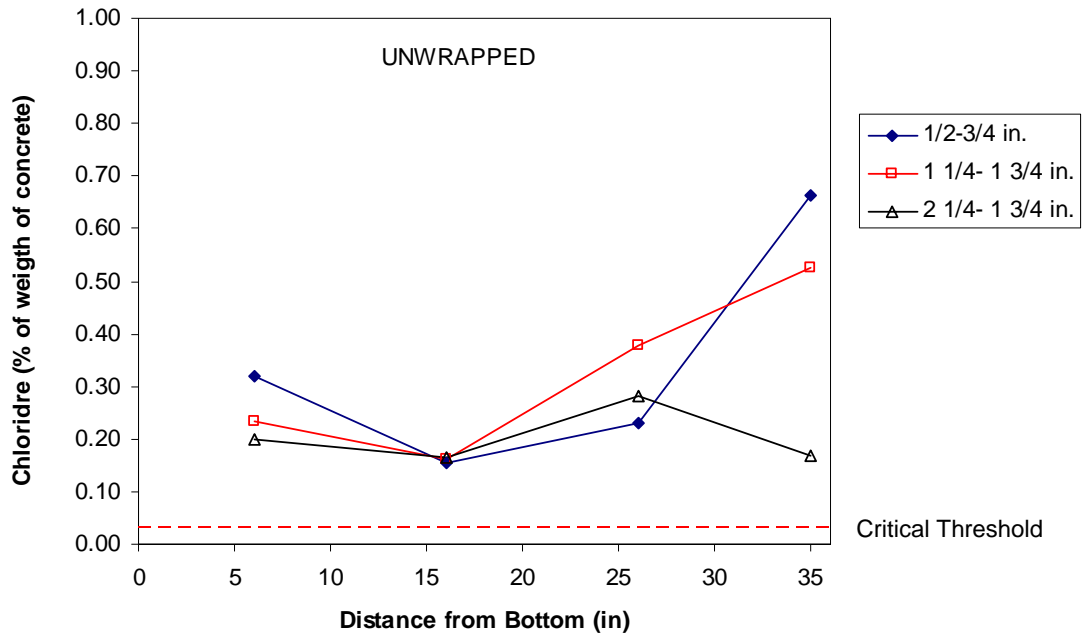
Figure 3.9 Example of chloride content profile

- (1) providing a graphical representation of the likelihood of chloride induced corrosion; and
- (2) serving as a comparison with the other profiles generated by half-cell potential mapping.

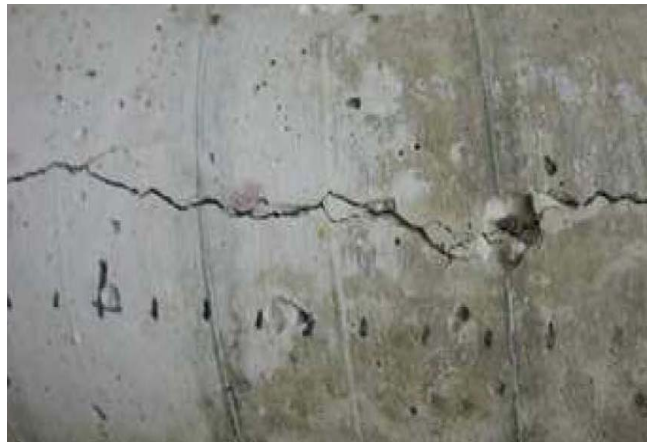
*Figure 4.1 One of two large cracks located at upper-portion of CC10.*

This specimen was characterized by two large cracks (Figure 4.1), both of which extended from the top of the cylinder downwards. One crack was located between rebars A and B (See Figure 3.2) and extended two inches from the top to eleven inches from the bottom. The second large crack was located between rebars C and D and extended three inches from the top down to the bottom.

With these extensive and wide cracks, it was not surprising that corrosion was visible across the entire length of the extracted rebar. The visual evidence of corrosion activity along the entire bar length (Figure 4.2a) was corroborated by both the half-cell and the chloride content data.

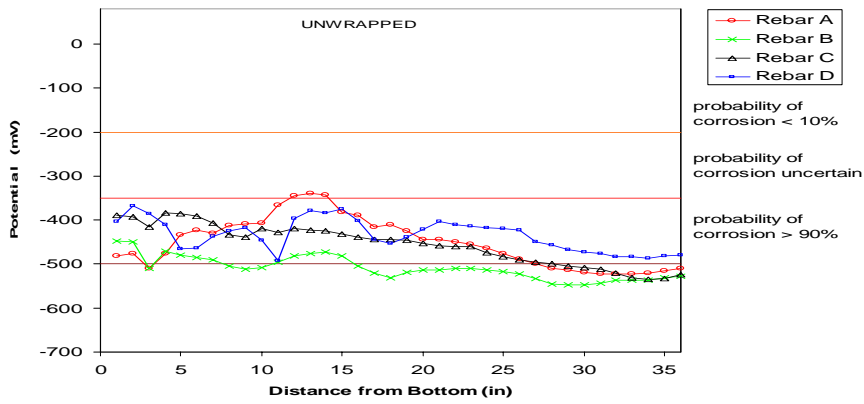
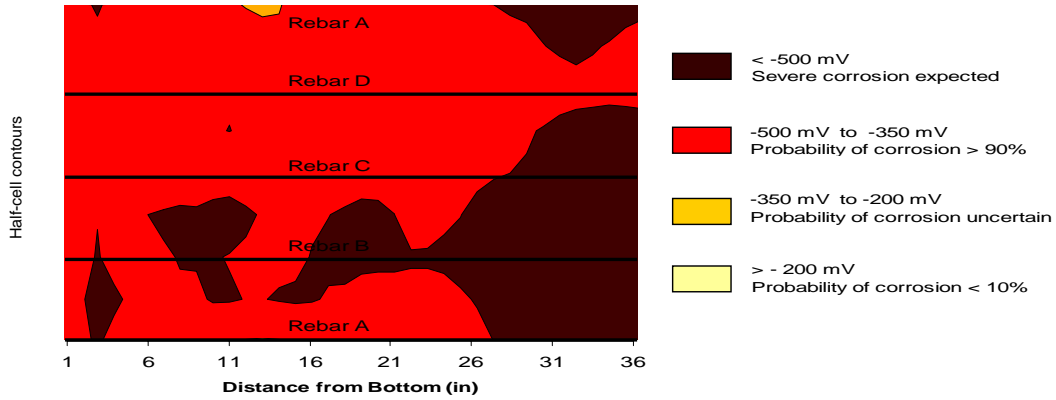
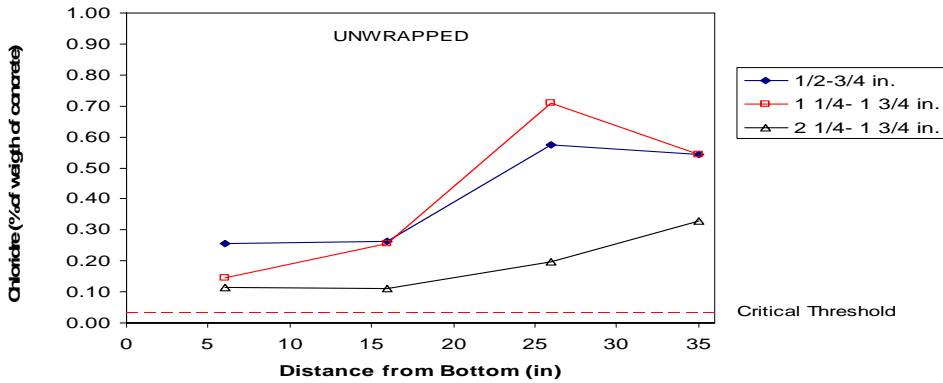
Figure 4.2 Data for Specimen CC10

b) Half-cell potential profiles

c) Half-cell potential contours

d) Chloride content profiles

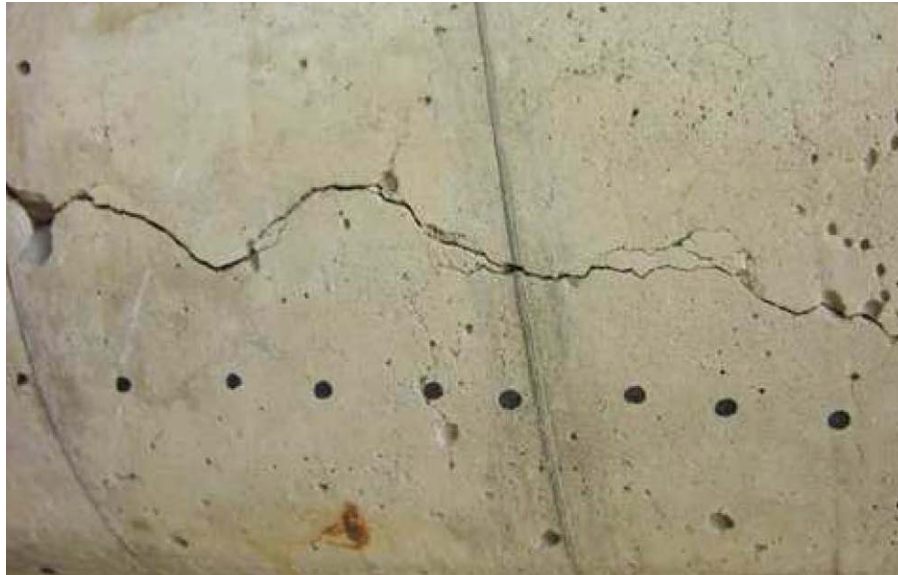
*Figure 4.3 Large crack on lower surface of CC11 (Typical)*

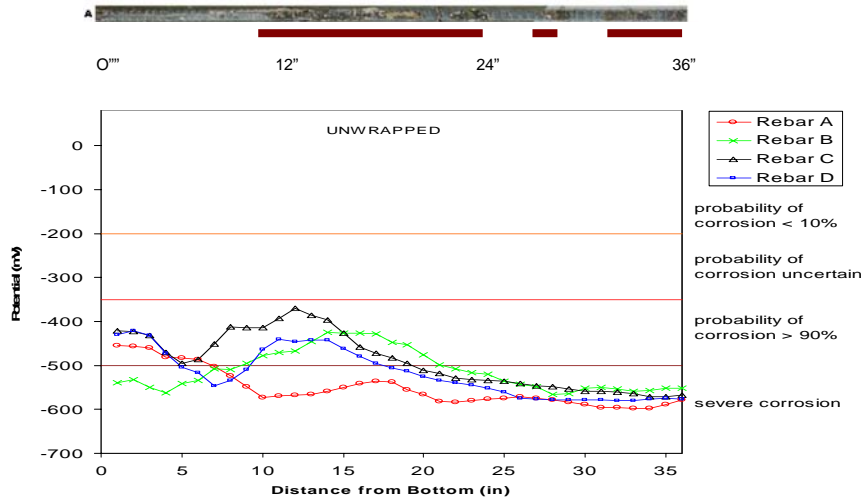
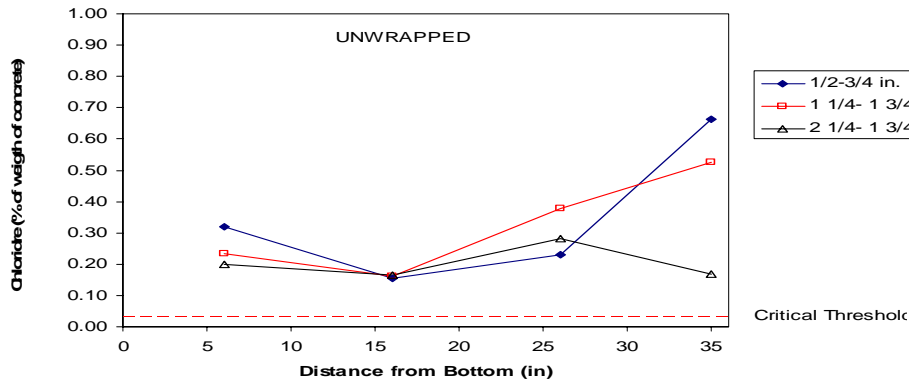
Figure 4.4 Data for Specimen CC11

a) Corrosion activity

b) Half-cell potential profiles

c) Half-cell potential contours

d) Chloride content profiles

The regions of corrosion activity in the lower two-thirds of the element, as shown in Figure 4.4a. The highest activity appeared to be in the bottom five inches and from 15 inches to 24 inches from the bottom.

The half-cell profile and contour plots indicate that corrosion was likely over the entire length of the specimen (Figs. 4.4b and c). Potential readings were beyond the 90% probability threshold. Interestingly, the region with the highest values is located in the upper-portion of this specimen, although visual evidence of corrosion on the exposed rebar does not indicate significant corrosion in this area. Further study of the remaining reinforcing elements will be necessary in order to confirm whether or not corrosion is taking place in the region near the top of the cylinder.

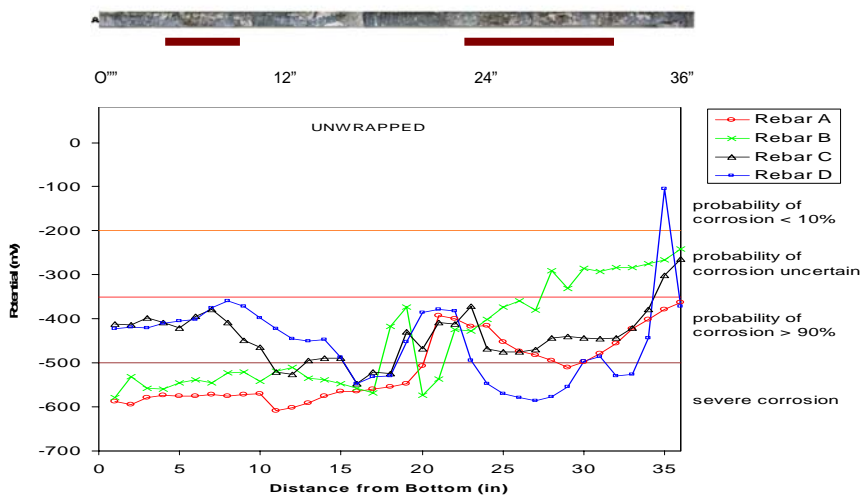
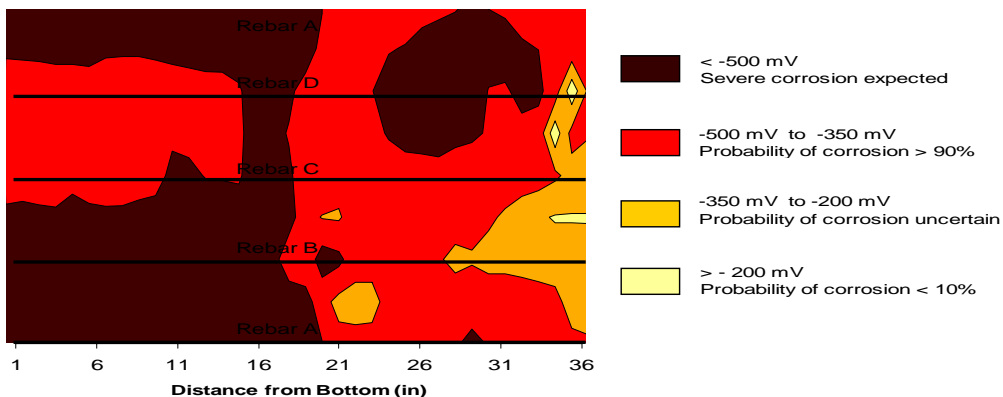
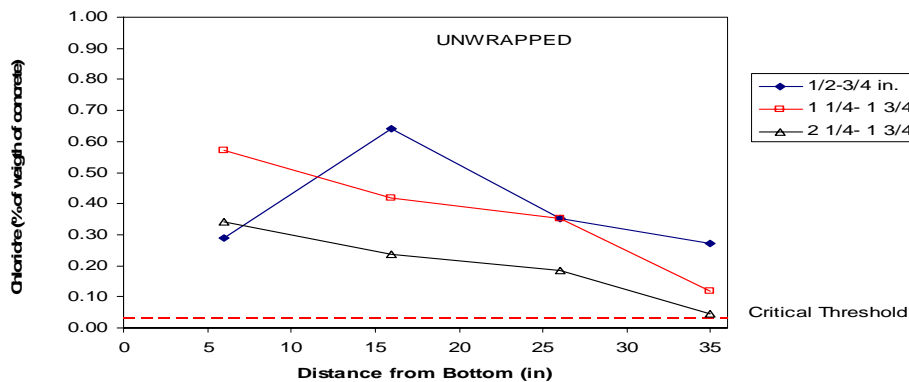
Figure 4.6 Data for Specimen CNC11

a) Corrosion activity

b) Half-cell potential profiles

c) Half-cell potential contours

d) Chloride content profiles

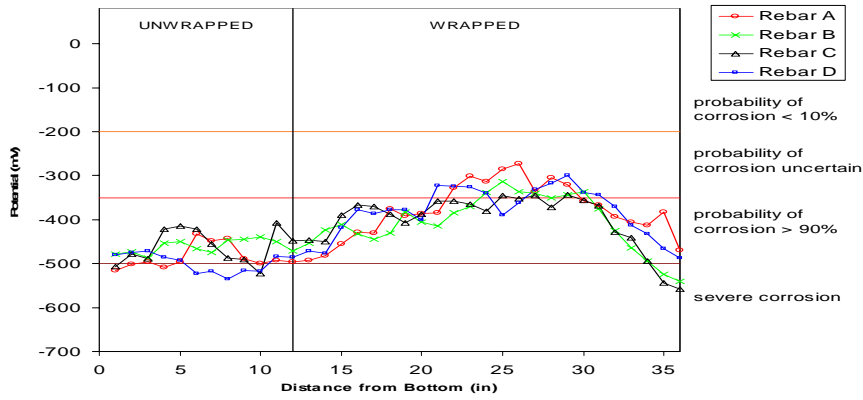
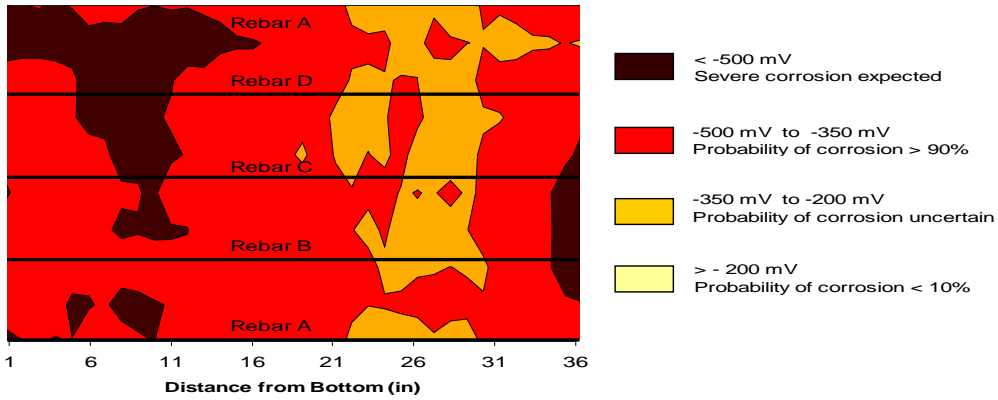
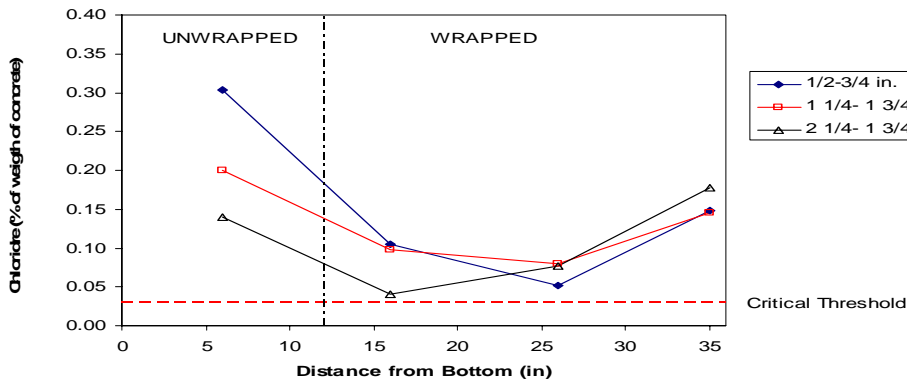
Figure 4.8 Data for Specimen CC15

b) Half-cell potential profiles

c) Half-cell potential contours

d) Chloride content profiles

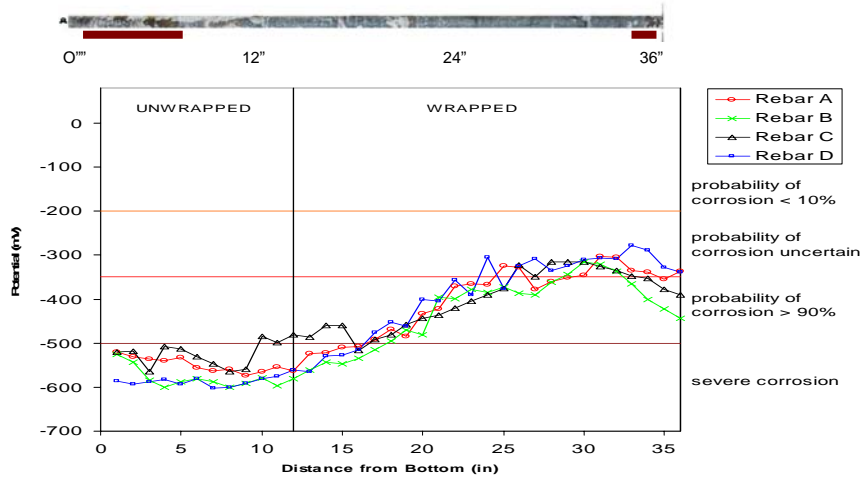
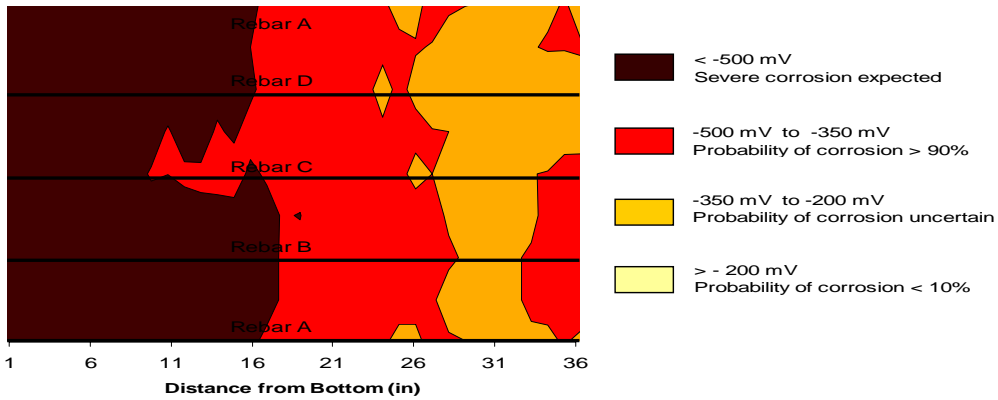
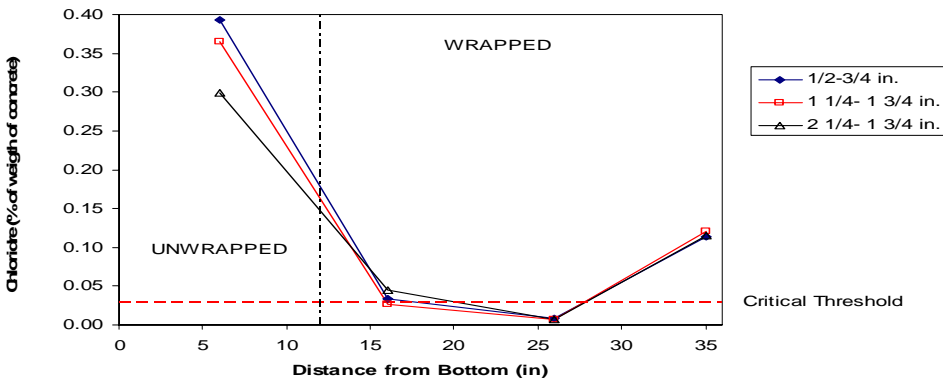
Figure 4.9 Data for Specimen CNC6

a) Corrosion activity

b) Half-cell potential profiles

c) Half-cell potential contours

d) Chloride content profiles

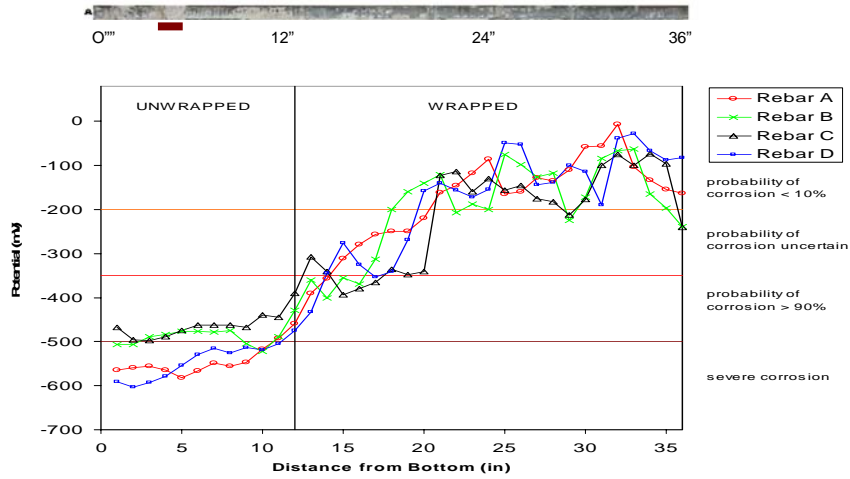
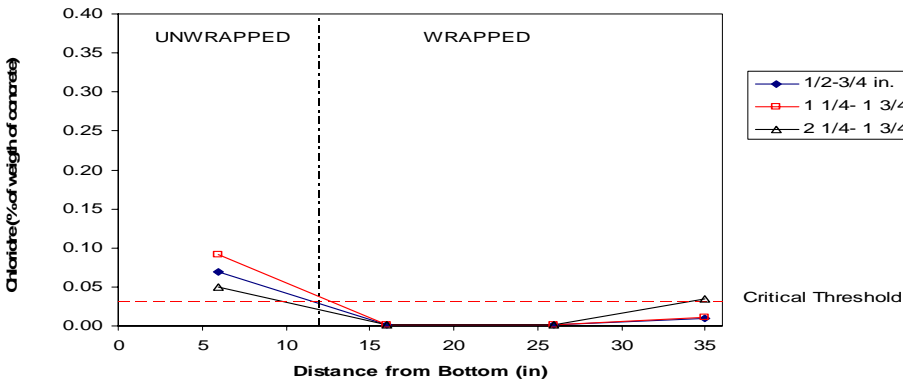
Figure 4.10 Data for Specimen CNC16

a) Corrosion activity

b) Half-cell potential profiles

c) Half-cell potential contours

d) Chloride content profiles

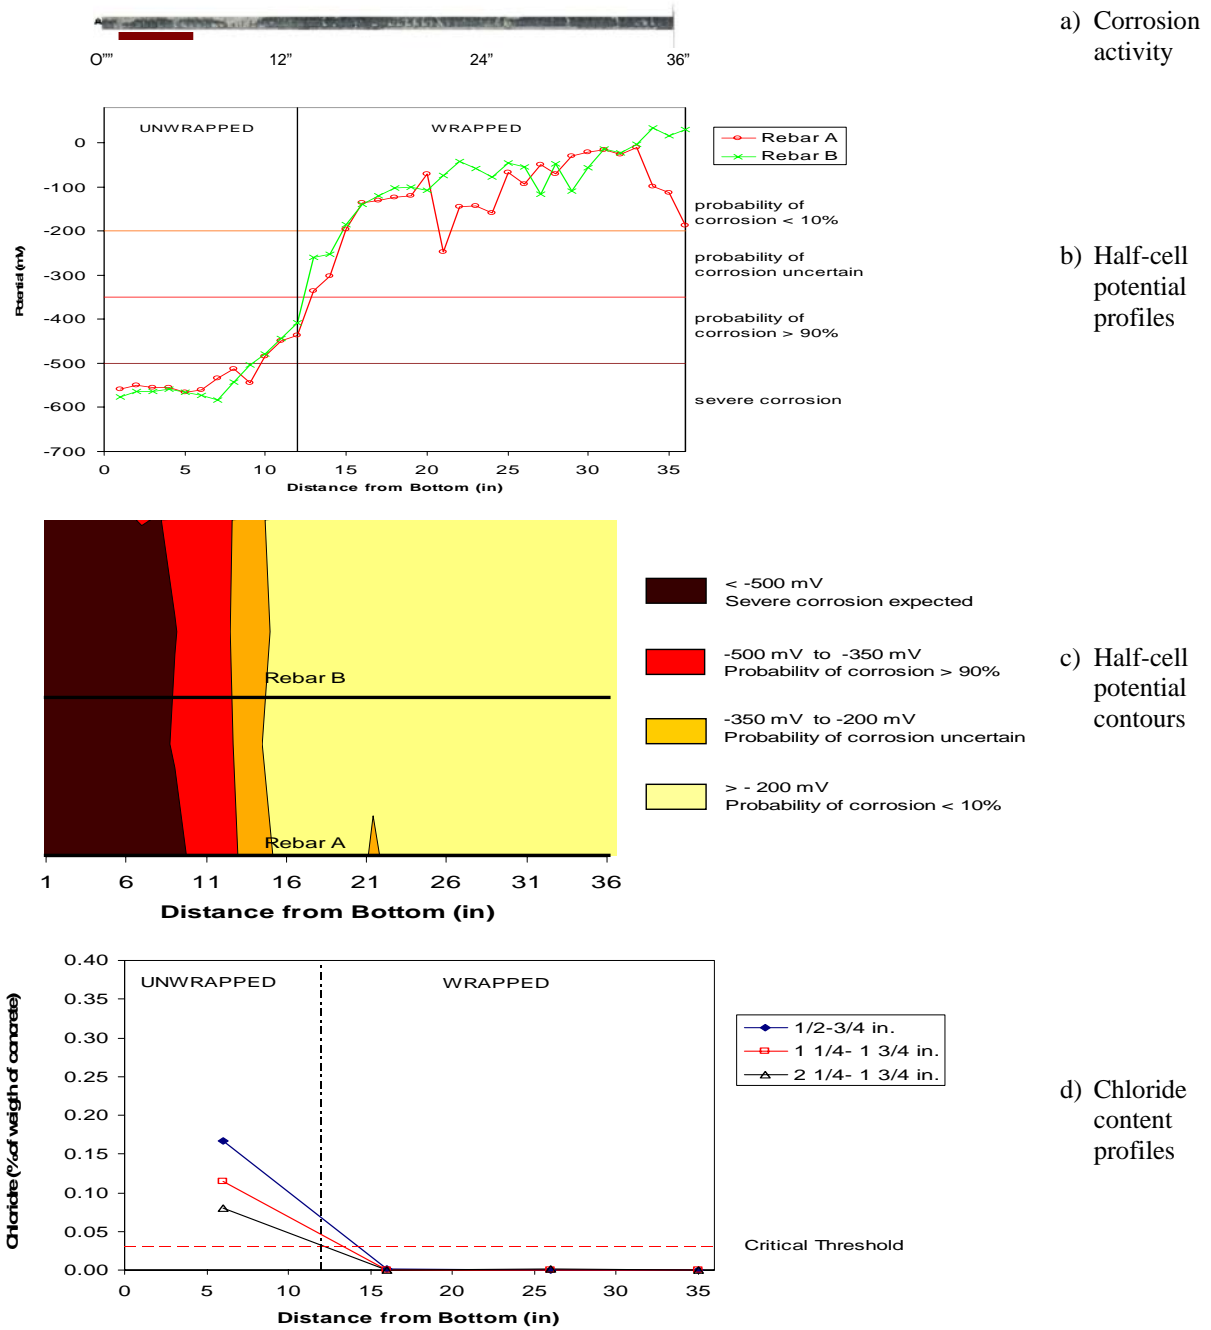
Figure 4.11 Data for Specimen CNC17

Wrap	Delta 24-in.
Resin	Delta System
Curing Agent	Delta System
Surface	Dry
Crack Condition	Uncracked
Repair Material	EG
Corrosion Inhibitor	None

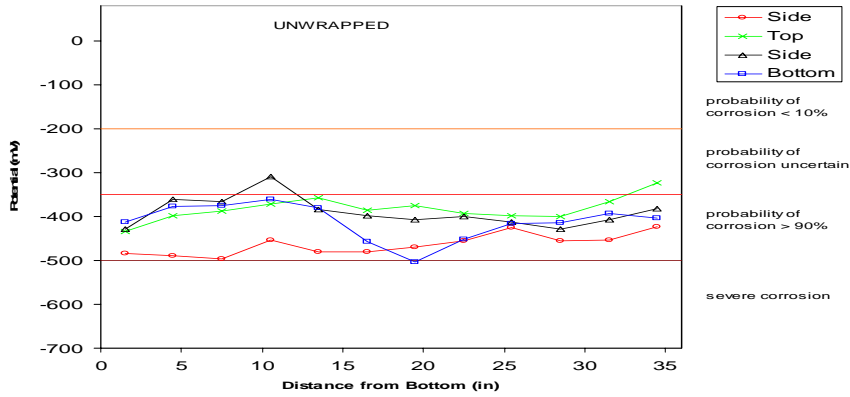
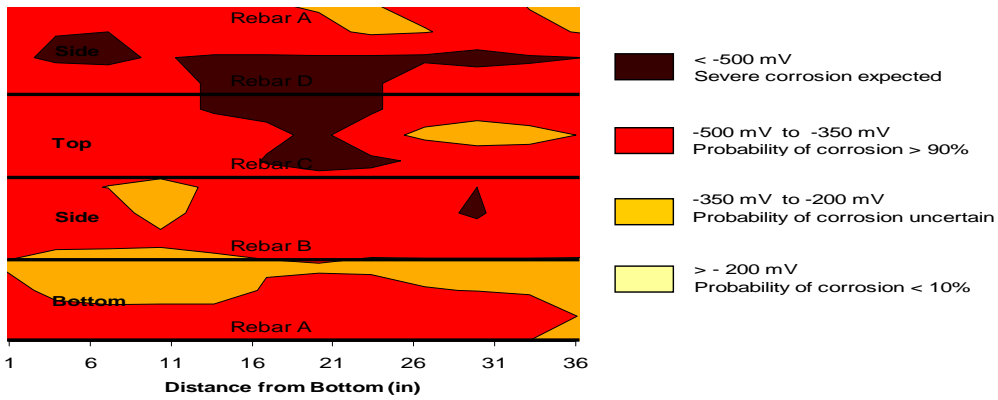
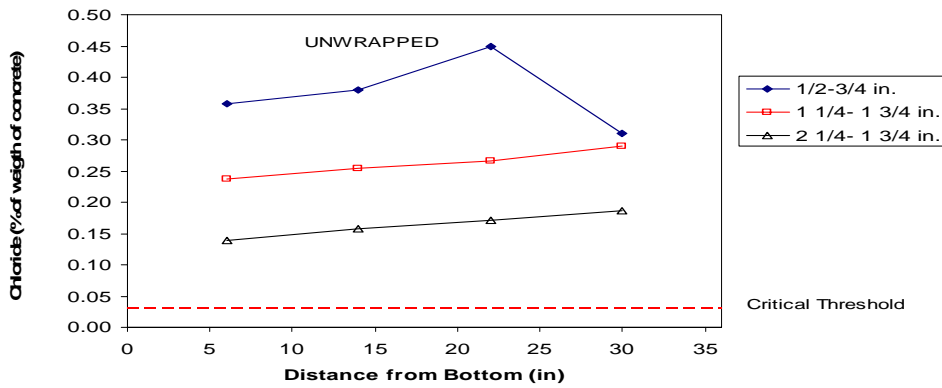
Figure 4.12 Data for Specimen RNC2

a) Half-cell potential profiles

b) Half-cell potential contours

c) Average chloride content profiles

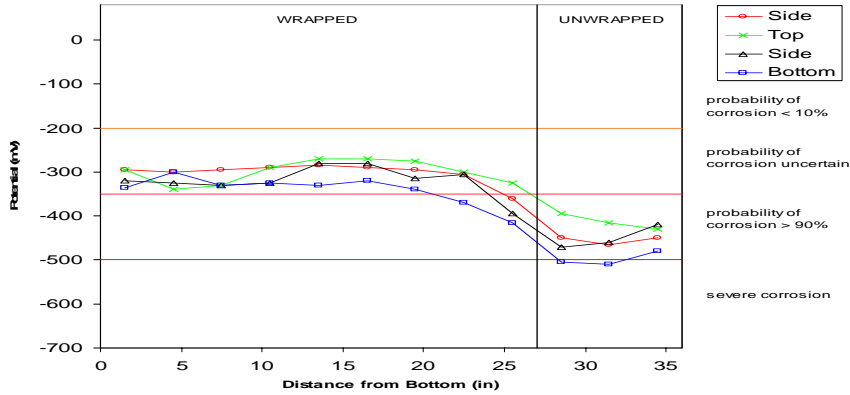
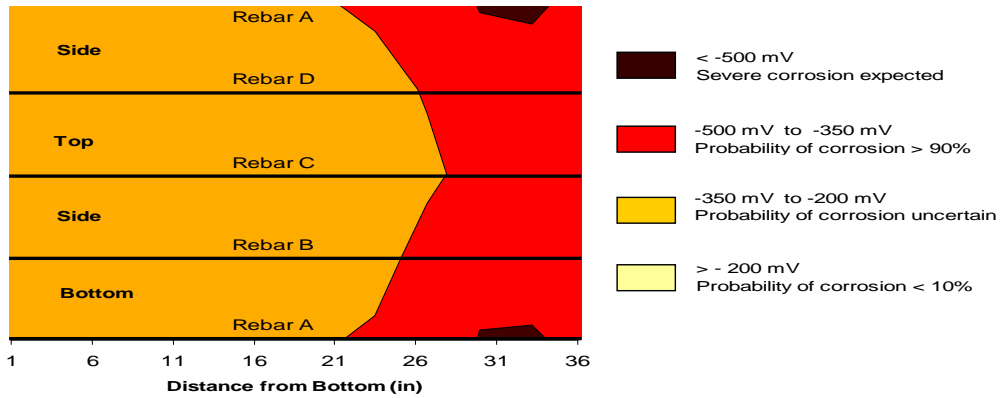
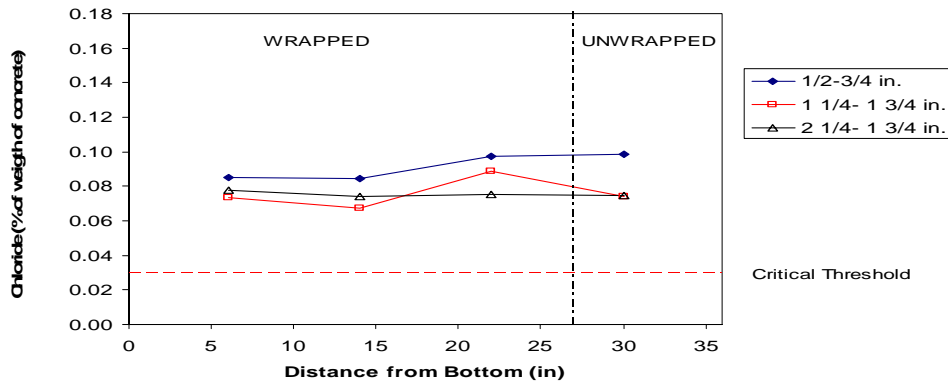
Figure 4.13 Data for Specimen RC3

a) Half-cell potential profiles

b) Half-cell potential contours

c) Average chloride content profiles

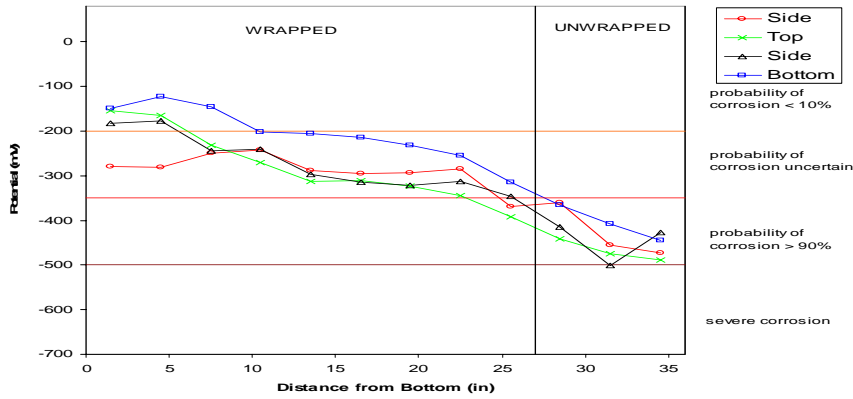
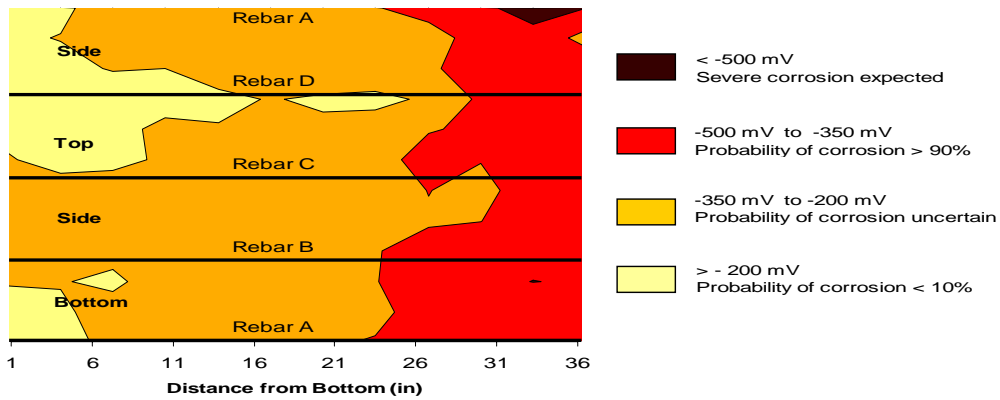
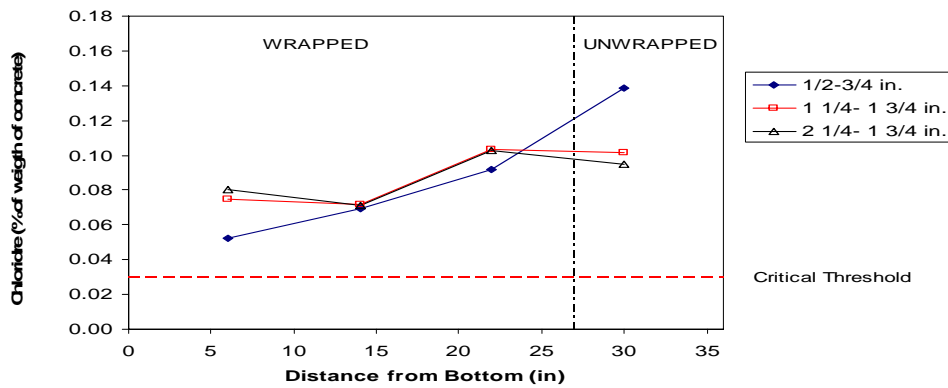
Figure 4.14 Data for Specimen RC5

a) Half-cell potential profiles

b) Half-cell potential contours

c) Average chloride content profiles

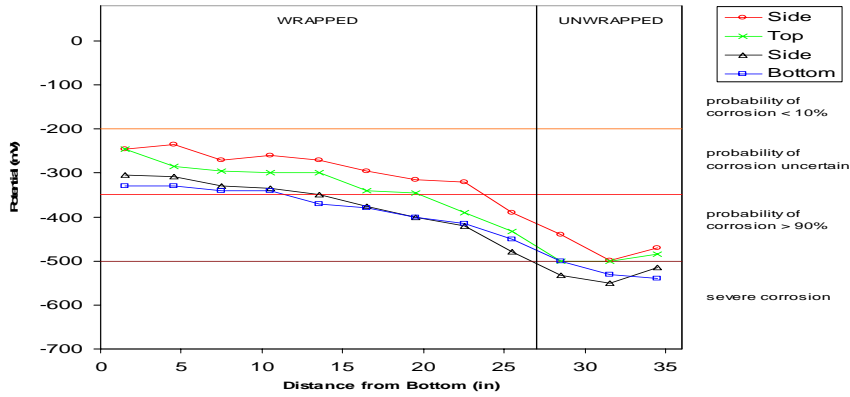
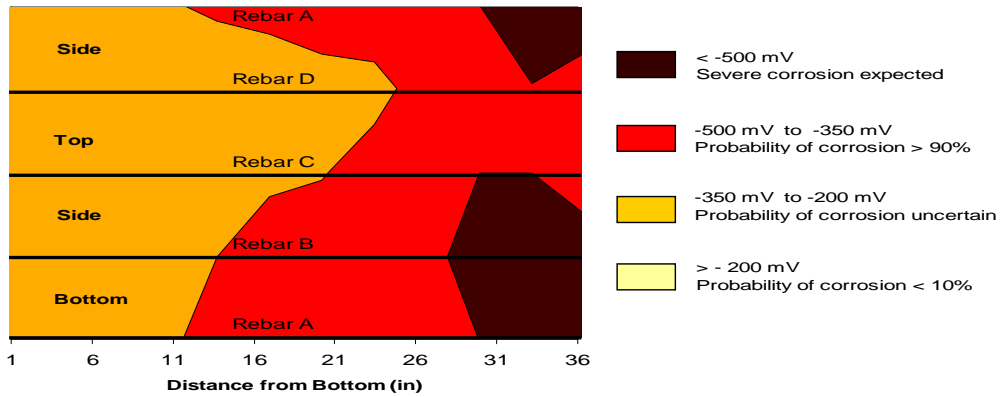
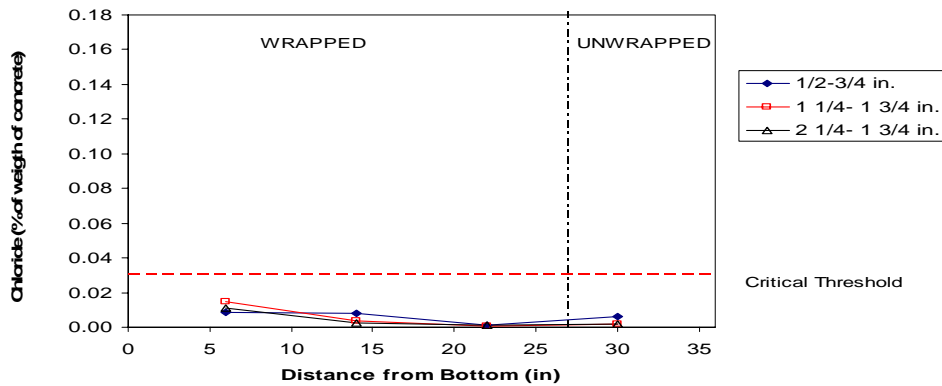
Figure 4.15 Data for Specimen RNC1

a) Half-cell potential profiles

b) Half-cell potential contours

c) Average chloride content profiles
