**DETAILED EVALUATION OF PERFORMANCE FRP WRAPPED  
COLUMNS AND BEAMS  
IN A CORROSIVE ENVIRONMENT**

Research Report No. 0-1774-3

*“Effect of Wrapping Chloride Contaminated Structural Concrete  
with Multiple Layers of Glass Fiber/Composites and Resin”*

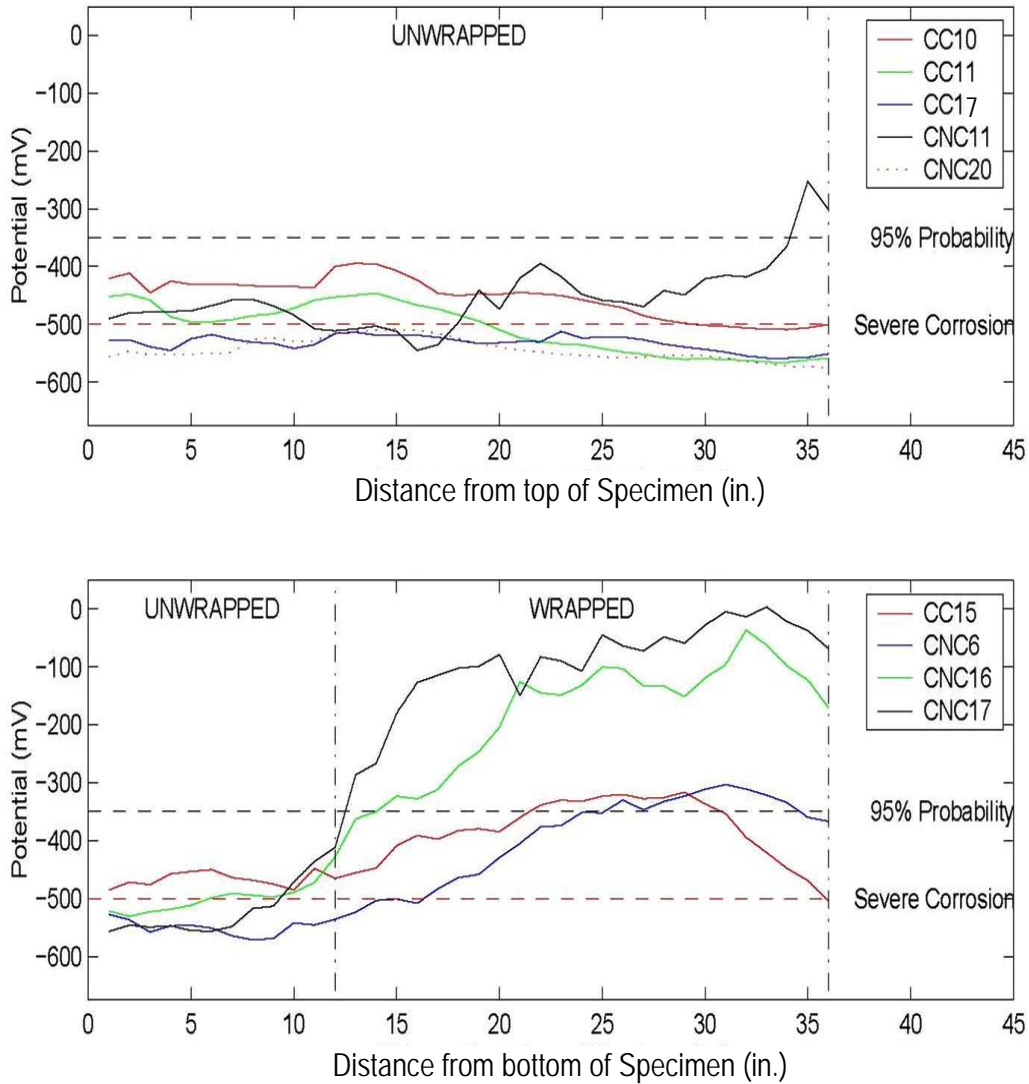
Figure 5.1 Average half-cell potential profiles for column specimens

The columns exhibit almost identical behavior within the bottom twelve inches where no wrapping was applied. Each of the nine specimens has an average potential that fluctuates around the -500 mV threshold. However, above 12-in, potential readings in the wrapped specimens are much lower, some well below the 95% probability of corrosion. The potential readings for unwrapped columns remain at the severe corrosion level along the entire column height.

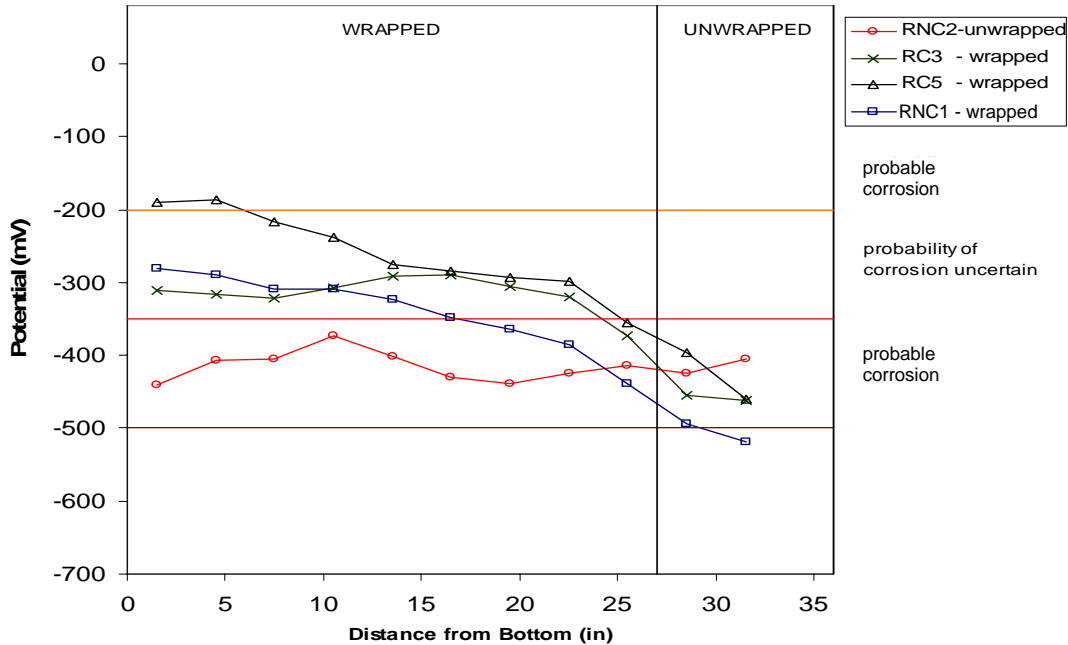
Figure 5.2 Average half-cell potential profiles for beam specimens

Average half-cell profiles recorded above the four embedded rebars for the beam specimens are shown in Figure 5.2. The potential readings for the unwrapped beam, RNC2, are between -350 and -500 mV, along its entire length. Potentials along the wrapped sections are between -200 and -350 mV and increase at the wrapped ends to values similar to those of RNC2.

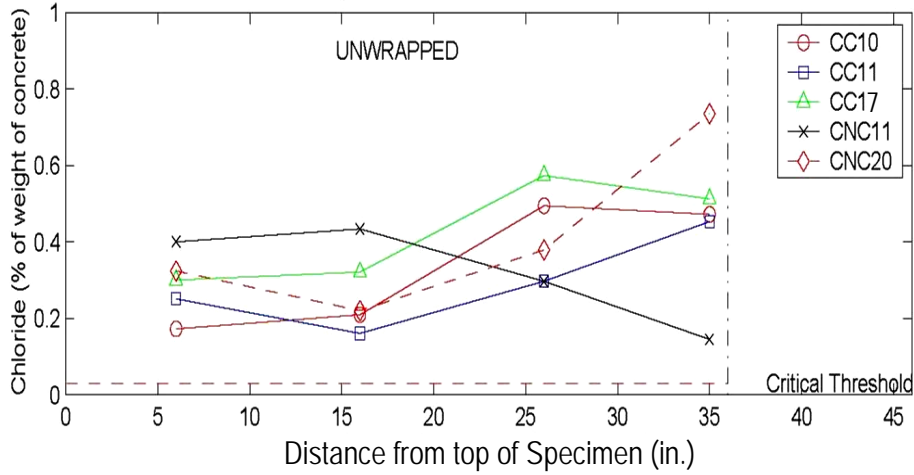
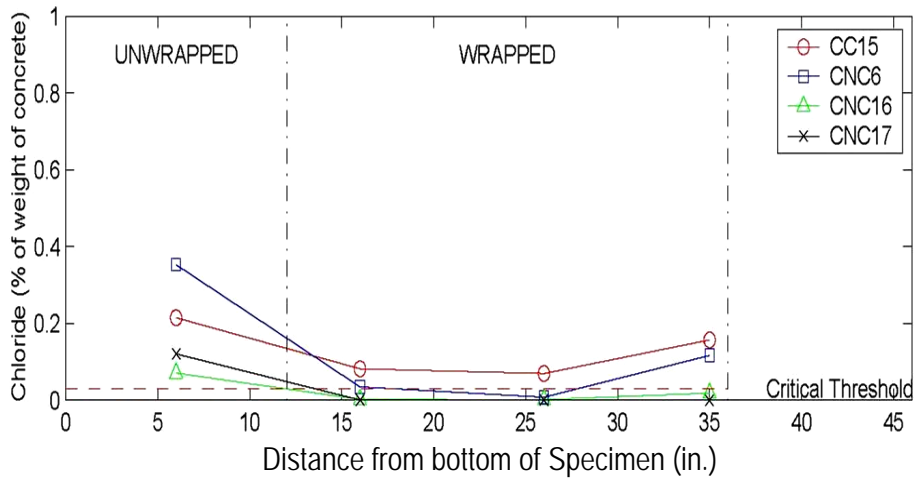
Figure 5.3 Average chloride content profiles for column specimens

Clearly, the FRP wrapping limited the influx of chlorides to the upper portions of the columns. By comparing these chloride concentrations and the photographs of the extracted bars that had very little corrosion above the lower twelve inches, the effectiveness of FRP wrapping as a protection strategy becomes clearer.

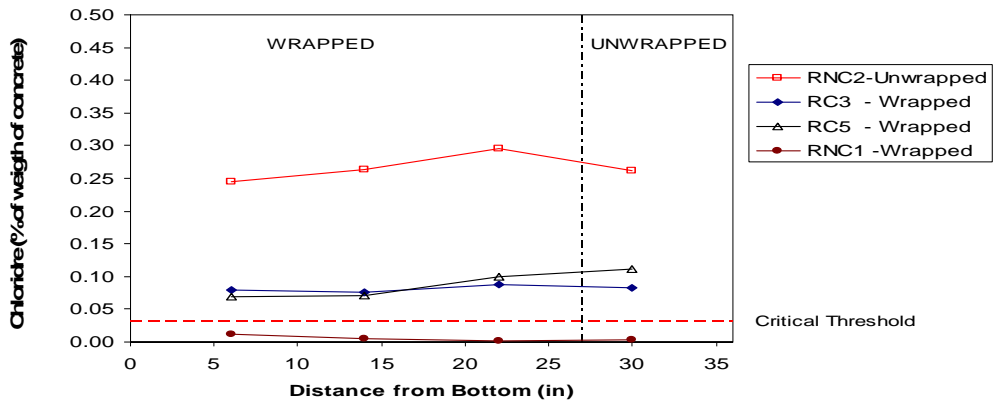
Figure 5.4 Average chloride contents for beam specimens
