**Pretensioned Box Beams:  
Prestress Transfer and Shear Behavior**

**Dissertation**

The University of Texas at Austin

December 2011

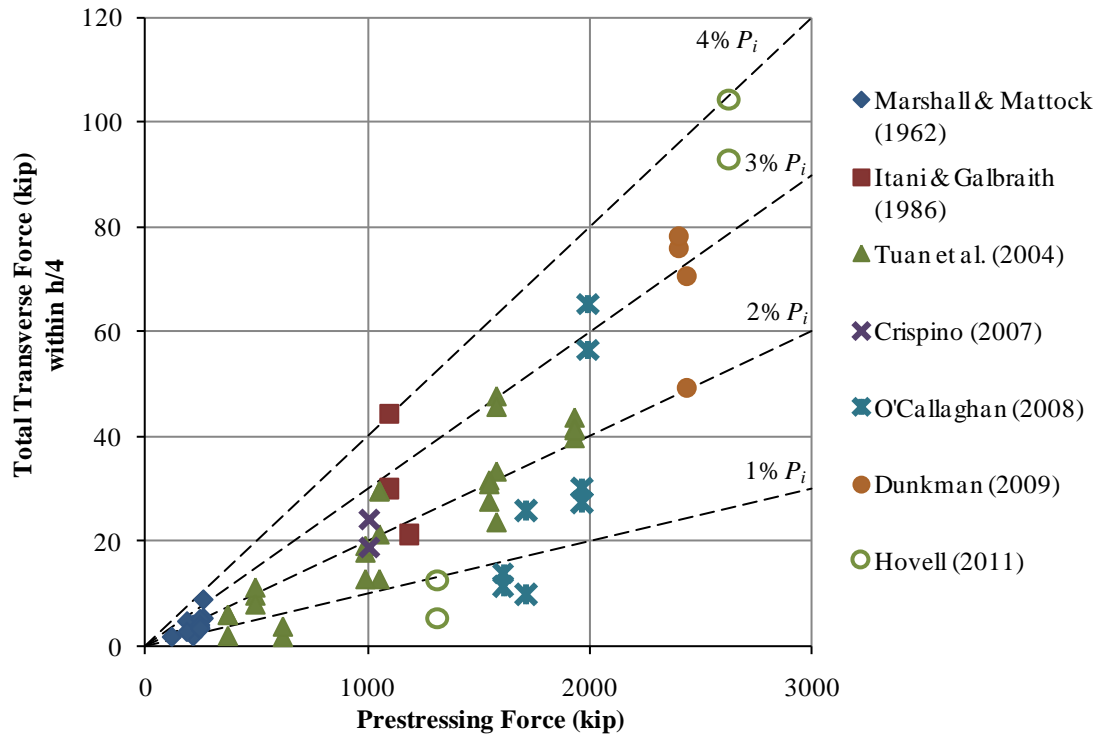
( $P_i$ ) prestressing force can be used as a safe upper bound for the magnitude of the transverse forces experienced upon prestress transfer in the end region. These transverse forces are located in the region bound between the end of the beam and a section located a distance  $h/4$  from the end of the beam. Results from the aforementioned references are illustrated in Figure 2-18.

**Figure 2-18: Results from experimental studies on Transverse Forces**

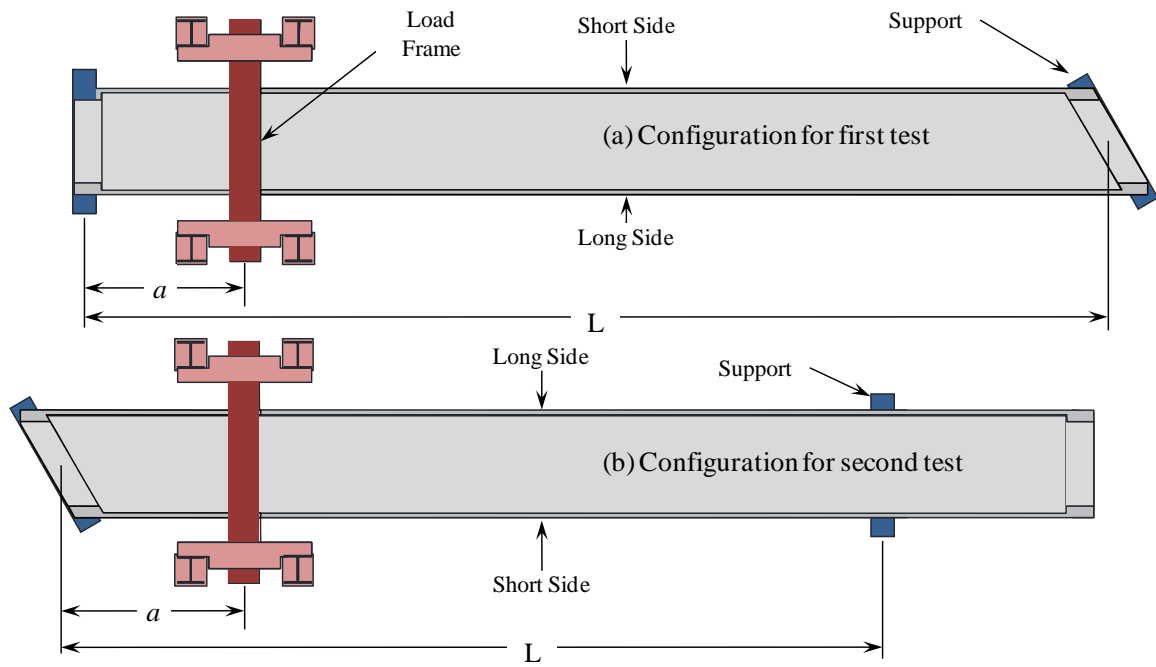
As explained in Chapter 3, each beam specimen was tested twice. A typical first test on a beam is illustrated in section (a) of Figure 4-3. A typical second test on a beam is illustrated in section (b) of Figure 4-3. A critical-shear section, located at the mid-length of the shear span, as illustrated in Figure 4-4, was used to evaluate the shear causing diagonal cracks in the web (see Section 4.2) and the shear strength calculation methods (see Section 4.7).

Figure 4-3: Plan view of shear test static configurations: (a) Configuration for first test, (b) Configuration for second test.

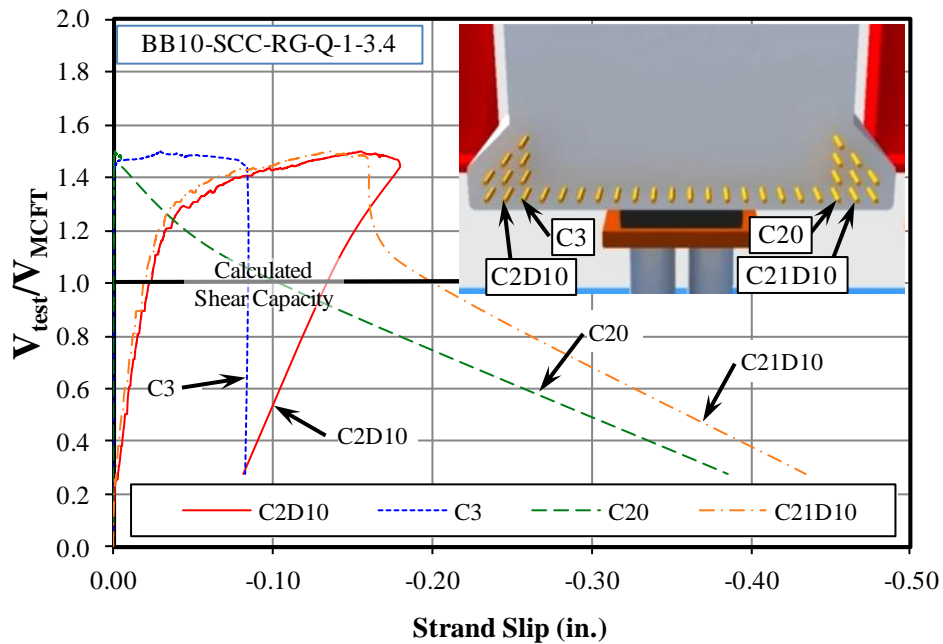
the concrete. The best example of such behavior is illustrated in Figure 4-15, where it can be seen how the residual slip in strands C2D10 matches the slip in strand C3 and the residual slip in strand C20 matches the slip in strand C21D10.

**Figure 4-15: Load vs. Strand Slip curves for test BB10-SCC-RG-Q-1-3.4 (Instruments Configuration A)**

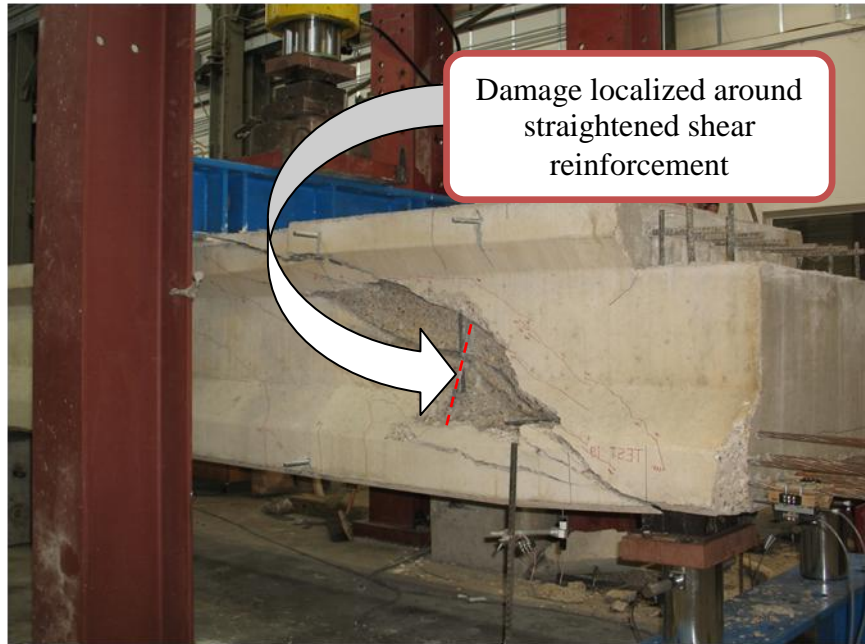
The beams fabricated with SCC failed at lower loads (18% less on average) and damage was more localized around the straightened shear reinforcement as shown in Figure 4-21. Conversely, failures in conventional concrete beams were associated with higher loads and very brittle and explosive failures of a larger portion of the web as shown in Figure 4-22.

**Figure 4-21: Failure of Square end of BB-09 (SCC).**

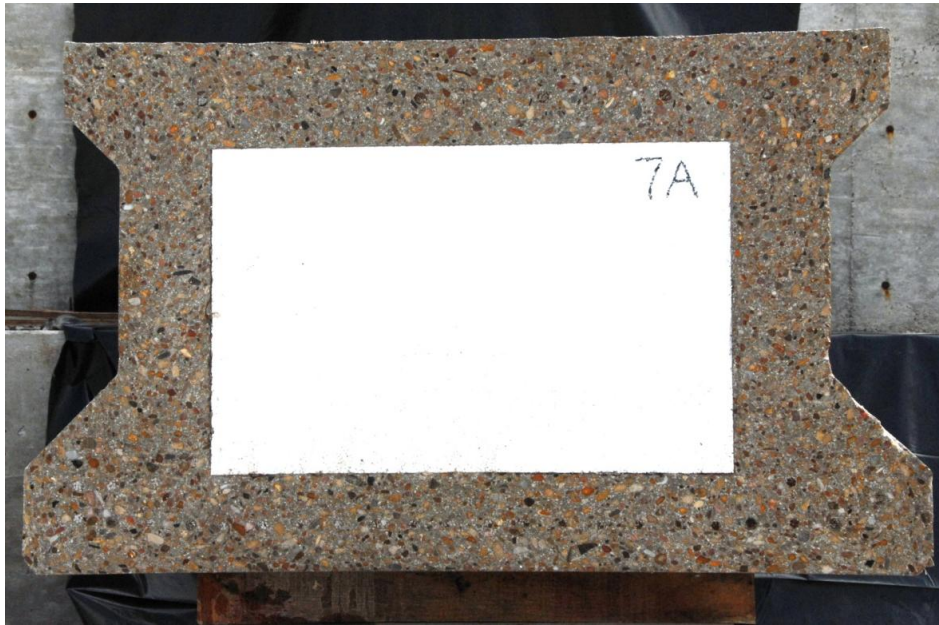
**Figure 4-29: Cut section of beam fabricated with SCC and river gravel.**

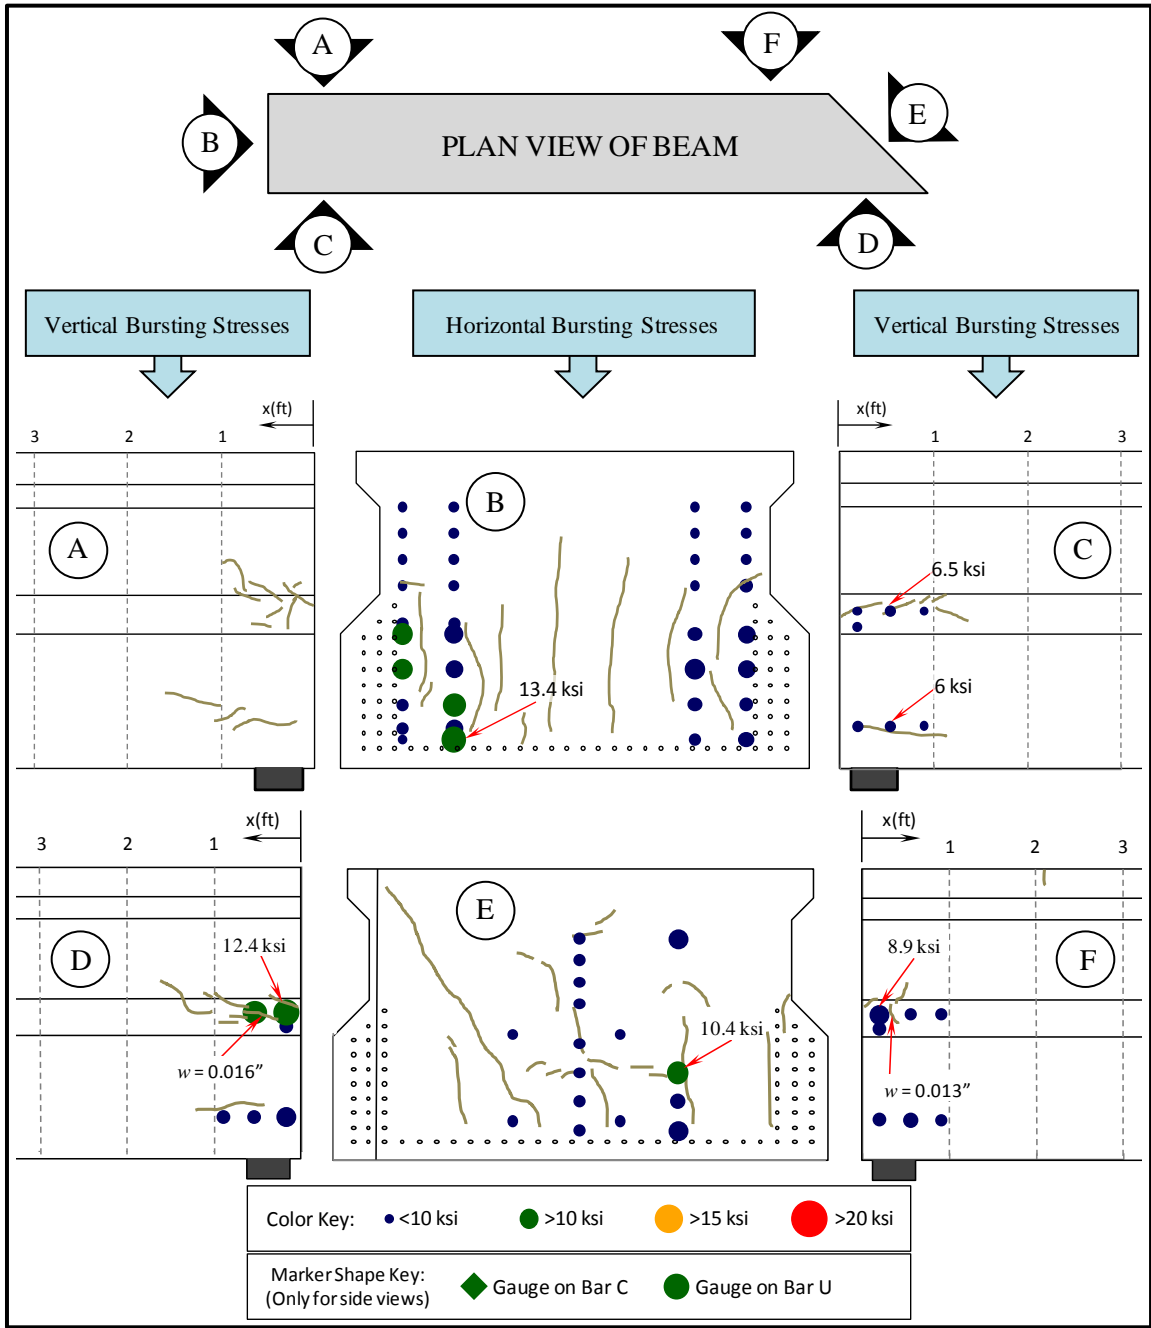
**Figure 5-16: Cracks and stresses registered at the time of prestress transfer in beam specimen 5B40-4**

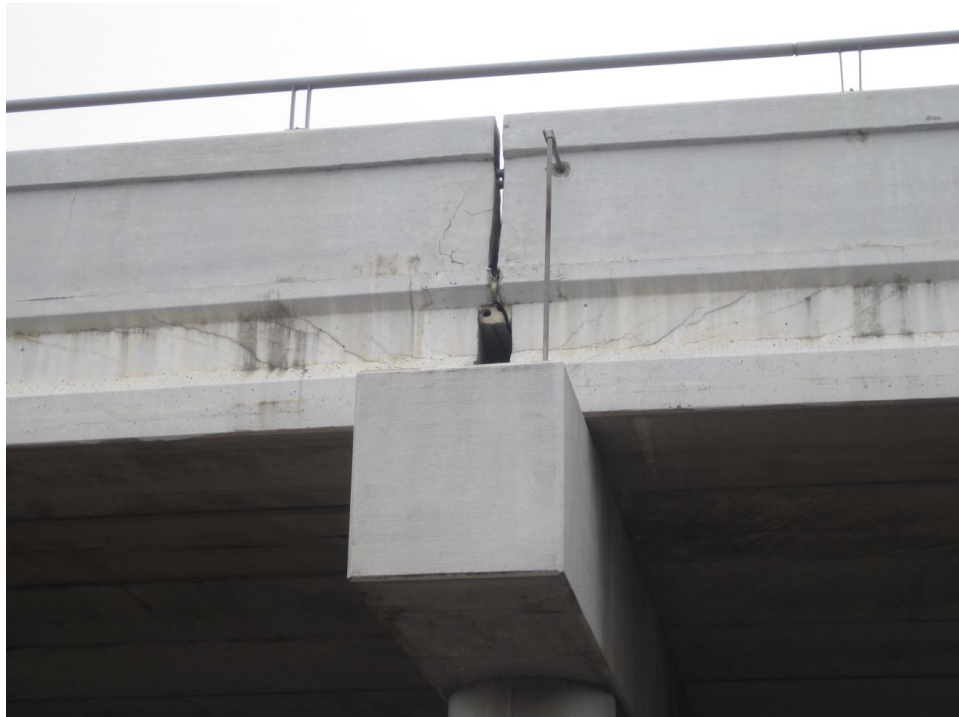
**Figure 6-1: Diagonal cracks in box beams over central bent cap in bridge over IH35.**

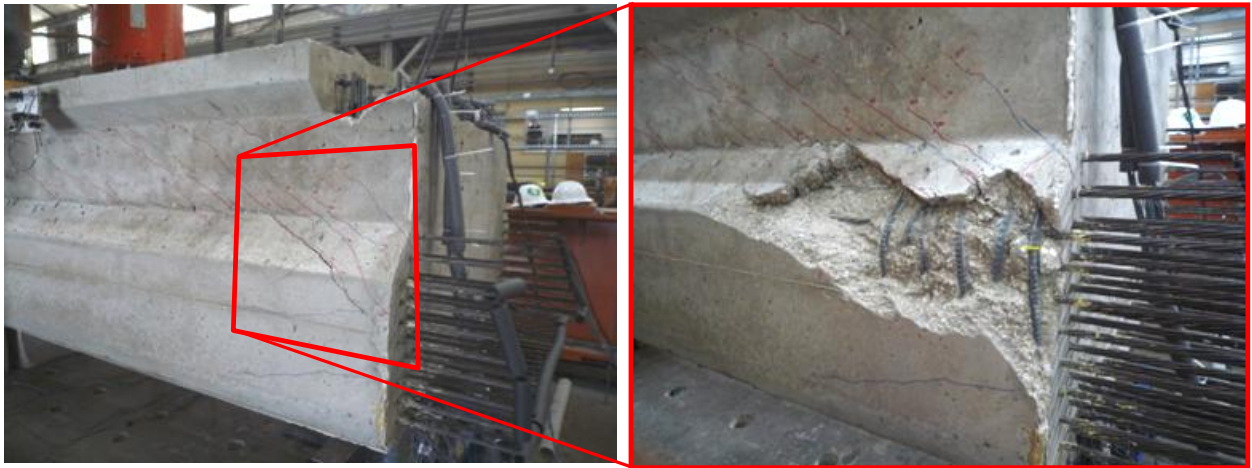
**Figure 6-16: Spalling of cover at end of beam. Square end of 5B40-1 is shown.**

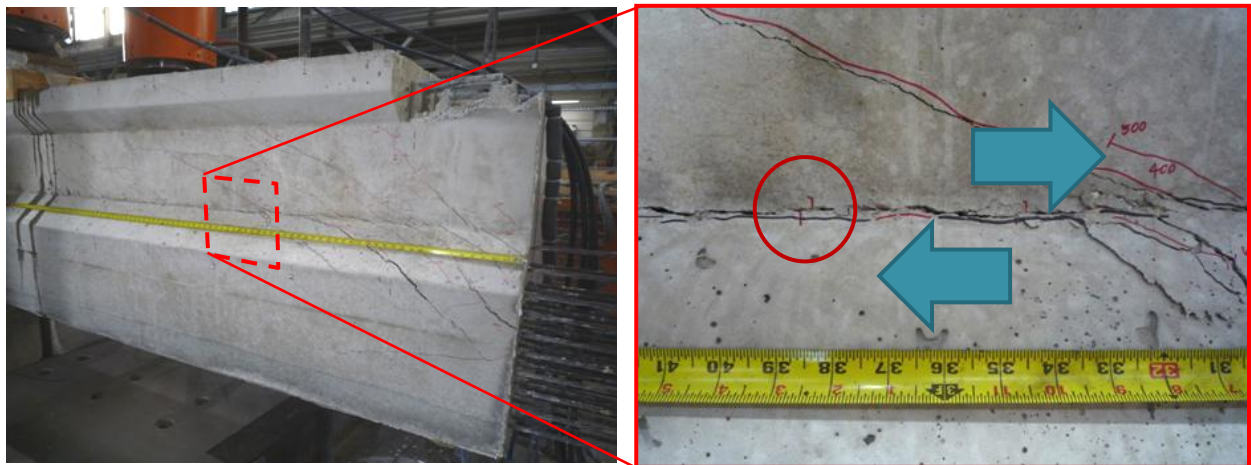
**Figure 6-26: Signs of horizontal shear distress. Square end of 5B40-3 is shown.**

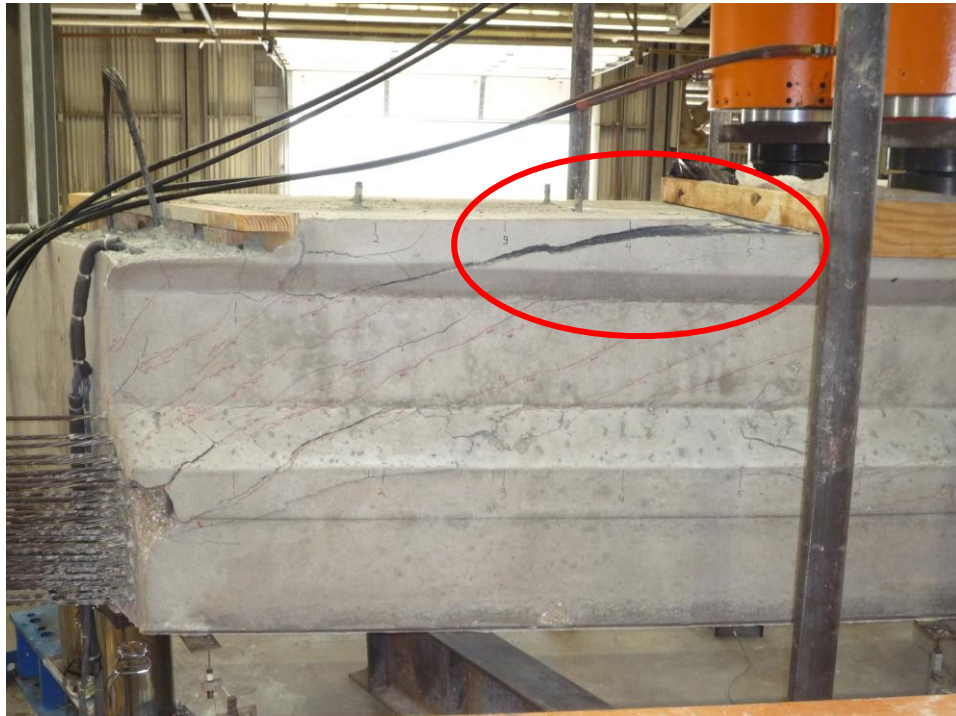
**Figure 6-28: Shearing through top flange. Skewed end of 5B40-3 is shown.**

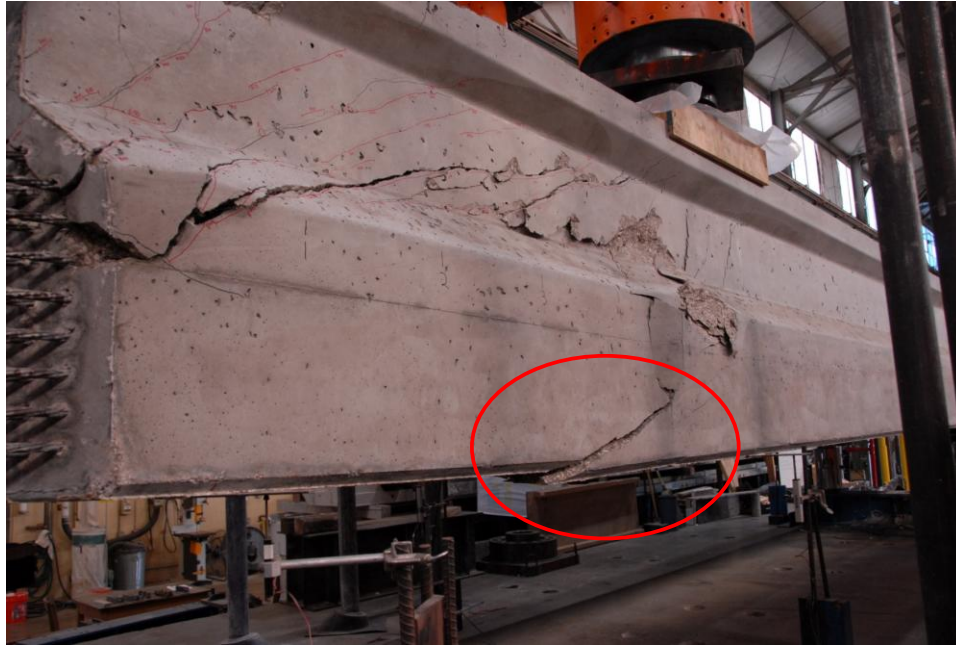
**Figure 6-29: Shearing through bottom flange. Skewed end of 5B40-4 is shown.**

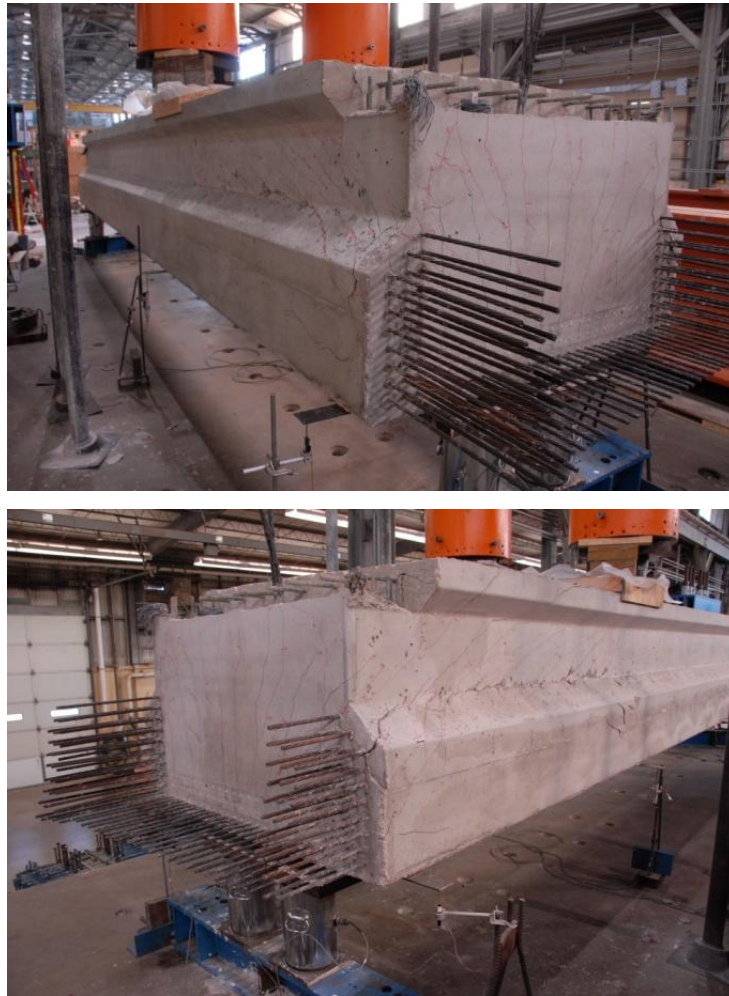
**Figure 6-31: Symmetric failure of both webs in 5B40-4-Q**

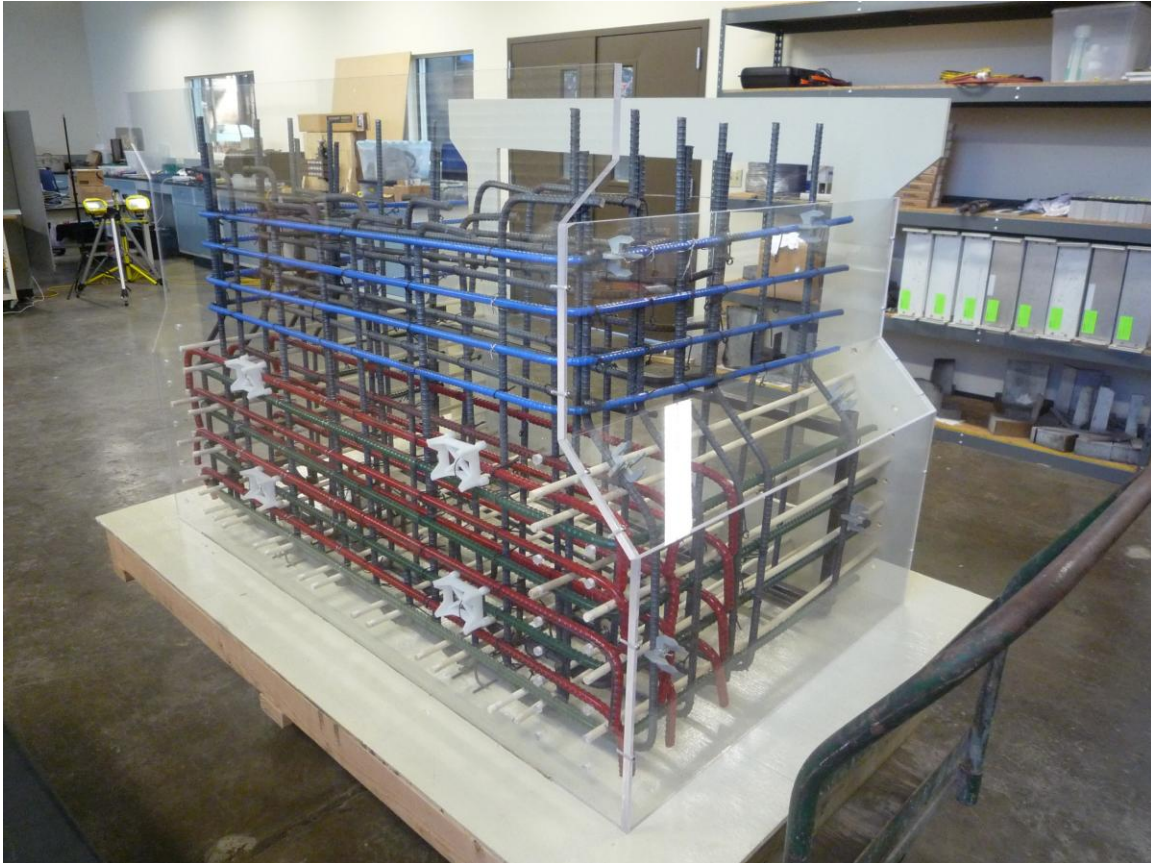
**Figure 7-2: Full-scale model of the improved end-region reinforcement used in beam 5B40-4**
