**SEISMIC RETROFIT OF NON-DUCTILE REINFORCED  
CONCRETE COLUMNS USING RECTANGULAR  
STEEL JACKETS**

**DISSERTATION**

The University of Texas at Austin

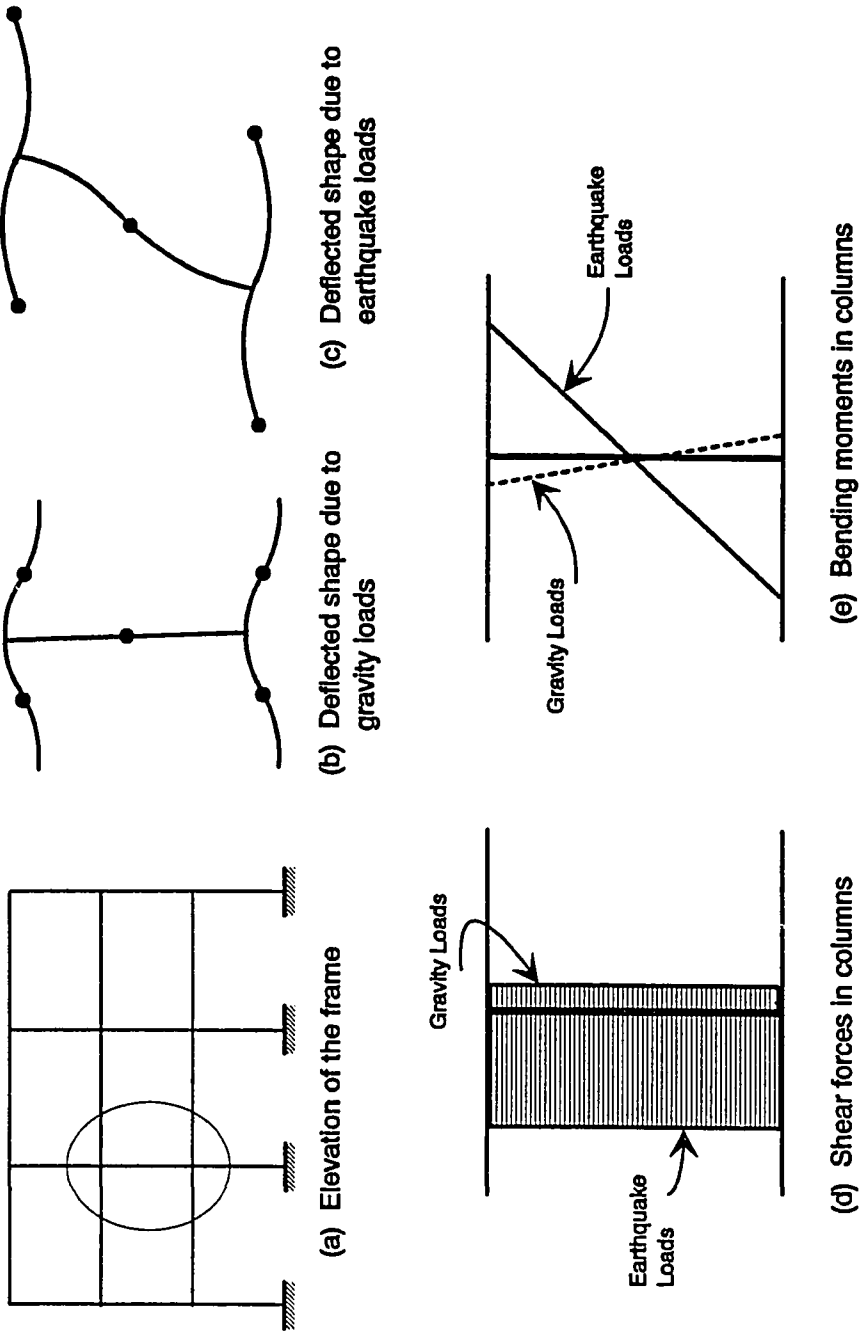
Figure 1.1 Forces and Deformations caused by Gravity and Earthquake loads

An elevation of a three story frame is shown in Figure 1.1(a). Under typical gravity loads, building columns see very small lateral deformations as shown in Figure 1.1(b), resulting in small shear forces and bending moments. However, under lateral loads, columns see large lateral deformations associated with much higher shear forces and bending moments as shown in Figure 1.1 (c-e). Reinforced concrete building columns must be adequately designed to resist these high shear forces through the use of a sufficiently large cross-section combined with an adequate amount of well detailed transverse reinforcement. Columns in older frames designed primarily for gravity load may lack adequate shear strength. Such columns may see rapid degradation in lateral strength and stiffness, and possible loss of gravity load capacity in a severe earthquake.

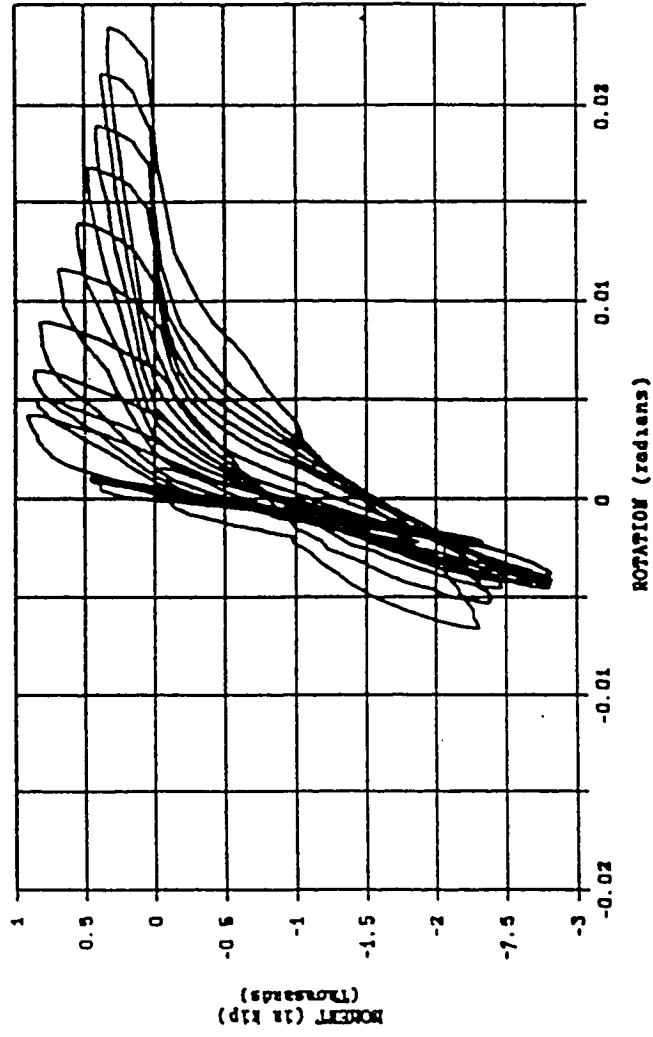
Figure 1.5 Typical Moment-Rotation Relationship for a R/C Beam-Column Subassemblage with Short Embedments of Beam Bottom Reinforcement, Ref. [13].

anchorage failure of beam positive reinforcement caused significant strength and stiffness degradation of the beam-column subassemblage specimens. Figure 1.5 shows a typical moment-rotation relationship for a specimen with short embedded bottom beam reinforcement.

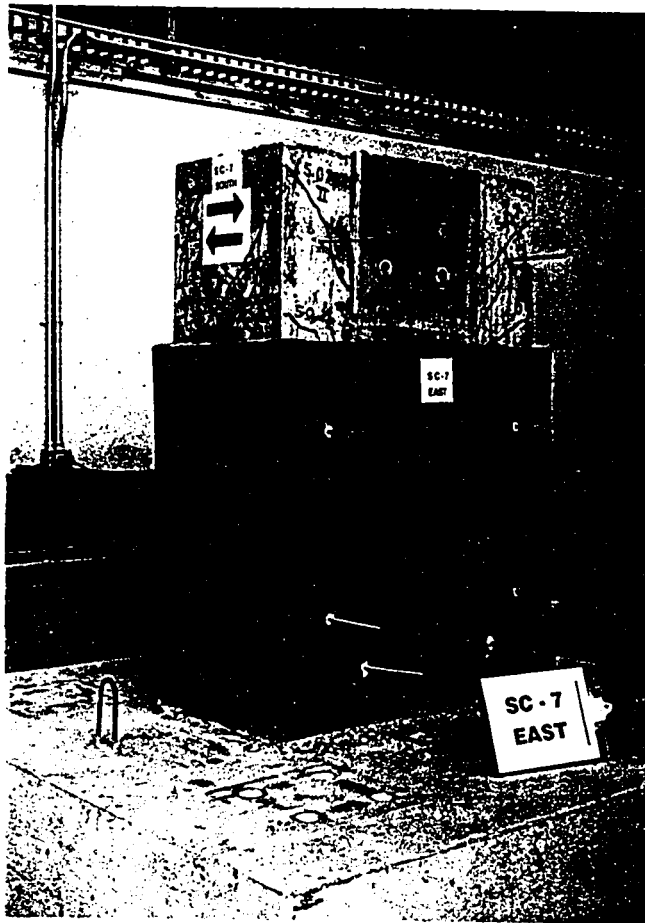
Figure 1.7 Column with Inadequate Shear Strength Retrofitted by Rectangular Steel Jacket.

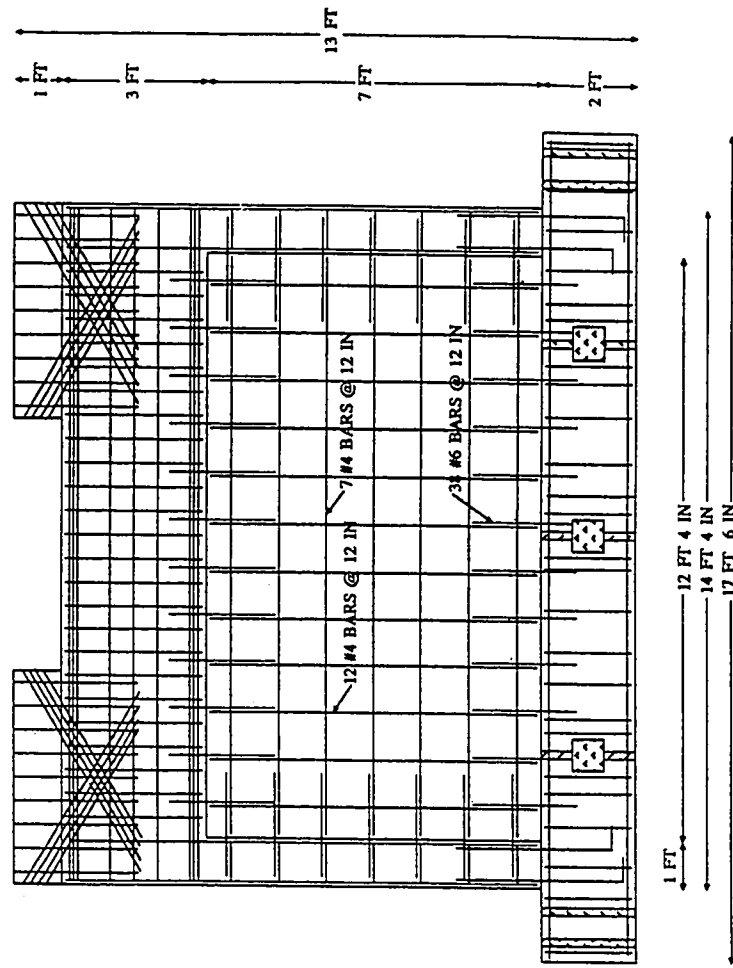
Figure 2.1 Seismic Strengthening by the Addition of Infill Walls,  
 Details of Concentric Infill Wall, Gaynor, Ref. [17].

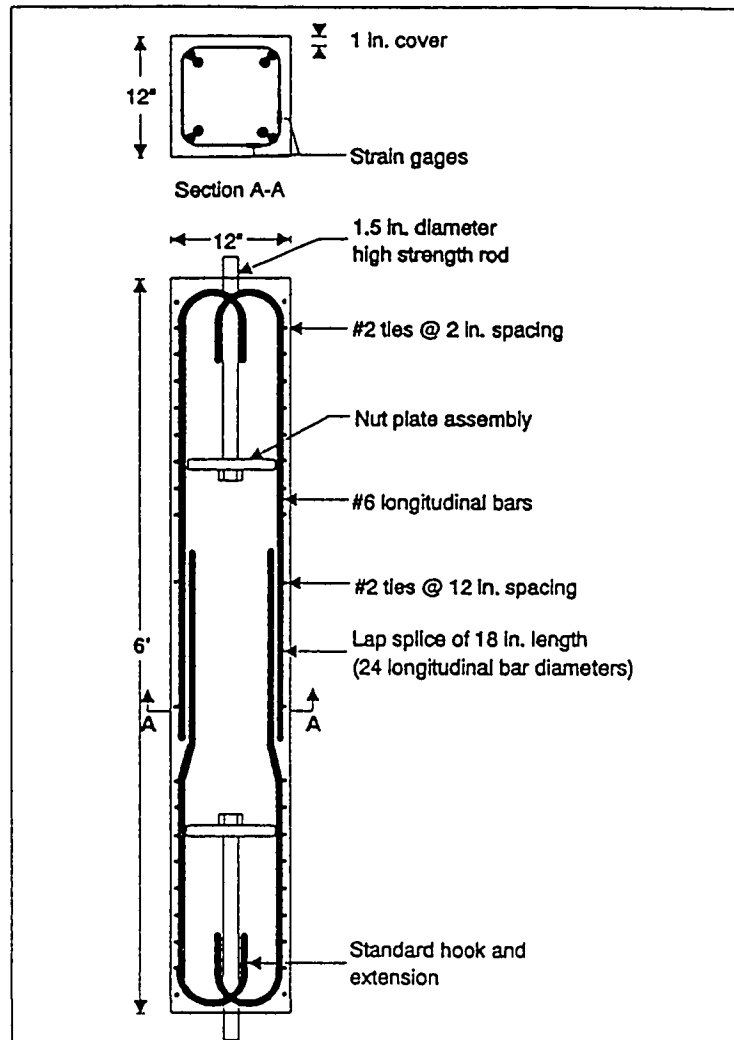
Figure 2.15 Strengthening of Columns With Inadequate Lap Splices, Reinforcement Details of the basic Column, Ref.[23].

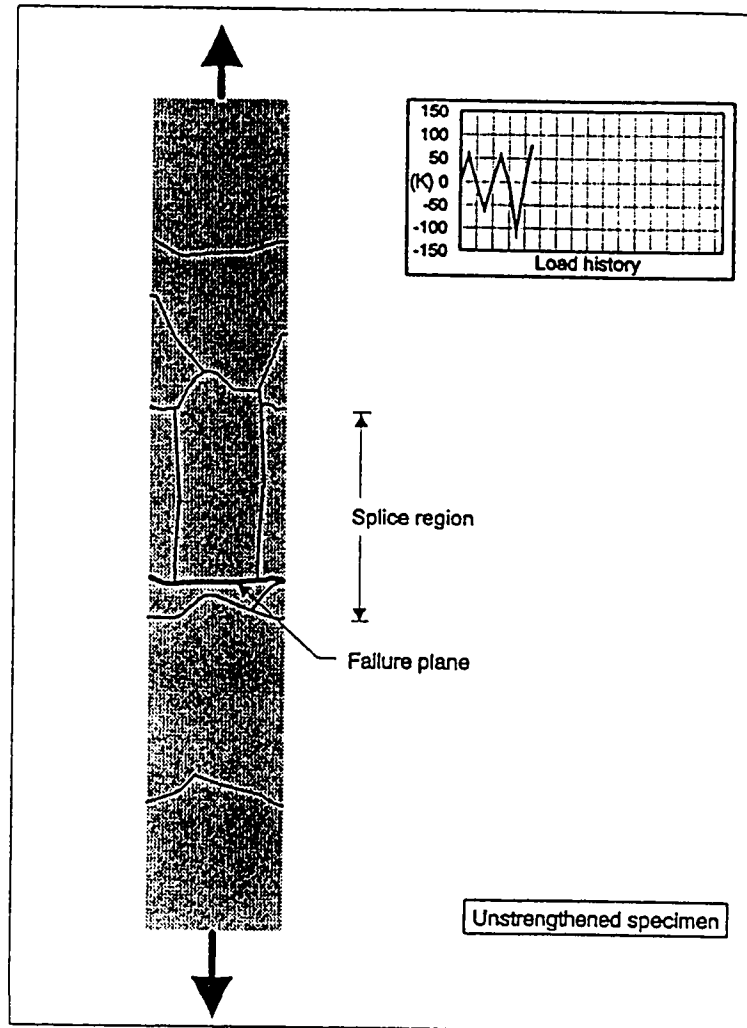
Figure 2.16 Strengthening of Columns With Inadequate Lap Splices, Crack Pattern in the Basic Unretrofitted Column, Ref.[23].

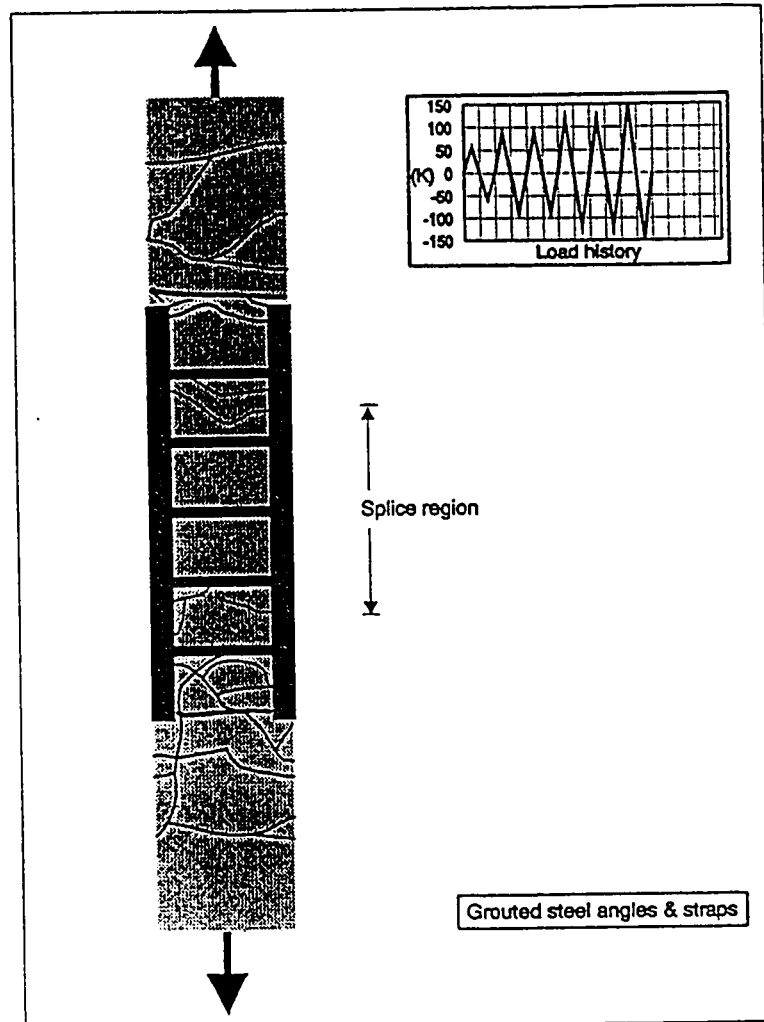
Figure 2.17 Strengthening of Columns With Inadequate Lap Splices, Crack Pattern in the Retrofitted Column, Ref.[23].

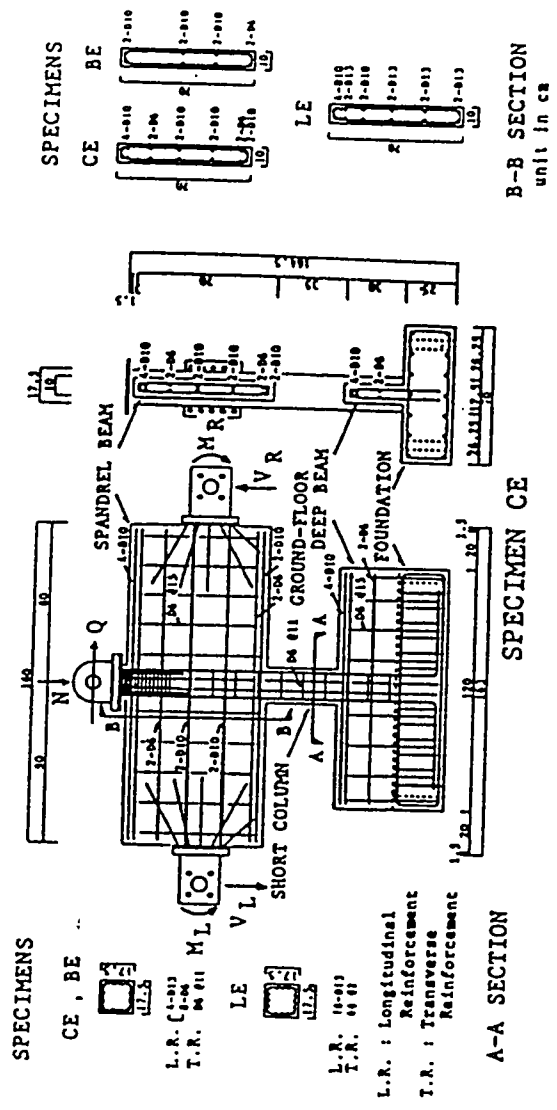
Figure 2.20 Shear Strengthening and Repair of Short Square Columns by the Use of Steel Jackets, Details of the Basic Test Specimen, Ref. [3].

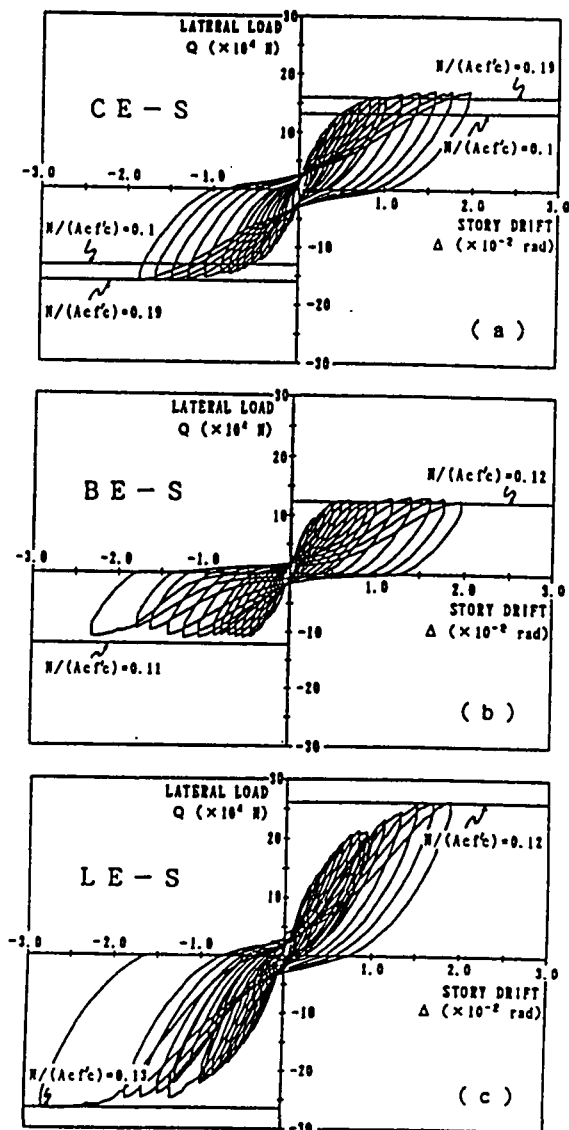
Figure 2.22 Response of Columns with Inadequate Shear Strength Retrofitted by the Use of Steel Jackets, Ref.[3].

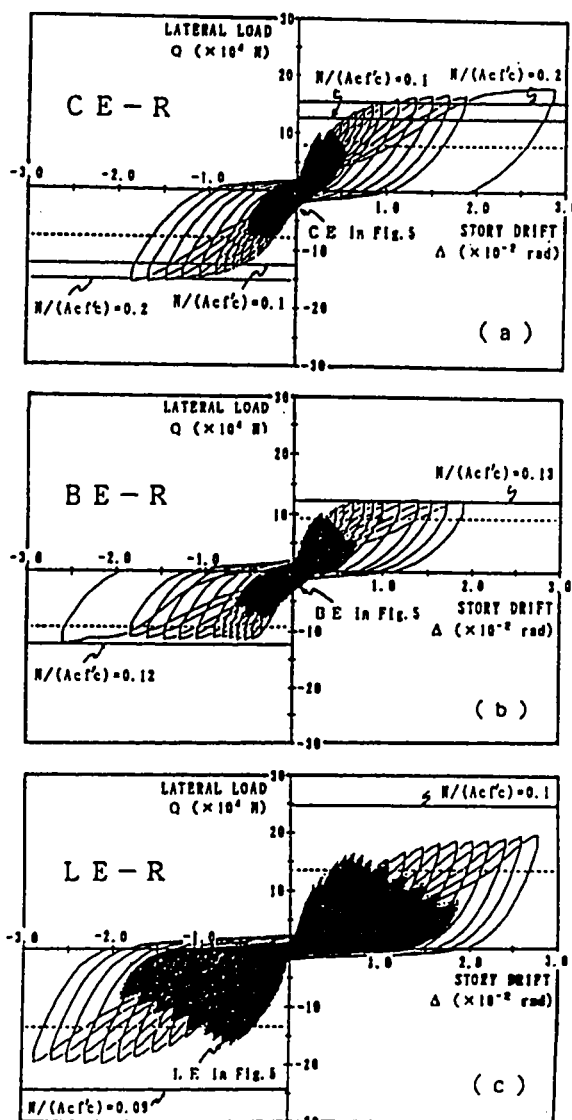
Figure 2.23 Response of Columns with Inadequate Shear Strength Repaired by the Use of Steel Jackets, Ref.[3].

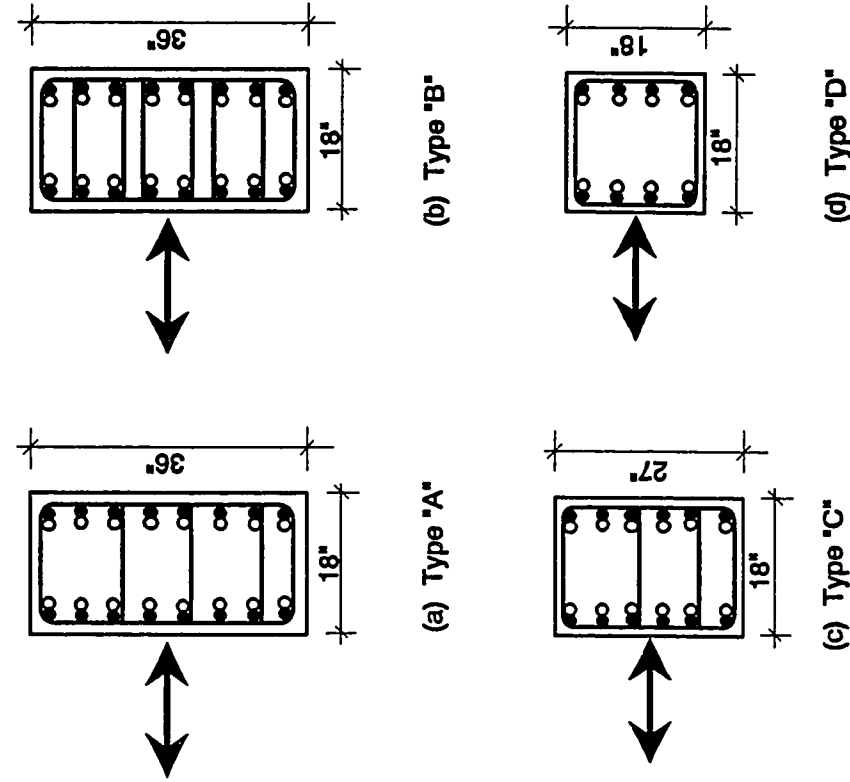
Figure 3.1 Details of the Basic Flexural Columns

Cross ties were provided with 90 degree hooks, as typically found in older buildings. A concrete cover of 1-1/2 inches was provided for all column ties.

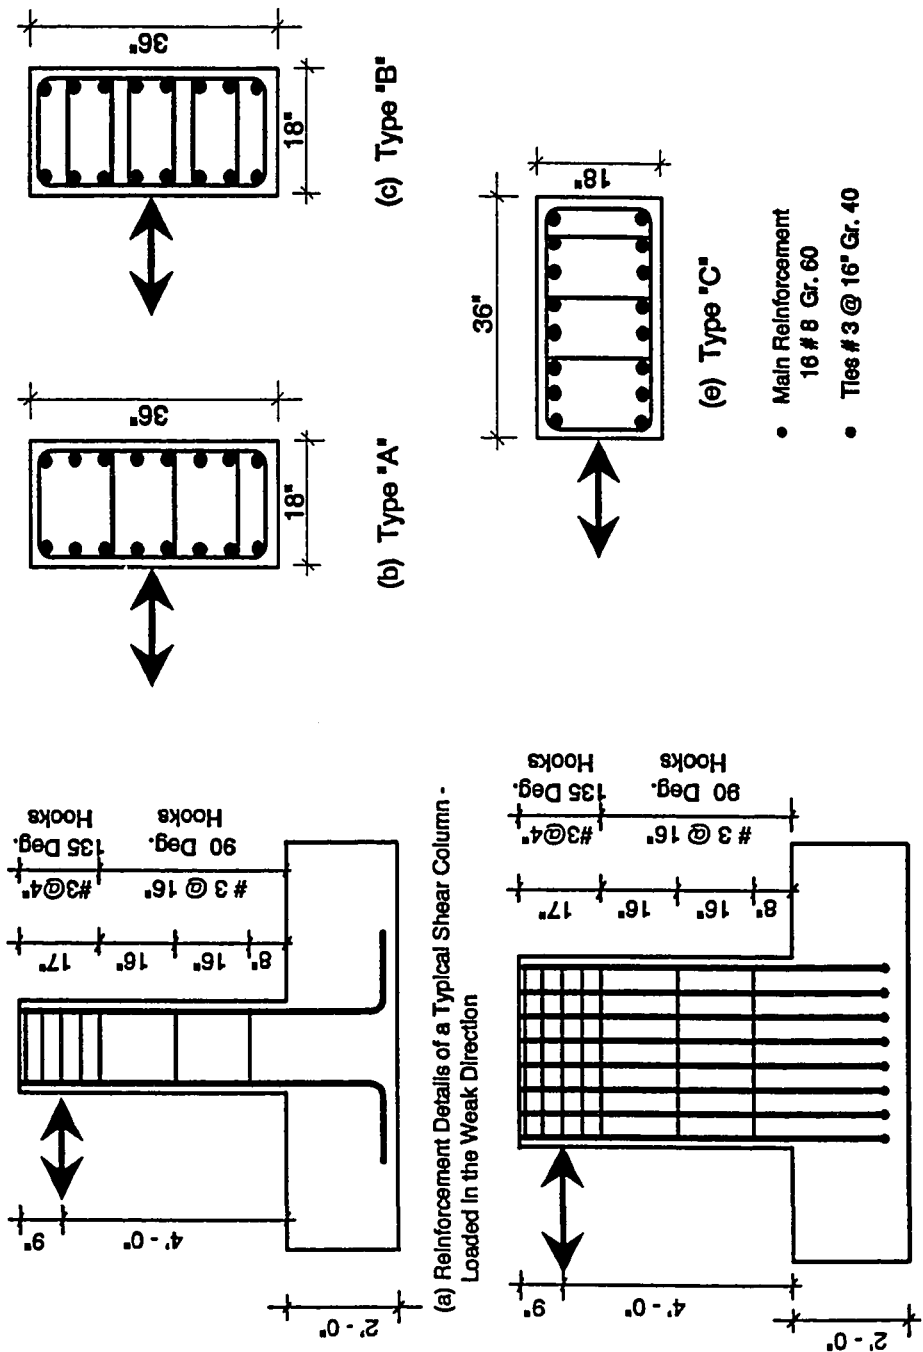
Figure 3.2 Details of the Basic Shear Columns

longitudinal deformed bars. Bars were not spliced, but continuous throughout the column and into the footing, as shown in Figure 3.2(a) & (d). Types "A" & "C" were transversely reinforced with cross ties at every other longitudinal bar. However, type "B" columns were transversely reinforced with cross ties at every longitudinal bar. Type "A" & "B" columns were loaded in the weak direction, while type "C" columns were loaded in the strong direction.

Figure 3.2 shows the details of the basic shear columns. Shear columns were built on footings similar to those used for the flexural columns. All shear columns were 4.0 feet high from the top of the footing to the point of load application, to ensure shear dominated behavior. Eight columns were loaded in the weak direction, having a shear span to depth ratio of 2.67. Three columns were loaded in the strong direction, having a shear span to depth ratio of 1.33. All columns were reinforced with 16#8 grade 60

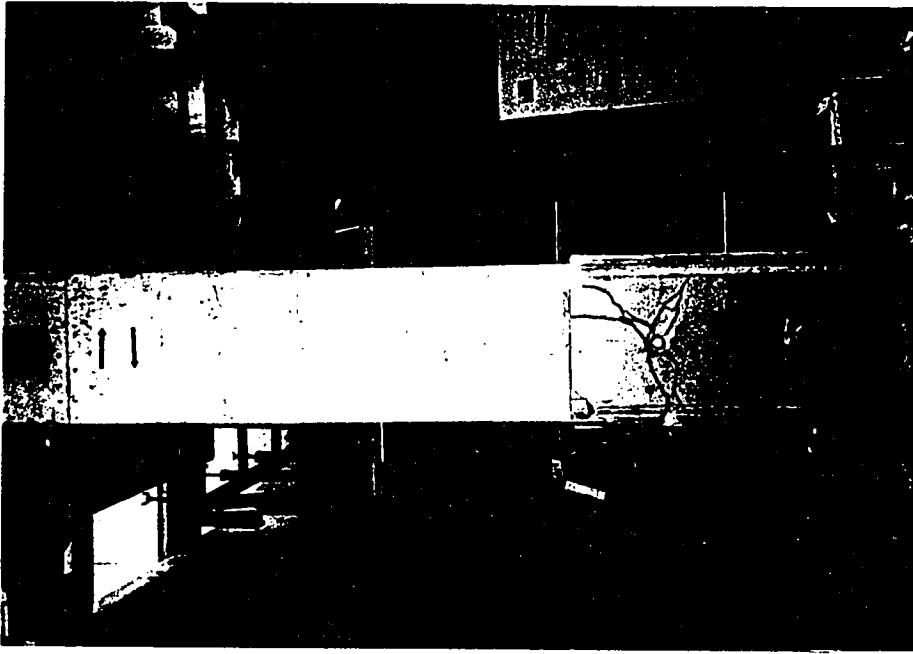
(b) Crack pattern , north side

Figure 4.4 Strengthened Flexural Column FC2

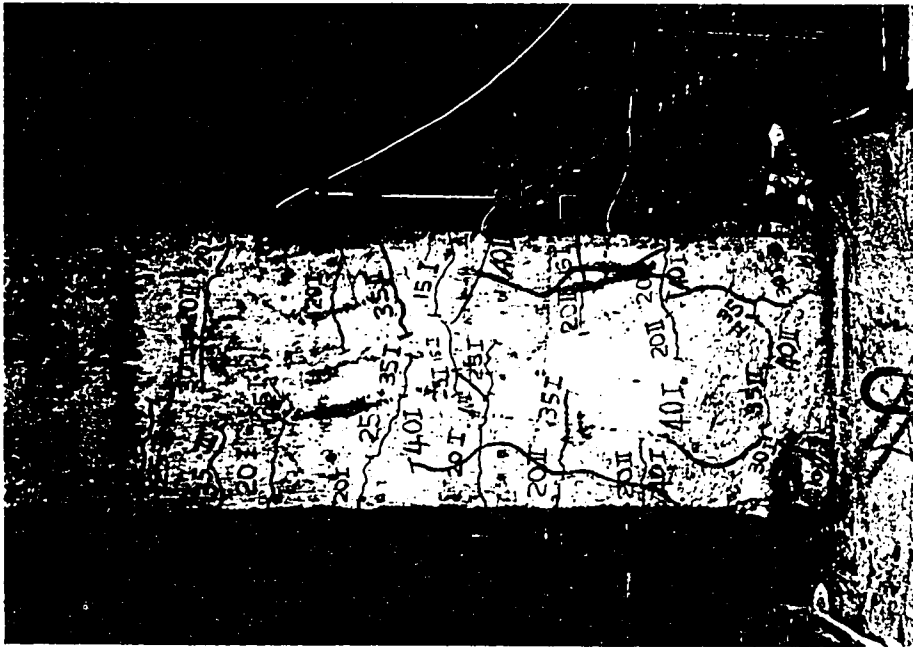
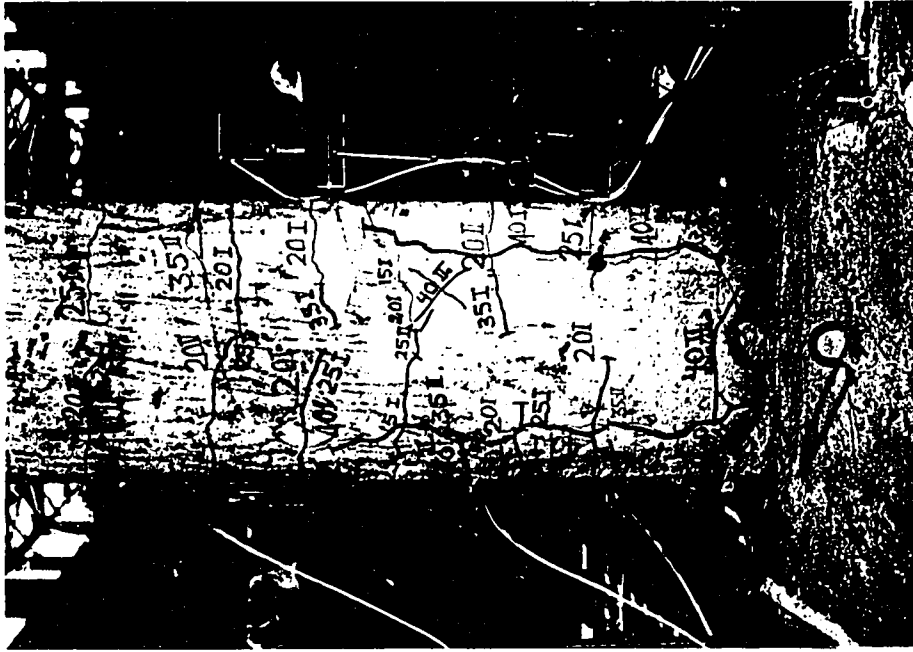
(a) Crack pattern at the splice, north side

(b) Crack pattern at the splice, south side

Figure 4.8 Basic Unretrofitted Flexural Column FC4

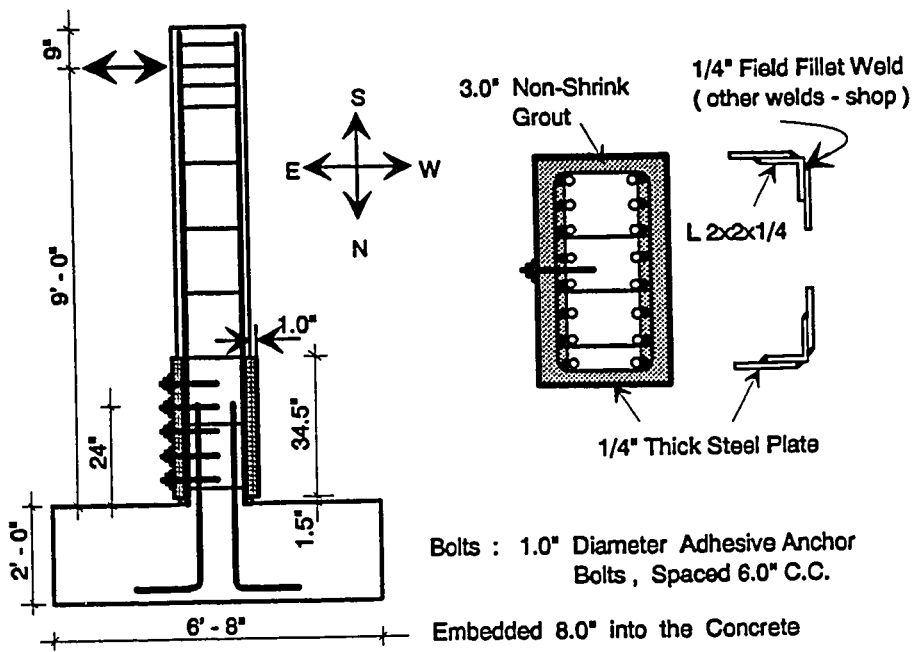
(a) Details of Column FC6

Figure 4.11 Repaired Flexural Column FC6

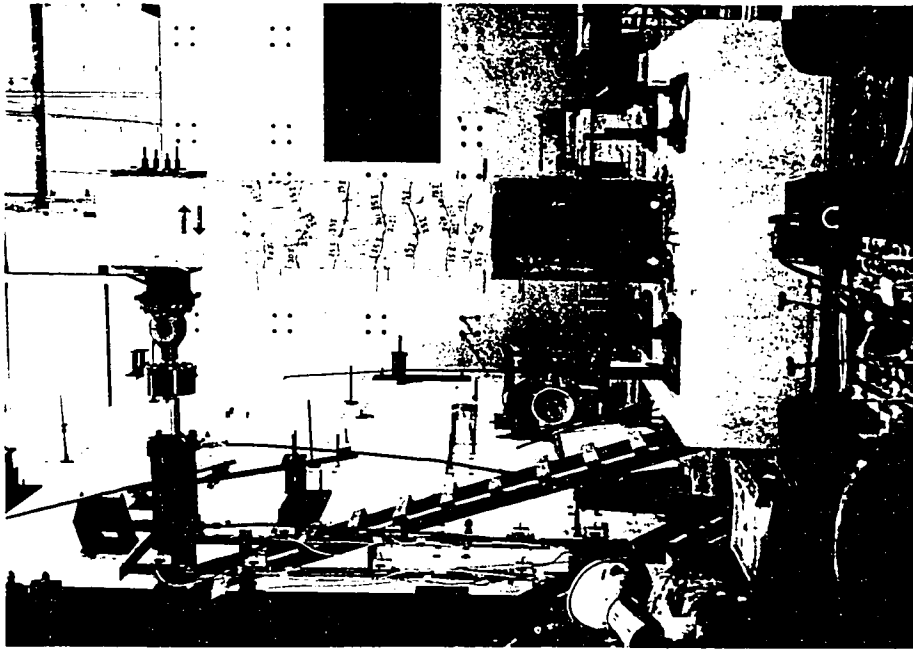
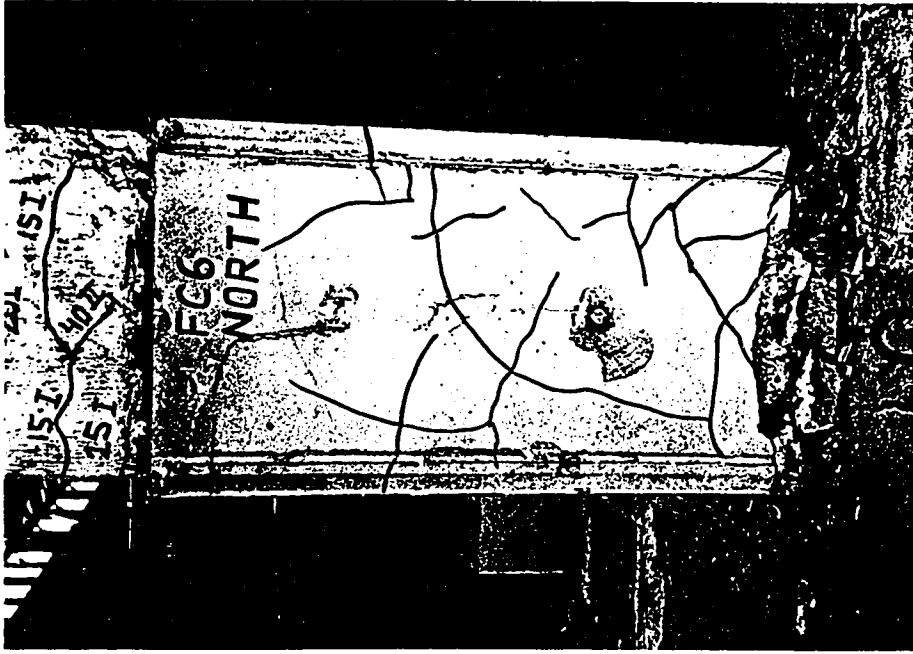
(a) Column FC6 during the test

(b) Crack pattern at the splice, north side

Figure 4.12 Repaired Flexural Column FC6

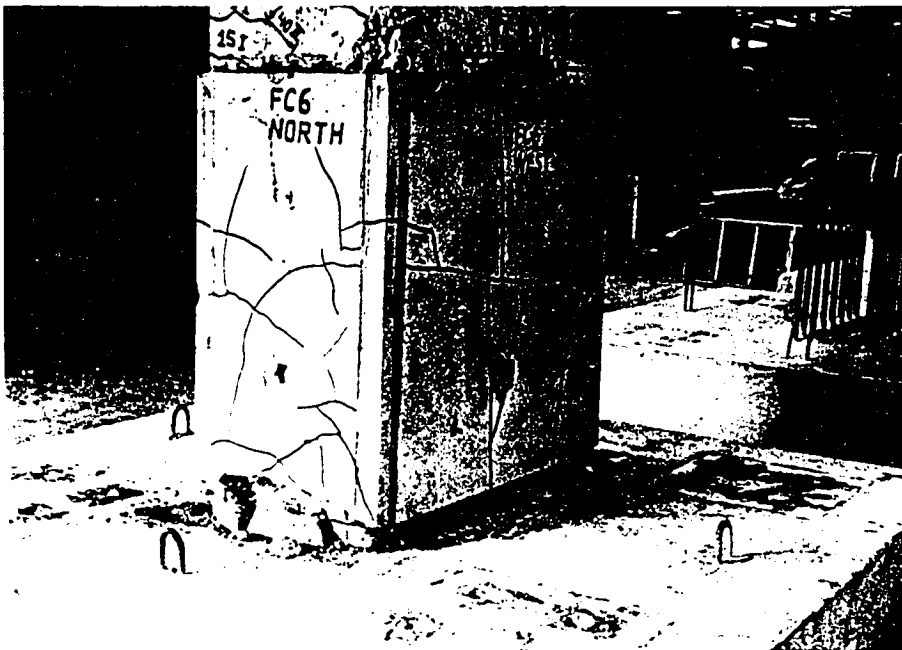
(a) Crack pattern on non-shrink grout, N-E side

(b) Crack pattern on non-shrink grout, N-W side

Figure 4.13 Repaired Flexural Column FC6

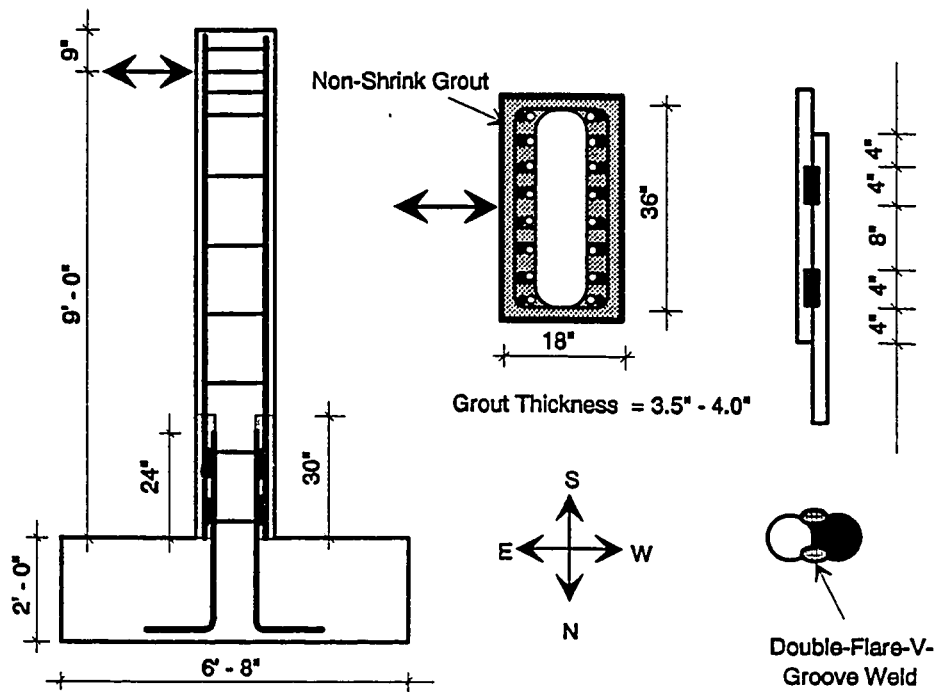
(a) Details of Column FC7

Figure 4.14 Repaired Flexural Column FC7

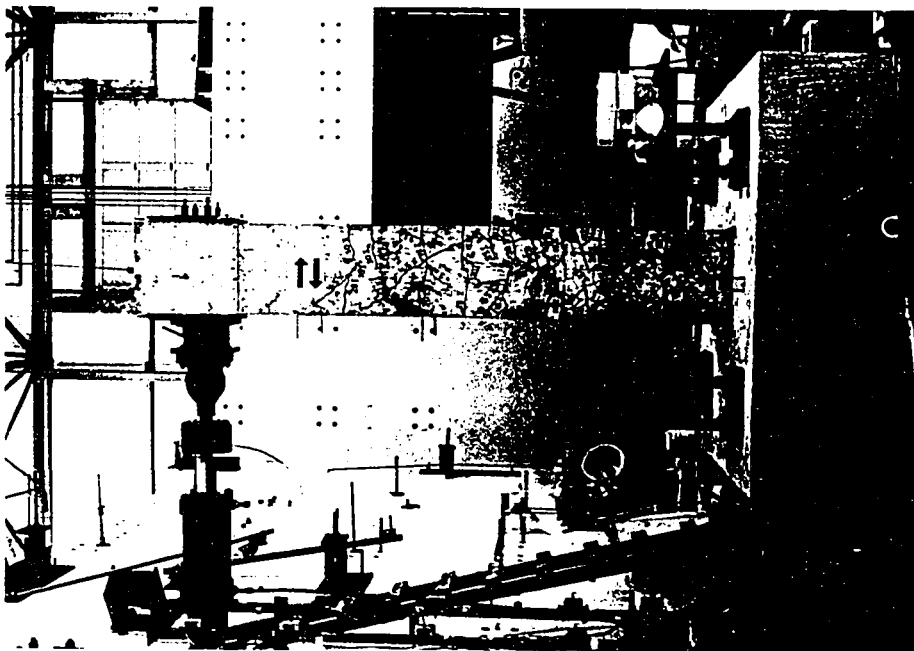
(a) Column FC7 at the end of the test

(b) Crack pattern at the splice, north side

Figure 4.15 Repaired Flexural Column FC7

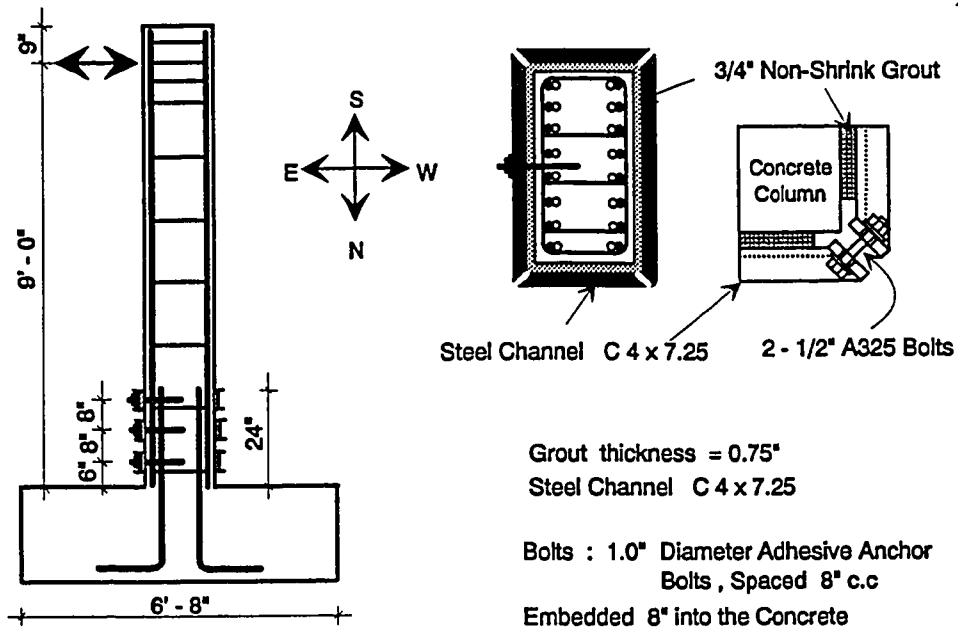
(a) Details of Column FC8

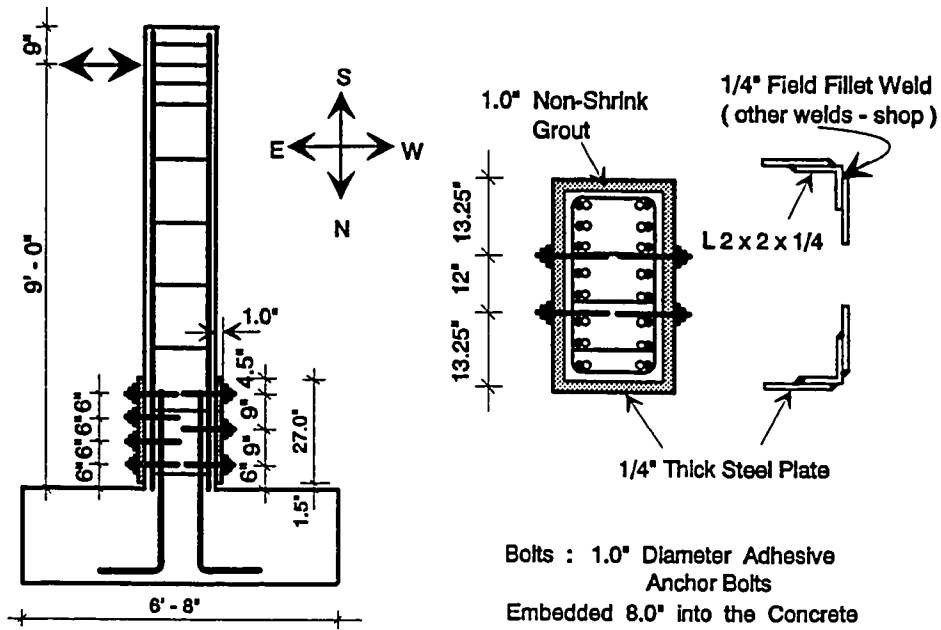
(a) Details of Column FC11

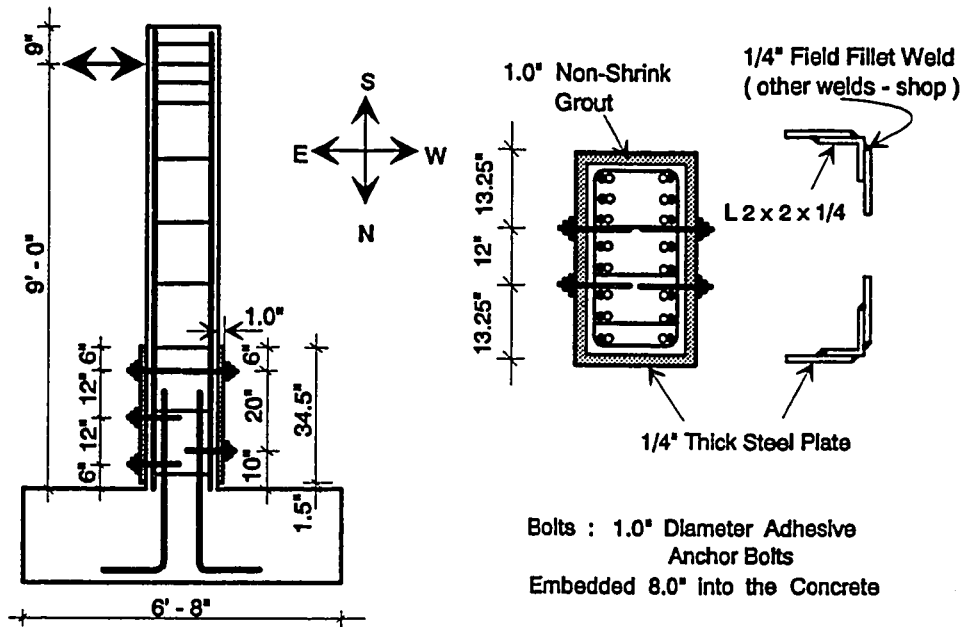
(a) Details of Column FC12

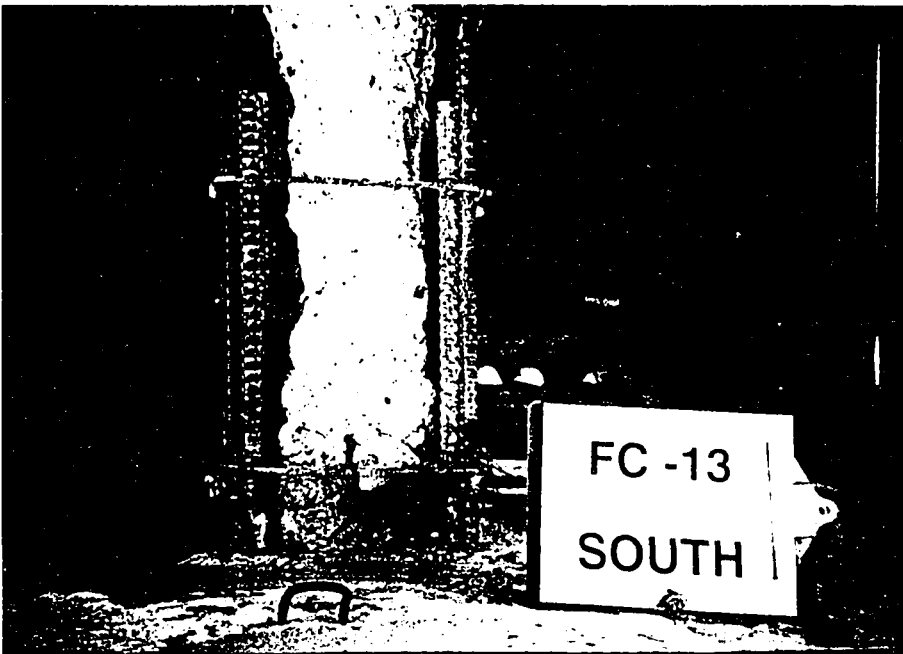
(a) Splice region after the removal of loose concrete

(b) Splice region after chipping off behind starter splice bars

Figure 4.30 Repaired Flexural Column FC13

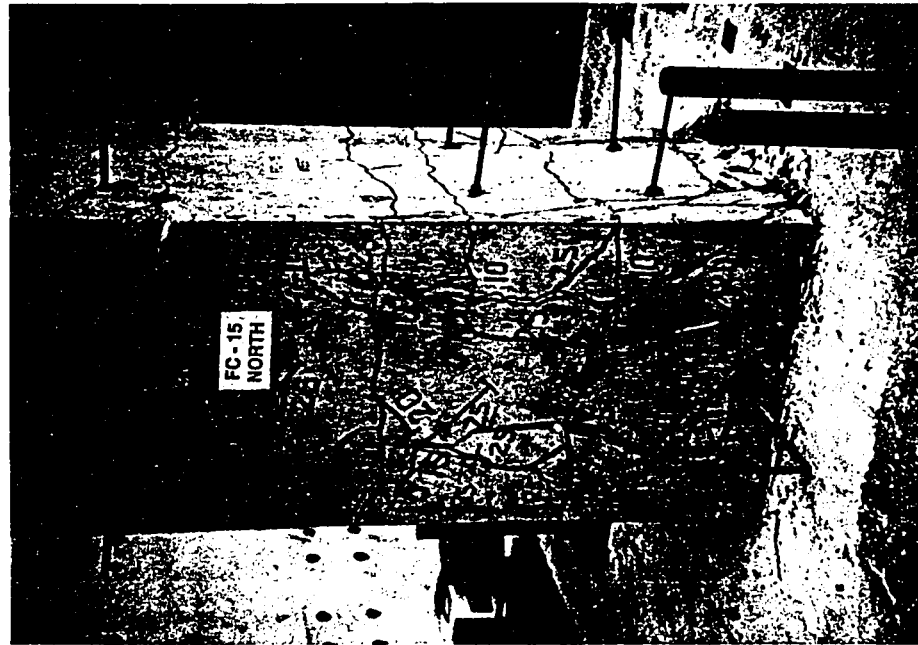
(a) Crack pattern at splice, N-W side

(b) Crack pattern at splice, S-W side

Figure 4.37 Basic Flexural Column FC15

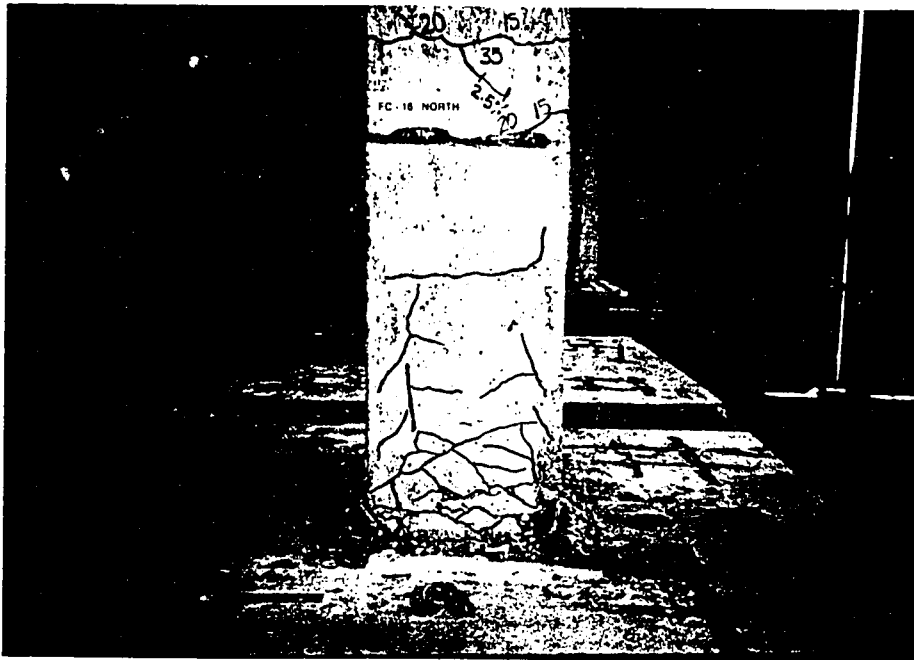
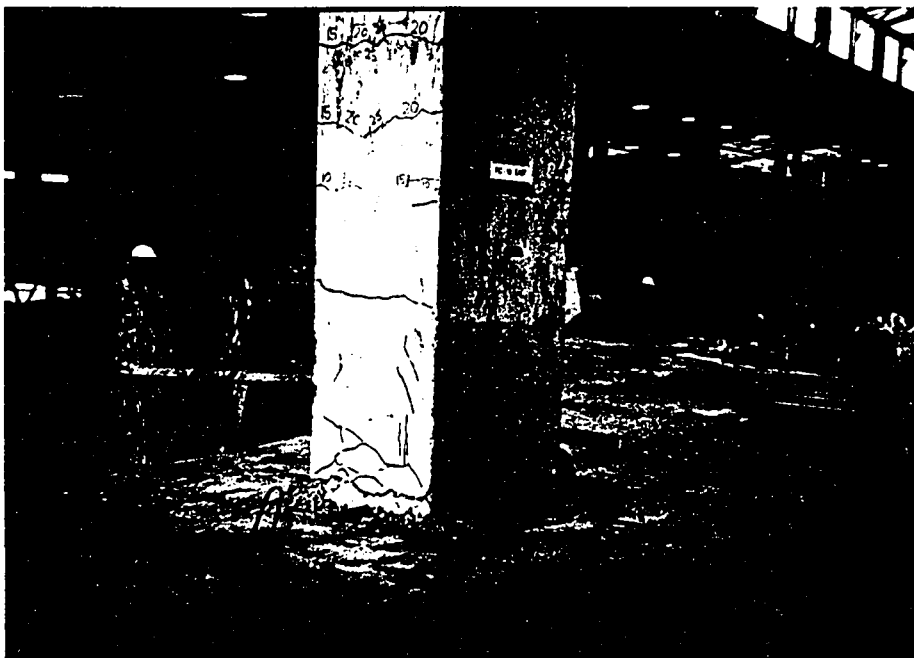
(a) Crack pattern at the splice, north side

(b) Crack pattern at the splice, S-E side

Figure 4.41 Strengthened Flexural Column FC16

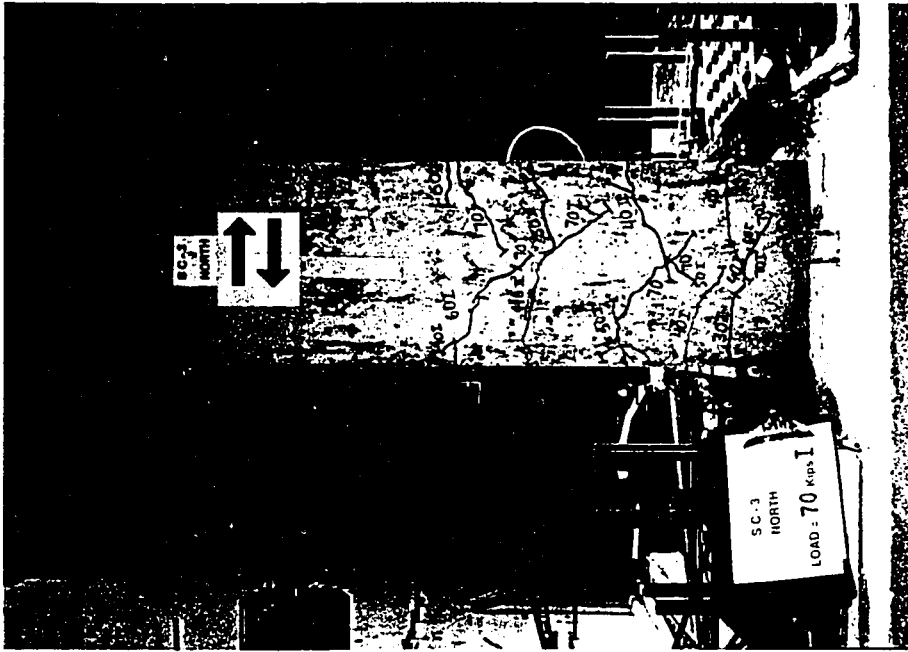
(a) Crack pattern during the cycle to 60 kips

(b) Crack pattern during the cycle to 70 kips

Figure 5.6 Basic Unretrofitted Shear Column SC3

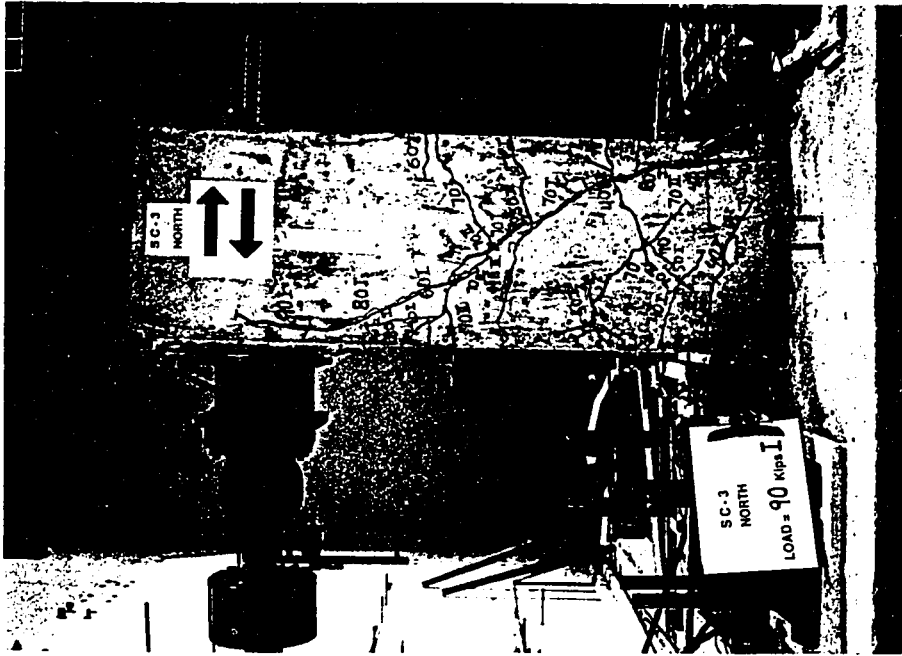
(a) Crack pattern during the cycle to 80 kips

(b) Crack pattern during the cycle to 90 kips

Figure 5.7 Basic Unretrofitted Shear Column SC3

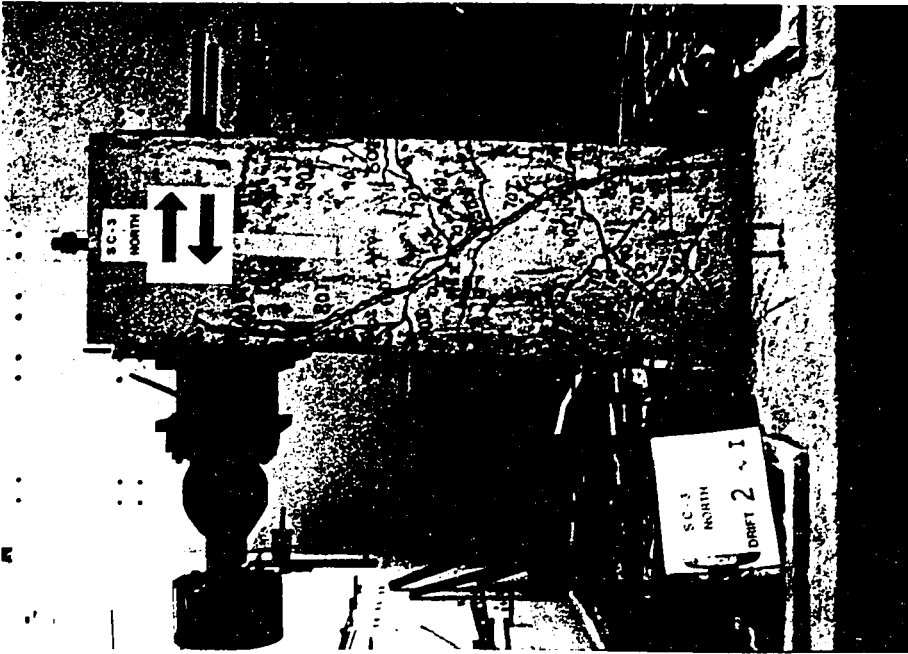
(a) Crack pattern during the cycle to 2.0% drift ratio

(b) Crack pattern during the cycle to 2.5% drift ratio

Figure 5.8 Basic Unretrofitted Shear Column SC3

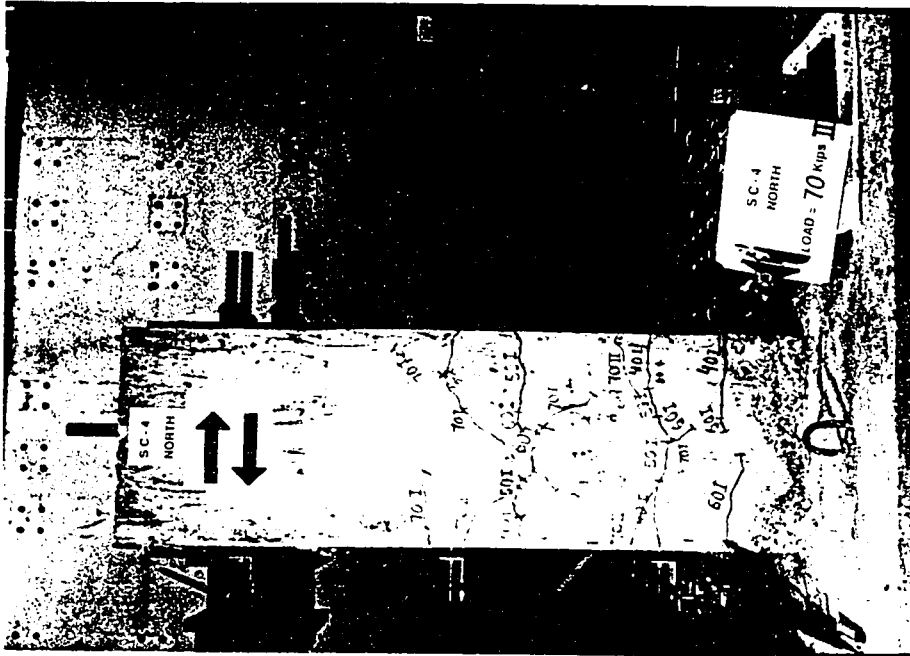
(a) Crack pattern during the cycle to 70 kips

(b) Crack pattern during the cycle to 80 kips

Figure 5.10 Basic Unretrofitted Shear Column SC4
