**SEISMIC RETROFIT OF NON-DUCTILE REINFORCED  
CONCRETE COLUMNS USING RECTANGULAR  
STEEL JACKETS**

**DISSERTATION**

The University of Texas at Austin

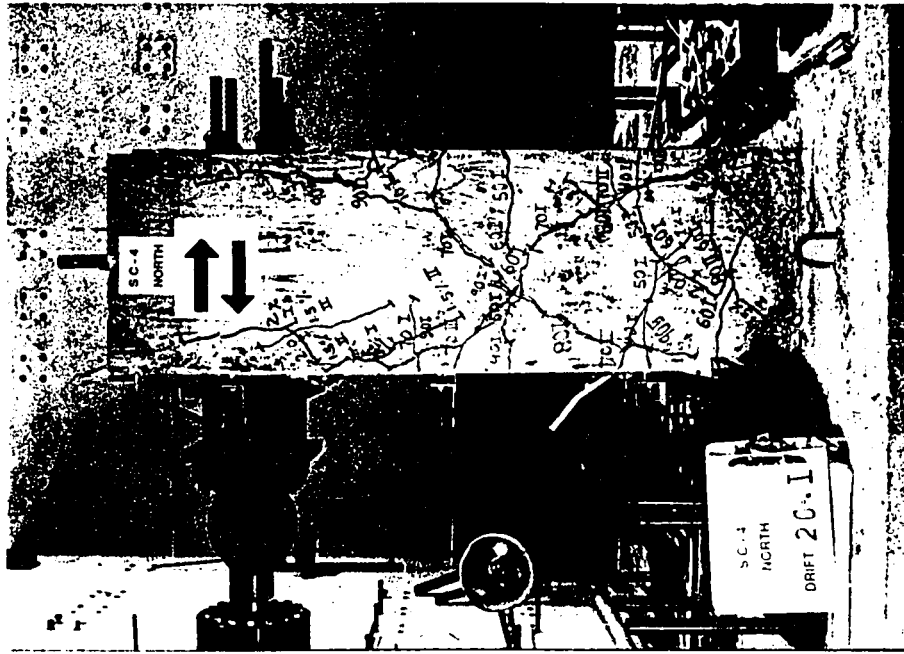
(a) Crack pattern during the cycle to 90 kips

(b) Crack pattern during the cycle to 2.0% drift ratio

Figure 5.11 Basic Unretrofitted Shear Column SC4

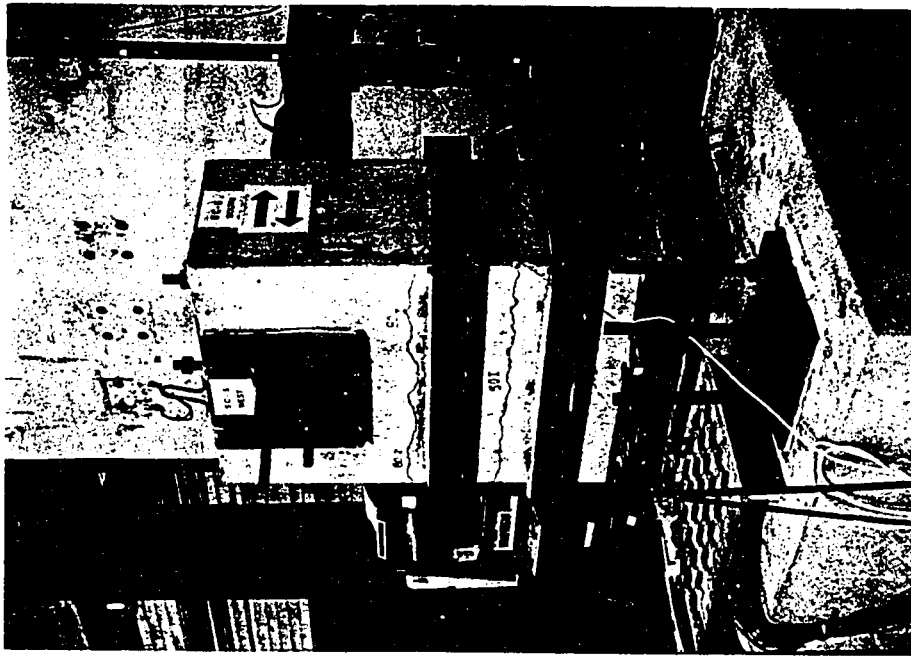
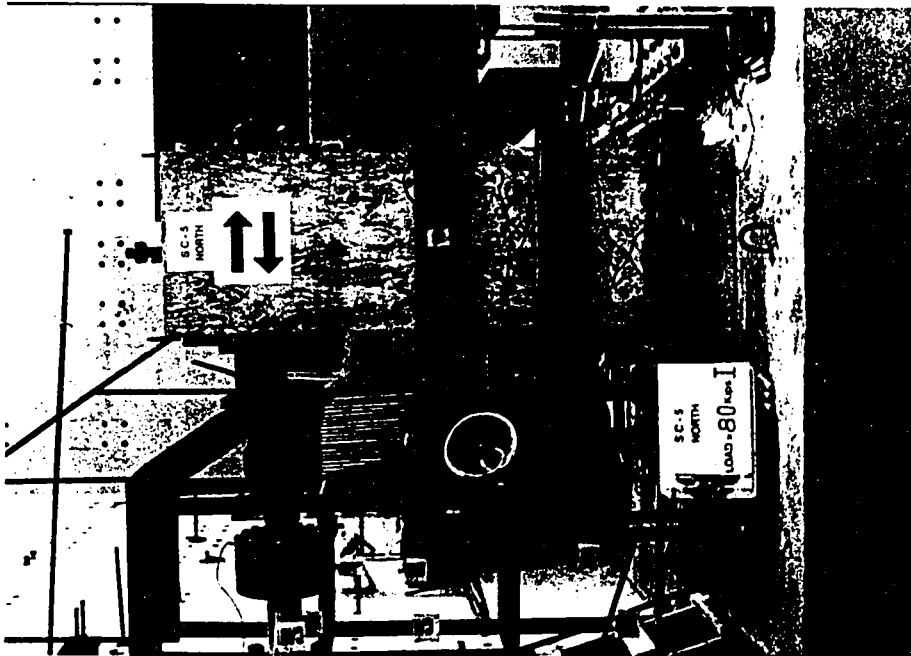
(a) Crack pattern during the cycle to 80 kip, S-W view

(b) Crack pattern during the cycle to 80 kips, north side

Figure 5.13 Strengthened Shear Column SC5

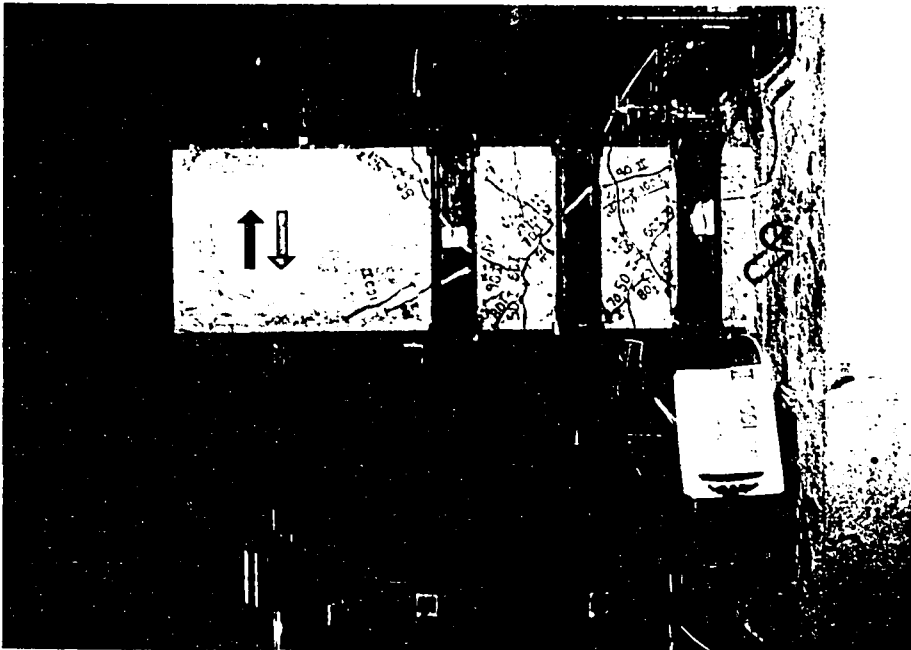
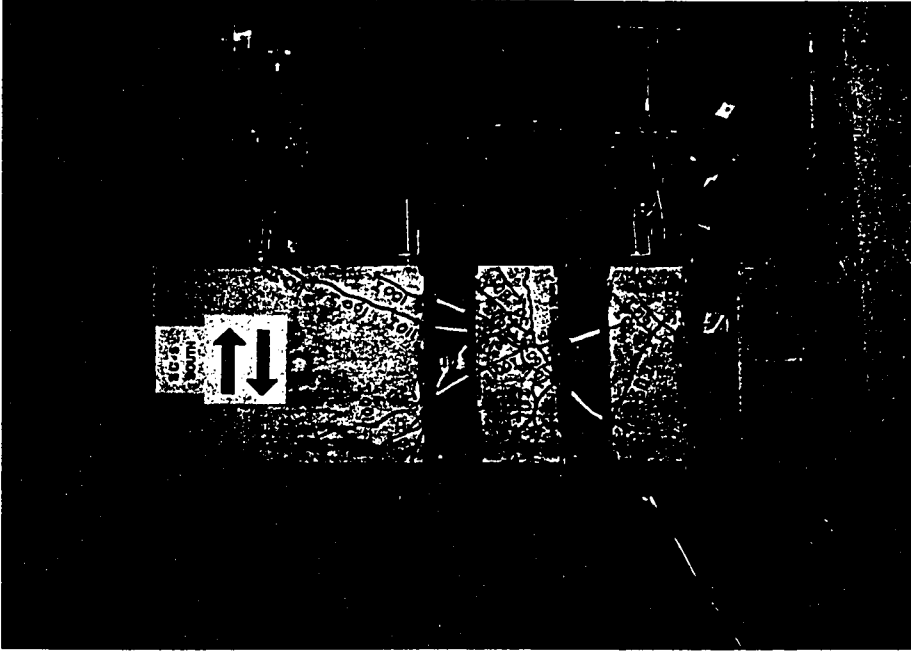
(a) Crack pattern during the cycle to 100 kips, north side

(b) Crack pattern during the cycle to 110 kips, south side

Figure 5.14 Strengthened Shear Column SC5

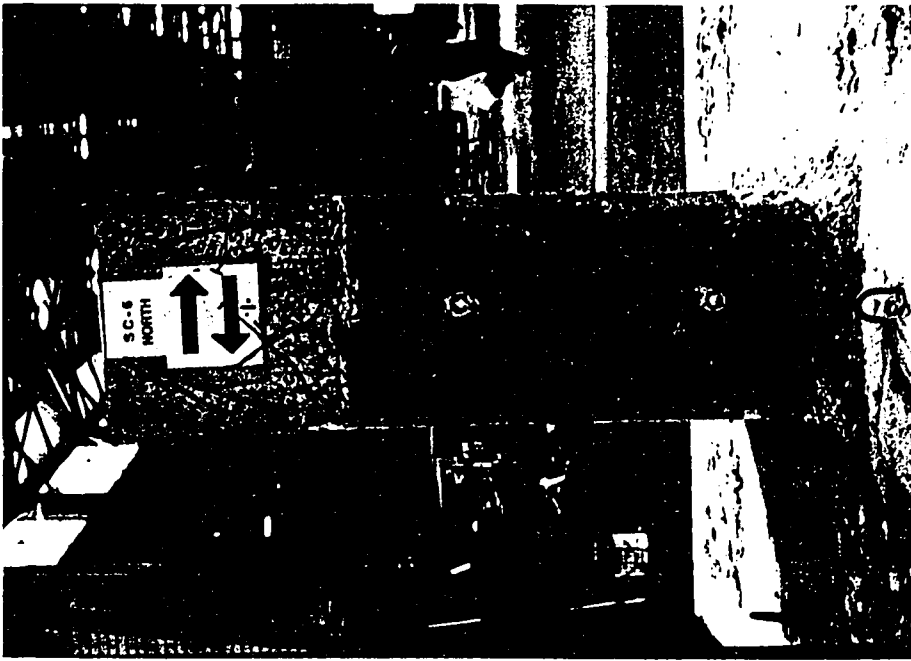
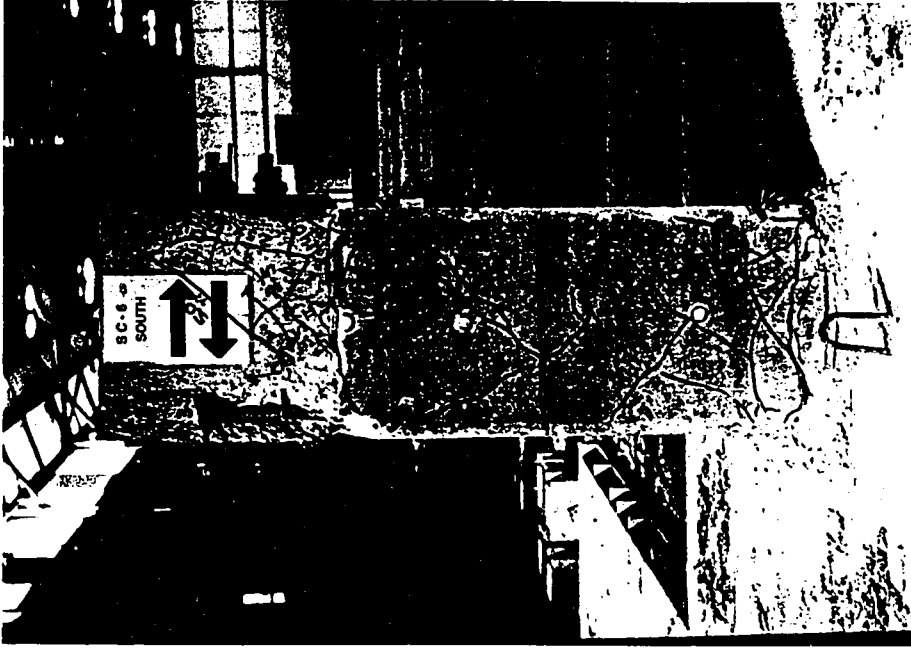
(a) Crack pattern on the north side

(b) Crack pattern on the south side

Figure 5.18 Strengthened Shear Column SC6

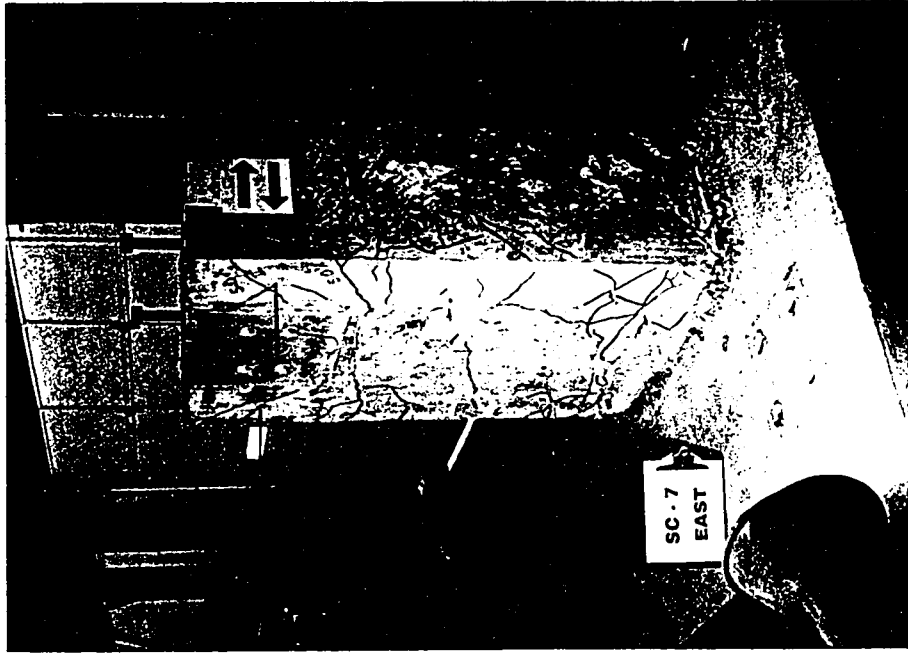
(b) Crack pattern, N-E view

Figure 5.21 Strengthened Shear Column SC7, after the test

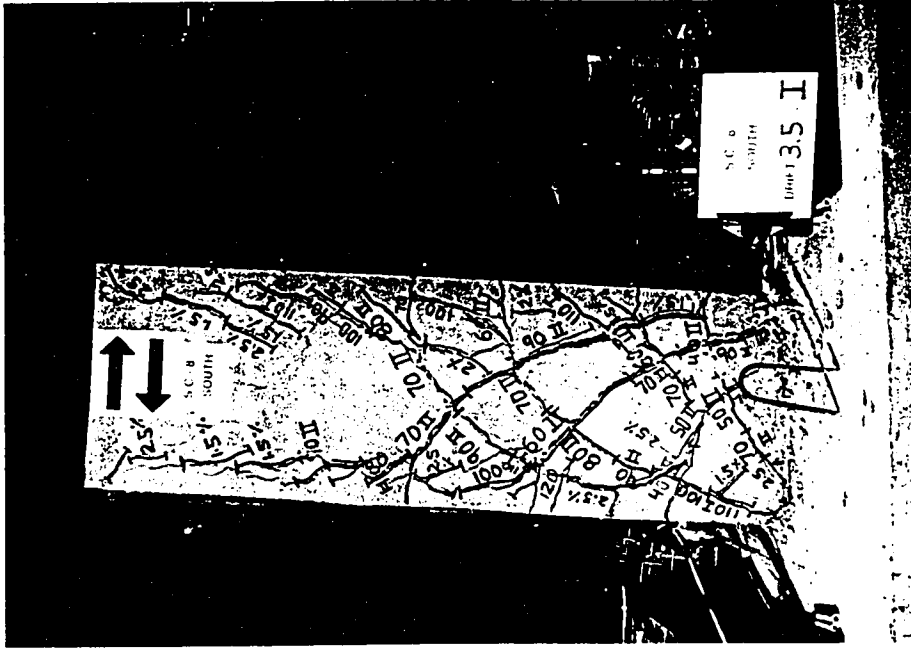
(b) Crack pattern during the cycle to 3.5% drift ratio

Figure 5.23 Strengthened Shear Column SC8

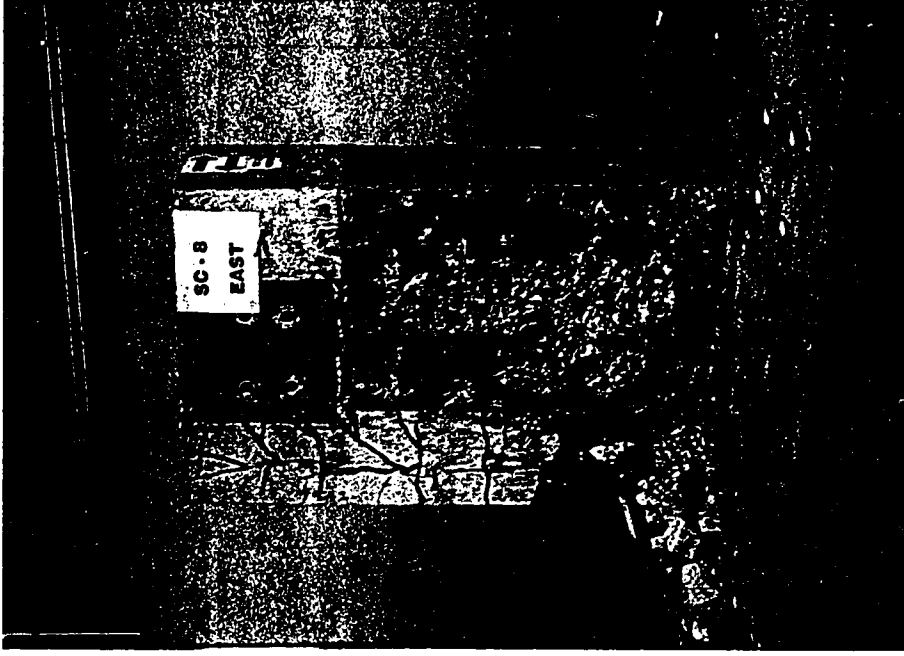
(b) Crack pattern after the removal of the steel jacket

Figure 5.25 Strengthened Shear Column SC8, after the test, east side

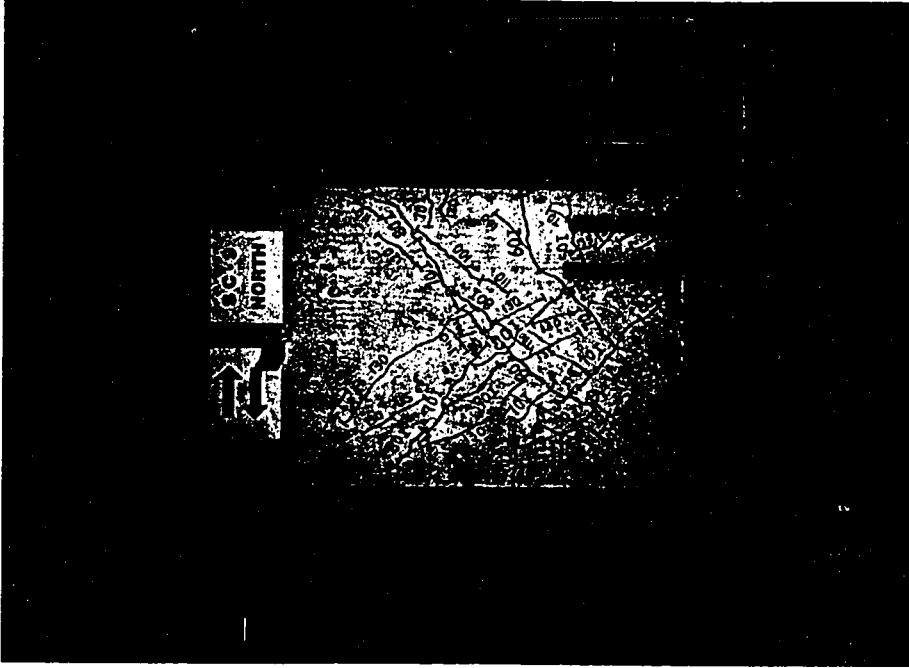
(a) Crack pattern during the cycle to 80 kips

(b) Crack pattern during the cycle to 140 kips

Figure 5.27 Basic Unretrofitted Shear Column SC9

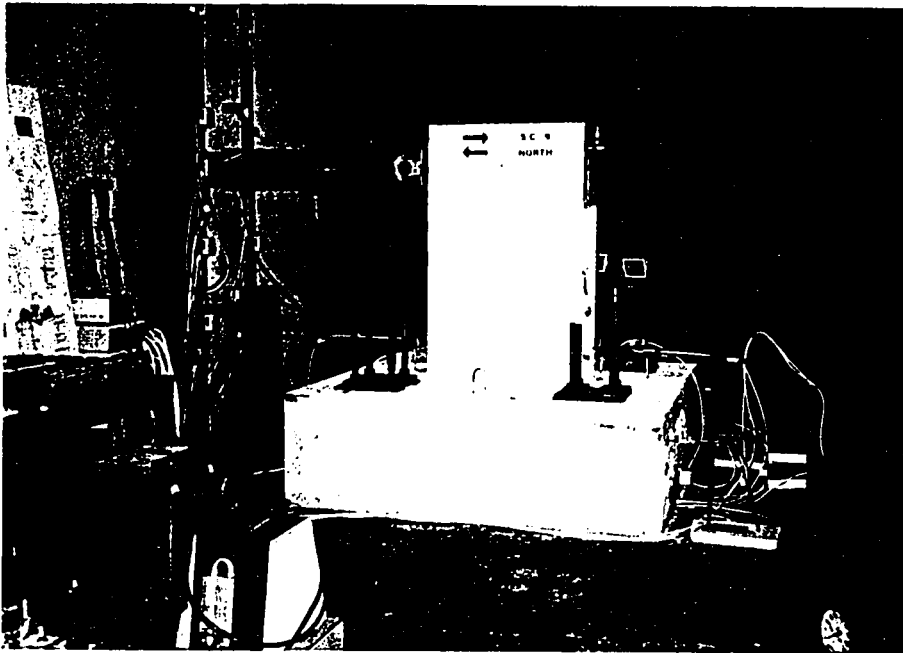
(a) Column SC9 under the test setup

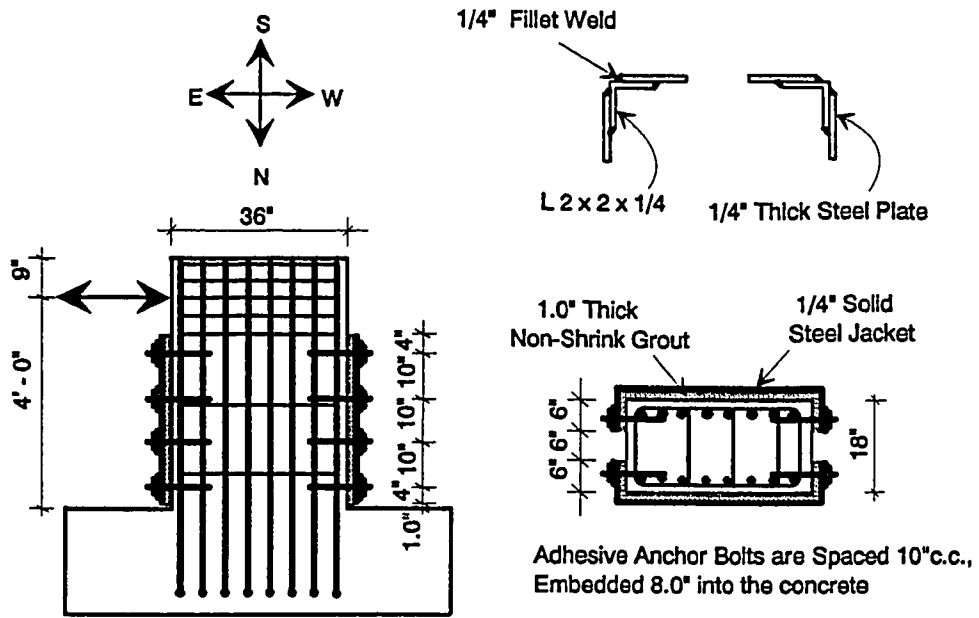
(a) Details of Column SC11

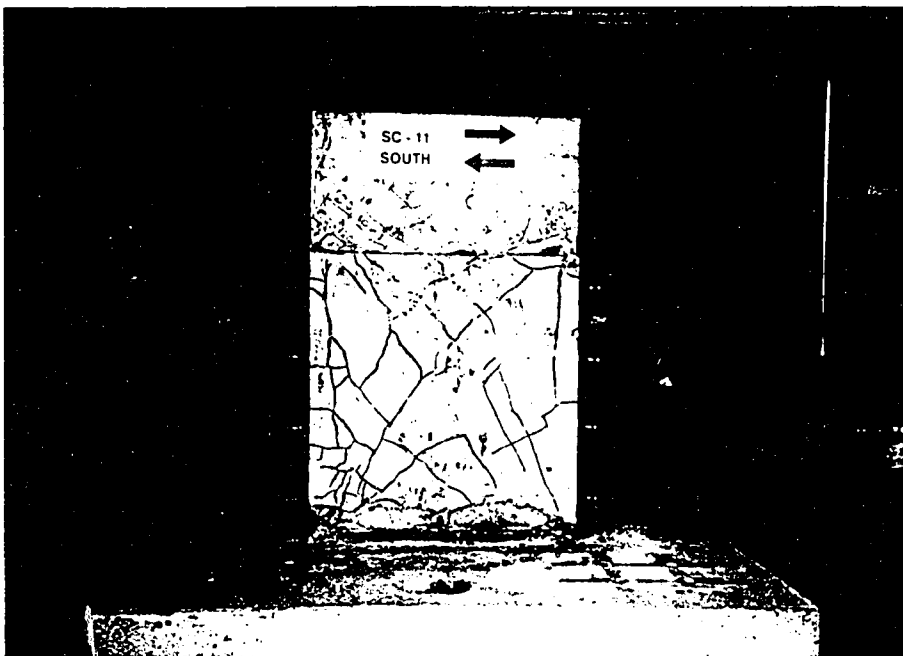
(a) Column SC11 at the end of the test

(b) Crack pattern after the removal of the steel jacket

Figure 5.33 Strengthened Shear Column SC11

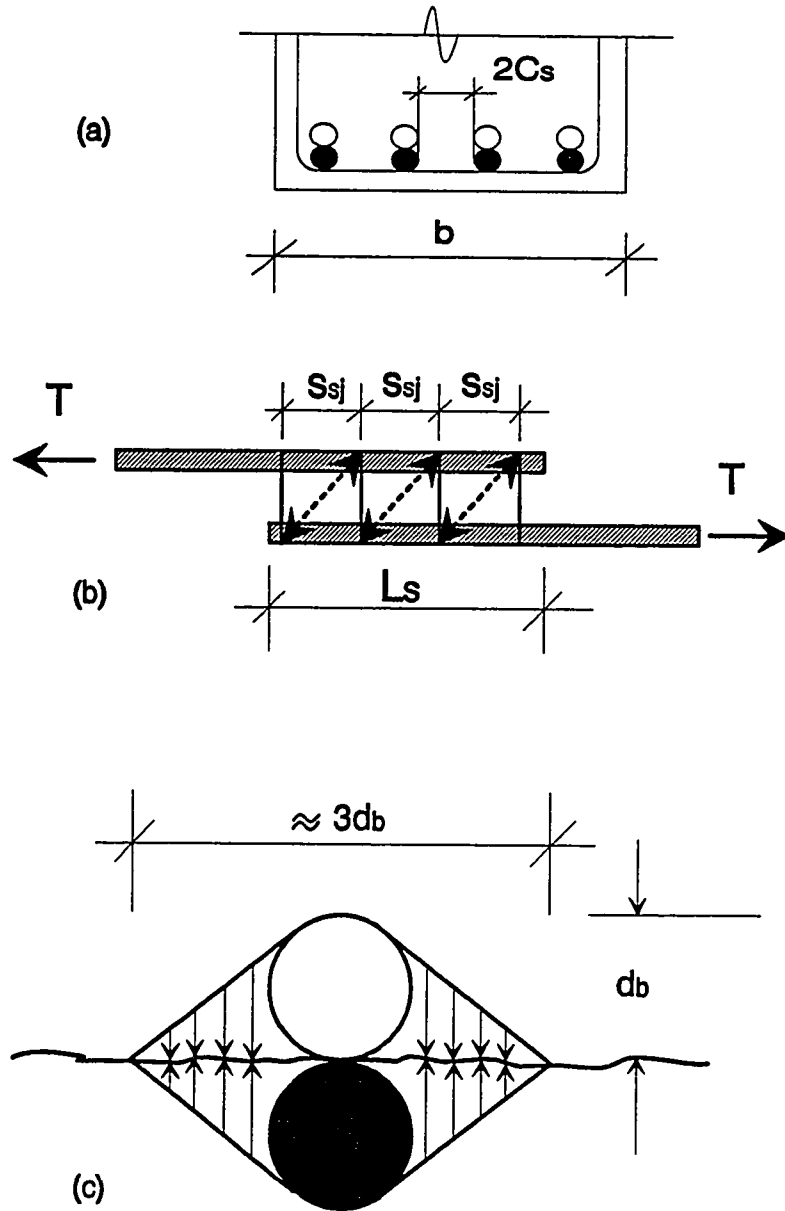
Figure 8.1 Compression Field Across Two Spliced Bars Developed by Steel Jacket

with inadequate lap splices was based on a shear friction mechanism of concrete in the plane of the spliced bars. The steel jackets may contain adhesive anchor bolts. The effectiveness of the steel jackets is considered limited by the critical dilation strain, which was determined experimentally.
