**Evaluation of the Fatigue Behavior of Bridge Decks with
Precast Panels at Expansion Joints**

Thesis

The University of Texas at Austin

**The University of Texas at Austin
May 2007**

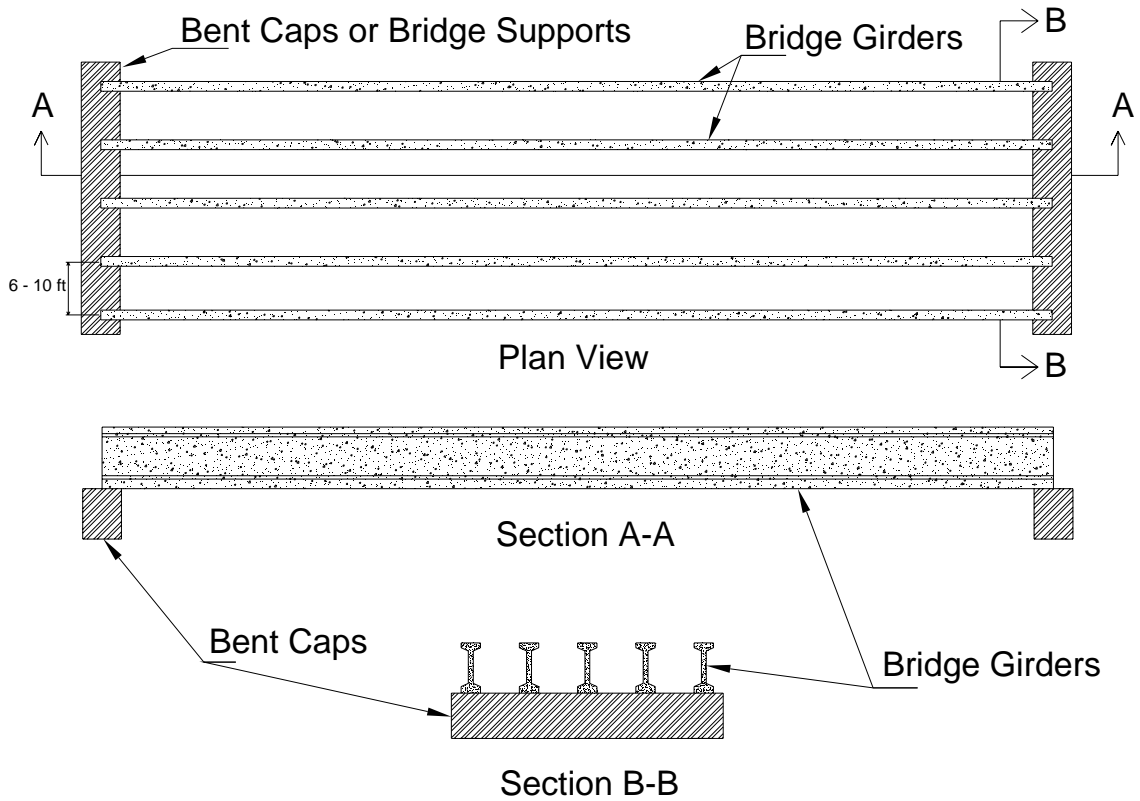
Figure 1.1: Typical Prestressed Concrete Bridge Construction Prior to Placing Bridge Deck

The construction sequence for a bridge deck is illustrated in Figure 1.1 and Figure 1.2. After completion of the supports (bent caps and abutments), the bridge girders are positioned in the longitudinal direction (Figure 1.1). The girder spacing typically varies between 6 and 10 ft.

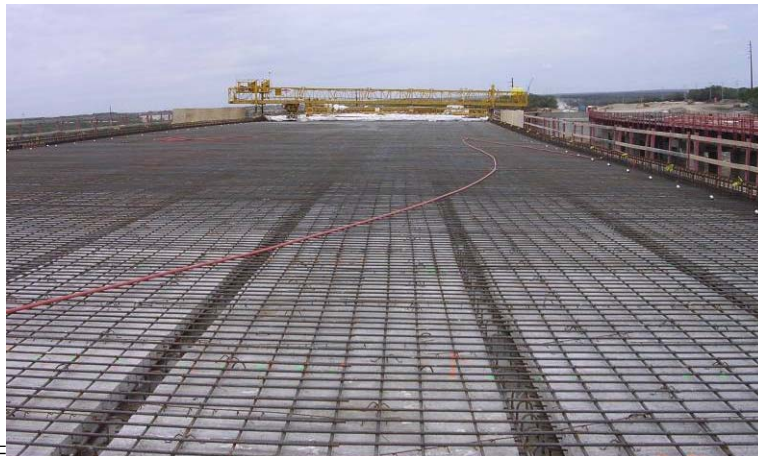
Figure 1.3: PC Panels and Reinforcing Steel Prior to Casting Topping Slab

Figure 1.2 is a simple representation of a typical bridge as the PC panels are placed during construction. Figure 1.3 also shows a photograph of a TxDOT bridge deck prior to casting the topping slab, in which the PC panels can be seen underneath the mat

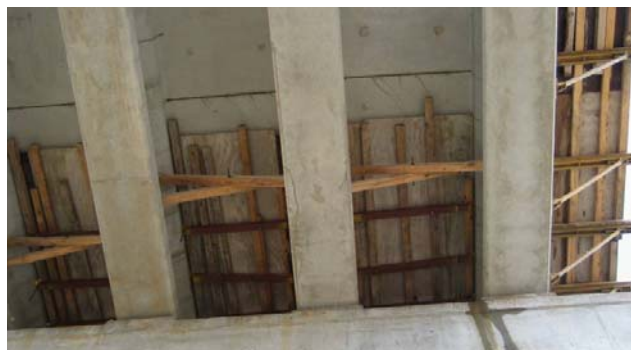
Figure 1.5: View from Underneath Bridge of Formwork for IBTS Detail

The primary construction difficulty associated with the IBTS detail is the temporary formwork that must be constructed to support the CIP concrete (Figure 1.5). Because bridge overpasses are often at an elevation high above grade, it is difficult and dangerous work to construct and remove this formwork.

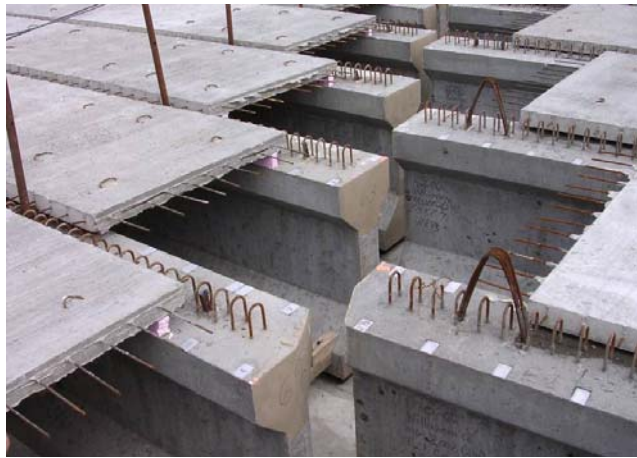
Figure 1.6: Construction of Expansion Joint with Skewed Angle Orientation

A second construction challenge at expansion joints is that the longitudinal direction of the bridge might be skewed with respect to the abutments or bent caps. Figure 1.6 illustrates that skew angles can create complex geometries when using rectangular PC panels at expansion joints.

The configuration of PC beams shown in Figure 1.6 highlights another potential problem. If the lengths of the adjacent spans differ, the number of beams is likely to be different in the spans.

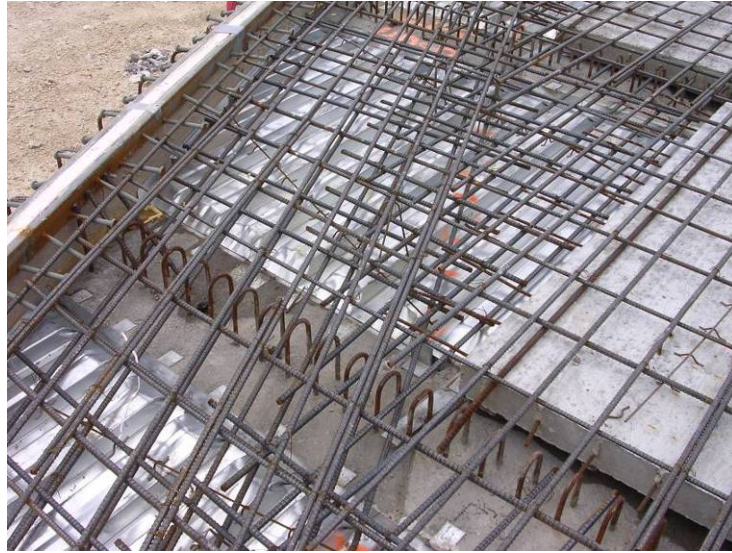
Figure 1.7: IBTS Detail Prior to Casting Topping Slab

Both bridges were constructed with PC girders, and PC panels were used as stay-in-place formwork for the interior portions of the bridge deck. Figure 1.7 shows the IBTS detail prior to casting the topping slab for a skewed bridge deck. The sealed

expansion joint can be seen along the upper left corner of the picture, and the reinforcing steel can be seen within the IBTS section.

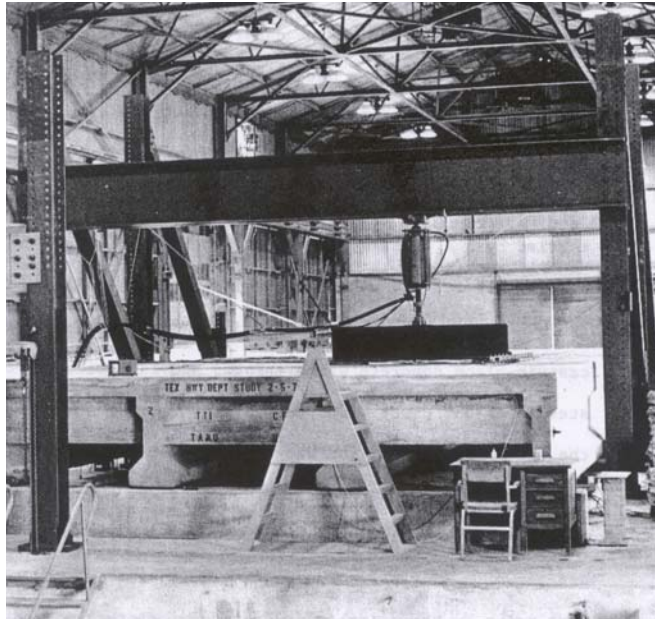
Figure 2.1: Full-scale Bridge Deck Specimen (Buth, et al. 1972)

The results of the fatigue tests indicated that the bond at the interface of the PC panel and CIP slab showed no signs of distress. Also, at the loading location near the butt-joints, the interface was not damaged. After the fatigue testing was concluded, the bridge deck was tested to failure. The lowest cracking load was 3.8 times the design wheel load, and the lowest measured failure load was 12.5 times the design wheel load.

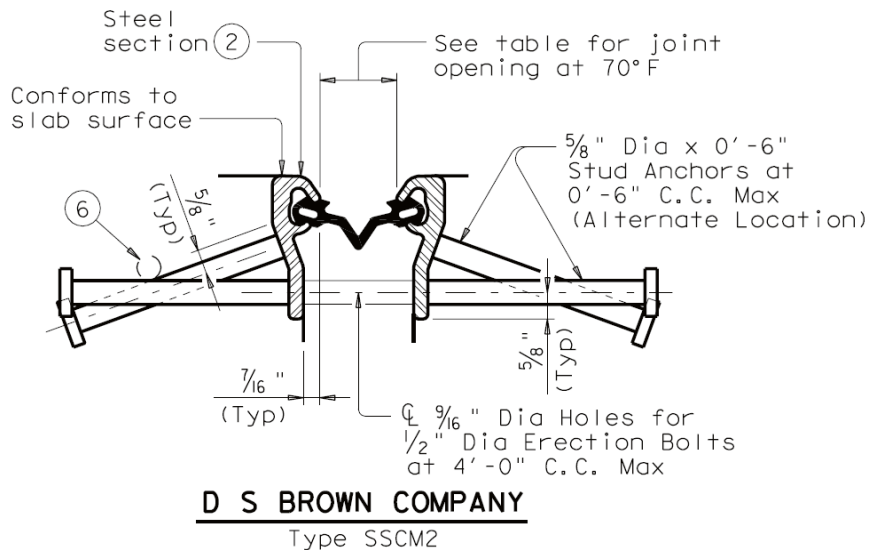
Figure 2.2: Sealed Expansion Joint (SEJ-A) Detail (TxDOT)

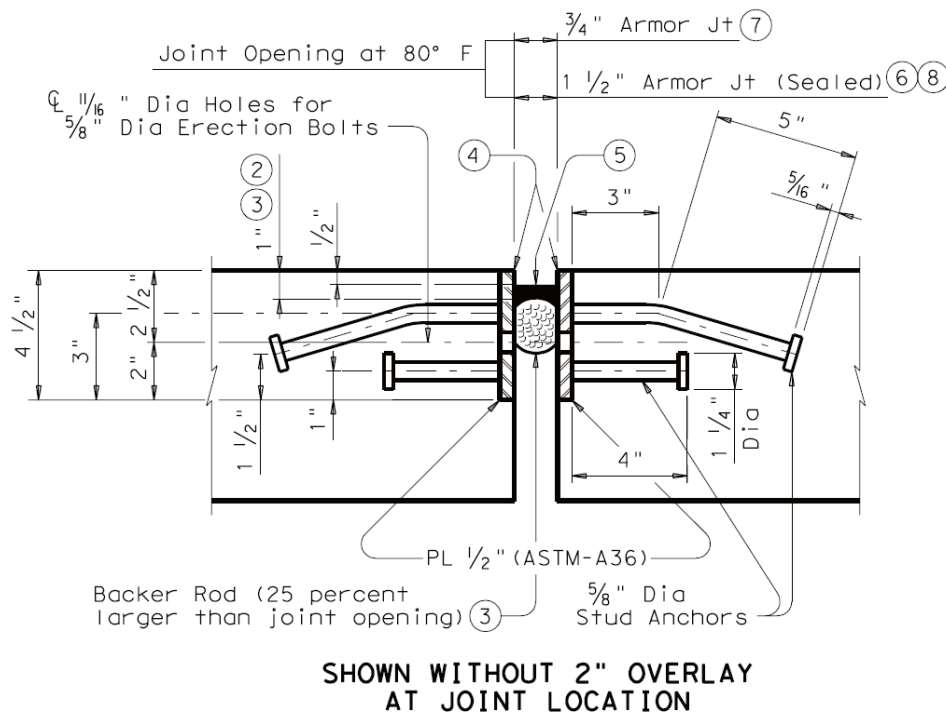
Figure 2.3: Cross Section of TxDOT Armor Joint Rail (TxDOT)

Several failures were reported where the steel studs had fractured from the steel sections. The research team removed samples of these failed joints from bridge decks to determine the cause of failure. They conducted several tests to measure the weld strength of the steel studs, and also measured the yield strengths of the steel sections and steel studs. They found that the yield strengths were sufficient and that all steel studs had been welded correctly. The conclusion of the research team was that the steel studs and expansion joint rails were sufficient, but the cause for failure was insufficient consolidation of the concrete around the steel studs. Insufficient consolidation resulted in uneven bearing of the steel studs that resulted in high stress concentrations at the weld, and under fatigue loading, the welds fractured.

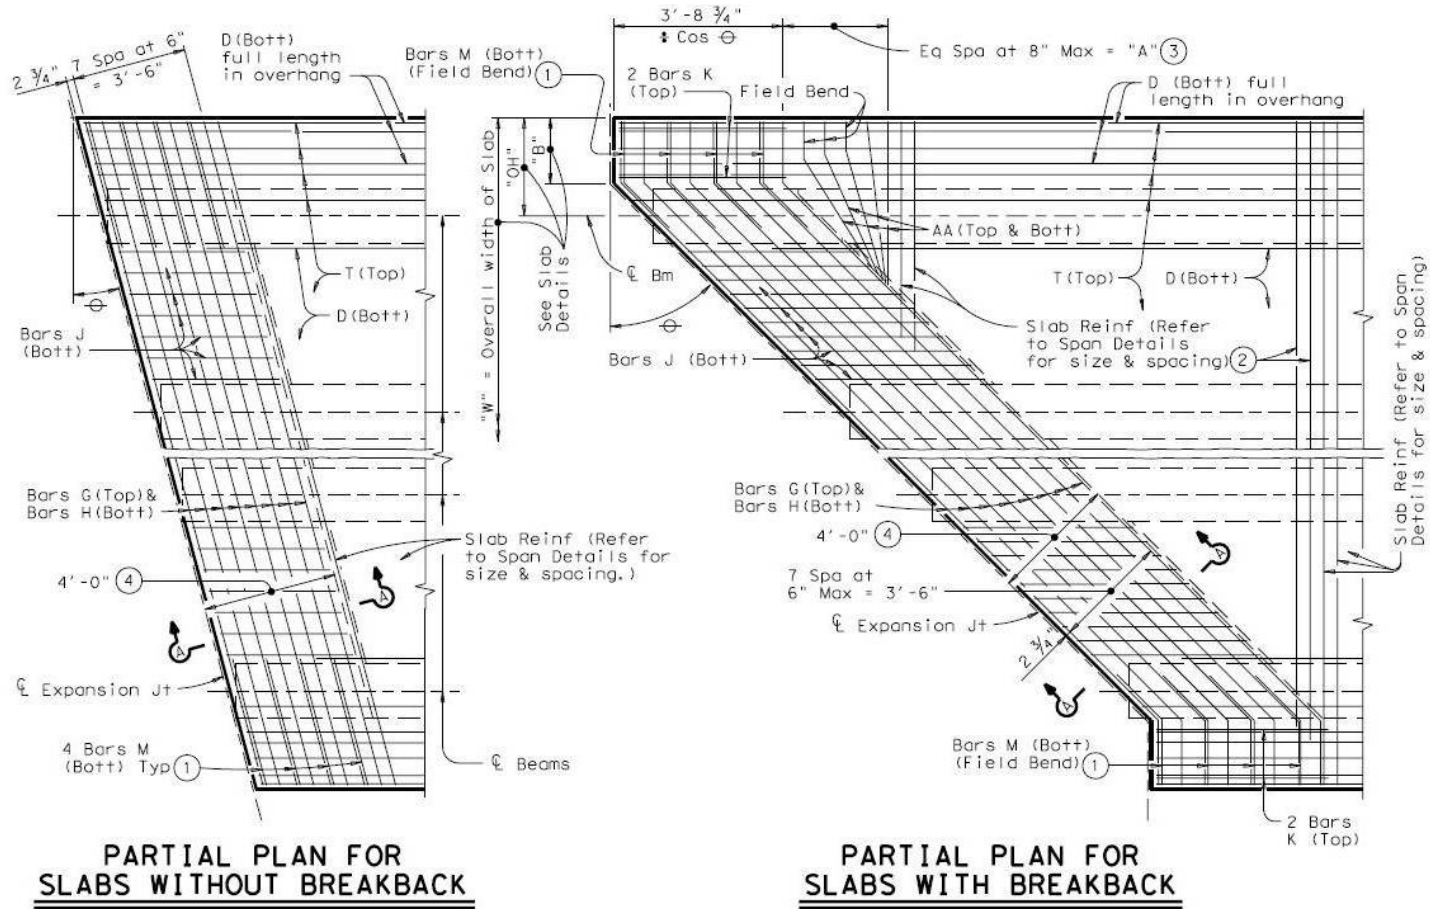
Figure 2.4: Plan View of IBTS Detail at Expansion Joints (TxDOT)

the girders. To sustain both the positive and negative moments in this slab end region, the IBTS detail is reinforced with top and bottom reinforcement in both the longitudinal and transverse directions. Typical bridge decks are constructed with the PC panels placed in the interior portions of bridge. However, the only area that was evaluated during this test was the expansion joint, and PC panels were not used for the interior portion of the test specimen.

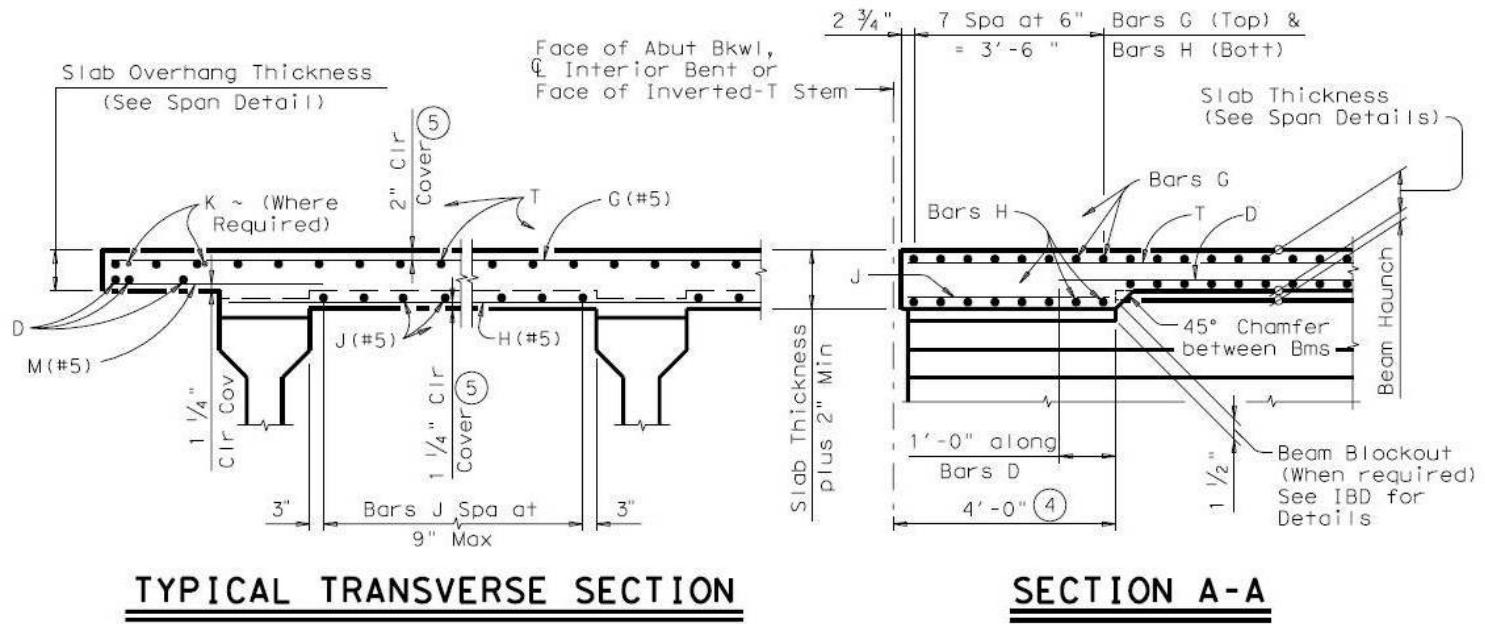
Figure 2.5: Cross Section Views of IBTS Detail (TxDOT)

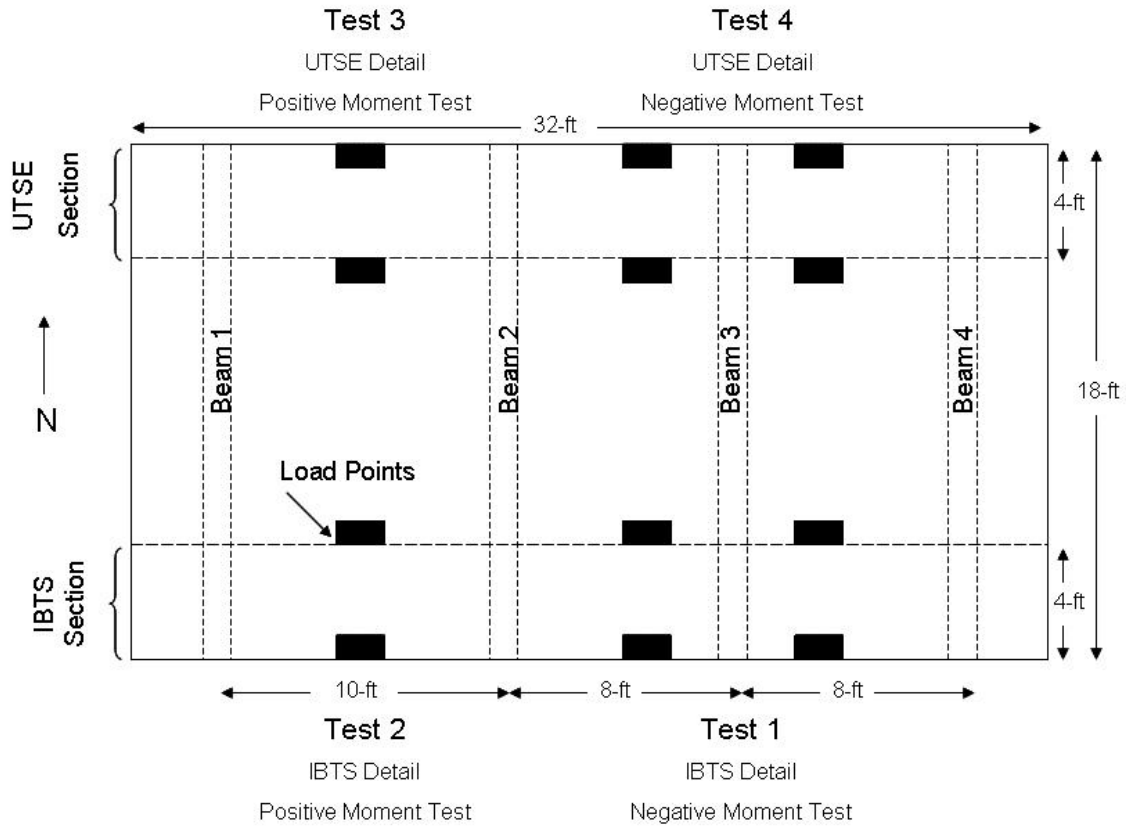
Figure 2.8: Plan View of 0° Skew Bridge Deck Specimen (Ryan 2003)

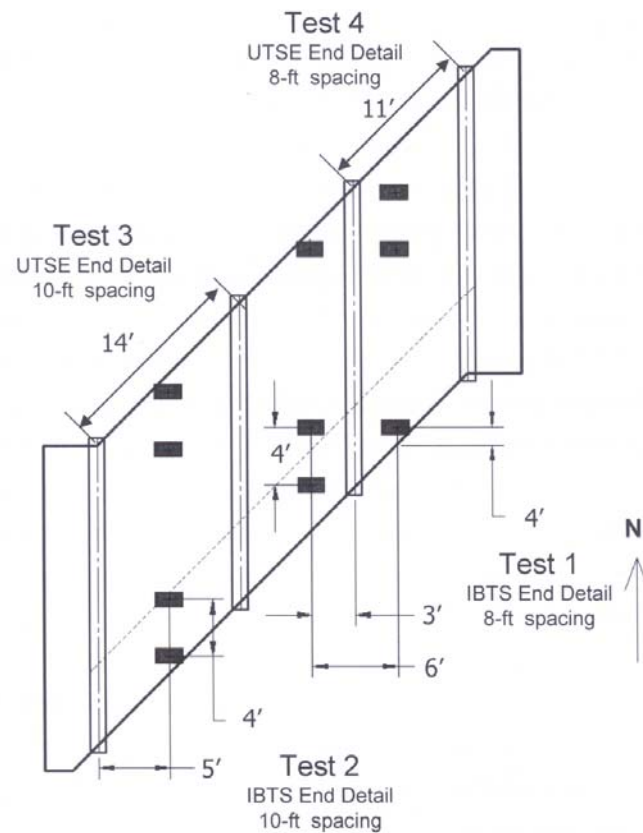
Figure 2.13: Second Specimen Loading Configurations (Griffith 2003)

After the relationship between the skew angle and the loading configuration was determined, four specific test areas were designed for the skewed specimen (Figure 2.13). Tests 2 and 3 evaluated the maximum positive moment experienced by the slab within the 10-ft span by placing at midspan two wheel loads from the HL-93 Design Tandem. Tests 1 and 4 investigated the maximum negative moment within the 8-ft span by centering the HL-93 Design Tandem across a beam, but only three wheel loads were located on the slab, as shown in Figure 2.13.

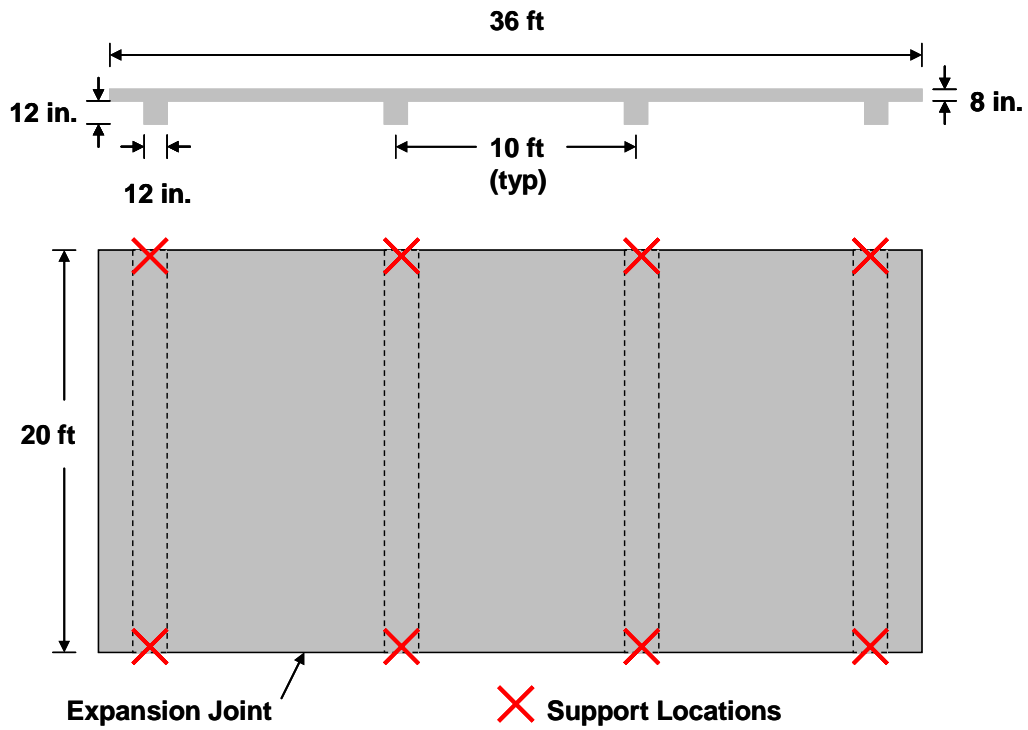
Figure 3.6: Cross Section and Plan Views of 3-D Model of Bridge Deck

The first model was a 32-ft wide bridge deck with four longitudinal girders (Figure 3.6.) The model was 20 ft in the longitudinal direction. The 8-in. slab was assumed to be monolithic with the girders. Each girder was 12 in. wide and extended 12 in. below the slab. The nodes at each end of the centerline of the beams were restrained against translation in all three directions.

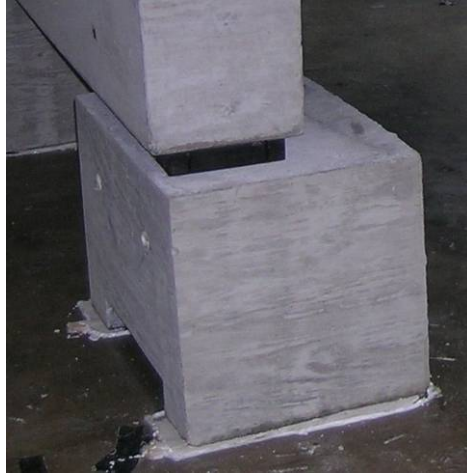
Figure 3.19: Concrete Support Block and Bearing Pad

20-in. tall) were positioned at each end of each beam. These blocks served to elevate the test specimens to a practical height (Figure 3.19).

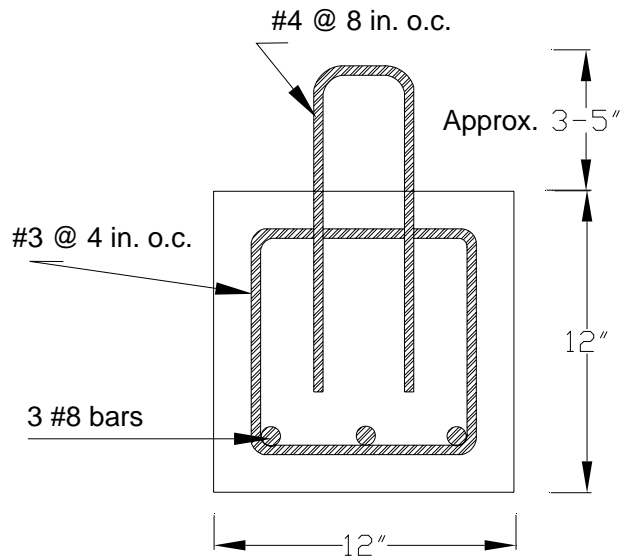
Figure 3.22: Cross Section of Precast Support Beams

The main purpose of these beams was to support the edges of the PC panel and to reproduce typical TxDOT conditions. In most TxDOT PC girders, horizontal shear reinforcement is included to resist the shear at the interface of the PC girder and the CIP deck. Therefore, #4 U-bars were cast in the support beams to reflect typical TxDOT conditions (Figure 3.22).

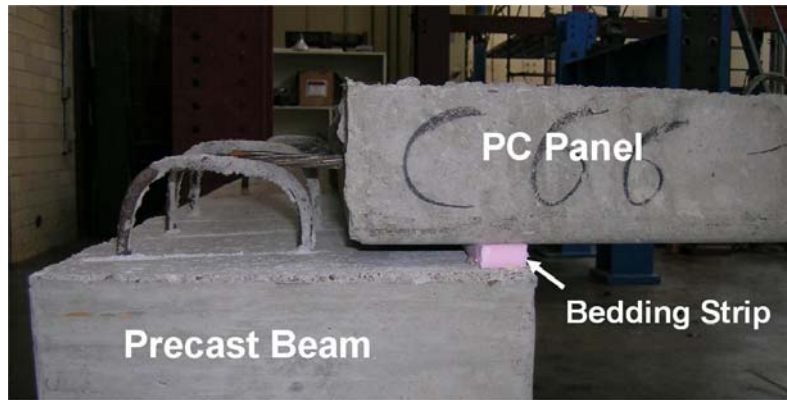
Figure 3.24: Test Specimen Bedding Strip and PC Panel Cross Section

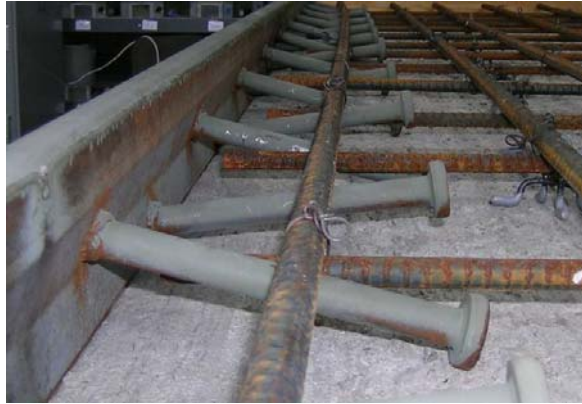
Figure 3.26: SEJ-A Steel Studs Prior to Casting

According to TxDOT, the most common expansion joint rail used in bridge slabs is the SEJ-A detail (Figure 2.2). Therefore, the SEJ-A section was chosen for the final design. The SEJ-A section is 3½ in. deep and fits within the space allowed by a 4-in. thick CIP topping. In the previous specimen tested by Coselli (2004), the SEJ-P was used, which required the studs to be bent because the SEJ-P section is deeper than the allowable 4-in. depth of the CIP topping. For this investigation, 6-in. steel studs were welded to the SEJ section at a spacing of 6 in. on center (Figure 3.26). Erection bolt holes were drilled every 4 ft along the member to connect to the formwork prior to placing the CIP topping.

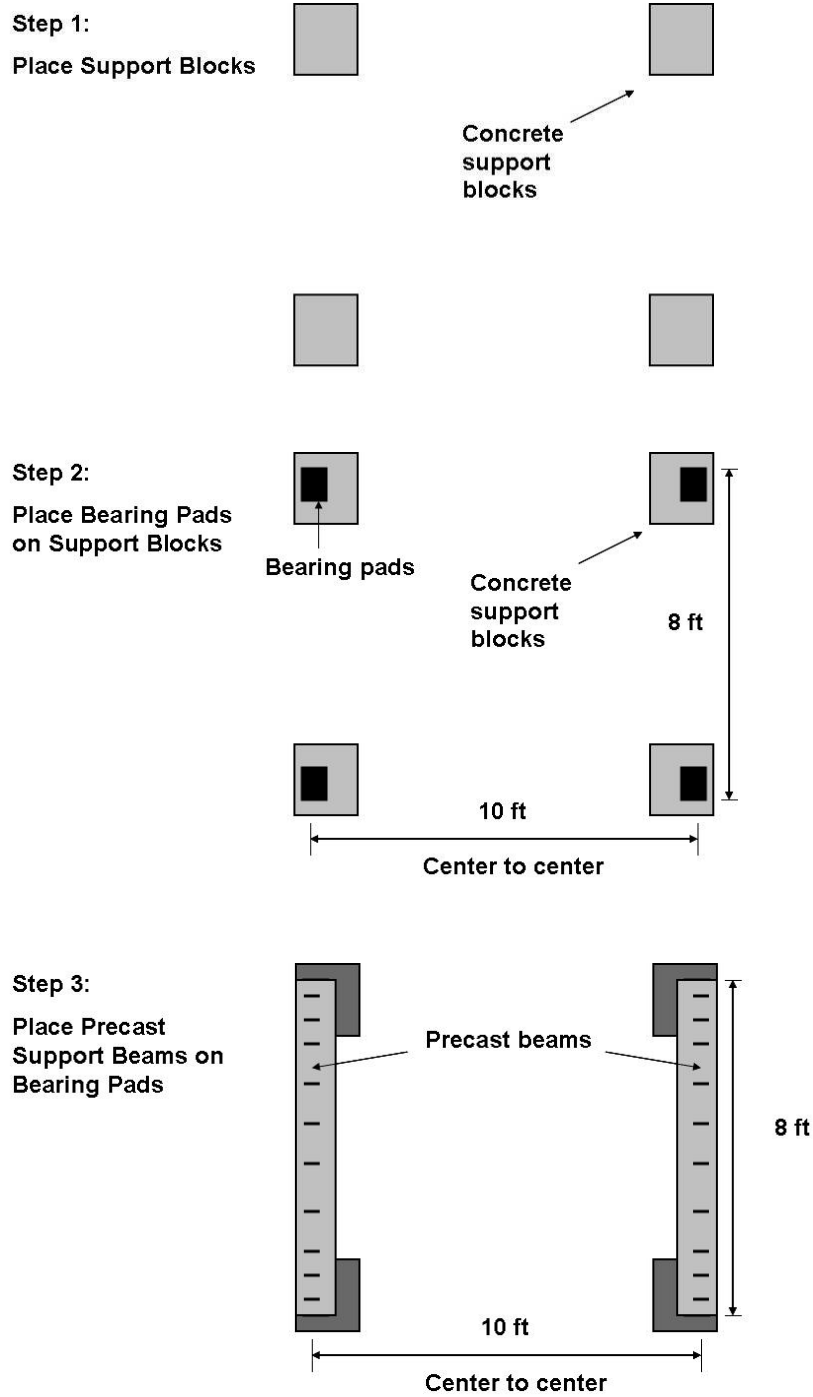
Figure 4.1: Construction of Positive Moment Specimens (Plan View)

For the specimens subjected to positive moment, the first step was to cast the concrete blocks and beams used to support the slabs. As shown in Figure 4.1, the blocks and beams were then positioned on the strong floor at Ferguson Structural Engineering Laboratory (FSEL). The concrete support blocks were placed at the corners of the specimen, and bridge bearing pads were placed on top of the blocks. The precast beams were then positioned on the bearing pads.

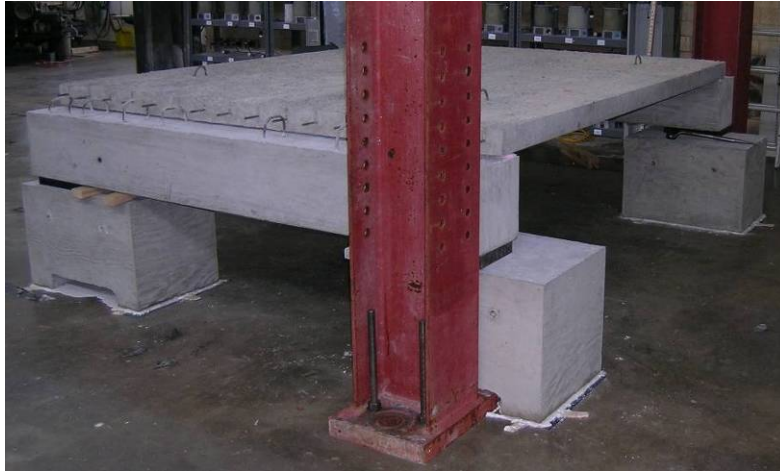
Figure 4.3: Specimen P0P1 After Placing PC Panel

Bedding strips were then glued in place along the edge of each beam, and the PC panels were placed on the beams, as shown in Figure 4.2. Figure 4.3 shows specimen P0P1 after the PC panel had been placed on top of the support beams, and the wide flange columns of the reaction frame bolted to the floor prior to building the test specimen.

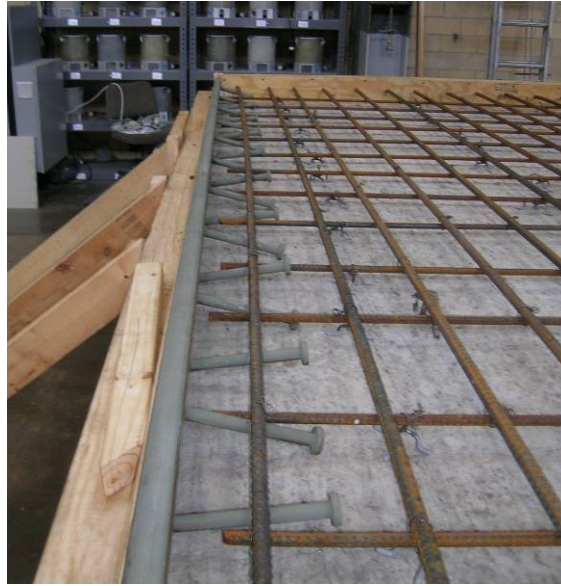
Figure 4.4: SEJ and Reinforcing Steel Prior to Casting Topping Slab

After the PC panel had been placed, formwork was constructed for the 4-in. topping slab. The formwork was braced by the strong floor, and the SEJ was attached to the formwork with erection bolts. Next, the steel reinforcement was placed and tied. In accordance with typical TxDOT standards, #4 bars were placed at 9 in. on center in the longitudinal direction. In the transverse direction, #5 bars were placed at 6 in. on center, and all reinforcing steel was supported on 7/8-in. high rebar chairs. A photograph of the SEJ and reinforcing steel is shown in Figure 4.4, and the entire specimen is shown prior to casting in Figure 4.5.

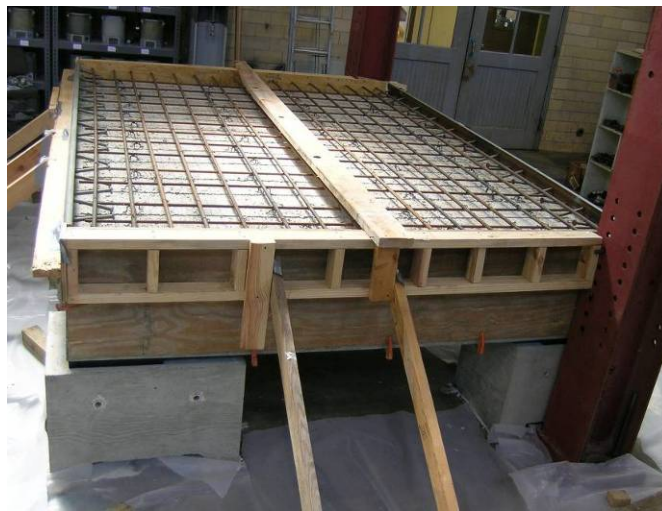
Figure 4.5: Specimen P0P1 Prior to Casting

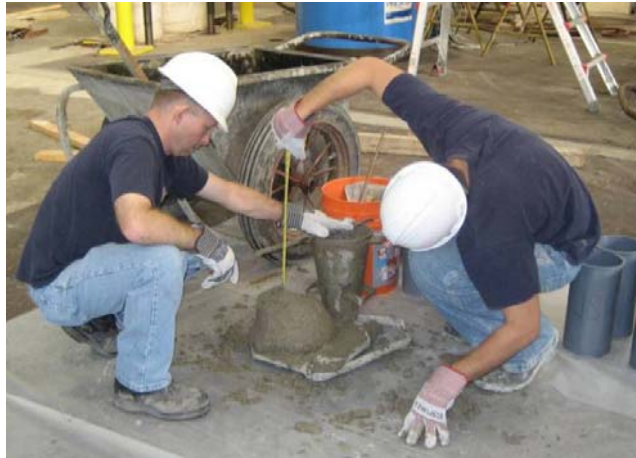
Figure 4.6: Slump Test for specimen POP1

TxDOT Class “S” structural concrete was provided by a local ready-mix supplier to cast the slab. As shown in Figure 4.6, a slump test was conducted before placing the concrete to determine if the batch was acceptable. Figure 4.7 shows the placement of the concrete for the topping slab and the consolidation of the concrete using hand-operated vibrators. After the concrete was placed, a screed was used to level the top surface, and the concrete was finished with hand trowels.

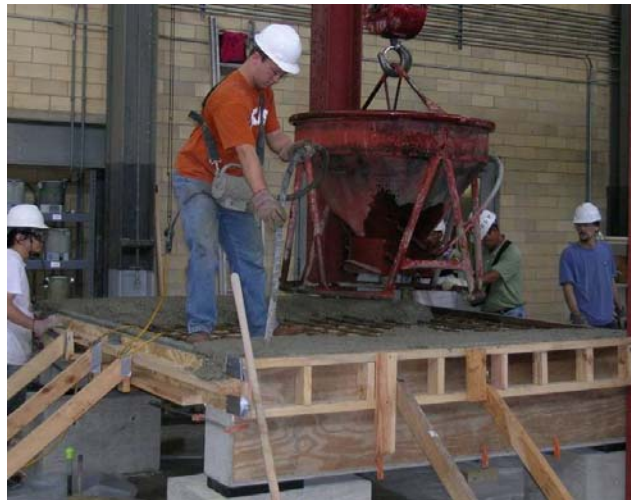
Figure 4.7: Placing Topping Slab for Specimen POP1

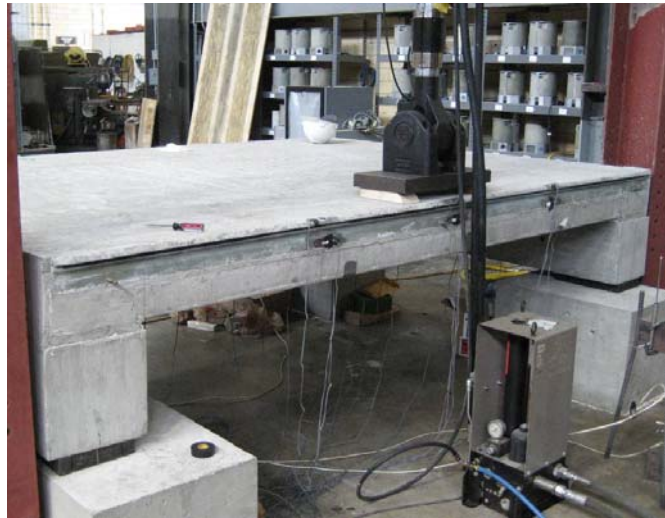
Figure 4.8: Specimen POP1 Before Testing

TxDOT typically cures the bridge slabs for 10 days by covering the slab with burlap sacks and/or plastic. For all test specimens, large sheets of plastic were cut and placed over the specimens, and the slab was allowed to cure for 10 days before removing the plastic. A photograph of the specimen POP1 before testing is presented in Figure 4.8.

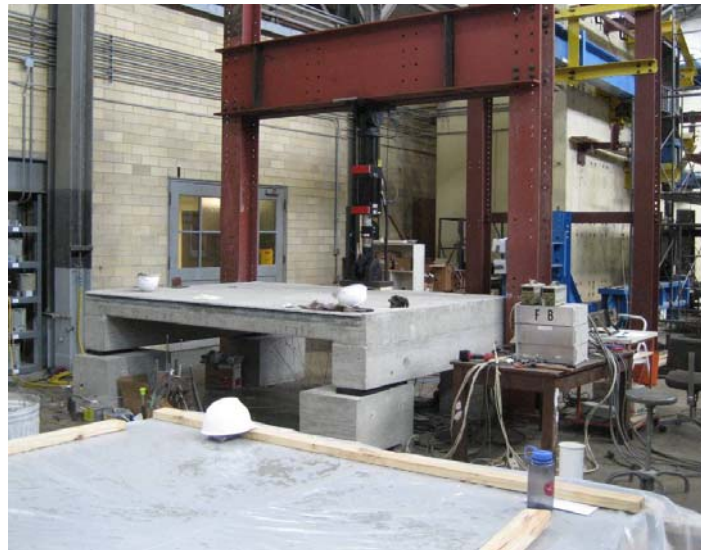
Figure 4.9: Specimen POP2 Curing While Testing Specimen POP1

Specimen POP2 was constructed similarly to specimen POP1, as shown in Figure 4.1 and Figure 4.2. However, specimen POP2 was constructed in a different location while the fatigue test of specimen POP1 was ongoing. Lifting inserts were cast in the support beams so that the completed specimen could be moved with the crane. The photograph in Figure 4.9 shows specimen POP2 immediately after casting the topping slab with specimen POP1 in the background.

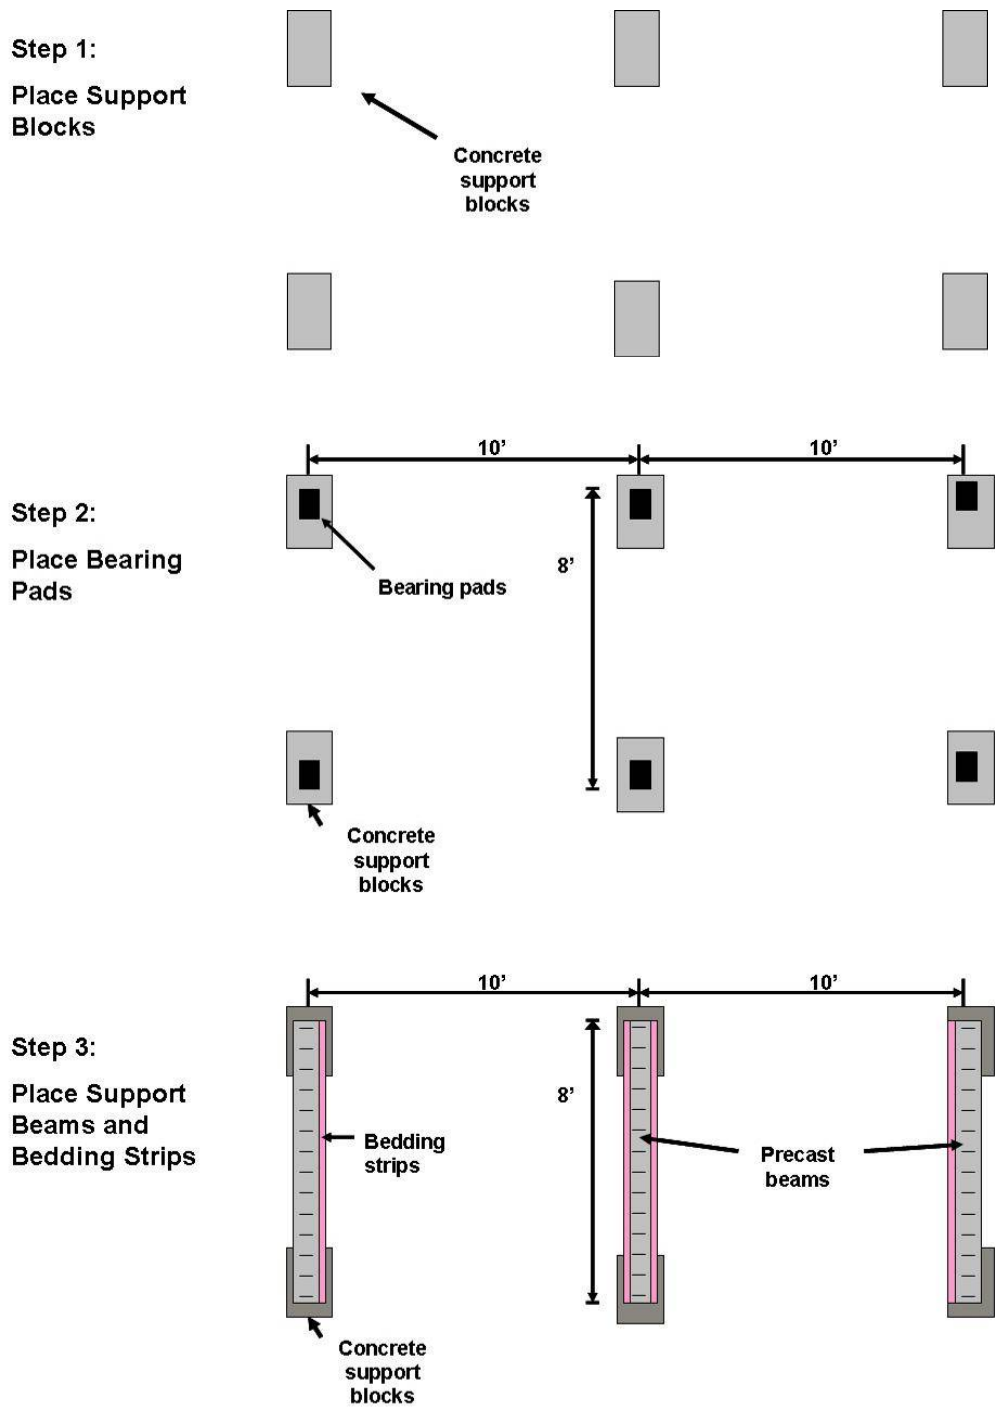
Figure 4.10: Construction Sequence for Negative Moment Specimens (Plan View)

The negative moment specimens, N0P1 and N0P2, were the third and fourth specimens constructed, and these specimens were built in a similar manner to the positive moment specimens. Different design details required three support beams and two PC panels for the negative moment specimens. To support the three beams, six support blocks were positioned on the strong floor, and then six bearing pads were placed on the blocks. Once the bearing pads were placed, the construction sequence was identical to the first two test specimens. Figure 4.10 and Figure 4.11 illustrate the construction of the negative moment specimens, and Figure 4.12 shows researchers consolidating the concrete and leveling the surface of the slab of specimen N0P1.

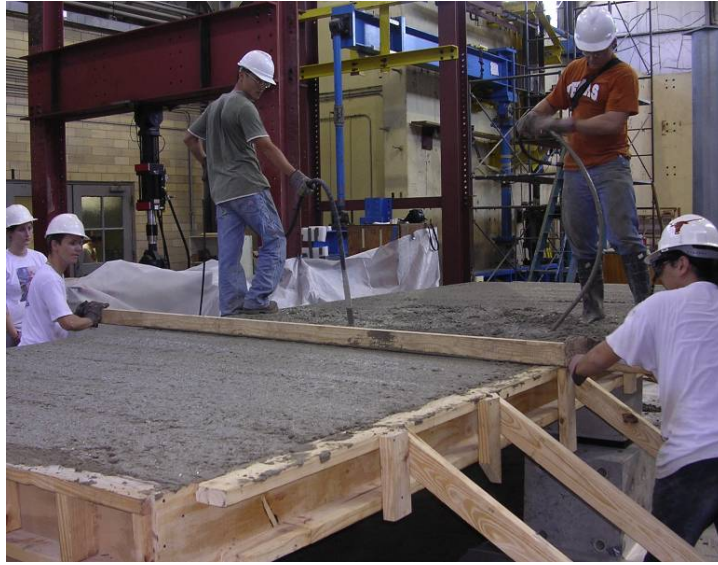
Figure 4.12: Placing Topping Slab on Specimen NOP1

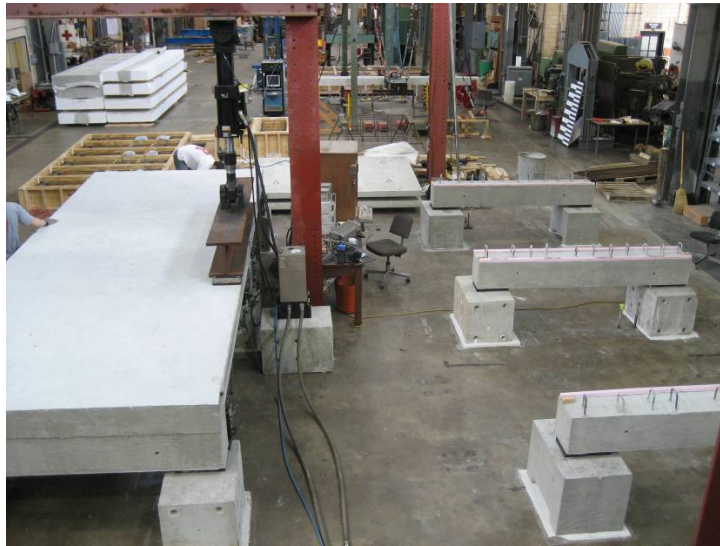
Figure 4.13: Construction of Specimen NOP2

Once testing had been initiated for specimen NOP1, construction began for specimen NOP2, and the photograph included in Figure 4.13 shows an overhead view of specimen NOP1 during testing, and the support beams for the construction of specimen NOP2.

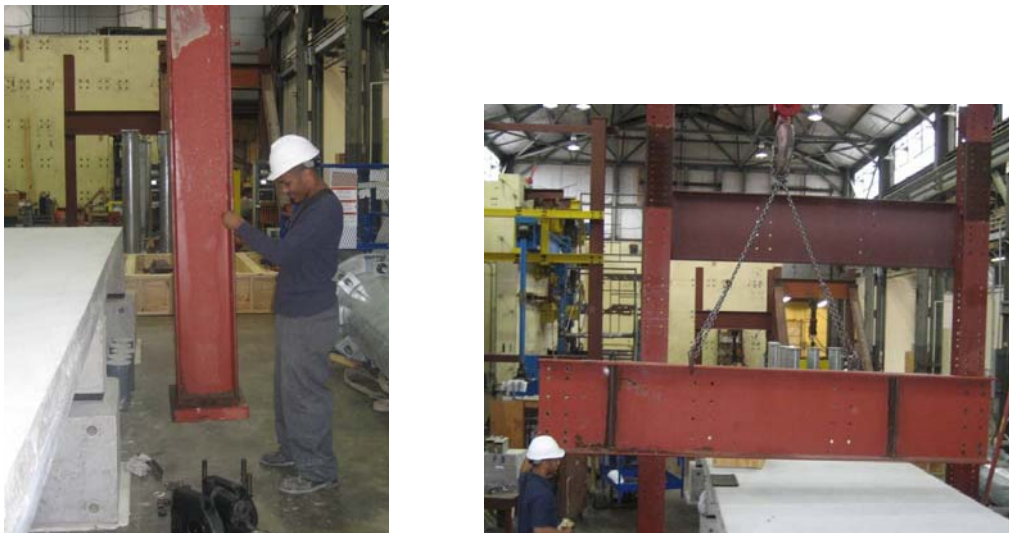
Figure 4.14: Assembling the Reaction Frame for Specimen NOP1

The reaction frame was designed to be disassembled and reassembled easily for each test specimen. Using resources provided by the Ferguson Structural Engineering Laboratory, two columns and cross beams spanned across each specimen to apply the design loads at the edge of the expansion joint. Each column was bolted to the strong floor with four $\frac{3}{4}$ -in. diameter threaded rods, and the cross beams were bolted to the columns with six $\frac{7}{8}$ -in. diameter A325 bolts. Photographs of the assembly of the reaction frame for specimen NOP1 are shown in Figure 4.14.

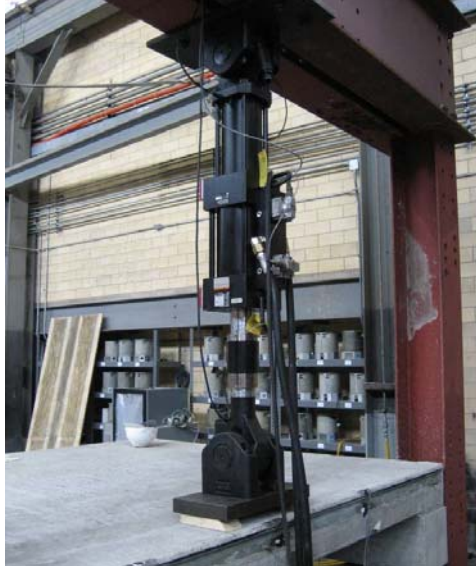
Figure 4.15: MTS Actuator and Load Plate for Positive Moment Specimens

The fatigue loads were applied to the specimens by a 50-kip, MTS hydraulic actuator with a 10-in. stroke. The actuator was bolted to a steel plate which was then bolted into place on the reaction frame. Oversize holes were drilled into the bottom flanges of the cross beams to allow the actuator to be placed directly above the designed load point. For the positive moment specimens, a 2.5-in. thick load plate was bolted to the actuator to represent the 10-in. by 20-in. wheel load area. The actuator and load plate can be seen on specimen POP1 in Figure 4.15. To represent an axle loading for the negative moment test specimens, the actuator was bolted to a spreader beam that

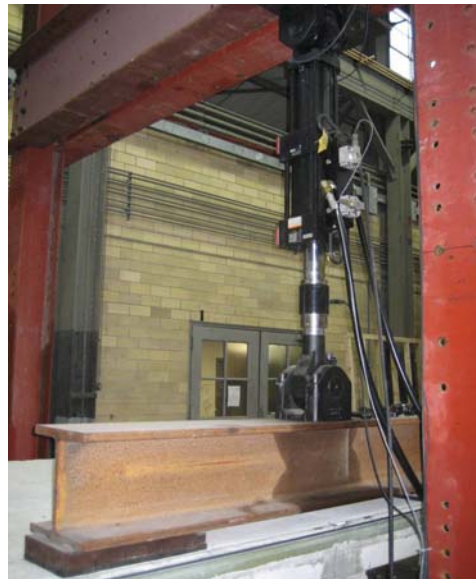
Figure 4.16: Actuator and Spreader Beam for Negative Moment Specimens

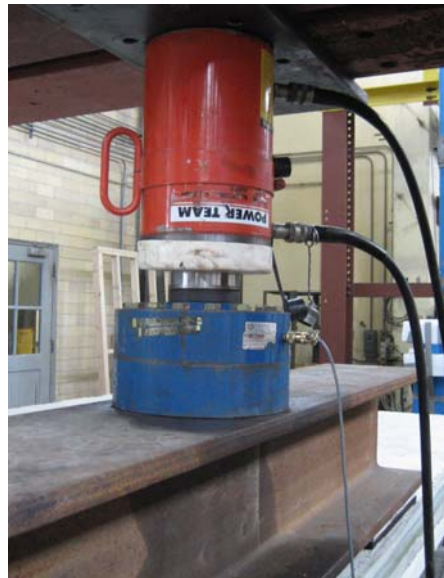
Figure 4.17: Hydraulic Ram Setup Used to Test Specimen NOP2 to Failure

The reaction frame had to be modified when each specimen was tested to failure, because the MTS actuator did not have the capacity necessary to fail the specimens. For the positive moment specimens, a hydraulic ram with a 150-kip capacity was used, and for the negative moment specimens, a 300-kip hydraulic ram was used. Each of the hydraulic rams was about 50 in. shorter than the actuator; therefore, the cross beams of the reaction frame had to be lowered by 50 in. Once the cross beams had been lowered, a 1-in. thick steel plate was attached to the ram, and the ram was then bolted in place on the cross beams. Figure 4.17 shows the hydraulic ram and spreader beam used for the test to failure of specimen NOP2.

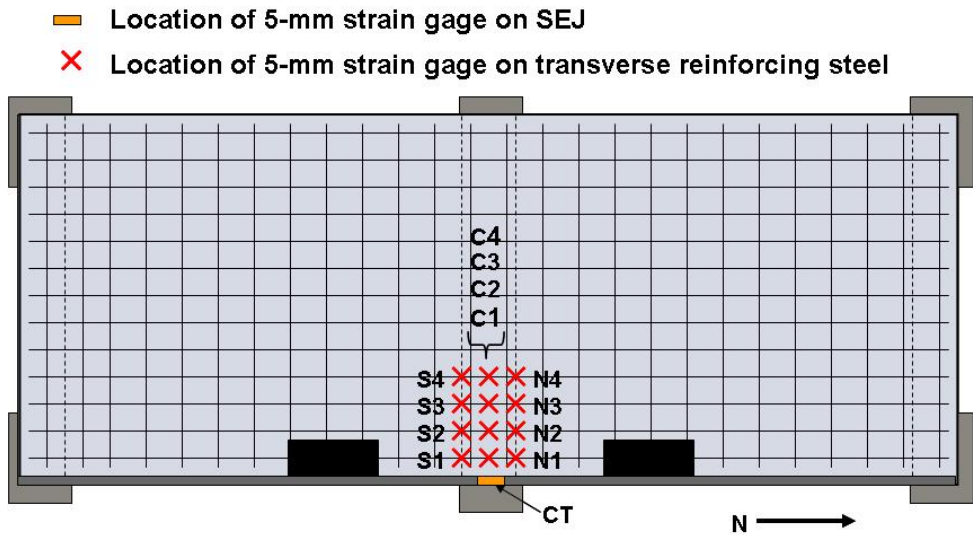
Figure 4.27: Layout of Strain Gages for Specimen N0P1

Because the third and fourth test specimens were subjected to negative moments, the extreme tension fiber was located at the top of the cross section. Fifteen, 5-mm strain gages were installed on the transverse reinforcement (parallel to the SEJ) in specimen NOP1. The strain gages were installed near the locations of the maximum negative moment, and were placed directly over the outer edges of the supporting beam, and along the centerline of the supporting beam. Figure 4.27 provides the locations and nomenclature of the strain gages on the #5 reinforcing steel bars in Specimen NOP1. To measure the strain in the SEJ, one strain gage was placed at the top of the SEJ section directly over the centerline of the central support beam.

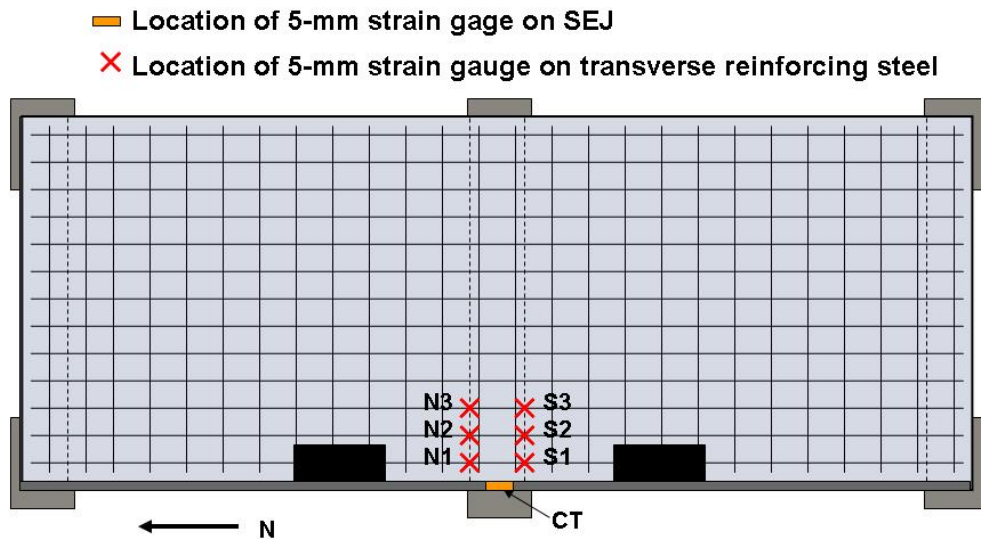
Figure 4.28: Layout and Nomenclature for Strain Gages in Specimen N0P2

When specimen N0P1 was loaded, cracks formed directly above the outer edges of the support beam. The results indicated that the strain gages located along the center line of the support beam, and on the fourth reinforcing bar, were experiencing low levels of stress. Therefore, it was decided to use fewer strain gages to measure the response of specimen N0P2. Figure 4.28 shows the layout of the seven strain gages attached to specimen N0P2.

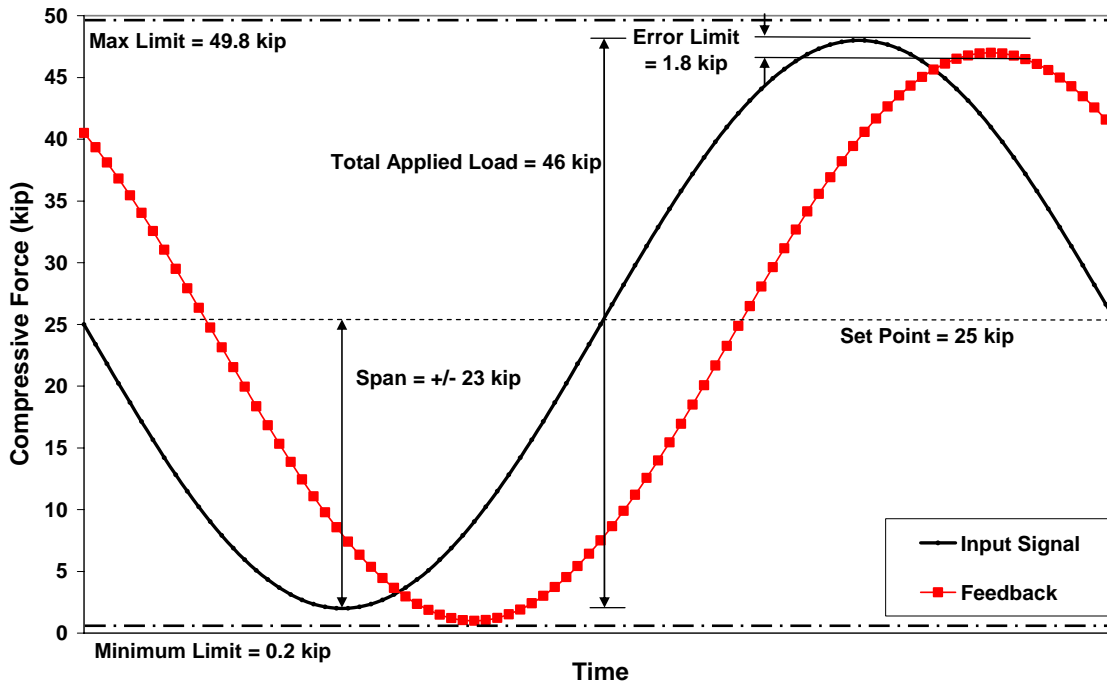
Figure 4.32: Input and Feedback Signals for Specimen N0P2

The input signal for specimen N0P2 was increased because the first three specimens had exhibited very little deterioration due to the fatigue loadings, and the results are presented in Chapter 5. The design loading for specimen N0P2 was 46 kip which represented the HL-93 Design Truck load multiplied by two load factors. The first load factor, 1.25, represented an overloaded truck, and the second load factor, 1.15, represented the dynamic impact factor used for fatigue in the AASHTO LRFD Specification. For specimen N0P2, the input signal was based on the HL-93 Design Truck, with a set point equal to 25 kip, and a span of 23 kip. This input signal cycled the loading from the baseline of 25 kip down to 2 kip and up to 48 kip using a sinusoidal pattern. The load limits were 0.2 kip and 49.8 kips, and the error limit was 1.8 kip. The input signal, associated feedback, and control limits for specimen N0P2 are shown in Figure 4.32.
