**Evaluation of the Fatigue Behavior of Bridge Decks with
Precast Panels at Expansion Joints**

Thesis

The University of Texas at Austin

**The University of Texas at Austin
May 2007**

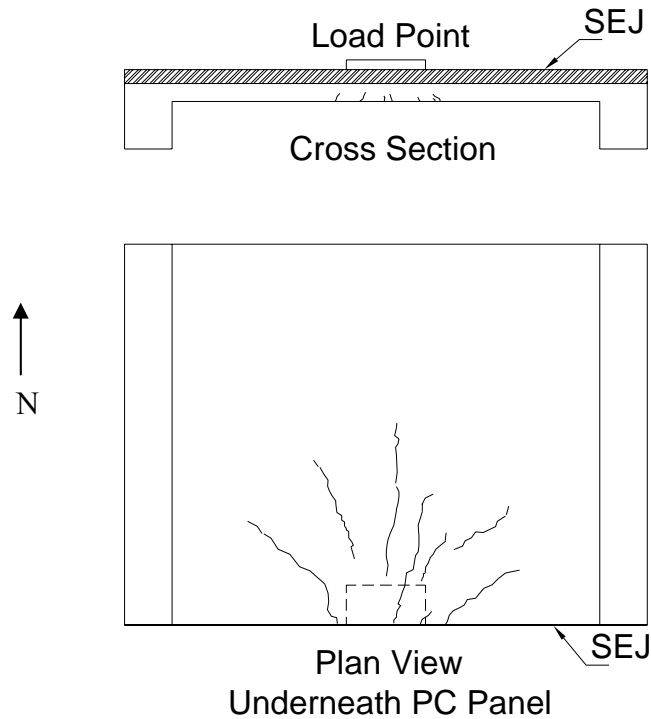
Figure 5.4: Cracks Observed during Static Overload Test for Specimen P0P1

The crack patterns observed after the overload test are shown in Figure 5.4. No cracks were observed on the top of the slab, but several cracks were observed on the bottom of the PC panel.

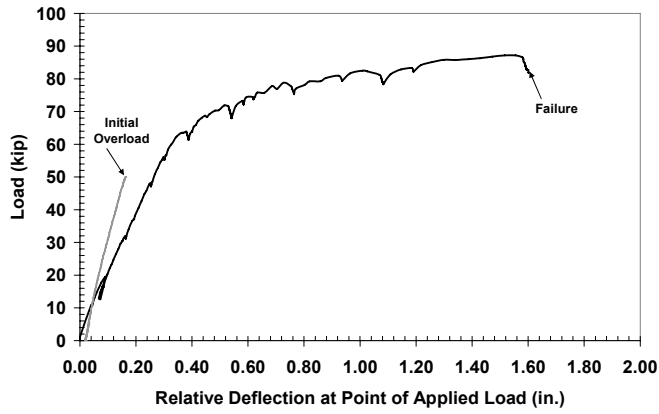
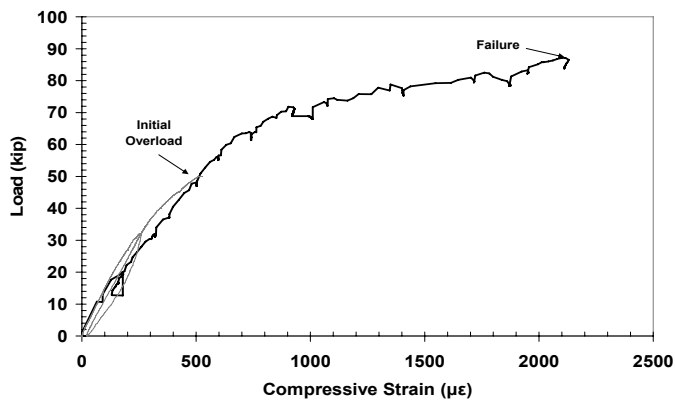
(a) Load-Deflection Response

(b) Tensile Strains on Surface of Concrete

(c) Compressive Strains on SEJ (Gage CT)

Figure 5.6: Measured Response of Specimen P0P1 during Static Test to Failure

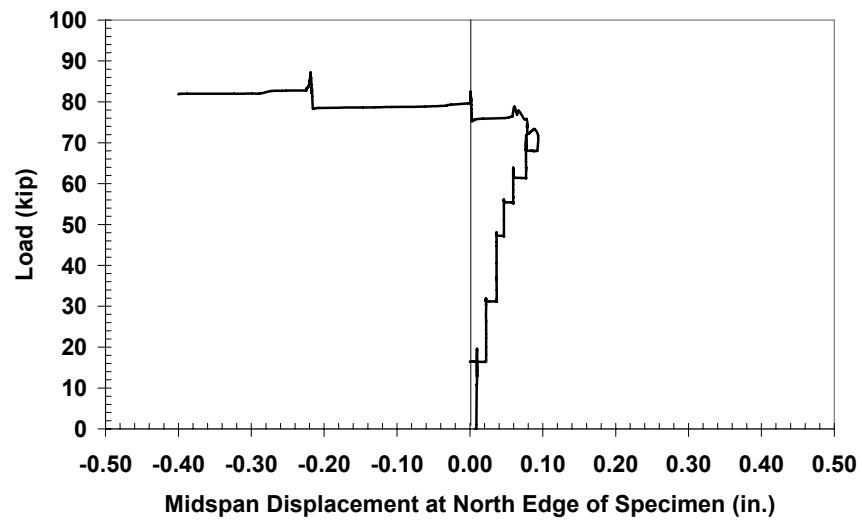
Figure 5.7: Upward Deflection of North End of Specimen P0P1 due to Delamination

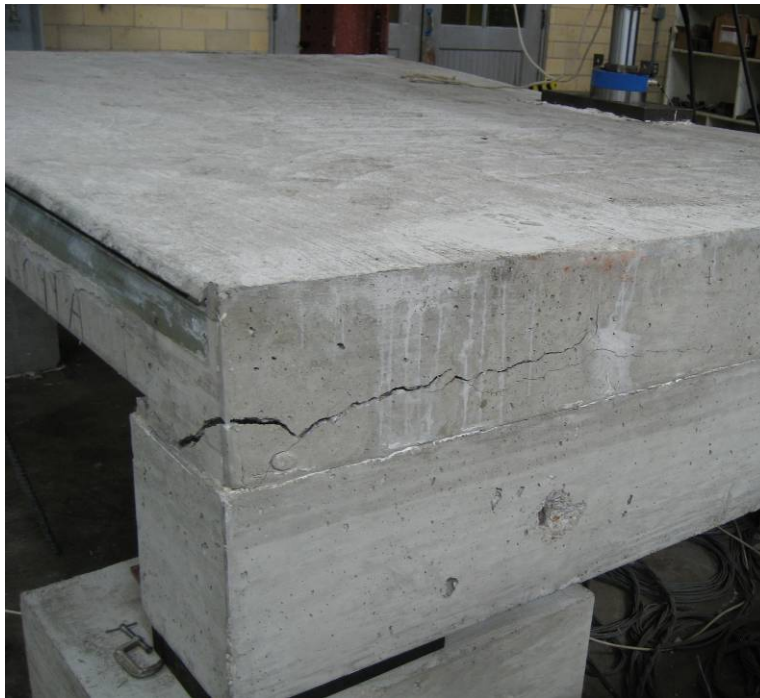
Figure 5.8: Delamination from Support Beams at Northeast Corner of Specimen P0P1

After completion of the fatigue test, the specimen was tested to failure. The measured response is shown in Figure 5.6. The specimen failed in punching shear at an applied load of 88 kip, which corresponds to more than 5 times the wheel load for the rear axle of the HL-93 Design Truck. However, the ductile response of the specimen was the result of delamination near the north corners of the specimen, where large cracks formed as the CIP slab pulled away from the support beams. The linear potentiometer (Figure 5.7) located at the north edge of specimen POP1 indicated that the specimen was experiencing slight downward deflections until these cracks (Figure 5.8) formed at an applied load of 77 kip.

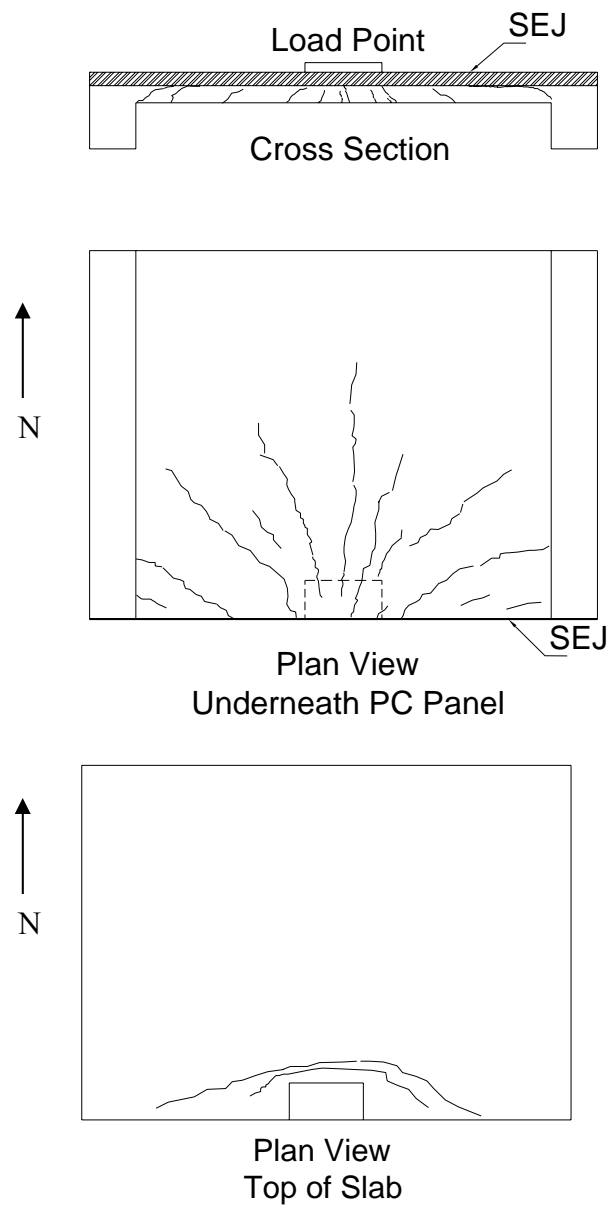
Figure 5.9: Crack Patterns for Specimen P0P1 after Punching Shear Failure

The crack patterns observed at failure are shown in Figure 5.9 and photographs of specimen POP1 are shown in Figure 5.10. At failure, the PC panel delaminated partially from the CIP deck near the support beams.

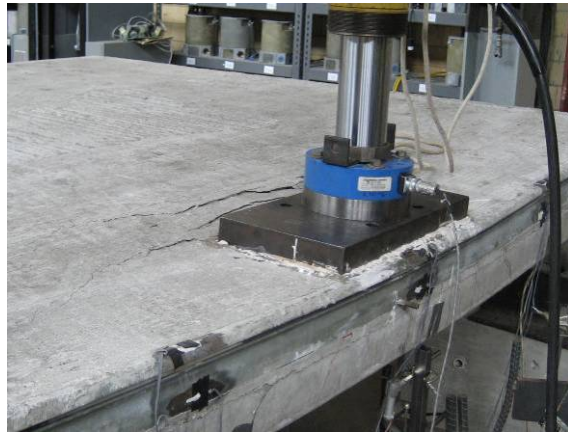
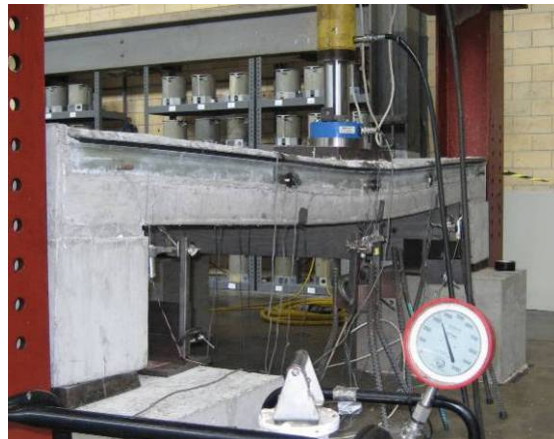
(a) Top of Specimen

(b) Southeast Corner of Specimen

(c) South End of Specimen

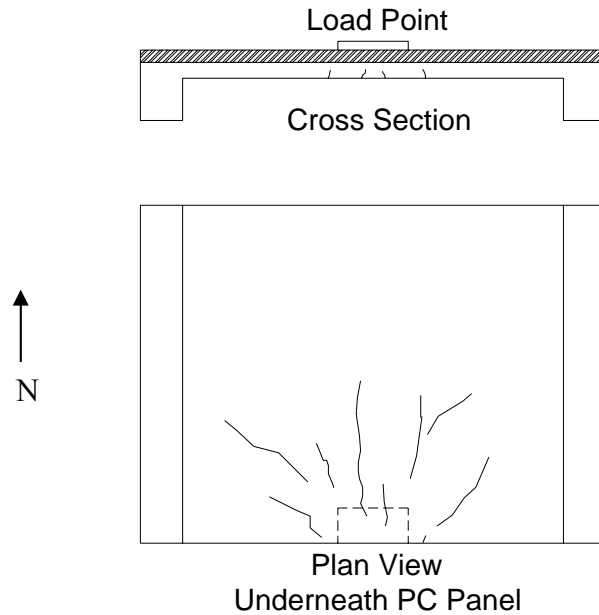
Figure 5.14: Cracks Observed during Static Overload Test for Specimen P0P2

The crack patterns observed after the overload test are shown in Figure 5.14. No cracks were observed on the top of the slab, but several cracks were observed on the bottom of the PC panel.

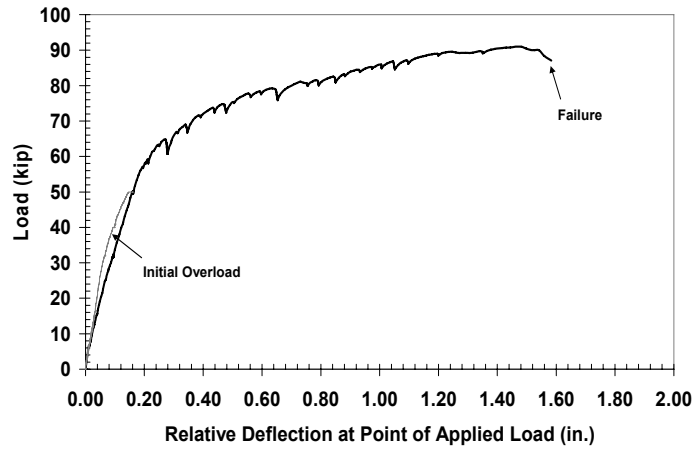
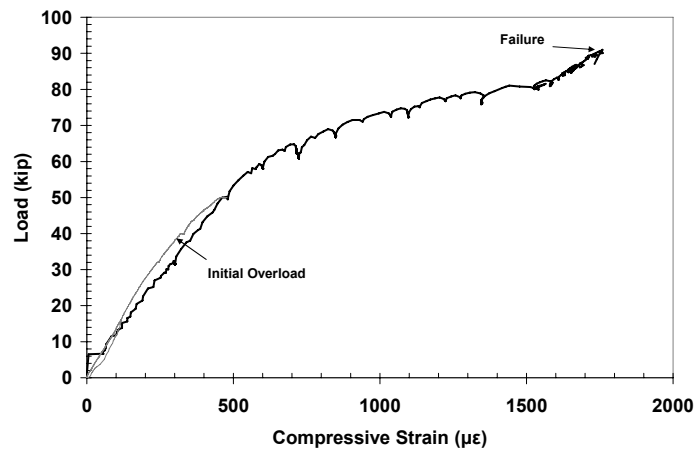
(a) Load-Deflection Response

(b) Tensile Strains on Surface of Concrete (Gage C2 and C4)

(c) Compressive Strains on SEJ (Gage CT)

Figure 5.16: Measured Response of Specimen P0P2 during Static Test to Failure

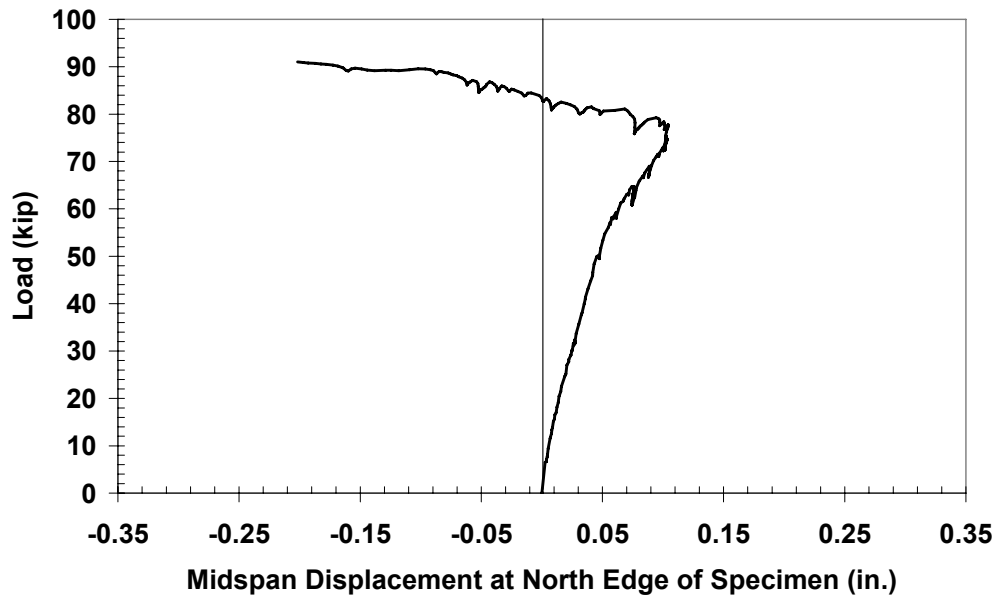
Figure 5.17: Upward Deflection of North End of Specimen P0P2 due to Delamination

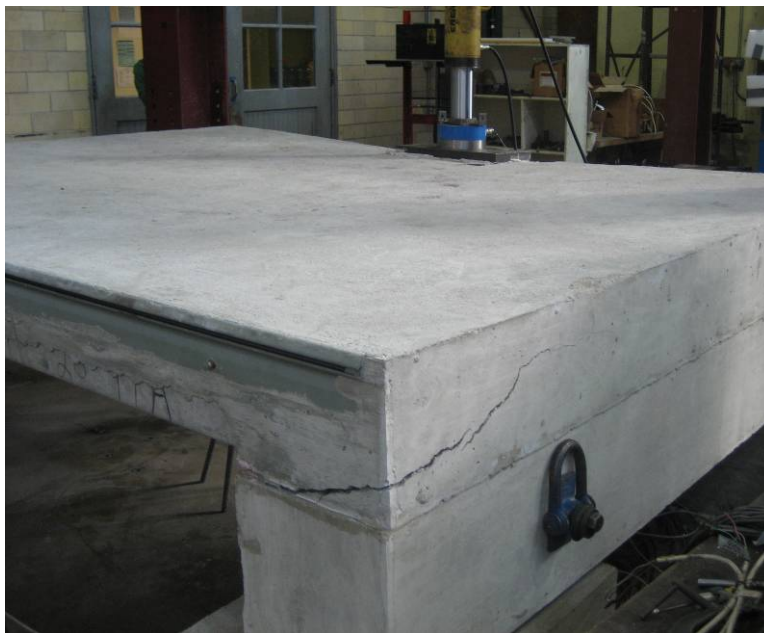
Figure 5.18: Delamination from Support Beams at Northeast Corner of Specimen P0P2

After completion of the fatigue test, the specimen was tested to failure. The measured response is shown in Figure 5.16. The specimen failed abruptly in punching shear at an applied load of 90 kip, which corresponds to more than 5 times the wheel load for the rear axle of the HL-93 Design Truck. Similarly to specimen P0P1, the ductile response of the specimen was the result of delamination near the north corners of the specimen, where large cracks formed as the CIP slab pulled away from the support beams. The linear potentiometer (Figure 5.17) located at the north edge of specimen P0P1 indicated that the specimen was experiencing slight downward deflections until these cracks (Figure 5.18) formed at an applied load of 79 kip.

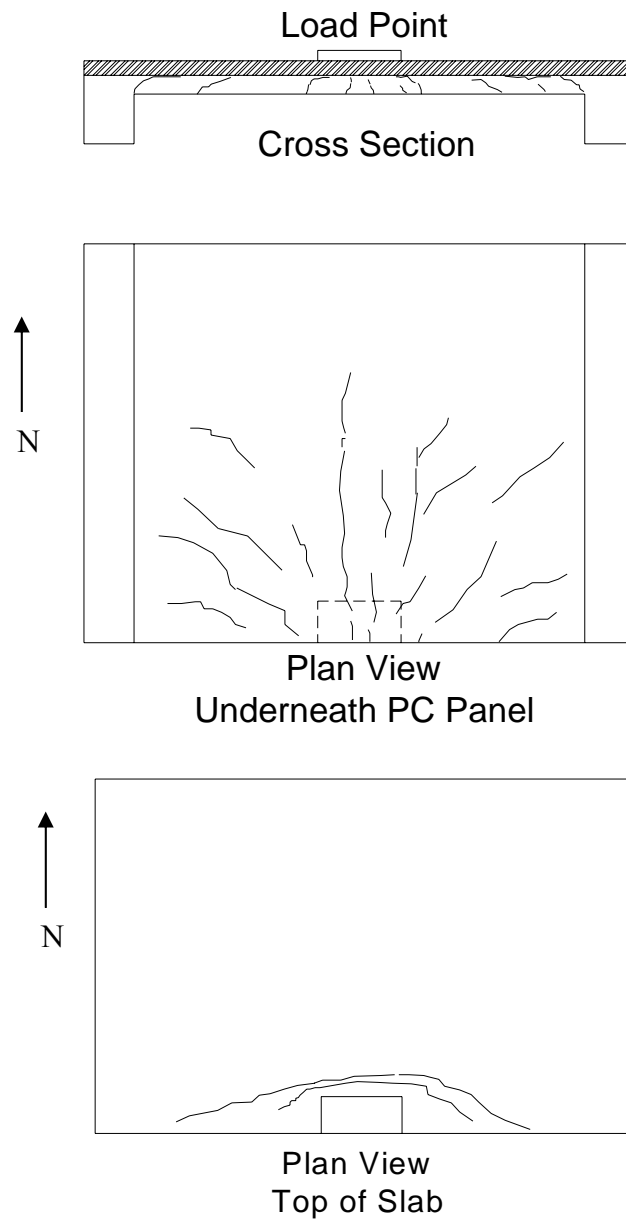
Figure 5.19: Crack Patterns for Specimen P0P2 after Punching Shear Failure

The crack patterns observed at failure are shown in Figure 5.19 and photographs of specimen P0P2 are shown in Figure 5.20. At failure, the PC panel delaminated partially from the CIP deck near the support beams.

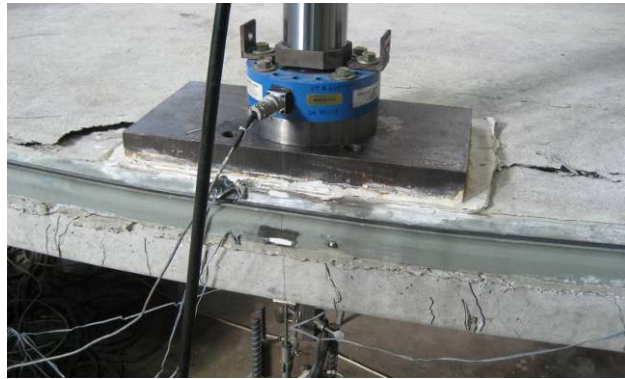
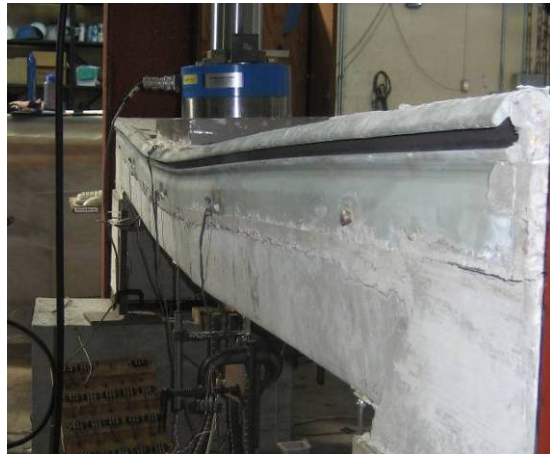
(a) Top of Specimen

(b) Southwest Corner of Specimen

(c) South End of Specimen

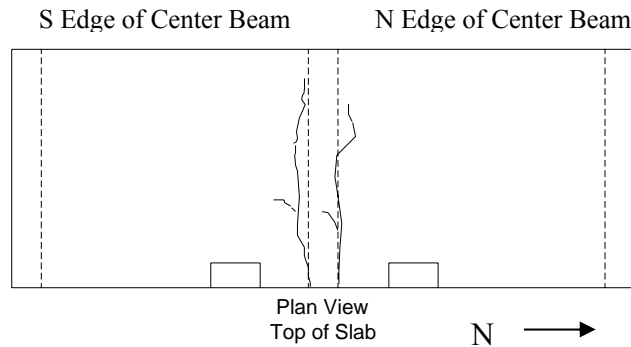
Figure 5.21: Cracks Observed in NOP1 before Initial Static Test

the shrinkage cracks observed by Coselli (2004) in project 0-4418 (Figure 5.22). The “overload” for the negative moment specimens did not cause an appreciable change in the measured response. Therefore, the data are presented in three sections corresponding to the applied load histories from the initial static test, periodic static tests, and the test to failure.

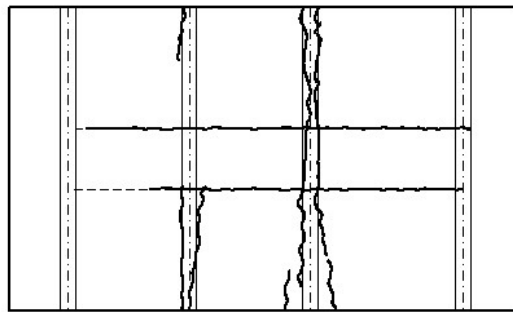
Figure 5.22: Shrinkage Cracks in Larger-Scale Specimen (Coselli 2004)

cracks in specimen N0P1 and the shrinkage cracks observed by Coselli (2004) in project 0-4418 (Figure 5.22).

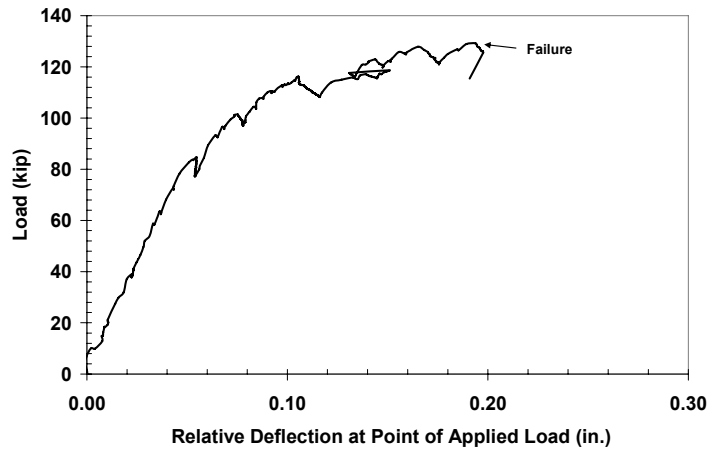
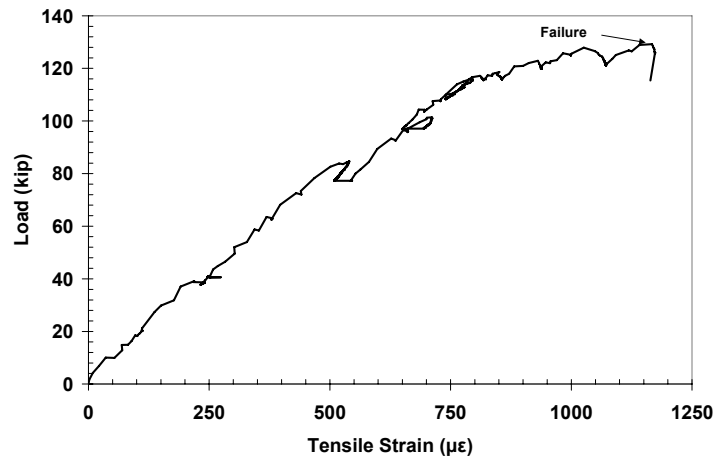
(a) Load-Deflection Response

(b) Tensile Strains on #5 Bars (S1-S4)

(c) Tensile Strains on SEJ (Gage CT)

Figure 5.25: Measured Response of Specimen N0P1 during Static Test to Failure

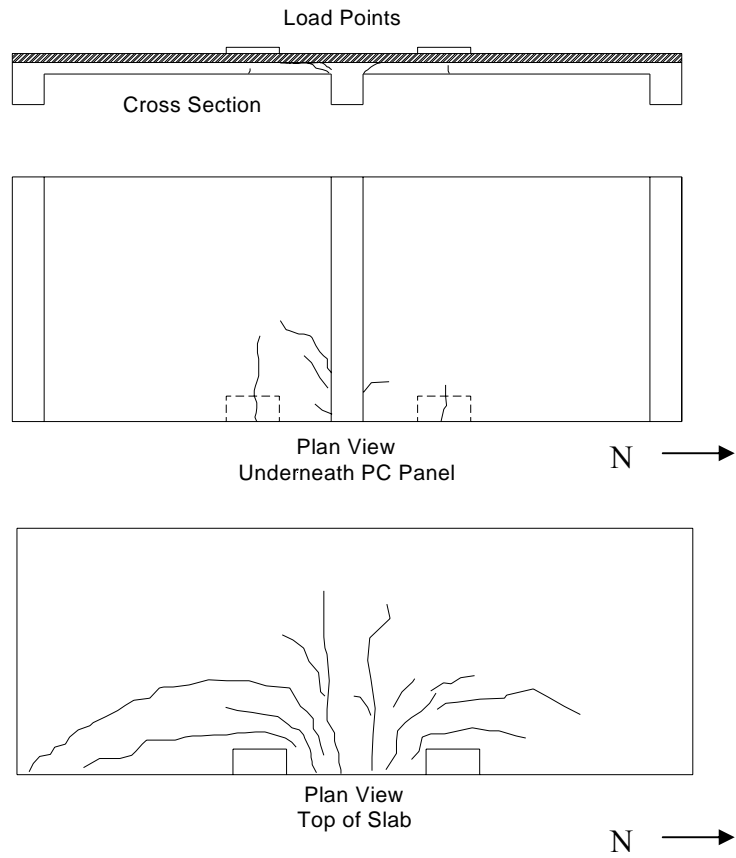
Figure 5.26: Crack Maps for Specimen N0P1 Test to Failure

The crack patterns observed at failure are shown in Figure 5.26 and photographs of specimen NOP1 are shown in Figure 5.27.

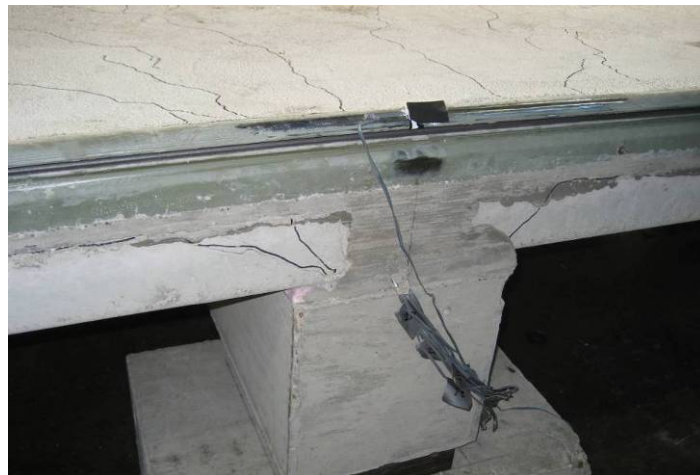
(a) Top of Specimen

Figure 5.27: Photograph of Specimen N0P1 after Punching Shear Failure

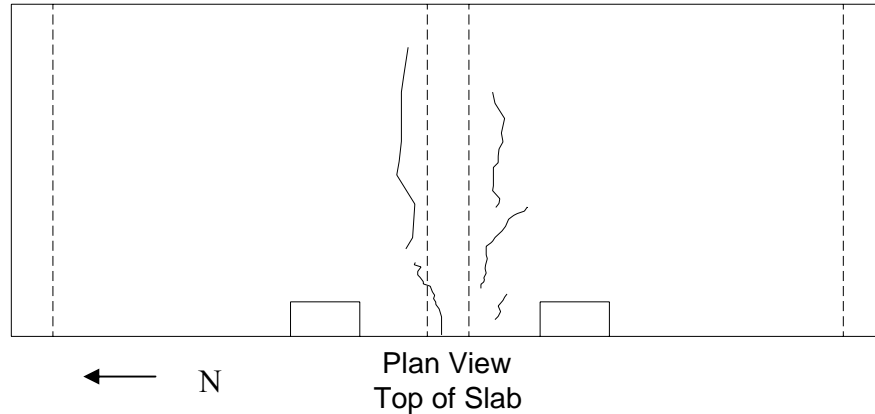
Figure 5.28: Cracks Observed in N0P2 before Initial Static Test

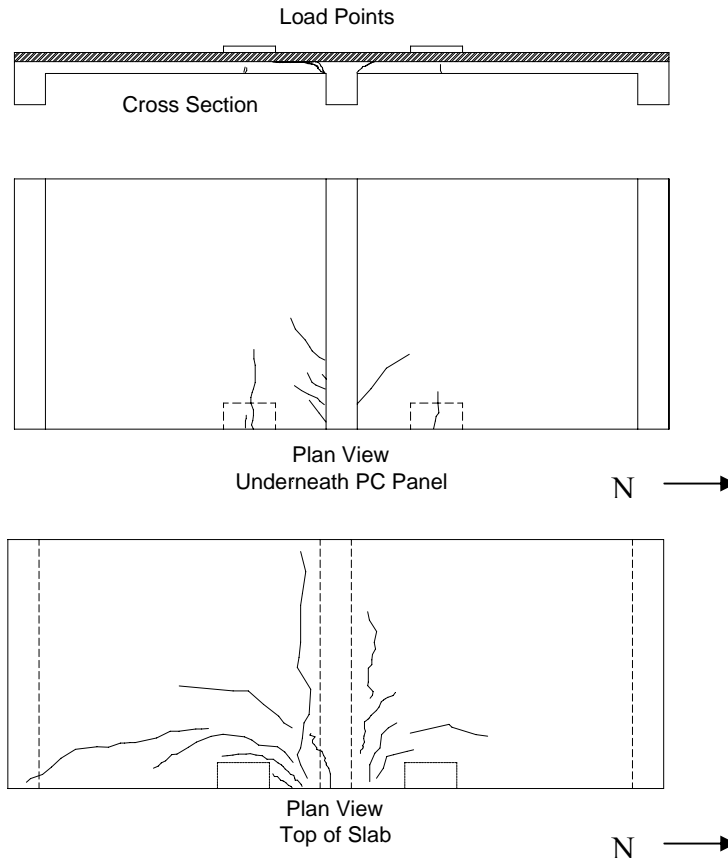
Figure 5.32: Crack Maps for Specimen N0P2 Test to Failure

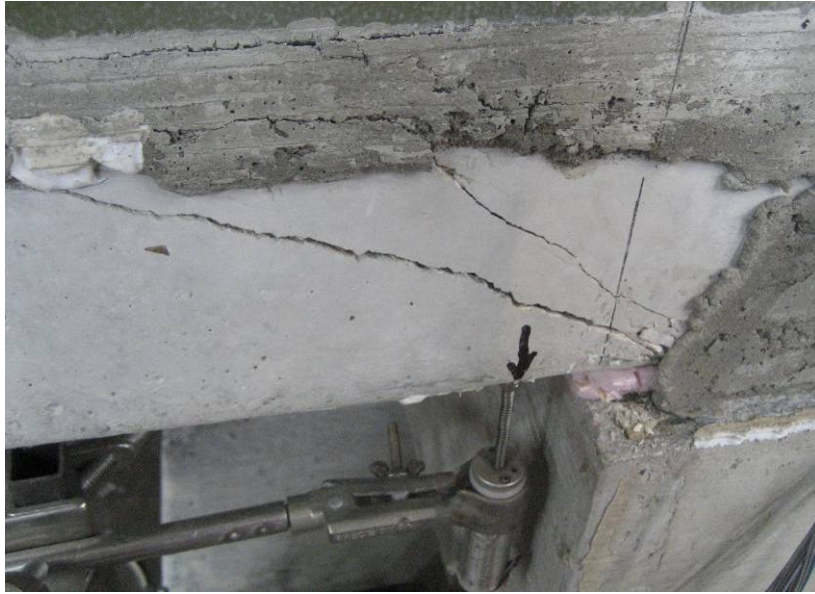
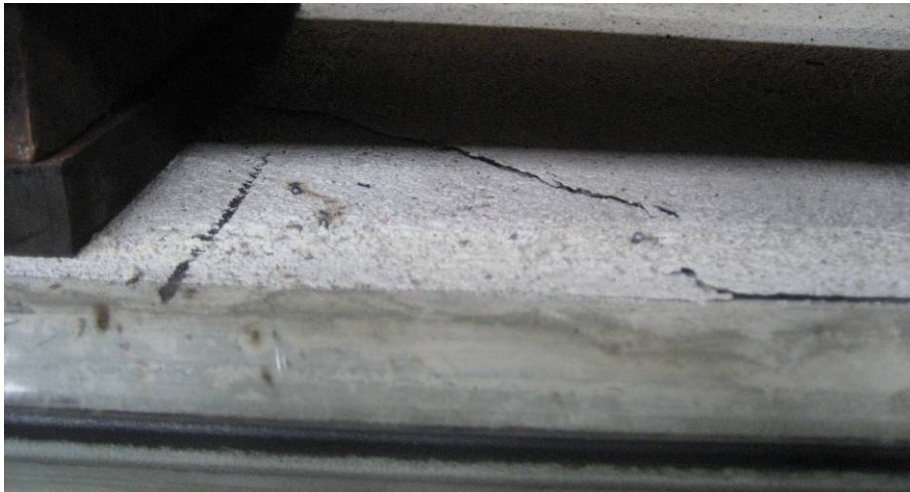
(a) West Side of Specimen above Central Center Beam

(a) Top of Specimen Near Bearing Pad along NW side of Specimen

Figure 5.33: Photograph of Specimen N0P2 after Punching Shear Failure

The crack patterns observed at failure are shown in Figure 5.32 and photographs of specimen N0P1 are shown in Figure 5.33.

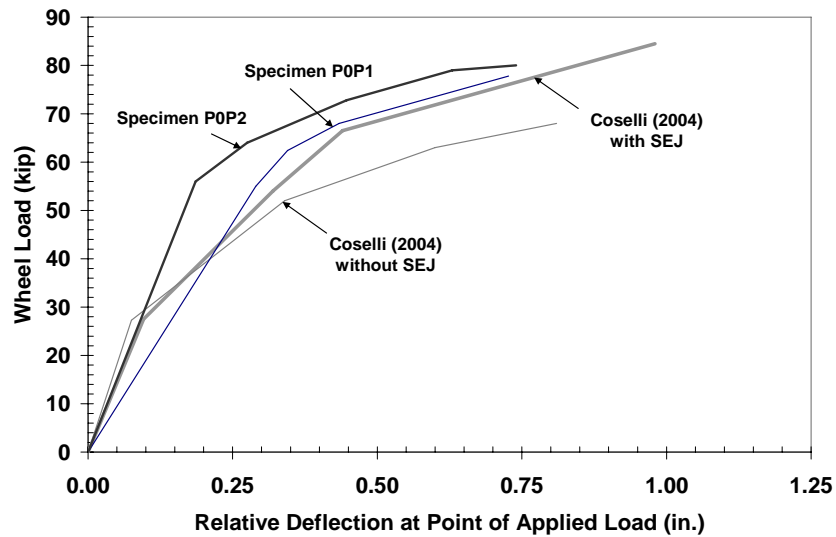
Figure 6.1: Comparison of Capacities of Specimens P0P1 and P0P2 with Larger-Scale Specimen

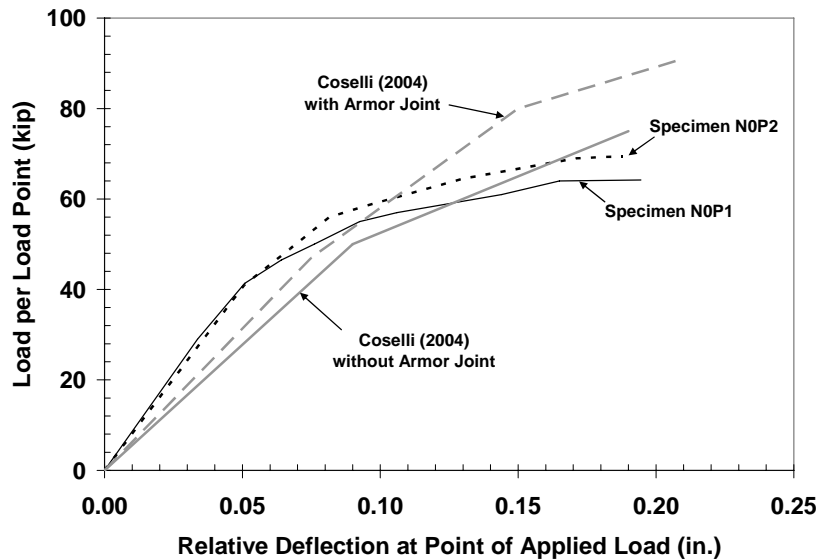
Figure 6.2: Comparison of Capacities of Specimens N0P1 and N0P2 with Larger-Scale Specimen

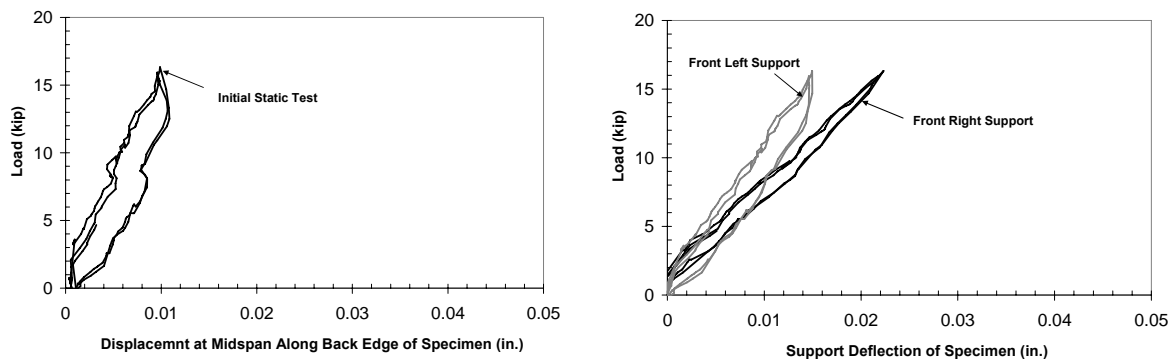
Figure A.1: Load vs. Deflection Response during Initial Static Test (P0P1)

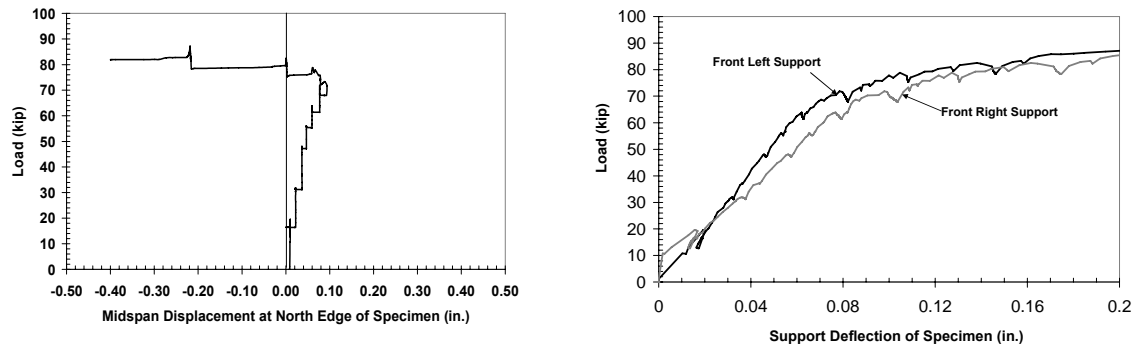
Figure A.2: Load vs. Deflection Response during Static Test to Failure (P0P1)

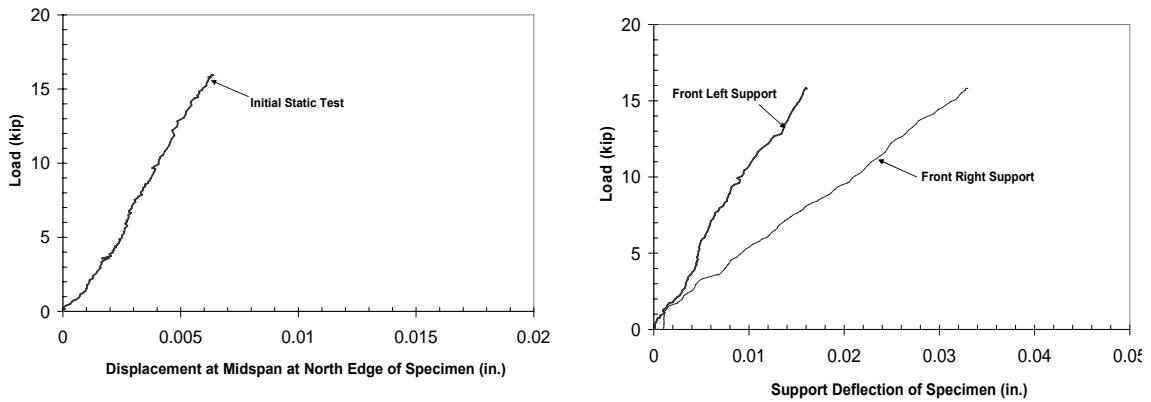
Figure A.4: Load vs. Deflection Response during Initial Static Test

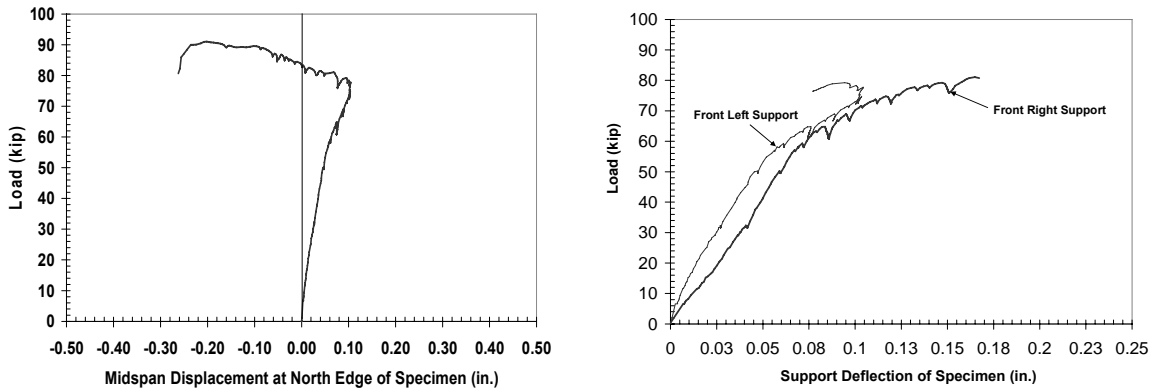
Figure A.5: Load vs. Deflection Response during Static Test to Failure
