**EFFECT OF DUCT SPACING ON BREAKOUT OF POST-  
TENSIONING TENDONS IN HORIZONTALLY  
CURVED CONCRETE BOX GIRDERS**

**REPORT**

**Presented to the Faculty of the Graduate School of  
The University of Texas at Austin  
in Partial Fulfillment  
of the Requirements  
for the Degree of  
Master of Science in Engineering**

**August, 1991**

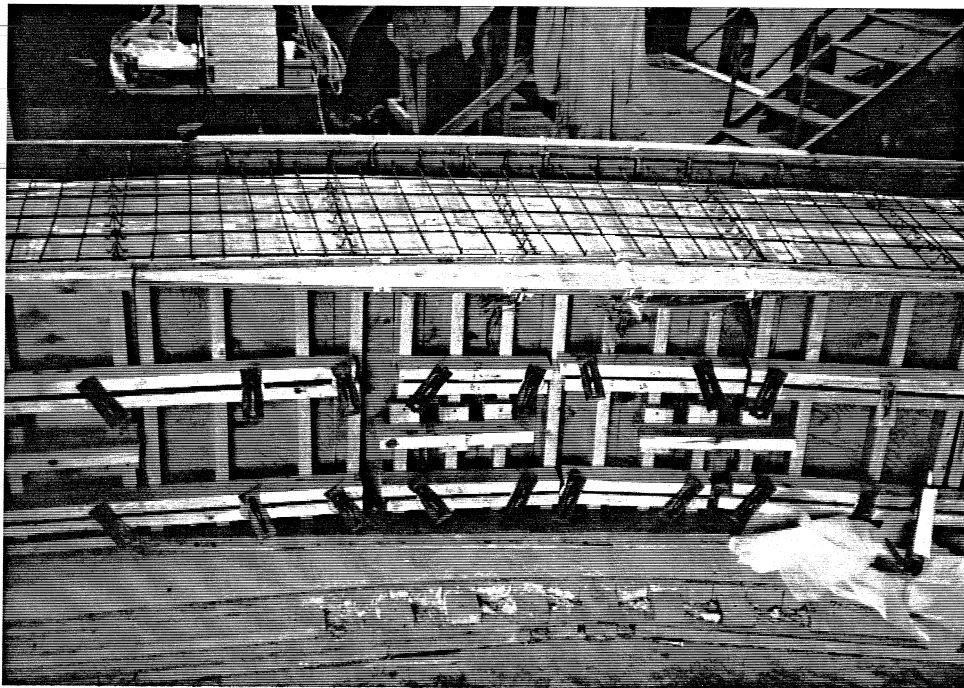
**Figure 3.1 Form Connection**

**3.1.1 Formwork Description:** The formwork consisted of two basic parts, the bottom part for the bottom slab and the forms for the remaining box section. The forms were constructed of plywood and lumber(2x4's and 2x6's). The formwork for the box section can be divided into inner and outer walls of the web, and the forms for the top slab. All the forms were constructed in panels. The panels for the webs of the curved part of the specimen were also made curved. All panels were connected to each other by bolts and whaler-tie arrangement(Figure 3.1). The web forms were bolted to couplers which were cast in the bottom slab.

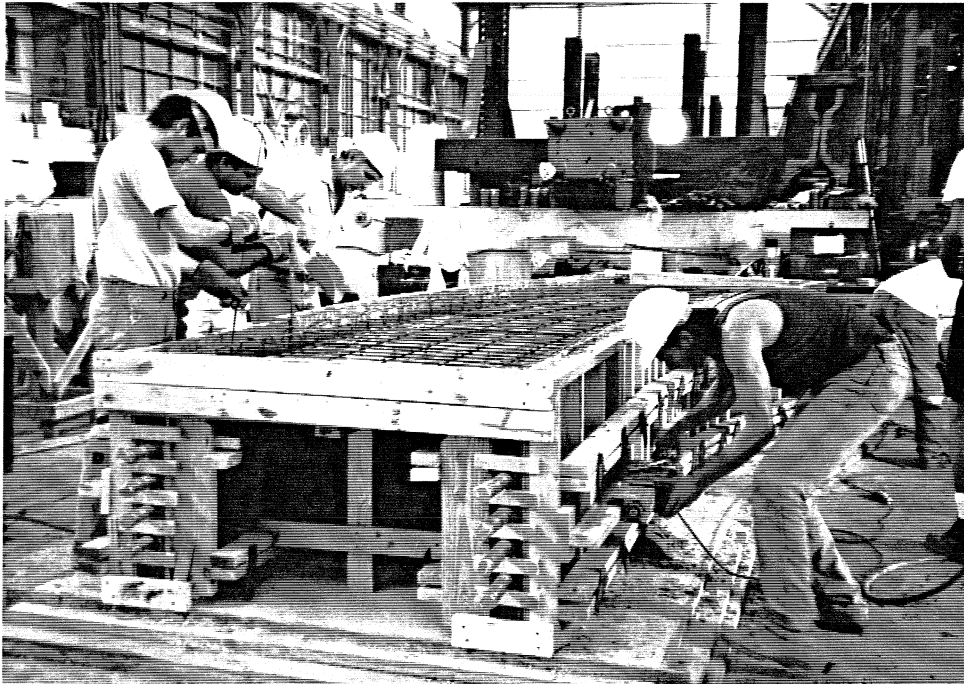
**Figure 3.12 Concreting Operation**

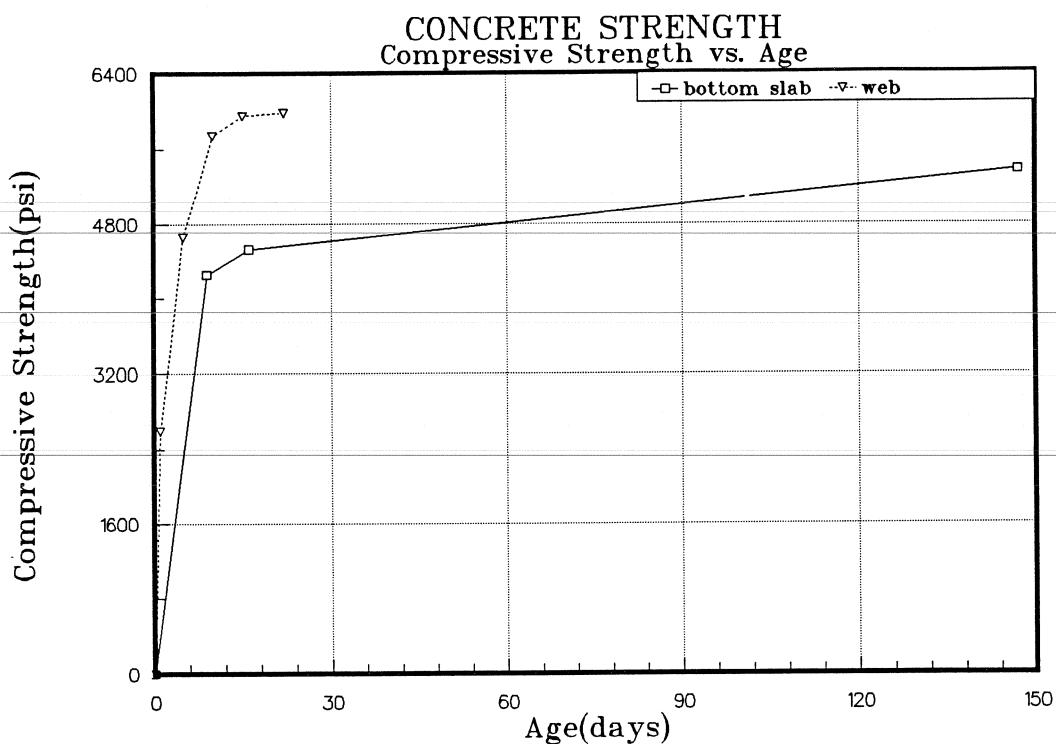
**Figure 3.15 Concrete Strength Vs Age**

Concrete cylinders were tested for compressive strength under uniaxial compression at various important ages. The variation of compressive strength of concrete with age is shown in Figure 3.15. The strength of web concrete at the time of the tests were 5951 psi (15 days after casting) and 5984 psi (27 days after casting). Bottom slab strength was 5365 psi on the day of the second test (147 days after pouring).

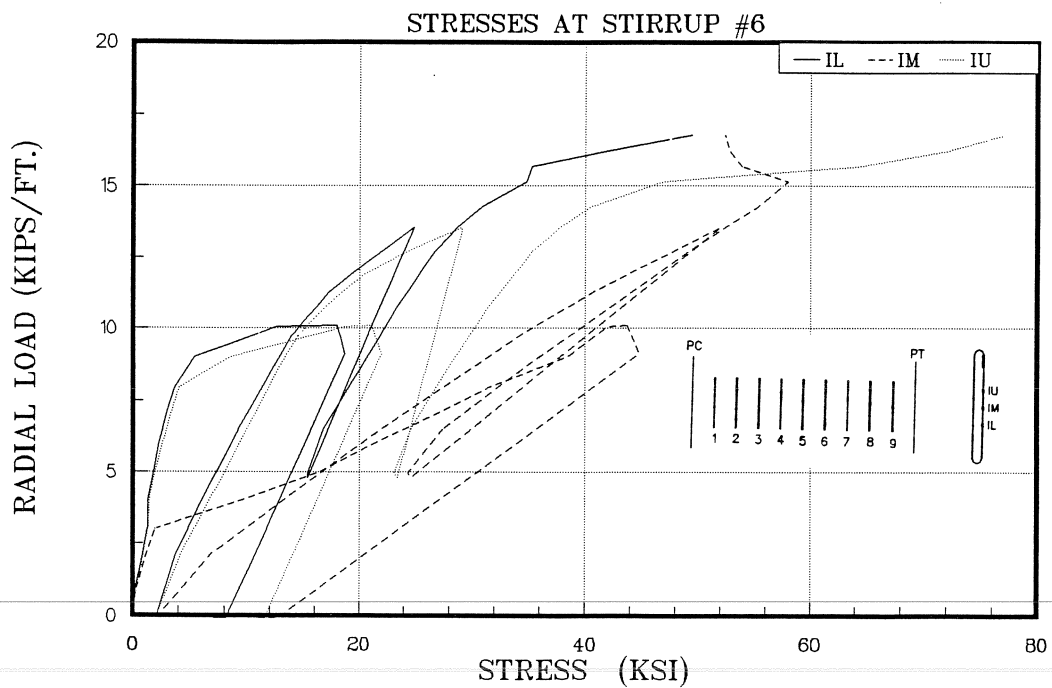
Figure 5.4 Stresses at Stirrup #6 of Web DC

Precaution was taken not to go near the web due to safety reasons. A theodolite and an automatic level were used to observe and detect cracks from a distance. As observed in Figure 5.4 there was a sharp increase in stresses at the IU and IL strain gage locations at a radial load level of 8 kips/ft. and 9.2 kips/ft. This probably indicated flexural cracking of concrete at these locations. The relationship between the stirrup stresses remained linear beyond the respective cracking loads.

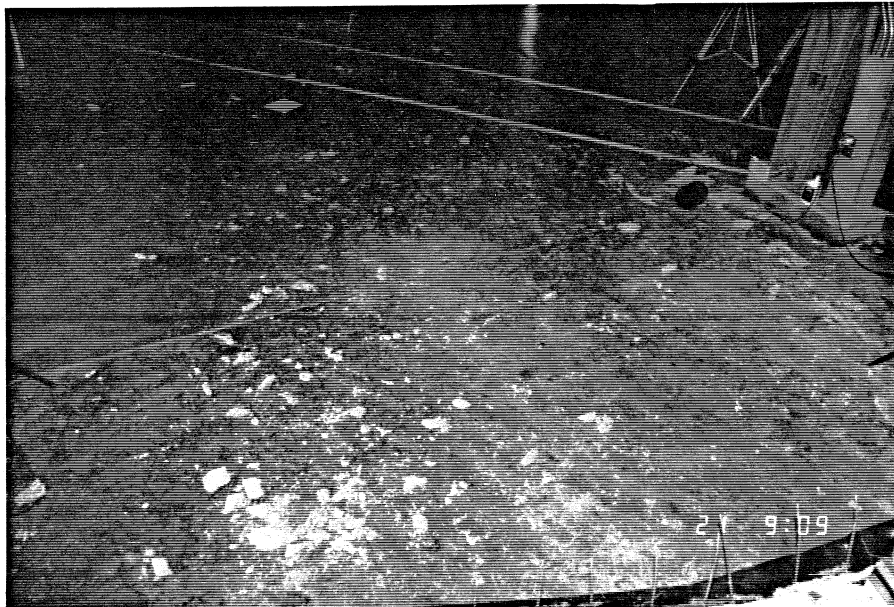
**Figure 5.7 Concrete Fragments in Front of the Web**

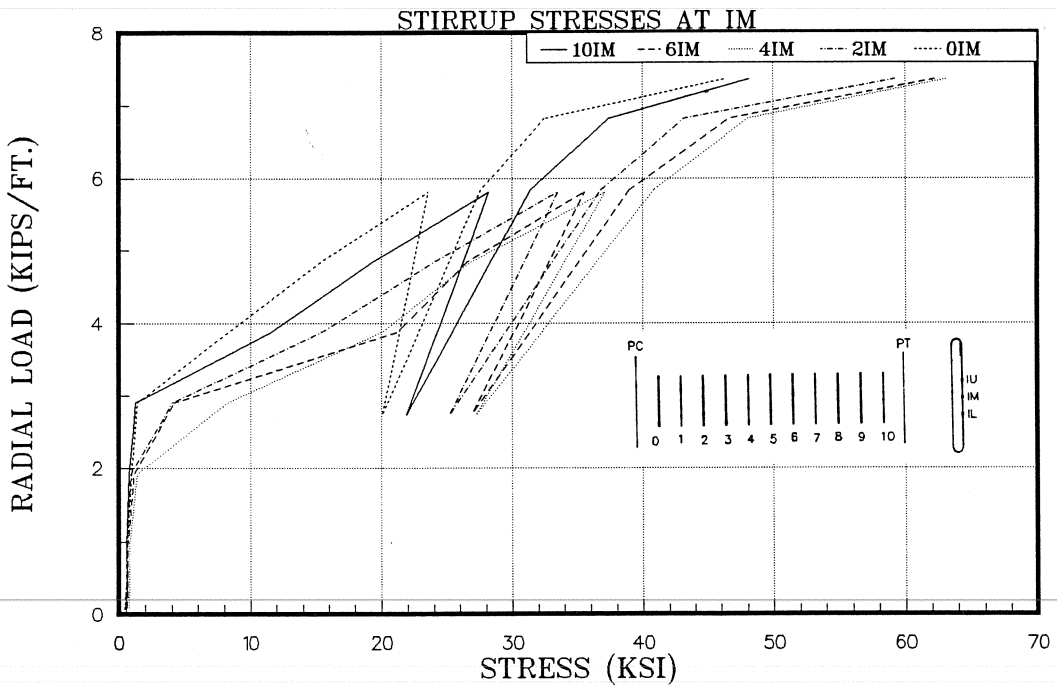
Figure 5.15 Mid Height Stirrup Stresses of Web BC

observed that the IM stirrup stresses at stirrups #2, #4 and #6 (central portion of the curve) show the reduction in slope at a radial load of 1.9 kips/ft. This observation suggests that the flexure cracks initiated in the central part of the curve at mid-height and were followed by flexural cracks all along the mid height of the curve at a radial load of 2.9 kips/ft. The first cracks were visually observed at a radial load of 4.85 kips/ft. using a theodolite as an optical remote sensing device.

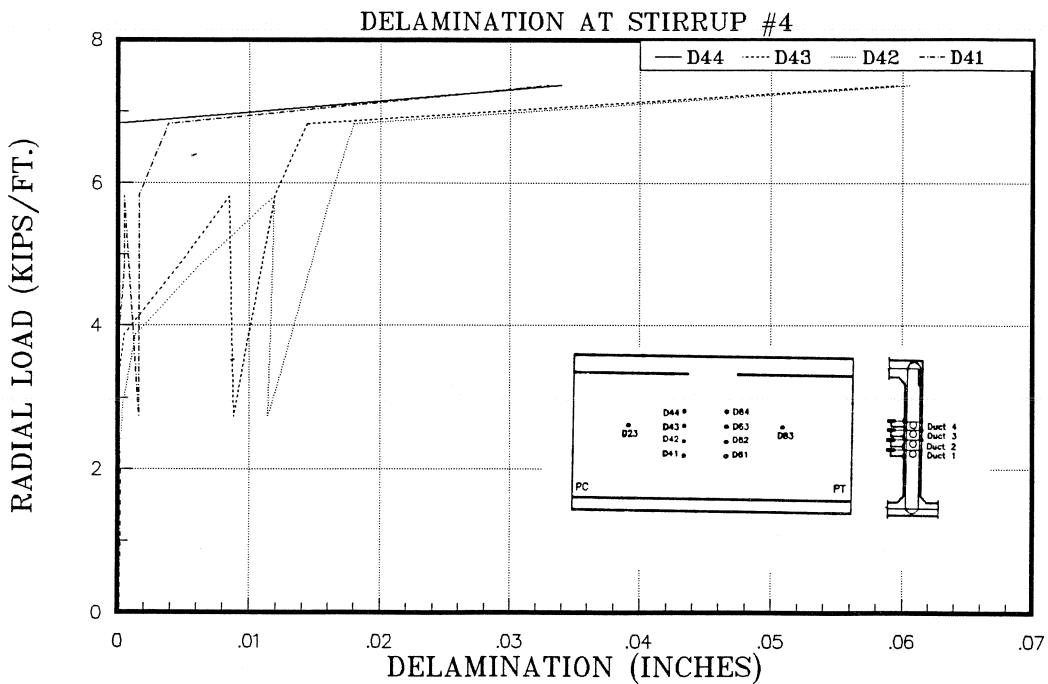
**Figure 5.18 Delamination at Stirrup #4 of Web BC**

Marked increases in delamination above the ducts at stirrups #4 and #6 with an increase in radial load in the web are shown in Figures 5.18 and 5.19. It was observed that the delamination started and was greatest at the center line of the duct arrangement (D42 & D62, henceforth referred to as DX2). Delamination at DX2 started to occur at a radial load of 2.9 kips/ft. D43 and D63 started delaminating shortly thereafter. DX1 gages which were symmetrical to the DX3 gages about the center line of the tendon group began to register delamination at a radial load of 4.0 kips/ft. and lagged much behind the DX3 gages. It was observed that the delamination was greatest at the center of the duct arrangement and no

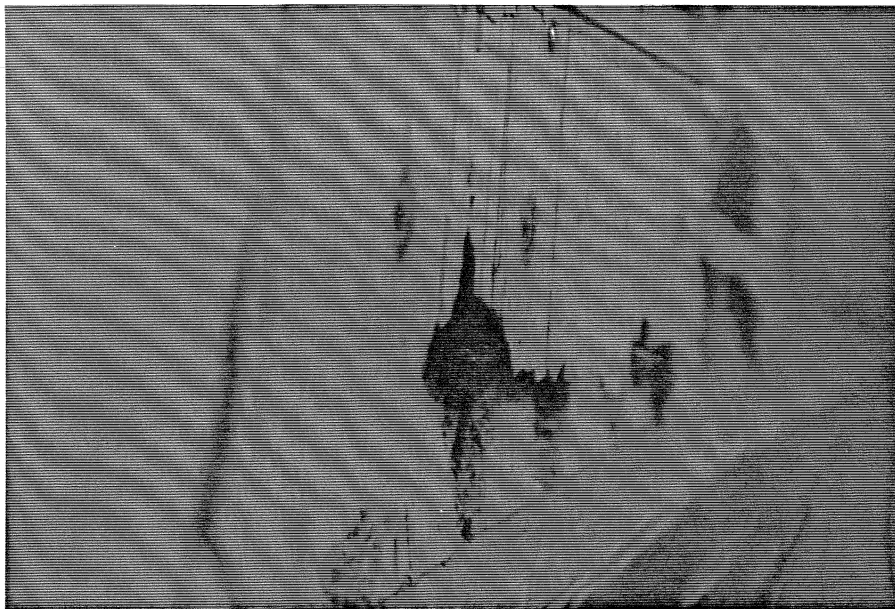
**Figure 5.20 Crack Pattern of Web BC**

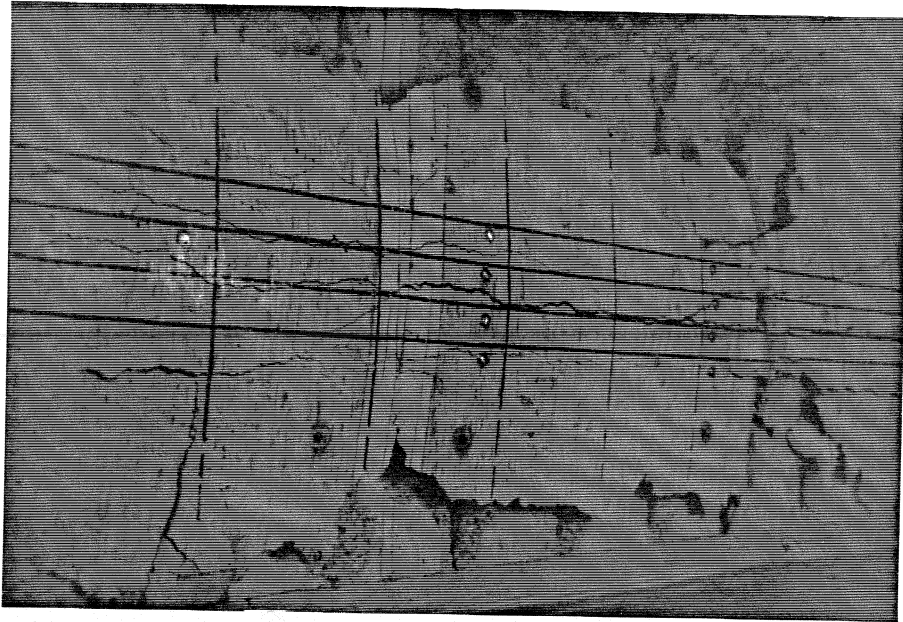
**Figure 5.25 Web BC after Failure**

The failure in the web occurred due to diagonal tension failure of concrete. The crack started near the top and bottom ducts probably near the last flexural crack in the local beam(spanning from the top of the top duct to the bottom of the lower most duct) at the load level of 6.83 kips/ft. The crack propagated out and up and out and down as shown in Figures 5.20 & 5.21. A non explosive failure occurred at the next load level of 7.4 kips/ft. The failure took place with some visual and audible warning as shown in Figures 5.22 - 5.26.
