**ACOUSTIC EMISSION SIGNATURE ANALYSIS OF FAILURE
MECHANISMS IN FIBER REINFORCED PLASTIC STRUCTURES**

Dissertation

The University of Texas at Austin

December 2002

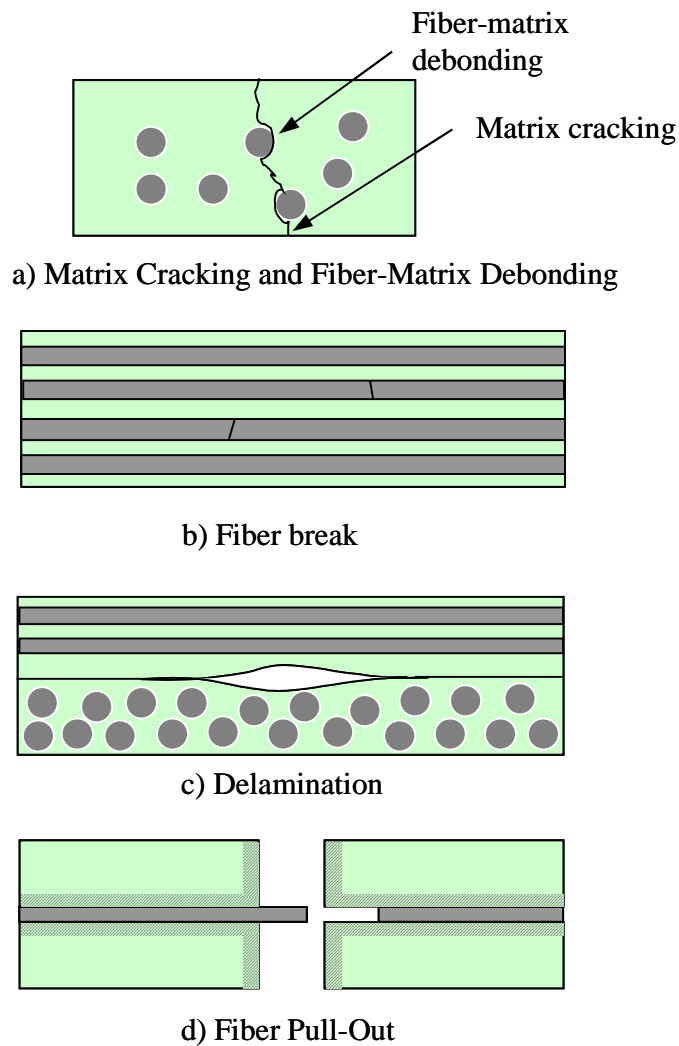
Figure 2.3: Schematic Illustration of Failure Mechanisms in Composites

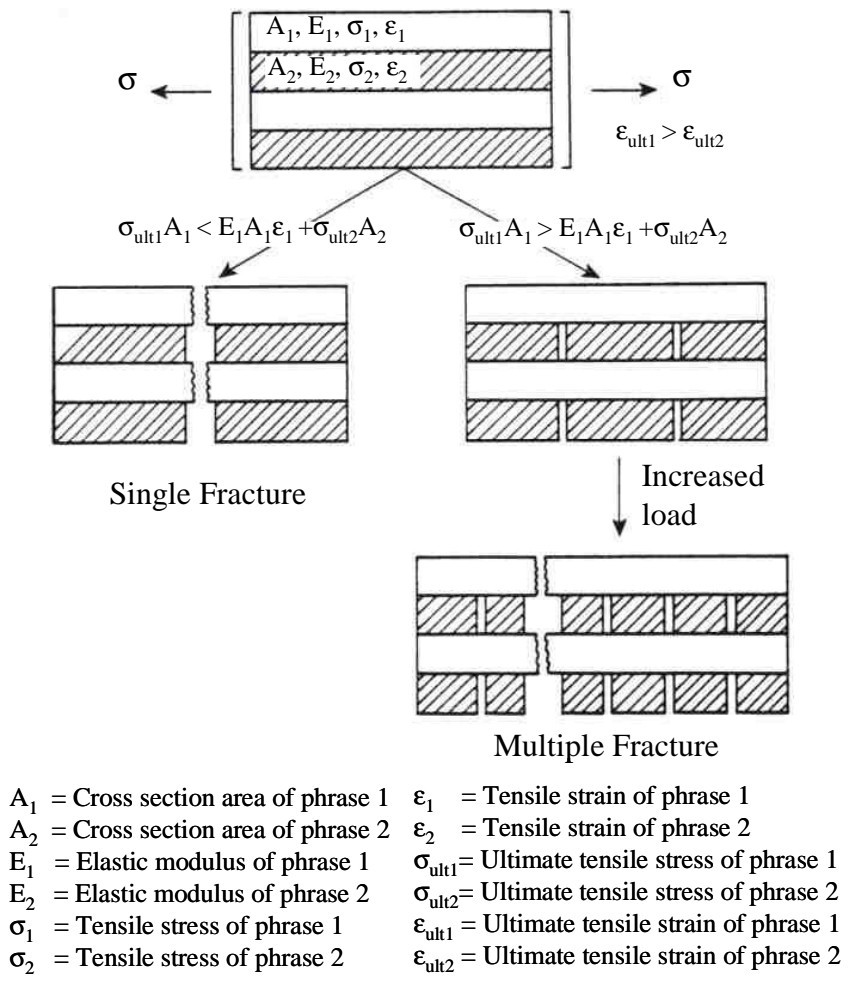
Figure 2.4: Single and Multiple Fracture: The More Brittle Phase is Shaded
 (Adapted From McGowan, 1983)

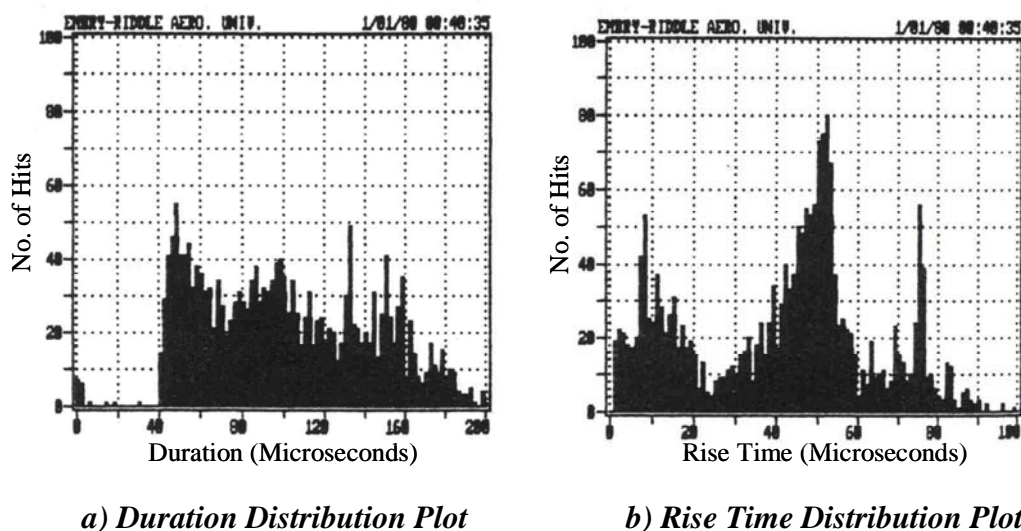
The hits from the last hump (duration more than 127 microseconds) were also analyzed. The risetime was found more than 61 microseconds, and the peak from the amplitude distribution plot was at 69 dB. This was believed to be longitudinal splitting.

Figure 2.18: Duration and Rise Time Distribution Plot After Removing Hits from Matrix Cracking (Adapted From Ely, 1992)

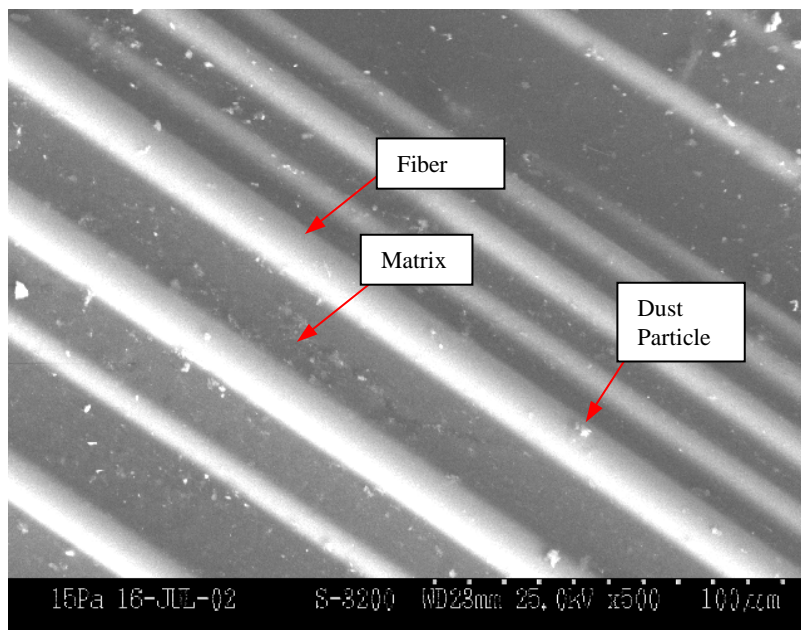
Overall, the specimen was in almost perfect condition. Most of the fibers had no imperfections, and the matrix showed no sign of cracks. Figure 4.5 shows a typical top view scan of specimen L1 before the test. The picture shows a group of undamaged fibers running in the unidirectional direction. The picture also shows a perfect condition of the matrix. It was also quite normal to see dust particles on the surface of the specimen.

***Figure 4.5: Typical View of Fibers and Matrix of Specimen L1 Before Testing
(500x Magnification)***

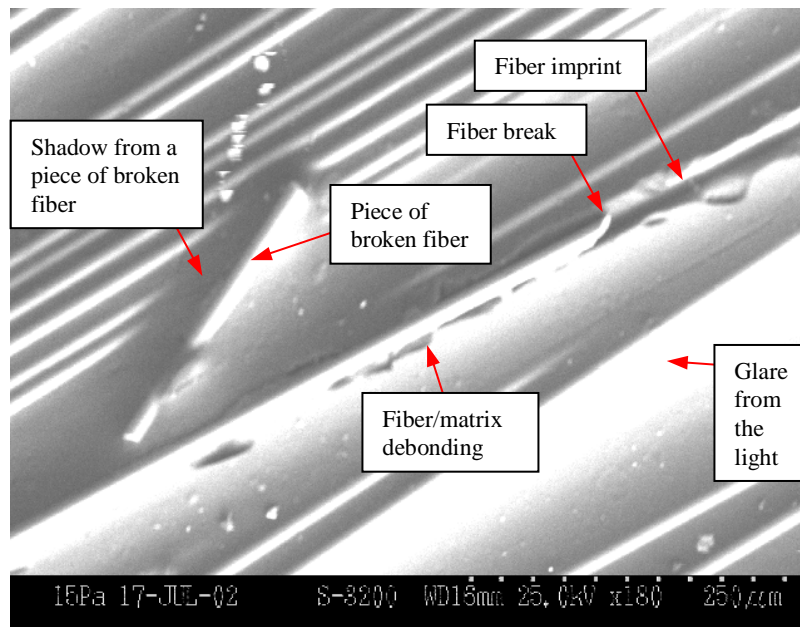
Figure 4.6: Typical Damages on Specimen L1 Before Testing (180x Magnification)

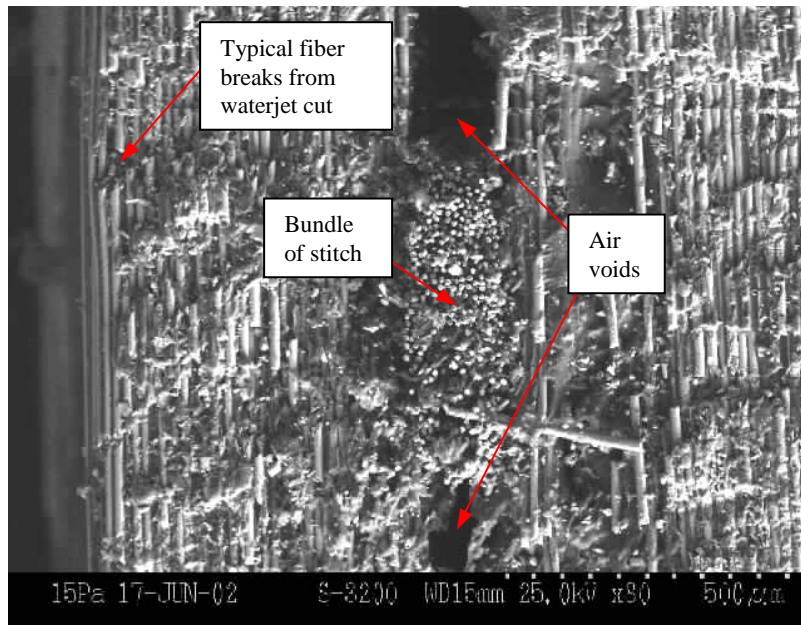
The side of the specimen was also observed. A number of damage sites involving fiber breaks due to the waterjet cut can be seen (see Fig. 4.7). As a result, the side of the specimen is not a proper area to observe the damage evolution. There are typical air voids on both sides of the stitch. These air voids can be attributed to absorbance of the resin into the stitch during the curing process.

Figure 4.7: View of the Side of Specimen L1 Showing Damage from Waterjet Cut and Air Voids Around a Stitch (80x Magnification)

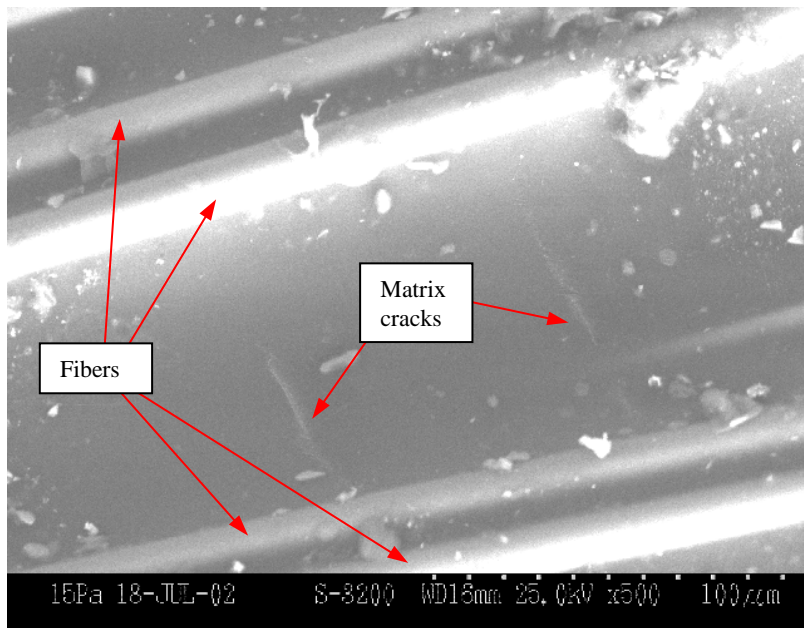
Figure 4.8: Typical Matrix Cracks Observed in Specimen L1 (500x Magnification)

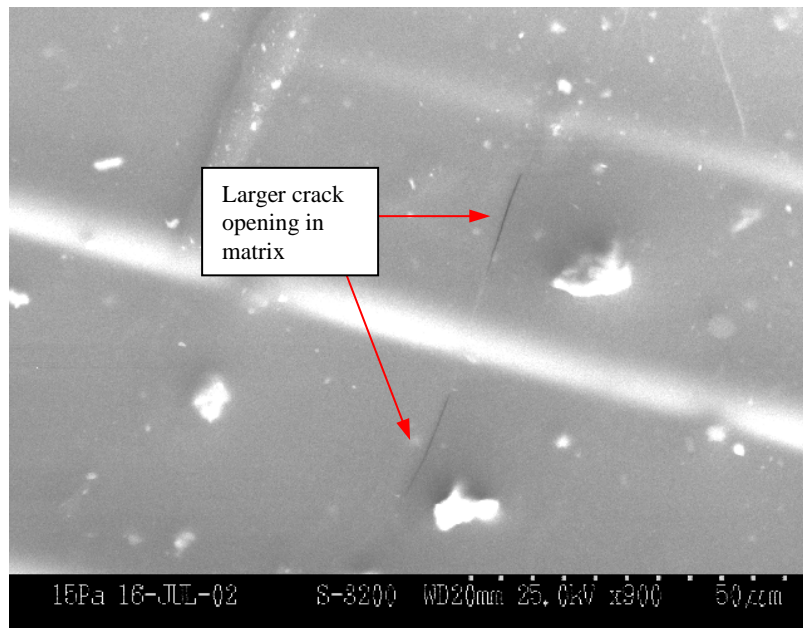
Substantial numbers of matrix cracks could be seen. Some matrix cracks propagated, and larger crack openings could be noticed (see Figure 4.10). A few fiber breaks could also be seen. Most of the fiber breaks in this specimen were associated with a crack continuation into the matrix, as shown in Figure 4.11. Figure 4.12 shows the overall view of the specimen. It can be seen from the picture that most of the fibers were still in good condition. Also, the sides of the specimen showed no development of new defects.

***Figure 4.10: Matrix Cracking with Larger Crack Openings of Specimen L2
(300x Magnification)***

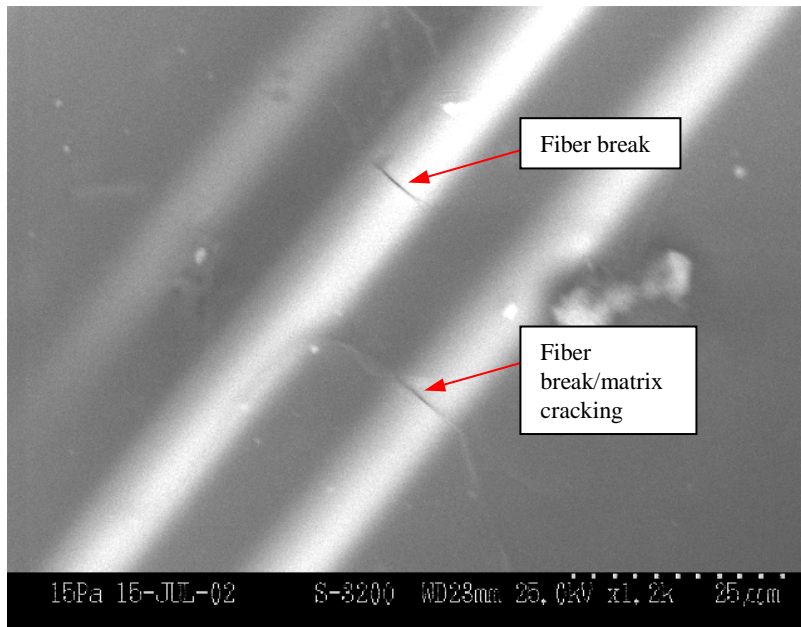
Figure 4.11: Fiber Breakage Continued with Matrix Cracking in Specimen L2 (1200x Magnification)

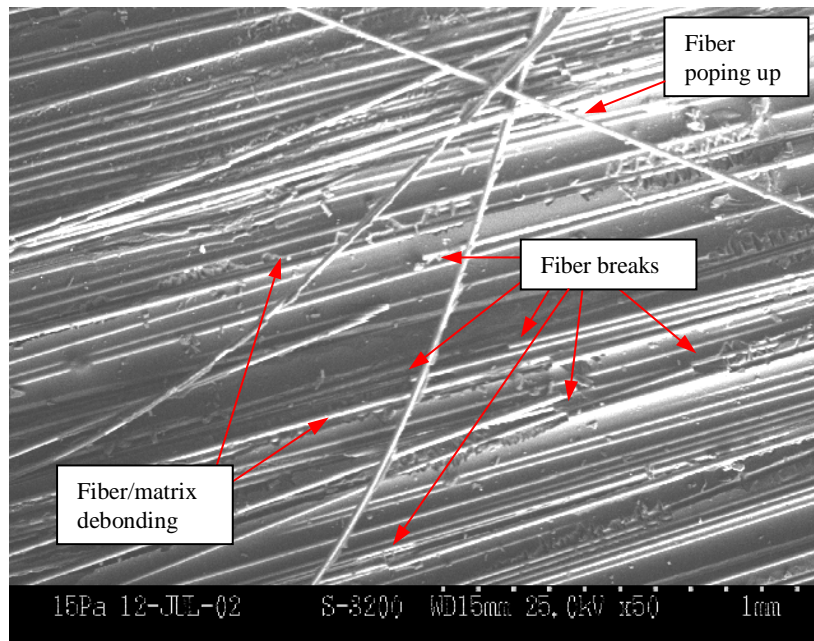
Many more fiber breaks were observed in specimen L3 than in specimen L2. Most of the fiber breaks were associated with fiber/matrix debonding (see Figure 4.13). However, the cracks continuing from fiber breaks to the matrix could still be seen in this specimen. Figure 4.14 is an overall photograph of the specimen. It can be seen in this picture that many fibers had been broken. There was no appearance of damage developed on the sides of the specimen.

Figure 4.13: Fiber Breakage and Fiber/Matrix Debonding in Specimen L3 (50x Magnification)

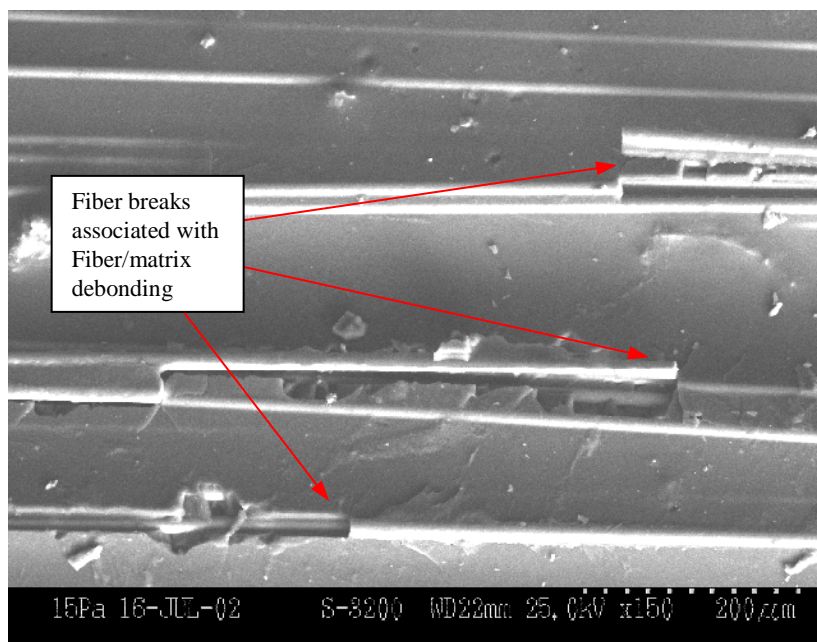
Figure 4.15: Fiber Breakage Associated with Fiber/Matrix Debonding in Specimen L4 (150x Magnification)

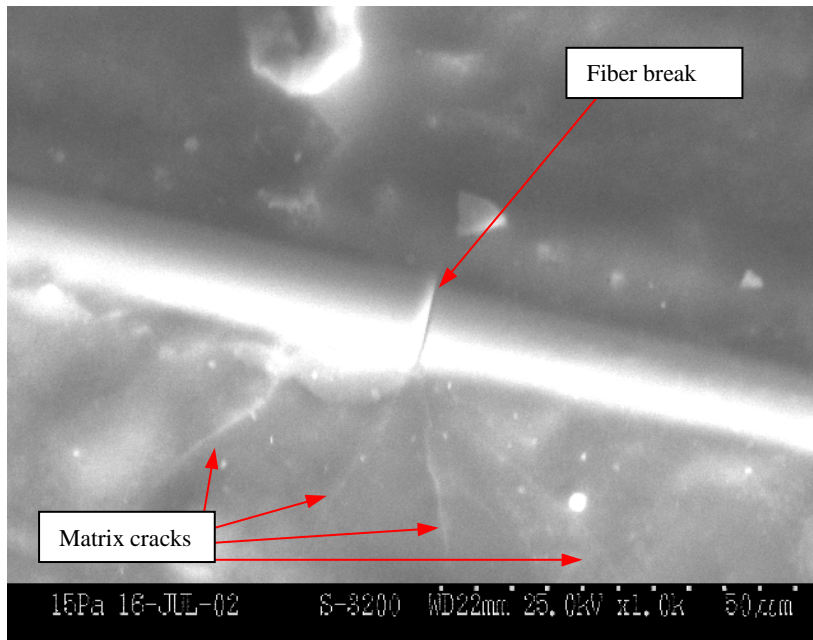
Figure 4.16: Fiber Breaks with Several Matrix Cracks in Specimen L4 (1000x Magnification)

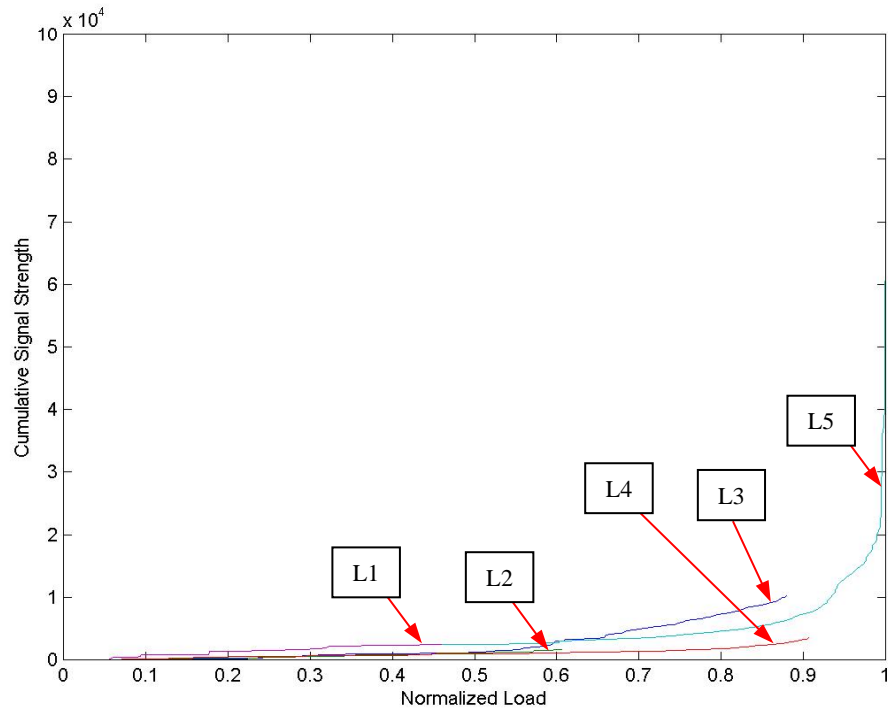
The plots of cumulative signal strength vs. load of each specimen are shown together in Figure 4.21. The curves of specimen L1 and L2 are flat compared with other specimens. The curve of specimen L4 ended just before reaching the knee of the curve, while the curve of specimen L3 passed the knee. This explains the reason that more fiber breaks were found in the specimen L3. The curve of specimen L5 rises steeply at ultimate, as commonly found in an AE test.

Figure 4.21: Cumulative Signal Strength vs. Load for All Specimens

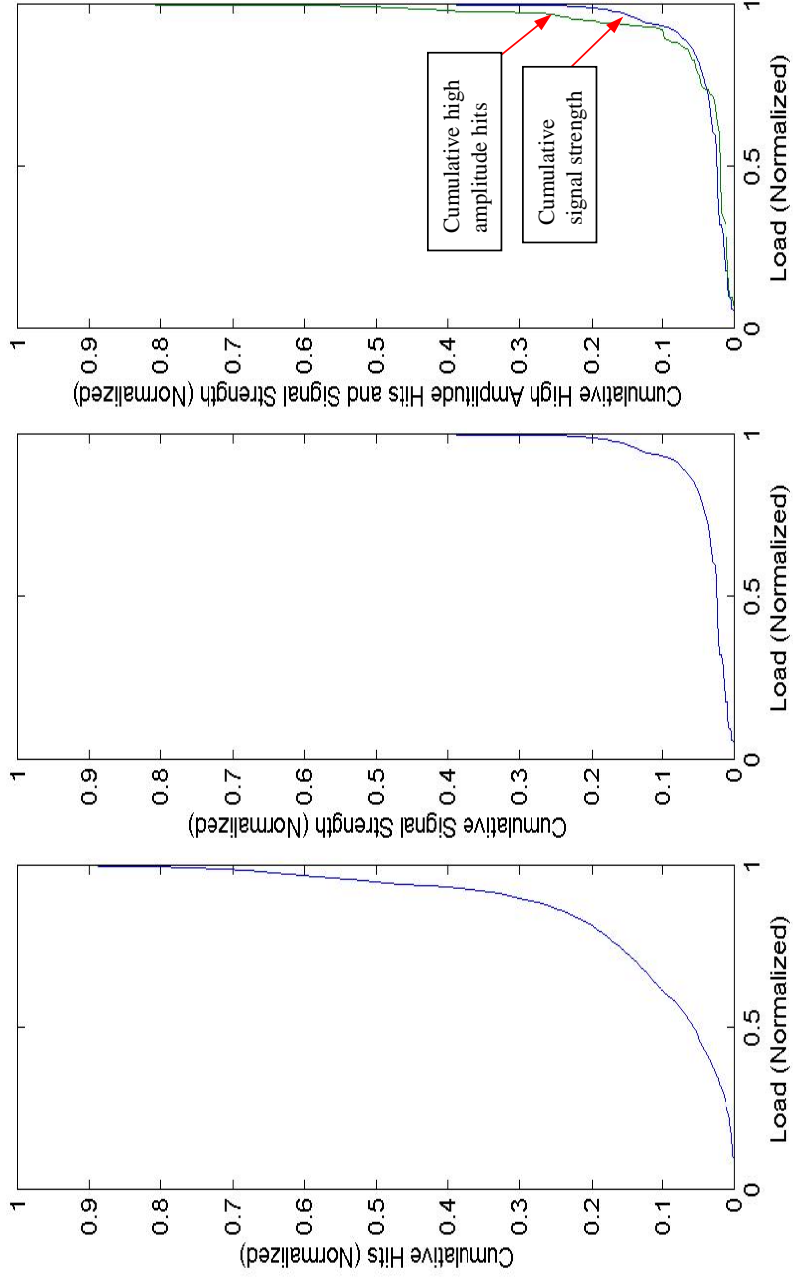
a) Cumulative Hits vs. Load b) Cumulative Signal Strength c) Cumulative High Amplitude Hit (≥ 74 dB) and Signal Strength vs. Load vs. Load

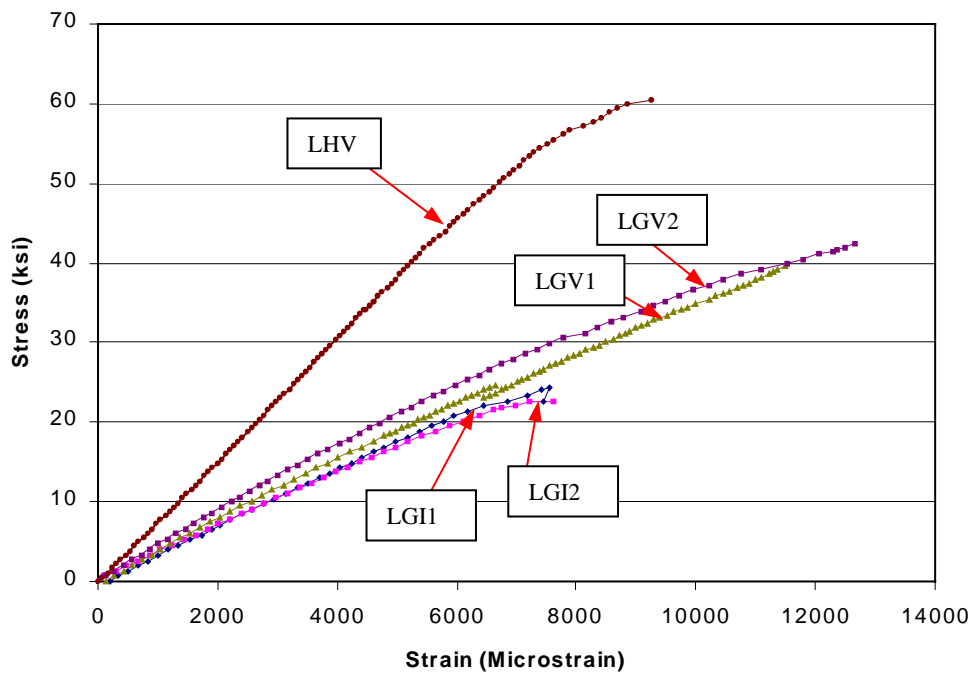
Stress-strain curves of the specimens are shown in Figure 4.33. Specimen LHV had the highest ultimate stress (61 ksi), while specimen LGV2 had the highest ultimate strain (12,000 microstrain). The elastic modulus of specimens LGI1 and LGI2 were approximately 3,500 ksi, while they were approximately 3,700 ksi for specimens LGV1 and LGV2. Specimen LHV gave an elastic modulus of 7,600 ksi. The carbon fibers in the specimen are the reason for the large modulus and higher ultimate stress. Table 4.4 summarizes ultimate stresses, ultimate strain, and elastic modulus of the specimens.

Figure 4.33: Stress-Strain Curves for All Specimens

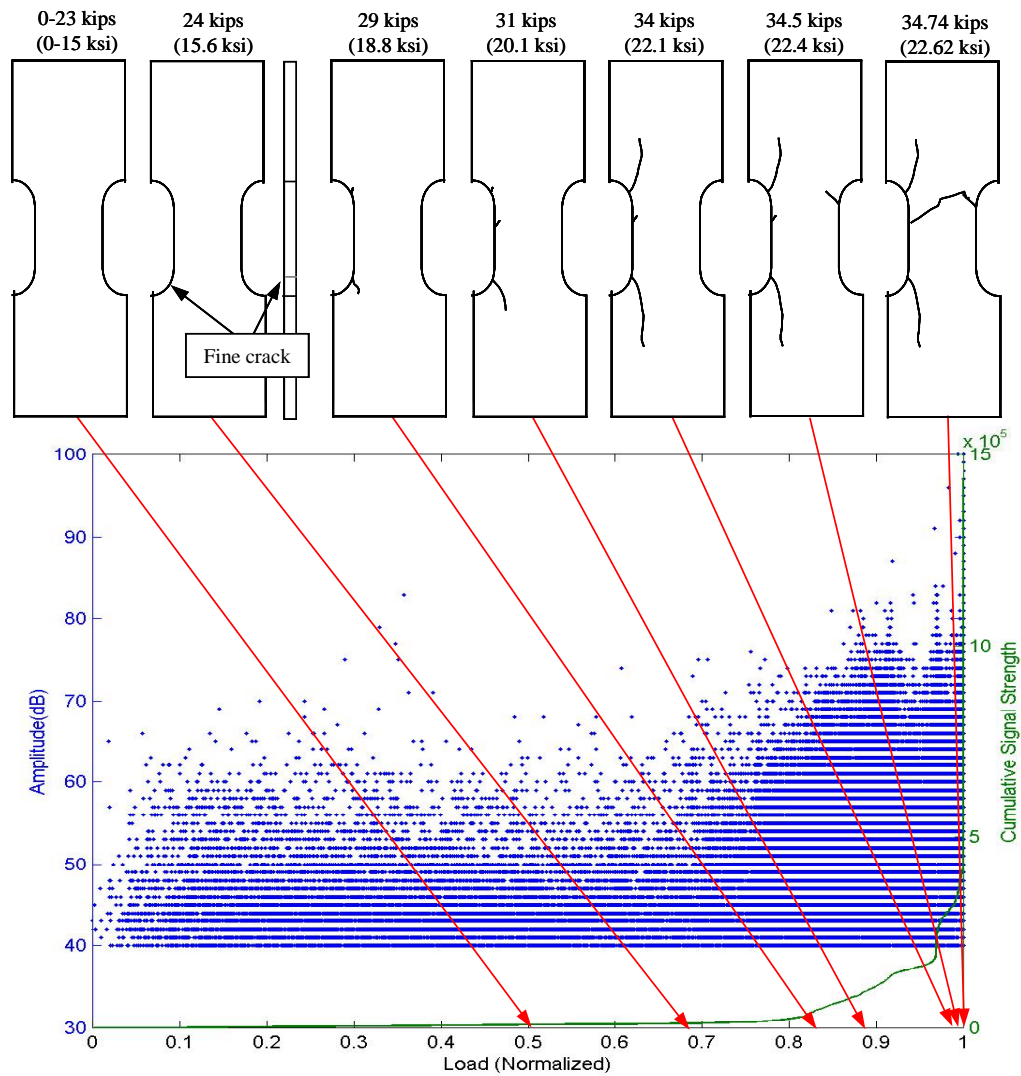
A detailed summary of the visual damage evolution as well as AE amplitude data of specimen LGI2 is also shown in Fig. 4.37.

Figure 4.37: Visual Damage Evolution on Specimen LGI2 Corresponding with AE Amplitude/Cumulative Signal Strength vs. Normalized Load (Sensor 2)

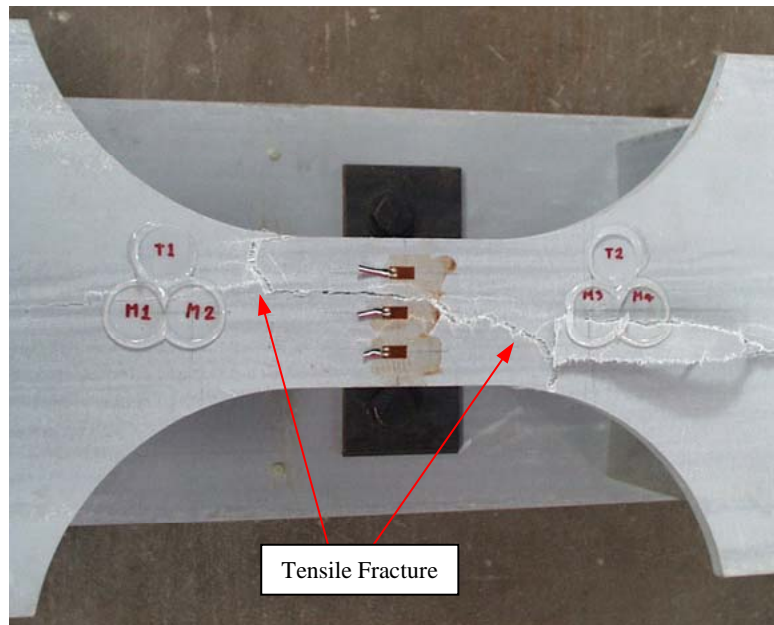
Figure 4.40: Bottom Flange at Failure of Beam FGI

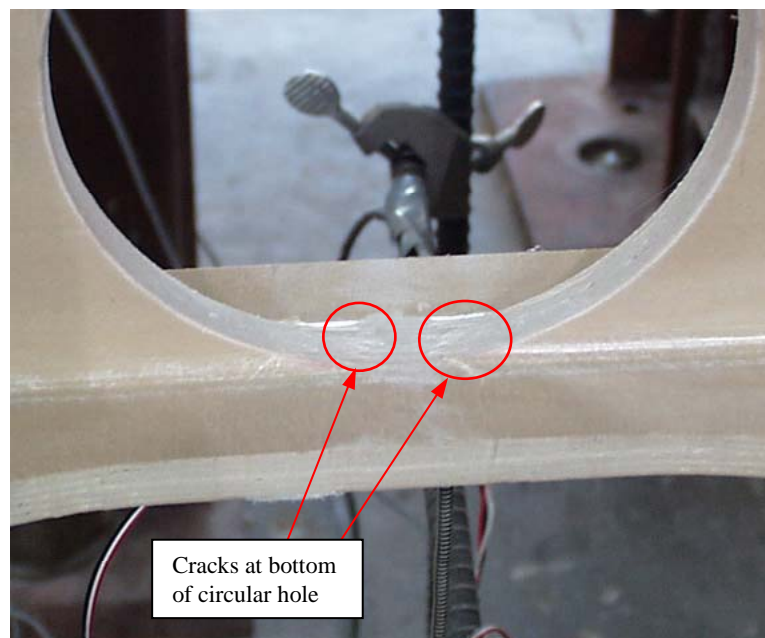
Figure 4.43: First Observed Crack at the Circular Hole

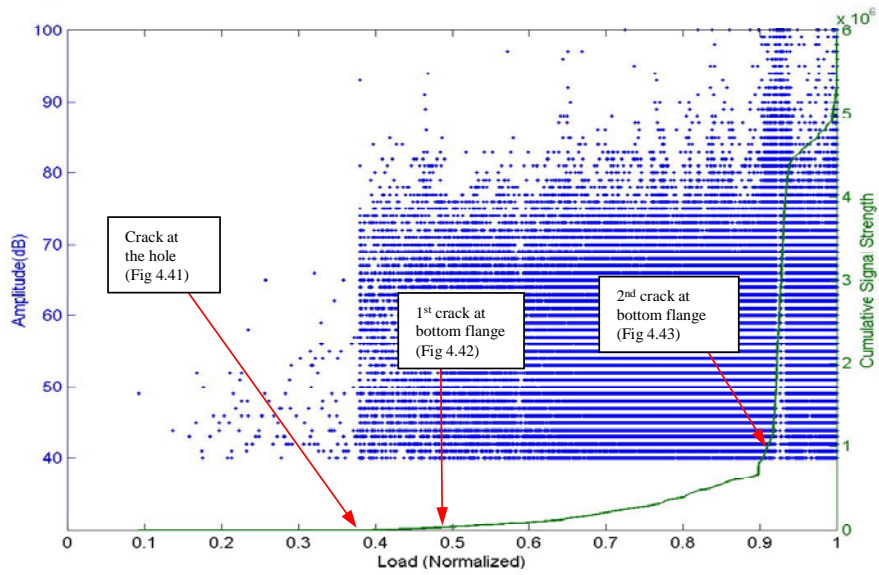
Figure 4.47 shows the AE response (amplitude/cumulative signal strength vs. normalized load) of beam FGV. Figure 4.48 shows the same plot but with a smaller signal strength range. This plot shows a knee of the signal strength curve corresponding with the crack at the hole. For beam FGI, the damage evolution occurred almost identically to that observed in beam FGV. The one exception was that there was no shear failure propagation. Figure 4.49 shows the amplitude/cumulative signal strength vs. normalized load plot of beam FGI. As was the case with FGV, it was noticed in beam FGI that the start of high amplitude hits was associated with the first crack found at the bottom of the circular hole.

Figure 4.47: Amplitude Superimposed with Cumulative Signal Strength vs. Load of Beam FGV

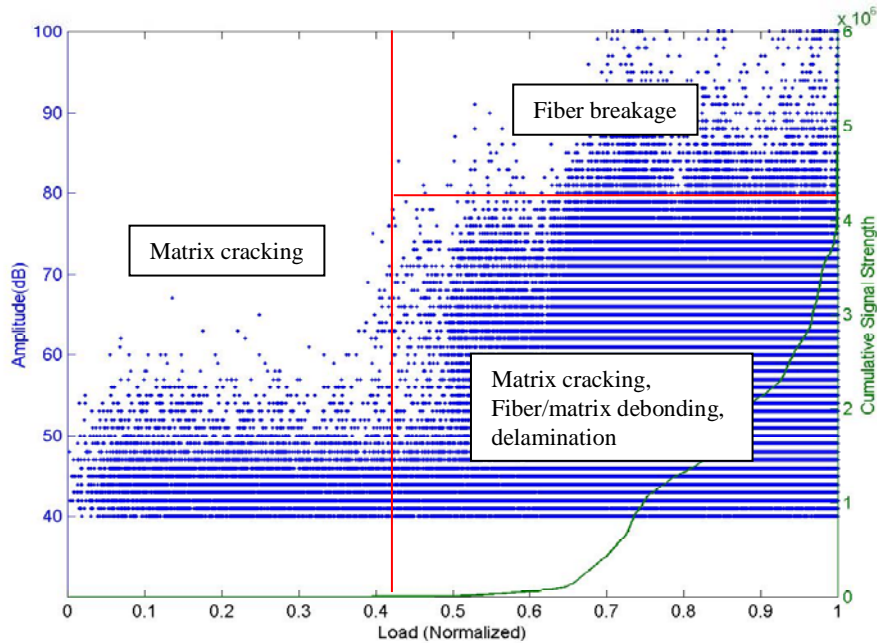
Figure 4.50: Summary of Failure Mechanisms of Specimen LGV

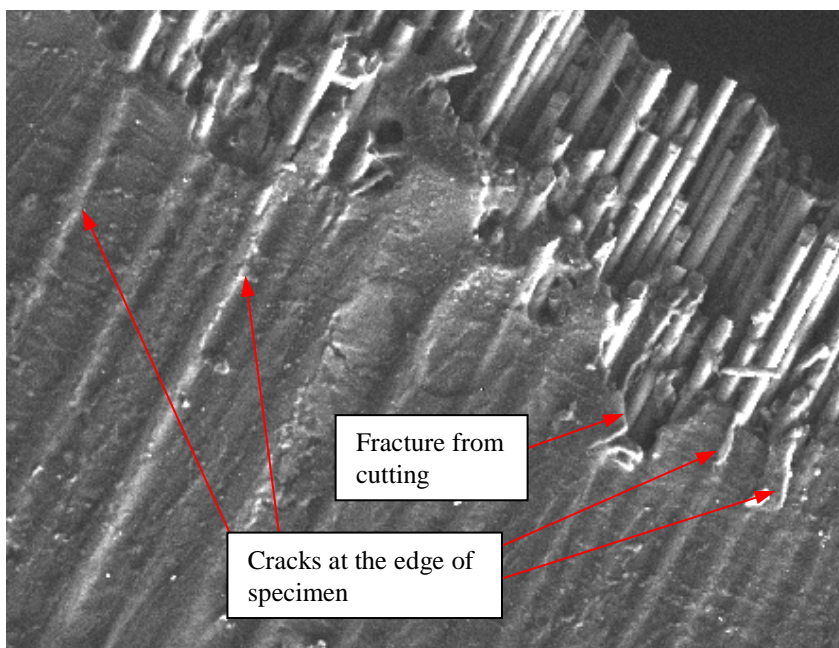
Figure 5.5: Cracks at the Edge of Specimen T1 (100x Magnification)

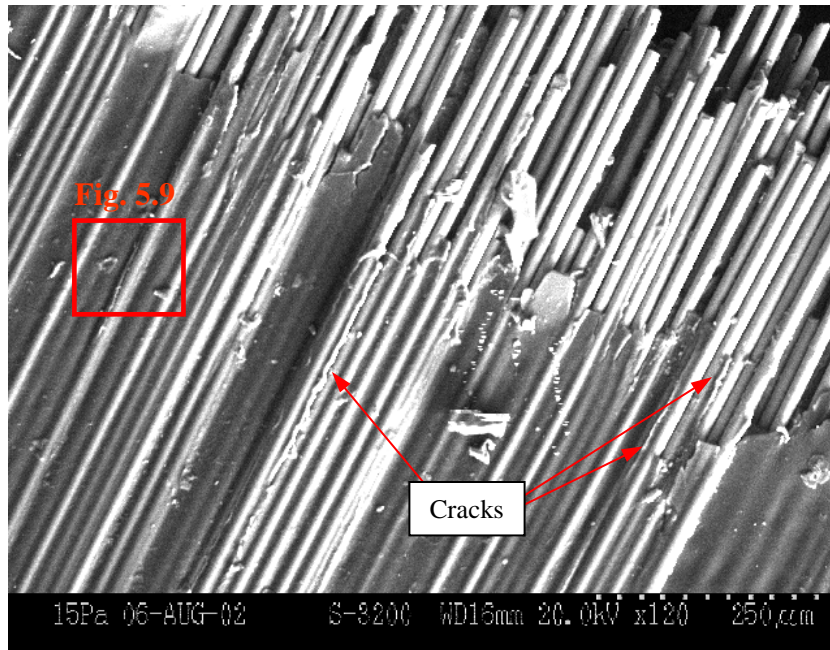
The same type of cracks that occurred in specimen T1 were found more frequently in specimen T2. Most of the cracks were longer than in specimen T2, indicating that they had propagated. The cracks observed in this specimen are shown in Fig. 5.8. Figure 5.9 is a zoom picture of one of the cracks in Fig. 5.8, which shows typical shell cracking. Additionally, the sides of the specimen showed no damage development.

Figure 5.8: Cracks at the Edge of Specimen T2 (120x Magnification)

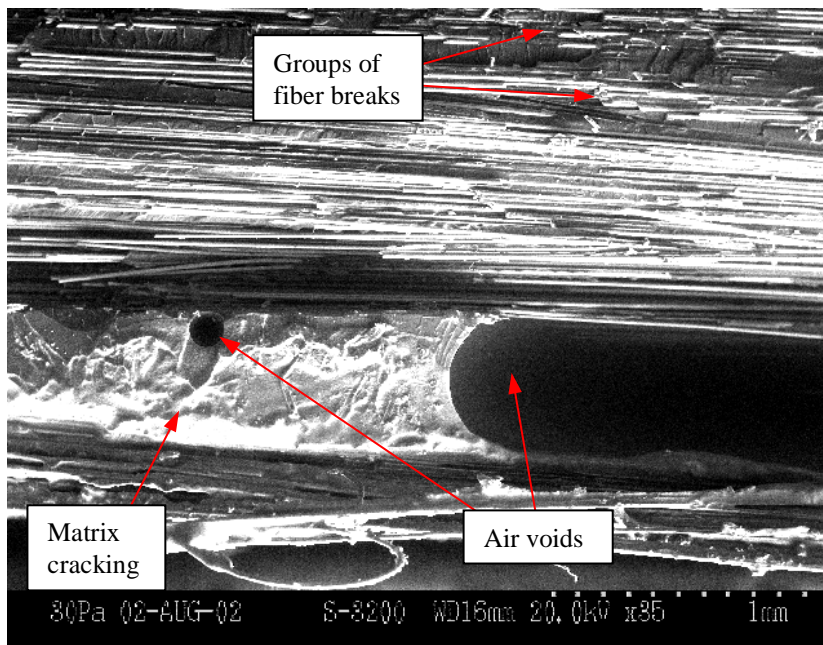
The specimen was then broken manually in order to inspect the cross section of the specimen. Figure 5.13 shows a view of the cross section showing the texture of matrix cracking caused by the test. The pictures also show several groups of fiber breaks, which based on the type of break, are believed to be the result of manually breaking the specimen.

Figure 5.13: View of Cross Section Showing Matrix Cracking and Air Voids (35x Magnification)

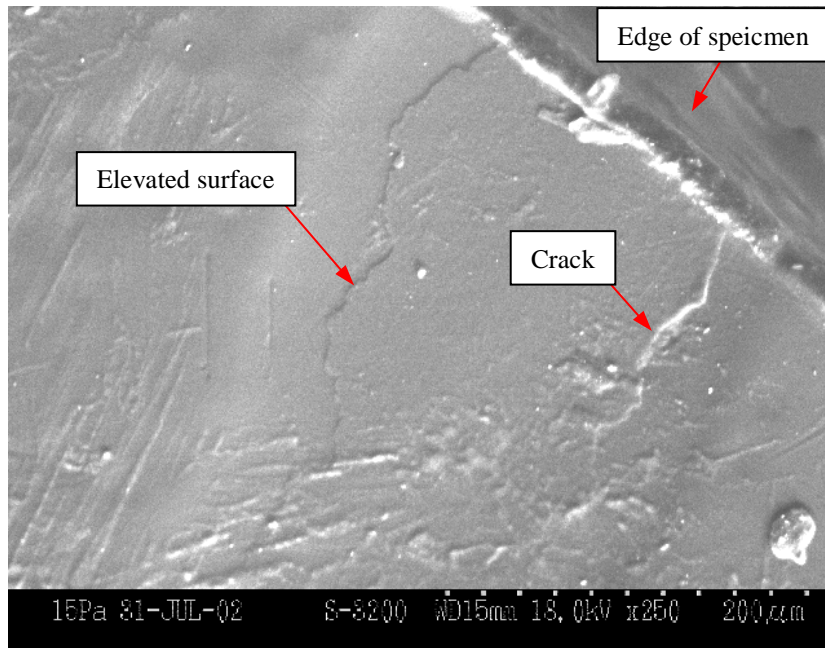
Several fine, short cracks were also observed at the edge of the specimen. Figure 5.15 shows an example of this type of crack, which is associated with matrix cracking. The picture also shows the elevated surface, which is a surface discontinuity that occurred during fabrication.

Figure 5.15: Fine Crack Near Edge of Specimen T3 (250x Magnification)

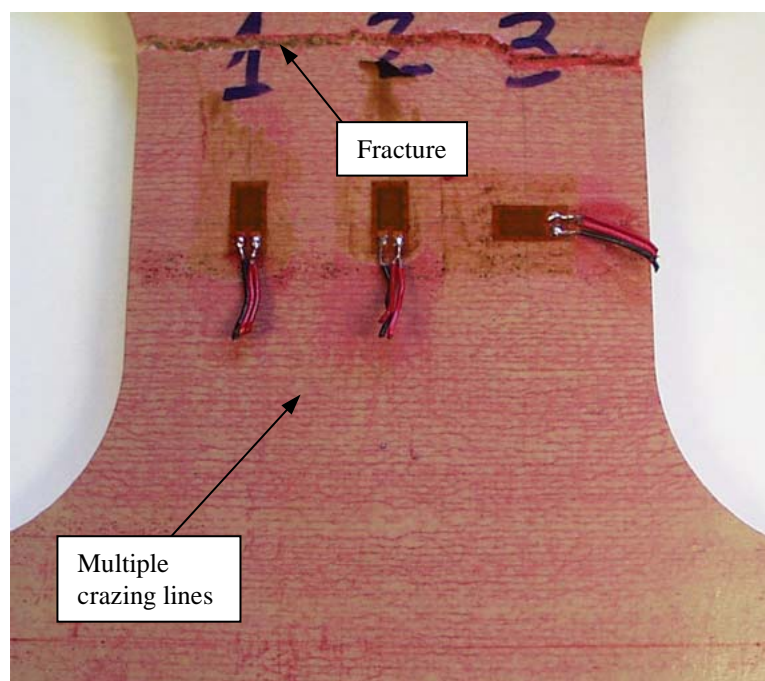
cross section at the end of the narrow section fractured. The specimen was subjected to a liquid dye penetrant method to help visualize the cracks. Figure 5.21 shows the fracture site. The multiple crazing lines are shown as red lines due to the red dye penetrant.

Figure 5.21: Tensile Fracture and Multiple Crazing of Specimen TGV

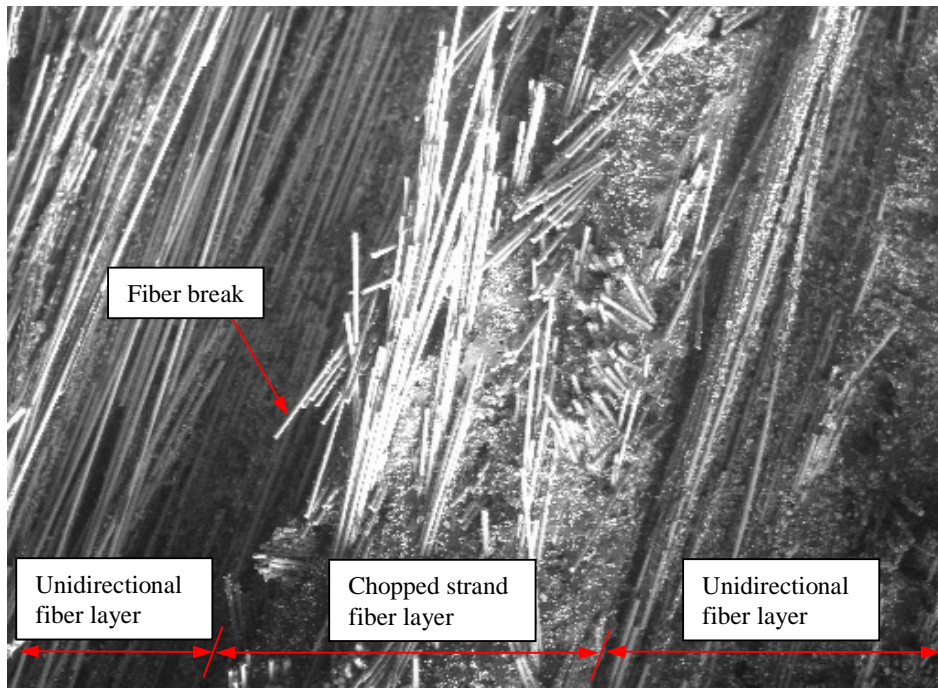
The fractures of all specimens were investigated. The SEM was performed on one representative specimen (TGI1). It was observed that the main failure mechanisms of the unidirectional fiber layers were matrix cracking and debonding. The main failure mechanism of the chopped strand fiber layers was fiber breakage, as shown in Figure 5.22.

Figure 5.22: SEM View of the Fracture of Specimen TG11

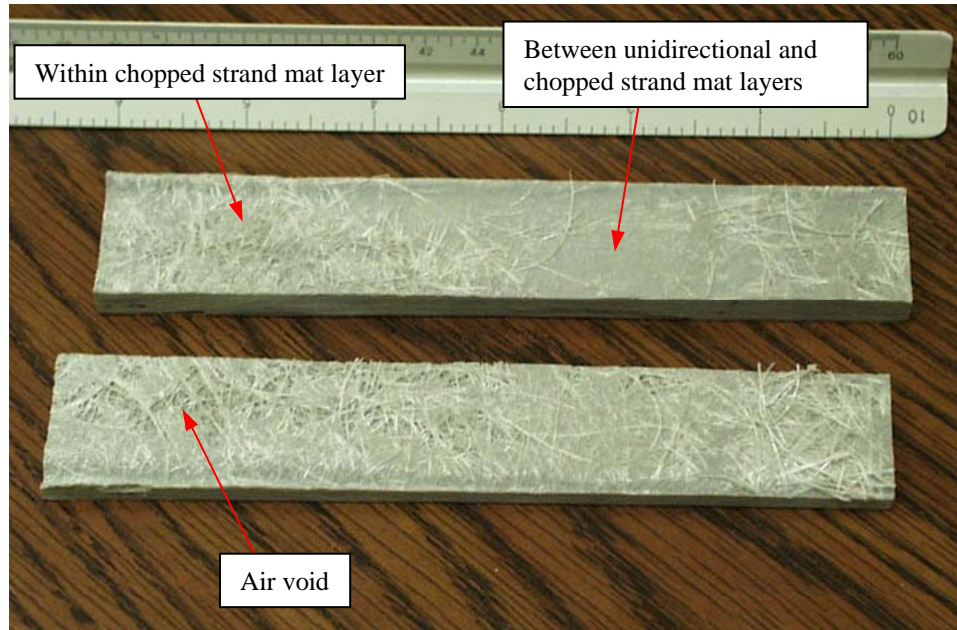
The delamination of specimen SGI1 was manually broken open to inspect the failure surface (Fig. 6.10). It was observed that the failure plane is located within a chopped strand mat layer. Also, in some areas, it extended into an interface between chopped strand mat and unidirectional fiber layers. Within the chopped strand mat layer, a significant number of air voids between fiber strands were observed. This generates a weak plane for the shear stress.

Figure 6.10: Failure Surface of Specimen SG11 After Breaking Off

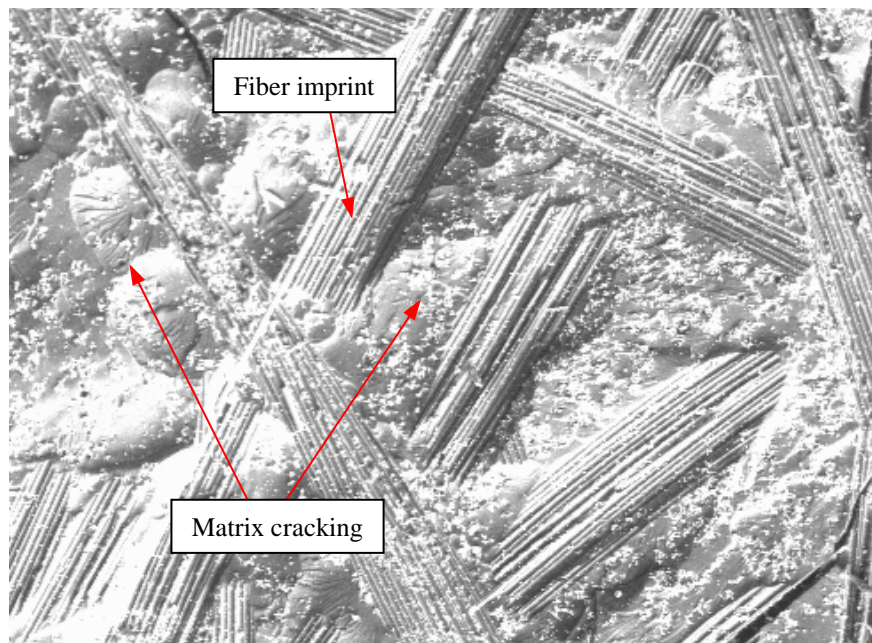
SEM observation confirms the mechanisms discussed above. Figure 6.12 shows fiber imprint, which is an indication of debonding. Also, fiber breaks were found from the SEM as shown in Fig. 6.13.

Figure 6.12: SEM Photo Showing Fiber Imprint (Debonding) and Matrix Cracking of Specimen SG11 (Approximately 40x Magnification)

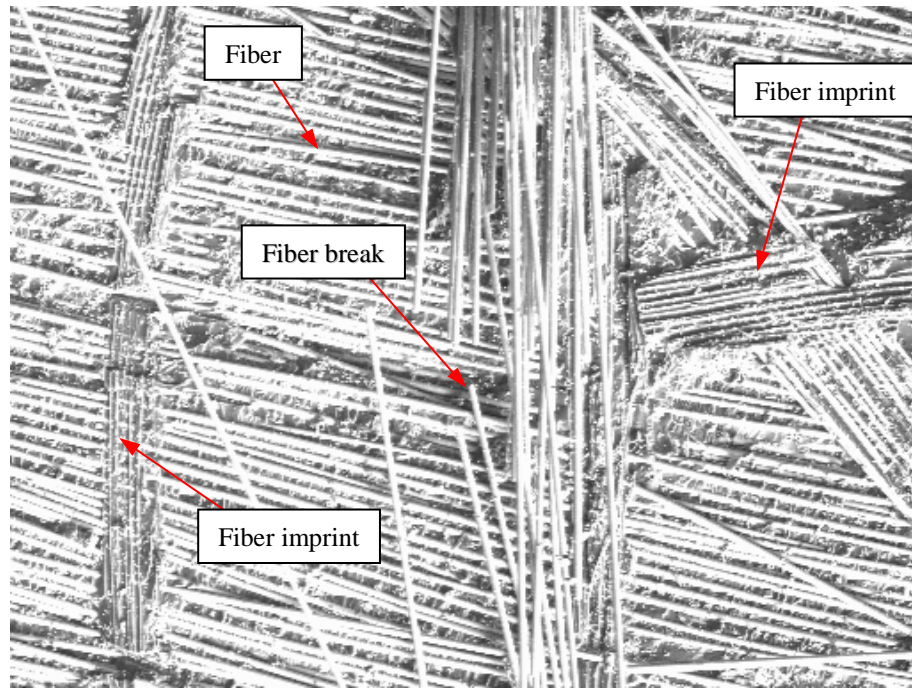
**Figure 6.13: SEM Photo Showing Fiber breaks of Specimen SG11
(Approximately 60x Magnification)**

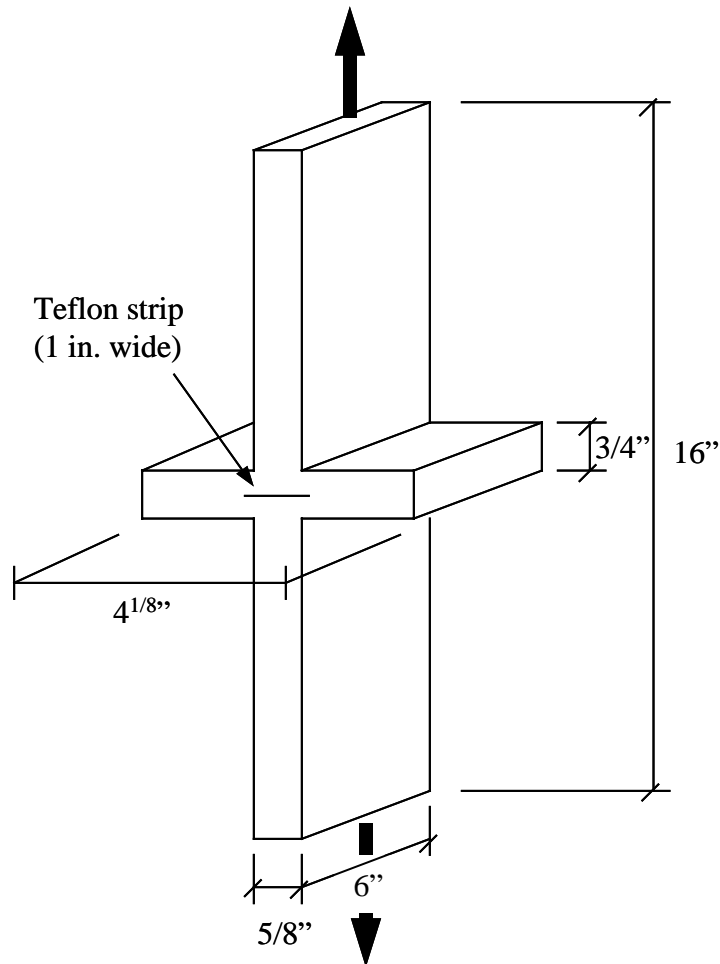
Figure 6.17: “T” Specimen Dimensions

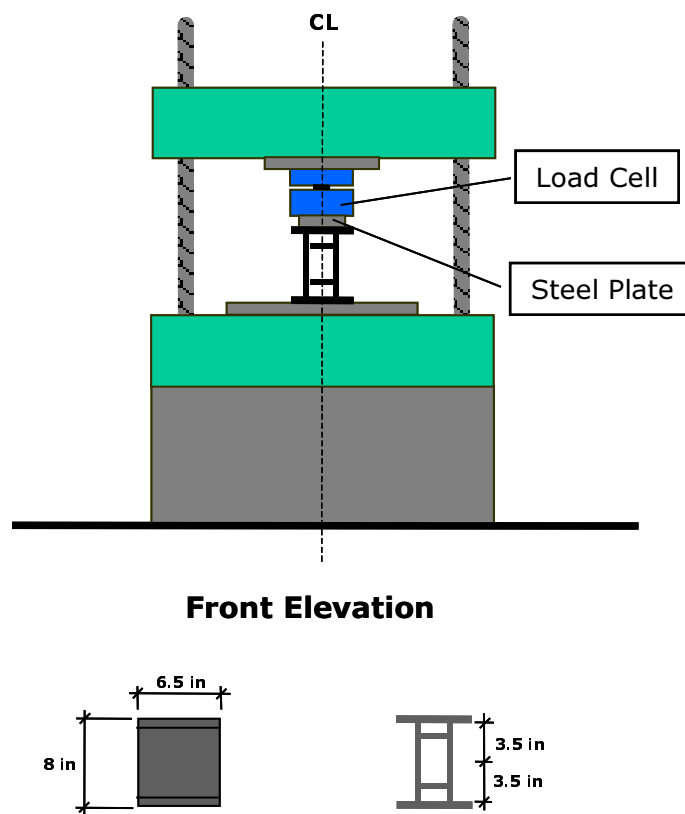
Three specimens (BHV1, BHV2, and BHV3) were cut from beam SW. Figure 6.26 shows the dimensions and test setup for the three specimens. This test is intended to determine the buckling capacity of the double web cross section.

*Figure 6.26: Compression Buckling Specimen, Dimension and Test Setup
(Ulloa, 2002)*

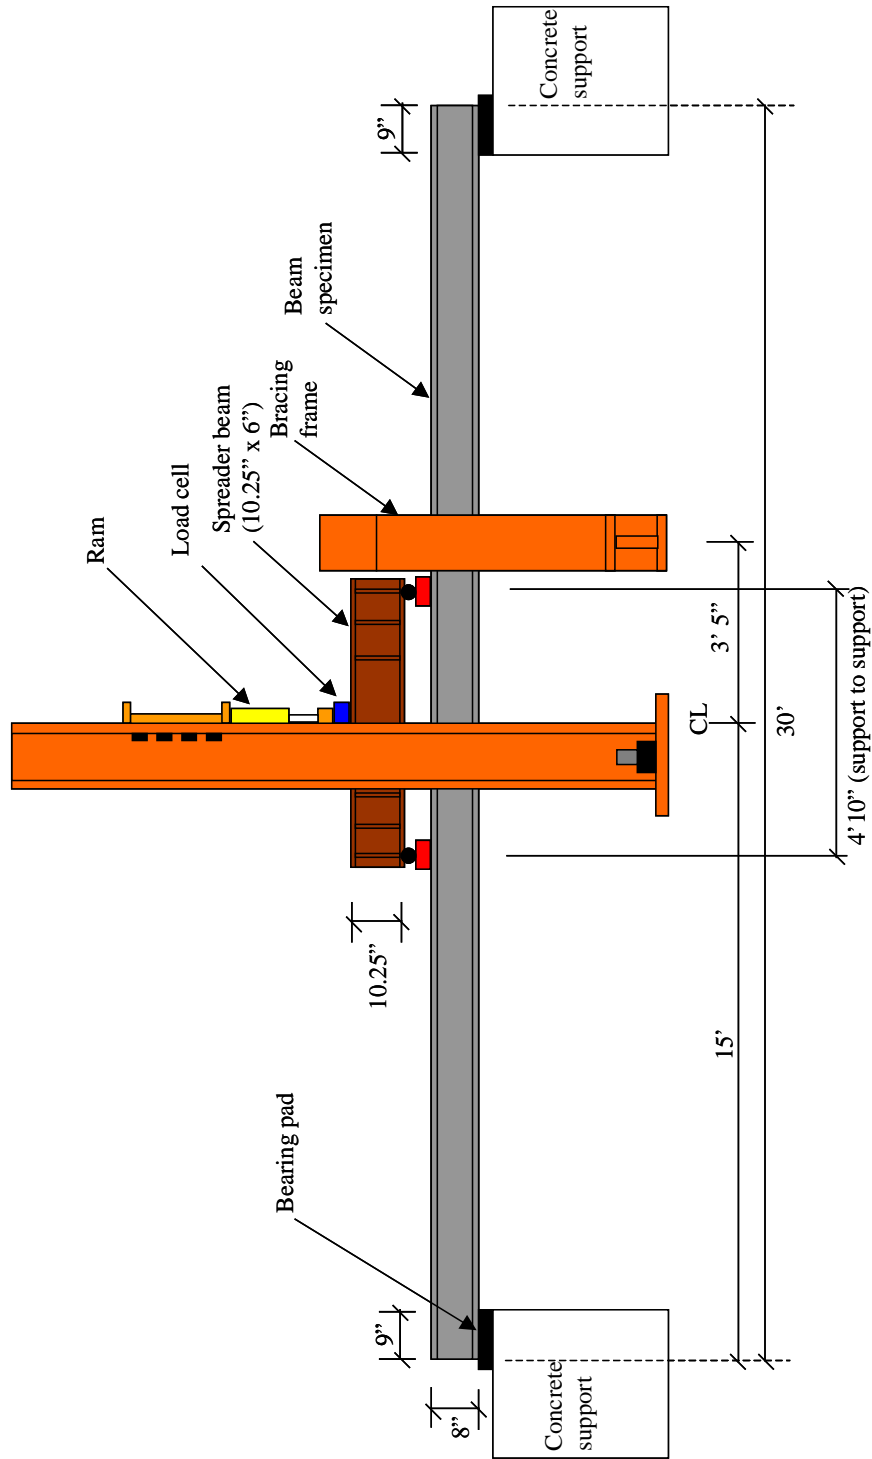
Figure 6.29 Four-Point Bending Test Setup and Dimensions of Specimen SW2

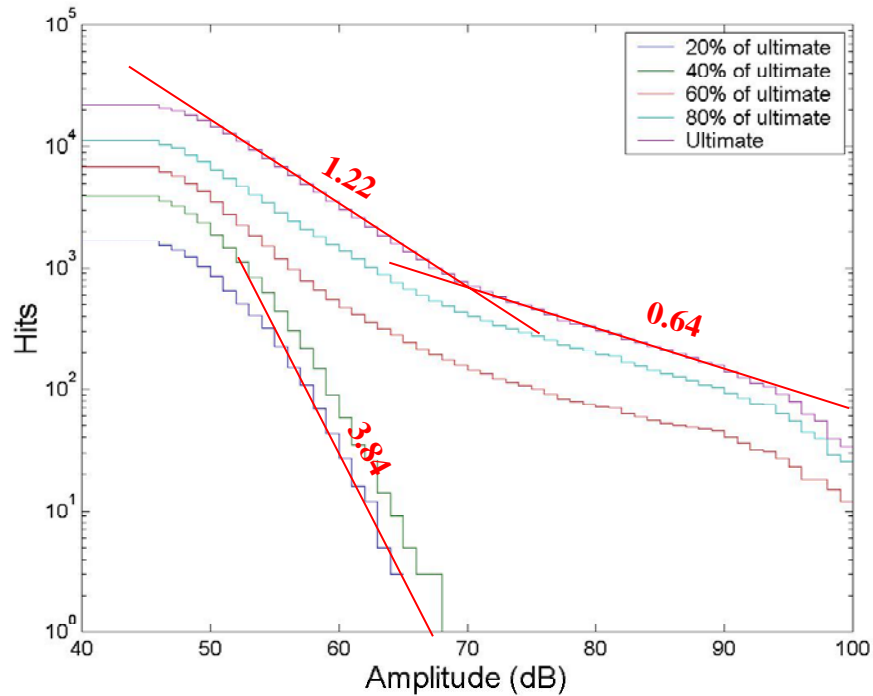
The slope value, or b-value, is provided above each plot. An example of how this number is calculated is shown in Fig. 7.18, which is the plot of specimen TGV.

Figure 7.18 : Example of How to Calculate the *b*-Value, or Slope, of the Cumulative Amplitude Distribution Plot
