**ACOUSTIC EMISSION SIGNATURE ANALYSIS OF FAILURE
MECHANISMS IN FIBER REINFORCED PLASTIC STRUCTURES**

Dissertation

The University of Texas at Austin

December 2002

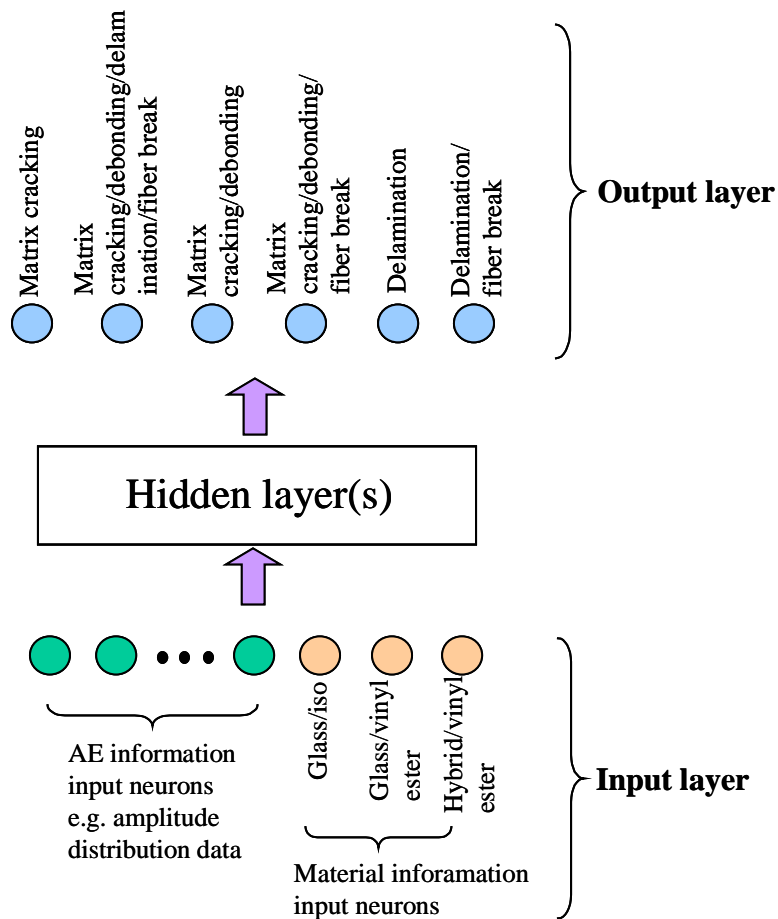
Figure 8.2: Typical Primary Neural Network Diagram

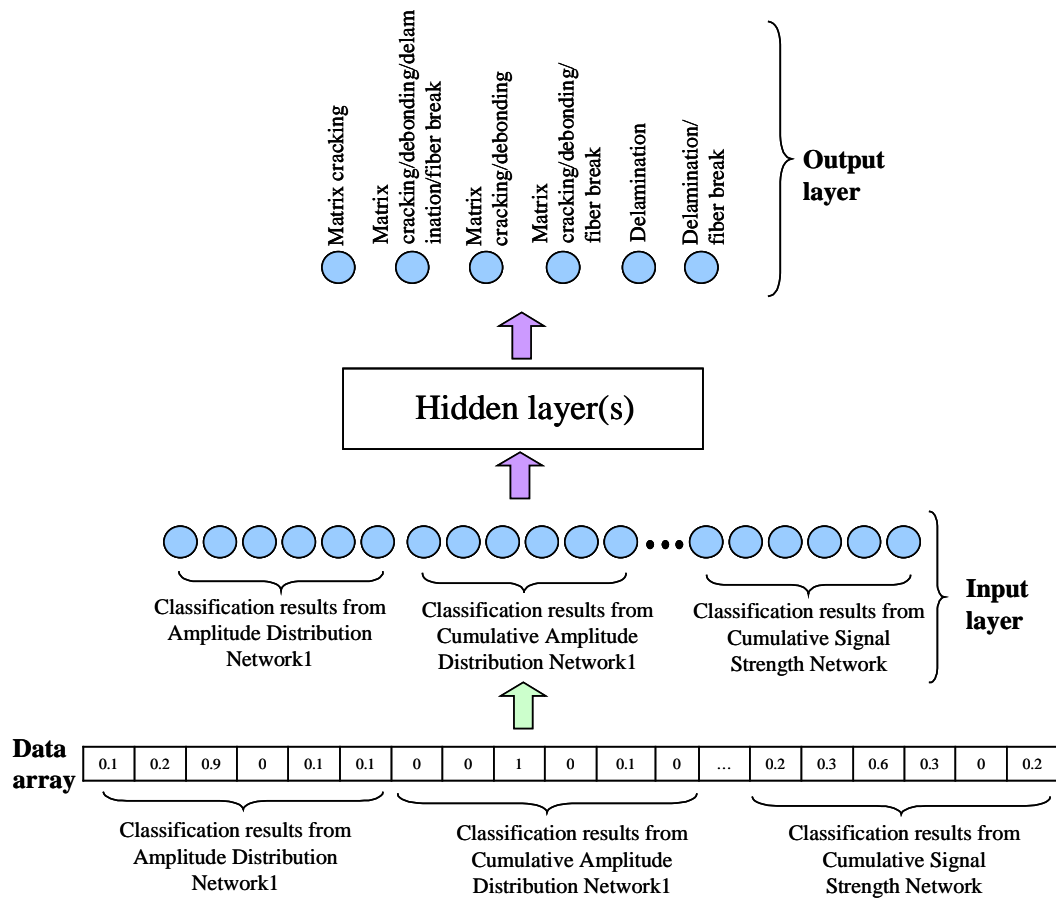
Figure 8.17: Secondary Neural Network Diagram

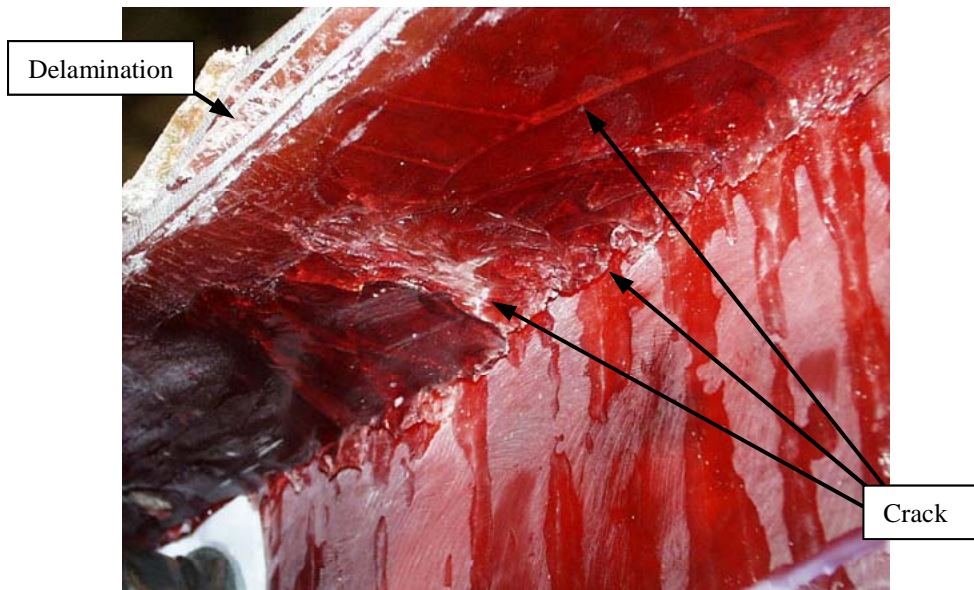
Figure 9.11: Cracks Under Top Flange Where Delamination Occurred (East Side)

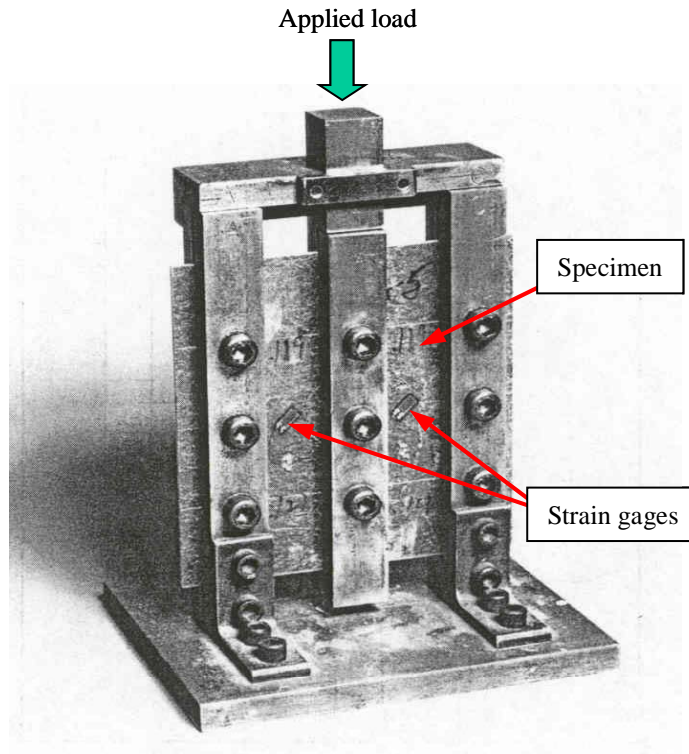
Figure 9.15: Three-Rail Shear Test Setup (ASTM D 4255)

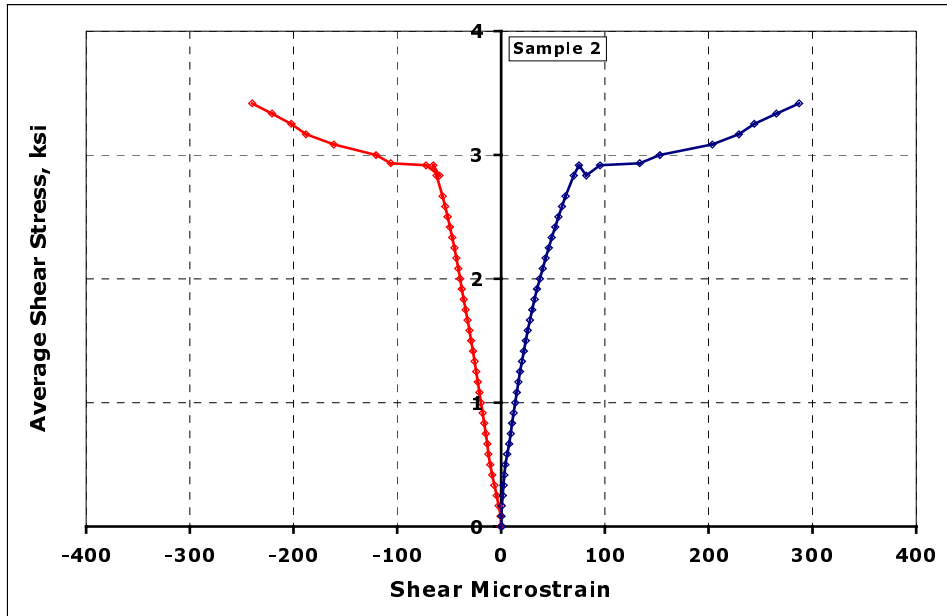
Figure 9.17: Shear Stress vs. Strain Curve of Specimen SHEAR2

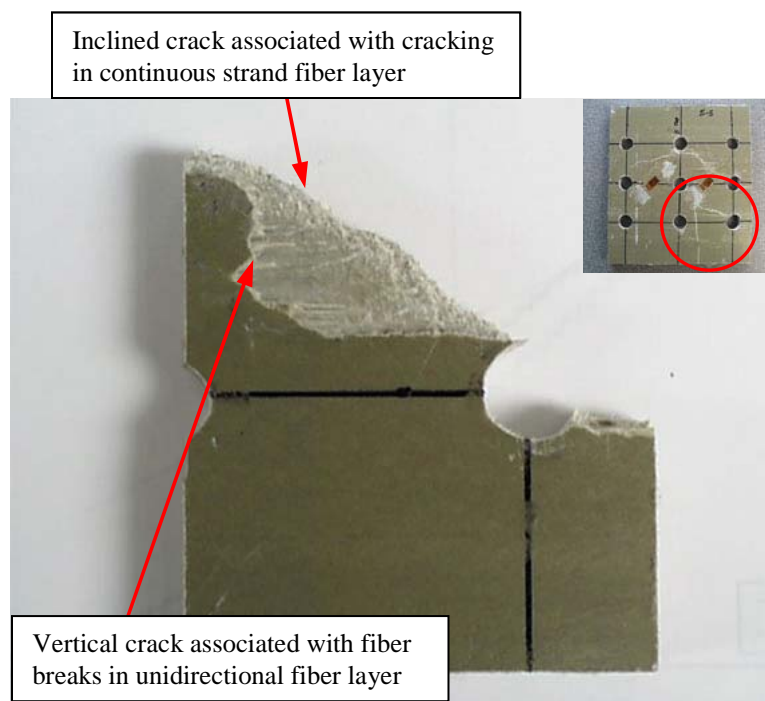
Figure 9.21: Autopsy of specimen SHEAR3 Showing Interior Inclined Crack and Exterior Vertical and Horizontal Crack
