Bending Fatigue Performance of Small-Scale Stay Cables

Thesis

The University of Texas at Austin

This thesis documents the construction and fatigue testing of small-scale specimens designed to model the longest stays on the Fred Hartman Bridge. Transverse stiffness and axial strains were monitored periodically during the fatigue tests to evaluate the degradation of the structural characteristics due to the accumulation of fatigue damage. Also, strand was tested axially to determine the mechanical and fatigue properties and to compare them to published values. The goal of the project is to compare the measured response of the small-scale specimens with analytical models used to evaluate the fatigue response of the bridge stays..

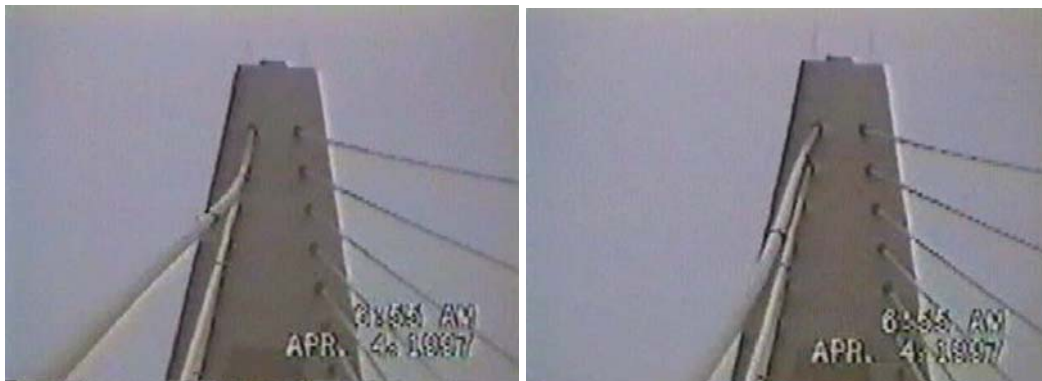
Figure 1-6 Observed large-amplitude vibrations of stay cables on Fred Hartman Bridge (TxDOT, 1997)

Large-amplitude vibrations on the Fred Hartman Bridge were observed for the first time during construction. Photos of large-amplitude stay cable vibrations are shown in Figure 1-6. The longest cables have experienced vibrations with amplitudes on the order of ± 20 in. (Poston, 1998). The frequency of the vibrations was between 1 to 3 Hz. These large-amplitude vibrations were observed under low to moderate wind speeds (10-45 mph) and rainy conditions (Zou, 2005).

Pebley created two, 3-D finite element models. The first model, of the longest stays on the bridge, was created to corroborate the video footage taken of the stays in large-amplitude vibrations (Figure 1-6). Pebley found that the displaced shapes of the cables could be modeled using parametric deck excitation as the input motion.

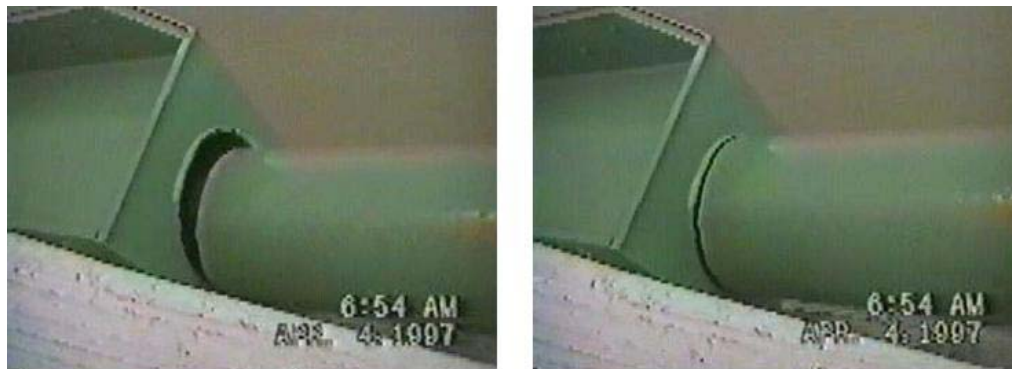
Figure 1-7 Broken guide pipe to anchorage box connections (TxDOT, 1997)

These large-amplitude vibrations caused 101 of 192 anchorage guide pipes to fracture during the time between construction was completed and 1998 when the research project was initiated (Figure 1-7). The damage to the guide pipes was a clear illustration that large-amplitude vibrations of the say cables can cause structural damage.

The guide pipes fractured because the stays cables came in contact with the guide pipes. This caused a fracture of the weld in most of the pipes (Figure 1-7). The guide pipes were repaired and stiffeners were added to help withstand lateral forces resisted by the pipes.

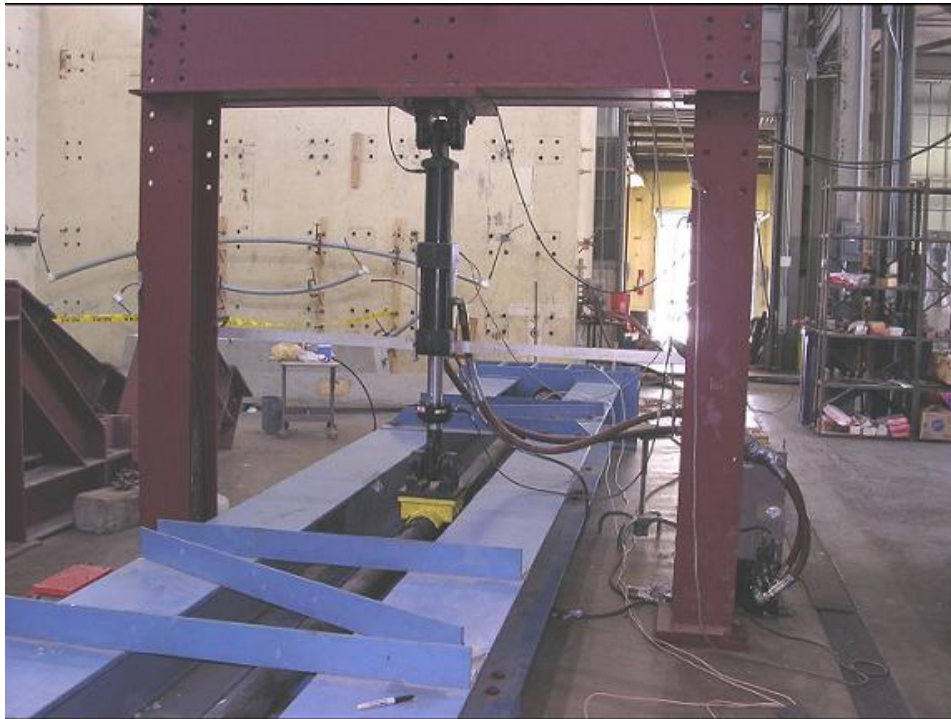
Figure 1-10 Large-scale bending fatigue tests (Ridd, 2004)

Large-scale tests were conducted at the Ferguson Structural Engineering Laboratory. Twelve, 32-ft long specimens, both grouted and ungrouted were tested. The specimens were constructed and tested in a reaction frame. Most tests were conducted on a 19-strand grouted specimen representing the smallest cables on the Fred Hartman Bridge. The design of the specimens was based on the geometry of the shortest stays on the bridge.

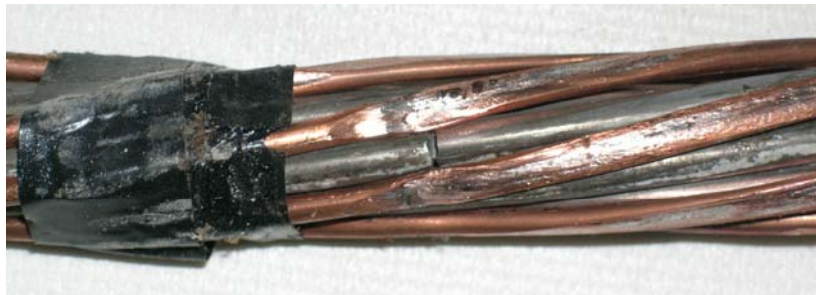
Figure 2-1 Wire break within grip

The testing objective was to obtain three acceptable tests for each strand at each stress range. An acceptable test is one that results in a run-out or with a break along the free length, between the grips. The tests that broke in the grips are not considered an acceptable break because the grips may have shortened the fatigue life by increasing friction on the strand or artificially increasing the fatigue damage.

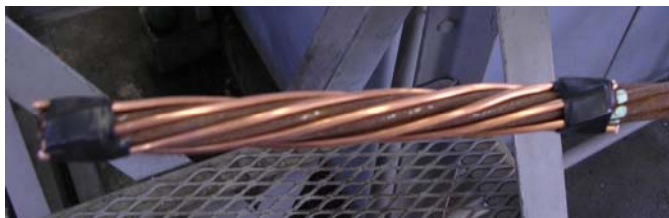
Figure 2-4 Strand wrapped with copper wire

Copper wires were placed between the aluminum grips and the steel prestressing strands to fill the space between the steel strand and the aluminum grips, to distribute the gripping force to the strand more evenly (Figure 2-4). The wire is 8-gage solid copper wire. Six pieces, 8-in. long were cut and formed to follow the helical wrap of the strand at each end. The copper wire was taped into place to secure them while the MTS clamps gripped the specimen. It was found that when the copper wires were formed to fit the strand properly, the gripping process and the testing were much easier to conduct and the specimen was much less likely to experience a wire break in the grip area.

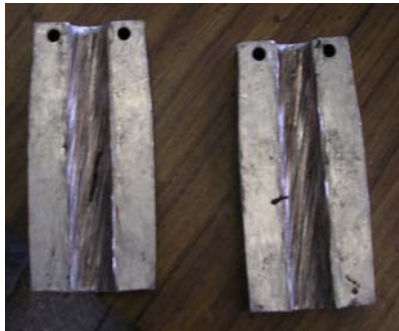
Figure 2-5 Aluminum grips after excessive use

The original aluminum grips were smooth along the inside where the grip came in contact with the aluminum strands. As these tests continued the smooth surfaces became worn. Helical groves formed around the inside of the grips (Figure 2-5). The outside of the grips also became worn from being clamped in the MTS clamps.

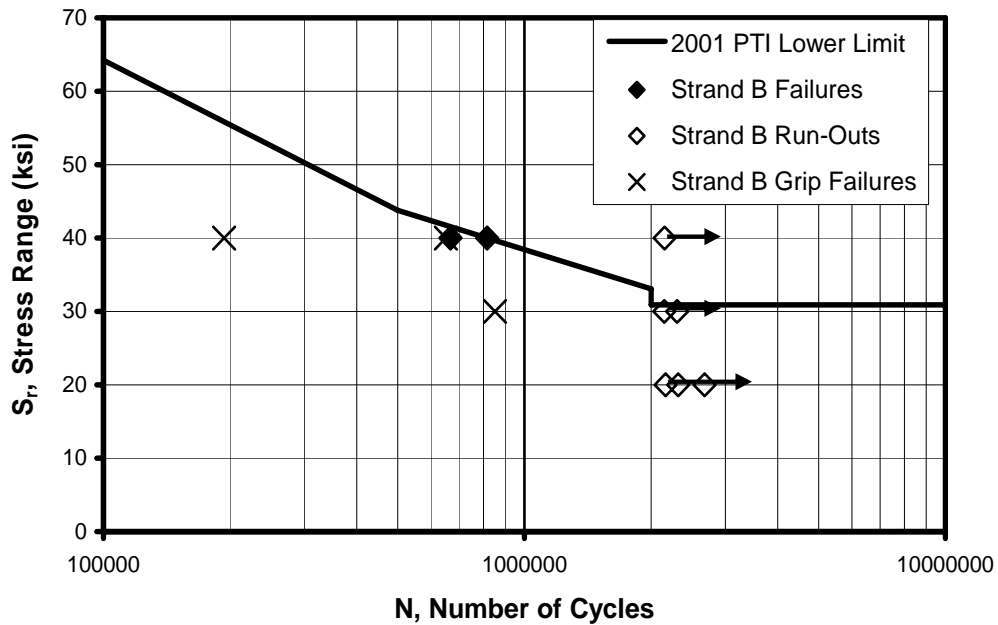
Figure 2-7 Strand B: Results of Tensile Fatigue Tests

A total of eleven axial fatigue tests were conducted using strand B (Table 2-6). Three specimens failed in the grips, and those results are not considered in the evaluation of the data. All three specimens tested at a nominal stress range of 20 ksi and both specimens tests at a nominal stress range of 30 ksi resisted more than 2 million cycles (Figure 2-7). For specimens tested at 40 ksi stress range, Test 2 did not satisfy the PTI specifications, Test 1 was just at the requirement and Test 5 acceptable.

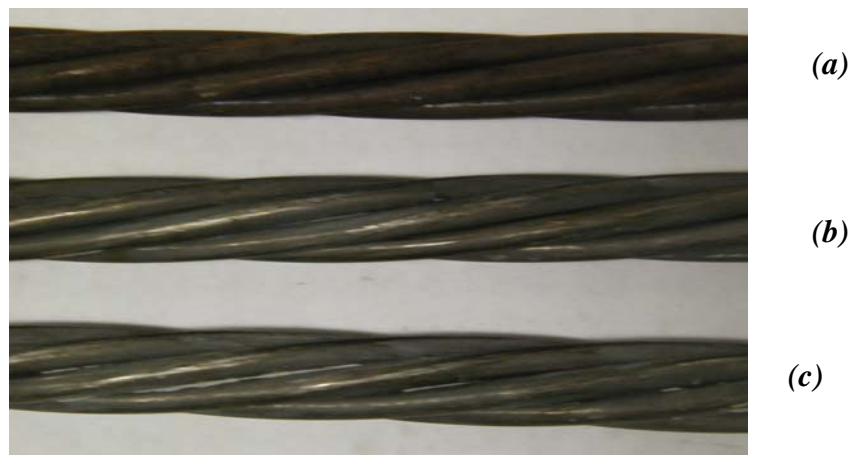
Figure 2-10 Photograph of surface of strands: (a) Strand A, (b) Strand B, (c) Recovered from bending fatigue specimen

Another difference in the two strands was the outer surface. Figure 2-10 shows the surfaces of the strands tested in axial fatigue. Strand A has a much darker outer surface. These small can cause fretting of the outer strands. It is noted that all of the wire breaks occurred on the outer wires, none were observed on the center wire

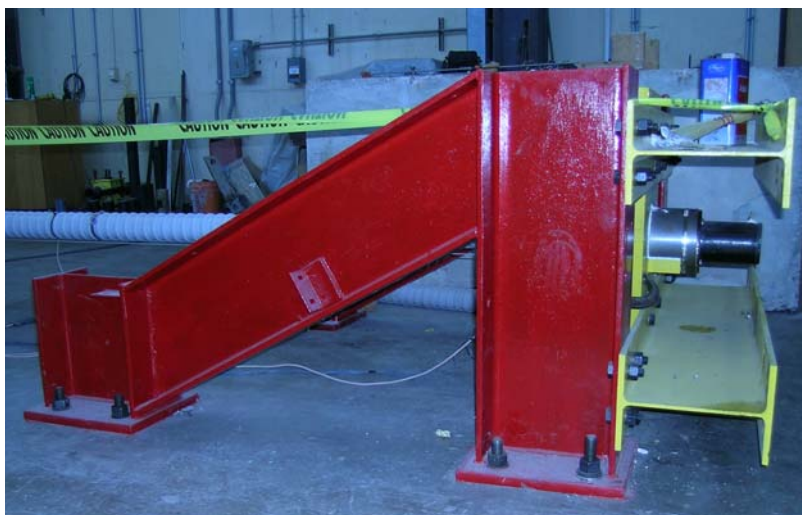
Figure 3-2 Reaction frame and anchor support

The idea of a self-reacting frame was abandoned for the small-scale specimens due to the increased length. Four independent reaction frames were fabricated and attached to the strong floor (Figure 3-1). Anchor support spanned

between the reaction frames and provided the reaction for the anchor heads. The dimensions of reaction frames and anchor supports are described in Appendix A.

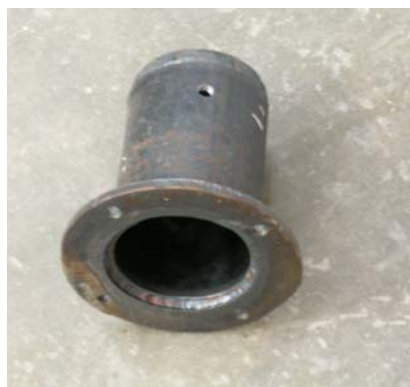
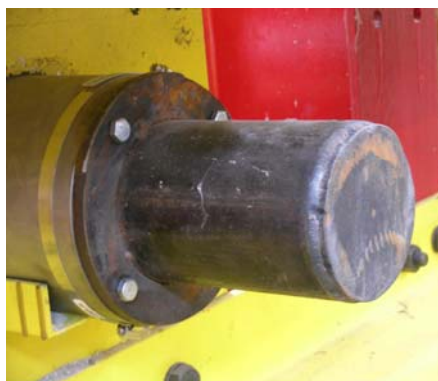
Figure 3-5 Grout cap

Grout caps were fabricated from steel plate and steel pipe for the small-scale specimens (Figure 3-5). The flange of the grout cap was bolted to the end of the anchor head after the strands were stressed. A styrofoam seal was placed between the flange of the grout cap and the anchor head to minimize leakage of

the grout. The grout caps were fabricated with a single vent, which was positioned on the top of the specimen, to ensure that the grout completely filled the grout cap.

(a) After fabrication

(b) Bolted to anchor head

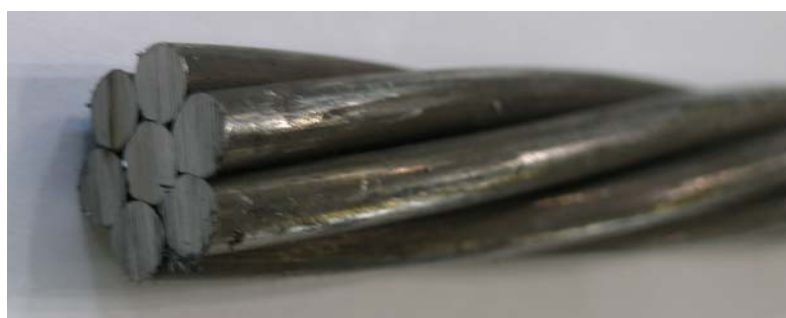
Figure 3-6 0.6-in. diameter prestressing strand

Two types of 0.6-in. diameter prestressing strand were tested in the large-scale bending fatigue tests (Ridd 2004). Strand B was used to fabricate all three small-scale specimens. Table 3-1 summarizes the ASTM A416 specifications for this weldless, low-relaxation strand and corresponding values provided on the mill certificate values. Strand B was designed specifically for stay cable applications and was manufactured with a larger center wire than is typically used for 0.6-in. diameter strand (Figure 3-6).

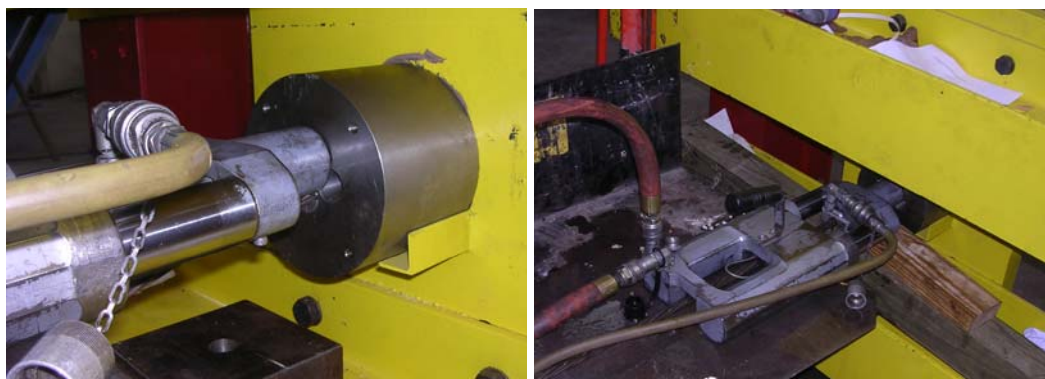
Figure 3-9 Stressing of strands individually with hydraulic ram

The strands were then stressed individually from the north end (Figure 3-9). The hydraulic ram used to stress the strands has a seating jack that applies uniform pressure to the wedges, which reduces the seating losses. A pressure gage was used to monitor the applied force. The target stress level in each strand was 50% of GUTS.

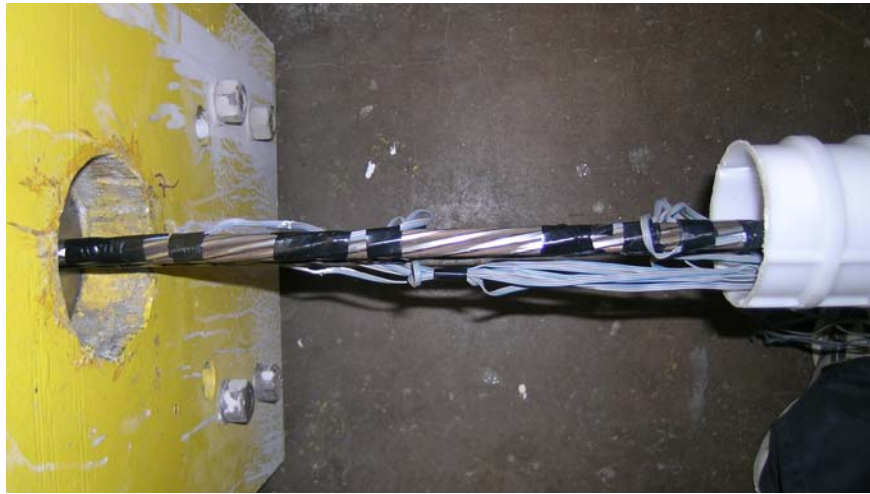
Figure 3-10 Strain gages on strands at north end with duct shifted to the side

After stressing the strand, strain gages were attached to the surface of the strand. Access to the desired location was obtained by sliding the sections of duct along the strands. Different locations were used for each specimen because the best locations for the gages were determined as testing progressed. Section 3.7 describes the locations of strain gages on each specimen. Figure 3-10 shows the position of the duct when the strain gages were attached to the north end of the specimen.

The number of strain gages attached to each specimen varied, and is presented in Section 3.7. However, at each gage line, strain gages were attached to wires on the top and bottom of each strand (Figure 3-10 and Figure 3-13). Holes had been drilled in the duct to accommodate the wires from the strain gages.

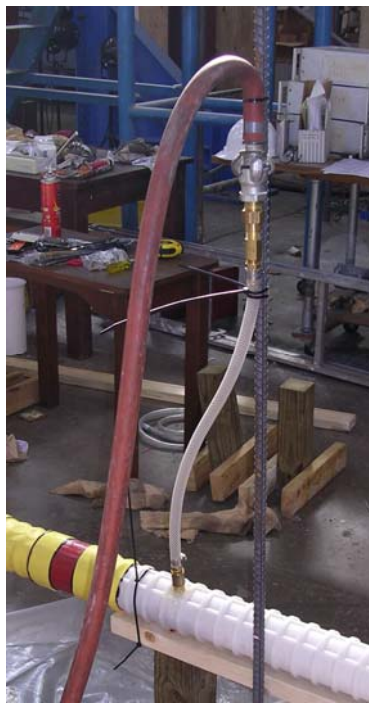
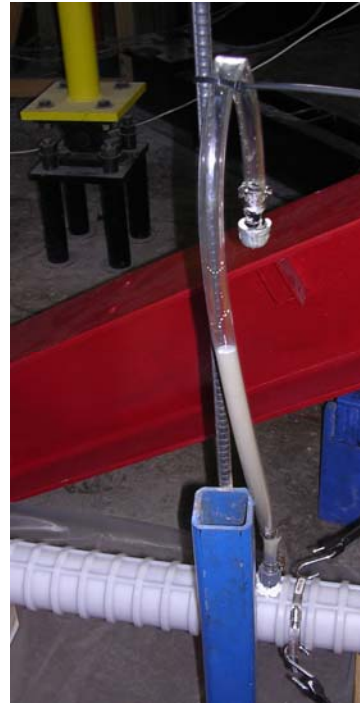
Figure 3-12 Grouting hoses and vents

A pre-packaged grout was used to construct the specimens. Grout was pumped into the duct near the center of the specimen. Air vents were placed at several locations along the length and at each grout cap. Three-ft sections of hose were attached to each of the air vents (Figure 3-14).

Grout was pumped continuously into the specimen flowed through each of the air vents. The ends of the hoses were then capped to prevent air from returning into the duct.

(a) Grout hose from pump

(b) Vent hose after grouting

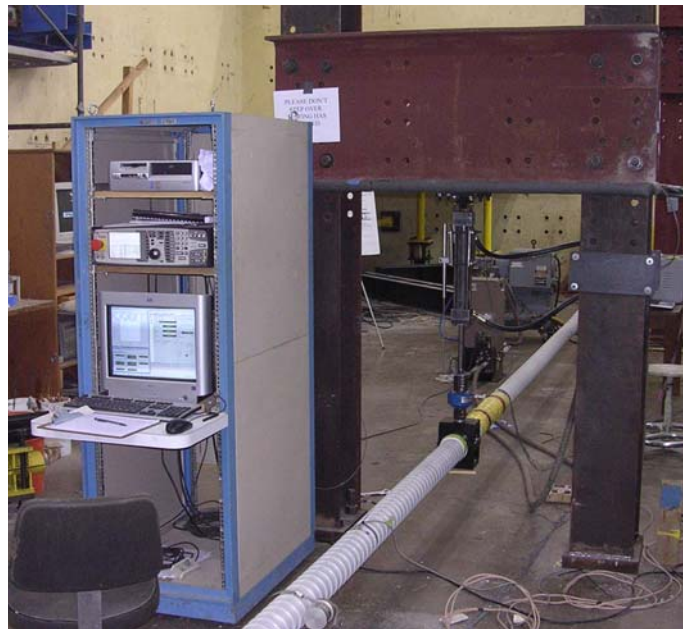
Figure 4-1 Set-up for fatigue tests

Fatigue loads were applied to the specimens by a single hydraulic actuator (Figure 4-1). The actuator was positioned near the north quarter point (Location 2 in Figure 3-1) for most tests. For stability reasons, the specimens were loaded in

one direction only. The actuator pulled the specimen up and allowed the specimen to almost return to the neutral position during each loading cycle. Specimens were loaded in both directions during the large-scale fatigue tests (Poser 2001, Ridd 2004), but the small-scale specimens were significantly longer and had a much smaller cross section. As a result, the small-scale specimens were extremely flexible and it was not possible to maintain alignment of the actuator if the specimen was pushed beyond the neutral position. The procedure used to setup the actuator is discussed in Section 4.1.1.

A 5-kip hydraulic actuator with a 12-in. stroke was used for all fatigue tests (Figure 4-1). The actuator was manufactured by Miller Fluid Power Division. The force imposed by the actuator was monitored by an external load cell and an external displacement transducer was used to monitor the position of the actuator (Figure 4-2).

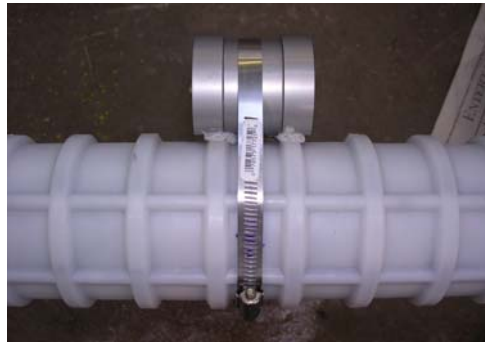
Figure 4-6 Acoustic sensors

The fatigue tests were monitored continuously using a system provided by SoundPrint, a division of Pure Technologies, Ltd. Acoustic sensors were placed on each anchor head and at two points along the free length as shown in Figures 4-5 and 4-6. Sensor locations are also summarized in Figure 4-5. The sensors were connected to a computer that was monitored remotely by SoundPrint. The sensors were set up to trigger automatically and were calibrated to detect wire breaks. Wire break events were recorded and time stamped by the system.

(a) Sensor attached to anchor head (b) Sensor attached along stay length

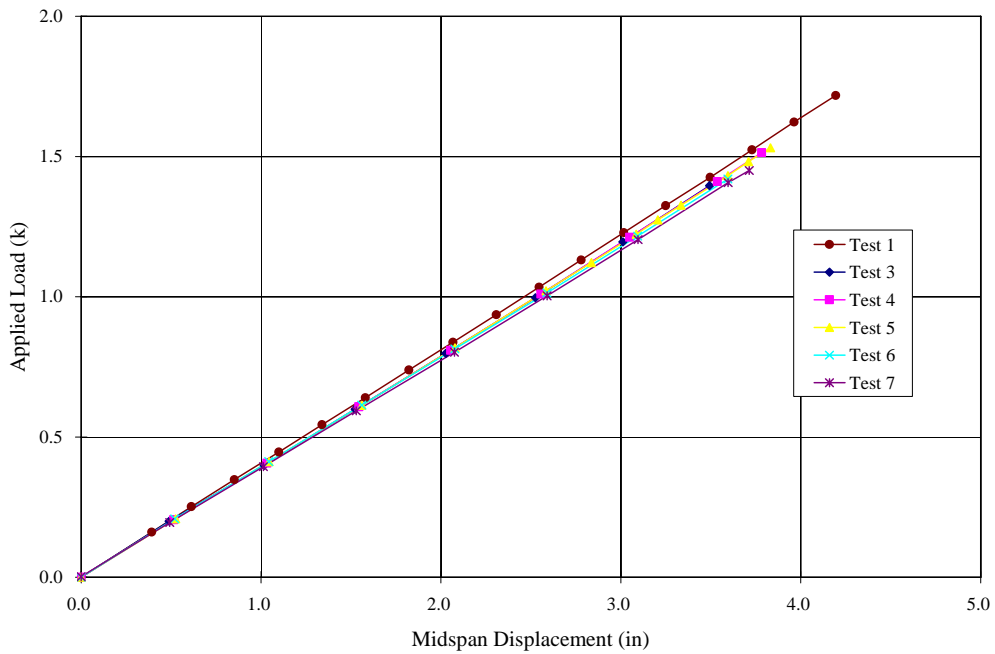
Figure 5-1 Measured response of Specimen 1 during static tests

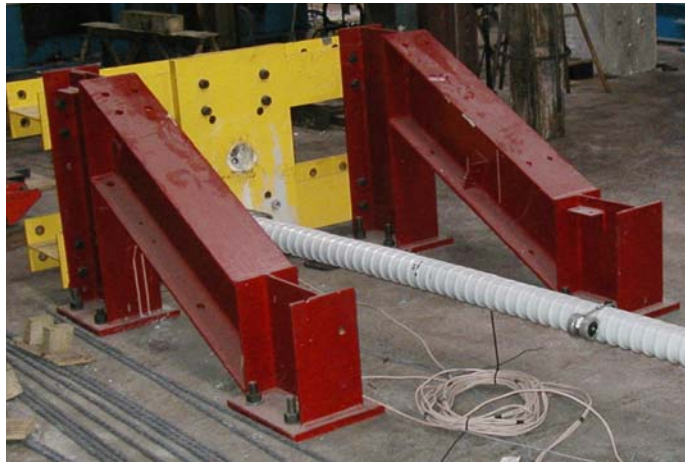
Figure 6-3 North end of Specimen 1 at end of fatigue test

Specimen 1 failed abruptly after more than 5 million cycles. All fourteen wires failed in the vicinity of the north anchor head, and the specimen was completely separated from the north reaction frame (Figures 6-4 and 6-5).

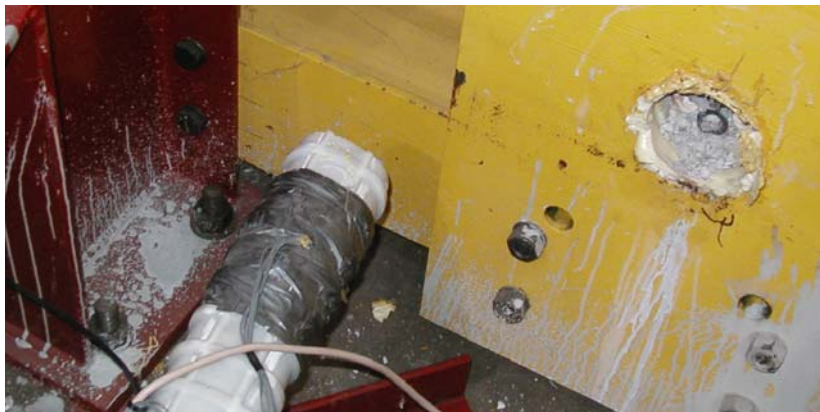
Figure 6-4 Fracture of all wires at north end of Specimen 1

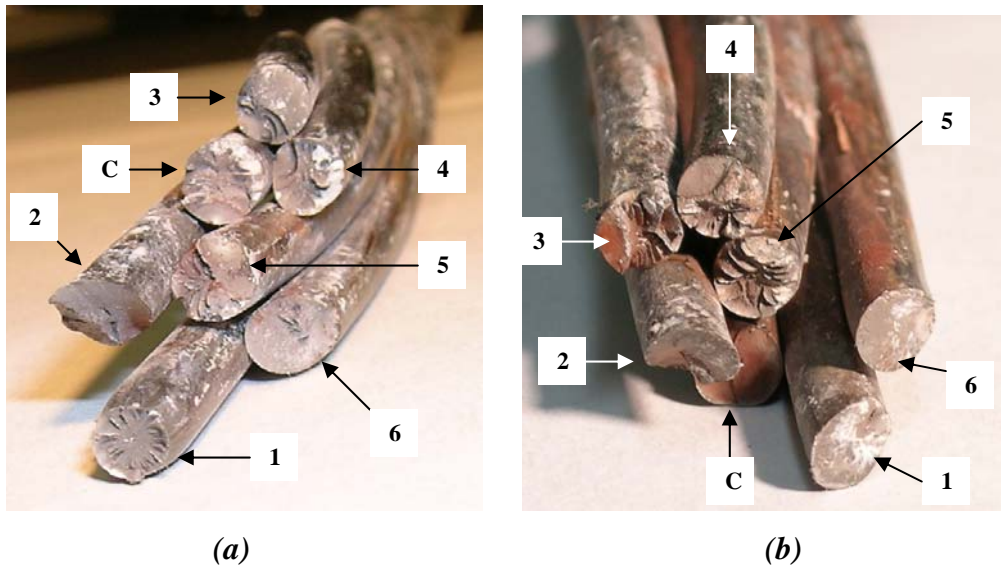
Figure 6-6 Photographs of wire breaks at north end of Specimen 1: (a) Top strand, (b) Bottom strand

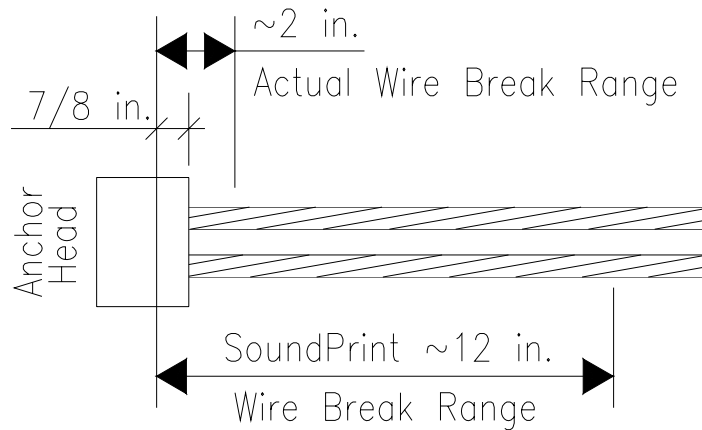
Figure 6-7 Comparison of wire breaks detected by SoundPrint with actual locations – Specimen 1 North End

However, comparing the locations of the wire breaks detected by SoundPrint with the distribution of actual wire breaks provides an indication of the accuracy of the acoustic detection system.

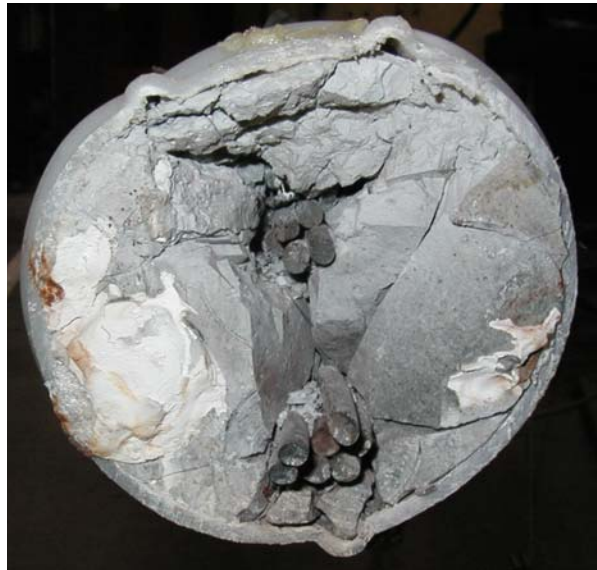
Figure 6-9 Photograph of condition of specimen after fracture at north end of Specimen 1

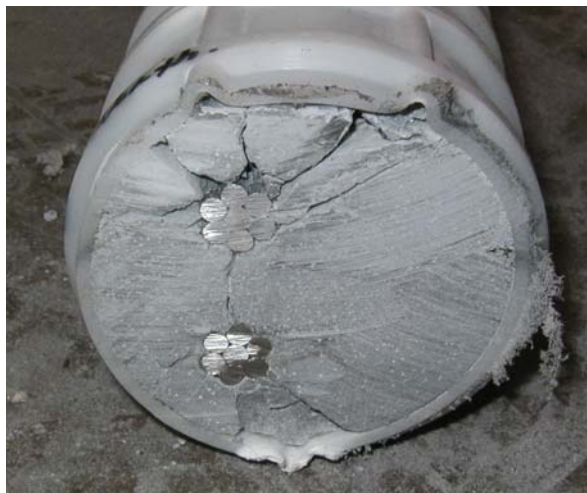
Figure 6-10 Typical section through Specimen 1

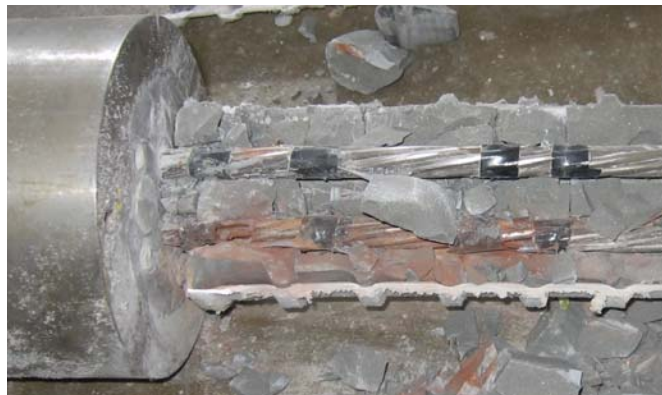
Figure 6-12 Autopsy of specimen 2

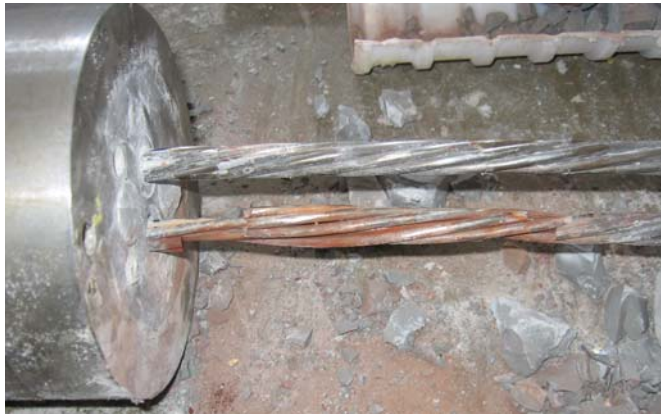
Figure 6-13 Specimen 2 after grout has been removed

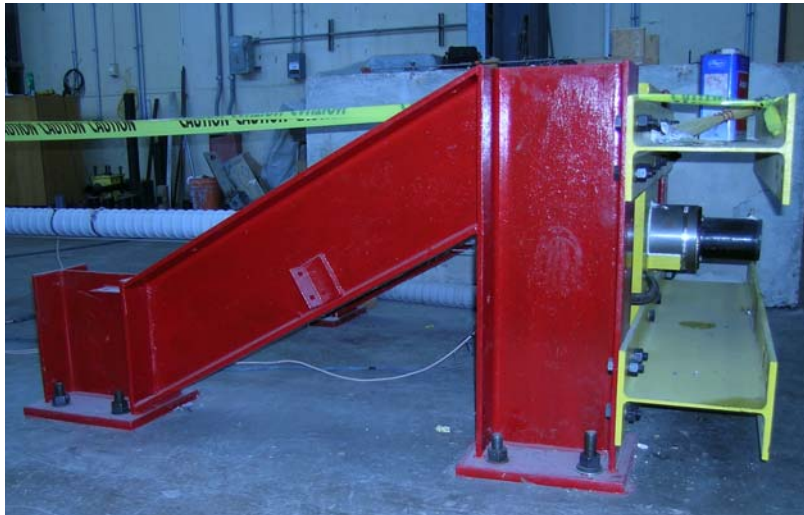
Figure A-1 Reaction frame

The small-scale bending fatigue specimens were supported by four reaction frames which were attached to the strong floor in the Ferguson Structural Engineering Laboratory. The reaction frames were constructed from W12x40 sections (Figure A-1 and A-2).

The frames stand 2'-10" high and are 5'-4" long. Two 1"x14"x12" plates were welded to the base of the reaction frames. The four frames hold the two yellow anchor supports at the correct locations.

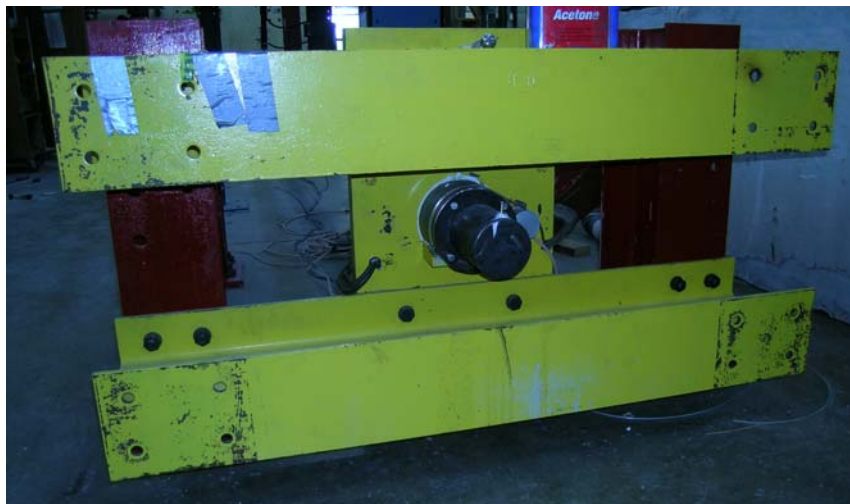
Figure A-3 Anchor support

The two yellow anchor supports span 4 ft between the pair of reaction frames at each end of the specimen. The anchor supports were also fabricated from W12x40 sections with a 2-in. plate bolted to the front of the support to hold the anchor head and to react against the prestressing strands (Figure A-3 and A-4).
