BEHAVIOR OF STRENGTHENED AND/OR REPAIRED REINFORCED CONCRETE
COLUMNS UNDER REVERSED CYCLIC DEFORMATIONS

THESIS

Presented to the Faculty of the Graduate School of
The University of Texas at Austin
in Partial Fulfillment
of the Requirements
for the Degree of
MASTER OF SCIENCE IN ENGINEERING

May 1984

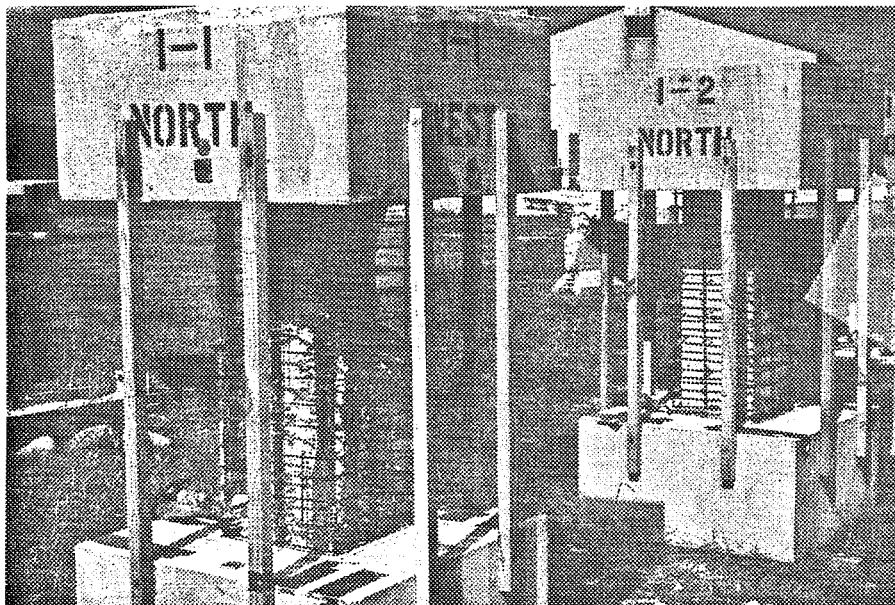
Fig. 2.13 Screed guides.

Fabrication of strengthened specimens consisted of tying the jacket reinforcement cages and then shotcreting. Specimens were roughened by light sandblasting using a No. 6 venturi nozzle and a fine sand (No. 6). As shown in Fig. 2.13, wooden screed guides were attached to each specimen's end blocks using ramset nails. Shotcrete quality was monitored using two vertical test panels (36 x 18 x 3 in.), shown in Fig. 2.14. One of the panels had a wood back while the other had a concrete back. The two types of materials were used to determine if shotcrete test panel rebound characteristics different from the actual column applications might alter quality control information. Half of each panel was reinforced identically to the jacket of Specimen 1-3, without crossties. Two sizes of core samples were to be taken from each panel. Large cores (4 x 3 in.) from the reinforced side of each panel were used to monitor void formation behind individual bars. Small cores (1-3/4 x 3 in.) from the unreinforced side were used for compressive strength tests. An experienced contractor shotcreted and float-finished (Figs. 2.15, 2.16) the specimens and panels, both of which were cured under polyethylene sheets for seven days. When the specimens were shotcreted, concrete temperature, slump, unit weight, and air content were measured. Two sets of control cylinders were cast; one set was taken using concrete directly from the ready-mix truck, the other set was taken using shotcrete placed in a wheelbarrow by the nozzle.

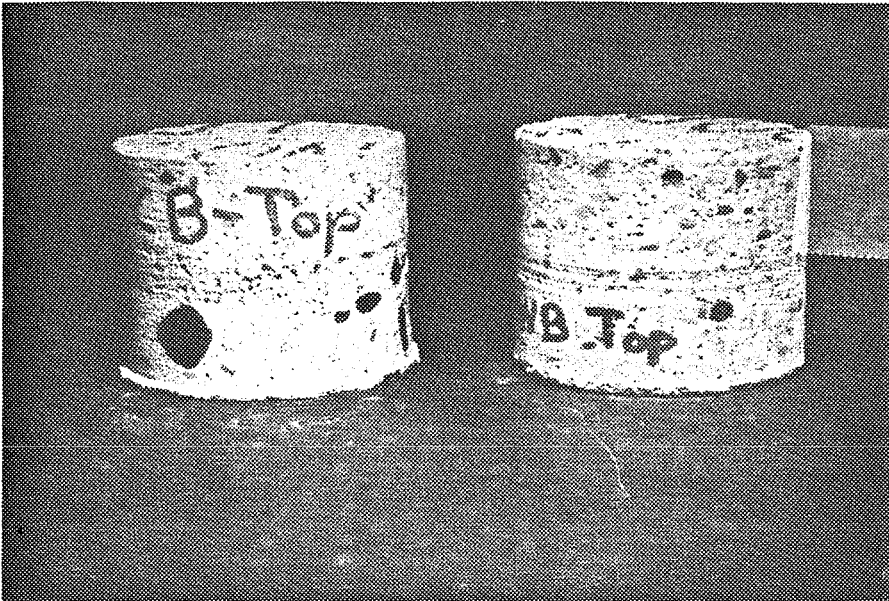
Fig. 2.17 Panel (top) core samples.

Four-inch cores (Figs. 2.17, 2.18) were taken from both the concrete-backed panel (CB) and the wood-backed panel (WB) to determine if voids were present behind the reinforcing. A single small void (1/4 x 1/4 in.) was found in one (CB) of the six samples. There was virtually no difference between the wood or concrete-backed panel samples. Smaller cores (1-3/4 x 3 in.) were taken from both panels, capped and tested in compression, with the results shown in Table 2.5.
