**Analysis, Testing, and Load Rating of
Historic Steel Truss Bridge Decks**

Dissertation

The University of Texas at Austin

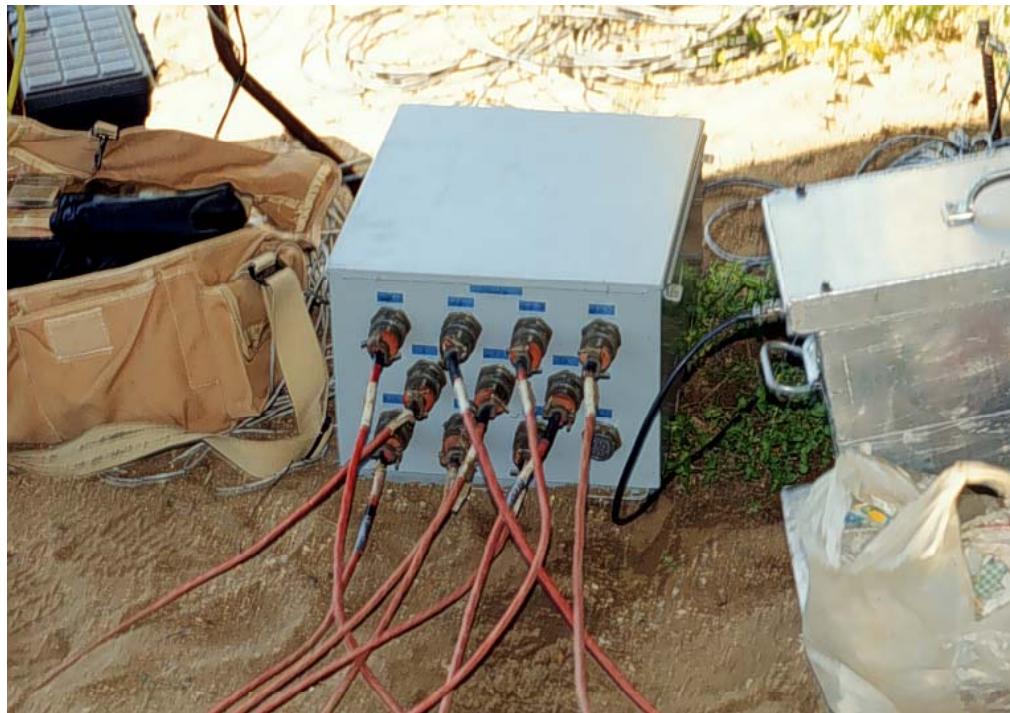
Figure 4.5 CR 9000 data logger

variables. The instruction code is downloaded into the CR9000 and stored in internal memory. A test is performed, and then the data is retrieved from the CR9000 by means of a laptop computer. All load tests for this project were sampled at a rate of 10 HZ, meaning each strain gage measurement was recorded every 1/10 of a second. Since the truck loading was slow (truck speed was approximately 5 mph), this sampling rate was adequate to accurately capture the response of the instrumented members.

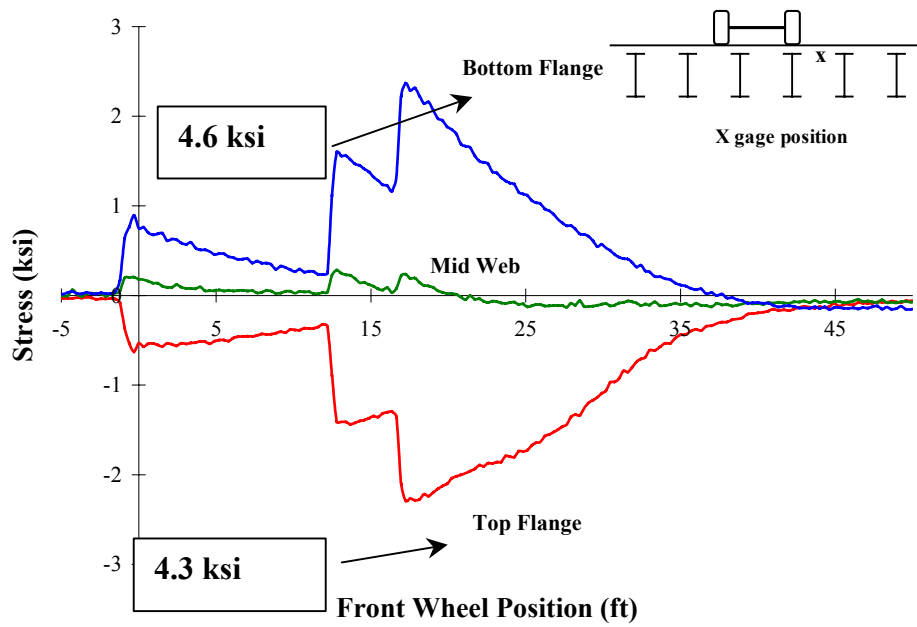
Transverse beams showed some composite behavior, but not in all tests and typically the stress difference between top and bottom flanges was less than 0.4 ksi. In some of the tests, the transverse beams showed nearly no composite behavior, while the longitudinal members showed some composite behavior in nearly every test. The reason for the difference in the degree of unintended composite action between the longitudinal stringers and transverse beams is unclear, but may be due to the details of the deck construction. As described in Chapter 2, the longitudinal stringers are embedded into the slab approximately 1 inch, whereas the transverse beams have no such embedment. Further, above each transverse beam is a slab construction joint, and the longitudinal slab reinforcement is not continuous over the transverse beams. Figure 4.25 shows the

Figure 4.23 Measured stresses in beam B1 in the first Llano test

Figure 4.24 Measured stresses in beam B2 in the first Llano test

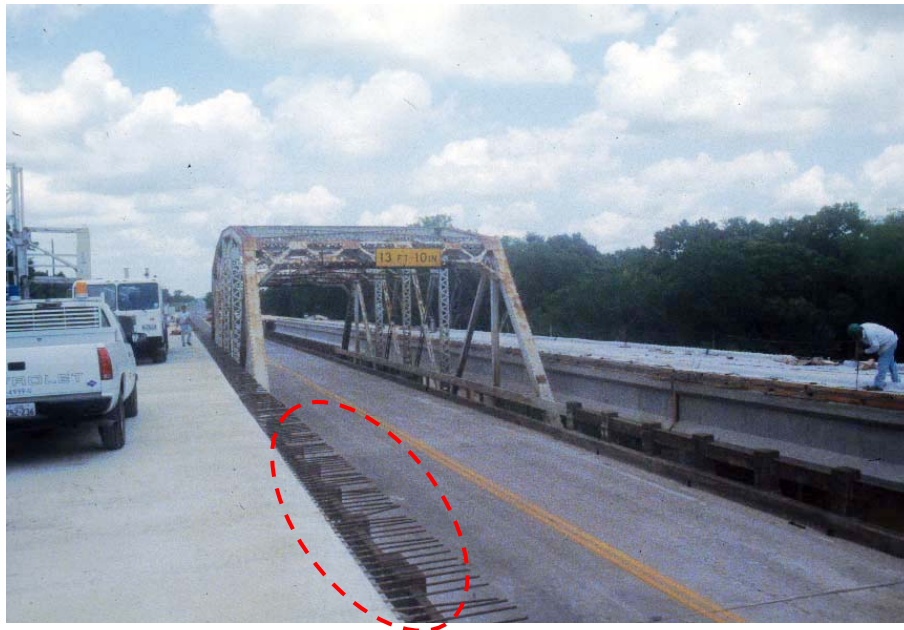
Figures 5.2 and 5.3 show the new bridge during construction, and after completion. Reinforcement steel can be seen protruding from the side lanes, ready to tie the future center lanes together. Figures 5.4 and 5.5 show the replacement bridge after completion.

Figure 5.2 Lanes built around the original bridge

Figure 5.3 Detail showing connecting rebar

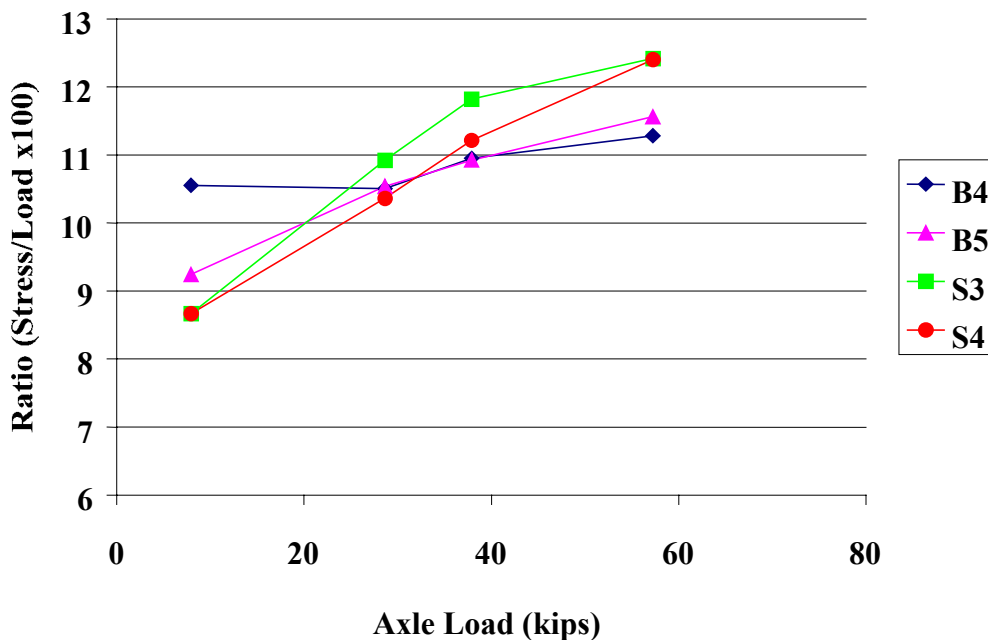
Figure 5.34 Axle Load versus Stress/Load Ratio

An additional observation from the Goliad test is that the ratio of the maximum stress to the load was not constant, i.e., the load – stress relationship is nonlinear. Since there was likely no inelastic material response, the stress should theoretically increase proportionately with the load. However, as shown in Figure 5.33, the ratio of maximum stress to load increases with increasing load. This phenomenon occurs with both the transverse and longitudinal members, but is most pronounced in the longitudinal members. A possible reason for this phenomenon may be that the degree of unintended composite action reduces at higher load levels, as discussed in the following section.

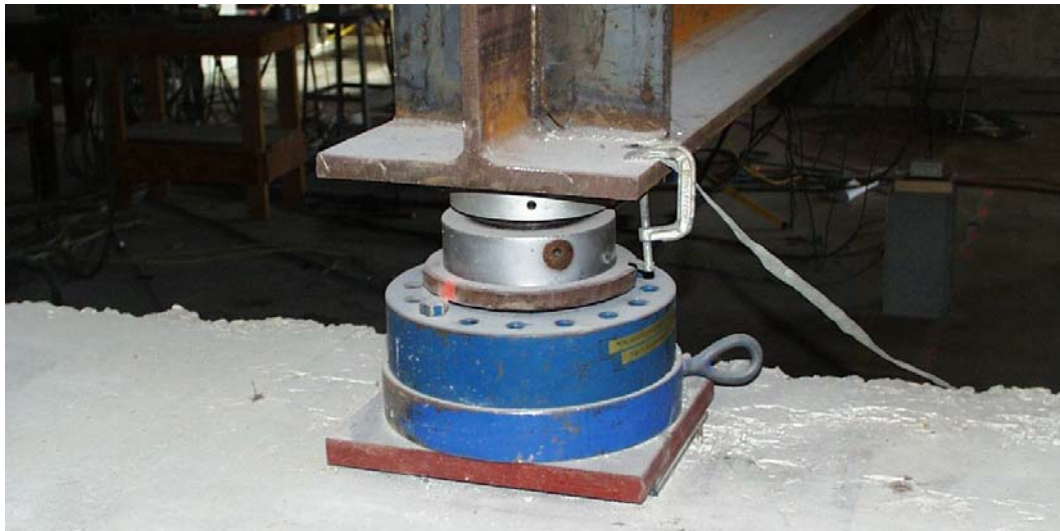
Figure 6.4 Transverse beam placed on (top to bottom) a swivel plate, a load cell, and leveling plates

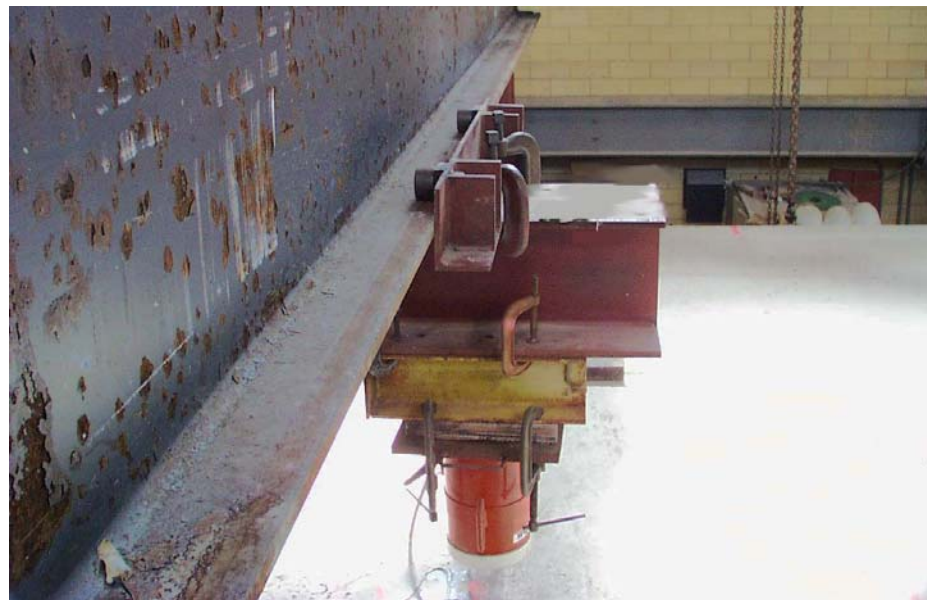
Figure 6.17 Roller attachment of actuators to load frame

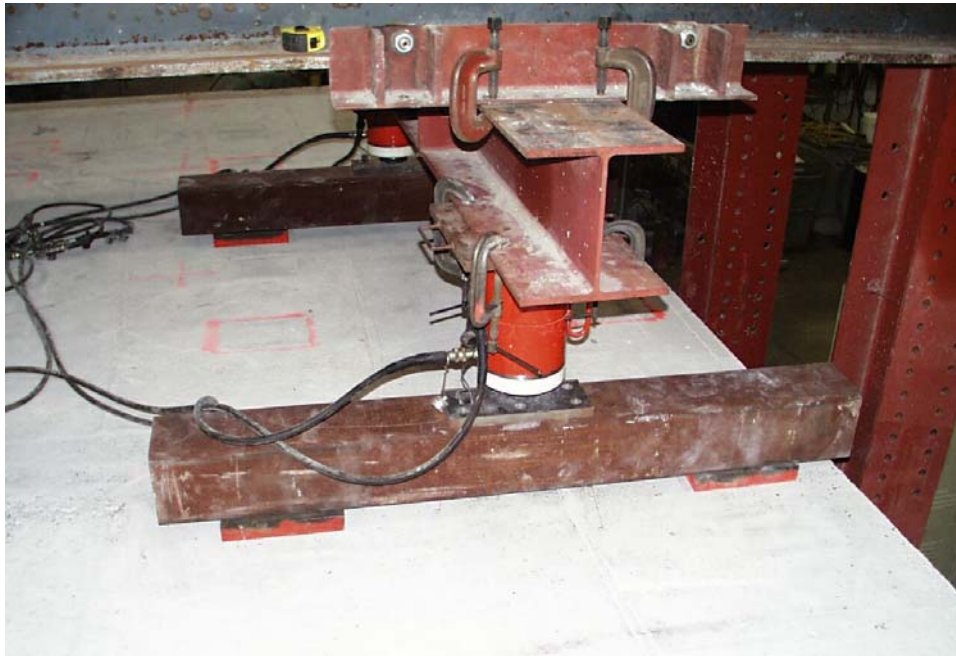
Figure 6.18 Approximation of tandem axle with structural tubing and rubber pads

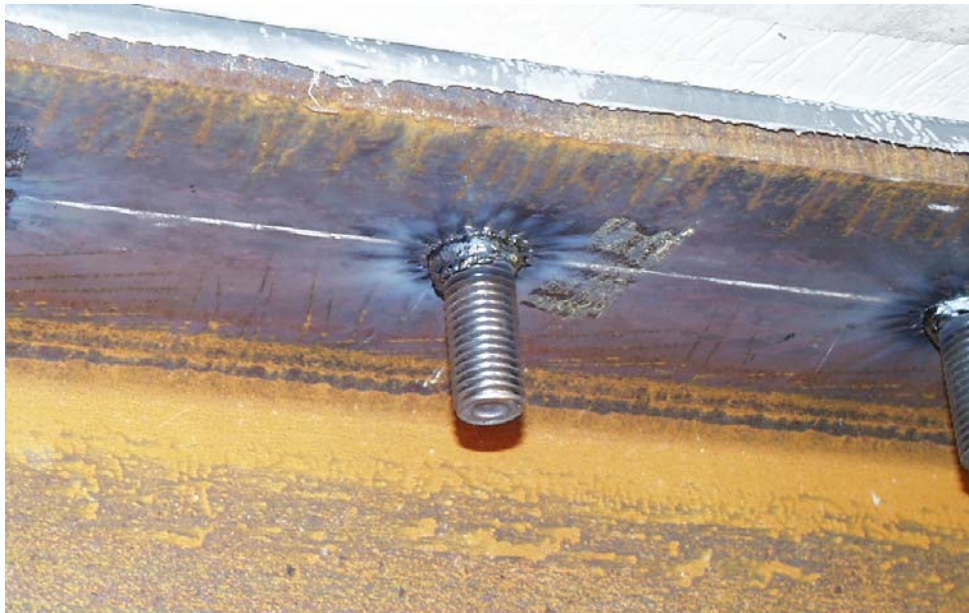
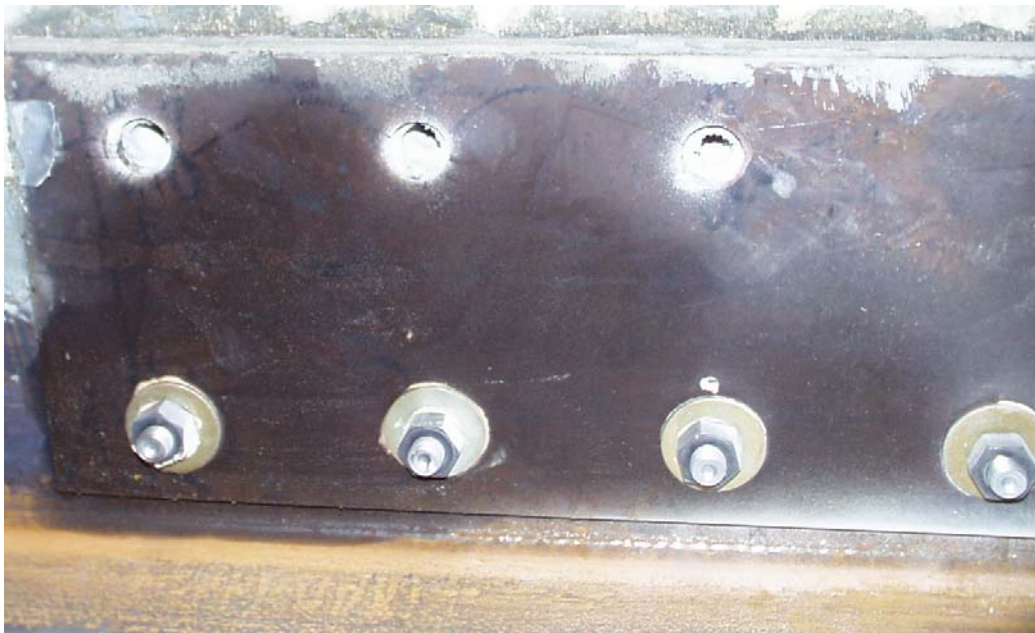
Figure 6.64 Close up view of the threaded stud

Figure 6.65 Plate attached to underside of beam top flange with threaded studs, and grouted

Figure 6.66 Holes drilled up through the plate into the slab

Figure 6.67 Threaded rod installed in slab with epoxy
