**Anchorage of Grouted Vertical Duct Connections for
Precast Bent Caps**

Dissertation

The University of Texas at Austin

December 2005

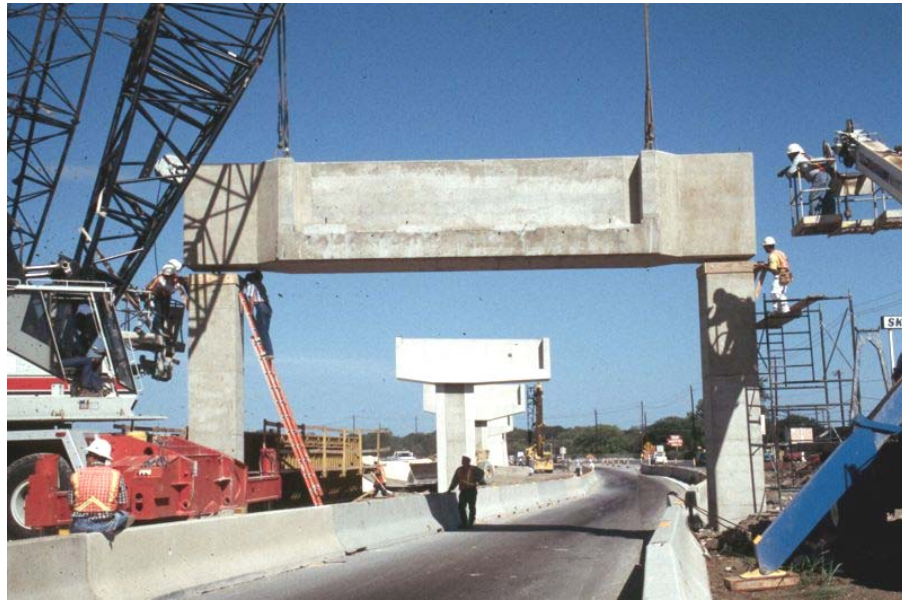
Figure 1.3 Red Fish Bay Project Precast Bent Caps

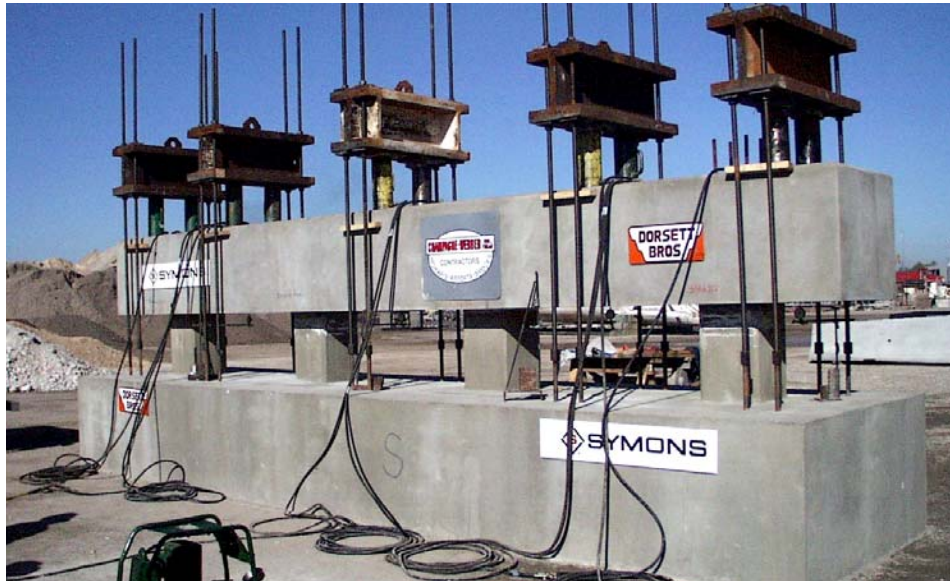
Figure 1.6 Connection Types Developed by TxDOT Research Project 1748 [1.5]

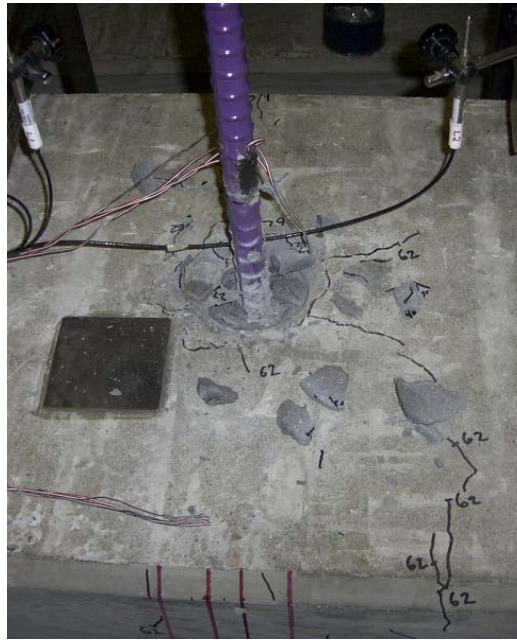
Figure 1.15 Flexural Failure Mechanisms for Precast Connection Using Grouted Ducts [1.10]

Stanton et al. [1.10] reported test results and a design methodology for eight moment resisting precast beam-column connections. Two of the connection specimens used #6 dowel bars that were either partially or fully grouted in ducts. The bars were embedded $24d_b$. In both connection tests, bars yielded and very ductile behavior was observed. Debonding of the bars did not lead to any noticeable improvement in performance. Figure 1.15 shows flexural failure mechanisms for the type of connection tested: (1) yielding of the beam top reinforcement, (2) yielding of the dowels at the joint, (3) crushing of concrete at

edge of column, (4) bond failure leading to pull-out before yielding of the connector, and (5) yielding of the dowel along the debonded length. To obtain ductile system behavior, mechanism (1) is the preferred failure mode, followed by mechanisms (2) and (5).

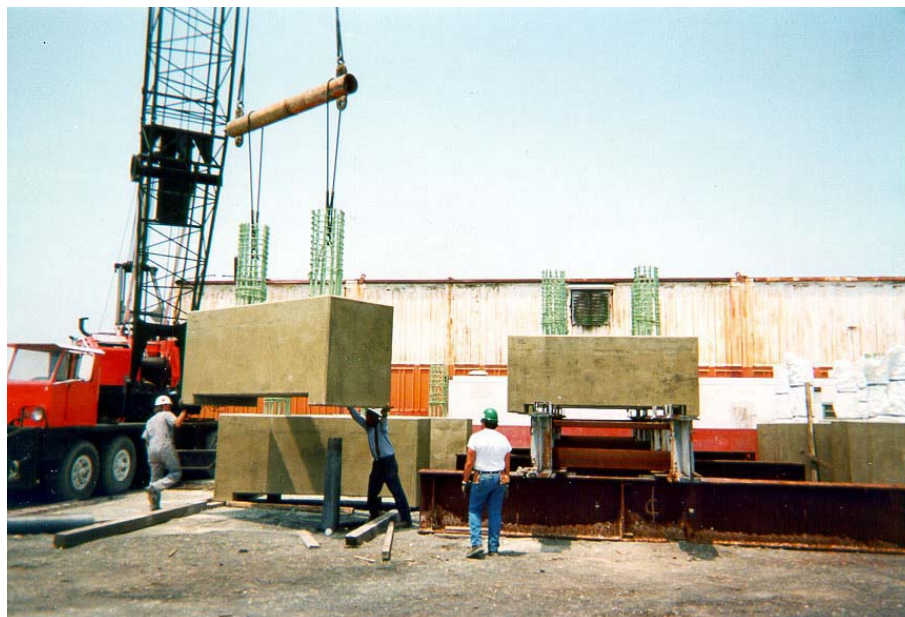
Figure 1.20 Wolf River Precast Bent Cap Connection [1.20]

The use of precast substructure and superstructure elements in the replacement bridge on Route 57 over the Wolf River in Moscow, Tennessee, facilitated rapid construction and made possible erection of the bridge from the top down without putting any equipment on the surrounding wetlands [1.21]. Bent cap connections consisted of grouted connectors placed inside corrugated metal ducts. The connection detail used in the bent caps is shown in Figure 1.20. A cylindrical recess 24 in. in diameter and 12 in. deep was formed at the bottom of the precast caps. One 4-in. diameter corrugated duct was also provided in the cap to accommodate a 1.5 in. diameter high-strength connector that passed through the joint into the pipe section. The void surrounding the connector was filled with concrete (pipe section) and grout (cap section). The contractor worked closely with engineers at the Tennessee Department of Transportation to develop a prototype connection adequate for the high seismic demands of the site.

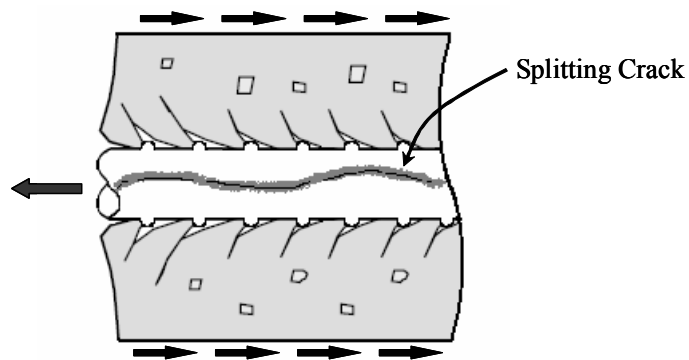
1.22 Forces between Deformed Bars and Surrounding Concrete

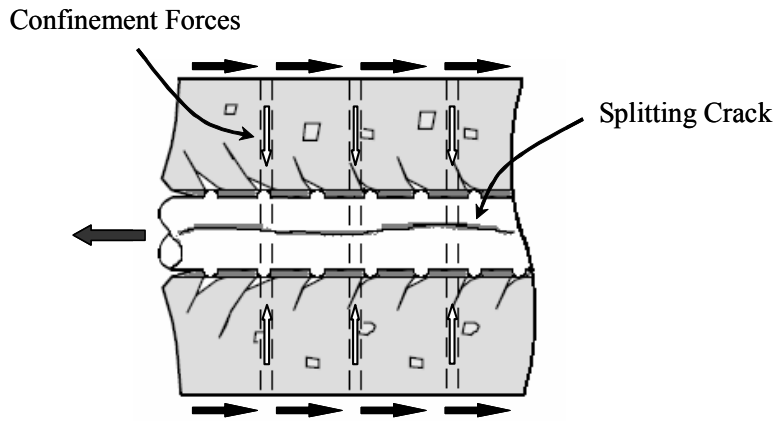
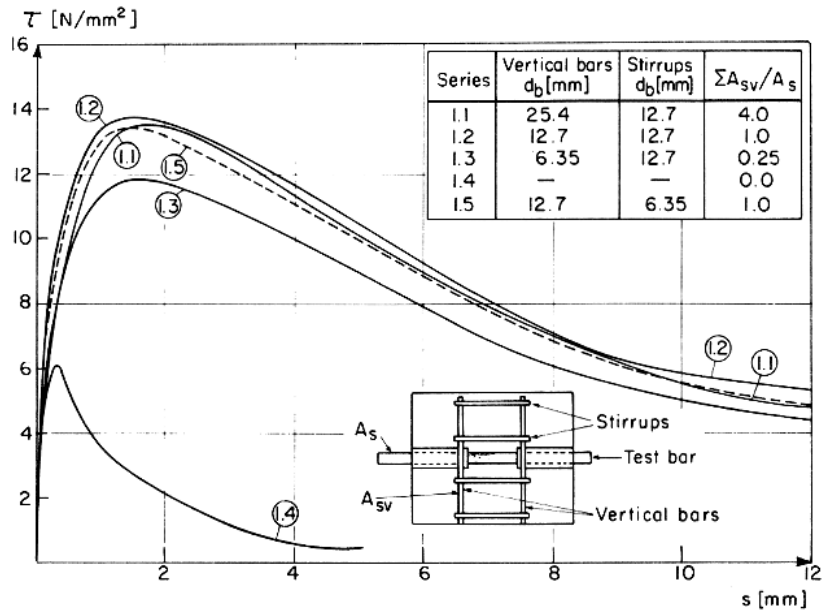
A. Bond Failure by Splitting

B. Bond Failure by Shearing of the Concrete Keys in Between Ribs (Pullout)

Figure 1.23 Effect of Confinement on Bond - Failure Modes

Slip of a deformed bar occurs as a result of both the wedging action of the steel ribs pushing the concrete away (splitting), and due to the crushing of concrete keys by the ribs (pullout). In the absence of confinement, deformed bars fail in bond by splitting, which depends primarily on the force on the concrete and not so much on the bar stress and the bar perimeter (Figure 1.23a). If confinement

is provided, usually by the use of stirrups and/or a large concrete cover, bond failure occurs by shear failure of the concrete keys between the steel ribs (Figure 1.23b), and the ultimate load per unit length depends increasingly on the bar perimeter [1.27]. After adhesion is lost and ribs begin to bear on the concrete, slip occurs by progressive crushing of the porous concrete paste structure in front of the rib. The compacted crushed concrete creates a wedge that becomes lodged in front of the rib and moves along with it. This, in effect produces a rib with a face angle of 30 to 40 deg [1.27]. Thus, the angle at which the steel rib bears on the concrete, α , changes as load acting on the reinforcing bar increases. As a result, radial splitting stresses tend to increase at a rate greater than the parallel bond stresses as tensile load in the bar rises.

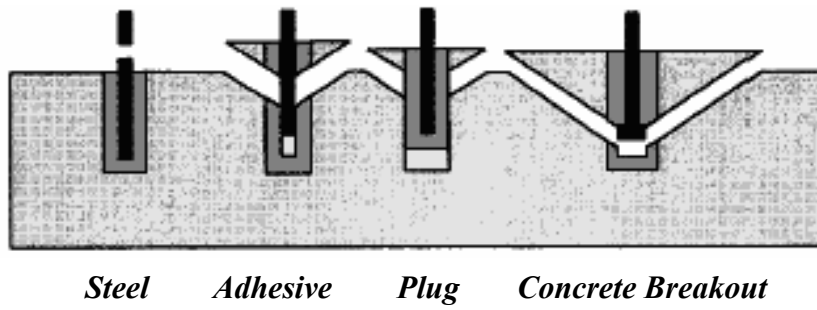
Figure 1.29 Basic Failure Modes for Grouted Connector [1.39]

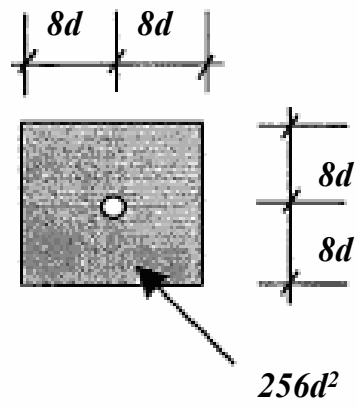
Figure 1.30 Influence Area for Single Straight Connector [1.39]

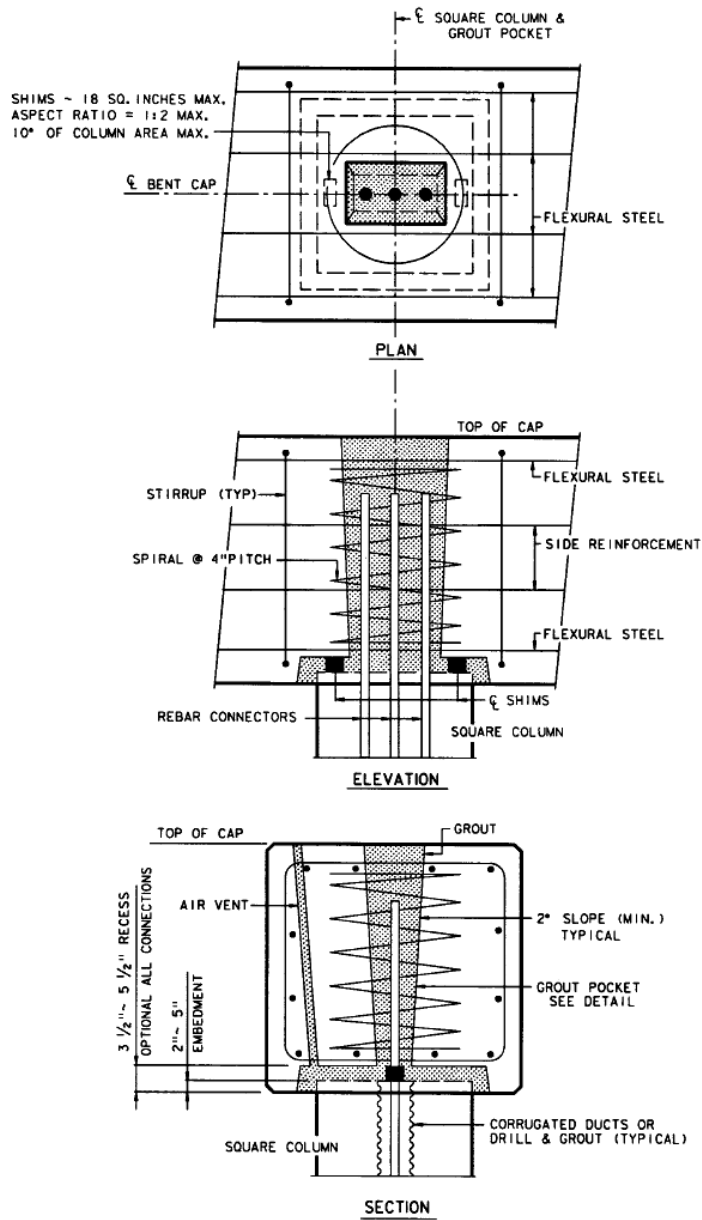
**Figure 2.1 Connection Detail for Single-line Grout Pocket on Pile
(Embedded Option) [2.1]**

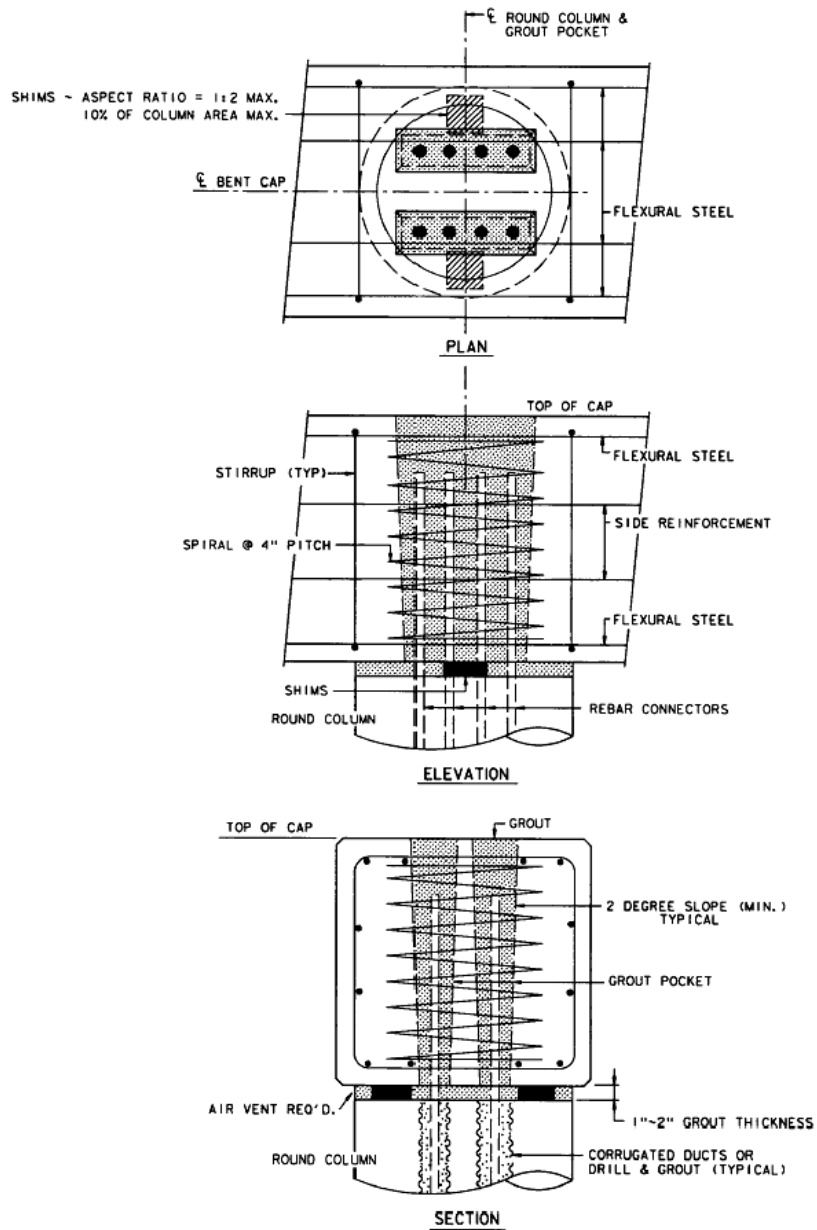
**Figure 2.2 Connection Detail for Double-line Grout Pocket on Column
(Surface-flush Option) [2.1]**

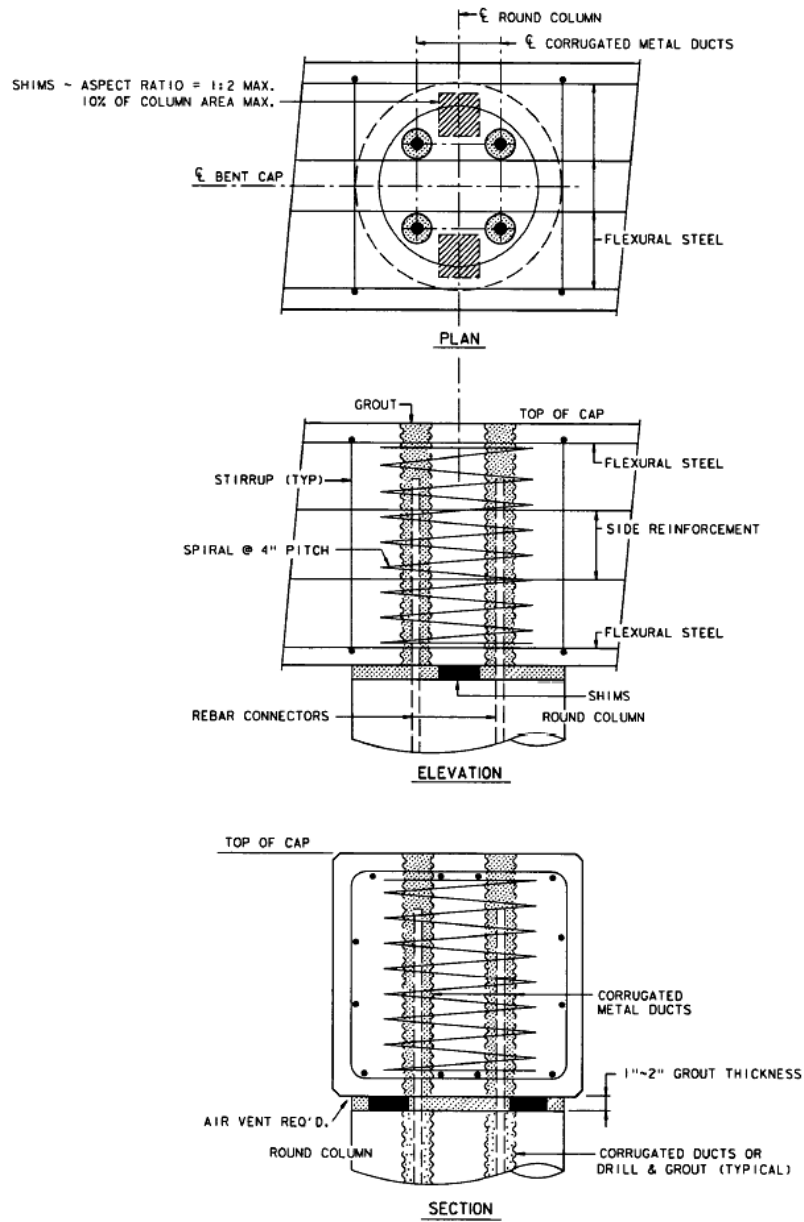
**Figure 2.3 Connection Detail for Grouted Vertical Ducts on Column
(Surface-flush Option) [2.1]**

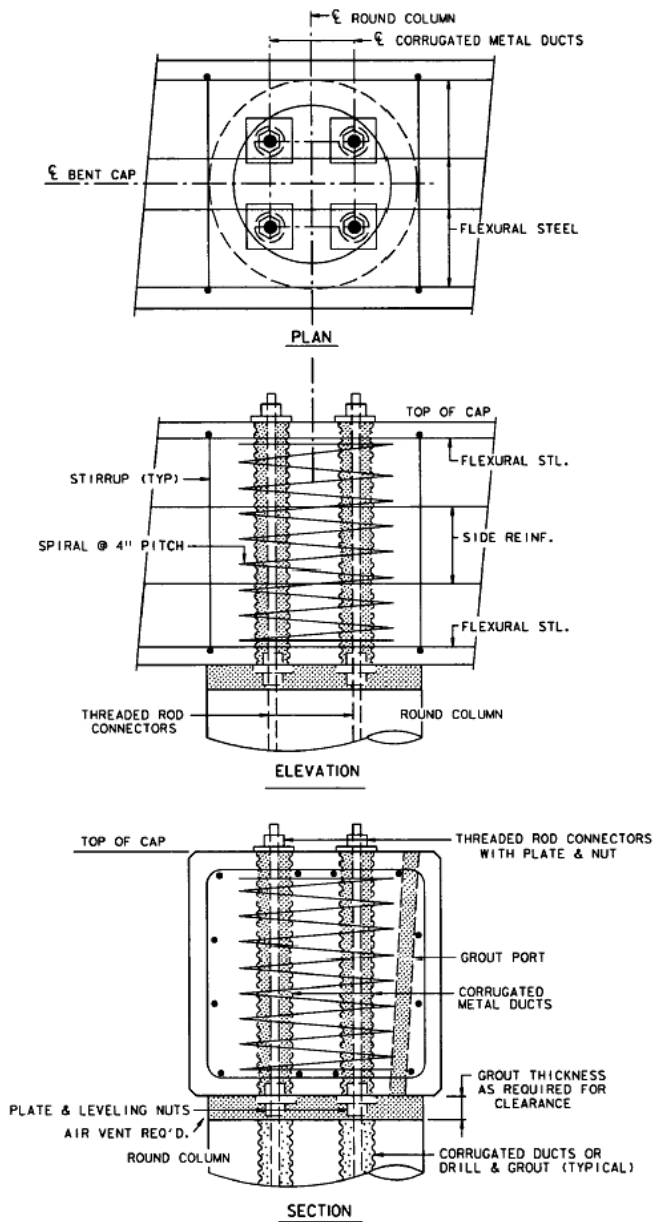
Figure 2.4 Connection Detail for Bolted Connection on Column (Surface-flush Option with Plate-and-Leveling Nut Option) [2.1]

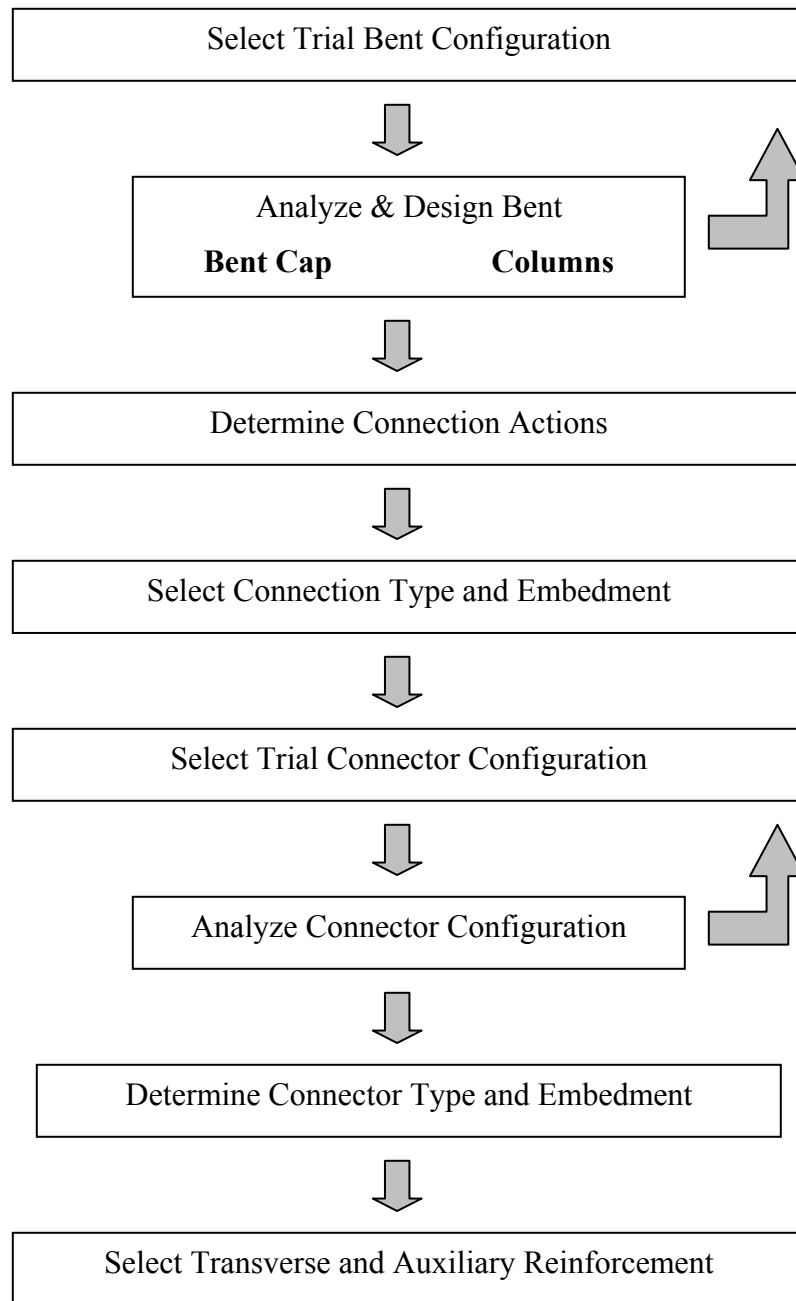
Figure 2.5 Design Flowchart for Precast Bent Cap System [2.1]

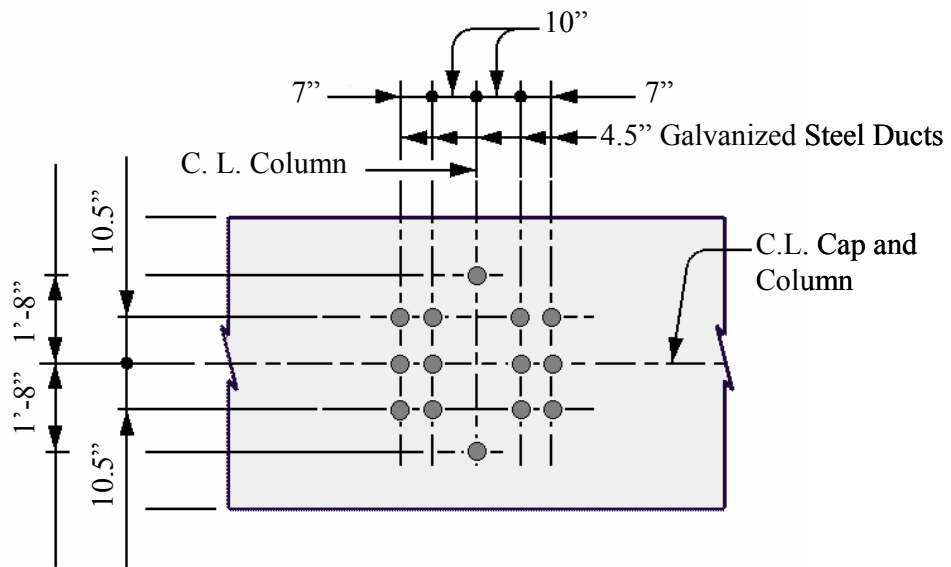
Figure 2.11 Bent Cap Connection Zone Detail [2.9]

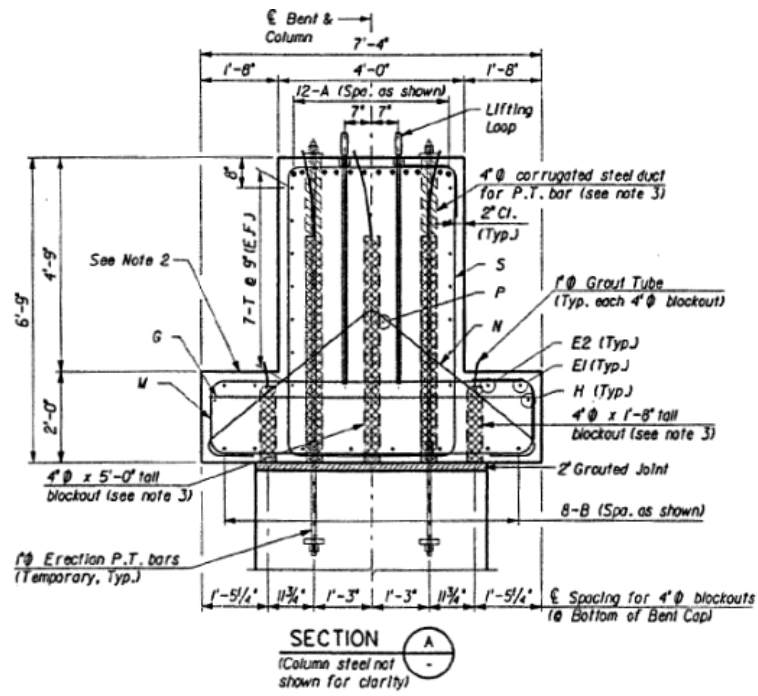
Figure 2.16 Detail of Bent Cap Cross Section

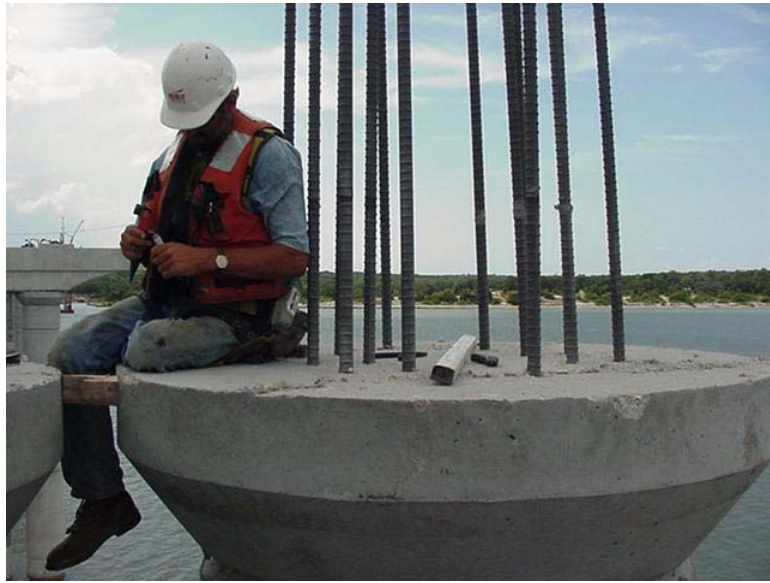
Figure 3.5 Improper Alignment of Reinforcing Bars that Project from Bridge Column at Lake Belton Bridge Project

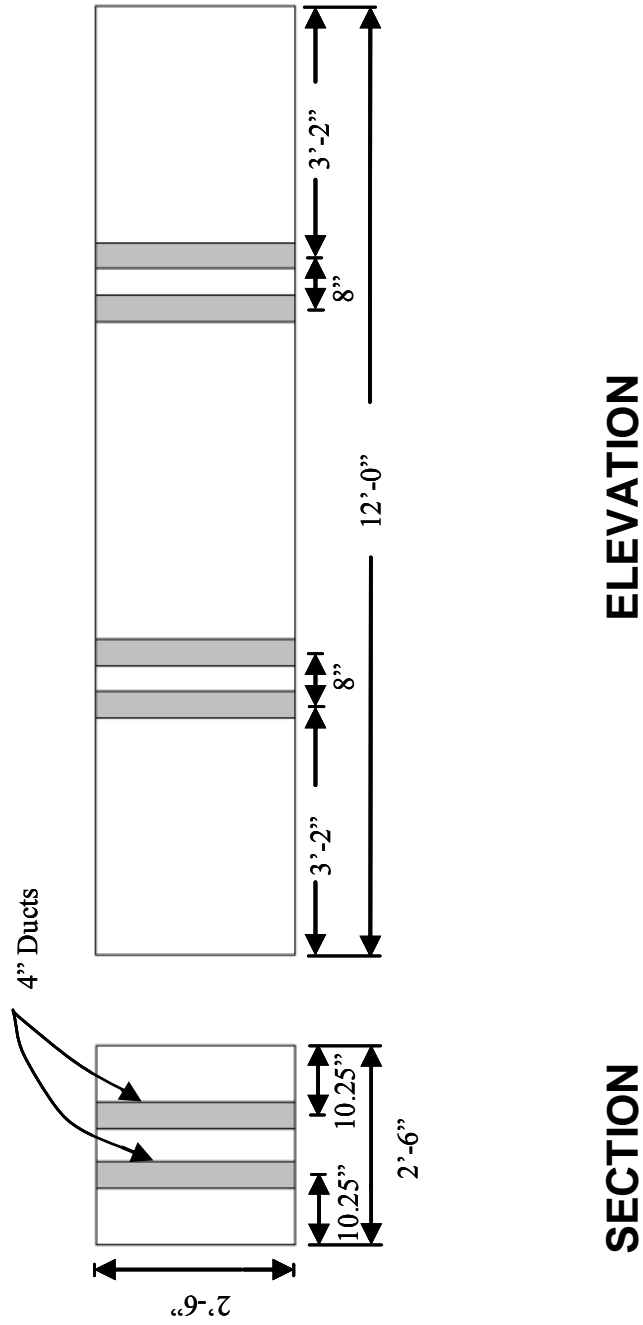
Figure 3.10 Test Specimen Dimensions

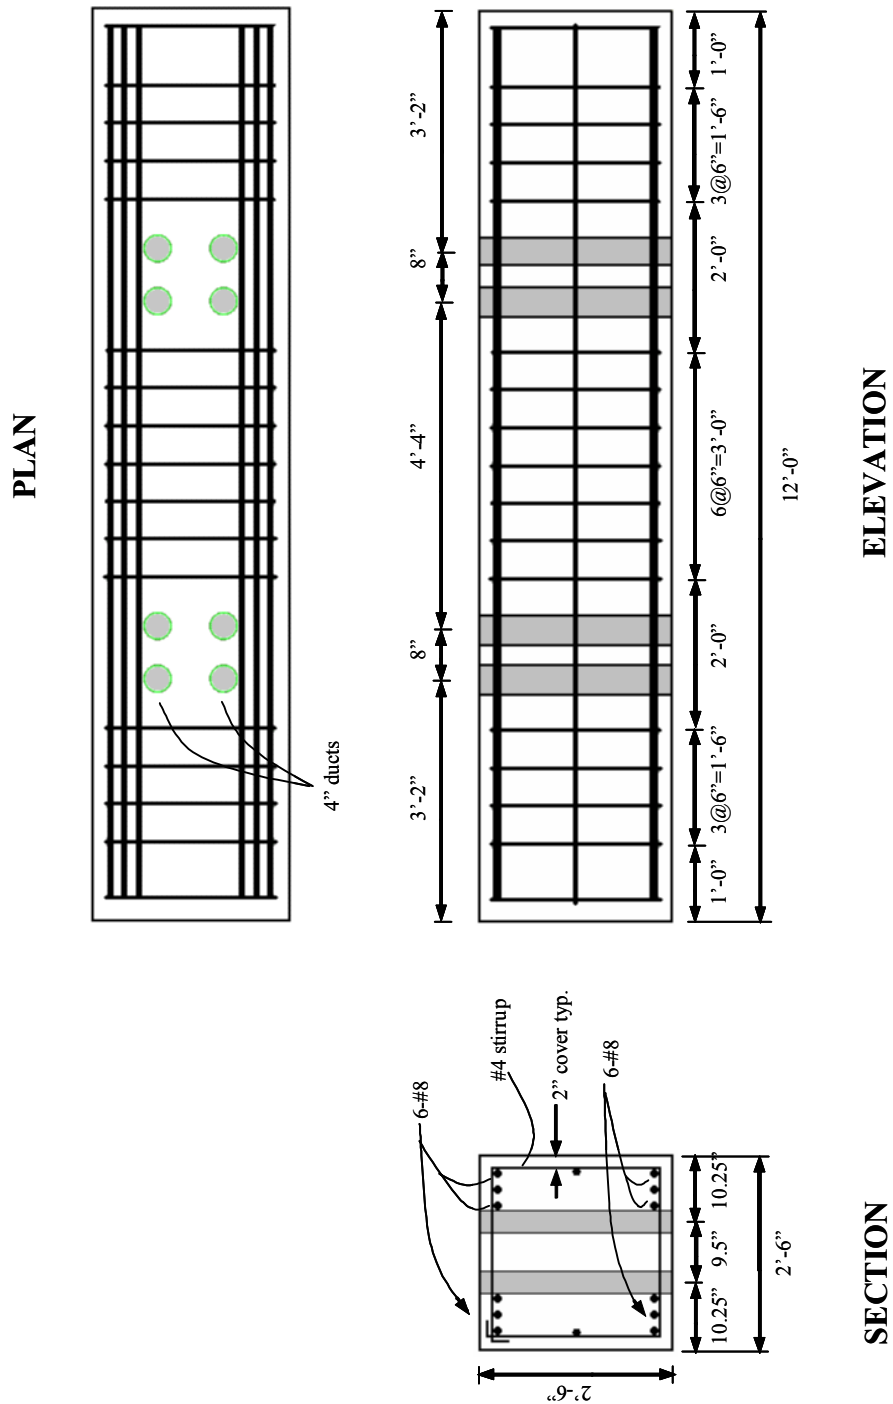
Figure 3.12 Test Specimen Reinforcement Scheme

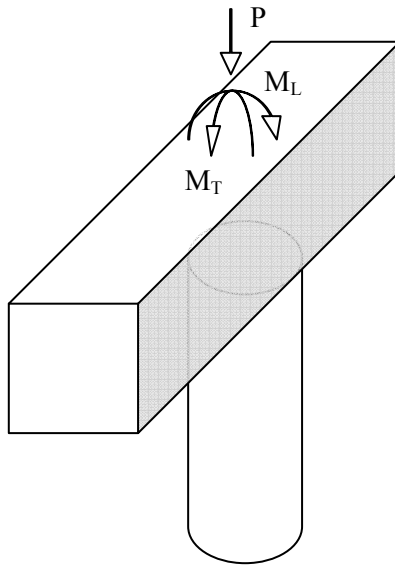
Figure 4.1 *Expected Applied Loads on a Precast Bent Cap Connection*

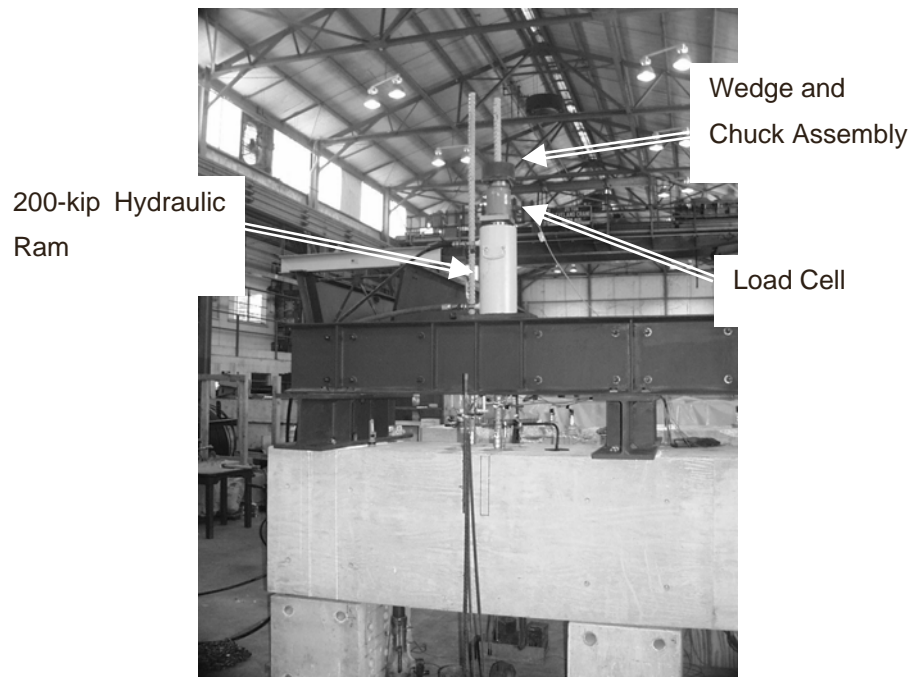
Figure 4.2 *Test Setup*

Load was applied until failure of the connection occurred. In cases where the test involved more than one connector, forces on each connector were kept approximately equal because the loading mechanism was force-controlled. Although the majority of these multiple-connector tests failed as a group, there were some instances where one connector failed before the others. In these cases, the failure load was taken as the load acting on the connection when the first connector failed, even though the remaining connectors sometimes reached a higher load when reloaded.

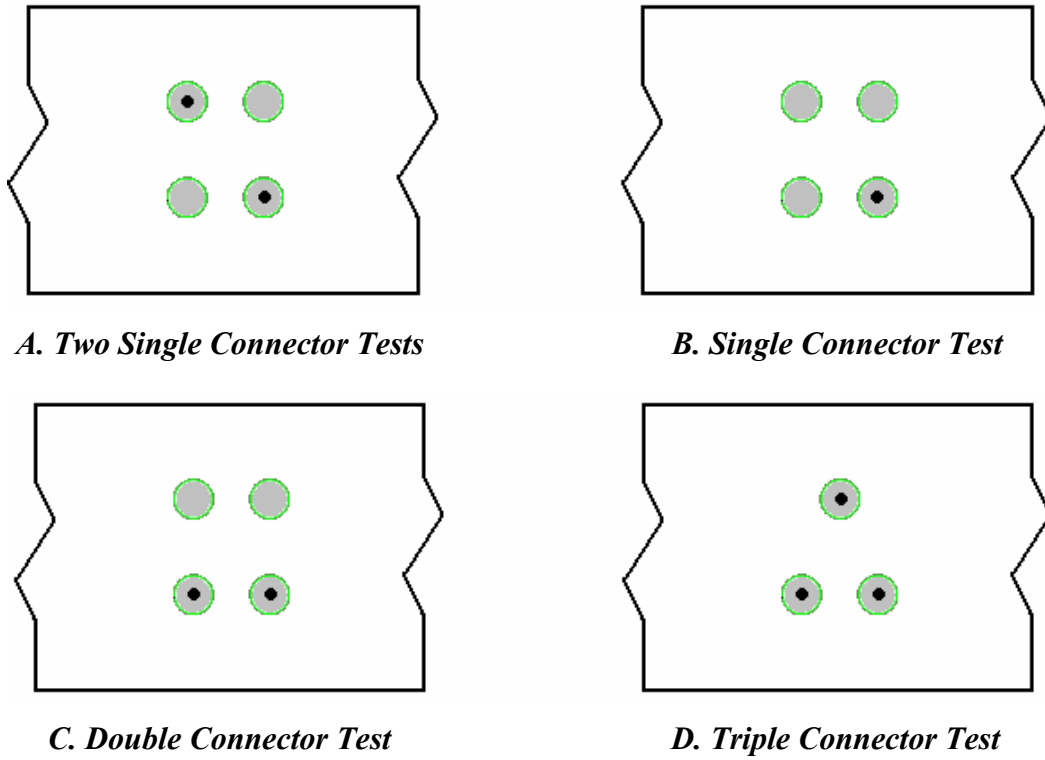
Figure 4.3 Test Connector Arrangements

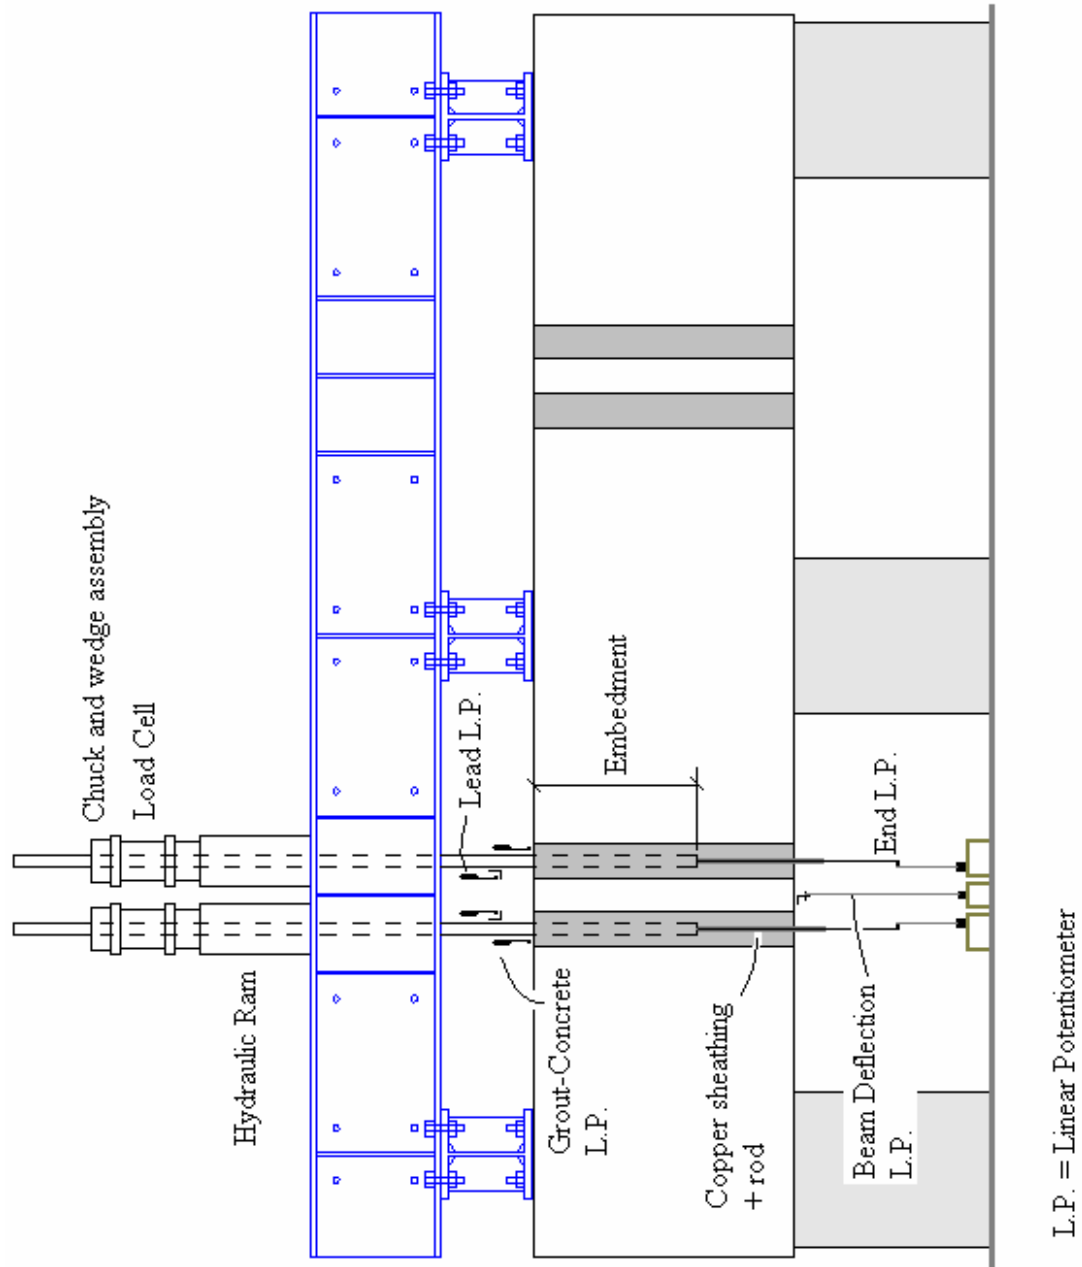
Figure 4.11 Schematic of Test Setup and Instrumentation

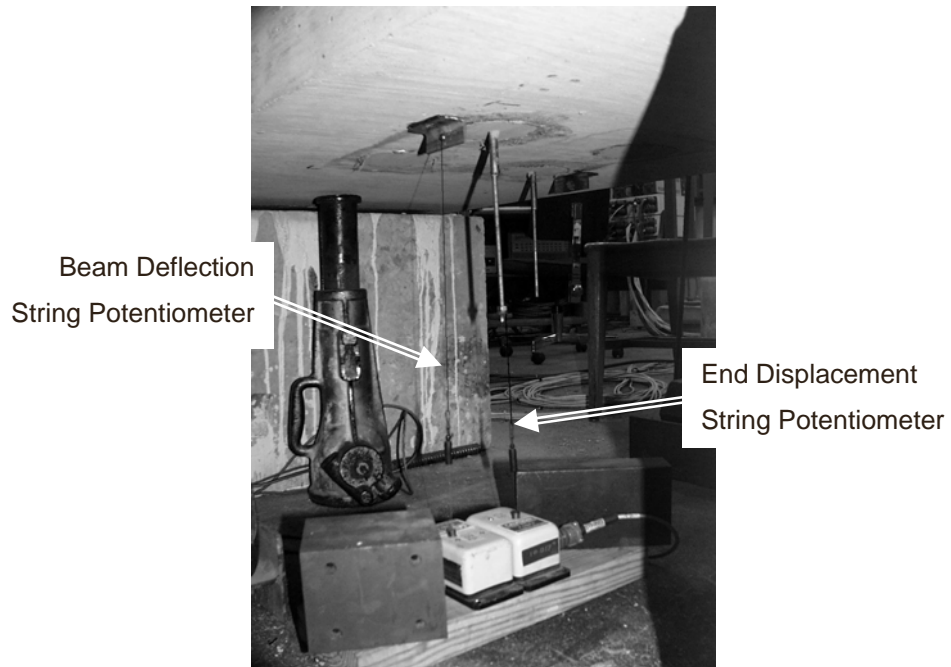
Figure 4.13 Instrumentation to Measure End Connector Displacement and Beam Deflection

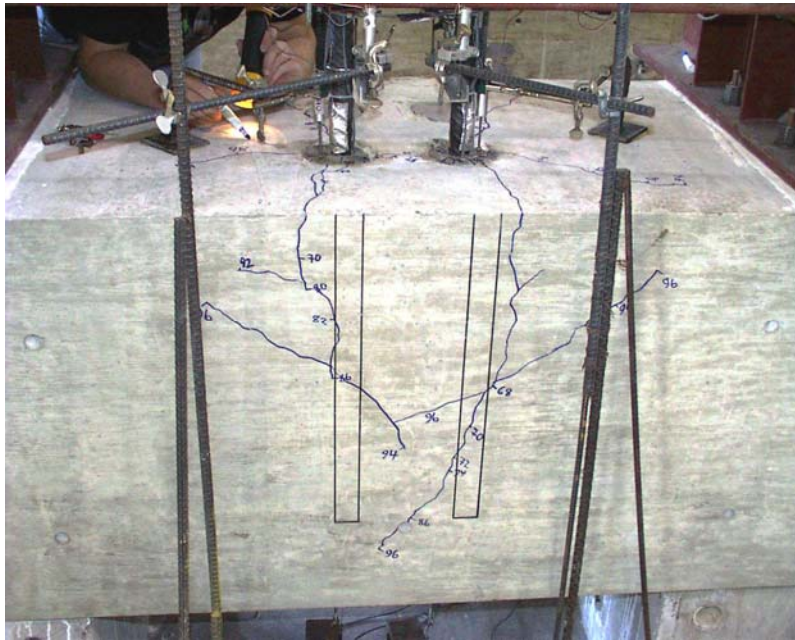
Figure 4.14 Marking of Crack Formations during a Test

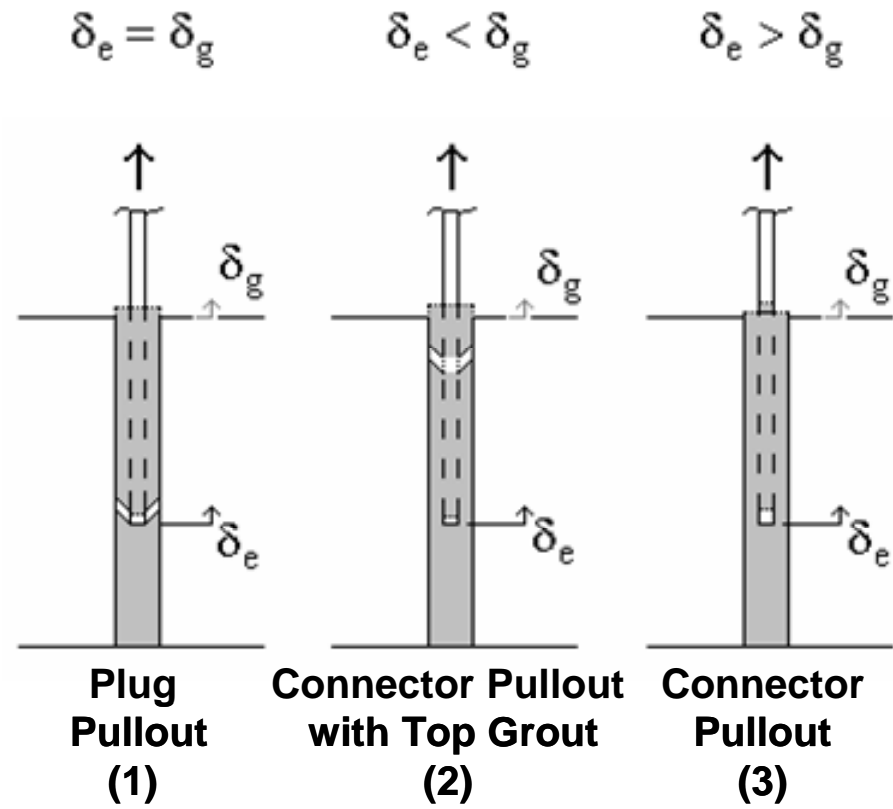
Figure 5.1 Pullout Failure Modes - Relationship between Connector End Slip and Grout Displacement

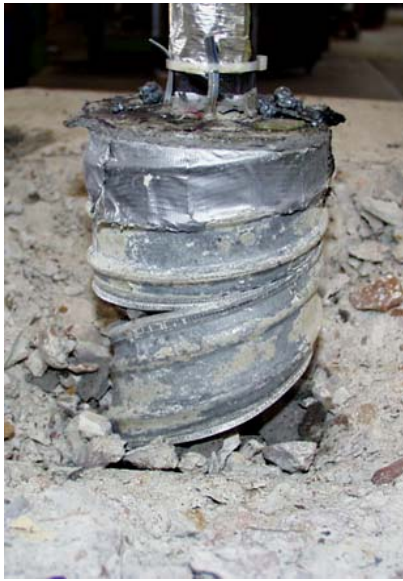
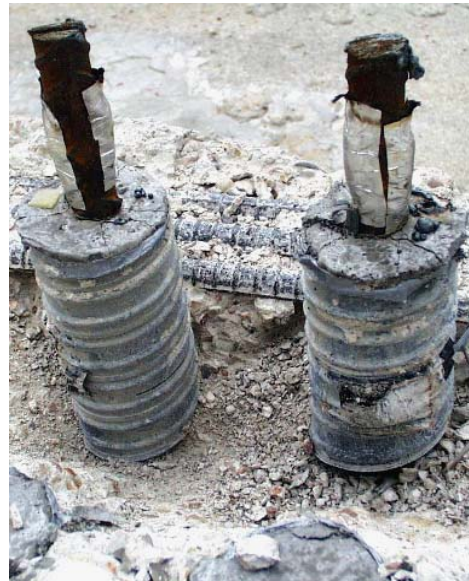
A. Single Connector

B. Multiple Connectors

Figure 5.2 Pullout Failure Modes for Galvanized Steel Duct Connections

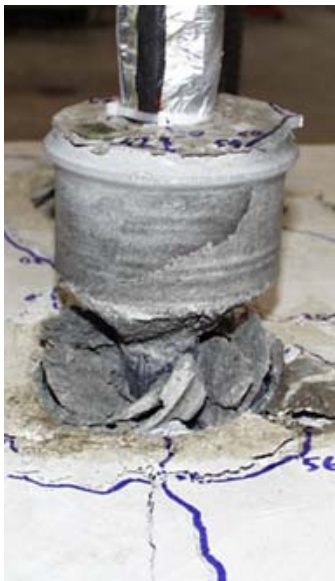
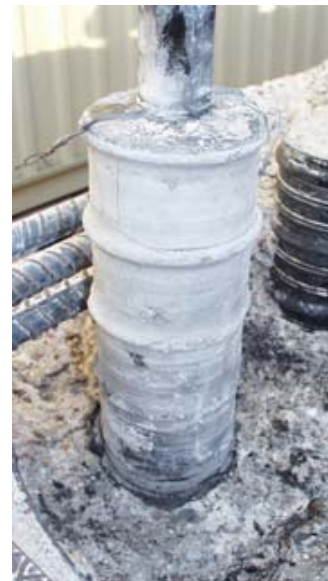
Figure 5.3 Pullout Failure Modes for Polyethylene Duct Connections

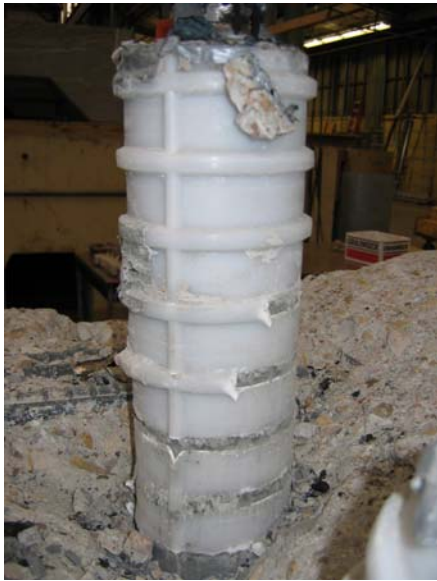
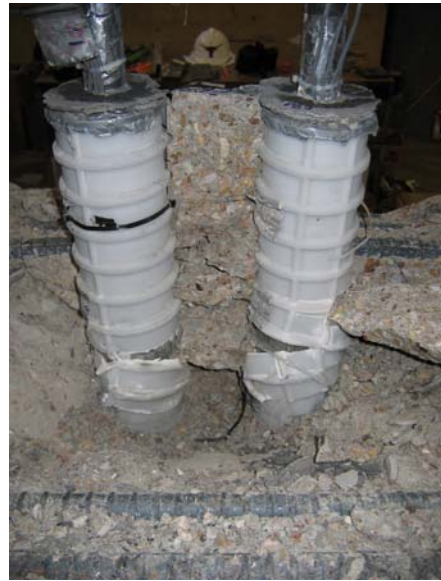
Figure 5.4 Pullout Failure Mode for Polypropylene Duct Connections (Tests No. 30 and No. 32)

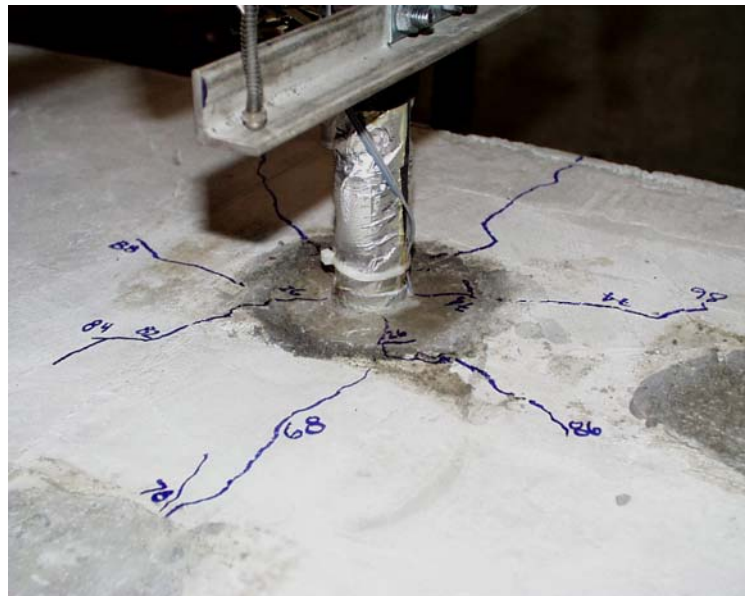
Figure 5.5 Widespread Splitting in Test No. 10

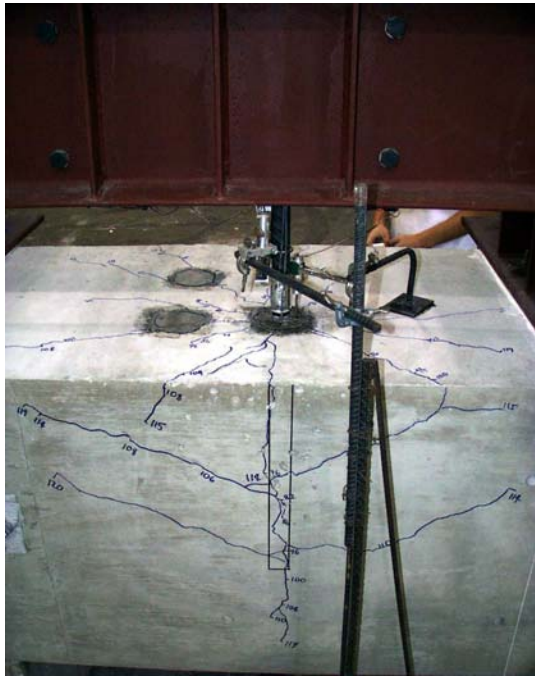
Figure 5.6 Cracking Pattern at Failure in Test No. 10

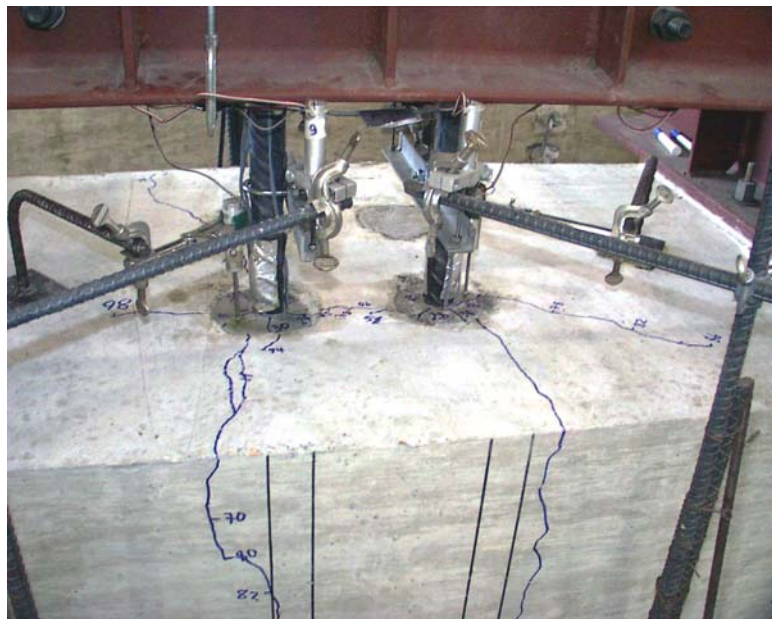
Figure 5.7 Widespread Splitting Cracks in Test No. 13

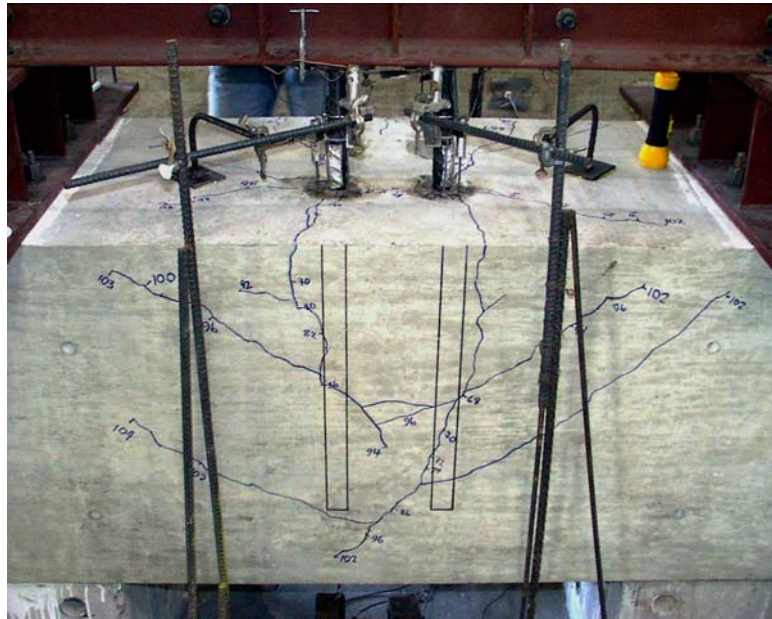
Figure 5.8 Double Connector Test with 1-D Duct Spacing (Test No. 13)

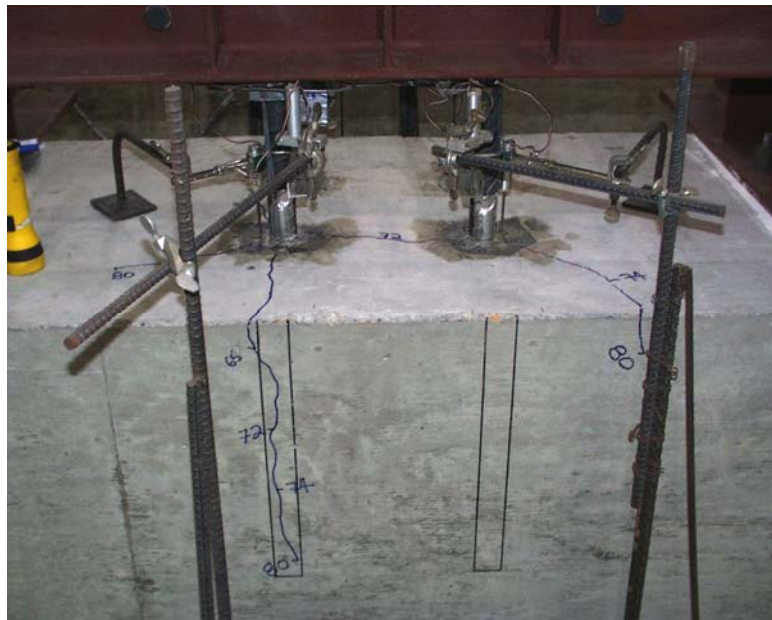
Figure 5.9 Widespread Splitting Cracks in Test No. 23

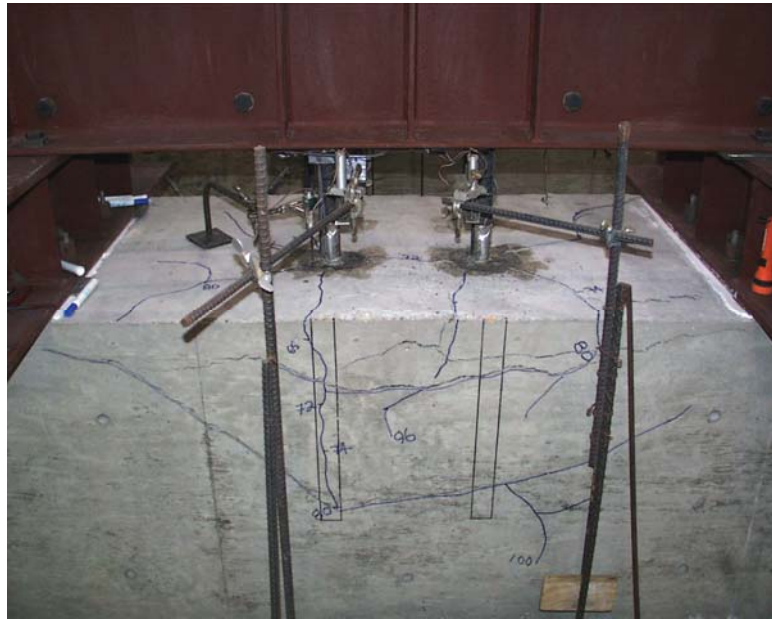
Figure 5.10 Double Connector Test with 2-D Duct Spacing (Test No. 23)

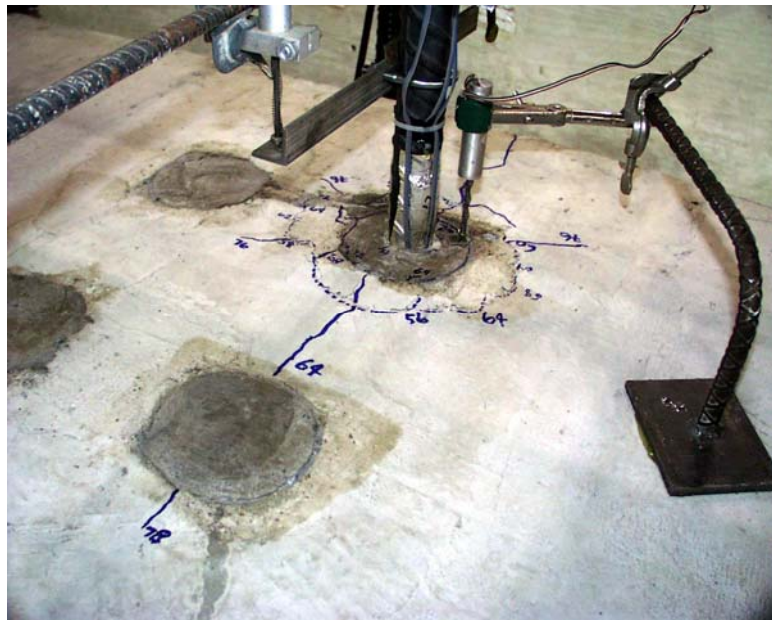
Figure 5.11 Splitting Cracks in Test No. 9
