**Anchorage of Grouted Vertical Duct Connections for
Precast Bent Caps**

Dissertation

The University of Texas at Austin

December 2005

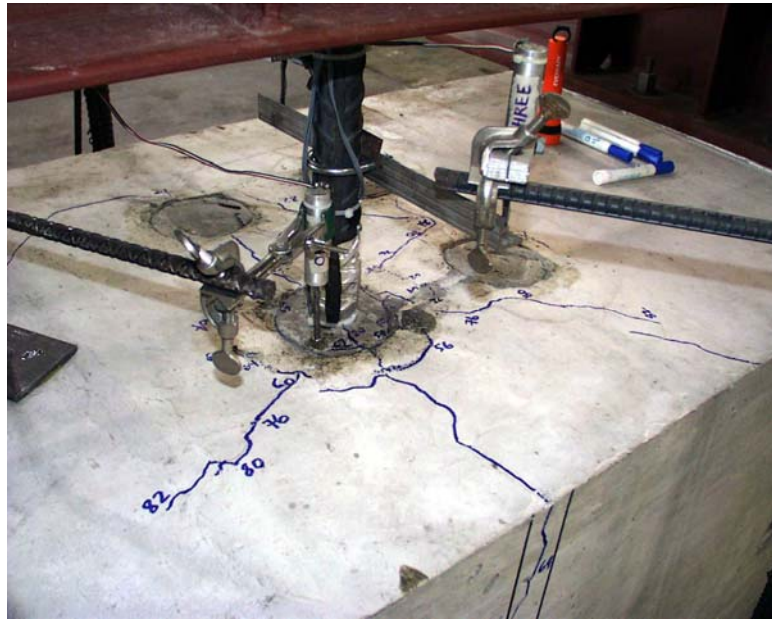
Figure 5.12 Test No. 9 at Failure Load

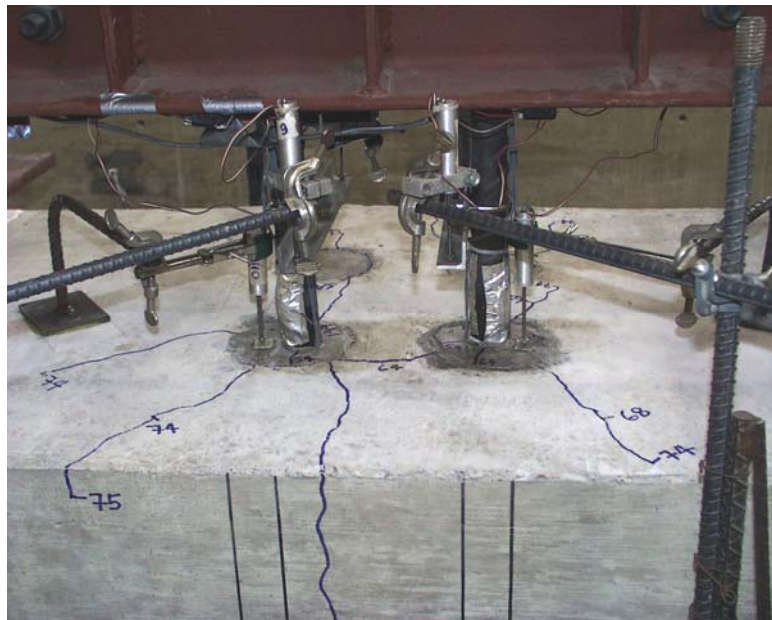
Figure 5.13 Widespread Radial Splitting in Test No. 14

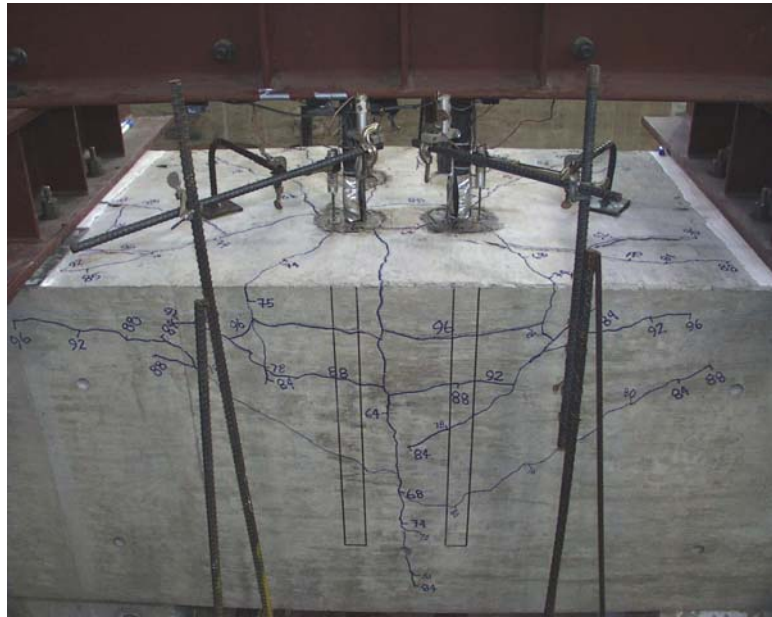
Figure 5.14 Test No. 14 at Failure Load

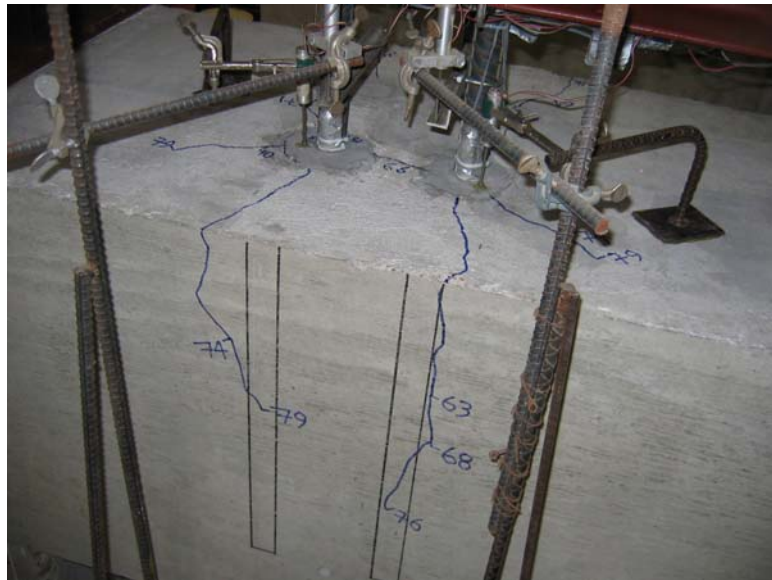
Figure 5.15 Widespread Radial Splitting in Test No. 28

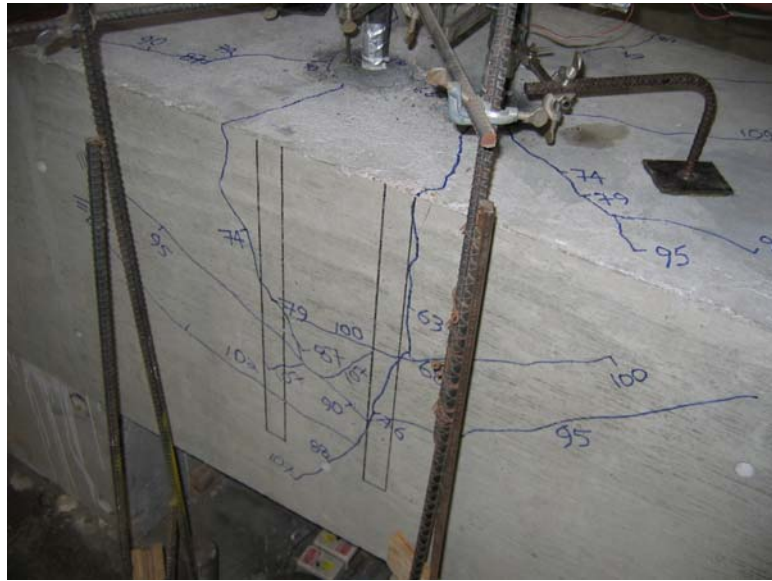
Figure 5.16 V-shaped Crack Formations in Test No. 28

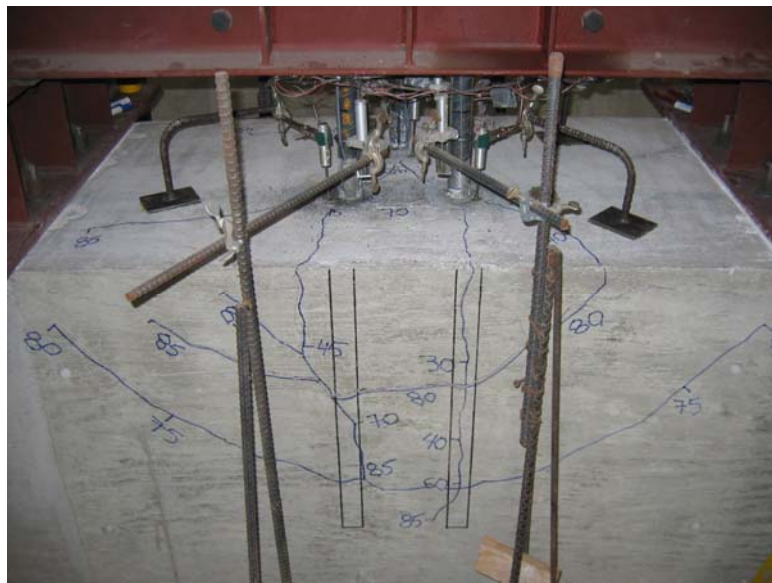
Figure 5.17 V-shaped Crack Formations in Test No. 32

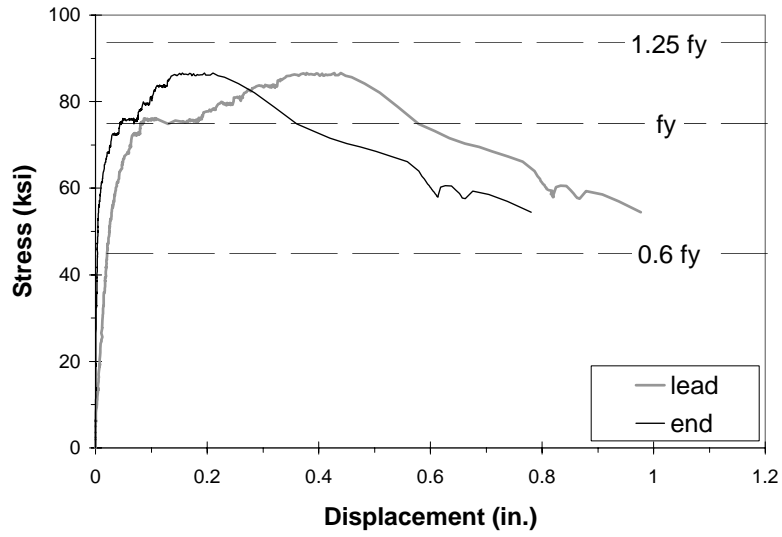
Figure 5.18 Measured Lead and End Connector Displacements (Test No. 3)

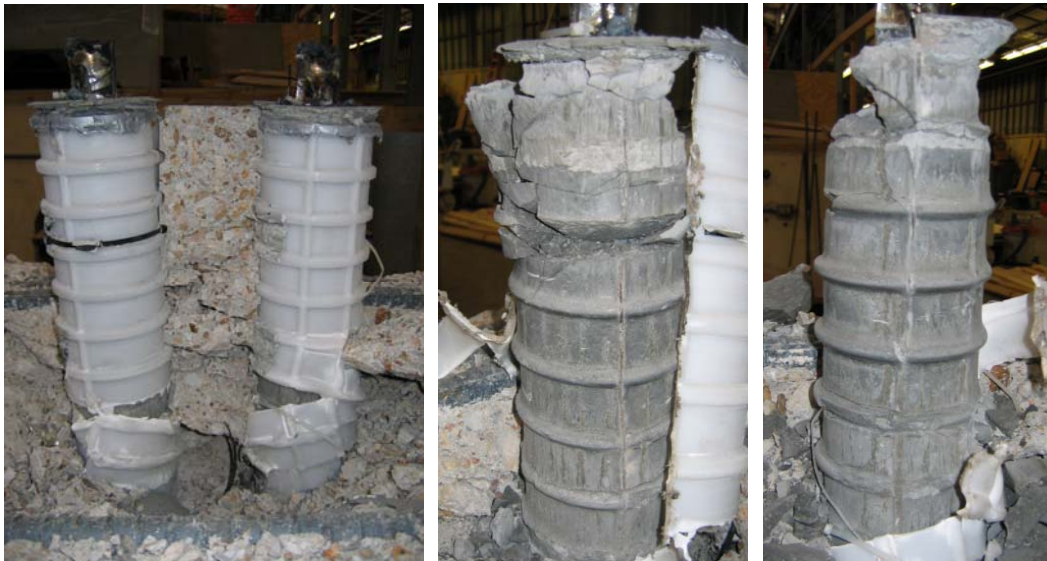
Figure 5.80 Autopsy on Polypropylene Duct Specimen (Test No. 28)

Test	Bars	Coating	l_e (d_b)	f_{max} (ksi)	Plug Pullout Failure Mode
28	2-#11	No	16	85	Slip of grout out of duct with top duct segment attached (both bars)
29	1-#11	No	8	40	Slip of grout out of duct with top duct segment attached
30	1-#11	No	12	68	Slip of grout and duct out of the concrete
32	3-#11	No	16	67	Slip of grout and duct out of the concrete (three bars) Left Bar: Grout fracture at 22 in., Right Bar: Grout fracture at 17 in., Third Bar: Grout fracture at 17 in.

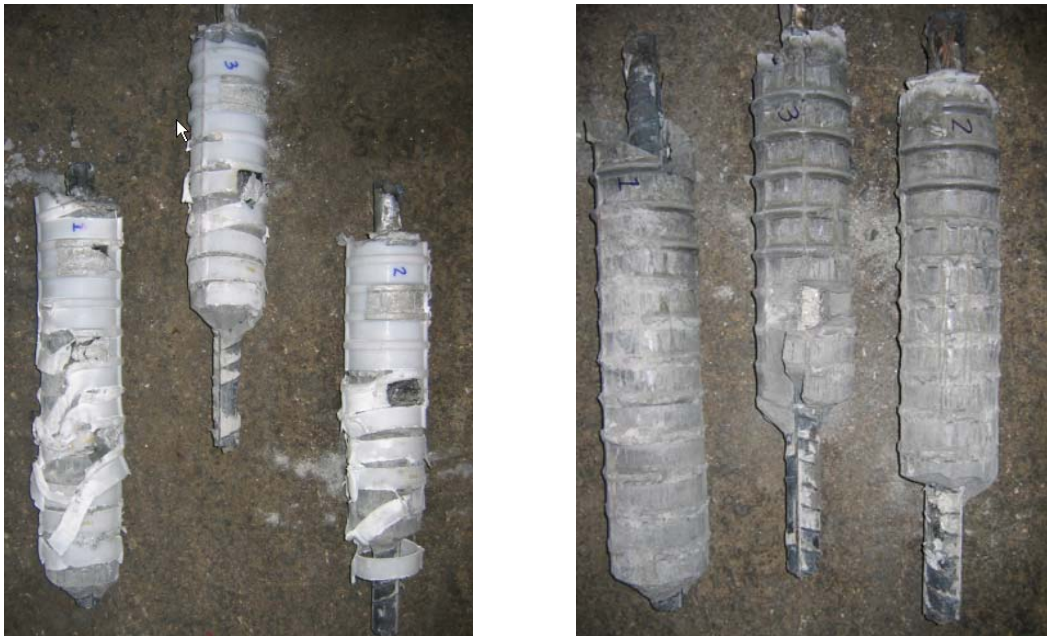
Figure 5.81 Autopsy on Polypropylene Duct Specimen (Test No. 32)

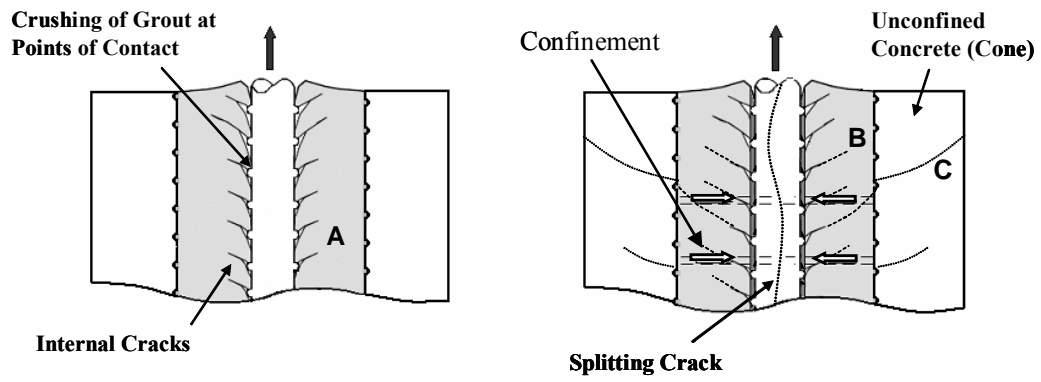
A. Initial Stages of Loading

B. Connector Pullout Failure Mode

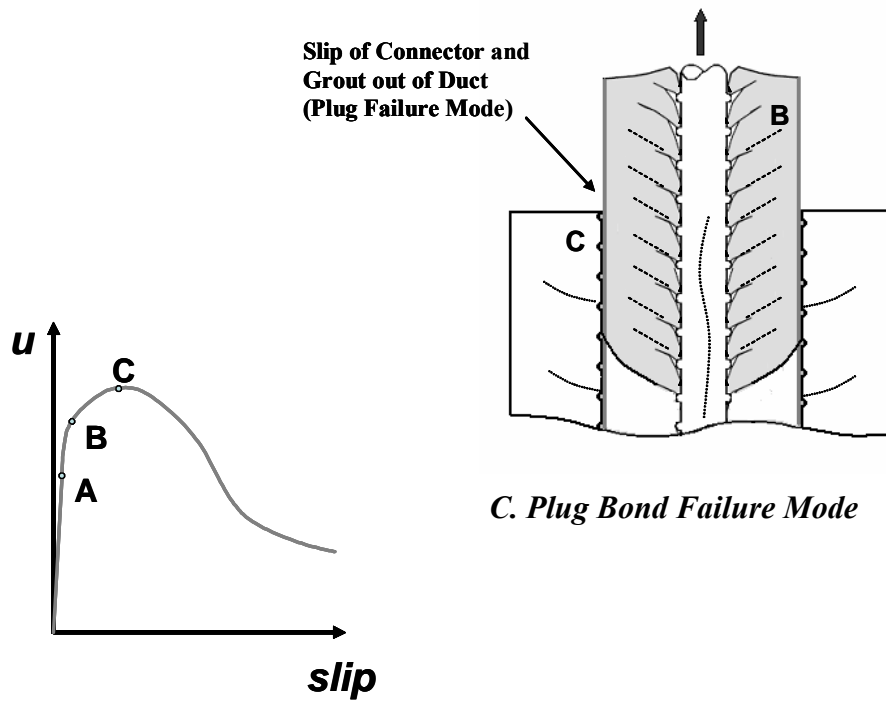
Figure 6.33 Bond Stress – Slip Model

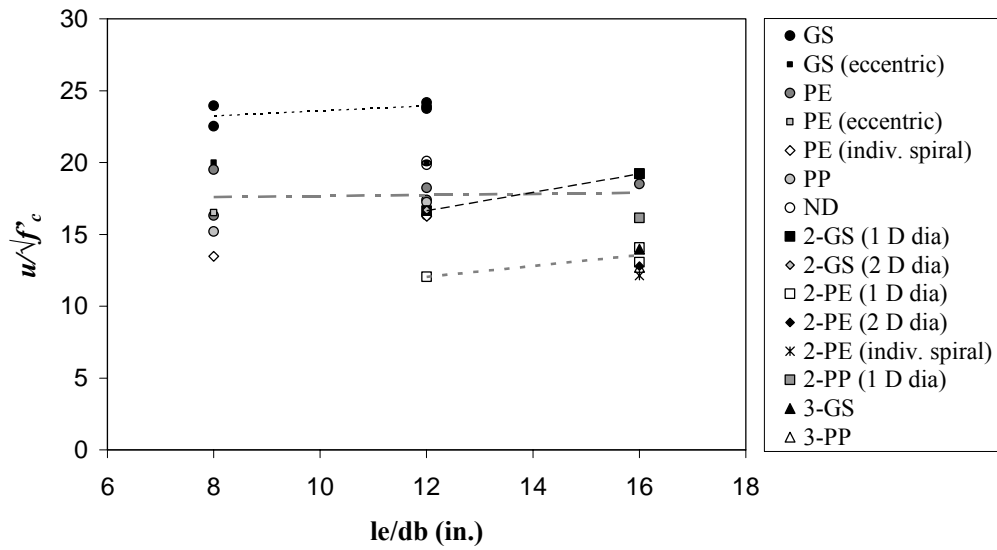
Figure 6.34 Effect of Embedment Depth on Average Peak Bond Strength

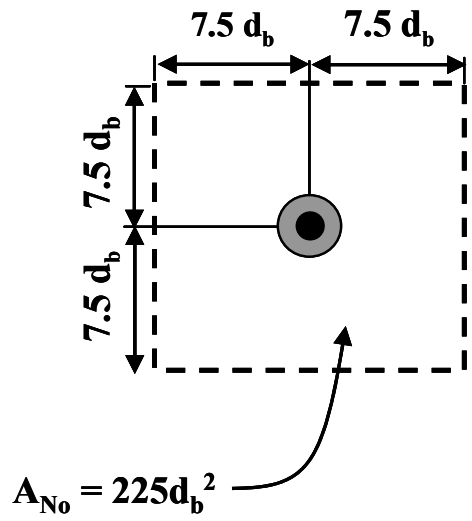
Figure 6.45 Projected Failure Surface for Individual Connector, A_{No}

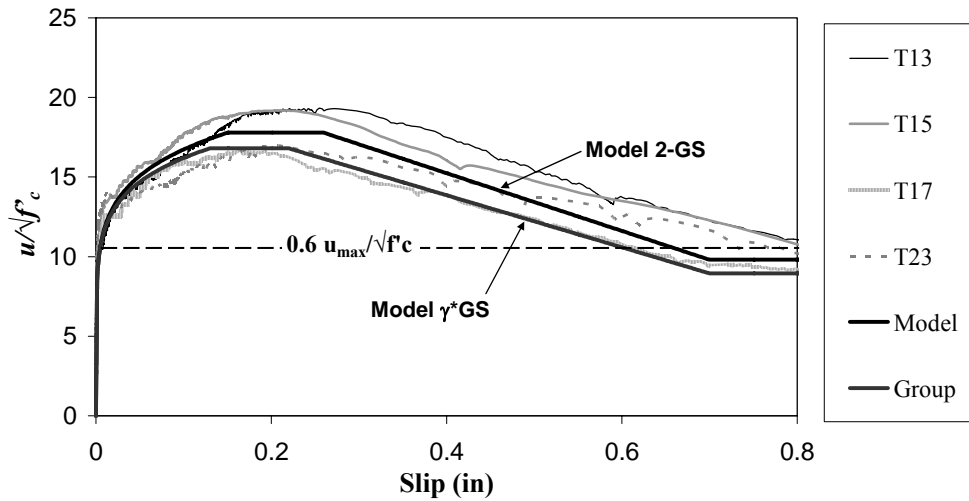
Figure 6.46 Comparison of Idealized Curves with Group Effect Modification Factor for Two Connectors in Galvanized Steel Ducts

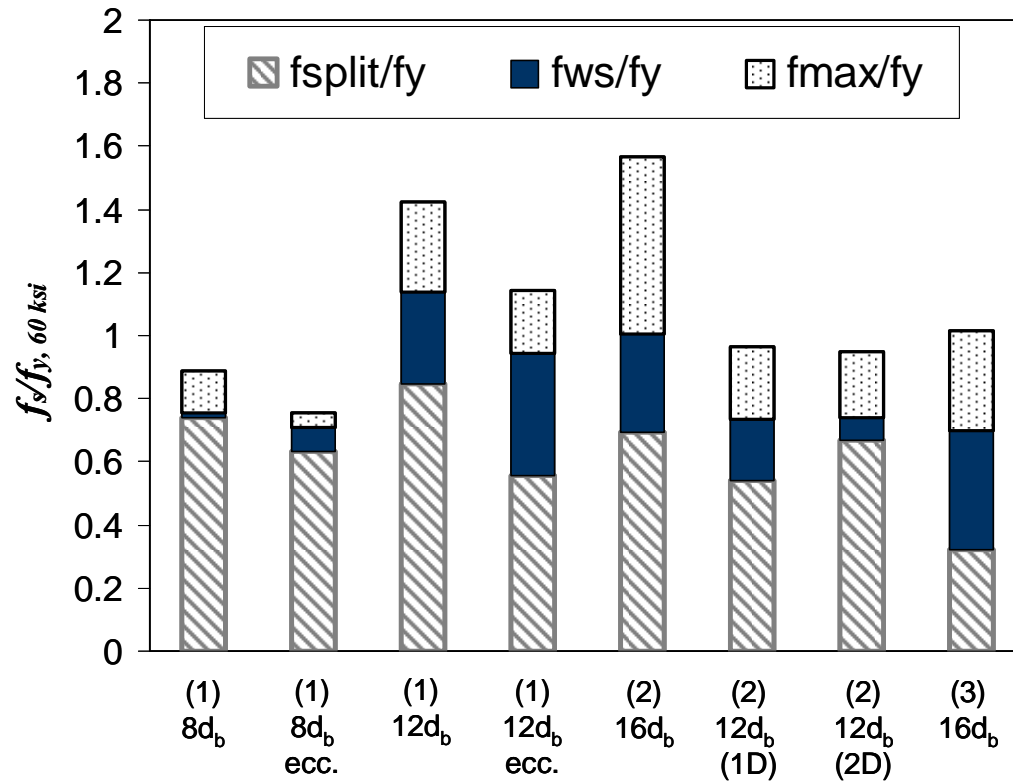
Figure 7.1 Connector Stress Ratios for Galvanized Steel Duct Specimens

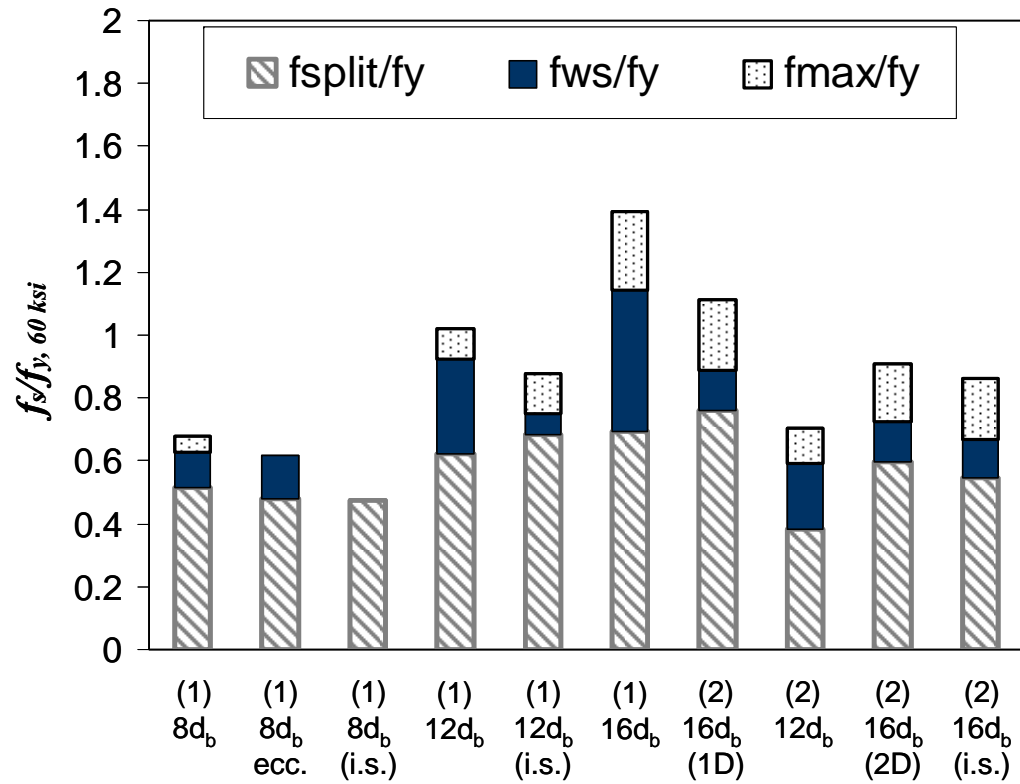
Figure 7.2 Connector Stress Ratios for Polyethylene Duct Specimens

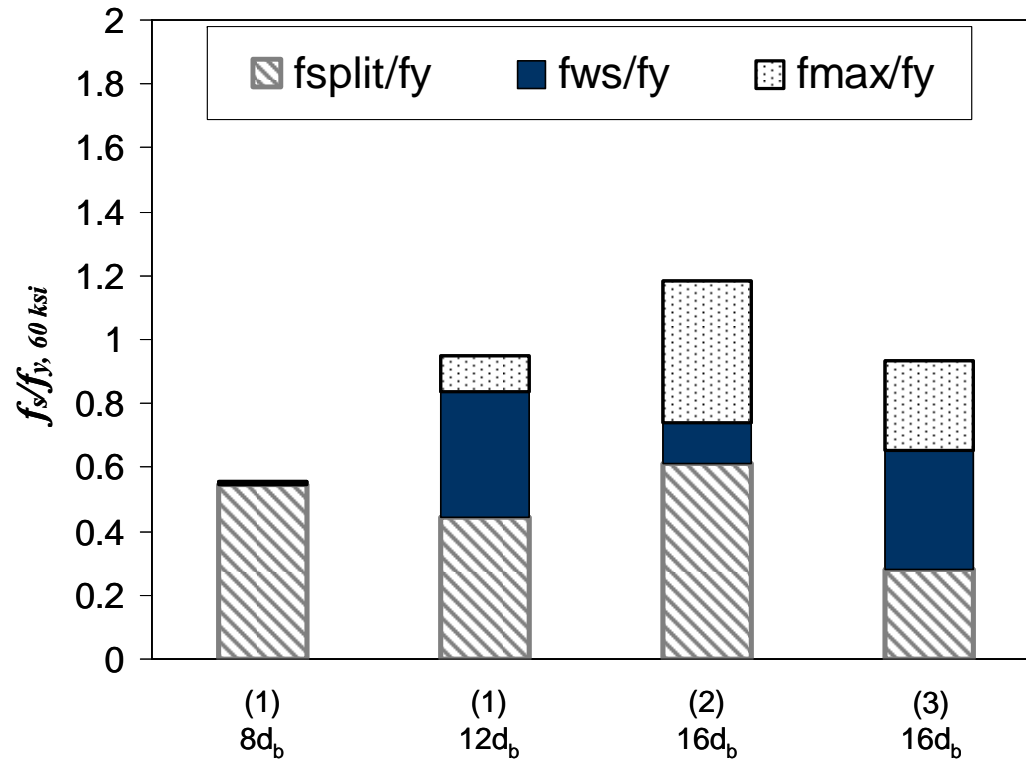
Figure 7.3 Connector Stress Ratios for Polypropylene Duct Specimens

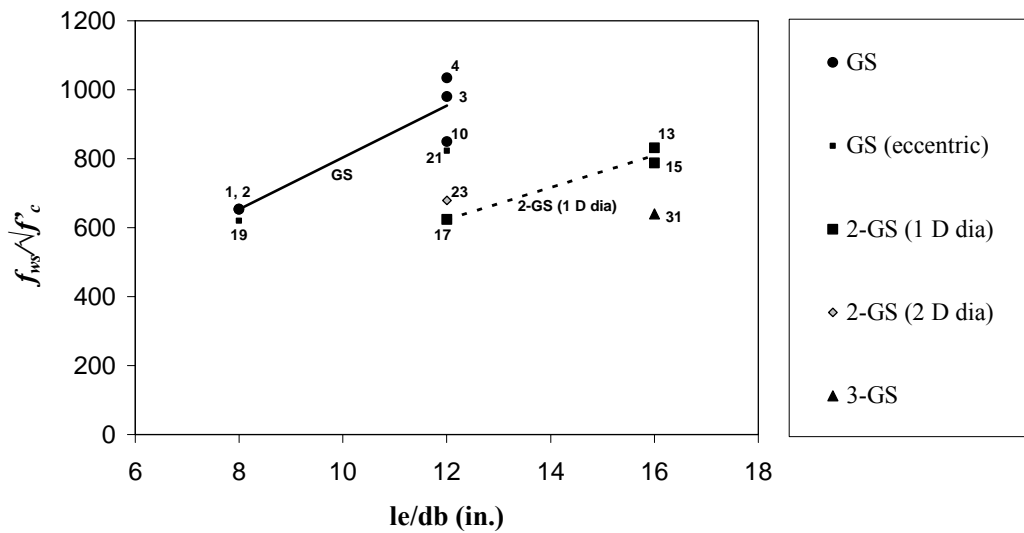
Figure 7.5 Influence of Embedment Depth on Connector Stress at Widespread Splitting in the Concrete (Galvanized Steel Ducts)

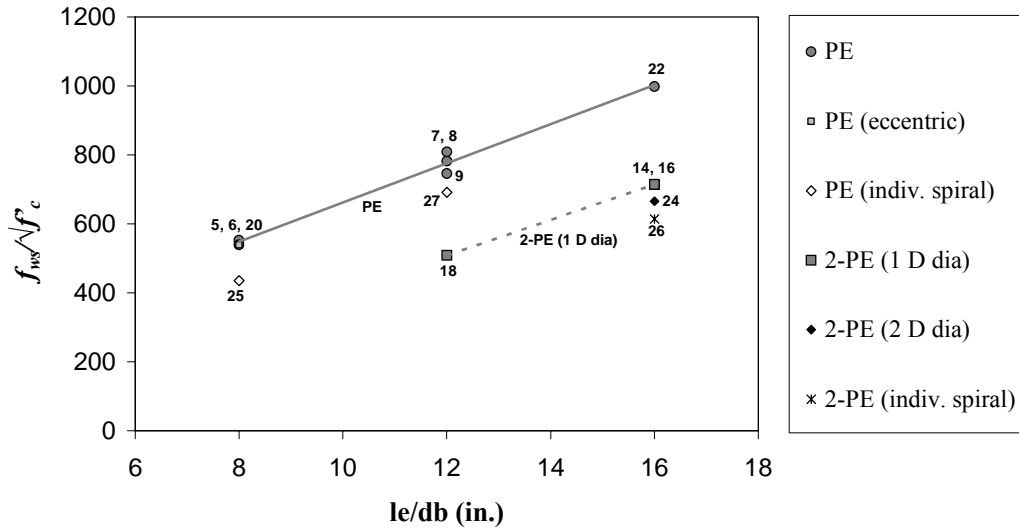
Figure 7.6 Influence of Embedment Depth on Connector Stress at Widespread Splitting in the Concrete (Polyethylene Ducts)

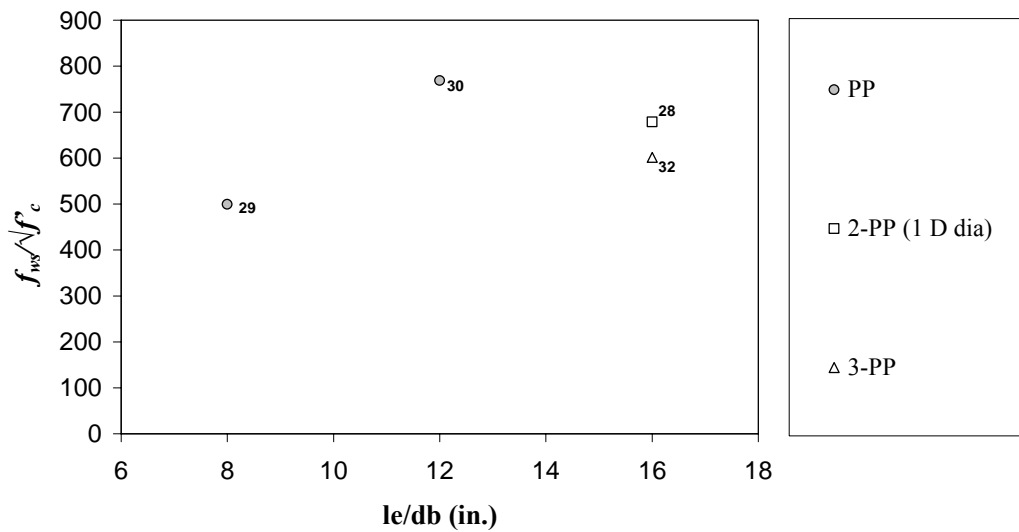
Figure 7.7 Influence of Embedment Depth on Connector Stress at Widespread Splitting in the Concrete (Polypropylene Ducts)

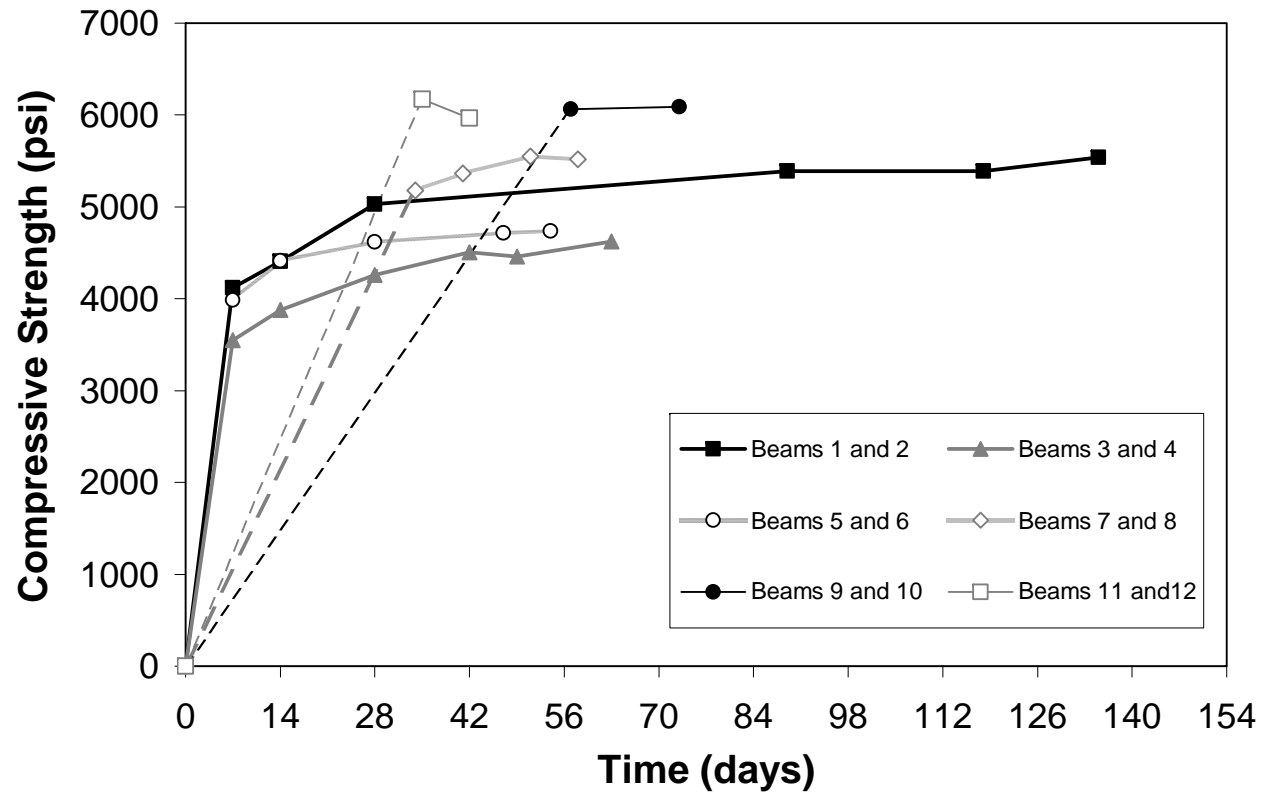
Figure C.1 Concrete Compressive Strengths for Beam Specimens
