**AAC Shear Wall Specimens:
Development of Test Setup and Preliminary Results**

THESIS

**The University of Texas at Austin
May 2000**

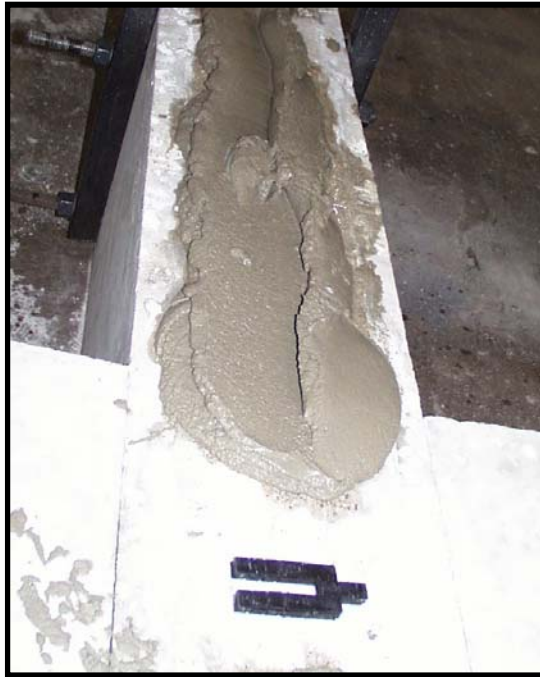
Figure 2-1: Combination of Type S mortar and thin-bed mortar on floor beam

The general construction process is independent of whether horizontal panels, vertical panels or blocks are used. First, the top of the concrete base or foundation is roughened by light bush-hammering, and shims are placed on top, level to within a tolerance of $\pm 1/32$ inch (0.8 mm). Next, a portland cement-lime masonry mortar is placed on top of the floor beam between the shims (Figure 2-1). The masonry mortar used in the tests for this thesis conformed to ASTM C270, Type S by proportion, with some thin-bed mortar added to enhance tensile bond strength and to help retain water. The shims and mortar provide a surface on which to level the first course of panels.

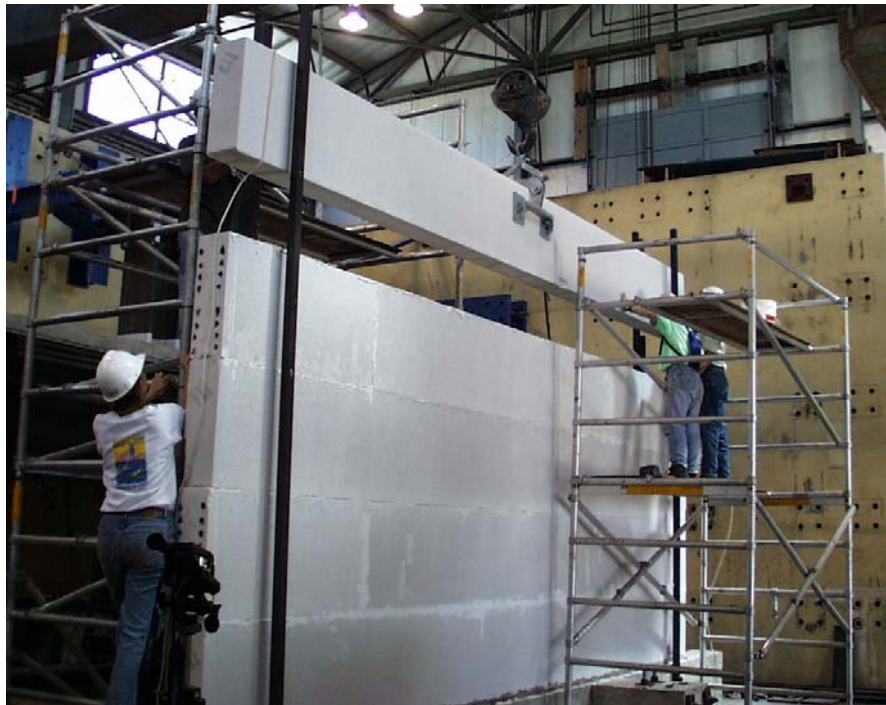
Figure 2-2: Placing horizontal panel during construction

Since the first course is level, the blocks are manufactured to close tolerances, and the mortar joints are quite thin, it is not necessary to level subsequent courses. Subsequent courses are laid over the preceding one with only a layer of thin-bed mortar separating them (Figure 2-2).

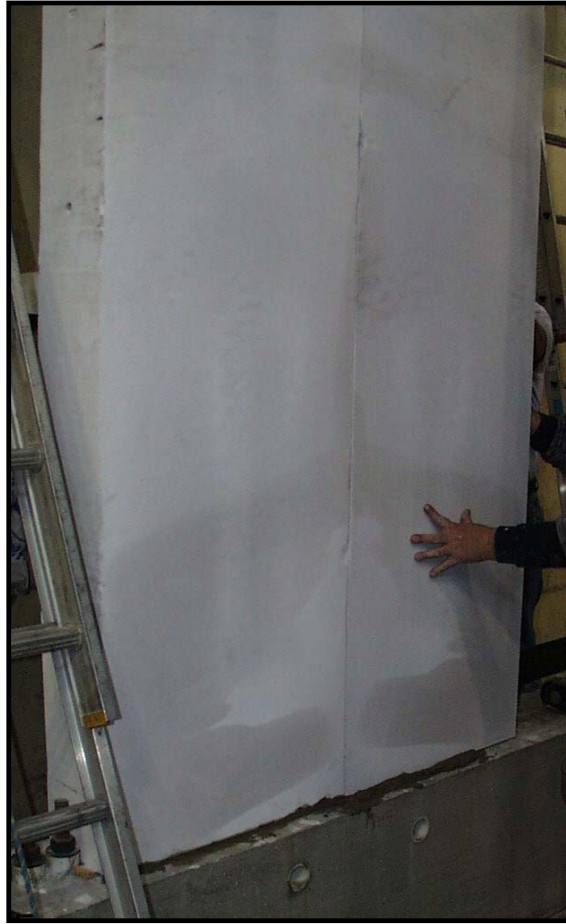
Figure 2-3: Placing vertical panels during construction

If the wall is constructed of vertical panels, each panel must be individually leveled. This requires placing leveled shims at each side of each panel and placing the conventional mortar on the base around the shims. The most critical panel is the first one. It is carefully plumbed. The following panels are set on their own shims and then clamped against the previously placed panel. These can be assumed to be plumb because of the tight tolerances in the panels. Figure 2-3 shows the placement of a vertical panel.

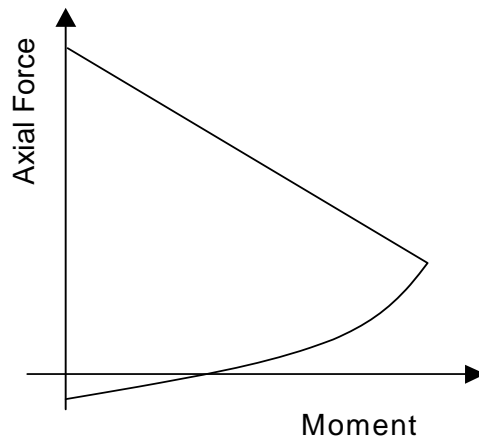
Figure 2-10: Schematic moment-axial force interaction diagram for AAC shear wall

Equation 2-15 can be used as an approximation to the lower portion of a moment-axial force interaction diagram like that shown in Figure 2-10. Interaction diagrams can be developed for first yield and for nominal capacity.

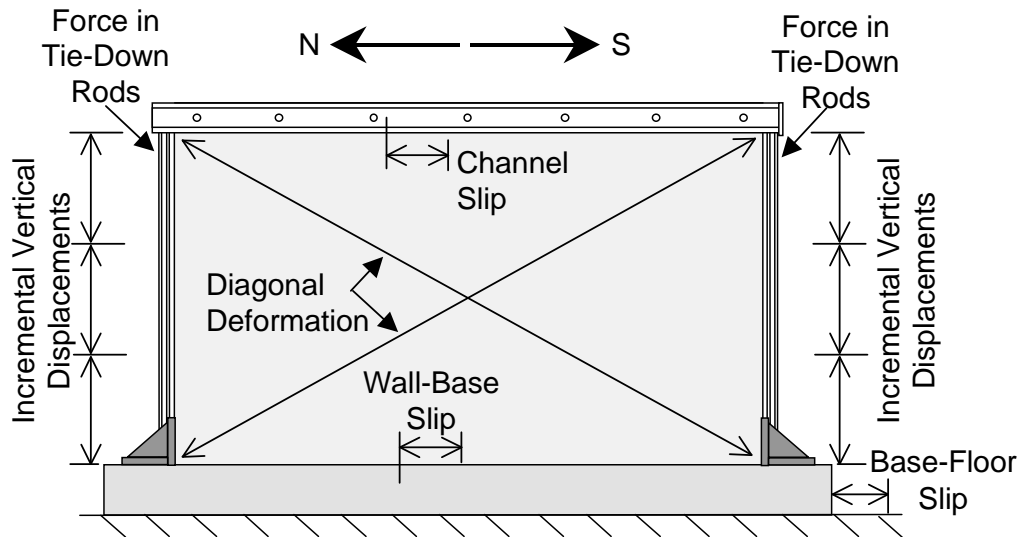
Figure 3-5: Instrumentation for measuring local behavior

- deformation across the diagonals of the specimen;
- incremental vertical deformations at the ends of the specimen;
- slip between the specimen and its base;
- slip between the base and the floor;
- slip between the channels and the top of the wall; and
- force washers to measure force in tie-down rods.

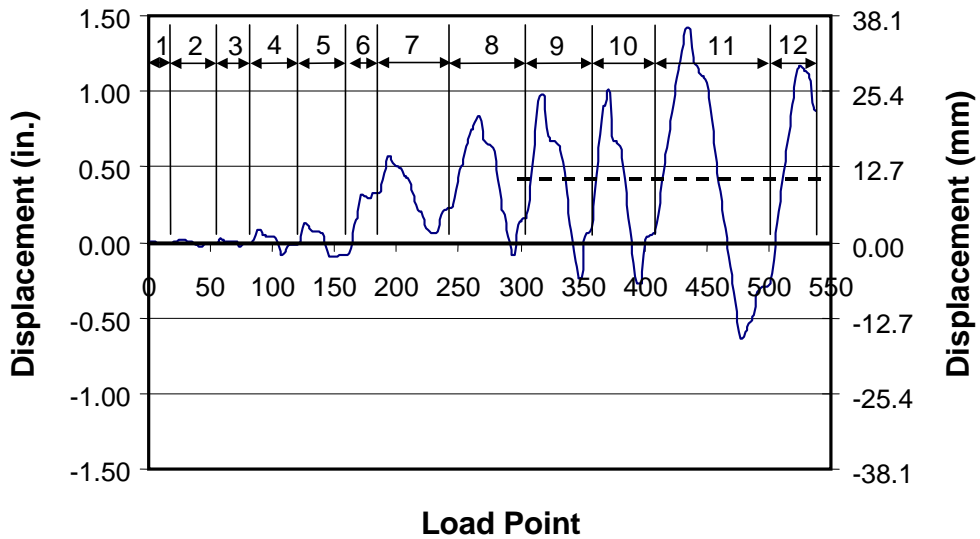
Figure 4-2: Actual displacement history for Shear Wall Pilot Specimen 1 (numbers at top of plot designate cycle numbers)

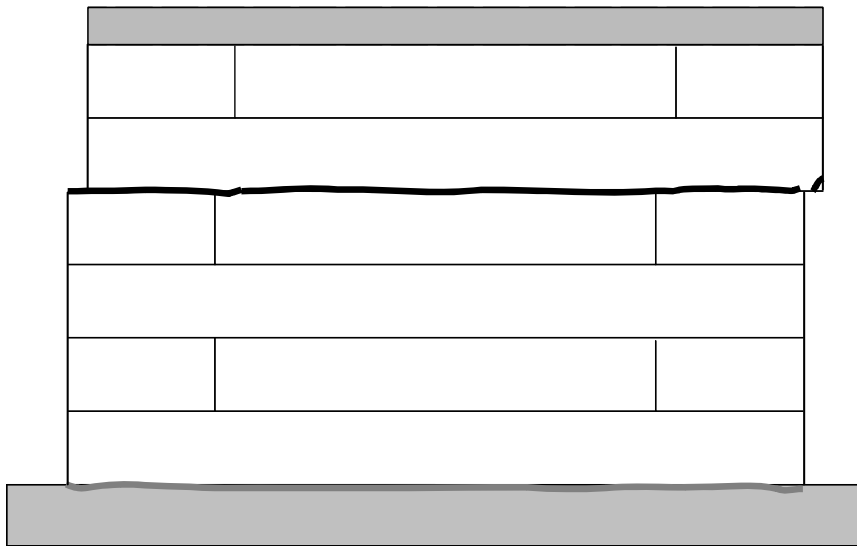
Figure 4-4: Cracking of Shear Wall Pilot Specimen 1 at Cycle 6a (horizontal crack at mortar joint under second panel from top)

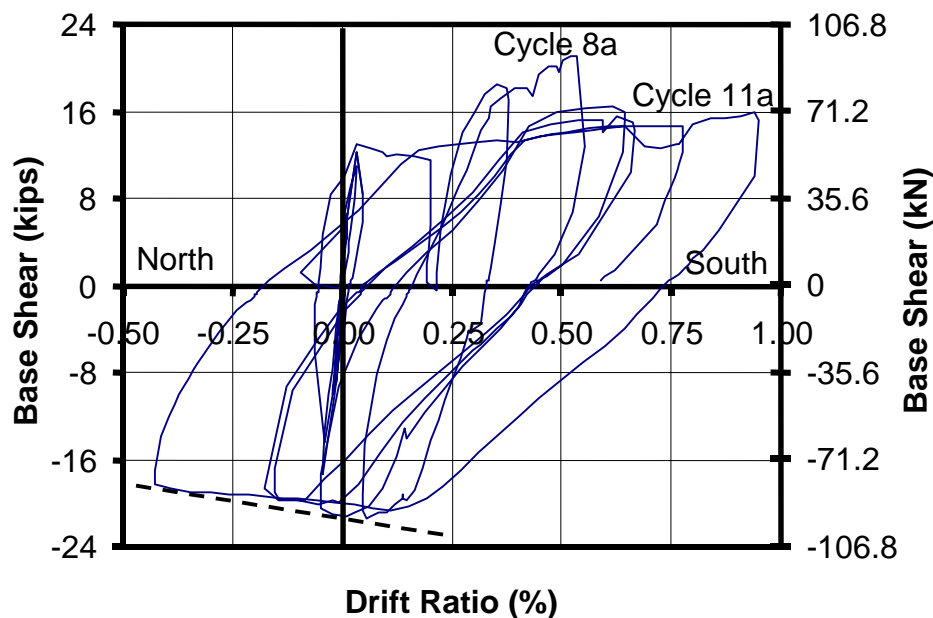
Figure 4-11: Base shear versus percent drift ratio after Major Event 5

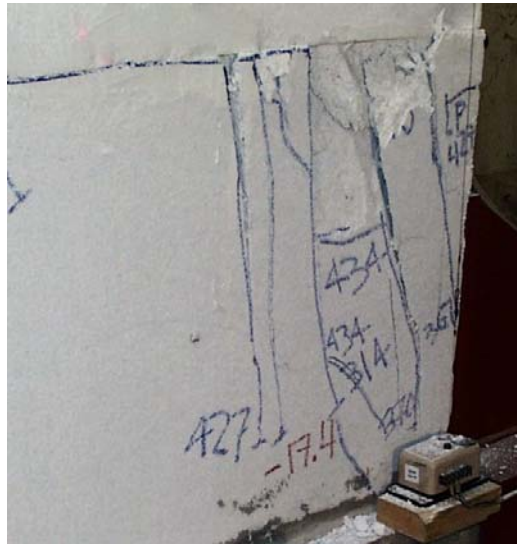
Figure 4-12: Cracks and spalled concrete at south end of Shear Wall Pilot Specimen 1 at end of test

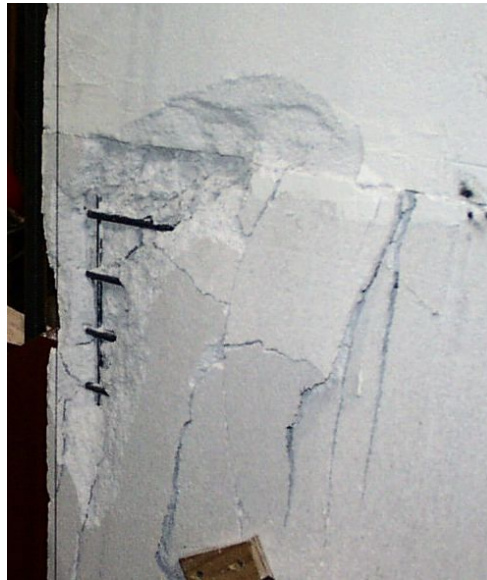
Figure 4-13: Back face of compression toe at end of test, Shear Wall Pilot Specimen 1

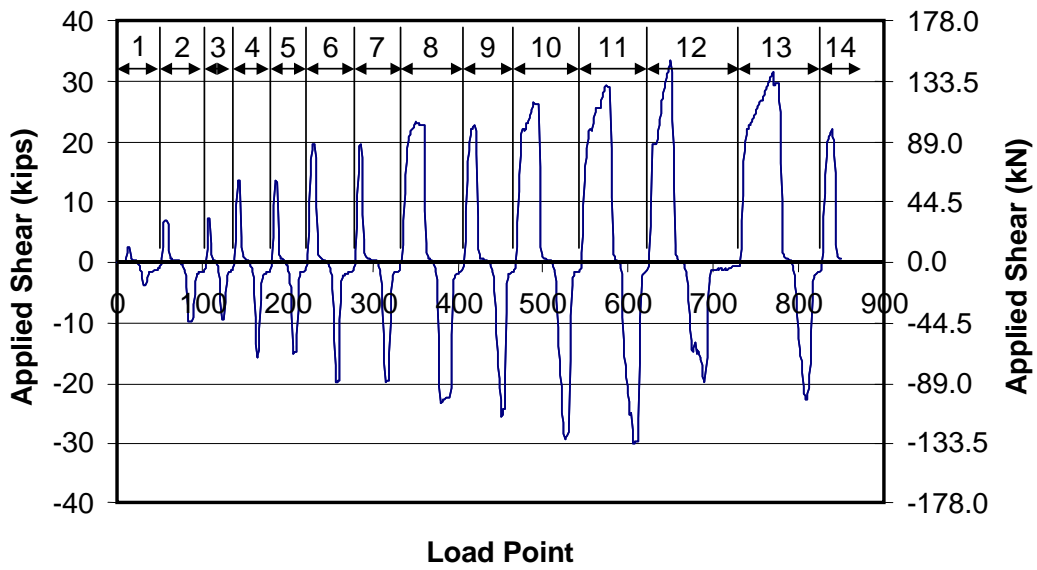
Figure 5-1: Actual loading history for Shear Wall Pilot Specimen 2 (numbers at top of plot designate cycle numbers)

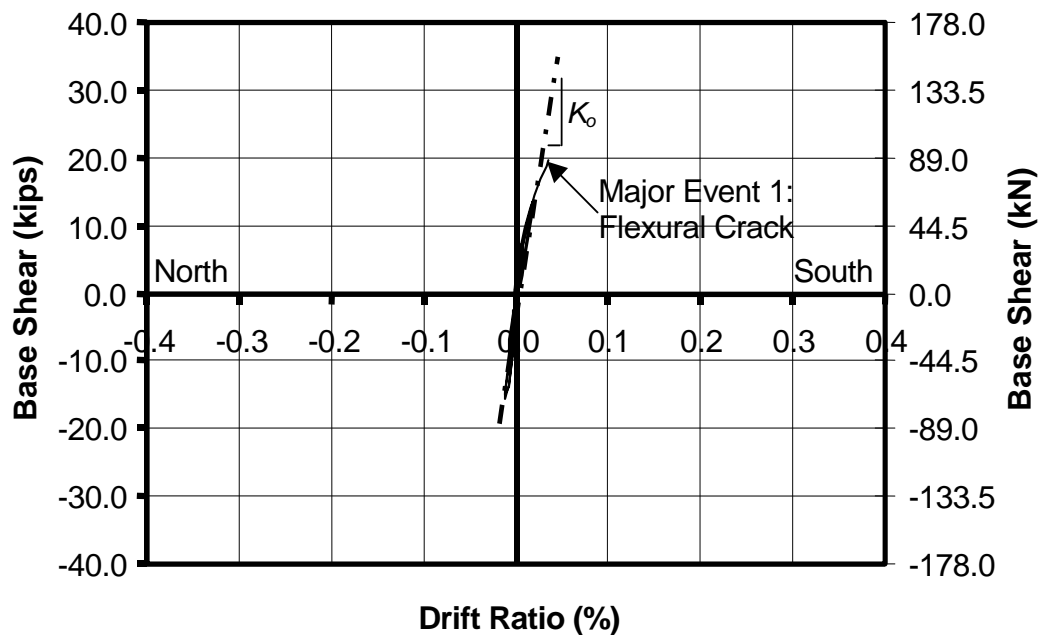
Figure 5-14: Load displacement curve through Major Event 1

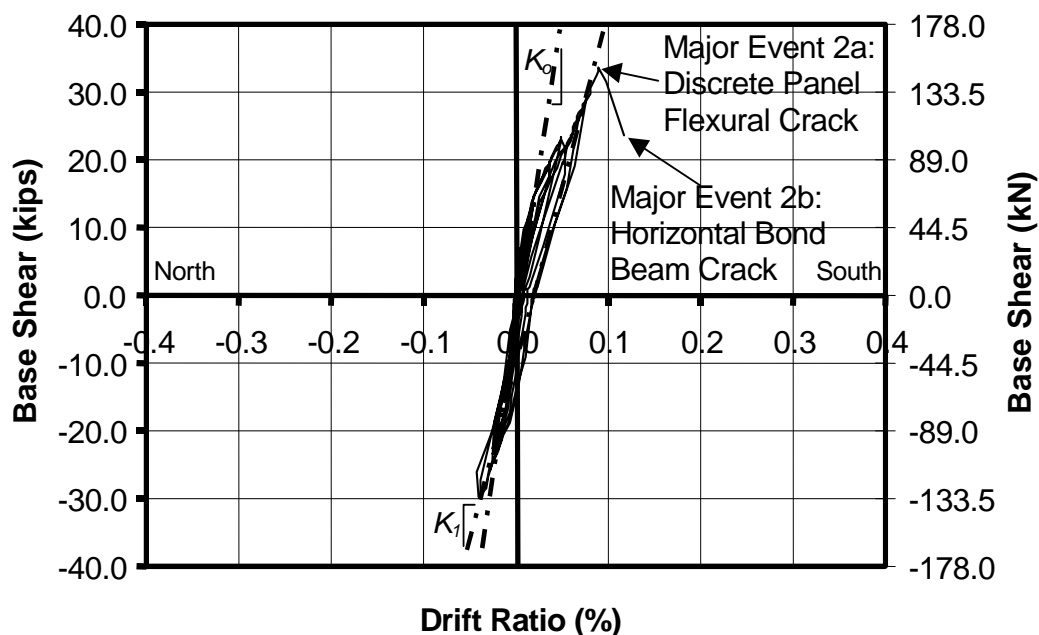
Figure 5-15: Load-displacement curve through Major Event 1

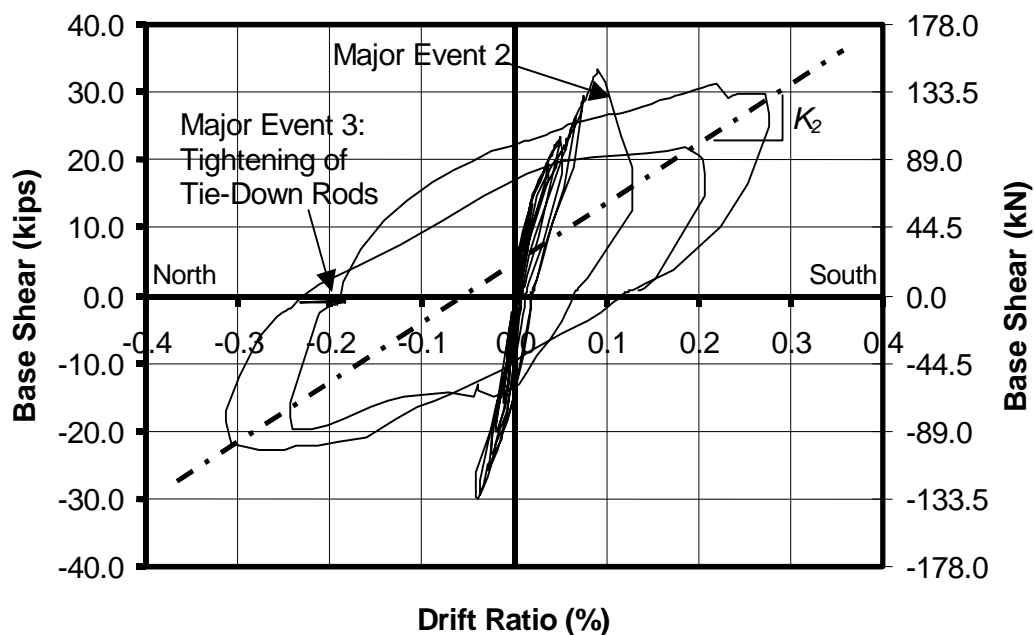
Figure 5-16: Load displacement curve through the end of the test

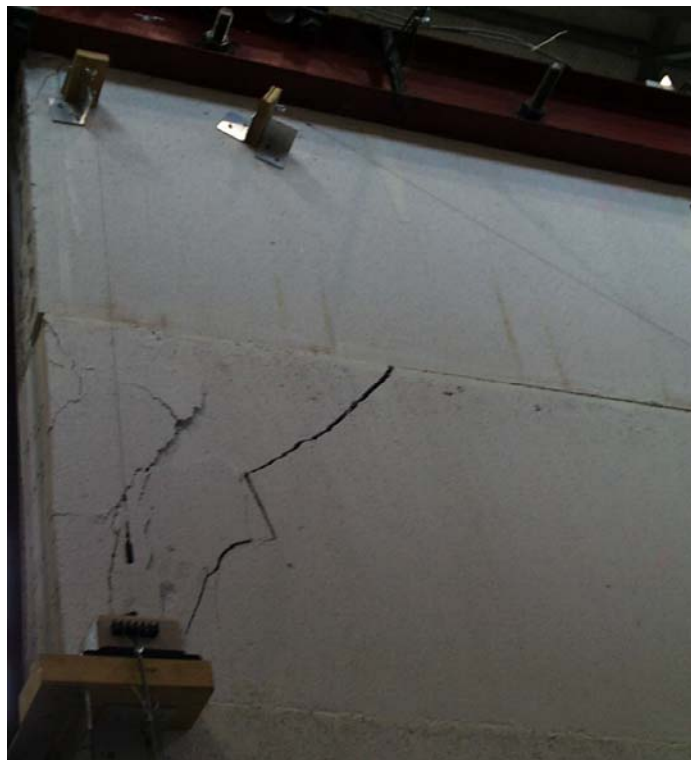
Figure 5-17: Cracked and spalled AAC on back of south end of Shear Wall Pilot Specimen 2 at end of test

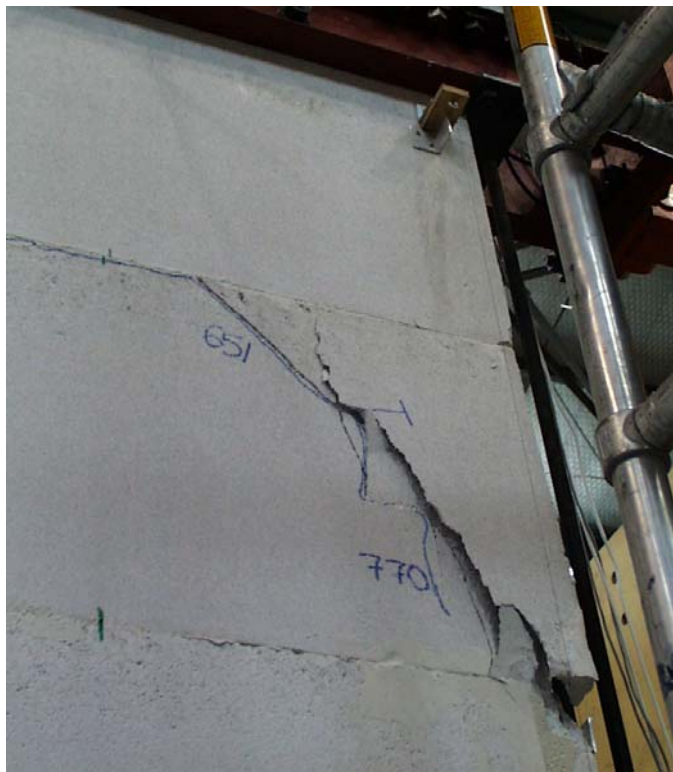
Figure 5-18: Cracked and spalled AAC at south end of Shear Wall Pilot Specimen 2 at end of test

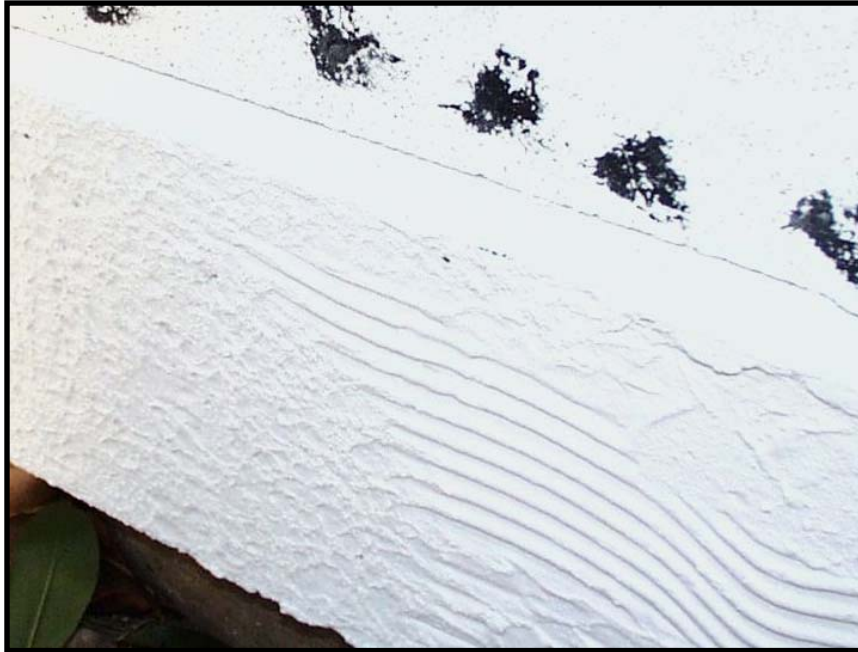
Figure 6-2: Typical vertical thin-bed mortar head joint in Shear Wall Pilot Specimen 1

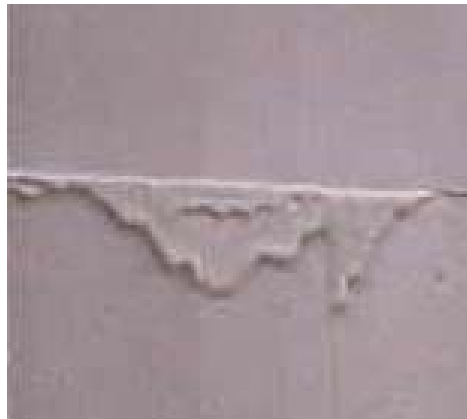
Figure 6-3: Excess thin-bed mortar squeezing out of a bed joint during construction

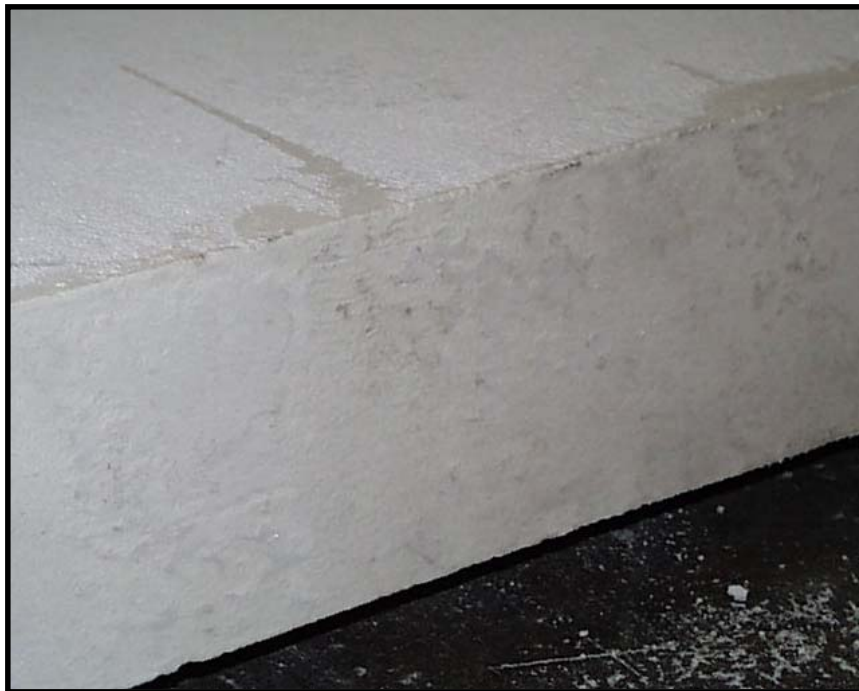
Figure 6-4: Typical thin-bed joint in Shear Wall Pilot Specimen 2

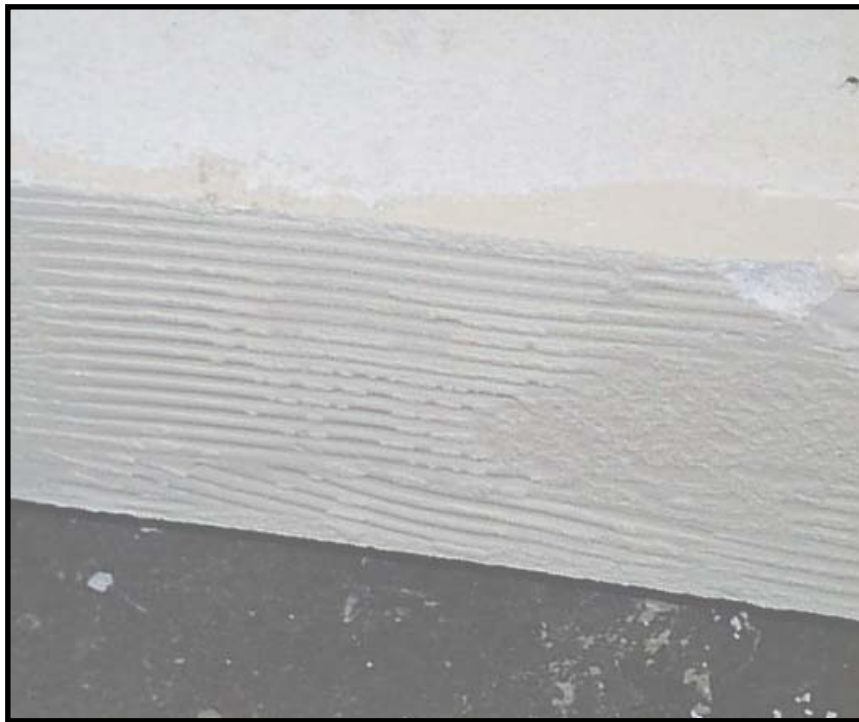
Figure 6-5: Typical vertical thin-bed mortar head joint in Shear Wall Pilot Specimen 2

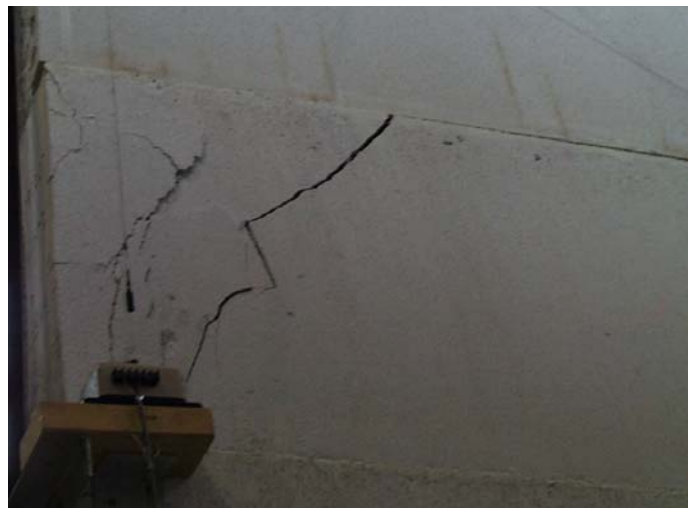
Figure 6-6: Crack on back of south end of Shear Wall Pilot Specimen 2 showing rotation of end of panel

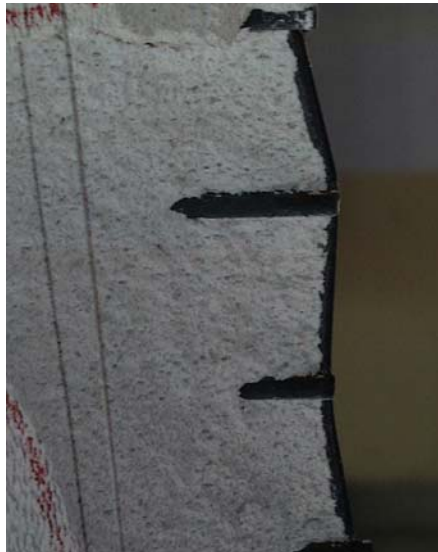
Figure 6-8: Yielding of vertical wire of reinforcement

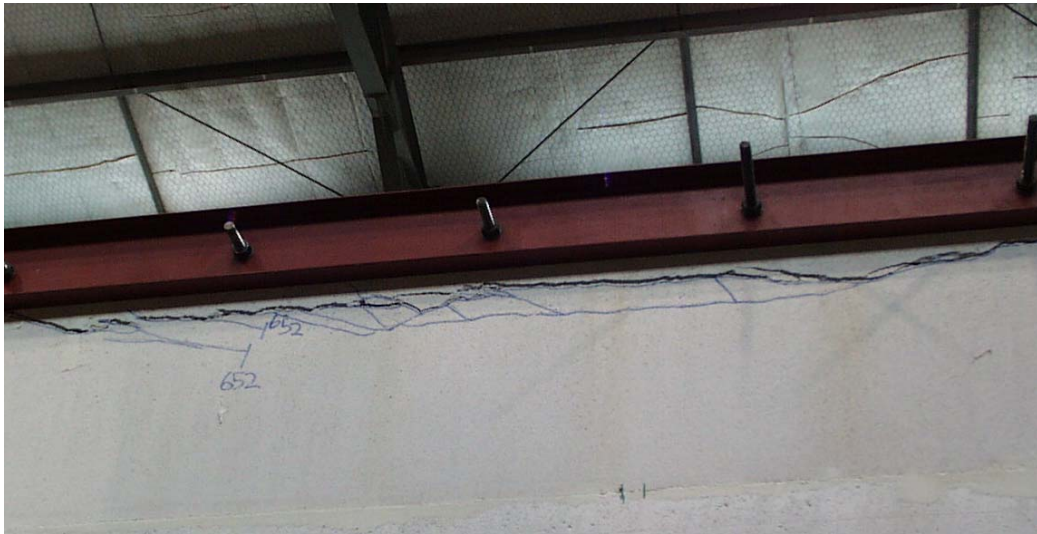
Figure 6-9: Tensile crack below bond beam

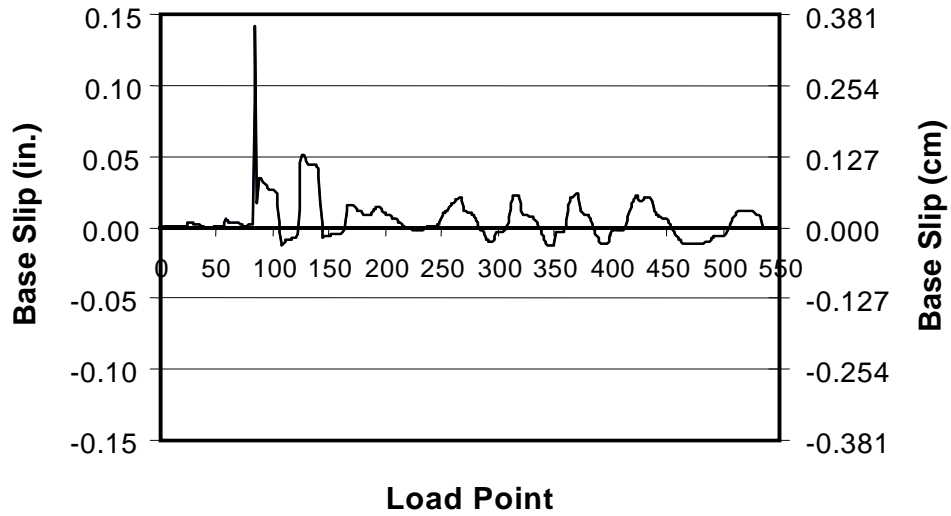
Figure B-1: History of slip at base of Shear Wall Pilot Specimen 1
