**Diagnostic Testing for Improved Load Rating of Reinforced
Concrete Slab Bridges**

Thesis

The University of Texas at Austin

May 1997

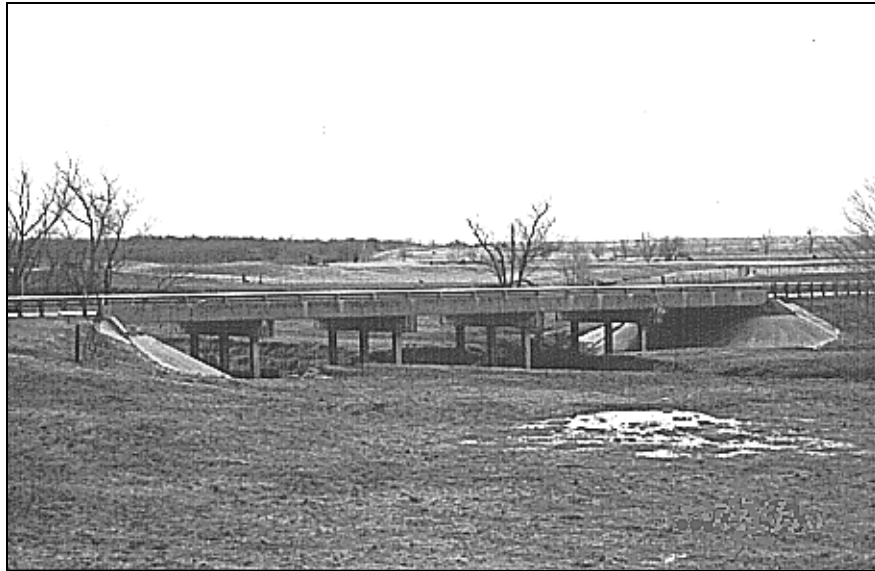
The bridge type selected for testing was a reinforced concrete slab bridge that utilized the curbs as structural members. The bridge is located on FM 1100 over Willow Creek. This location is approximately 15 miles east of Austin off of US 290. The bridge is 25 feet 4 inches in width with a clear roadway width of 23 feet 3 inches. The span length is 25 feet and there is no skew. Figure 2.1 is an elevation view of bridge taken from the north. Figure 2.2 shows the structural details of this bridge type [10].

Figure 2.1 Elevation View of the Slab Bridge Tested.

Figures 2.2 and 2.3 show details of the reinforcing steel layout. The concrete cover is 1.75 inches to center of the reinforcing bar. The curbs on this bridge were retrofitted with a steel rail that is anchored into the top of the curb. This additional rail can be seen in Figure 2.1.

The bridge was in good condition. There was minor cracking of the underside of the slab. The cracking was concentrated at center line and midspan. Based on the inspection performed in April 1994, the deck, superstructure and substructure rated a 6 out of a possible 9.

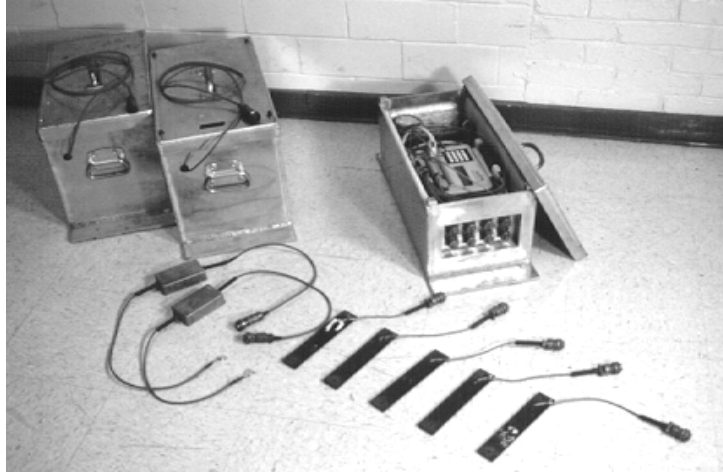
The data acquisition system used was developed for TxDOT as a part of a previous research project [17]. The system was modified slightly in order to sample data at a rate required for moving loads. The data acquisition system was capable of recording 7 channels at a sample rate of 16 Hz. The data acquisition

system, the required 12 volt batteries and the mechanical strain transducers are shown in Figure 3.2.

Figure 3.2 Data acquisition system and strain transducers used in test.

capable of recording 7 channels at a rate of 16 Hz. The data acquisition system, the required 12 volt batteries and the mechanical strain transducers are shown in Figure 3.2.

Figure 3.2 Data acquisition system and strain transducers used in test.

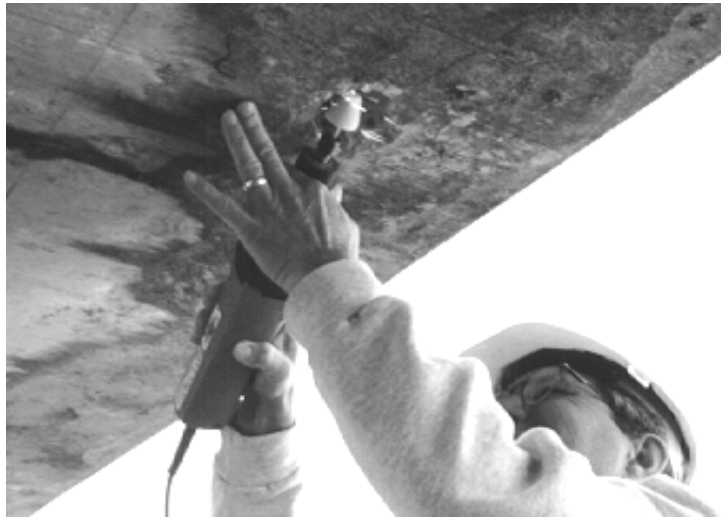
The installation of each type of instrument required a different technique. The reinforcing steel gages required exposing a section of rebar at midspan and preparing the rebar for gage installation. A hole of approximately 6 in. in diameter was broken out of the concrete to access the rebar. The preparation of the rebar involved grinding, sanding and cleaning. Figure 3.4 shows the grinding process while Figure 3.5 shows a rebar ready for application of a gage.

Figure 3.4 Grinding the rebar in preparation for strain gage installation.

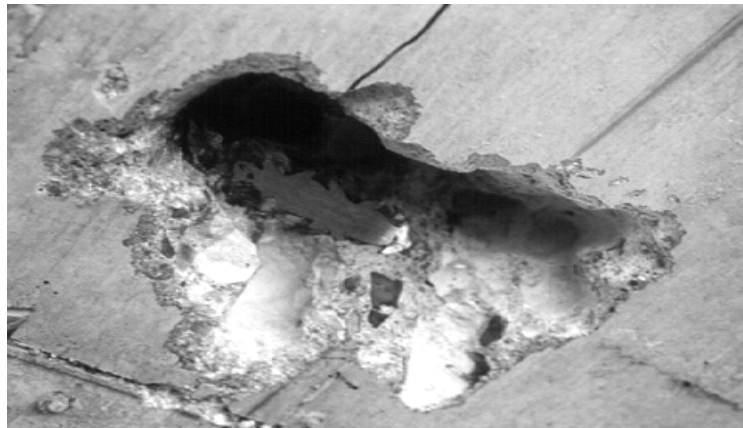
Figure 3.5 Reinforcing steel prepared for strain gage installation.

Once the reinforcing steel was prepared, the gage was installed according to manufacturer's instructions which are outlined in Appendix A. After installation, the gage was protected by applying a coating of white acrylic and

The installation of each type of instrument required a different technique. The reinforcing bar gages required exposing a section of rebar at midspan and preparing the rebar for gage installation. A hole of approximately 6 in. in diameter was broken out of the concrete to access the rebar. The preparation of the rebar involved grinding, sanding and cleaning. Figure 3.4 shows the grinding process while Figure 3.5 shows a rebar ready for gage installation.

Figure 3.5 Reinforcing bar prepared for strain gage installation.

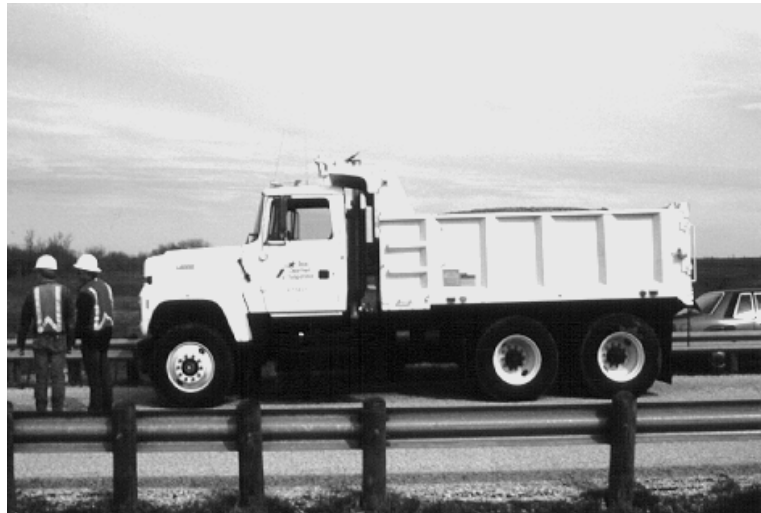
The loading vehicle was acquired from the TxDOT maintenance office in Taylor, TX. The truck was a standard 10 cubic yard dump truck as shown in Figure 3.9. The truck was loaded with roadway base material and weighed approximately 49,000 pounds. The truck was driven across the bridge at both a crawl speed, approximately 5 miles per hour, and at 30 miles per hour depending on the test. The 30 mph pass was an attempt to measure impact. Because of the limited sampling rate of the data acquisition system, adequate data could not be obtained for this test.

Figure 3.9 Test Truck provided by TxDOT.

In order to compare the results from this test with those obtained during previous load tests [10], the truck was driven across the bridge in four transverse positions. In the first location, the right front wheel of the truck was two feet from the inside face of the north curb. In the fourth location, the left front wheel was approximately three feet from the inside face of the south curb. The truck was closer to the center line of the bridge in the remaining two positions.

The loading vehicle was acquired from the TxDOT maintenance office in Taylor, TX. The truck was a standard 10 cubic yard dump truck as shown in Figure 3.9. The truck was loaded with roadway base material and weighed approximately 49,000 pounds. The truck was driven across the bridge at both a crawl speed, approximately 5 miles per hour, and at 30 miles per hour depending on the test. The 30 mph pass was an attempt to measure impact. Because of the limited sampling rate of the data acquisition system, adequate data could not be obtained for this test.

Figure 3.9 Test Truck provided by TxDOT.

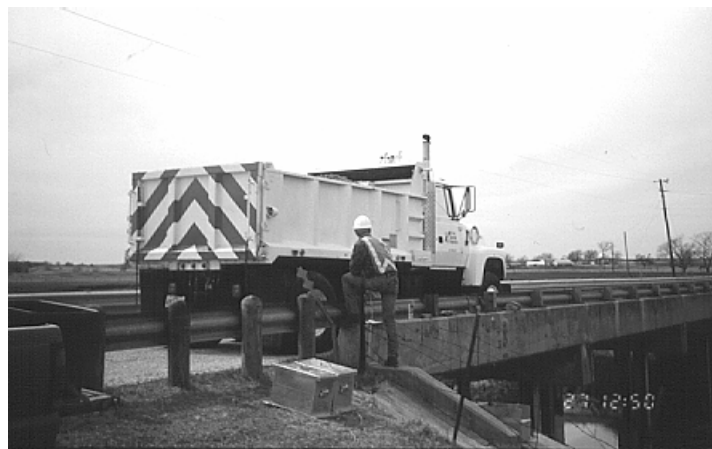
Each test series required connecting the appropriate gages for that series. The gages were then checked with the data acquisition system software to insure they were operational. The truck was then driven across the bridge in the appropriate location. An electronic marking device was used to mark the longitudinal truck position in the data. The device was triggered by a member of the testing team when the front axle crossed a designated location. Data were downloaded from the data acquisition system while the truck backed up into position for the next run. This procedure was repeated until testing was complete. There was a slight delay between each test series to connect the appropriate gages. This delay ranged from 10 to 15 minutes. Figure 3.10 shows the test in progress.

Figure 3.10 Load test in progress.

Each test series required connecting the appropriate gages for that series. The gages were then checked with the data acquisition system software to insure they were operational. The truck was then driven across the bridge in the appropriate location. An electronic marking device was used to mark the longitudinal truck position in the data. The device was triggered by a member of the testing team when the front axle crossed a designated location. Data were downloaded from the data acquisition system while the truck backed up into position for the next run. This procedure was repeated until testing was complete. There was a slight delay between each test series to connect the appropriate gages. This delay ranged from 10 to 15 minutes. Figure 3.10 shows the test in progress.

Figure 3.10 Load test in progress.

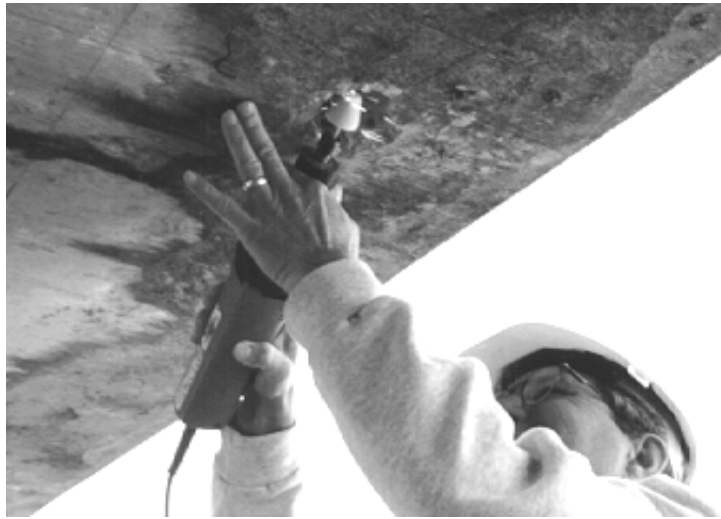
Figure 3.4 Grinding the rebar in preparation for strain gage installation.

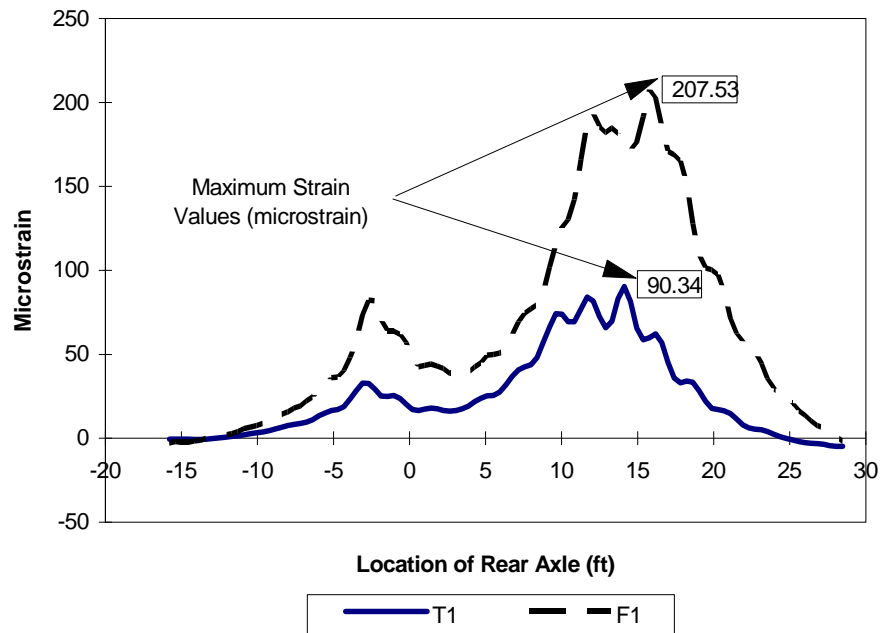
Both strain transducer T1 and strain gage F1 were placed on the tension surface of the slab (See Appendix A for location). These gages both spanned across the same crack in the bottom of the slab. Figure 4.1 shows the strain comparison of these two gages. The large difference between the two strain readings is due to the fact that the strain is an average strain and the transducer has more than twice the gage length of the strain gage. The shift in maximum value is due to the varying speed of the truck between the two tests and is not pertinent to this discussion.

Figure 4.1 Comparison of Strain for Transducers and Strain Gages.

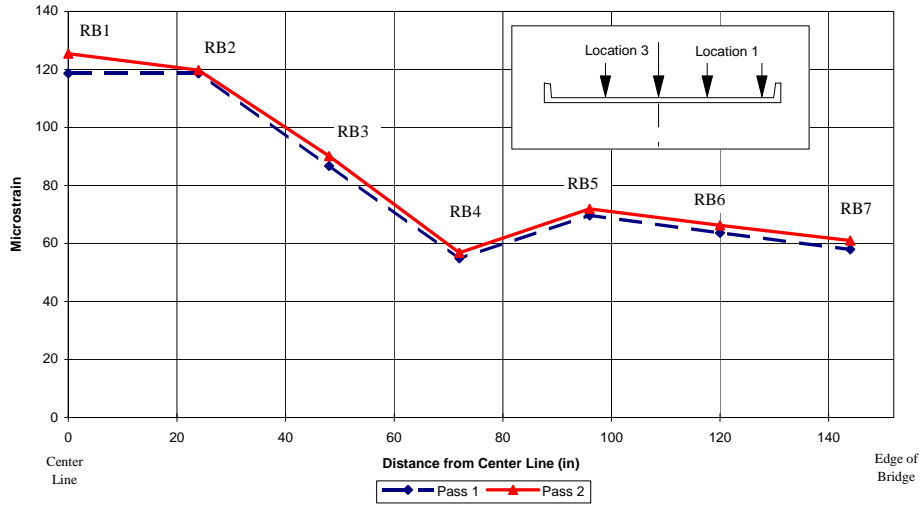
Figures 4.2 and 4.3 show the distribution of strain in the longitudinal reinforcing steel. The strain values for truck locations 1 and 2 are superimposed to give values for comparisons with previous tests [10]. These comparisons will be shown in Chapter 5. As shown in Figures 4.2 and 4.3 the strains near center line are considerably greater than the other strains. This difference may be due to the fact that the two strain gages nearest to center line (RB1 and RB2) were in a cracked section. There were visible crack observed in these areas.

Figure 4.2 Strain Distribution in longitudinal reinforcing bars for Truck Locations 1 & 3.

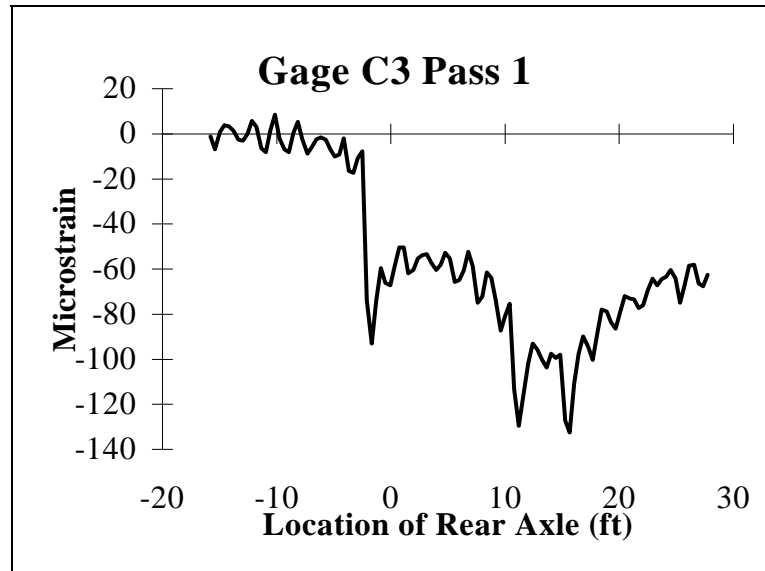
results. An example of the noisy and erratic behavior of a gage is shown in Figure 4.6. This was a later test series where a wheel had passed over the gage.

Figure 4.6 Erratic Behavior of a Concrete Gage on Top of Slab.

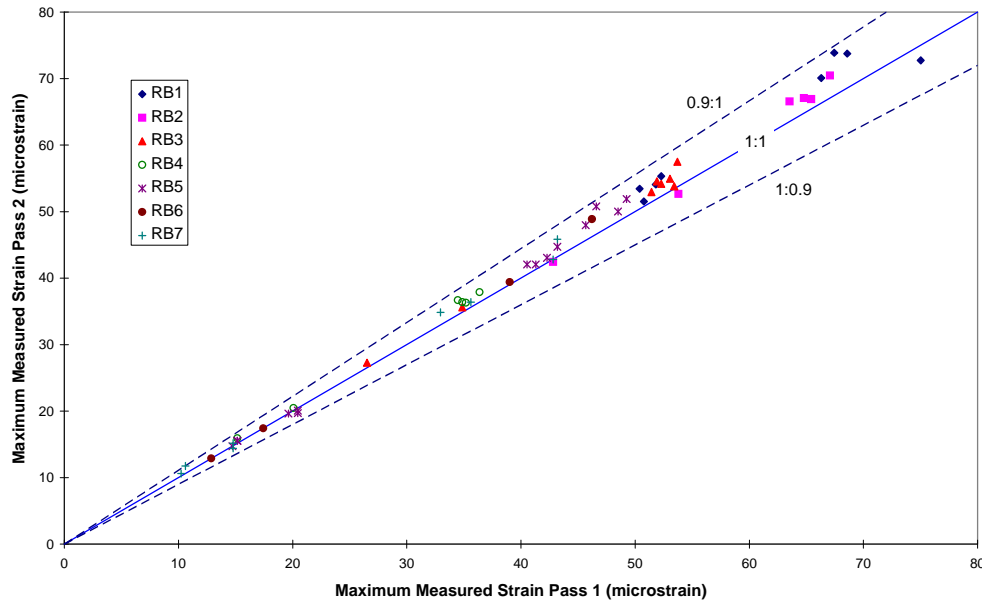
Figure 4.3 shows a plot of strain values comparing pass 1 to pass 2 for each reinforcing bar gage. The data lie within a $\pm 10\%$ range which indicates the strain readings are not very sensitive to exact truck location. The second pass of the truck can be driven within 8 to 12 in. of the transverse location of the first pass. This method of loading appears sufficiently accurate based on Figure 4.3.

Figure 4.3 Comparison of Maximum Strain values for Pass 1 and Pass 2.

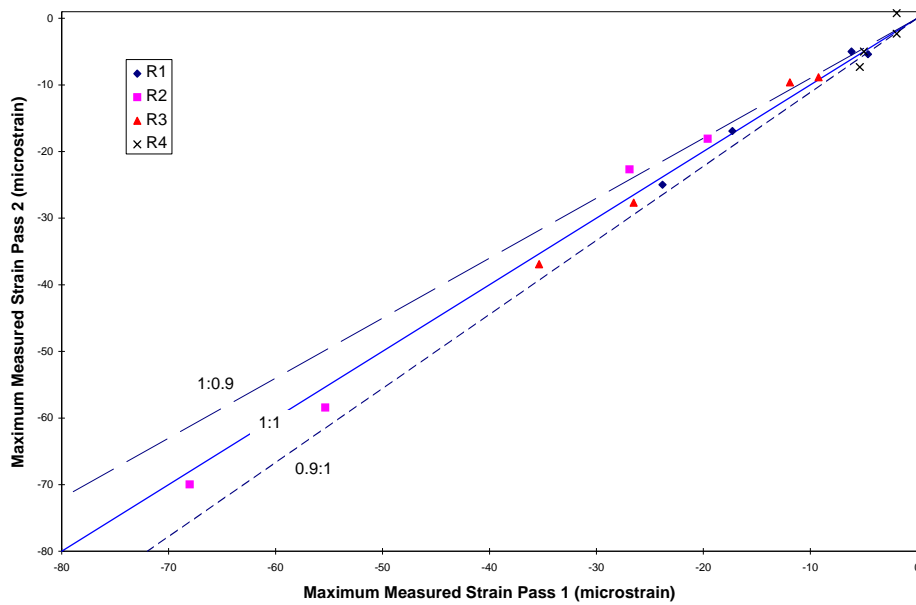
Figure 4.7 Comparison of Maximum Curb Strains for Pass 1 and Pass 2.

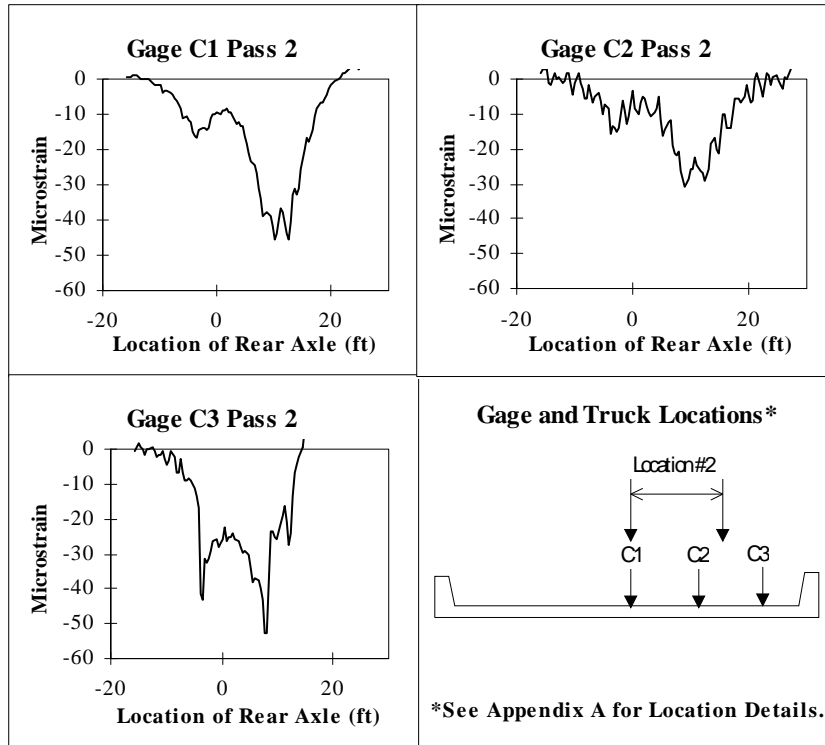
the most difficult to install, but were the least reliable of the gages used in this series of tests. Figure 4.8 shows the general behavior of the slab strain during testing. As shown in the figure, the gages appear to have considerable noise and variation.

Figure 4.8 Strain Data for Test Series 3, Location 2, Pass 2.

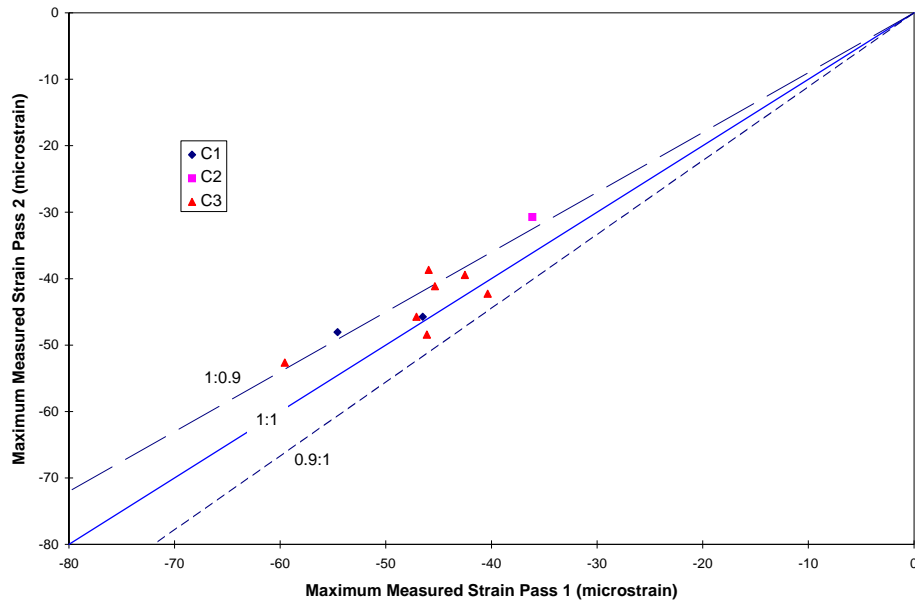
slab gages had a sensitivity of ± 5 microstrain. This sensitivity is based on analyzing the data before the bridge is loaded.

Figure 4.9 Comparison of Maximum Strain Values for the Top of Slab Gages.

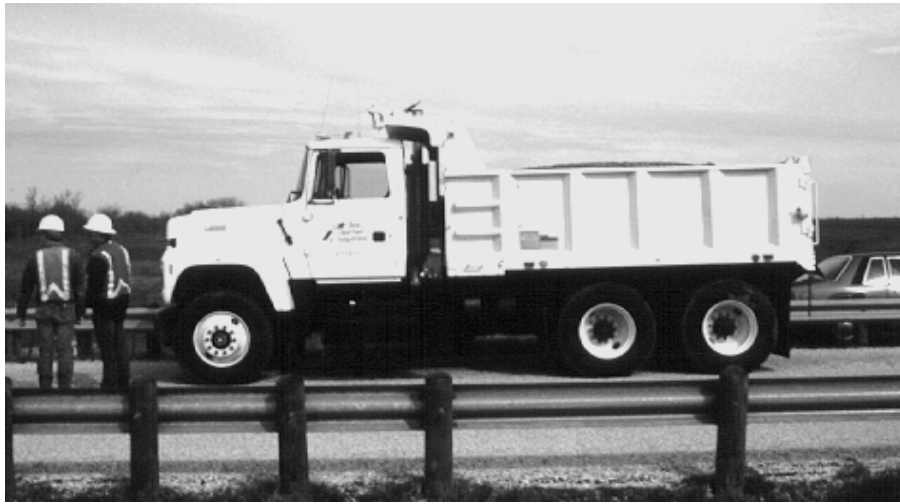
The loading vehicle used for this test was a 10 cubic yard dump truck. The vehicle and driver were furnished by TxDOT. Figure A.5 shows the truck used during the test. The truck was weighed using scales at a local feed mill. The truck was loaded with roadway base material and the gross weight was 48,740 pounds. The truck had a single front axle weighing 10,850 pounds and a tandem rear axle weighing 37,890 pounds. Figure A.6 shows a sketch of the axle weights and the axle spacing.

Figure A.5 Side View of Truck Used for the Load Test.
