Behavior of Bridge Decks with Precast Panels at Expansion Joints

Thesis

The University of Texas at Austin

May 2004

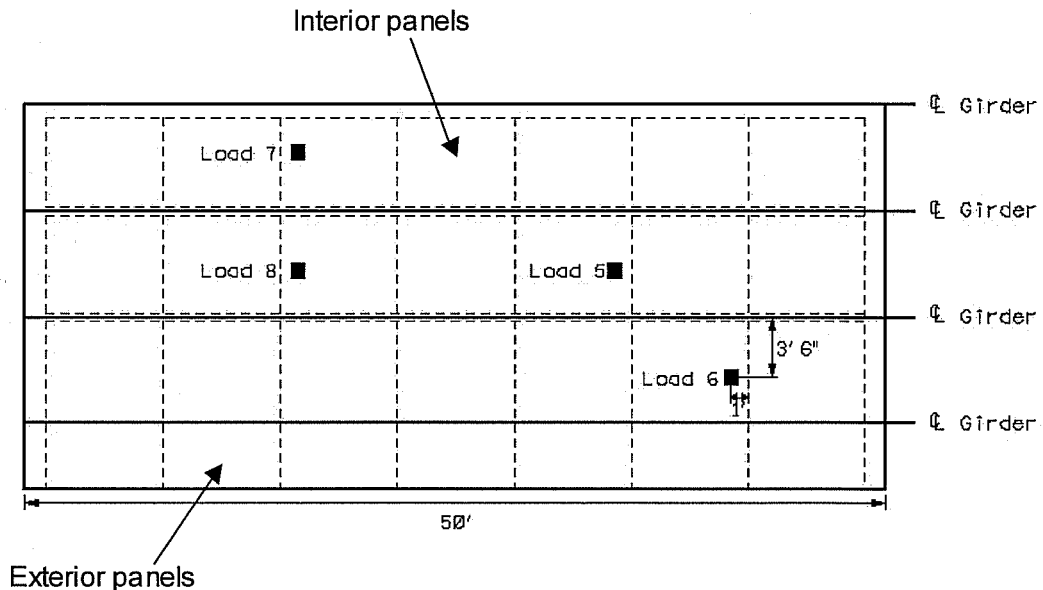
Figure 2.1 Static load locations (Buth, Furr and Jones 1972)

The full-scale bridge slab specimen (Figure 2.1) was constructed using current AASHTO standards. The specimen was 23 ft wide and spanned 50 ft. Four Type B prestressed, precast girders supported the specimen. To better represent then current bridge construction, several diaphragms were installed at the edge and interior of the bridge slab. The deck section consisted of 3-¼ in. thick PC panels and 3-½ in. thick CIP concrete topping. Two types of panels were used: interior panels, which spanned between the girders, and exterior panels, which were supported by two girders and then extended 2 ft, 6 in. past the exterior girder. In addition to the PC panels, various techniques for transfer of forces across the PCP/CIP slab interface were used at various locations on the bridge slab. The three techniques for improving bond were: Z-bars used for shear and tensile bonding (Figure 2.2), portland cement grout used as a bonding agent, and no treatment of the panel or interface (as-delivered) for the remaining sections of the slab. Dowel bars were placed on the surface of the panels over select transverse butt joints to investigate load transfer over those joints (Figure 2.2). The second specimen was a segment of a full-scale bridge deck, 8 ft, 6 in. by 9 ft. The purpose of the slab segment was to evaluate a panel butt joint reinforcing detail of Z-bars and dowel bars across the panel butt joint. The two PC panels were 3-½ in. thick and a 4-½ in. CIP concrete topping was cast atop of the panels. Both specimens were instrumented to measure deflection, deformation, and rotations, especially the deflection between the panel and the girders.

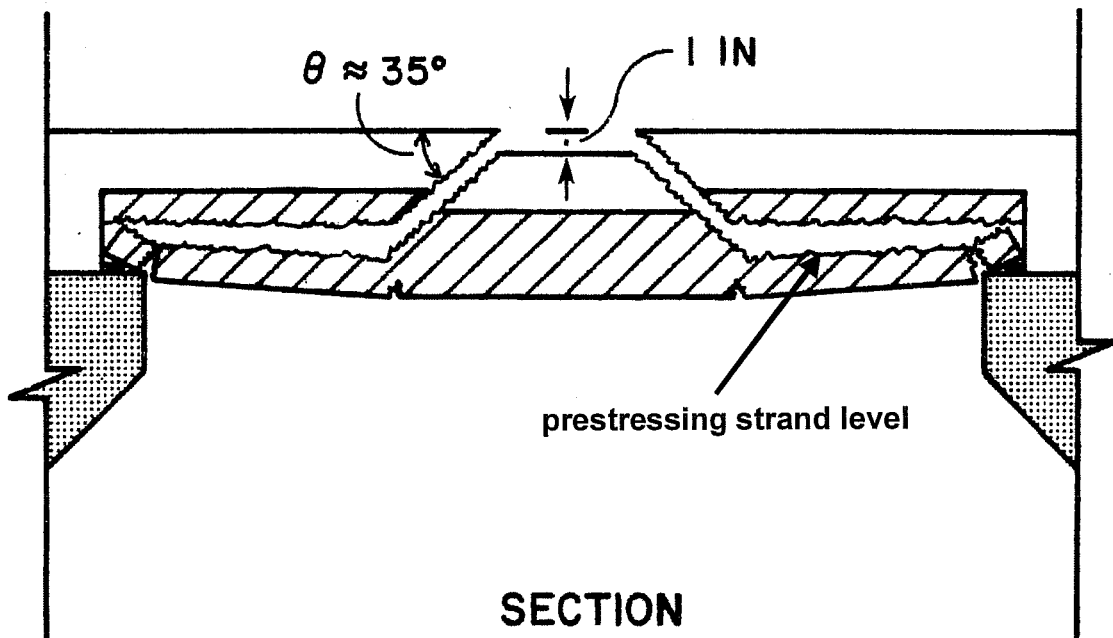
Figure 2.10 Failure surface of interior slab location (Bieschke & Klingner 1982)

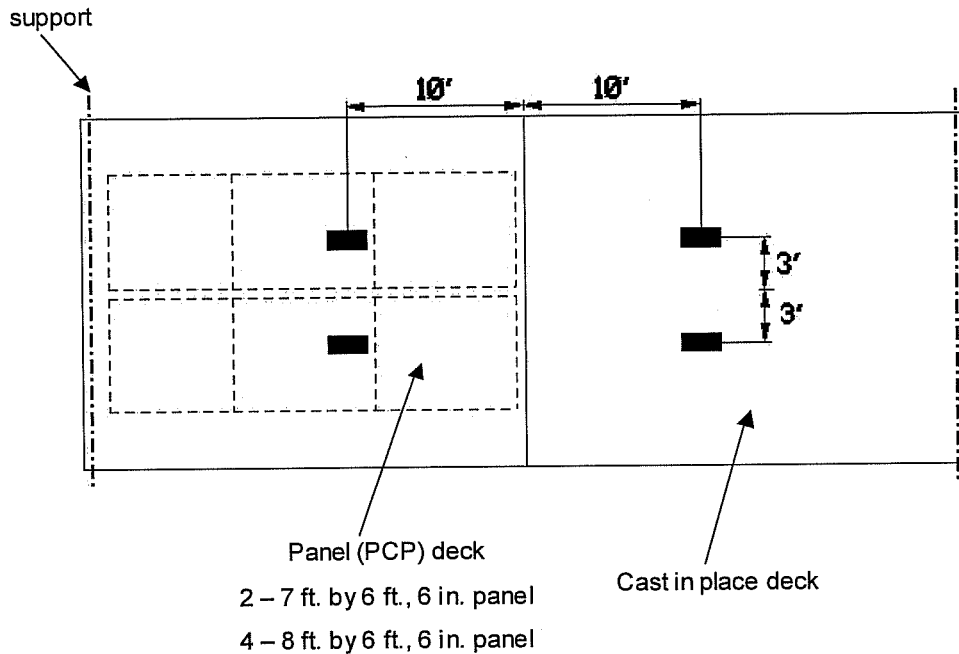
Figure 2.13 Loading pattern for Phase I (Fang et al. 1990)

static loading based on AASHTO truck loadings and impact factor. The maximum load during the fatigue testing was 25 percent higher than the service load of 16 kips, and static tests were conducted using multiples of AASHTO design load. The bridge was first loaded statically to approximately three times the AASHTO design load, and then subjected to 5 sets of fatigue loading with 1 million cycles and a maximum and minimum load of 26 and 5 kips, applied in each set. After the fatigue testing cycles, the deck was then loaded statically to approximately 40 kips to observe its service and overload behavior after fatigue loading. A series of dial gauges and strain gauges were used to observe load-deflection and load-deformation of the deck at several locations (midspan, over the girders, slip between girders and concrete). Test results indicated no significant change in stiffness occurred in the CIP and PC panel regions of the deck after fatigue loading. During the first static loading, the cracking load was very close to the load predicted by the analytical model. In addition, cracks formed on the bottom face of the deck under the loading plate and on the top face of the deck over the supports. During the fatigue-loading phase, cracks extended in the CIP deck, but not in the PC panel deck. Crack widths for the CIP and PC panel regions at service loads were 0.008 in. and 0.003 in., respectively. The load-deformation plots indicated fatigue cycling after flexural cracking had developed did not further degrade stiffness. In addition to the pre- and post-fatigue behavior, the effect of intermediate diaphragms was observed. Test results indicated the presence of diaphragms did not significantly change the load-deflection behavior of the deck near the loaded point and the stresses at the girders.

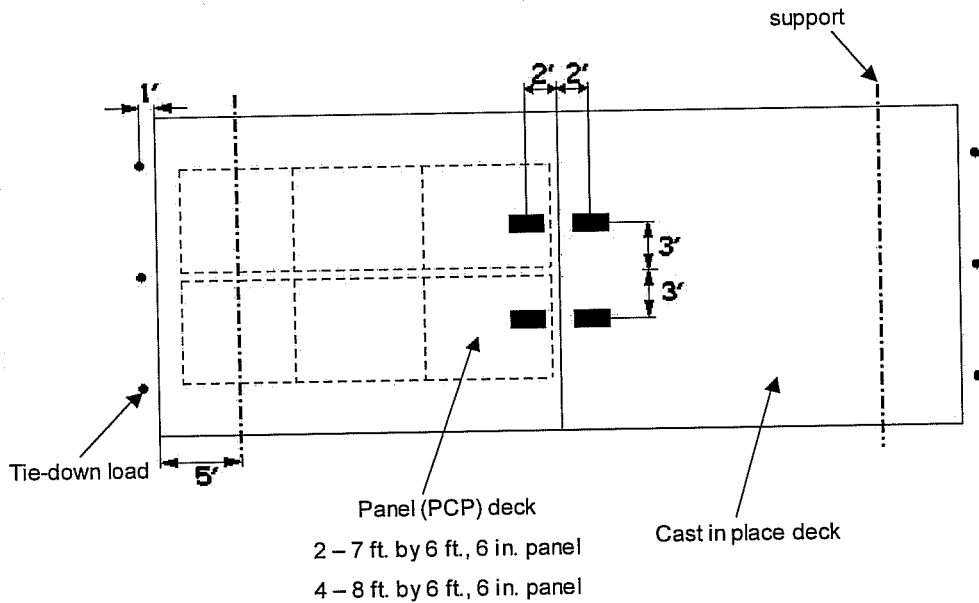
Figure 2.14 Loading pattern for Phase II (Fang et al. 1990)

In the second phase of testing, the loading pattern shown in Figure 2.14 produced maximum moments at the interior support. The testing procedure was similar to the first phase, only the maximum load for the first static loading was 30 kips (1.5 times the service live load). The deck was then subjected to the same number and magnitude of fatigue cycles as in the first phase tests. The maximum static load following the fatigue cycles was 55 kips. Similar to the first phase, deck cracking did not significantly affect the deck's stiffness. Again cracking occurred during the first static loading for both the CIP and the PC panel ends of the deck, and cracking developed in the CIP end of the deck and not the composite end of the deck during fatigue testing. The lack of crack development during fatigue testing indicated the panel deck, with a higher concrete strength and prestressing, has a higher cracking moment than the CIP deck. Test results showed residual strains from fatigue loading did not affect the measured reinforcement strains during static load tests.

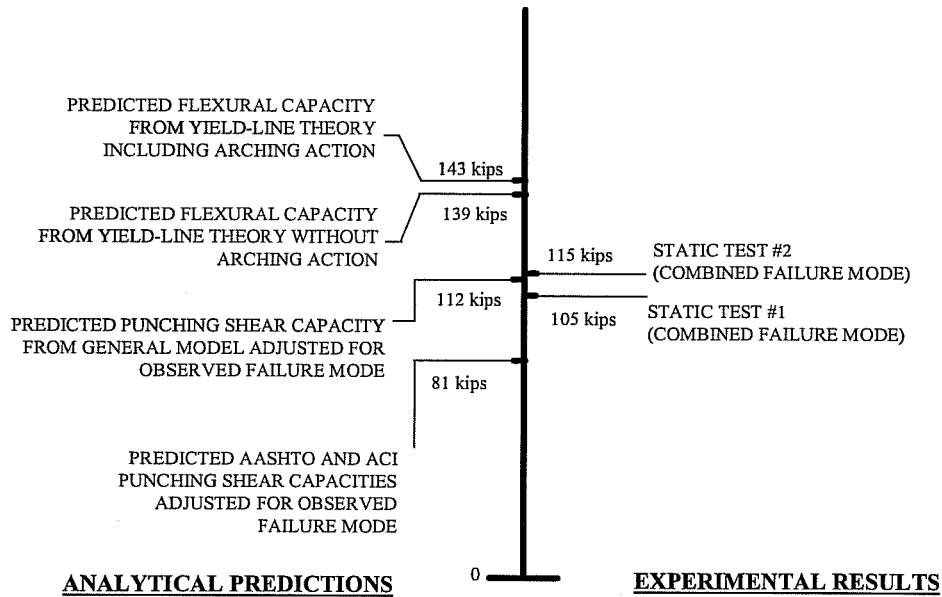
(a) CIP specimens

Figure 2.18 Predicted versus observed failure loads for static tests: (a) CIP specimens; (b) PCP specimens (Graddy et al. 2002)

(b) PCP specimens

Flexural capacities were calculated using yield-line analysis, and compressive membrane forces, estimated using finite-element analysis and the results of previous research, were used in calculations of flexural capacity. In addition, predicted AASHTO LRFD and ACI 318-95 punching-shear capacities were calculated for both the predicted and observed failure mode. Resulting predictions and experimental results are shown in Figure 2.18.

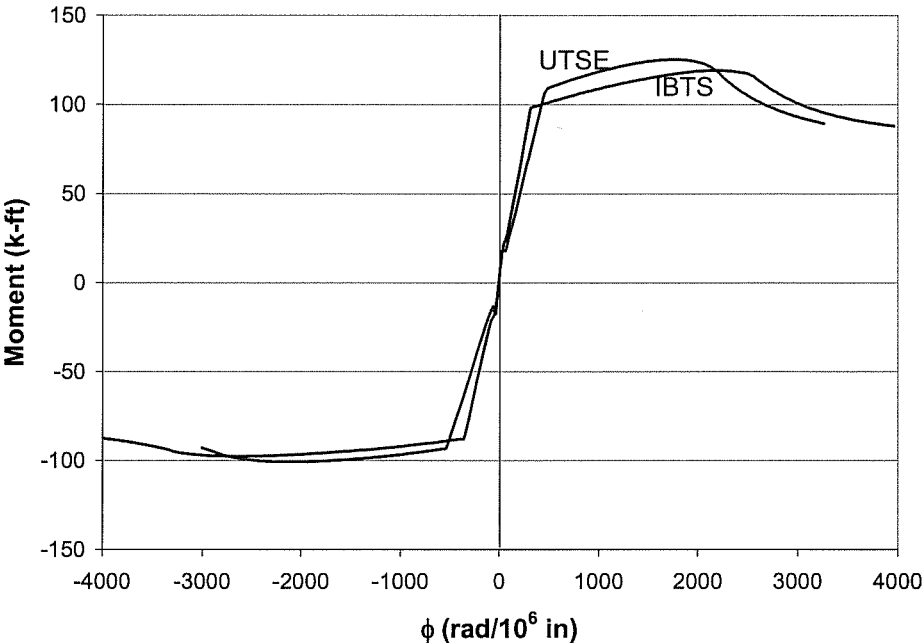
Figure 3.6 *Moment-curvature analysis of IBTS and UTSE details (Ryan 2003)*

the UTSE detail has a lower stiffness before and after cracking. In reality, the continuity of rest of the slab will cause cracking to initiate at the slab edge and penetrate into the slab. The actual cracking moments and stiffnesses for both sections were higher than the analytical values, because the actual slab is restrained along the interior boundary of the edge slab section.

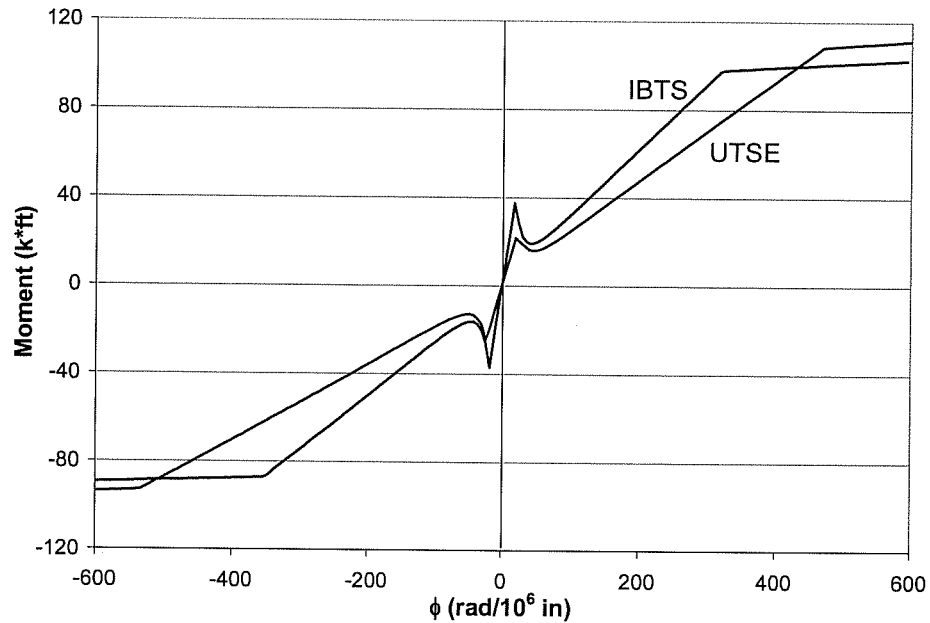
Figure 3.7 *Moment-curvature behavior, focused on cracking (Ryan 2003)*

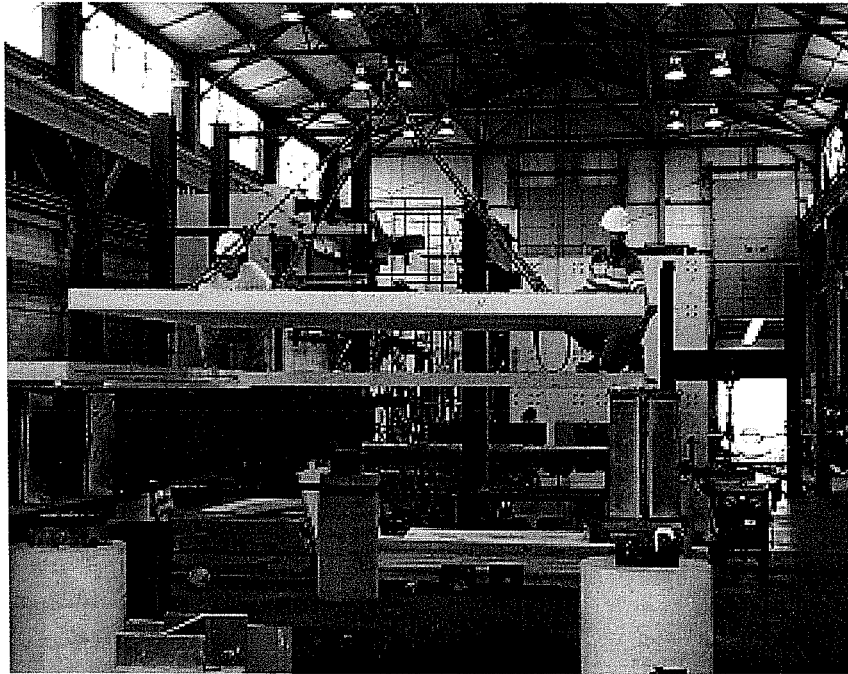
Figure 4.4 Placing precast panels

Once the girders were erected on the columns, 1-in. wide by 1-in. thick 60-psi foam bedding strips were attached to the top flange along the length of the girders for the PC panels. According to TxDOT standards, the bedding strips were placed to provide space for at least 1-½ in. of mortar to flow under the panels as the slab concrete is placed. After the bedding strips were in place, the panels were placed using the laboratory crane, as seen in Figure 4.4. The crane lifted each panel by the U-shaped bars embedded in the top of the panels. After the panels were in place, a work platform and elevated formwork were built for the overhangs using 4-ft by 8 ft plywood panels, ¾ in. thick (Griffith 2003). Four 2- x 6-in. stringers, spaced 16 in. apart, were attached to each panels. The panels were supported from the ground by 4- x 4-in. posts and from the girder by 2x4's wedged between the bottom girder flange and the 2- x 6-in. stringers. Posts were braced in two directions with 2x4's.

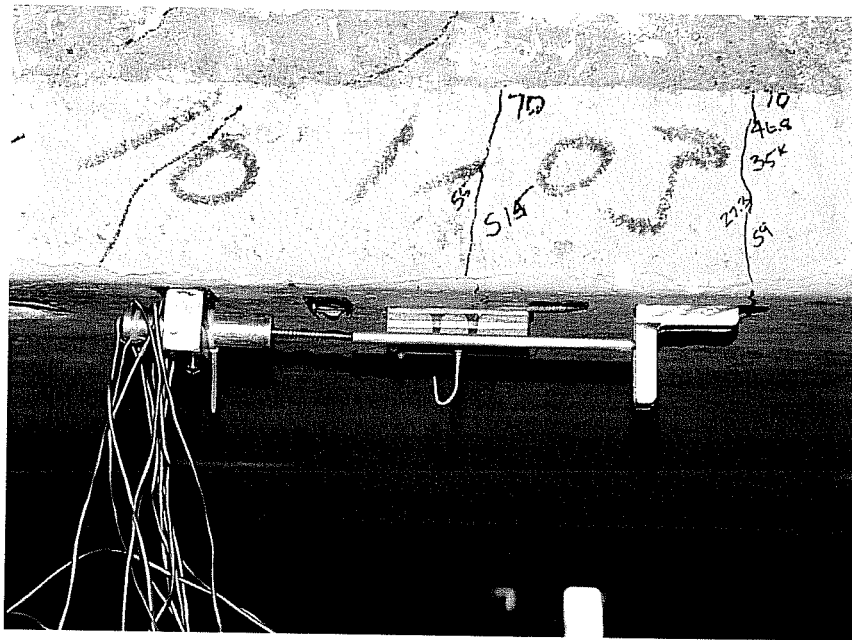
Figure 4.11 Linear potentiometer to measure strain of the panel

Strain gauges were the primary instrumentation used in the bridge slab of the test specimen (Griffith 2003). Since the strain gauges were placed before the concrete was cast, they were attached carefully and protected to avoid any damage during concrete placement and finishing. In order to measure the strain induced in the panels from testing, a linear potentiometer was mounted to the underside of the panel at midspan of each bay (Figure 4.11). The gage length was about 9-in. These linear potentiometers were added just prior to testing of the bridge slab.

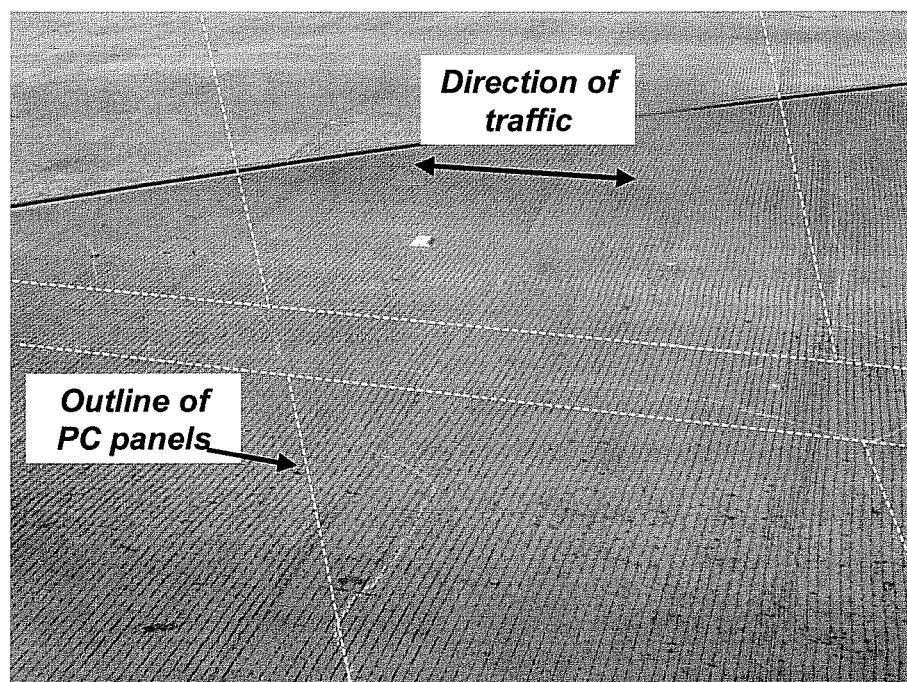
Figure 5.5 Shrinkage cracking in TxDOT bridge (Brown 2002)

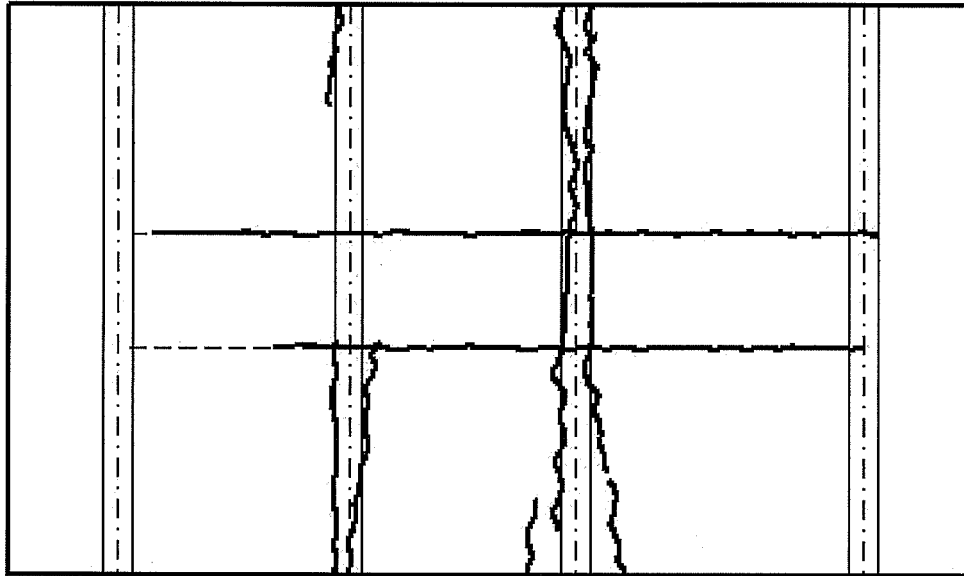
Figure 5.6 Shrinkage cracking, top view of slab

wide) cracks were found along the girder and the joints between adjacent PC panels (Figure 5.6). Calculations were carried out to determine if a load of 0.5 HS-25 was sufficient to cause such cracking in the CIP concrete topping. Assuming that typical concrete strains due to shrinkage effects are about $300 \mu\epsilon$, and adding the effects of the applied loads, it was found that such low applied loads would produce cracking at locations where shrinkage stresses developed. It was decided that although the shrinkage cracking had not developed prior to testing, had the testing begun weeks later, the shrinkage cracking would have been visible prior to testing. Therefore since testing was done before shrinkage cracking had developed, small additional stresses from the first loading and the tensile stresses due to shrinkage and thermal effects caused the CIP concrete topping to crack at such a low load. Later discussions with TxDOT engineers indicated that such cracking is evident in all TxDOT bridges using PC panels.

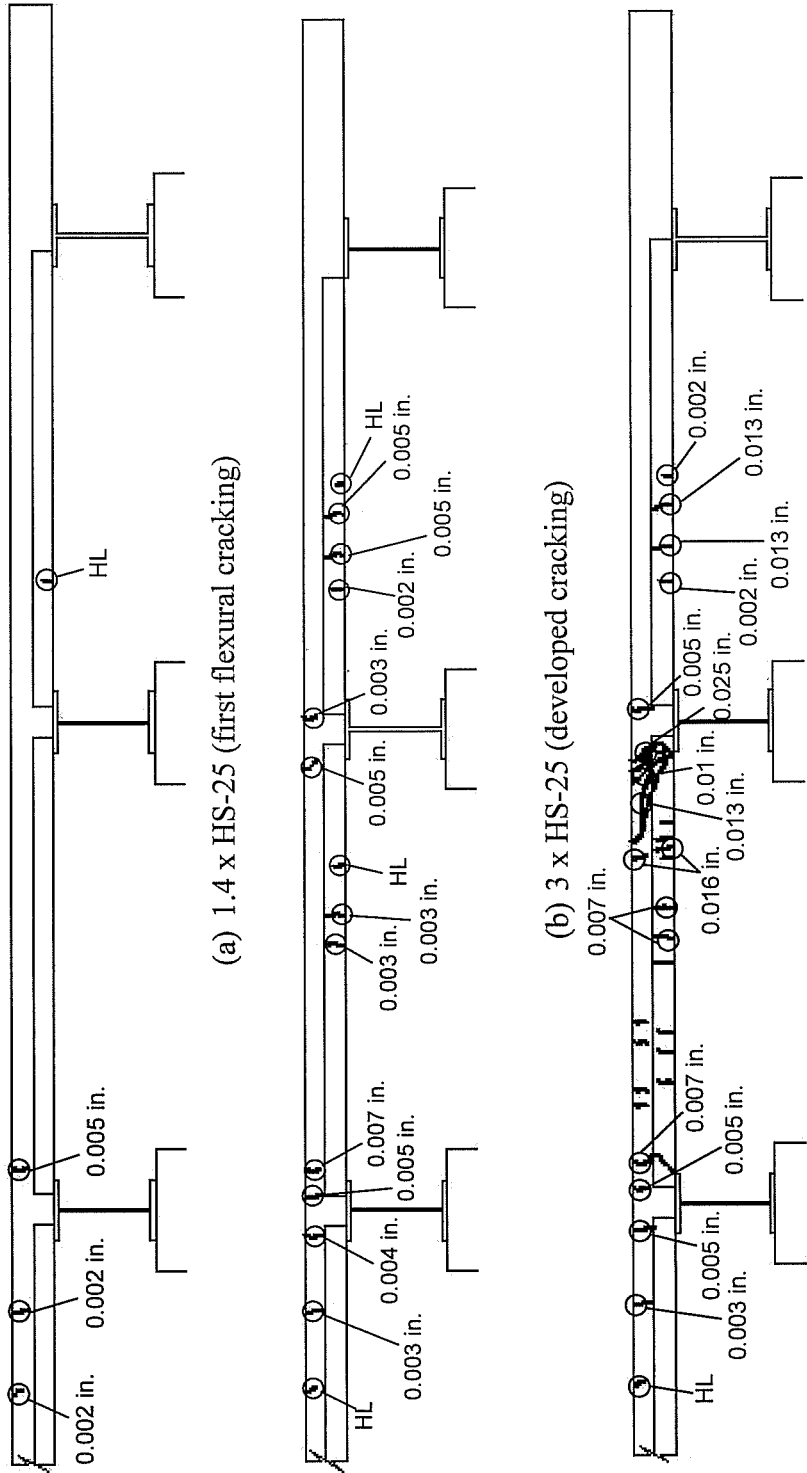
Figure 5.14 Crack map, 3-7/8 in. top reinforcement spacing, negative moment region; side view of slab

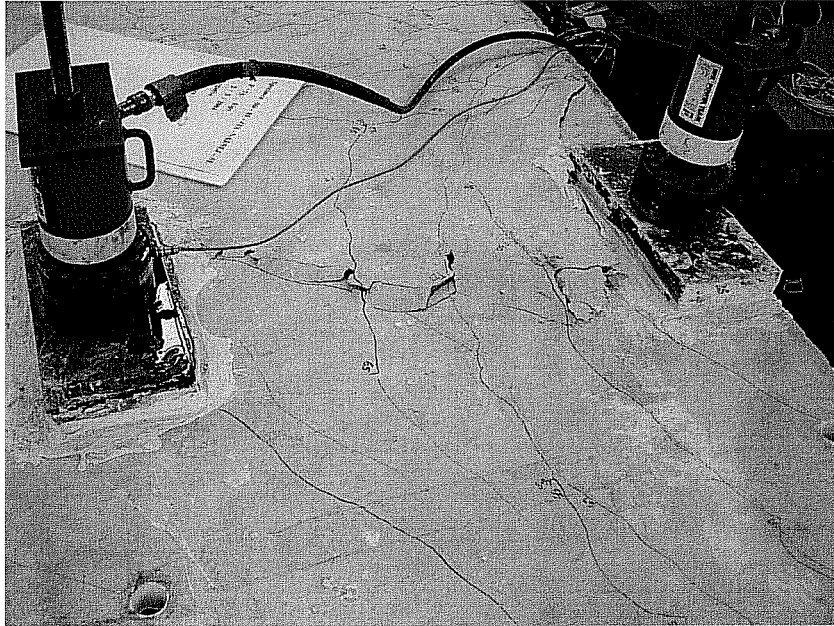
Figure 5.15 Interior bay failure at top of slab, facing southeast

At 4.8 x HS-25, a punching shear failure occurred at the edge tire in the interior 8 ft bay. Pictures were taken of the failure surface (Figure 5.15, Figure 5.16, Figure 5.17). Cracks formed between the two load points and around the edge load point. Because the area around the edge load point was more extensively damaged than the area around the interior load point, failure was probably initiated by punching shear at the edge load point, where the shear perimeter is significantly less than the interior load point. Cracks wrapping semi-elliptically around the edge load point formed around 3.5 x HS-25 and existing flexural cracks opened on the top surface up to and at failure. Little evidence of failure was visible on the bottom surface of the slab, except for a large crack running parallel to the panel bearing strip. The side surface indicated some delamination (Figure 5.17 b) occurring between the panel and the CIP concrete topping at high loads and failure. Some separation was seen around 4.5 x HS-25.

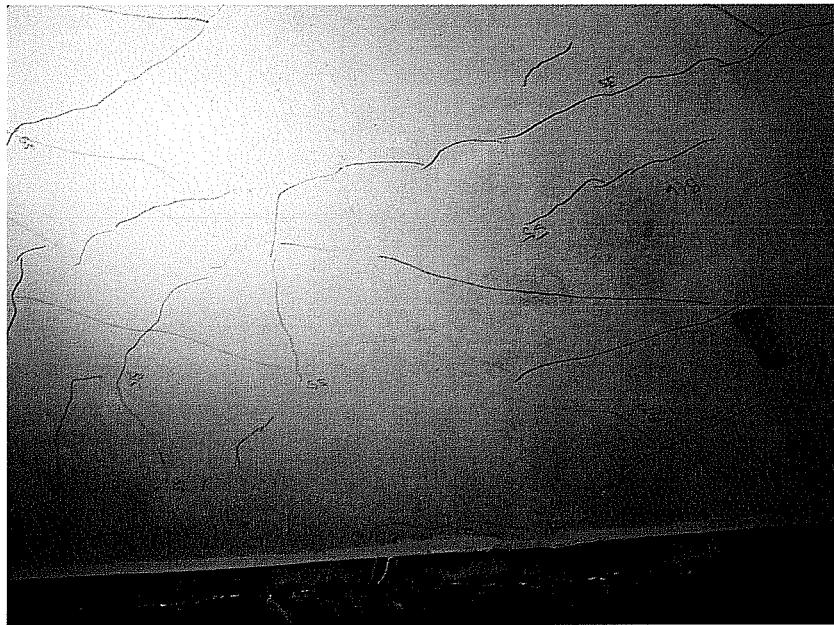
Figure 5.16 Interior bay failure surface at bottom of slab, facing east

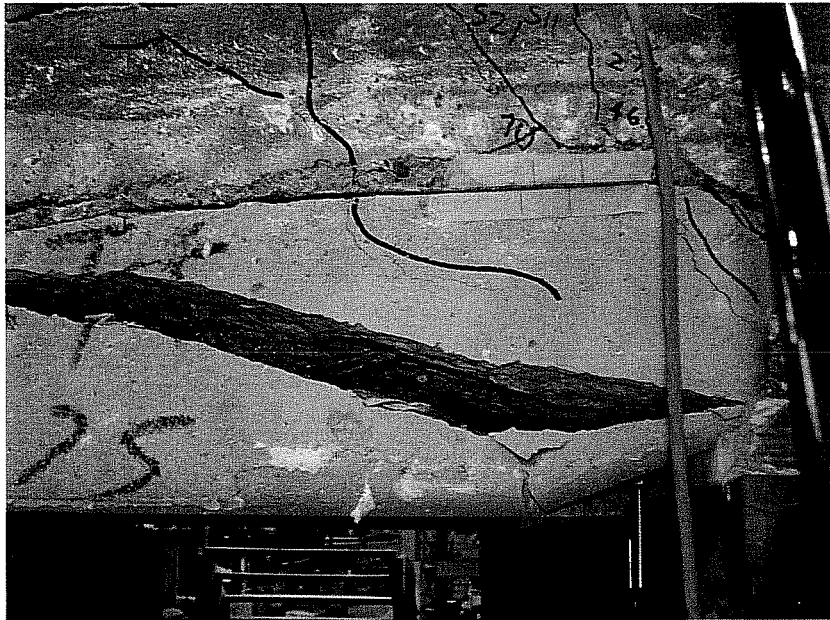
(b) Close up of delamination, facing north

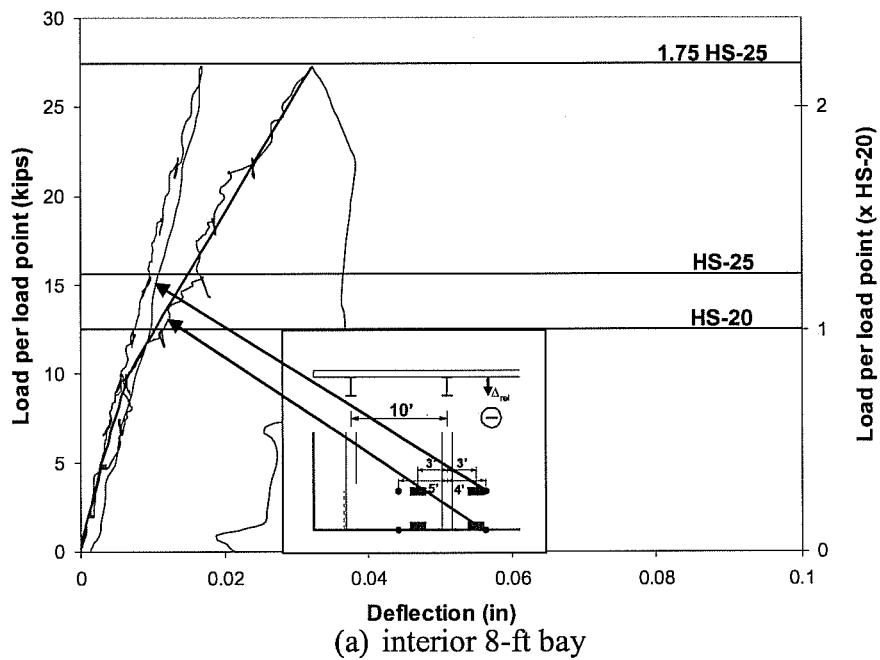
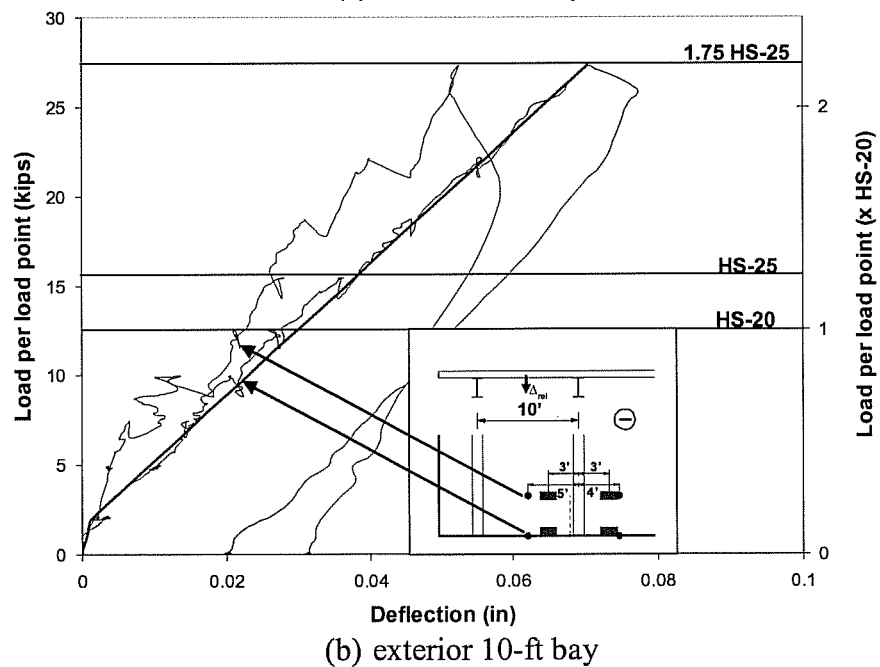
Figure 5.19 *Relative midspan deflections and edge deflection envelopes, 6-in. top reinforcement spacing, negative-moment region: (a) interior 8-ft bay; (b) exterior 10-ft bay*

Both the 8-ft and 10-ft bays exhibited a relatively linear elastic response up to 1.75 x HS-25. The 8-ft bay exhibited a slightly higher stiffness than the 10-ft bay (Figure 5.19). The load deflection envelope indicates one change in slab stiffness in the 8-ft bay, occurring around 0.6 x HS-25. This change in stiffness is most likely caused by cracking due to shrinkage effects. Although cracking occurred due to shrinkage effects, it does influence the overall response of the test specimen.

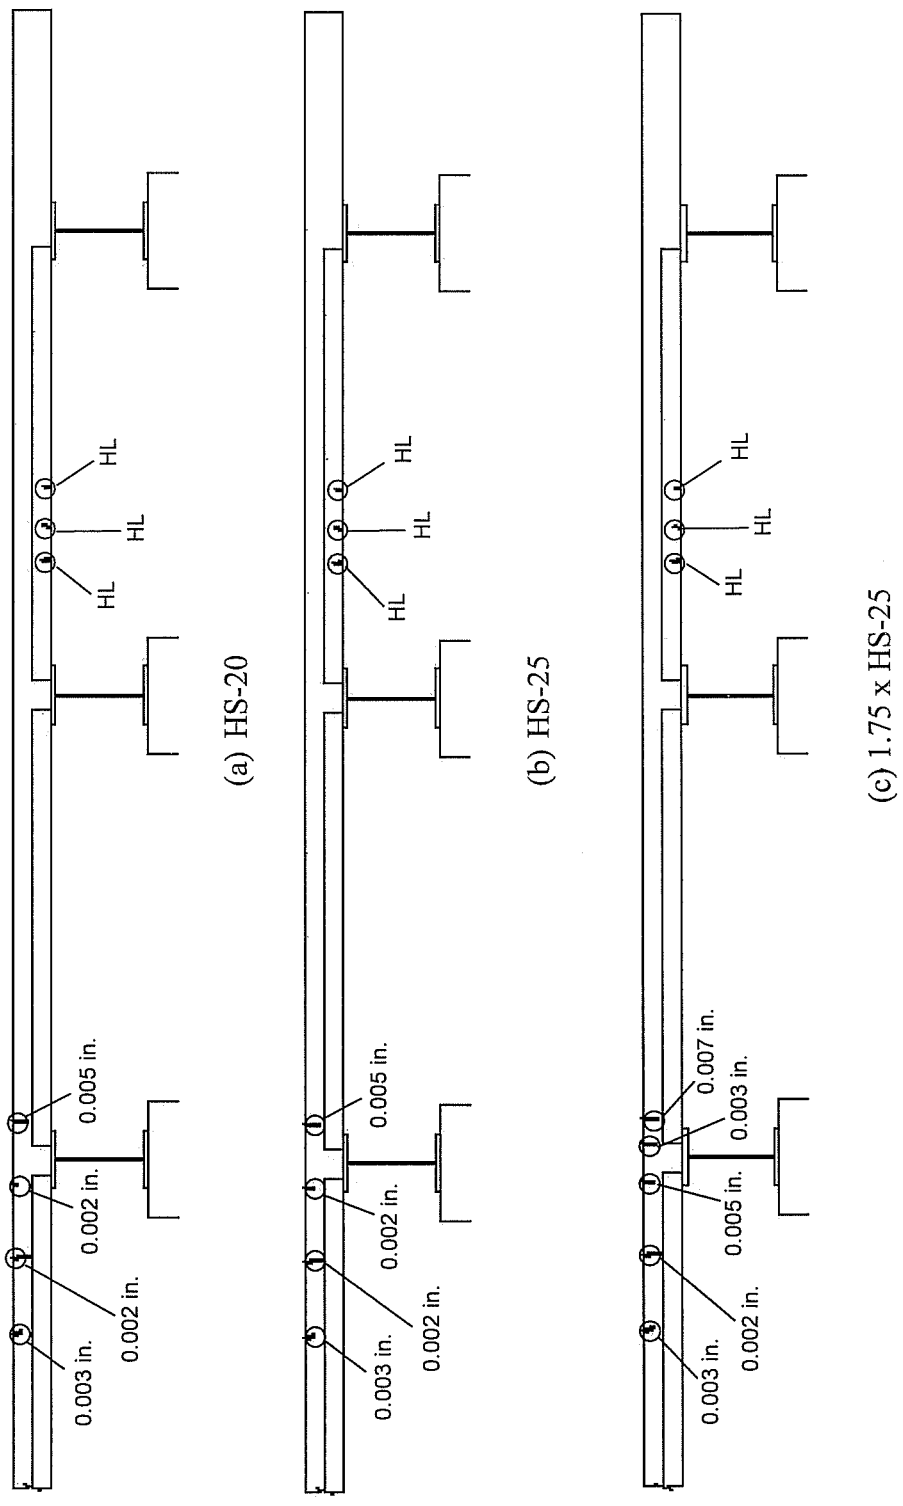
Figure 5.24 Crack map, 6 in. top reinforcement spacing, negative-moment region, side view of slab

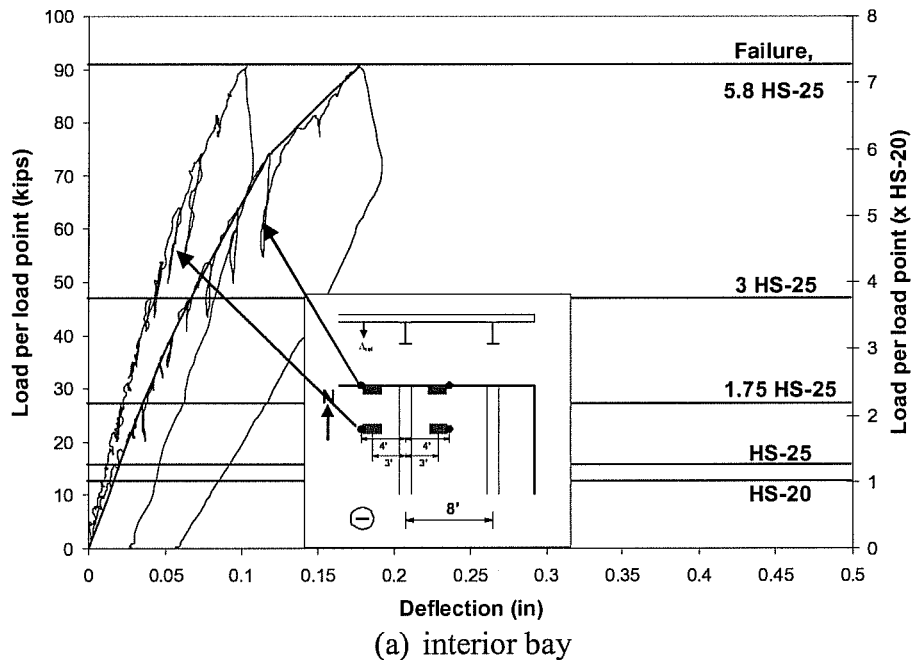
Figure 5.34 *Relative midspan deflections and edge deflection envelopes, AJ, 6-in. top reinforcement spacing, negative-moment region: (a) interior bay; (b) exterior bay*

approaches zero at approximately 5.8 x HS-25 in the exterior bay. The edge deflection practically doubles in the exterior bay compared to the deflection in the interior bay. Details on the locations and sizes of the cracks are given in Section 5.5.2.5.

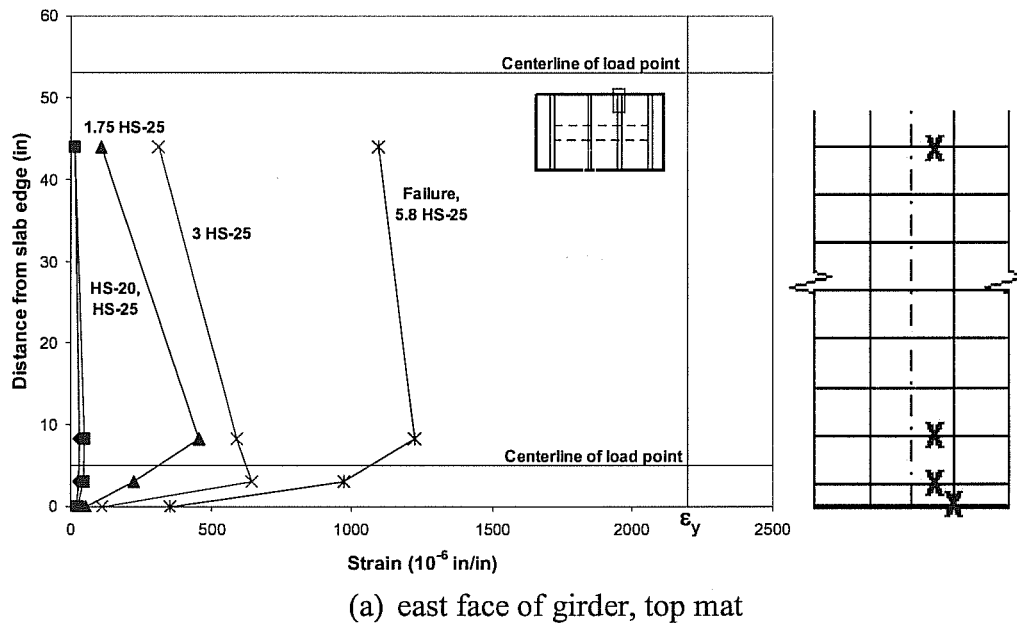
Figure 5.37 Strain profile, AJ, 6 in. top reinforcement spacing, negative-moment region: (a) east face of girder, top mat; (b) west face of girder, top mat

loads approached the failure load, strains in the reinforcement near both load points became much larger than the strains measured between the load points. As seen in the profiles, the second reinforcing bar measures the most critical strain due to the addition of the AJ.

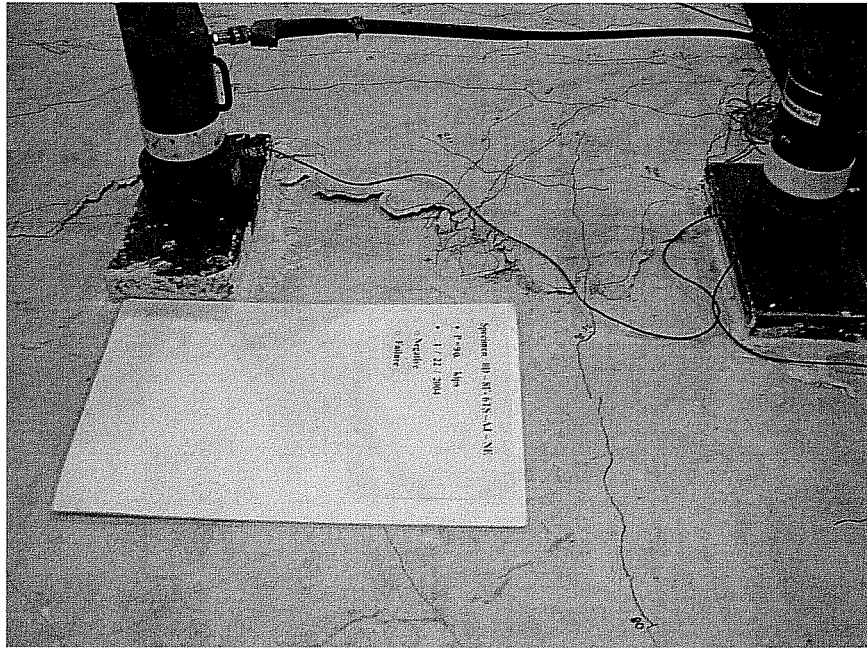
Figure 5.41 East exterior 8-ft bay failure at top of slab, facing west

At 5.8 x HS-25, a punching shear failure occurred at the loading plate 4 ft from the slab edge in the exterior 8 ft bay. Pictures were taken of the failure surface (Figure 5.41, Figure 5.42, Figure 5.43). Crack formed between the two load points and around the interior load point. Because the area around the interior load point was more extensively damaged than the area around the edge load point, failure was probably initiated by punching shear at the interior load point. The failure surface indicates the AJ contributes to the capacity of the edge region by making the interior loading point, not the edge loading point, the critical section. Cracks wrapping semi-circularly around the edge load point formed around 4.8 x HS-25 and existing flexural cracks opened on the top surface up to and at failure. Little evidence of failure was visible on the bottom surface of the slab, except for a large crack running parallel to the panel bearing strip. The side surface of the slab was not visible due to the AJ.

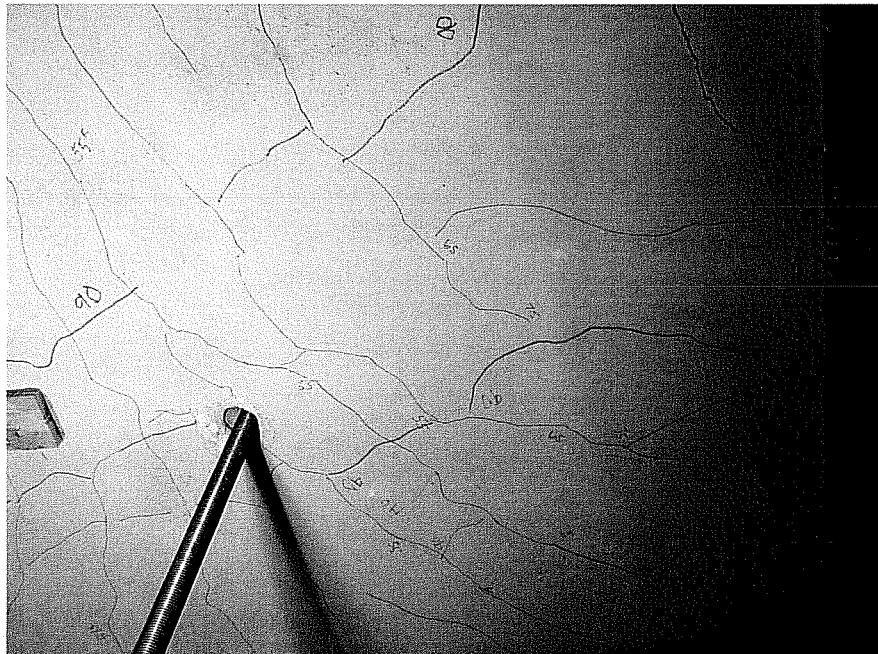
Figure 5.42 East exterior 8-ft bay failure at bottom of slab, facing west

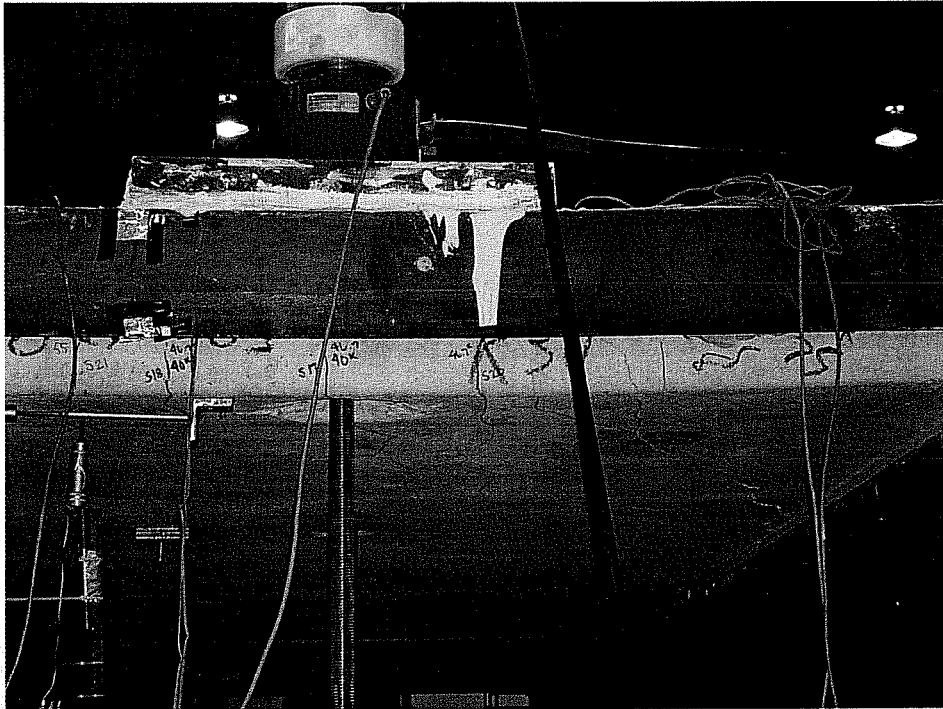
Figure 5.43 East exterior 8-ft bay failure at side of slab, facing south

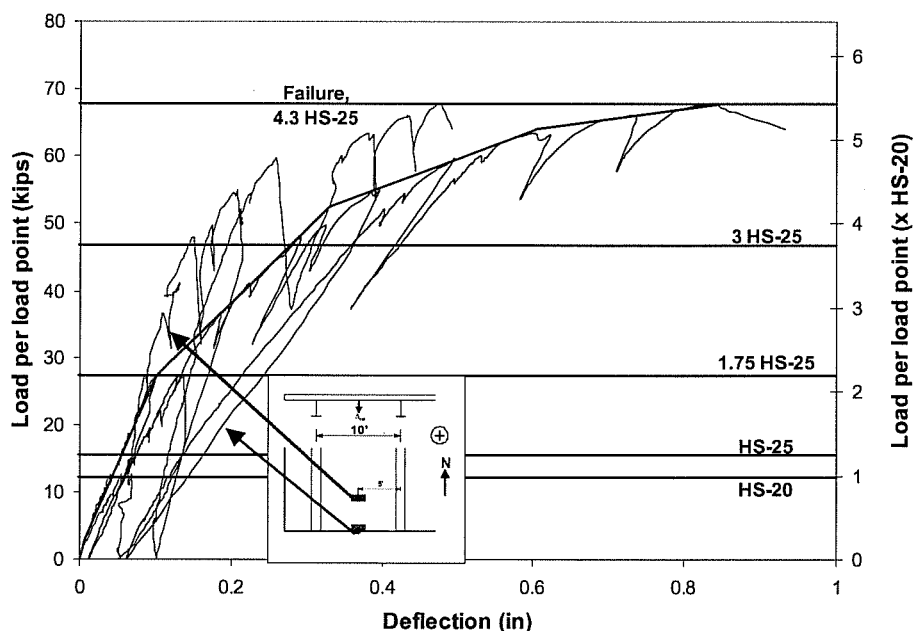
Figure 5.45 *Relative midspan deflections and edge deflection envelope, 6-in. top reinforcement spacing, positive-moment region*

For the positive moment, the term “major change in stiffness” is used to describe the load at which the second change in stiffness can be identified in the load-deflection response. The second change coincided with the initiation of multiple cracks and subsequent decrease in slab stiffness, so the “cracks at major change in stiffness” will be discussed for test regions where positive moment was maximized. Details on the locations and sizes of the cracks are given in Section 5.6.2.5.

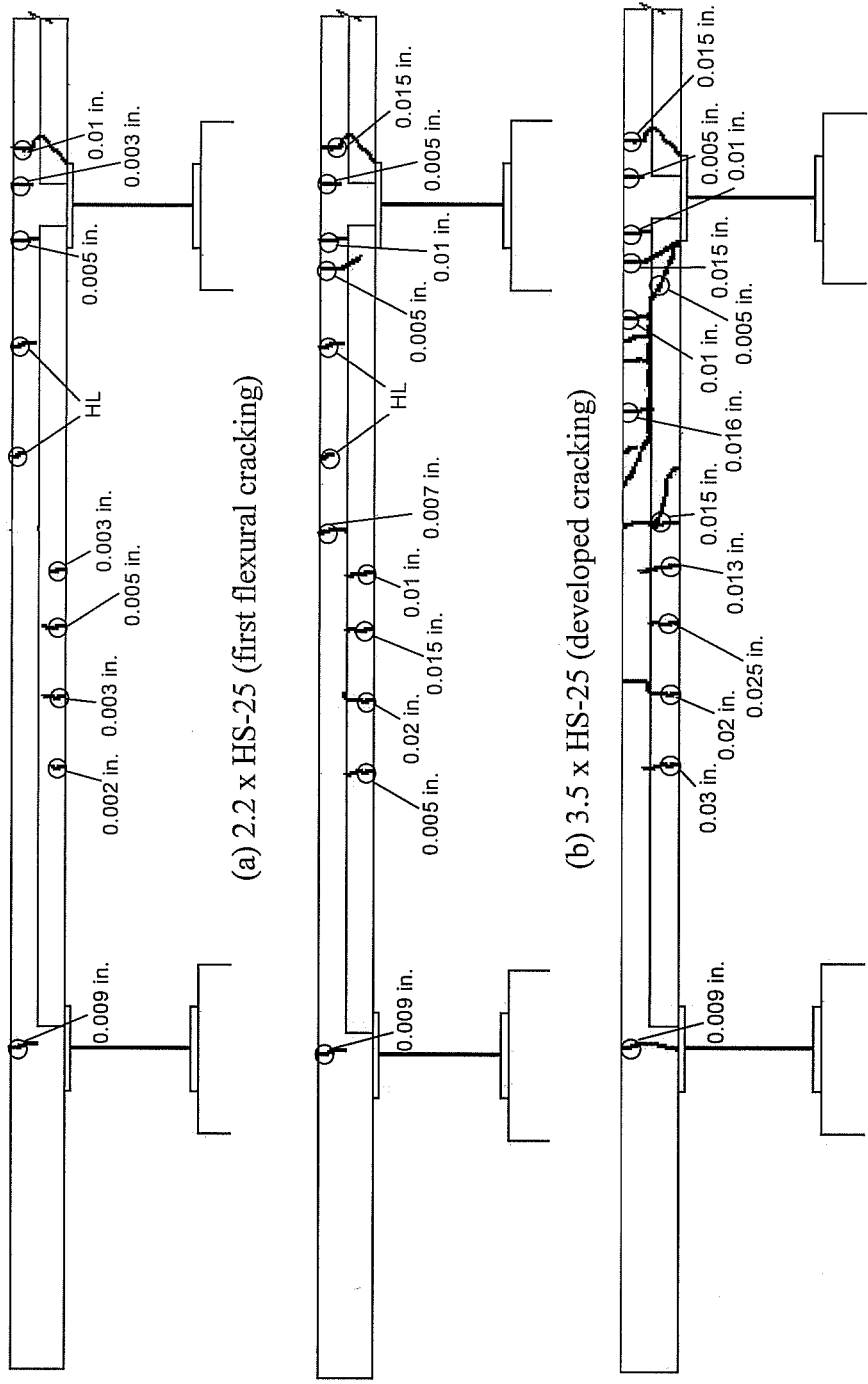
Figure 5.51 Crack map, 6 in. top reinforcement spacing, positive-moment region, side view of slab

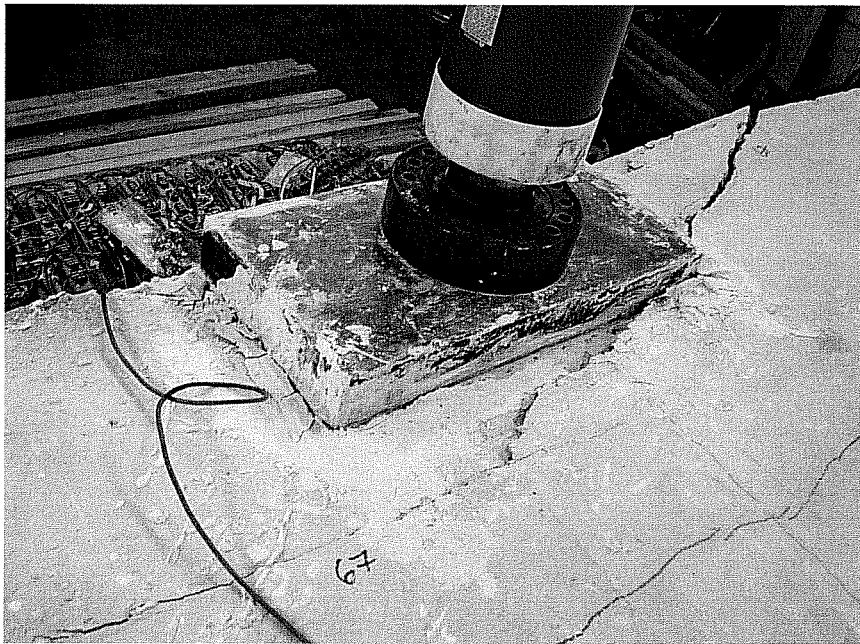
Figure 5.52 West exterior 10-ft bay failure at top of slab, facing southwest

At 4.3 x HS-25, a punching shear failure occurred at the edge load point in the 10-ft bay. Pictures were taken of the failure surface (Figure 5.52, Figure 5.53, Figure 5.54). Cracks wrapping semi-circularly around the edge load point formed around 3.5 x HS-25 and existing flexural cracks opened on the top surface up to and at failure. From the side of the slab, shear cracks extend from the CIP topping to the bottom of the panel, with the crack running along the interface near the west-interior girder. The side surface indicated some delamination (Figure 5.54 b) occurring between the panel and the CIP concrete topping at high loads and failure. Some separation was seen around 3.8 x HS-25. The failure surface is easily visible from beneath the slab.

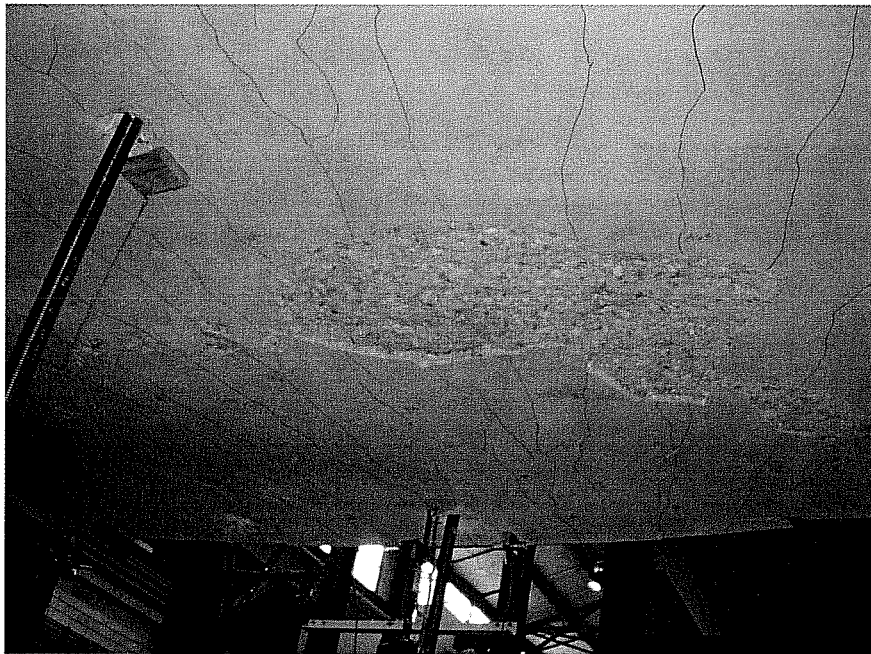
Figure 5.53 West exterior 10-ft bay failure surface at bottom of slab, facing south
