Behavior of Bridge Decks with Precast Panels at Expansion Joints

Thesis

The University of Texas at Austin

May 2004

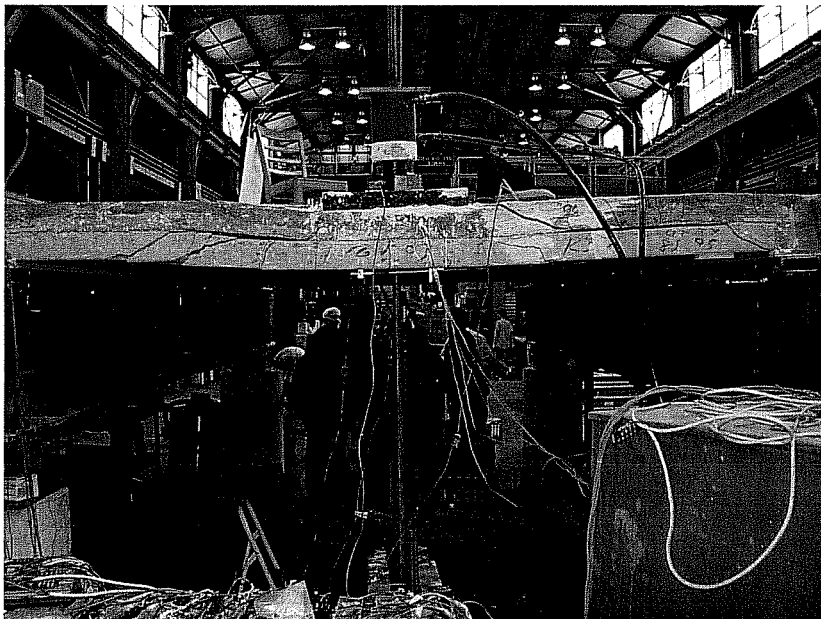
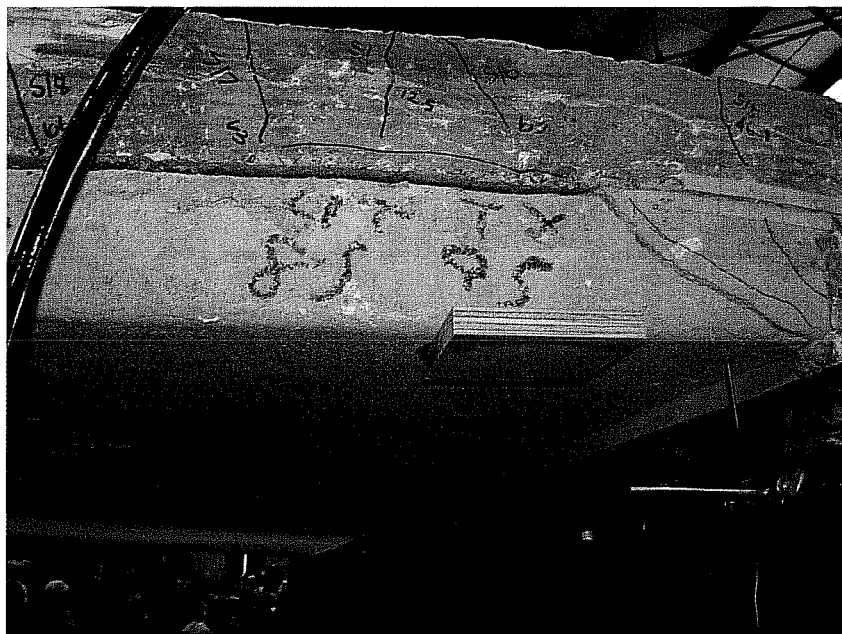
(a) Facing north

(b) Close up of delamination, facing north

At 4.3 x HS-25, a punching shear failure occurred at the edge load point in the 10-ft bay. Pictures were taken of the failure surface (Figure 5.52, Figure 5.53, Figure 5.54). Cracks wrapping semi-circularly around the edge load point formed around 3.5 x HS-25 and existing flexural cracks opened on the top surface up to and at failure. From the side of the slab, shear cracks extend from the CIP topping to the bottom of the panel, with the crack running along the interface near the west-interior girder. The side surface indicated some delamination (Figure 5.54 b) occurring between the panel and the CIP concrete topping at high loads and failure. Some separation was seen around 3.8 x HS-25. The failure surface is easily visible from beneath the slab.

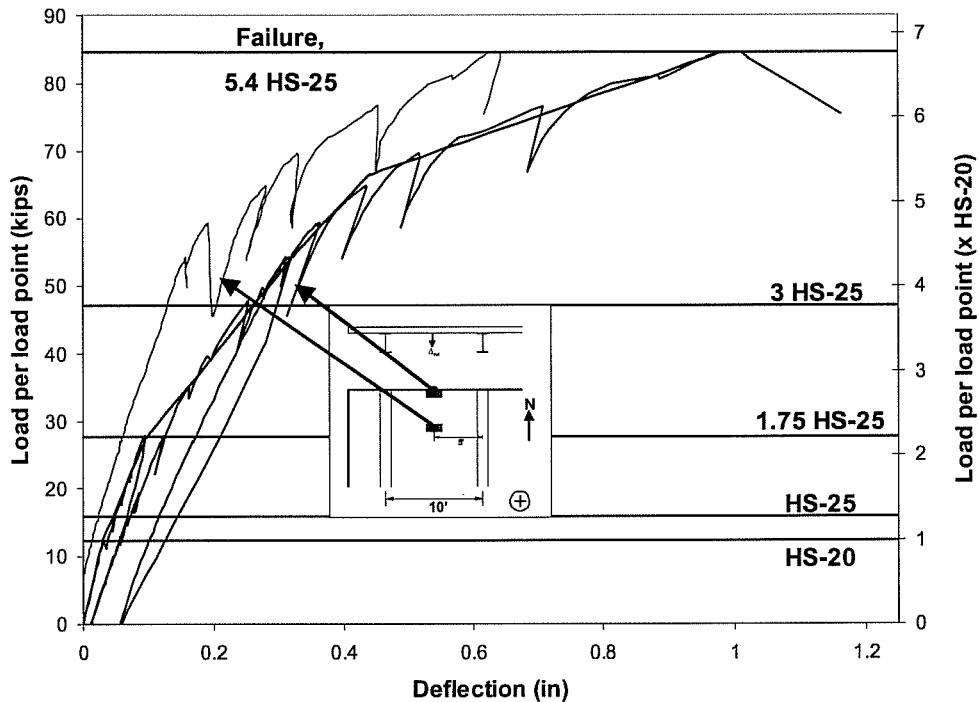
Figure 5.56 *Relative midspan deflections and edge deflection envelope, SEJ, 6-in. top reinforcement spacing, positive-moment region*

The load deflection envelope indicate four changes in slab stiffness in the west exterior (10-ft) bay during all tests in the area. The first change in stiffness, occurs at 1.75 x HS-25 when the first flexural cracking is observed. The major change in stiffness occurred at 3.4 x HS-25. At approximately, 4.3 x HS-25, the stiffness reduced to nearly zero as failure progressed. At 5.4 x HS-25, the edge region failed in punching shear of the edge load point. Details on the locations and sizes of the cracks are given in Section 5.7.2.5.

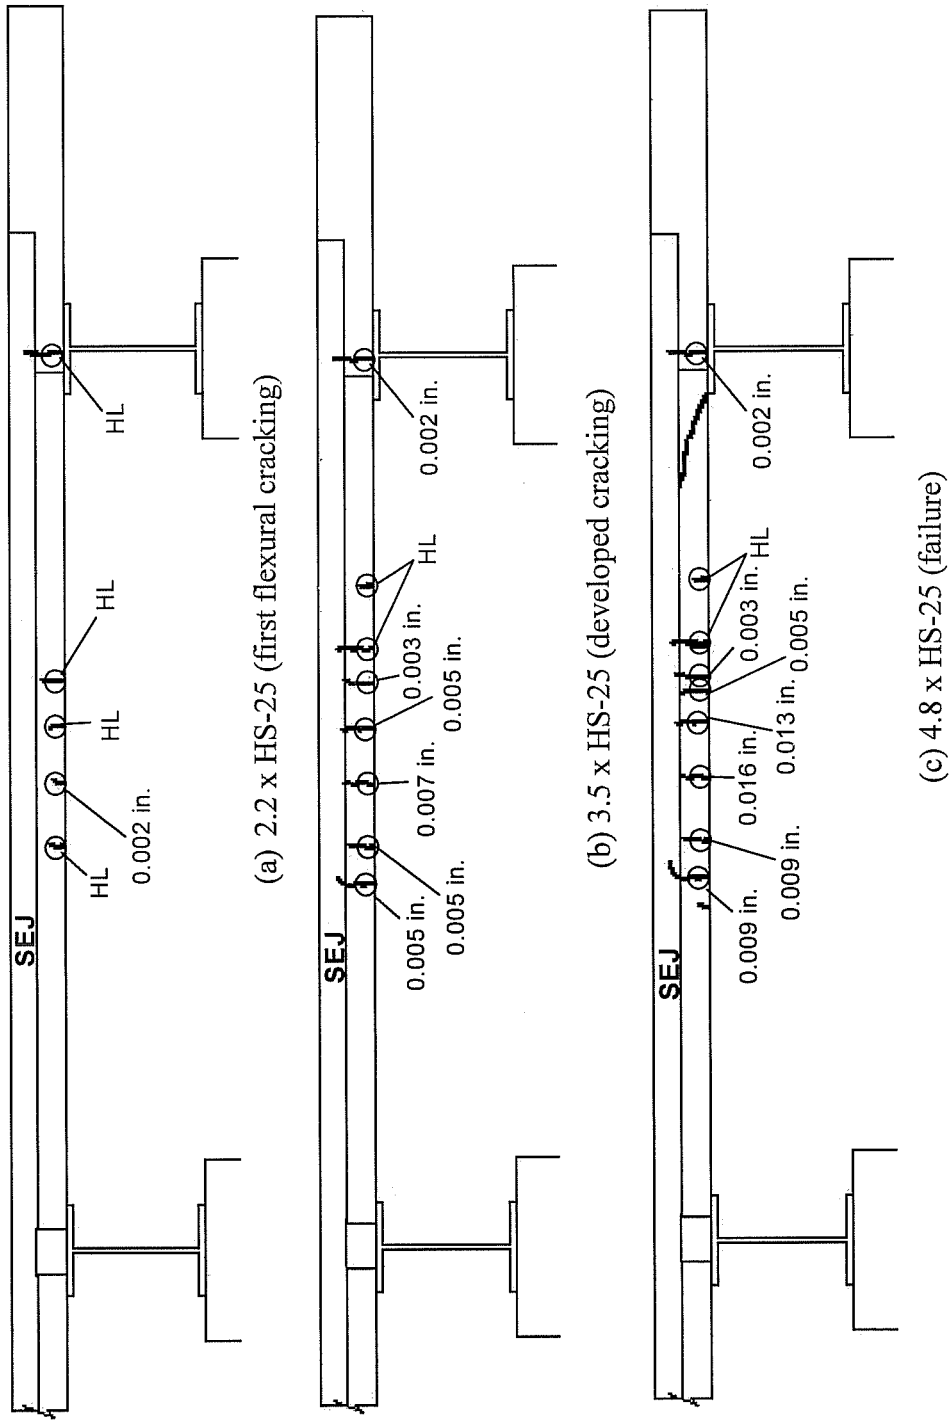
Figure 5.62 Crack map, SEJ, 6 in. top reinforcement spacing, positive-moment region, side view of slab

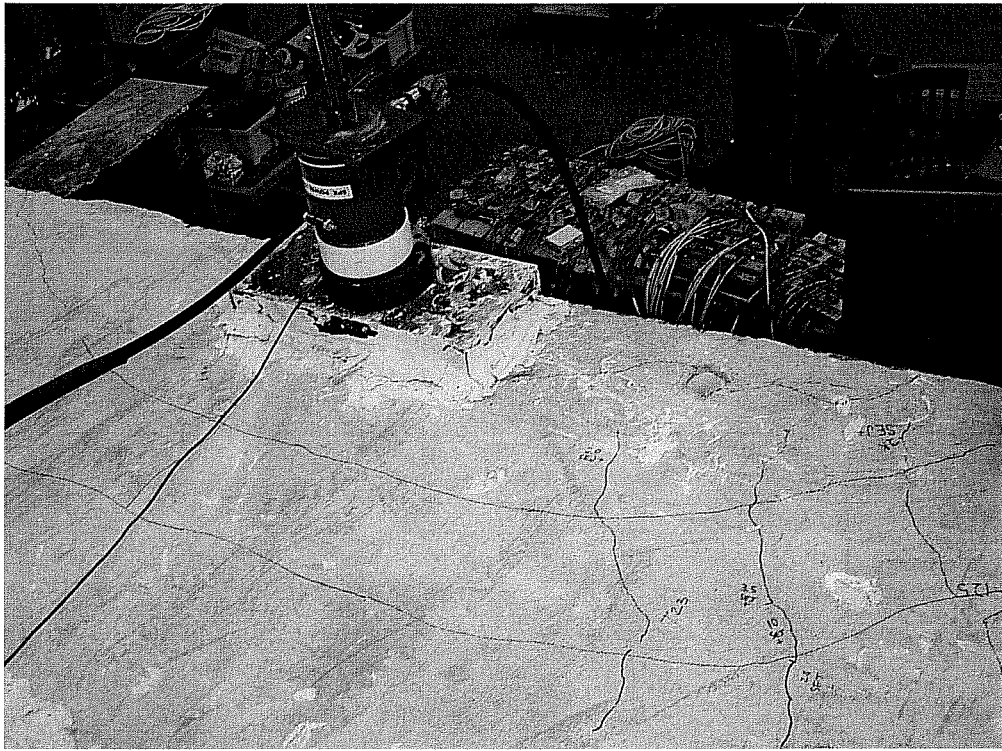
Figure 5.63 West exterior 10-ft bay failure at top of slab, facing northwest

At 5.4 x HS-25, a punching shear failure occurred at the edge tire in the west exterior 10 ft bay. Pictures were taken of the failure surface (Figure 5.63, Figure 5.64, Figure 5.65). Cracks wrapping semi-circularly around the edge load point formed around 3.5 x HS-25 and existing flexural cracks opened on the top surface up to and at failure. A yield line pattern began to develop on the bottom surface of the panel, and cracking was confined to the panel section being loaded. From the side of the slab, shear cracks extend from the CIP topping behind the SEJ to the bottom of the panel, with the crack running along the interface near the west-interior bay. The side surface indicated some delamination (Figure 5.65 b) occurring between the panel and the CIP concrete topping at high loads and failure. Some separation was seen around 5.0 x HS-25. The failure surface is easily visible from beneath the slab. A large section up to the prestressing strand level near the west interior girder spalled off at failure.

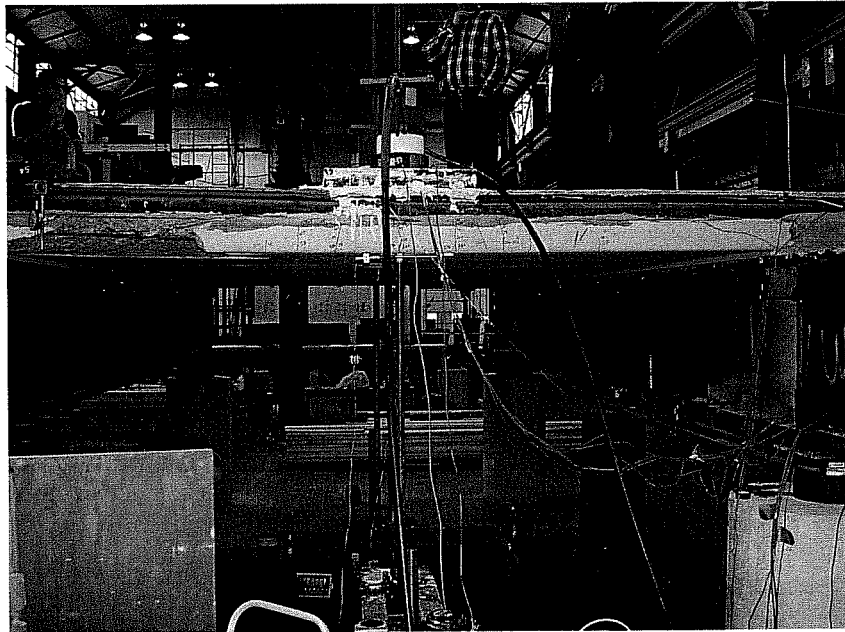
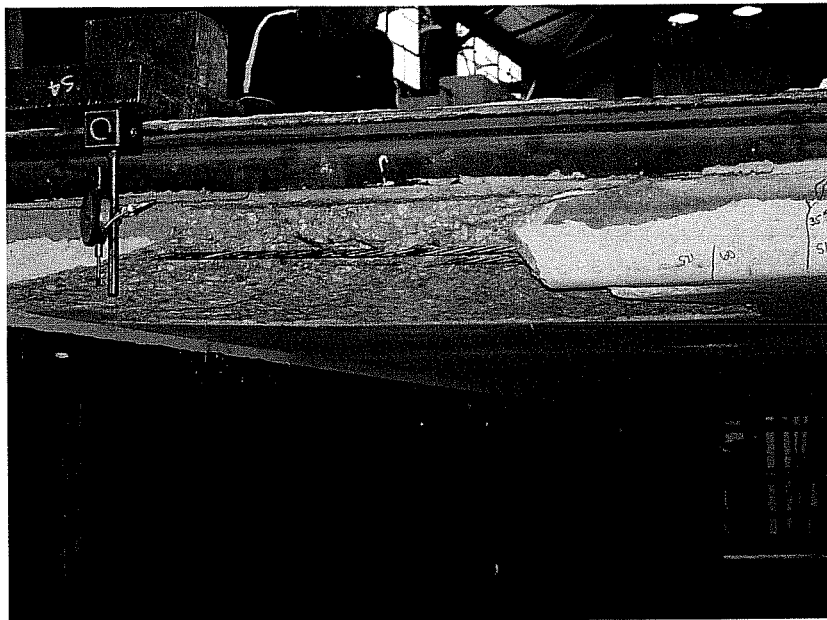
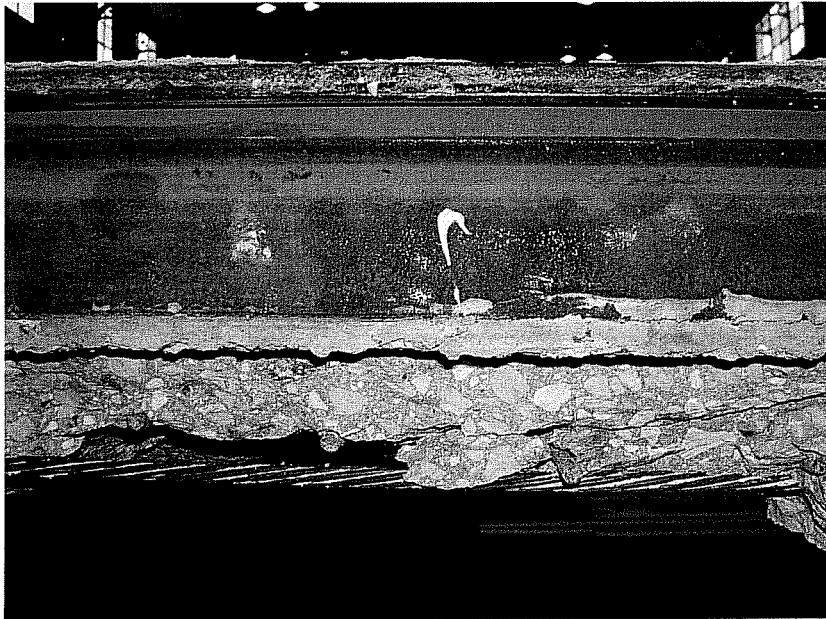
(a) facing south

(b) close up of spalled section

Figure 5.65 West exterior 10-ft bay failure at side of slab: (a) facing south; (b) close up of spalled section; (c) close up of delamination

(c) close up of delamination

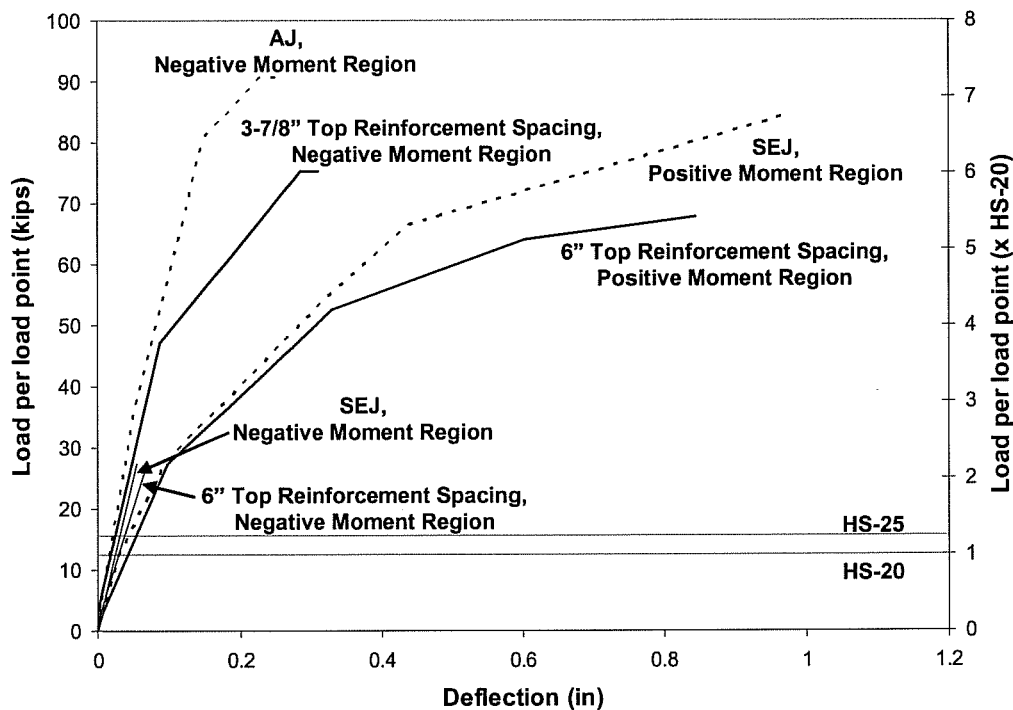
Figure 5.66 Deflection envelopes, all expansion joint edge tests

Figure 5.66 shows deflection envelopes for the six test areas on the PC panel specimen. Overall, the tests maximizing negative moments behaved similarly, and the test maximizing positive moments behaved similarly. In the negative-moment failure tests, reserve strength was higher, stiffness was greater, and deflections were smaller than in the positive-moment tests. All test areas exhibited first flexural cracking above design loads. The test areas with the AJ and SEJ rails exhibited a higher stiffness, lower tensile strains, and smaller deflection, than the test areas without AJ and SEJ rails.

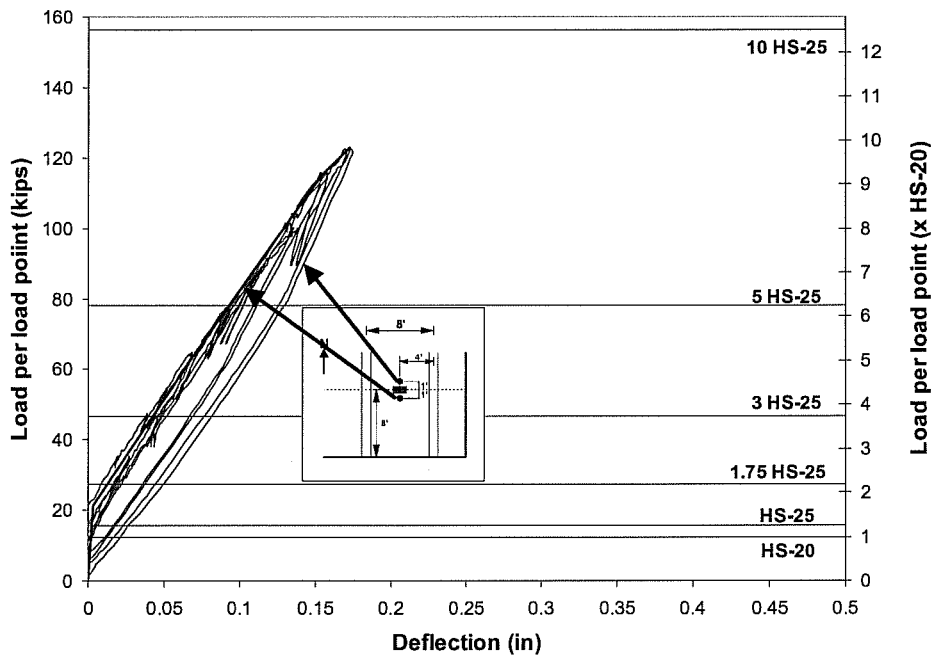
Figure 5.72 Load-deflection envelope, joint punching shear test

deflection at HS-20 and HS-25 was 0.0038 in. and 0.0044 in. The maximum measured deflection at 120 kips was 0.17 in.

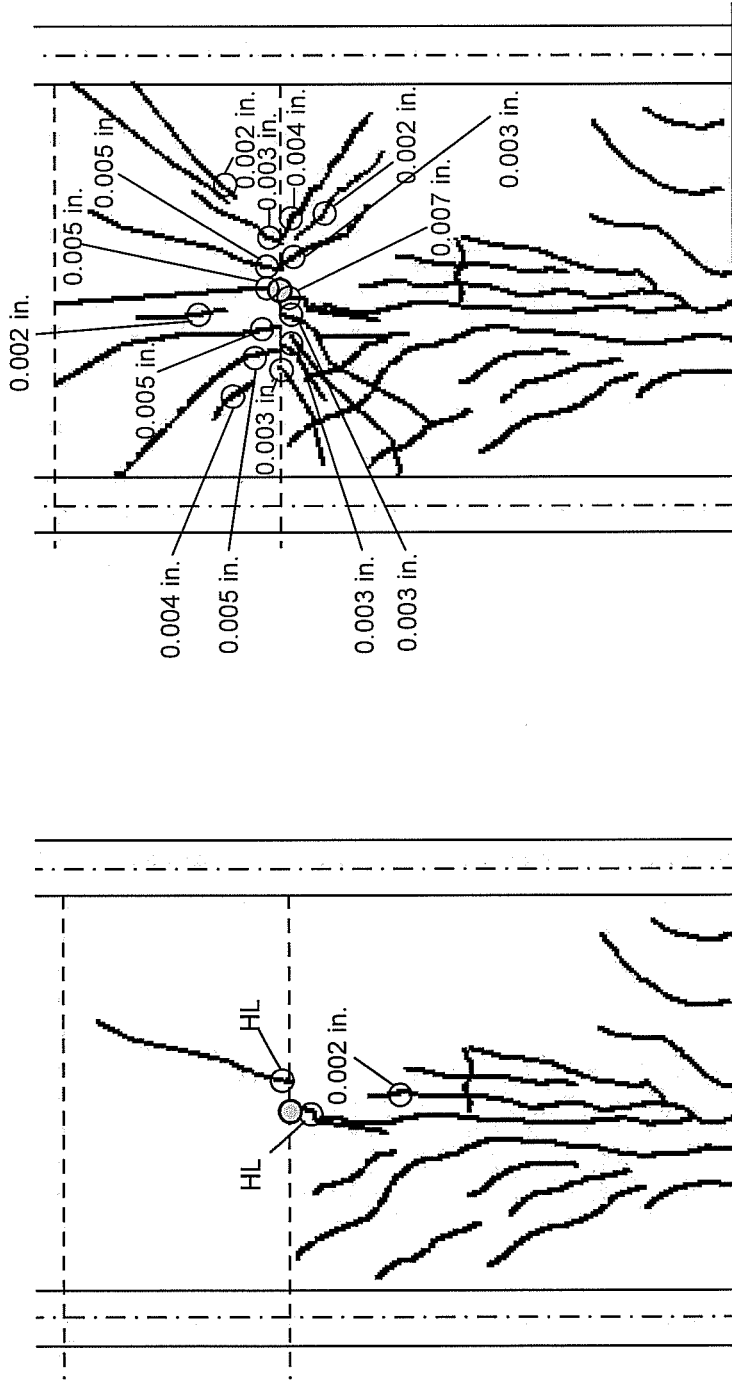
(a) 55 kips (first cracking)

At 100 kips, several new cracks formed and existing cracks elongated and widened, indicative of a change in stiffness. All cracks began parallel to the girders and then began to bend towards the girders after a certain distance. The largest crack width on the bottom surface of the panel was 0.005 in. At 120 kips, three new cracks developed similar to the previous cracks, where they began parallel to the girder and then bend towards the girders. The largest crack width at 120 kips was 0.007 in. at the crack under the load point near the joint. As seen in Figure 5.73, the cracks on the bottom face of the panel do not indicate that the joint has an effect on the cracking pattern. Most of the cracks that reach the joint on one panel have a nearly identical crack on the adjacent panel.

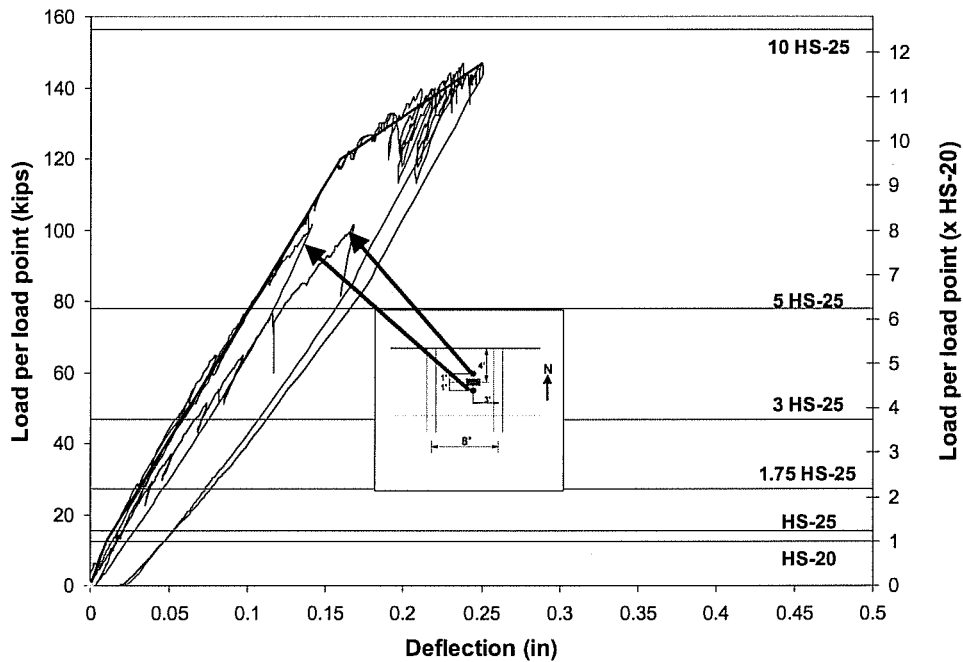
Figure 5.75 Load-deflection envelope, interior punching shear test

A load-deflection response and envelope is shown in Figure 5.75. The load-deflection response indicates a linear elastic response up to approximately 120 kips (7.7 x HS-25). The two linear potentiometers measured essentially the same deflection and slope throughout the test. The maximum measured deflection at HS-20 and HS-25 was 0.016 in. and 0.017 in. The maximum measured deflection at 120 kips and 145 kips was 0.17 in. and 0.25 in., respectively.

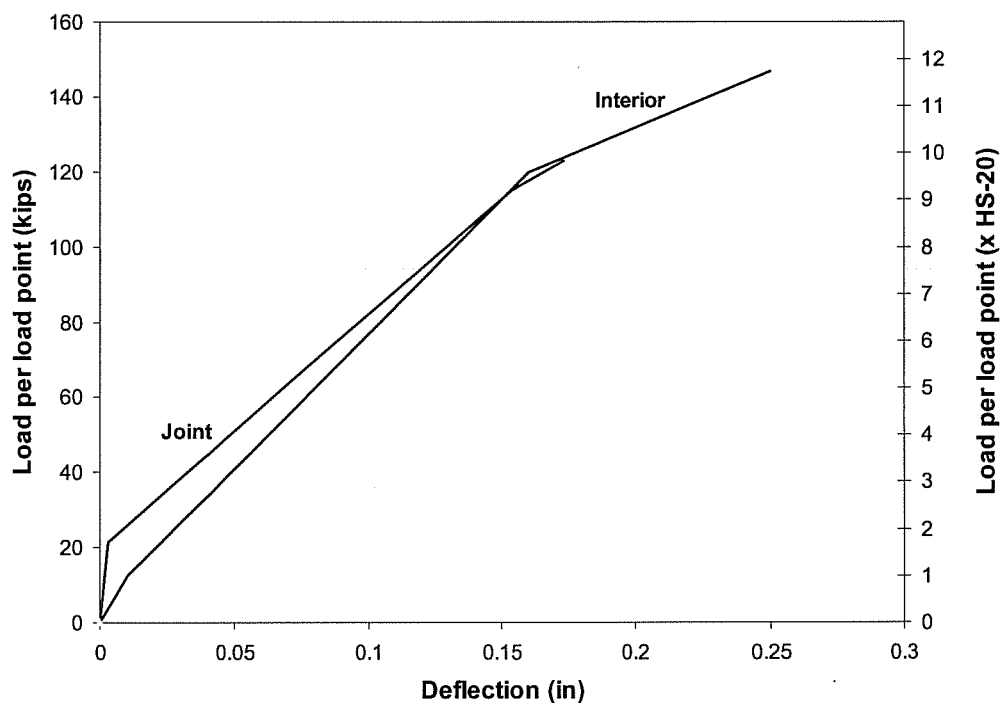
Figure 5.77 Deflection envelopes, punching shear tests

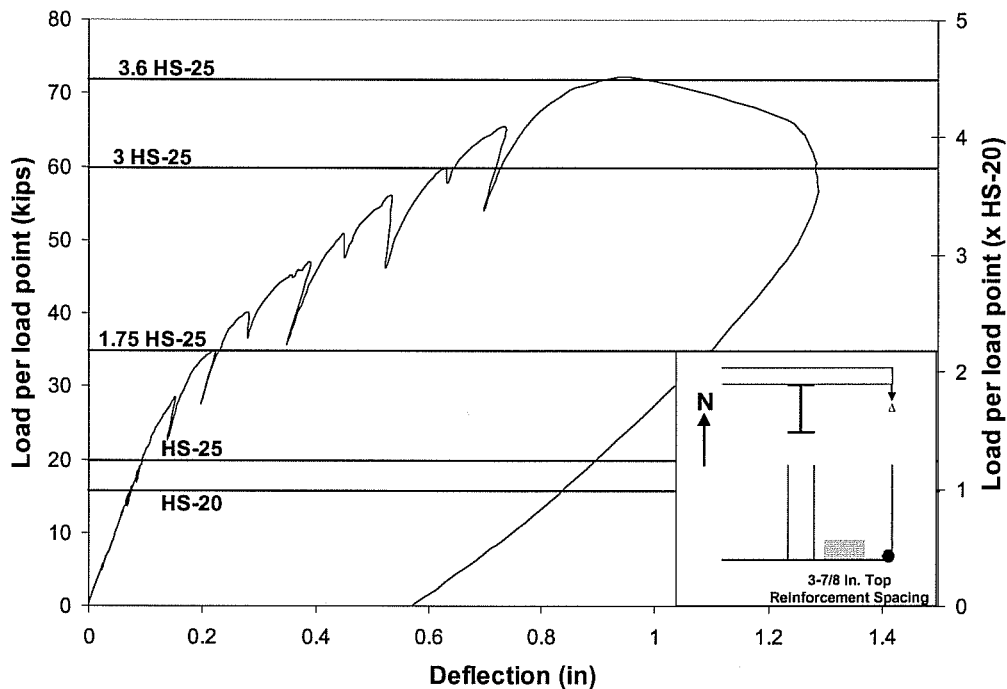
Figure 6.5 Tip deflection, Overhang Test 1, 3-7/8 in. top reinforcement spacing

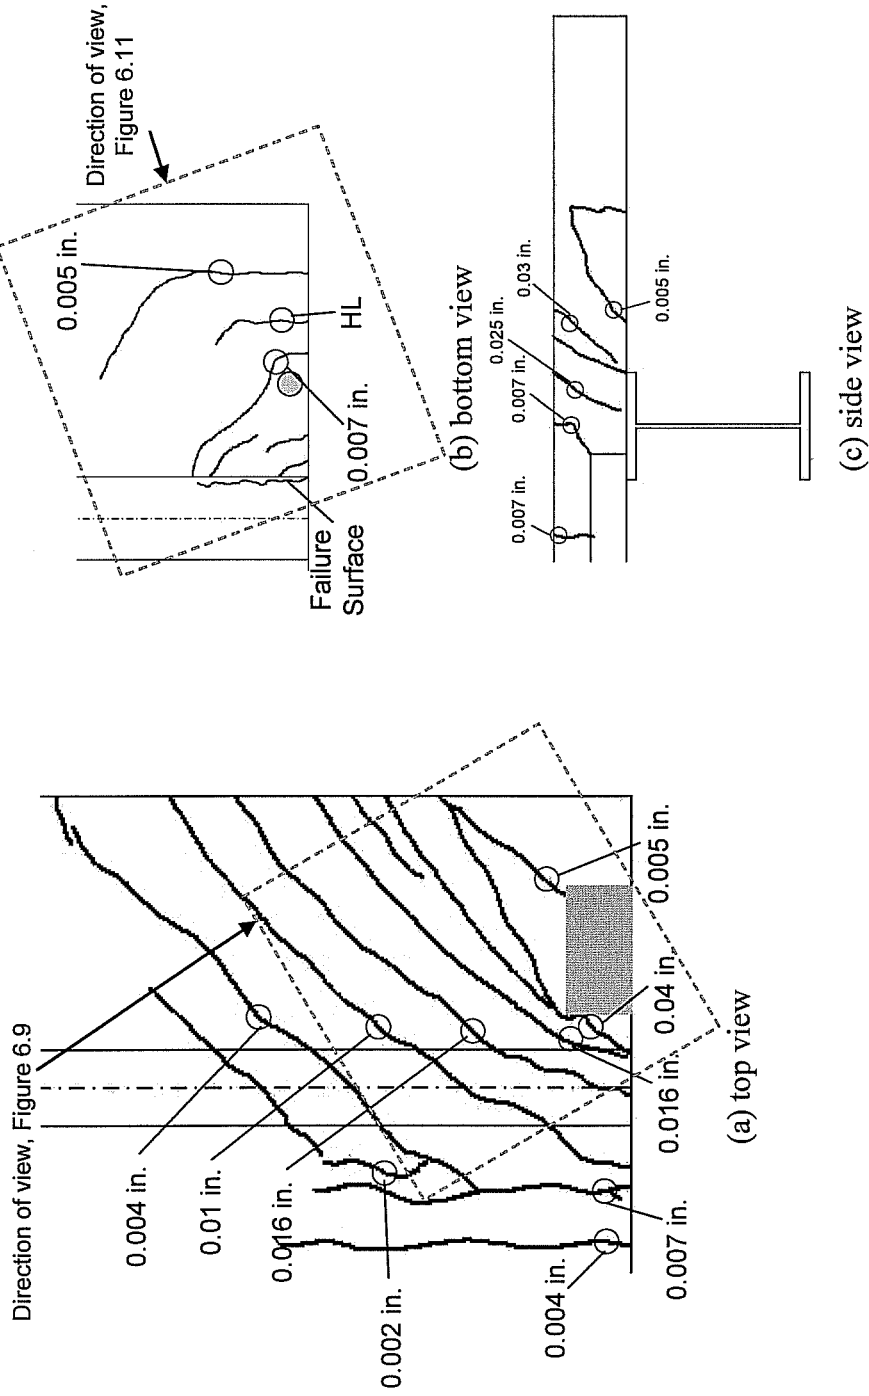
Figure 6.8 Crack map at failure, Overhang Test Area 1, 3-7/8 in. top reinforcement spacing: (a) top view; (b) bottom view; (c) side view, facing north

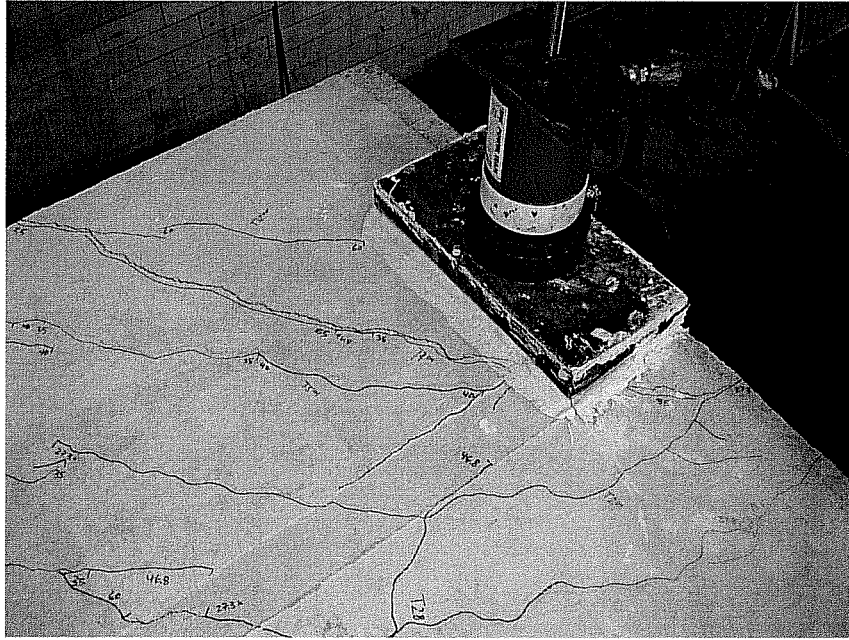
Figure 6.9 Failure of Overhang Test Area 1, top view, facing southeast

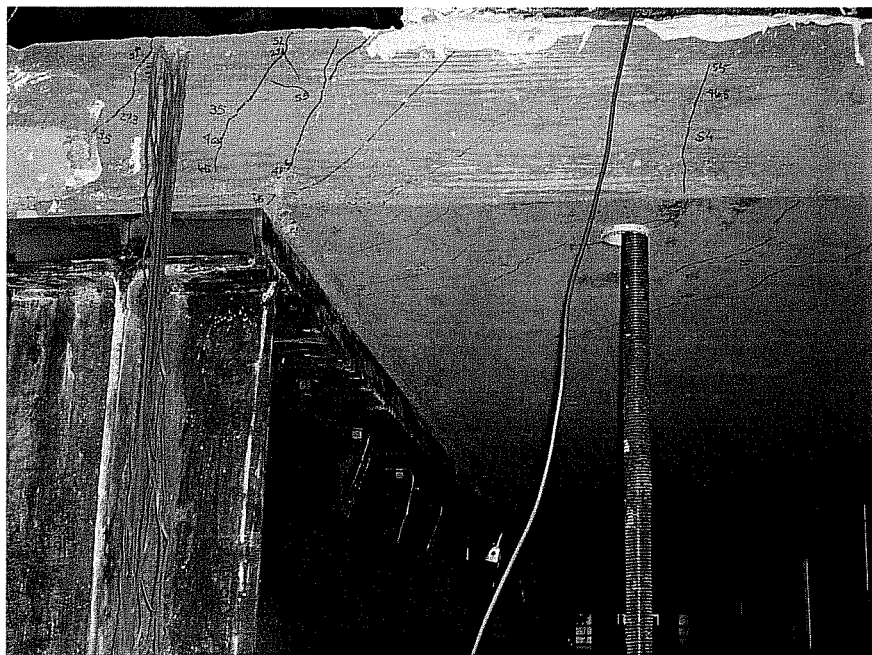
Figure 6.10 Failure of Overhang Test Area 1, side view, facing north

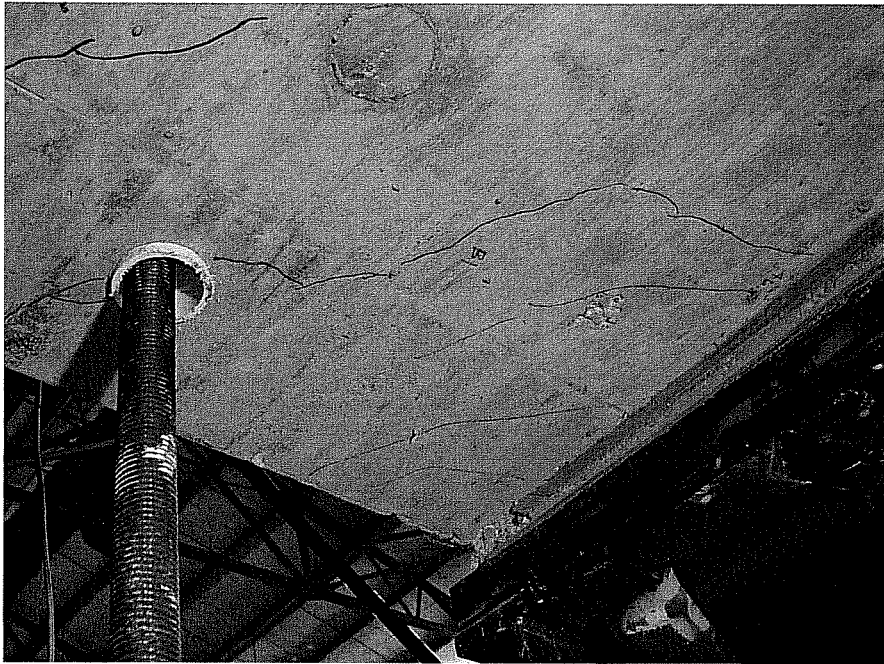
Figure 6.11 Failure of Overhang Test Area 1, bottom view, facing southwest

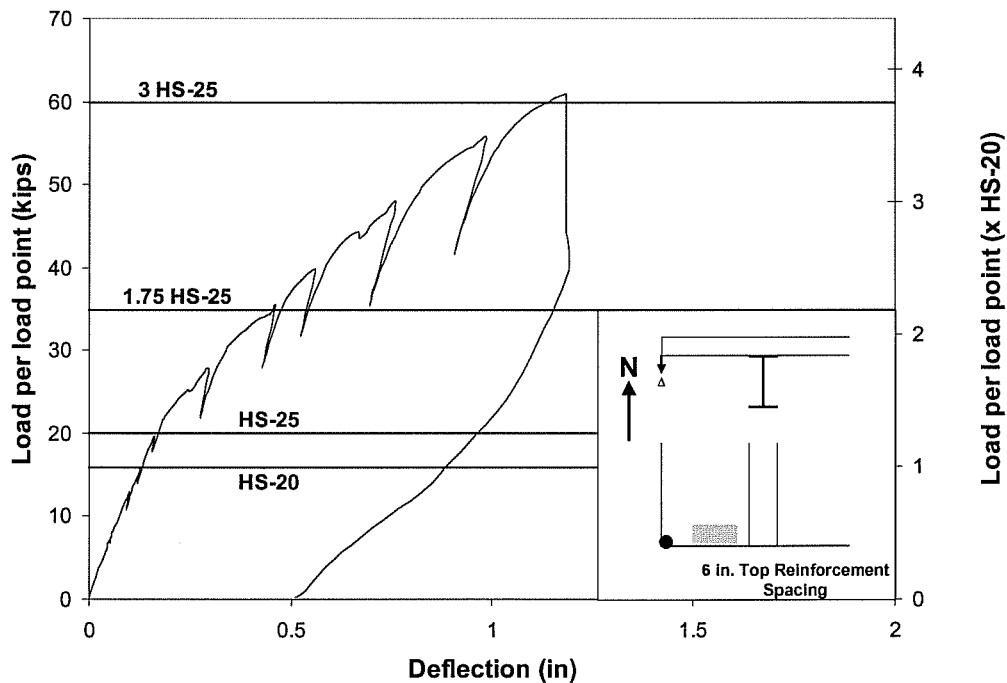
Figure 6.13 Tip deflection, Overhang Test Area 2, 6 in. top reinforcement spacing

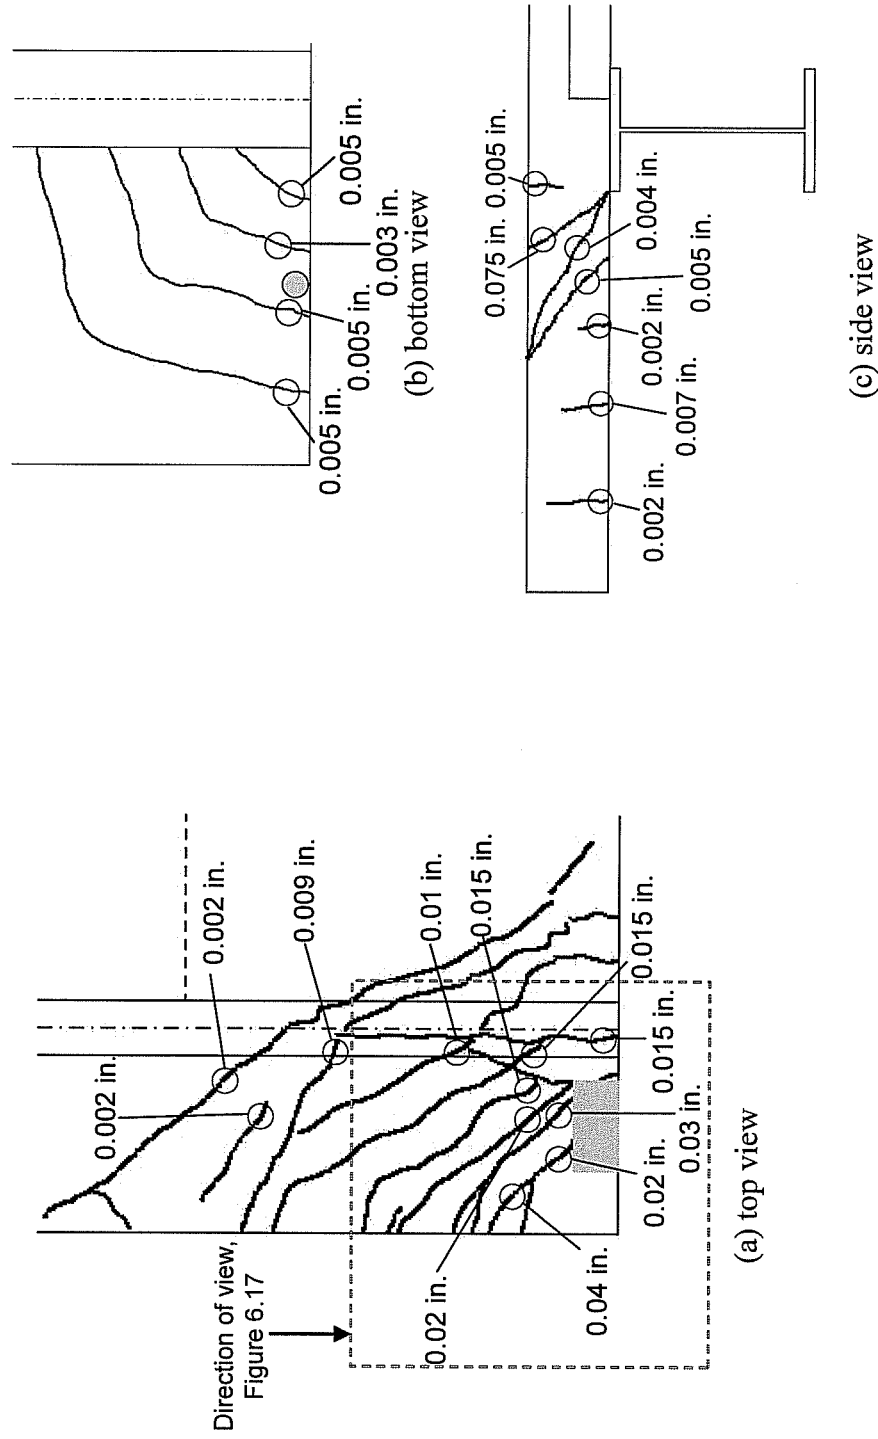
Figure 6.16 Crack map at failure, Overhang Test Area 2, 6 in. top reinforcement spacing: (a) top view; (b) bottom view; (c) side view, facing north

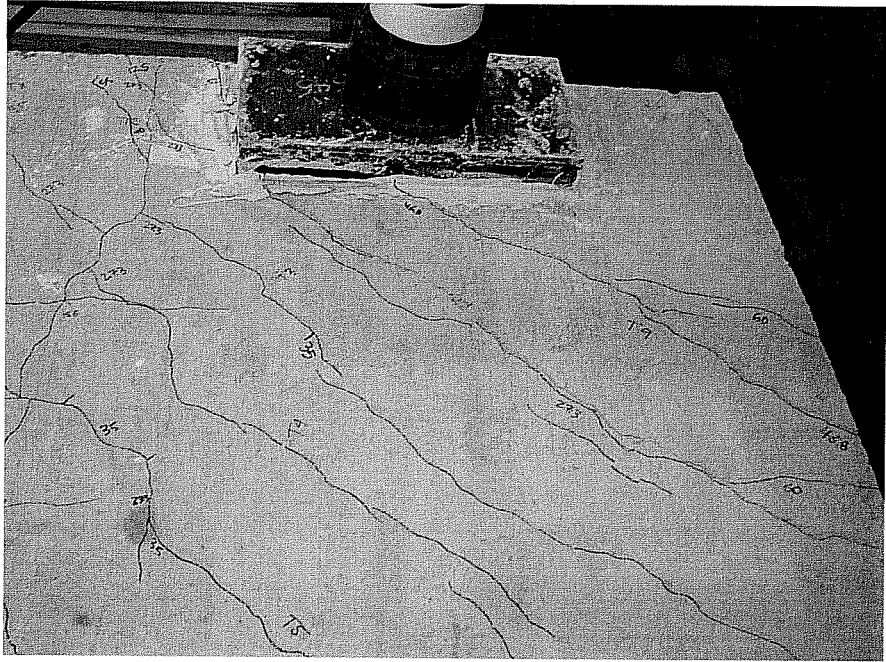
Figure 6.17 Failure of Overhang Test Area 2, top view, facing south

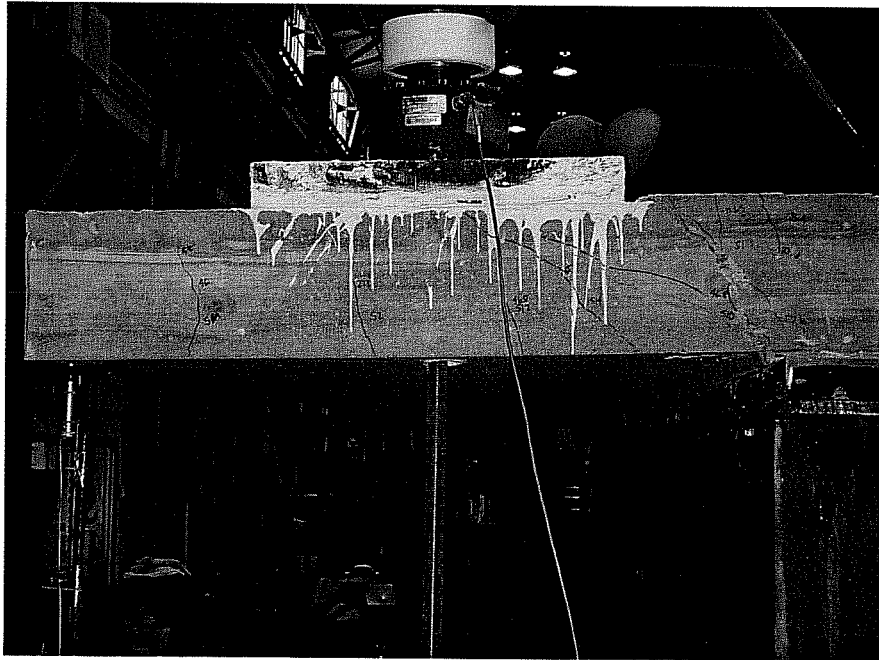
Figure 6.18 Failure of Overhang Test Area 2, side view, facing north

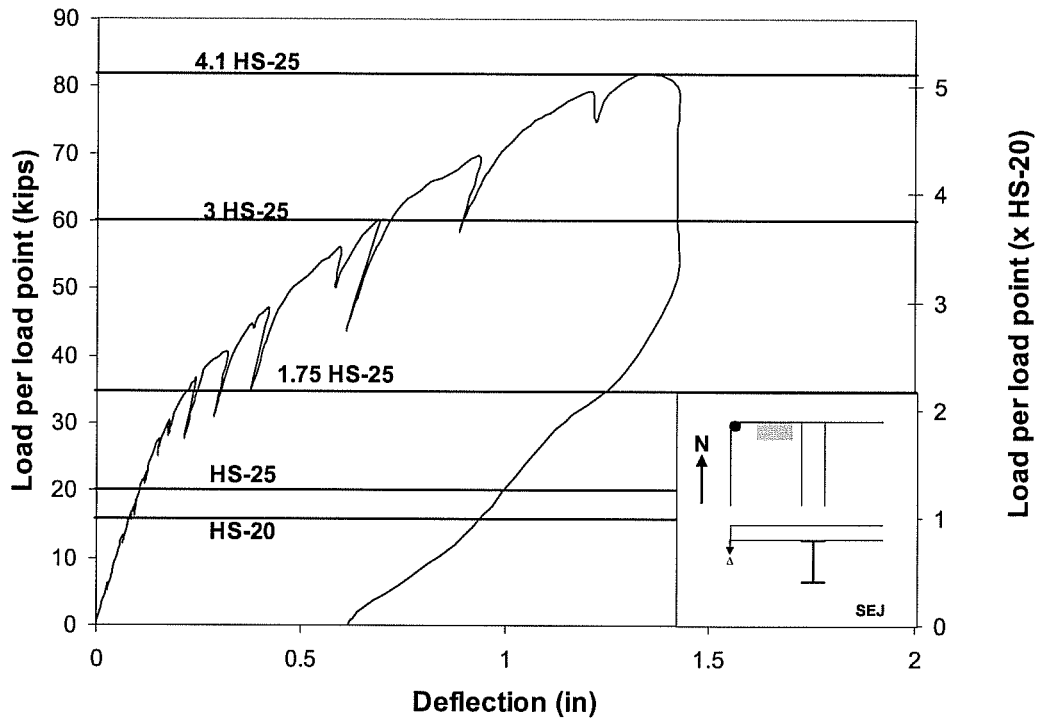
Figure 6.20 Tip deflection, Overhang Test Area 3, SEJ and 6 in. top reinforcement spacing

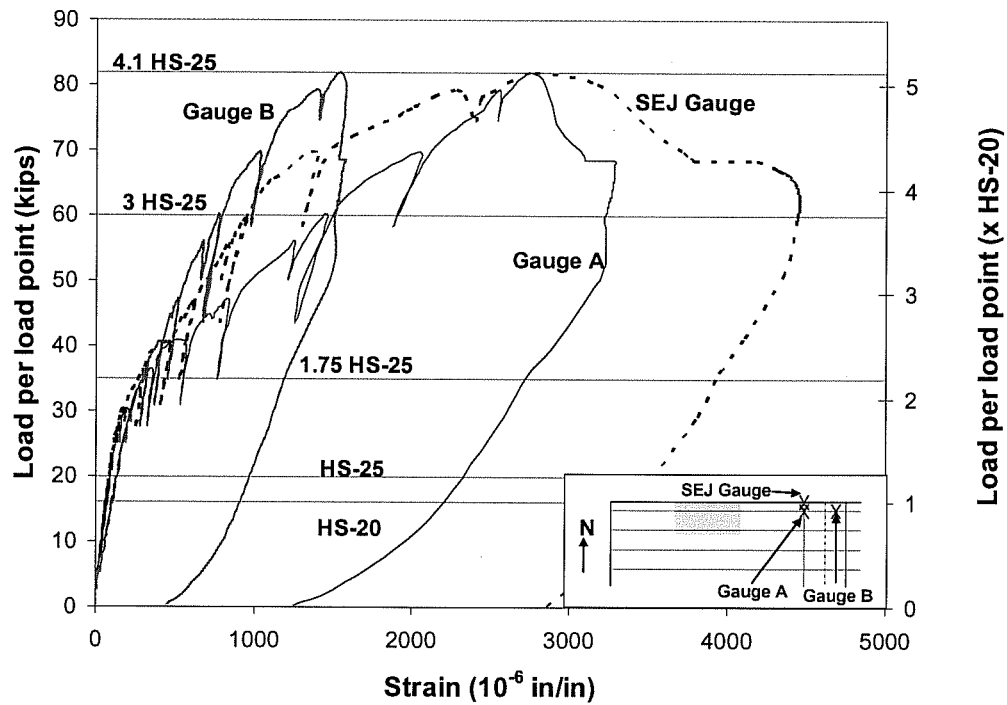
Figure 6.21 Load-strain response, Overhang Test Area 3, SEJ and 6 in. top reinforcement spacing

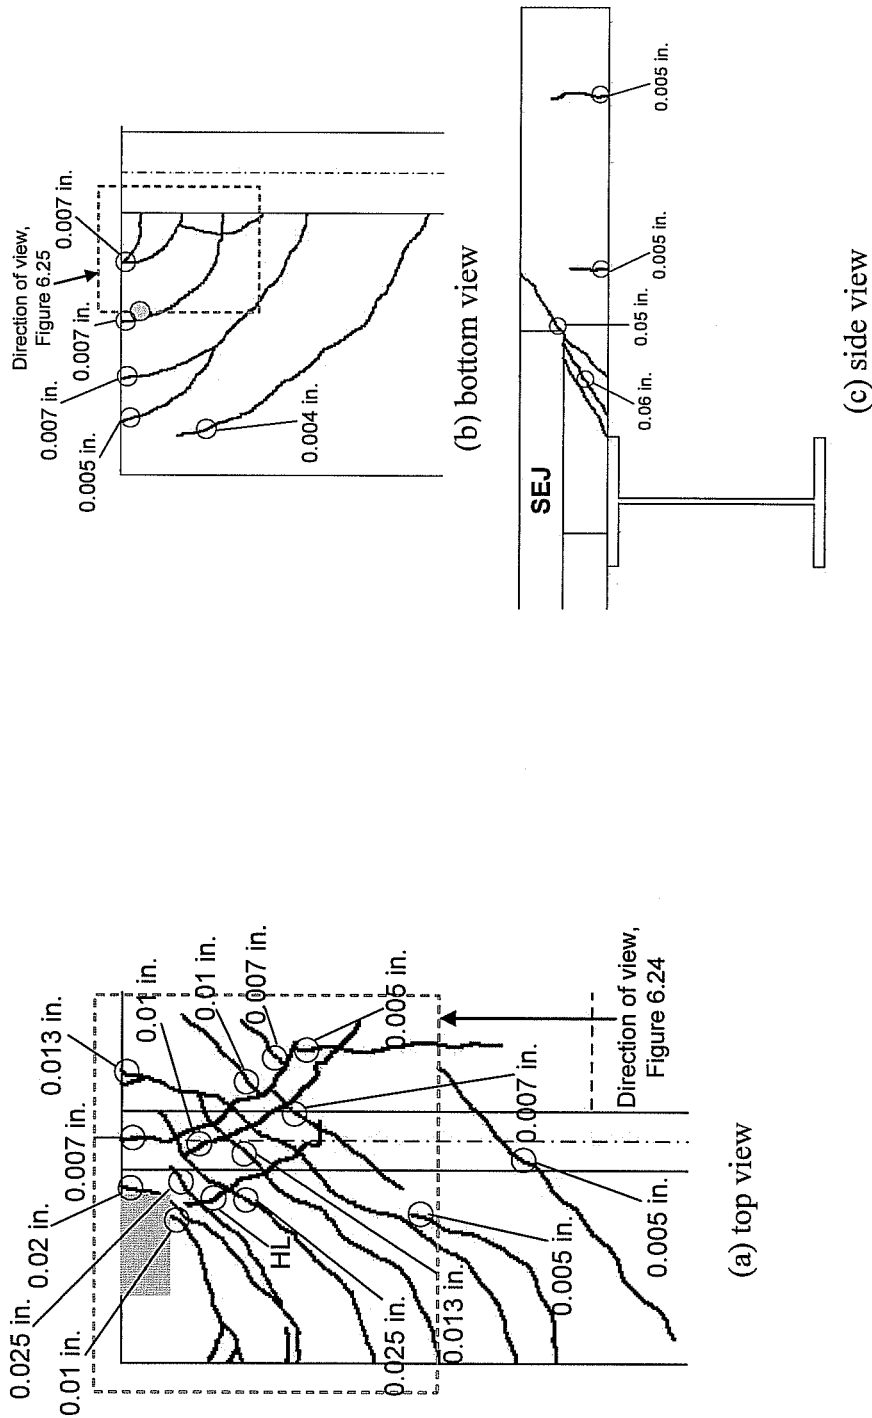
Figure 6.23 Crack map at failure, Overhang Test Area 3, SEJ: (a) top view; (b) bottom view; (c) side view, facing south

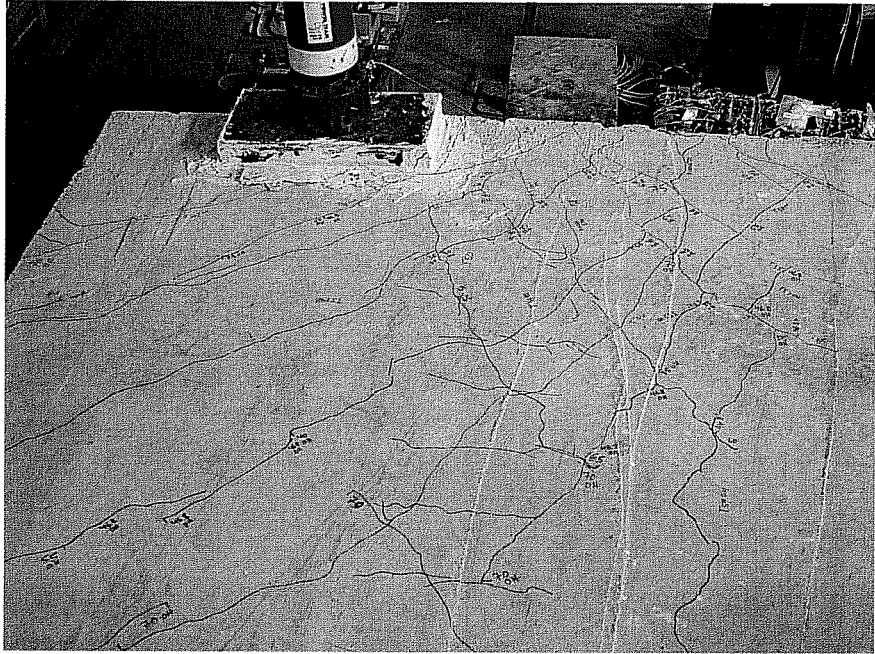
Figure 6.24 Failure of Overhang Test Area 3, top view, facing north

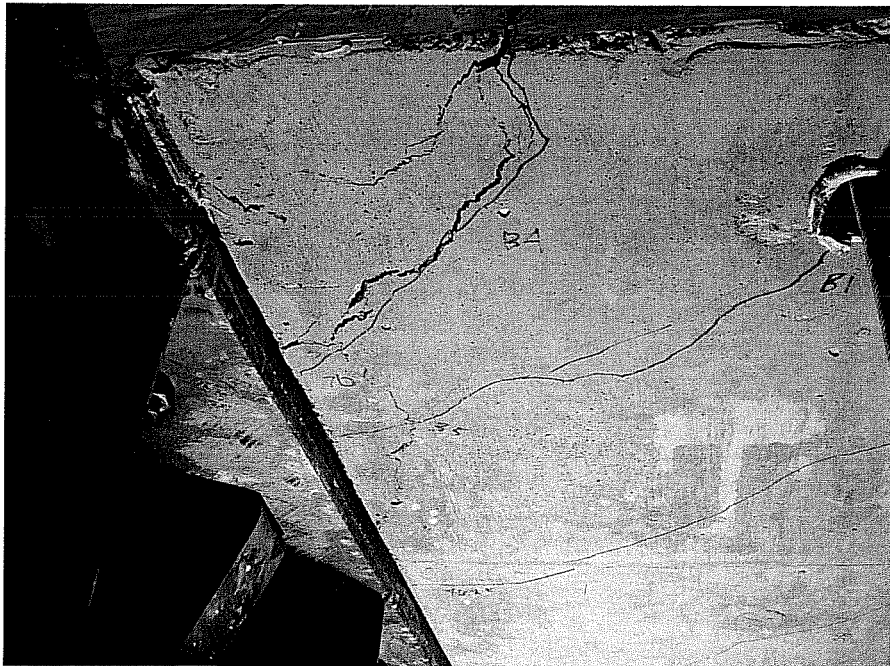
Figure 6.25 Failure of Overhang Test Area 3, bottom view, facing southwest

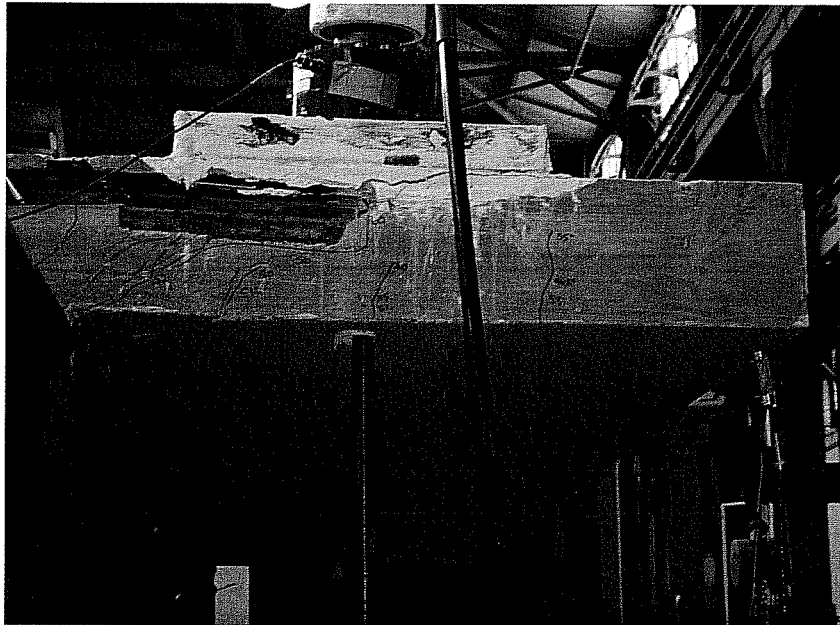
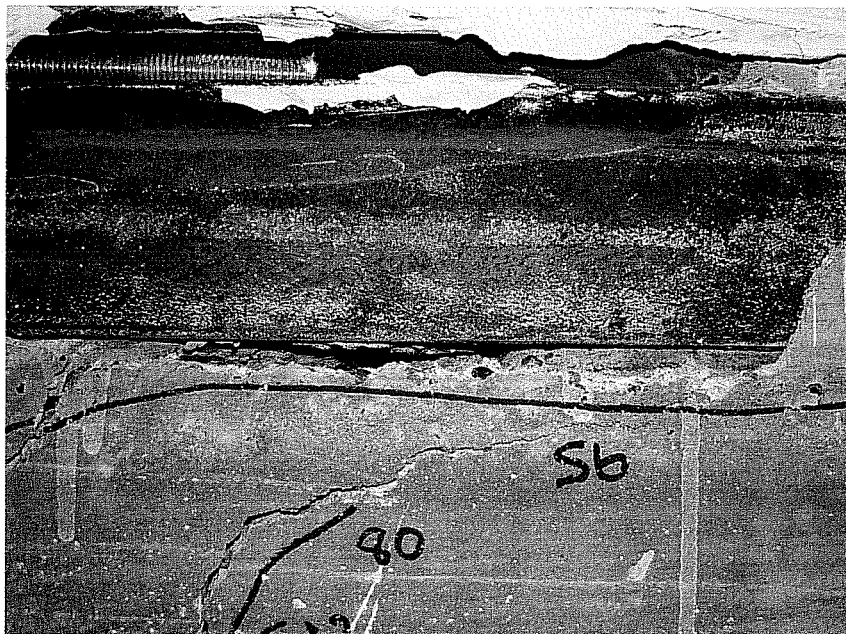
(a) side view, facing south

(b) close up of SEJ at failure
