Behavior of Bridge Decks with Precast Panels at Expansion Joints

Thesis

The University of Texas at Austin

May 2004

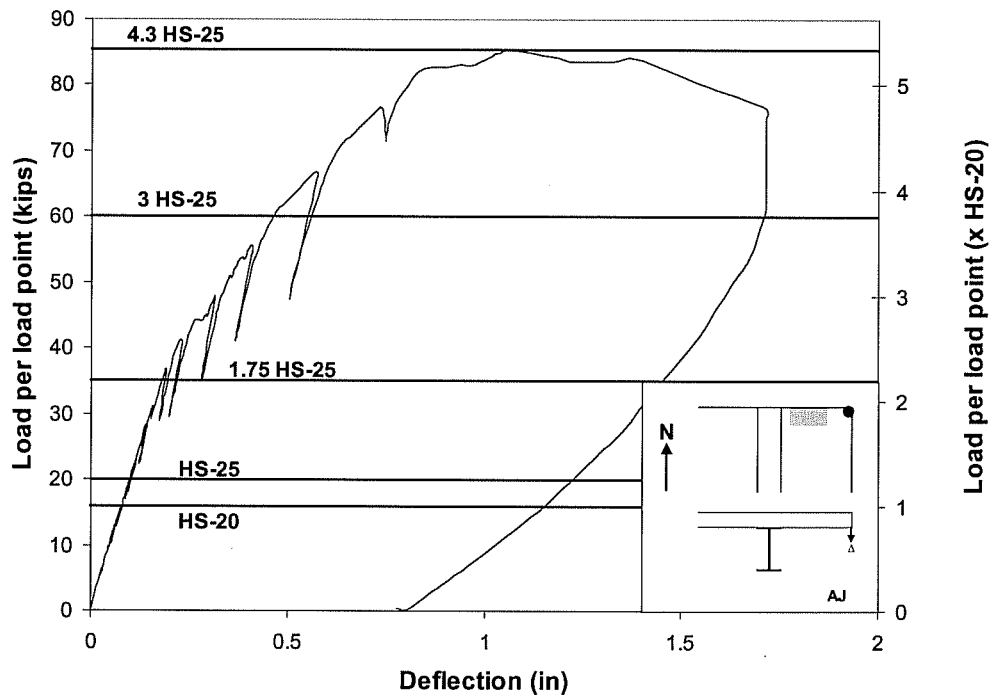
Figure 6.28 Tip deflection, Overhang Test Area 4, AJ and 6 in. top reinforcement spacing

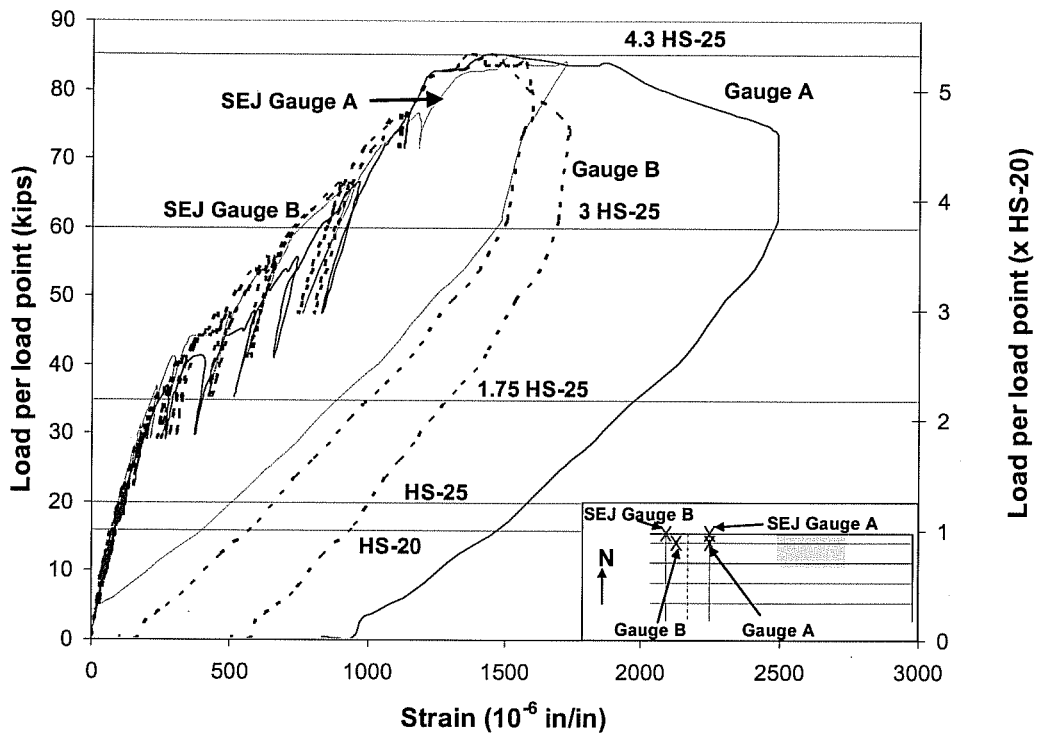
Figure 6.29 Load-strain response, Overhang Test Area 4, AJ and 6 in. top reinforcement spacing

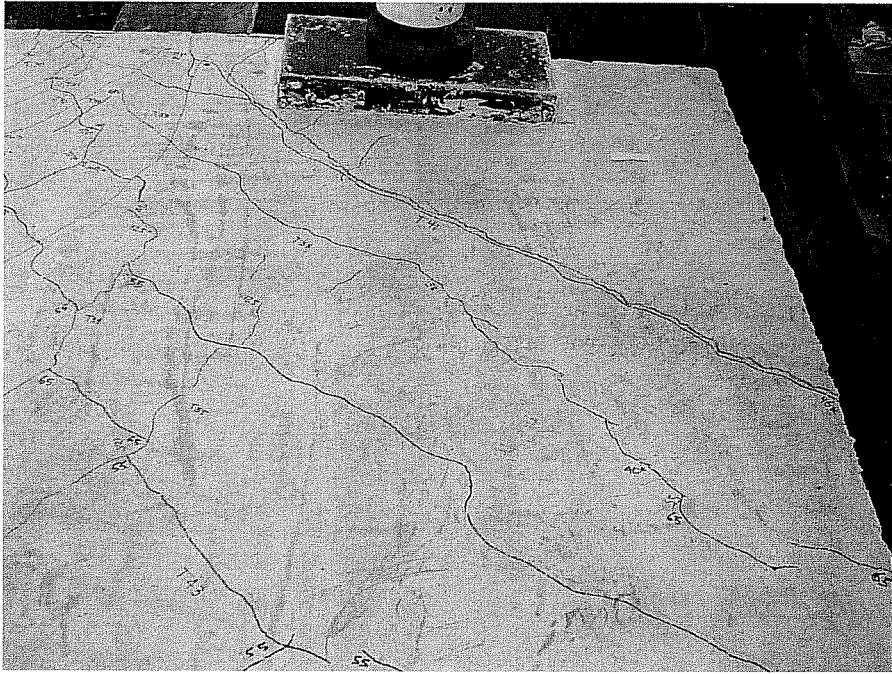
Figure 6.32 Failure of Overhang Test Area 4, top view, facing north

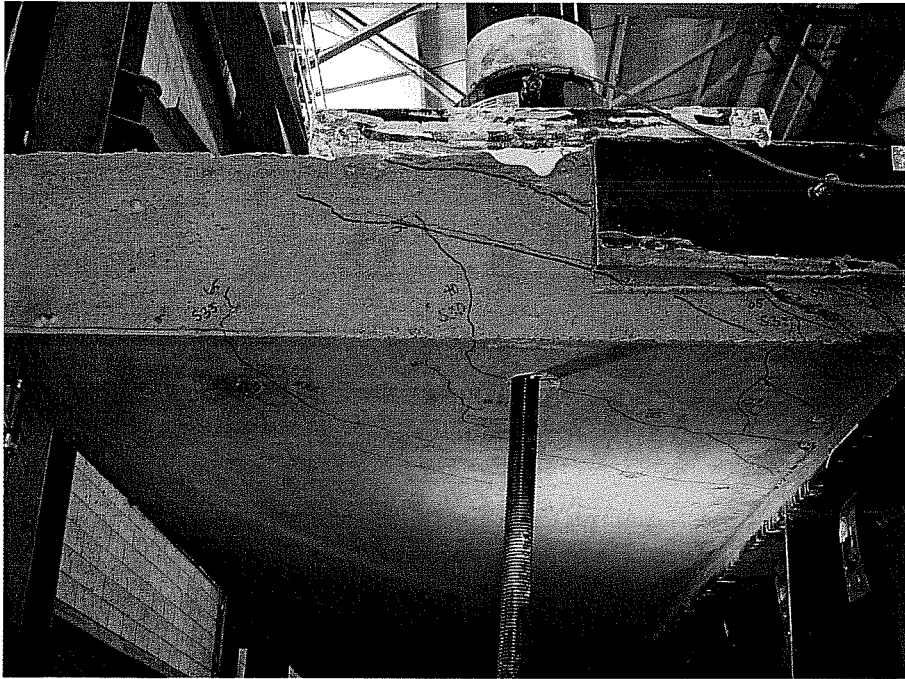
Figure 6.33 Failure of Overhang Test Area 4, side view, facing south

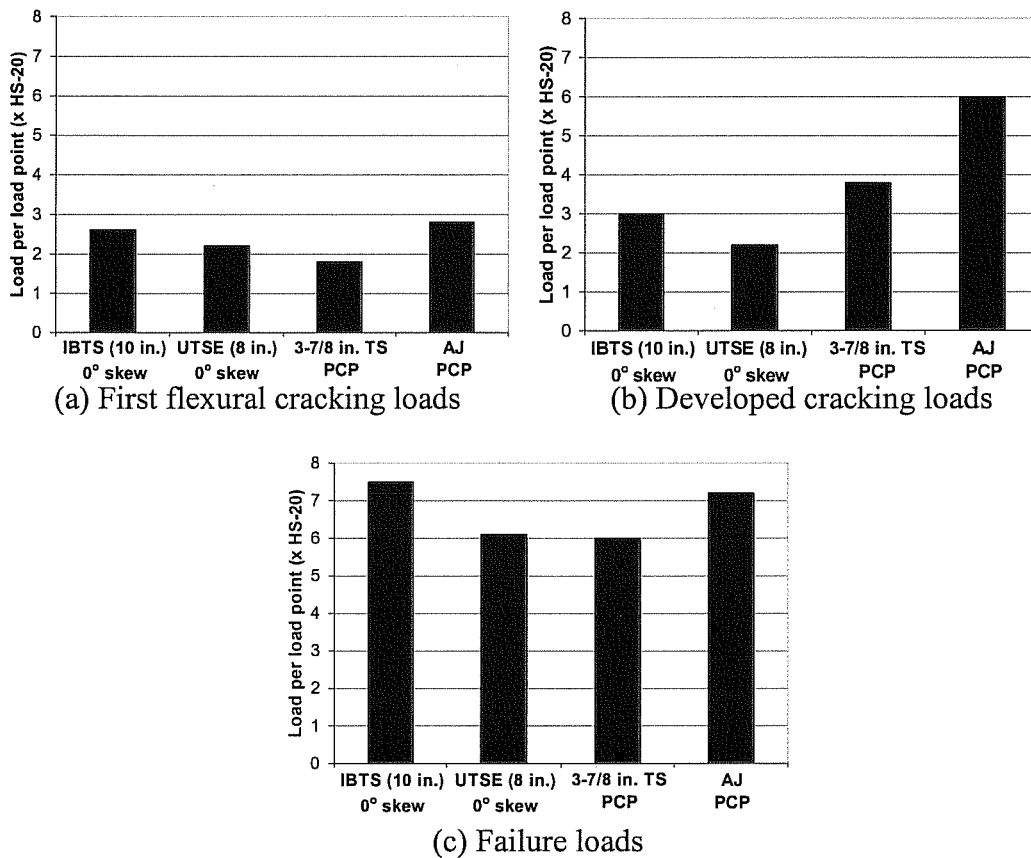
Figure 7.2 Comparison of behavior of negative-moment failure test regions: (a) first flexural cracking loads; (b) developed cracking loads; (c) failure loads

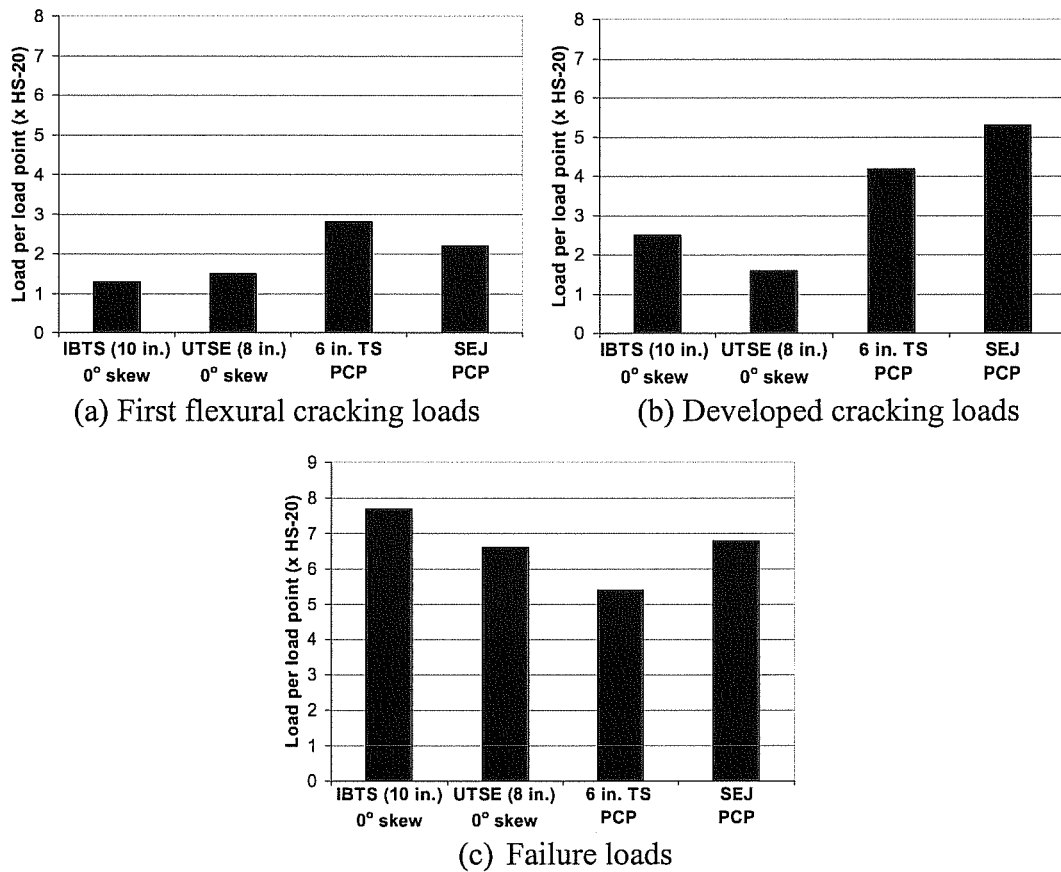
Figure 7.4 Comparison of behavior of positive-moment test regions: (a) first cracking loads; (b) developed cracking loads; (c) failure loads

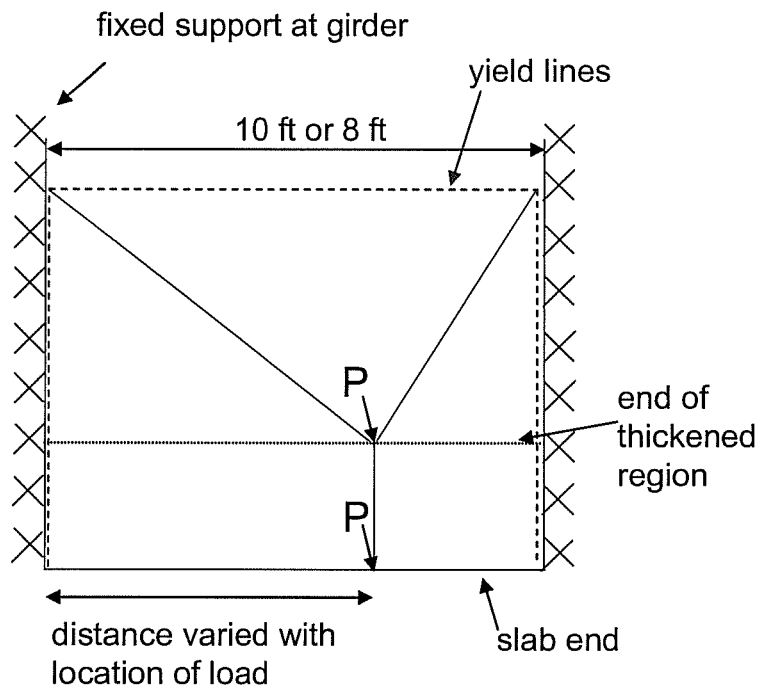
Figure 7.5 Yield-line mechanism, 0° skew slab edge (Griffith 2003)
