**Measurement Based Performance Evaluation of
a Segmental Concrete Bridge**

Dissertation

The University of Texas at Austin

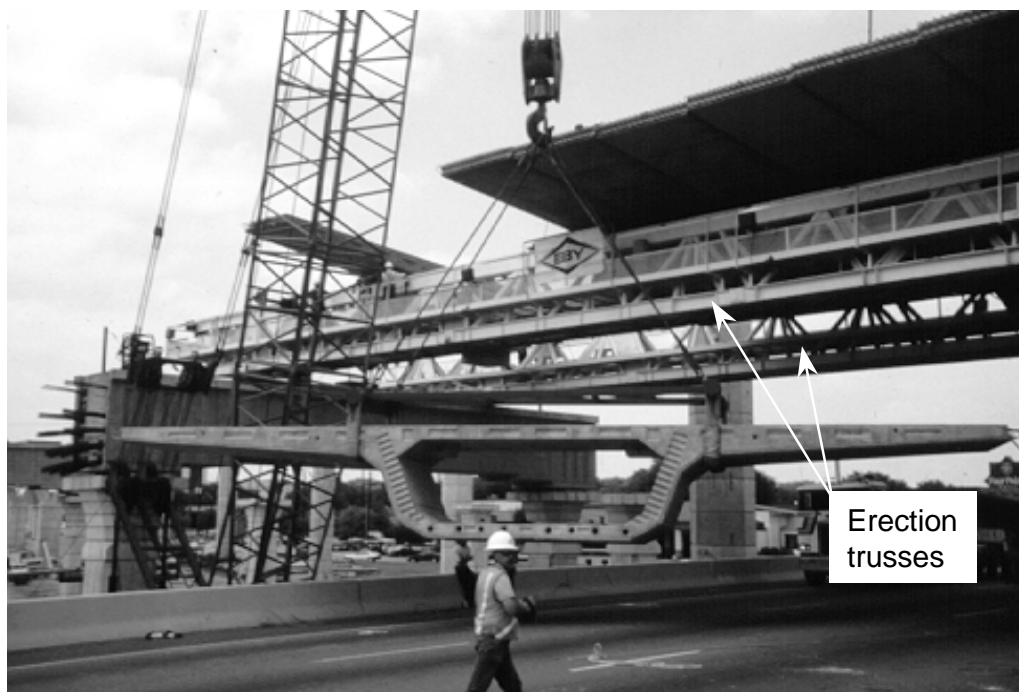
Figure 1.2 Span by span construction

Twin precast segmental box girders constructed by the span-by-span method (Figure 1.2) were selected as the structure type most suited to much of the site for several reasons. The structure could be constructed from above the completed frontage roads while traffic could be maintained beneath. Single column piers were used beneath the single-cell box girders allowing the frontage roads to be built beneath the structure overhangs, maximizing the number of lanes (12) in the narrow right-of-way. With over 10 kilometers of structure, precast concrete box girder construction, including fabrication of erection trusses and construction of a precasting facility, was also an economical solution. The box girder design option was the low bid at \$71.3 million over an alternate multiple precast delta and I-girder design with cast-in-place closures. Martin K. Eby Construction was the contractor in a joint venture with Flatiron Structures Company. A summary of all bids is shown in Table 1.1.

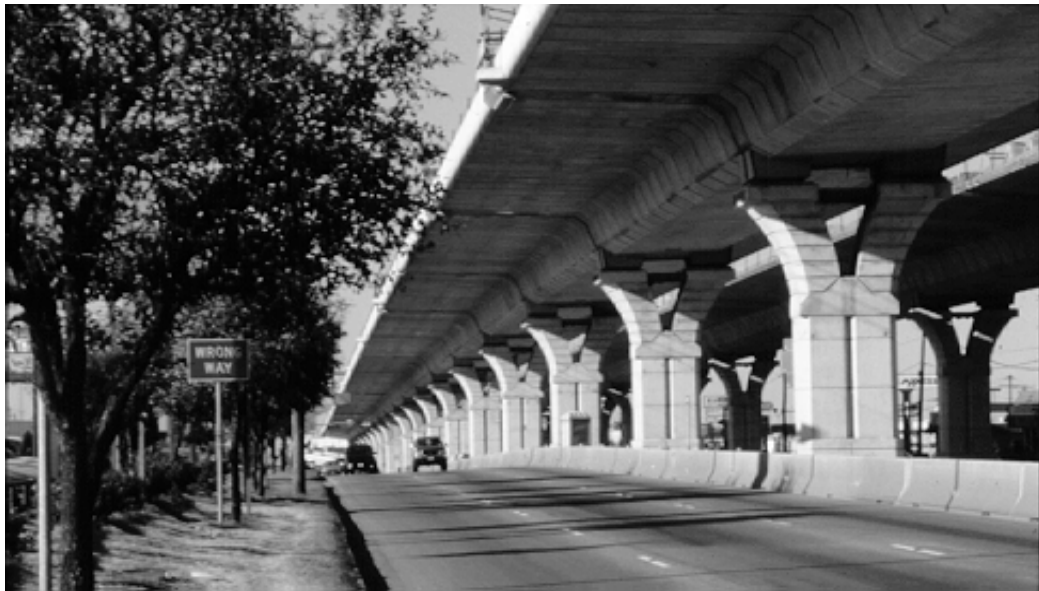
Figure 1.3 Mainlane structure

An important consideration in selecting a box girder for the site was aesthetics. Austin residents are very sensitive to potential influences on their high quality of life in the state capital. A structure as potentially intrusive as the U.S. 183 elevated would have to be designed as a signature structure for Austin, while minimizing visual impact. The segmental box girder option gave the designers a girder type known for its simple form and lightweight appearance. The designers, the TxDOT Bridge Division, used a spine beam style box girder, with narrow soffit and long wings, to further enhance the light appearance of the structure. Architectural details reflecting the masonry construction of the State Capitol and The University of Texas Main Building were successfully blended into the design, especially of the single column piers, by TxDOT engineers as seen in Figure 1.3. Table 1.2 shows the cost of the U.S. 183 box girders and Y-shaped piers compared to the average Texas girder and pier costs [1]. The span lengths of the segmental box girders on U.S. 183 were somewhat longer than the average span length for a pretensioned I-girder. Also, the standard multiple circular column with bent cap piers could not have been used at this site because of conflicts with the right-of-way requirement for the frontage roads.

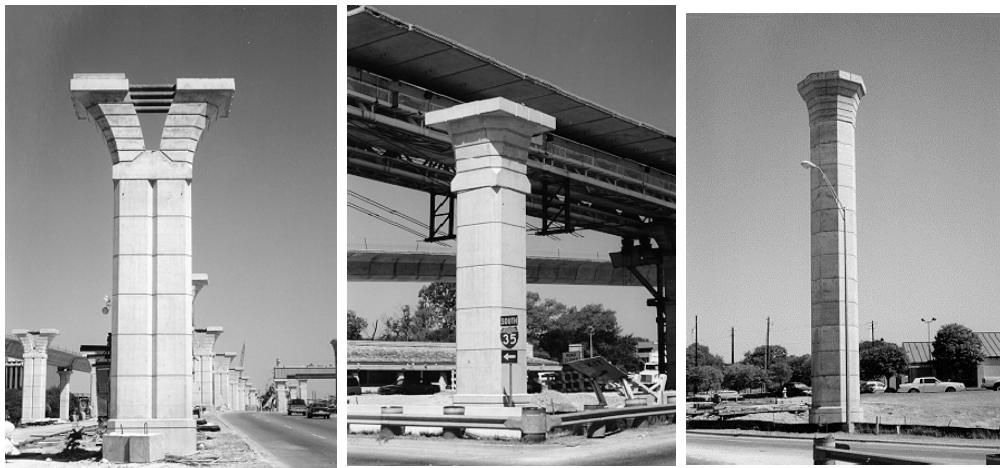
Figure 1.10 Pier types

The U.S. 183 segmental viaduct project was originally designed with three types of segmentally constructed piers (see Figure 1.10). However, the contractor opted to cast two of the pier types in place. One cast-in-place Y-shaped mainlane pier and one segmentally constructed large ramp pier were instrumented, and the small ramp piers were not selected for study.

(a) Mainlane Y-Pier

(b) Small Ramp Pier

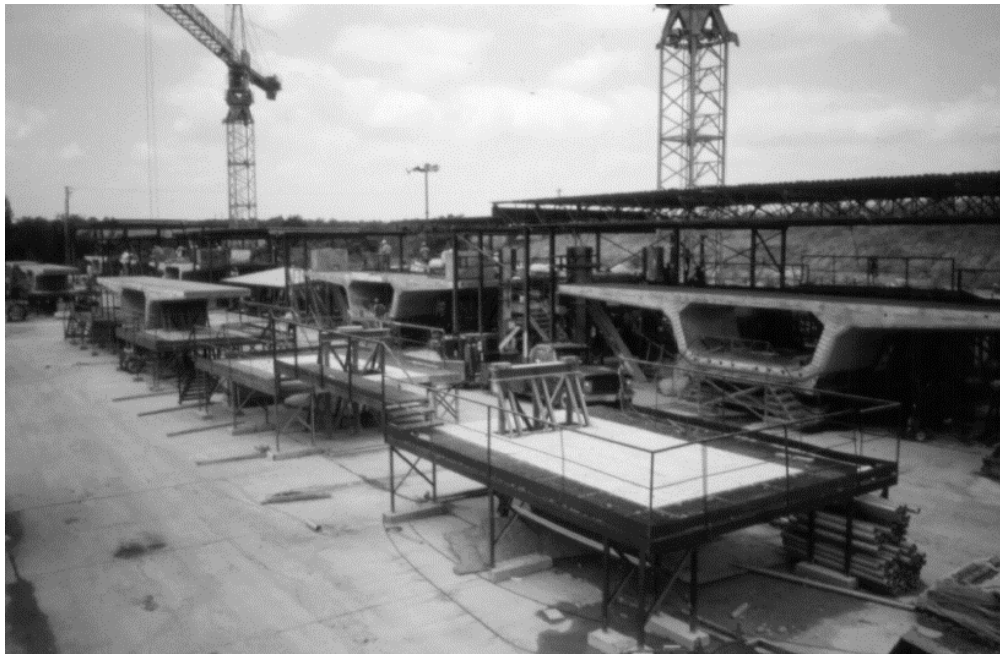
Figure 1.12 Casting machines

All concrete segments were cast at a precasting facility in southeast Austin that was constructed solely for the U.S. 183 segmental project. The precasting yard, shown in Figure 1.11, was constructed in an inactive shallow quarry. The yard had as many as twelve casting machines in operation, serviced by four overhead cranes and one mobile crane (see Figure 1.12). Every pair of casting machines was surveyed from survey houses located along the central axis of the casting yard. Segments were taken to storage from the casting machines by a straddle crane. With no provision to double stack segments, the storage yard filled to near capacity at one point in time. As additional erection trusses came on line, the storage yard emptied and the casting machines were progressively staged out of service.

The casting yard quickly became a model of efficiency, with a segment produced each day from every casting machine, except from the heavy end diaphragm casting machines. Out of the total 3200 segments cast, only about 0.5% were rejected, usually for large voids in congested webs or deviator blocks. Repetition, excellent construction engineering and quality assurance personnel, including the on site TxDOT inspectors, and experienced construction workers resulted in very high quality segments. Project success at the precast yard was important. 60% of the project construction cost occurred at the precasting yard.

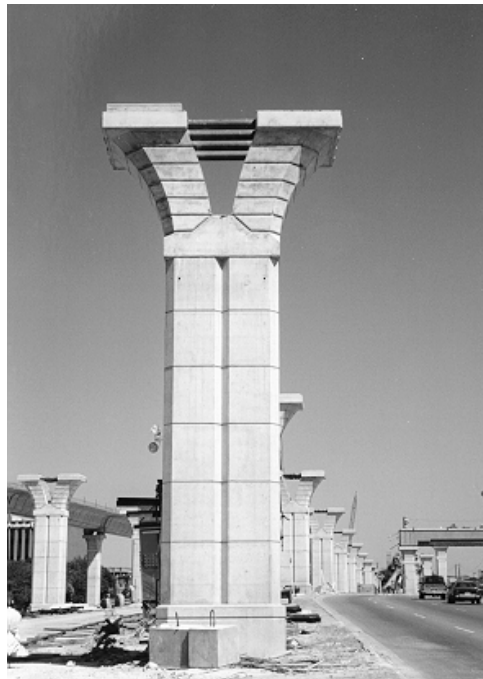
Figure 1.13 Mainlane pier

The standard highway piers used to support I-girder superstructures were rejected for use at U.S. 183 for aesthetic reasons alone. The U.S. 183 mainlane bridge piers are not, by any means, typical bridge piers. They are functional and also innovative, with great emphasis placed on aesthetics, as shown in Figure 1.13. They provide an opportunity to investigate the behavior of a non-standard bridge substructure.

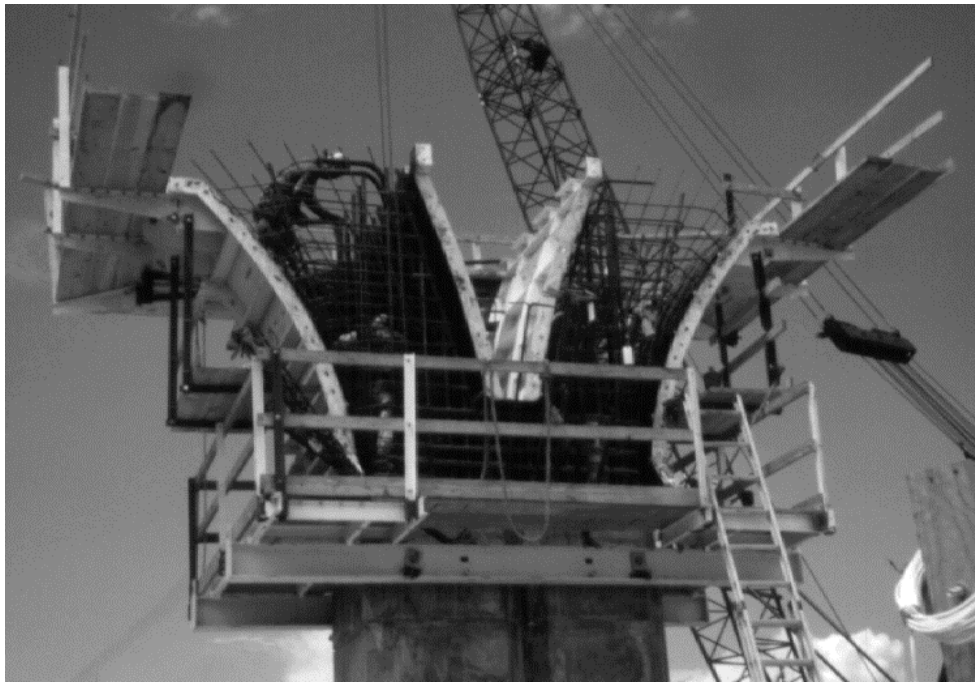
Figure 1.16 Construction of mainlane pier capital

Mainlane pier D6 was selected for instrumentation, and its location is shown on the map in Figure 1.1. Pier construction began at the north end of the project and moved southward, with piers for both C and D mainlanes constructed simultaneously. Selection of pier D6 allowed research to begin as early during construction as possible. Access to pier D6 from the laboratory and from the ground was also optimal. The mainlane piers were cast in two pours above the footing for an overall height of 7700mm. The reinforcing bar cage for the capital was actually tied inside the form, as shown in Figure 1.16. The forms used maintained the appearance, including all chamfers and reveals, originally intended for the pier as a precast post-tensioned structural element.

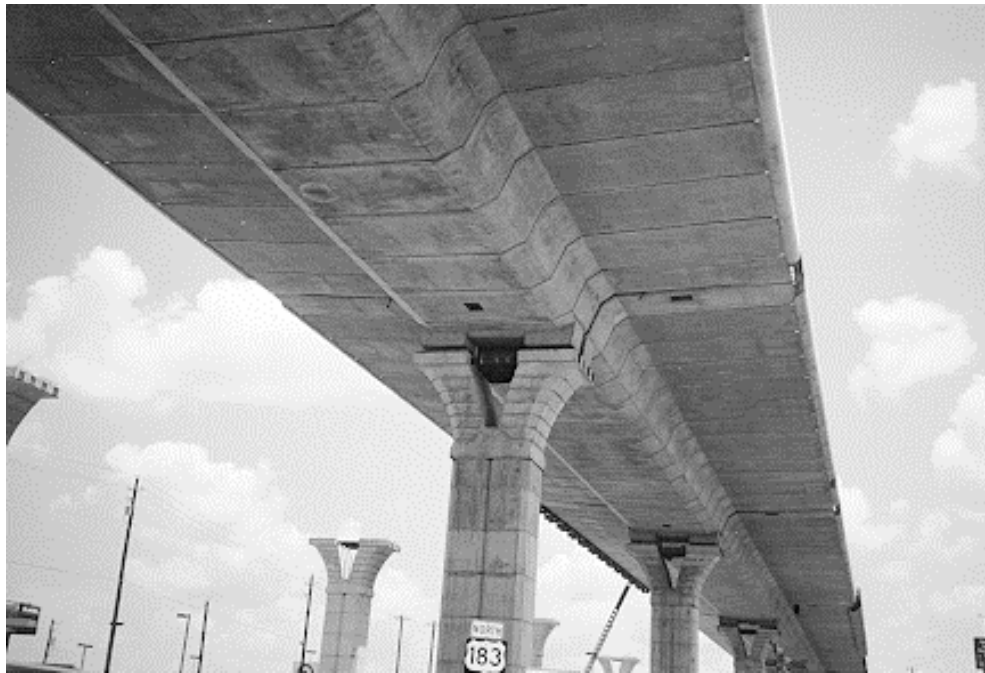
Figure 1.17 Mainlane girder

The general shape of the U.S. 183 mainlane girder was based on a design concept by T.Y. Lin International originally intended for the San Antonio Y segmental project. The girder was conceived as a spine beam with narrow soffit, shallow structural depth, short spans, and very wide wings. The girder actually used at the San Antonio Y maintained the spine beam concept, but had slightly better structural proportions for transverse bending of the top flange. The box girder used for the U.S. 183 mainlane, shown in Figure 1.17, was similar to the San Antonio girder in transverse proportions, but was 300mm deeper in structural depth to accommodate longer spans (39m for U.S. 183 versus 33m at the San Antonio Y). One major difference between the U.S. 183 mainlane girders and the San Antonio Y mainlane girders is the lack of fully continuous spans at U. S 183.

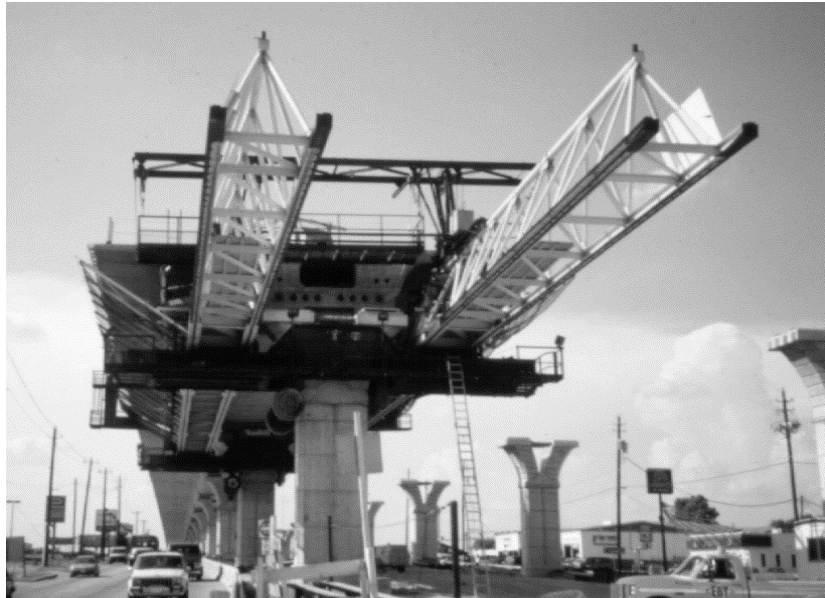
Figure 1.18 Construction of a mainlane girder

The economical method of erecting precast segmental girders up to about 46m in length is by the span-by-span method. This method uses a pair of erection trusses (see Figure 1.18) to construct the bridge one span at a time. All segments are loaded onto the trusses and stressed together generally from one end of the girder. The girder, with ungrouted tendons at this point, must support its own dead load plus the enormous live load of the construction equipment and segments passing over to construct the next span. The flexural stiffness benefits of a fully continuous structure are not realized until after the most critical loads the bridge may ever see have already been placed on the structure. Furthermore, construction of a continuous structure requires that continuity tendon post-tensioning operations, bearing placement, and closure pours occur directly behind the advanced erection trusses, complicating and possibly slowing down construction of the span on the trusses, as seen at the San Antonio Y. From a design standpoint, a continuous box girder must be designed for a thermal gradient load case that creates bending moments over interior piers of a multi-span bridge unit opposite to those induced by live load forces. This requires additional continuity post-tensioning over the interior piers of a continuous bridge unit. For these reasons, TxDOT engineers designed the mainlane structure, and most of the ramp spans, as simple spans. A two or three span partially continuous bridge unit was created, after construction of the girders had been completed, by casting a deck slab between the

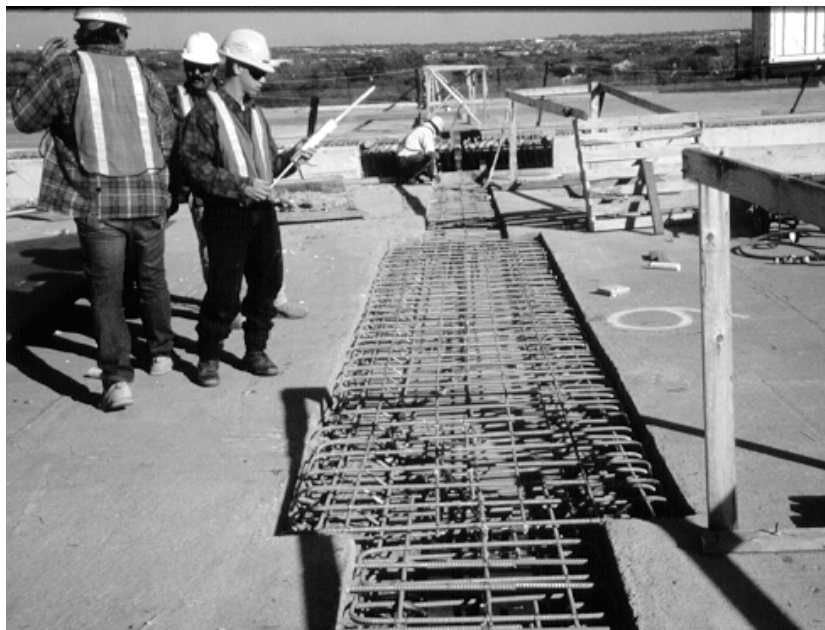
Figure 1.19 Construction of a cast-in-place deck joint

box girder top flanges. This “Poor-boy” continuity, as it is known to TxDOT, provides an inexpensive and smooth riding surface at locations other than the finger joints (see the “Poor-boy” cast-in-place deck joint under construction in Figure 1.19).

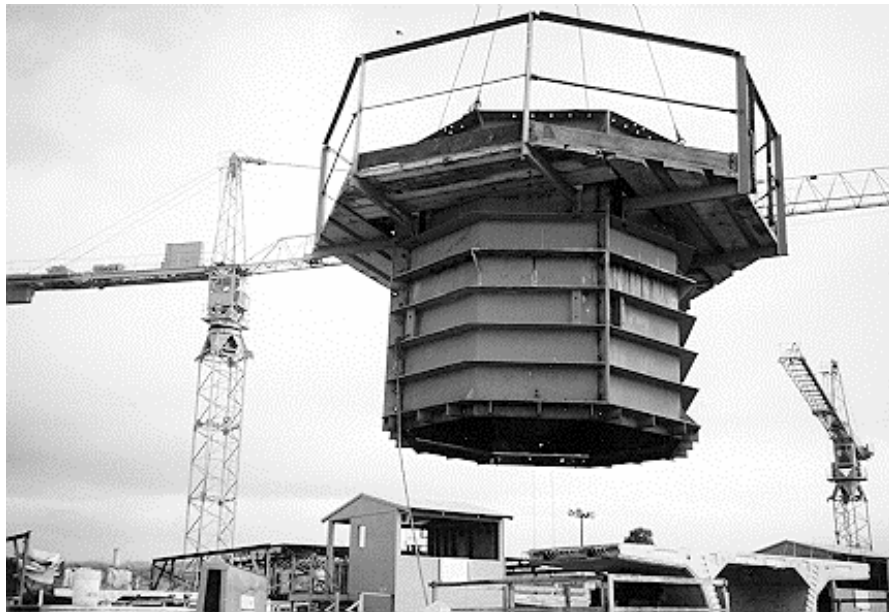
Figure 1.37 Placement of outer pier segment form

The cycle continued with the placement of the steel outer form onto the top of the match casting segment (see Figure 1.37). The form was supported by the segment and a steel support cage with a set of jacks that could be leveled independently of those supporting the bulkhead segment (Figures 1.38 and 1.39). The reinforcement cage, that had been assembled in a jig during the previous day's casting operations, was then lowered into the outer form. Steel ductwork for the post-tensioned tendons and temporary post-tensioning bars, PVC drainage piping, and electrical wiring ducts were placed at this point in the cycle. Steel pipe mandrels were inserted into all ducts to ensure good duct alignment between segments. The inner core form was placed, and blockouts were installed in the top face for temporary post-tensioning bar anchor plates. Lifting hooks were also installed so that the segment could be carried by the yard's straddle crane. Shear keys were formed into the top segment face with small, hand-held key forms inserted into the fresh concrete. The form was made plumb with the match casting segment by the surveyors, then concrete was cast.

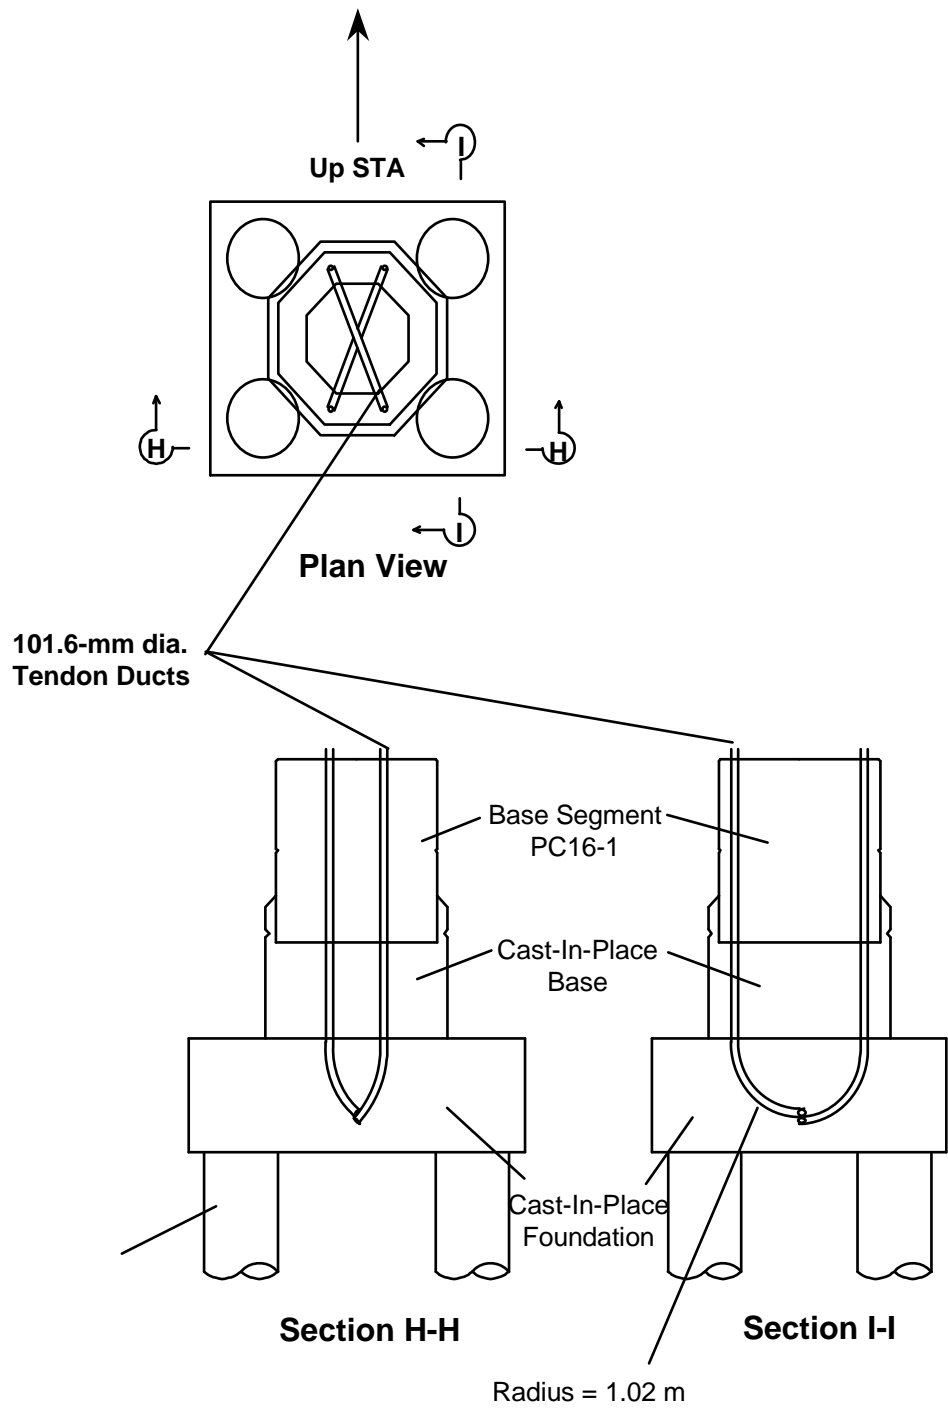
Figure 1.40 U-shaped tendon ducts located in pier foundation

The segmental piers on the U.S. 183 project were designed to be post-tensioned from the top of the capital segment. For this reason the post-tensioning ducts were designed with a U-shaped bend at the base of the pier. Figure 1.40 shows this duct configuration at the pier's foundation. After completion of the cast-in-place foundation, an adjustable steel frame was installed on top of the footing to support the first segment, PC16-1, on pier P16 (see Figure 1.41).

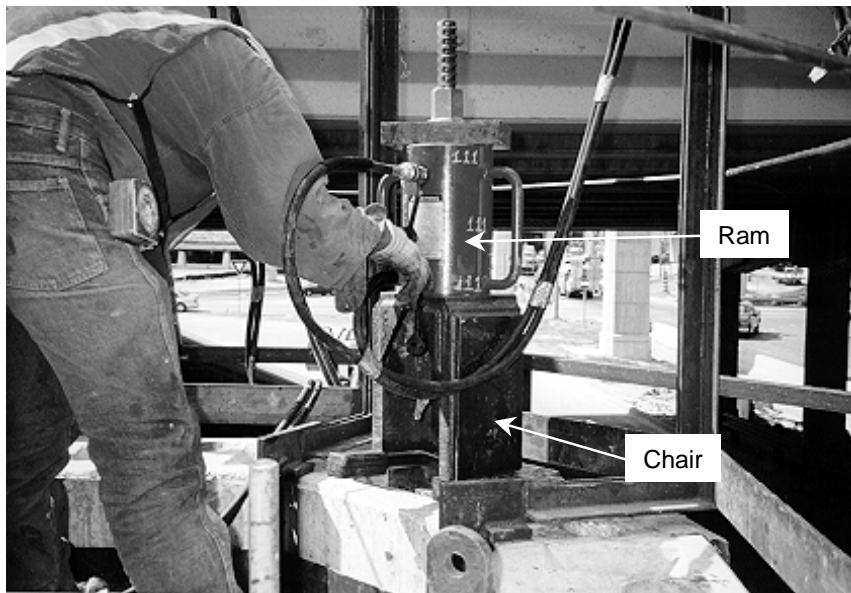
Figure 1.43 Hydraulic ram stressing temporary post-tensioning bars

Subsequent segments, as shown in Figure 1.42, were placed using a mobile crane. Segment joints were epoxyed like the superstructure segments, but the post-tensioning threadbars used to provide the squeezing force on the joint were left in place permanently. Figure 1.43 shows the hydraulic ram used for post-tensioning the threadbars. A portable scaffold was slipped up the pier by the crane as construction proceeded.

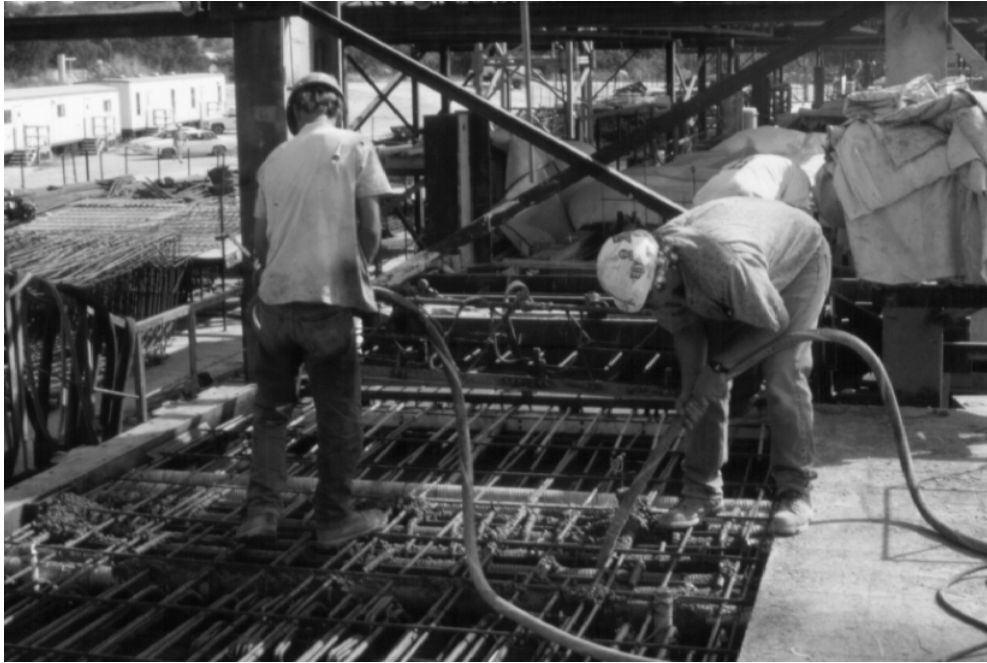
Figure 2.2 Vibrating concrete near instrumentation

Durability of the instrumentation and of the data acquisition systems was a primary concern. Many of the transducers were quite fragile, especially the strain gauges. The gauges were protected from direct impact with multiple layer coatings, but could not readily be protected from vibration, such as during concrete placement shown in Figure 2.2, or more critically from a hammer impact. Many strain gauges were lost entirely during concrete placement, or showed evidence of delamination from the steel to which they were bonded. Since much of the project was precast, many of the gauges had to be installed months ahead of the time they would be needed to take measurements. Although most of the gauges that survived the casting procedure worked well for months or years afterward, some of the gauges demonstrated erratic output or quit working altogether. Thermocouples had nearly a 100% survival rate for the length of the project, easily surviving the casting process and not suffering any long-term degradation. The dataloggers selected for the project were built for field use, and had been used with great success on previous field studies, especially at the San Antonio Y [10]. Many of the instrumentation systems used

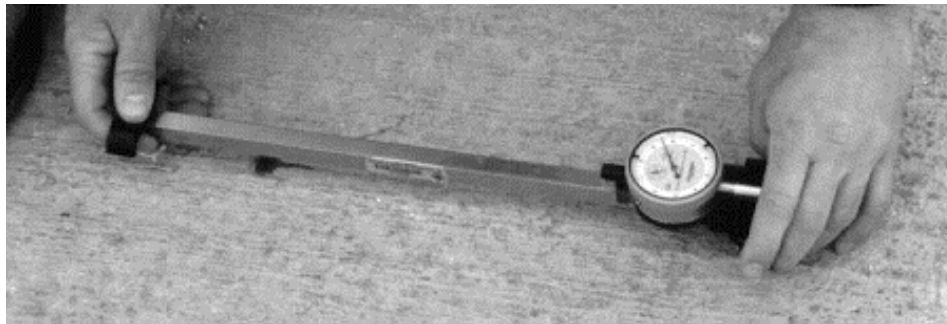
Figure 2.25 The Demec extensometer

A Demec extensometer shown in Figure 2.25, is a mechanical device that measures strain on the surface of concrete or any material. Two steel points are installed into the concrete after it has hardened. These points can be glued to the concrete surface. However, HILTI® brand Hit anchors were used on this project to anchor the points into the concrete to a depth of about 32mm. A small 0.8mm diameter hole was drilled into the steel nail head of the Hit anchor. The Hit anchor was installed into the concrete at the precasting yard storage area. A 10mm hole was

drilled into the concrete. A small amount of epoxy was injected into the hole. The Hit anchor was placed in the hole and hammered firm. Another Hit anchor was then placed a distance of 400mm away from the first point, and in the direction that the strain was to be measured. The Demec extensometer has points on each of its ends that fit into the holes in the Hit anchors, shown in Figure 2.26. One of the points can pivot to accommodate movement between the Hit anchors, and a dial gauge on the reader registers the amount of movement. The Demec extensometer mechanically measures changes in the distance between the two 0.8mm holes in the Hit anchors and gives readings in terms of strain. The Demec extensometer used in the U.S. 183 study had an accuracy of 4×10^{-6} m/m. Demec measured strains gave alternative strain data to compare with the electronic data from the C-gauges.

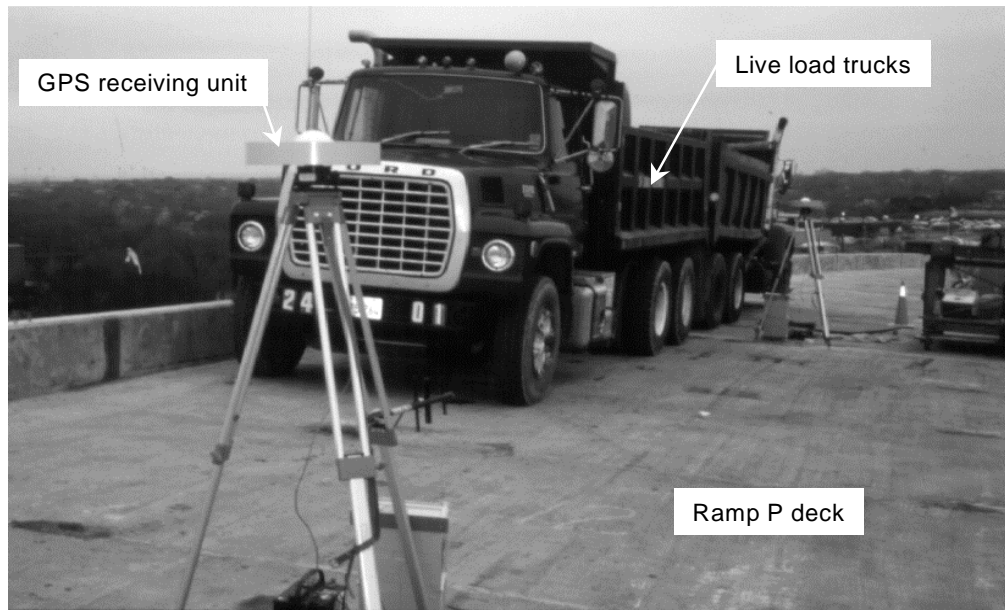
Figure 2.29 GPS deflection measurement equipment

Deflections were also measured with Global Positioning System survey equipment during several tests. The measurements were taken by Michael Hyzak from Applied Research Laboratories of The University of Texas in Austin as an exercise in the use of GPS. Accuracy of the equipment is about 5mm, which was on the same order of magnitude as the measured span deflections under live load. The GPS receiving units were placed at various points along the spans during testing, as seen in Figure 2.29.

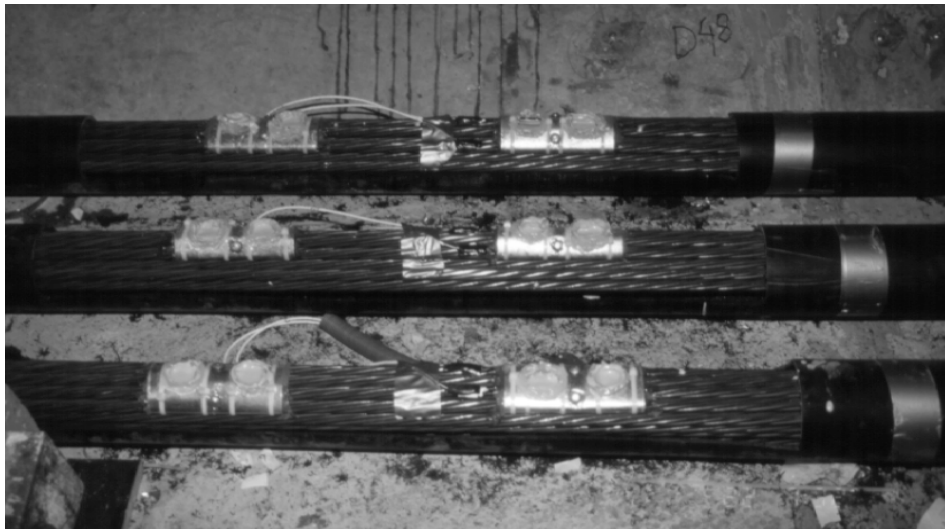
Figure 2.31 Epoxy sleeve strain measurement system

An epoxy sleeve strain measurement system was used to measure tendon strains in the mainlane girder. The system consists of a pair of cylindrical sleeves cast in epoxy around a group of strands. Two sets of Demec points are mounted in each pair of epoxy sleeves. The system was originally developed by Arrellaga [11], and used by Roberts [10] at the San Antonio Y. Because of problems with grouting the ducts after removal of an entire section of duct at the San Antonio Y, only half the duct was removed on U.S. 183, as seen in Figure 2.31. Although tests in the laboratory, such as the bench test shown in Figure 2.32, successfully used the epoxy sleeve system to measure strains, field installation allowed only a partial depth sleeve, which was very difficult to seal. Each epoxy sleeve took about 2 hours to construct. The time would have been better spent installing several more electronic strain gauges at each location. Data from the epoxy sleeves used on the mainlane were quite erratic.

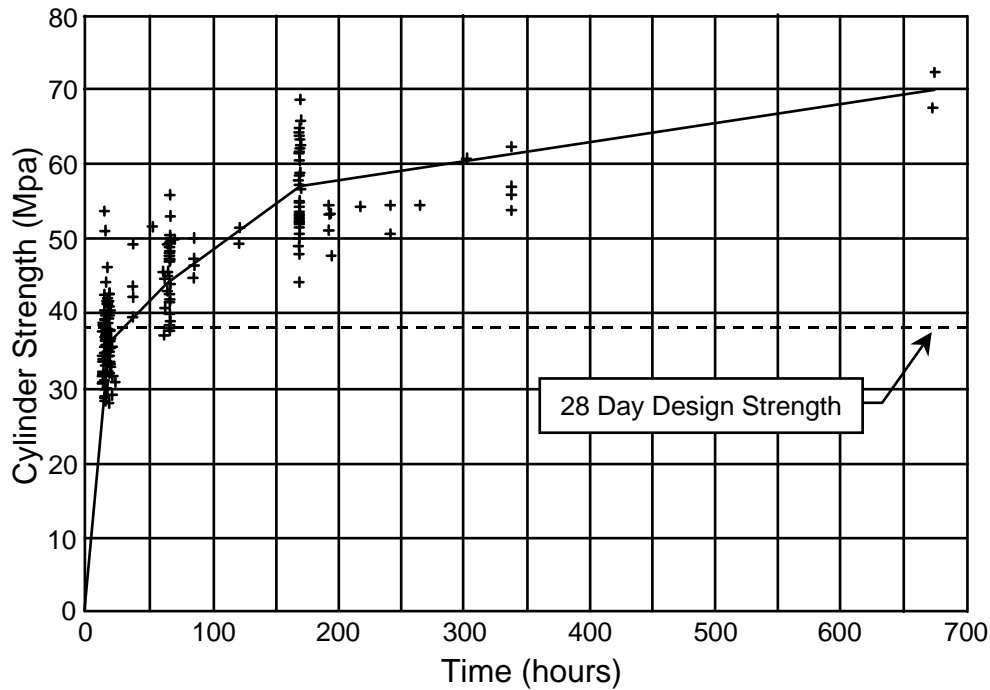
Figure 2.69 Concrete compressive strengths for mainlane D

Concrete compressive strengths (f'_c) measured at the precasting yard for mainlane D are shown in Figure 2.69. Very few of the compressive test cylinders were tested beyond the 7 day break because the 28 day design strength of 37.9Mpa was usually achieved by this point in time. Concrete strengths of over 62Mpa were the norm at 28 days. Strengths probably continued to increase beyond the 28-day strength since 25% of the cementitious material was fly ash.

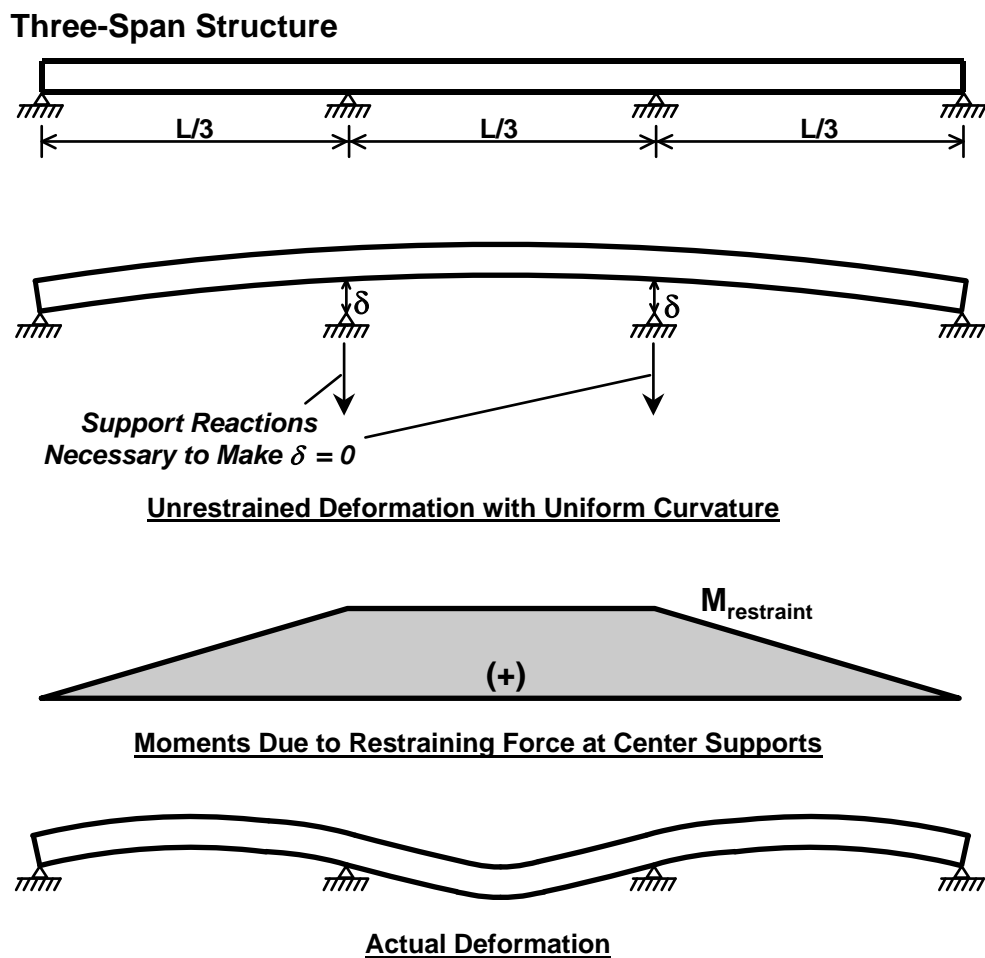
Figure 4.5 Effect of linear thermal gradient components on a statically indeterminate bridge structure

Figure 4.5 shows the response of a three-span continuous structure under the same linear thermal gradient loading as shown for the girder in Figure 4.4. In this case, the uniform elongation from the uniform temperature change is accommodated by expansion bearings at three of the four bearing locations. On the other hand, the girder cannot assume its new equilibrium position in a circular shape because of the dead weight of the structure or restraint at the bearings. The new equilibrium shape of the girder causes bending in the girder and reactions at the bearings.

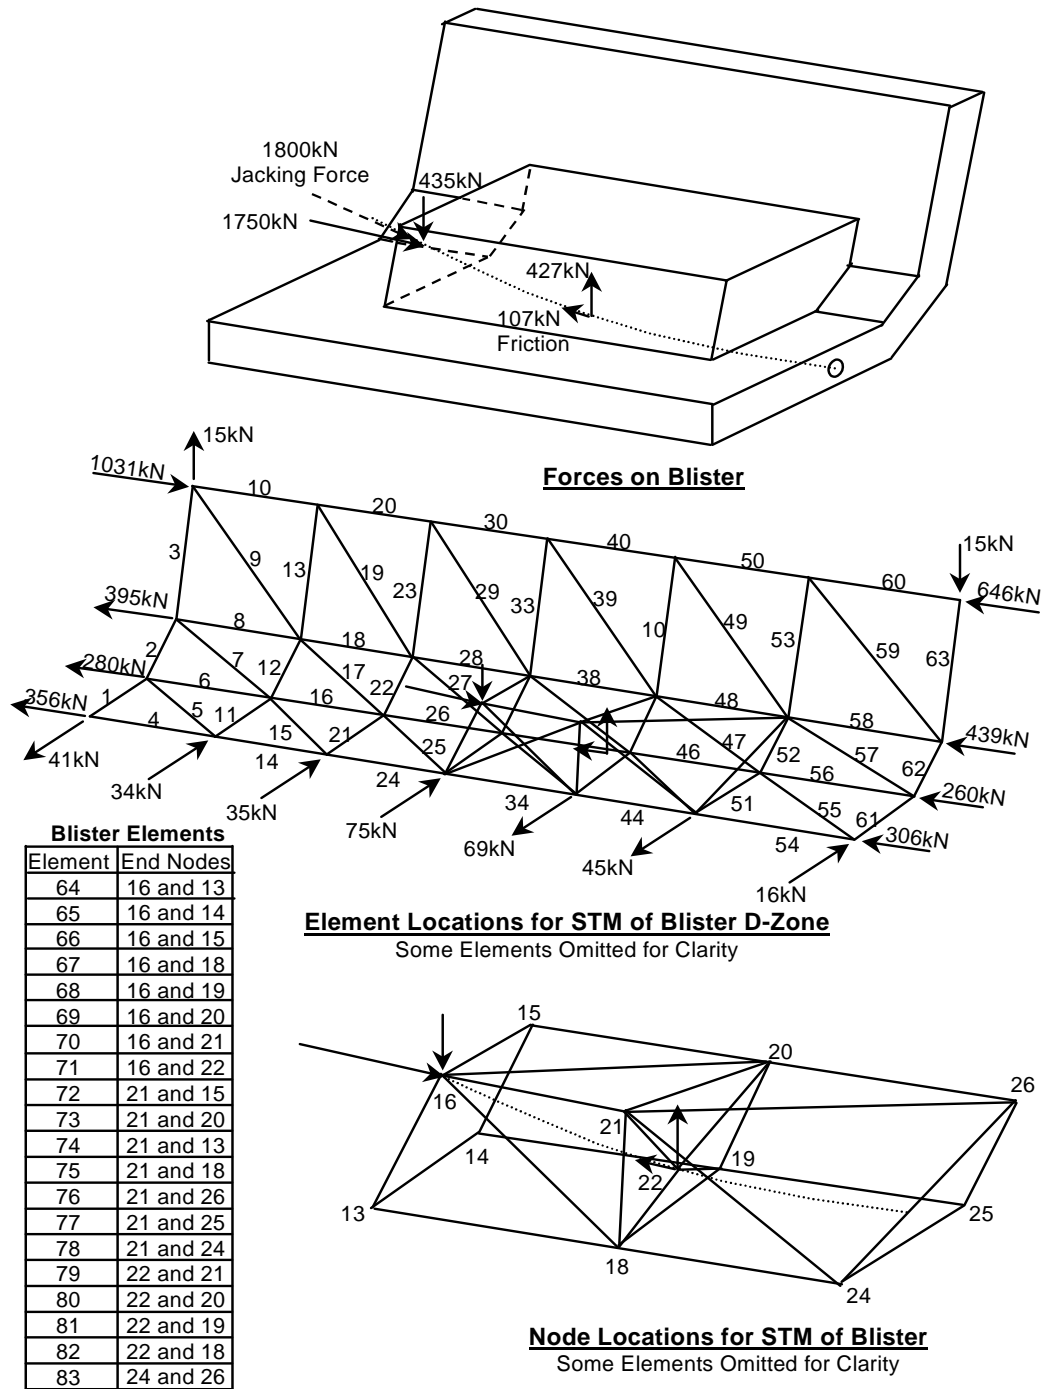
Figure 6.36 Strut-and-Tie model for segment P16-4 anchorage blister for service load forces from Tendon T22

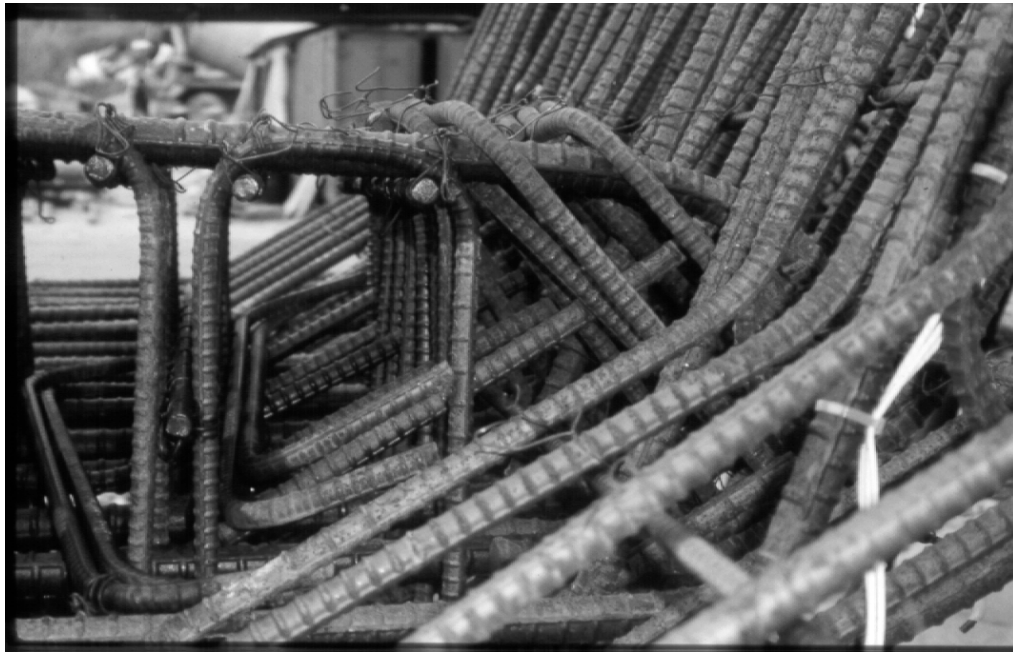
Figure 6.38 Ramp P girder segment P16-10 deviator to web detail

Priority should be given to the placement and development of the bars connecting the deviator to the webs, since this is the critical force path for developing the ultimate moment capacity of the girder. Figure 6.38 is a photograph of the actual reinforcement connecting the deviator to the web of the ramp P girder. This demonstrates that the heavy concentration of web to bottom slab fillet typical reinforcement, as well as the main web reinforcement, makes it difficult to include properly located and anchored inclined reinforcement. The excellent performance ($\epsilon_{smax} < 10\% \epsilon_y$) dictates that some reinforcement might be removed. Prime candidates for removal would be those bars placed parallel to the compression field. Further model tests could confirm the result of reducing such reinforcement.

Deviator ducts should be smoothly radiused over the full length of the deviator to improve service level performance. A sharp bend may also increase friction between tendon, grout and duct, increasing horizontal loads on the deviator at ultimate. The reinforcement details for both deviators were easily constructed at points away from the girder webs. Near the web to deviator intersection, the heavy web stirrup bars and other bars transitioning the web to the bottom flange remained unchanged from that for a typical section. This left little room for the deviator top bars or shear reinforcement.

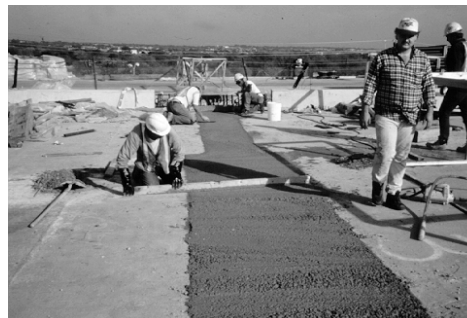
Figure 7.3 Actual cast-in-place joint construction

The contractor decided to provide temporary construction access along the length of the bridge deck by spanning the gaps between spans with heavy timbers covered by steel plates instead of using the concrete drop-in panel. The joints were then fully cast-in-place three at a time well after construction of the main spans. The construction sequence of the joints is shown in Figure 7.3. All reinforcing was epoxy coated, including the 90° splice bars in the anchor segment.

c). Deck joint concreting
