**Response of Stay Cables to High-Amplitude Vibration**

**Thesis**

The University of Texas at Austin

**May 2001**

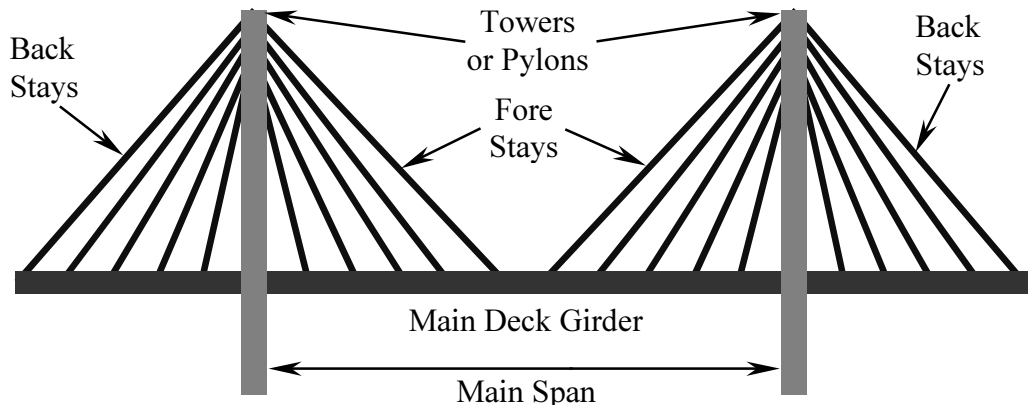
**Figure 1.5: Major Components of a Modern Cable-Stayed Bridge**

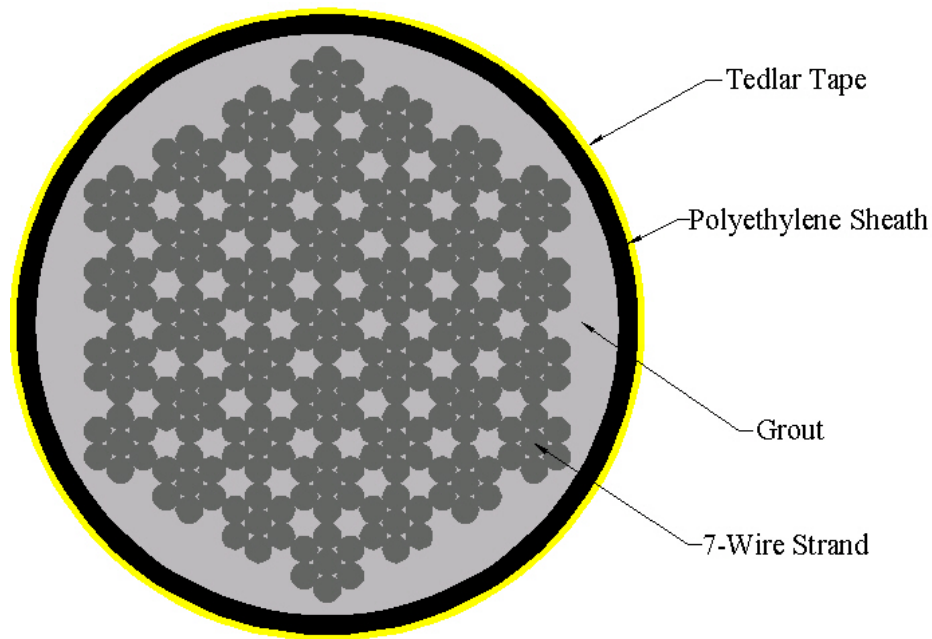
**Figure 2.6: Example Cross Section of Grouted Stay Cable**

Theoretically, the grouted cable corrosion protection scheme should provide the load carrying steel with a dual barrier from a corrosive environment. Recent tests at the University of Texas at Austin by Hamilton (1995) have indicated that this belief may not be true. Hamilton found that wherever the polyethylene sheath was breached, the grout contained fine cracks attributed to either traffic load or shrinkage encouraged by the exposure to air that was provided by the breach in the sheath. This discovery has spawned concern over the adequacy of corrosion protection systems for stay cables (Hamilton 1995).

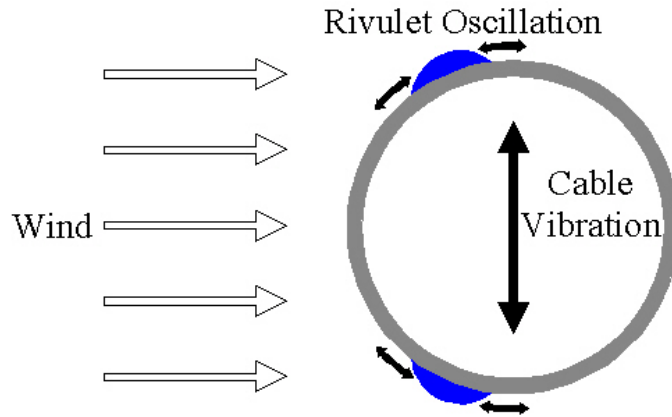
**Figure 2.8: Rain-Wind Induced Vibration**

Eventually the mechanism of rain-wind induced vibration was established. In short, rainwater streaming down a smooth stay cable forms one or more rivulets that alter the cable's aerodynamic profile. In combination with wind forces, this altered profile can experience large amplitude oscillations. As the cable vibrates, the rivulet or rivulets oscillate at the same frequency as the cable, continuously changing the cable's cross-section and maintaining the vibration (Figure 2.8). The formation of rivulets is the key to the vibration mechanism. Therefore, the phenomenon can occur even in light rain. Further, heavy wind can blow the water off of the cable preventing rain-wind induced vibration. The

severity of this form of cable movement lies in the typically large displacements that are produced. Stay cables are tested for axial fatigue, but they are not fatigue tested for the bending of the magnitude observed during rain-wind induced vibration.

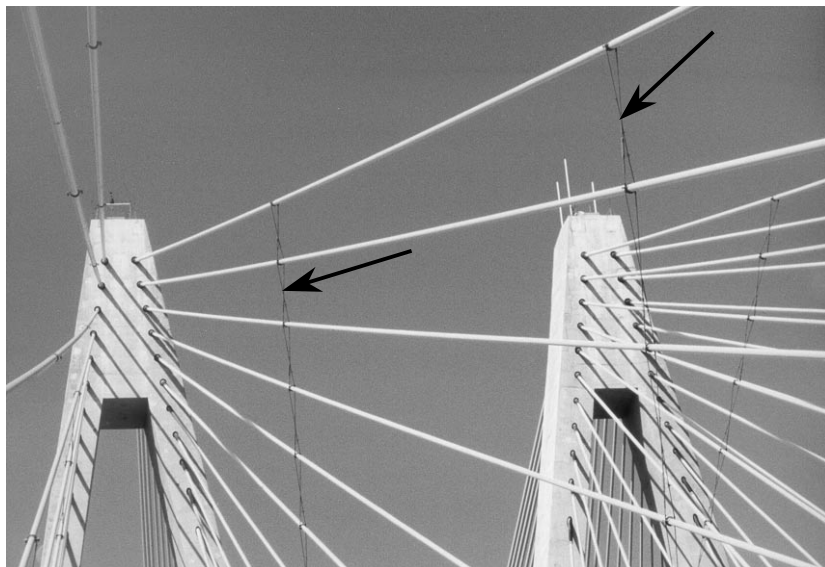
**Figure 2.9: Cable Restrainers on the Fred Hartman Bridge**

Structural mitigation involves the addition of structural elements to the design to restrain vibration. Cable restrainers or cross ties are commonly used to connect adjacent cables to one another (Figure 2.9). The cable restrainers stiffen the stay cable system and allow vibration energy from one cable to be transferred to others. The cross ties generally prevent a single cable from vibrating in a low mode. However, a single stay cable may still vibrate at higher modes, or the plane of stays may still vibrate as a unit. Overall, though, this technique has been successful at reducing rain-wind induced vibration. Nevertheless, this form of structural mitigation is not considered aesthetically pleasing and is expensive to maintain. Therefore, cable restrainers are used often only as a temporary control device (Yamaguchi and Fujino 1998; Virlogeux 1998; Bournand 1999).

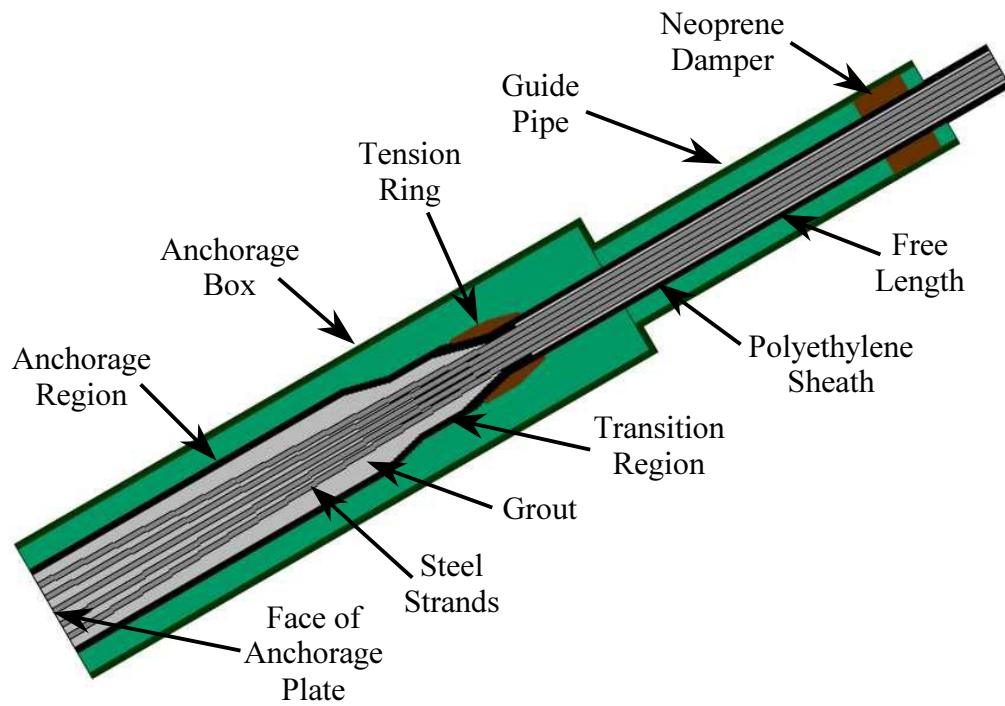
**Figure 3.4: Cross Section of Typical Stay Cable Anchorage**

Each cable has a constant free length diameter, which then becomes larger at the anchorages (Figure 3.4 and Figure 3.5). At the anchorage, each strand is secured into an anchor head or anchorage plate with wedges. The larger diameter of pipe at the anchorage is referred to as the anchorage region and contains the strand profile that reduces the arrangement of the strands into a compact configuration. A tension ring is positioned at the beginning of the free length that facilitates the transition of the strands into this compact arrangement. A steel anchorage box and a steel guide pipe enclose each cable's anchorage region and

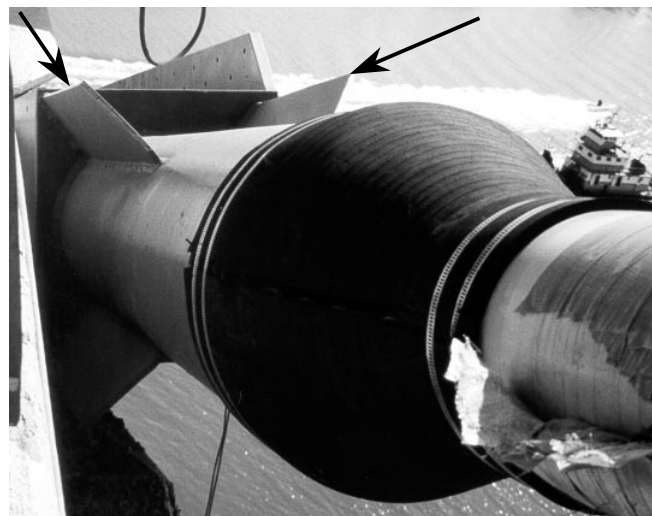
**Figure 3.8: Retrofit Stiffeners on Guide Pipe**

While the stiffeners do allow the guide pipe to better resist excessive cable vibration, they do not prevent or control the vibration itself. Additionally, the cable restrainer system is designed to be temporary. Therefore, a permanent solution to the problem of rain-wind induced vibration on the Fred Hartman

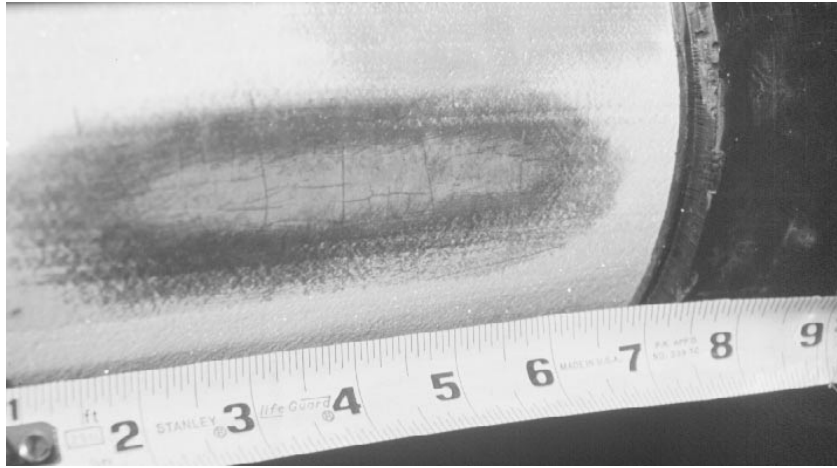
**Figure 3.11: Inspection of Grout in Anchorage Region**

Grouted stay cable systems are difficult to inspect for fatigue damage because the load-carrying steel strand is not visible. Rather than compromising

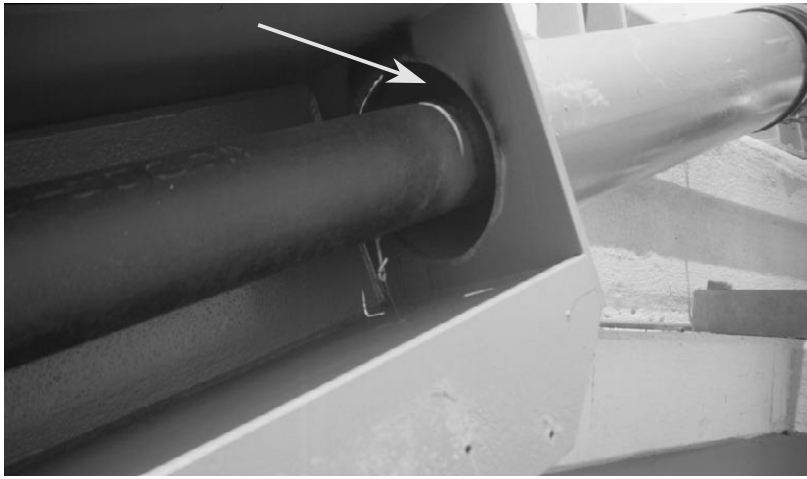
**Figure 3.12: Location of Polyethylene Sheath Inspection**

An inspection of the exterior of the polyethylene pipe was also conducted at the location where the cable exits the anchorage box and enters the guide pipe (Figure 3.12). For the estimated displacement amplitudes of Table 3.1 to be accurate, damage to the polyethylene pipe in this area of minimal clearance was expected. For cables A24N, A24S, and A23S, indentations were found that go all the way around the pipe (Figure 3.13). Each depression is consistently deeper on

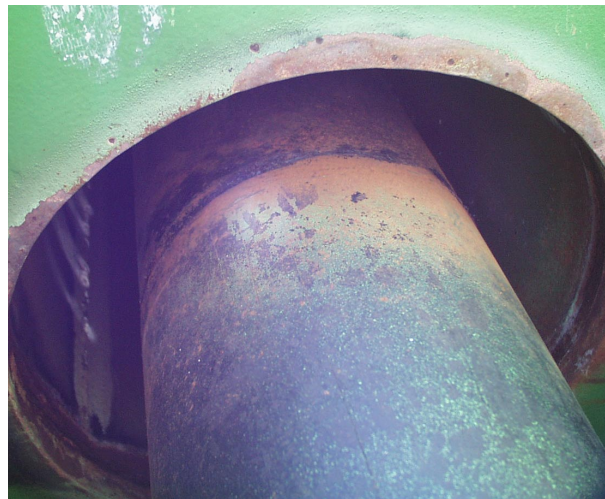
**Figure 3.13: Indentation in Polyethylene Sheath at Anchorage Box**

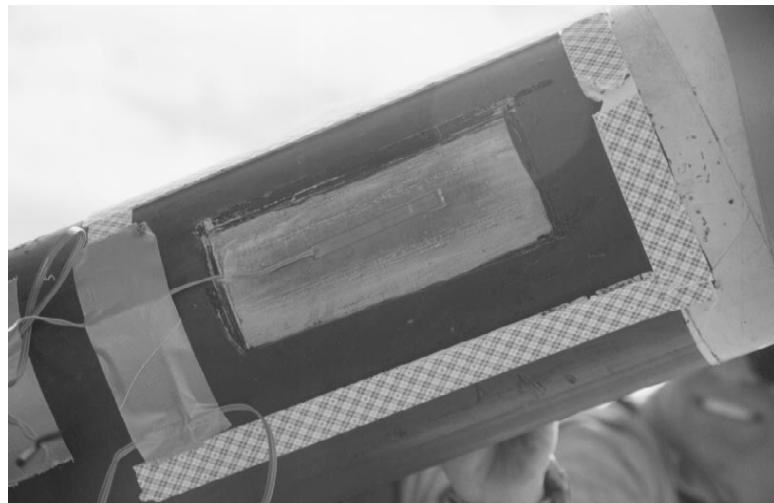
**Figure 3.14: Strain Gage Applied to Grout Surface**

Multiple strain gages have been attached to the exterior grout surface of several stay cables over the past few years in order to measure ambient traffic response (Figure 3.14). A sample of these data is shown in Figure 3.15. The plot shows strain from four strain gages applied around the circumference of the cable at approximately the same distance along the cable's length. The four gages shown were installed on the top, bottom, inside, and outside of the cable (Figure 3.16). Each of the four gages provides a similar strain history, indicating that the cable was acting predominately as an axial member. If the cable had been

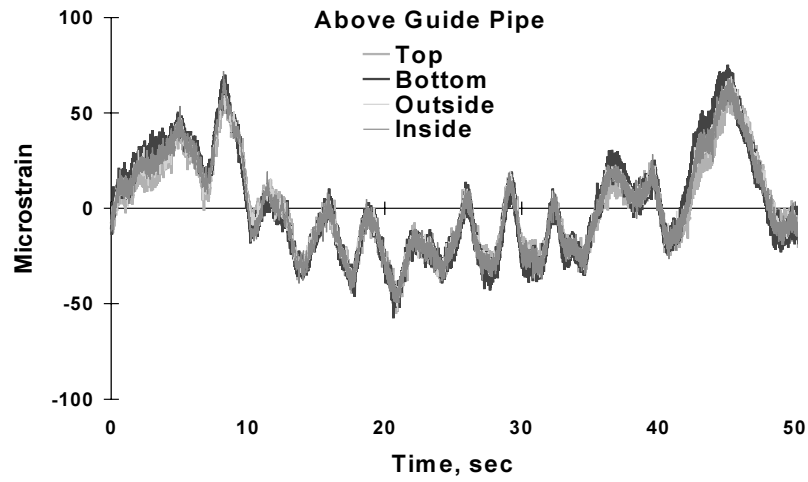
**Figure 3.15: Sample Strain Data Produced by Ambient Traffic Response**

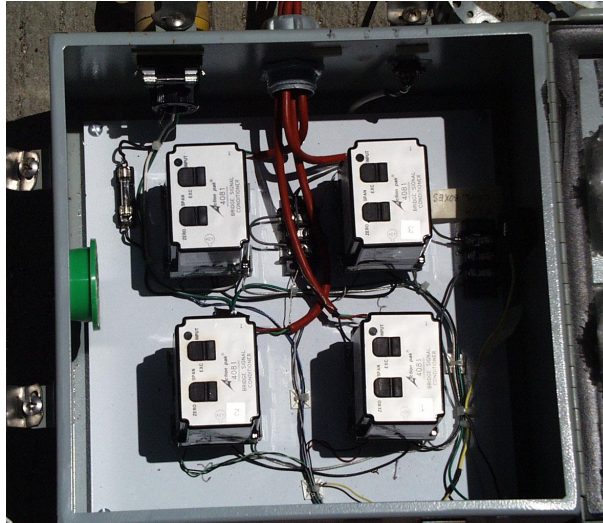
**Figure 4.2: Four Signal Conditioners Mounted in a Box**

To circumvent this problem, the instrumentation installed on the bridge included signal conditioners (Figure 4.2). These devices were enclosed in a box attached to the guardrail near the gaged cables and accepted the voltage signal from the strain gages. One signal conditioner was required for each gage. A schematic of the strain measurement instrumentation is shown in Figure 4.3. Each signal conditioner changed the respective voltage signal into a current signal, which was then transmitted to the pylon containing the data acquisition system. Before the signal was read, however, it had to be converted back into a voltage signal because the data acquisition system could only monitor voltage. This conversion was accomplished by routing the current signal across a known resistance to produce a voltage proportional to the current. Finally, the voltage signal was recorded by the data acquisition system.

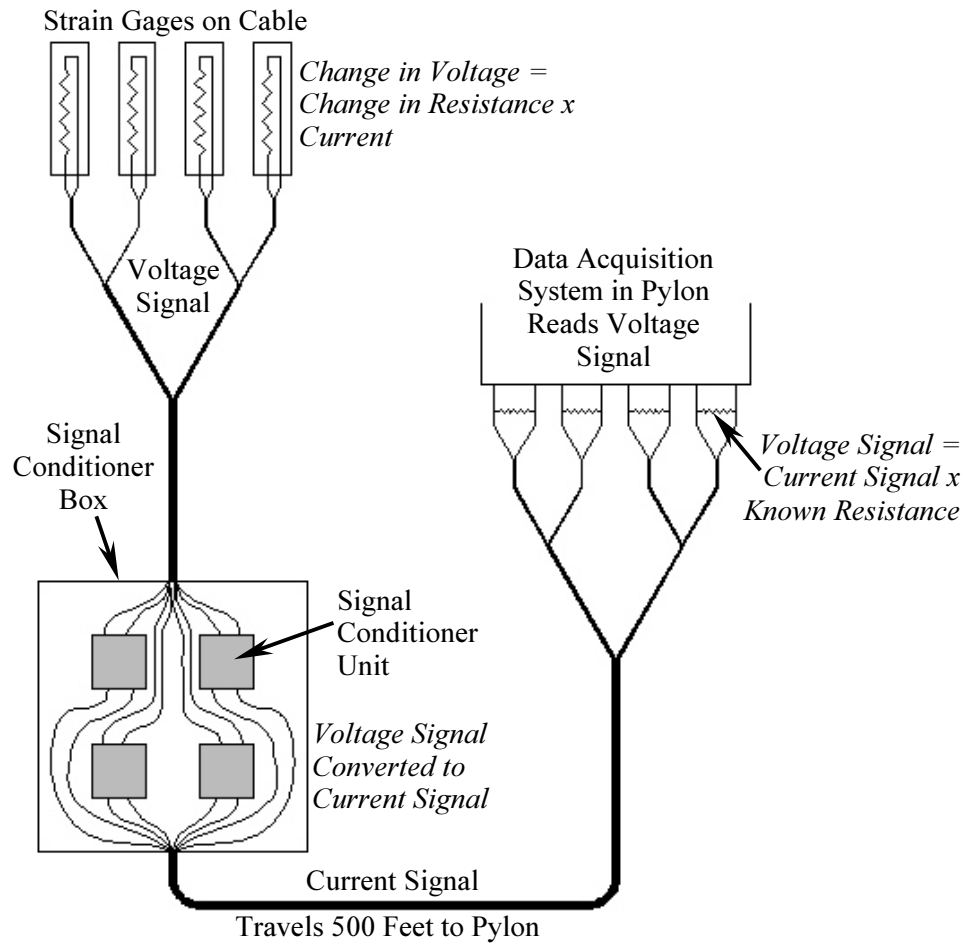
**Figure 4.3: Schematic of Instrumentation for Strain Data Collection**

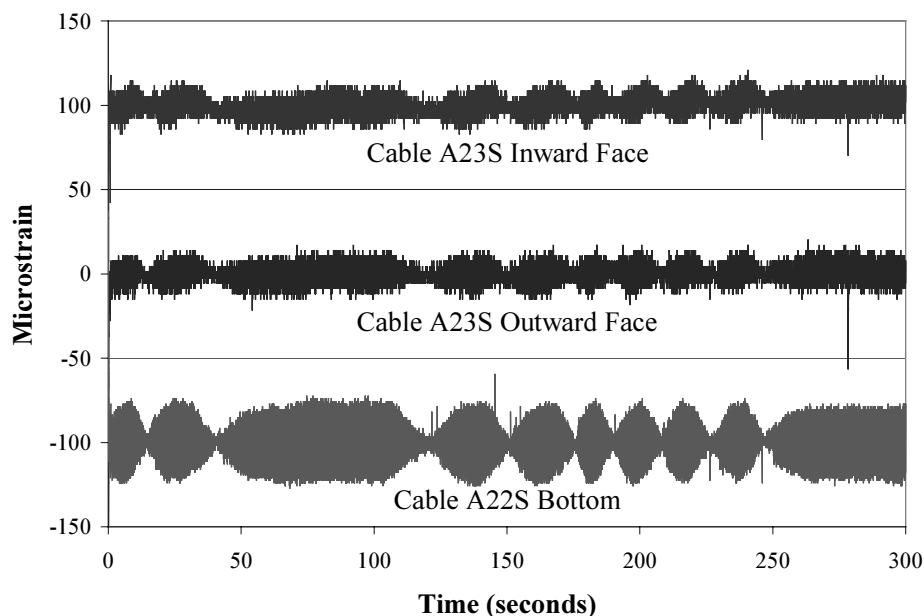
**Figure 4.6: Typical Noise Signal from Strain Data Collection**

Despite the inadequacy of this first group of data records, some valuable information was gained. At least one gage required replacement. Of the three gages that provided information, all exhibited a significant amount of noise that resulted in a beating-type signal shown in a sample record (Figure 4.6). The zero of each gage's signal was shifted so that each history could be displayed

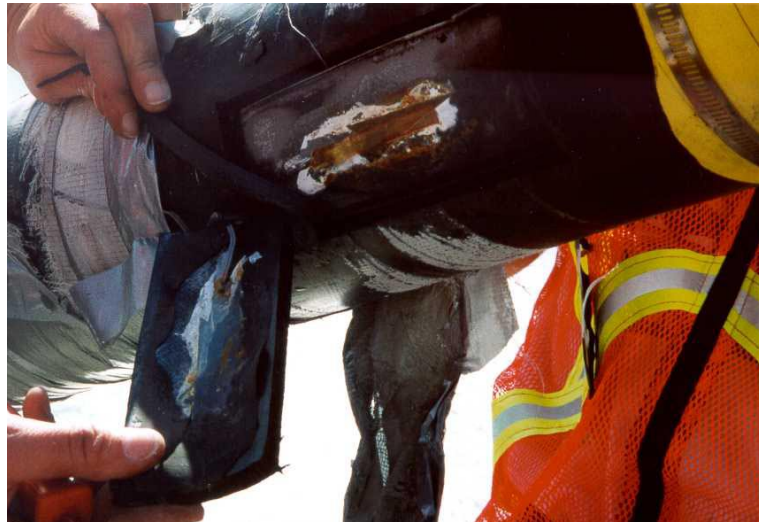
**Figure 4.7: Corrosion Damage to Strain Gage**

In April of 2000, the strain gages connected to the instrumentation system were inspected. Severe corrosion was found at the location of the gage that had stopped responding (Figure 4.7). The corrosion was attributed to a process initiated by the temporary breach in the polyethylene sheath. Injected grouts very frequently contain water-retentive admixtures that trap moisture (Feld and Carper

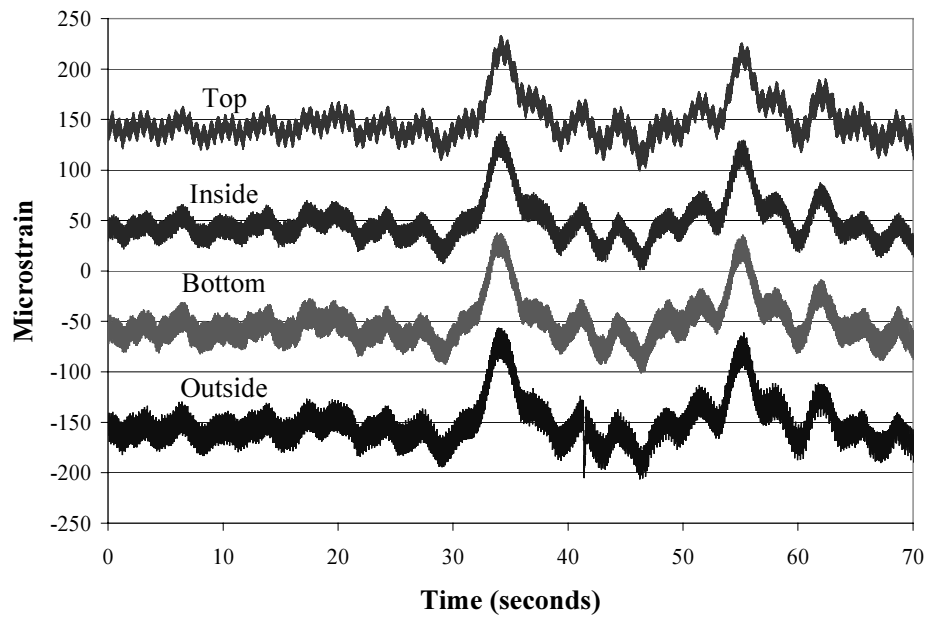
**Figure 4.9: Sample Traffic Data Collected by CR9000 on Cable A22S**

After reinstallation, several five-minute, 40-Hertz records, from triggered events, were obtained from the Johns Hopkins University monitoring system. A plot of a typical excerpt from one of these data sets allowed a relative comparison of noise levels among the individual signals (Figure 4.10). The zero of each

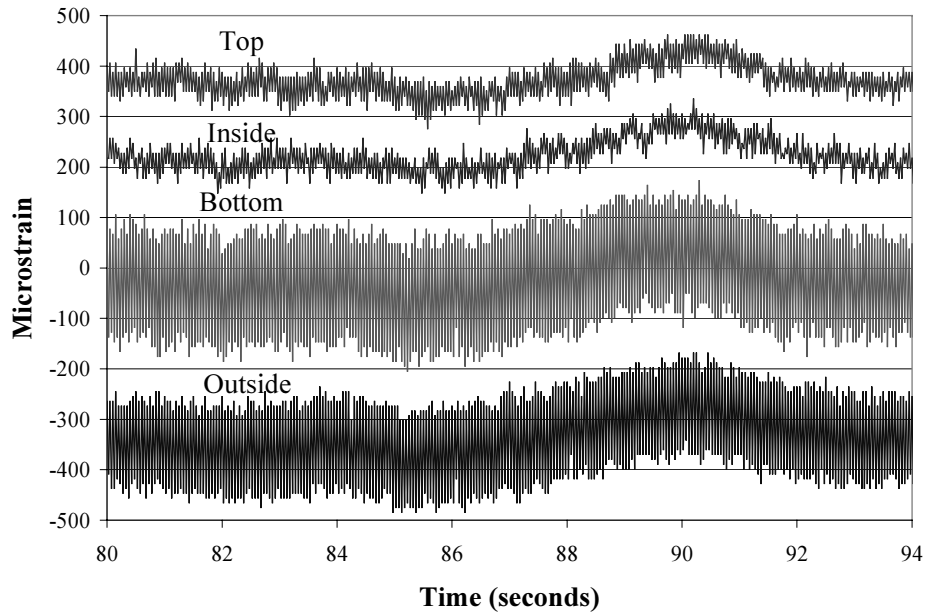
**Figure 4.10: Typical Strain Record Excerpt from Cable A22S Following Reinstallation of Instrumentation**

gage's signal was again shifted for visual clarity. The top and inside strain gages displayed a noise level corresponding to a 40-50 microstrain range, while the bottom and outside gages exhibited almost a 200 microstrain variance. All of these noise levels were very high, but the 200-microstrain range was considered to be unacceptable. Nevertheless, all four gages revealed an axial strain event, signifying actual strain data within the record, but the excessive noise caused noteworthy events to be difficult to identify. Therefore, the strain collection system had been improved in that strain events were being detected, but considerable noise was still presenting a significant problem.

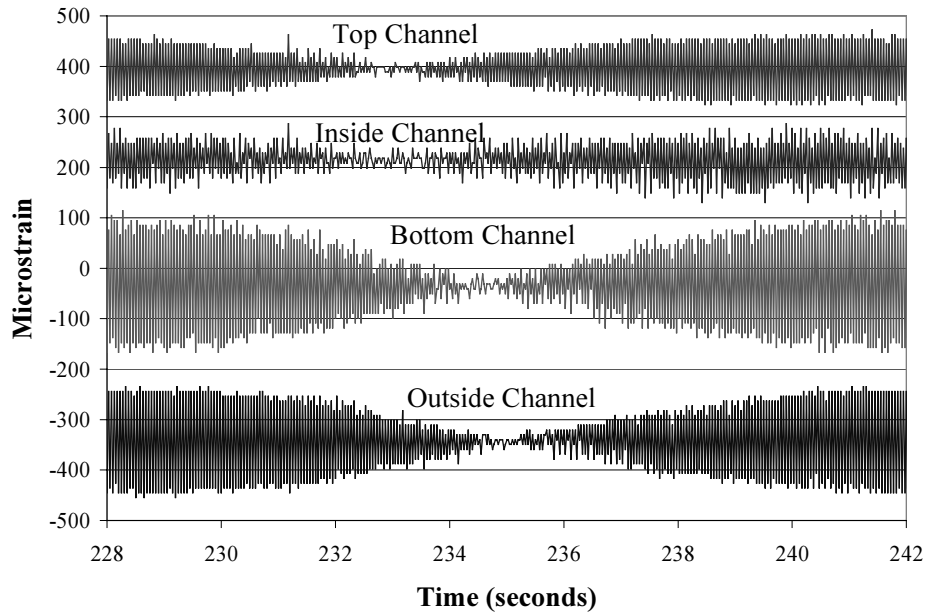
**Figure 4.11: Typical Signal Excerpt from the Channels Assigned to Cable A22S Prior to Reinstallation of Instrumentation**

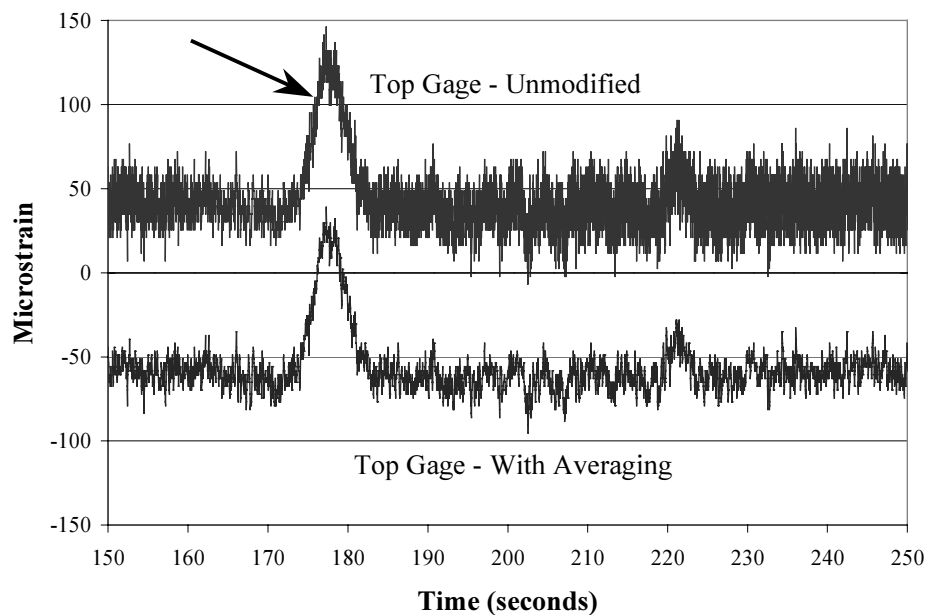
**Figure 4.12: Strain Record Excerpt from a Typical Traffic Event**

techniques, but using a floating point averaging method provided higher clarity (Figure 4.12). Strain signals from traffic events were not periodic. Rather, they consisted, generally, of a single large peak. The large peaks, typically with a magnitude of approximately 100 microstrain, were likely heavy trucks. Assuming that the strain in the grout was identical to the strain in the steel strand, the 100-microstrain range may be translated into a fatigue steel stress range of almost 3 kips per square inch (20 megaPascals). The most significant traffic event reached a strain of almost 200 microstrain (6 kips per square inch, 40 megaPascals), but smaller peaks were observed as well. For example, Figure 4.12 shows a smaller peak around 220 seconds. As demonstrated in the plot, these smaller peaks are more difficult to identify within the noise. The characterization of axial strain from traffic was validated by similar events that were witnessed while recording

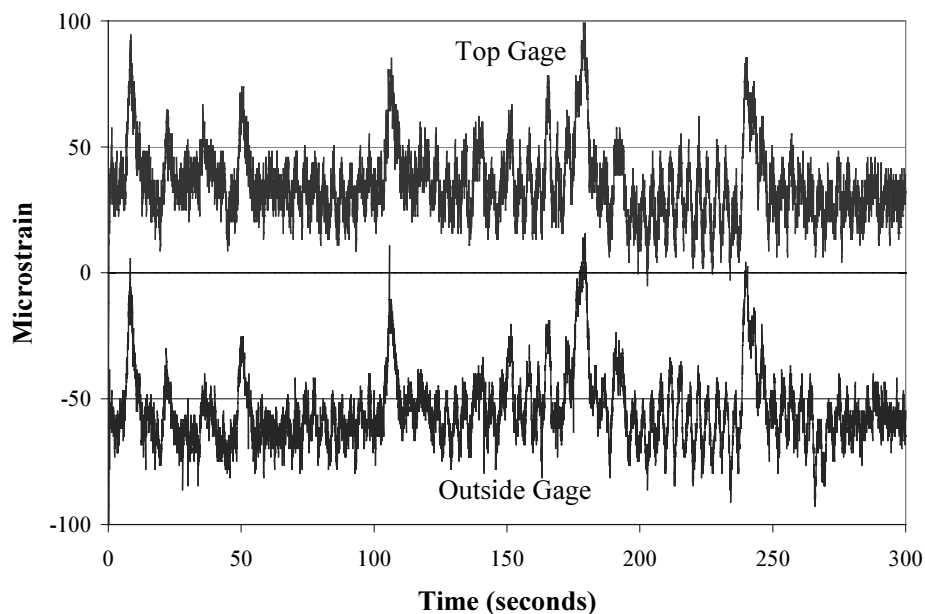
**Figure 4.13: Five Minute Strain History (with Floating Averaging) Showing Traffic Events and Deck Vibration**

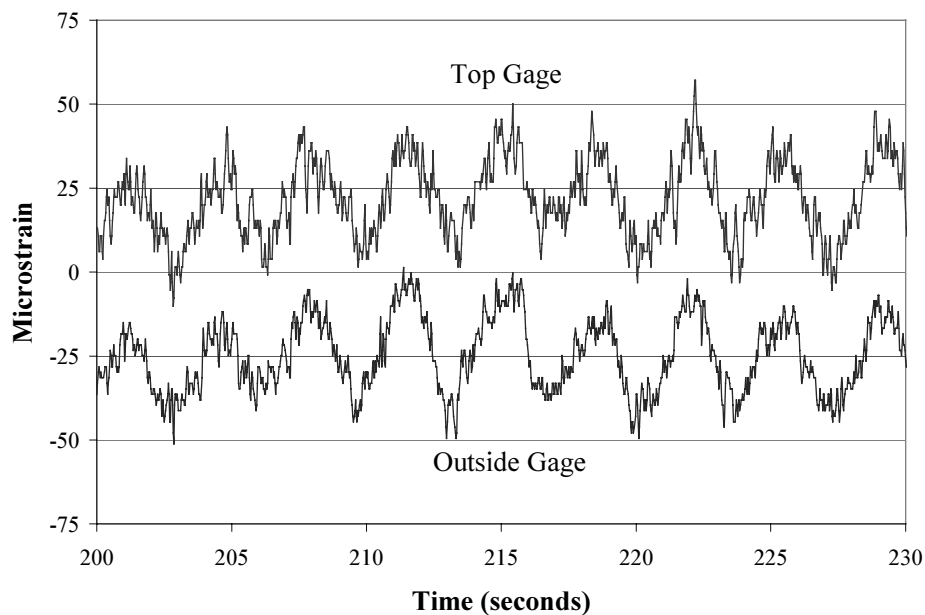
**Figure 4.14: Strain Record Excerpt from a Typical Deck Vibration Event**

Cable A22S, the element from which the strain measurements were taken, possessed a fundamental first mode frequency near 0.7 Hertz. As the frequencies for all other modes of vibration are higher than the first mode's frequency, the strain history exhibited in Figure 4.14 was likely not the result of cable vibration. Johns Hopkins University recorded and calculated that the first two modes of vibration of the Fred Hartman Bridge's deck were very close to 0.29 Hertz. Thus,

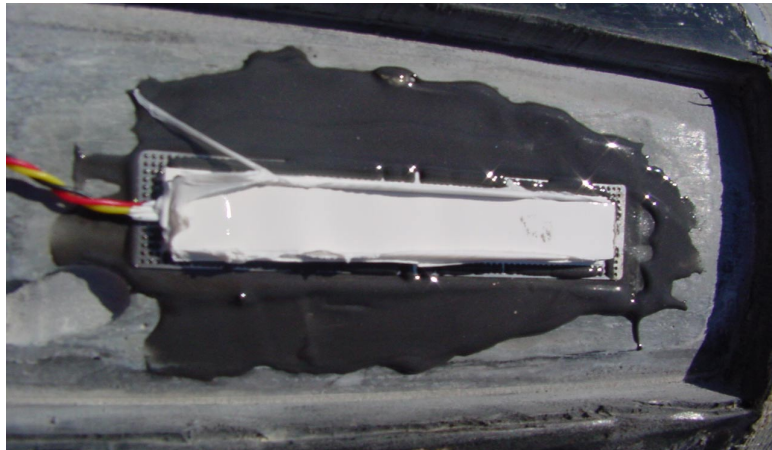
**Figure 4.15: Encapsulated Strain Gage on Cable A22S**

In addition to the four strain gages mounted on cable A22S at the level of the guardrail, two strain gages were installed near the tension ring of the same stay cable. Gage application was limited in this region due to the confinement of

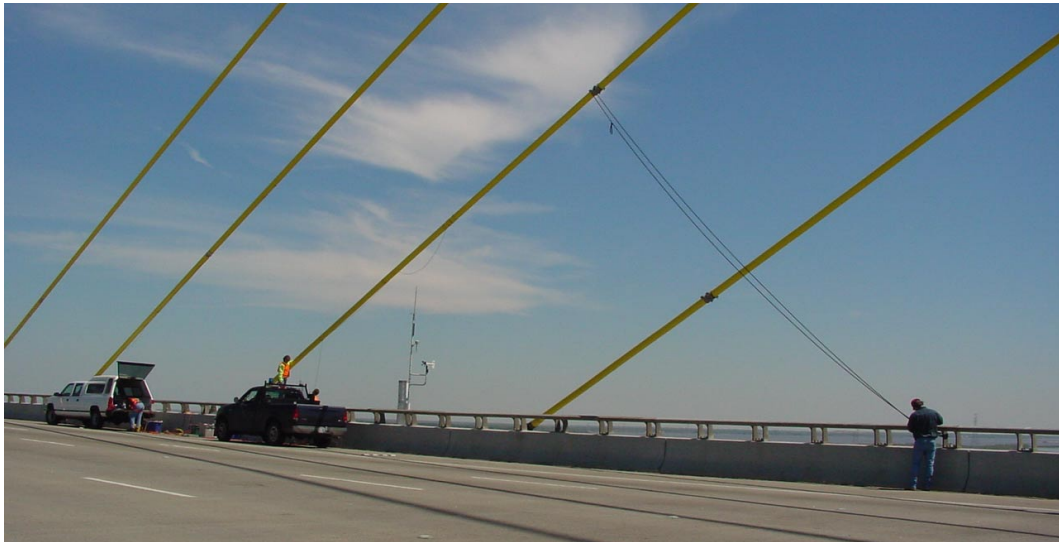
**Figure 4.16: Pluck Test of Cable A22S**

To establish a relationship between strain and vibration of cable A22S, an attempt was made to excite the cable manually. Whitlock Dalrymple Poston and Associates (WDP) had performed pluck tests to experimentally determine the frequencies of the lower modes of vibration of several stay cables (Kesner and Poston 1999). The test procedure involved imposing a forced vibration by pulling on a rope attached along the free length of the cable (Figure 4.16). So the forcing frequency did not affect the results, data was collected during the free vibration period directly following the excitation. Investigation of the frequency domain of

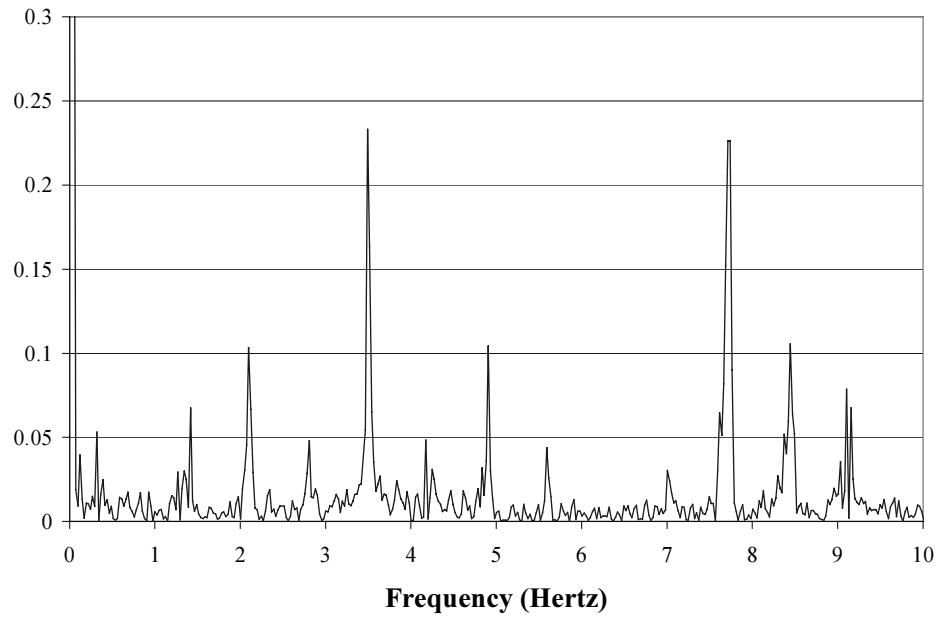
**Figure 4.17: Sample Acceleration Frequency Response**

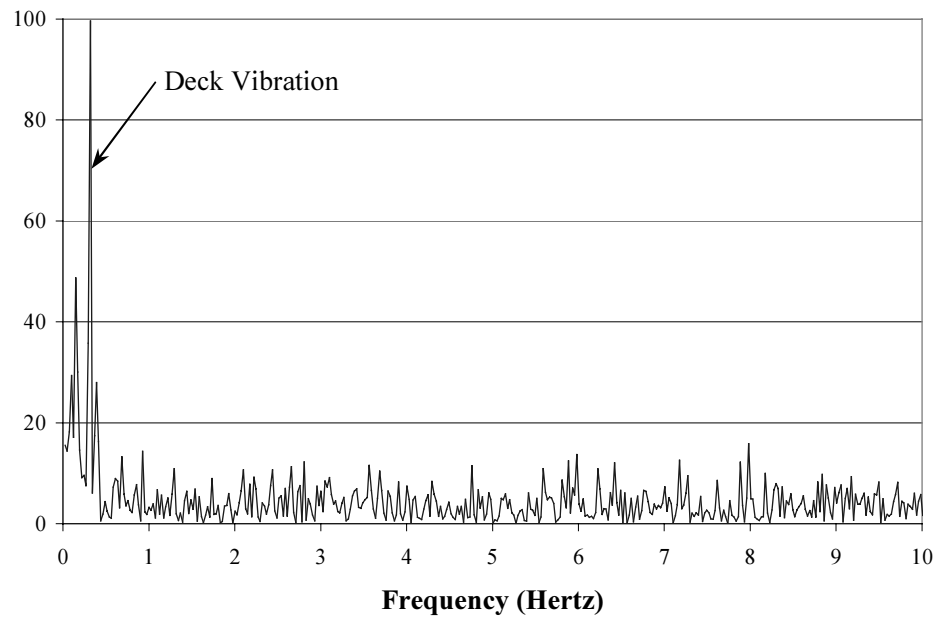
**Figure 4.18: Sample Strain Frequency Response**

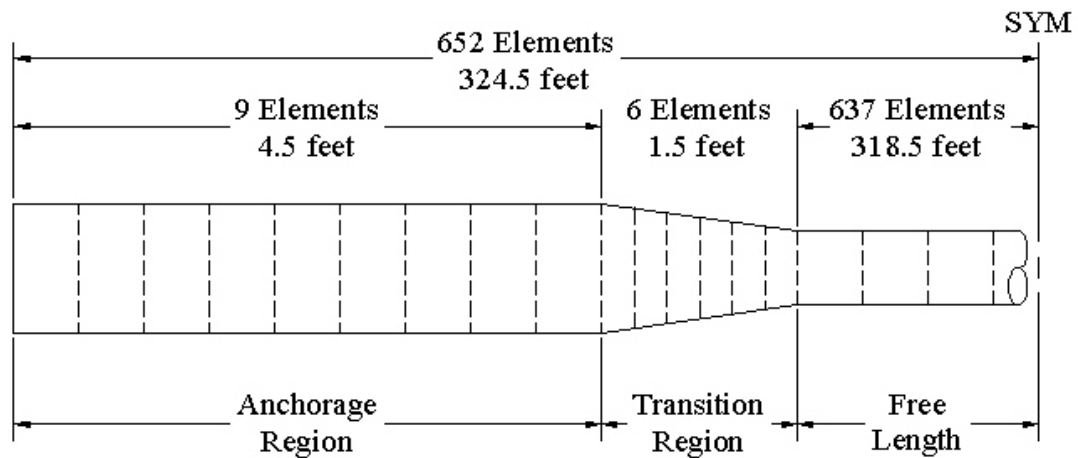
**Figure 5.2: Linear Mesh of Cable A24S for ABAQUS Finite Element Model**

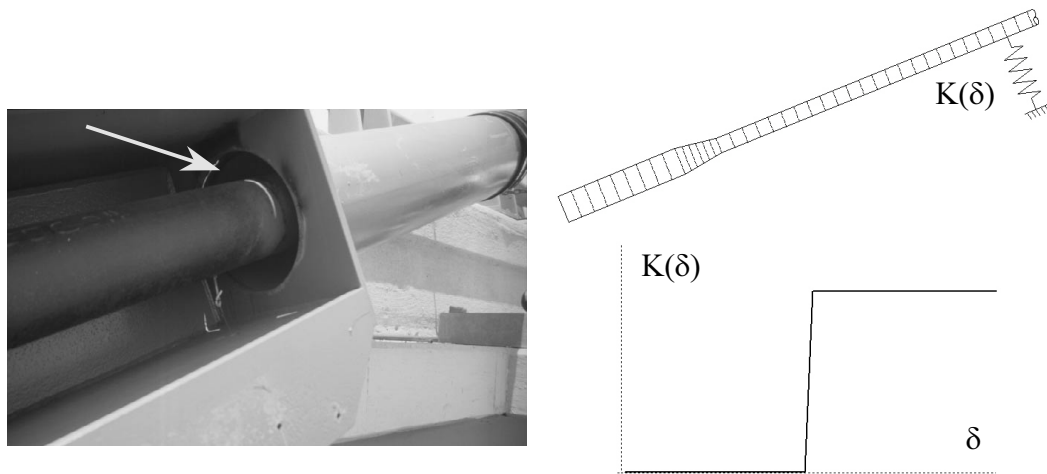
**Figure 5.3: Nonlinear Spring Representation of Anchorage Box Opening**

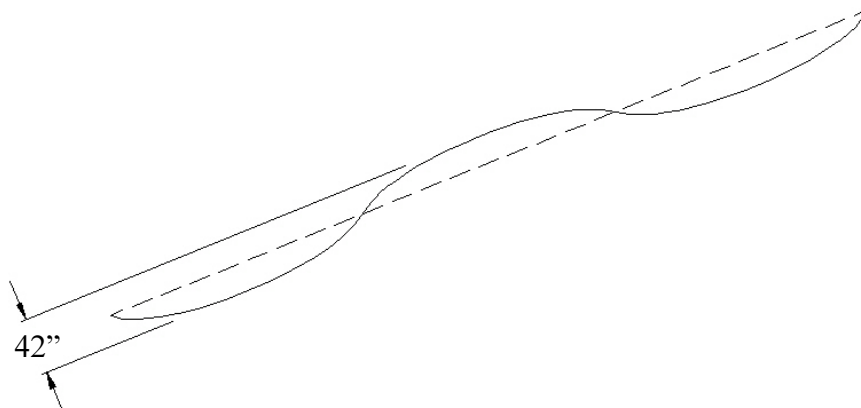
**Figure 5.4: *Worst-Case Scenario* Vibration Event for Cable A24S Model**

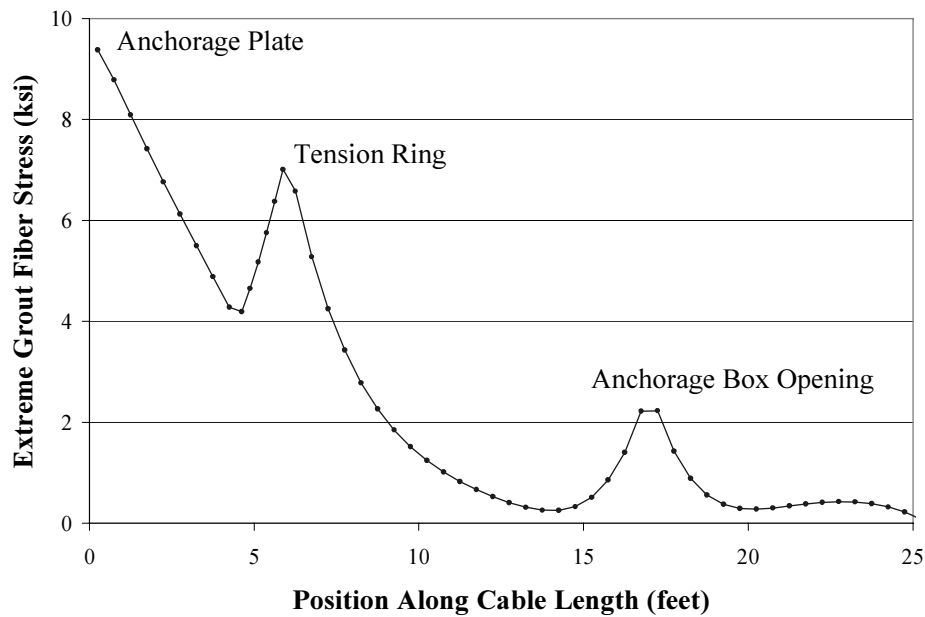
**Figure 5.6: Extreme Grout Fiber Stress Profile for 25 feet of Cable A24S Model Nearest the Deck Anchorage**

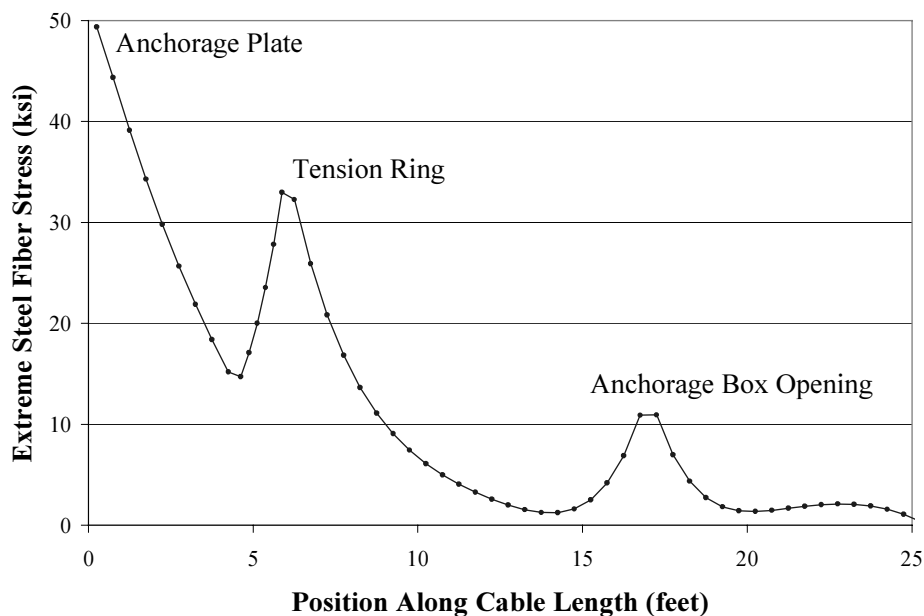
**Figure 5.7: Extreme Steel Fiber Stress Profile for 25 feet of Cable A24S Model  
Nearest the Deck Anchorage**

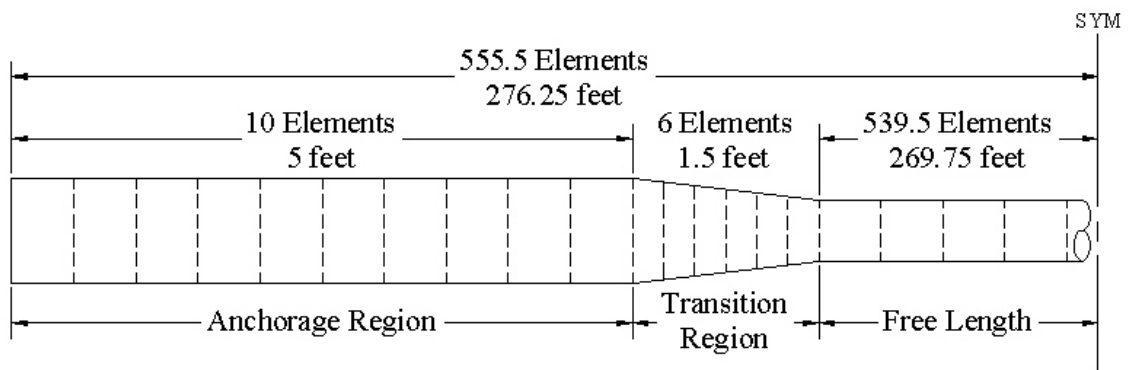
**Figure 5.8: Linear Mesh of Cable A22S for ABAQUS Finite Element Model**

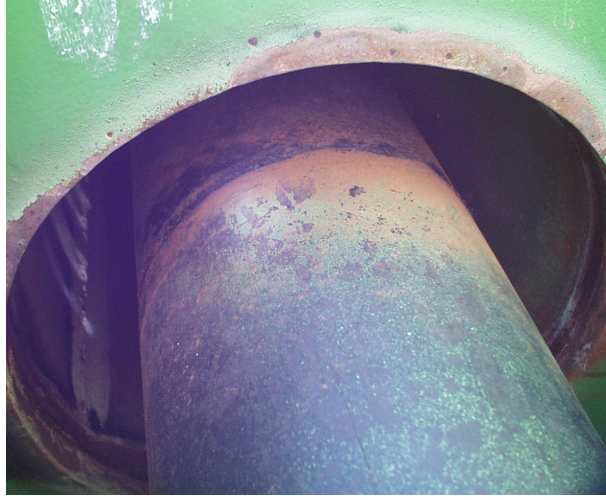
**Figure 5.9: Example of Indentation in Polyethylene Sheath at Anchorage Box Opening**

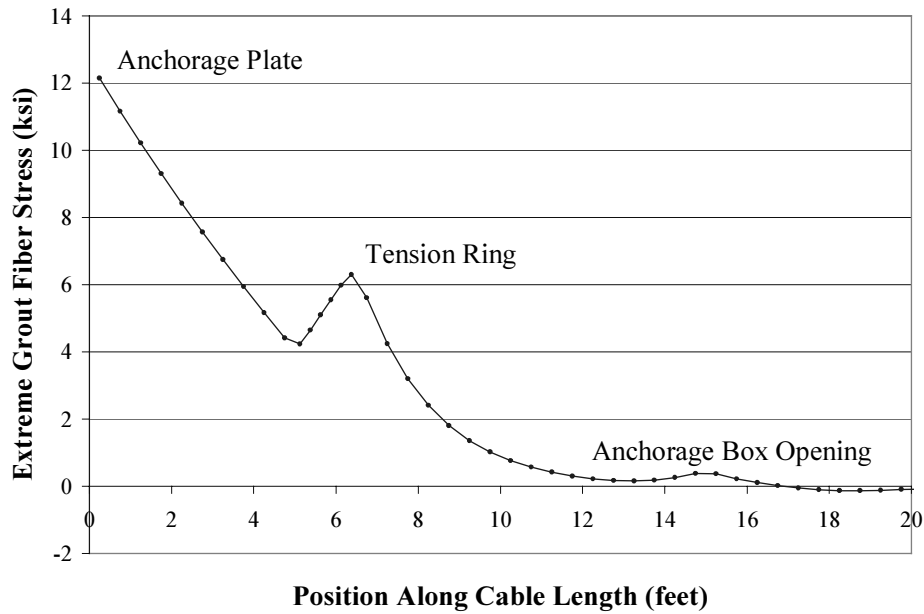
**Figure 5.10: Extreme Grout Fiber Stress Profile for 20 feet of Cable A22S**

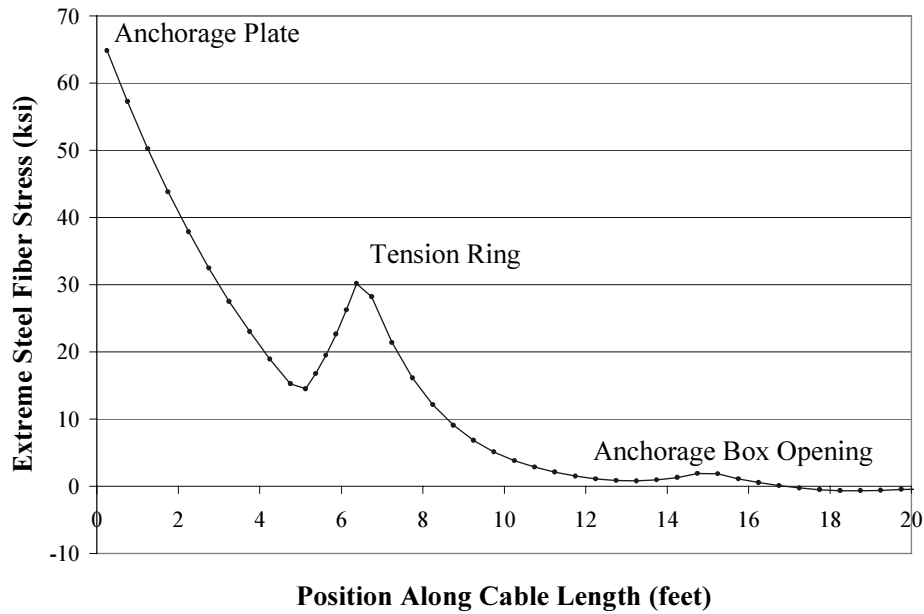
**Figure 5.11: Extreme Steel Fiber Stress Profile for 20 feet of Cable A22S Model Nearest the Deck Anchorage**

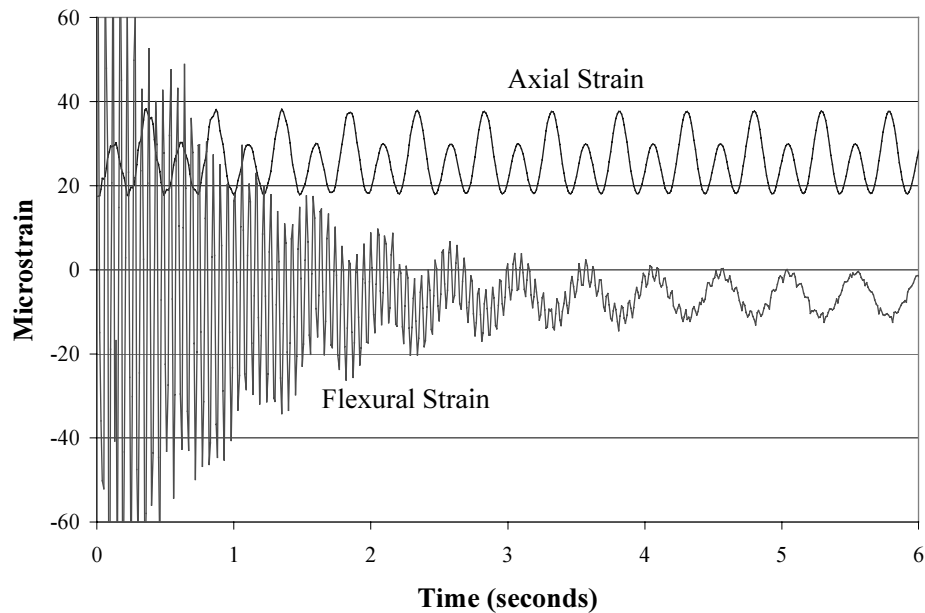
**Figure 5.12: Comparison of Axial and Flexural Strain at the Strain Gage Location on Cable A22S**

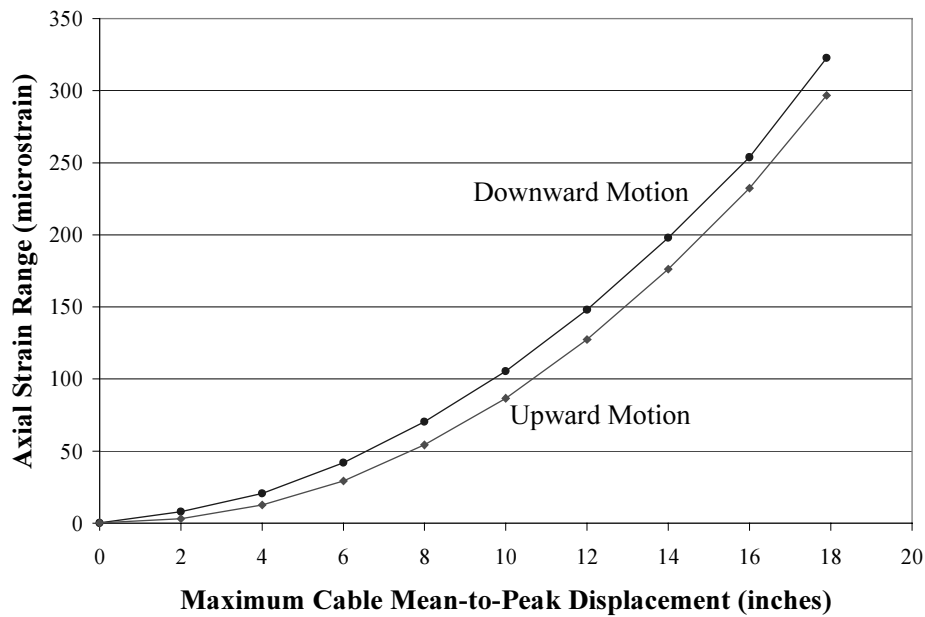
**Figure 5.13: Axial Strain Ranges at the Cable A22S Gage Location Corresponding to Maximum Mean-to-Peak Displacement Amplitudes**

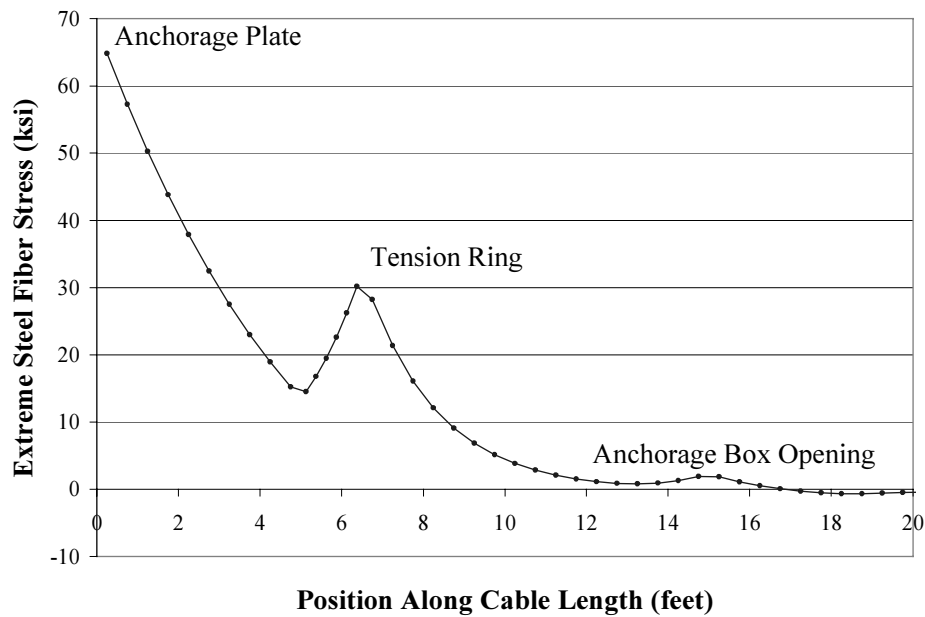
**Figure 6.2: Extreme Steel Fiber Stress Profile for 20 feet of Cable A22S Model  
Nearest the Deck Anchorage**

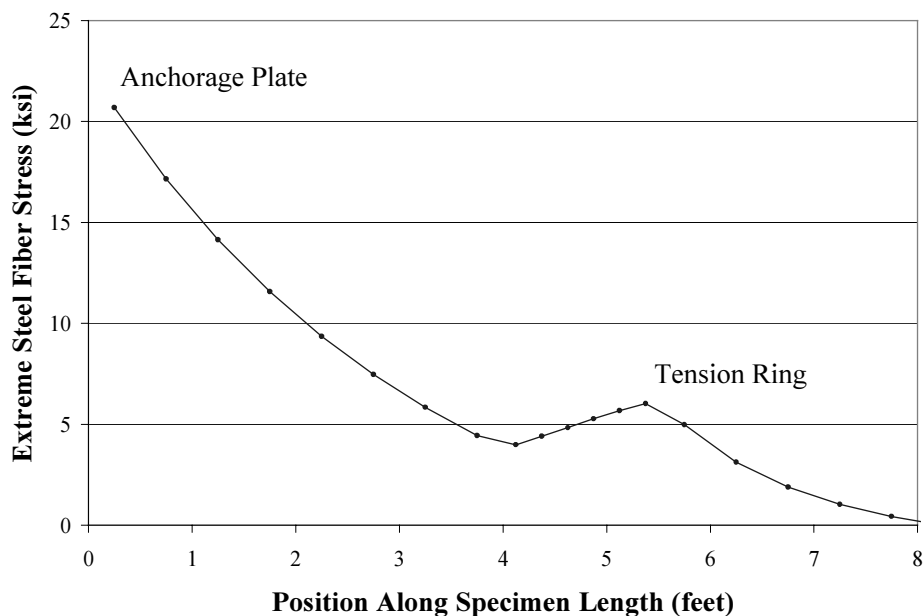
**Figure 6.4: Typical Specimen Steel Stress Profile in the Anchorage Zone for a Peak of Motion**
