**Response of Stay Cables to High-Amplitude Vibration**

**Thesis**

The University of Texas at Austin

**May 2001**

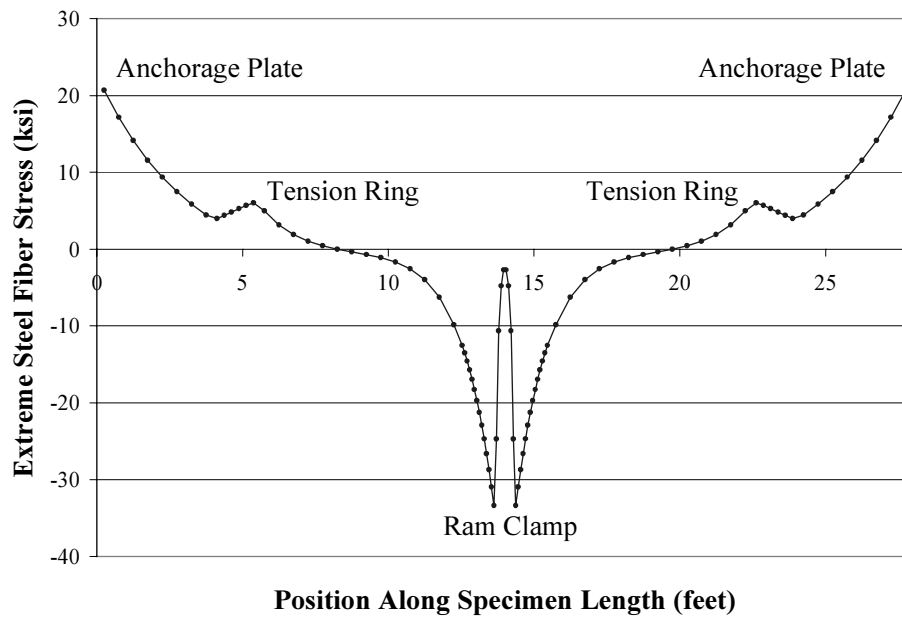
**Figure 6.5: Typical Specimen Steel Stress Profile for a Peak of Motion**

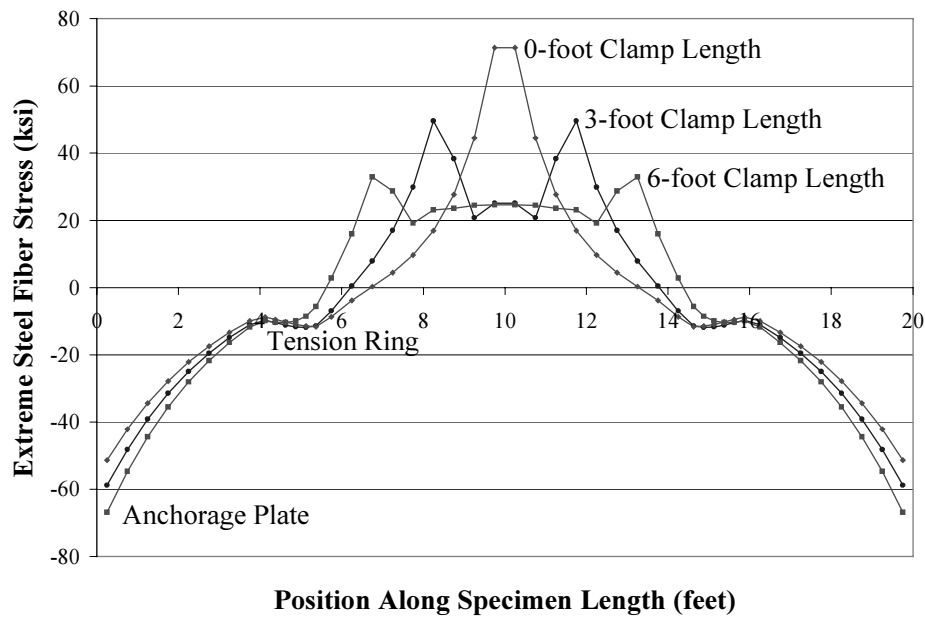
**Figure 6.6: Effect of Ram Clamp Length on Steel Stress Profile When Using Direct Displacement Control**

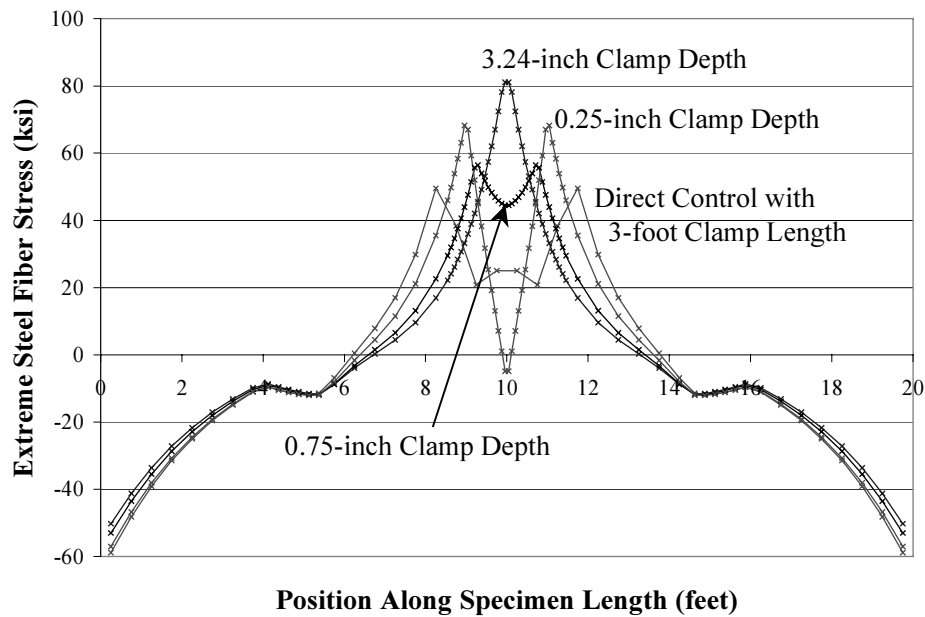
**Figure 6.8: Effect of Ram Clamp Internal Curvature on Steel Stress Profile  
When Using Contact Surface Control**

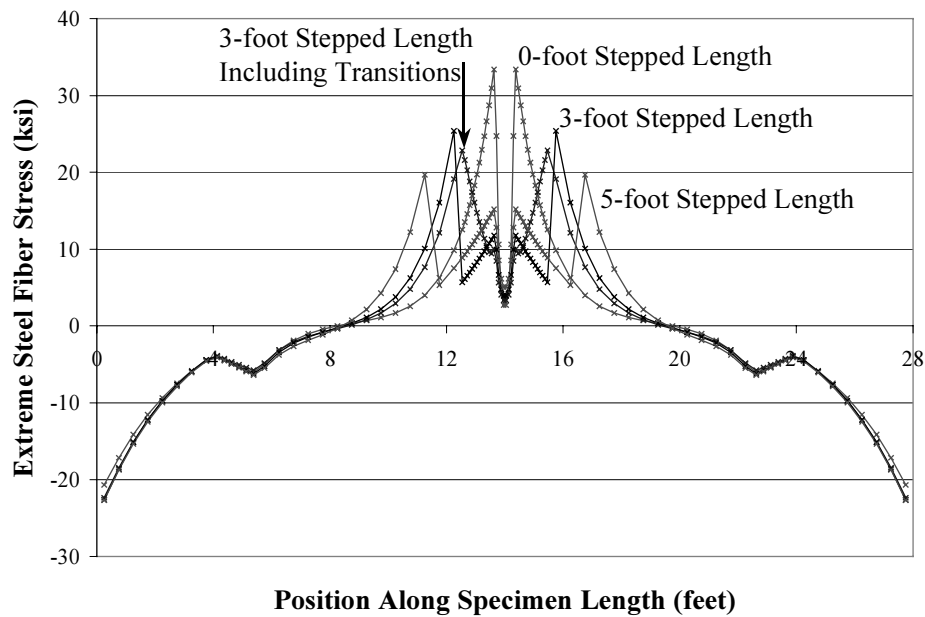
**Figure 6.10: Effect of Midspan Stepped Grout Diameter Length on Steel Stress Profile**

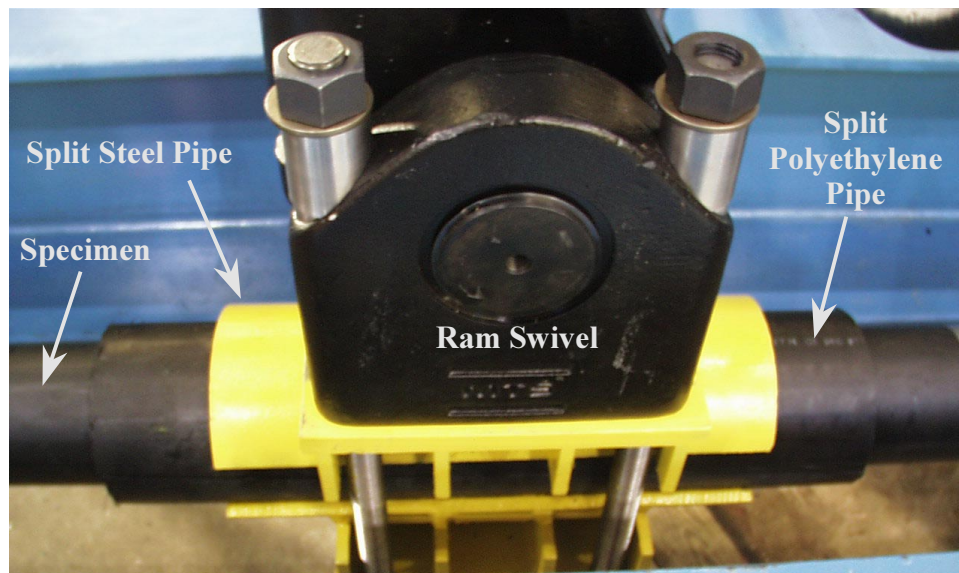
**Figure 6.11: Ram Clamp Used for First Laboratory Fatigue Test**

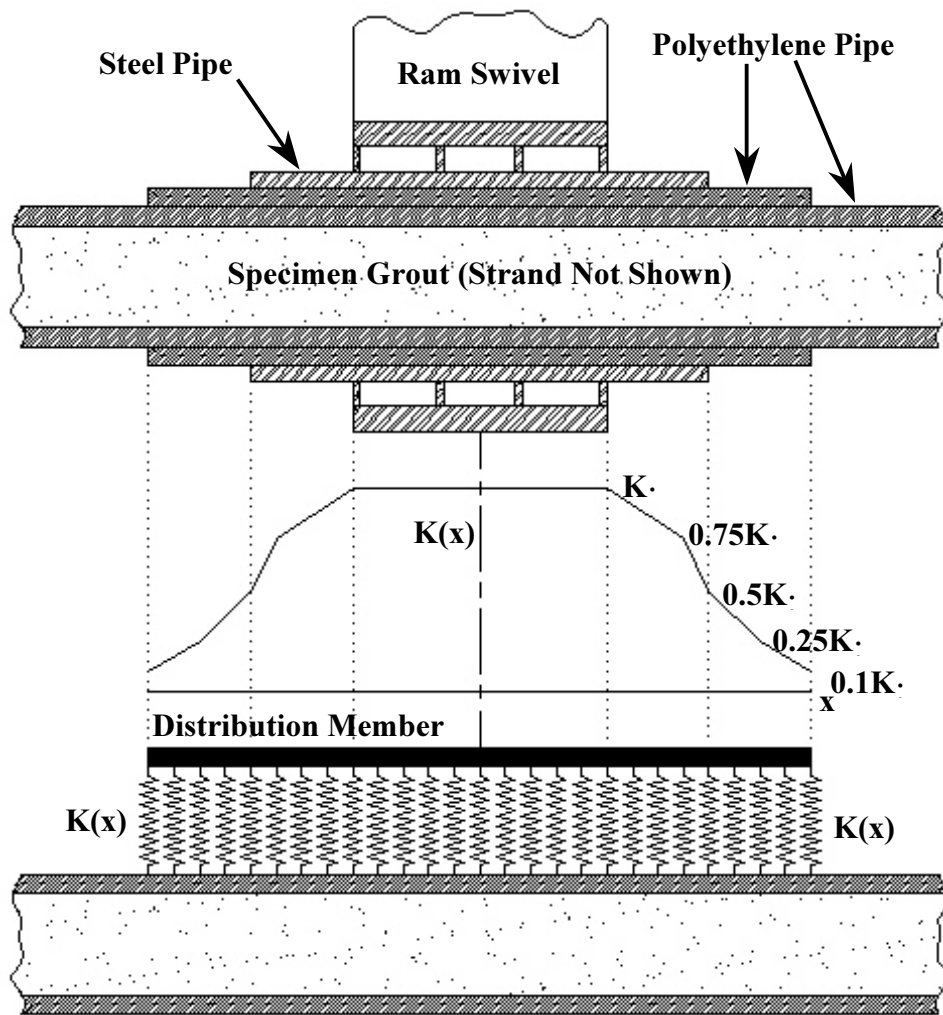
**Figure 6.12: Cross-Section and Modeling Approach for Ram Clamp Used for First Laboratory Test**

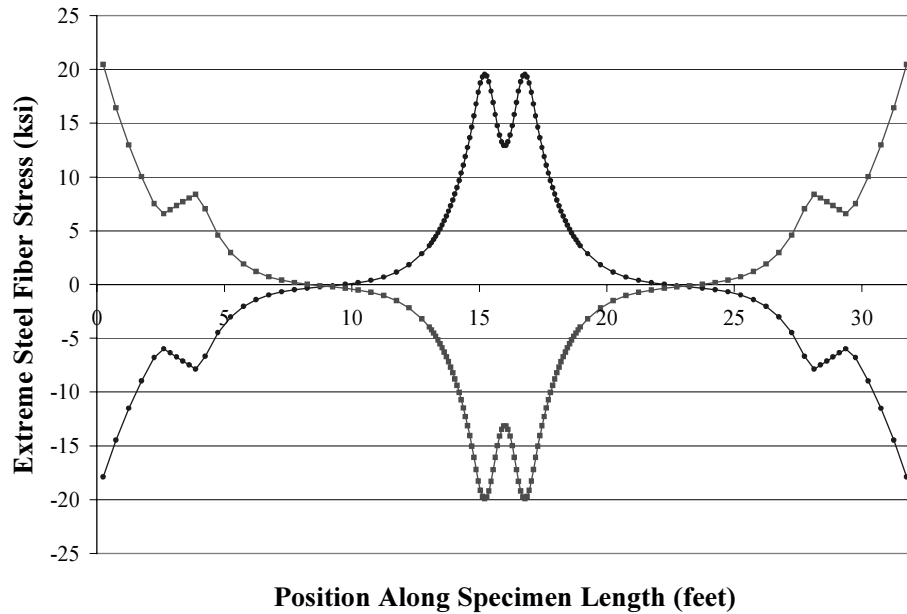
**Figure 6.13: Predicted Extreme Steel Fiber Stress Profiles for Peaks of Motion  
– Uncracked Model**

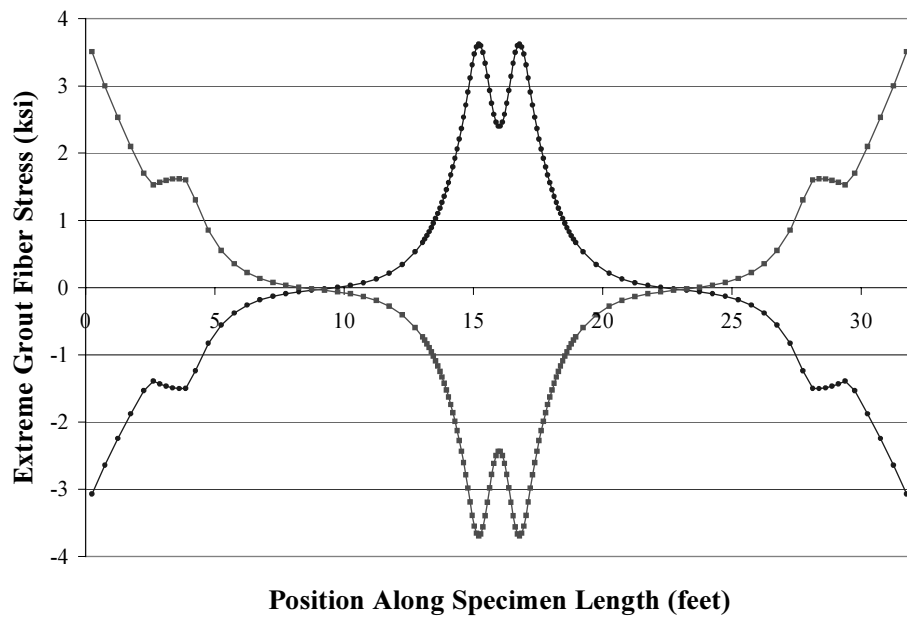
**Figure 6.14: Predicted Extreme Grout Fiber Stress Profiles for Peaks of Motion  
– Uncracked Model**

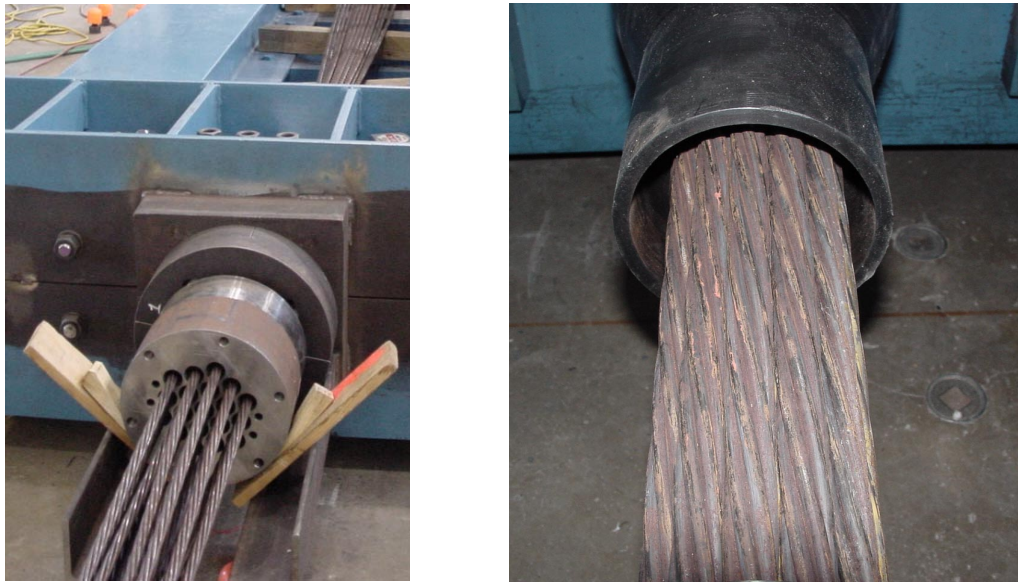
**Figure 7.1: Installation of Strand During Construction of Stay Cable Specimen**

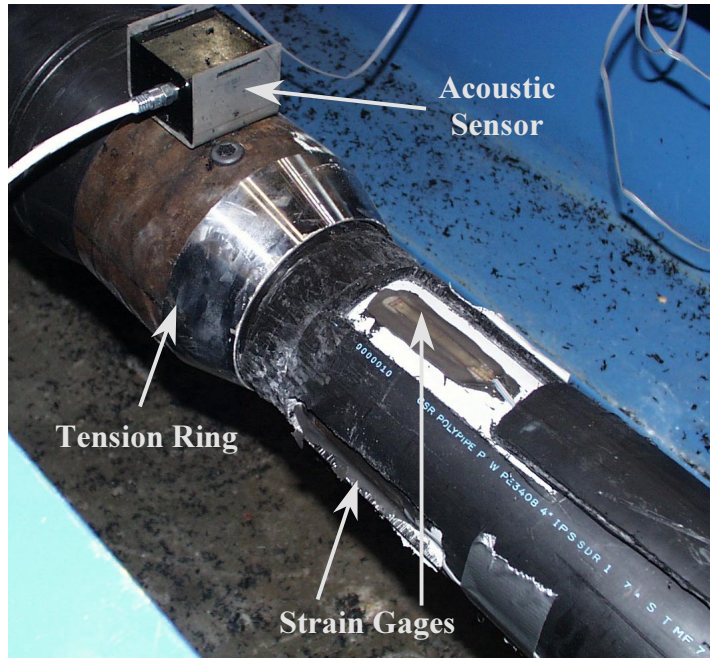
**Figure 7.4: Strain Gages Near the Tension Ring**

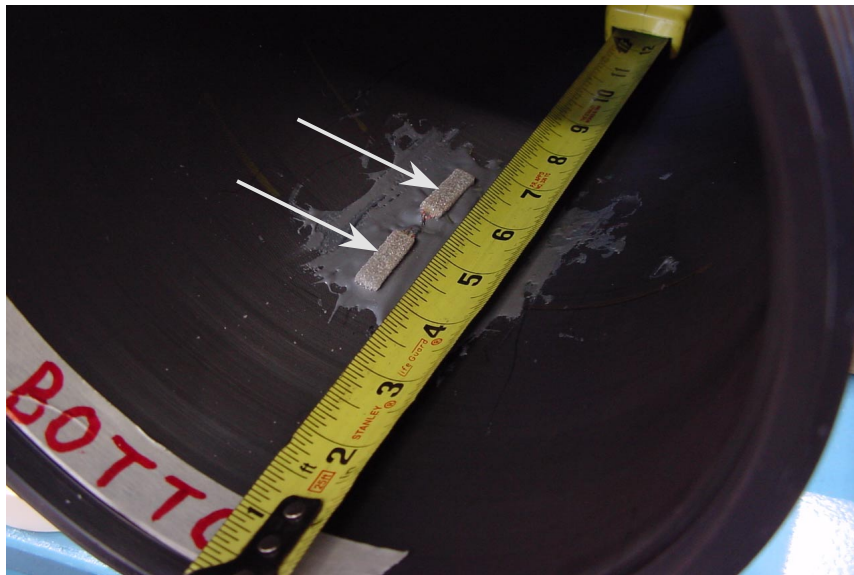
**Figure 7.5: Strain Gages Near the Anchorage Plate**

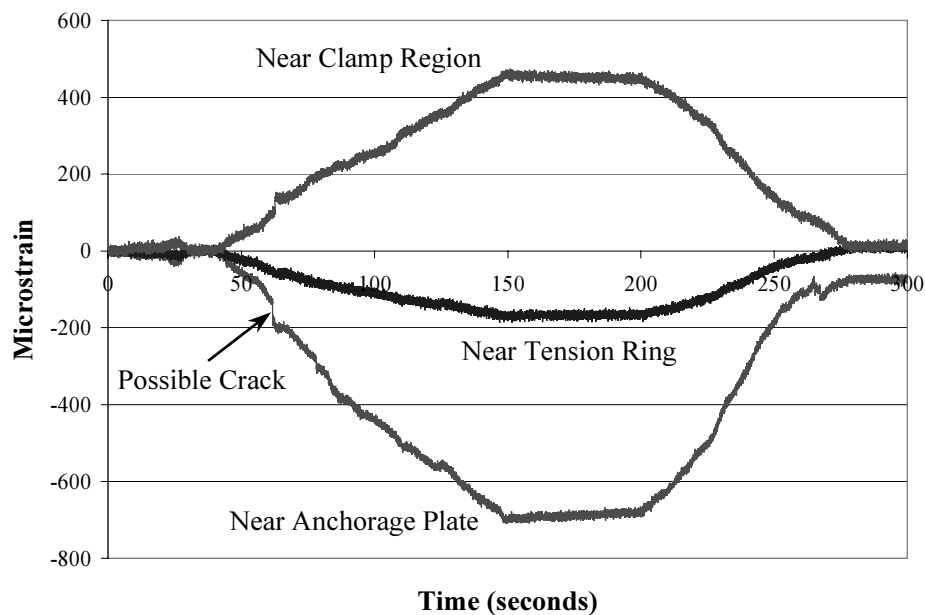
**Figure 7.6: Top Gage Strain Histories for Upward Motion of the Static Test**

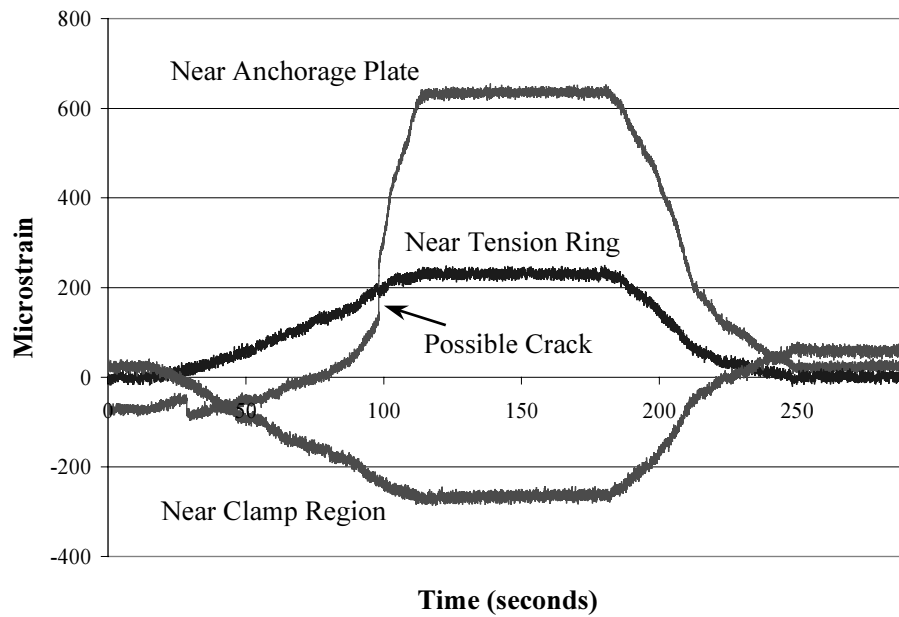
**Figure 7.7: Top Gage Strain Histories for Downward Motion of the Static Test**

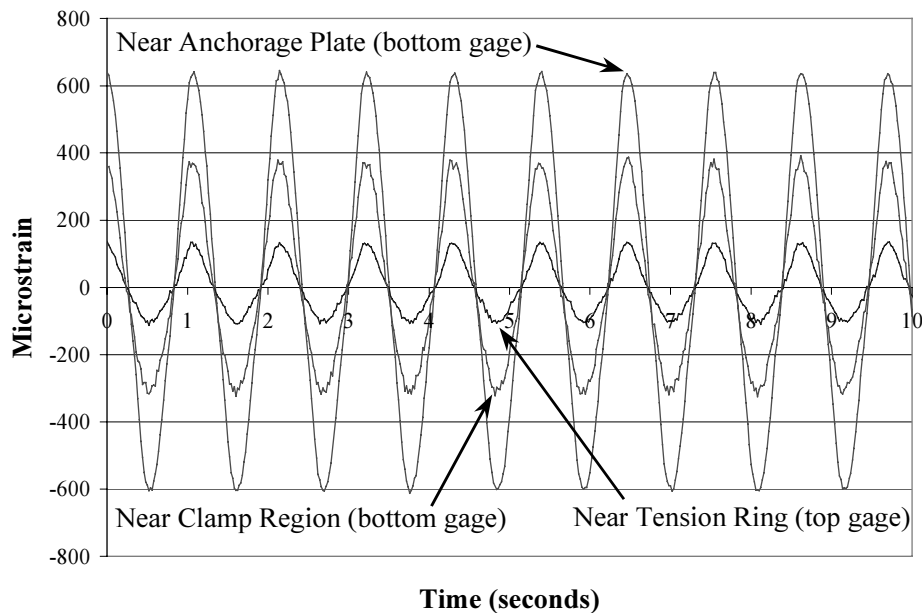
**Figure 7.8: Strain Histories During Cycling at 77,000 Cycles**

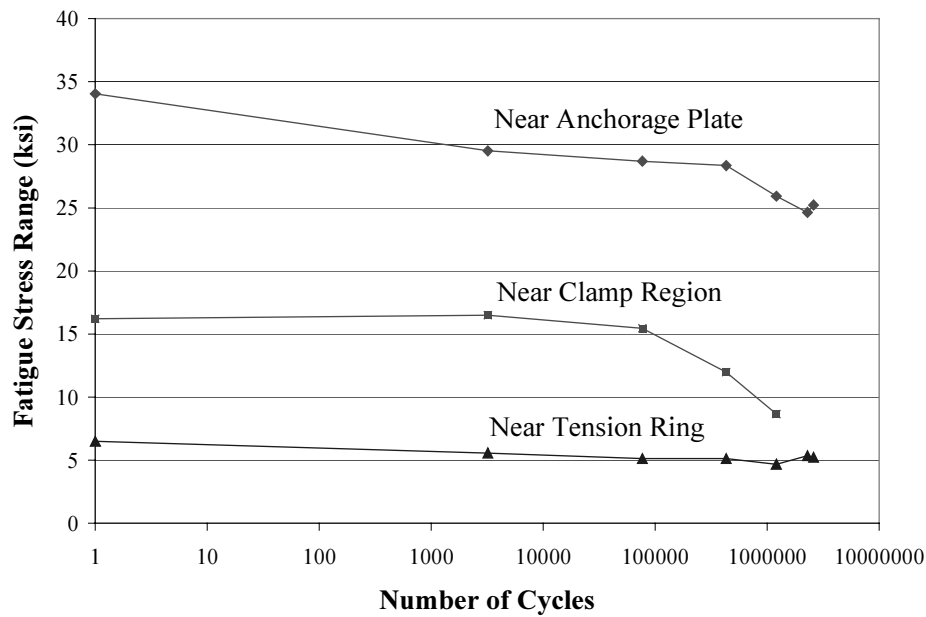
**Figure 7.9: Deterioration of Extreme Steel Fiber, Fatigue Stress Ranges**

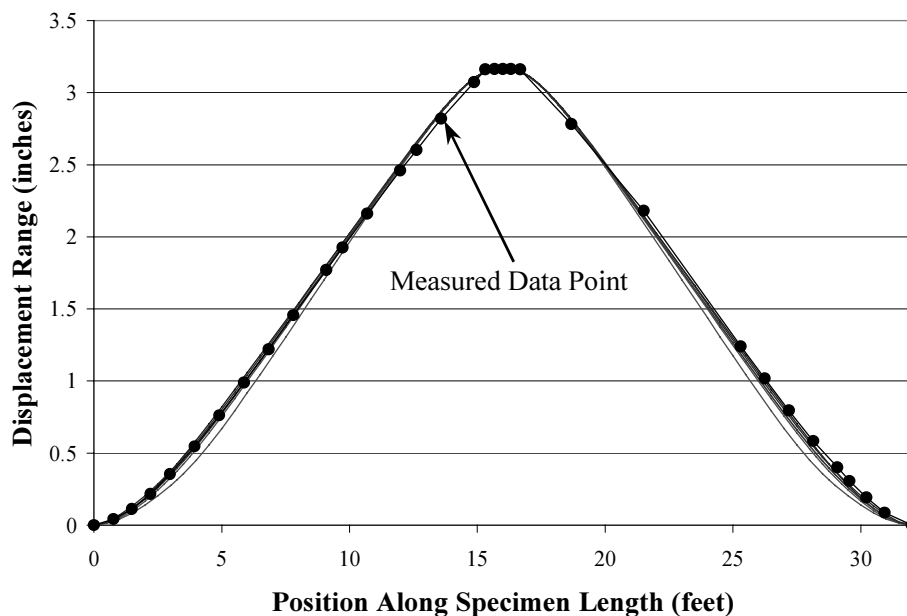
**Figure 7.10: General Agreement of Specimen Models to Measured Data Based Upon Displacement Range**

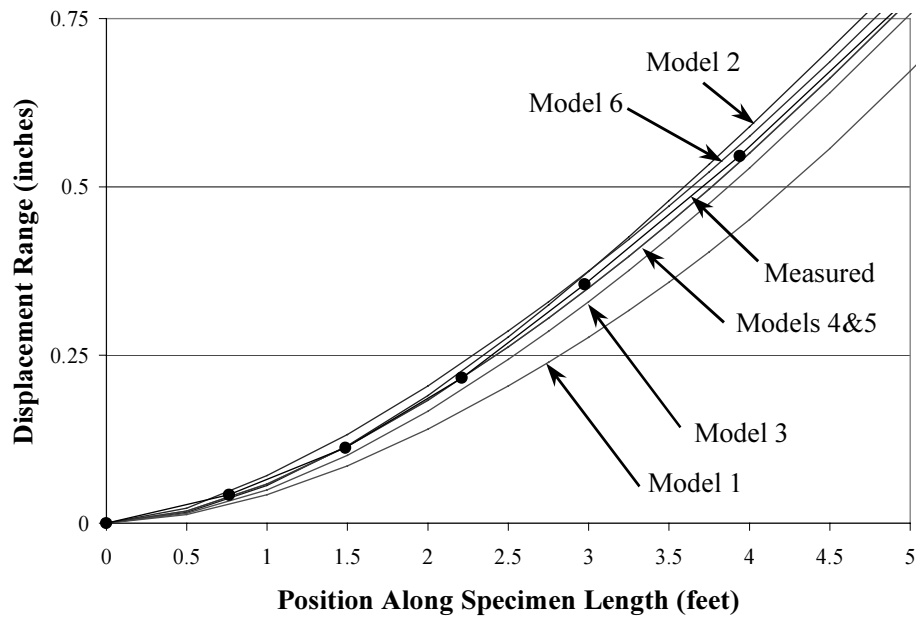
**Figure 7.11: Agreement of Specimen Models to Measured Data Based Upon Displacement Range Near Anchorage Without Wire Breaks**

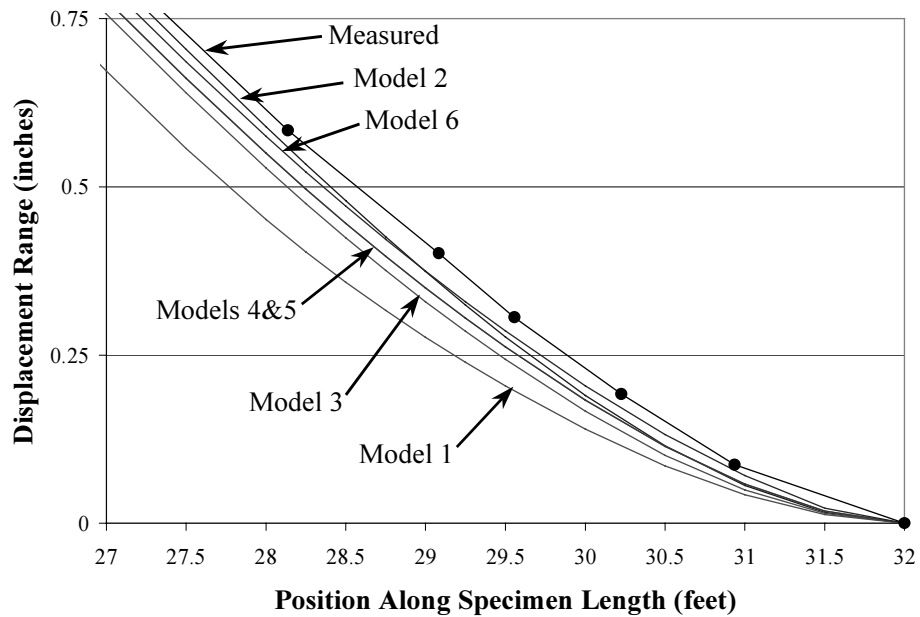
**Figure 7.12: Agreement of Specimen Models to Measured Data Based Upon Displacement Range Near Anchorage With Wire Breaks**

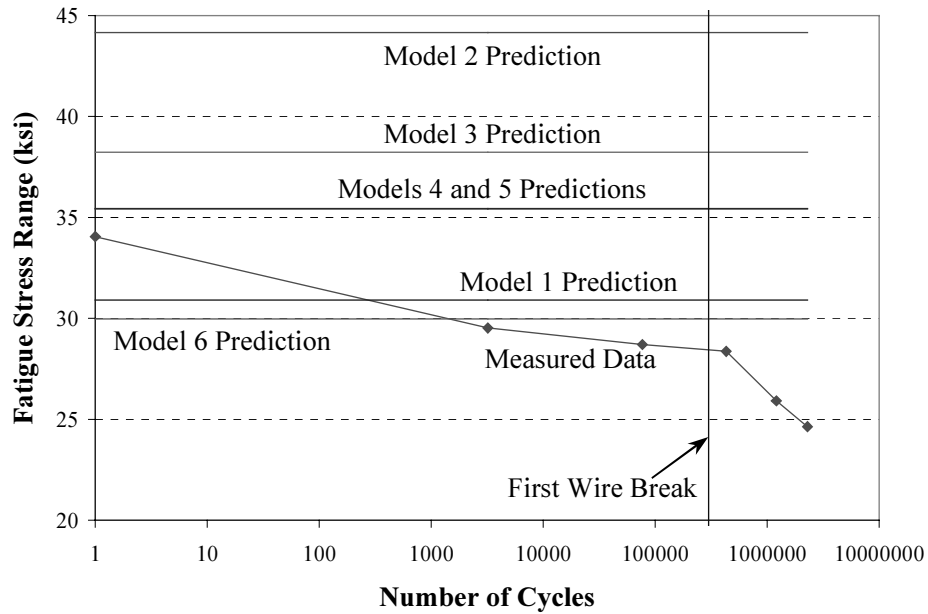
**Figure 7.13: Comparison of Predicted and Measured Extreme Steel Fiber Fatigue Stress Ranges Near the Anchorage Plate**

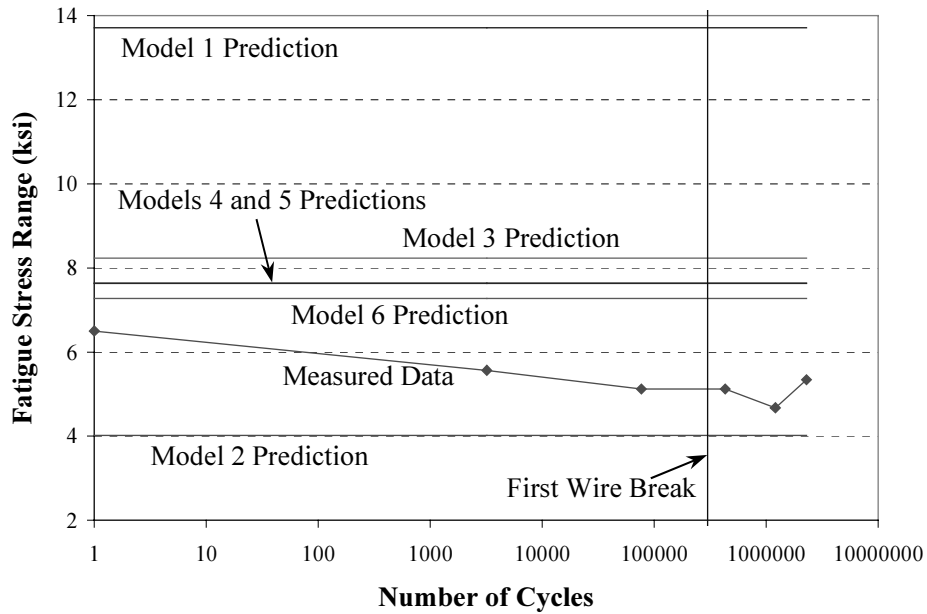
**Figure 7.14: Comparison of Predicted and Measured Extreme Steel Fiber Fatigue Stress Ranges Near the Tension Ring**

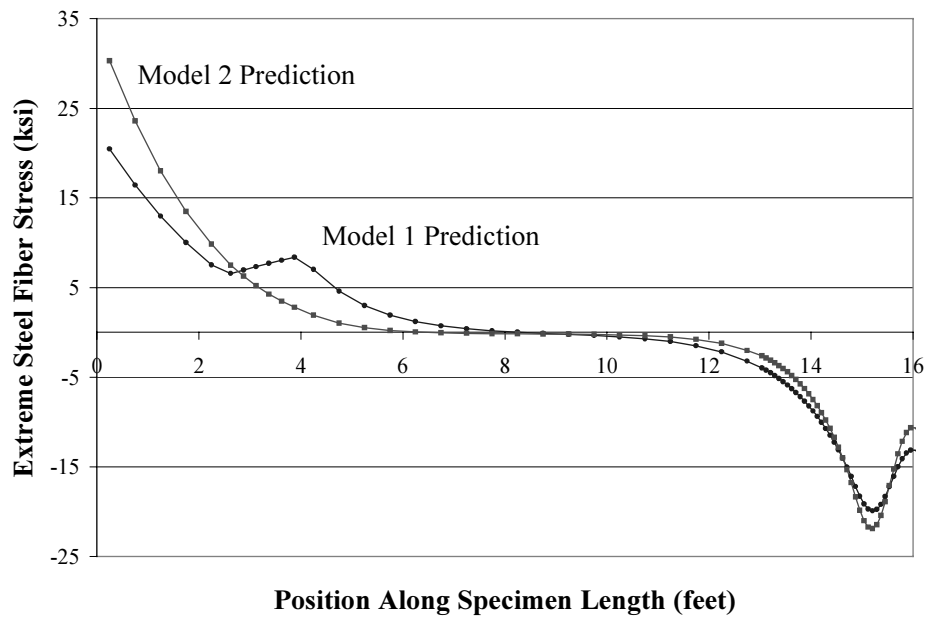
**Figure 7.15: Extreme Steel Fiber Stress Profiles for Models 1 and 2**

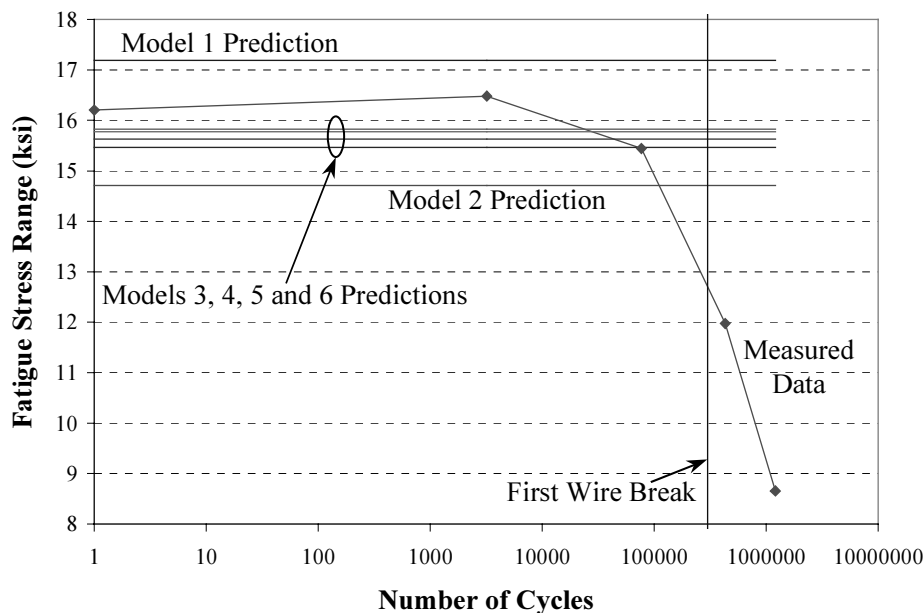
**Figure 7.16: Comparison of Predicted and Measured Extreme Steel Fiber Fatigue Stress Ranges Near the Ram Clamp**

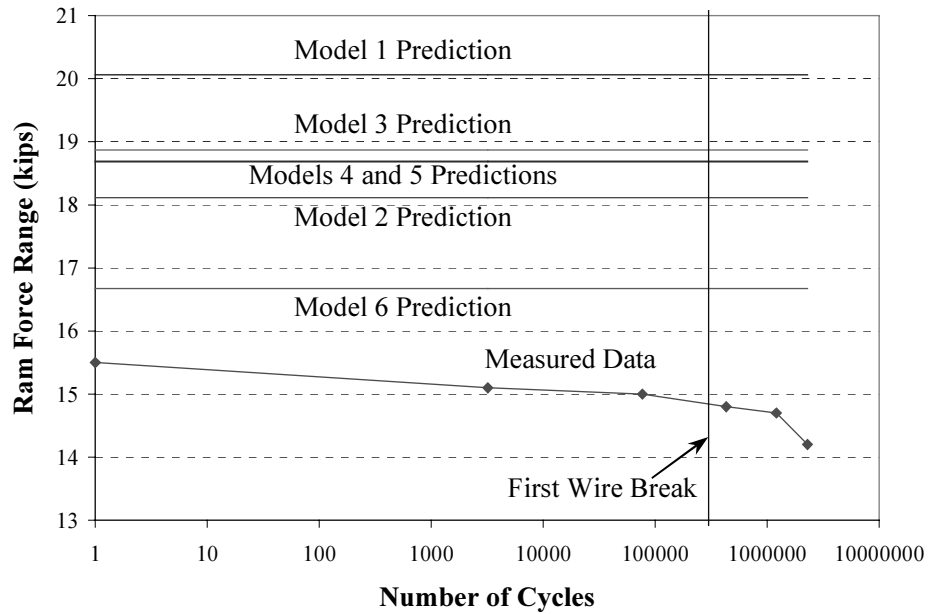
**Figure 7.17: Comparison of Predicted and Measured Ram Force Range**

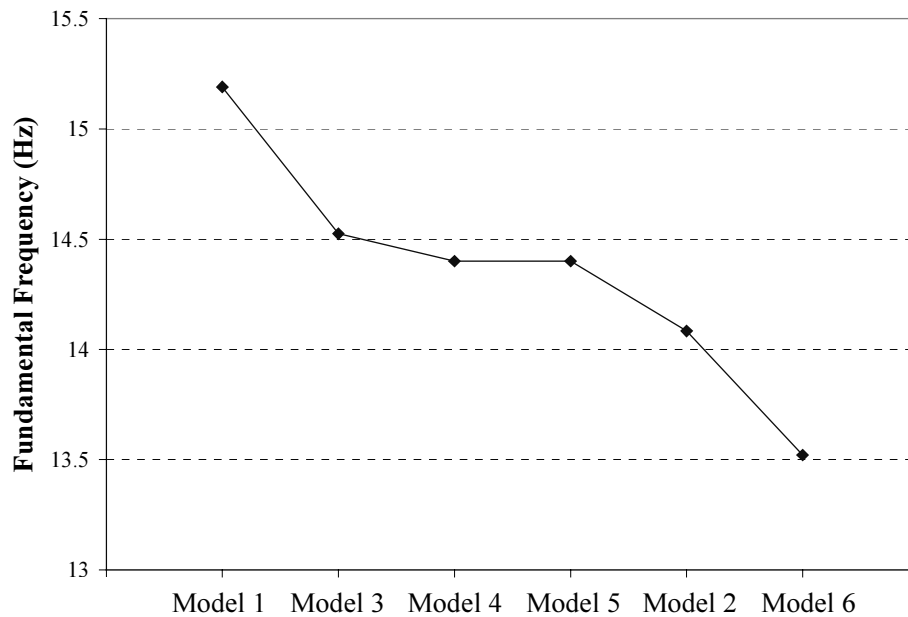
**Figure 7.18: Comparison of Predicted First Fundamental Frequencies**

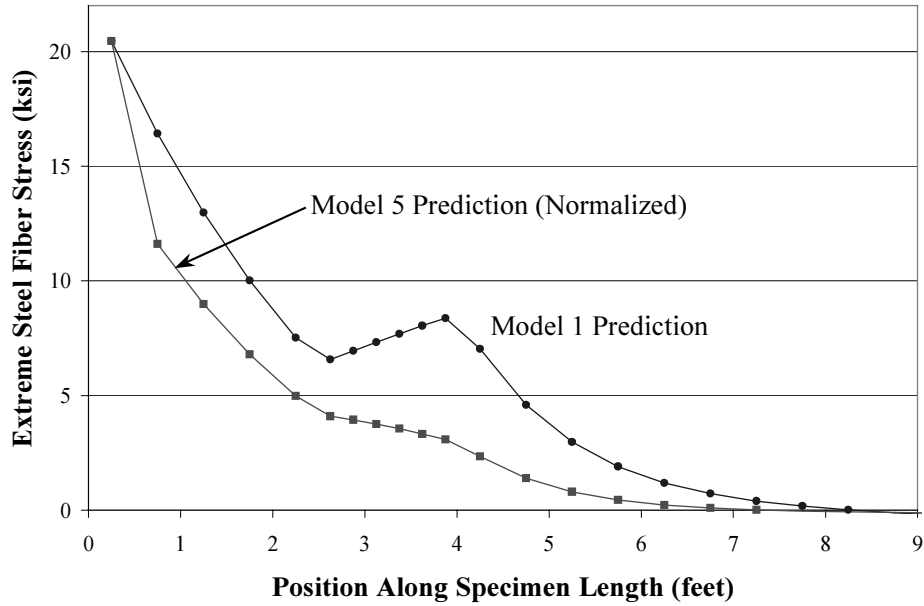
**Figure 8.1: Effect on Stress Profile of End Rotation Due to Local Damage**
