**A Study on the Application of the Acoustic Emission Method for
Steel Bridges**

Thesis

Master of Science in Engineering

The University of Texas at Austin

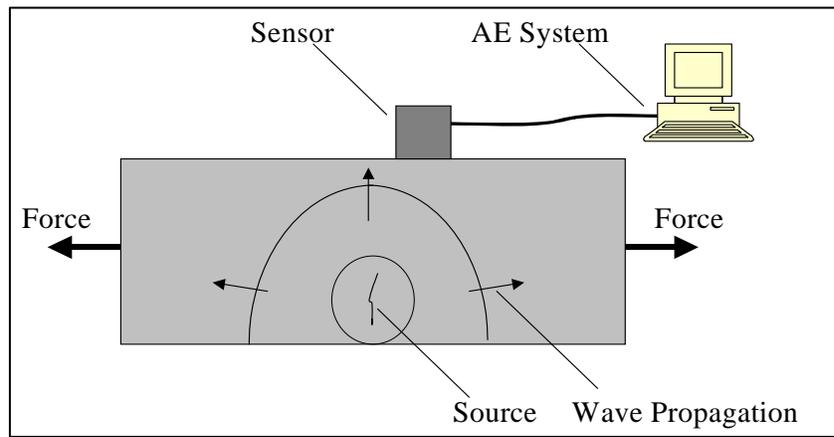
AE is defined as a transient elastic wave generated within a material by means of the rapid release of energy from a localized source (ASTM 1999). When a material is subjected to a force, the resulting stress becomes the stimulus and produces local plastic deformation, and breakdown of the material at specific places. The material breakdown produces AE, which travels outward from the source, echoing through the body until it arrives at a sensor. The sensor translates the sound energy into an electrical signal, which is passed to electronic equipment for further processing. The AE process is schematized in Figure 2.1.

Figure 2.1 Schema of the AE Process

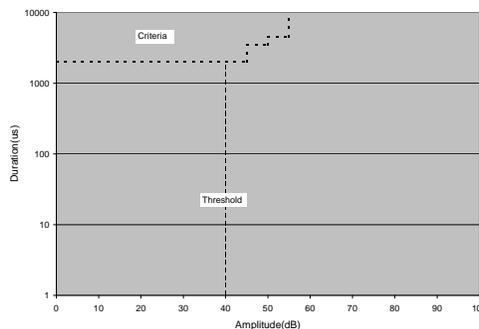
The Swansong criteria listed above are shown schematically in Figure 2.2 for a threshold equal to 40 dB. Data above and to the left of the dashed line corresponds to the criteria.

Figure 2.2 Swansong Filter

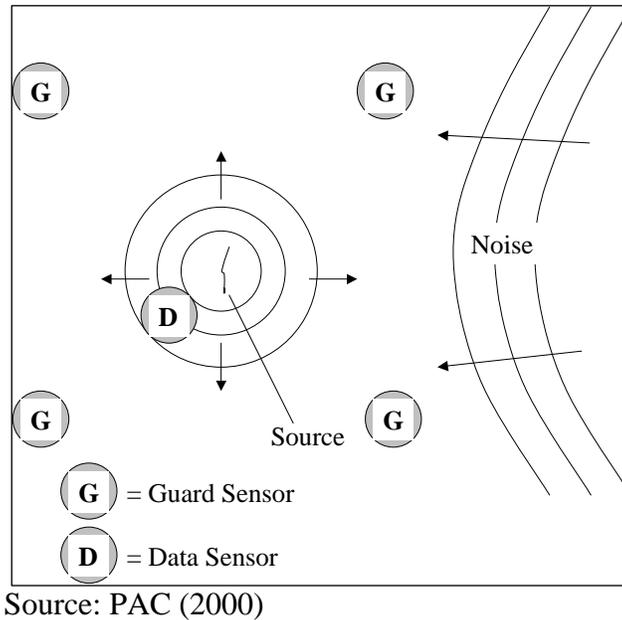
The idea of the guard sensor technique was developed in the early 1960's (1995 Pollock). The concept of this technique is illustrated in Figure 2.3.

Figure 2.3 Guard Sensor Concept

A data sensor is placed on the area of interest, surrounded by several guard sensors. AE waves from the area of interest will arrive at or hit the data sensor before hitting any of the guard sensors. Waves from outside the area of interest will hit at least one of the guard sensors before they hit the data sensor. By shutting down the data sensor for a certain period when the wave hits the guard sensor first, all hits on the data sensor which are coming from outside are not recorded.

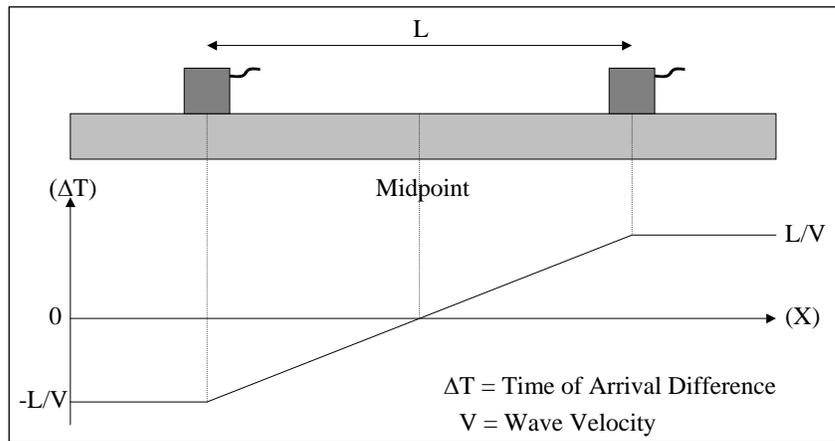
Source location capability is considered one of the advantages of AE for this application. A single event can be captured by several sensors as successive hits on those sensors. The difference of the arrival times tells us the location of the source. The principle of linear location is shown in Figure 2.4.

Figure 2.4 Principle of Linear Location

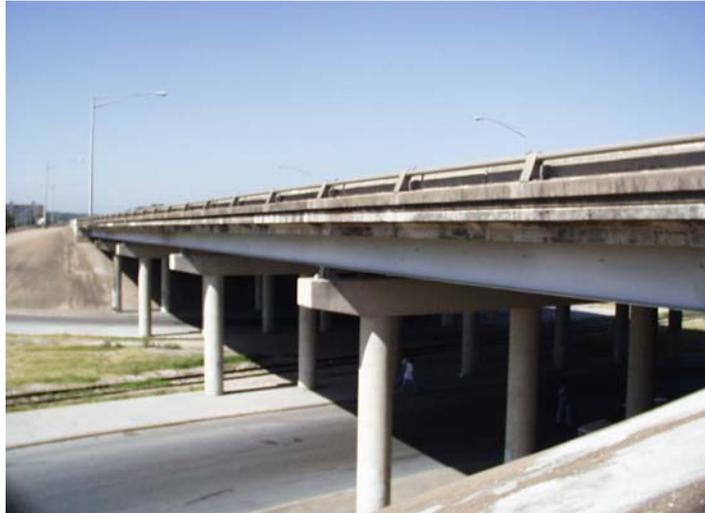
I-35 Bridge	Texas-71 Bridge
Type	Non-composite 5 span continuous rolled girder bridge	Non-composite 5 span continuous rolled girder bridge
Approximate Spans (ft.)	45+60+60+60+45	35+50+35+50+35
# of girders	8	6
Approximate Girder spacing (ft.)	8	8
Approximate Rolled Section	W27 x 114	W27 x 129
Bearing	Steel rocker	Steel rocker

Figure 3.1 I-35 Bridge over 4th street

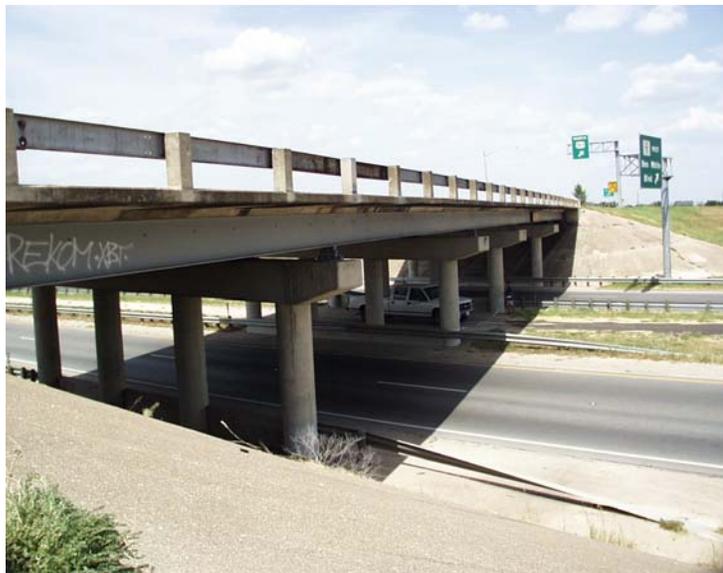
Figure 3.2 Texas-71 Bridge over US-183

Field AE monitoring was conducted at the Texas-71 Bridge over US-183 (see Figure 3.2). Two types of specimen were used for this test; one was a cracked plate, identical with the one of laboratory test, the other was a plane plate. These specimens were mounted on the bridge by using clamps and monitored continuously under the normal bridge traffic conditions using the guard sensor technique and source location technique.

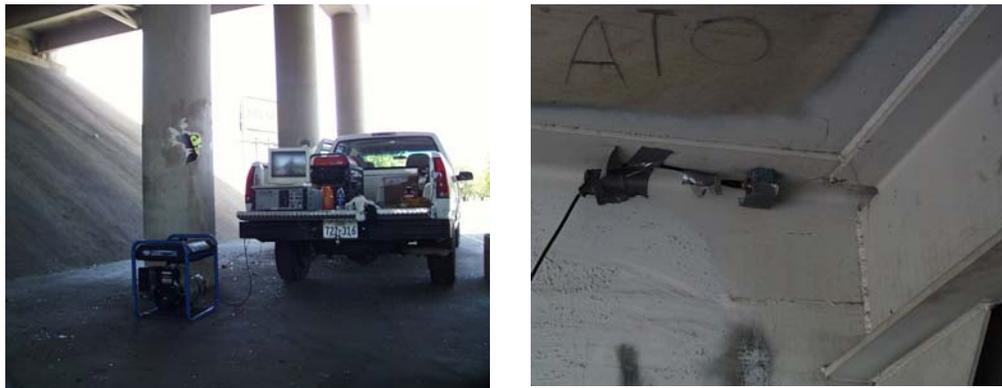
Data were collected using a 4-channel Physical Acoustic Corporation LOCAN-320 acoustic emission instrument and 150 kHz resonant sensors (R15I) and 300 kHz resonant sensors (R30I) with integral preamplifier. The sensors were mounted on the beam using magnetic hold-downs. In order to accomplish good acoustic contact between the sensor face and the beam, vacuum grease was used.

Figure 3.3 Instrumentation

In order to duplicate field conditions in the laboratory and verify that the crack is long enough to grow in the field, it is necessary to know an actual stress range of the bridge where the continuous AE monitoring was performed. The flange stress was measured on the Texas-71 Bridge over US-183 (see Figure 3.3) to determine the stress range for the laboratory test.

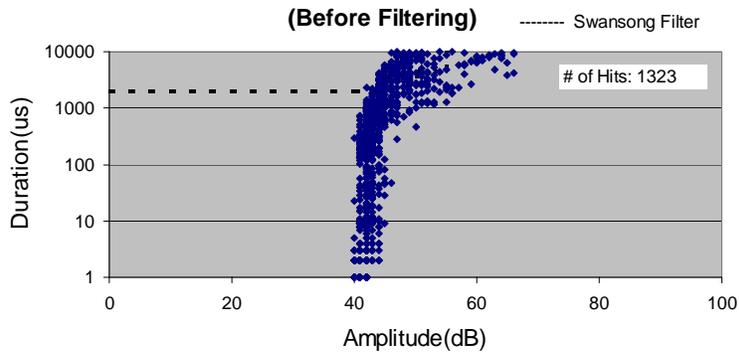
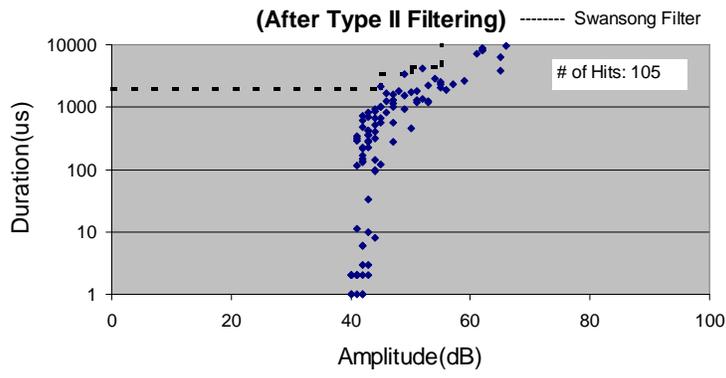
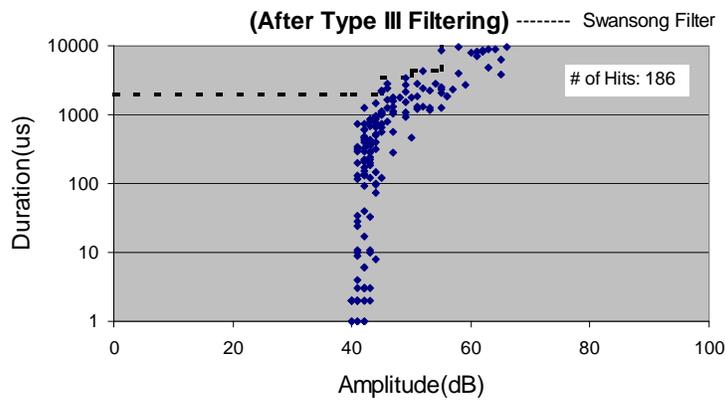
Figure 3.9 Duration-Amplitude (after applying Swansong II and III filter)
[Period 1, Channel 1]

The R30I sensor, the higher frequency transducer, did not capture as much noise as the R15I sensor. This is caused by the fact that higher frequencies are attenuated more than lower frequencies. The maximum amplitude of the signal was about 60 dB for R30I, 80 dB for R15I. The minimum amplitude of the signal was 38 dB even though the threshold was 40dB. This is inherent in the older instruments, and has to do with the circuitry. The newer instruments have a software cut-off that eliminates anything below the threshold. Period 5 indicates that the 3rd girder from the outside was noisier than far outside girder. As Period 1, 3, 4 indicate, the web was noisier than the lower flange. Although the Swansong II and III Filter did reduce the noise data by 63% and 50% on average respectively, it could not eliminate the noise data completely. The remaining data seems to come mainly from the impact due to moving vehicles.

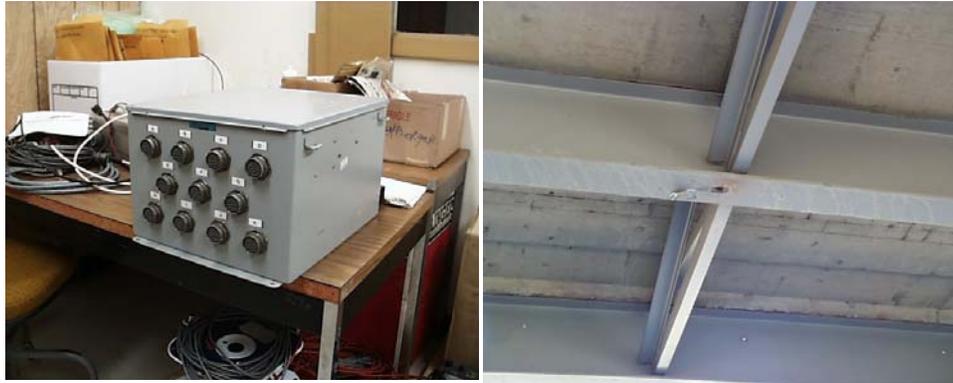
The stress measurement was conducted by measuring the strains using electrical-resistance strain gauges, Tokyo Sokki Kenkyujo Cooperation FLA-10-11. The stress was calculated by multiplying the strain with Young's modulus of steel (29×10^6 psi). Strain data were collected using a Campbell Scientific, INC CR9000 Measurement and Control data acquisition system.

Figure 4.1 Instrumentation

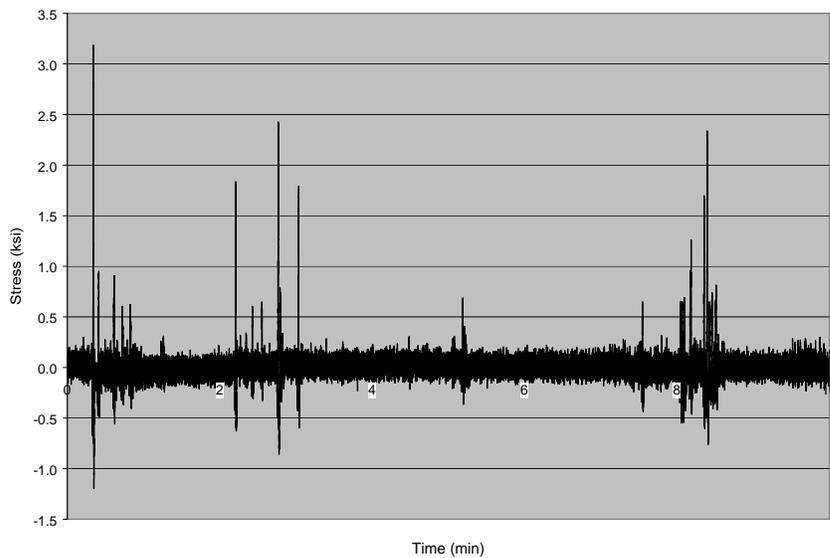
Figure 4.2 Stresses of 10-minute Measuring (Period 2, 2nd girder)

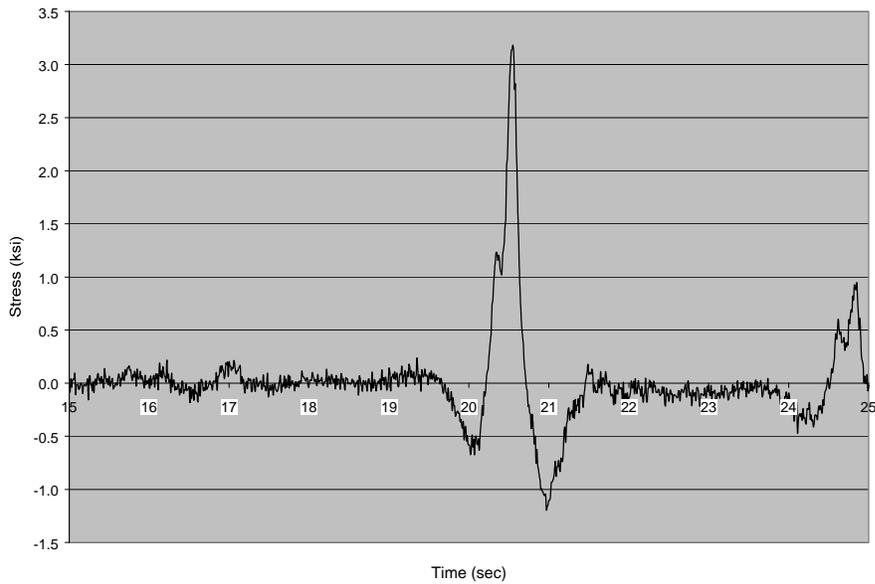
Figure 4.3 Stress Variation During 10 Seconds (Period 2, 2nd girder)

The stress variation shown in Figure 4.3 was the expected form which matches the influence line for the moment at the center span of the continuous beam. This justifies the validity of the results that the stresses were generated by moving vehicle loads. The maximum stress range for the event in Figure 4.3 is 4.4 ksi. Judging from these results, 3 ksi was selected as a reasonable value to use as a stress range for the laboratory test.

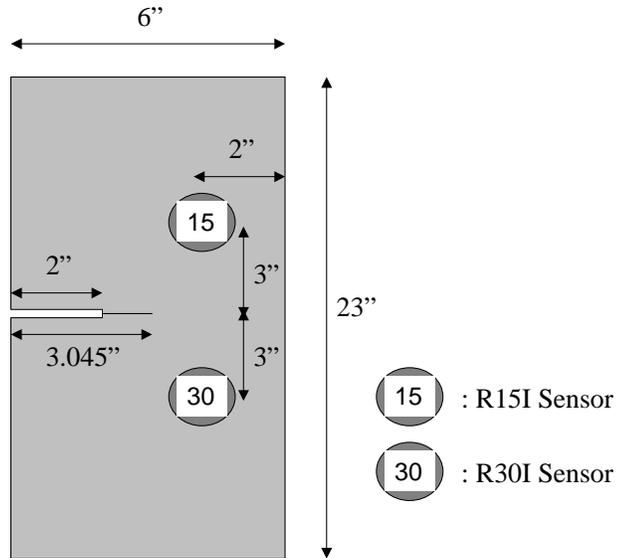
The specimen geometry and sensor location is shown in Figure 5.1.

Figure 5.1 Specimen Geometry and Sensor Location (1)

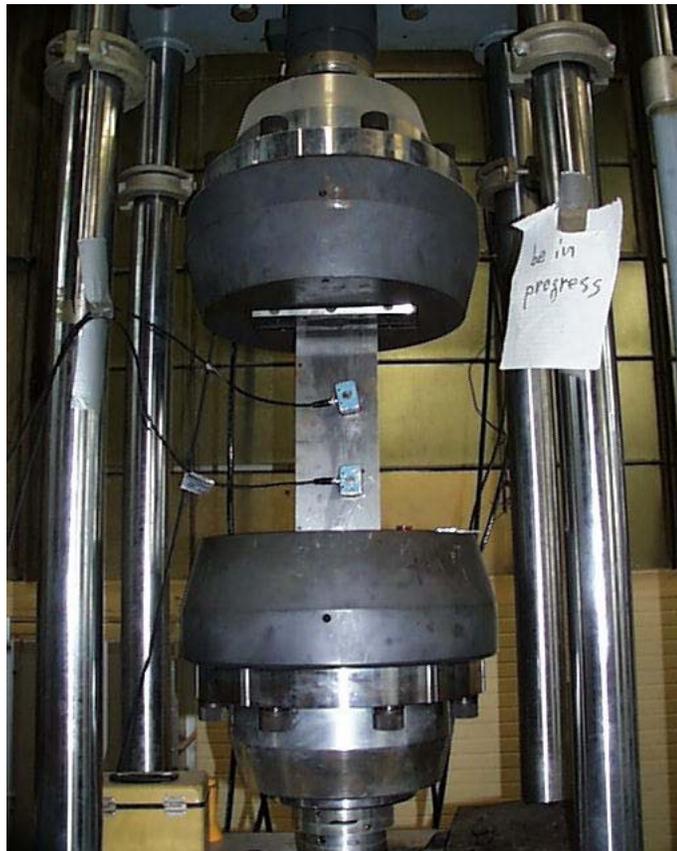
This specimen was tested in load control using a model 811 MTS closed-loop fatigue machine. The loading applied to this specimen was positive load ratio only. The stress range (S_R) used in this test was 4 ksi (5 ksi – 1 ksi) and the loading frequency was 3 Hz. The applied force was obtained by multiplying the stress with the gross area of the specimen ($3/32'' \times 6''$). The cyclic loading and the AE monitoring were interrupted occasionally to measure the crack length. The hardware set up of the AE instrument was the same as in the background noise monitoring (see Table 3.1), except that the threshold was raised to 50 dB. The

dye penetrant method was used to detect the crack tip. This test was continued until the specimen fractured. Figure 5.2 shows an overall view of this test.

Figure 5.2 Overall View of AE Monitoring of Fatigue Crack Growth (1)

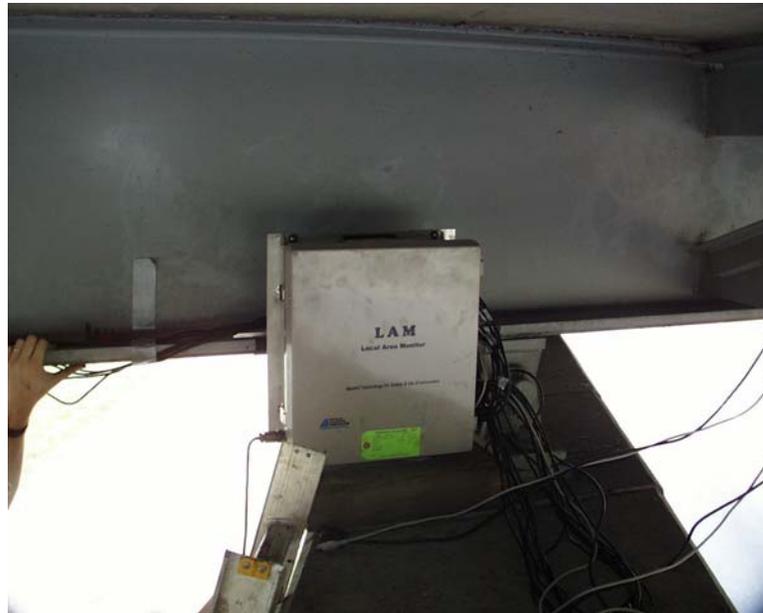
AE data were collected with an 8-channel Physical Acoustic Corporation Local Area Monitor (LAM) acoustic emission instrument and 4 sensors (R15I). This instrument was developed under a contract from the Federal Highway Administration and has several advantages for field monitoring as compared to conventional ones: it is weather proofed for use outside and can be run by internal batteries. It can be mounted on a bridge as showed in Figure 5.3.

Figure 5.3 Instrumentation (LAM)

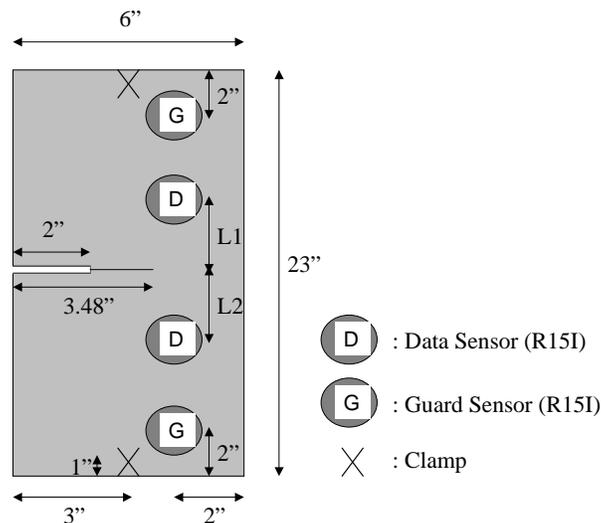
Specimen details were almost the same as in 5.3.1 except for the crack length. Because one of our objectives was to identify the crack growth by AE activity both in the laboratory and in the field and to compare those two results, the crack length needed to be long enough for the crack to grow easily and increase number of AE hits. The crack was generated at a stress range of 6 ksi in the same manner as the first test. After cyclic loading at a stress range of 6 ksi, the crack length was 3.480". The specimen was then tested at the stress range of 3 ksi. The corresponding stress intensity factor, ΔK , ($S_R = 3$ ksi, $a/W = 3.480/6$) is 37.1 ksi-in.^{1/2}. The specimen geometry and sensor location is shown in Figure 5.4.

Figure 5.4 Specimen Geometry and Sensor Location (2)

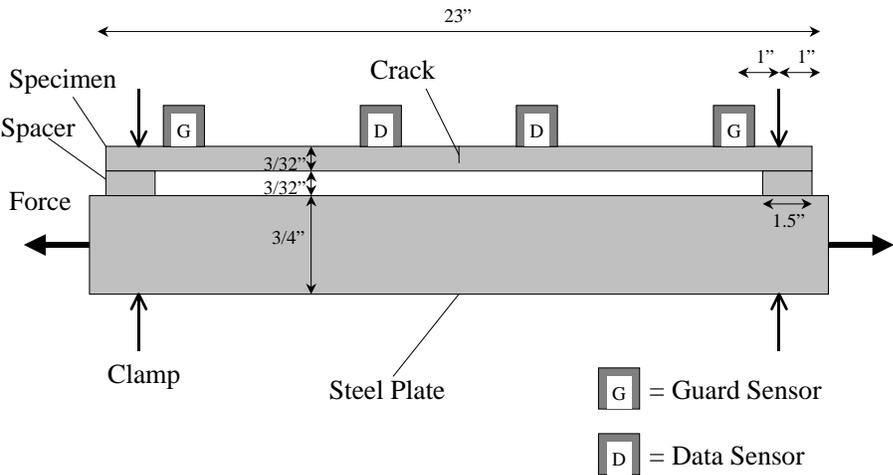
The test program was almost the same as in the first test. In this test, however, the specimen was mounted on the bigger steel plate by using two clamps to simulate the field condition. Spacers (3/32" thick plates) were inserted between the specimen and the steel plate to provide clearance. In addition, the guard sensor technique and source location technique were used. The stress range (S_R) used in this test was 3 ksi. Three experiments were performed for 50,000 cycles of loading at a frequency of 1 Hz. The data sensors spacing or the use of guard sensor was varied in each repetition case. In Case 1 the sensors spacing was symmetrical with respect to the crack location and the guard sensor was on. In Case 2 the sensors spacing was symmetrical and the guard sensor was off. In Case 3 the sensors spacing was unsymmetrical and the guard sensor was on. The comparison between Case 1 and Case 2 was done to determine the effect of the guard sensor, and the comparison between Case 1 and Case 3 to determine the effect of the crack location. Data sensors and guard sensors were located linearly as shown in Figure 5.4. The specimen was clamped at 1" from the both ends, while guard sensors were located at 2" from the ends (see Figure 5.5). This means that noise coming from outside the specimen is supposed to be captured by guard sensors before being captured by data sensors. Figure 5.6 shows the specimen in the machine. Crack length was measured at the end of each fatigue test. Gain of transducers was adjusted within ± 3 dB with respect to 40 dB to keep

Figure 5.5 Elevation of AE Monitoring of Fatigue Crack Growth (2)

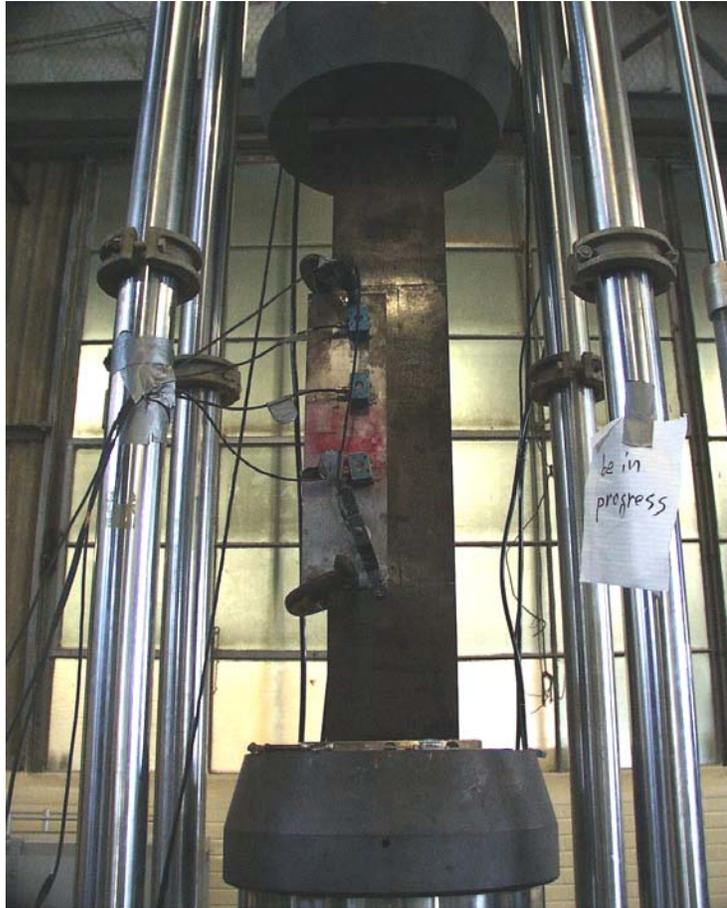
Figure 5.6 Overall View of AE Monitoring of Fatigue Crack Growth (2)

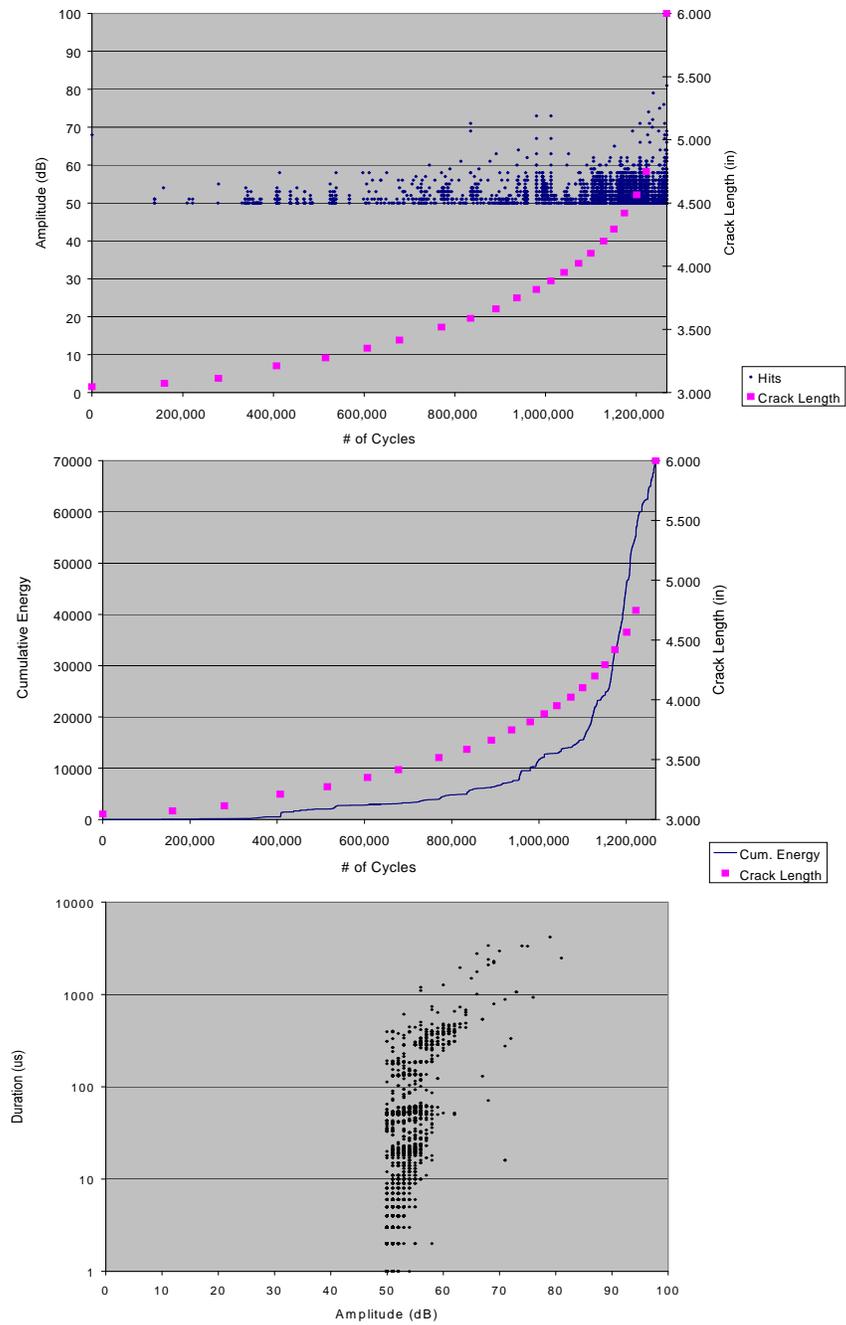
In Figure 5.7 and 5.8, the AE from the fatigue crack in the first specimen, number of hits vs. number of fatigue cycles, cumulative energy vs. number of fatigue cycles, and duration vs. amplitude, of each sensor are shown as well as the crack length. Figure 5.9 shows the fatigue crack.

Figure 5.7 AE from Growing Fatigue Crack (R15I)

The specimen broke after 1,267,387 fatigue cycles. A large number of hits were obtained by the R15I, while few hits were obtained by the R30I, the higher frequency transducer. The cumulative energy correlated with fatigue crack growth at a high ΔK region.

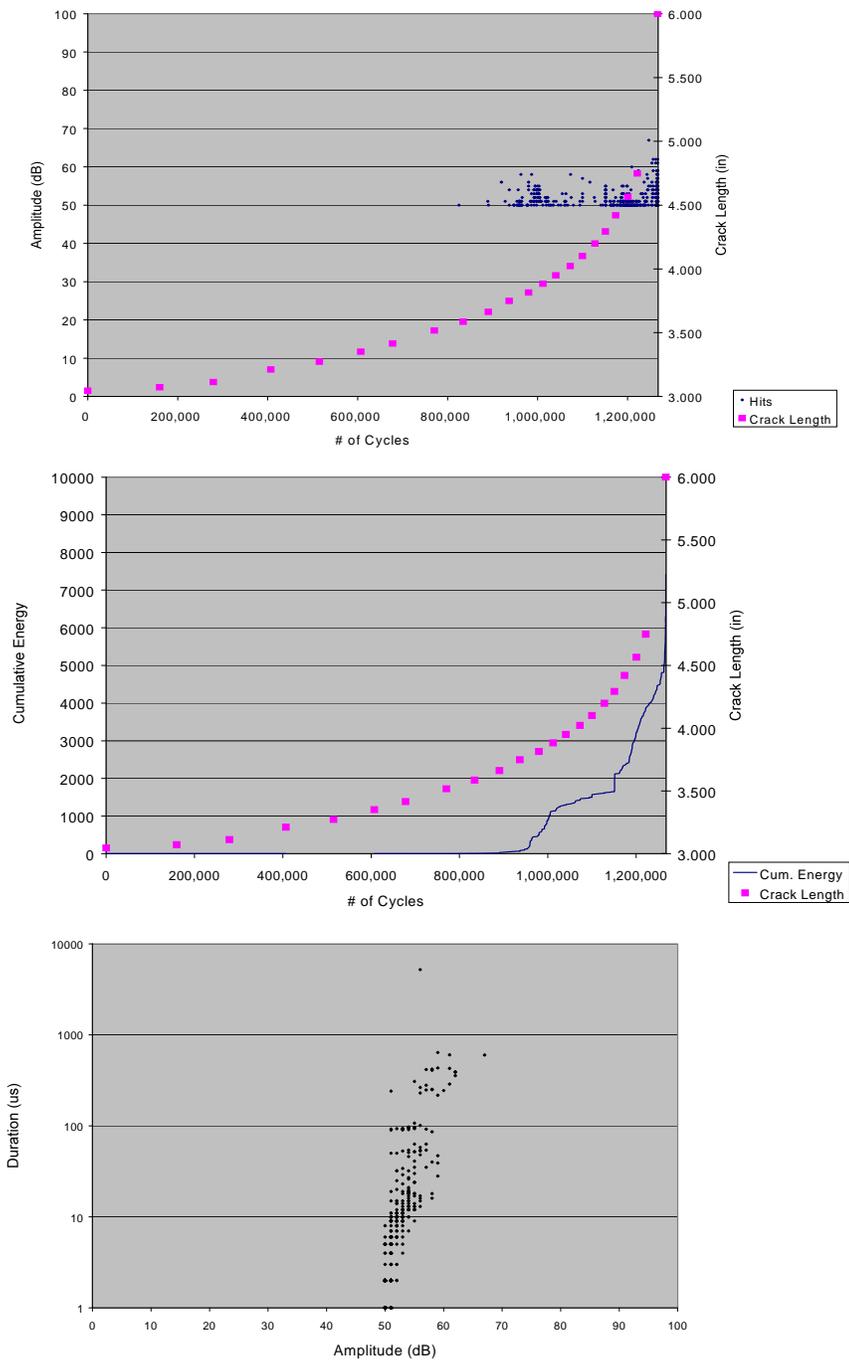
Figure 5.8 AE from Growing Fatigue Crack (R30I)

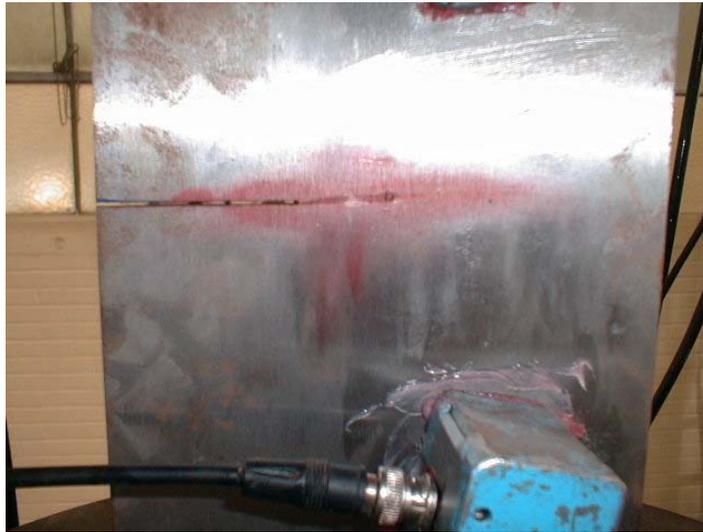
Figure 5.9 Fatigue Crack

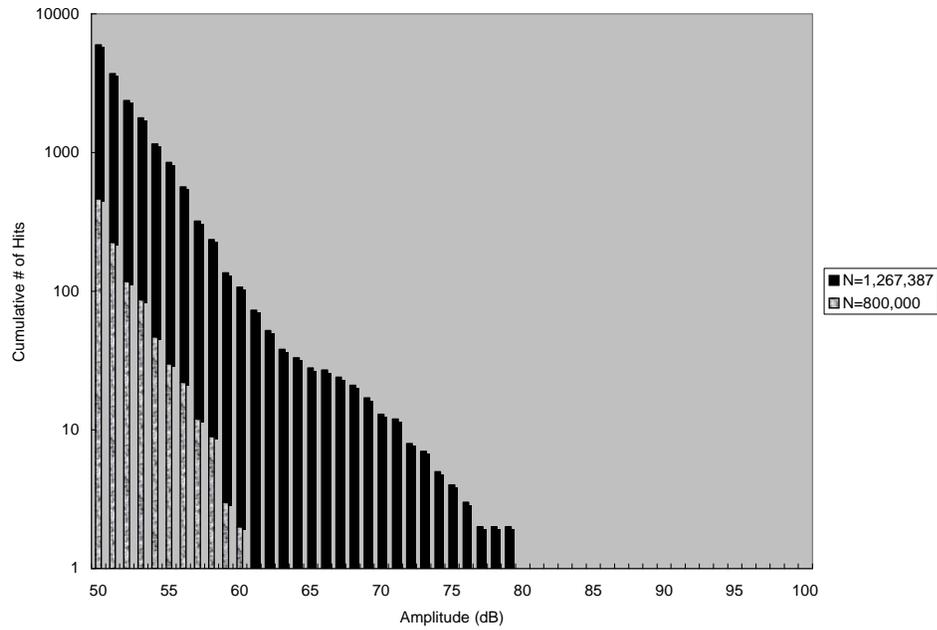
The cumulative amplitude distribution of the R15I sensor is presented in Figure 5.10 at two stages: after 800,000 cycles and 1,267,387 cycles of loading. Bilinear relation can be seen at the 1,267,387 fatigue cycles, while linear relation can be seen at the 800,000 fatigue cycles. The slopes of these lines are called “b values”, which is characteristic of the material and the deformation mechanism (Pollock 1981). Pollock concludes that a steeper slope represents the yielding and a shallow slope represents the crack growth. Therefore according to his interpretation, the deformation mechanism shifted from one mechanism

(yielding) to the combination of two mechanisms (yielding and crack growth) as the number of fatigue cycles increased.

Figure 5.10 Cumulative Amplitude Distribution (R15I)

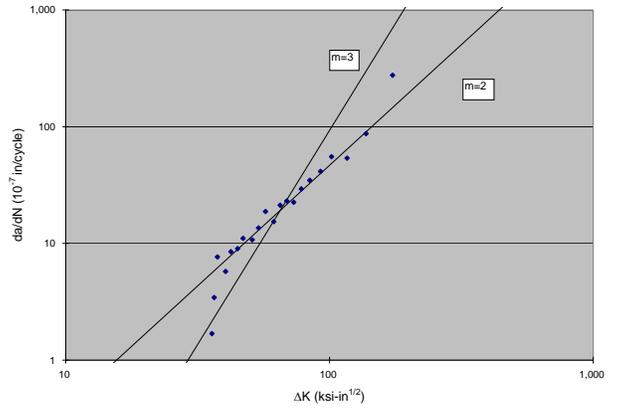
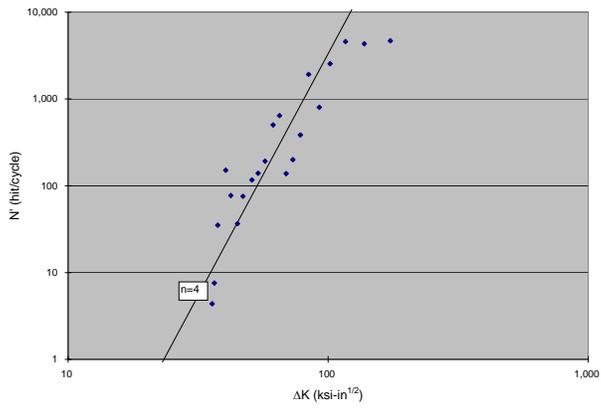
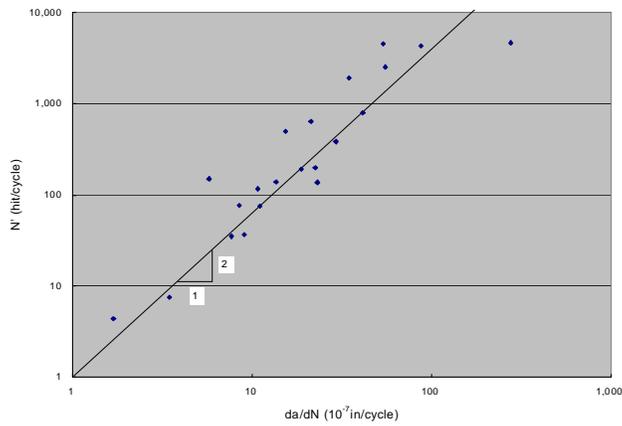
Figure 5.11 indicates the correlation regarding crack growth rate (da/dN), stress intensity factor (ΔK) and AE hit rate (N') of the R15I sensor.

Figure 5.11 Correlation Between Crack Growth and AE (R15I)

where A and n are also material constants (ASNT 1987 and Morton *et al.* 1973). From Figure 5.11, it appears that the result of this test agree well with the above two relationships. The slopes on the log-log scales were estimated as $m=2$, $n=4$ respectively, while typical m value for metals is 3. AE hit rate and crack growth rate were correlated, but with a larger scatter in the results. The approximate slope was 2.

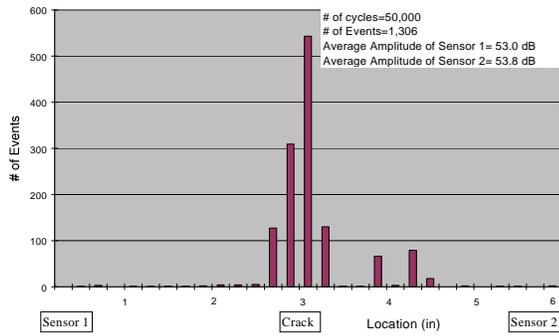
Figure 5.12 through Figure 5.14 show the location displays; and Figure 5.15 through Figure 5.17 show the graphs of duration vs. amplitude observed in each case.

Figure 5.12 Location Display (Case 1)
[Symmetrical Sensor Spacing, Guard Sensor On]

The linear location technique provided good location displays even when no guard sensors were used and when the data sensors spacing was unsymmetrical as indicated in Figure 5.12 through Figure 5.14. The number of events was almost the same in each case; about 1000. Location display of Case3 was less precise compared with Case 1 or Case2. One possible reason for lower precision in Period 3 monitoring may be the closeness of sensor 1 to the crack. In this case, the size of the sensor is significant compared to the distance of travel of the wave. AE hits tended to be less than 1000 μ s in duration and less than 70 dB in amplitude in each case as indicated in Figure 5.15 through Figure 5.16. Judging from the similarity in data quality (duration vs. amplitude) as well as in location display of Case 2 to other two cases, there was little influence of noise in the laboratory.

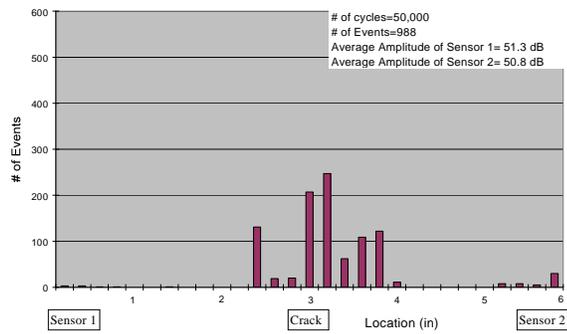
Figure 5.13 Location Display (Case 2)
[Symmetrical Sensor Spacing, Guard Sensor Off]

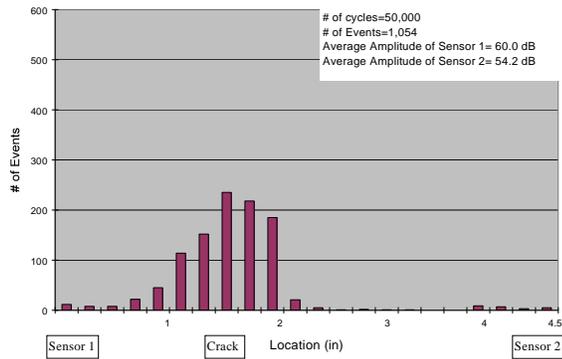
Figure 5.14 Location Display (Case 3)
[Unsymmetrical Sensor Spacing, Guard On]

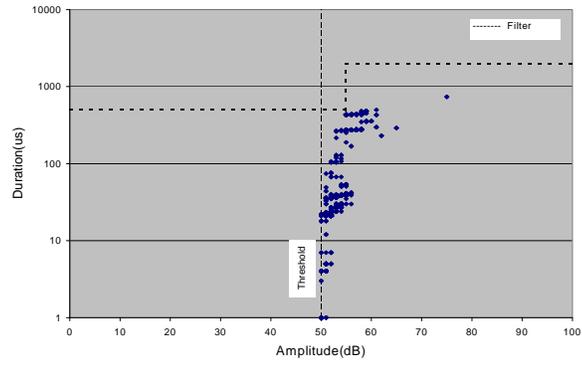
Figure 5.15 Duration-Amplitude (Case 1)
[Symmetrical Sensor Spacing, Guard On]

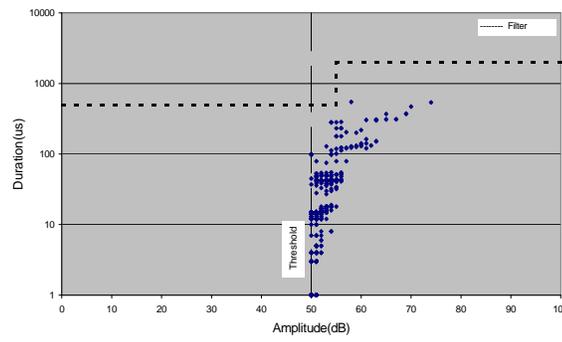
Figure 5.16 Duration-Amplitude (Case 2)
[Symmetrical Sensor Spacing, Guard Sensor Off]

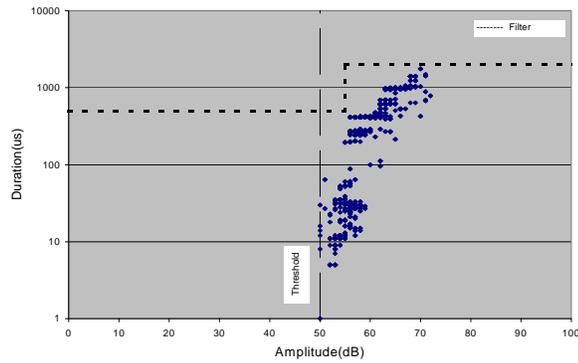
Figure 5.17 Duration-Amplitude (Case 3)
[Unsymmetrical Sensor Spacing, Guard Sensor On]

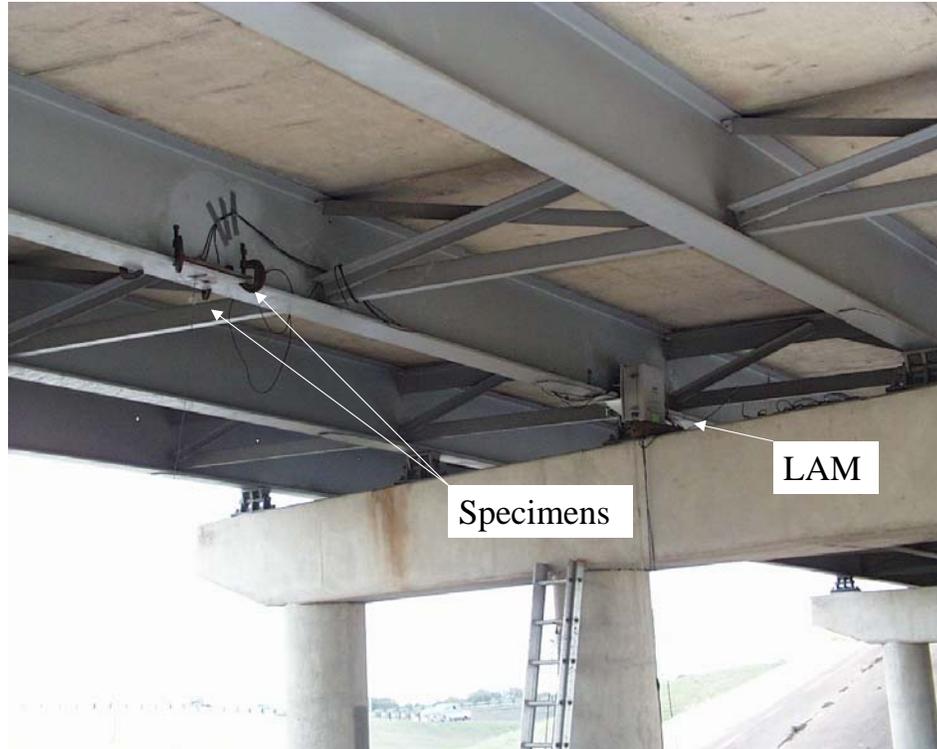
Figure 6.1 Overall View of Field Test

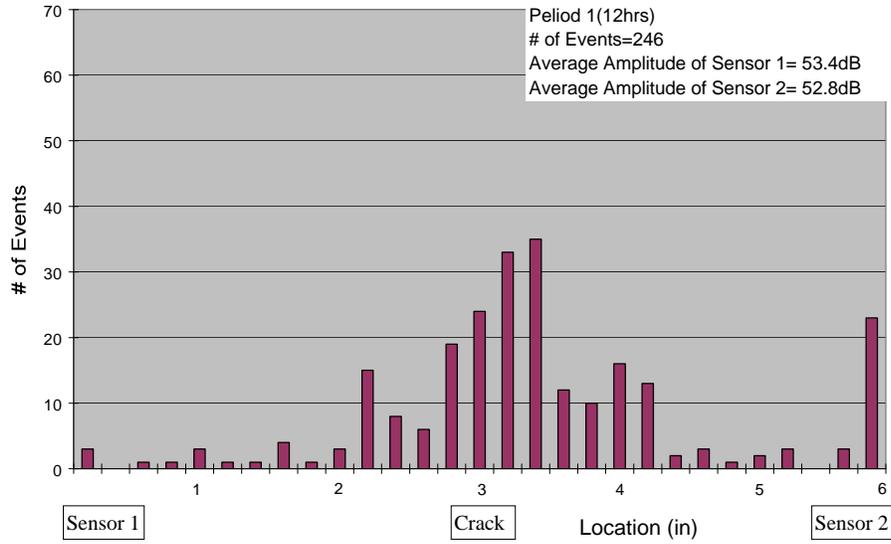
Figure 6.2 through Figure 6.6 show the location displays, and Figure 6.7 through Figure 6.11 plot duration vs. amplitude of each period.

Figure 6.2 Location Display (Period 1, Cracked Plate)
 [Symmetrical Sensor Spacing, Guard Sensor On]

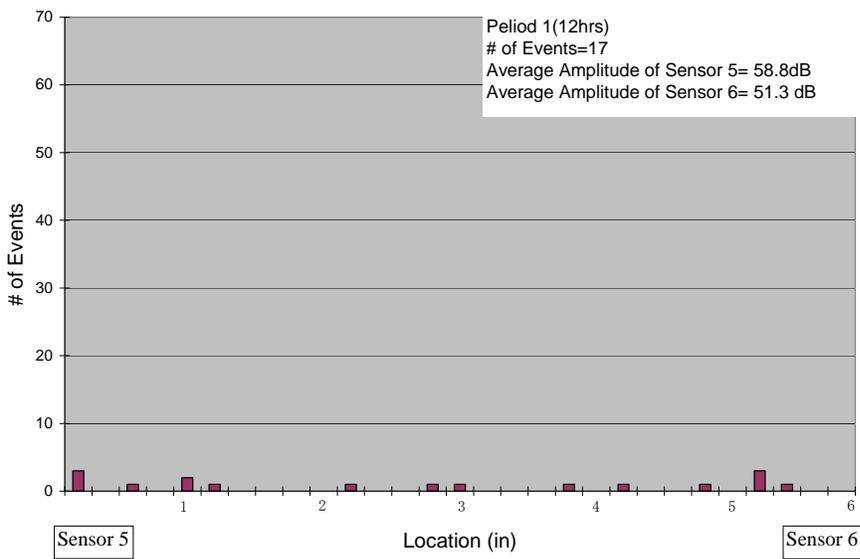
Figure 6.3 Location Display (Period 1, Plane Plate)
 [Symmetrical Sensor Spacing, Guard Sensor On]

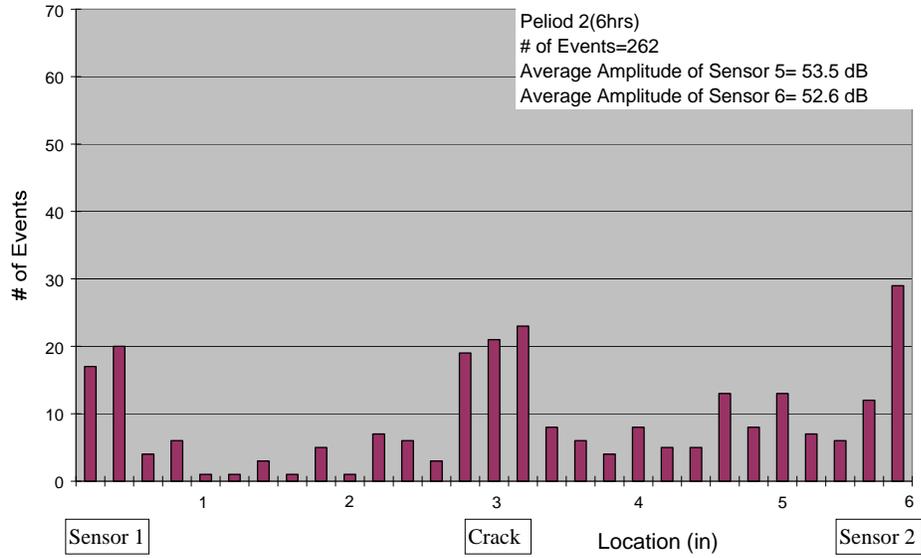
Figure 6.4 Location Display (Period 2, Cracked Plate)
 [Symmetrical Sensor Spacing, Guard Sensor Off]

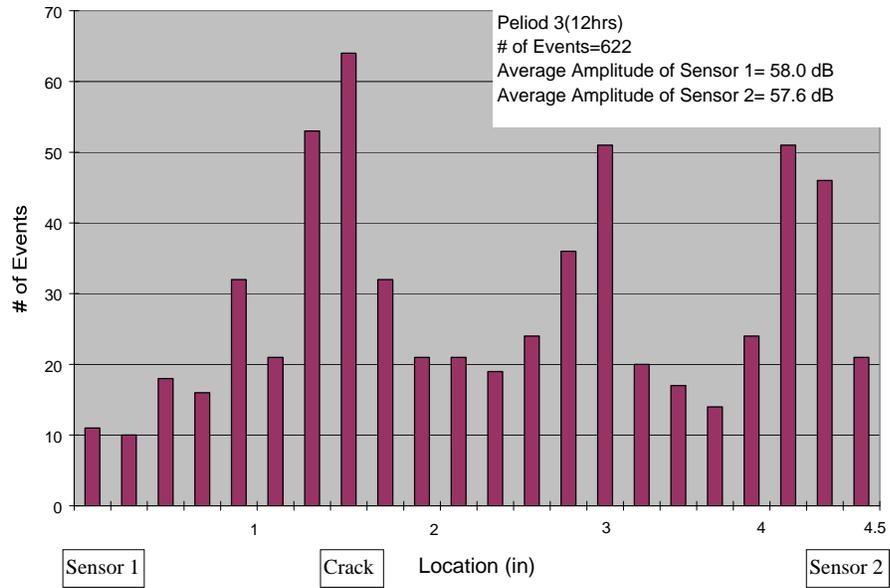
Figure 6.6 Location Display (Period 3, Cracked Plate)
 [Unsymmetrical Sensor Spacing, Guard On]

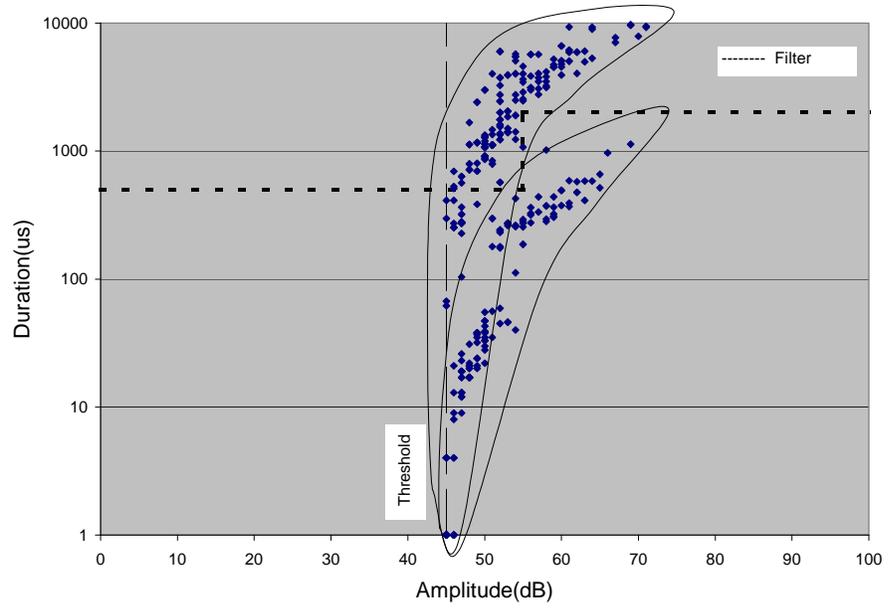
Figure 6.7 Duration-Amplitude (Period 1, Cracked Plate)
 [Symmetrical Sensor Spacing, Guard On]

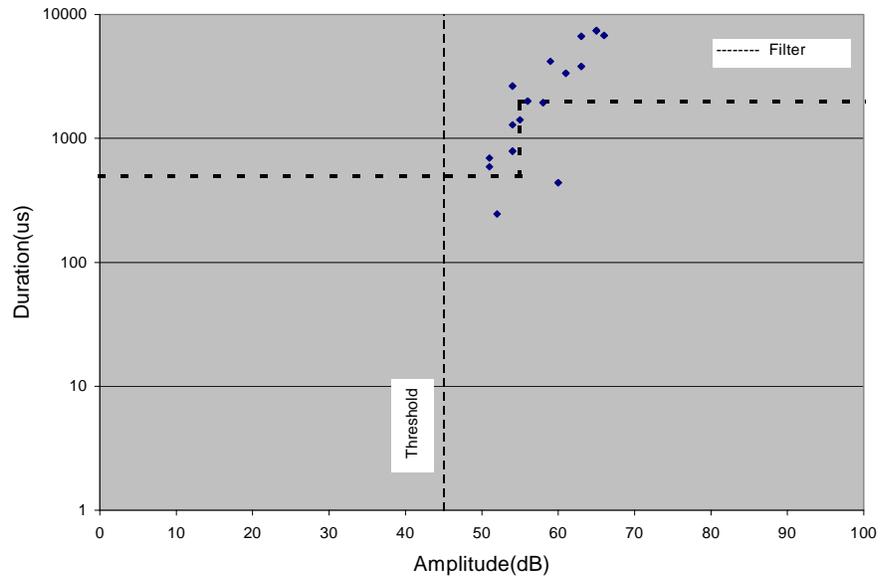
Figure 6.8 Duration-Amplitude (Period 1, Plane Plate)
[Symmetrical Sensor Spacing, Guard On]

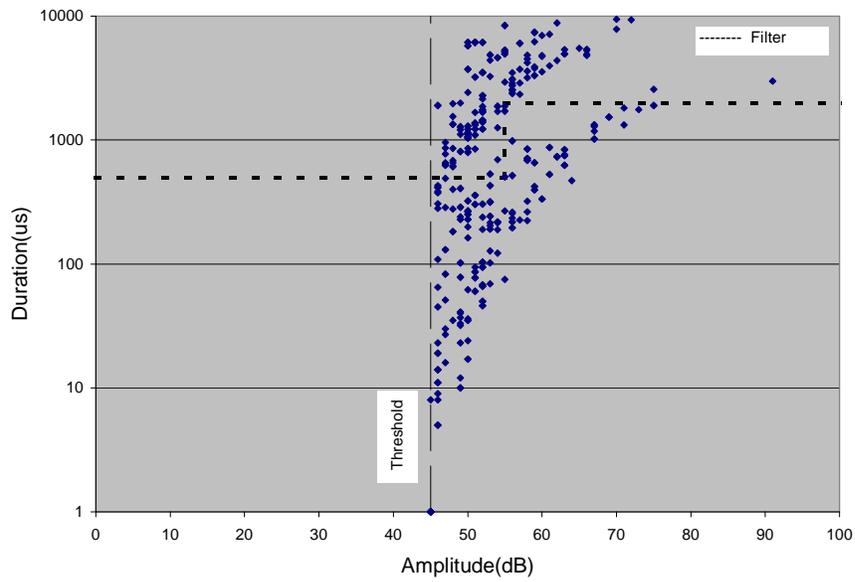
Figure 6.9 Duration-Amplitude (Period 2, Cracked Plate)
[Symmetrical Sensor Spacing, Guard Off]

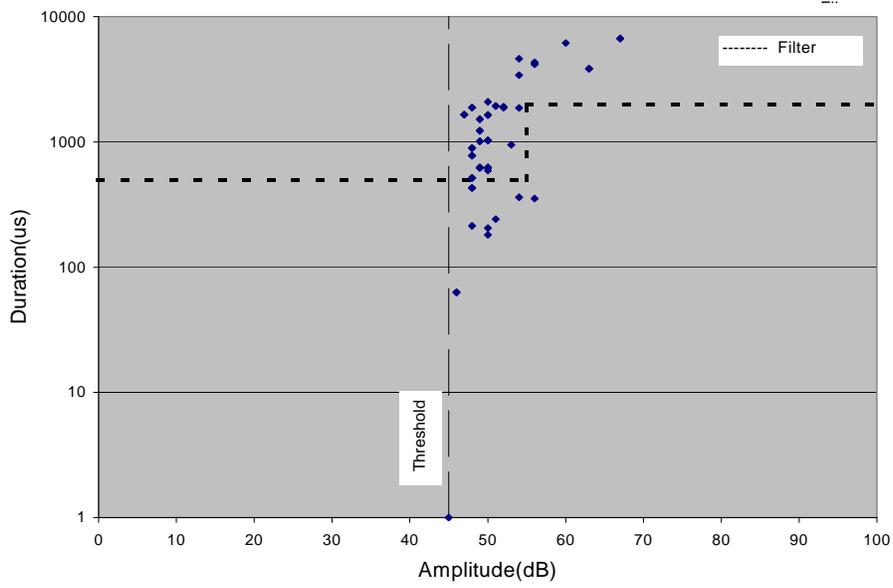
Figure 6.10 Duration-Amplitude (Period 2, Plane Plate)
[Symmetrical Sensor Spacing, Guard Off]

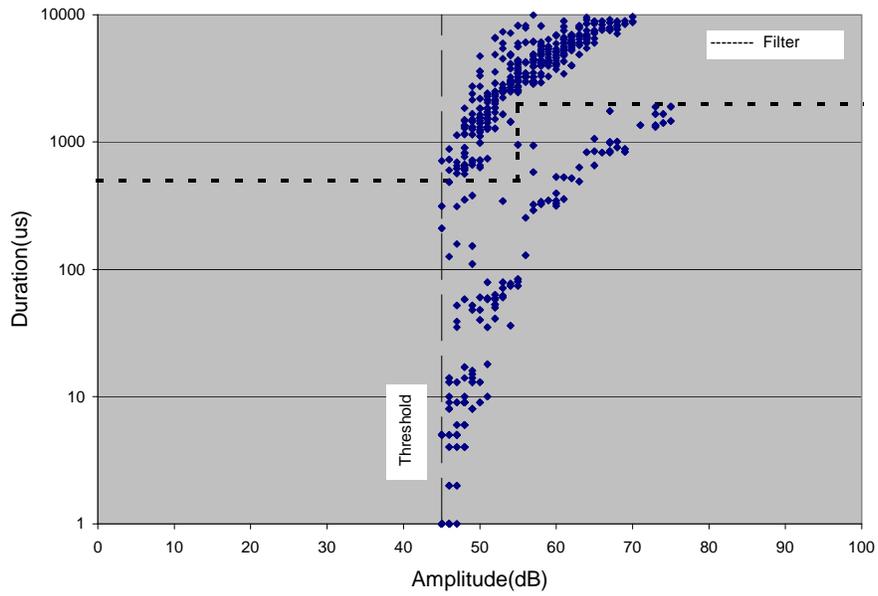
Figure 6.11 Duration-Amplitude (Period 3, Cracked Plate)
[Unsymmetrical Sensor Spacing, Guard Sensor On]

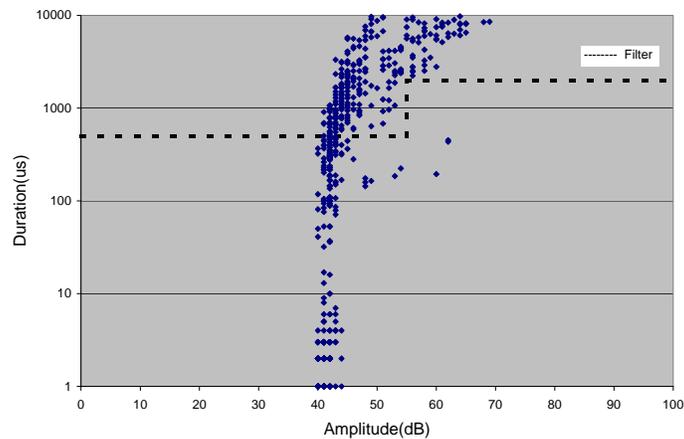
the background noise monitoring (see Chapter 3), it seems possible to assume that the upper band was mainly caused by extraneous noise and the lower band by the crack. This hypothesis can be also supported by the concept of the Swansong Filter described in 2.3.1, which states that false hits due to extraneous noise have long duration and low amplitude. One of the results of the background noise monitoring is showed in Figure 6.12. The majority of the hits have longer duration and low amplitude.

Figure 6.12 Result of the Background Noise Monitoring
[Period 5, Texas-71 Bridge, Ch.1]

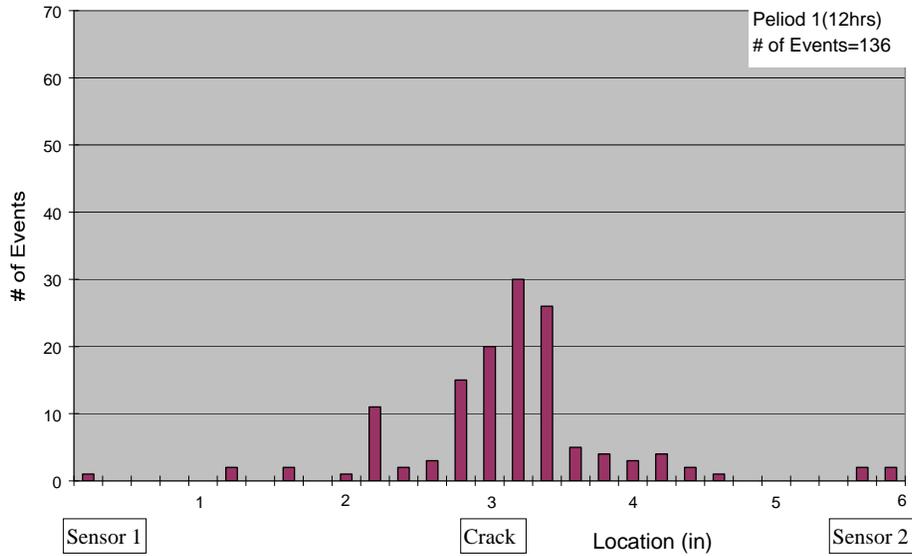
Figure 6.12 through Figure 6.16 show the location displays after applying the above filter.

Figure 6.12 Location Display (Period 1, Cracked Plate, After Filtering)
[Symmetrical Sensor Spacing, Guard Sensor On]
