**A Study on the Application of the Acoustic Emission Method for
Steel Bridges**

Thesis

Master of Science in Engineering

The University of Texas at Austin

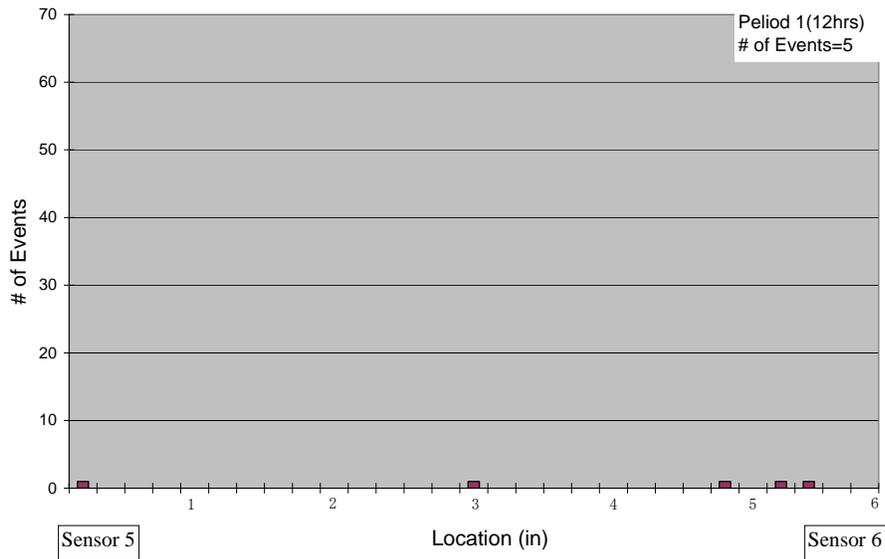
Figure 6.13 Location Display (Period 1, Plane Plate, After Filtering)
[Symmetrical Sensor Spacing, Guard Sensor On]

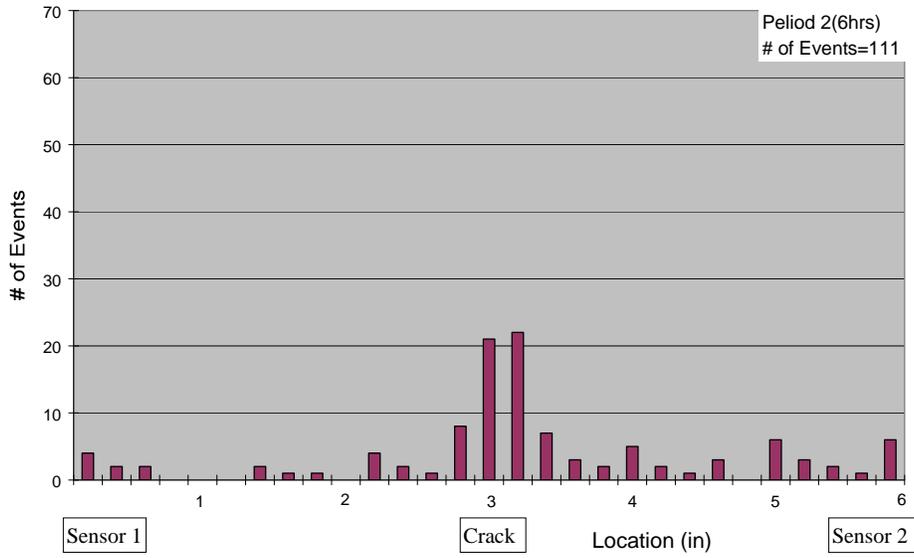
Figure 6.14 Location Display (Period 2, Cracked Plate, After Filtering)
[Symmetrical Sensor Spacing, Guard Sensor Off]

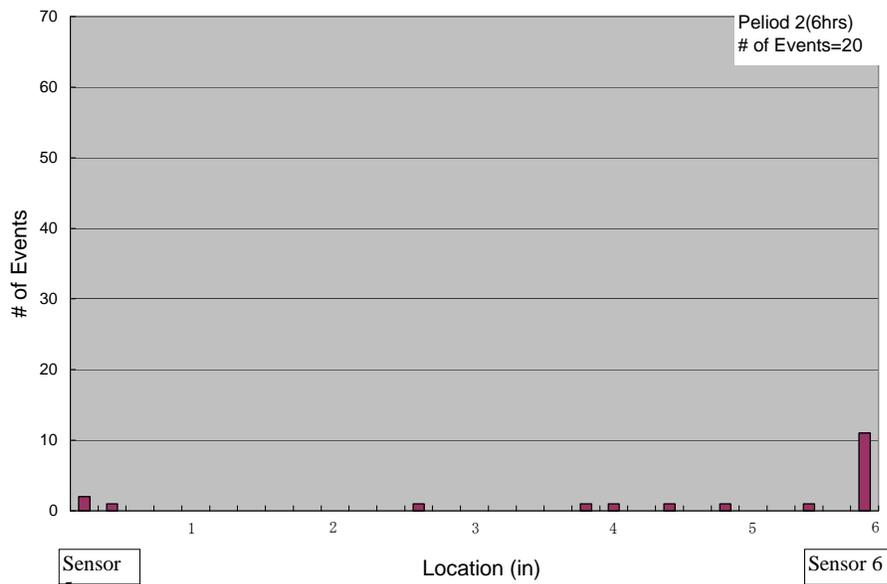
Figure 6.15 Location Display (Period 2, Plane Plate, After Filtering)
[Symmetrical Sensor Spacing, Guard Sensor Off]

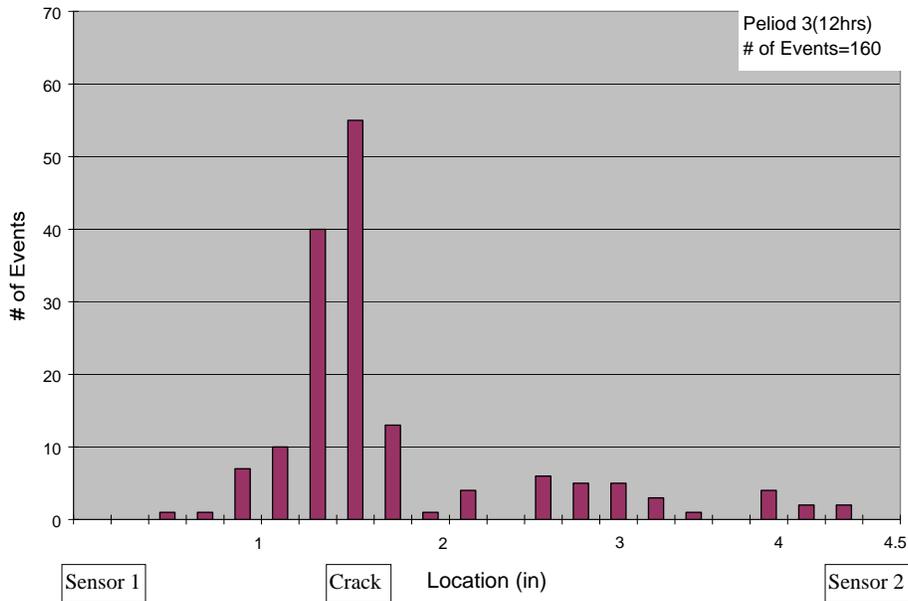
Figure 6.16 Location Display (Period 3, Cracked Plate, After Filtering)
[Unsymmetrical Sensor Spacing, Guard On]
