**MEASUREMENTS OF DEFORMATIONS AND STRESSES DUE TO  
PLATE OUT-OF-FLATNESS IN A STEEL TWIN BOX GIRDER  
BRIDGE SYSTEM**

**THESIS**

The University of Texas at Austin

**MAY 2007**

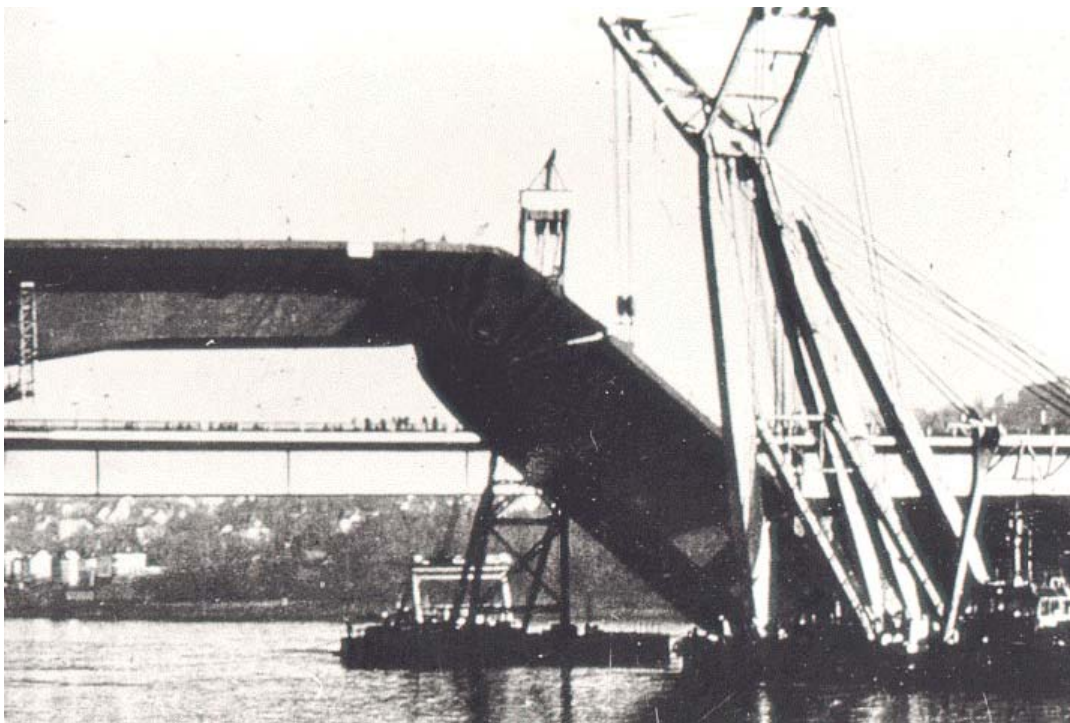
**Figure 1-1 Koblenz Bridge Failure 1971 (Grzebieta, 2007)**

Although box girders have many aesthetic and structural advantages, the relatively wide plate elements in the cross-sections can lead to local instabilities that could influence the systems overall strength. Some box girder bridge failures in the 1970's have emphasized the importance of considering local buckling in the design process. Figure 2-1 shows the failure of the Koblenz Bridge that crossed over the Rhine in Germany in November of 1971.

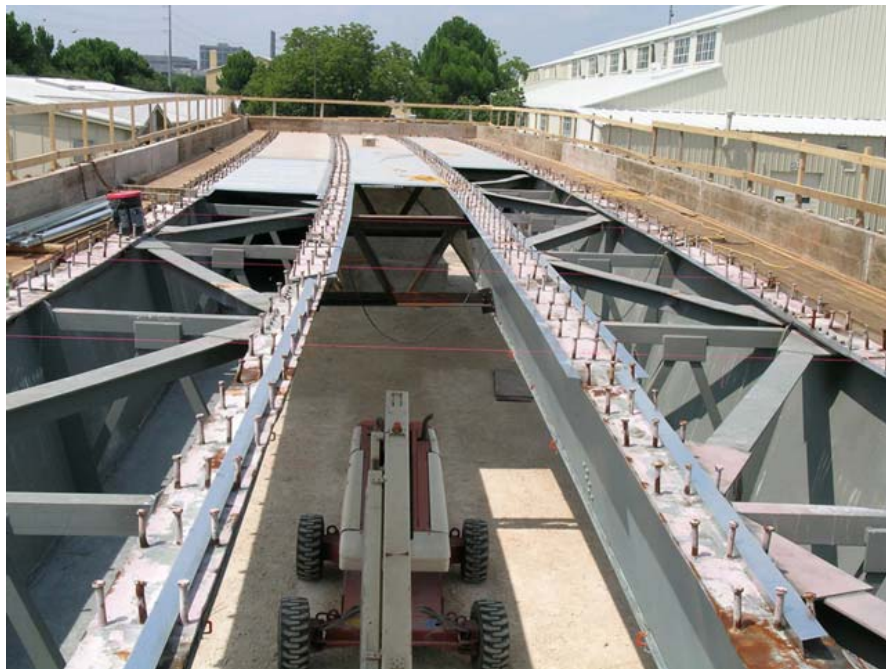
**Figure 1-3 Internal Bracing System**

As previously stated, box girder bridges are known for their superior torsional stiffness. However, this stiffness is only achieved once the concrete deck is in place and gains sufficient strength. During transportation, erection, and construction, the girder is an open section with low stiffness due to its relatively thin elements. To help increase the overall stiffness of the girders themselves during these crucial events, internal bracing systems are often installed. Figure 1-3 presents some of the typical bracing systems, which include braces both internal and external to the boxes. The internal bracing system consists of vertical cross-frames that are evenly spaced along the length of the girders as well as a top flange lateral truss that consists of both diagonals and struts. The internal K-frames are typically positioned at a panel point of the top flange lateral truss so that the strut of the internal K-frame is also a strut in the top flange lateral truss. The main purpose of the top flange truss bracing system is to help increase the torsional stiffness of the system during erection and construction. In addition to the internal braces, box

girders also often have external braces that frame between adjacent girders. These braces may consist of solid plate diaphragms that are used at the supports of the girders or may also consist of external K-frames at intermediate locations along the length of the bridge. The solid plate diaphragms stay on the bridge throughout the service life, while intermediate K-frames are often removed after construction to avoid potential fatigue problems that might occur in the vicinity of the braces. While severity of the potential fatigue problems from the external braces have not been documented, the braces are removed based upon past problems that have occurred in I-girder systems – particularly those with heavily skewed supports.

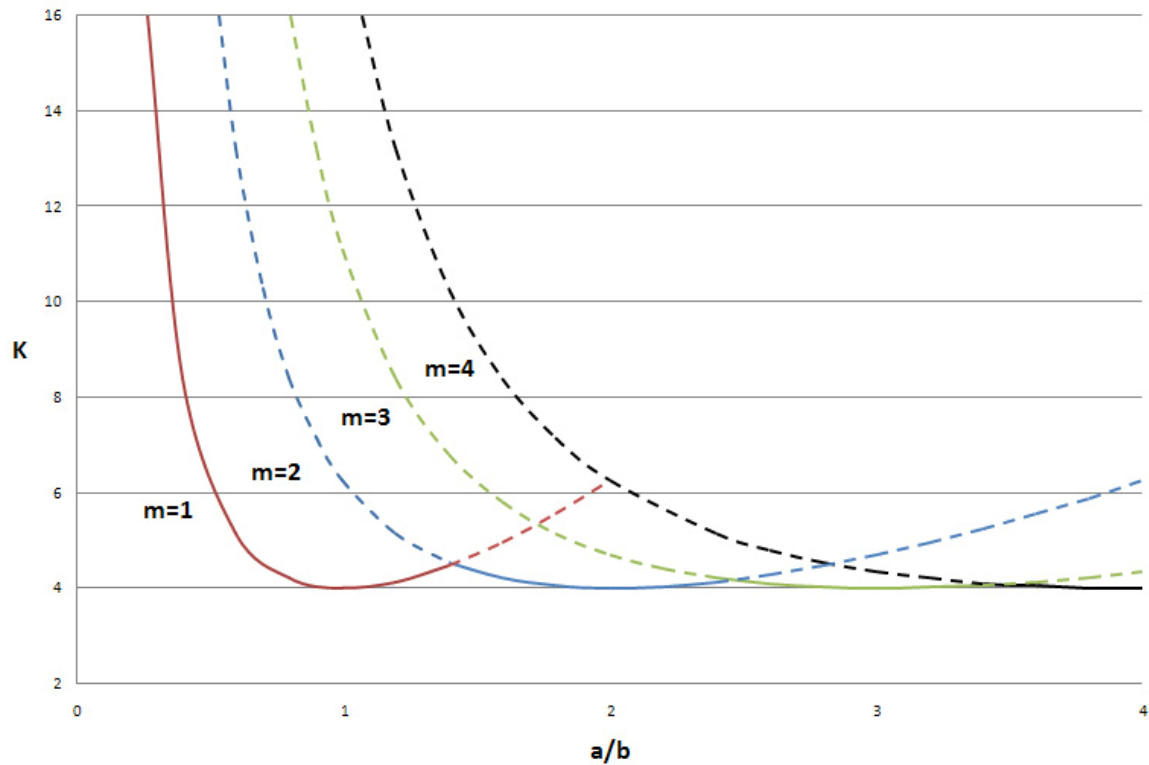
**Figure 2-3 Plate Aspect Ratios vs. Buckling Coefficients (Allen, 1980)**

Values of  $m = 1$  through  $m = 4$  are plotted and for each value of  $m$ , there is a non-linear relationship between  $k$  and  $a/b$ . As shown on the graph minimum values of  $k$  can be found when  $m = a/b$ . Equation (2.5) and (2.6) are for plates that are simply supported along the edges. As the boundary conditions change, the buckled shapes change which leads to different buckling coefficients. A diagram showing various boundary conditions and their corresponding buckling coefficients is shown in Figure 2-4.

The buckling mode of the plate changes as the aspect ratio increases. Figure 2-3 shows a graph relating the number of waves in a buckled shape ( $m$ ), aspect ratios ( $a/b$ ), and the buckling coefficients ( $k$ ).

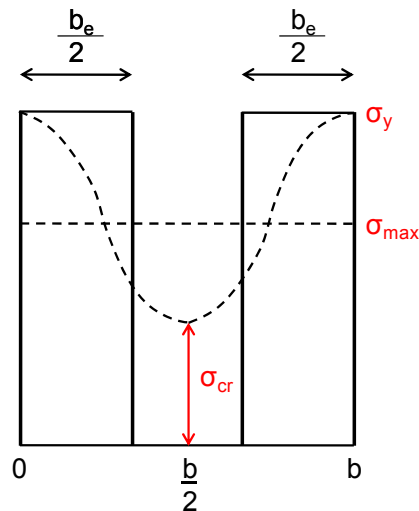
**Figure 2-7 Effective Width Stress Distribution (Allen, 1980)**

Figure 2-7 shows the stress distribution on the effective width of the plate and the basis of how Equation (2.10) was derived.

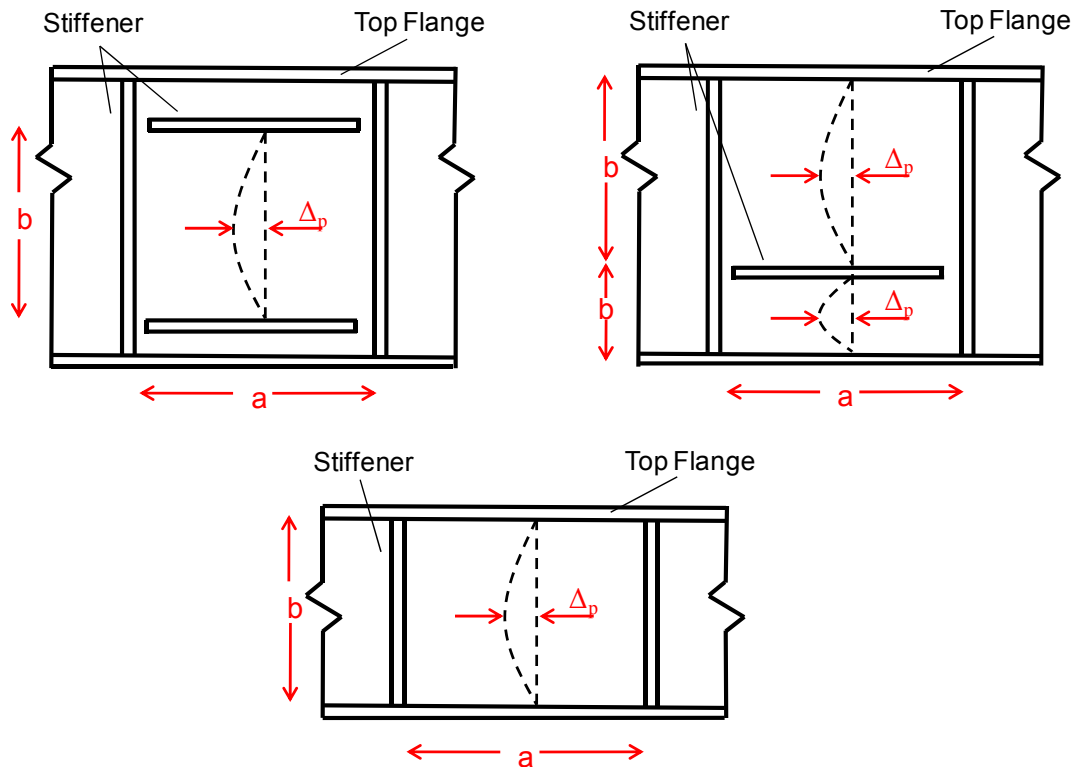
Figure 2-8 Out-of-Plane Deviations (Korol & Thimmhardy, 1987)

During various construction stages, geometric distortions and structural imperfections are created. Plate elements, particularly thin plates, always have initial out-of-flatness. Plate elements are subject to residual stresses during the welding process, in which compressive stresses are formed where the weld metal cools and shrinks. Residual stresses result premature yielding on the cross-section that lowers the effective stiffness of the built up member. The residual stresses can also deform the original element. Figure 2-8 shows some typical out-of-plane deviations.

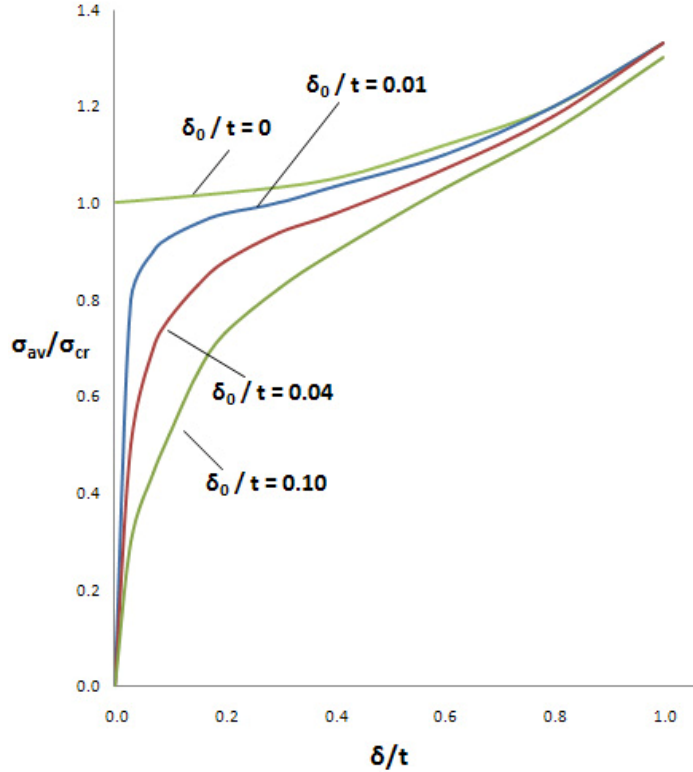
**Figure 2-9 Deflection of Plates with Initial Deviation (Allen, 1980)**

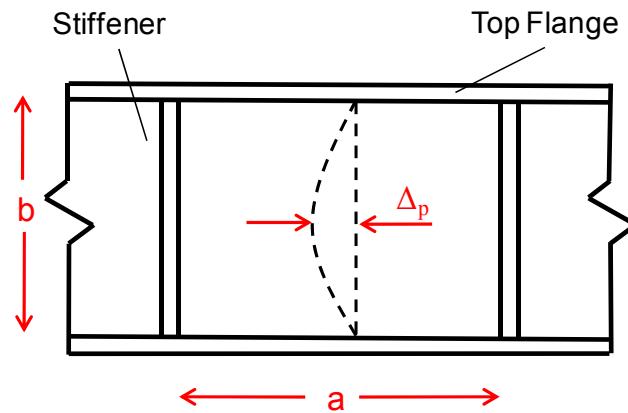
Figure 2-17 Typical Imperfection Measurement (Korol & Thimmhardy, 1987)

Even though different countries may provide different tolerances, most specifications measure out-of-flatness based on the imperfection depicted in Figure 2-17. Tolerances throughout the European countries had a large variability before the development of the Eurocode 3 Design of Steel Structures (1993). Tolerance values from various countries in Europe ranged from  $b/133$  to  $b/500$ . As stated earlier, it is typical for individual countries to base their own specifications on common practice and knowledge, which would differ in various parts of the world. Various plate tolerance limits throughout Europe prior to the 1993 Eurocode are shown in Figure 2-18.

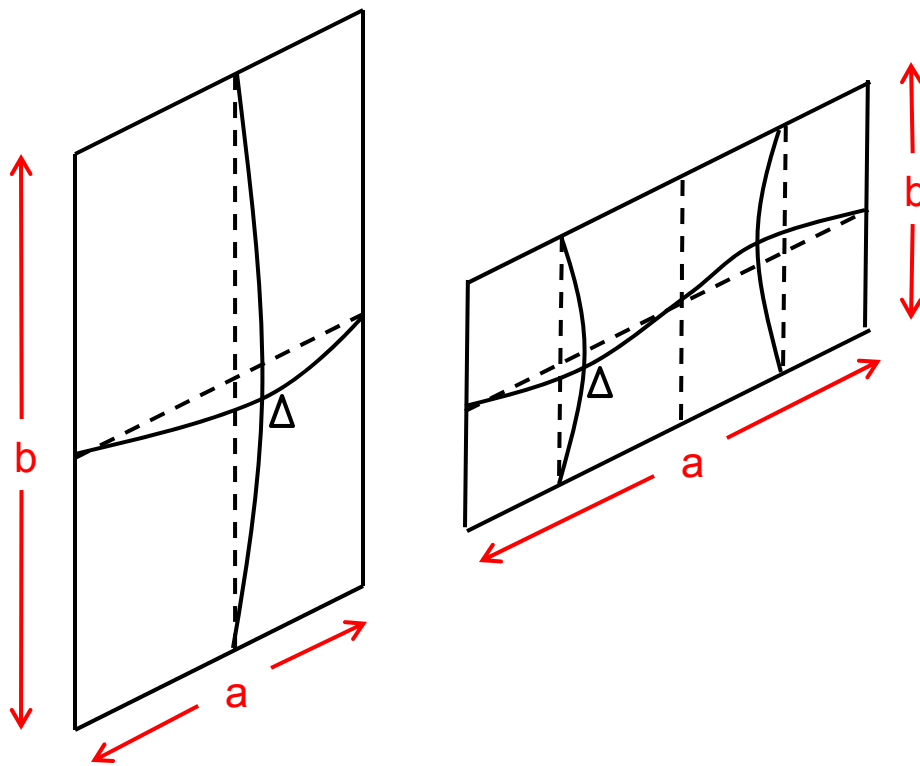
**Figure 2-19 Panel Imperfection Details (Eurocode 3, 2003)**

The Eurocode 3 Part 1.5 (EN 1993-1-5 2003) provides specifications for plate structures. The specification addresses both global and local imperfection tolerances. According to the specification, the shape and magnitude of the geometric imperfections should be considered. Figure 2-19 shows details providing proper use of the specification. The tolerance limit of the imperfection is the smaller of  $a/200$  or  $b/200$  (Mercan, 2005).

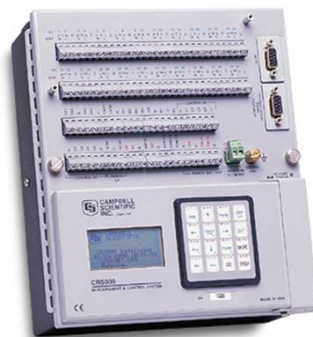
CR5000 Datalogger

The data acquisition system used on the instrumented bridge included equipment manufactured by Campbell Scientific, Inc. The main components of the system included 3 CR5000 Dataloggers, 16 AM416 Relay Multiplexers, 2 AVW100 Vibrating Wire Interfaces, 44 4WFB350 4 Wire Full Bridge Terminal Input Modules, and 103 4WFB120 4 Wire Full Bridge Terminal Input Modules. Figure 3-4 shows pictures of these instruments. The instrumentation components are discussed in further detail in the following sections.

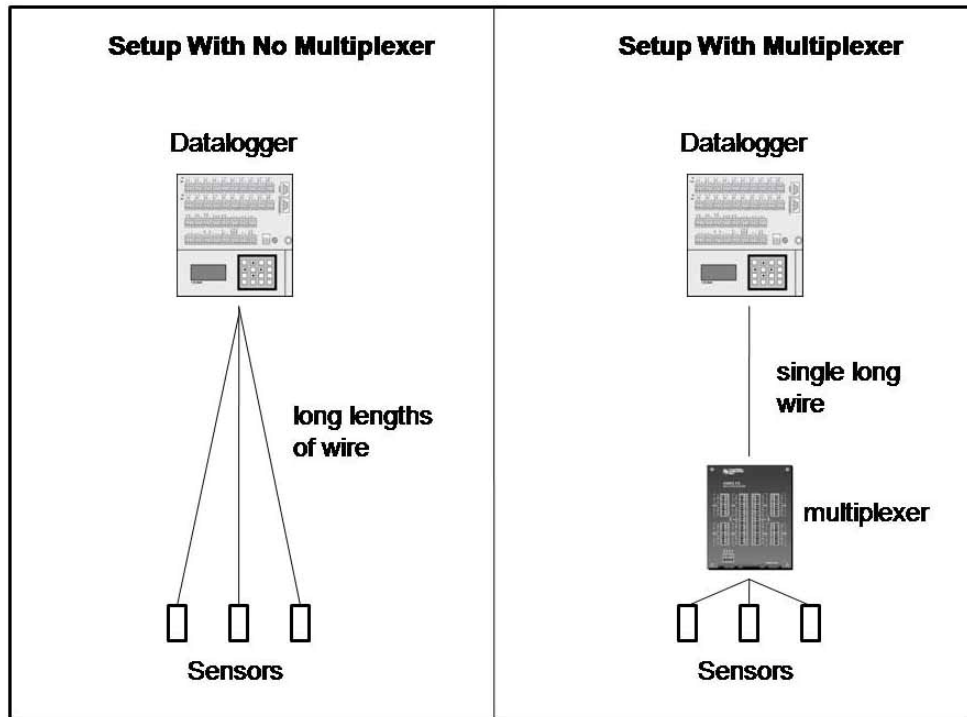
**Figure 3-5 Multiplexer Scenarios**

The CR5000 datalogger is not capable of directly reading the vibrating wire strain gages, and therefore an interface attachment is needed. The AVW100 Interface was used in conjunction with the instrumentation setup. In theory, each vibrating wire strain gage should be connected to an interface, and then the interface connected to the datalogger. However, in practice, each vibrating wire strain gage is connected to the multiplexer, which is then connected to a single interface that is connected to the datalogger. This efficient method was practiced in the instrumentation of the box girder bridge system.

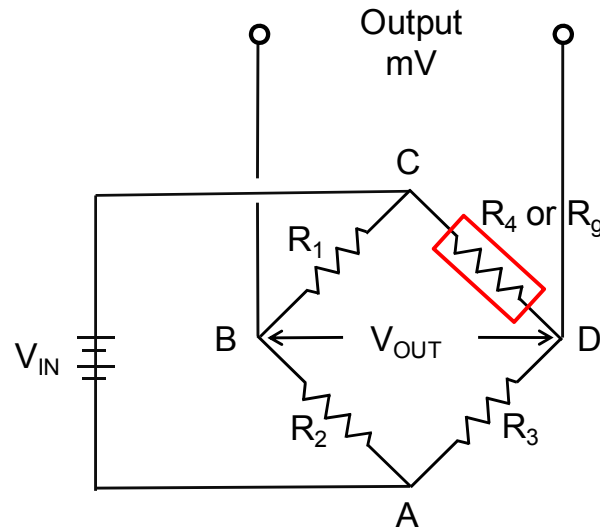
**Figure 3-7 Wheatstone Bridge Circuit (National, 2007)**

To gain an indication of expected strain changes, Hooke's Law can be rearranged to solve for the strain  $\epsilon = \sigma/E$  within the elastic range of the material. For steel,  $E = 29000$  ksi and for a 1 ksi stress change the corresponding change in strain is 34.5 microstrains. Therefore ideally in structural applications the accuracy of the strain sensors should be within a few microstrains. To achieve this, the gage must be connected to an electrical circuit that is capable of measuring minute changes in resistance. A bridge configuration with a voltage excitation source, named a Wheatstone bridge, is preferably used to achieve this. Figure 3-7 shows the circuitry of a Wheatstone bridge.

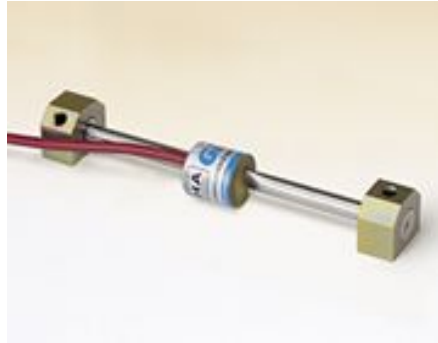
**Figure 3-10 Geokon Model 4000 Vibrating Wire Strain Gage**

reading device, the vibrating wire strain gage. Figure 3-10 shows a Geokon Model 4000 vibrating wire strain gage.

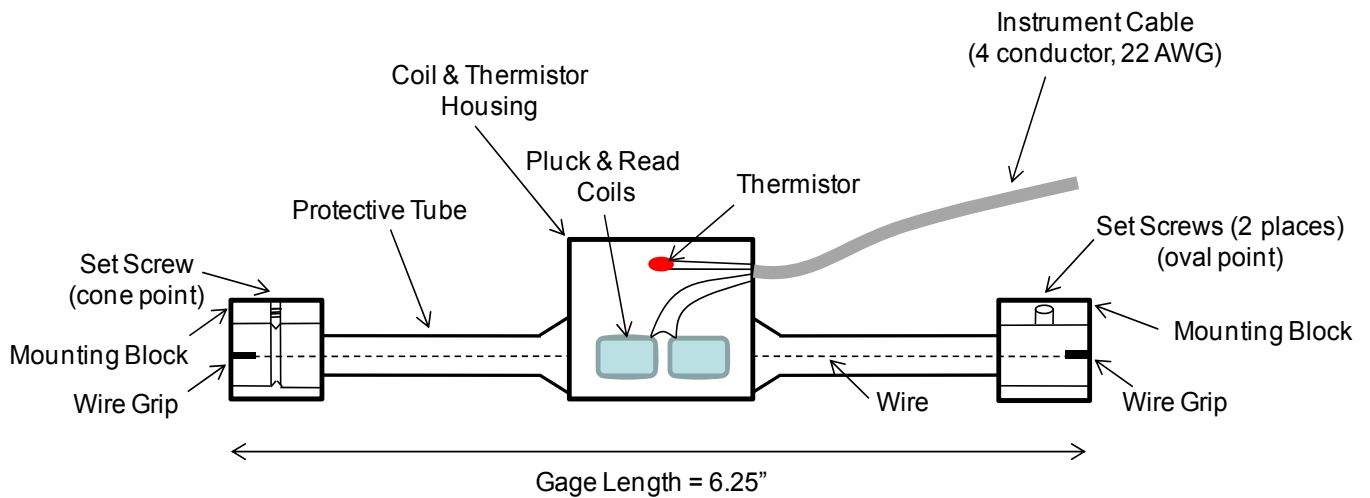
**Figure 3-11 Vibrating Wire Strain Gage Schematic (Geokon, 2005)**

Strains are measured using the vibrating wire principle. Within the protective tube runs a thin steel wire that is tensioned prior to mounting. The gage is supported by two mounting blocks that can be bolted, welded, or epoxied to the surface of the specimen. Deformations on the specimen surface cause the mounting blocks to shift and change position causing the tension in the wire to change. The resonant frequency of vibration of the wire is a function of its tension, thus if the tension in the wire changes, so will the frequency of the gage. Attached to the gage is a unit that houses a thermistor and pluck & read coils. This housing unit plucks the thin steel wire and the electromagnetic coils then measure the frequency. The frequency can then be converted to strain values. As previously stated, the vibrating wire strain gage housing unit also contains a thermistor. A change in the thermistor's temperature causes a change in its resistance. A relationship between the resistance and temperature of the device can be defined using the Steinhart-Hart equation:

Vibrating wire strain gages have many advantages. Since the gages work based upon mechanical means, they can provide long term consistent readings. The gages are much more rugged and durable than conventional. As a bonus, the gages are reusable and under the right conditions can provide stable long-term consistent results. Vibrating wire strain gages also have the ability to measure not only strain values, but temperatures as well. Another advantage is that wire lengths are not an issue and do not affect measurements, which can be a problem with resistive strain gages. One drawback to vibrating wire strain gages is that they are not suitable for the measurement of dynamic or rapidly changing strains. A detailed drawing of the vibrating wire gage can be seen in Figure 3-11.

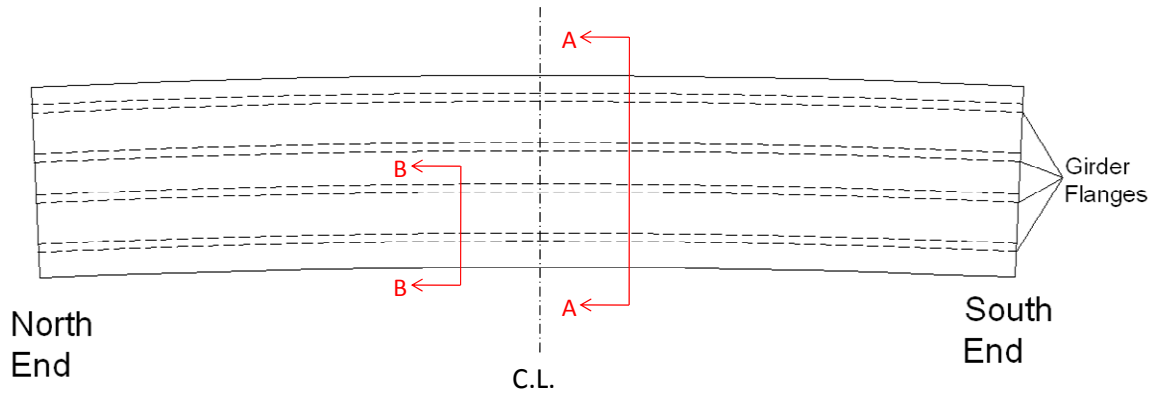
**Figure 3-13 Section Locations for Instrumentation**

Section A-A (known as Section A from here on out) is located 72 inches south of the center line and extends through both the interior (western) and exterior (eastern) girders. Section B-B (known as Section B from here on out) is located 70 inches north of the center line and is only located on the interior girder. These locations were chosen because of their relative close distance to the centerline while still maintaining some distance from the blast-test location (midspan centerline). Section B was only instrumented on the interior girder because the exterior girder was to be fractured with the blast test and would produce stresses in the interior girder that would later be studied on another project.

Two regions of the bridges were instrumented for this project. Figure 3-13 shows the locations of the two instrumented sections on the twin girder system. Sections A-A and B-B are both located on the two bridge girders.

discussed in this section. The box girders were instrumented at a main cross-section (Section A) and at a secondary section (Section B) (see Figure 3-13, Figure 3-14 and Figure 3-17 for dimensions).

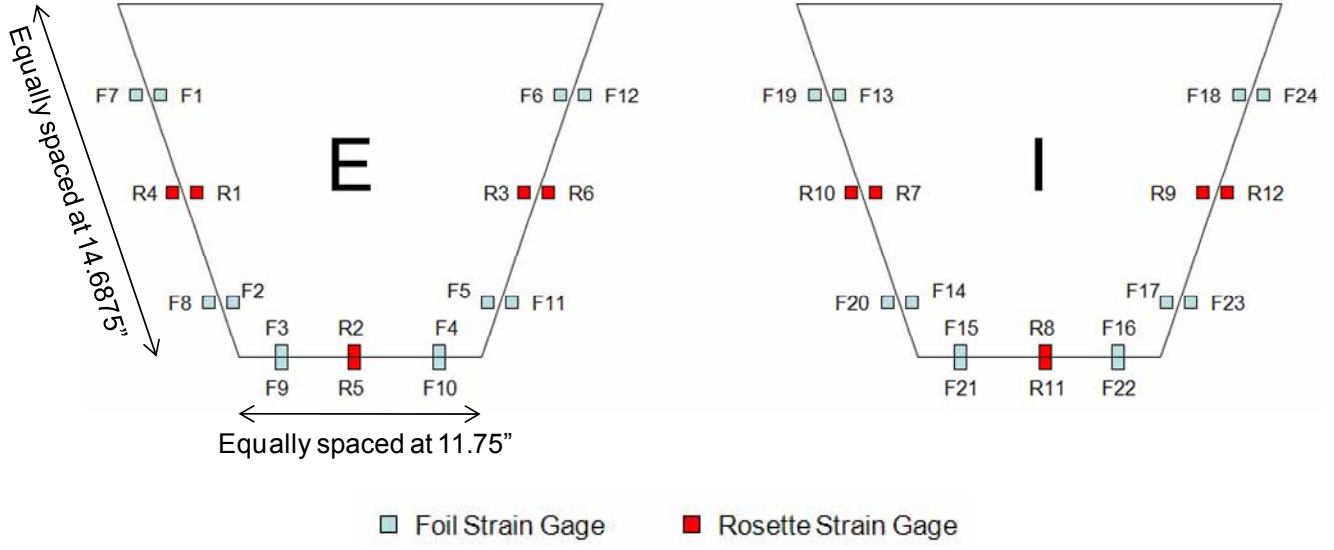
Section A was the primary location for data on this project and contained 24 foil strain gages, 12 rosette foil strain gages, 18 vibrating wire strain gages, and 18 thermocouples. Figure 3-14, Figure 3-15, and Figure 3-16 show the different cross-sections of section location A. The spacing for all gages on the main section was constant throughout the cross-section.

**Figure 3-14 Section A Foil and Rosette Locations**

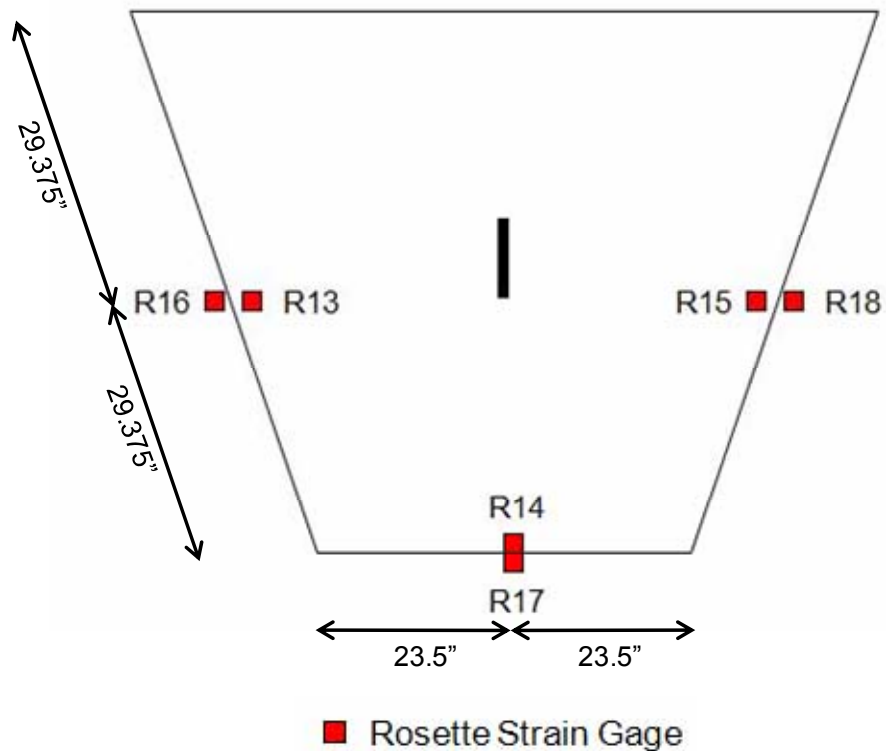
**Figure 3-17 Section B Rosette Strain Gage Locations**

Section B contained 6 rosette strain gages and was primarily instrumented to monitor changes to the interior girder during and after the blast loading. Although these gages were primarily installed for the blast loading, data was still recorded and analyzed during the construction and live loading phases. Measurements were recorded to later be compared to the section A measurements. Figure 3-17 shows a cross-section of section B.

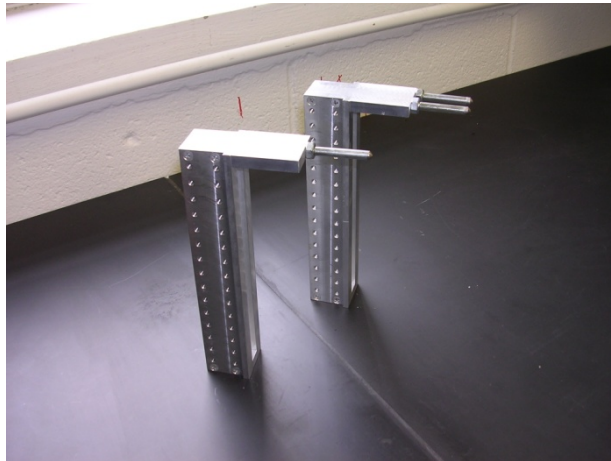
**Figure 3-18 End Caps**

Readings of the plate imperfections and deformations were made using the Linear Potentiometer Displacement Gage (LPDG) developed by Mercan, 2005. The LPDG is composed of a main aluminum channel section, five linear potentiometers, and two adjustable aluminum end caps. The linear potentiometers are equally spaced along the main aluminum channel, enabling the device to simultaneously measure and record the out of flatness at five locations along the plate. This setup is useful because the LPDG provides a measure the profile of a web or flange plate at a certain location simultaneously. Because there are a variety of girder depths and bottom flange widths, the LPDG was designed to be flexible in accommodating these variables. Figure 3-18 shows a picture of the end caps separate from the main channel. The end caps are machined sections roughly 8 inches in length with a grid of connection holes drilled at  $\frac{1}{2}$  inch increments along their lengths. Thus, when connected to the main channel section, screws can be used to connect and adjust the end caps position on the main channel. This enables the researcher to vary the total length of the LPDG according the project's needs. On the underside of the ends of the end caps are machined end tips that act as support legs forming a tripod that balances the overall device when used.

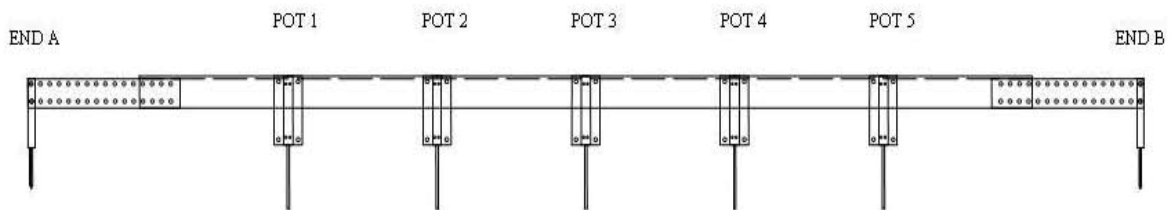
**Figure 3-19 Linear Potentiometer Displacement Gage (Mercan, 2005)**

It should be noted that different length main channel sections were also used. The geometry of bridge girders can significantly vary, and when initially designed, the LPDG was to be used for any type of girder regardless of size. In this project, researchers used 2 separate main channels. The C 1 ½ x 1 ½ x 1/8 aluminum channels were 2.67 and 4 feet in length. The smaller channel section was used for the bottom flange measurements, while the larger was used for the web plates. Figure 3-19 shows the LPDG and its components.

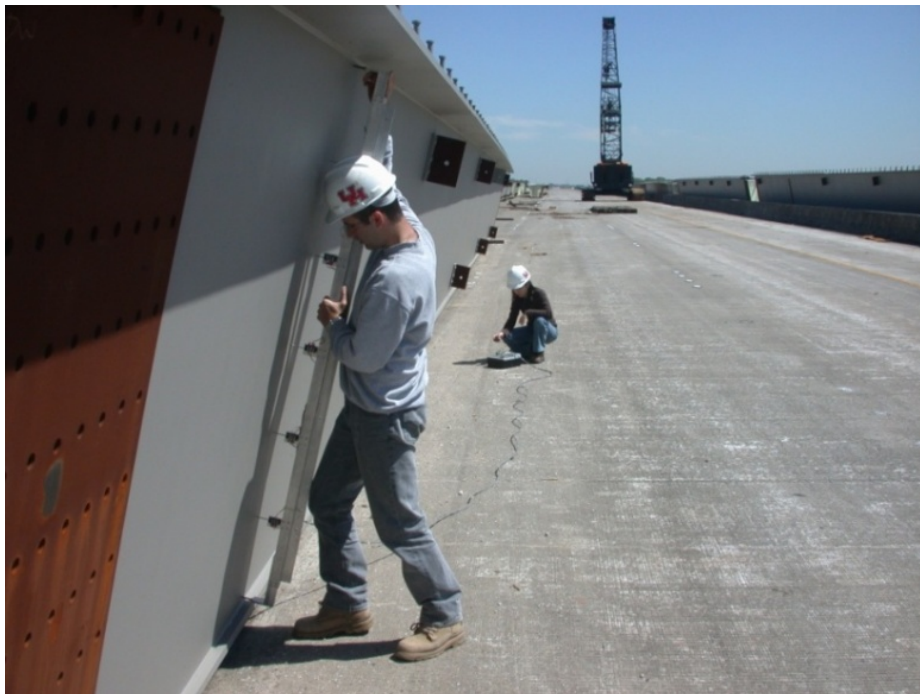
**Figure 3-21 Measuring Web Imperfections (Mercan, 2005)**

at the desired location and firmly pressing down on the entire apparatus engaging the linear potentiometers until the three support points rested on the plate. The switch on the datalogger was then activated to take a reading of the plate imperfection. The LPDG was then removed from the plate and the process was repeated until three readings were taken at each location. If there was a malfunction in the placement of the LPDG, a note was made in the manual log that was taken during the reading process and an additional reading was taken so that three readings were recorded. Figure 3-21 and Figure 3-22 depict two researchers operating the LPDG in the field on both web and flange plates. Results regarding imperfections are discussed in Chapter 5.

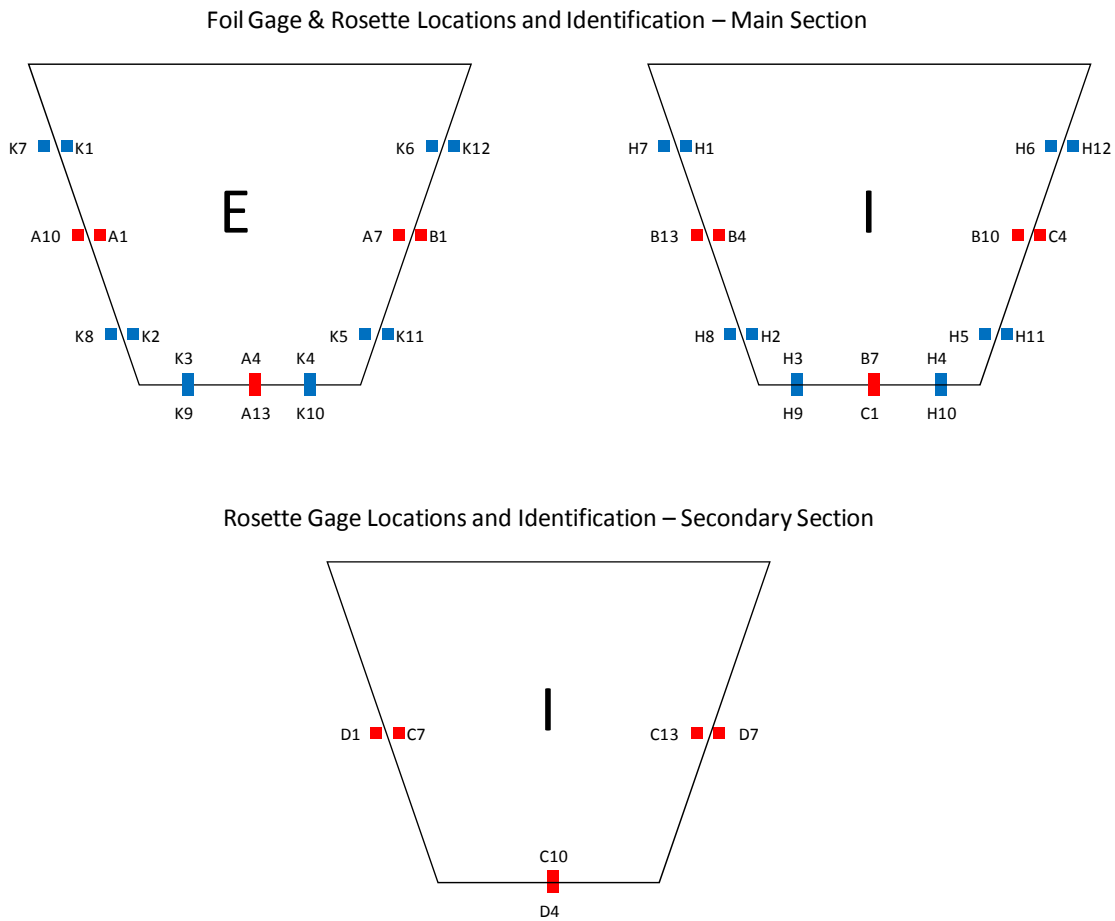
**Figure 4-1 Strain Gage Locations and Labels**

The data presented in this section represents the stress changes due to the casting of the concrete deck and rails on the girder bridge system. The entire construction process was monitored and documented with photos. The weight of the deck and the rails totaled approximately 380 kips of applied load. The effects of daily thermal cycles can cause large stress gradients on steel bridge girders. To minimize the thermal effects and obtain a measure of the stress changes due to construction activity, strain gage data recorded in the early morning (midnight-5 am) time period were chosen for study. Since temperature reading devices were installed at numerous locations alongside foil gages, the ideal time (according to temperature) for a strain reading could be located. Figure 4-1 shows the locations of the strain gages from which the readings are presented and

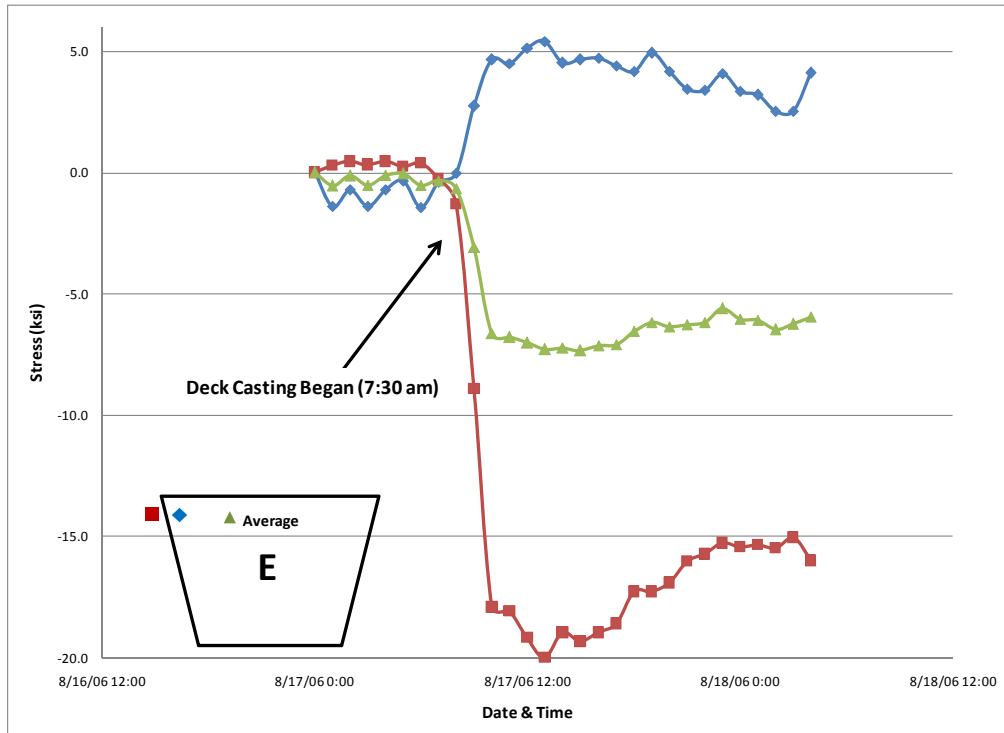
Figure 4-5 Stress Development during Deck Casting – Top of Web

concrete deck at single locations along the exterior web of the exterior girder. The graphs show the stress levels as a function of the time period in which the casting took place. It can be seen that stress levels started to change significantly at 7:30 when the concrete placement began. The rapid increase between 8:30 and 9:30 was due to the weight of the weight of the wet concrete and the screed that was used to finish the surface. Between 9:00 and 9:20 the screed was directly over the main section of the girders that were instrumented. Average stress values are graphed to show values that negate the plate bending effects. It should also be noted that the some of the stress changes are likely due to temperature effects. During the pouring of the concrete deck, the ambient temperature changed however the sunlight exposure also changed as the sun rose in the sky during the concrete placement. Additional thermal effects can also happen due heat of hydration during the concrete curing. The combined effects from the temperature led to variability in the gage readings even after the concrete placement finished. However the stress readings tended to level out after the sun set and the bridge temperature normalized during the night.

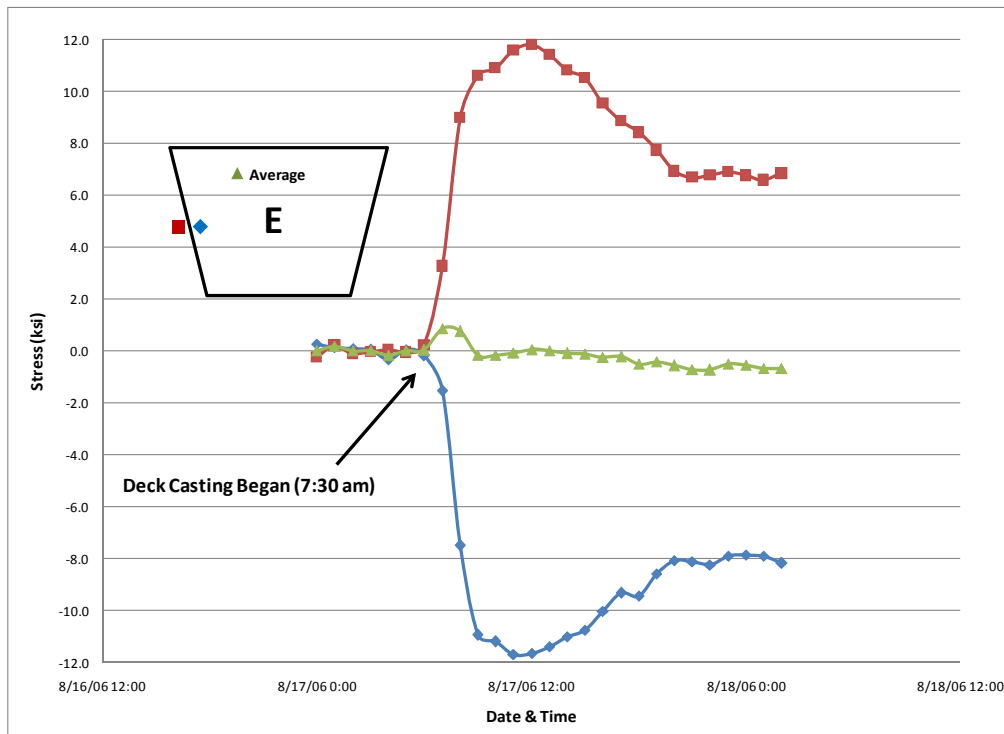
Figure 4-6 Stress Development during Deck Casting – Mid-Height of Web

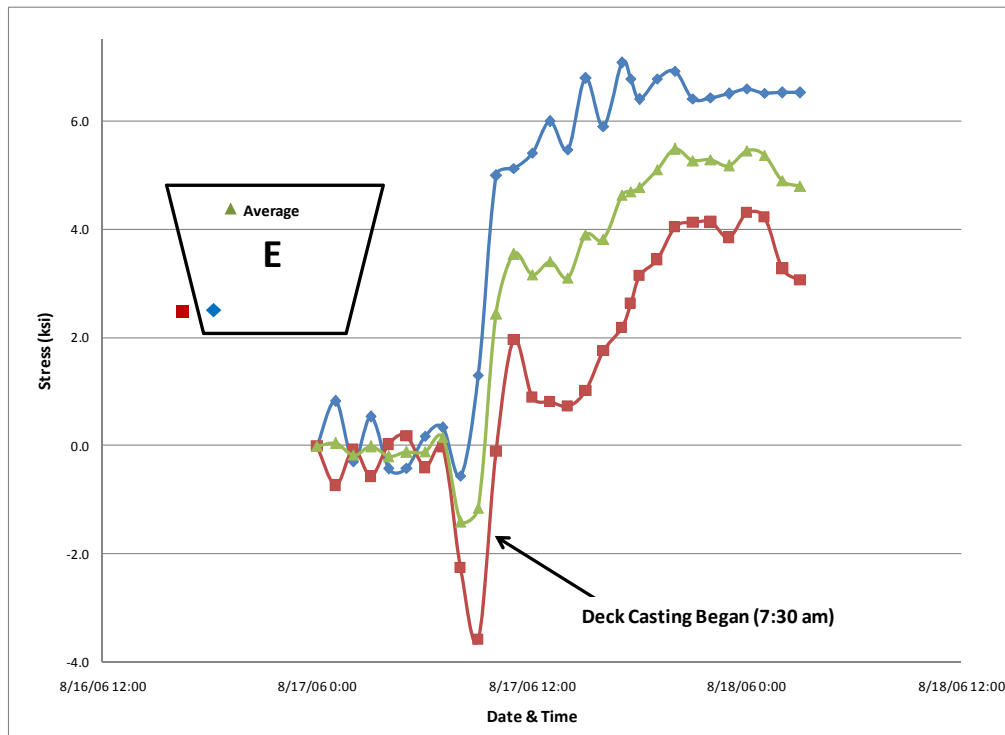
**Figure 4-7 Stress Development during Deck Casting – Bottom of Web**

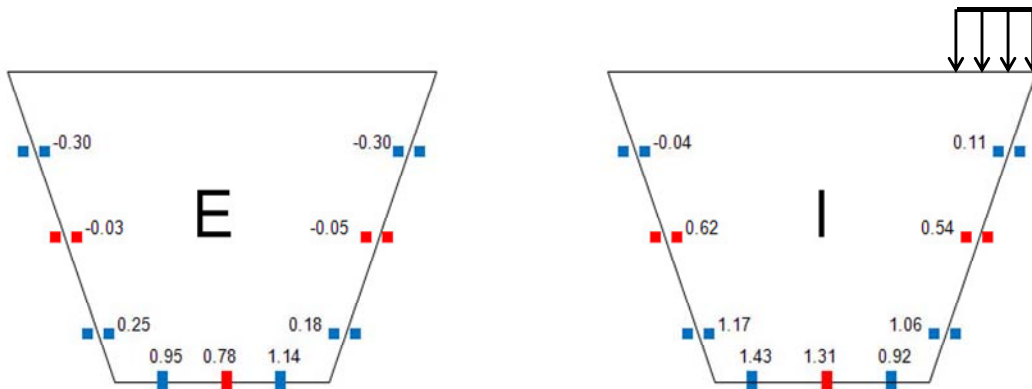
**Figure 4-11 Average Stress Changes due to West Rail (ksi) Section A**

As presented in the casting of the concrete deck, measurements were recorded and graphed at a secondary location for the casting of the west rail. Much like the results of the casting of the concrete deck, the comparison of the interior girders at both locations in response to the casting of the west rail is somewhat similar. Figure 4-12 and Figure 4-13 present the actual and average stress change values at Section B in relation to the casting of the west rail, respectively. It is not clear why the sign of the web rosette readings are opposite of those shown for Section A in Figure 4-11. Due to the relatively small stress

magnitude, the difference is not a major concern. The bottom flange stresses are relatively similar for the two locations. Graphs monitoring stress values at single locations throughout the construction of the west rail are provided in Appendix B.

The change in the stress distribution may be caused by the stiffening on the interior side of the bridge caused by the previously cast west rail. This would explain the smaller stresses caused on the interior girder (Figure 4-15, 0.59 ksi maximum bottom flange stress) during casting of the east rail when compared to the stresses in the exterior girder during casting of the west rail (Figure 4-11, 1.14 ksi maximum bottom flange stress). Although the distribution differs, the magnitudes of the stress changes are very

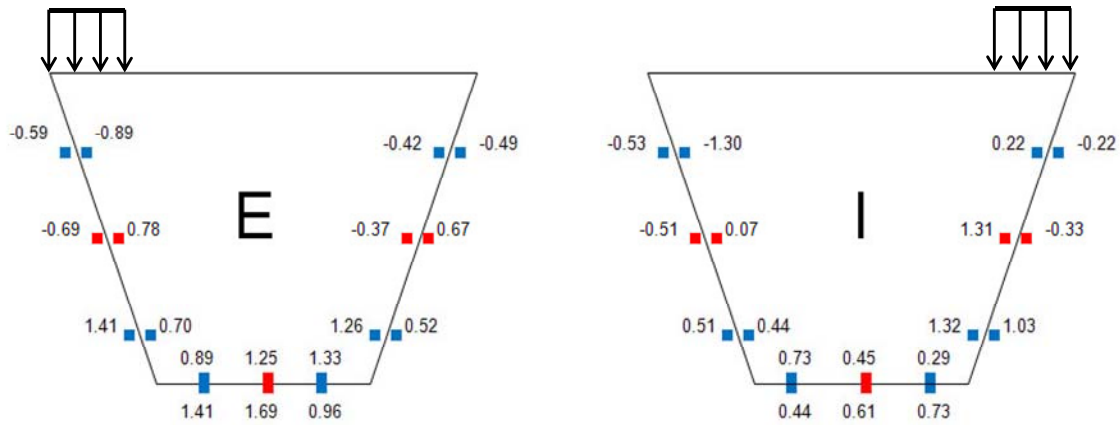
**Figure 4-14 Stress Changes due to East Rail (ksi) Section A**

The stress changes during casting of the east rail are shown in Figure 4-14 with the averaged strain gage readings given in Figure 4-15. The stress magnitudes were similar to those observed for the casting of the west rail. From the average stress readings, the neutral axis appears to be located between the top gages and the strain rosettes. The distributions of the stresses differ from what was observed during casting of the west rail where nearly all of the gage readings were in tension for the girder closest to the rail.

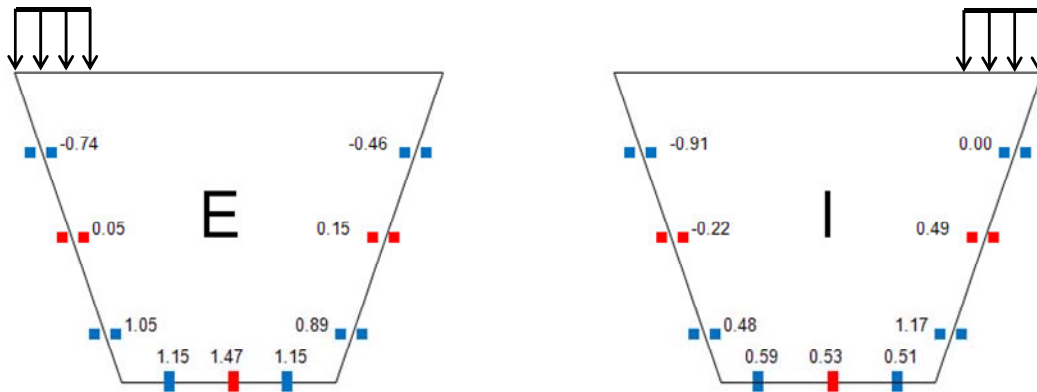
**Figure 4-15 Average Stress Changes due to East Rail (ksi) Section A**

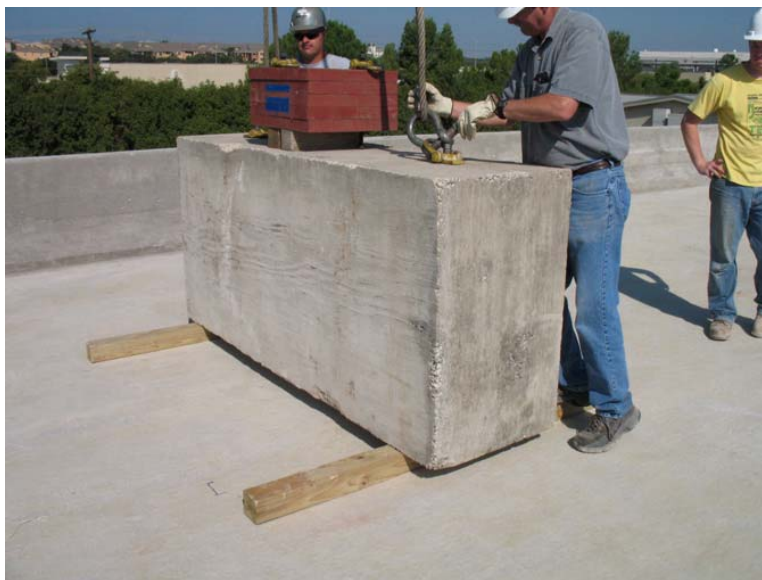
**Figure 4-18 Live Load Simulation - Front Axle**

The simulated HS-20 truck was positioned for maximize moment and torsion in the girders as per AASHTO guidelines. The truck axle spacing was 14 feet for both the front and rear axles. The front axle was represented with a concrete block with dimensions 2 ft. W x 3.33 ft. H x 7.33 ft. L. Five steel plates, with dimensions 1.5 ft. W x 0.167 ft. H x 1.67 ft. L, were then bolted together and placed on top of the concrete block as shown in Figure 4-18. The truck mid and rear axle weights were simulated using AASHTO Type IV prestressed concrete beams that were available at the Ferguson lab from a previous research investigation (Figure 4-19). The entire live load simulation weighed 76 kips and is shown positioned on the bridge system in Figure 4-20.

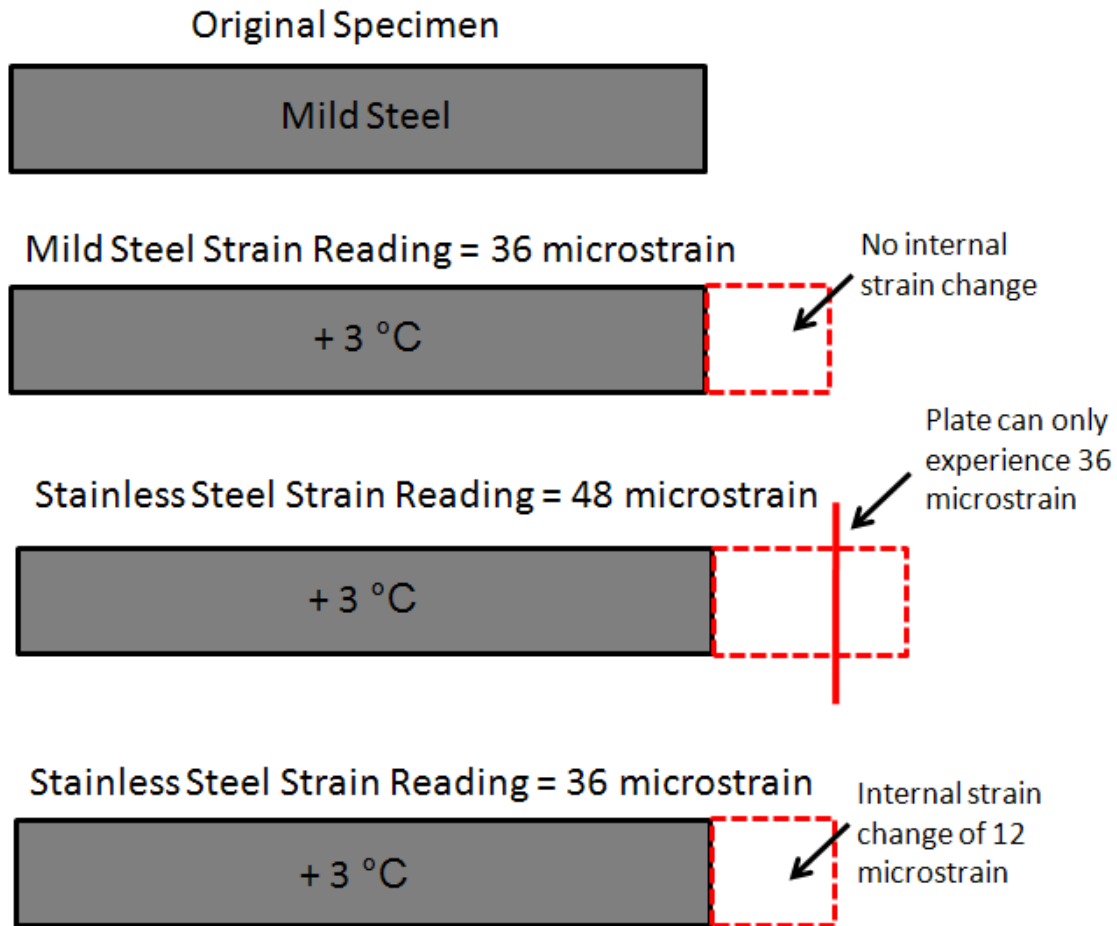
**Figure 4-24 Steel Plate Experiment Scenario**

To explain this correction, a simple experiment was performed at the Ferguson Lab to validate the correction method used. A flat steel plate was instrumented with a mild steel strain gage, a stainless steel strain gage, and a thermocouple. The strain and temperature reading devices were monitored using the CR5000 Datalogger as used in previous aspects of this research project. The experiment included positioning the flat steel plate in different environments varying in temperature. Strain readings were taken in each location and recorded. When the specimen was exposed to temperature changes, strain changes were to be expected due to the coefficient of thermal expansion. However, since the specimen was unconstrained, strain values were expected to vary from temperature to temperature. But since the specimen was composed of mild steel, the strain readings for the mild steel strain gage were not expected to vary. Although, the stainless steel strain gage was expected to show strain changes. For example, assume the coefficients of thermal expansion for the mild and stainless gages are 12 microstrain / °C and 16 microstrain / °C respectively. Thus a three degree increase in temperature would cause the mild steel strain gage to show a strain increase of 36 microstrain, but since the specimen is composed of mild steel, this will be accounted for and the strain reading will vary minimally from the original strain reading before the temperature change. The stainless steel strain gage will act differently though, experiencing a strain of 48 microstrain. But since the specimen is composed of mild steel, the specimen cannot experience a strain from temperature of more than 36 microstrain, thus leaving the additional 12 microstrain to be locked in the specimen as an additional compressive strain. Therefore, the results would show the stainless steel strain gage with a 12 microstrain difference from the original strain reading before the temperature change. Figure 4-24 explains this method more visually.

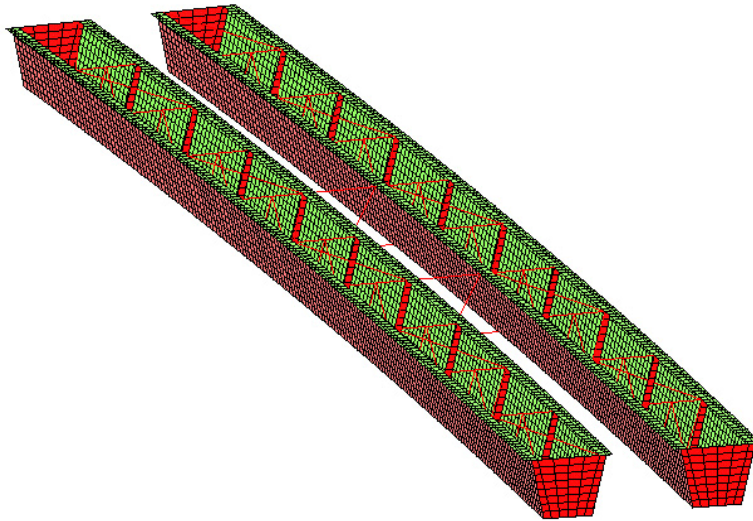
**Figure 4-40 FEA Steel Box Girders Model**

truss. The actual web imperfections were modeled on the girders using measurements from the LPDG that was discussed in Chapter 3.
