**MEASUREMENTS OF DEFORMATIONS AND STRESSES DUE TO  
PLATE OUT-OF-FLATNESS IN A STEEL TWIN BOX GIRDER  
BRIDGE SYSTEM**

**THESIS**

The University of Texas at Austin

**MAY 2007**

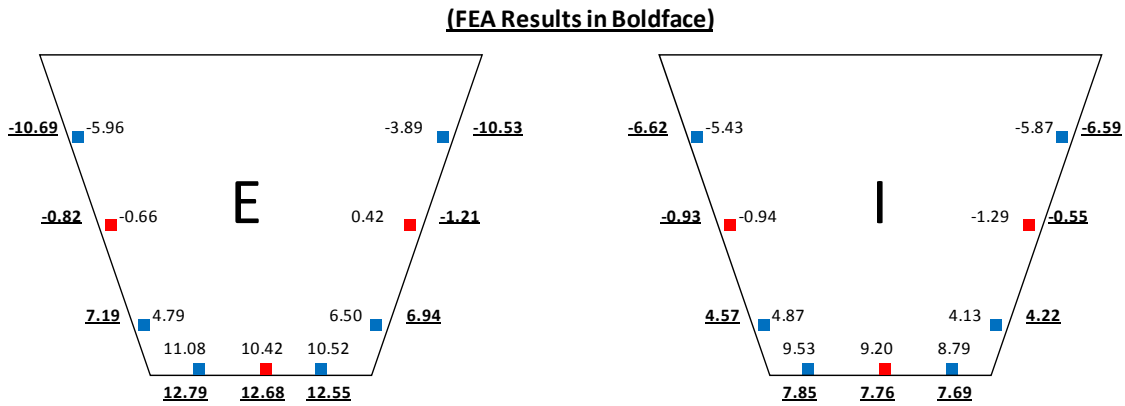
**Figure 4-41 Field & FEA Results for Construction of Deck (ksi) Section A**

The comparison of the FEA solution and the measured results are presented simply to demonstrate the accuracy of the finite element modeling techniques that are also being conducted on the project for the parametric investigations. Figure 4-41 presents a comparison of the FEA and field results of the effects of the concrete deck casting on the girders at Section A. It should be noted that the results presented are average values of stresses used to eliminate the effects of plate bending. Field measurements are distinguished by normal text font, whereas the FEA numerical results are bold and underlined. The accuracy of the computational and measured results varies at different locations around the cross-section. The results tended to agree better on the interior girder compared to the exterior girder. The bottom flange stresses tended to agree better than web stresses; however there are some uncertainties in how to properly

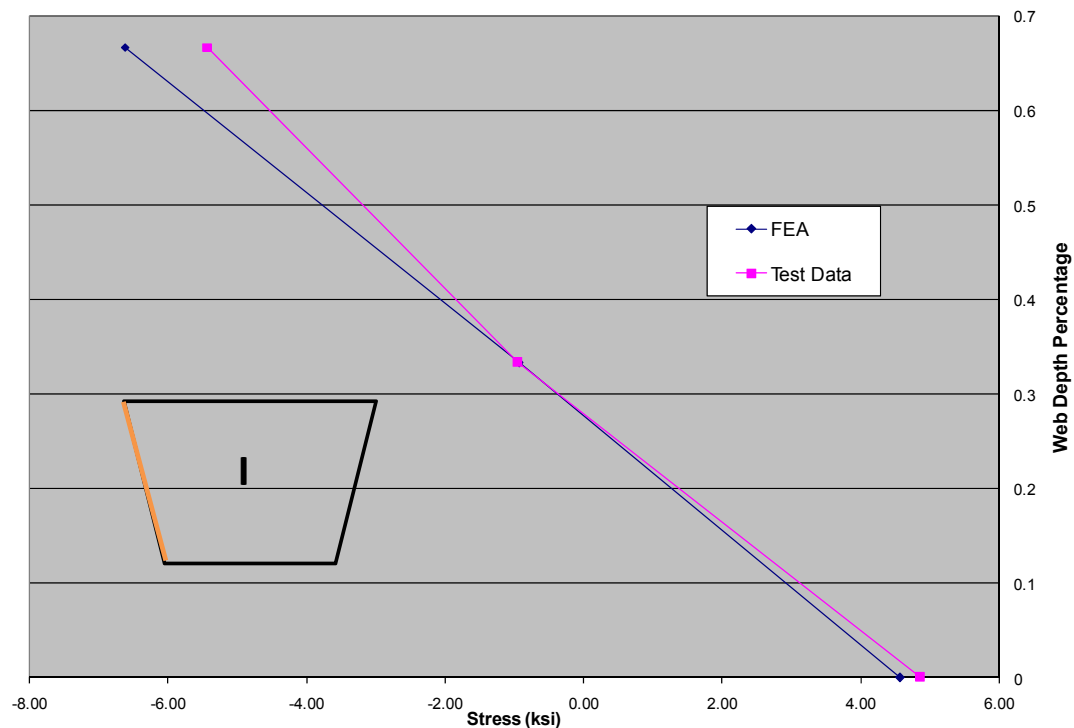
**Figure 4-47 Stress Distribution due to Deck – Inner Web of Interior Girder**

is evident that the stress distribution along the web is linear as assumed. Traveling from top to bottom along the web's depth, compressive stresses eventually become no stress (neutral axis), and then later form tensile stresses as indicated.

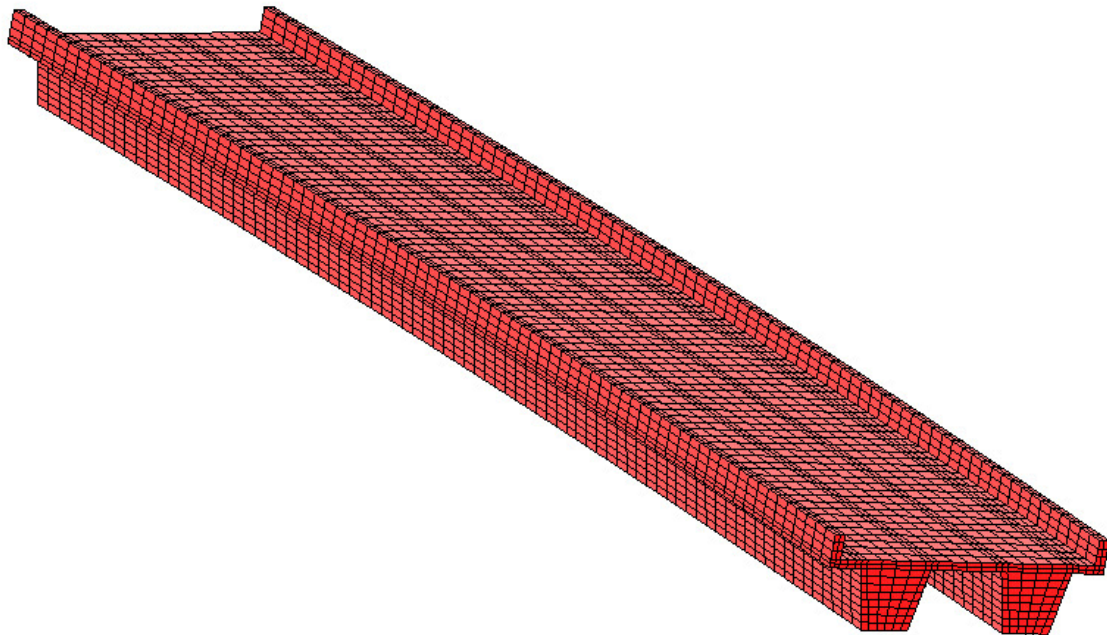
**Figure 4-48 FEA Live Load Testing Model**

Live load testing results were also compared and analyzed. The finite model was recreated to include a solid concrete deck that was fully cured and strengthened, as well as the rails. Figure 4-48 shows the model used without the live load applied.

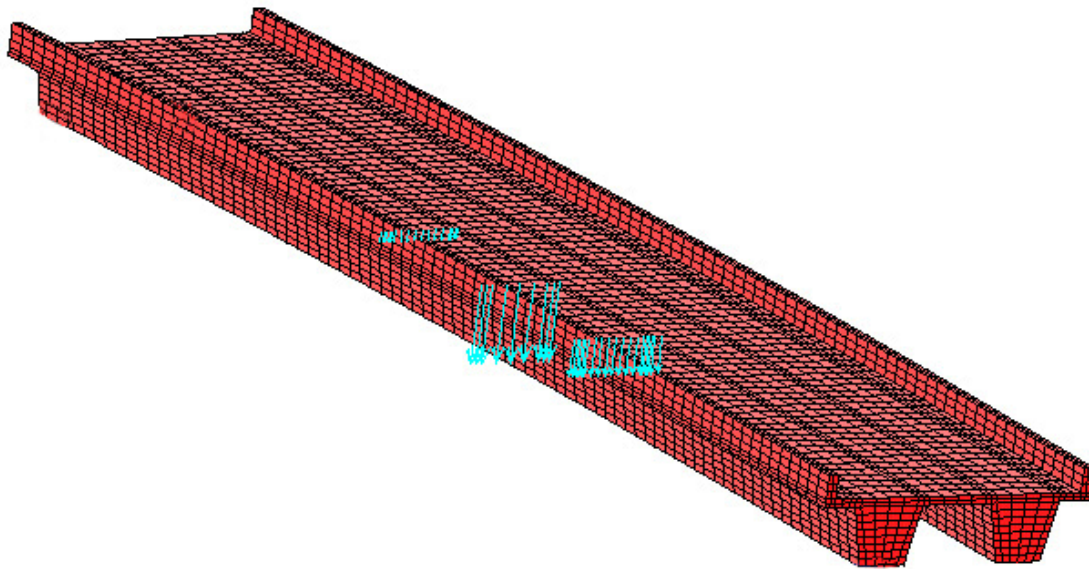
**Figure 4-49 FEA Live Load Testing Model with Applied Loads**

Figure 4-49 shows the FEA model that was used including the applied simulated truck live load. The truck loads are represented as point loads distributed over the exact locations as position 1 shown in Figure 4-21.

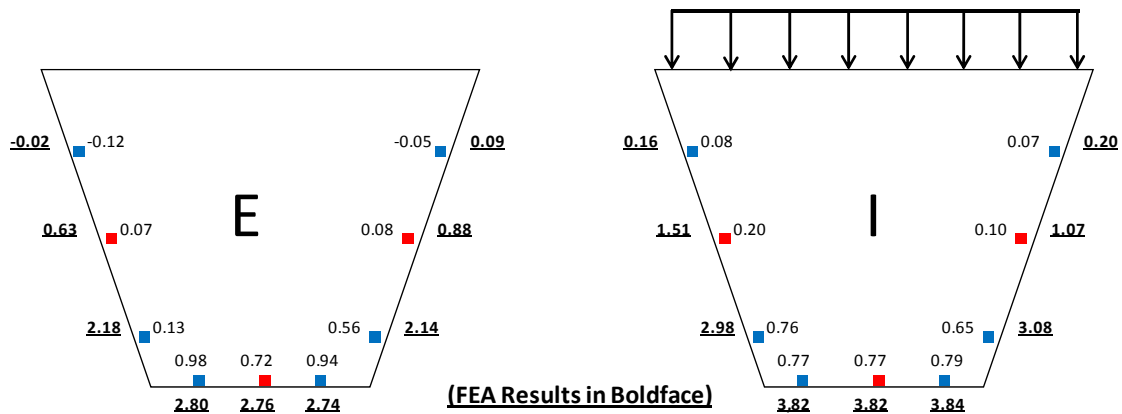
Figure 4-50 Field & FEA Results for Live Load Position 1 (ksi) Section A

Figure 4-50 presents a comparison of the FEA and field results of the effects of live load position 1 on the girders at Section A. There seems to be no obvious similarities in the results, and differences seem to be scattered. At Section B, the interior web results are similar. But as Figure 4-51 depicts, the other elements results show a relatively large difference between the FEA and measured results. Although the stress magnitudes are relatively small, the difference is similar to those observed at Section A.

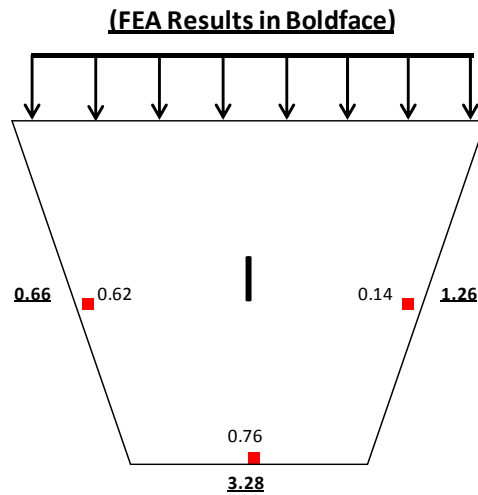
Figure 4-51 Field & FEA Results for Live Load Position 1 (ksi) Section B

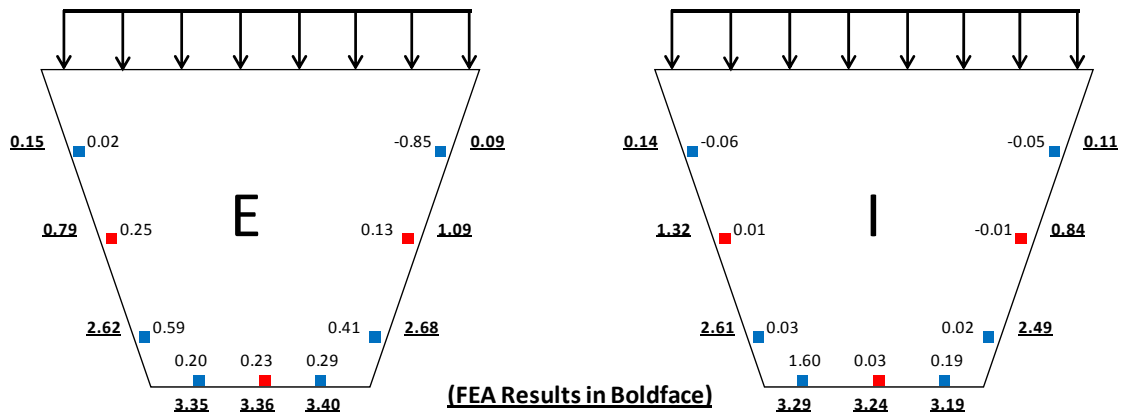
Figure 4-52 Field & FEA Results for Live Load Position 2 (ksi) Section A

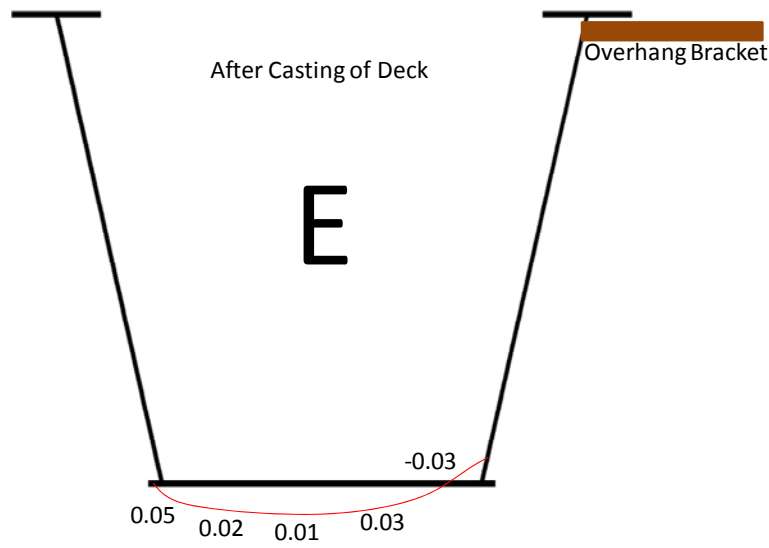
**Figure 5-8 Ext. Girder Bottom Flange Deformations due to Casting of Deck**

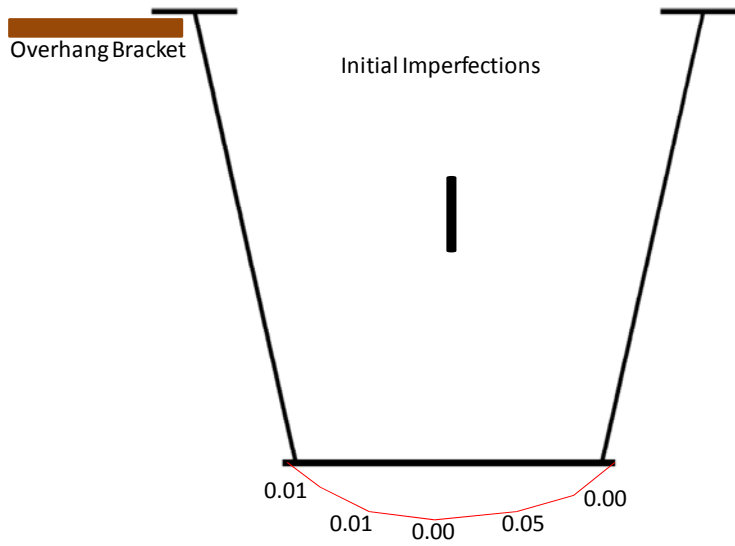
**Figure 5-9 Int. Girder Bottom Flange Initial Imperfections**

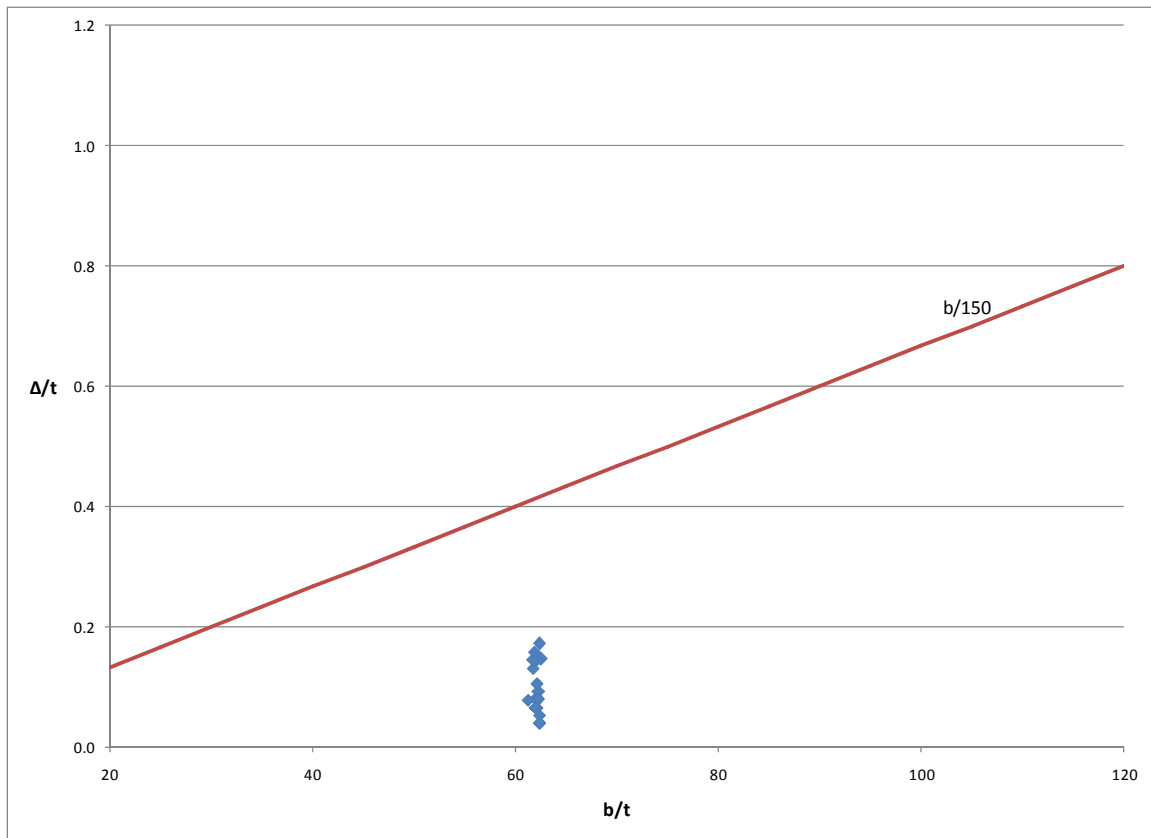
**Figure 5-12 Maximum Bottom Flange Imperfections**

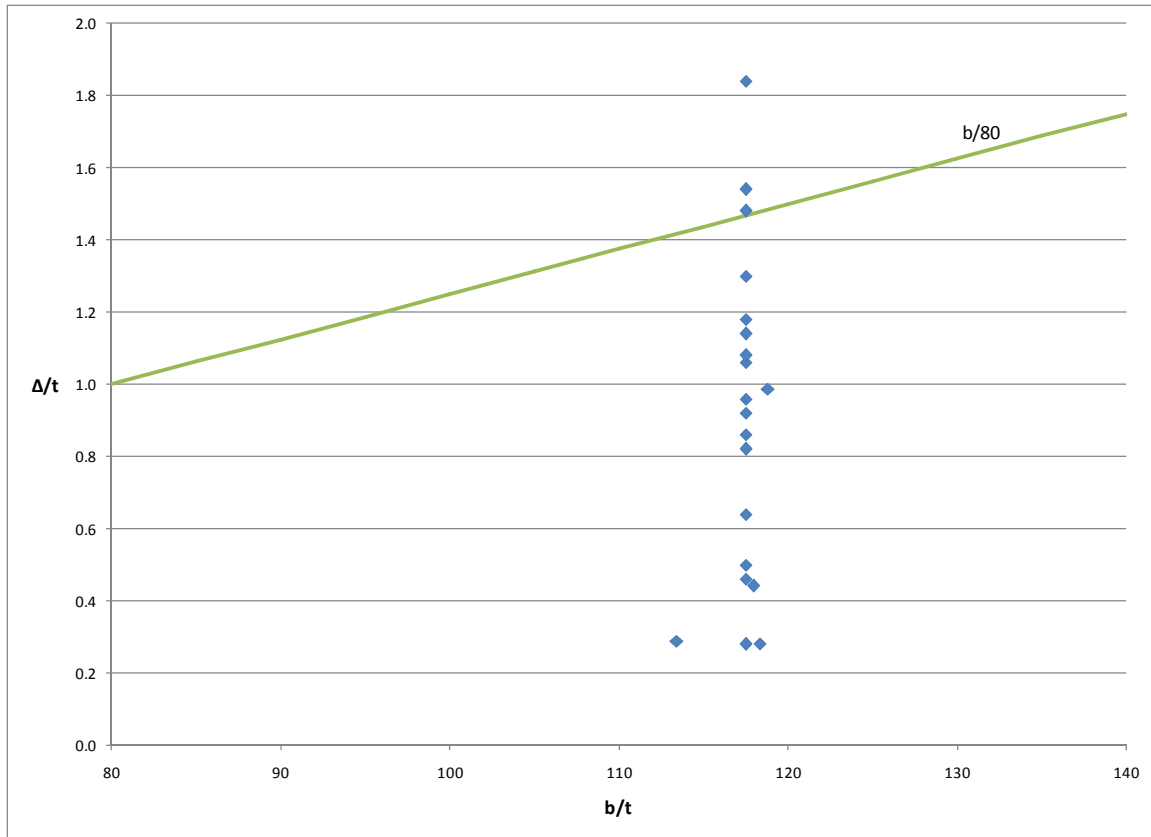
**Figure 5-13 Maximum Exterior Web Imperfections**

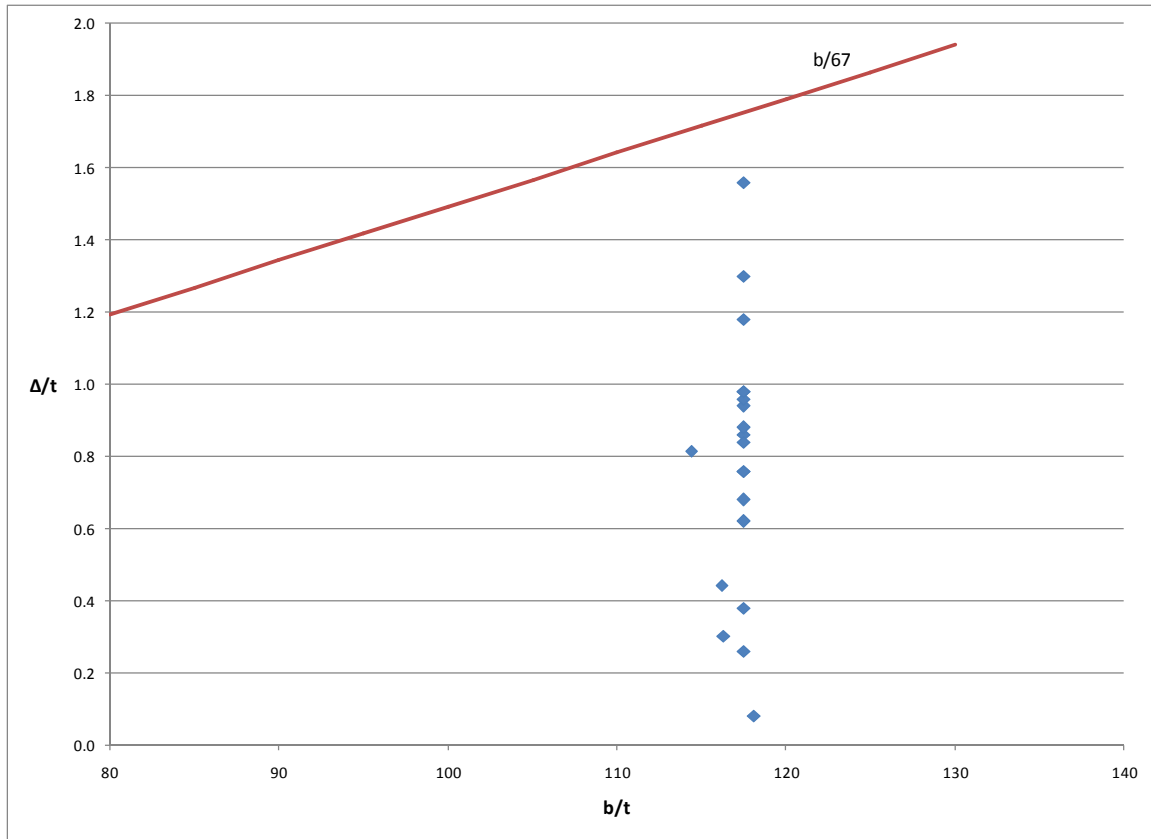
**Figure 5-14 Maximum Interior Web Imperfections**

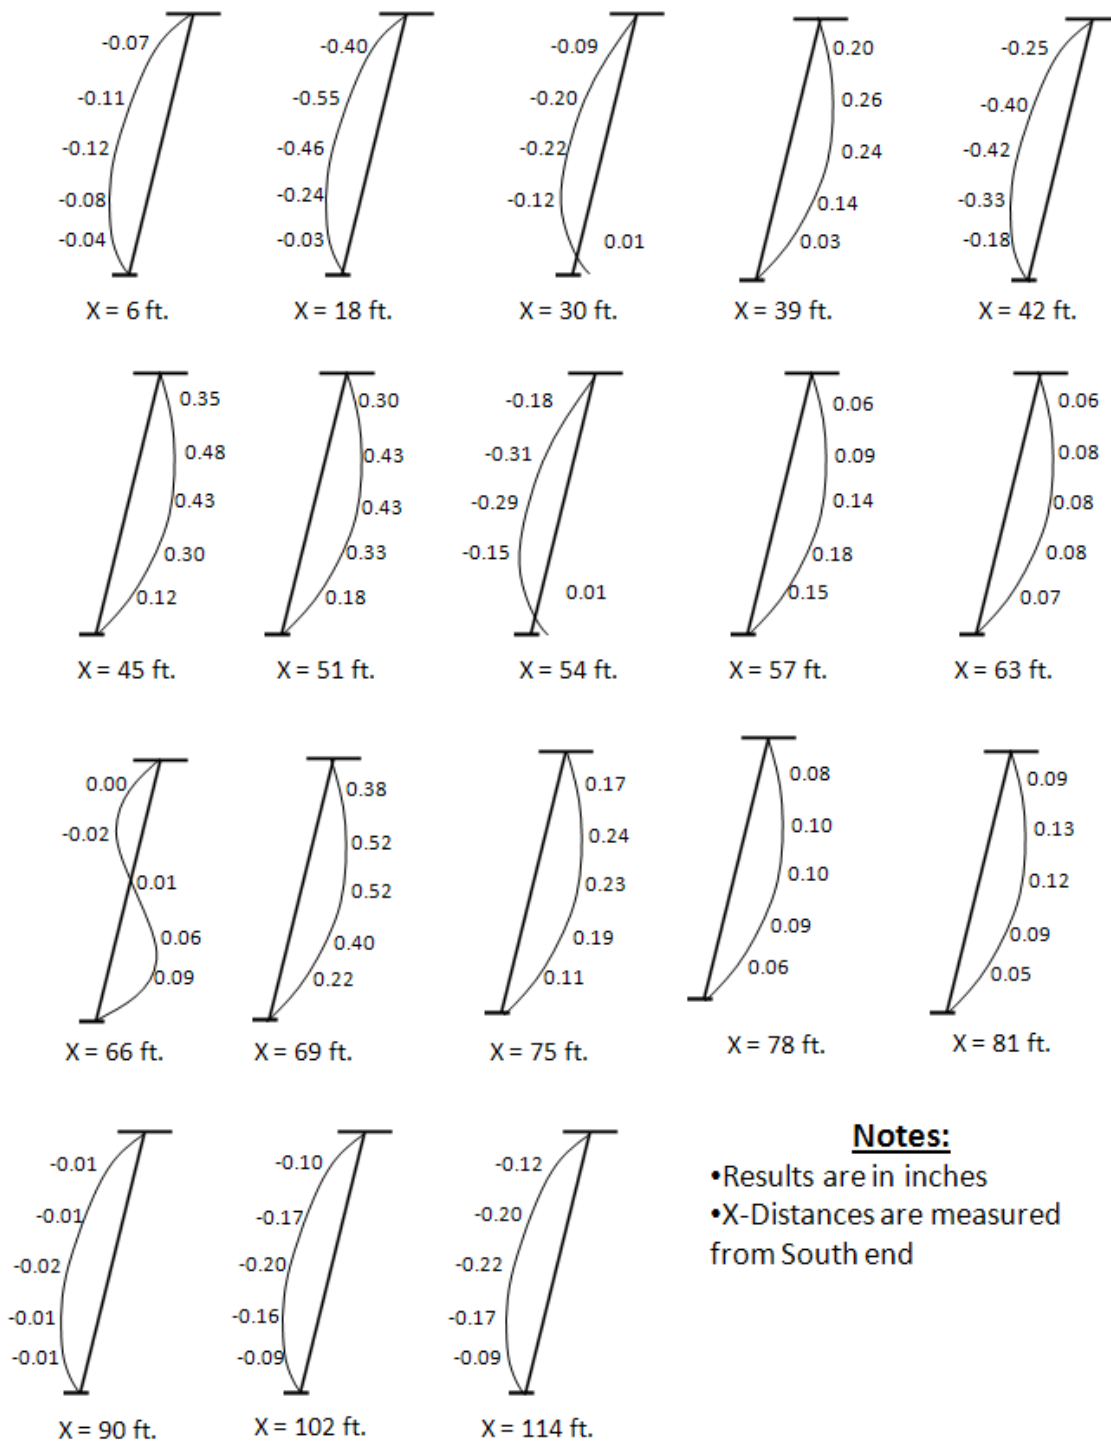
**Figure D-1 Exterior Girder Outer Web - Initial Imperfections**

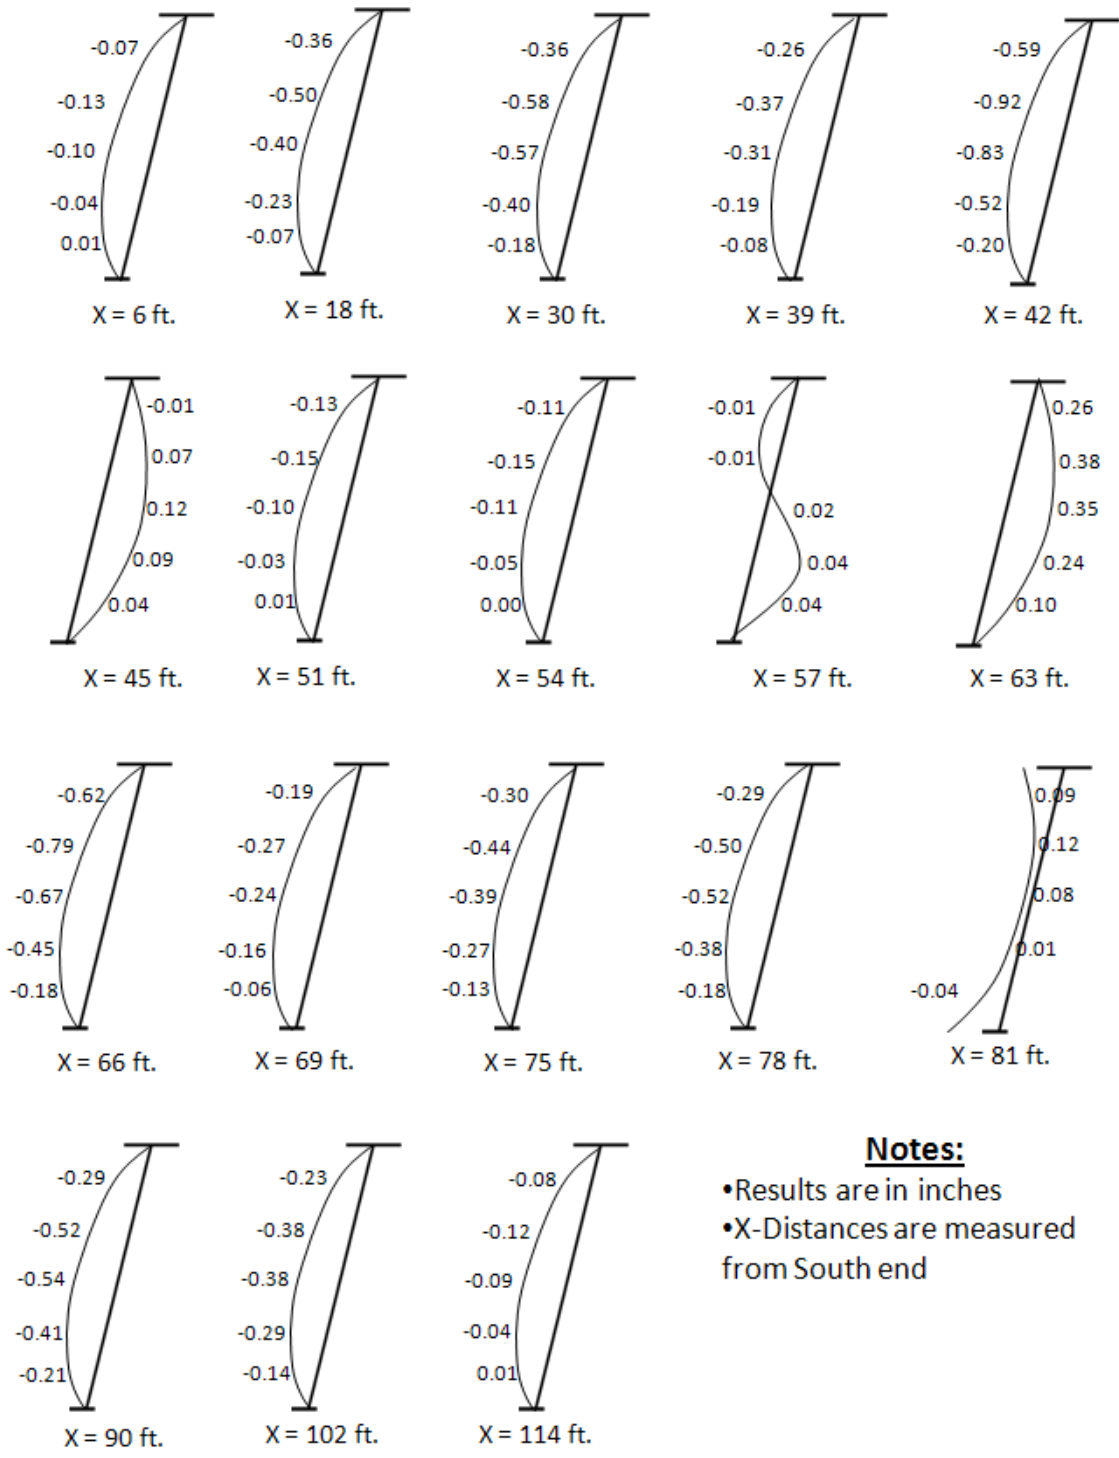
**Figure D-2 Exterior Girder Outer Web - After Casting of Deck**

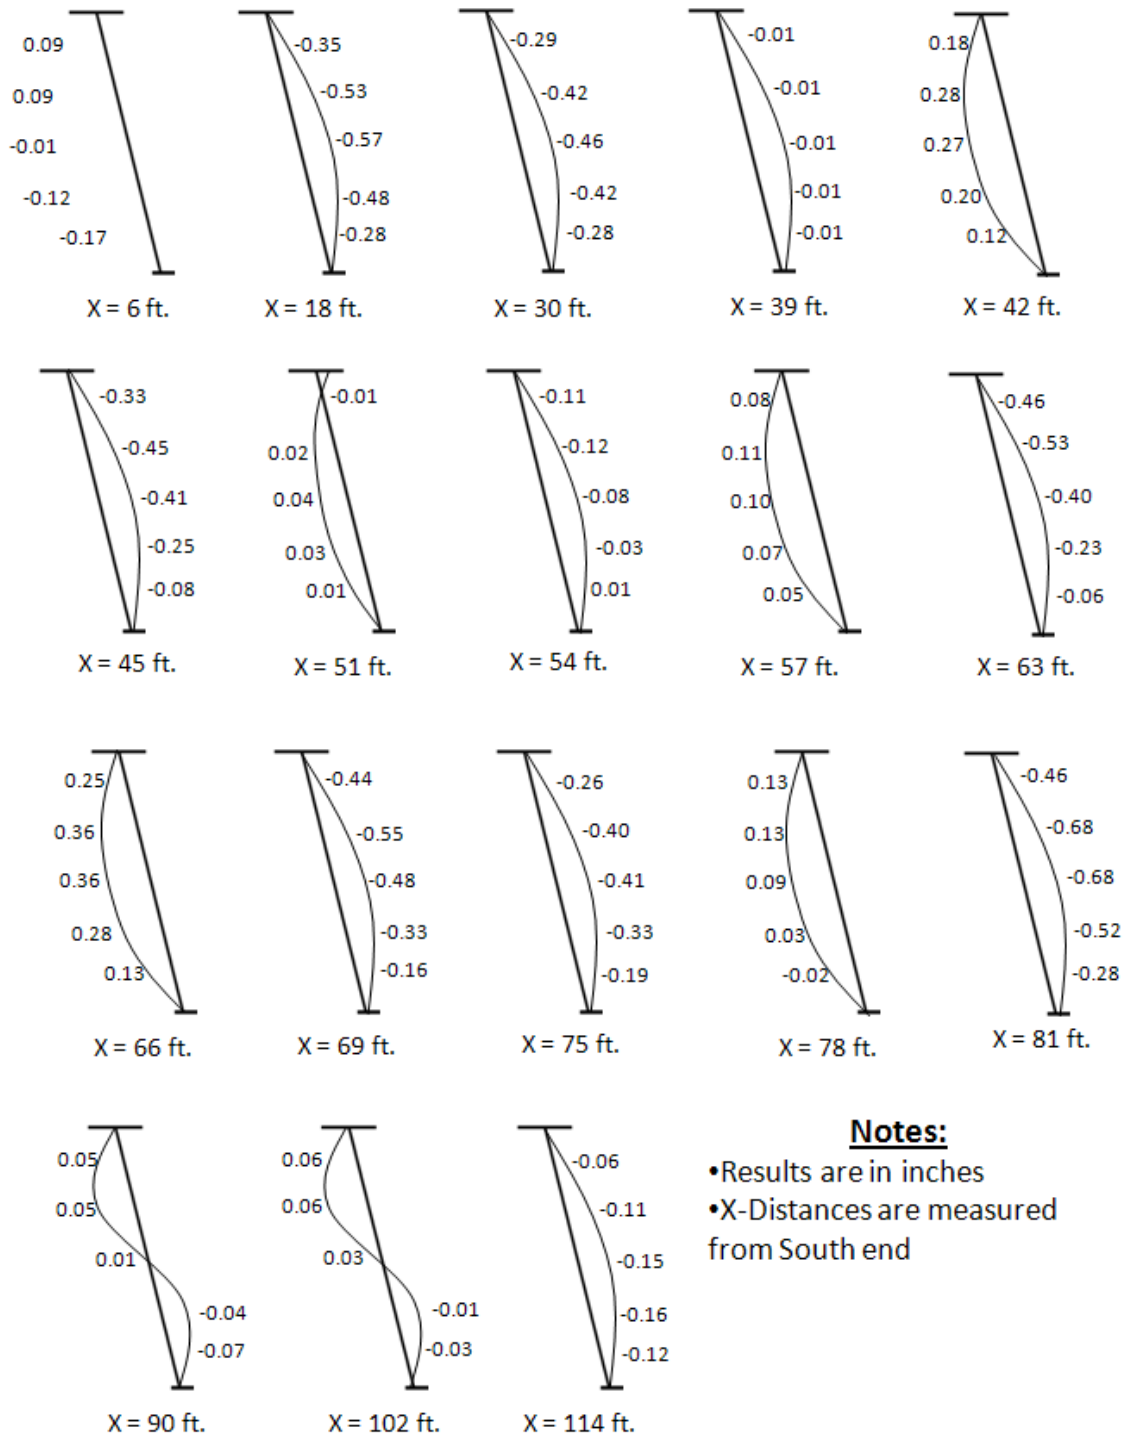
**Figure D-4 Exterior Girder Inner Web - Initial Imperfections**

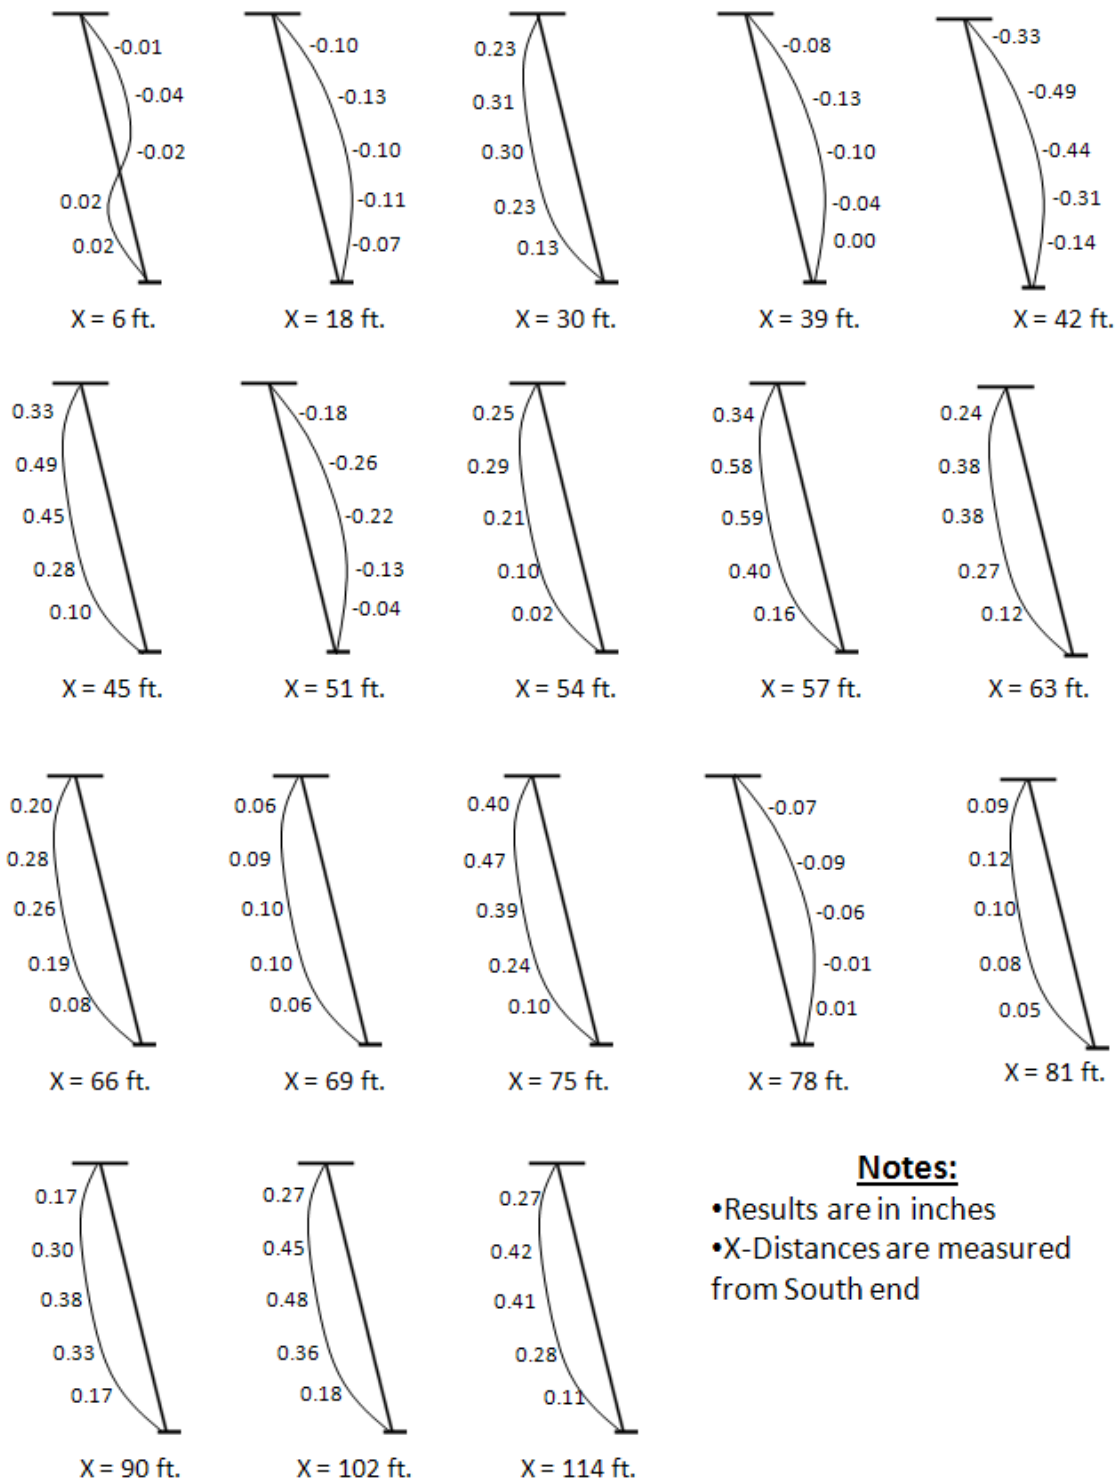
Figure D-5 Exterior Girder Inner Web - After Casting of Deck

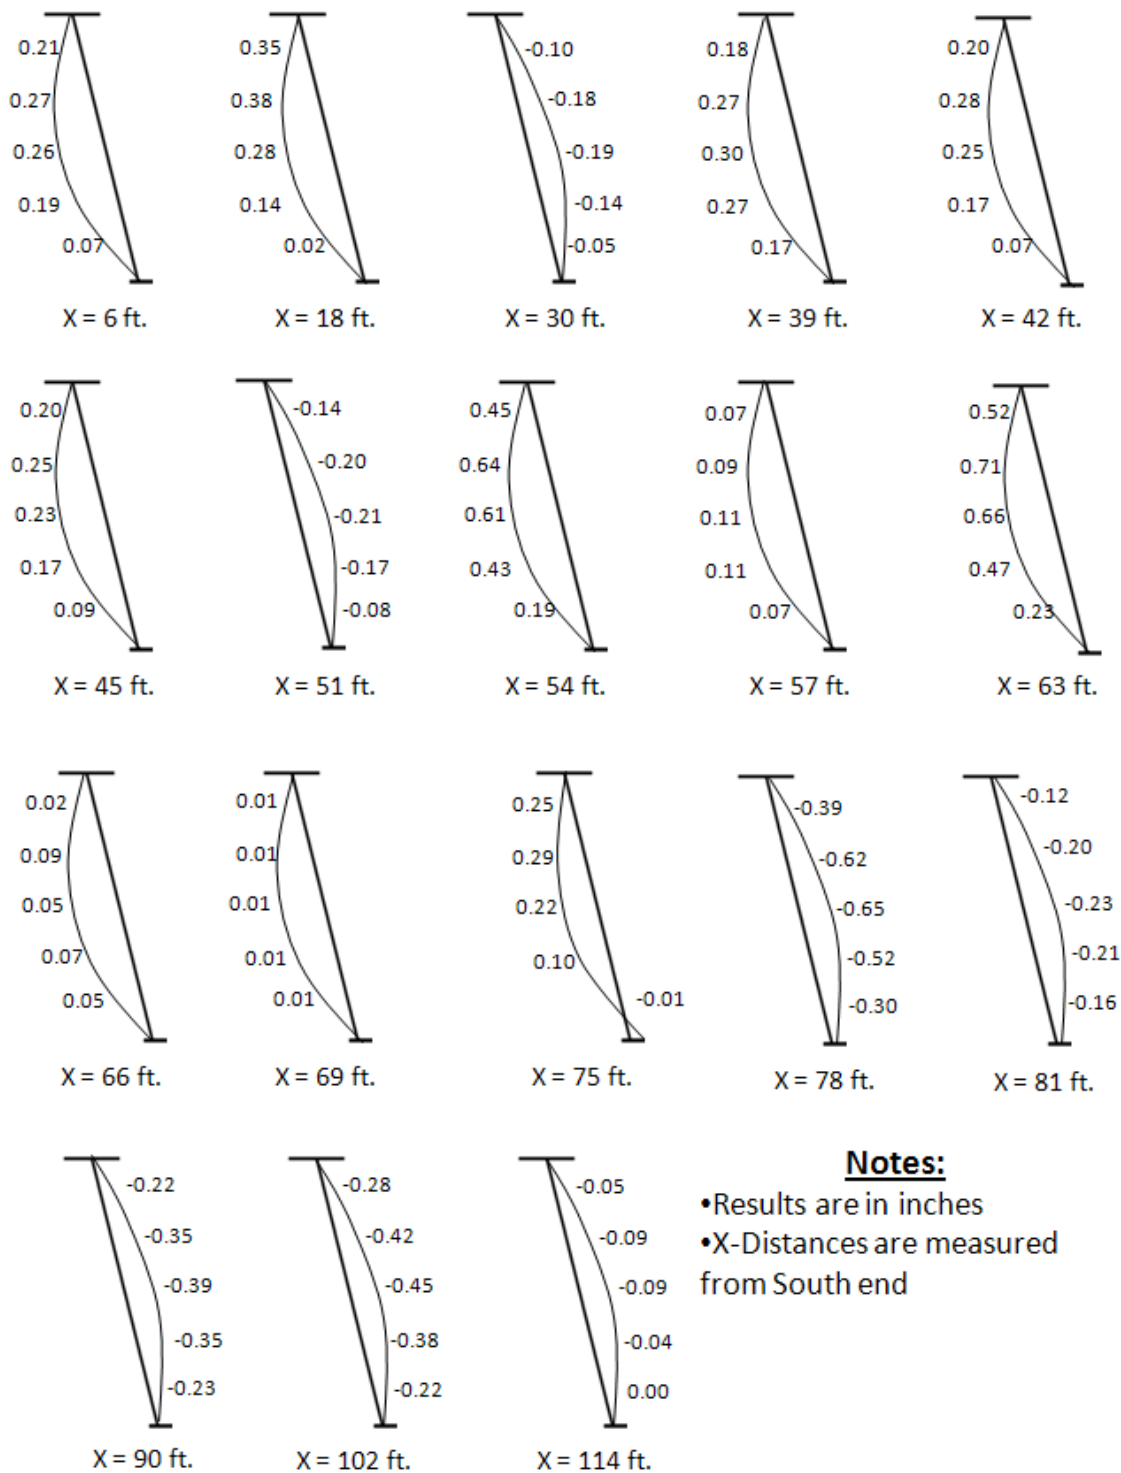
**Figure D-6 Interior Girder Outer Web - Initial Imperfections**

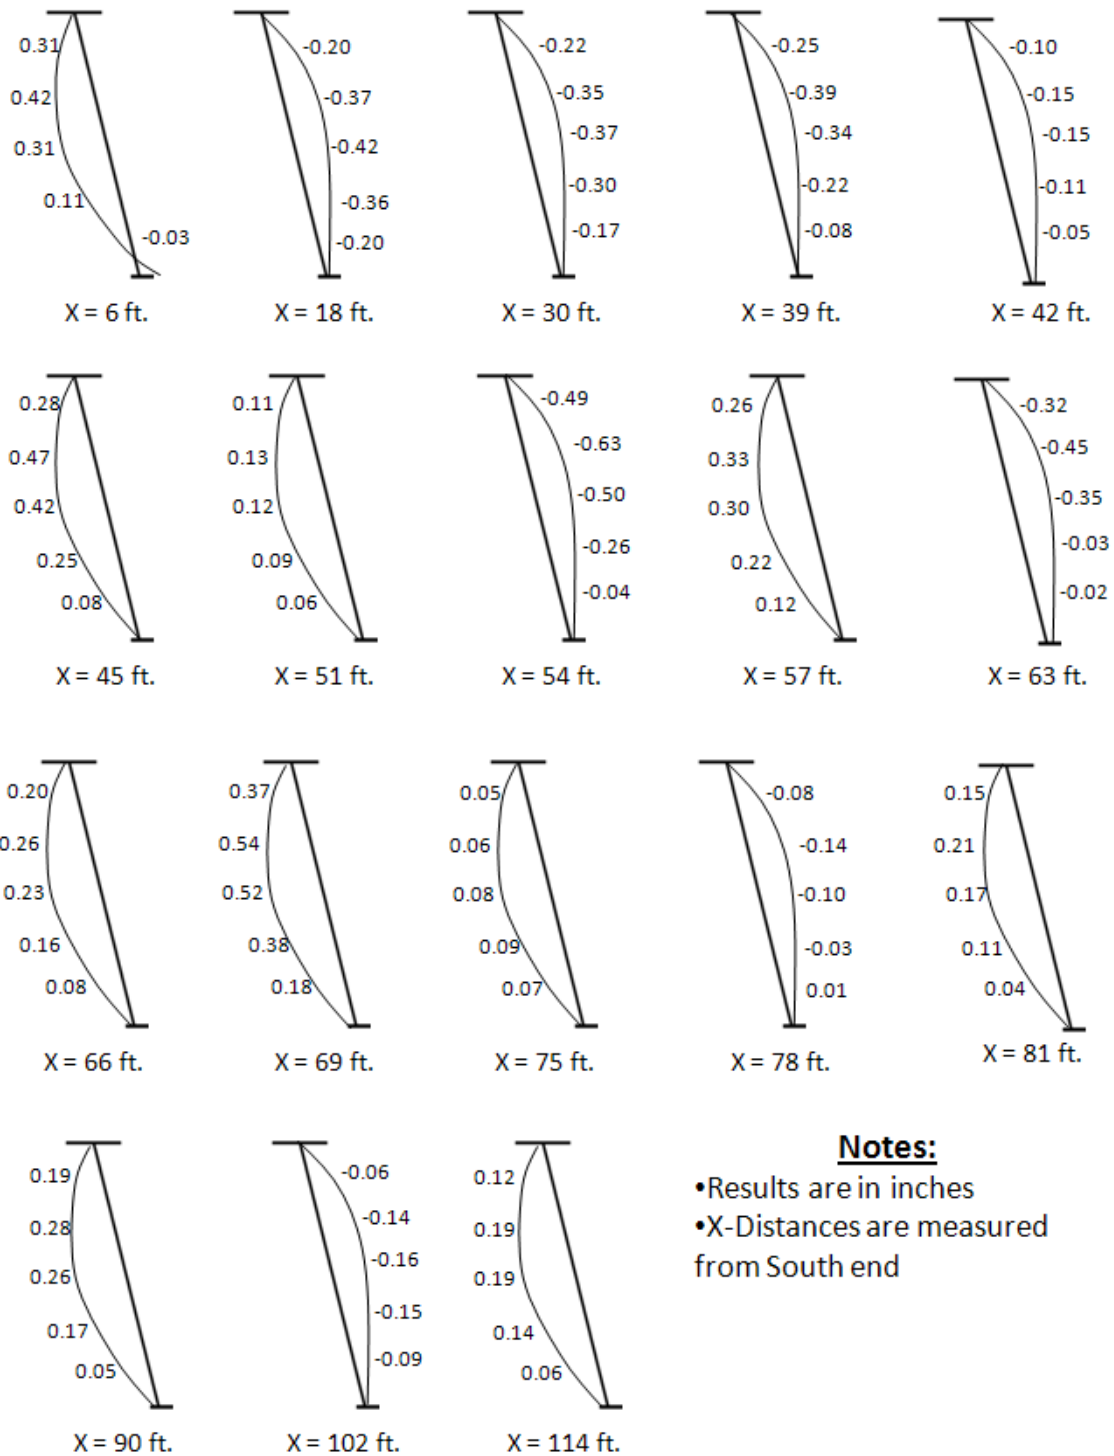
**Figure D-7 Interior Girder Outer Web - After Casting of Deck**

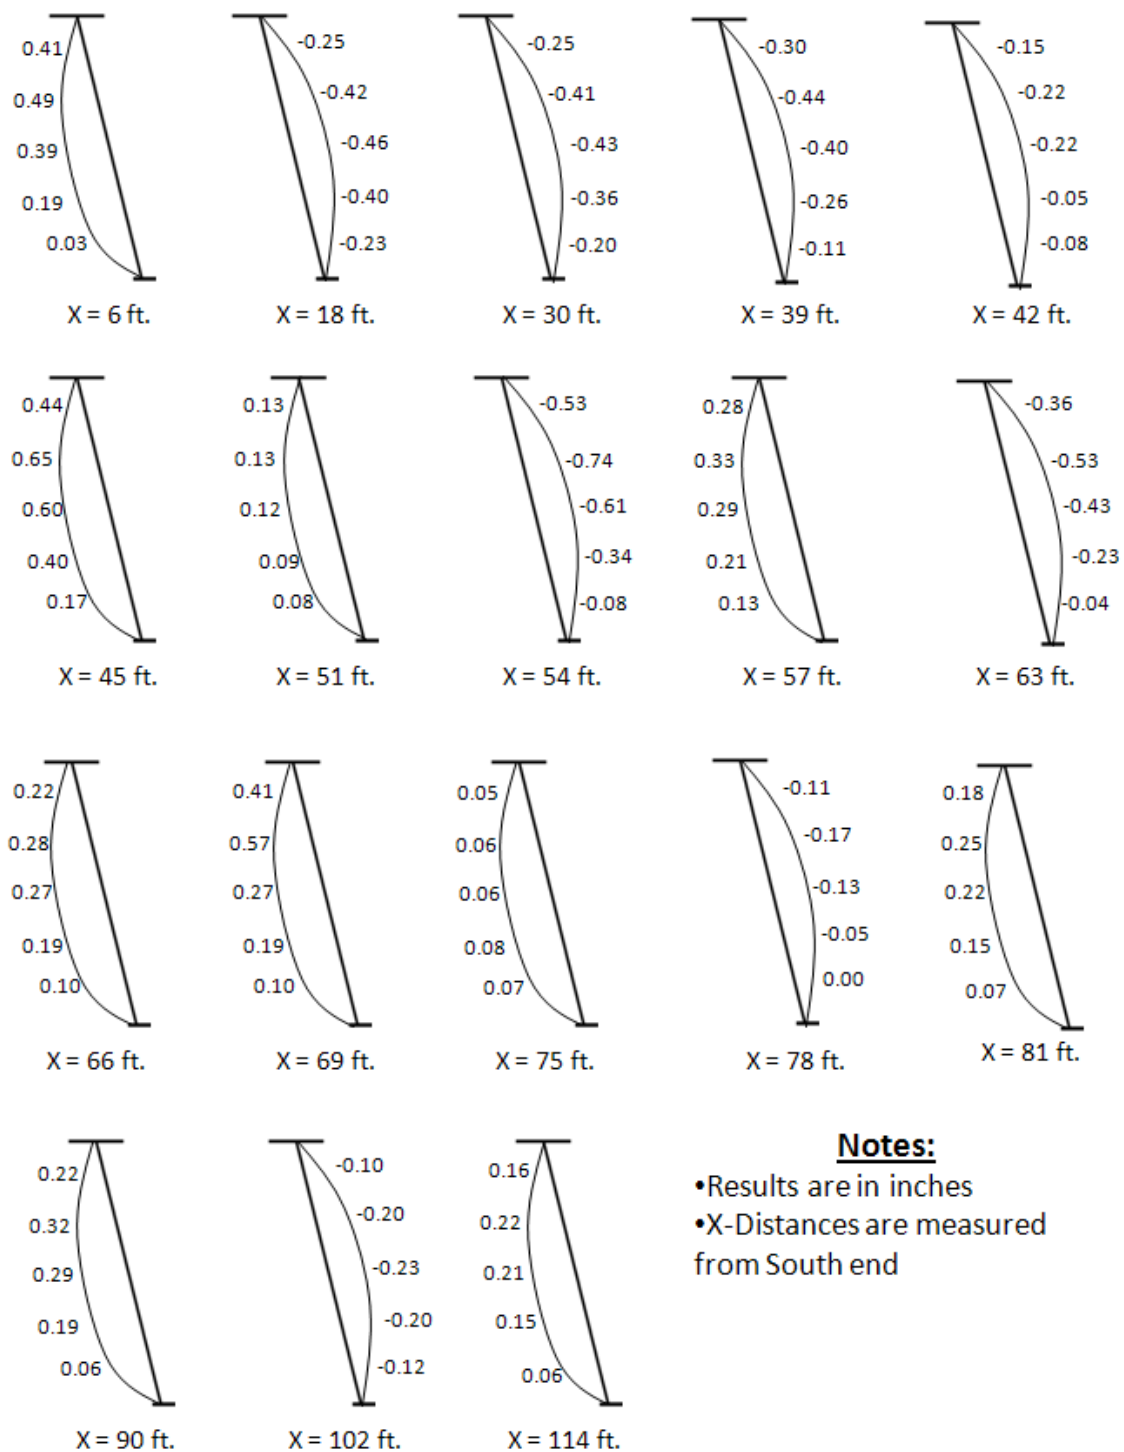
**Figure D-8 Interior Girder Outer Web - After Bracket Removal**

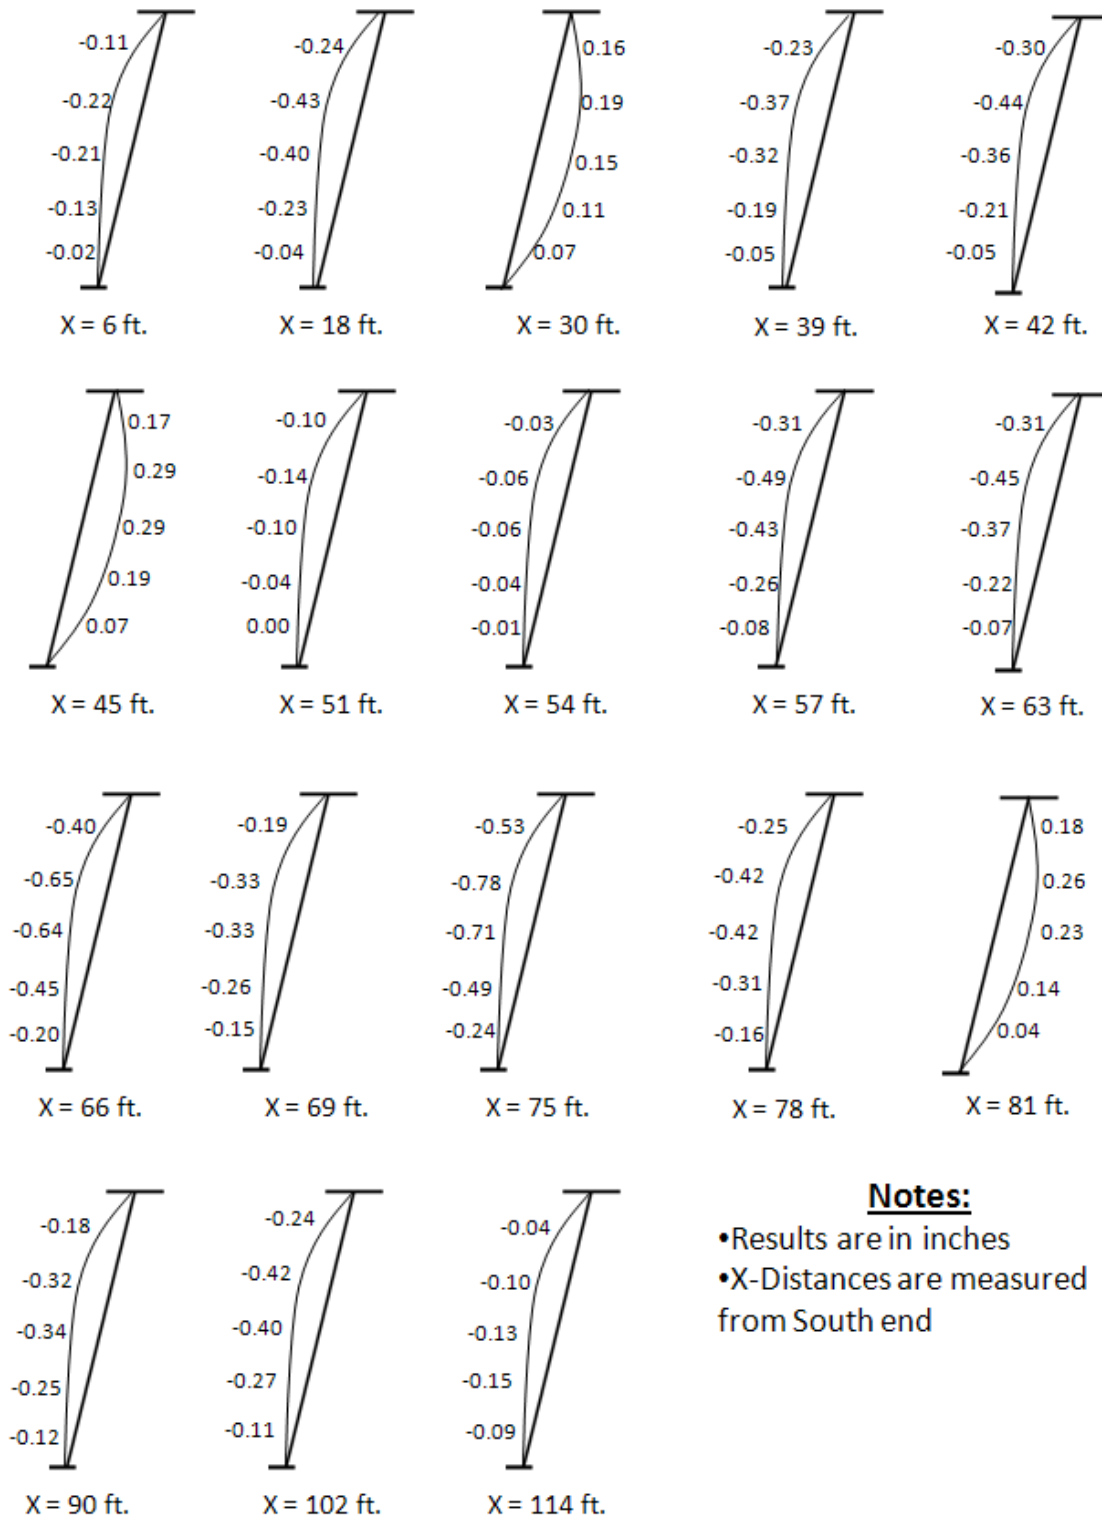
**Figure D-10 Interior Girder Inner Web - After Casting of Deck**
