**Comparative Study of the Corrosion Resistance of Different
Prestressing Strand Types for use in Post-Tensioning of Bridges**

Thesis

The University of Texas at Austin

May 2009

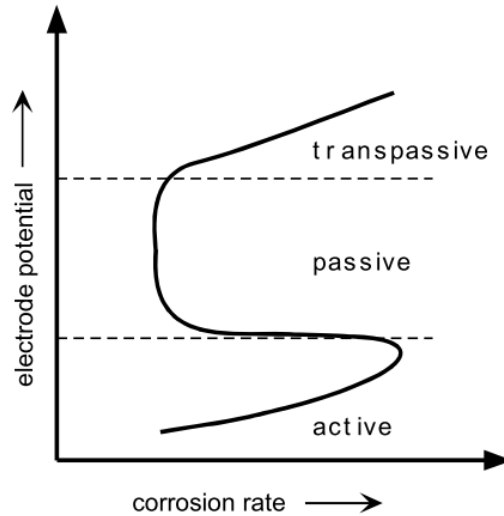
Figure 1.1: Passive Polarization Behavior¹⁹

Steel and all the different forms of steel, such as stainless, exhibit passivity in some degree among active, passive, and transpassive states¹². See Figure 1.1 below for the different ranges. The state at which a metal is acting depends on the potential of the metal which governs the corrosion rate¹². Conventional steel in concrete exhibits a passive state, and a passive protective layer is formed. Therefore, grouting the ducts of a post-tensioning system helps create this passive layer¹⁹. Chlorides have been found to enter the concrete through cracking which then break down this protective layer causing the metal to enter a transpassive state and begin to corrode. This has been the motivation for the research in finding a material that can withstand chloride exposure and keep the passive protective layer longer. Some materials tested, such as the stainless steel, are developed with a natural passive protective layer which makes it appealing to use for corrosion resistance.

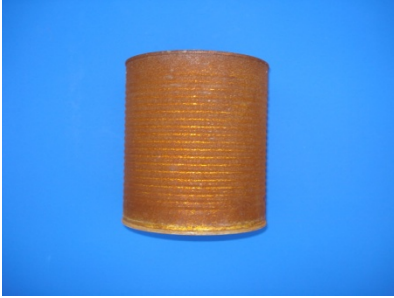
Figure 1.2: Examples of Uniform and Pitting Corrosion¹²

When a metal corrodes, it can undergo many types of corrosion depending on the type of metal and its passivity capabilities, chemical exposure, exposure duration, exposure cycle, temperature, and concentration of corrosive. Some of the most common types of corrosion are uniform, galvanic, crevice, pitting, and blistering¹². See Figure 1.2 below for examples of uniform and pitting corrosion. Many times, the corrosion will start out as uniform and build up to create blisters, while in some instances the corrosion is local and will result in pitting or crevices.

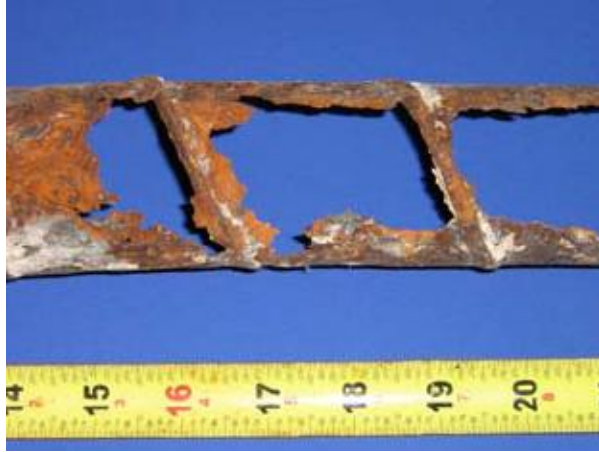
Figure 1.3: Corroded Hot Dip Galvanized Duct²²

From the above Figure, the major corrosion problem with the hot dip galvanized duct system can be seen. The remains of the duct provide no tendon protection.

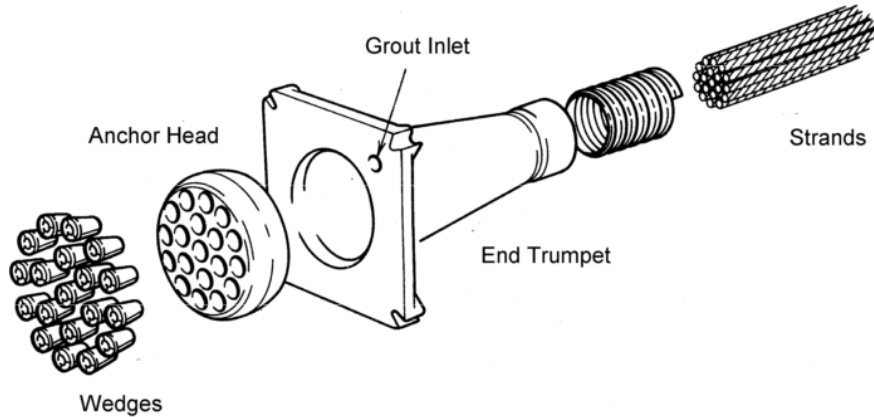
Figure 1.4: Post-Tensioning Anchorage System¹⁹

Another concern of durability is the anchorage of the system. The strands are tensioned and held using a hydraulic jack. When they are cut, the strands are resisted by a system of wedges. Figure 1.4 shows a layout of a post-tensioned anchorage system.

The force pulling on the strands creates interstitial defects in the strand as they bear against the wedges creating higher stresses at these locations¹⁹. The ends are grouted, but if chlorides are able to penetrate, they are able to enter the ducts and reach the entire tendon through these defects. Also, the corrosion at these affected cross-sections increases the stress, and ultimately, failure will occur at these points.

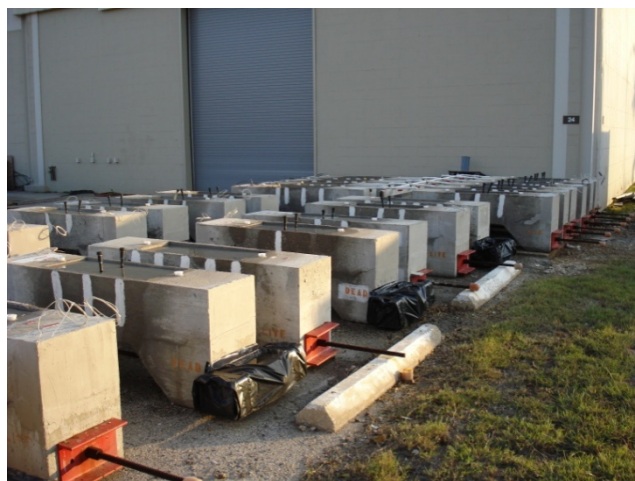
Figure 2.1: Layout of Large Scale Exposure Specimens

Project 0-4562 is a large scale assessment of post-tensioned concrete exposure beams currently being conducted at the Phil M. Ferguson Laboratory at the University of Texas at Austin. The project is being supported by the Texas Department of Transportation and the Federal Highway Administration and is a continuation of Project 0-1405 started by West²³ and Schokker¹⁹. The beam specimens consist of a variety of combinations of such aspects as tendon type, duct type, and bearing plate¹. There are a total of twenty-four beam specimens that all undergo a biweekly wet and dry cycle which consists of keeping the specimens wet with a chloride solution for two weeks and completely dry for the remaining two weeks. Ten of the specimens undergo a chloride solution spray exposure on the ends once a month to attack the grouted bearing plates. At the end of four to six years, the specimens will be autopsied to determine the level of corrosion to the ducts, tendons, and bearing plates. Figure 2.1 shows a layout of the specimens at Ferguson Laboratory.

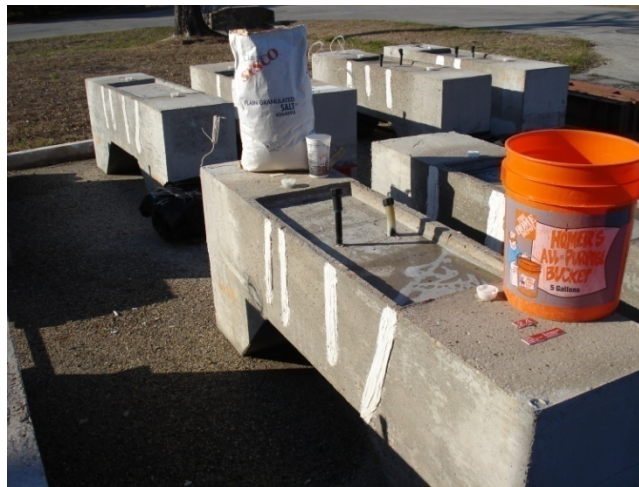
Figure 2.2: Specimen Embedment and Equipment Used to Apply Solution

The beam specimens must undergo daily and weekly maintenance and monitoring. The specimens undergo a biweekly wet and dry cycle where for the first two weeks of the month, they are exposed to a 3.5% by weight chloride solution which is placed in an embedment on top of the specimens. Figure 2.2 shows the embedment and the equipment used to apply the solution; this consists of a five-gallon bucket and a bag of salt.

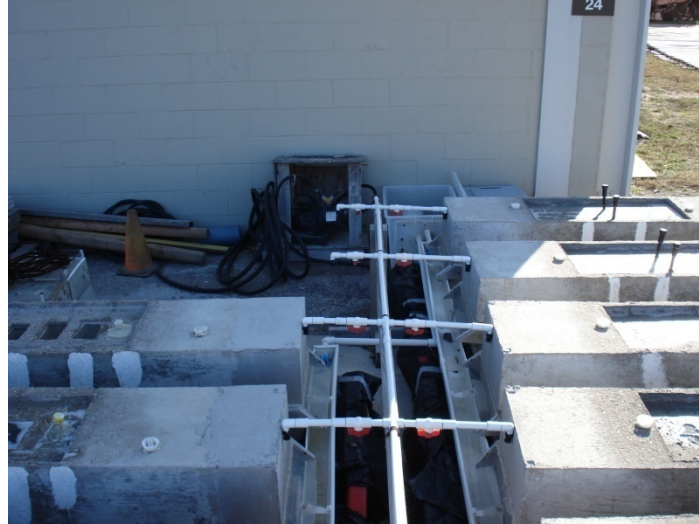
Figure 2.3: System Spraying Chloride Solution onto the Bearing Plates Beneath the Grout

Throughout the last two weeks of the month, the specimens are cleared of the solution and are kept completely dry. During the wet cycle, a 3.5% by weight chloride spray is applied to the grouted ends of ten of the beams to determine the exposure properties of the grout. Figure 2.3 shows the system used to apply the spray. As can be seen, a pump is used to take water from a holding tank and send it through a pipe system that then sprays the ends. The water is collected by plastic troughs that take the water back to the holding tank. During the dry cycle, half-cell potentials are taken to help determine the corrosive state of the tendons. The process is carried out by following ASTM C 876 – 99: *Standard Test Method for Half-Cell Potentials of Uncoated Reinforcing Steel in Concrete*³. This is done by hooking one side of a voltmeter to exposed copper wires attached to the tendons inside the specimen.

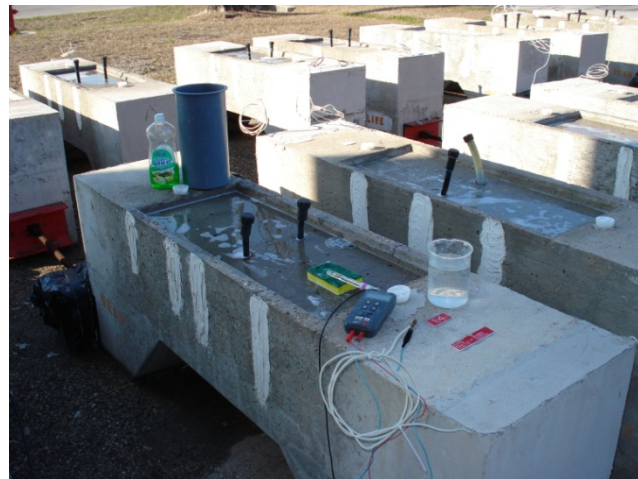
Figure 2.4: Equipment Used to Measure Half-Cell Potentials

The other side of the voltmeter is attached to a calomel reference electrode. See Figure 2.4 for the configuration. The electrode is placed on certain points along the embedment of the specimen, and a potential reading is obtained.

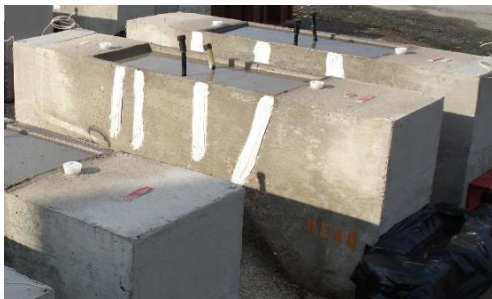
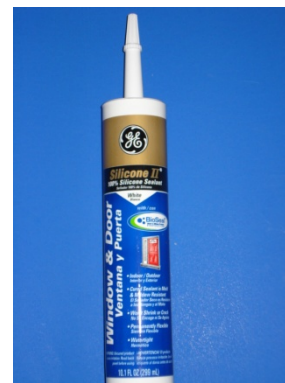
Figure 2.5: Caulked Region on Beam Specimens and Type of Caulk Used

Other miscellaneous maintenance is done to the beam specimens. Initially, the specimen was cracked on top under service loads to allow the chloride solution to enter more easily. These cracks propagated along the sides of the specimen, therefore needing to be plugged. Caulk is used to plug these cracks, so water will not be able to leak out of the sides. Over time, the caulk deteriorates and must be scraped off and reapplied. The caulk used is a 100% Silicone Sealant by GE. Figure 2.5 shows the caulked areas along with the type of caulk used.

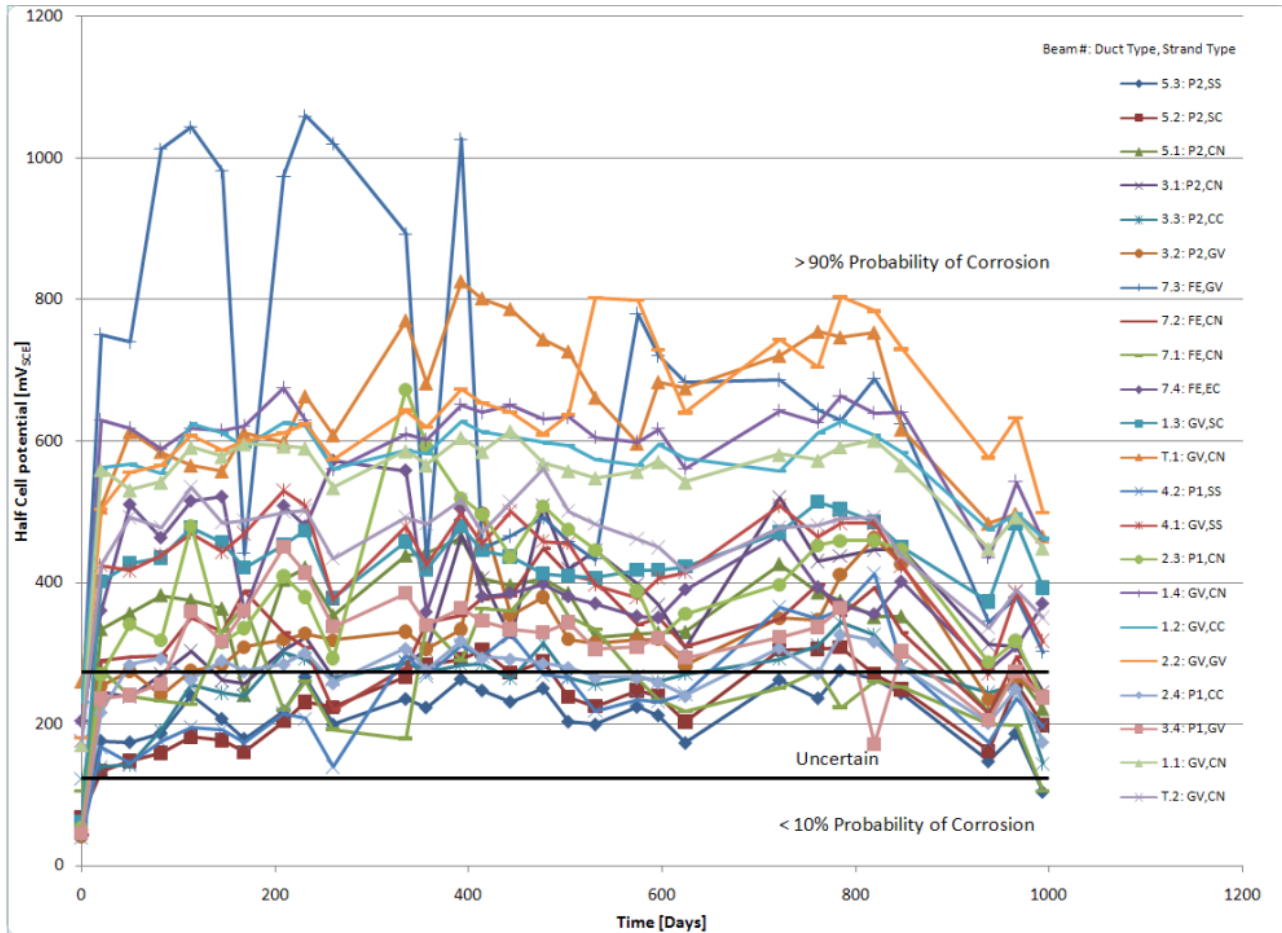
Figure 2.6: Plot of Half-Cell Potential versus Time

The data gathered from the collection of half-cell potentials is plotted in Figure 2.6 with potential versus time.

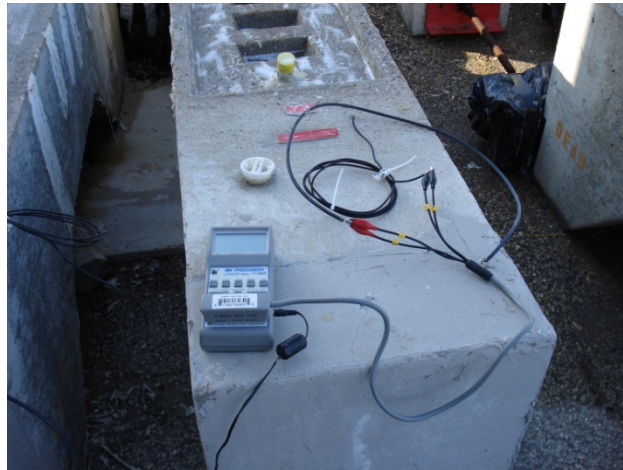
Figure 2.7: Impedance Measurement Device

because it changes as a function of corrosion. The equipment used to gather the data is a LCR/ESR meter made by BK Precision and provided by VSL. The equipment can be seen in Figure 2.7. The equipment attaches to a coil tendon wire and a copper reinforcing bar wire of the specimen.

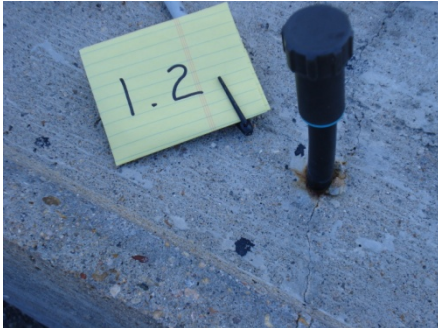
Figure 2.8: Rust Spots on Beam 1.2 and 2.2

Overall, the trend of the specimens tends to show that the worst systems on a durability standpoint tend to have ducts made of hot dip galvanized and strands made of conventional steel. These trends match the hypotheses made and are also reinforced with visual observations. On the specimens containing hot dip galvanized ducts, rust spots appear on the top of the specimen in the embedment along the cracks. These spots do not appear on the specimens containing plastic ducts. See the Figures below which show the rust spots on the designated specimens.

Duct Type: Galvanized

Strand Type: Copper Clad

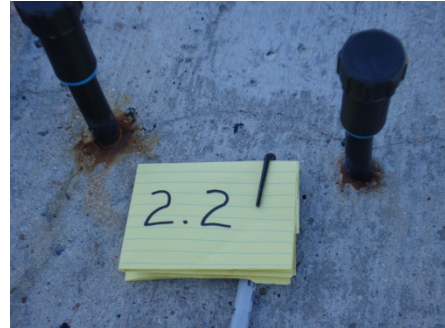
Strand Type: Hot Dip Galvanized

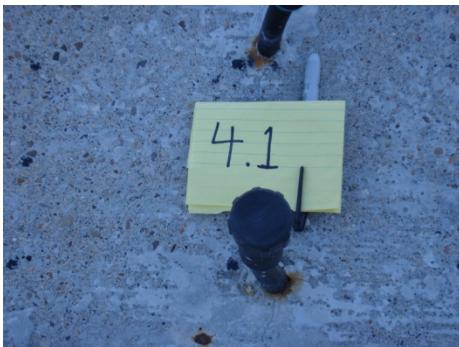
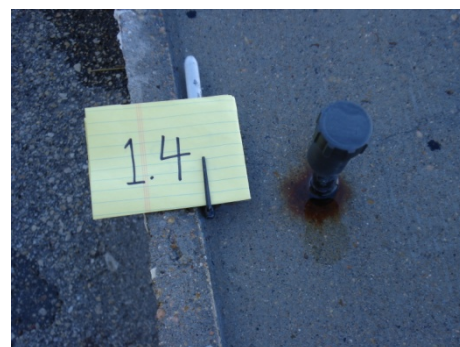
Figure 2.9: Rust Spots on Beams 4.1 and 1.4

Strand Type: Stainless Steel

Duct Type: Galvanized

Strand Type: Conventional

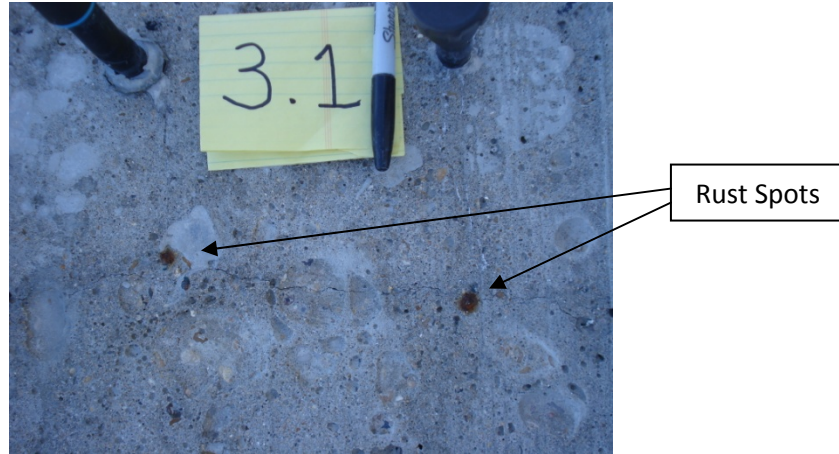
Figure 2.10: Rust Spots on Beam 3.1

Strand Type: Conventional

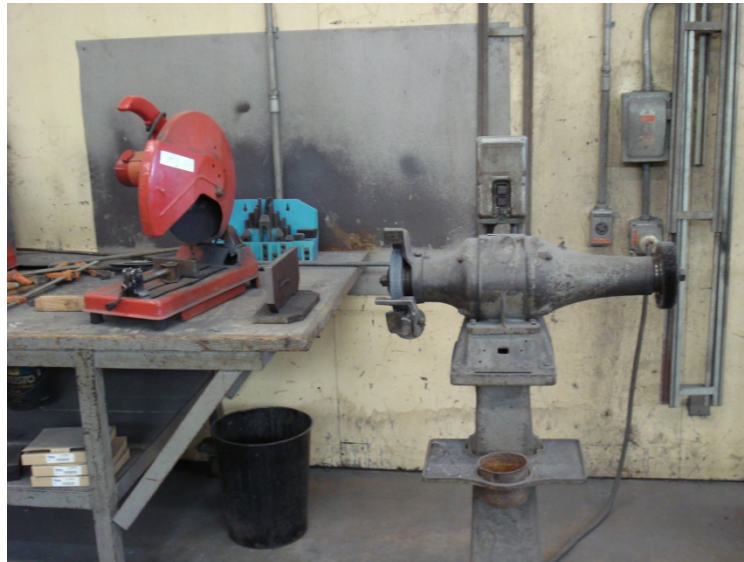
Figure 3.1: Chop Saw and Table Grinder

covered with epoxy, and placed in a pipe that was closed off. The equipment used to cut and grind the strands is shown in Figure 3.1.

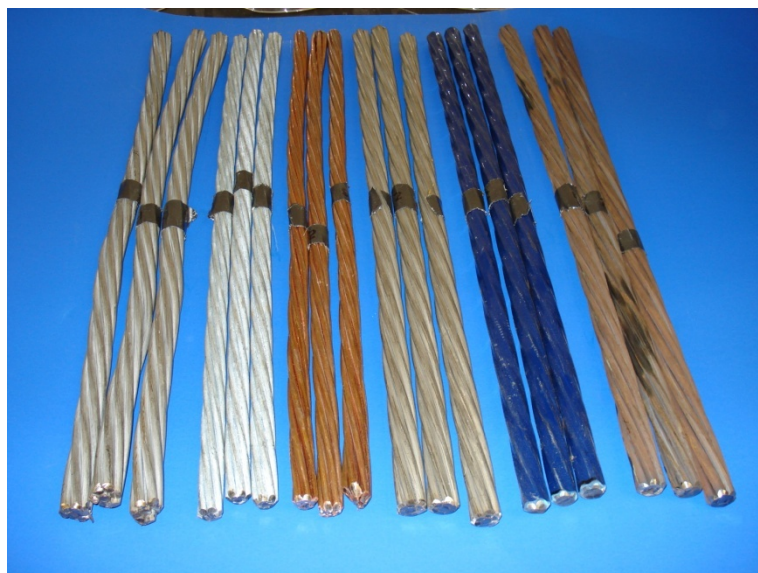
Figure 3.2: Specimens Used in Exposed Strand Test

Figure 3.2 shows all the strand types along with the ground ends. The specimens in Figure 3.2 are identified from left to right as stainless steel, hot dip galvanized, copper clad, stainless clad, flow-filled epoxy, and conventional steel. Notice the ends are ground down to round the cut edge.

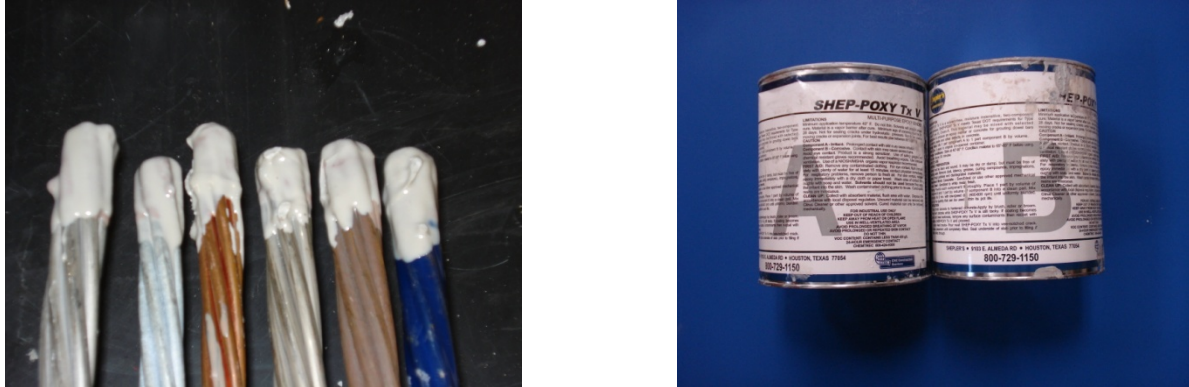
Figure 3.3: Strands with Epoxy Ends and the Epoxy Used

The epoxy used was a one-to-one ratio by volume mix provided by Shepler's and was of the type SHEP-POXY Tx V. Figure 3.3 below shows each type of strand with epoxy applied to the ends along with the type of epoxy used.

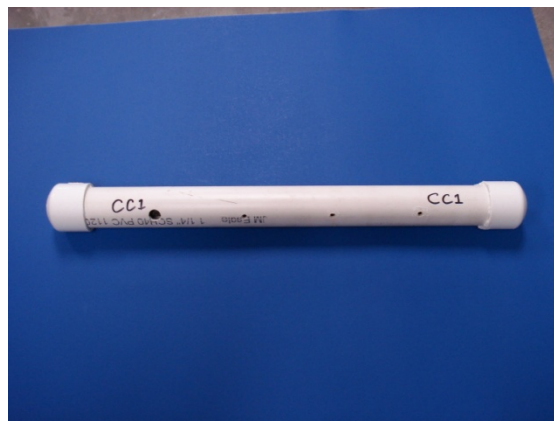
Figure 3.4: Pipe Configuration with Capped Ends and Holes Drilled

The length of each strand and corresponding pipe is 18 in. The pipe used is PVC pipe with a 1.25 in. inside diameter. The pipe is then closed off, but not sealed, with an end-cap on each end. To allow the exposure of the atmosphere, three holes are drilled on one side of the pipe using a 1/8 in. drill bit. A fourth hole is drilled using a 1/2 in. drill bit to allow a funnel to be placed inside when filling the pipe with solution. Figure 3.4 shows the configuration.

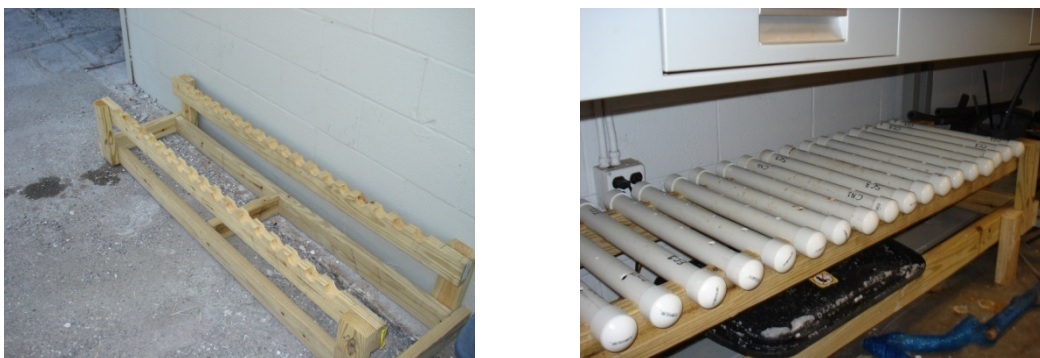
Figure 3.6: Wood Rack and Final Specimen Setup

The final task was to build a rack to keep the sealed pipes horizontal in order to have even distribution of solution. A rack was constructed of 2x4 lumber and can be seen in Figure 3.6 along with the final setup of the specimens.

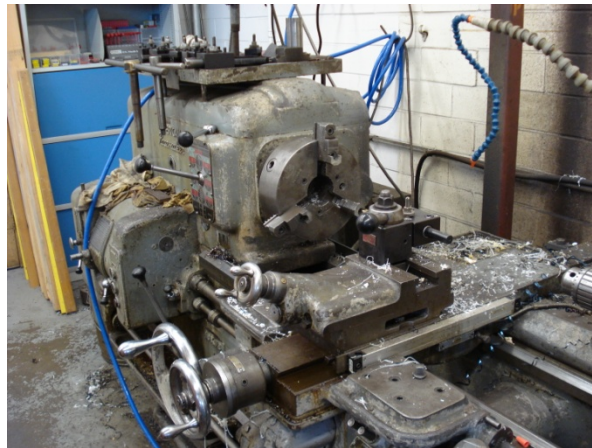
Figure 3.8: Lathe Used For Machining

The next phase of the setup involved preparing the PVC pipes. As mentioned above, since the strand diameters are of different size, machining of the pipes is necessary to keep the variables the same. A lathe was used to bore the inside of the PVC pipes (See Figure 3.8).

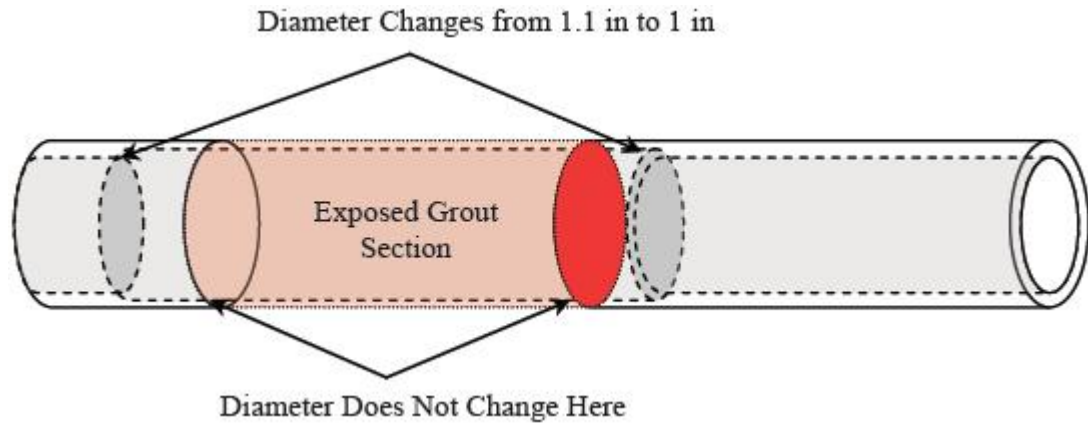
Figure 3.9: Diagram of Bored Elements¹⁴

The initial inside diameter of the pipes is one inch and the final diameter of the pipes used for 0.6 in. strand is 1.1 in. Therefore a total of 0.1 in. in diameter must be bored out. The boring action caused the clear pipe to become slightly distorted due to the passing of the lathe tool but not enough to keep the grout from being seen. To prevent unnecessary stresses in the specimen due to an abrupt change in diameter, the outer components of the 0.6 in. specimen pipes were bored out one inch. This allows a more gradual transition in the exposed grout region which can be seen in Figure 3.9.

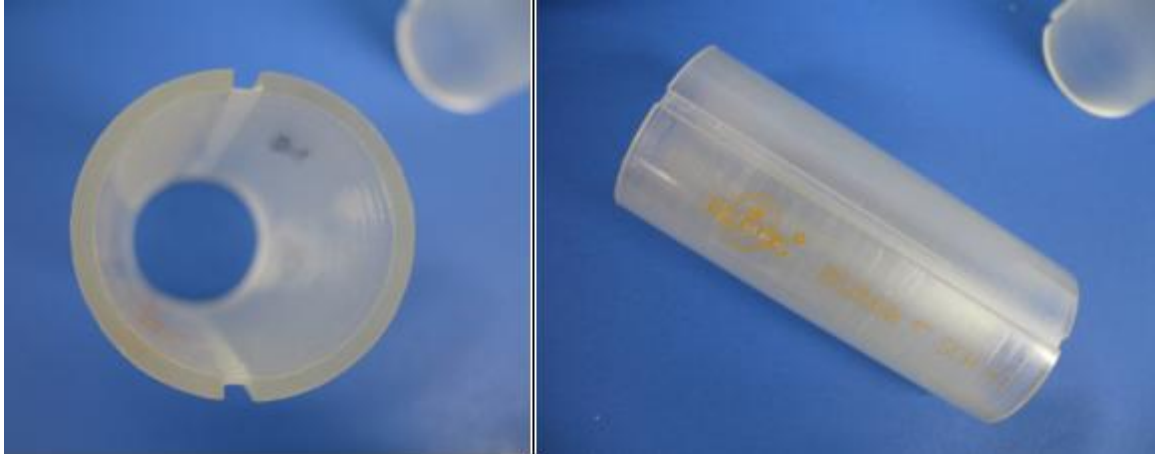
Figure 3.11: Section of Pipe Grooved and Bored Out¹⁴

These grooves would allow easier removal of this section after curing. The grooves were made as deep as possible, so there would be just enough material left as seen in Figure 3.11. Note in Figure 3.11, the inside diameter is bored out for the 0.6 in. strand.

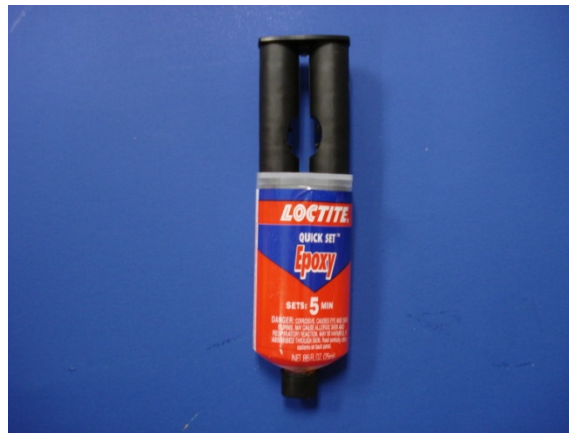
Figure 3.13: Quick Set Epoxy Used to Fill Acrylic Holes

The acrylic rods were placed through the holes and sealed with Loctite Quick Set epoxy shown in Figure 3.13. The epoxy is fast drying and water tight, keeping any grout from escaping.

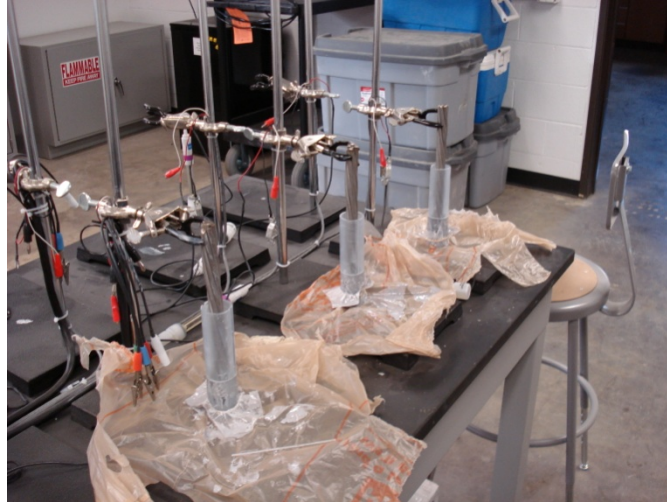
Figure 3.14: Applying Epoxy to the Bottom of the Strand

The next phase of the setup was to set one end of the strand in high-strength epoxy. The high-strength epoxy used is the same as in the previous section. This was done by setting the two-inch outer end on plastic, placing the strand through the acrylic grid, and holding it 0.25 in. from the bottom. The strands were held using grips from the accelerated test setup. The epoxy was then poured into the pipe filling the bottom to where the end of the strand was covered in epoxy. Figure 3.14 shows this process.

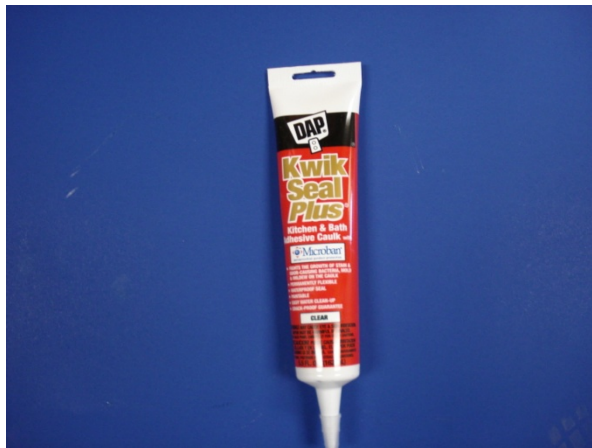
Figure 3.15: Silicone Used to Assemble Pipe Components

After the epoxy cured, the rest of the pipe was placed around the strand. The middle section of the pipe was first attached to the outer two-inch section using an adhesive silicone seen in Figure 3.15. The adhesive silicone allowed fast drying and a water tight connection among the parts of the pipe.

After boring, the exposed grout section was grooved as in Section 3.3.2.1 using the Lagun Republic Mill. There was just enough material left in the groove to keep the section connected. This allowed for easy removal after the specimens cured. To keep the strands centered in the pipe, a grid of 1/16" acrylic rods was placed in each of the outer sections. The holes were drilled using the Lagun Republic Mill. Figure 5.12 shows an outline of the grid. After all the sections were machined, construction of the pipe began. First, the acrylic rods were placed and held using a fast drying epoxy. The brand name is Loctite Quickset Epoxy as used in Section 3.3.2.1. Next, the outer sections were attached using a clear silicone (See Figure 3.15). When the sections were firmly set, the end cap was placed using plumbing cement.

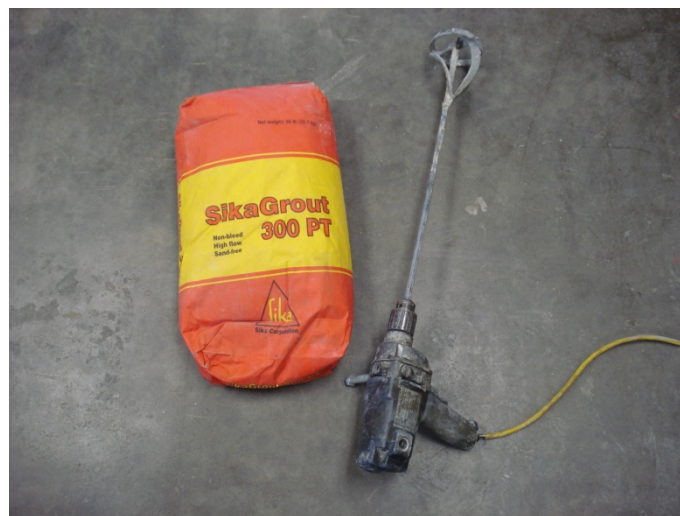
Figure 3.16: Grout Type and Variable Speed Mixer

After the preparation of the specimens, the grout was mixed and poured into the pipe. The grout used was SikaGrout 300 PT because it is a pre-mixed, non-bleed, high-flow grout. The water to cement ratio was chosen to be 0.3 to allow easy flowing into the pipes. The grout was mixed using a variable speed mixer attached with a high shear blade. The grout and mixer can be seen in Figure 3.16.

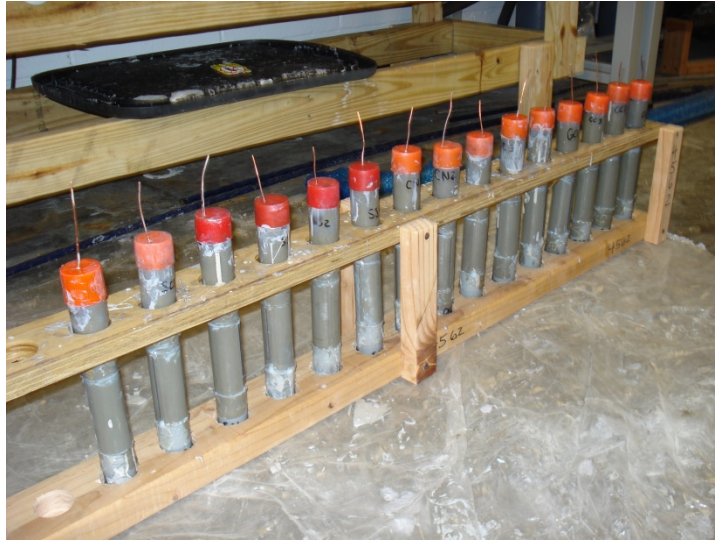
Figure 3.17: Final Configuration Before Curing

The grout was poured into each specimen using a funnel and then agitated to remove any air bubbles created. The tops of each specimen were left ungrouted a distance of 0.25 in. Immediately after pouring the grout, epoxy was poured to form a cap. To keep the epoxy covered during curing, a plastic cap was placed over the top. Figure 3.17 shows the final stage of specimen preparation before curing.

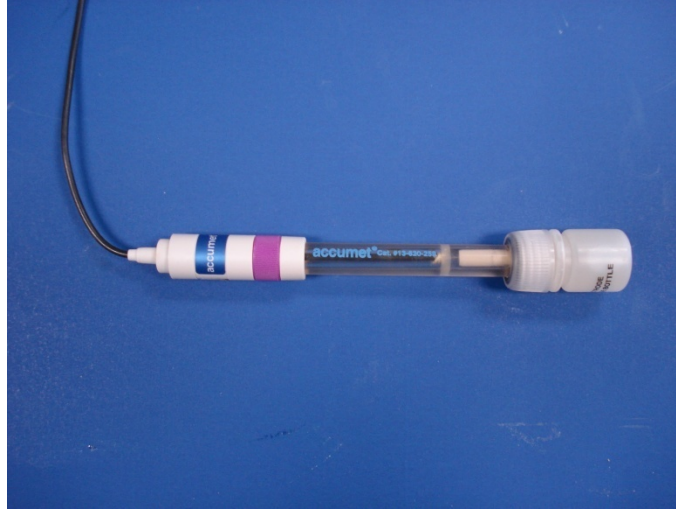
Figure 3.18: Saturated Calomel Electrode

The specimens were first immersed in a 5% chloride solution by weight in a 3000 mL beaker. In the system, the specimen acts as the working electrode accompanied by a counter electrode and a reference electrode. The counter electrode is a 0.05 in. platinum clad wire provided by Anomet products. The reference electrode is a saturated calomel electrode (SCE) manufactured by Fisher Scientific (See Figure 3.18).

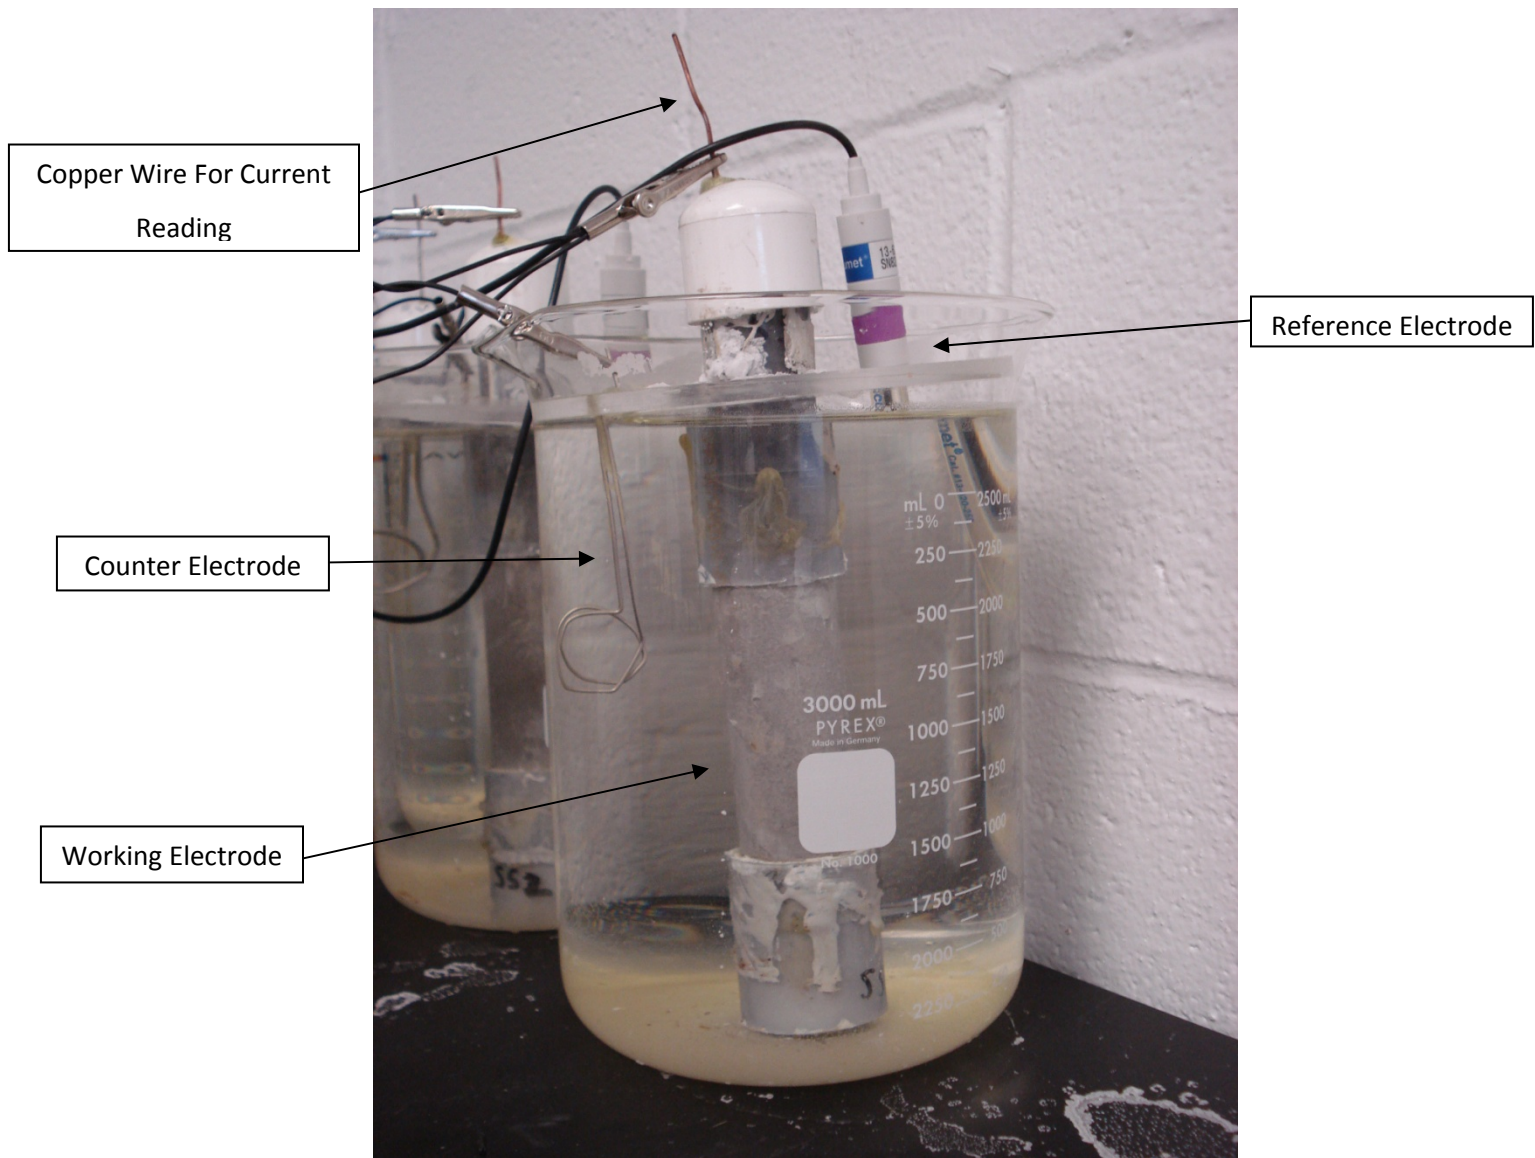
Figure 3.19: Grouted Strand Test Cell Setup

All the electrodes are held in place by the cell cover which fits over the beaker. The cell cover is made from 0.25 in. acrylic and was manufactured at the lab. First, the acrylic was cut into squares, followed by lathing the squares into the required diameter, and finally lathing the inside diameter for the specimen to fit through. The same lathe was used as in Section 3.3.1. The holes needed in the cell cover for the other electrodes were drilled using a hand drill. The platinum clad counter electrode was attached using the quick-dry epoxy. Figure 3.19 shows the complete setup of electrodes and wire attachments.

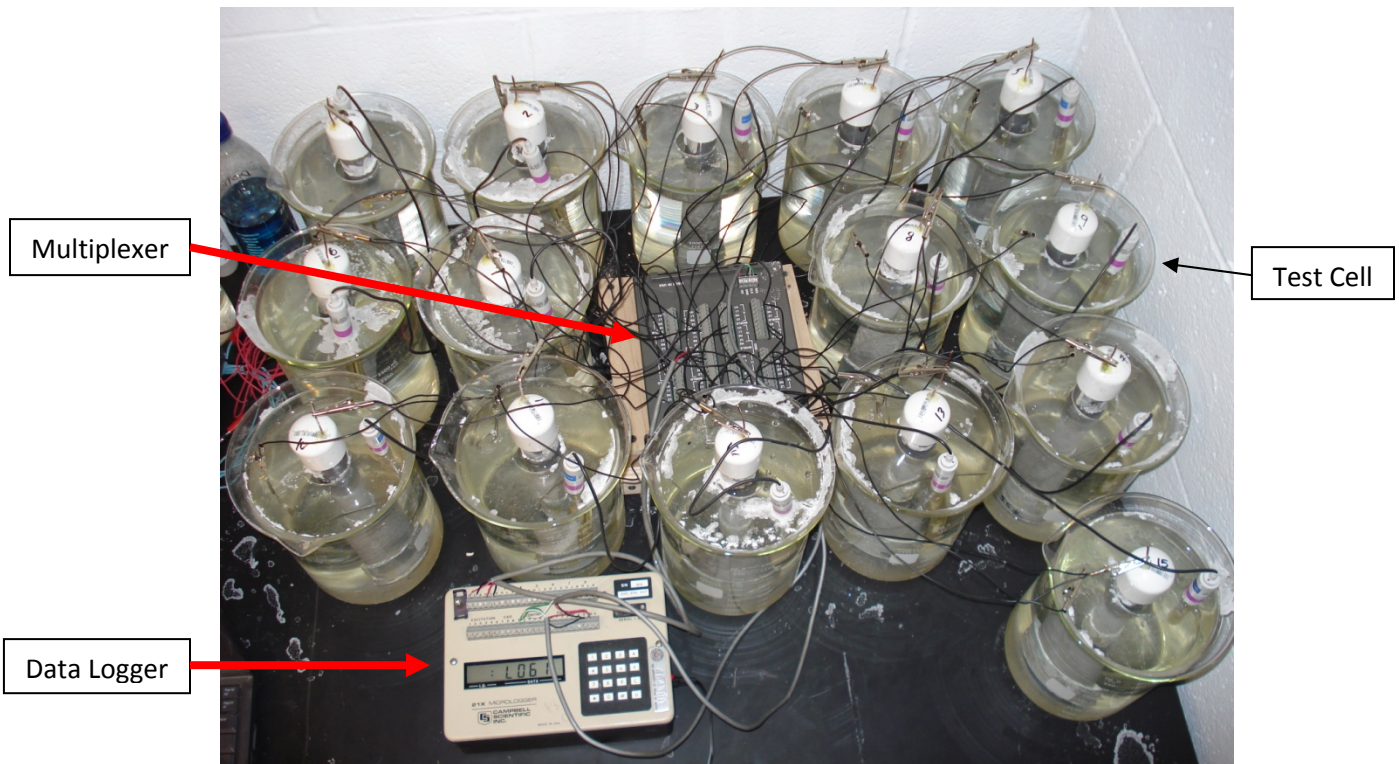
Figure 3.20: Grouted Strand Test Complete Setup

programmed to take data readings twice a day. The readings will then be used to plot potential and current versus time to get an idea as to how the specimens corrode relative to each other. Figure 3.20 shows the final test setup with the wires attached from the specimens to the multiplexer and data logger.

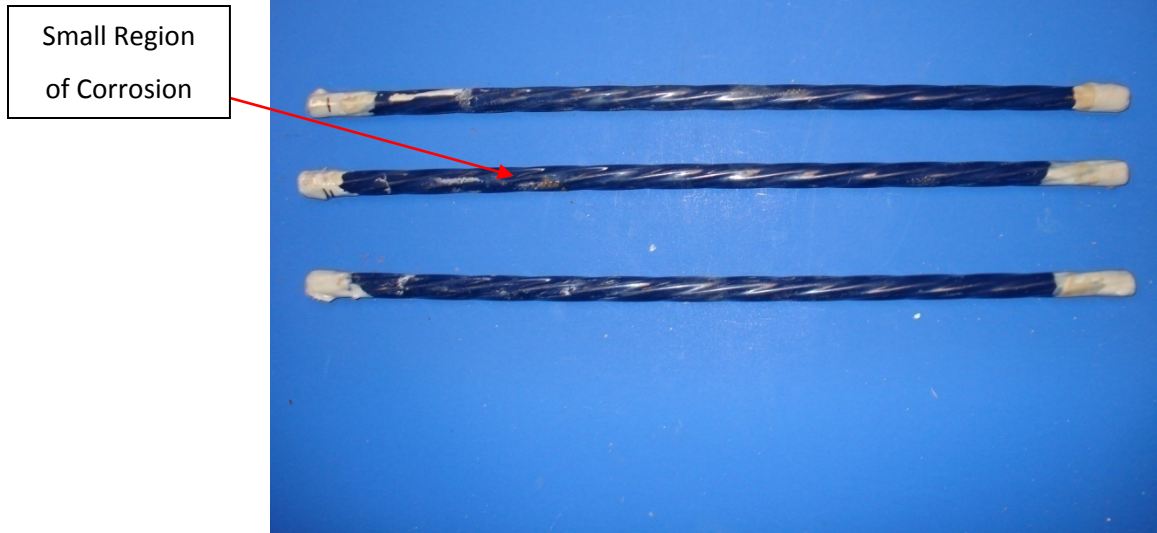
Figure 4.1: Flow Filled Epoxy Coated Strands at Six Months

The flow-filled epoxy coated strand was used in this test as a basis to compare the other strands. Since the ends of the strand were epoxyed, there was no chance for corrosion to begin. Therefore, the epoxy coated strand should have no change in corrosion rating and weight change. This was not totally true in the test, since the outer layer of epoxy coating had very small tears in them in some locations. Corrosion began at these areas but was confined there. The epoxy coated strands at six months can be seen in Figure 4.1. Note the small region of corrosion in strand number two (middle strand).

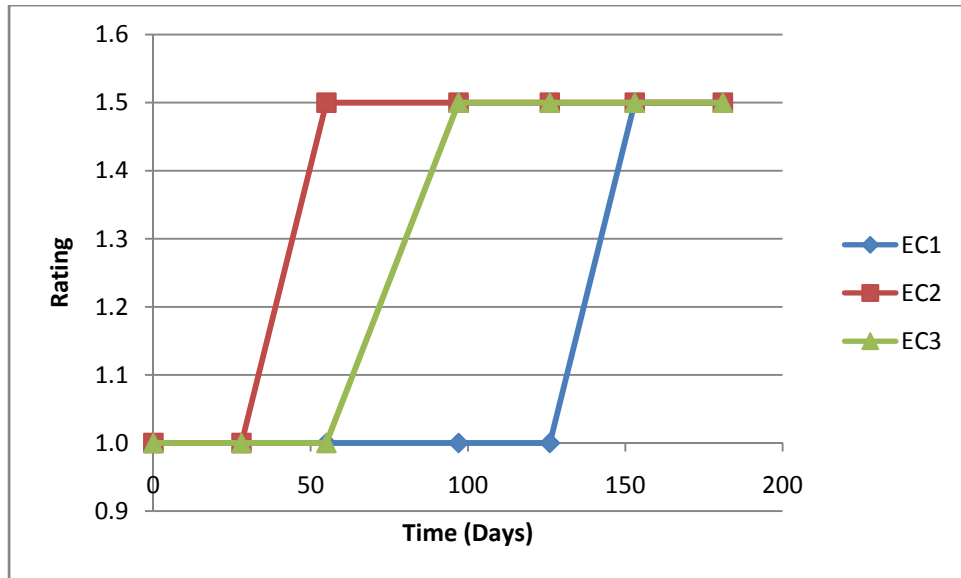
Figure 4.2: Corrosion Rating Over Time for Flow-Filled Epoxy Coated Strands

EC1	EC2	EC3
Corrosion Rating	1.5	1.5	1.5
Weight Loss (grams)	0.7	0.5	0.6

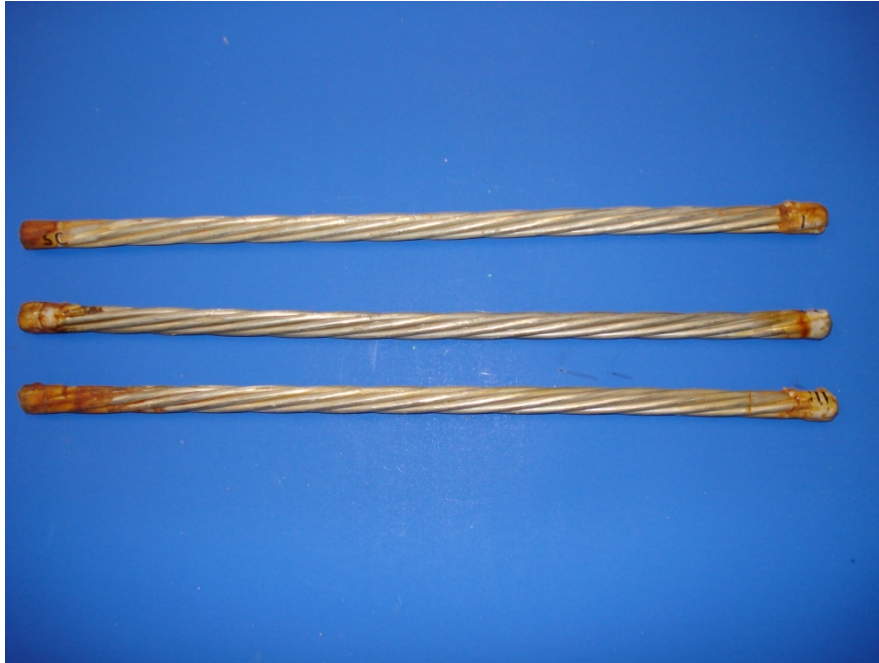
Figure 4.3: Stainless Clad Strands at Six Months

The stainless clad strands were expected to perform very well in this test considering that the cut ends were protected by epoxy, and there were no defects on the strands before the test began. The strands at six months are shown in Figure 4.3.

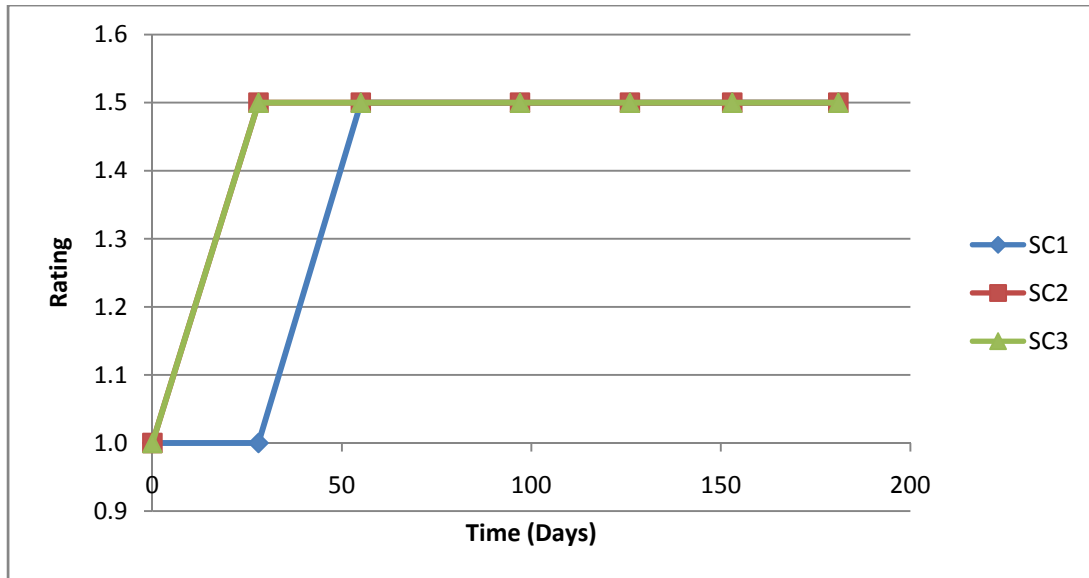
Figure 4.4: Corrosion Rating Over Time for Stainless Clad Strands

SC1	SC2	SC3
Corrosion Rating	1.5	1.5	1.5
Weight Loss (grams)	1.3	1.0	0.9

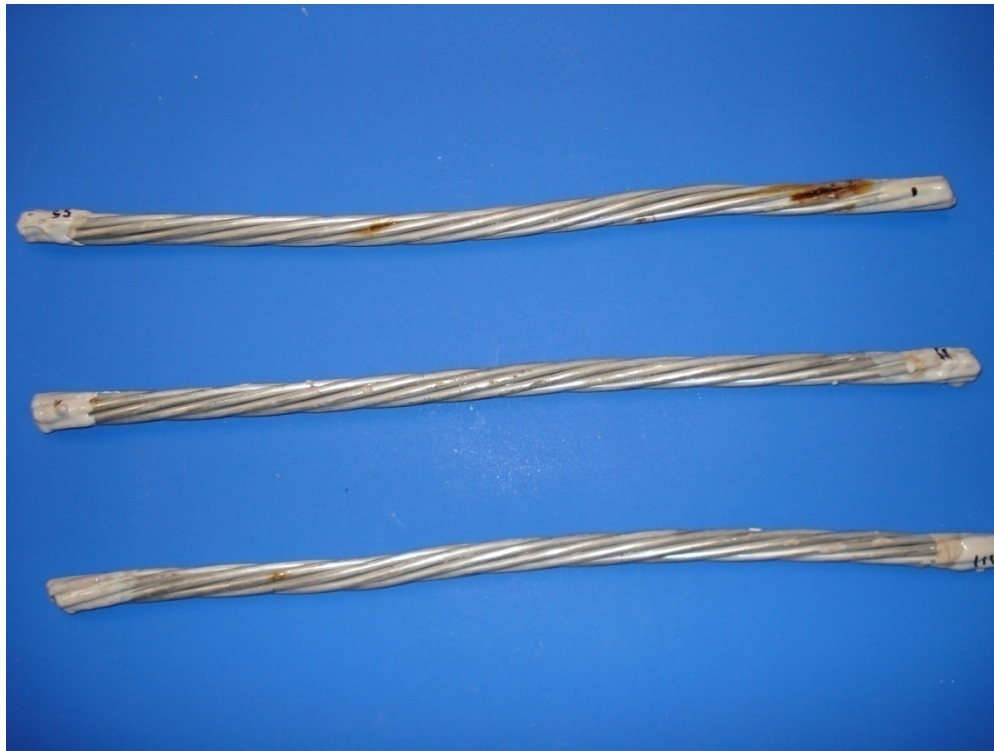
Figure 4.5: Stainless Steel Strands at Six Months

The stainless steel strands were expected to do very similar to the stainless clad strands during this testing. The strands at six months are shown in Figure 4.5. Note that the behavior is similar to the stainless clad in that there is small corrosion in the middle of the strands. The stainless steel strands did not show as much corrosion near the ends as the stainless clad strands because the material is fully stainless steel.

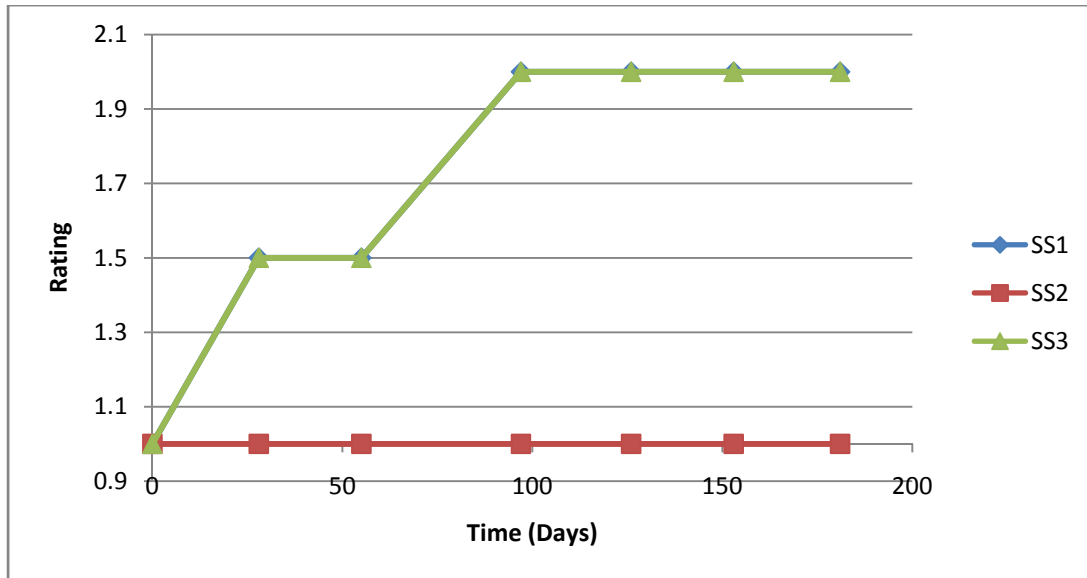
Figure 4.6: Corrosion Rating over Time for Stainless Steel Strands

SS1	SS2	SS3
Corrosion Rating	2.0	1.0	2.0
Weight Loss (grams)	1.0	1.2	1.1

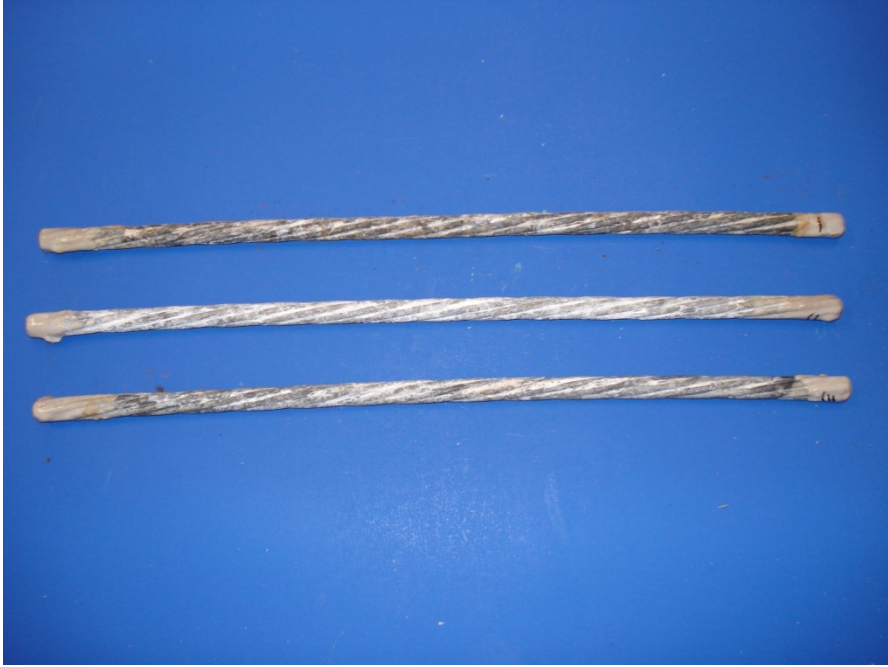
Figure 4.7: Hot Dip Galvanized Strands at Six Months

corrosion ratings even though no rust is present. The corrosion ratings and weight losses of the strands at six months can be found in Table 4.5.

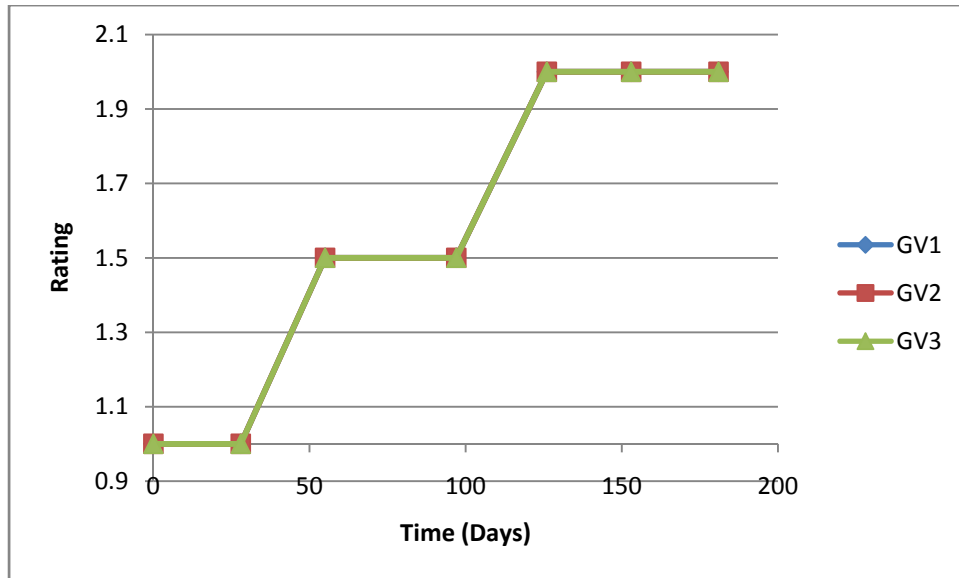
Figure 4.8: Corrosion Rating Over Time for Hot Dip Galvanized Strands

GV1	GV2	GV3
Corrosion Rating	2.0	2.0	2.0
Weight Loss (grams)	2.1	1.9	2.1
