**Comparative Study of the Corrosion Resistance of Different
Prestressing Strand Types for use in Post-Tensioning of Bridges**

Thesis

The University of Texas at Austin

May 2009

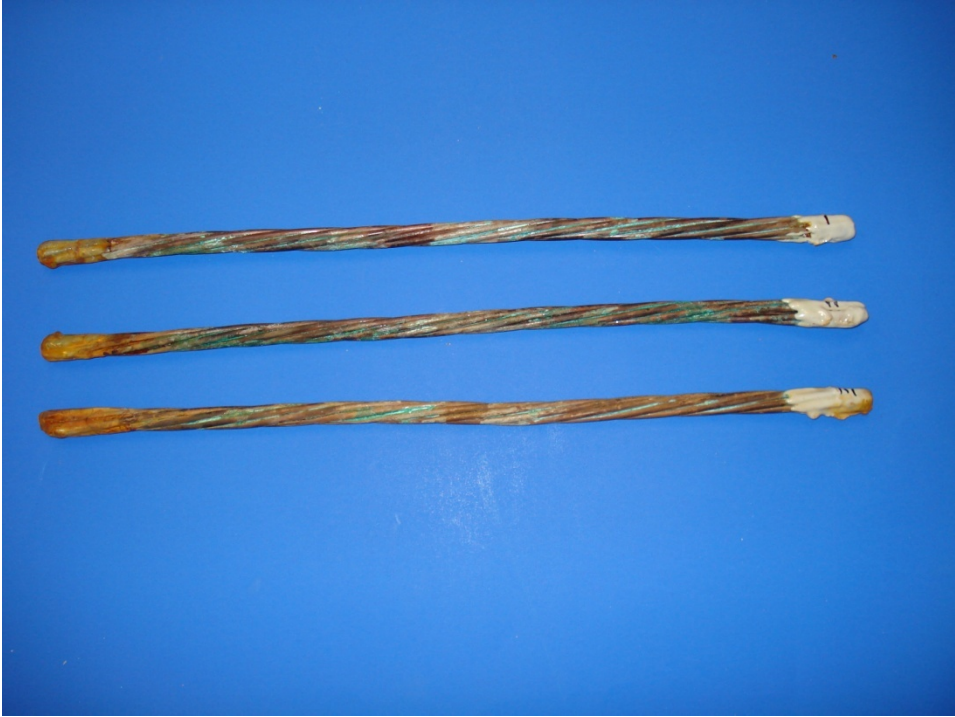
Figure 4.9: Copper Clad Strands at Six Months

penetration of the chloride solution within the interstices of the strand. The corrosion rating and weight loss for each strand at six months is found in Table 4.6.

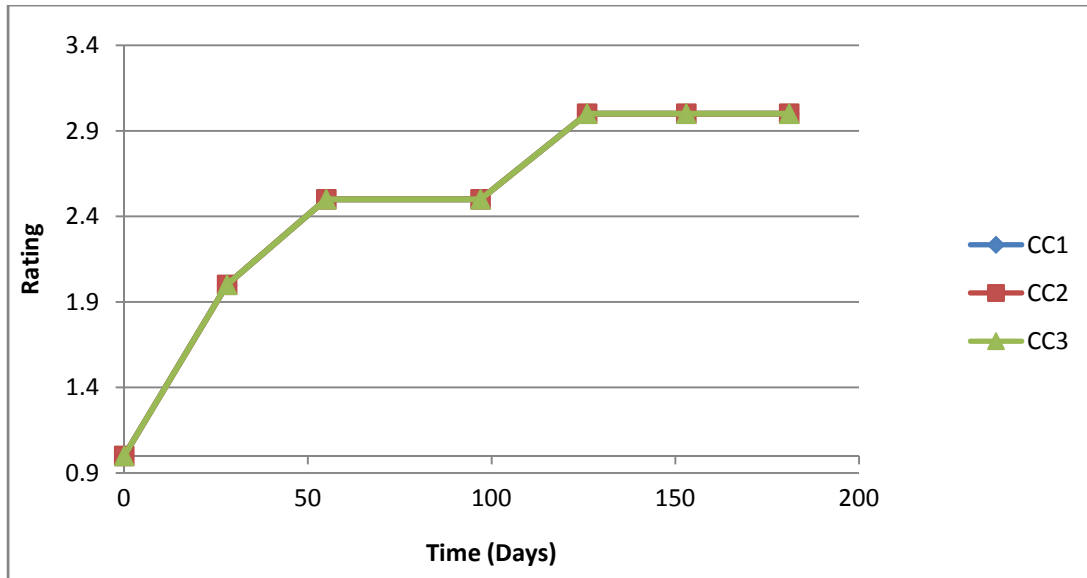
Figure: 4.10: Corrosion Rating Over Time for Copper Clad Strands

CC1	CC2	CC3
Corrosion Rating	3.0	3.0	3.0
Weight Loss (grams)	1.1	1.2	0.8

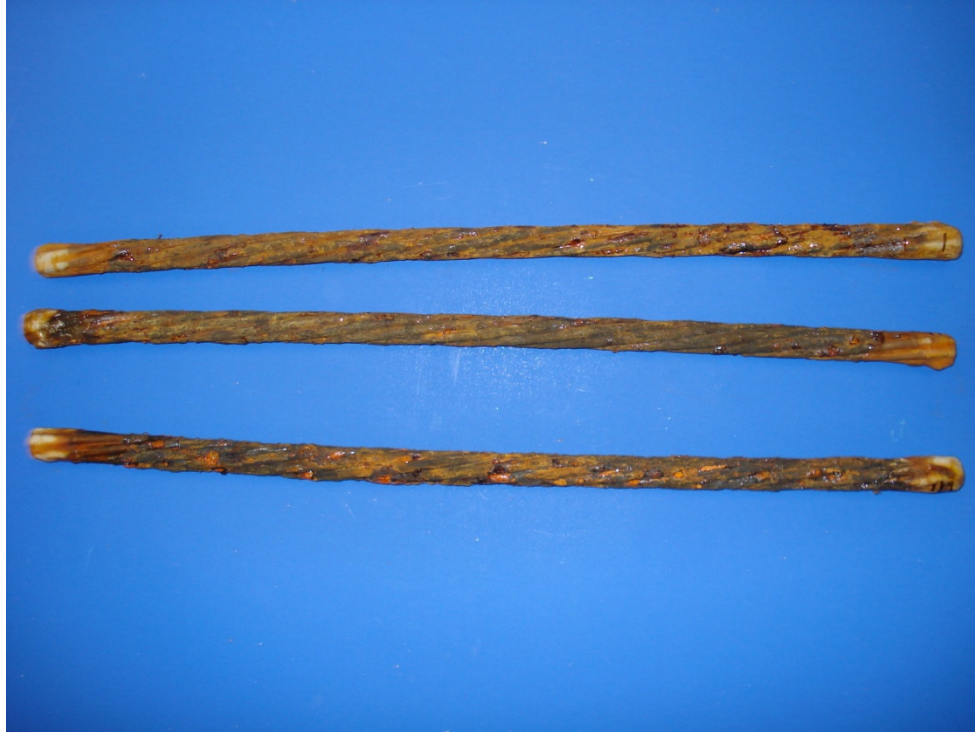
Figure 4.11: Conventional Strands at Six Months

The conventional strands were expected to severely corrode, and they all did exactly that. The strands at six months can be seen in Figure 4.11. Notice the blisters and pitting that have formed on each of the strands which are both signs of extreme corrosion.

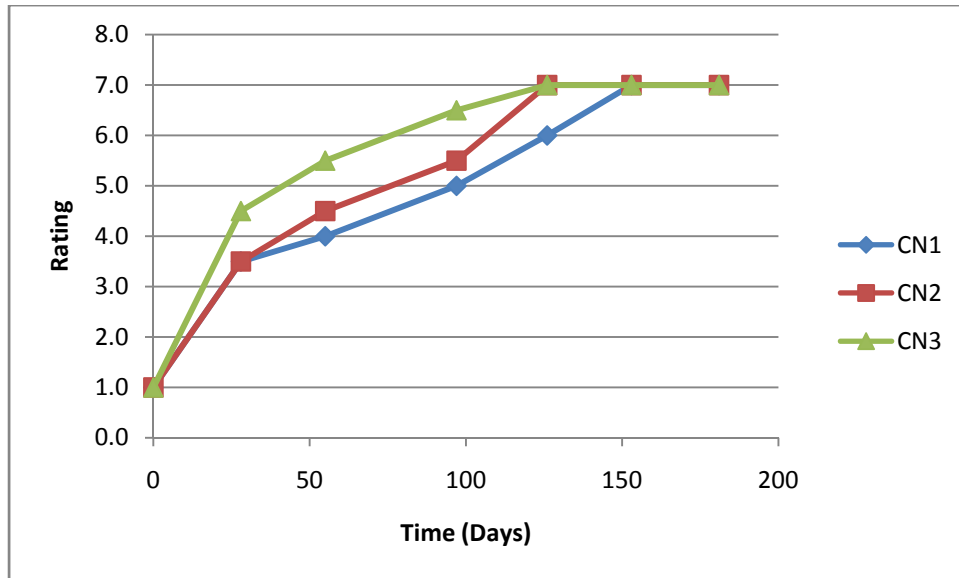
Figure 4.12: Corrosion Rating Over Time for Conventional Strands

CN1	CN2	CN3
Corrosion Rating	7.0+	7.0+	7.0+
Weight Loss (grams)	8.3	9.5	12.6

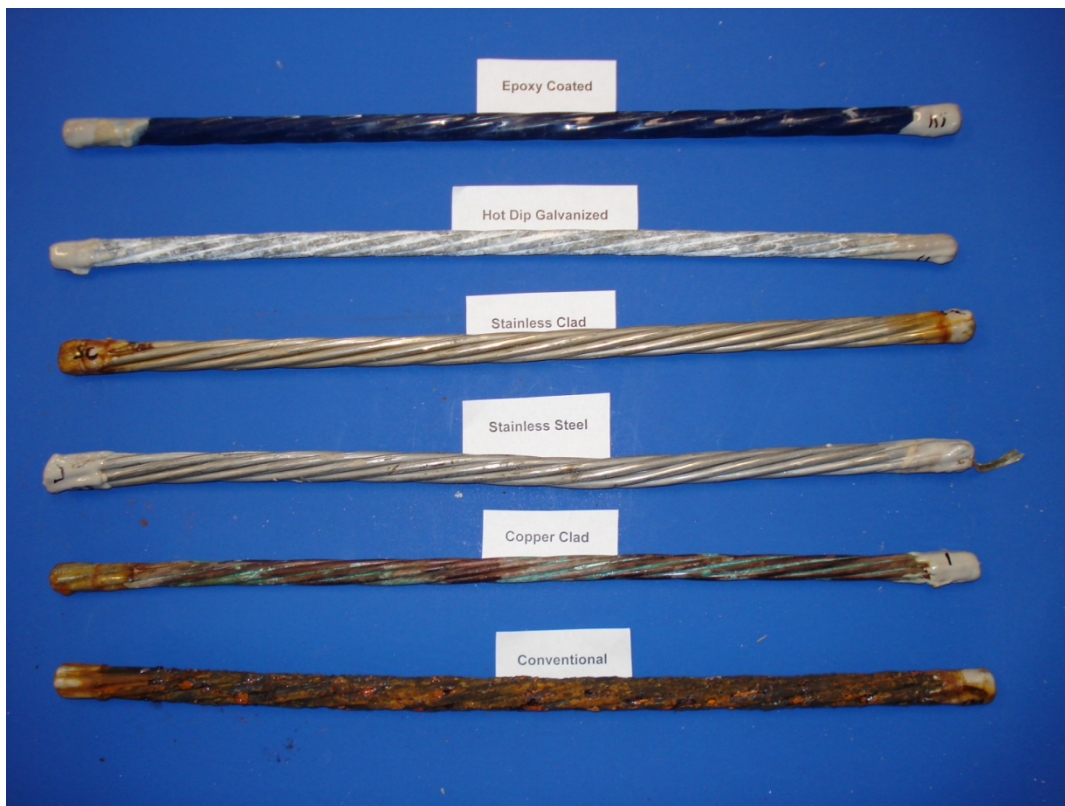
Figure 4.16: All the Strands After Six Months

better show the other strands. Finally, all the strands compared to each other at six months can be seen in Figure 4.16.

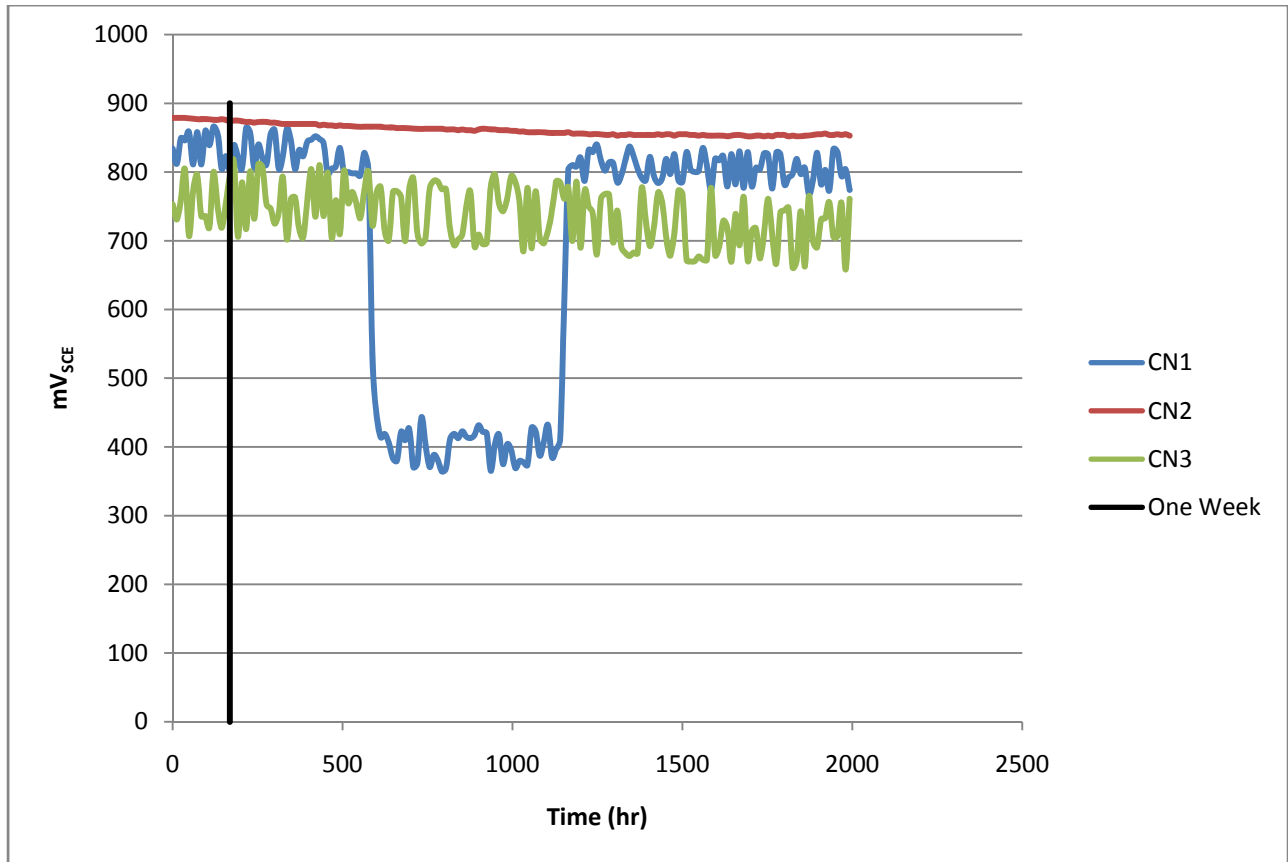
Figure 4.17: Potential vs Time for Conventional Strand

The conventional strands had fairly decent results in that the first week potentials were within one hundred mV_{SCE} of each other, and they all followed similar trends over time. The first and third specimens (CN1 and CN3) had variable scatter over time with CN1 having a severe increase in potential over time at approximately 600 hours and holding that potential until 1200 hours before rejoining the original trend. Due to the scatter in CN1 and CN3, the second specimen CN2 was chosen as the representative specimen with a corrosion potential, $E_{corr} = -875 mV_{SCE}$. Figure 4.17 shows the plot of potential versus time for the specimens.

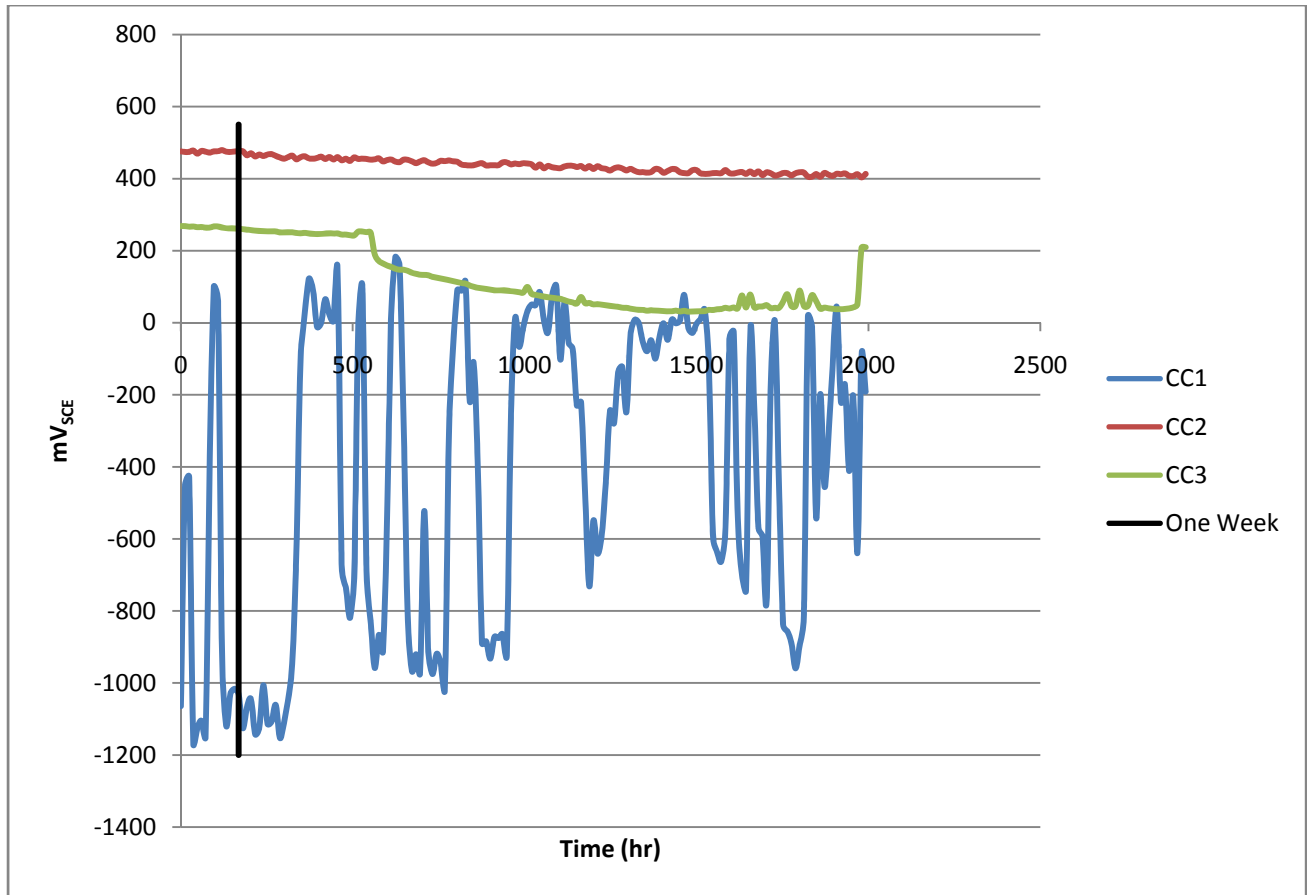
Figure 4.18: Potential vs Time for Copper Clad Strand

Two of the specimens (CC2 and CC3) performed without scatter while CC1 had a considerable amount and was rejected right away. The first week data for both CC2 and CC3 are constant with the corrosion potentials being $E_{\text{corr}2} = -475 \text{ mV}_{\text{SCE}}$ and $E_{\text{corr}3} = -265 \text{ mV}_{\text{SCE}}$. Since both specimens exhibit constant potential versus time in the first week, the average of the two corrosion potentials will be used as the representative value of $E_{\text{corr,AVG}} = -370 \text{ mV}_{\text{SCE}}$. An average line of potential versus time between the two specimens will be used to compare against the other strand types. The potential versus time for the copper clad strands can be seen in Figure 4.18.

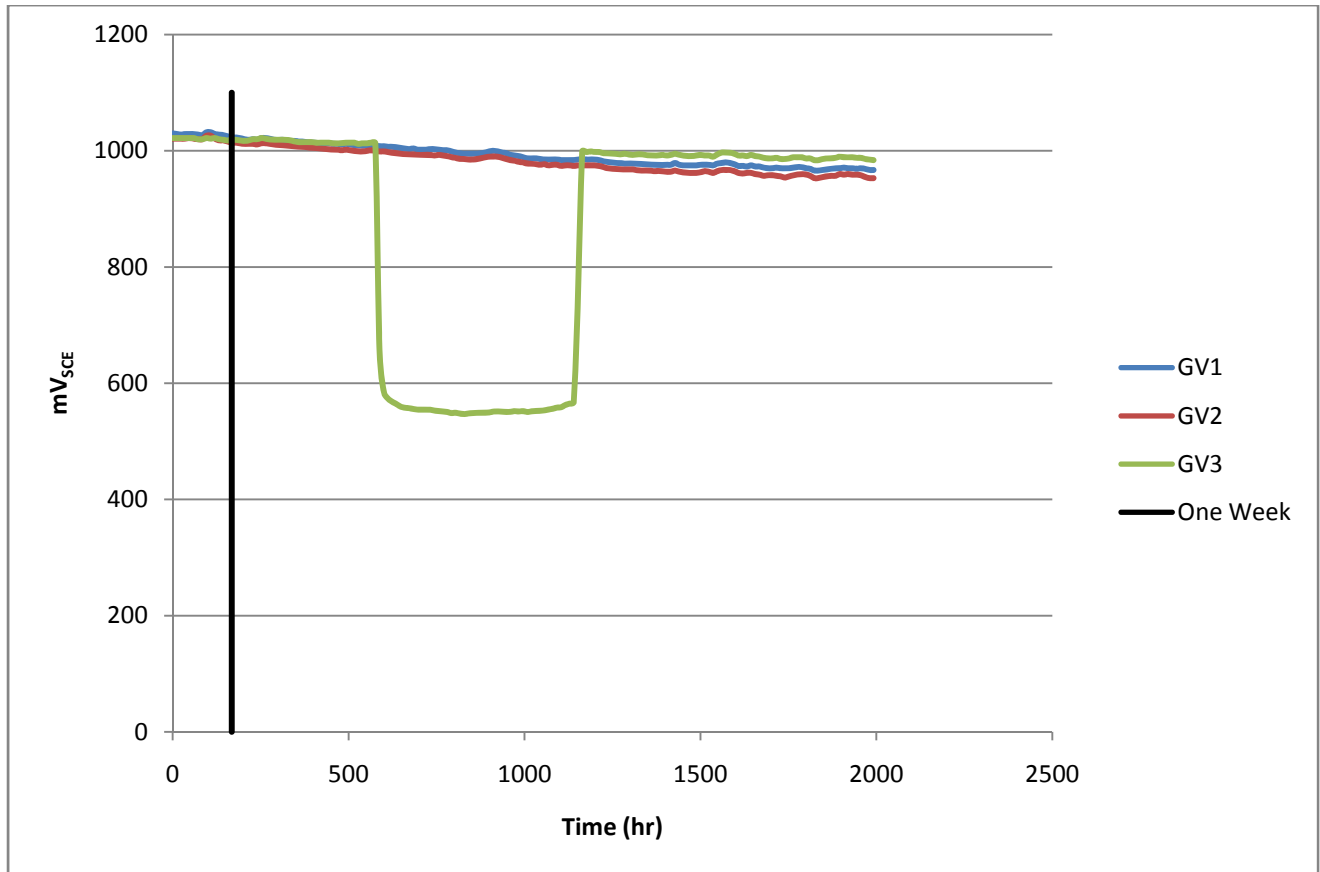
Figure 4.19: Potential vs Time for Hot Dip Galvanized Strand

All of the specimens followed almost identical lines in the first week and even up until approximately 600 hours where the third specimen (GV3) has a spike in potential until 1200 hours when the line rejoined the original. Since this same spike is exhibited in the first conventional strand specimen (CN1 in Figure 4.16), the behavior of both is most likely explained by an error in the multiplexer. Since all of the specimens are alike in the first week, the first specimen (GV1) was chosen as the representative specimen by default. The corrosion potential of the specimens is $E_{\text{corr}} = -1025 \text{ mV}_{\text{SCE}}$. Figure 4.19 shows the potential versus time for the specimens.

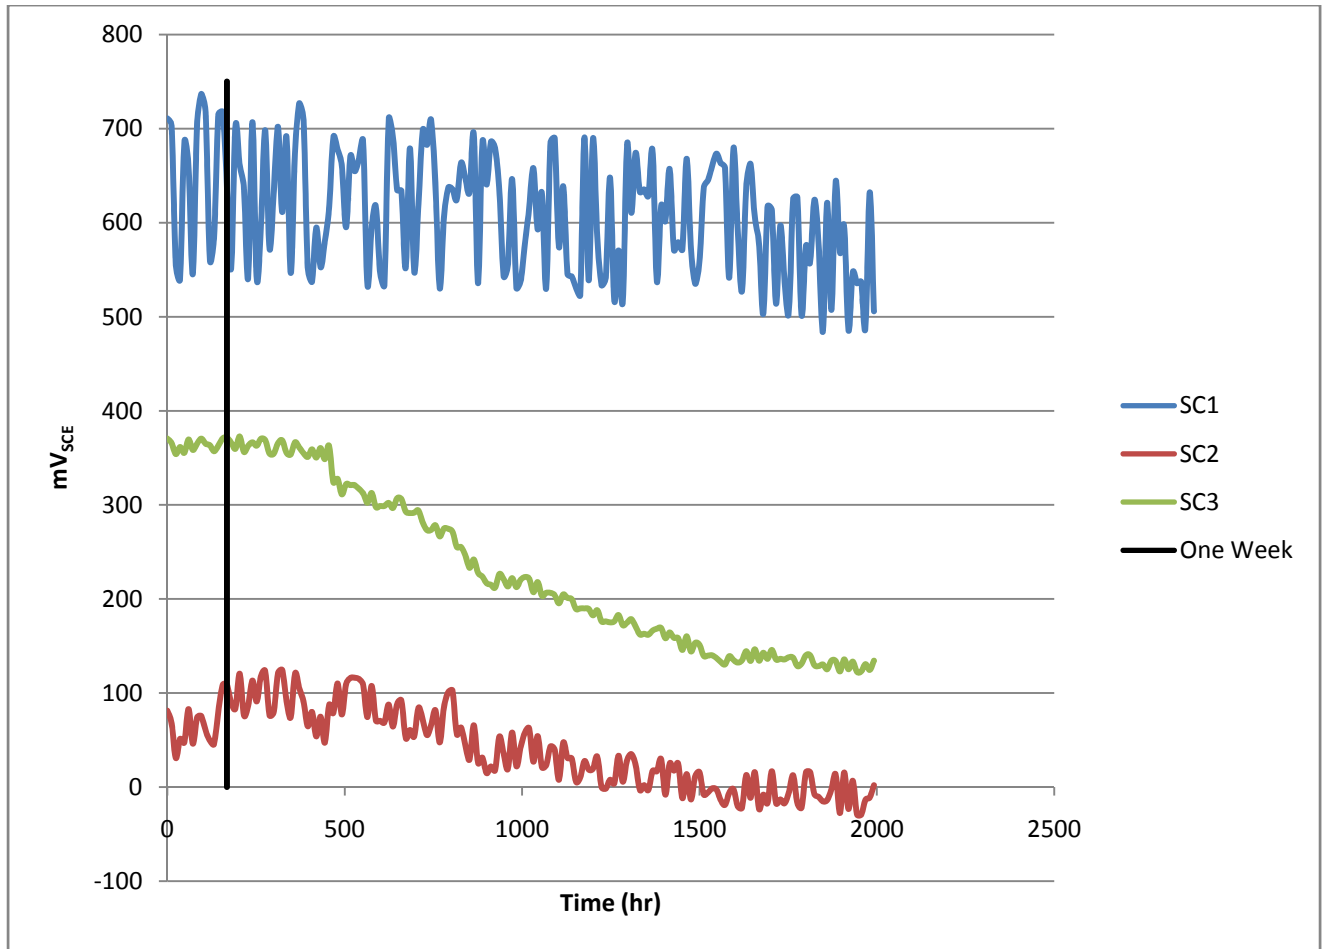
Figure 4.20: Potential vs Time for Stainless Clad Strand

All the specimens showed some sort of scatter with the third specimen (SC3) having the least over time and the most constant plot in the first week. Therefore, SC3 was chosen as the representative specimen with a corrosion potential, $E_{\text{corr}} = -360 \text{ mV}_{\text{SCE}}$. The plot of potential versus time can be seen in Figure 4.20.

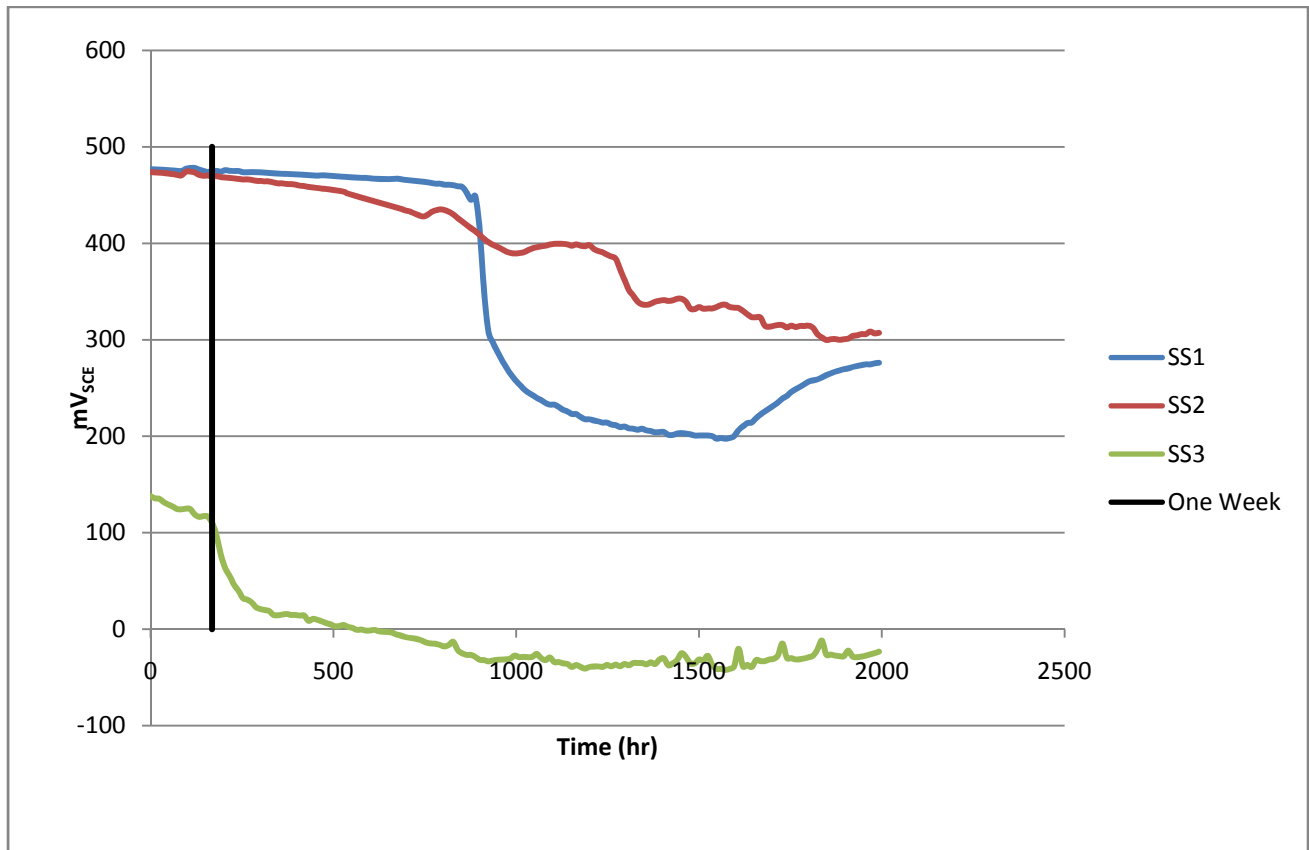
Figure 4.21: Potential vs Time for Stainless Steel Strand

All of the specimens showed smooth lines over time but the third specimen (SS3) was the obvious outlier, so it was removed first. The other two specimens exhibited very similar behavior in the first week but fell off considerably after that over time. Since the second specimen (SS2) showed the least variability over time, it was chosen as the representative specimen. The corrosion potential of SS2 and SS1 are very close; therefore, SS2 will represent the specimen's corrosion potential well. The corrosion potential is $E_{\text{corr}} = -475 \text{ mV}_{\text{SCE}}$. Figure 4.21 shows the potential versus time for the specimens.

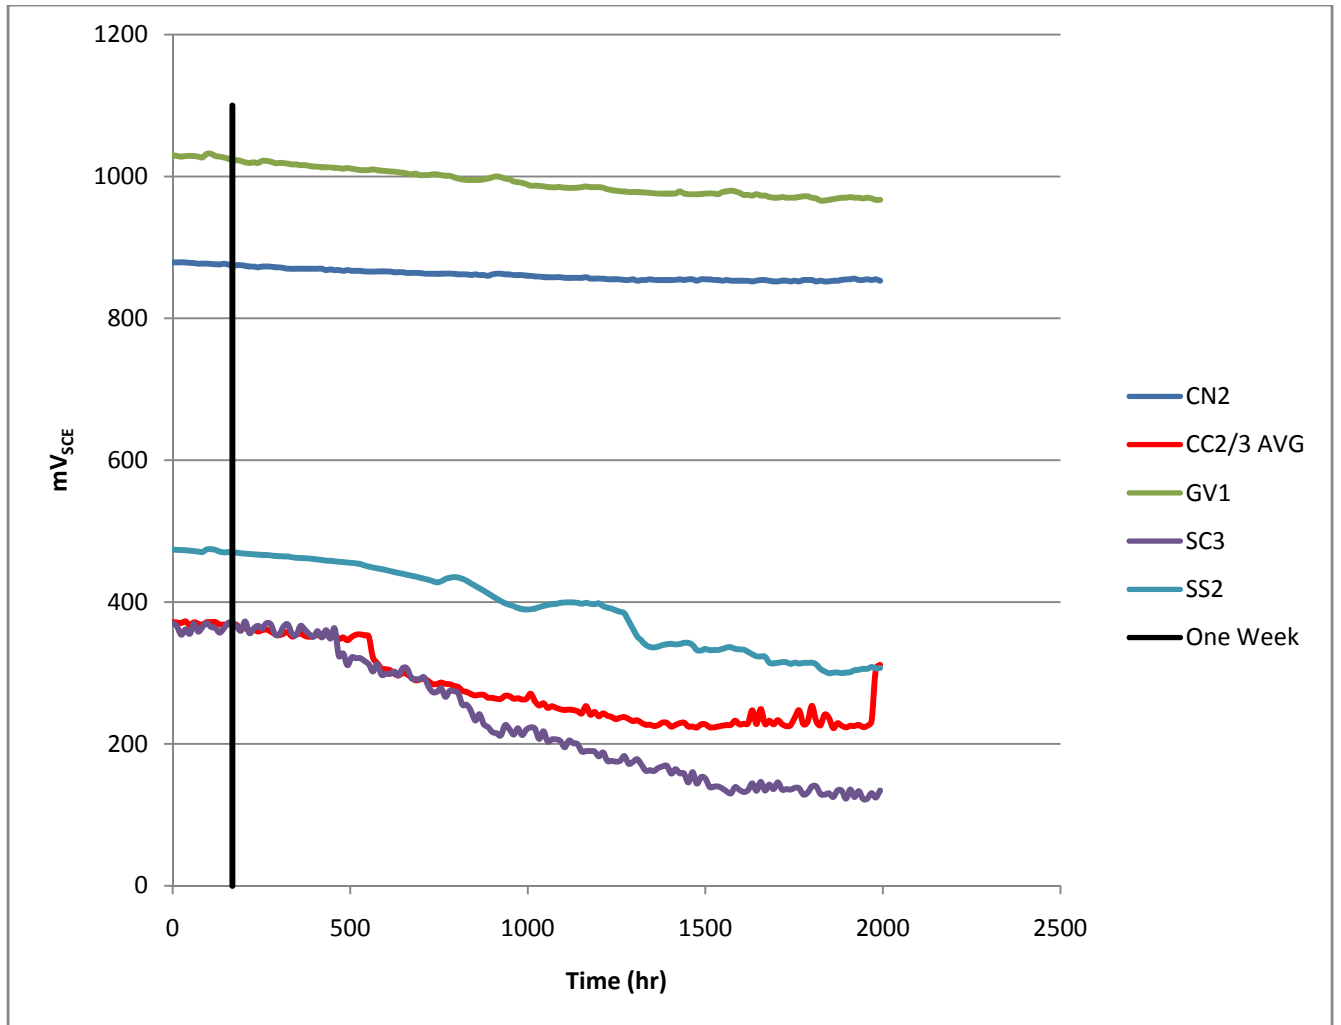
Figure 4.22: Potential vs Time for the Representative Specimens

Despite the specimens having some scatter and variability over time, the first week represented the corrosion potential well for the specimens. A representative specimen was chosen from each strand type to be plotted and compared relative to each other. Note that an average of the second and third copper clad specimens (CC2 and CC3) was used as the representation. Figure 4.22 shows the potential versus time of the representative strands.

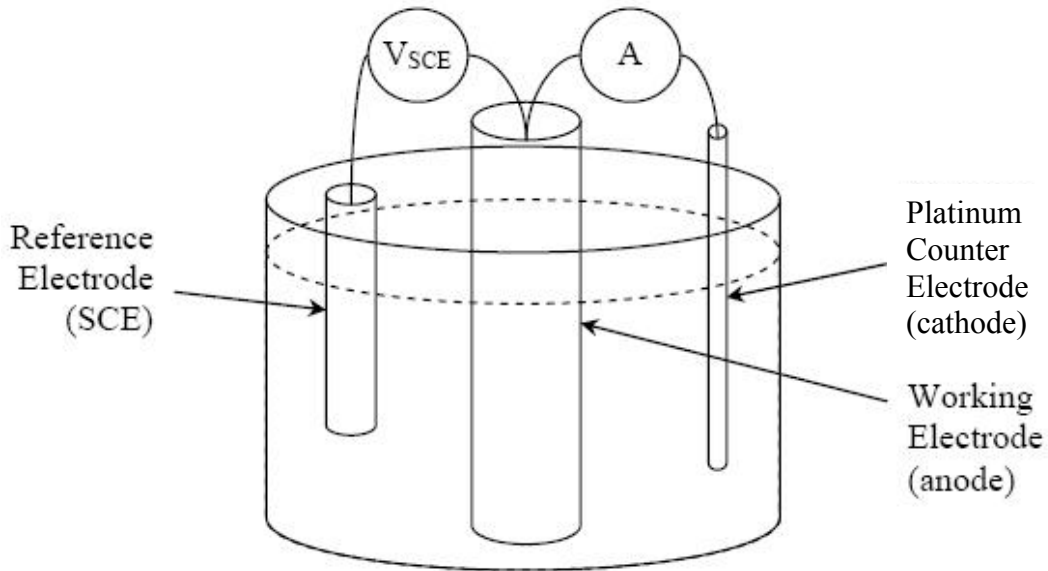
Figure 5.1: Basic Test Setup¹⁴

The half-cell potential (corrosion potential) of the working electrode (strand) can be measured by introducing another electrode into the system. This is known as a reference electrode, and the half-cell potential (corrosion potential) will be measured relative to the known electromotive force potential of the reference electrode. See Figure 5.1 for the system used in testing. The reference electrode chosen is a Saturated Calomel Electrode (SCE) which is a common reference for these tests and is also used in field applications such as Project 4562. Other references are available and can be found in Table 5.2.

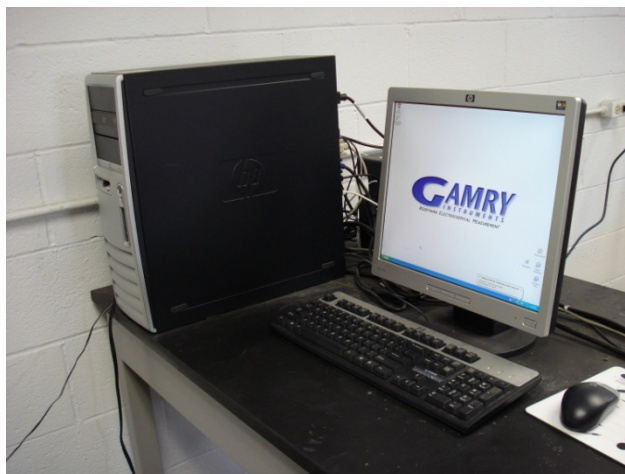
Figure 5.8: Potentiostat Built into Computer

The grout used in the specimens is the same as in Section 3.3.2.1 which is SikaGrout 300PT. The electrolyte used is a 5% chloride solution by weight, stored in a 1000 mL beaker. The specimens are cast and allowed to cure in a fog room for twenty-eight days. After curing, the pipe is removed over the exposed region of grout (See Figure 5.13 below). The specimen is then pre-cracked using the device in Figure 5.7. The exposed region for the 0.5 in. strand is 3.5 in., and for the 0.6 in. strand, the exposed region is 3.2 in. as can be seen in Figure 5.10 in Section 5.6 below. Once cracked, the specimens are ready to be tested. They are placed in the beaker of chloride solution and attached to the equipment. The equipment used was provided and installed by Gamry Electronics and consists of the Series G 750 Potentiostat/Galvanostat/ZRA. The Potentiostat was installed directly inside a computer and can be seen in Figure 5.8.

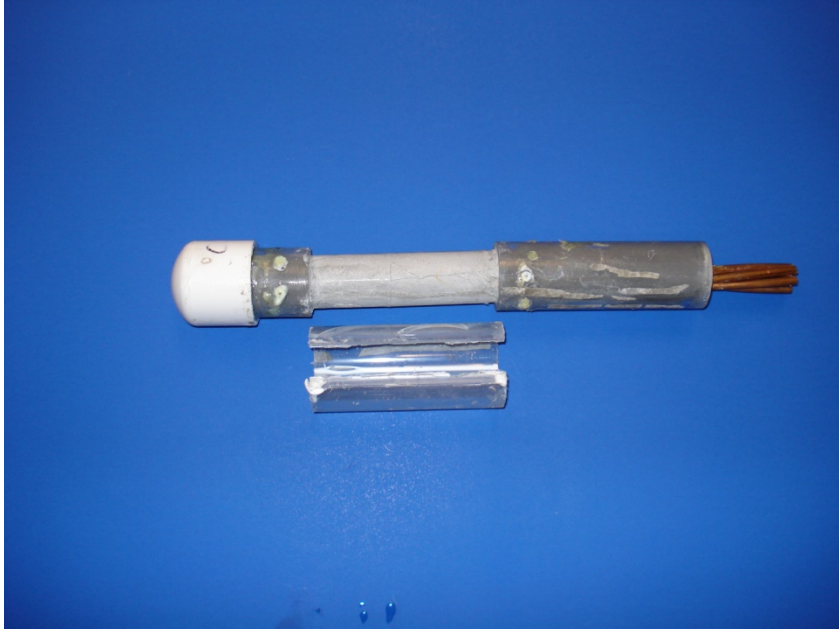
Figure 5.13: Specimen After Removal of Pipe Over Exposed Region

Three strands of each type were chosen for testing. They were cut to a length of twelve in. using the chop saw, and the ends were ground down using the table grinder, both in Figure 3.1. The strands were then cleaned of debris and placed in the pipes through the acrylic grids. The grout used for the specimens was the same as in Section 3.3.2.1 - SikaGrout 300 PT which is a pre-mixed, non-bleed, high-flow grout. The water to cement ratio was chosen as 0.3 to allow for easy flow into the pipes. The grout was mixed using a variable speed mixer with a high-shear blade (See Figure 3.16). A funnel was used to channel the grout into the pipes. The specimens were poured in phases such that six would be tested per day for three days. They were allowed to cure for twenty-eight days in a fog room. Once curing was complete, the pipe over the exposed grout region was removed. Figure 5.13 shows the section after removal of the pipe over the exposed region. The specimens were then placed in the cracking device to be pre-cracked. Then they were put into the electrolyte solution and attached to the testing equipment.
