**Autoclaved Aerated Concrete (AAC) Masonry: Lap-Splice Provisions  
and Nominal Capacity for Interface Shear Transfer between  
Grout and AAC**

**Thesis**

The University of Texas at Austin

**December 2010**

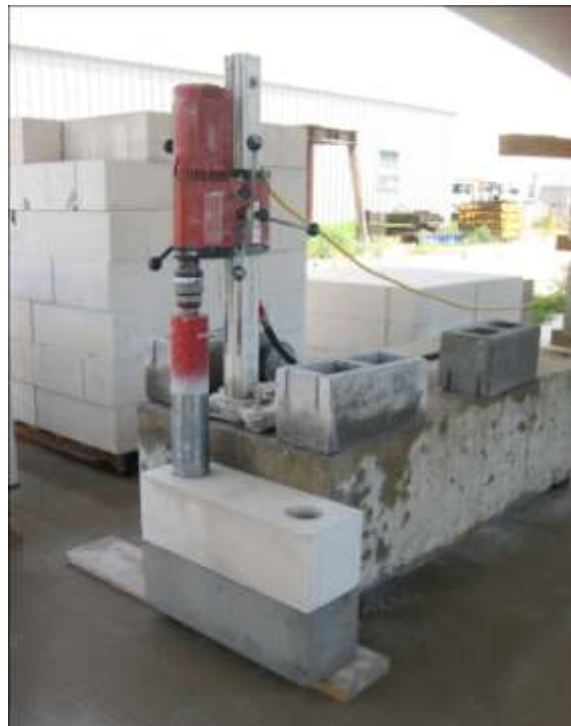
**Figure 3.7 Core drilling of blocks in lap-splice specimens**

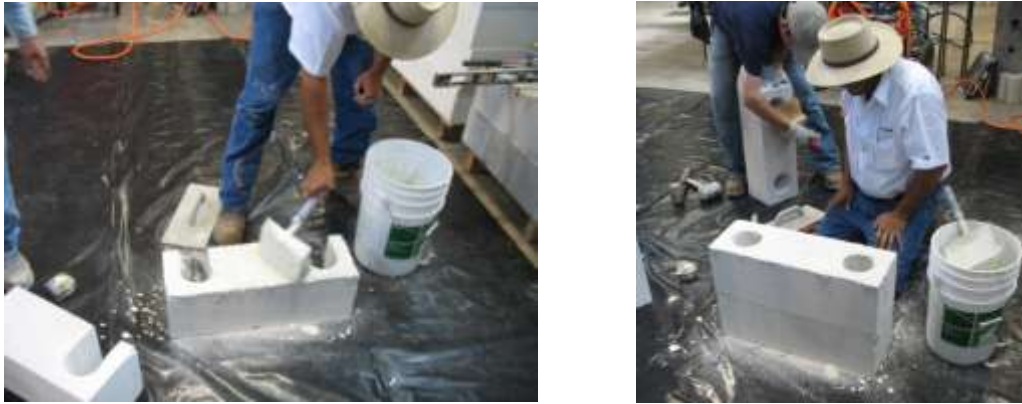
***Figure 3.8 Construction of base-walls***

Six base-walls were constructed using four of the same type of blocks, also placed in stack bond and joined together using thin-bed mortar. These walls were used to support the specimens in an upright position during grouting and curing, providing enough clearance from the floor to accommodate the bars projecting through the bottom of the specimens. Four plywood panels with drilled holes were nailed to the base-walls, two at the top and two at the bottom, to hold the bottom bars in place during construction. The two top boards also served to contain the fresh grout. Those boards were covered with plastic sheathing in the set of specimens with the No. 3 bars to break the bond between the grout and the plywood. For the other two sets of specimens, form oil was applied to these pieces instead, because the plastic sheathing proved to be too slippery.

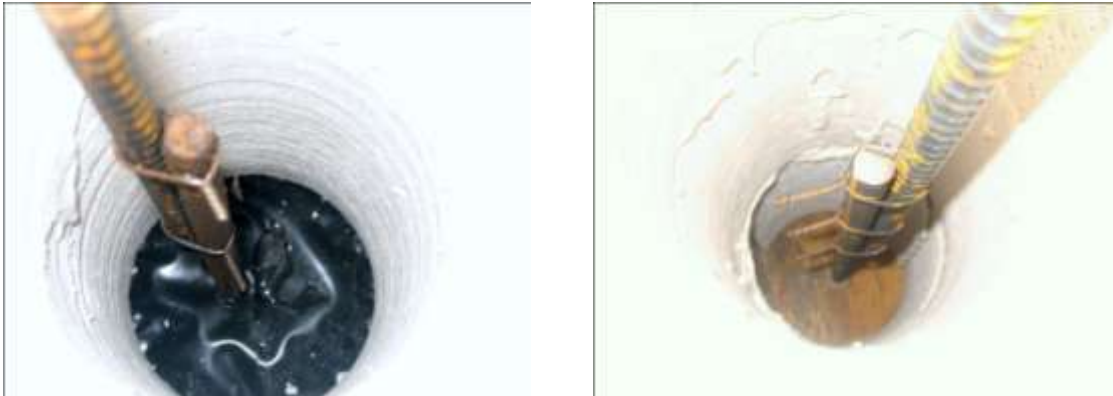
***Figure 3.9 Bars spliced inside a core – No. 3 bars (left) and No. 4 bars (right)***

The day before each specimen was grouted, the splices were inspected and the cores cleaned. In the specimens with No. 4 and No. 5 bars, the cleanouts were closed by applying thin-bed mortar to the top and the sides of the same pieces that had been cut out of the AAC blocks, and putting them back in place, as shown in Figure 3.10. Boards were clamped to the front and back of the bottom course so that the fresh grout would not break the bond between the clean-out pieces and the bottom blocks.

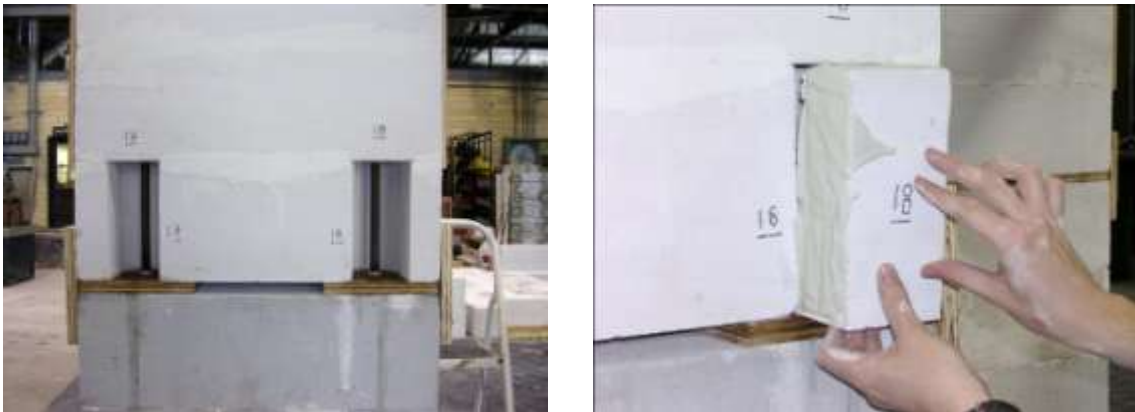
***Figure 3.10 Cleanouts in a lap-splice specimen with No. 5 bars***

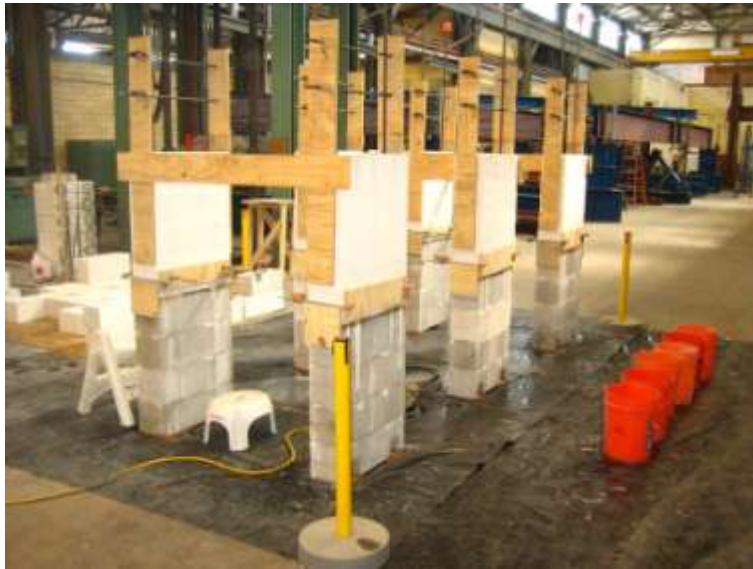
*Figure 3.11 Splice specimens prior to grouting – No. 5 bars*

Figure 3.11 illustrates the typical setup of the specimens prior to grouting. The specimens were wetted thoroughly 24 hours and again 1 hour before grouting. The cores

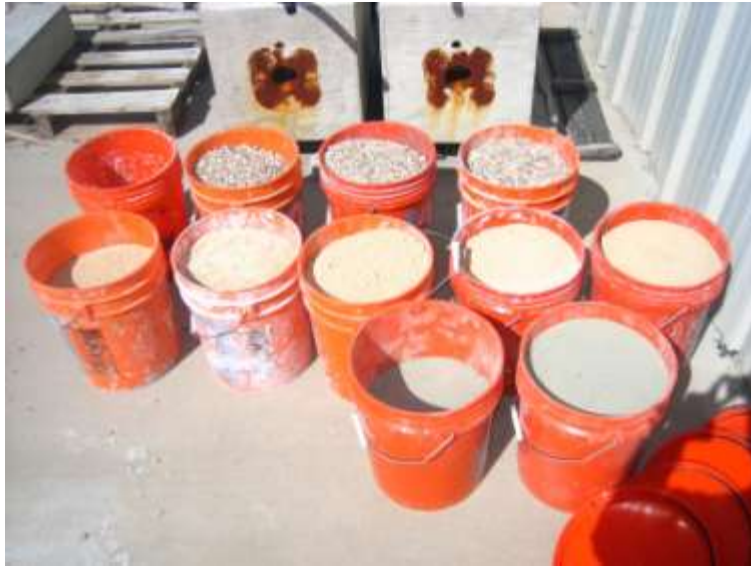
*Figure 3.12 Cement, sand, and pea gravel used to grout the specimens with No. 4 bars*

Figure 3.12 shows the materials that were mixed to grout the splice specimens containing No. 4 bars. Figure 3.13 is a photograph of the mixing of the grout used in the splice specimens containing No. 5 bars. Figure 3.14 shows the initial slump test prior to grouting the splice specimens containing No. 5 bars.

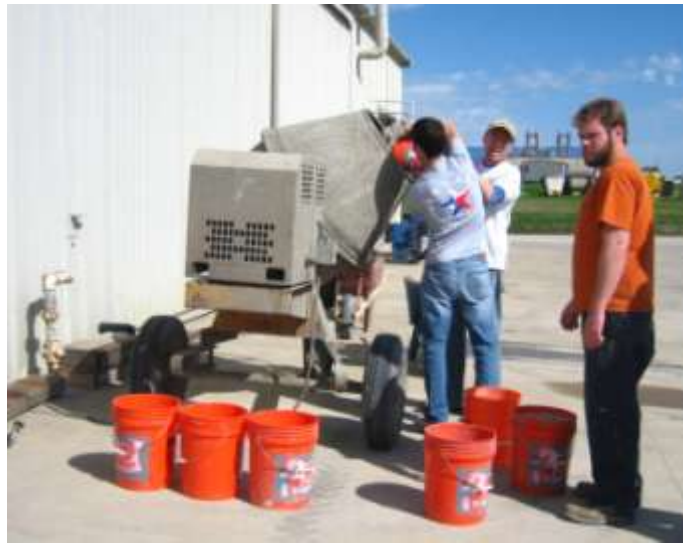
*Figure 3.13 Mixing of the grout used in the splice specimens with No. 5 bars*

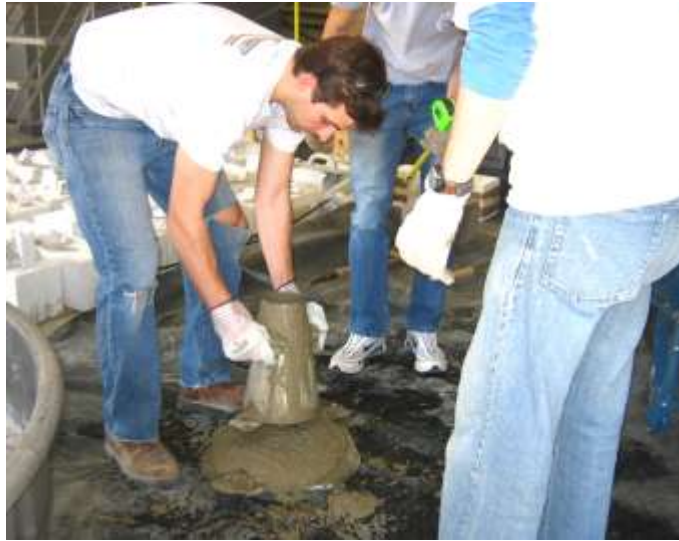
***Figure 3.14 Initial slump test – Grout used in splice specimens with No. 5 bars***

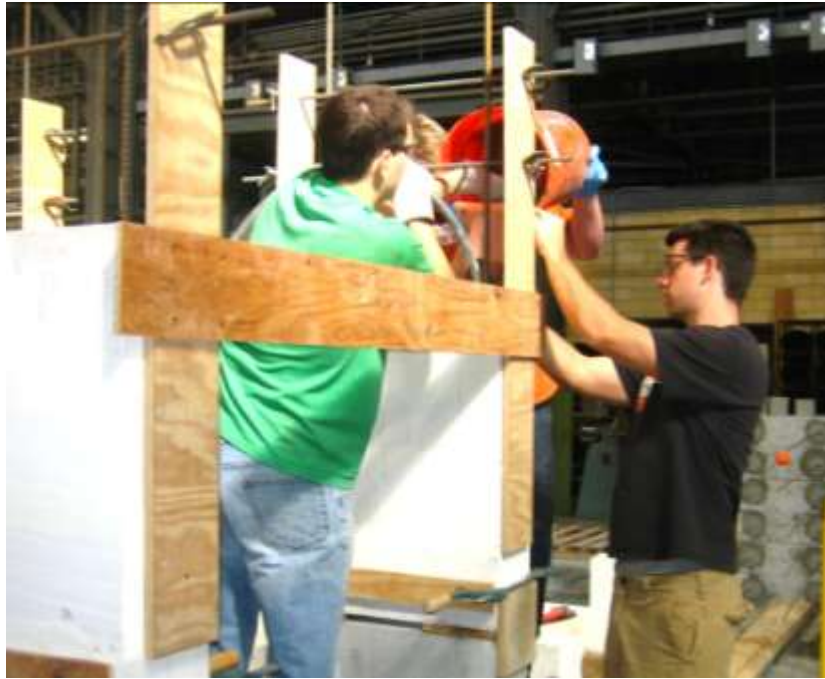
*Figure 3.15 Grouting of lap-splice specimens with No. 5 bars*

Figure 3.15 illustrates the grouting process. A  $\frac{3}{4}$ -in. vibrator was pre-placed in each core, and then the core was filled to the top with grout. The grout was poured through a truncated cone into the cores using 5-gallon buckets. The vibrator was then turned on and extracted in about 10 seconds. After all of the specimens in a set were filled and vibrated, additional grout was poured in each core and the top 2 in. was reconsolidated by puddling with a rod. Finally, the top of each core was leveled with a trowel. The specimens were wetted every other day after grouting, for a week. After removing the side boards and the cross-bars, specimens were lifted from the base-walls with a crane and a scissor-clamp, and were stacked flat one on top of each other on the laboratory floor until testing.

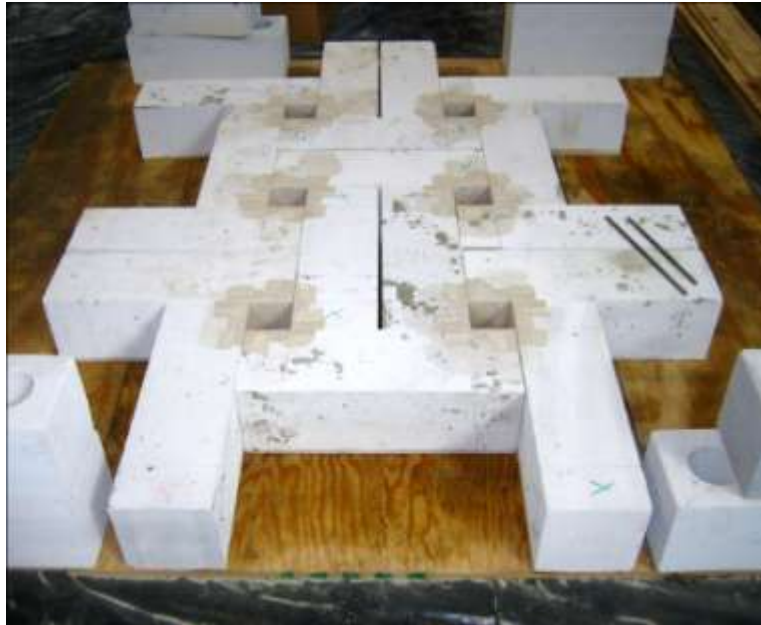
**Figure 3.16 Fabrication of grout prisms**

Samples of the grout and the reinforcing bars were tested. Along with each set of lap-splice specimens, six 4- x 4- x 8-in. grout prisms were fabricated in accordance with ASTM C1019-09 for compressive strength testing (Figure 3.16). AAC blocks were used as molds, with paper towels as permeable liners. The blocks were wetted prior to fabrication, and the prisms were wetted after grouting, exactly the same as the lap-splice specimens. One week after fabrication, the prisms were removed from the molds and stored next to the specimens. Three prisms were tested approximately 28 days after grouting and the other three soon after testing the corresponding lap-splice specimens. Two samples of each bar size were tested by ASTM A370-09a.

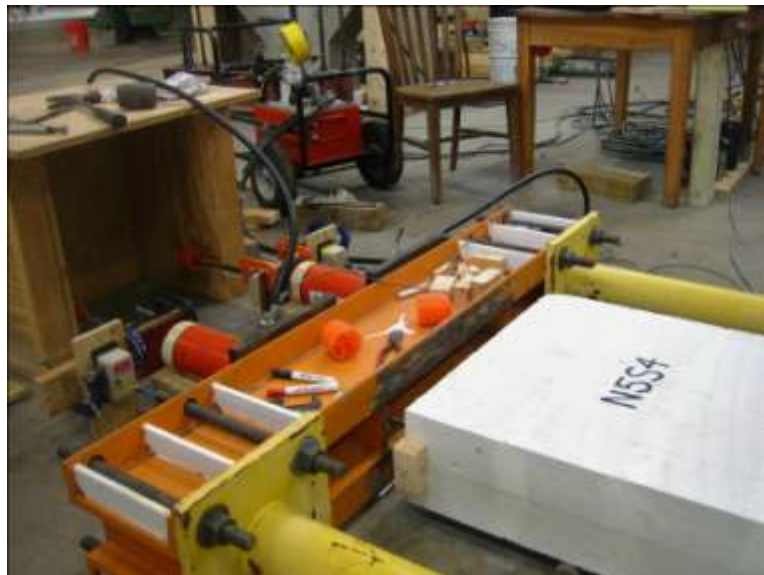
***Figure 3.18 Rams and pressure gauge connected to air-driven hydraulic pump***

Two steel plates with a hole in the center were attached to the outside of the top beam. Two 50-kip load cells and two 30-ton rams with through holes were placed against those plates, supported on wood blocks. The rams and a pressure gauge were connected to an air-driven hydraulic pump. Figure 3.18 shows the top beam, the rams and the pump.

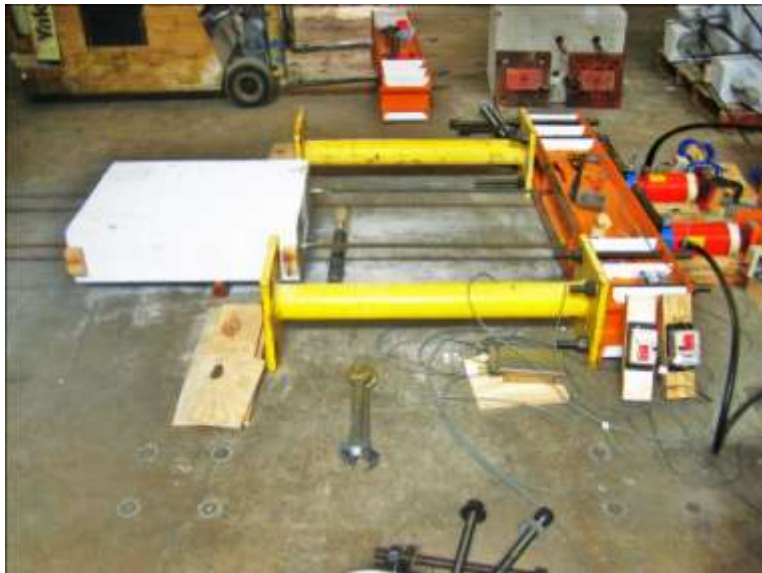
*Figure 3.19 Lap-splice specimen on rollers prior to testing*

Prior to setting each specimen, the bottom beam was removed. The specimen was then placed on top of 1-in. diameter rollers lying on the floor, as shown in Figure 3.19. The specimen was then rolled into the frame while the bars on one end went through the top beam, the steel plates, the load cells, and the rams. The rollers were left underneath the specimen, allowing it to move freely during the test.

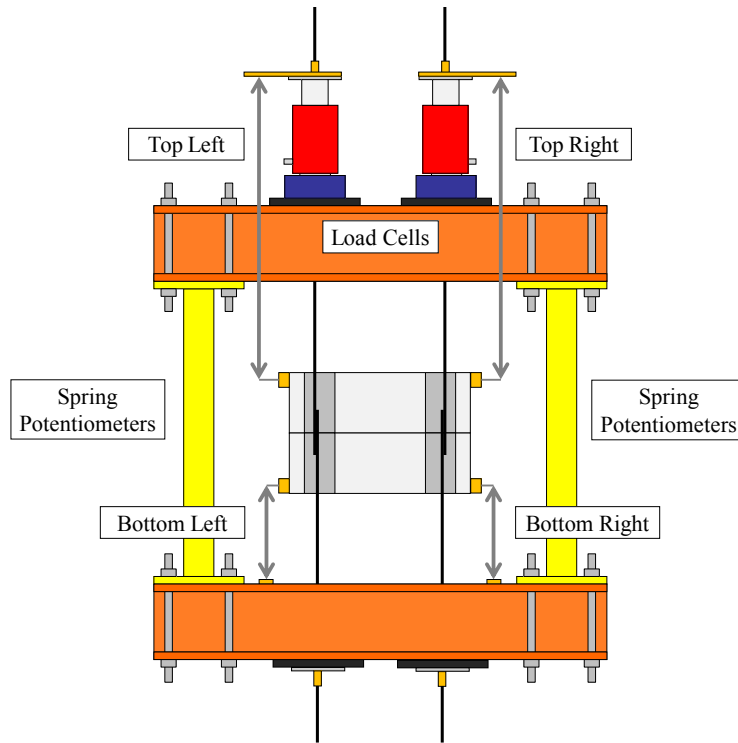
**Figure 3.20 Instrumentation – lap-splice test**

The instrumentation used in the lap-splice tests, illustrated in Figure 3.20, included the two load cells noted in Section 3.7 and four 5-in. string potentiometers. The load cells measured the tensile force applied to the left and the right splices. Two of the string potentiometers measured the displacement of the specimen's bottom end corners with respect to the inside of the bottom beam (referred to as "bottom left" and "bottom right"); and the other two measured the displacement of the plates between the rams and the strand chucks with respect to the corners of the other end of the specimen (referred to as "top left" and "top right"). The six instruments were connected to a data acquisition

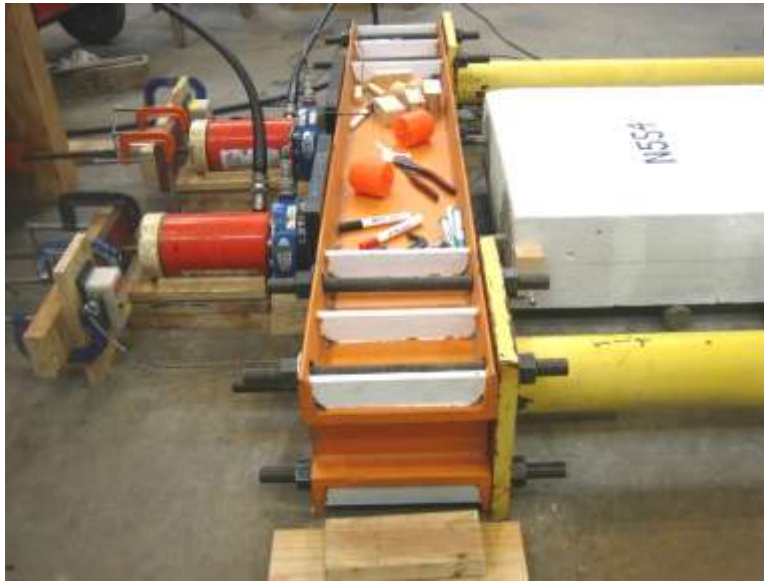
*Figure 3.21 Instrumentation – top end of specimen*

system with a 10-V power supply and recording data in a desktop computer at a rate of one reading per second. Figure 3.21 and Figure 3.22 show the instrumentation in the top and the bottom end of the specimens, respectively.

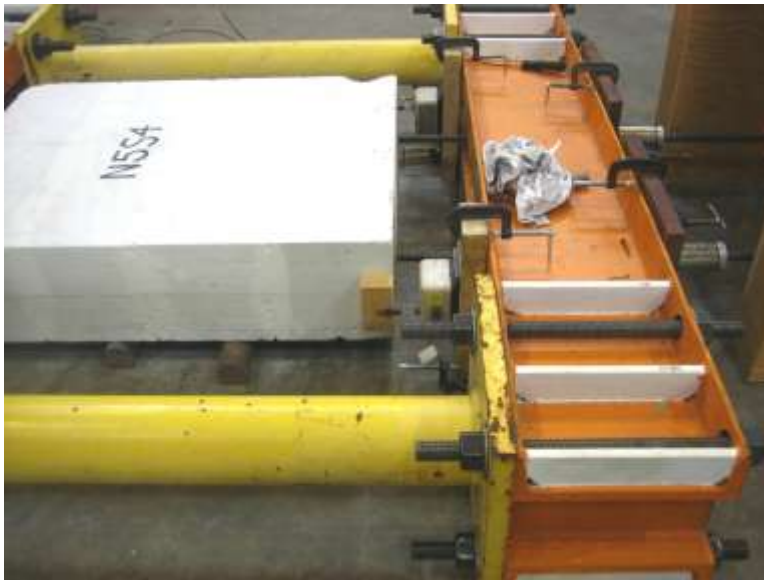
*Figure 3.22 Instrumentation – bottom end of specimen*

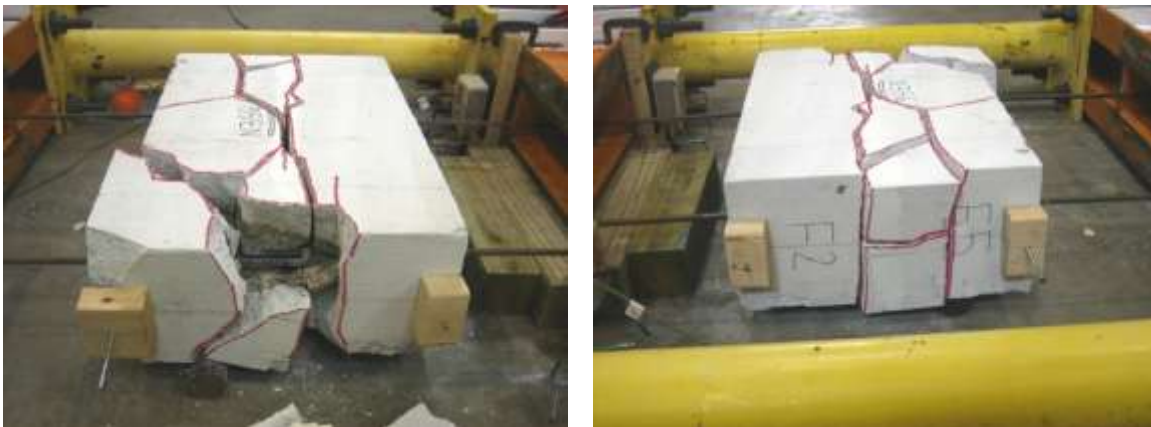
**Figure 3.23 Specimen N3S6 – Left and right splices**

All test specimens failed in the splices themselves, due to splitting of the gout and the AAC blocks. Figure 3.23, Figure 3.24, and Figure 3.25 illustrate typical specimens after testing. A photographic record of the specimens after testing is presented in Appendix A.

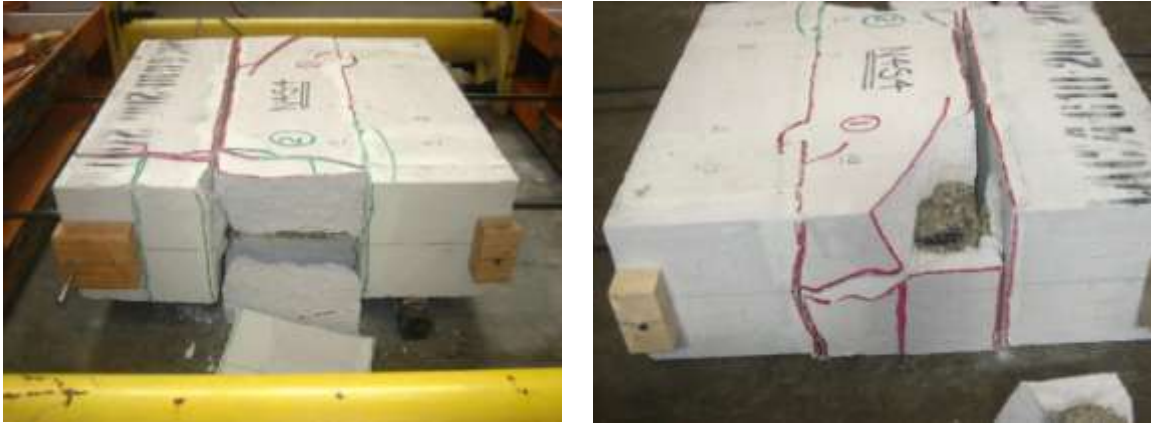
*Figure 3.24 Specimen N4S4 – Left and right splices*

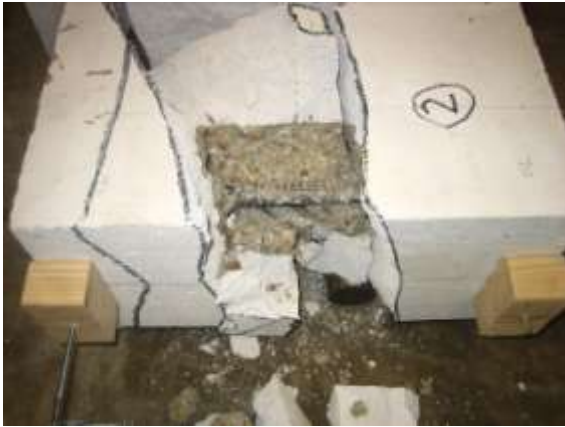
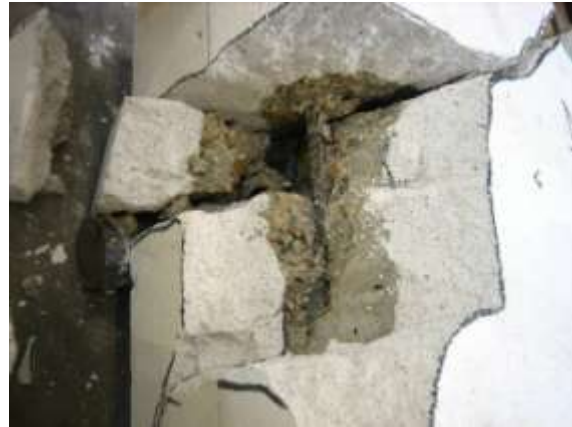
*Figure 3.26 Left splice N3S1 (left) & left splice N3S5 (right)*

Inspection of the specimens after testing confirmed that all failed due to longitudinal splitting of the grout. The pieces of the specimens were set apart and photographed during this inspection as shown in Figure 3.26, Figure 3.27, and Figure 3.28. Evidence of proper consolidation of the grout surrounding the splices was revealed by this inspection, except in the case of the right splice in Specimen N3S4. A void close to the bottom of the core was found (Figure 3.29), which might have been caused by starting to extract the vibrator before turning it on. The overall strength of this splice was the second lowest in its series of specimens. Thus, improper consolidation of the surrounding grout may have reduced the strength of the splice.

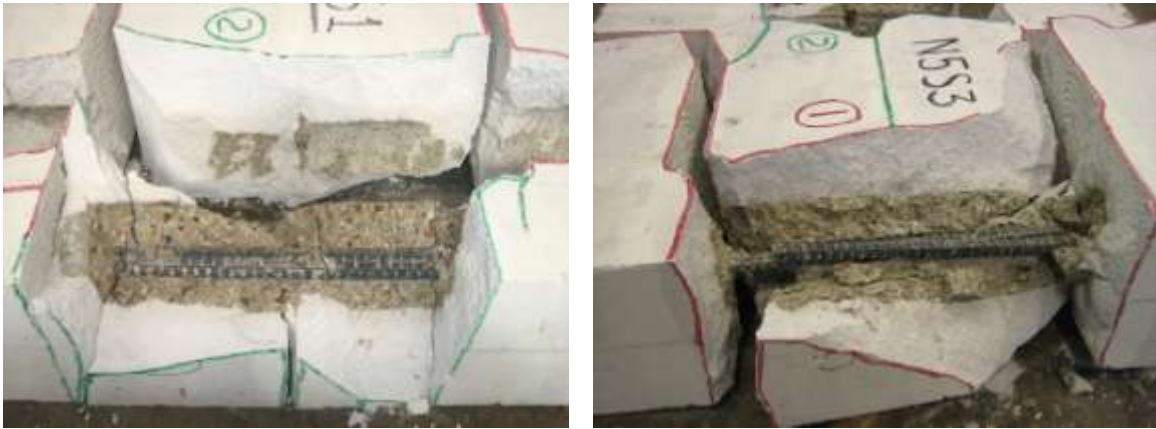
*Figure 3.28 Right splice N5S1 (left) & right splice N5S3 (right)*

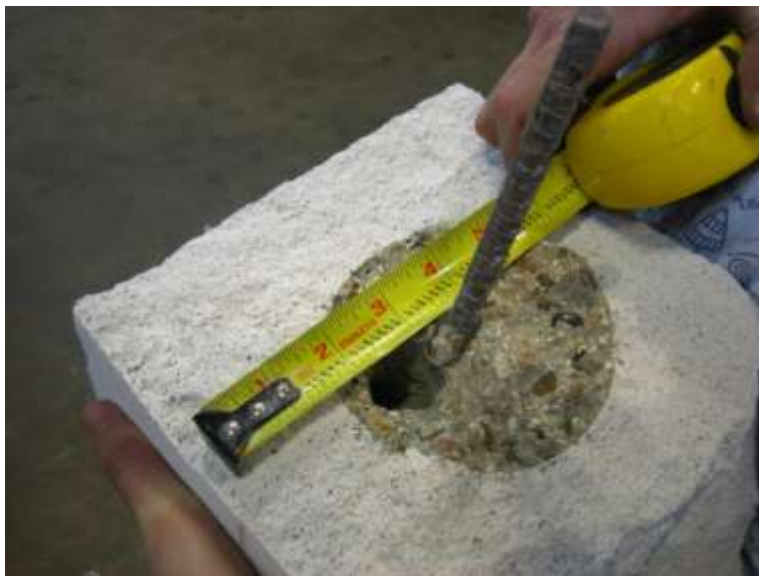
*Figure 3.29 Void in grout surrounding the right splice of Specimen N3S4*

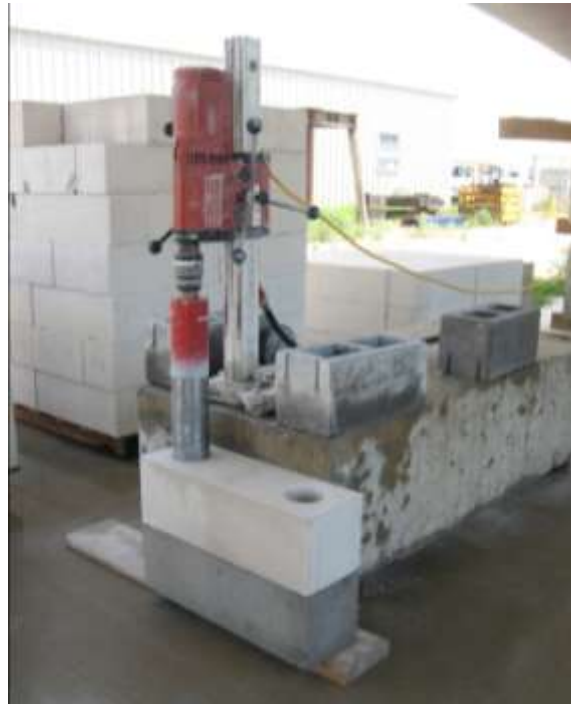
*Figure 4.2 Core drilling of holes in specimens (repeated from Chapter 3)*

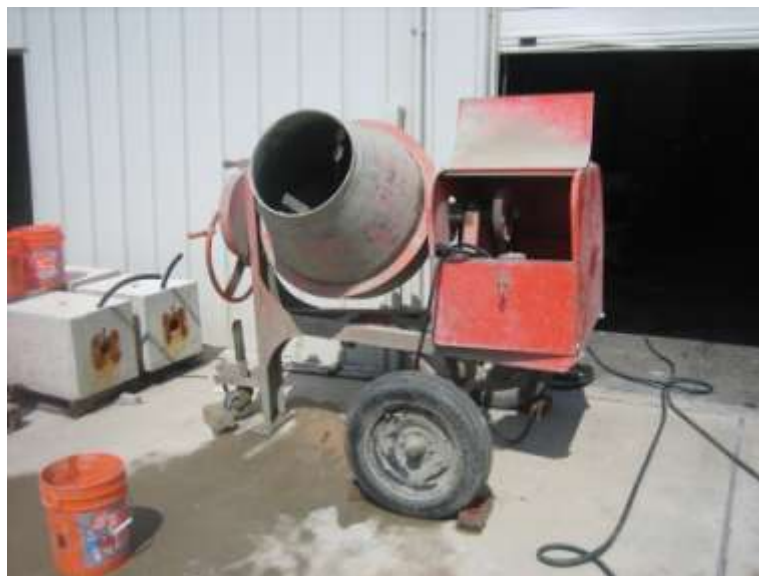
*Figure 4.4 Mixer used to produce the grout*

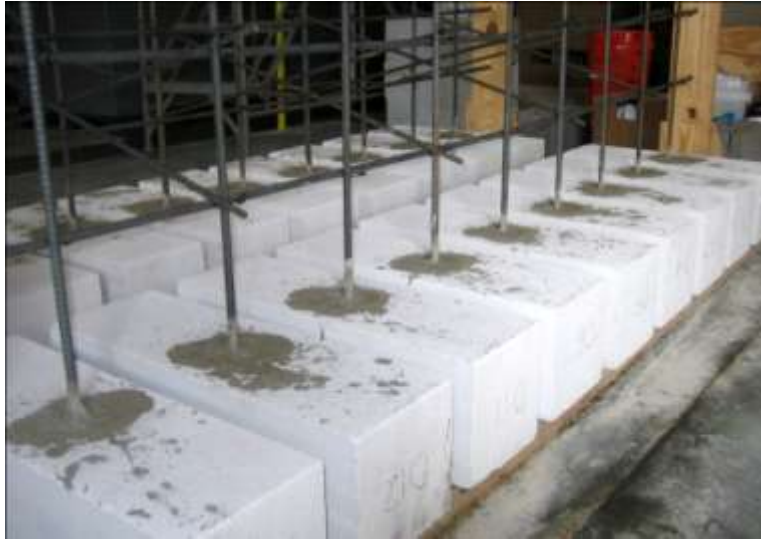
*Figure 4.5 Pullout specimens after grouting*

The grout was poured in the cores in two equal layers using a medium size trowel, and each layer was consolidated by puddling with a rod. After all of the specimens were filled and consolidated, additional grout was poured in each core and the top 2-in. was reconsolidated. Finally, the top of each core was leveled with a trowel. Figure 4.5 shows the specimens after grouting. The specimens were wetted every other day after grouting, for a week, and left in place until testing.

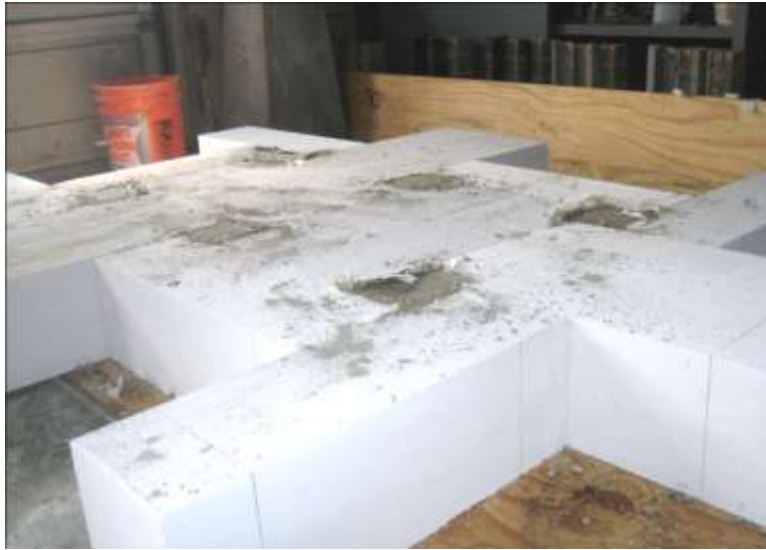
*Figure 4.6 Fabrication of grout prisms*

Samples of the grout and the reinforcing bars were tested. Along with the specimens, six 4- x 4- x 8-in. grout prisms were fabricated in accordance with ASTM C1019-09 for compressive strength testing (Figure 4.6). AAC blocks were used as molds, with paper towels as permeable liners. The blocks were wetted prior to fabrication, and the prisms were wetted after grouting, exactly the same as the pullout specimens. One week after fabrication, the prisms were removed from the fabrication setup and stored next to the specimens. Three prisms were tested approximately 28 days after grouting and the other three soon after testing the pullout specimens. Two samples of the reinforcing bars were tested by ASTM A370-09a.

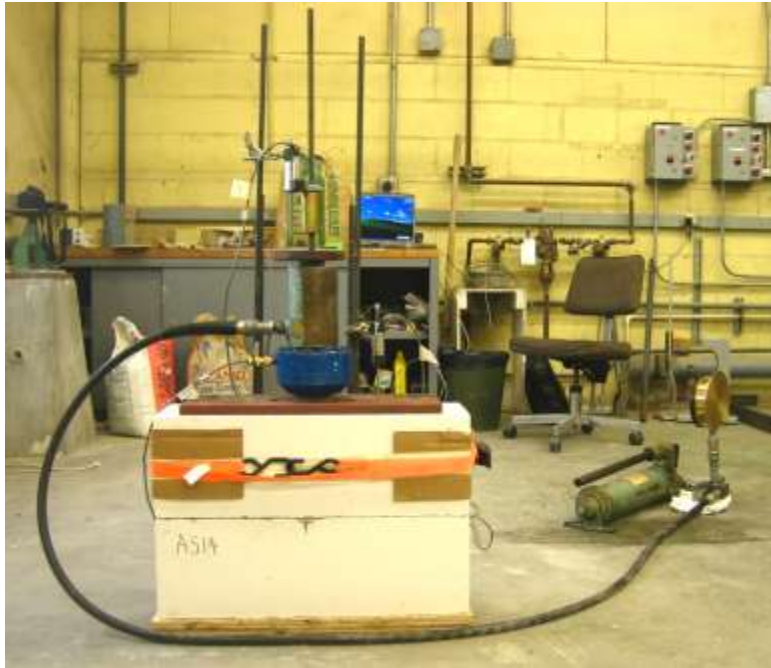
*Figure 4.7 Photograph of pullout test setup*

A second block with a 3-in. core, similar to the ones used for the test specimens, was placed on top. The bottom edge of the core of the top block was chamfered to avoid contact between the top block and the grouted core during the test. A steel plate with a hole in the center was placed over the top block. A 25-kip load cell and a ram with through holes were placed on top. The ram was connected to a pressure gauge and a hydraulic hand pump. A small steel plate with a hole was introduced over the top and placed against the ram. Finally, a ½-in. strand chuck was placed about 2 in. over the plate.

The instrumentation used in the pullout tests, shown in Figure 4.7 and Figure 4.8, included the load cell noted in Section 4.6 and two 2-in. linear potentiometers. The load cell measured the tensile force applied to the reinforcing bar. One of the linear potentiometers measured the displacement of the steel plate bearing on the top block, and the other one the displacement of the plate bearing on the ram, both with respect to the floor. The relative displacement between the plates was calculated using the difference between their readings. The three instruments were connected to a data acquisition system with a 10-V power supply and recording data in a laptop computer at a rate of one reading per second.

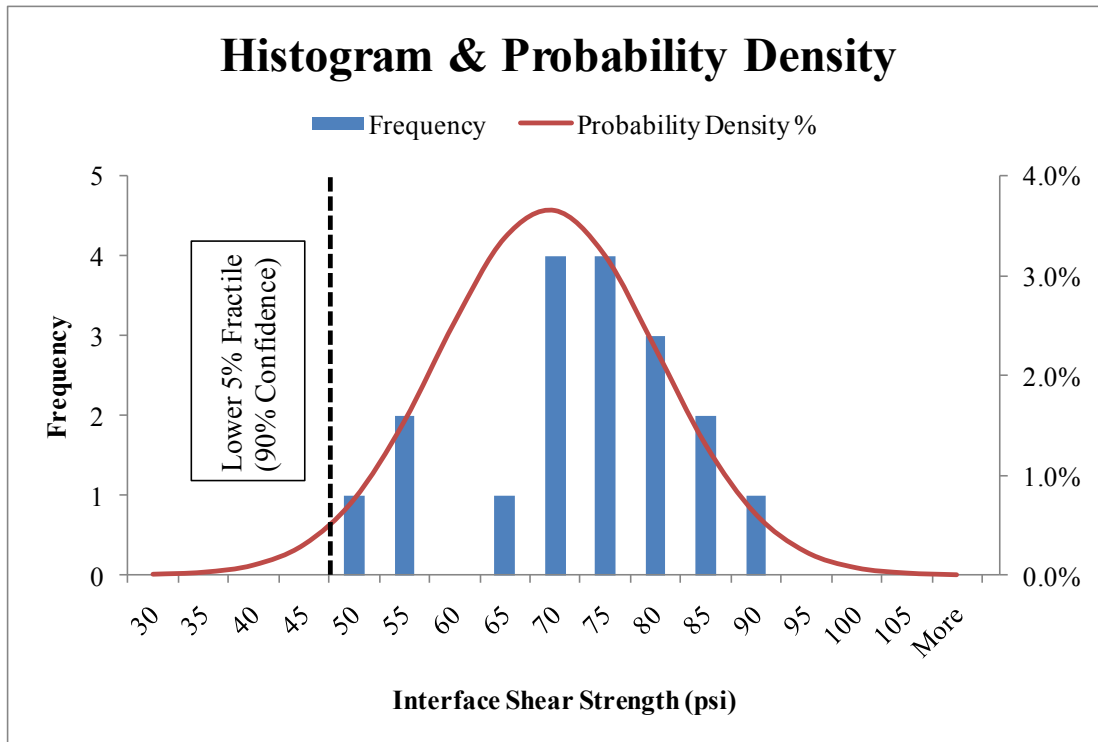
**Figure 4.9 Histogram and probability density of the pullout test results**

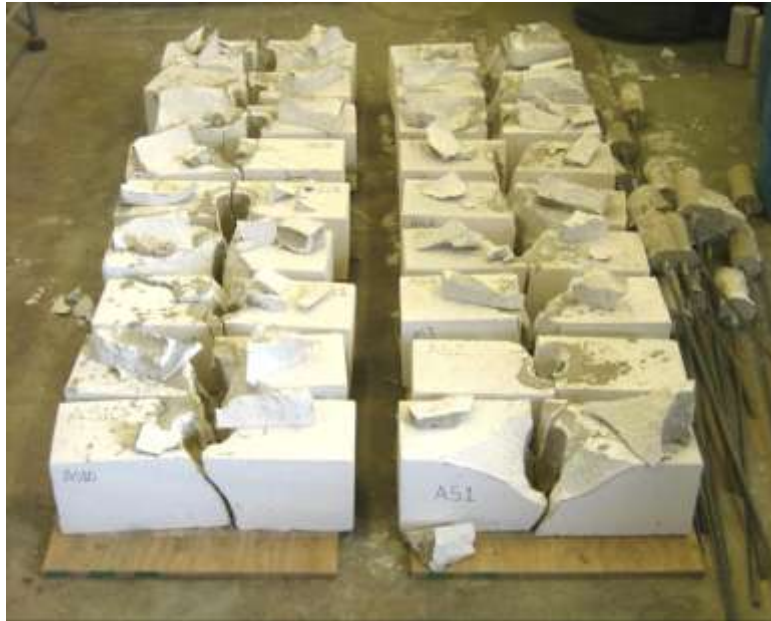
*Figure 4.12 Blocks – AS1 through AS9 (right) & AS10 through AS18 (left)*

Inspection of the specimens after testing revealed that none of them failed due to longitudinal splitting of the grout. The blocks of AAC split at the end of the test, yet the grout core remained bonded to the reinforcing bars, covered in part by patches of AAC. Stains of grout were also observed on the inner surfaces of the cores of the AAC. Based on these observations, it can be concluded that the strength of the specimens was controlled by a combination of bond failure between the grout and the AAC, and material failure in the AAC surrounding the core.

Predominance of one type of failure was inferred by the extent of the patches of AAC covering the grout core and of the stains of grout on the AAC. Bond failure was predominant where the extent of the patches was lesser, while the extent of the stains was greater. Such is the case with Specimens AS3, AS15, AS16, and AS17. Material failure was predominant where the “patches” was greater, while the extent of the “stains” was lesser. Such is the case with Specimens AS1, AS4, AS8, and AS13. The specimens in which material failure was predominant failed at higher loads than the ones in which bond failure was predominant.

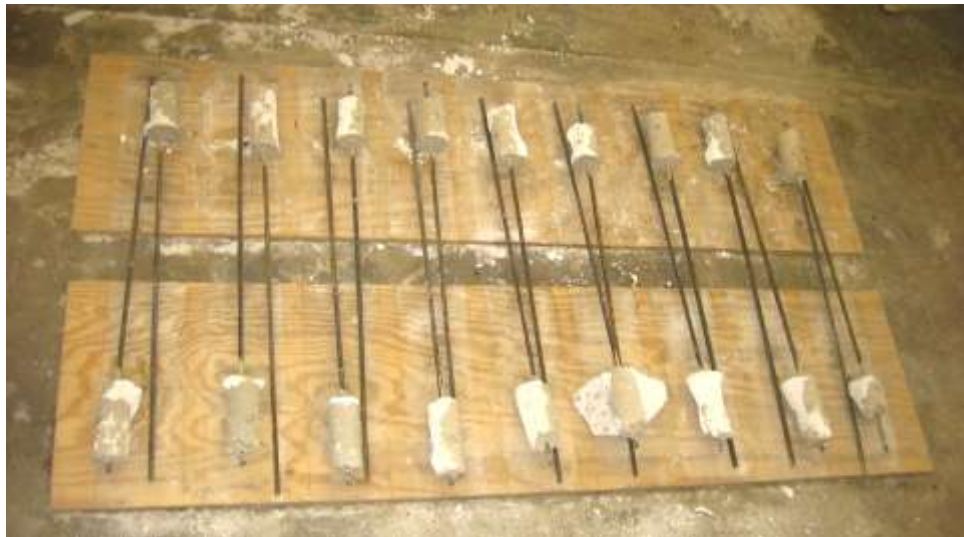
*Figure 4.13 Grout cores – AS1 through AS9 (top) & AS10 through AS18 (bottom)*

Specimens AS4 and AS10 failed differently from the rest of the specimens. The grout core split transversely close to the bottom third of the core; the top part remained bonded to the bar, while the bottom part remained bonded to the AAC block. In these two specimens, the pullout strength was limited by the strength of the grout in direct tension and the bond between the bottom end of the reinforcing bar and the grout.

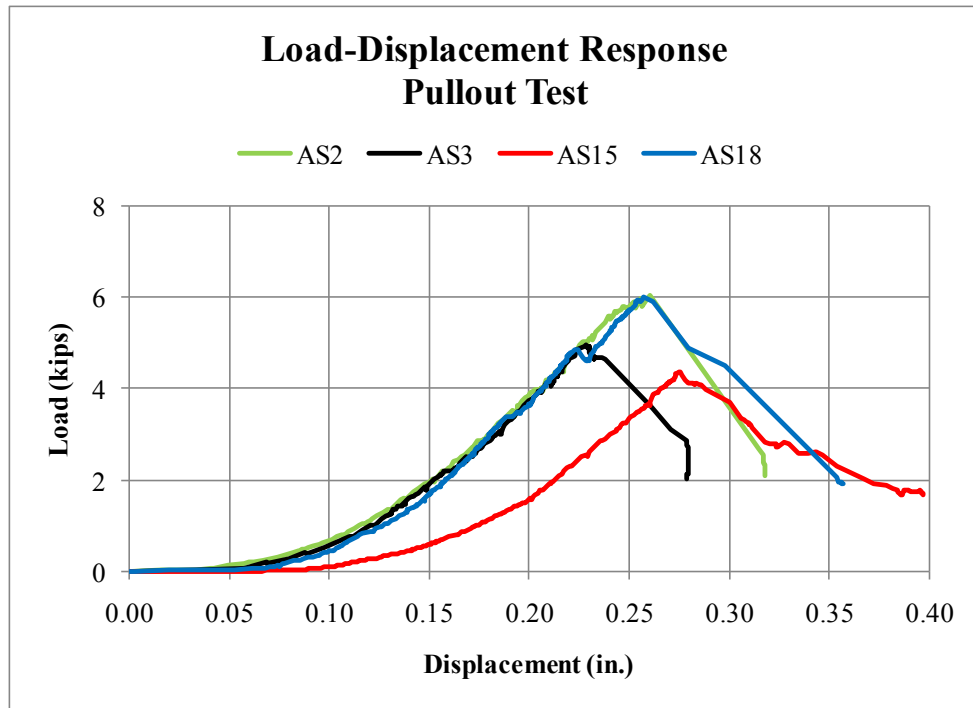
**Figure 4.14** Load-displacement response – Specimens AS2, AS3, AS15 and AS18

The load-displacement response of four specimens during the pullout test is shown in Figure 4.14. This figure is representative of the response of all of the specimens. It shows no evidence of slip between the bar and the grout, or between the grout core and the block. It also confirms that the reinforcing bars did not yield. The load-displacement responses of all specimens during the test are presented in Appendix B.

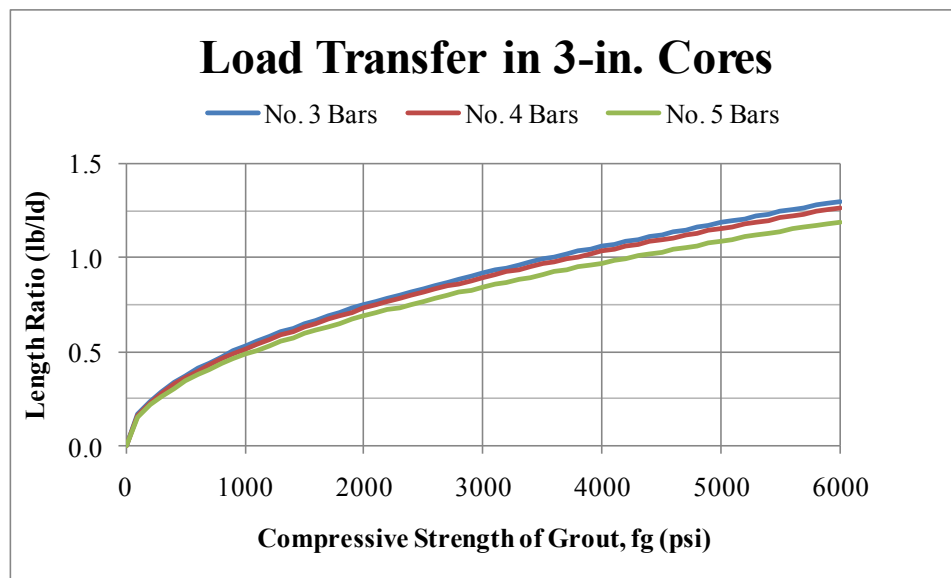
**Figure 4.15 Length ratio for reinforcing bars in 3-in. cores**

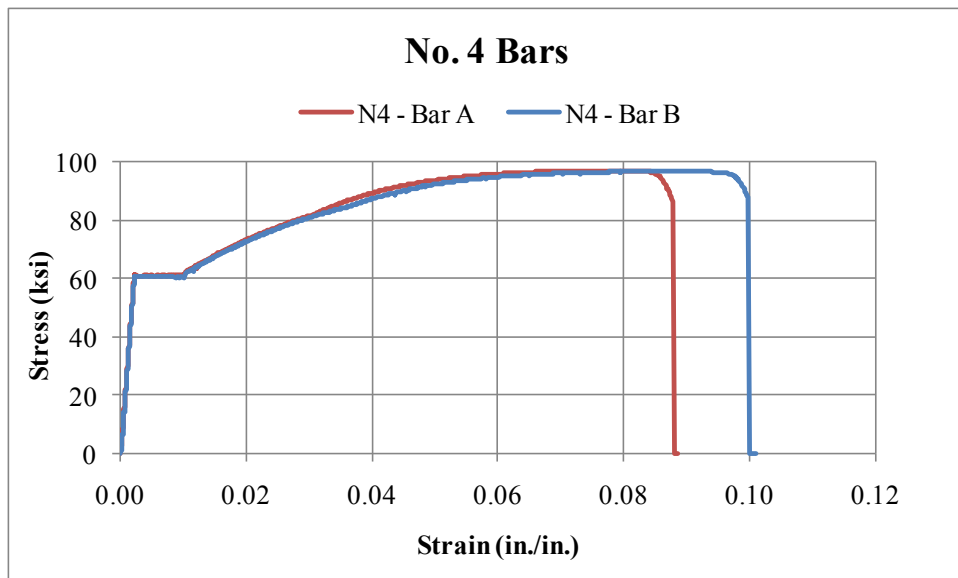
*Figure C.2 Stress-strain curve – No. 4 bars*
