**Factors Affecting Bond in Multi-Strand Post-Tensioning Tendons  
Including the Effect of Emulsifiable Oils**

**Thesis**

**The University of Texas at Austin**

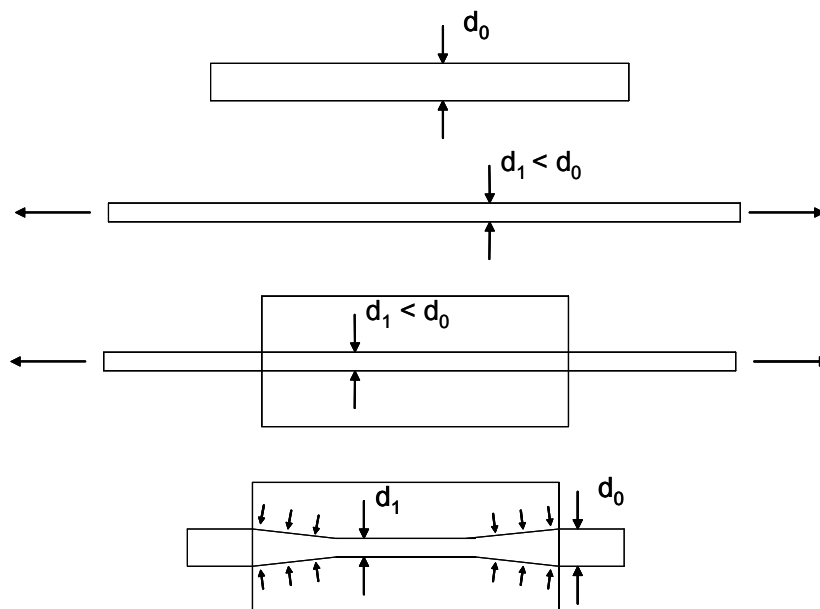
**Figure 2-1 Hoyer Effect**

not equal the compressive strain in the concrete at the same point. Adhesion therefore cannot contribute to transfer bond, since slip has occurred in this region. Both friction and mechanical interlock play important roles in the development of transfer bond. When a strand is stressed, its diameter decreases according to Poisson's ratio. After the concrete cast around the strand hardens, the external restraint on the strand is released, and the stress at the ends of the strand returns to zero. The strand near the ends then attempts to return to its initial diameter, exerting a radial pressure against the hardened concrete that in turn creates a clamping force on the strand. (Collins and Mitchell, 1997) This clamping force or pressure creates a corresponding frictional resistance to slip. Figure 2-1 provides a pictorial representation of this action, often called the Hoyer effect. Mechanical resistance also occurs as slippage in the transfer zone changes the pitch of the strand, and the helical shape of the prestressing strand develops resistance against its impression in the concrete. (Janney, 1954; Hanson and Kaar, 1959)

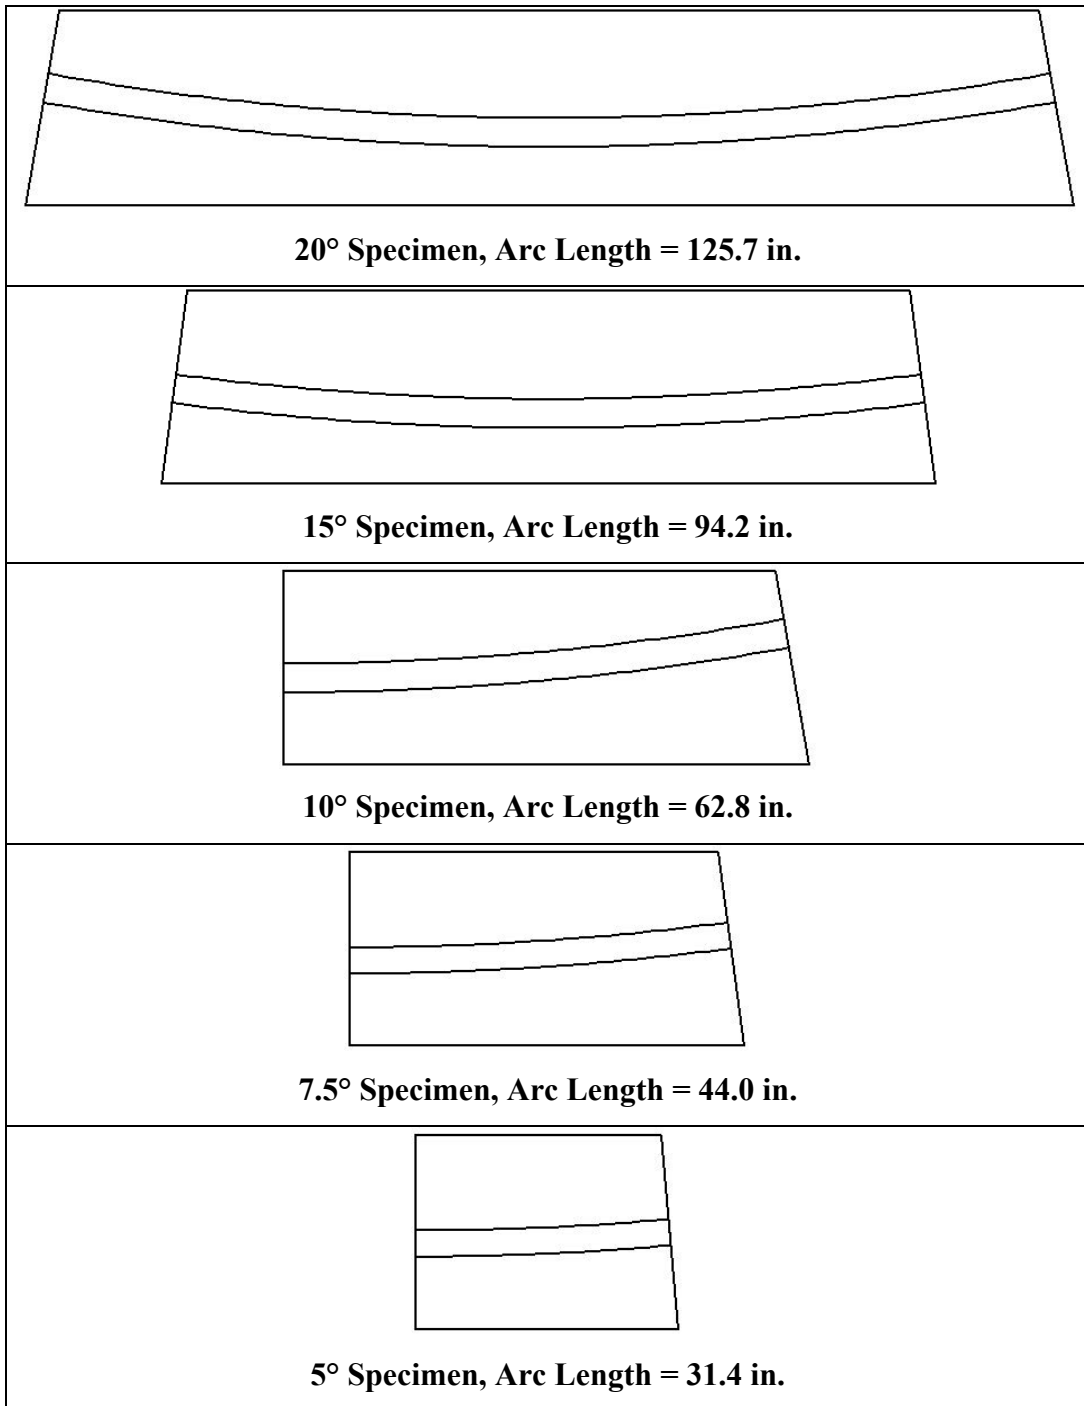
*Figure 3-1 Specimen Profiles*

All specimens were 24 in. square in cross-section, and each end was constructed perpendicular to the tangent of the duct. In the 15° and 20° specimens, both ends of the specimen were inclined in order to preserve a 2 ft. by 2 ft. cross-section. In these cases, the tendon angle change was equally distributed between the two ends; that is, the tendon profile was symmetrical

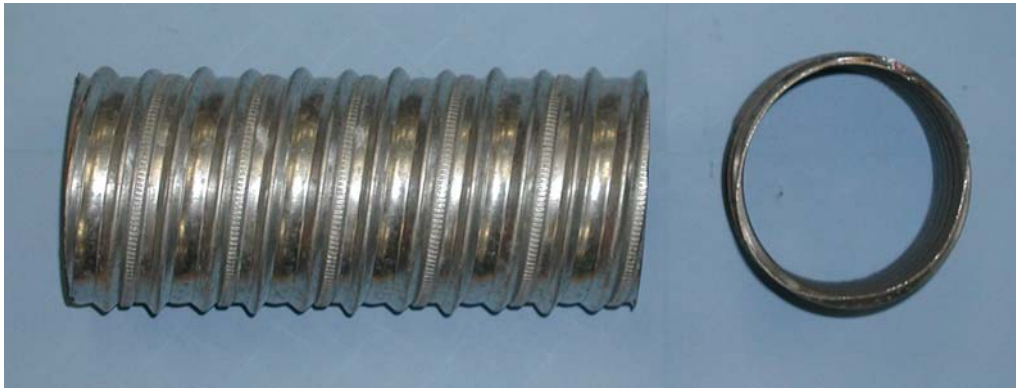
*Figure 3-2 Galvanized Steel Duct*

Three types of duct were tested in this program: industry standard galvanized metal duct, industry standard HDPE duct, and galvanized steel pipe. Each duct had a nominal diameter of 3 in. The galvanized metal duct had an inner diameter of 2.92 in. and an outer diameter of 3.20 in. The industry standard HDPE duct had an inner diameter of 2.92 in. and an outer diameter of 3.18 in. The outer diameter of the ribs was 3.55 in. The galvanized steel pipes consisted of Schedule 40 steel pipe bent to the appropriate centerline radius and galvanized by hot-dipping. The inner diameter of the final product was 3.06 in. and the outer diameter was 3.53 in. Both the inner and outer surfaces of the pipe were smooth and free of deformations induced by the bending process. Figure 3-2, Figure 3-3, and Figure 3-4 show the galvanized metal duct, HDPE duct, and galvanized steel pipe, respectively.

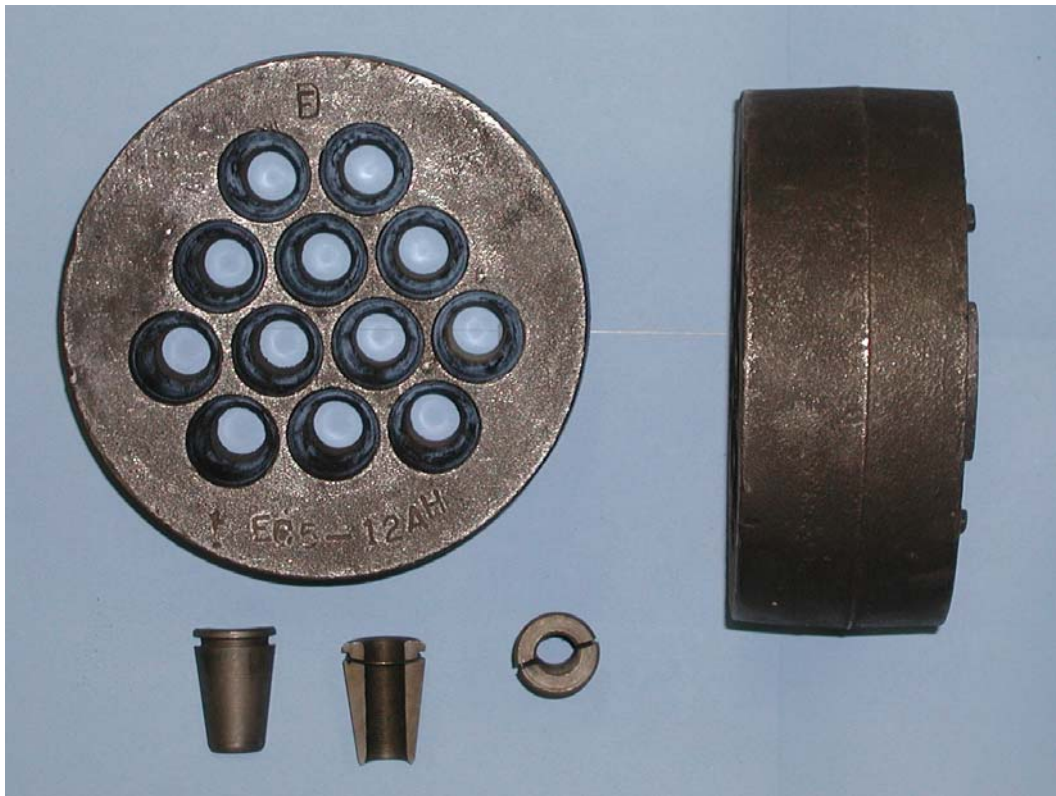
*Figure 3-5 Post-Tensioning Anchor Head and Wedges*

Standard 12-strand anchor heads and the appropriate wedges were purchased from a post-tensioning supplier. Each anchor head was reused multiple times. However, new wedges were used for each pullout test. Figure 3-5 shows a sample of the anchor head and wedges used in the testing program.

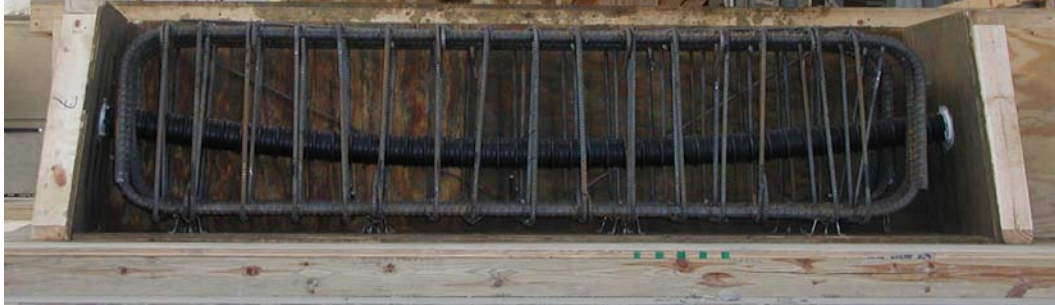
*Figure 3-8 Assembled Specimen Cage, Duct, and Formwork*

Between two and six specimens were cast concurrently to speed the testing process. After the reinforcing cage was placed in the forms, the duct was installed. The duct protruded through the end wall of the form and was sealed with duct tape to prevent debris from entering the duct during the placement of concrete. Care was taken to align the duct vertically and horizontally by tying it to the reinforcing cage with wire. Figure 3-8 shows a 15° tendon angle change specimen with HDPE duct prior to placing the last form wall.

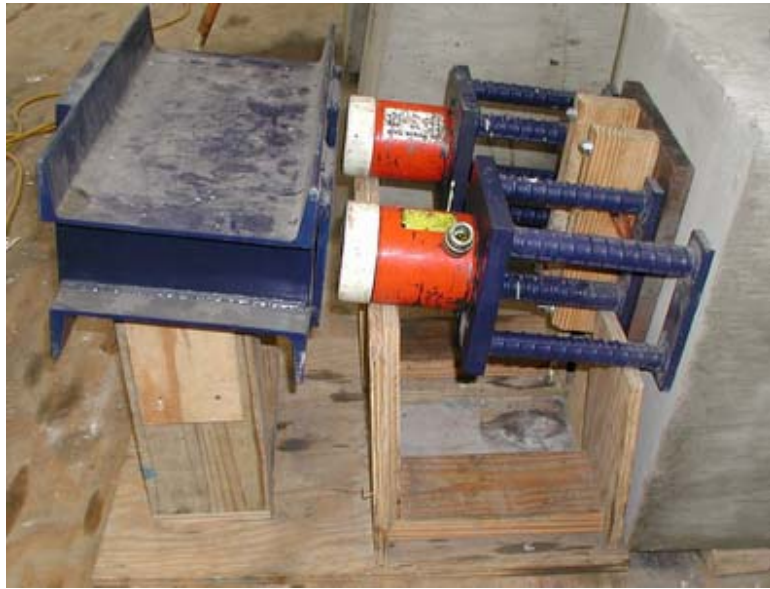
*Figure 3-10 Prestressing Equipment on Supports*

After placing the tension ring bearing plate, a hydraulic ram and chair were placed on either side of the duct in front of a beam upon which the anchor head beared. This equipment was used in the prestressing operation detailed in Section 3.5.2, and was held in place by timber supports which were customized depending on the angle of the face and the elevation of the duct. Figure 3-10 shows the prestressing equipment in place on the supports for the inclined end of a specimen with  $7.5^\circ$  of tendon deviation. Figure 3-11 shows the tension ring bearing plate and 2x4 frame in place on the same specimen. At this point the specimen is ready for installation of the tendon.

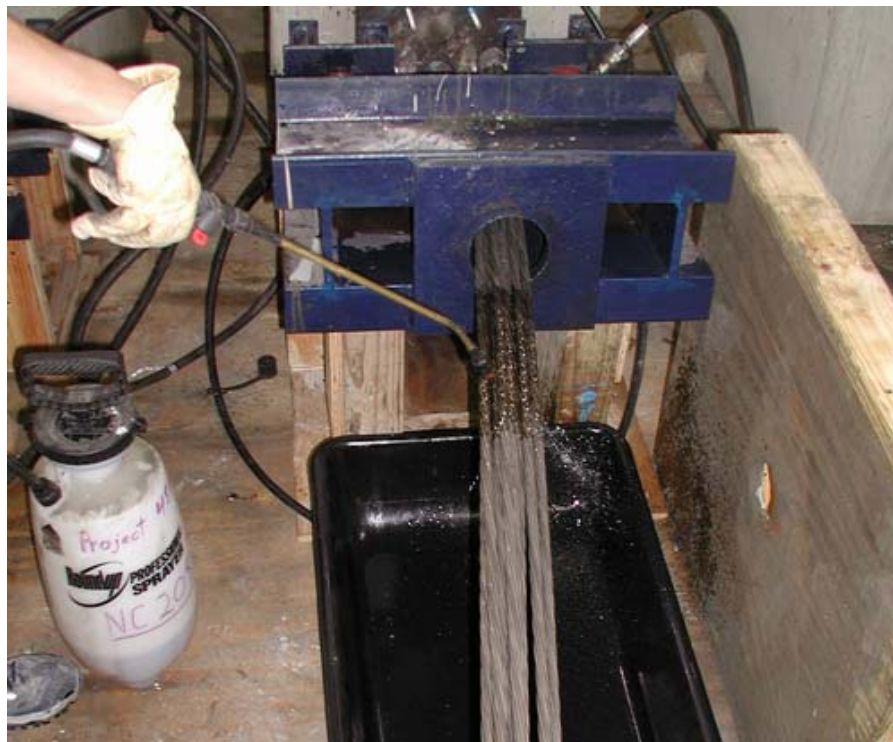
*Figure 3-12 Oil Application*

After positioning the equipment, the 12-strand tendon was fed through the specimen, and anchor heads were installed on each end. If the specimen was to be coated with oil, the oil was applied to the tendon with a garden-type sprayer as it was fed into the duct. Figure 3-12 shows the application of oil. Figure 3-13 shows the profile of a specimen with prestressing equipment in place on both ends and a tendon installed.

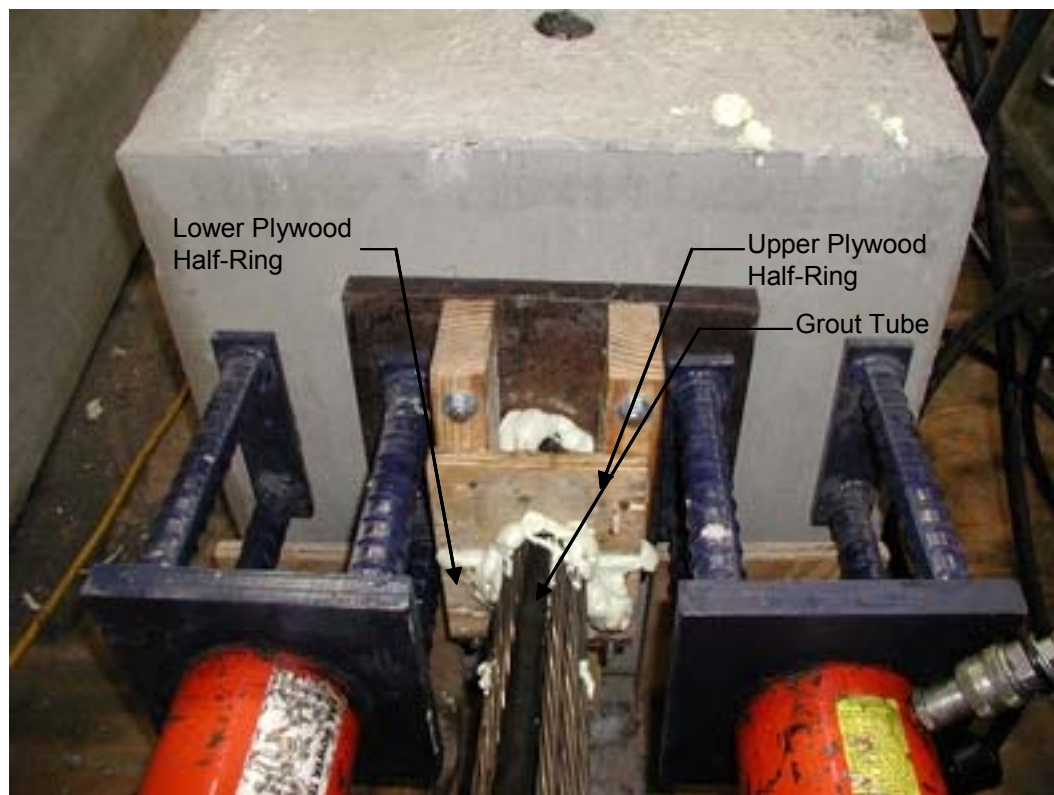
***Figure 3-14 Completed Initial Foaming***

After sealing the inner hole, two half-rings cut from plywood were placed around the tendon and grout tube and screwed onto the face of the 2x4 frame. Expanding insulating foam was again used to seal the gaps between this hole and the tendon bundle and grout tube. At this point, an effort was made to fill the gaps between individual strands as much as possible. The foaming activities up to this point were called “initial foaming”. Figure 3-14 shows this step completed with important items labeled.

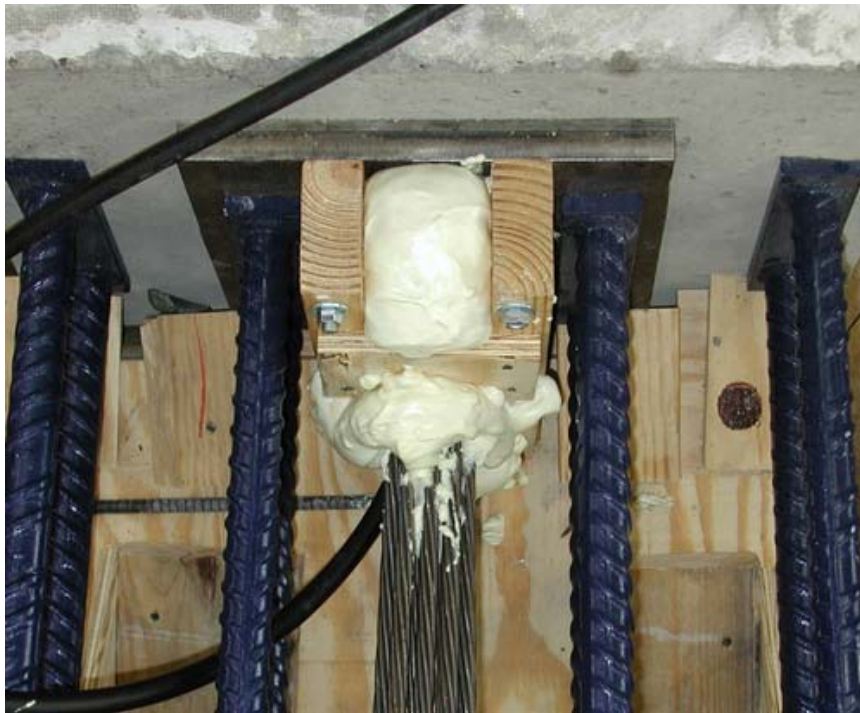
*Figure 3-16 Completed Final Foaming*

After the initial foaming had cured for about a day, the void remaining in the 2x4 frame was completely filled with foam. This operation was called “final foaming”. Figure 3-15 shows the tendon ready for final foaming, and Figure 3-16 shows the final foaming completed.

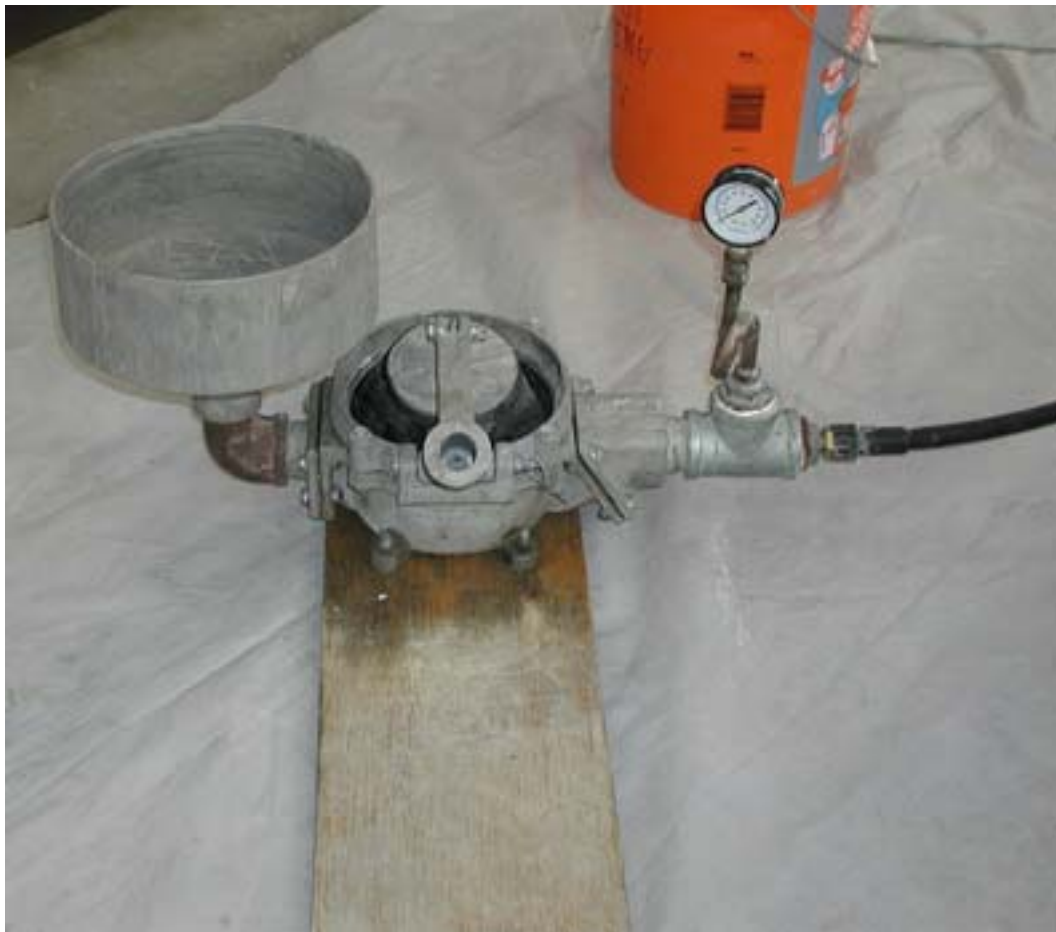
*Figure 3-17 Hand Grout Pump*

A hand grout pump, shown in Figure 3-17, was attached to the grout tube using typical garden hose connections. Care was taken to ensure that the hopper on the grout pump remained full, preventing air from being drawn into the system. When grouting tendons which had unequal end elevations, grout was always pumped from the lower end of the tendon. Once grout began to flow evenly from the vent at the far end, it was capped and pumping ceased. The grout pump was then disconnected from the grout tube and the tube was capped.

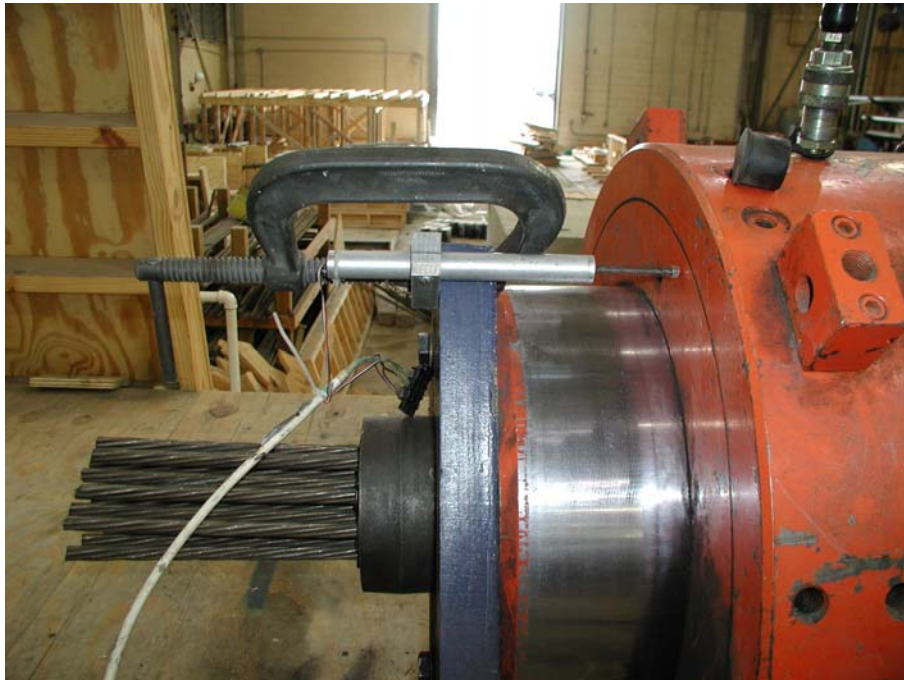
*Figure 3-18 Live End Linear Potentiometer Placement*

Displacements of the live and dead end were recorded using linear potentiometers. The live end displacement was measured with a 5-in. potentiometer attached to the bearing plate on the cylinder of the ram and extending to the body of the ram. Figure 3-18 shows the placement of the live end potentiometer. On the dead end, a single 2-in. potentiometer was placed against the cut tendon end. Because of the size of the tendon bundle, using more than one potentiometer was impractical. The potentiometer was typically placed such that its tip was bearing on one of the internal strands in the tendon bundle. Figure 3-19 shows a typical dead end linear potentiometer placement. In all pullout tests, there was no visually perceptible differential movement between individual strands at the tendon's dead end. Before beginning the testing program, each linear potentiometer was calibrated to determine the correct calibration factor.

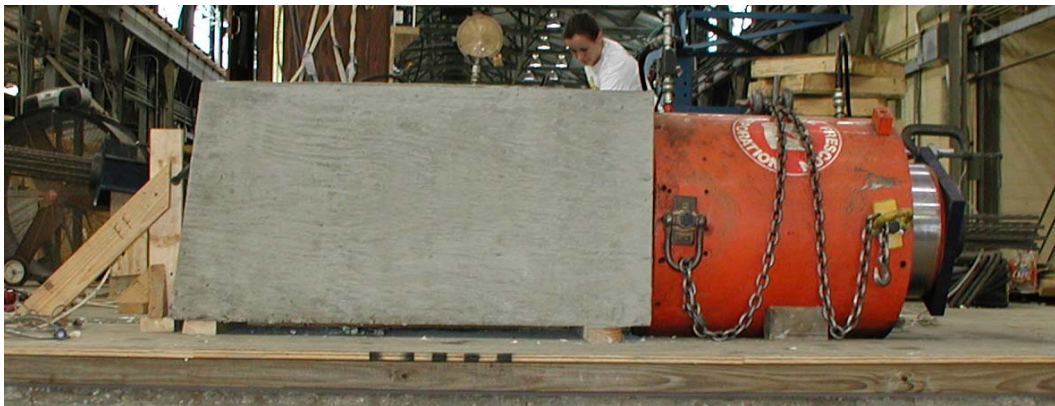
*Figure 3-20 A Specimen Ready For Testing*

Figure 3-20 shows a specimen ready for testing. The following is a summary of the test procedure:

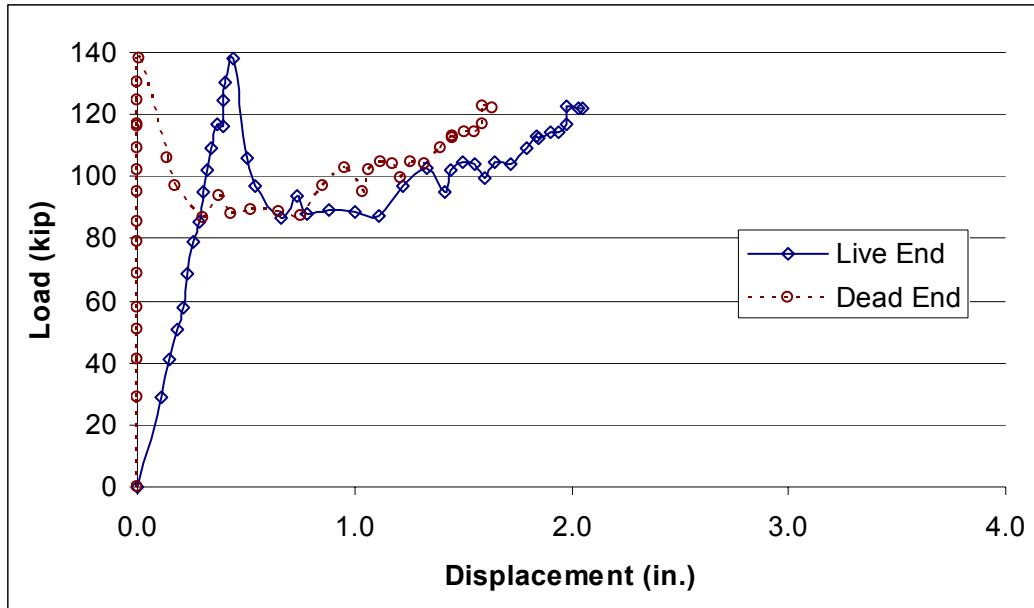
**Figure 4-5 Live End Load-Displacement and Dead End Load-Slip Response for Specimen 0-SP-20°-1**

Figure 4-5 is the load vs. live end displacement and load vs. dead end slip plot for specimen 0-SP-20°-1. The figure indicates that the peak load achieved was 138 kip, at which point an extremely pronounced reduction in resistance occurred. Figure 4-6 is the load vs. dead end slip plot for the specimen. It shows slip behavior at an amplified scale over a smaller range of displacement values. This highlights the slip behavior prior to and just after failure. The figure shows that very little slip occurred prior to the maximum load. The maximum load corresponds to the point where the first appreciable dead end slip occurred, after which substantial displacement accumulated on both the live and dead ends at lower load levels. Failure occurred at the grout-duct interface for this specimen prior to a dead end slip of 0.02 in. Figure 4-7 shows the specimen after testing, with the tendon and grout pulled several inches out of the specimen.

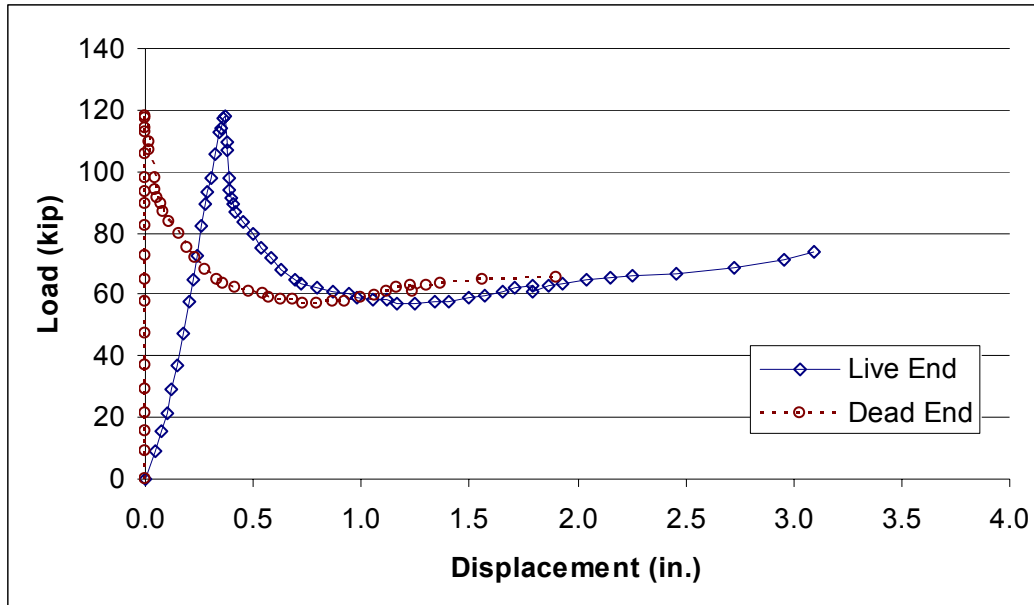
*Figure 4-8 Live End Load-Displacement and Dead End Load-Slip Response for Specimen 0-SP-15°-1*

Figure 4-8 is the load vs. live end displacement and load vs. dead end slip plot for specimen 0-SP-15°-1. The figure indicates that the peak load achieved was 118 kip, at which point an extremely pronounced reduction in resistance occurred. Figure 4-9 is the load vs. dead end slip plot for the specimen. It shows slip behavior at an amplified scale over a smaller range of displacement values. This highlights the slip behavior prior to and just after failure. The figure shows that very little slip occurred prior to the maximum load. The maximum load corresponds to the point where the first appreciable dead end slip occurred, after which substantial displacement accumulated on both the live and dead ends at lower load levels. Failure occurred at the grout-duct interface for this specimen prior to a dead end slip of 0.02 in. Figure 4-10 shows the specimen after testing, with the tendon and grout pulled several inches out of the specimen.

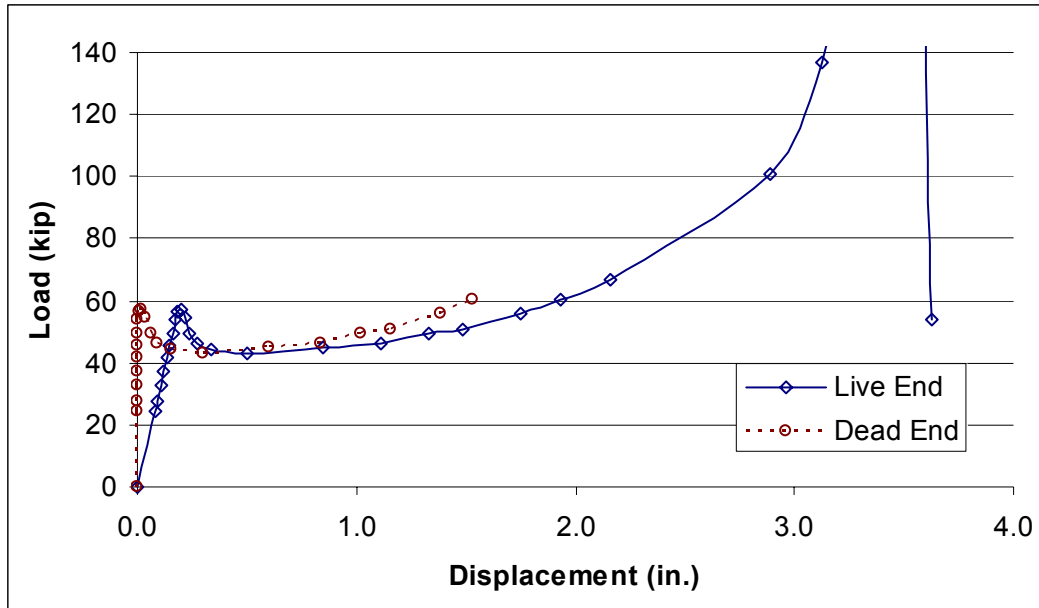
*Figure 4-11 Live End Load-Displacement and Dead End Load-Slip Response for Specimen 0-SP-10°-1, Normal Range*

With continued displacement, the load began to increase at a rapid rate, reaching a maximum load of 233 kip at a live end displacement of over 3 in., as indicated by Figure 4-13. An extremely pronounced reduction in resistance occurred as the pipe broke away from the concrete. This behavior is believed to result from the solid tendon and grout plug binding up as it tried to rotate as a rigid body out of the specimen. Because of its orientation, the hydraulic ram continued to pull the tendon and grout normal to the face of the specimen. This misalignment caused the tendon and grout to kink against the pipe and the load to increase until a bond failure occurred between the pipe and the concrete. Figure 4-14 shows the specimen after testing, with the tendon and grout pulled several inches out of the pipe, and the pipe pulled about 1/4 in. out of the specimen.

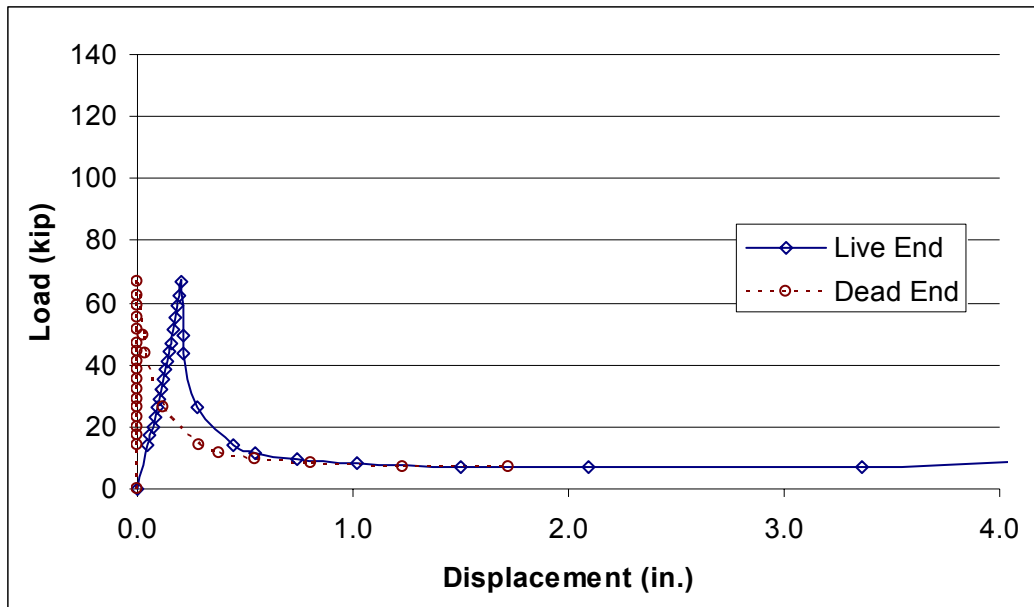
*Figure 4-17 Live End Load-Displacement and Dead End Load-Slip Response for Specimen 0-SP-7.5°-1*

Figure 4-17 is the load vs. live end displacement and load vs. dead end slip plot for specimen 0-SP-7.5°-1. The figure indicates that the peak load achieved was 67.1 kip, at which point an extremely pronounced reduction in resistance occurred. Figure 4-18 is the load vs. dead end slip plot for the specimen. It shows slip behavior at an amplified scale over a smaller range of displacement values. This highlights the slip behavior prior to and just after failure. The figure shows that very little slip occurred prior to the maximum load. The maximum load corresponds to the point where the first appreciable dead end slip occurred, after which substantial displacement accumulated on both the live and dead ends at lower load levels. Failure occurred at the duct-concrete interface for this specimen with a dead end slip of less than 0.02 in. Figure 4-19 shows the specimen after testing, with the duct and tendon pulled several inches out of the specimen.

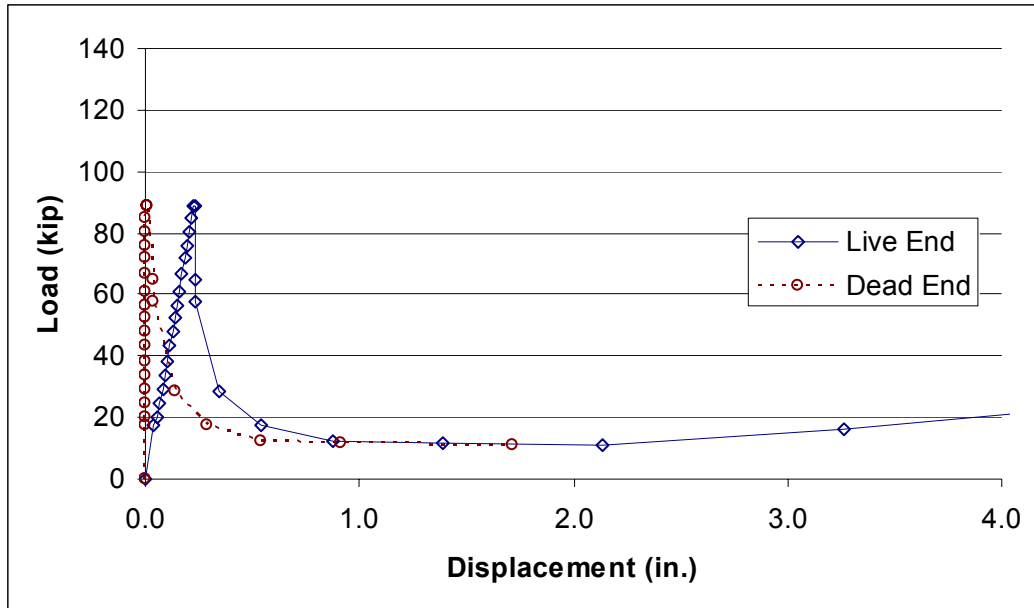
**Figure 4-20** *Live End Load-Displacement and Dead End Load-Slip Response for Specimen 0-SP-7.5°-2*

Figure 4-20 is the load vs. live end displacement and load vs. dead end slip plot for specimen 0-SP-7.5°-2. The figure indicates that the peak load achieved was 89.1 kip, at which point an extremely pronounced reduction in resistance occurred. Figure 4-21 is the load vs. dead end slip plot for the specimen. It shows slip behavior at an amplified scale over a smaller range of displacement values. This highlights the slip behavior prior to and just after failure. The figure shows that very little slip occurred prior to the maximum load. The maximum load corresponds to the point where the first appreciable dead end slip occurred, after which substantial displacement accumulated on both the live and dead ends at lower load levels. Failure occurred at the duct-concrete interface for this specimen with a dead end slip of less than 0.02 in. Figure 4-22 shows the specimen after testing, with the duct and tendon pulled several inches out of the specimen.

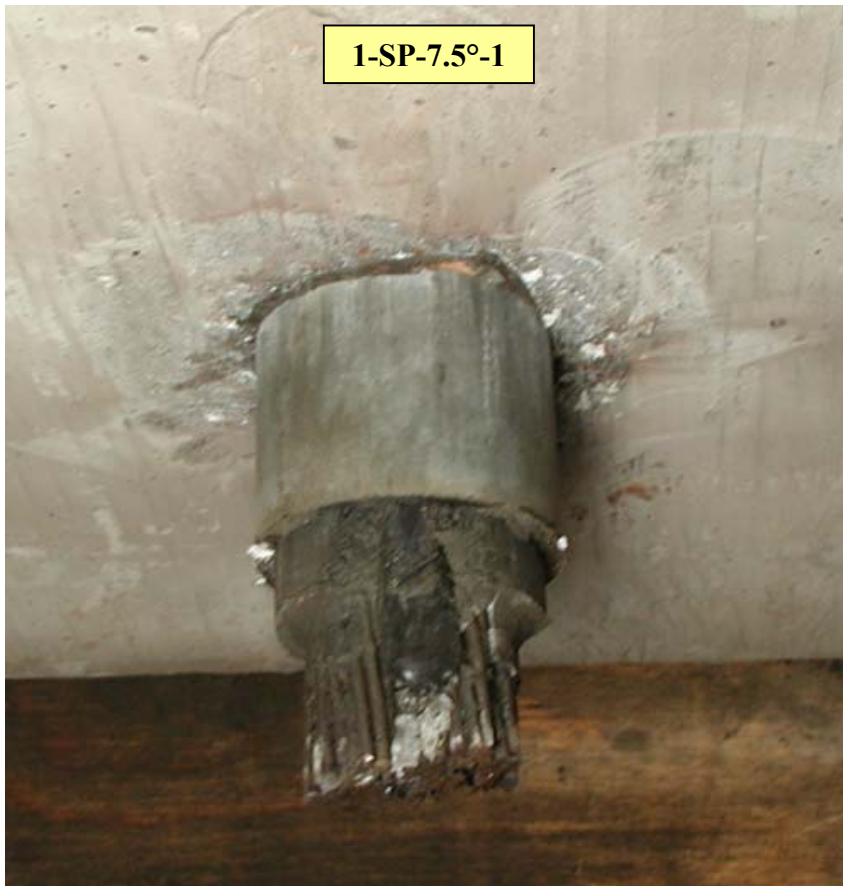
*Figure 4-25 Photo of Specimen 1-SP-7.5°-1 after Testing*

Upon inspection of the specimen after testing, a dark slimy residue was observed on the grout plug. This residue is most likely residual oil that collected on the lower surface of the duct since it was not observed on any of the uncoiled specimens. It is highly likely that this residual oil contributed to the loss of adhesion that was observed between the grout and the duct in this specimen. Figure 4-25 is a picture of the live end of the specimen after testing. The tendon and grout are pulled about 1 in. out of the pipe, and the pipe is pulled about 2.5 in. out of the specimen.

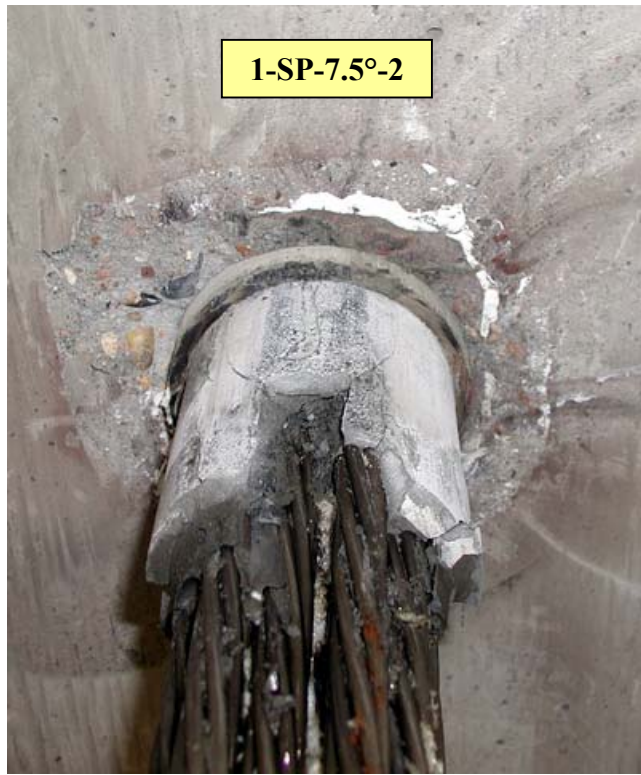
*Figure 4-28 Photo of Specimen 1-SP-7.5°-2 after Testing*

Upon inspection of the specimen after testing, a dark slimy residue was noted on the underside of the grout plug. This residue is most likely residual oil that collected on the lower surface of the duct since it was not observed on any of the unoiled specimens. It is highly likely that this residual oil contributed to the loss of adhesion observed between the grout and the duct in this specimen. Figure 4-28 is a picture of the live end of the specimen after testing with the tendon and grout pulled about 3 in. out of the pipe and the pipe pulled about 1/4 in. out of the specimen.

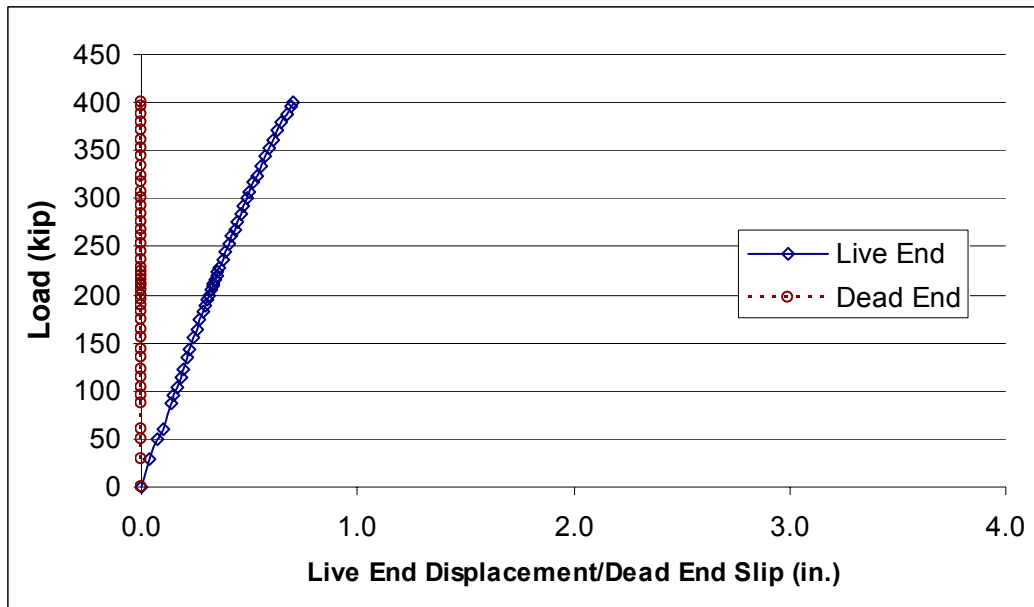
*Figure 4-29 Live End Load-Displacement and Dead End Load-Slip Response for Specimen 0-GD-20°-1*

Figure 4-29 is the load vs. live end displacement and load vs. dead end slip plot for specimen 0-GD-20°-1. The figure indicates that a load of 400 kip was achieved without a pullout failure. Figure 4-30 is the load vs. dead end slip plot for the specimen. The maximum dead end slip recorded was less than 0.02 in. No cracking of the concrete was observed during this test.

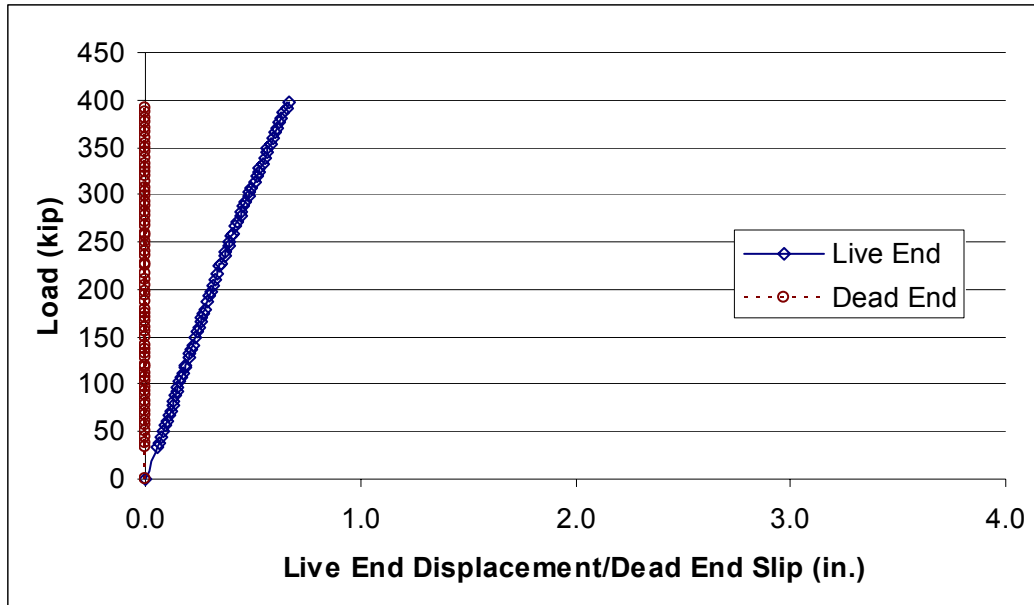
*Figure 4-31 Live End Load-Displacement and Dead End Load-Slip Response for Specimen 0-GD-15°-1*

Figure 4-31 is the load vs. live end displacement and load vs. dead end slip plot for specimen 0-GD-15°-1. The figure indicates that a load of 400 kip was achieved without a pullout failure. Figure 4-32 is the load vs. dead end slip plot for the specimen. A maximum dead end slip of less than 0.02 in. was recorded. No cracking of the concrete was observed during this test.

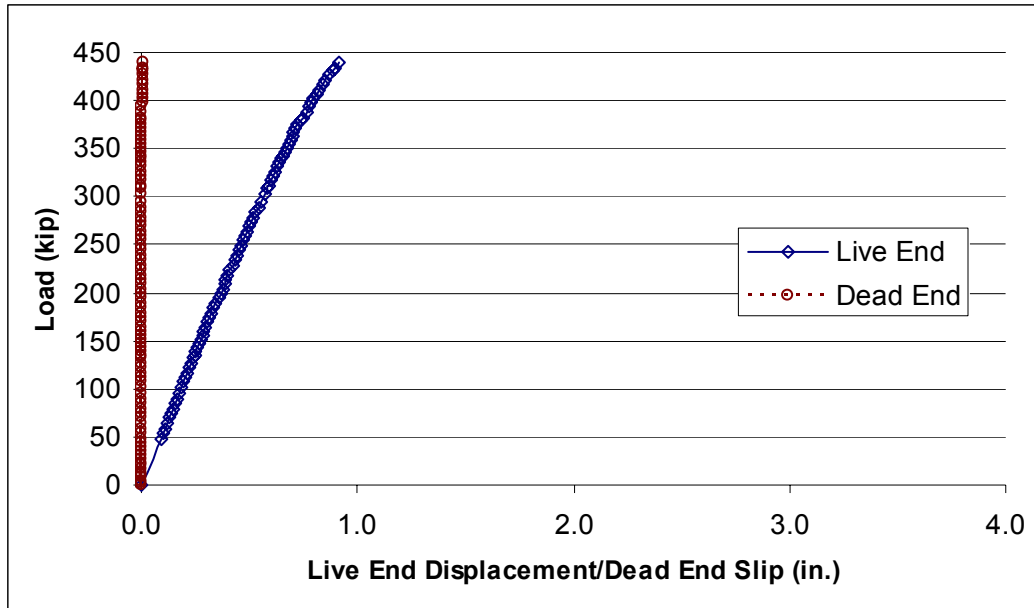
*Figure 4-33 Live End Load-Displacement and Dead End Load-Slip Response for Specimen 0-GD-10°-1*

Figure 4-33 is the load vs. live end displacement and load vs. dead end slip plot for specimen 0-GD-10°-1. The figure indicates that a load of 438 kip was achieved without a pullout failure. The loading was halted when individual wires in the tendon began to break. Figure 4-34 is the load vs. dead end slip plot for the specimen. The figure shows that the maximum dead end slip achieved during testing was less than 0.02 in. No cracking of the concrete was observed during this test.

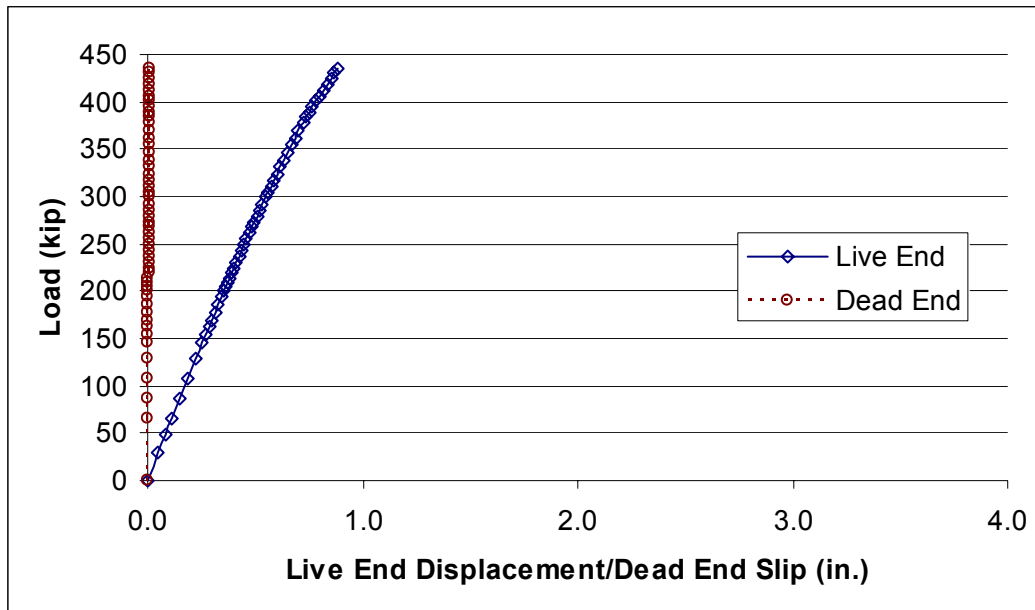
*Figure 4-35 Live End Load-Displacement and Dead End Load-Slip Response for Specimen 0-GD-10°-2*

Figure 4-35 is the load vs. live end displacement and load vs. dead end slip plot for specimen 0-GD-10°-2. The figure indicates that a load of 436 kip was achieved without a pullout failure. The loading was halted when individual wires in the tendon began to break. Figure 4-36 is the load vs. dead end slip plot for the specimen. The figure shows that the maximum dead end slip achieved during testing was less than 0.02 in. No cracking of the concrete was observed during this test.

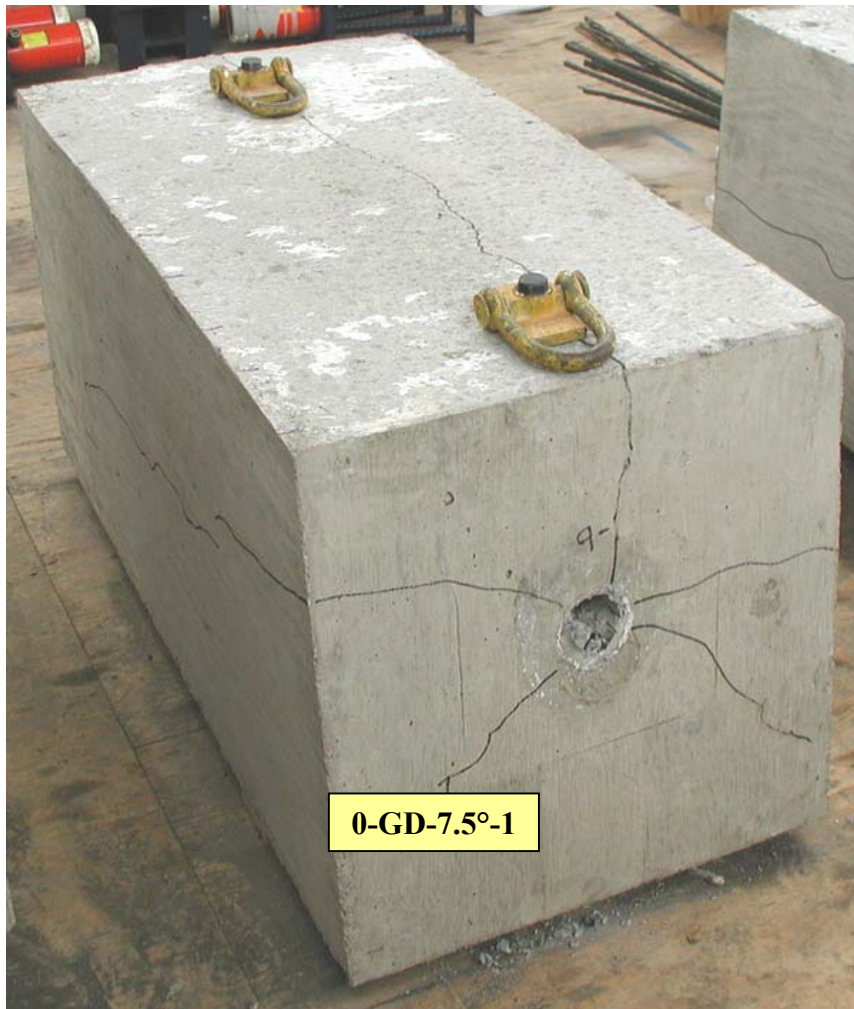
*Figure 4-39 Profile of Specimen 0-GD-7.5°-1 after Testing*

Significant cracking of the concrete occurred simultaneously with the initial maximum load in the specimen. Figure 4-39 shows a profile of the specimen after testing with the dead end in the foreground. The figure shows the pattern of cracking observed in the specimen, with splitting cracks spreading radially out from the duct. The crack on the top of the specimen extended all the way to the live end of the specimen, while the cracks on the sides extended from the dead end about three quarters of the length of the specimen.

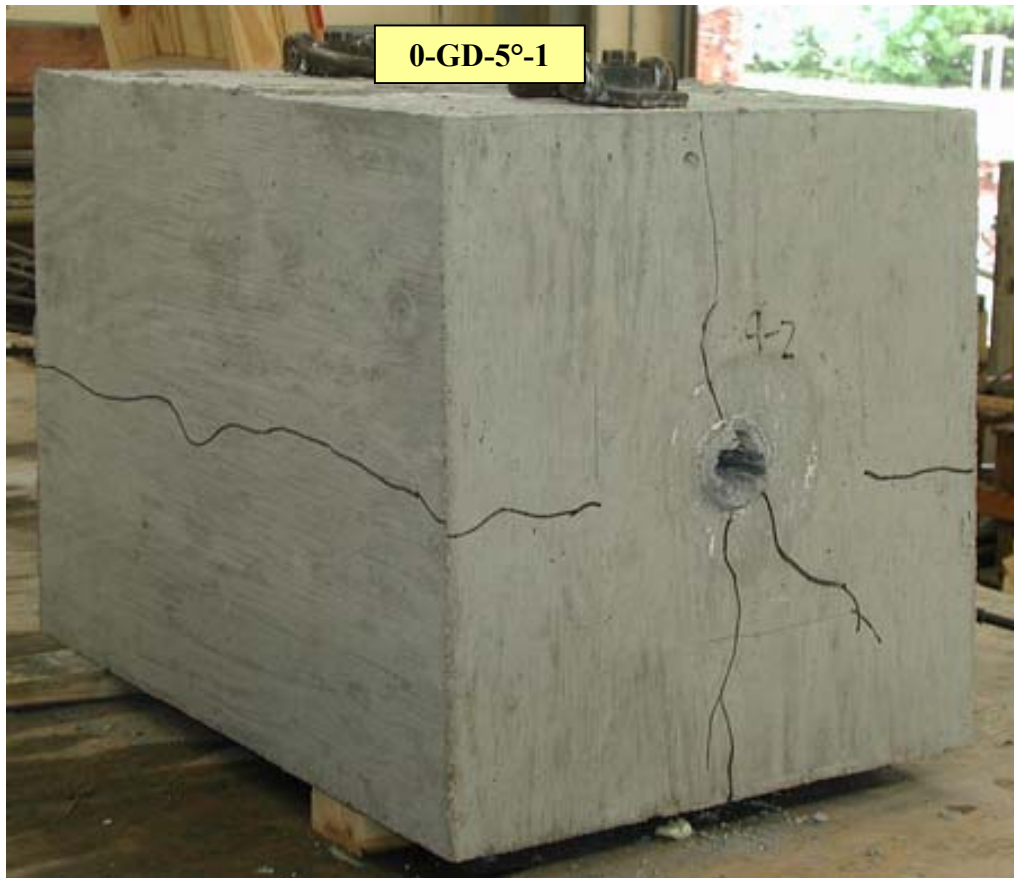
*Figure 4-48 Photo of Specimen 0-GD-5°-1 after Testing*

Significant cracking of the concrete occurred simultaneously with the maximum load in the specimen. Figure 4-48 shows a profile of the specimen after testing with the dead end in the foreground. The figure shows the pattern of cracking observed, with splitting cracks spreading radially out from the duct. A crack in the top extended the entire length of the specimen, as did the crack on the side of the specimen shown in the photo. A crack on the opposite side of the specimen extended from the dead end about three quarter of the length of the specimen.

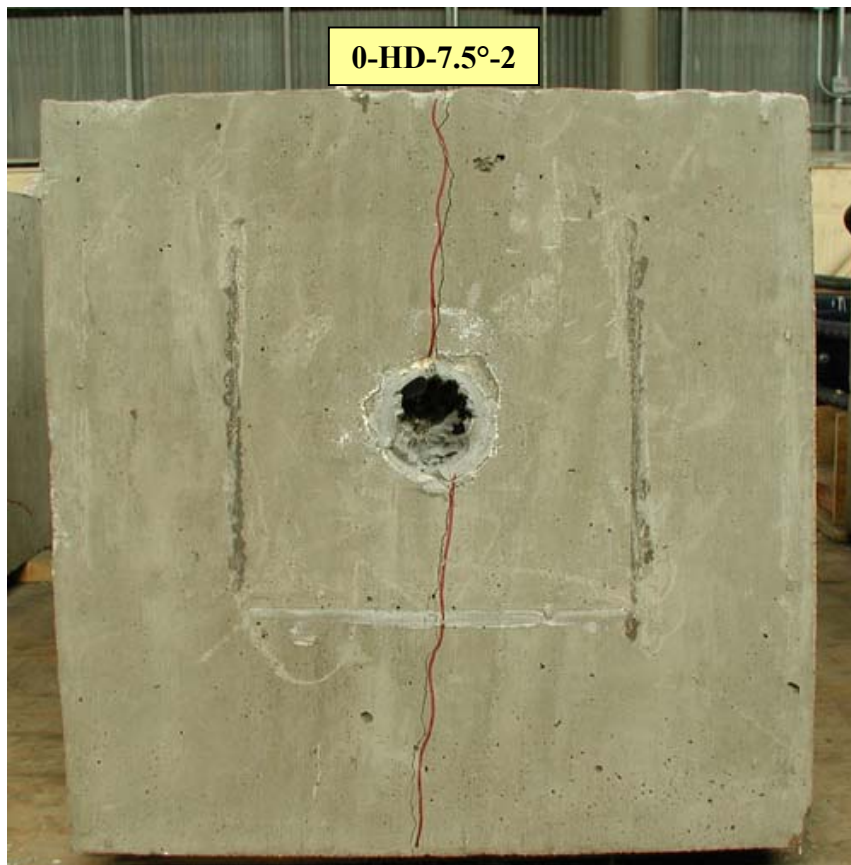
*Figure 4-72 Photo of Specimen 0-HD-7.5°-2 after Testing*

Significant cracking of the concrete occurred simultaneously with the maximum load in the specimen. Figure 4-72 shows the dead end of the specimen after testing. The figure shows the pattern of cracking observed, with a splitting crack bisecting the cross-section vertically. The crack on the top extended the full length of the specimen.
