**Factors Affecting Bond in Multi-Strand Post-Tensioning Tendons  
Including the Effect of Emulsifiable Oils**

**Thesis**

**The University of Texas at Austin**

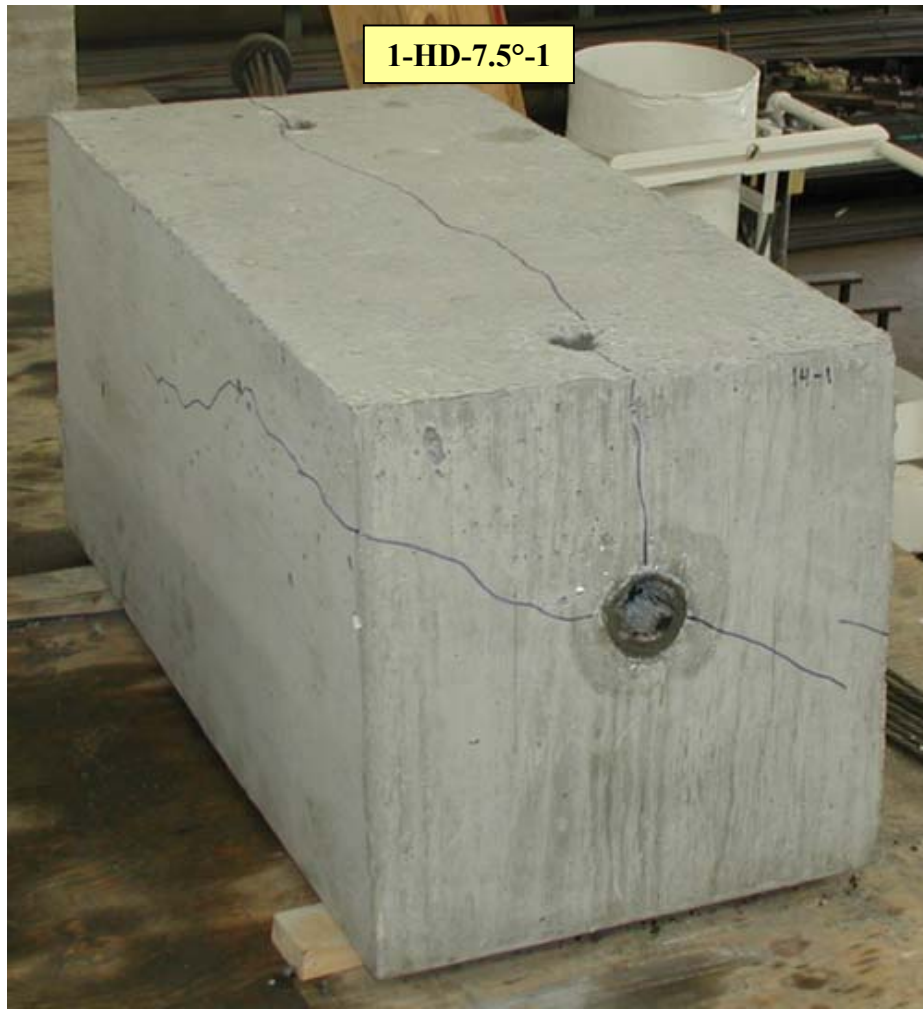
*Figure 4-79 Photo of Specimen 1-HD-7.5°-1 after Testing*

Significant cracking of the concrete occurred simultaneously with the peak load in the specimen. Figure 4-79 shows the specimen after testing with the dead end in the foreground. It illustrates the pattern of cracking observed in the specimen, with splitting cracks spreading radially out from the duct. The crack in the top extended the entire length of the specimen, while cracks on the sides extended from the dead end about three quarters of the length of the specimen.

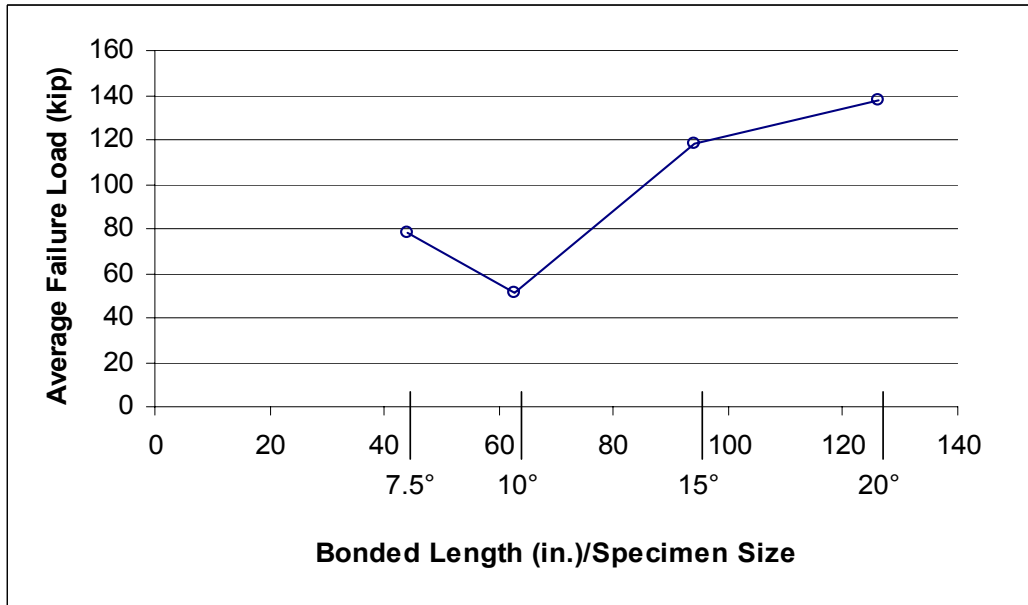
*Figure 5-1 Failure Load vs. Bonded Length for Galvanized Pipe Specimens*

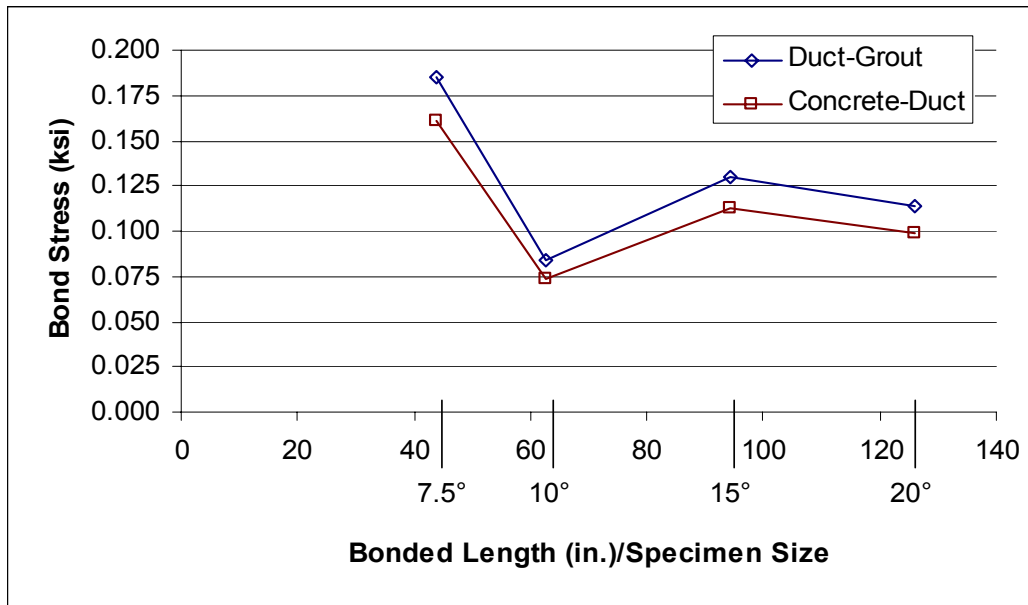
*Figure 5-2 Bond Stress vs. Bonded Length for Galvanized Pipe Specimens*

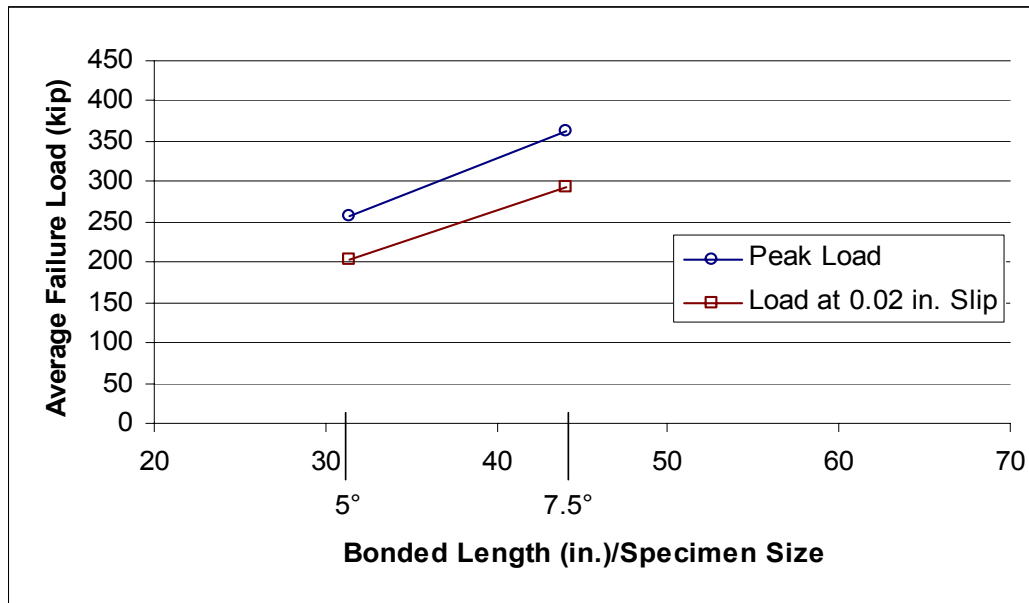
**Figure 5-3 Failure Load vs. Bonded Length for Galvanized Metal Duct Specimens**

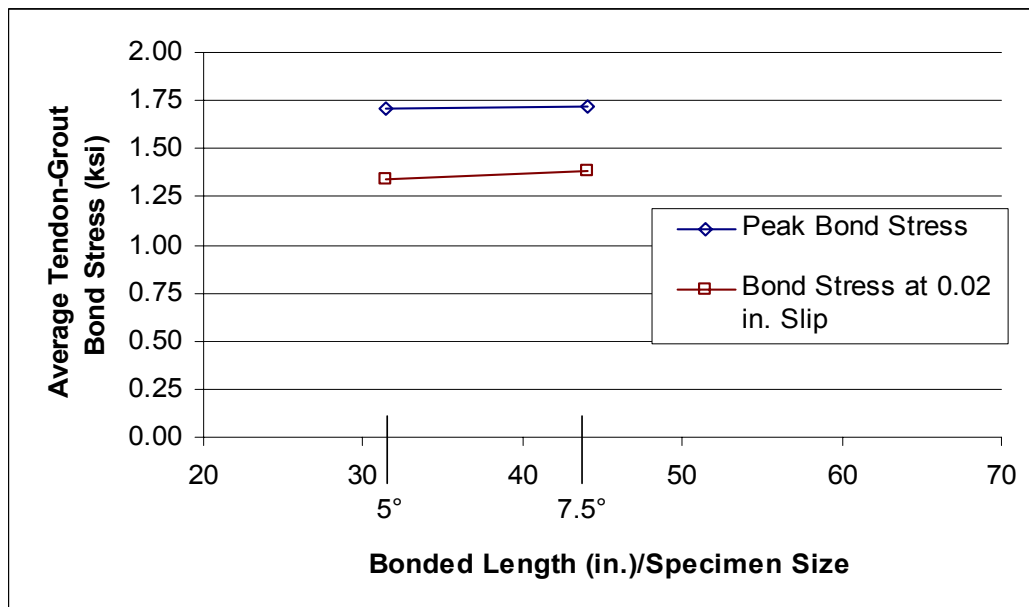
**Figure 5-4 Tendon-Grout Bond Stress vs. Bonded Length for Galvanized Metal Duct Specimens**

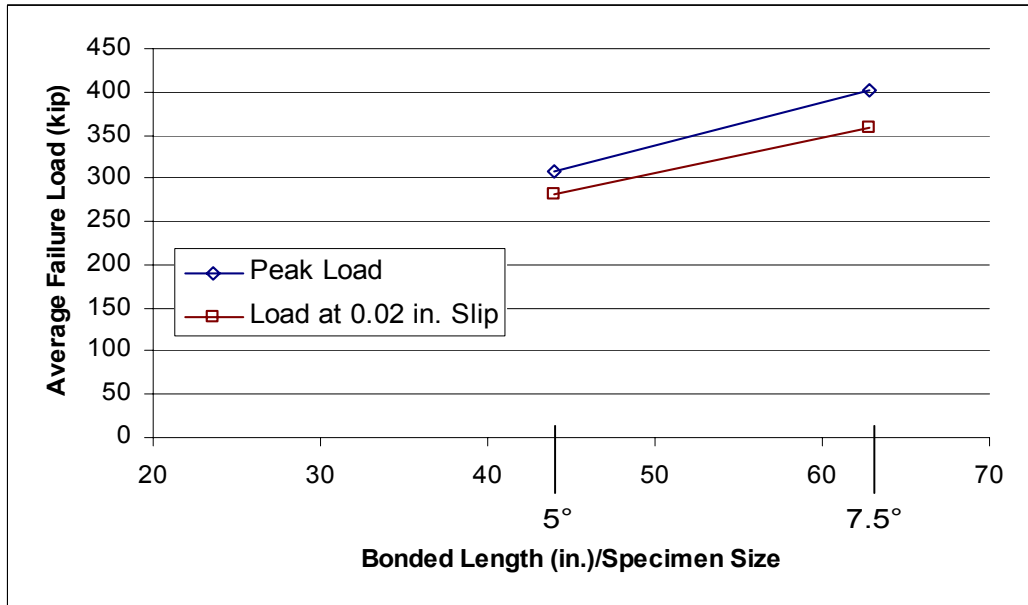
*Figure 5-5 Failure Load vs. Bonded Length for HDPE Duct Specimens*

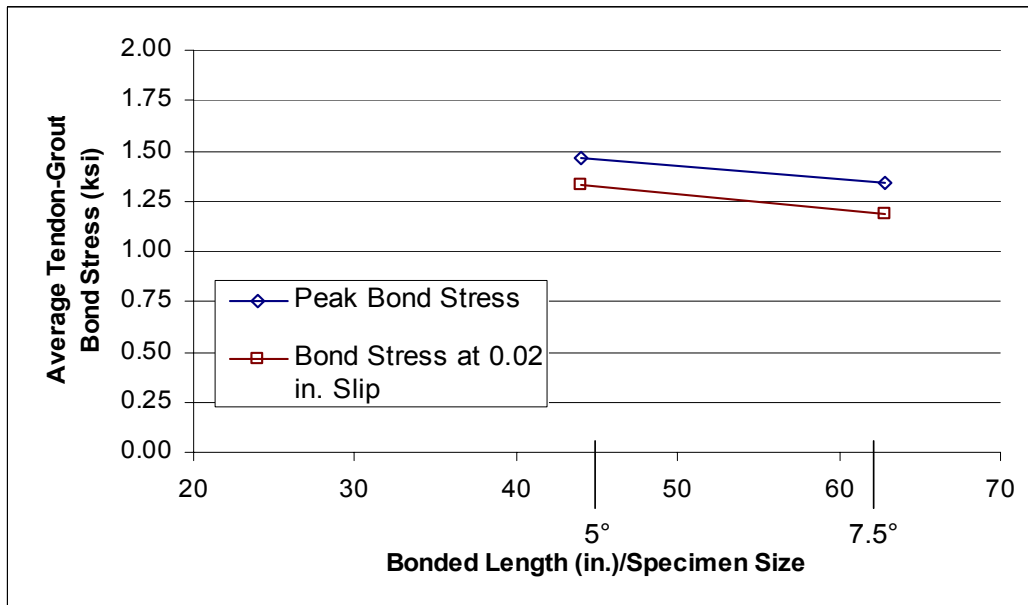
*Figure 5-6 Tendon-Grout Bond Stress vs. Bonded Length for HDPE Duct Specimens*

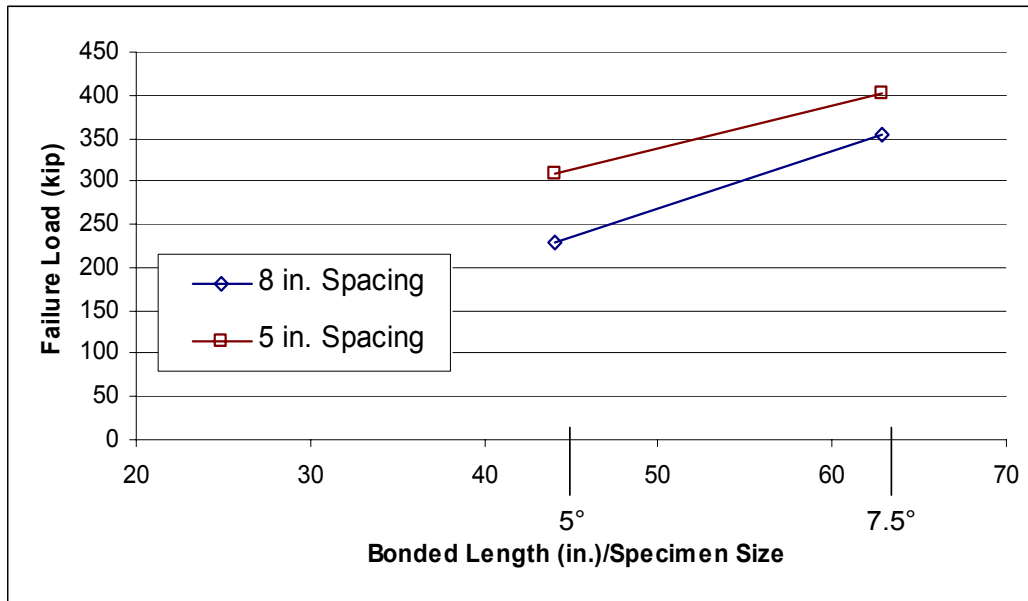
**Figure 5-7 Peak Failure Load vs. Bonded Length for Different Transverse Reinforcement Spacings**

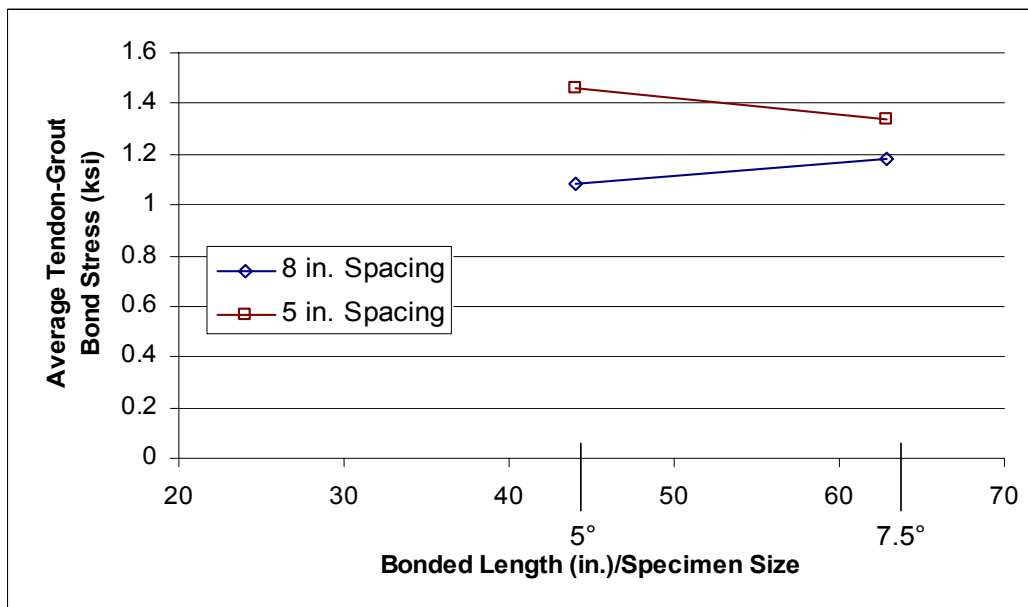
**Figure 5-8 Tendon-Grout Bond Stress vs. Bonded Length for Different Transverse Reinforcement Spacings**

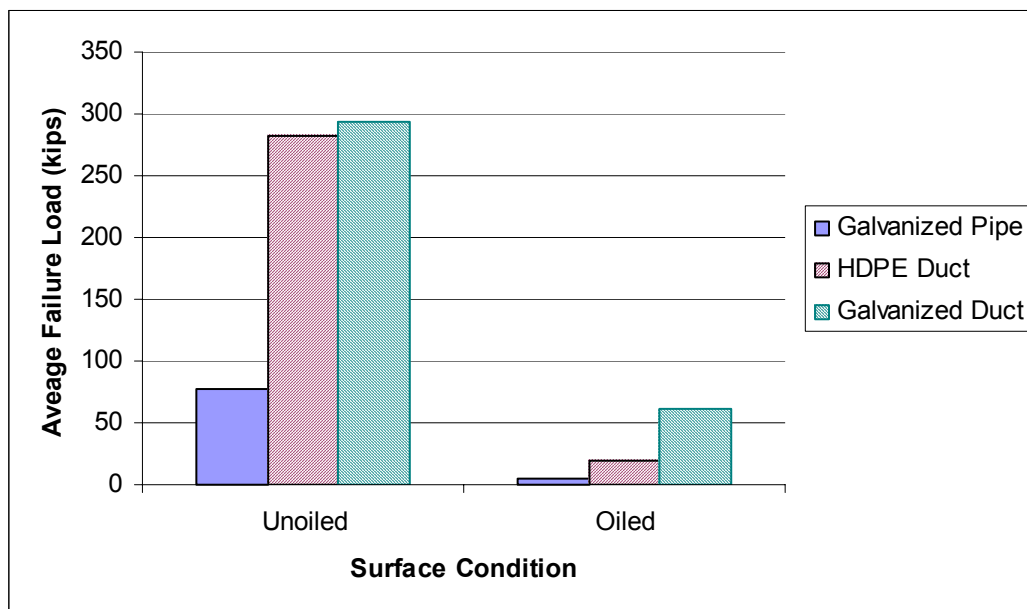
**Figure 5-10 Average Failure Loads for 7.5° Specimens with Oiled and Unoiled Tendons**

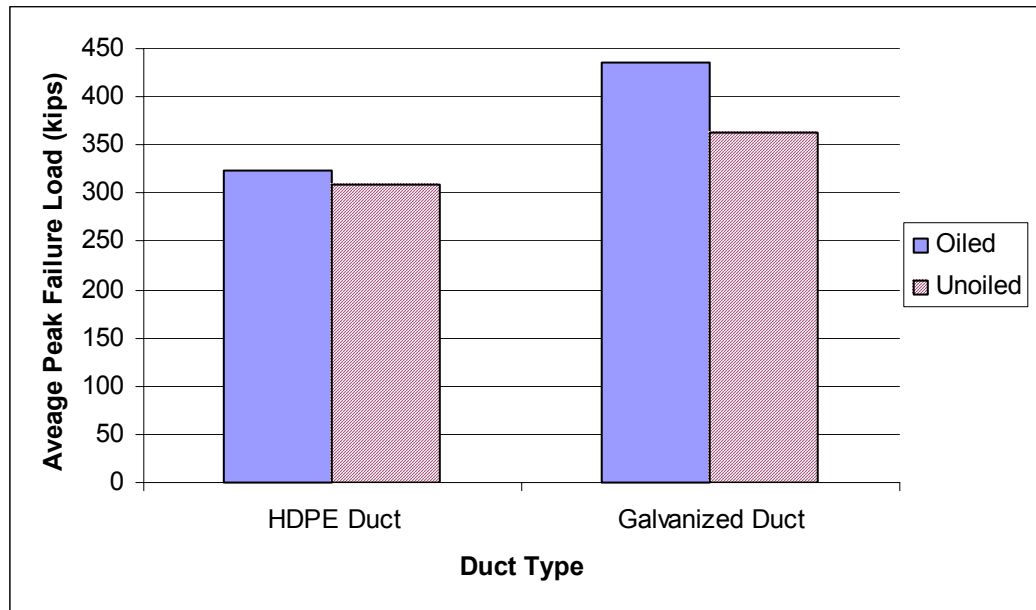
***Figure 5-11 Peak Loads for 7.5° Specimens with Oiled and Unoiled Tendons in Galvanized Metal and HDPE Ducts***
