Behavior of Bridge Slab Ends at Expansion Joints

Thesis

The University of Texas at Austin

December 2003

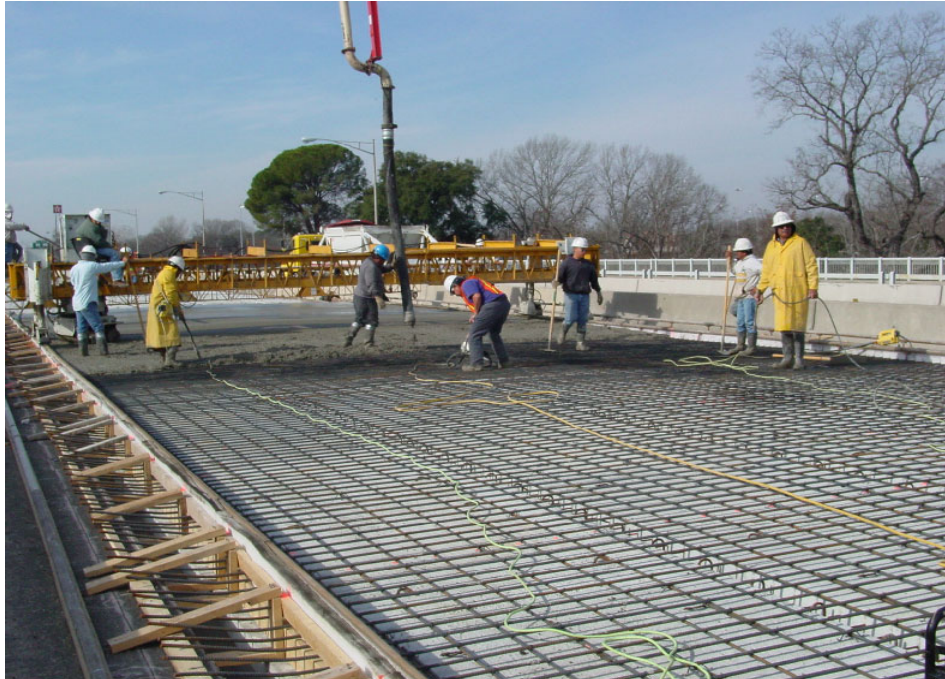
Figure 1-5: Placing of concrete in the field

In the field, deck concrete was placed using a concrete pump, and was consolidated with mechanical vibrators. It was leveled using a vibrating, movable screed on temporary rails (Figure 1-5), and finished with bull floats. The process was continuous, allowing long lengths of deck to be placed efficiently. These

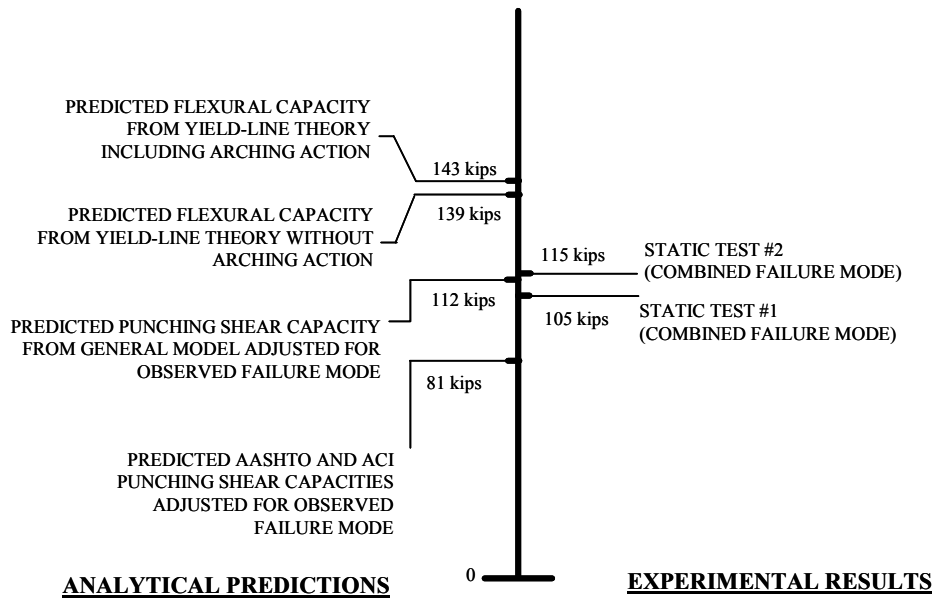
Flexural capacities were calculated using yield-line analysis, and compressive membrane forces, estimated using finite-element analysis and the results of previous research, were used in calculations of flexural capacity. In addition, predicted AASHTO LRFD and ACI 318-95 punching-shear capacities were calculated for both the predicted and observed failure mode. Resulting predictions and experimental results are shown in Figure 2-8.

(a) CIP specimens

(b) PCP specimens

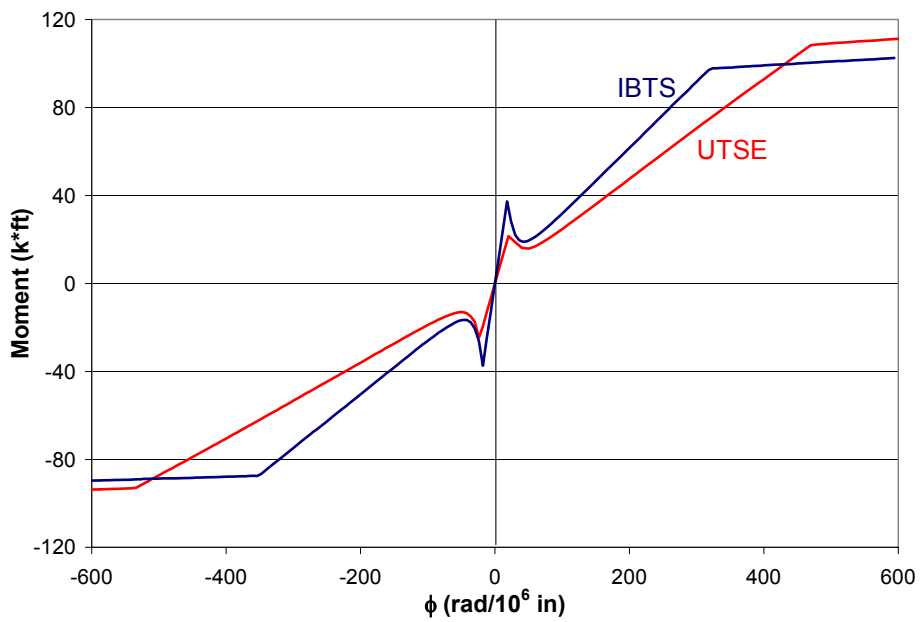
Figure 3-6 Moment-curvature behavior, focused on cracking³¹

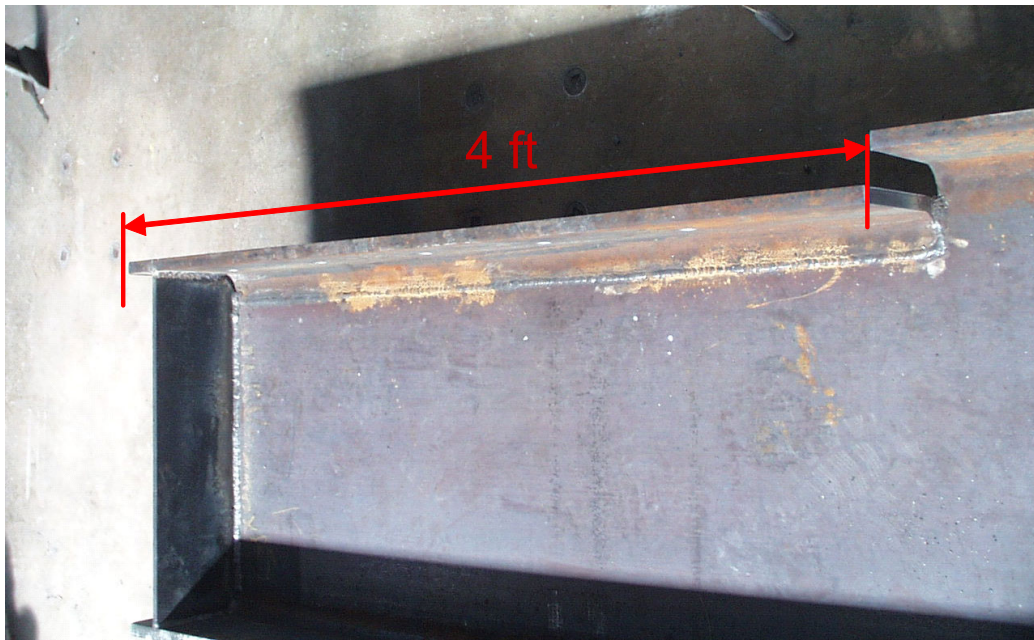
The steel W shapes used as girders in the 0° skew specimen were reused in the 45° skew specimen. The girders were modified to accommodate the change in slab depth from 8 in. (203 mm) to 10 in. (254 mm) at the IBTS slab end. In the 0° skew specimen, this required that the top girder flange be reduced in height by 2 in. (45 mm) over a length of 4 ft (1.22 m) (Figure 4-1). As discussed in Ryan (2003), the top girder flange was cut off, a 2-in. (45 mm) strip of web was cut out, and the top flange was then reattached with a full-penetration weld. For the 45° skew specimen, the longitudinal length of the drop-down was increased from 4 ft (1.22 m) to 5 ft 9 in (1.75 m), and the same procedure was used to reduce the girder depth for an additional 1.75 ft (533 mm) length.

Figure 4-1 Drop-down in top girder flange³¹

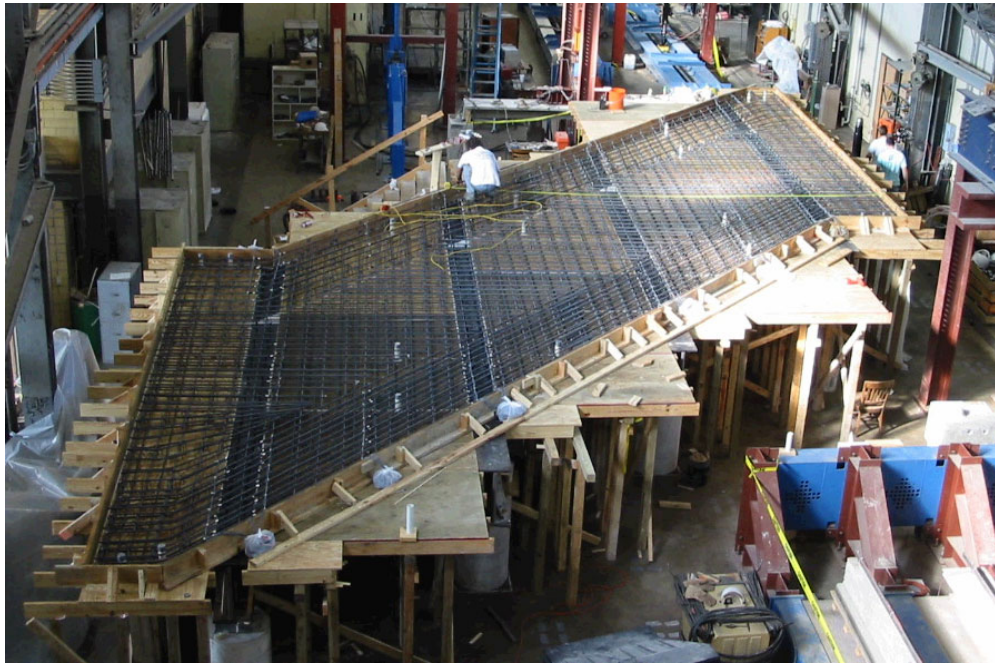
Figure 4-2 Forms before pouring

To provide a redundant connection between the girders and the formwork for the overhang forms, fabricated metal clips linked the shear studs to the panels.³¹ Edge boards, which formed the sides of the slab, were diagonally braced to the lower formwork. Gaps in the forms were closed with silicone sealant, and the forms were oiled to make them easier to remove. Reinforcing steel, both instrumented and bare, was then placed on chairs and tied together. Block-outs of PVC pipe were placed in the bridge slab where loading rods would pass through the slab. Prior to placing the concrete, the locations of strain gauges were recorded and the strain-gauge wires were routed out of the specimen.

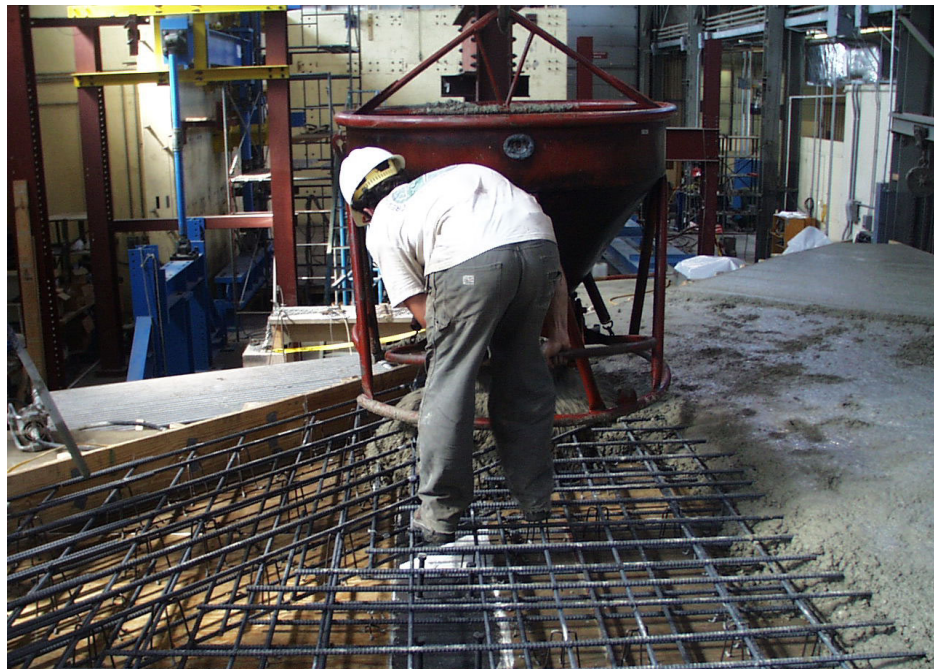
Figure 4-3 Pouring the slab

Concrete was transported within the lab with a bottom-drop bucket hoisted by a crane (Figure 4-3), was placed, and was consolidated by electric vibrators (Figure 4-4).³¹ An aluminum screed was used to level the top surface of the bridge slab. Finally, bull floats and hand trowels were used to create a smooth, flat surface. The specimen was cured for seven days by placing saturated strips of burlap, covered by plastic sheeting to reduce evaporation, over the entire surface of the slab. After 14 days, the forms were stripped and block-outs were removed; and after 28 days, slab testing began.

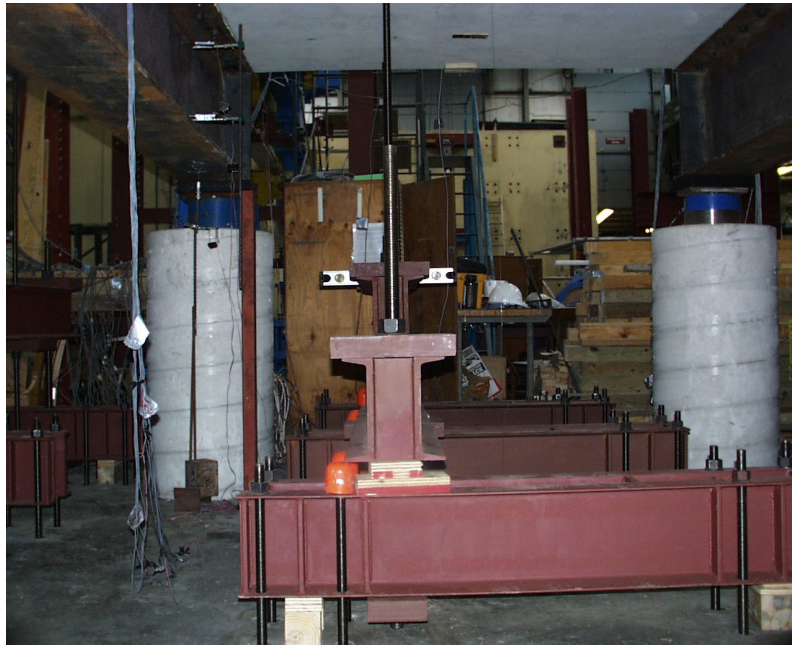
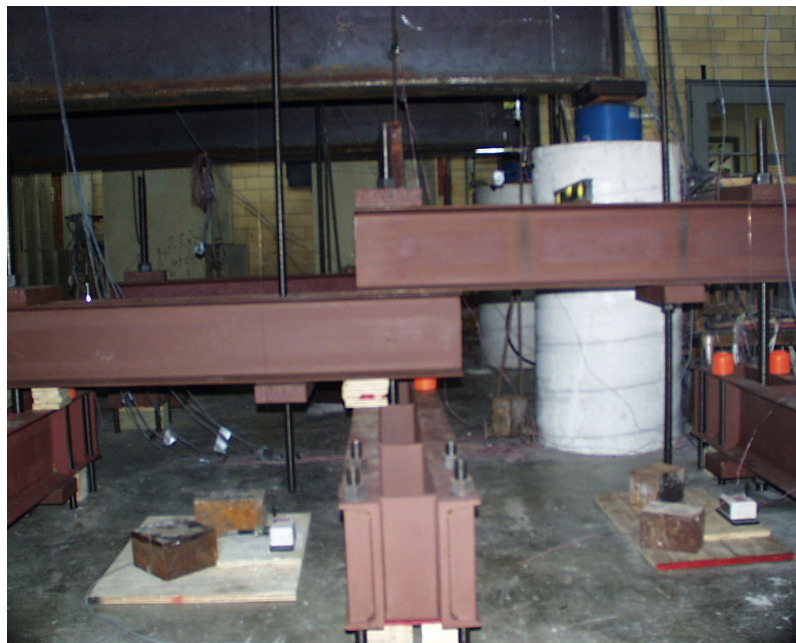
Figure 4-6 Pictures of load frame³¹

Both test specimens were built on the strong floor of the Ferguson Structural Engineering Lab to allow application of the vehicle loads. Because the test specimen was large and the load frame was to be moved frequently, loading the bridge slab from above with a reaction frame was not feasible. A compact, reconfigurable load frame was designed and built which could fit underneath the test specimen and be moved with hand trucks (Figure 4-5, Figure 4-6).

(a)Facing south (same view as Figure 4-5)

(b)Facing east (perpendicular to view in Figure 4-5)

Threaded rods were routed through the loading assembly on top of the bridge slab and attached to a load arm, labeled in Figure 4-5 as “upper load arm”. The upper load arm was connected to two lower load arms by two, 2-in. (51-mm) diameter threaded rods. The rods connecting the two arms were prestressed to

eliminate rotation of the arm due to minor misalignment. The upper and lower load arms were constructed by attaching two C10x20 channels back-to-back with steel plate spacers, to allow loading through their shear center. The lower load arm flanges were drilled to match the strong-floor bolt pattern, and were stiffened adjacent to the holes (Figure 4-5, Figure 4-6). Six lower load arms and four upper load arms were built, enabling the application of up to four tire loads at any location under the slab.

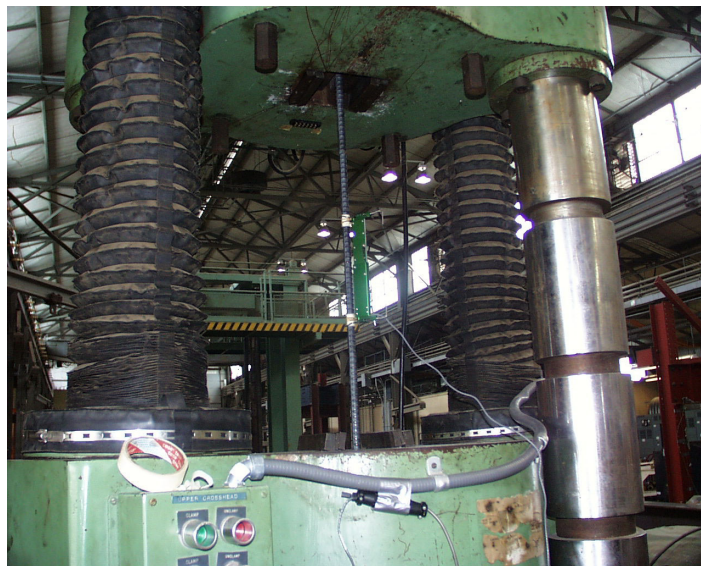
Figure 4-11 Rebar tension test setup³¹

Two lengths of reinforcing bar from each heat were tested in tension. An extensometer and strain gauges were used to determine strains, and load cells in the test machine were used to measure the applied loads (Figure 4-11). After converting the load measurements to stresses, stress-strain plots were created (Figure 4-12).

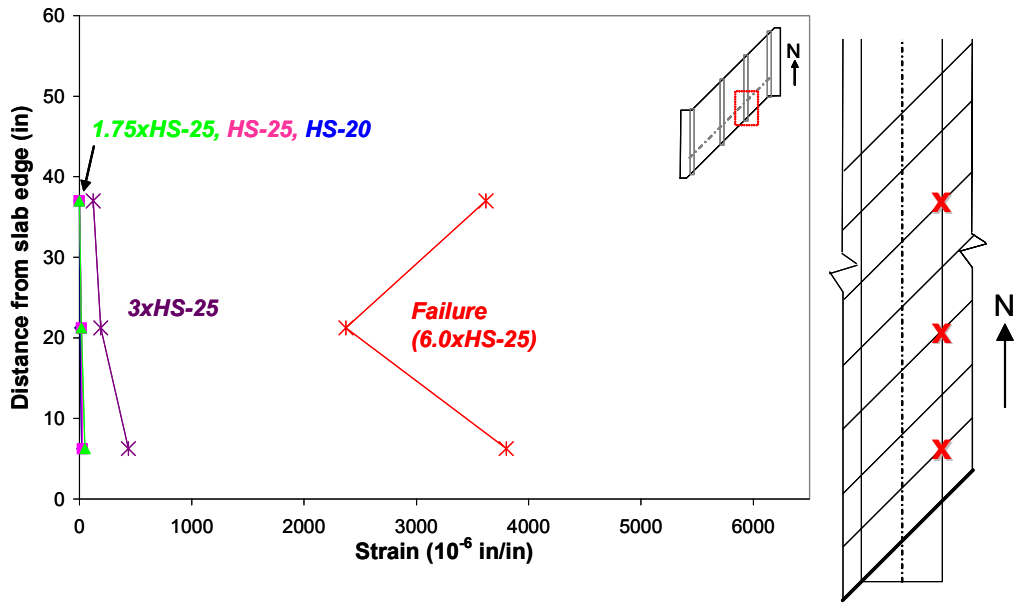
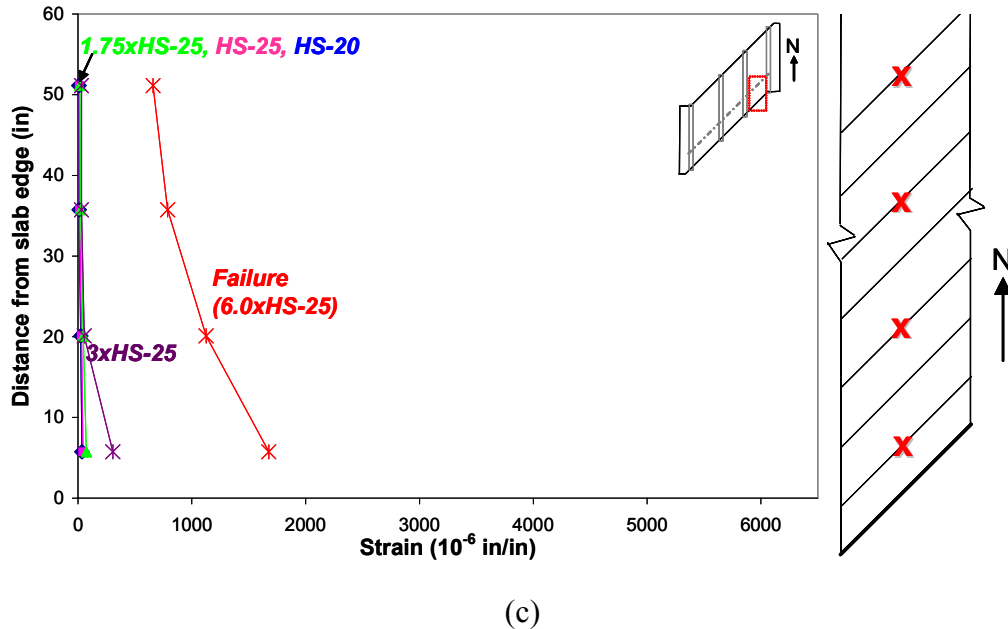
Figure 5-9 Strain profile, IBTS, negative-moment region: (a) east side of girder, top mat; (b) west side of girder, top mat; (c) midspan, bottom mat

Figure 5-9 cont'd. Strain profile, IBTS, negative-moment region: (a) east side of girder, top mat; (b) west side of girder, top mat; (c) midspan, bottom mat

In Figure 5-9(a), (b), and (c), strain profiles are shown for three locations in the IBTS, positive moment test section. In this test area, the largest strains occurred on the west side of the beam, and the smallest occurred at midspan, where maximum positive moment occurs. The increase in strain from HS-20 to HS-25 is extremely small. At 1.75 x HS-25, HS-25, and HS-20 loads, the strain distribution was nearly uniform through the end region. As loads approached the failure load, strains in reinforcement near the slab edge became much larger than strains measured closer to the interior of the section.

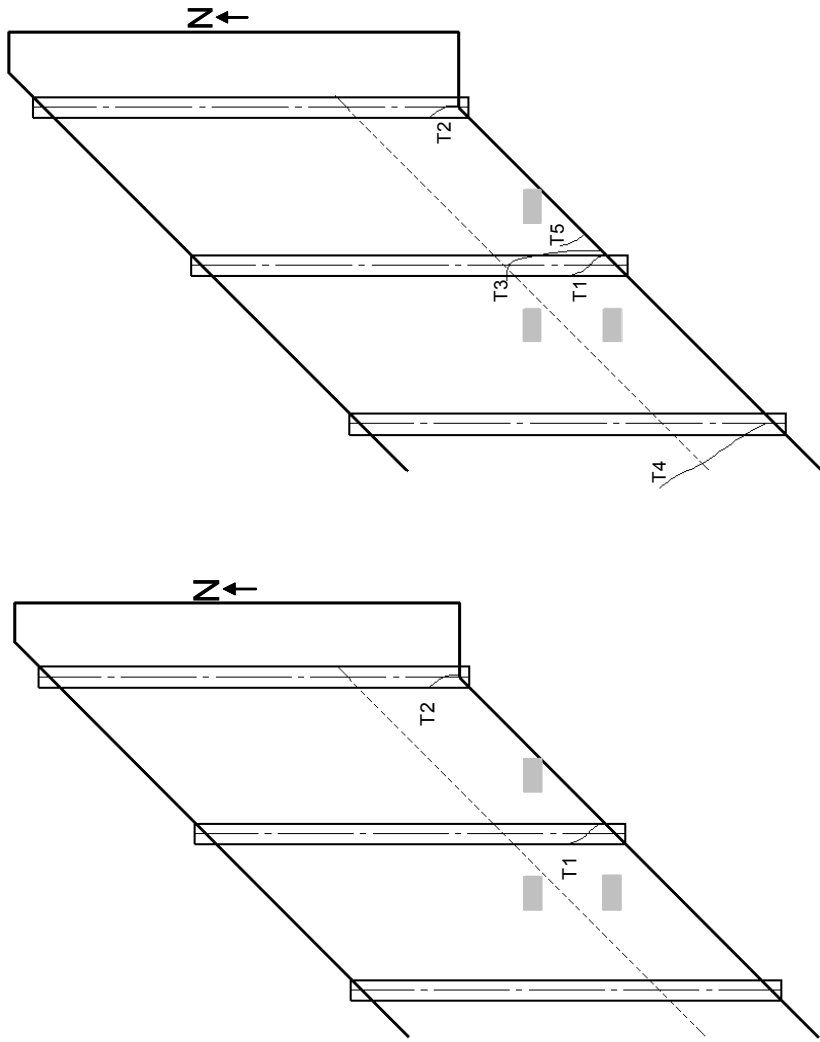
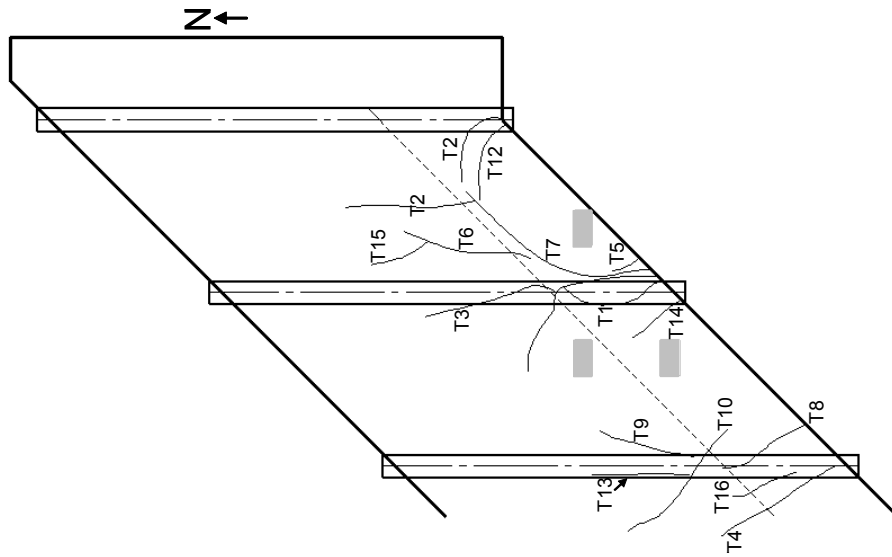
(a) 2.1 x HS-25 (first cracking) (b) 3.1 x HS-25 (load step after developed cracking)

Figure 5-10 Crack map and key, IBTS, negative-moment region; top view of slab

(c) 6.0 x HS-25 (failure)

Figure 5-10 cont'd. Crack map and key, IBTS, negative-moment region; top view of slab

The crack map at 6.0 x HS-25 shows cracks formed during testing and just after failure. At failure, a large shear crack formed between and around the two load points in the interior bay. Visible on the top of the slab were flexural cracks that formed around the load points in the exterior span and the interior span. Flexural cracks formed parallel to the interior girder on the east side. Additional flexural cracks opened over the interior girder on the west side. On the top of the slab, the largest measured crack width before failure was 0.06 in. (1 mm) for crack T6, a flexural crack in the east-exterior bay. As seen from underneath the slab at failure, a series of flexural cracks formed parallel to the girders in the interior bay, fanning out past the load points. Cracks also formed along the edge of the thickened section. On the bottom of the east-exterior bay, flexural cracks formed perpendicular to the slab end on either side of the loaded point, and did not extend past the thickened end section. Flexural cracks that had formed on the bottom of the slab beneath the east-exterior bay load point could be seen on the side of the slab. At failure, the widest crack visible from the bottom of the slab was Crack B4, which was 0.15 in (4 mm) wide. Additional flexural cracks, on the top of the slab over the girder, extended through the entire depth of the slab. Several flexural cracks also formed beneath the location of the interior load points. Although Crack S8 was the widest crack visible on the side of the slab at 0.03 in. (0.8 mm), Crack S15 opened wide during failure.

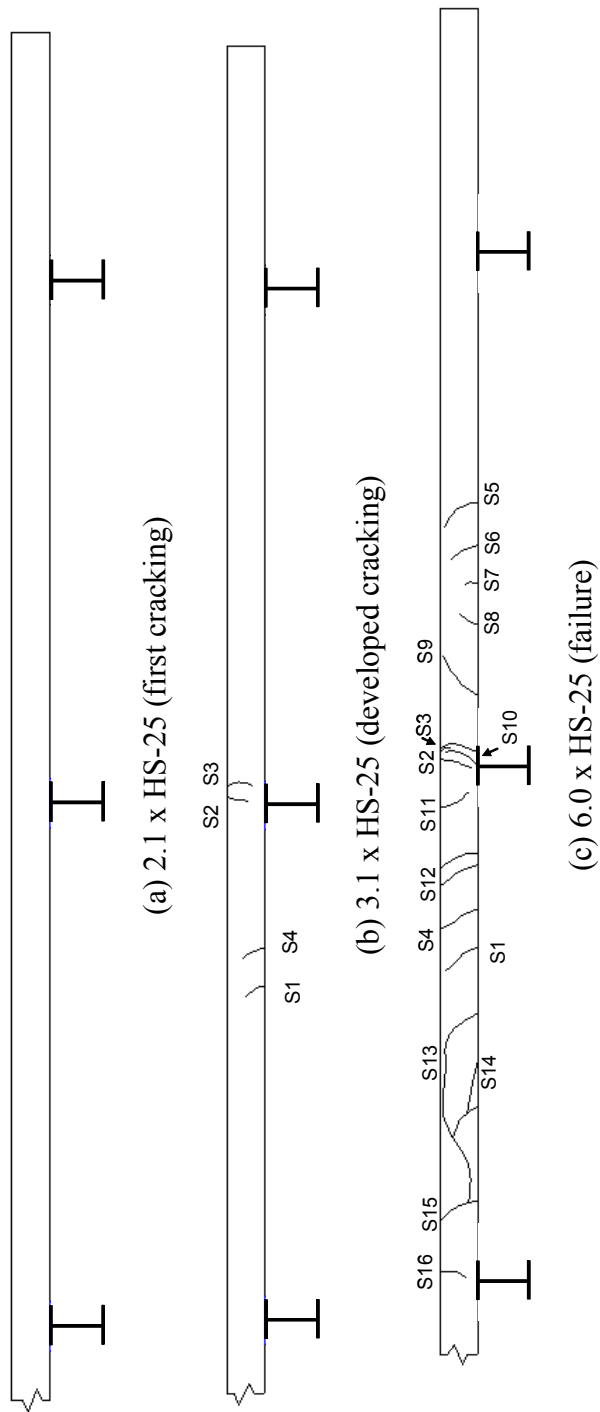
Figure 5-12 Crack map and key, IBTS, negative-moment region; side view of slab

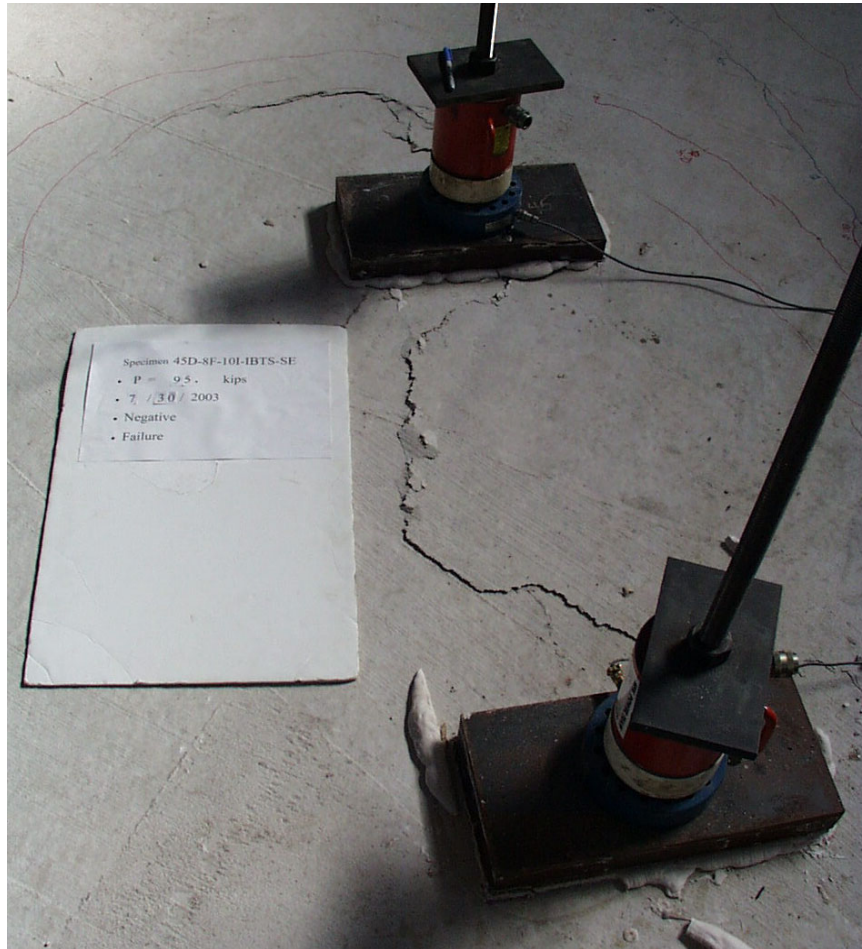
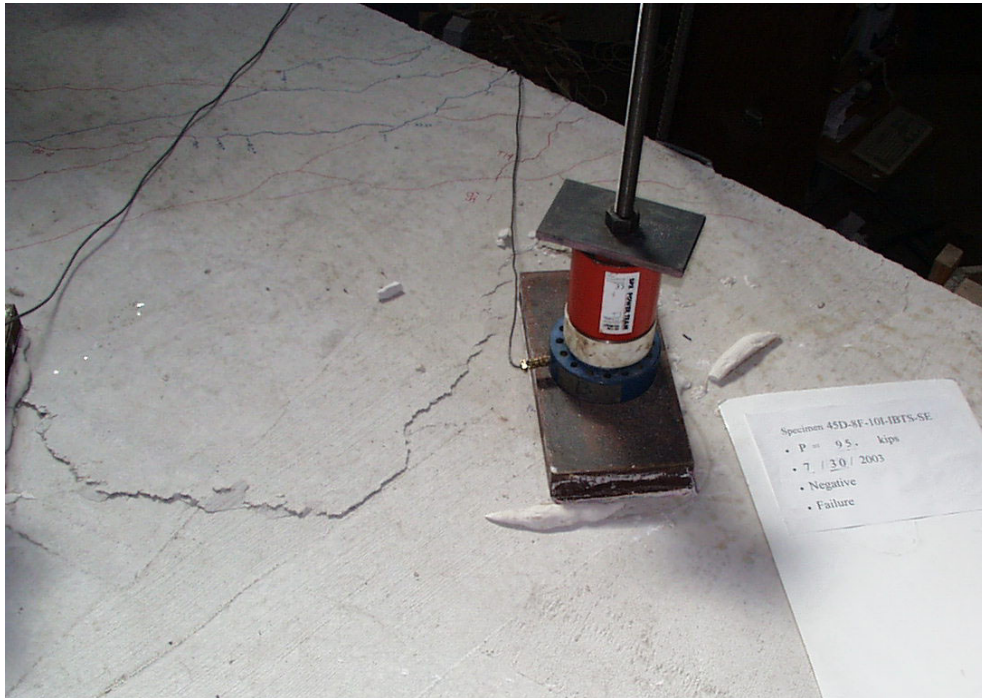
(a) Facing north

Figure 5-13 Interior bay failure surface at top of slab

(b) Facing southeast

Figure 5-13 cont'd. Interior bay failure surface at top of slab

flexural cracks opened on the top surface, but little evidence of failure was visible on the bottom or side surfaces of the slab.

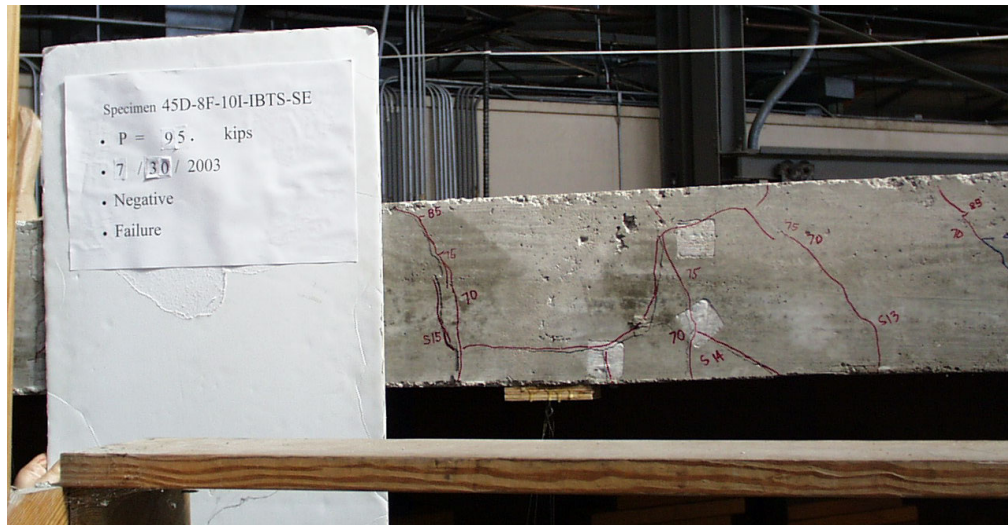
Figure 5-14 Interior bay failure surface at side of slab, facing north

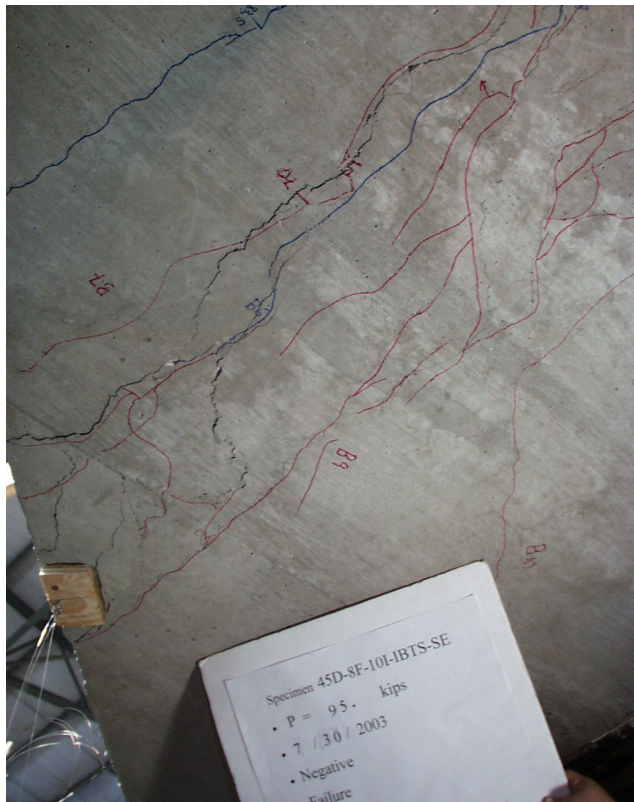
Figure 5-15 Interior bay failure surface at bottom of slab, facing west

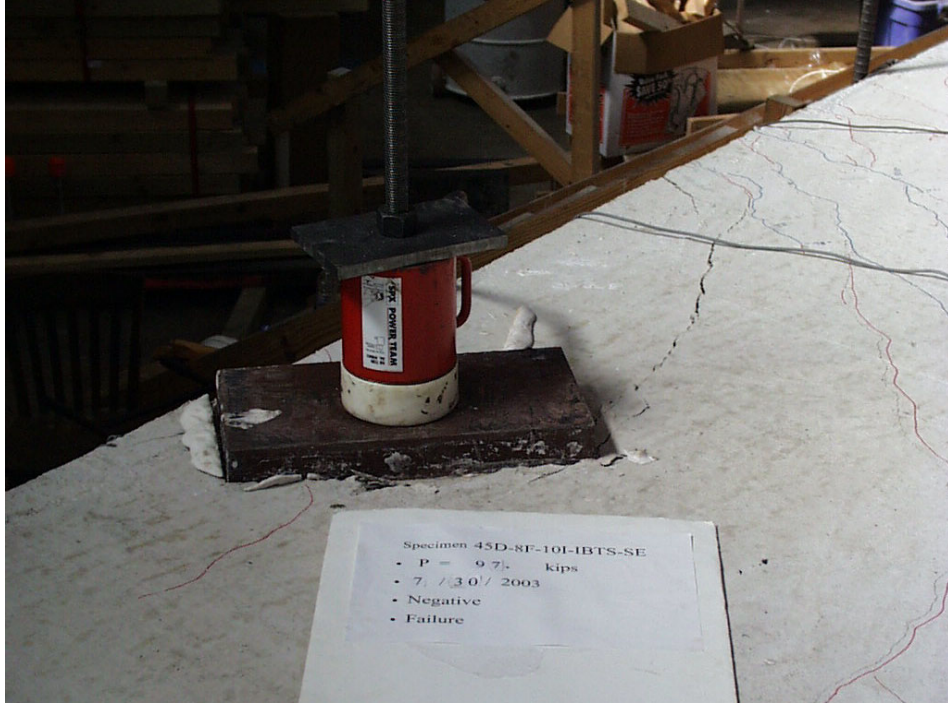
(a) Facing south

Figure 5-16 Exterior bay failure surface at top of slab

At the top surface of the slab, shear cracks around the load point indicate punching shear failure. The crack closely followed the perimeter of the load point on the west and north sides of the plate, and propagated to the slab edge on both sides. The failure surface that was visible on the bottom surface had a shape similar to that of cracks on the top surface.

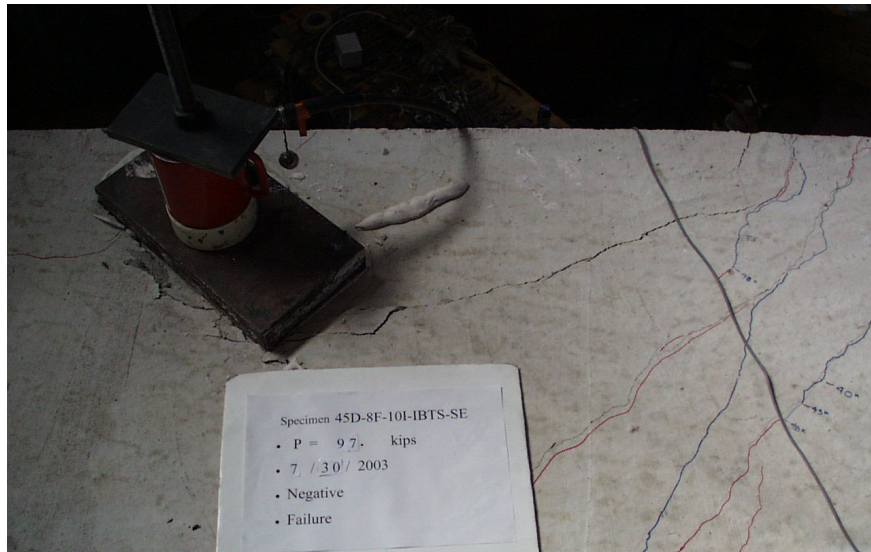
Because only the interior bay of the test area failed in punching shear, the remaining load point in the exterior bay was also loaded to failure, which occurred by punching shear at a load of $6.2 \times HS-25$. Figure 5-16 and Figure 5-17 show the failure surface after the test.

(b) Facing south

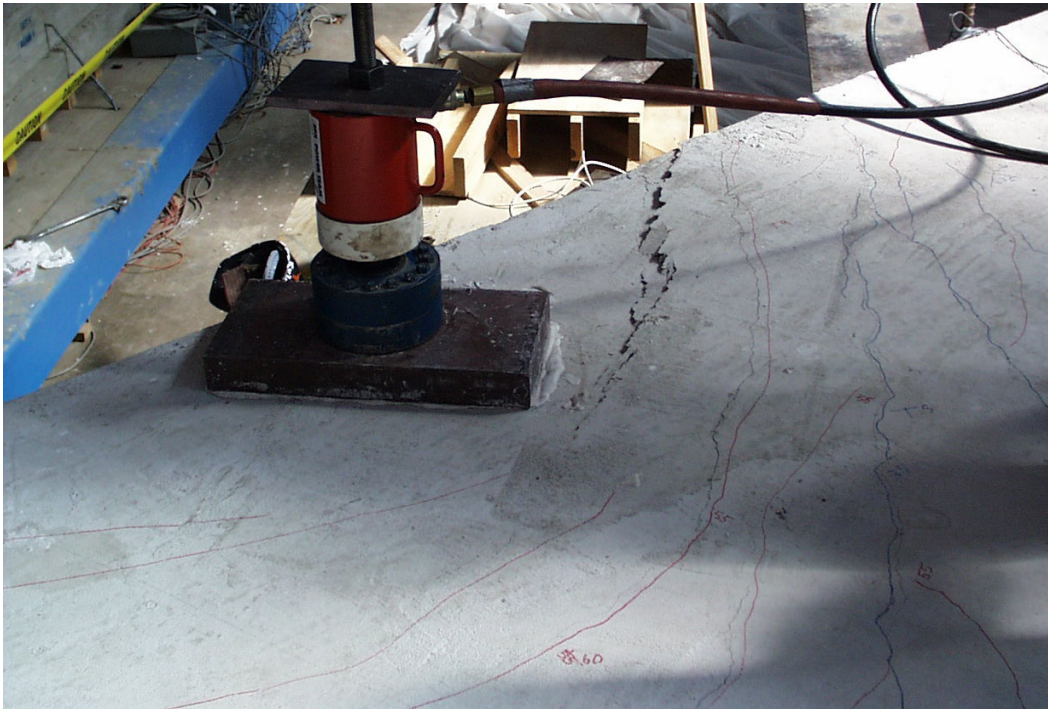
Figure 5-25 Interior bay failure surface at top of slab, facing north

At failure, cracks formed around the load point and extend to the slab edge of either side, in a pattern suggestive of punching shear failure. Figure 5-37 shows the failure surface as seen from the side of the slab. A large shear crack, labeled S13 during testing, opened wide during failure. Only a short section of the failure surface could be seen from the bottom of the slab. At the east-interior girder, the failure surface, as seen on the side of the slab, extends beneath the slab for a short distance.

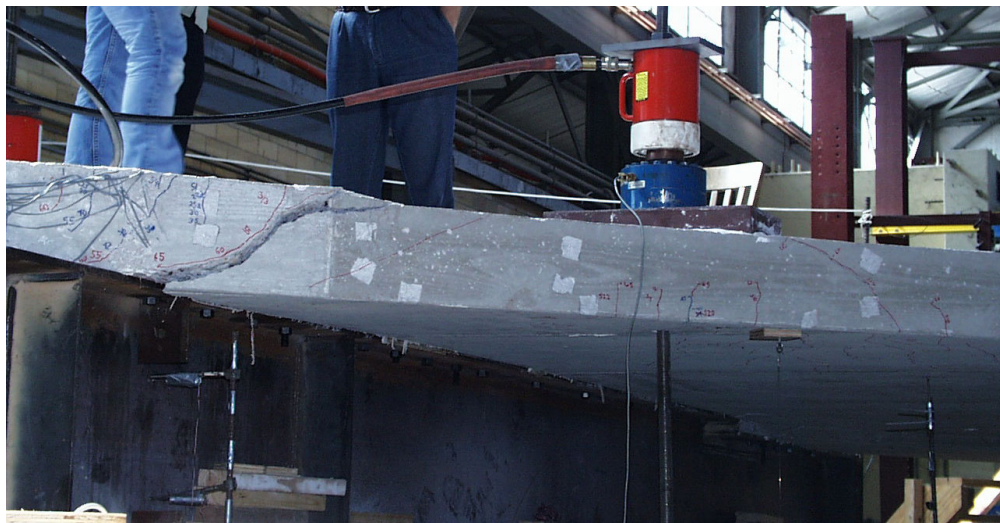
Figure 5-26 Interior bay failure surface at side of slab

At 4.3 x HS-25, punching shear failure occurred around the exterior loaded point in the interior bay. After failure, pictures were taken of the failure surface (Figure 5-25, Figure 5-36, Figure 5-27).

(a) Facing south

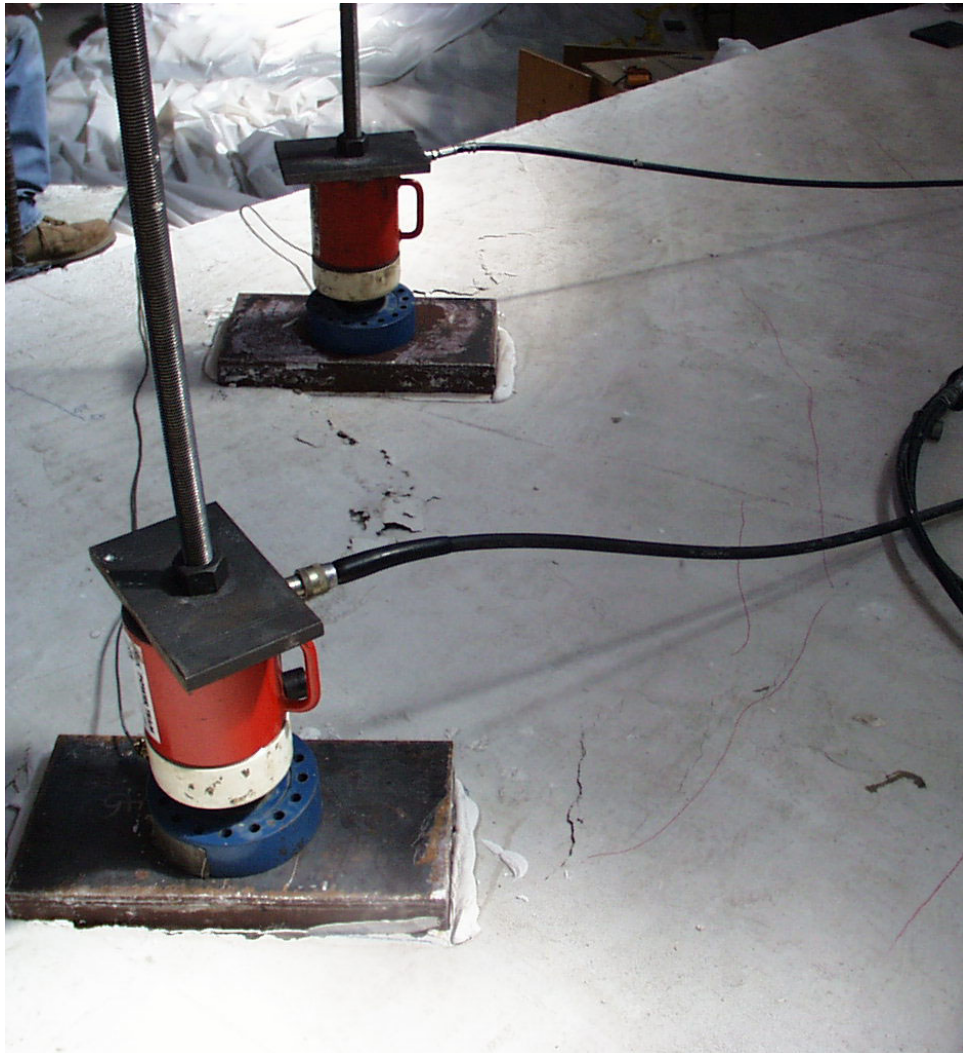
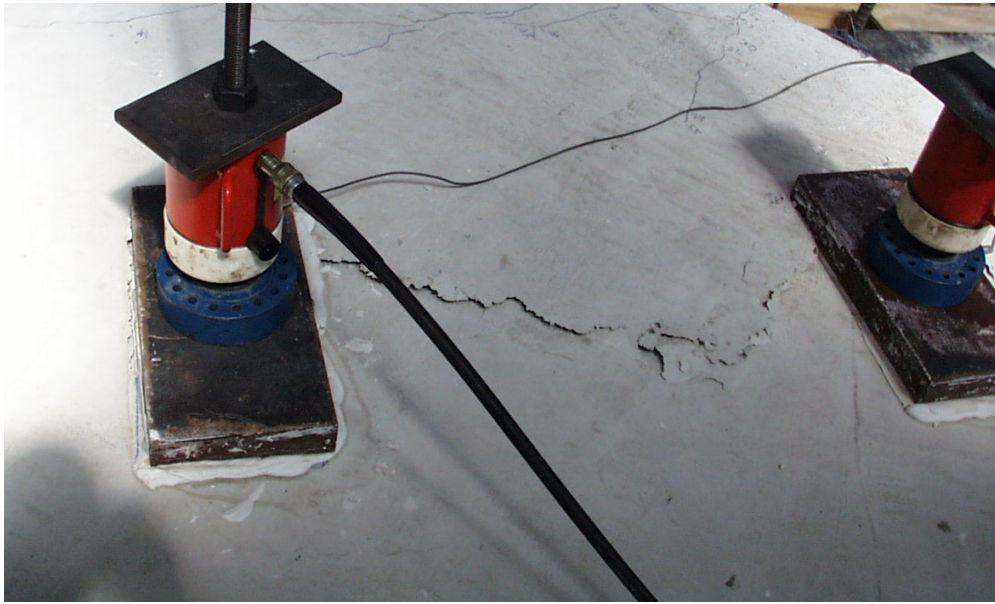
(a) Facing north

Figure 5-28 Exterior bay failure surface at top of slab

(b) Facing west

Figure 5-28 cont'd. Exterior bay failure surface at top of slab

Because only the interior bay of the test area failed in punching shear, the load points in the east-exterior bay were subsequently loaded to failure as well. Figure 5-28, Figure 5-29, and Figure 5-30 show the failure surface after failure occurred in the exterior bay. Failure initiated on the west side of the load plates simultaneously at 5.1 x HS-25. Simultaneous punching shear failures occurred near both plates, with the failure surfaces merging to form a single failure surface with an appearance like that corresponding to a one-way shear failure. The failure surface, as seen from the top of the slab, shows a shear crack around the exterior loaded point, to the slab edge (Figure 5-28). Figure 5-29 shows the failure surface from the side of the slab, including shear cracks with a small angle to the plane of the slab. Underneath the slab, the failure surface is visible around the interior load point and near the girder (Figure 5-30).

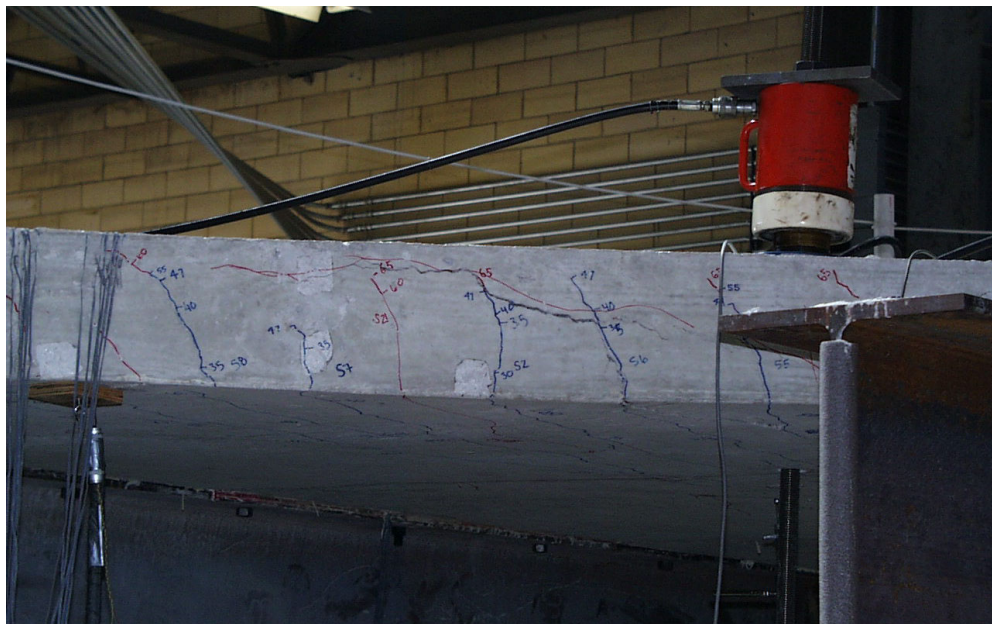
Figure 5-29 Exterior bay failure surface at side of slab, facing south

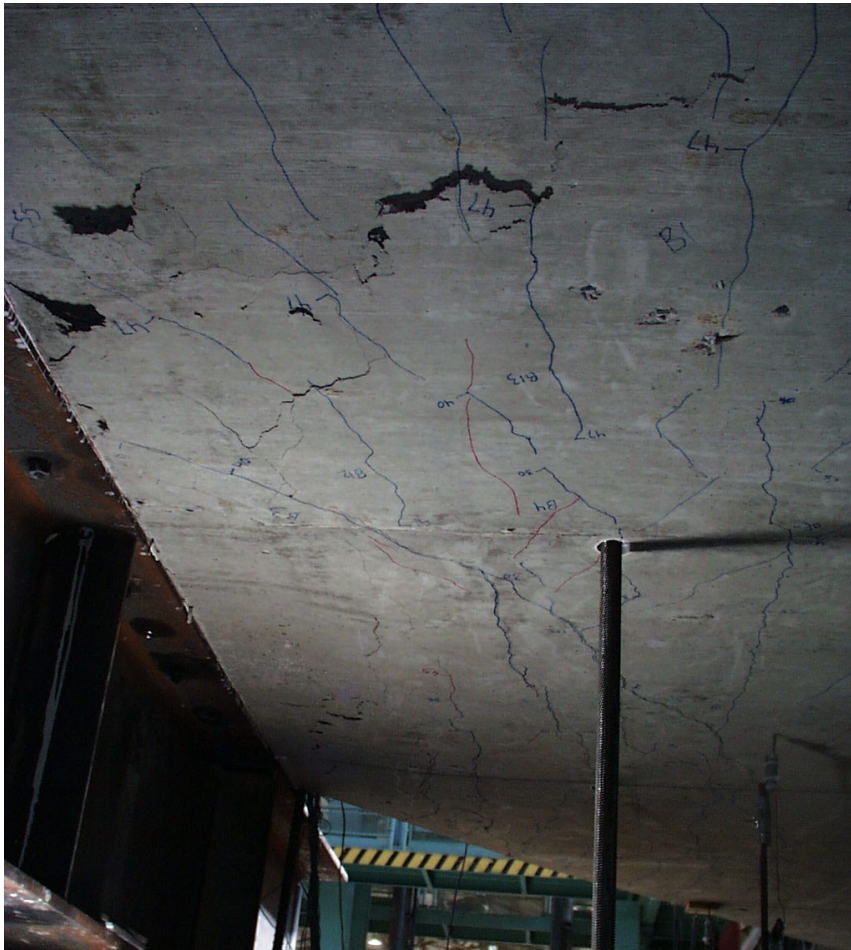
Figure 5-30 Exterior bay failure at bottom of slab, facing north

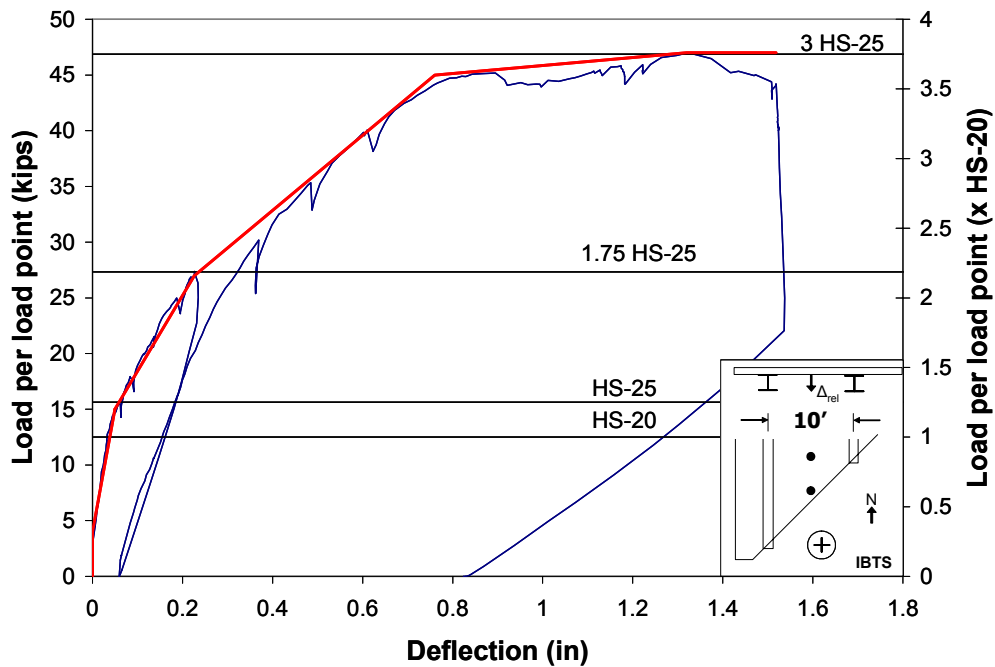
Deflections measured under HS-20 and HS-25 loads were extremely small compared to the girder spacing (1/4000 and 1/2000 respectively). The edge at midspan deflected 0.03 in. (0.8 mm) at HS-20, and 0.06 in. (1.5 mm) at HS-25 (Figure 5-32). Because cracking began at the latter load level, deflection did not increase proportionately with the load, to 0.23 in. (5.8 mm) at 1.75 x HS-25, and to 1.52 in. (39 mm) at failure.

Figure 5-32 Relative midspan edge deflection, IBTS, positive-moment region

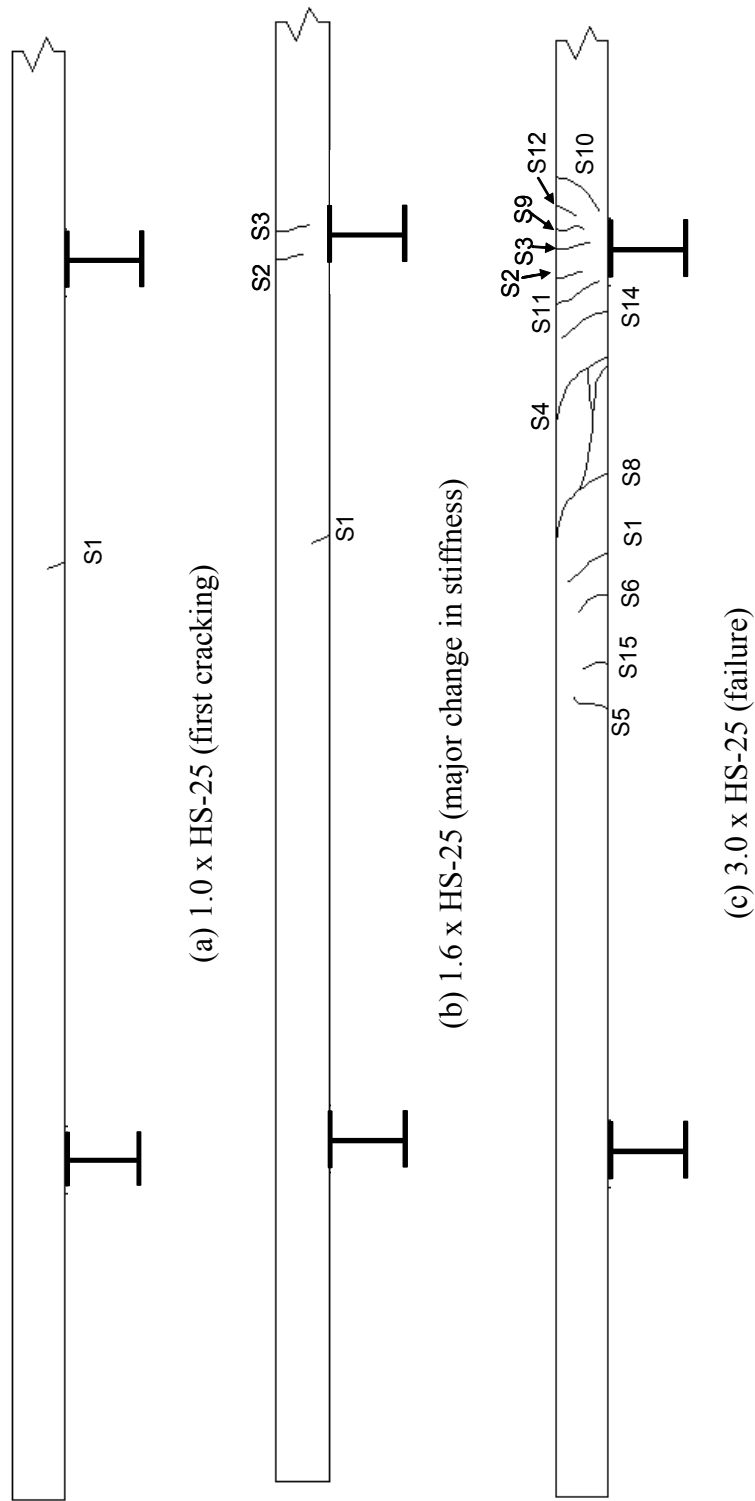
Figure 5-37 Crack map and key, IBTS, positive-moment region; side view of slab
