Behavior of Bridge Slab Ends at Expansion Joints

Thesis

The University of Texas at Austin

December 2003

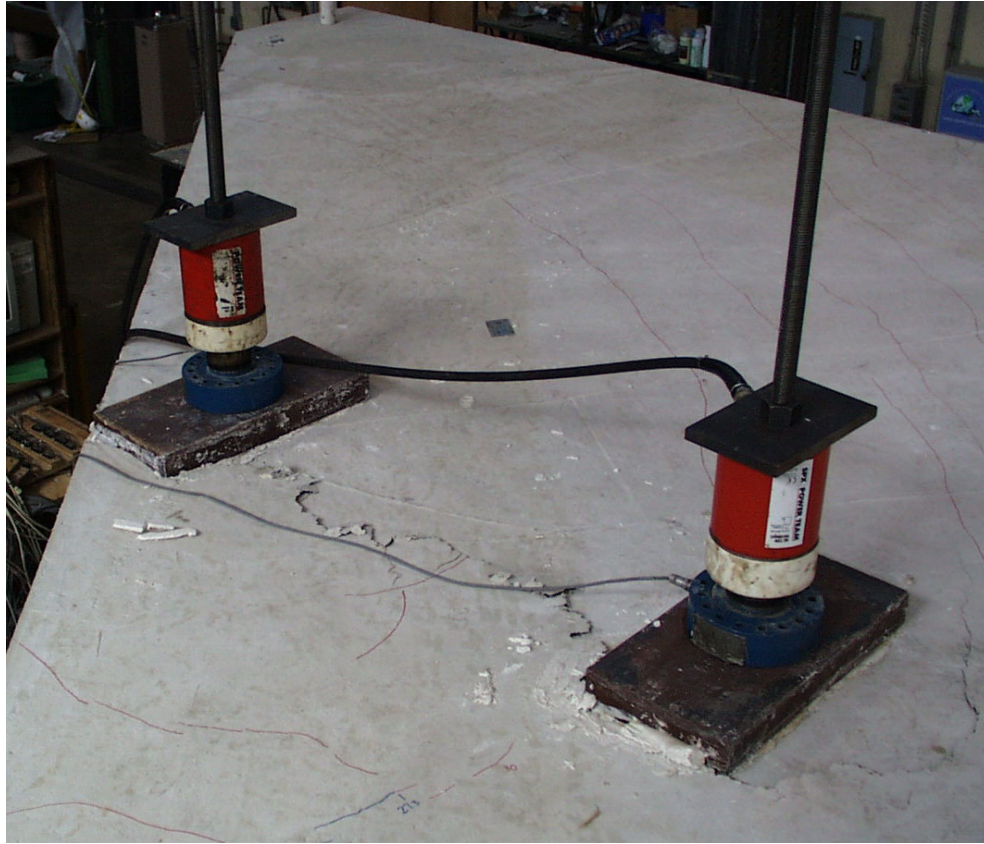
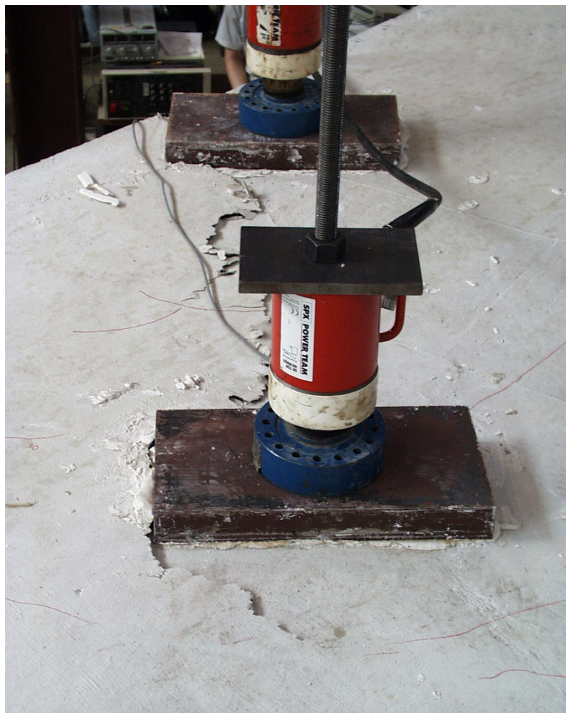
Figure 5-38 Failure surface at top of slab

Photographs of the failure surface are shown in Figure 5-38, Figure 5-39, and Figure 5-40. At 3.0 x HS-25, one-way shear failure occurred. The extension of the failure plane through the thickened end indicates that the section acted as a wide beam. As visible from the top of the slab, the one-way shear failure was parallel to the girders on the east side of the loaded points, and extended to the interior loaded point. The failure surface on the bottom of the slab was approximately parallel to the failure surface on the bottom of the slab. Beneath the slab, the failure surface extended through the end region, turned, and followed the end of the thickened section to the girder. As seen from the side of the slab, a large shear crack, labeled S8 during testing, opened wide during failure. As

corroborated by the three views, the failure surface extends through the full depth of the thickened end region.

(a) Facing southwest

(b) Facing south

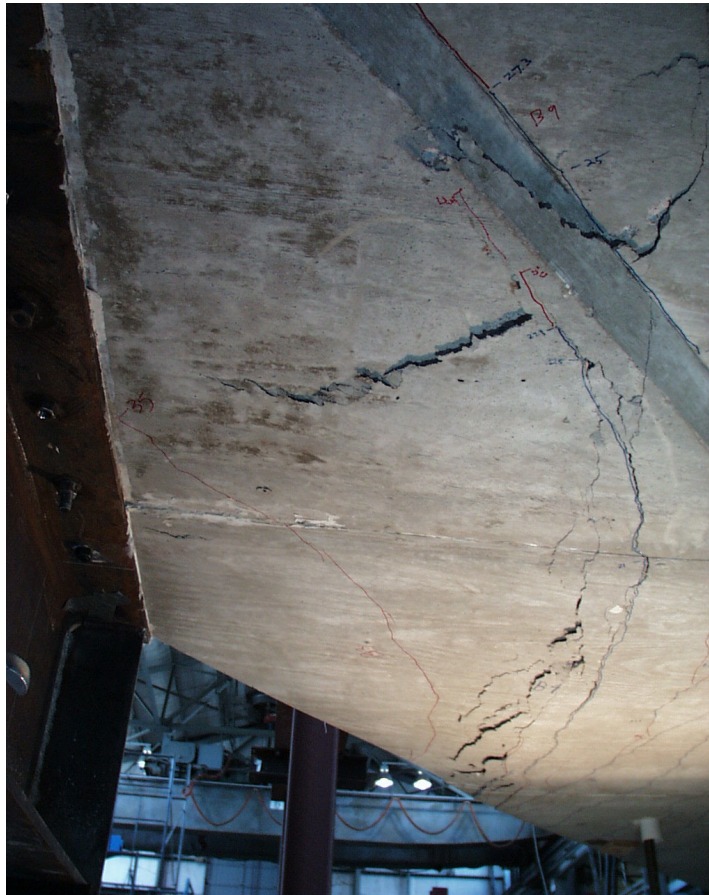
Figure 5-40 Failure surface at bottom of slab, facing south

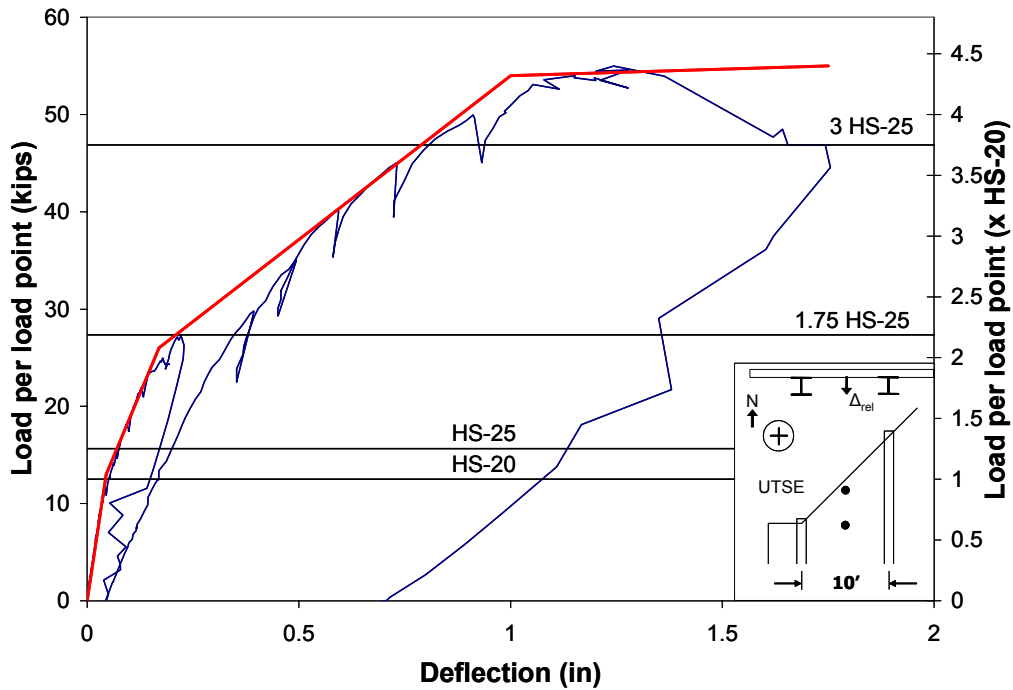
Deflections measured under HS-20 and HS-25 loads were extremely small compared to the girder spacing ($1/2400$ and $1/1500$ respectively) (Figure 5-42). At HS-20, the edge at midspan deflected 0.05 in. (1.3 mm). At HS-25, the deflection was 0.08 in. (2.0 mm). The measured edge deflection did not increase proportionately with the load between these two load steps. At $1.75 \times$ HS-25, the relative deflection was 0.22 in. (5.6 mm), and at $3 \times$ HS-25, it was 0.82 in. (21 mm). At failure, the relative deflection at the edge was 1.74 in. (44 mm).

Figure 5-42 Relative midspan edge deflection, UTSE, positive-moment region

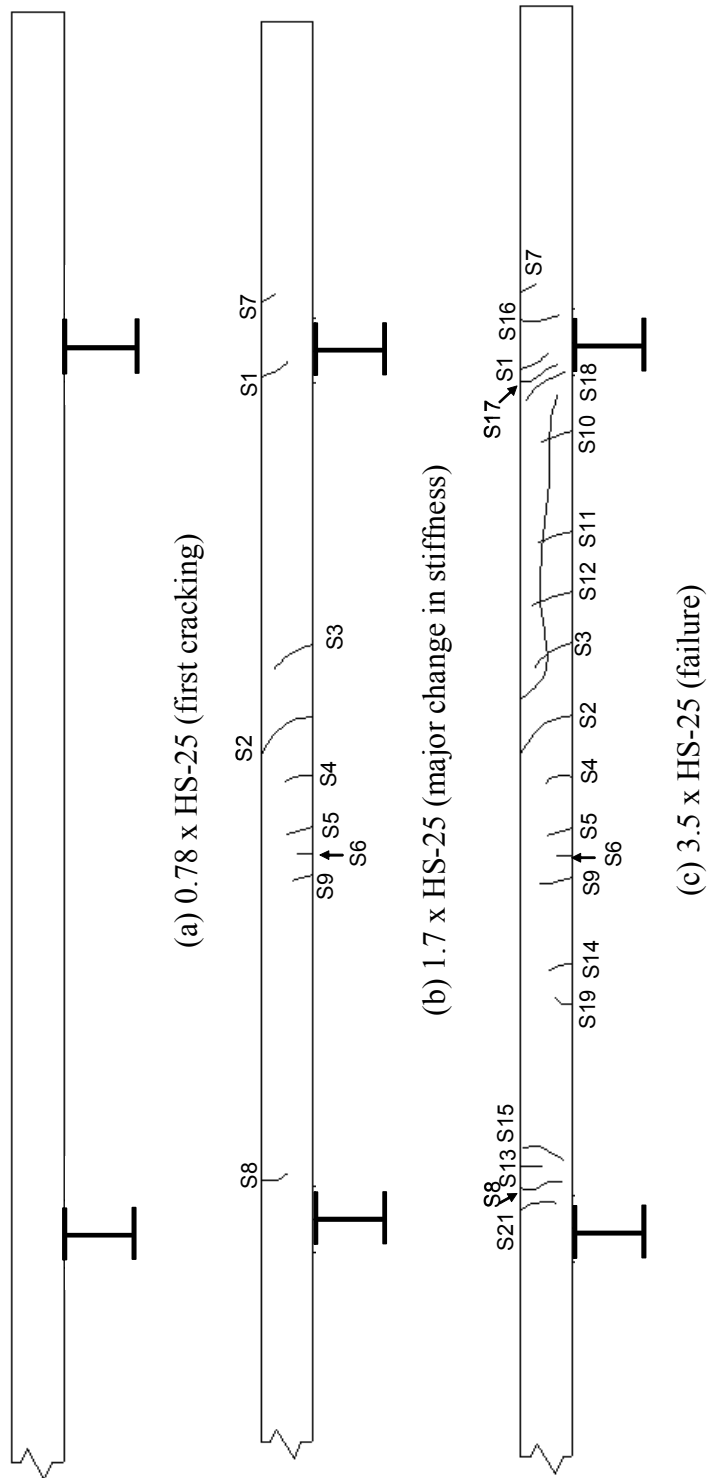
Figure 5-47 Crack map and key, UTSE, positive-moment region; side view of slab

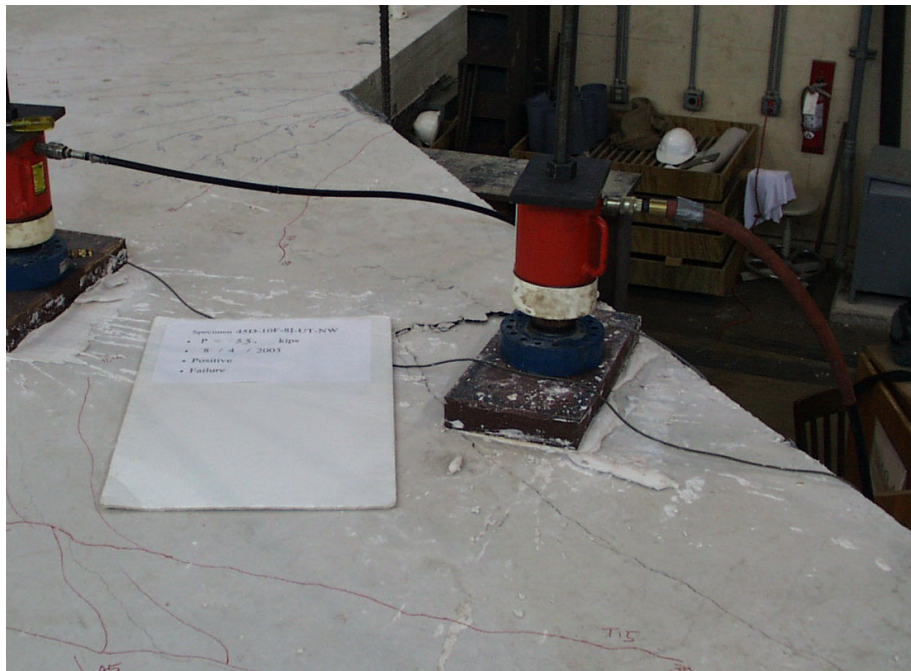
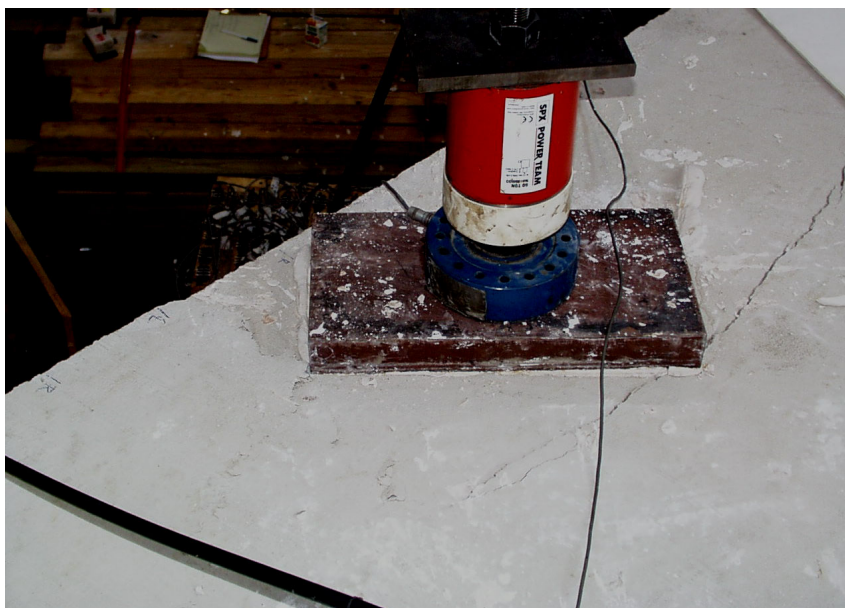
(a) Facing west

(b) Facing north

Figure 5-48 Failure surface at top of slab

At 3.5 x HS-25, failure was initiated by punching shear at the loaded point closest to the edge of the slab (Figure 5-48, Figure 5-49, Figure 5-50). From the top of the slab, the failure surface extended around the loaded point to the slab edge on both sides. From the side of the slab, shear cracks extend from the top of the slab to the bottom on both sides of the loaded point. The failure surface is easily visible from beneath the slab.

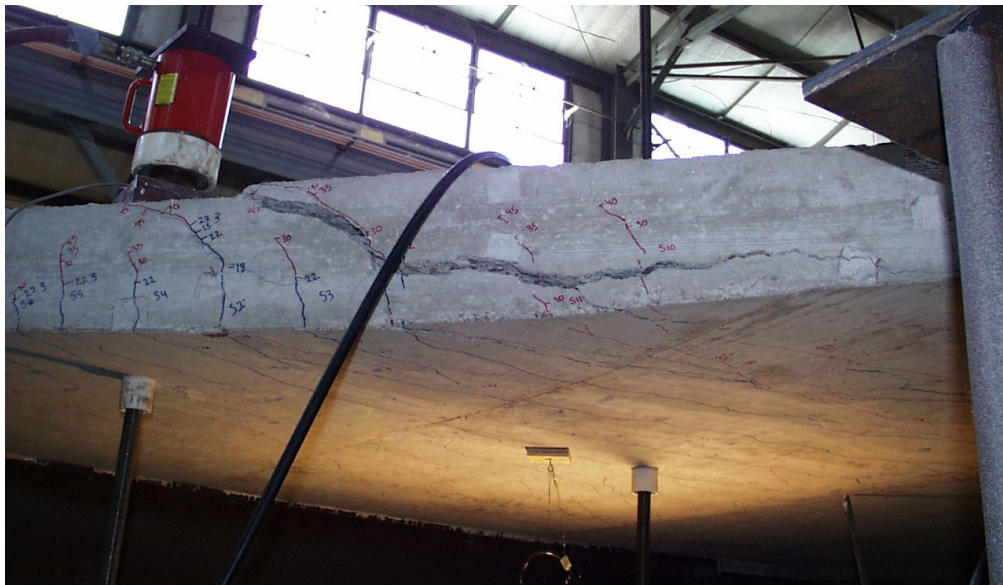
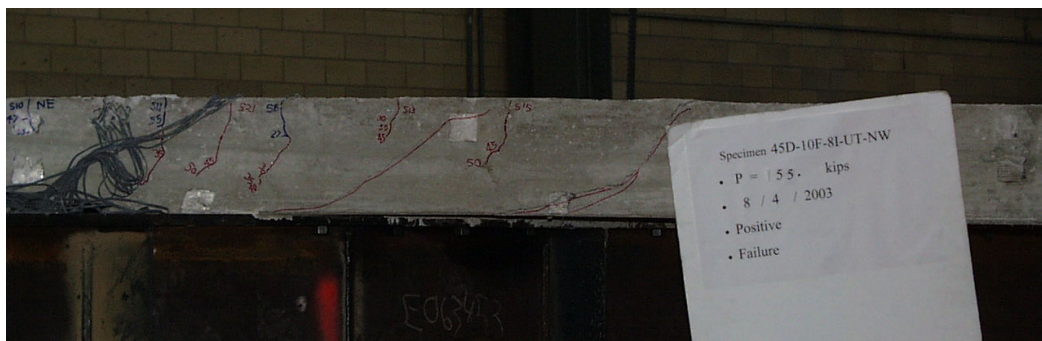
Figure 5-49 Failure surface at side of slab

(a) Facing south

(b) Facing south

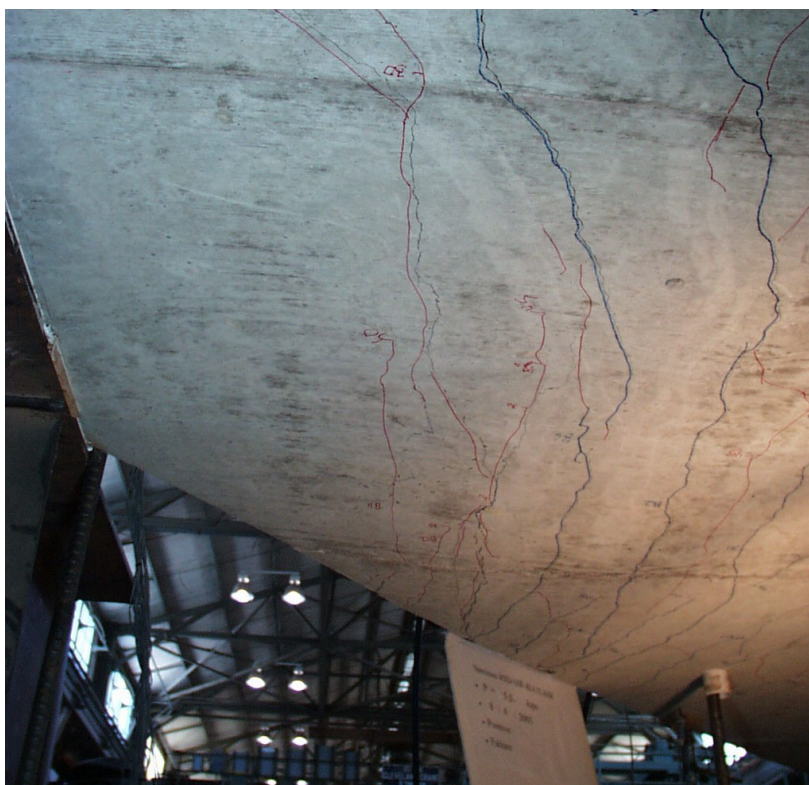
Figure 5-50 Failure surface at bottom of slab, facing north

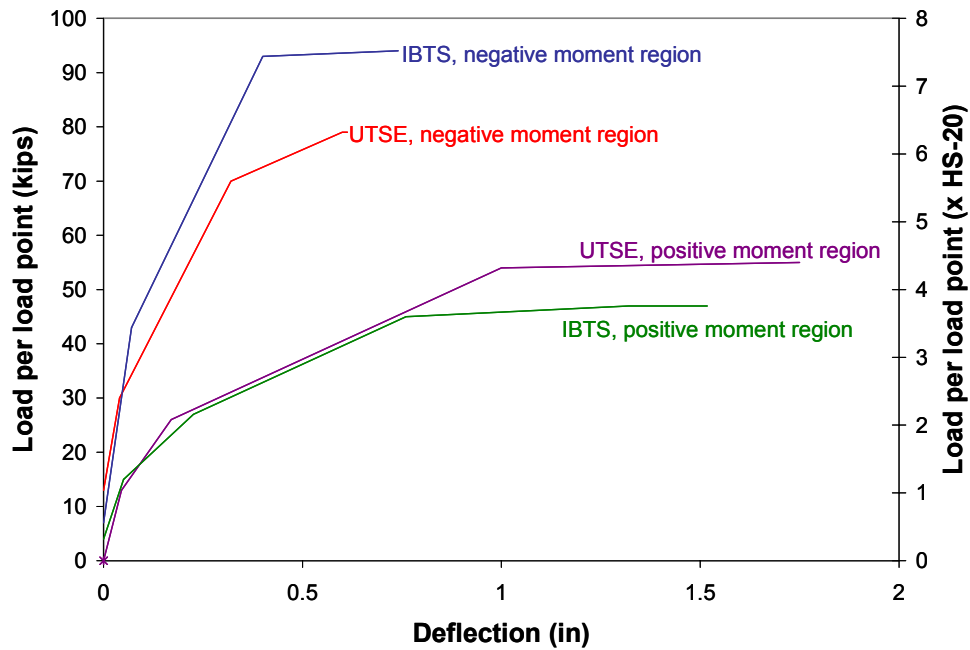
Figure 5-51 shows deflection envelopes for all four test areas on the 45° skew test specimen. Overall, the tests maximizing negative moments behaved similarly, and the tests maximizing positive moments behaved similarly. In the negative-moment tests, reserve strength was higher, stiffness was greater, and deflections were smaller than in the positive-moment tests. In the positive-moment test regions, first cracking was observed earlier, and tensile strains were higher for respective end detail tests.

Figure 5-51 Deflection envelopes, all tests

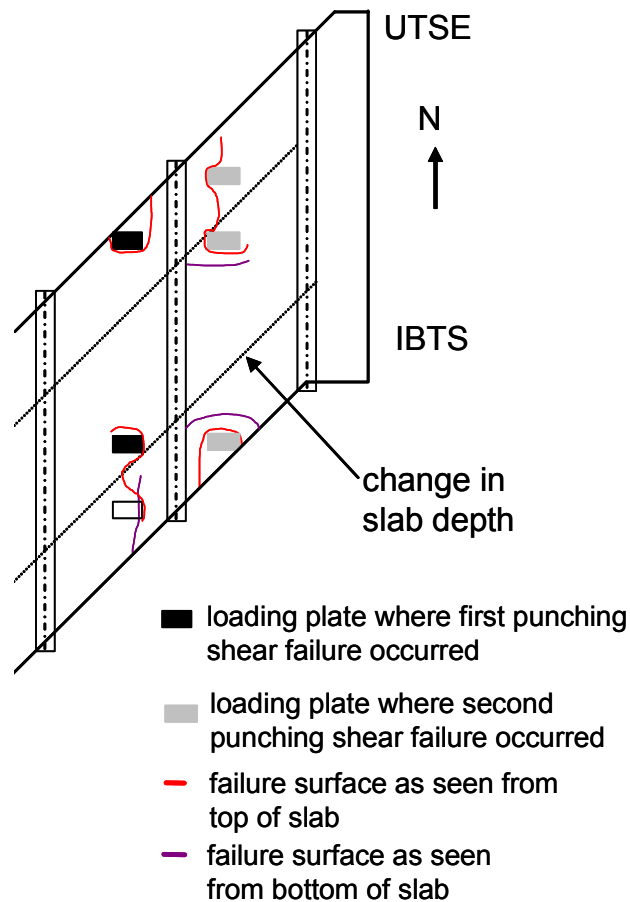
Figure 5-52 Locations of punching shear failure, negative-moment tests

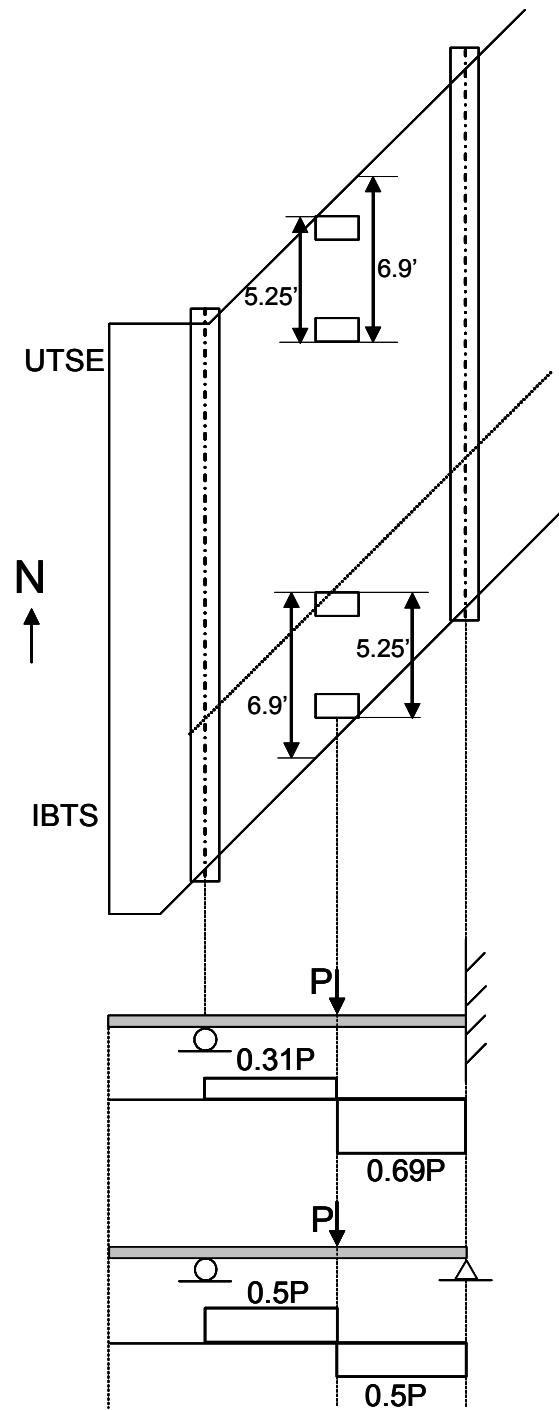
Combining the two effects, the IBTS detail would experience higher shear forces at a location where the length of the critical section for beam shear is shorter. The UTSE detail would experience lower shear forces at the shorter critical section or higher shear forces at the longer critical section. Although the UTSE detail failed in punching shear, a small beam-shear crack formed after punching shear failure, indicating that the failure load was in the vicinity of the beam-shear failure load when punching shear failure was experienced.

Figure 5-54 Elastic shear distribution, positive-moment tests

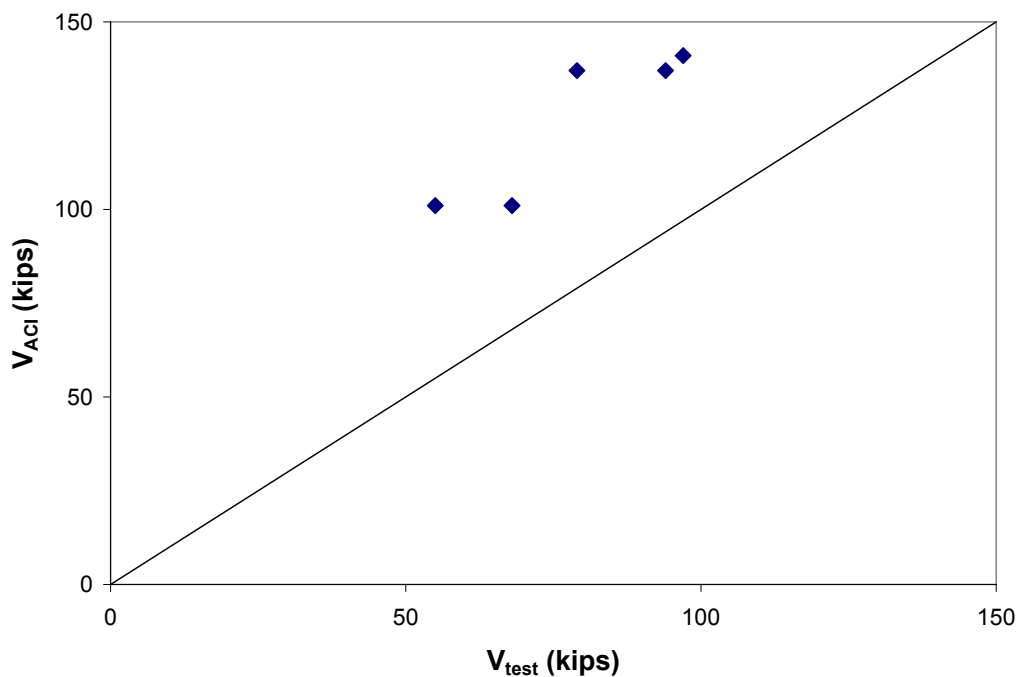
Figure 5-57 compares the observed punching-shear capacities from the 45° skew span tests against the nominal capacity by ACI 318-02 provisions (Equation 5-3 and Equation 5-4), assuming a uniform shear distribution on the perimeter of the critical section. For the tests on the 45° skew specimen, the assumption of a uniform stress distribution results in unsafe predictions of punching-shear capacity. The punching capacity of the bridge slab, loaded with an AASHTO load configuration, is only about 45% to 85% of that predicted by ACI 318-02 and AASHTO LRFD provisions, assuming a uniform shear stress distribution.

Figure 5-57 Comparisons of ACI 318-02 predictions with experimental results

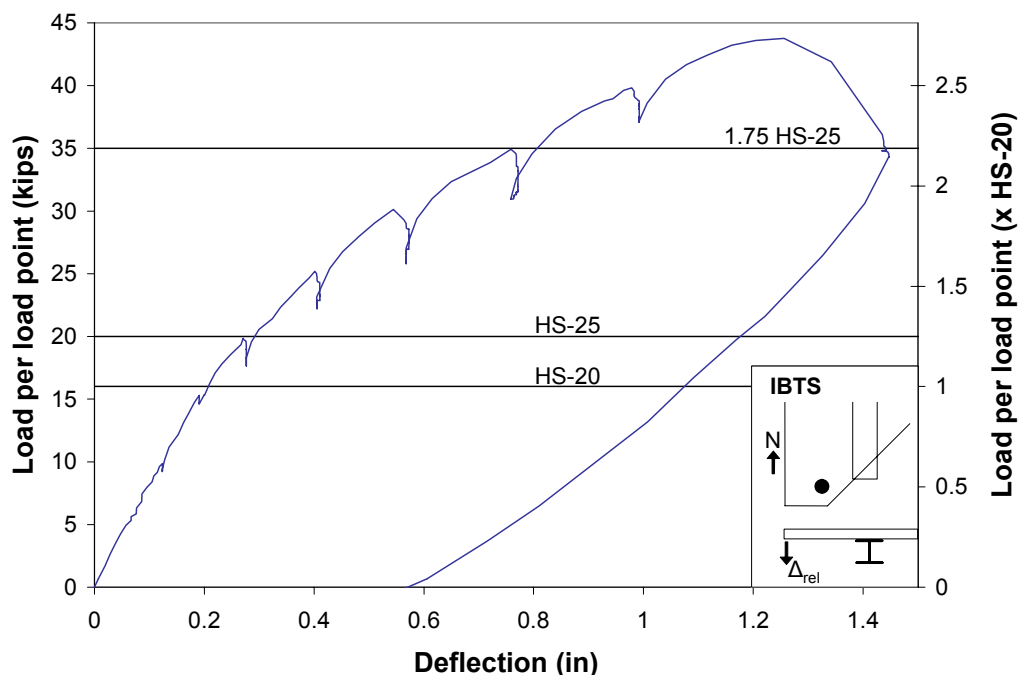
in. (7 mm) at HS-25. At 1.75 x HS-25, it was 0.76 in. (19 mm). The largest deflection measured before failure was 1.34 in. (34 mm).

Figure 6-7 Tip deflection, breakback IBTS overhang

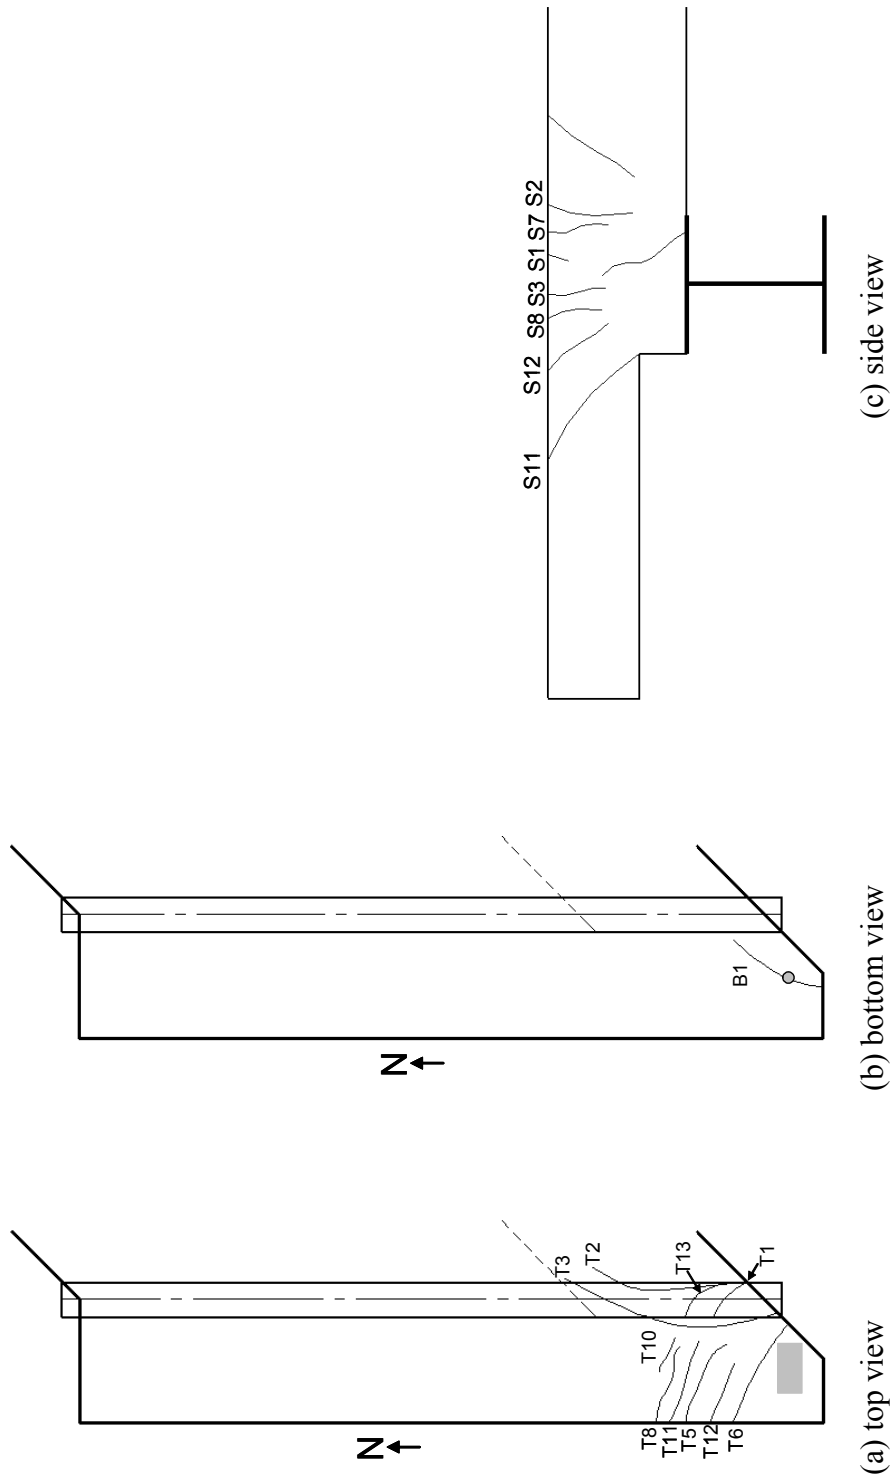
Figure 6-10 Crack map at failure, breakback IBTS overhang: (a) top view; (b) bottom view; (c) side view, facing north; (d) key to crack widths and lengths at failure

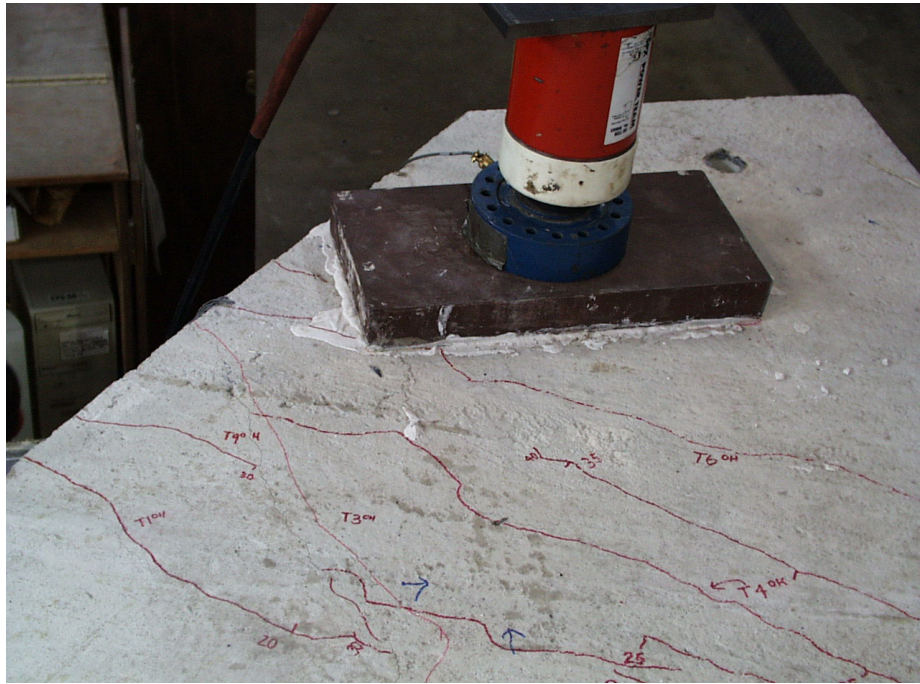
Figure 6-11 Failure of breakback IBTS overhang, top view, facing south

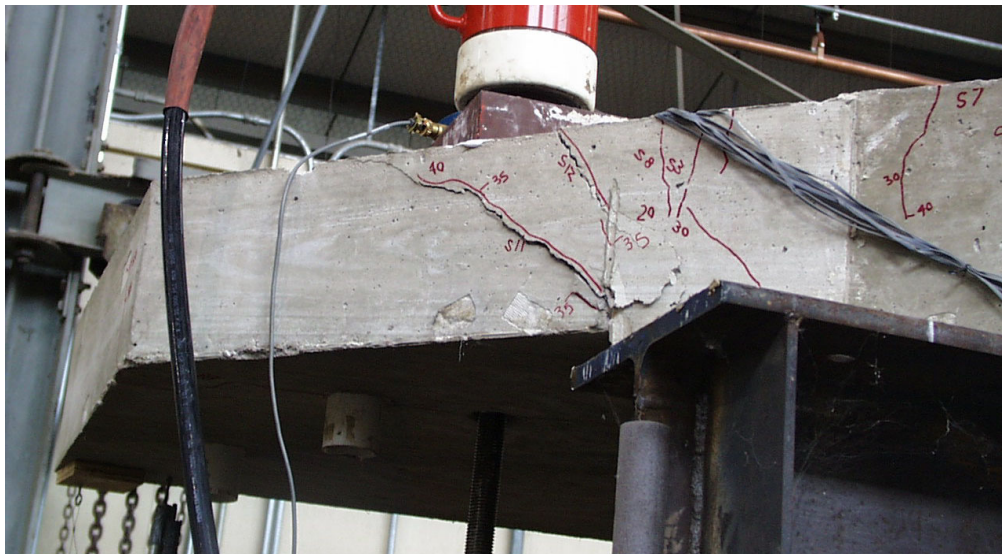
Figure 6-12 Failure of breakback IBTS overhang, side view, facing northeast

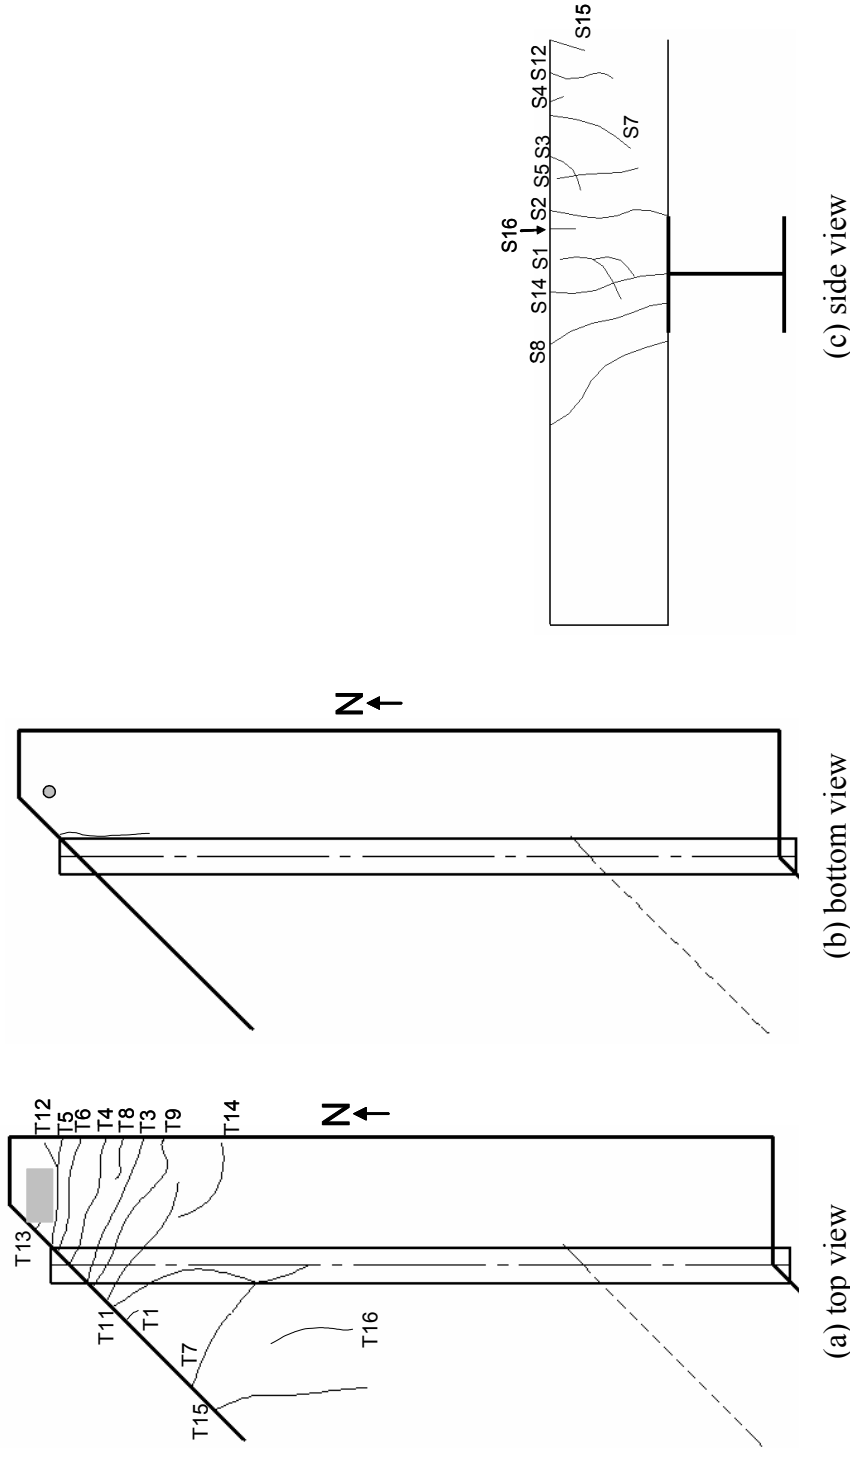
Figure 6-17 Crack maps at failure, breakback UTSE overhang, top view of slab: (a) top view; (b) bottom view; (c) side view, facing south; (d) key to crack lengths and widths at failure

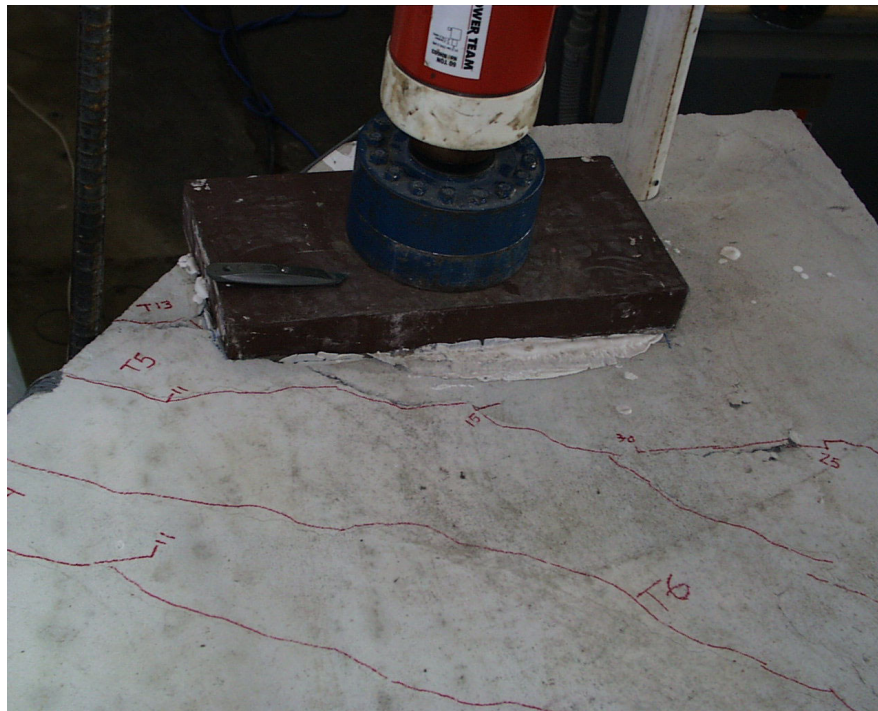
Figure 6-18 Failure of breakback UTSE overhang, top view of slab, facing north

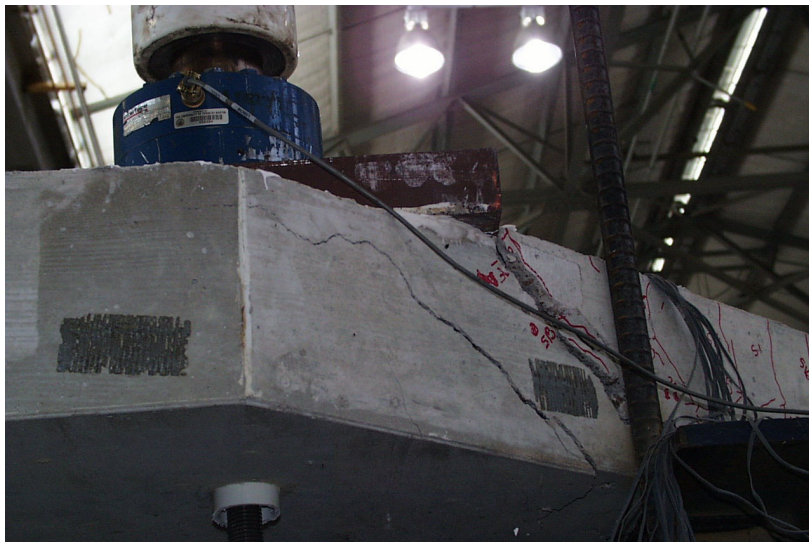
Figure 6-19 Failure of breakback UTSE overhang, side view of slab, facing south

During testing, cracks were first observed at 0.7 x HS-20 on the top and side of the deck. As applied loads were increased, cracks formed primarily perpendicular to the skewed slab end and parallel to the girder over the girder (Figure 6-17). The pattern of cracks visible on both the top and side of the deck indicate flexural and torsional cracking. Flexural and torsional cracks formed on the top of the deck, were visible on the side of the deck, but did not propagate through to the bottom of the deck. Shear cracks were visible on the side of the deck at failure, and are best illustrated in the pictures taken at failure (Figure 6-19).

Figure 6-18, Figure 6-19, and Figure 6-20 show the slab after failure. The shape of the failure surface indicates that this area failed in one-way shear. During failure, a large shear crack formed on the side of the deck, propagating from the edge of the girder leading up to the corner of the load plate (Figure 6-19). No cracks formed on the bottom of the deck during testing; just before failure, however, a failure surface formed beneath the slab at the intersection of the girder and slab (Figure 6-20). Cracking on the bottom of the deck is difficult to identify in the pictures taken after failure, so the locations of cracks is shown in Figure 6-17b (crack map of the bottom of the deck).

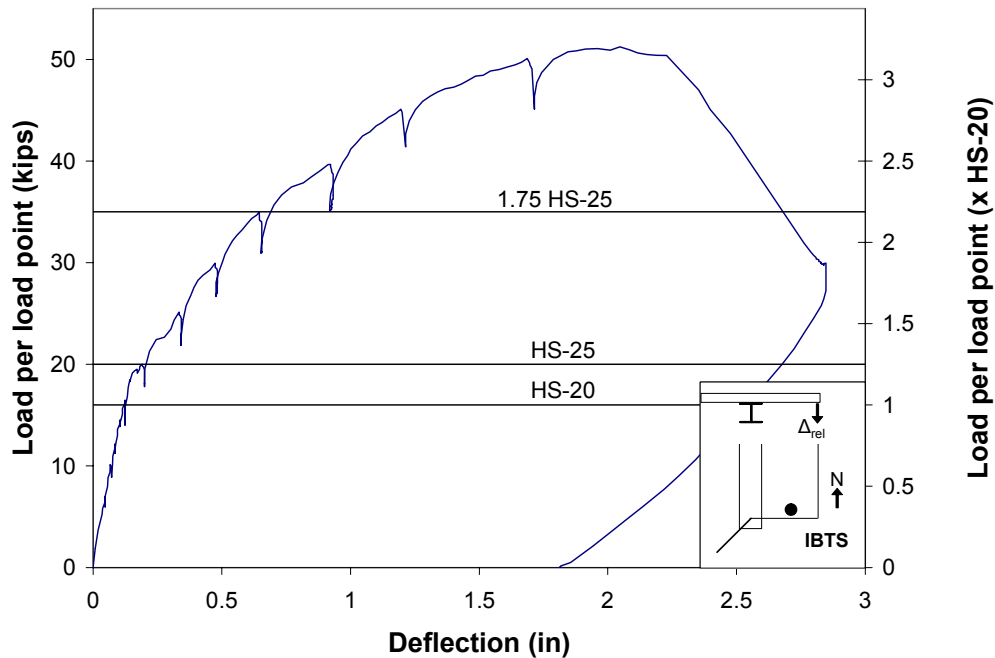
Figure 6-22 Tip deflection, simulated 0° skew IBTS overhang

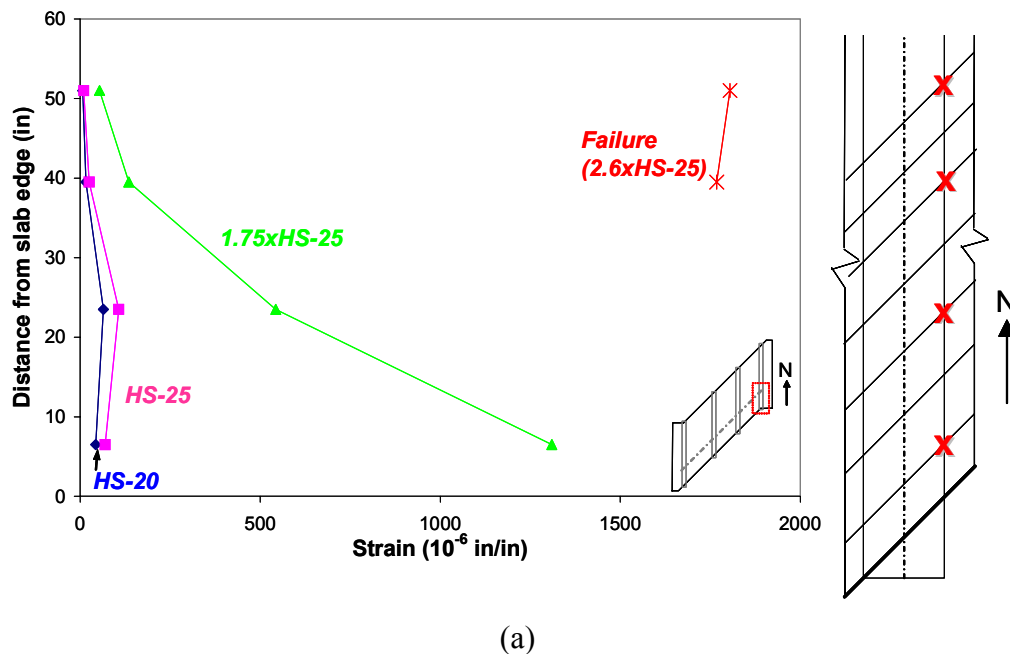
Figure 6-24 Strain profile, simulated 0° skew IBTS overhang: (a) east side of girder, top mat; (b) west side of girder, top mat

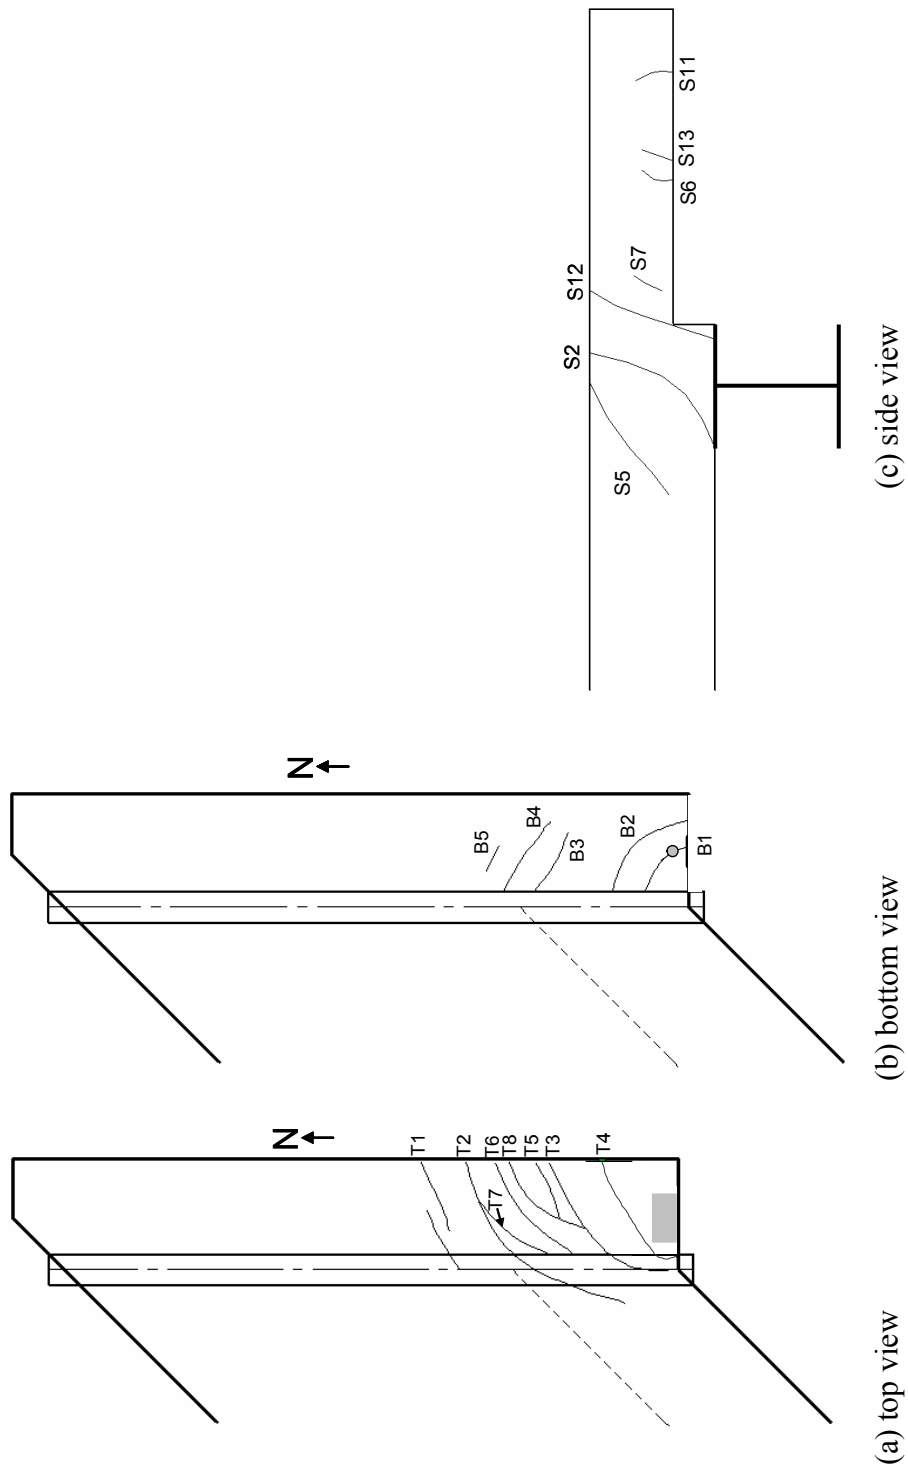
(a) top view (b) bottom view (c) side view
Figure 6-25 Crack maps at failure, simulated 0° skew IBTS overhang: (a) top view of slab; (b) bottom view of slab; (c) side view of slab, facing north; (d) key to crack widths and lengths

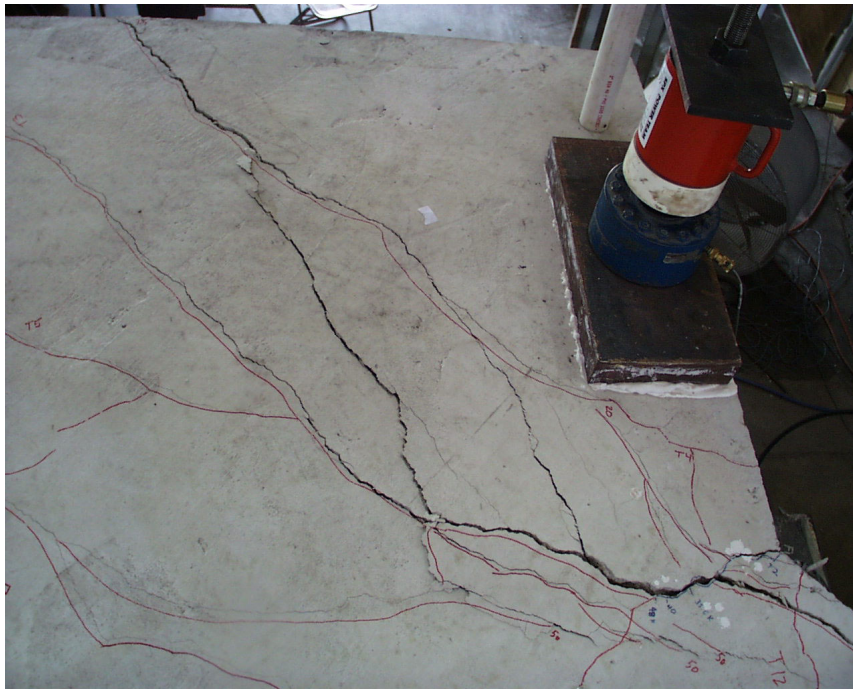
Figure 6-26 Failure of simulated 0° skew ITBS overhang, top view of slab, facing east

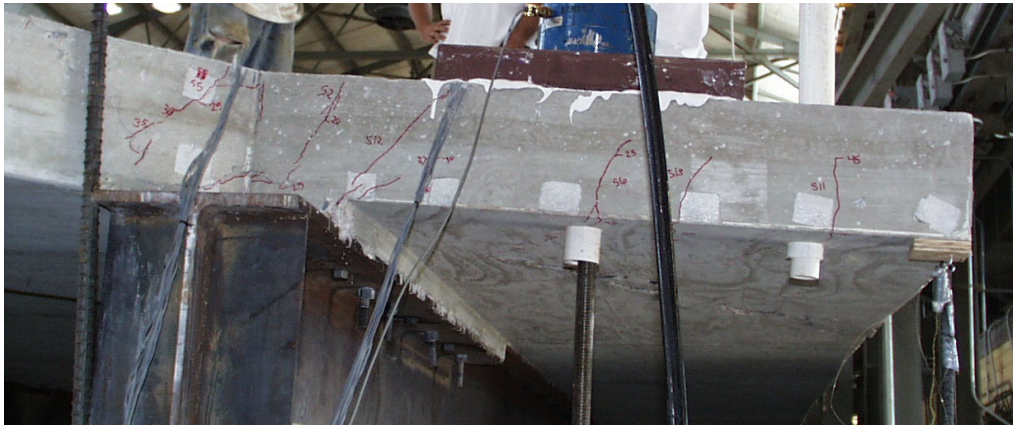
(a) Facing north

Figure 6-26, Figure 6-27, and Figure 6-28 show the slab after failure. The shape of the failure surface indicates that this area failed in punching shear. During failure, a shear crack was visible on the top of the slab around the load plate. This failure surface extended from the free edge of the overhang to slab edge over the girder. From the south side of the deck, a large shear crack could be seen propagating from the crack on the top of the slab; on the east side of the deck, the same shear crack can be traced to the bottom of the deck (Figure 6-28). Although extensive torsional cracking was visible on the top and bottom of the deck during testing, torsional moments did not initiate failure. The failure surfaces on the bottom and on the top surfaces of the deck are parallel to each other, and clearly indicate a two-way shear failure.

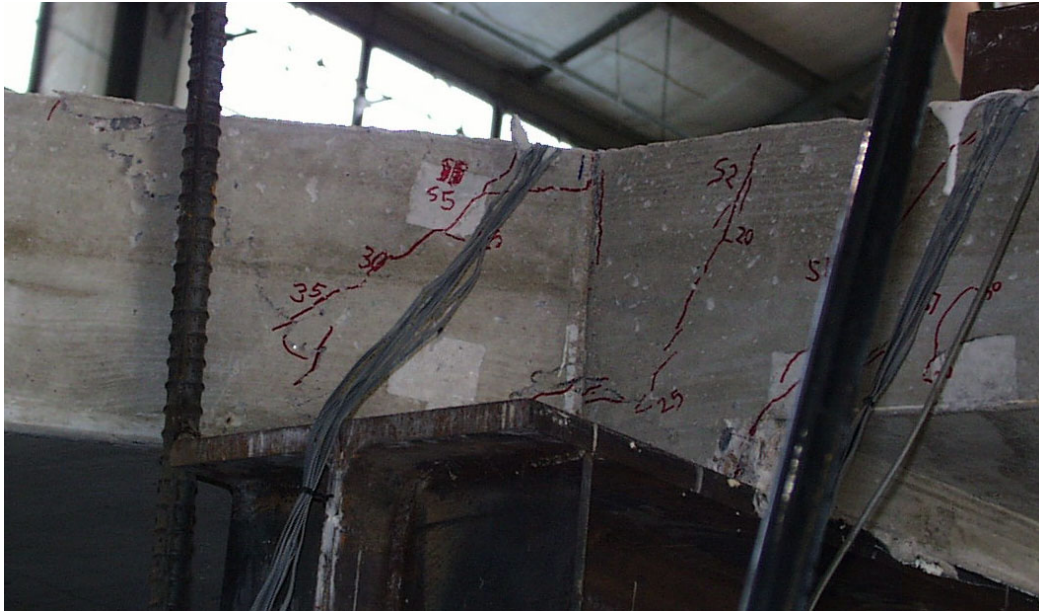
(b) Facing northwest

Figure 6-27 Failure of simulated 0° skew IBTS overhang, side view of slab

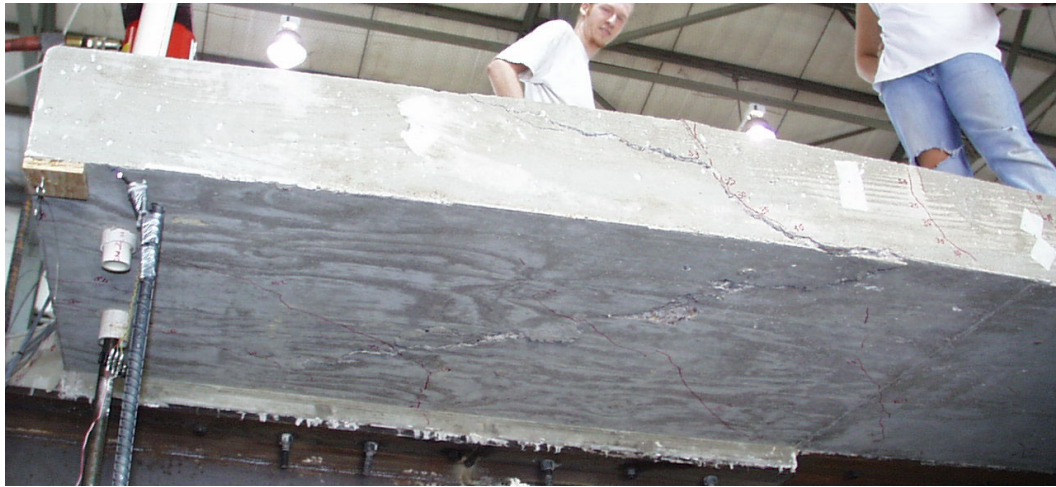
Figure 6-28 Failure of simulated 0° skew IBTS overhang, bottom view of slab facing west

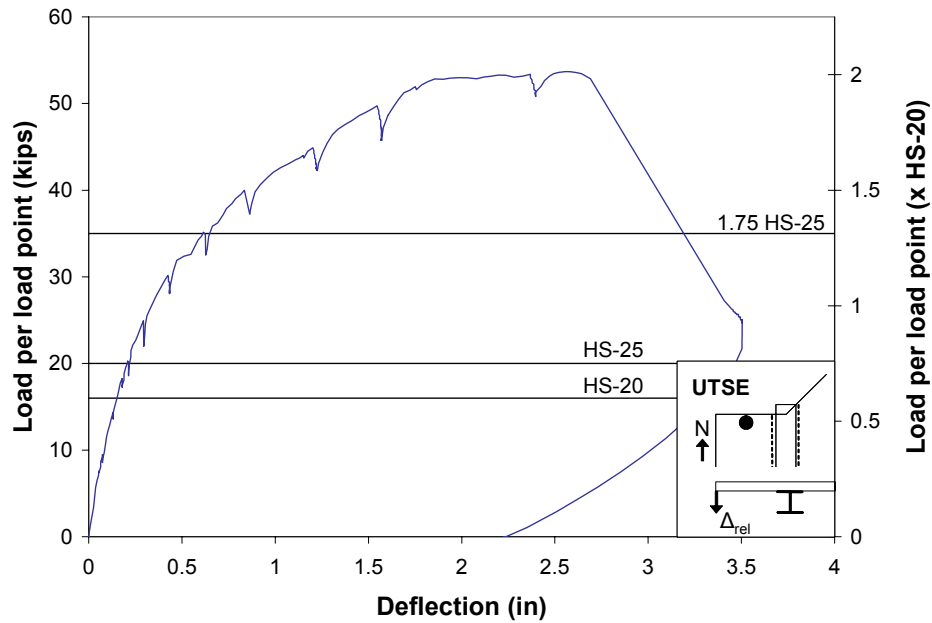
Figure 6-30 Tip deflection, simulated 0° skew UTSE overhang
