Behavior of Bridge Slab Ends at Expansion Joints

Thesis

The University of Texas at Austin

December 2003

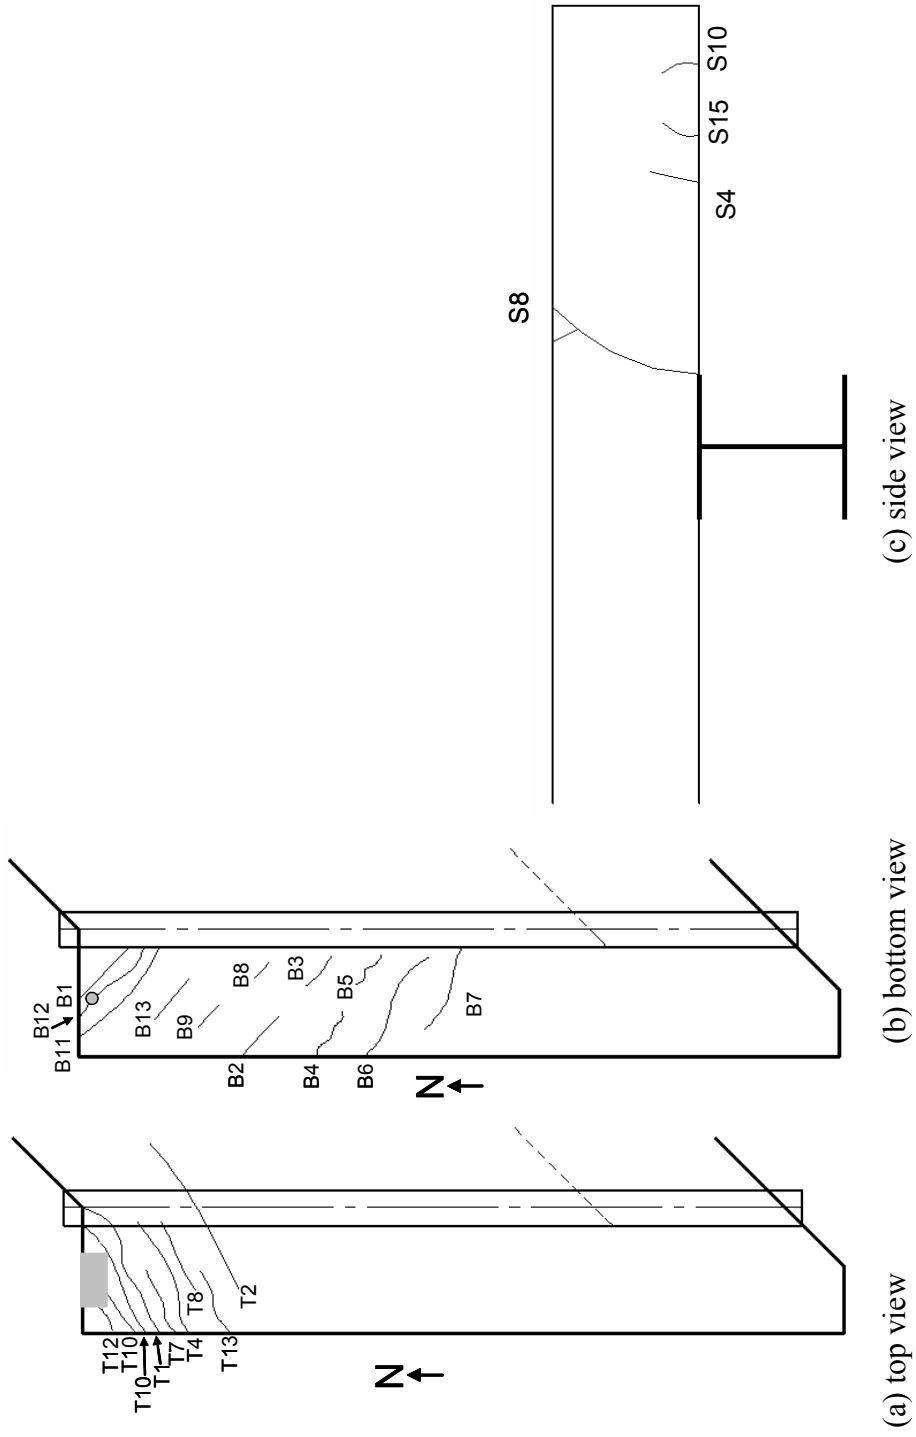
Figure 6-33 Crack maps at failure, simulated 0° skew UTSE overhang: (a) top view of slab; (b) bottom view of slab; (c) side view of slab, facing north; (d) key to crack widths and lengths at failure

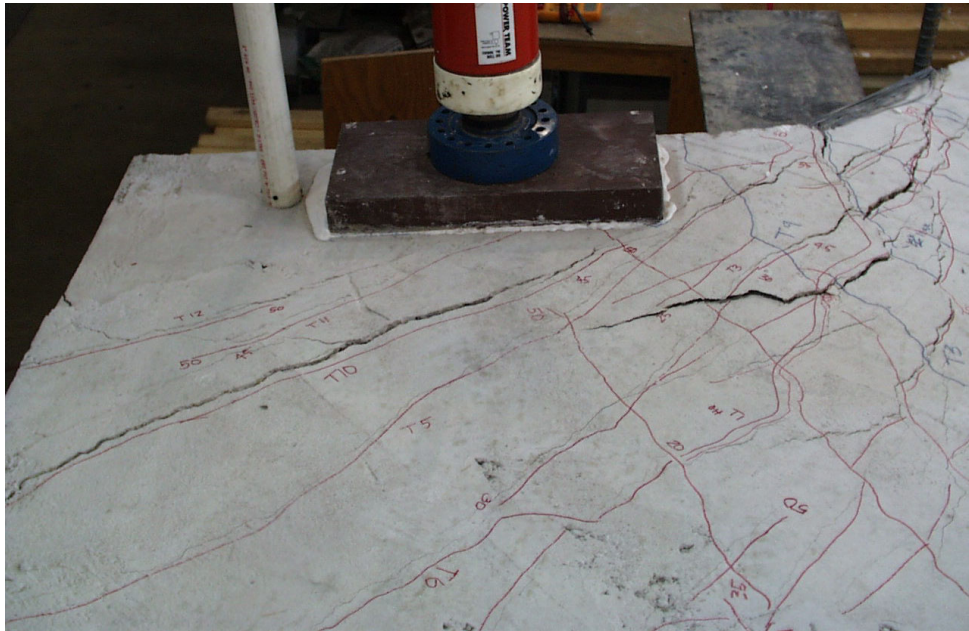
Figure 6-34 Failure of simulated 0° skew UTSE overhang, top view of slab, facing north

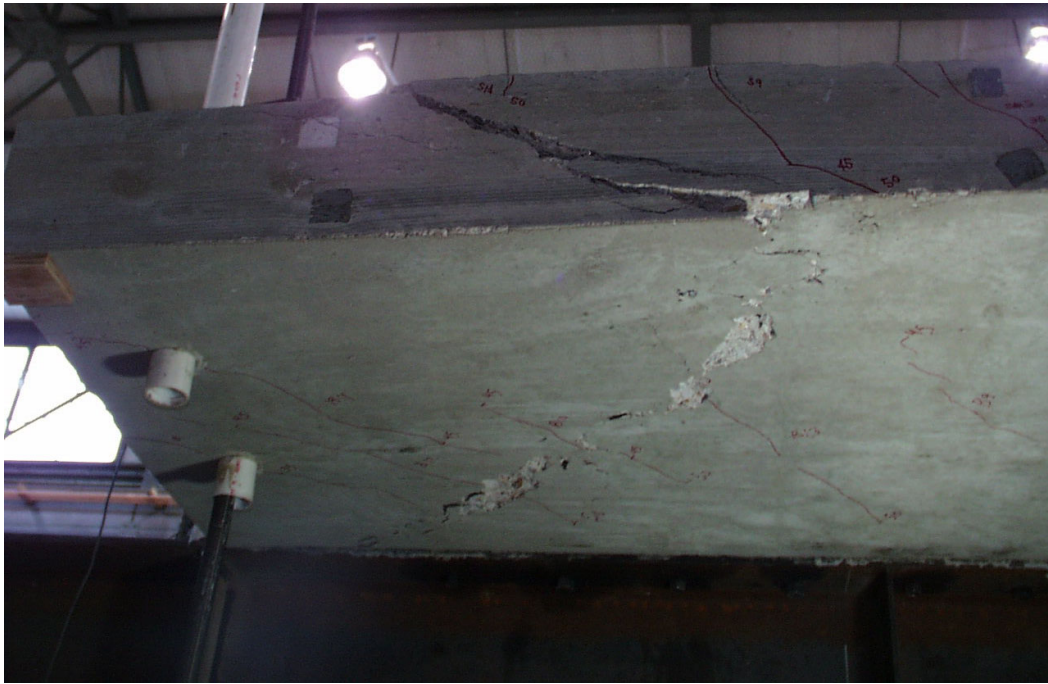
Figure 6-36 Failure of simulated 0° skew UTSE overhang, bottom view of slab, facing east
