**Structural Assessment of Bridge Piers with Damage similar to Alkali  
Silica Reaction and/or Delayed Ettringite Formation**

**Thesis**

The University of Texas at Austin

**May 2006**

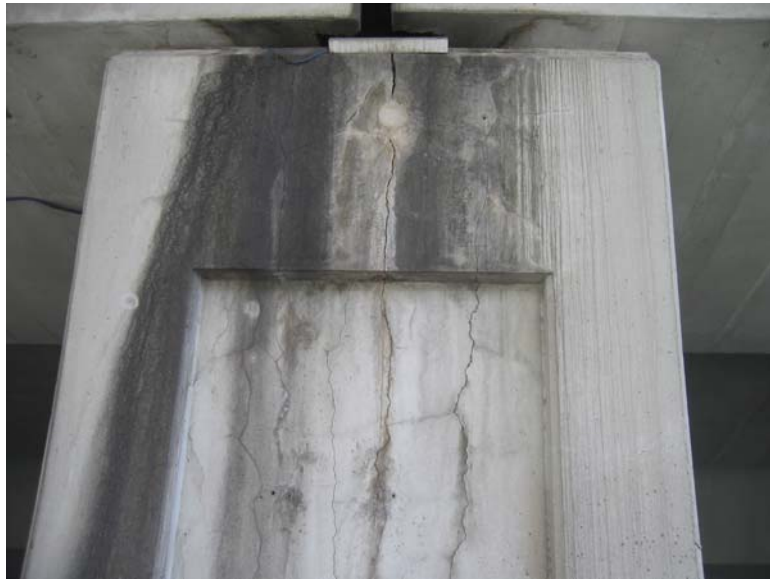
*Figure 1.2: ASR and/or DEF Damage in Reinforced Concrete (DD-6)*

Through testing conducted at the Concrete Durability Center at The University of Texas at Austin, it has been found that many structural elements in the San Antonio Y, including the columns in spine DD, are suffering from materials related distress. The two main causes for distress are Alkali-Silica Reaction (ASR) and/or Delayed Ettringite Formation (DEF) (Folliard 2005). ASR and DEF are both chemically related internal forms of deterioration in concrete. Figures 1.2 and 1.3 are illustrations of the type of damage that can occur in reinforced concrete suffering from ASR and/or DEF.

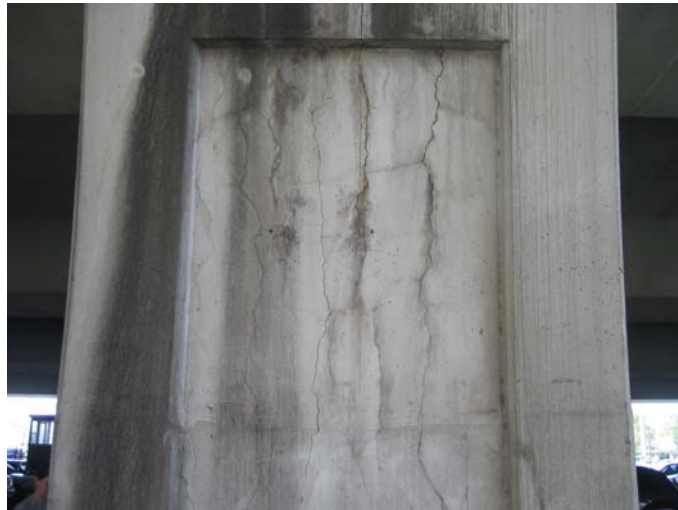
*Figure 1.4: DEF Related Damage in DD-6*

DEF is another form of durability related distress in concrete. It is a type of internal sulfate attack where ettringite forms several months or years after the concrete has hardened. DEF can be attributed to a thermal decomposition mechanism. Ettringite which is formed in the early age of the concrete is destroyed by high temperatures ( $>158^{\circ}F$ ). Then, when the concrete element is later exposed to moisture, ettringite develops again as sulphate ions are released into the concrete. This crystal growth of ettringite causes swelling forces to form in the concrete which can cause cracking (Colleparidi 2003). Figure 1.4 is an illustration of DEF related damage in column DD-6 in the San Antonio Y.

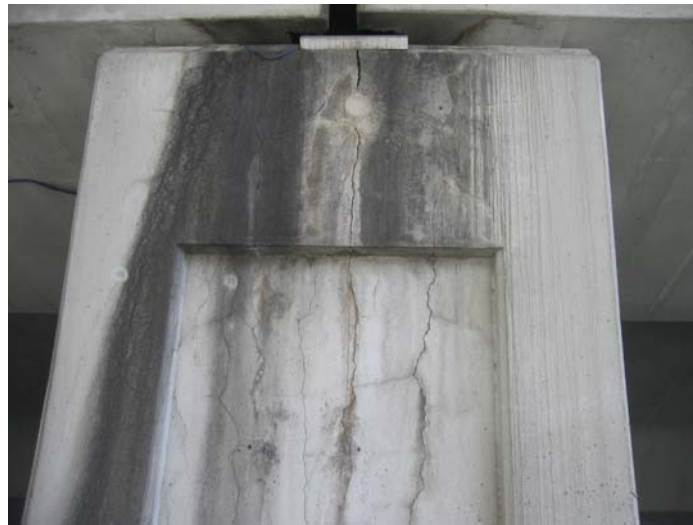
***Figure 2.2: Longitudinal Cracking of Spine DD Column***

Cracking associated with ASR will generally reflect the reinforcement pattern or the direction of major stresses in restrained or significantly stressed elements. Longitudinal cracking along the path of the primary reinforcement is typical in reinforced concrete columns and beams. This type of cracking is typical of the columns in the DD spine of the San Antonio Y as shown in Figure 2.2.

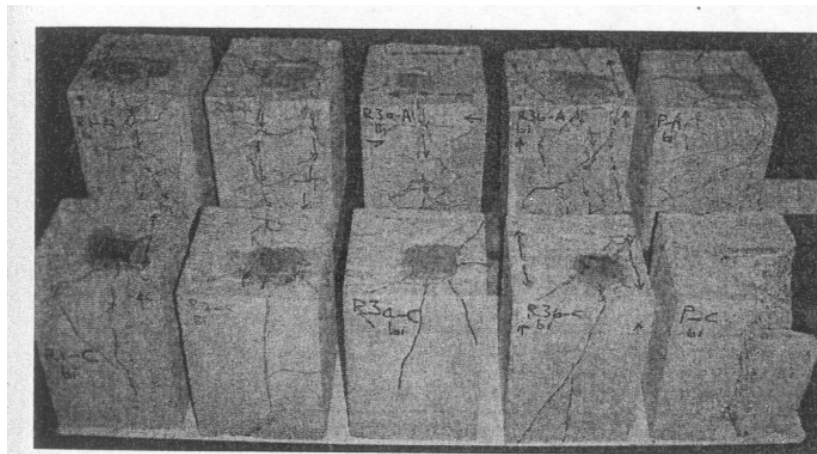
**Figure 2.7: Bearing Capacity Test Results for Eccentrically Loaded Specimens (Ahmed 1999, Structural)**

Fig. 9—200 x 200 x 300-mm concrete blocks tested under 50 x 50-mm square bearing plate positioned: (a) concentrically; (b) eccentrically; and (c) biaxially.

The results from the smaller test specimens damaged by ASR indicated a significant reduction in the ultimate bearing strength. This reduction decreased as the amount of confining reinforcement increased. A reduction in capacity due to ASR was also observed in the eccentric and biaxial loading conditions. The reduction in tensile strength which results from ASR causes a significant reduction in the bearing capacity of concrete when it is subjected to eccentric loading. The small ASR damaged specimens loaded eccentrically experienced losses of ultimate bearing capacity in the neighborhood of thirty-five to forty percent. The results from these tests as well as pictures of test specimens are shown in Figures 2.7 and 2.8.

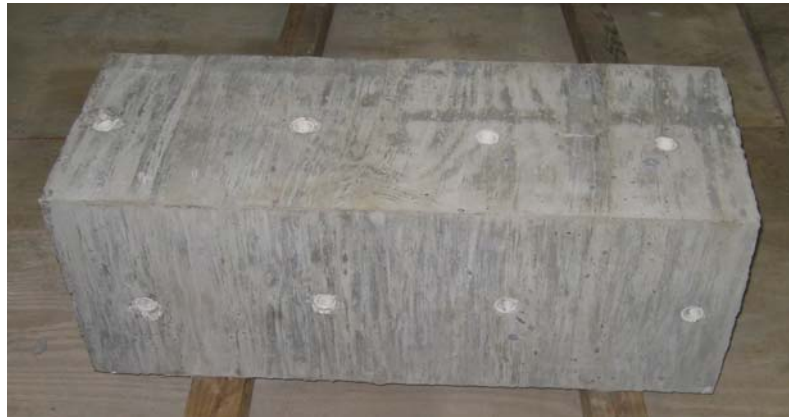
***Figure 4.2: Splitting Wedge Test Specimen***

In order to determine the effectiveness of using splitting wedges to crack concrete, a limited experimental study was conducted. A series of 15in. x 15 in. x 40 in. reinforced concrete columns were constructed. PVC pipes were sawed in half and inserted into the formwork before the concrete was cast. The PVC pipes were used to provide sleeves for the wedges to be inserted. Figure 4.2 shows a test specimen.

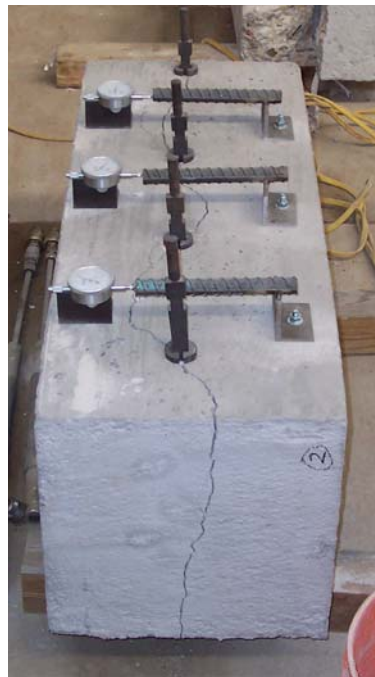
***Figure 4.3: Cracked Specimen using Splitting Wedges***

Dial gauges were then mounted onto the concrete column and the wedges were driven inward. Figure 4.3 shows a tested specimen.

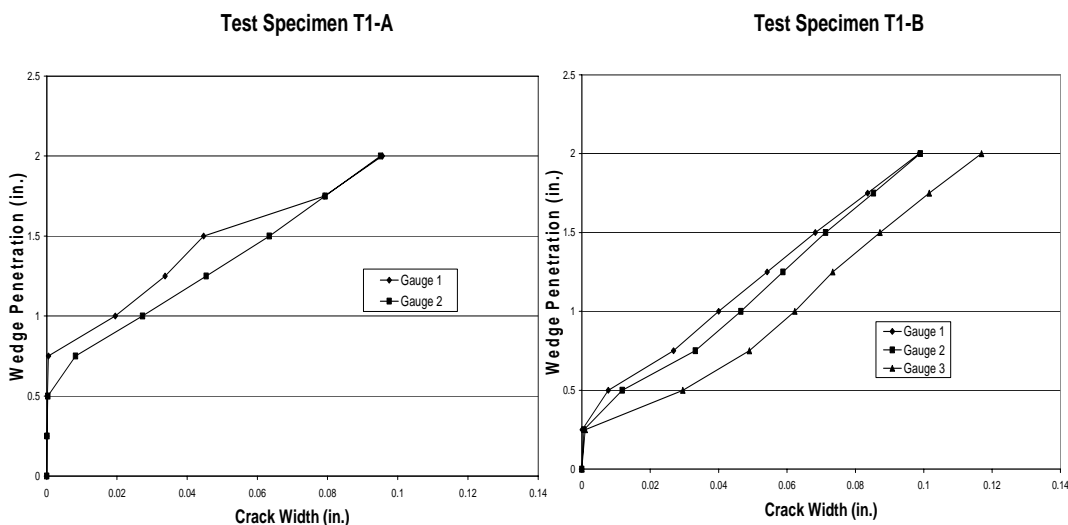
**Figure 4.4: Wedge Penetration vs. Crack Width for Splitting Wedge Method**

linear and that the width could be controlled by wedge penetration. It was also observed that the cracks tended to travel along the line of the wedges. This confirmed that a longitudinal crack of significant size and controlled width could be formed along the entire length of the column using this method. It was concluded that using wedges to effectively split a column in four pieces was a feasible method.

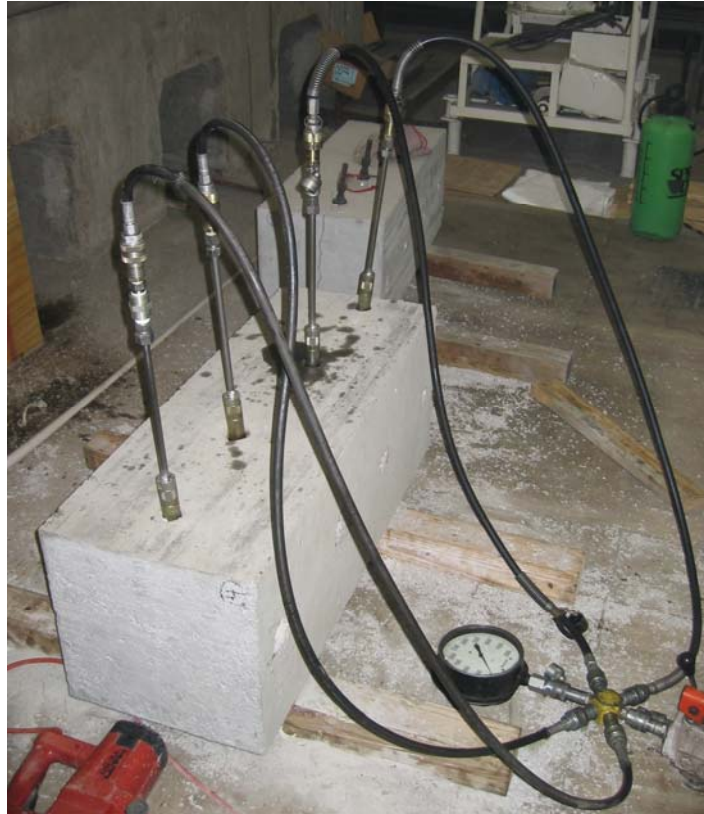
*Figure 4.6: Hydraulic Packer Test Setup*

A test was conducted using four such packers on a similar reinforced concrete column. Figure 4.6 illustrates the setup used to test with the packers.

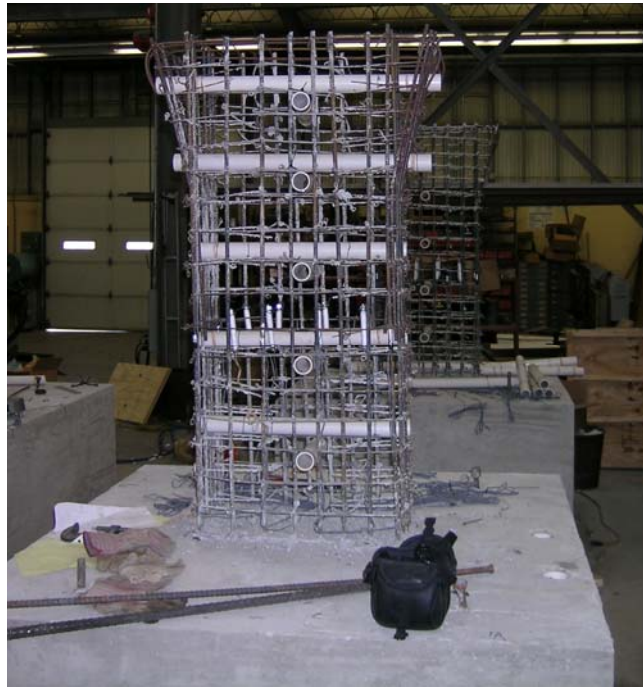
***Figure 4.7: Design Location of PVC Pipes***

PVC pipes were sawed in half and installed in the reinforcing cage to provide sleeves for the splitting wedges. The design location of the 1.5 inch PVC tubes is shown in Figure 4.7. Figure 4.8 is a picture of a fully constructed column reinforcement cage with the PVC pipes installed.

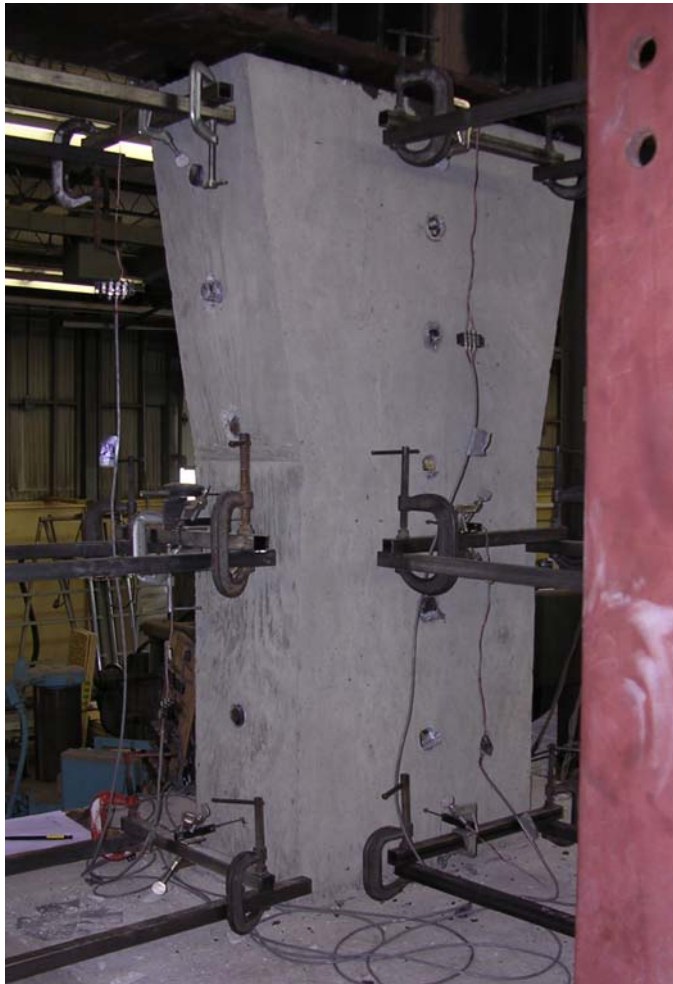
***Figure 4.15: Test S2 Linear Potentiometers***

Linear potentiometers were used to measure the deflection of the test specimens. Potentiometers were placed on two sides of the column at three points along its height corresponding to locations near the base, midpoint, and top. The potentiometers were placed close to the centerline of the column in both directions. Figure 4.15 shows the potentiometers prior to testing specimen S2. The exact positions of the gauges for each of the five tests are listed in Appendix B. A mechanical dial gauge was also used to verify readings taken from the linear potentiometers.

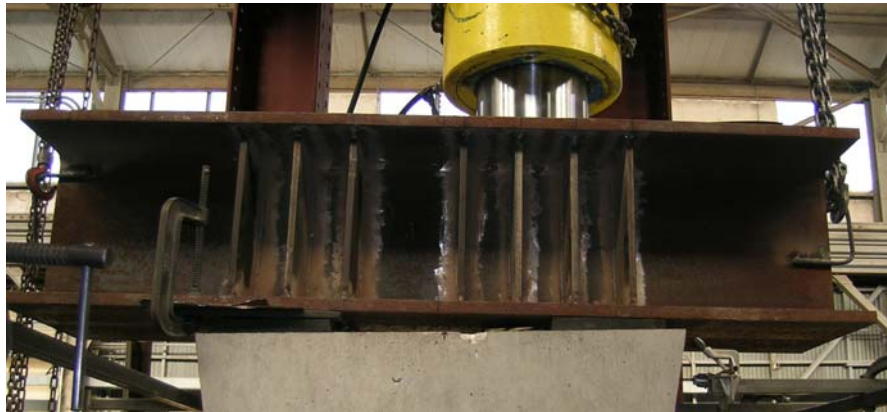
*Figure 4.18: Spreader Beam*

A heavily reinforced spreader beam was used to distribute the load from the ram to all four pads. The beam was designed to be very stiff in order to provide proper load distribution to the bearing pads. A W14x 109 section with stiffeners welded at the critical locations was determined to be an adequate section. The spreader beam is shown in Figure 4.18.

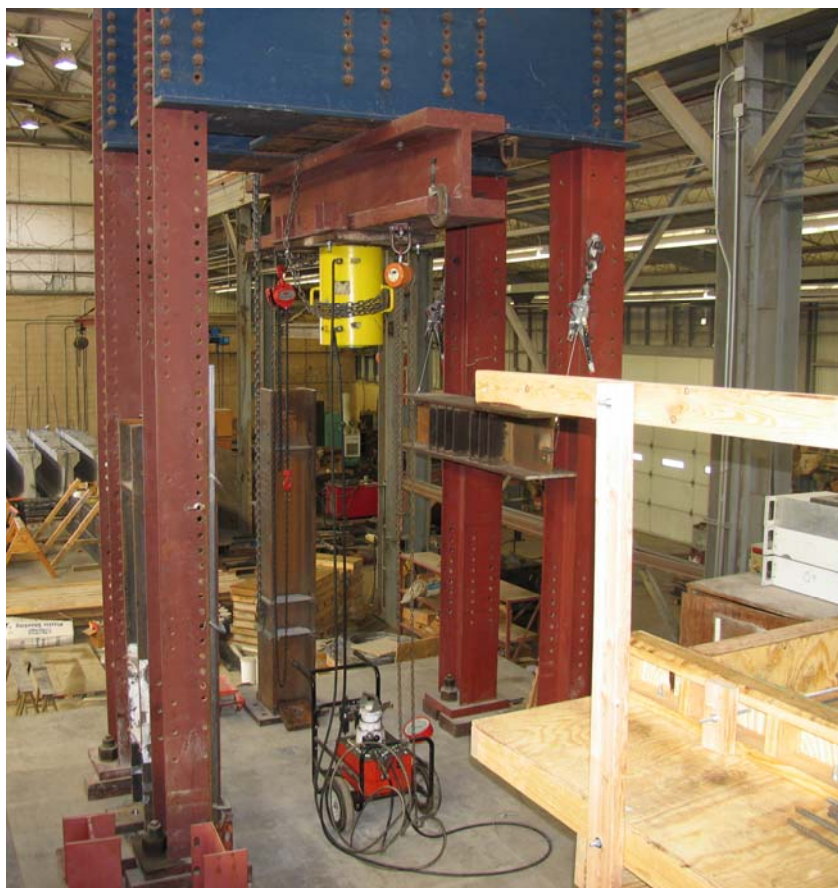
***Figure 4.19: Test Setup***

frame for the remaining specimens. The frame did not slip during the remainder of the tests. In addition to this problem, a spherical seat was not used for the first test. It is likely that this resulted in some improper distribution of load on the column. Also, the PVC tubes cast into the specimens crushed during the first test. It was determined to insert steel into the open sleeves for specimen S2 to match the behavior of columns with wedges. Finally, unreinforced bearing pads were used to test column S1 in contrast to reinforced pads which were used for the remaining specimens. These factors need to be taken into consideration when analyzing the test results. Much greater confidence is given to the results of tests two through five than those of test one.

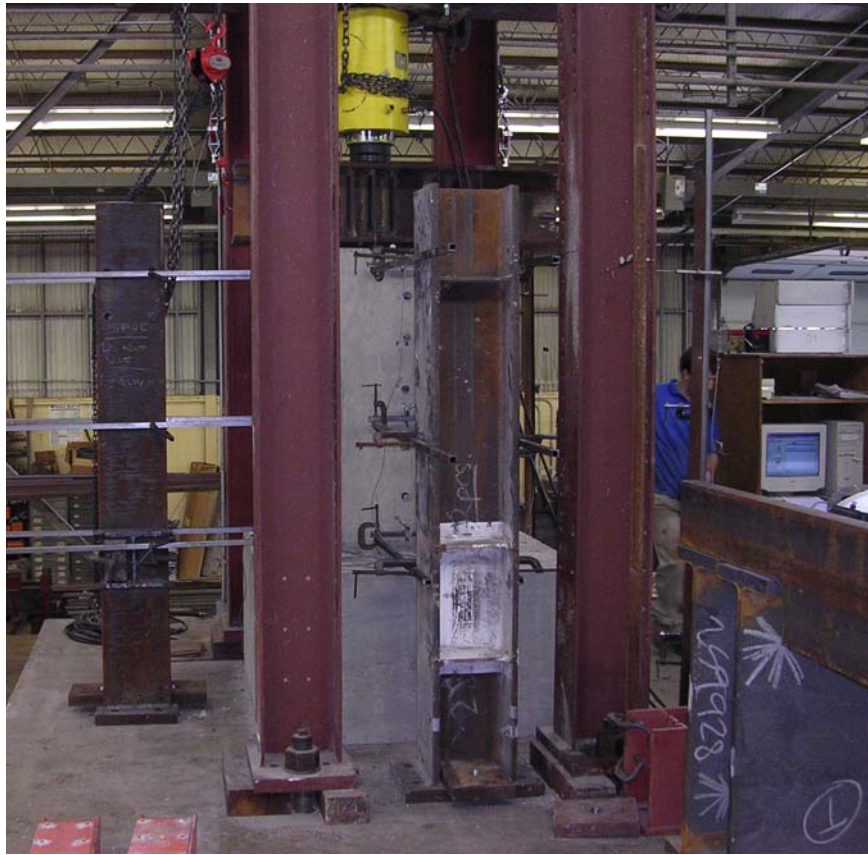
*Figure 4.20: Specimen S2-Setup*

The column was loaded in 50 kip increments until damage began to appear. After that load level was reached, the load increments were reduced to 25 kips until the specimen failed. Any cracks that formed during the loading process were properly marked and photographed between each load increment. Figures 4.19 and 4.20 show the setup used to test the model columns. After testing was complete, the specimens were removed from the test setup. At which time, a hammer was used to chip away loose concrete near the failure zone. Then, final photographs of the failure zone were taken. This process was repeated for each of the remaining tests.

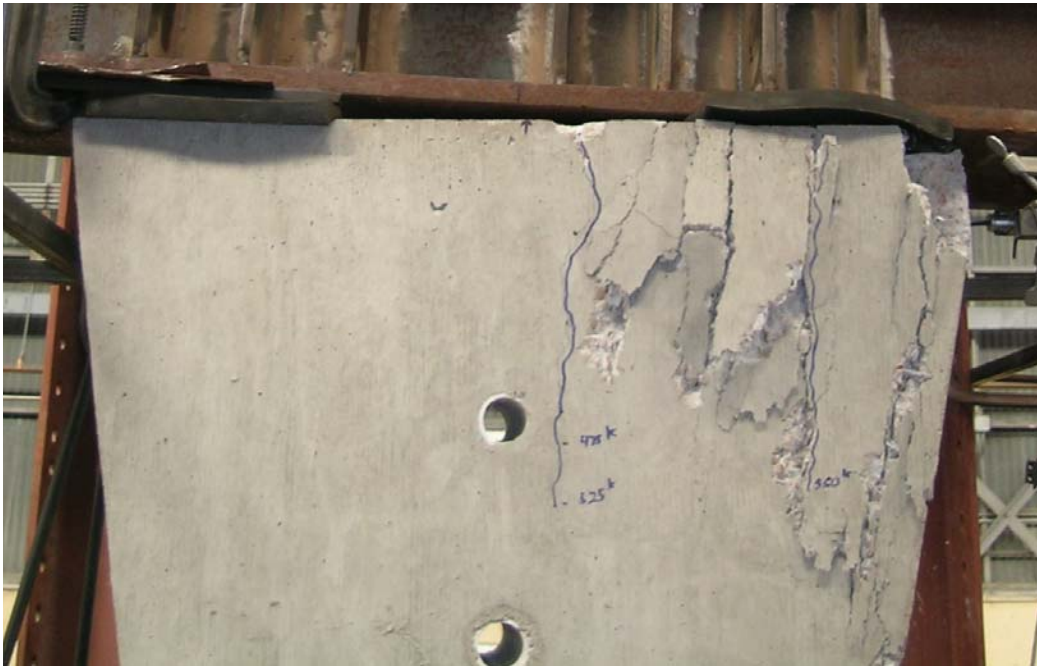
*Figure 5.5: S1-Concrete Crushing*

When the specimen was loaded to approximately 88 percent of the failure load, the concrete cover began to spall. As the load was increased to ultimate, the concrete under the two most heavily loaded bearing pads began to crush. The majority of the damage was observed directly under the most heavily loaded pad. The initial crushing of the concrete is clearly illustrated in Figure 5.5. After completing the test and removing the loose concrete fragments, it could be seen that the transverse reinforcement near the top of the column had fractured. Figure 5.6 shows the fractured transverse tie near the top of the column. In conclusion, the column sustained significant damage under the two most heavily loaded pads with the most damage directly underneath the pad with the largest load. The damage sustained in this local area resulted in failure of the specimen.

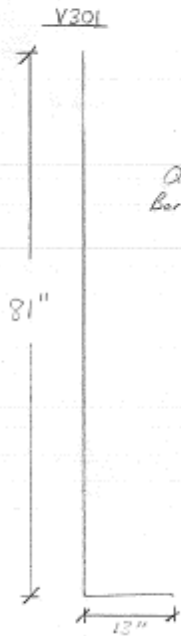
Model Column Reinf. Steel

Quantity = 104  
Bar Size = #3
