**Preservation Alternatives for Historic Metal Truss Bridges:
Shackelford County Bridge – A Case Study**

Thesis

The University of Texas at Austin

August 2000

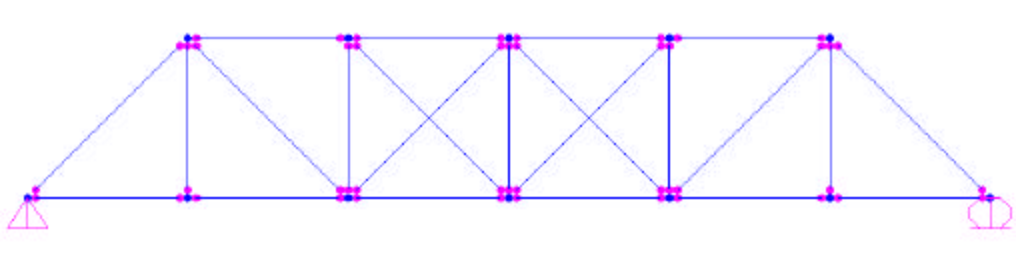
Figure 4.1: The simple 2-D model of the truss

All the truss members are modeled as pin-ended truss elements. The supports were modeled as hinge support at one end of the bridge and roller support at the other end to represent the idealized support conditions for the actual bridge. The Figure 4.1 shows the model, the frame elements with end releases and the supports.

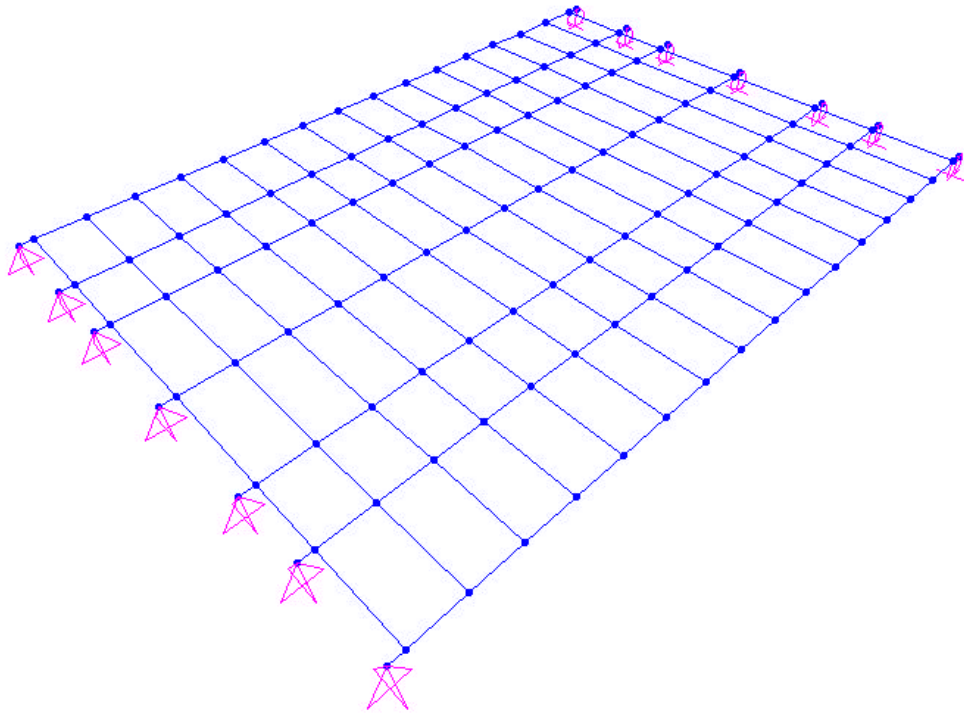
Figure 4.4: The 3-D model of the bridge deck

All the timber planks and stringers were modeled using frame elements. The stringer supports were modeled as hinged at one end and as a roller at the other end. All the sectional properties were based on the actual measured dimensions. All the material properties were based on the AASHTO standard design specification, [AASHTO, 1996]. Three different models were studied. All the three models were identical in all respects except for the torsional rigidity used for different frame elements. In the first model, torsional rigidity for all the planks and the stringers was considered, in the second model, torsional rigidity was considered only for planks, and in the third model, torsional rigidity was neglected for both the planks and the stringers. Figure 4.4 shows the model and the supports.

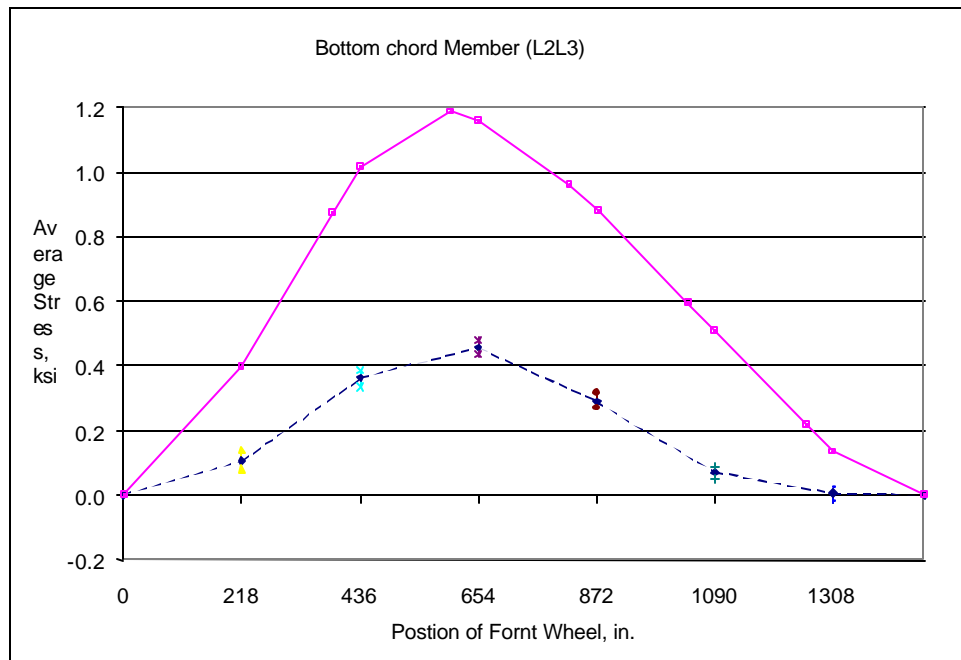
Graph 5.1: Average stress: Bottom chord (L2L3)

a) Significantly lower stresses in the bottom tension chords, i.e., L0L1 through L5L6, were found. The stresses measured on opposite faces of each element were different. These differences in stresses strongly indicate that the bottom tension chord members are subjected to bending moment. This is clearly indicated by Graphs F.45 through F.49. The average stresses are presented in Graphs F.87 and F.88. Graph F.88 is reproduced here as Graph 5.1.

The average stresses in the bottom tension chord members were lower, about half, as compared to stresses obtained from analysis. The lower stresses in the tension chord members can likely be attributed to the locked roller supports. The roller supports for both trusses are dislocated.

Due to accumulation of debris they are likely not functioning as a true rollers. The locking of the rollers leads to the reduction of forces in the bottom tension chords. However, one should not count on this mechanism in the analysis for reduction on the forces. This is due to fact that the behavior may not be same at higher load levels, and after rehabilitation the rollers will function as the true rollers and will not provide this type of resistance. This type of behavior can be taken into account by modifying the support conditions in the analysis model, by modeling the roller as a pin. This analysis was done with simple 2-D truss model. The analysis also showed a reduction, 50% to 80%, or reversal in the bottom tension chord member forces.

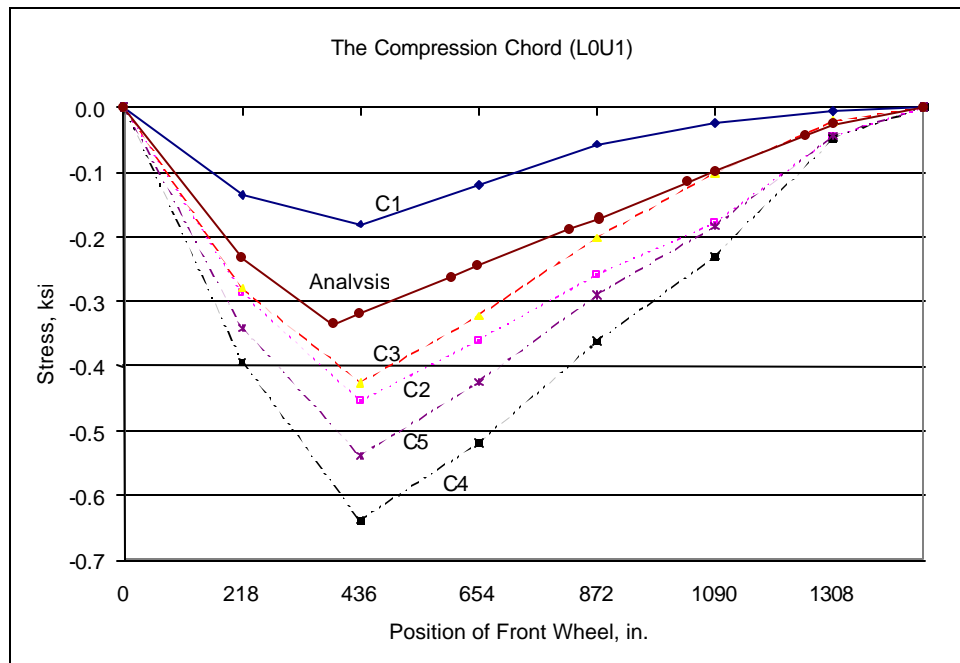
Graph 5.2: Stress variation: Top Chord (L0U1)

- b) Five gages mounted on inclined compression chord, LOU1, showed a highly variable stress distribution across the section. This is shown by Graphs F.50 through F.54. The comparison of these measured stresses is presented in Graphs 5.2 and F.98. This graph indicates non-uniform stress distribution across the cross-section. The average measured stress is presented in Graph F.89. The average measured stress was found to be higher than the analysis result. A closer look at the stresses revealed that the individual elements of this built-up section were bending about different axes. This made data interpretation very difficult. It can be concluded that even with five gages it is difficult to estimate an accurate state of stress for built-up sections.

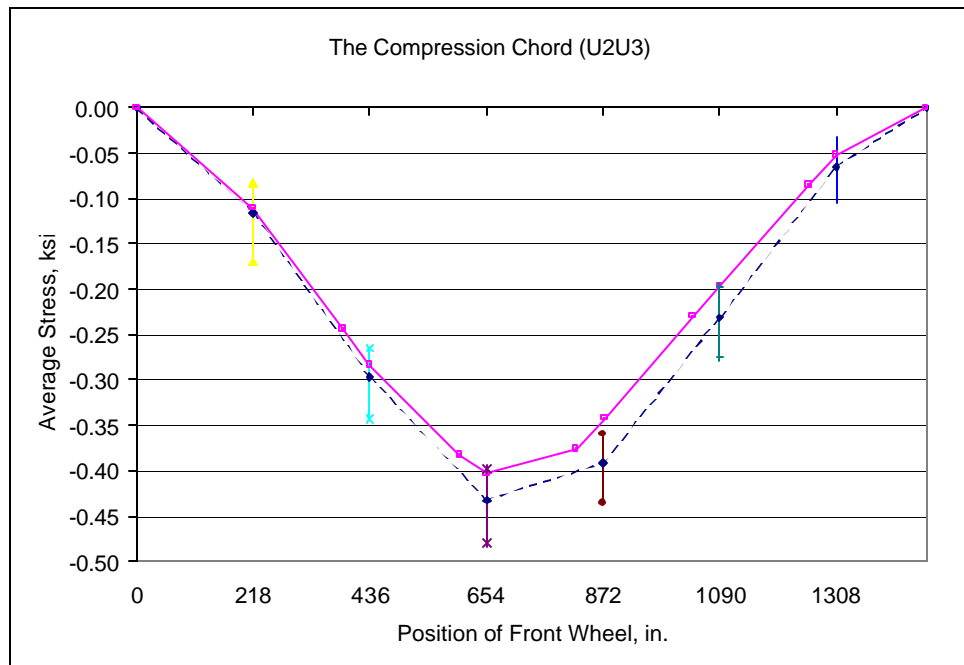
Graph 5.3: Average stress: Top Chord (U2U3)

- c) Five gages mounted on each of top compression chords U1U2 and U2U3, showed some variation of stresses across the cross-section. This is indicated by Graphs F.55 through F.63. The average stresses for members U1U2 and U2U3 are presented in Graphs F.90 and F.91 respectively. Graph F.91 reproduced here as Graph 5.3. The average measured stresses for these members were found to be in good agreement with the analysis results.

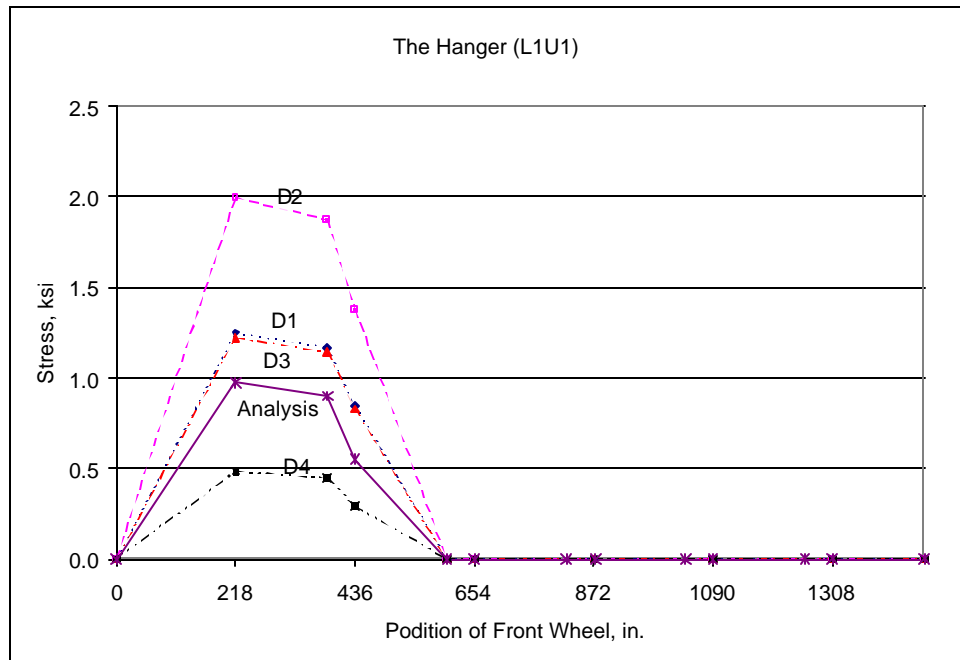
Graph 5.4: Stress variation: Vertical Hanger (L1U1)

d) Eight gages mounted on vertical hanger, L1U1, showed variation in the measured stresses across the cross-section. This is shown by Graphs F.64 through F.72. The variation in the measured stresses is presented in Graphs 5.4 and F.97. The average measured stress is presented in Graph F.92. The average measured stress was found to be higher than the analysis result by about 25%. From the first test results, it was higher by about 50%. After eliminating bending component from the measured stresses, it is higher by 25%. This indicates that these hangers are subjected to a significant amount of bending stresses. However, the reason for the 25% higher measured stresses is unclear and needs more

evaluation. As discussed above, a possible reason is a lower cross-sectional area.

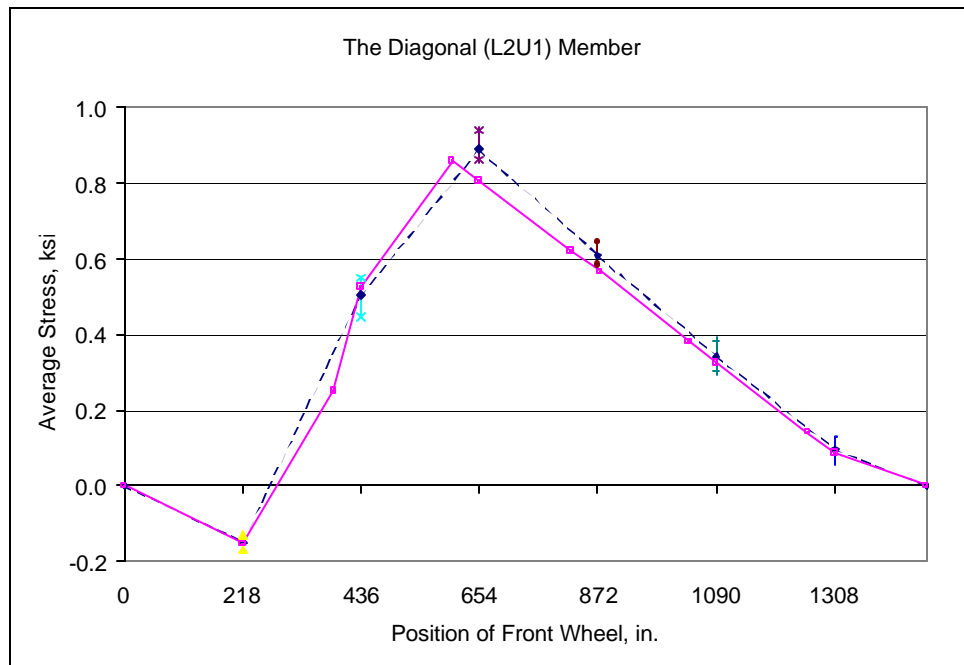
Graph 5.5: Average stress: Diagonal member (L2U1)

- e) The measured stresses in vertical compression member (L2U2), and diagonal members (L2U3, L2U1, and L3U2), were found to be non-uniform. This was clearly indicated by Graphs F.73 through Graph F.86. However, the average stresses calculated for these members were found to be in good agreement with the analysis results, as showed by Graphs F.93 through F.96. Graph F.93 reproduced here as Graph 5.4.

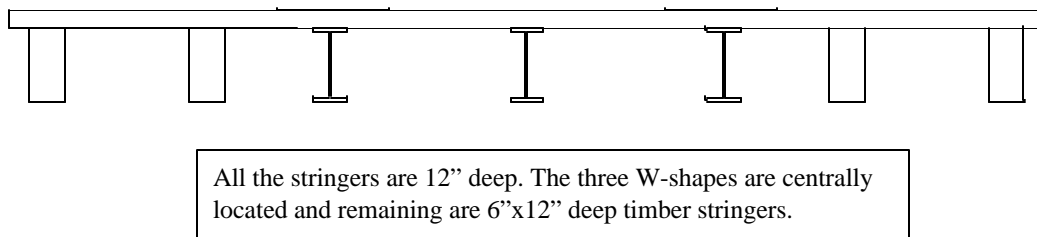
Figure 6.3: New timber deck layout with W-shape stringers

Figures 6.1 to 6.3 shows three possible options for stringer replacement. There are, of course, many other suitable options. For each layout preliminary analysis was carried out to determine load distribution between different stringers.

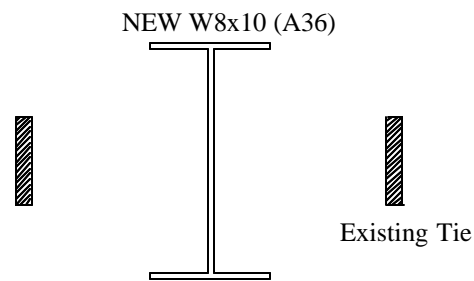
Figure 6.4: Addition of member to tension chord

The truss tension chord, hangers and all diagonal members are currently rated below HS20. Hence, major strengthening measures would be needed. For rehabilitation of the tension chord, addition member can be added as shown in Figures 6.4 and 6.5. This detail is presented in a paper by Bondi, [Bondi, R.W., 1985]. The hangers need to be replaced with new hangers as the geometry of the cross-section will not allow any suitable means of rehabilitation. The diagonal members can be strengthened either by addition of new member or by post-

tensioning. The analysis of post-tensioned trusses is described in the Section 6.3.4. The other details of the truss i.e. pins, joint details, and the U-bolt connection details at the metal floor beam ends must also be properly evaluated for the higher load levels.

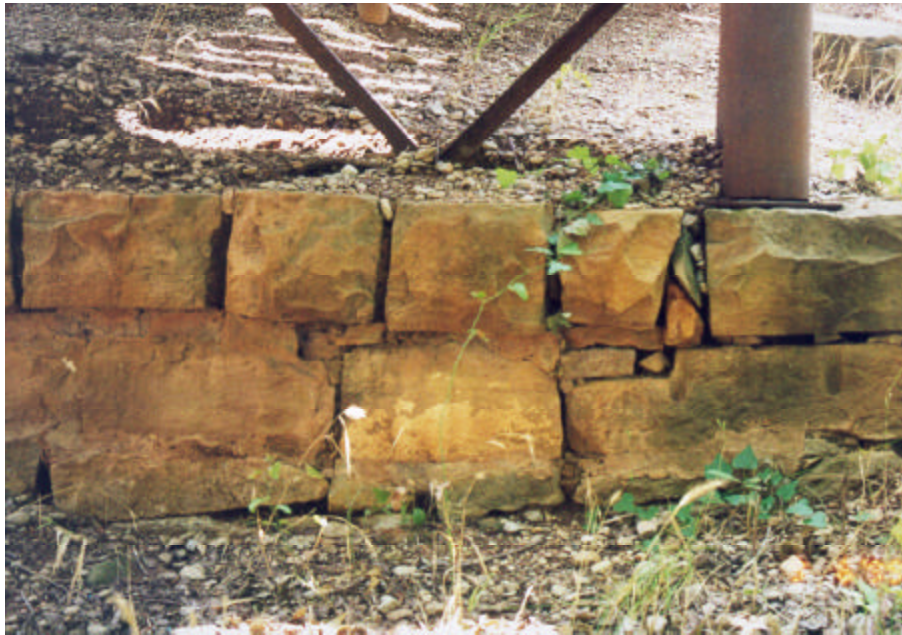
Photograph A.34: Deteriorated foundation of metal bents for north approach span

Foundations for metal bents are not visible at many places. At one bent of the north approach, the foundation is visible as it is projecting above the ground. The masonry joints of this foundation are open. This suggests the possibility that the foundations of all bents may have open joints. The south approach span abutment has many stones dislocated from their original position. All the joints of the abutment are filled with soil. The north approach abutment is not visible due to the metal retaining plate.

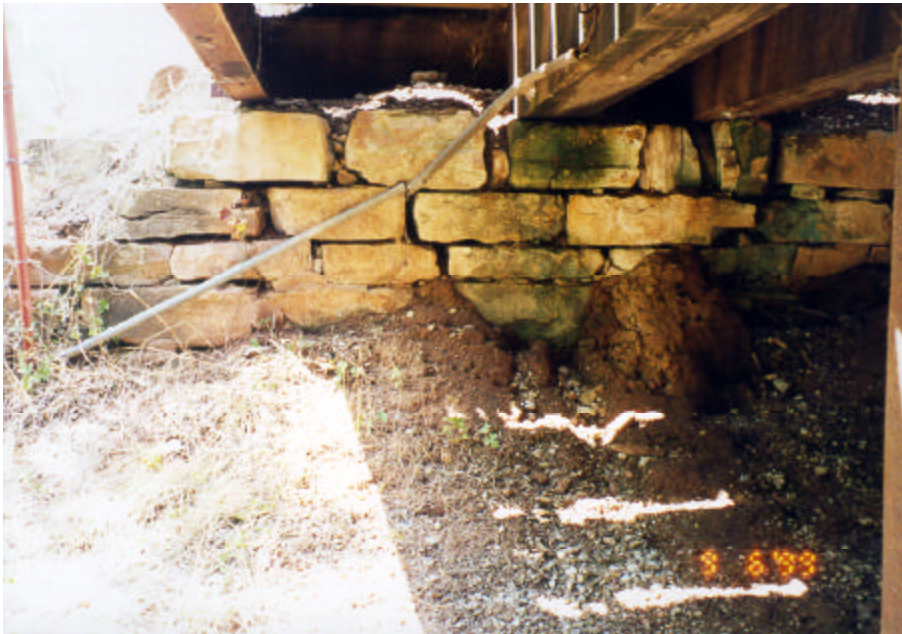
Photograph A.35: Deteriorated abutment at south end of south approach span

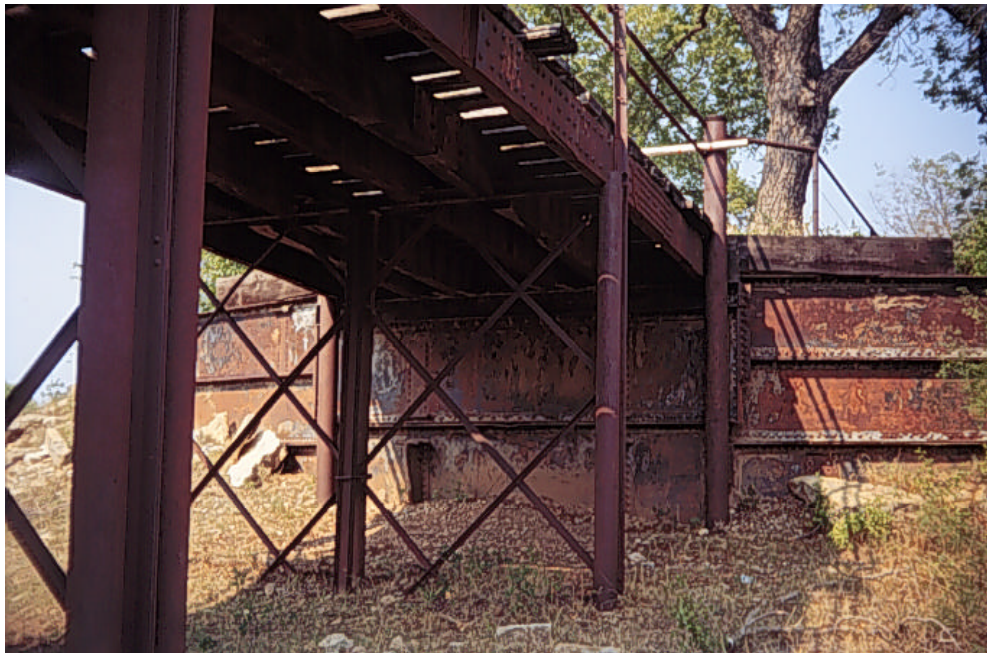
Photograph A.37: Details of the metal retaining wall at the north abutment

This metal retaining wall is heavily corroded. Looking at the plate, it appears that it was not an original part of the bridge but was added afterwards. This plate seems to be taken out from another structure and then added to the bridge.

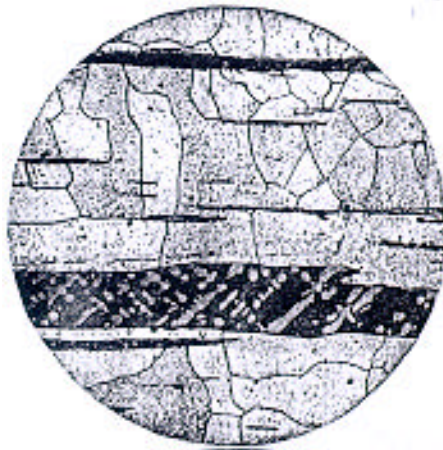
Figure D.1: Longitudinal section of wrought iron

The grain size of hot-worked wrought iron may be controlled by continuing the working until the temperature has decreased to about 1300°F (704°C). The fibrous structure of wrought iron is exhibited in a tensile test by a jagged, fibrous fracture and in a nickbend test by a longitudinal fibrous fracture. If there is any appreciable amount of carbon in the iron, it shows at the junctions of the ferrite polyhedra as dark, irregular particles of pearlite, the amount of this constituent varying from zero to about 12 percent of the area as the carbon content varies from zero to 0.1 percent.

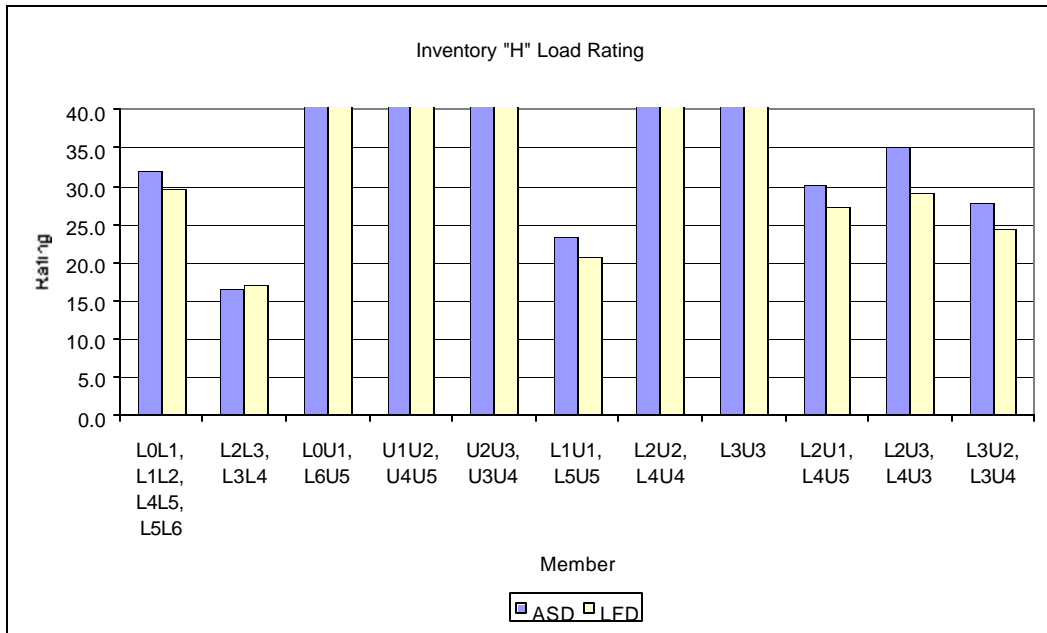
Graph E.1: Inventory "H" load rating of the truss

The above load ratings are graphically presented in the Graph E.1 through Graph E.4. The truss rating is controlled by the bottom chord members L2L3 and L3L4.

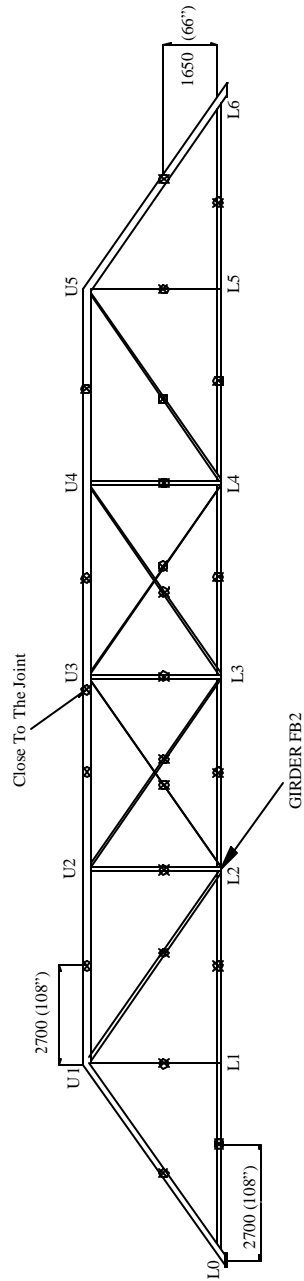
Figure F.1: Field load test No.1 – Locations of instrumented members

Since the bottom chord members were found to be critical from the load rating, it was decided to instrument as many of these as possible. All the six bottom chord members of the upstream truss were instrumented with two strain gages, one on each eyebar of each chord member as shown in Figure F.4(a). Top chord member U2U3 was instrumented with gages both at mid-span and at neat joint U3. These two sets of gages were provided to determine if any bending moment developed in these member.

The two strain gages on the metal floor beam were mounted on the top flange of the beam only. These gages were installed from the bridge deck. The bottom flange and the web of the floor beam were not easily accessible.
