SEISMIC REHABILITATION USING PRECAST INFILL WALLS

Dissertation

The University of Texas at Austin

May 1996

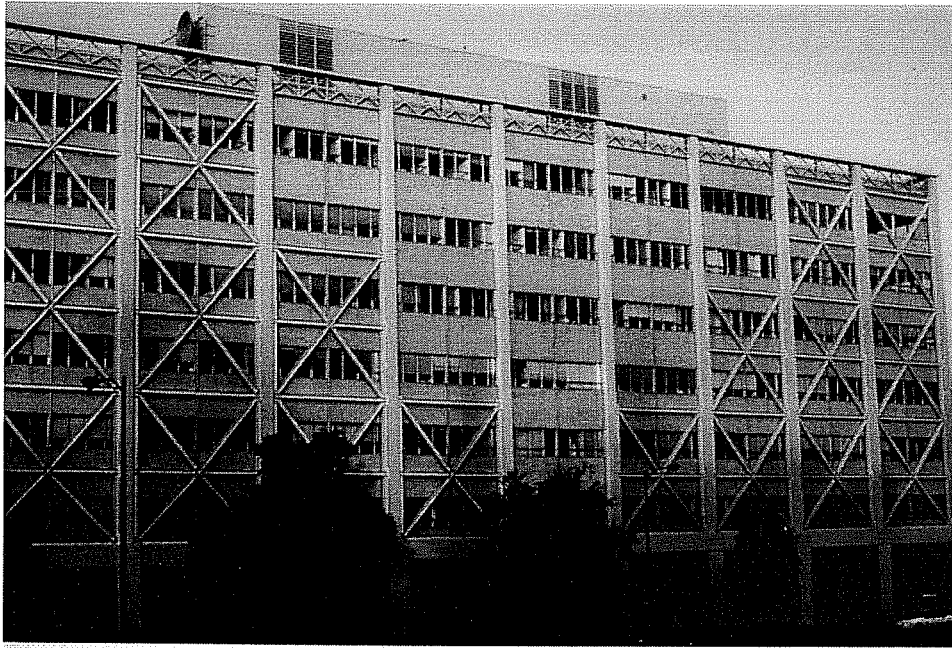
Figure 1.7: Steel Bracing

The building presented in Figure 1.7 is a good example of effective rehabilitation by bracing. The braces were attached to the exterior of the building to reduce inconvenience to occupants both during and after construction. Relatively easy attachment of the braces to the building frame was possible since the columns protrude from the face of the curtain wall. It should be noted, however, that the rehabilitation work altered the exterior appearance of the building. Therefore, this technique may not be feasible where architectural considerations control such as in historical rehabilitation or other projects where the appearance of the structure cannot be altered.

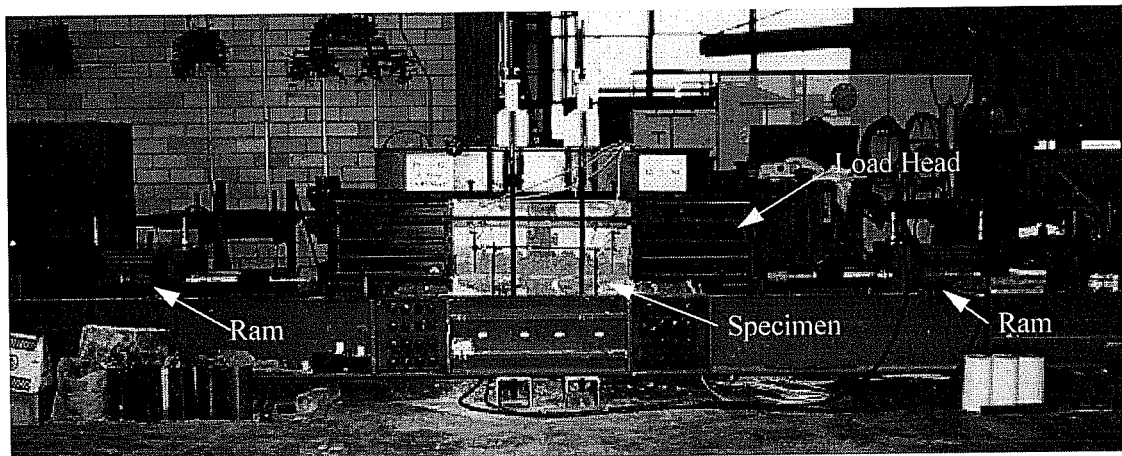
Figure 2.13: Test Setup

The test setup (Figure 2.13) was designed to subject the specimens to direct cyclic shear along the connection interface. The connection specimen was seated, and a hydrostone grout was used to secure the specimen. Two 400 kip hydraulic rams at each end of the setup allowed for pushing the top portion of the wall relative to the bottom portion. A self-equilibrating load system was also available to apply compressive loading or to restrain the specimen vertically (Figure 2.14). In general, testing was conducted without compression across the interface to produce lower bound interface shear strengths.

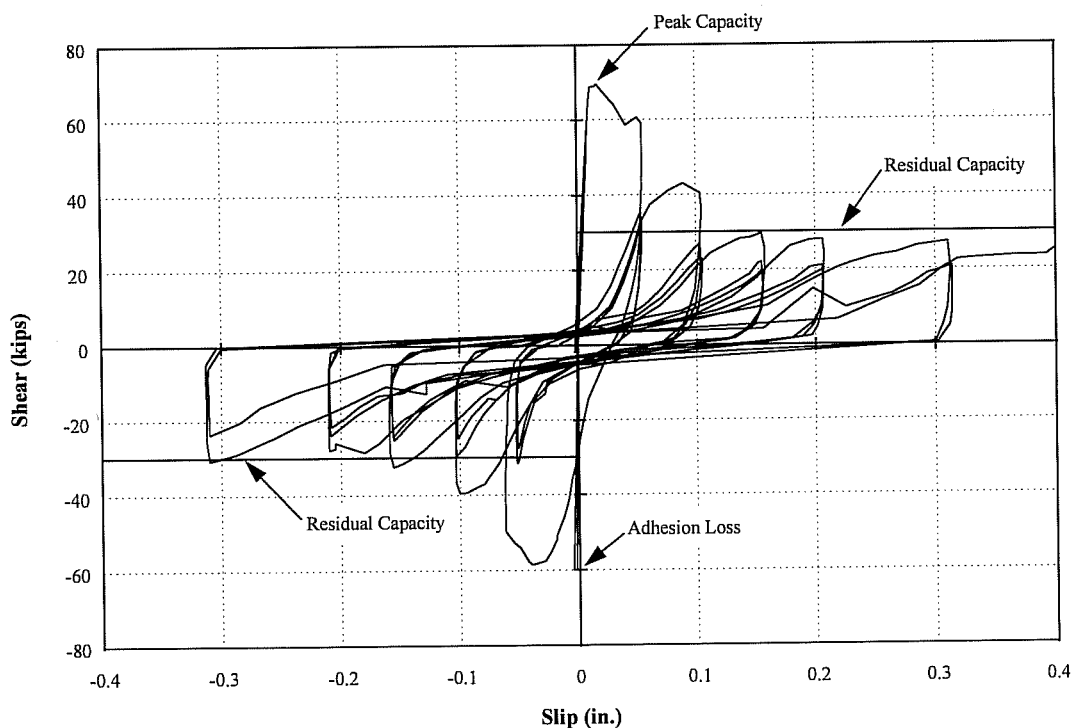
Figure 2.16: Panel Connection Test (PC-5)

The general behavior of the test specimens is discussed, and a representative load-displacement relationship is shown in Figure 2.16. The specimen was very stiff initially and behaved monolithically up to the point where adhesion at the panel shear key/grout strip interface was lost. Uplift along the joint occurred and stresses were induced in the vertical joint reinforcement. Following adhesion loss, loading could be further increased until a failure occurred through the shear plane. When the peak capacity was reached, the vertical reinforcement was yielded. The failure surface is shown in Figure 2.17. After the peak capacity was reached, there was a transition to a lower load plateau or residual capacity which was maintained through large slip levels. A specific discussion of each test specimen follows. Test results for all specimens are presented in Appendix A and are summarized in Table 2.5.

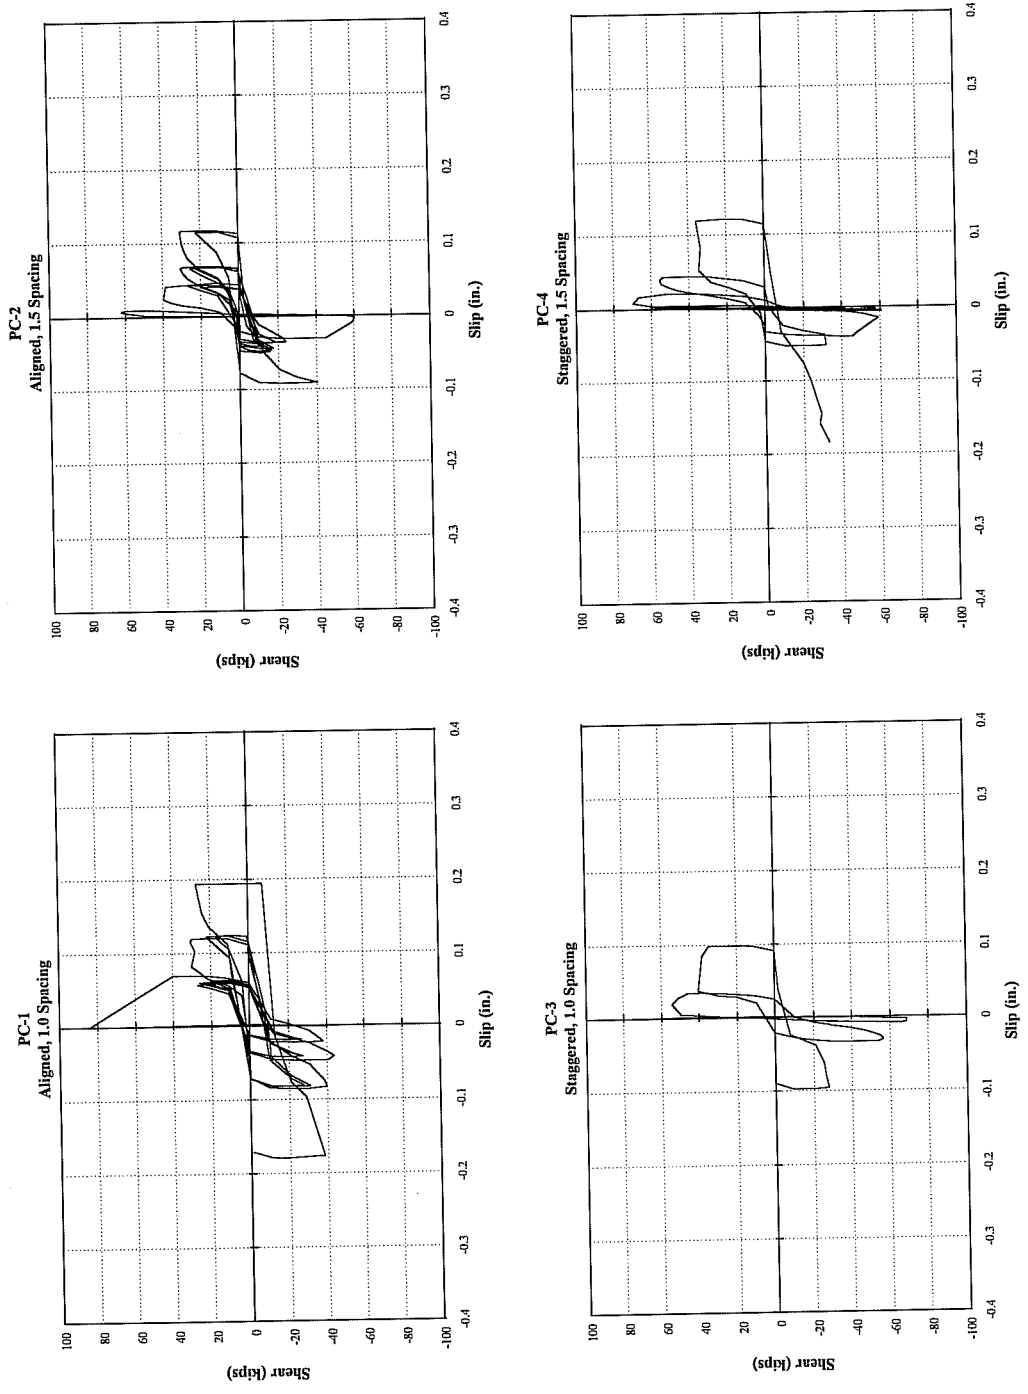
Figure 2.23: Shear Key Configuration Analysis

There did not appear to be any significant effect of the key configuration. As shown in Figure 2.23, specimens PC-1 through PC-4 exhibited similar behavior. The peak capacity was slightly affected depending on the effect of the key pattern on the shearing cross section of the panel (total shear key area at the base of the keys). If the shear cross sectional area was larger, the peak load was slightly higher. It must be noted, however, that variations in the amount of air entrapment can also produce similar changes in peak capacity. Therefore, it is difficult to quantify the exact effect of the configuration. In terms of the residual capacity, however, the configuration did not have any significant effect. The same residual capacities were noted for all four specimens.

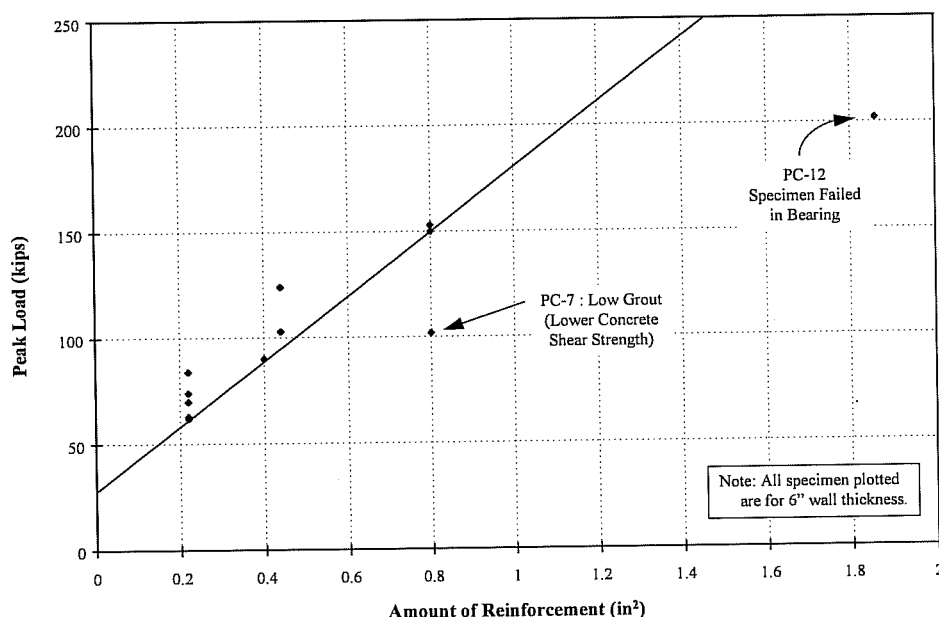
Figure 2.30: Effect of Vertical Reinforcement on Peak Capacity

Additionally, the shear strength of the concrete was affected by the vertical reinforcement as shown in Figure 2.30 where the peak capacity was plotted versus the amount of vertical steel. In all tests, the reinforcement was fully yielded in tension at the peak load. Therefore, compression was developed across the concrete interface to resist the reinforcement tension. This compression enhances the shear strength of the concrete due to biaxial effects as illustrated in Figure 2.31 using a Mohr's circle analysis with the Zia^[40] assumed failure theory for concrete. This approach has been used in previous research^[19] to explain the effect of vertical reinforcement in interface shear transfer. Elemental stresses at the interface are shown. As normal compression was increased, the analysis indicated that the concrete failure shear stress will increase. Furthermore, the analysis indicated that the shear stresses will increase approximately linearly with increasing compression.

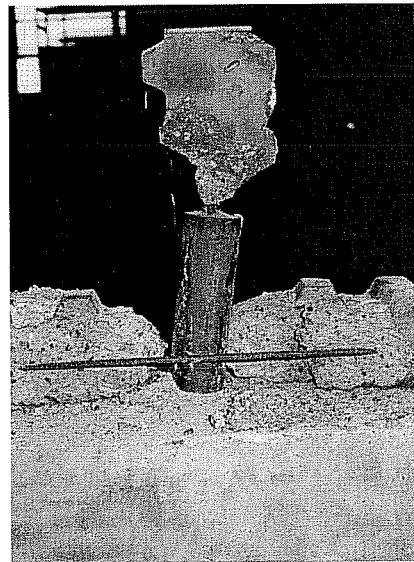
Figure 3.13: Flexural Yielding of Pipe (FC-2)

Further analysis of the test data and material properties indicated that these pipes were not adequately embedded. Design for the embedment lengths was determined based upon the nominal

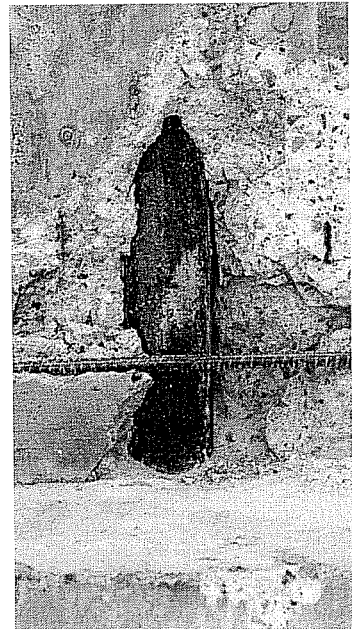
Figure 3.14: Shear Yielding of Pipe (FC-4)

Specimen FC-4 was provided adequate embedment length since the actual material strength was close to the nominal. Therefore, a shear failure was expected. The deformed shape of the pipe indicated that the design methodology for pipe embedment was acceptable since a shear yielding occurred as shown in Figure 3.14. The top half of the S shape, indicative of shear yielding, was evident. Additionally, after weathering, the localized yielding near the existing frame interface was evident from the rusted area. The extent of the yielding zone supported that shear yielding was the mode of deformation for this specimen.

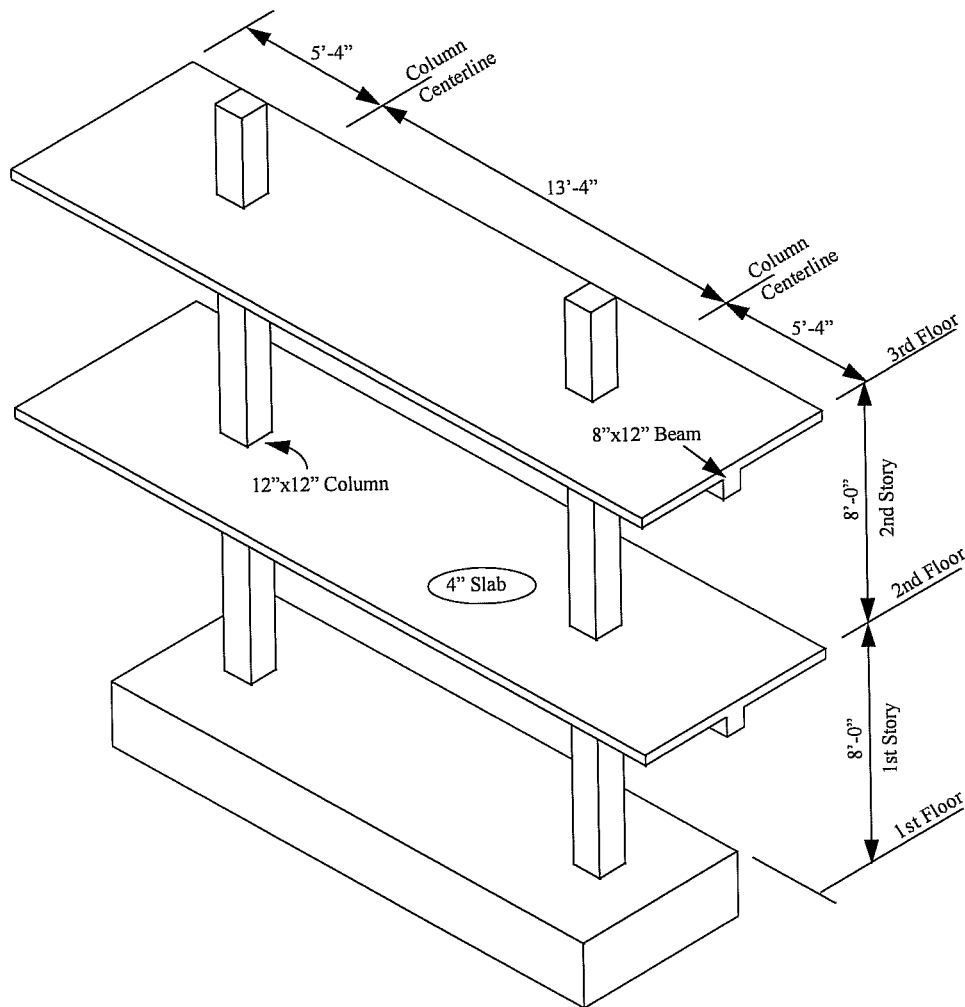
Figure 4.1: Existing Frame Specimen

section of the building and is shown in Figure 4.1. Complete structural drawings and details are presented in Appendix C.

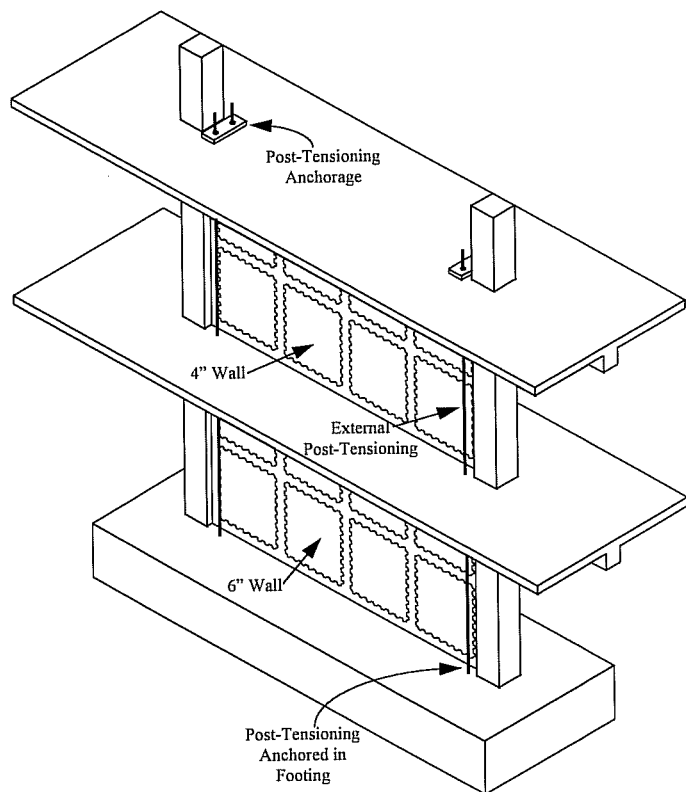
Figure 4.3: Infill Wall Specimen

The specific philosophy used in design was to provide for monolithic behavior of the precast infill wall system. Additionally, the infilled wall should have sufficient shear strength to permit the development of flexural yielding at the base of the wall. The shear strength of the wall should be controlled by the shear lugs provided around the interface since yielding of the lugs will provide some ductility. Since the column splices were not modified, a tension failure would be inevitable during a major seismic event. Therefore, shear resistance from the columns was neglected as was column tensile capacity in considering the collapse limit state design. The infill wall was designed using the design recommendations previously presented in Chapters 2 and 3 and in accordance with relevant sections of ACI 318-89^[3] and UBC 1991.^[37] Details of the infill wall design are presented below, and the design scheme for the rehabilitated structure is shown in Figure 4.3. Complete structural drawings and details are presented in Appendix D.

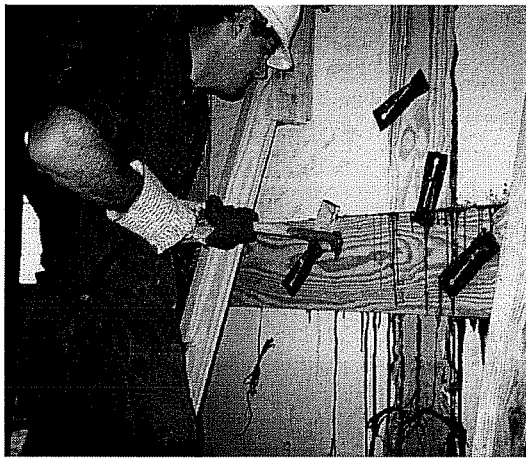
Figure 4.27: Vibration Through Access Holes

beam) horizontal strips were vibrated through access holes (Figure 4.27). Simultaneous horizontal and vertical vibration was essential for good grout flow. Figure 5.28 illustrates the simultaneous operations occurring on the two floor levels. The second floor pipe lugs (Figure 4.29) and the vertical strip reinforcing steel that was spliced

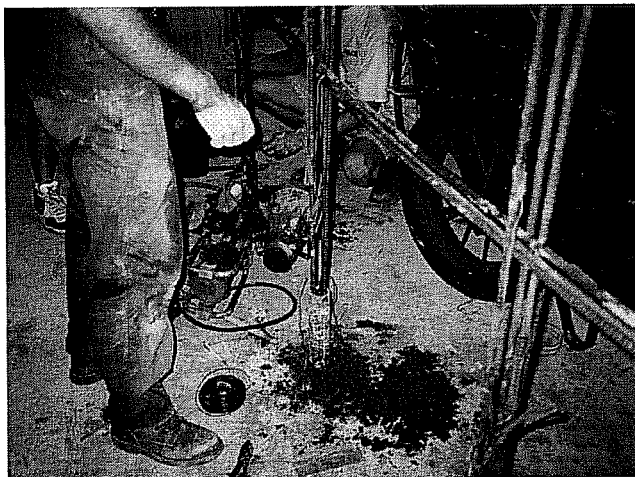
Figure 4.30: Vertical and Horizontal Strip Reinforcement Installed

inside the pipe at this location (Figure 4.30) were installed after grouting of the strips in the panels below was completed. As noted previously in Chapter 3, a stop should be provided on or under the pipe lugs to ensure proper embedment lengths because vibration will cause the pipe to settle.

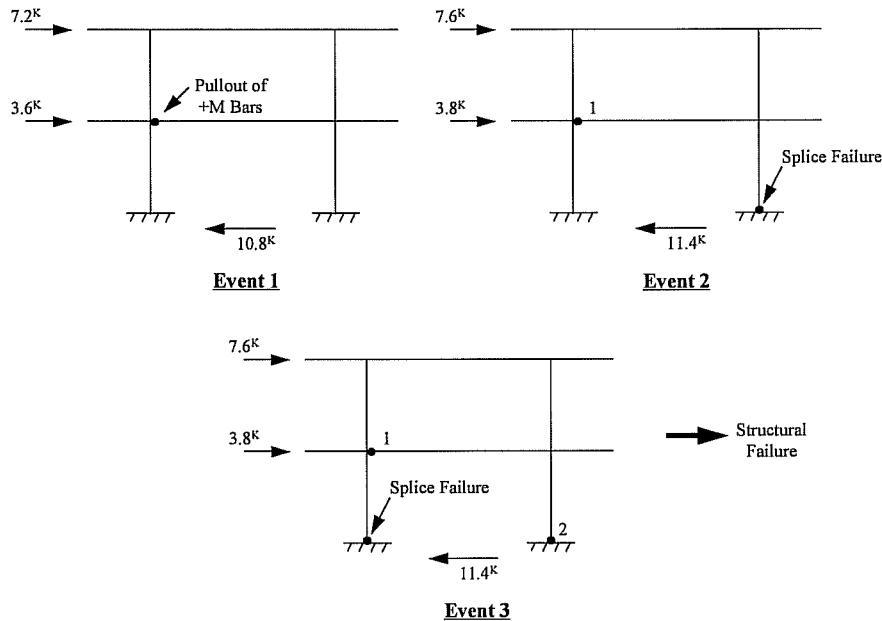
Figure 5.2: Failure Sequence

An analysis of failure modes of the test specimen for the triangular loading distribution selected predicted a base shear capacity of 11.4 kips. A pull out failure of the bottom reinforcing steel in the second floor beam is expected at a base shear of 10.8 kips. The subsequent moment redistribution causes an increase in moments at the base of the columns and in the forces on the bottom column splices. A slight increase in the lateral load (0.6 kips) causes failure in the download column splice which is immediately followed by failure of the other column. The sequence of events is shown in Figure 5.2. The maximum displacement at failure was calculated to be 0.89 in. using cracked section properties. The collapse sequence is nonductile; failure occurs with little or no warning.

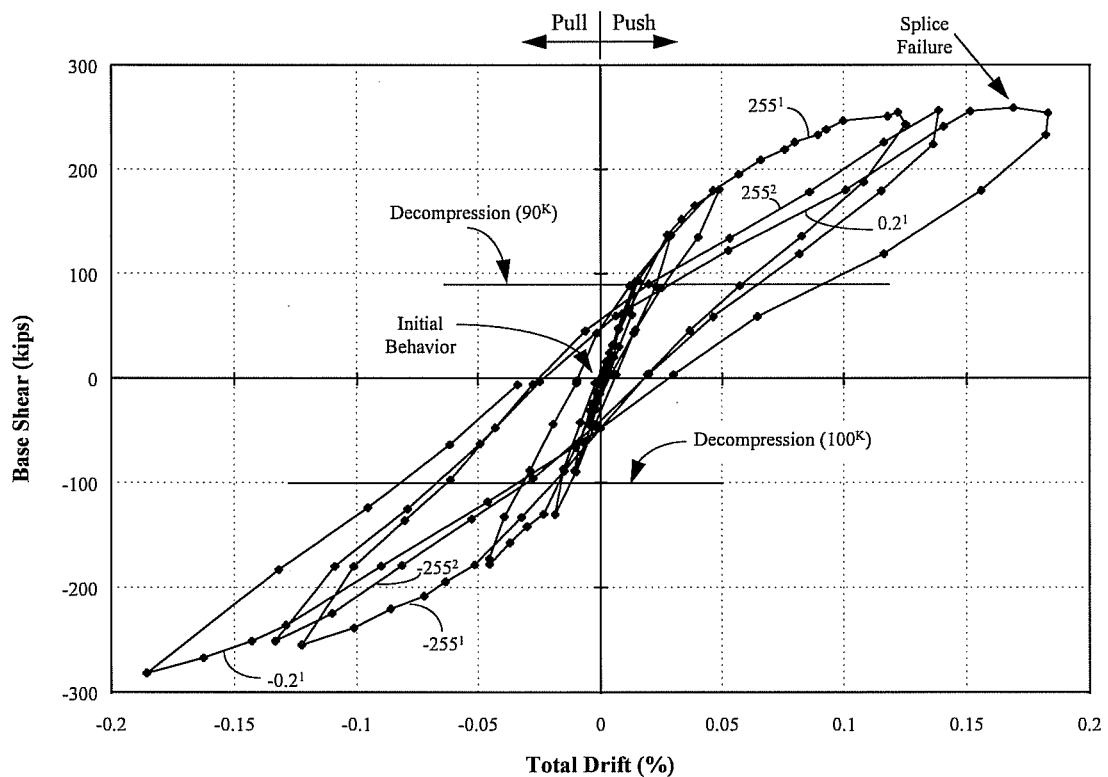
Figure 6.4: Test 1 Response Prior to Splice Failure

Under initial loading, the structure was quite stiff as shown in Figure 6.4 which presents behavior prior to splice failure. Strain gage measurements indicated that compressive stresses across the interface from the post-tensioning were maintained in initial load cycles (22.5¹ and 45¹). The structural response was elastic, and the same stiffness was maintained in both loading directions.

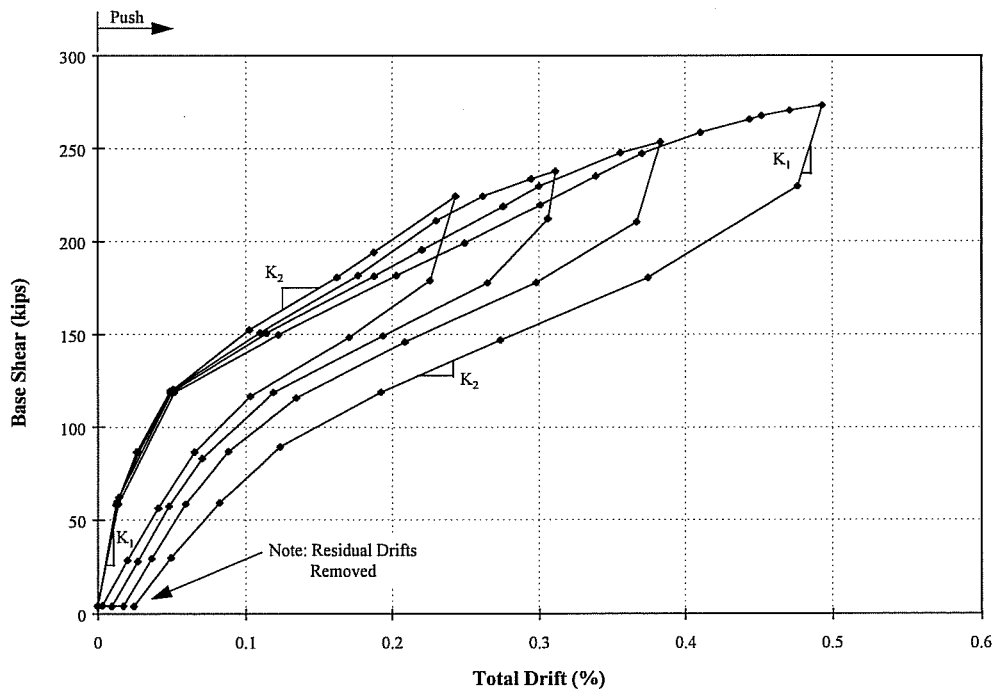
Figure 6.6: Loading Behavior After Splice Failure

The structure responded in all cycles with the same initial stiffness (K_1) up to 60 kips (zero tension load). Figure 6.6 clarifies this finding since residual drifts were removed to illustrate the loading behavior (curves are shown originating at zero deflection). There was a gradual transition in stiffness until approximately 120 kips (slightly beyond the decompression load of 90 kips). Following this level, behavior in all cycles was fairly linear with approximately the same stiffness (K_2). There was a trend, however, of gradually degrading stiffness with increasing displacement cycles. In cycles up to 0.45 % drift, the post-tensioning steel remained elastic.

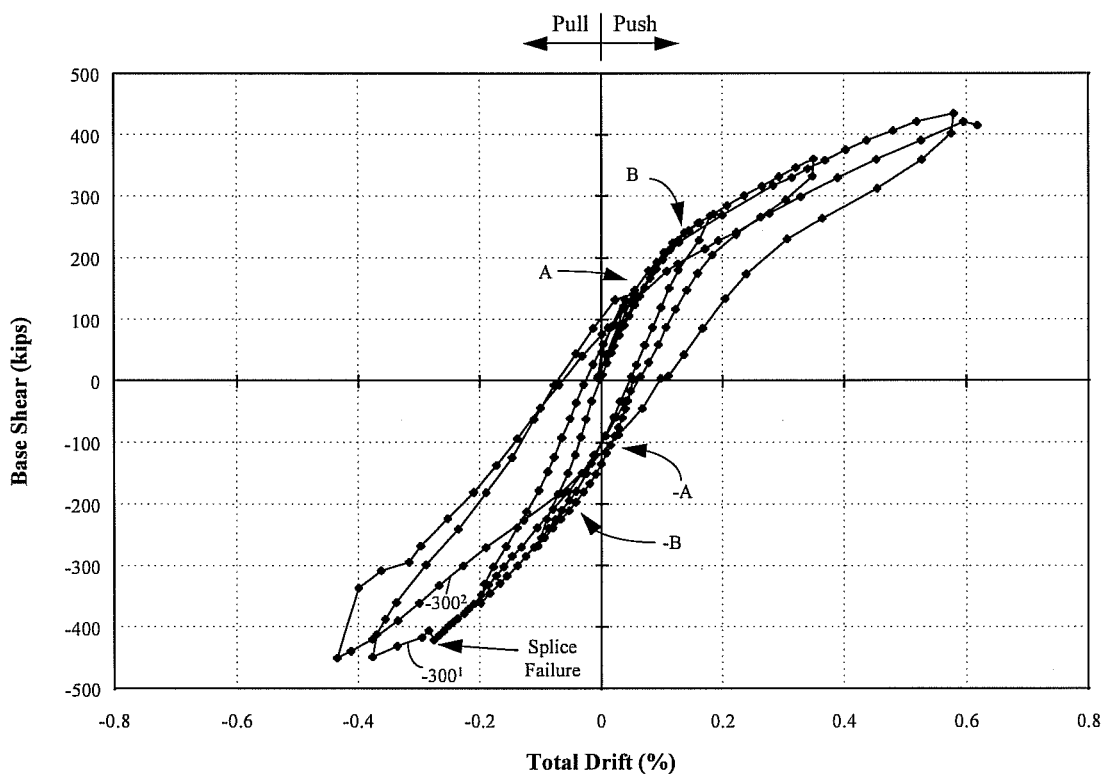
Figure 6.8: Test 2 Response

indicating that the zero tension load had been reached. As load was increased beyond point A, there was a gradual change in stiffness up to point B (approximately 200 kips) where a distinct change in the load response was observed. Loading beyond point B occurred at a new slope and was fairly linear in both the push and pull directions. The distinct change in behavior occurring at point B was termed the decompression load as in Test 1. Loading beyond point B produced different behavior in both loading directions. The specimen was stiffer in the pull direction since the tension column splice was intact. In the push direction, a lower stiffness was expected since only the unbonded post-tensioning bars provided tensile capacity.

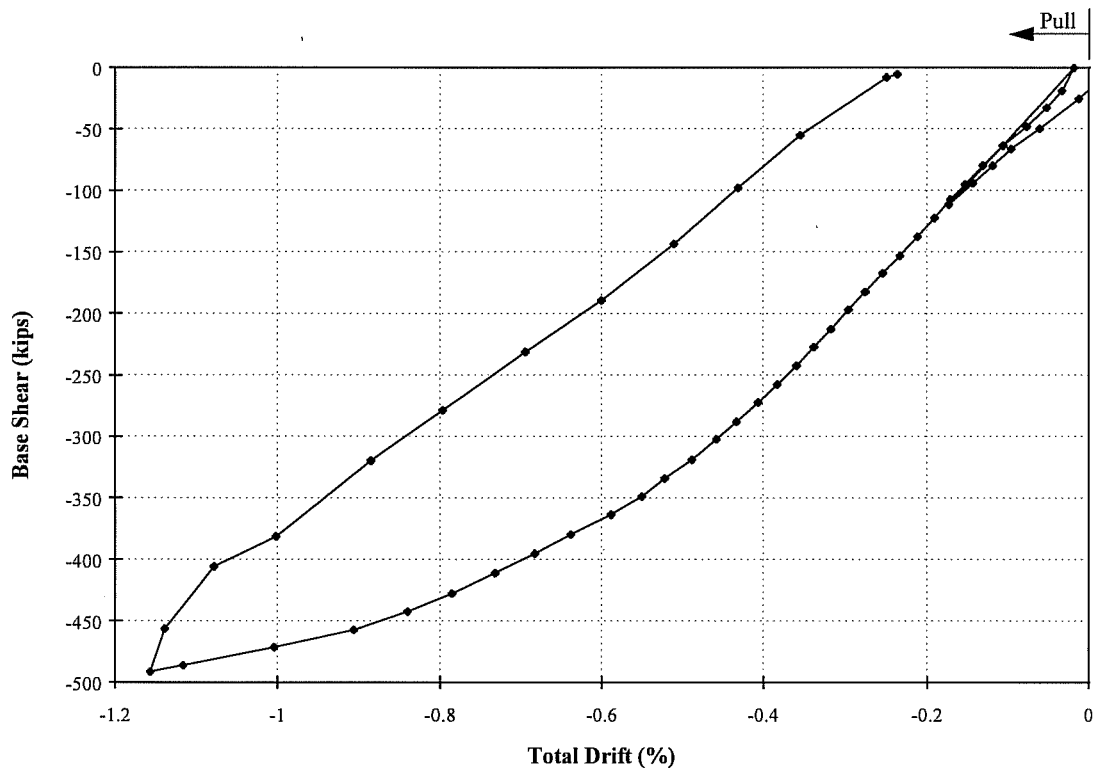
Figure 6.9: Test 3 Response

decreased with further loading as increased shear cracking occurred in the wall; the increased cracking increased the shearing deformations. The trend of stiffness degradation continued until approximately 460 kips where a distinct change in the slope of the curve was noticed. Fairly large deformations occurred with only a small increase in load.

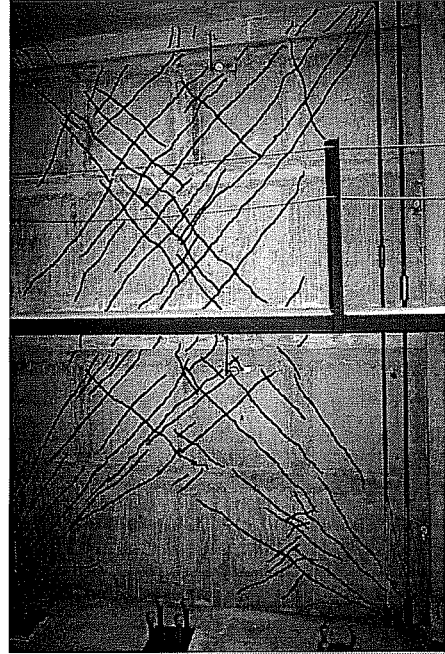
Figure 6.11: Wall Cracking Pattern

Diagonal cracks were continuous through panels and grout strips. There was no indication of distress along grout strips. The cracking pattern indicated that the wall behaved in a monolithic fashion even though it was constructed of smaller, individual units.

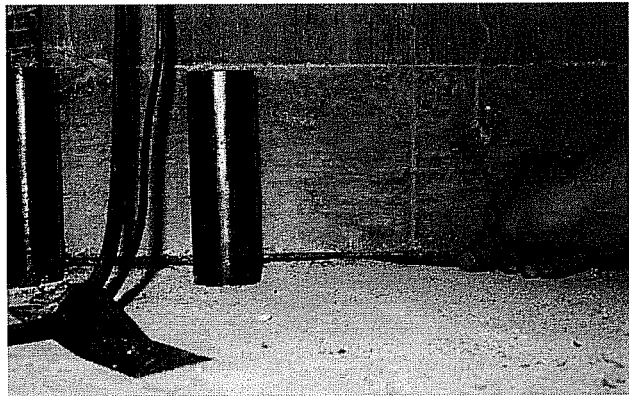
Figure 6.14: Crack at Wall Base

The joint at the wall-footing interface opened as shown in Figure 6.14. The crack originated at the boundary element (existing column) and extended along the base of the wall. At the column, the crack was accommodated originally through flexural cracking of the column and following splice failure through the failed splice as shown in Figure 6.15. Prior to splice failure, the opening was small; but after splice failure, extremely large crack widths were noted (up to 3/4 in.). As loads were increased, the crack width also increased. Since the post-tensioning system which served as the tension steel at the boundary was unbonded, only one flexural crack formed in the structure; no flexural cracking occurred within the wall. Therefore, there was a concentrated rotation at the base of the structure

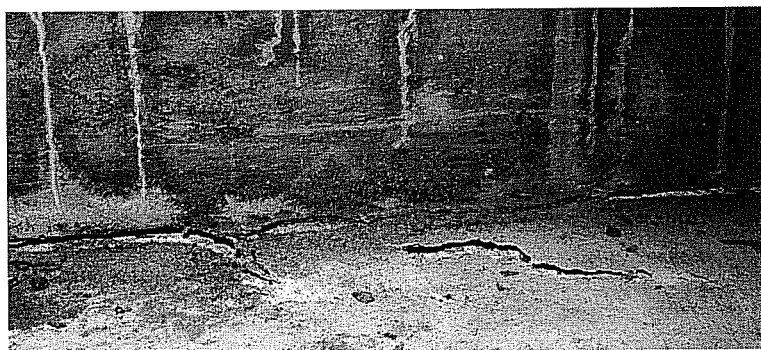
Figure 6.16: Pull-Out of Shear Lugs

Due to the large vertical displacement required at the interface, the pipe shear lugs pulled out of the footing as shown in Figure 6.16. The pipes pulled out a cone of concrete from the footing. In addition, the vertical reinforcement also pulled out since it was anchored inside the pipe. The size of the crack coincided with the elongation of the post-tensioning steel which was about equal to the uplift at the second and third floor levels. In Test 1, at initial yield of the post-tensioning bars, the maximum crack width was measured at approximately 0.75 in. as shown in Figure 6.17. After unloading, the crack closed completely in all tests under the compressive force of the post-tensioning system.
