Shear Cracking in Inverted-T Straddle Bents

Thesis

The University of Texas at Austin

August, 2011

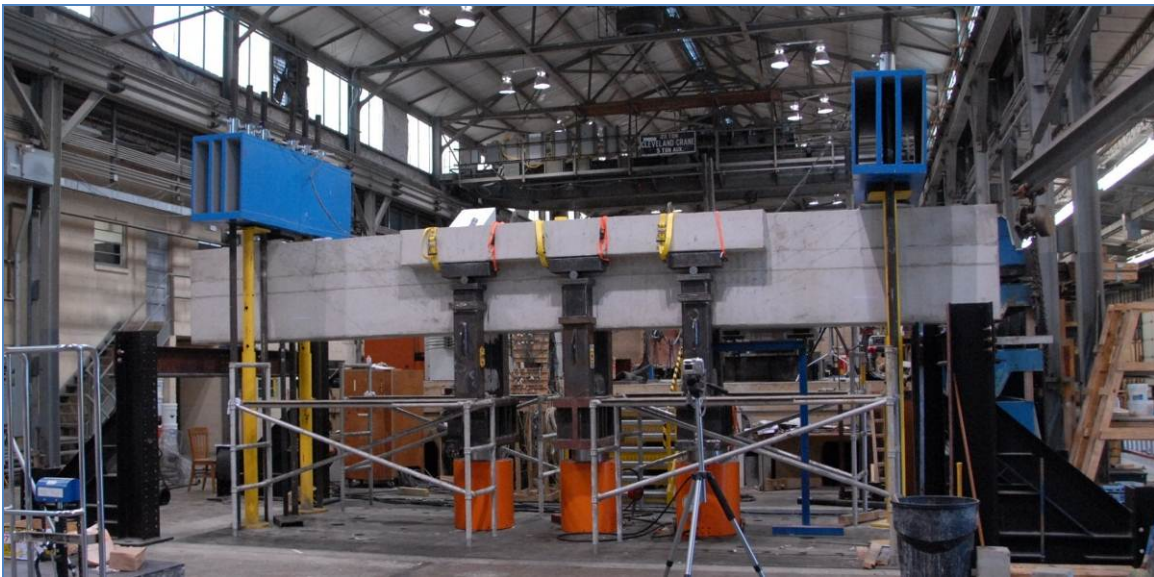
Figure 3-18: Beam specimen in test set-up with three point loads

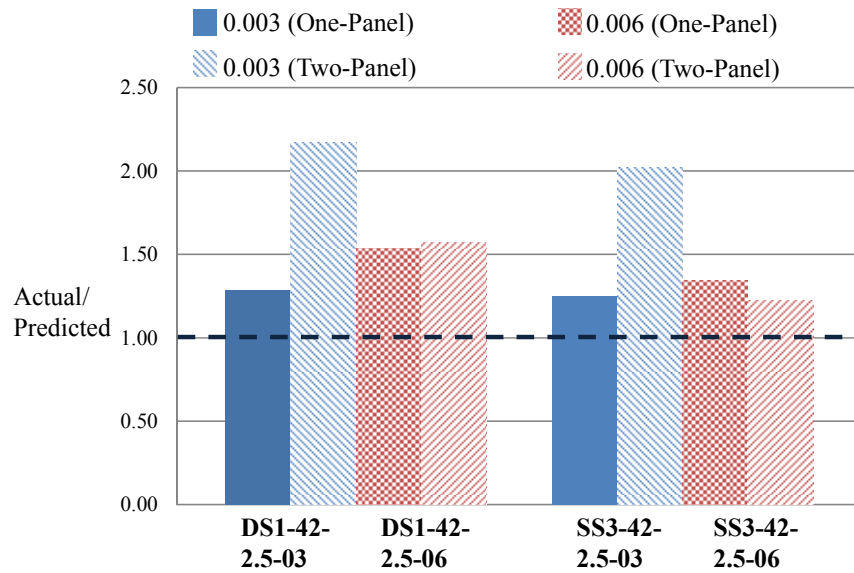
Figure 4-15: Actual capacity to predicted capacity ratio for both one- and two-panel failures

In Figure 4-15, the ratio of the experimental capacity to calculated capacity for each specimen is presented in terms of both the one-panel and two-panel mechanisms. The STM provisions of TxDOT Project 0-5253 resulted in conservative estimations of the shear capacity, regardless of the web reinforcement ratio and ledge depth. The ratio of the experimental capacity to calculated capacity, using a two-panel model, varied from 1.2 to 2.2; well within the evaluation database scatter observed during TxDOT Project 0-5253.

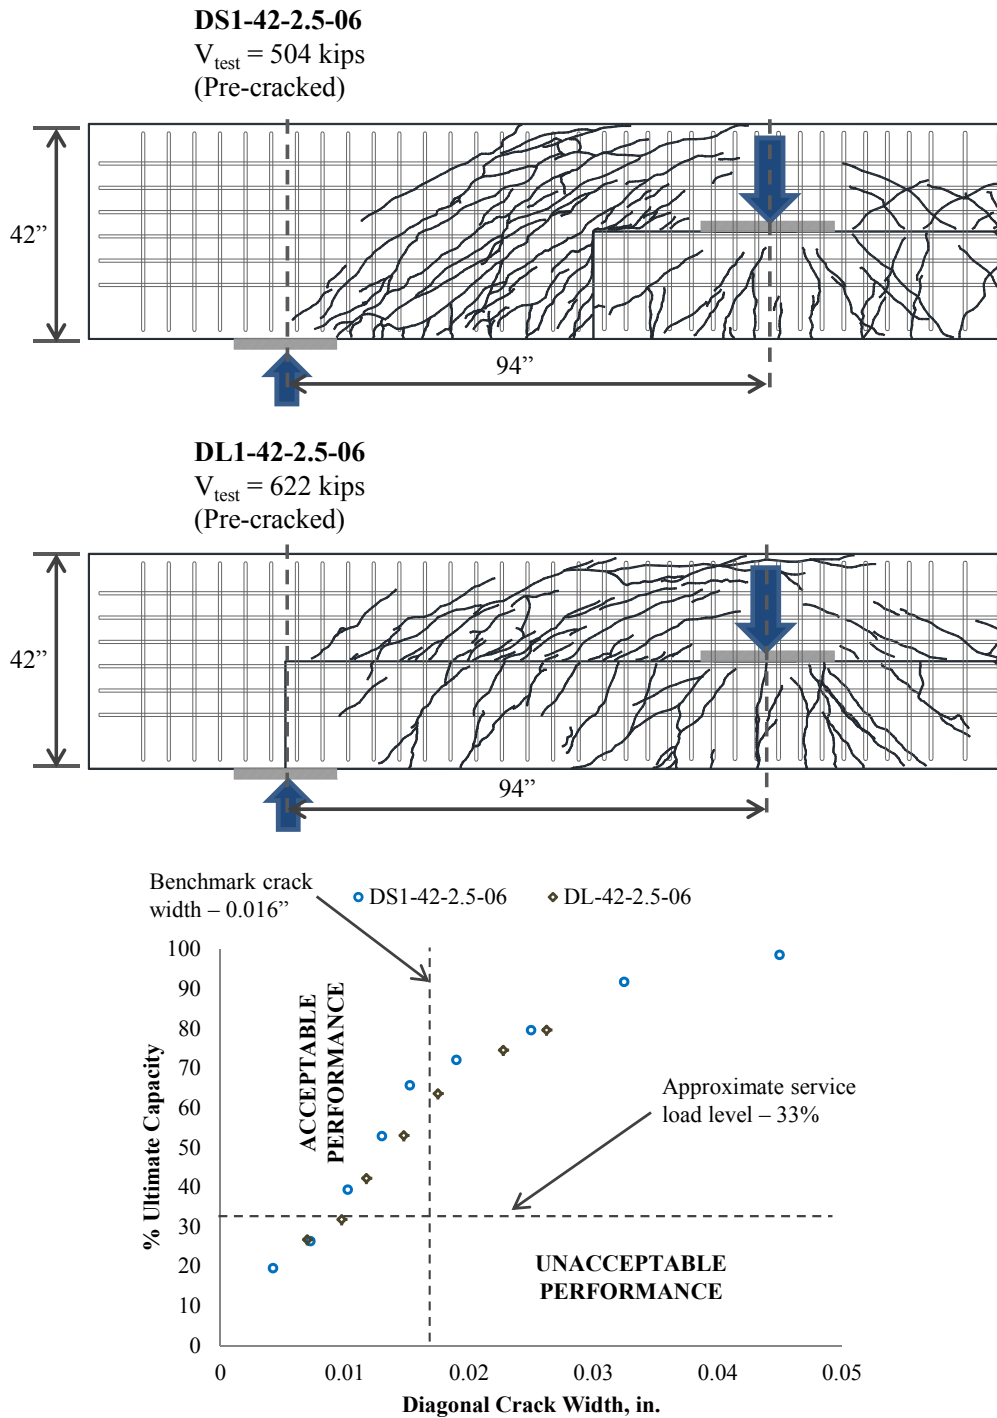
Figure 4-31: Serviceability data for deep-short and deep-long ledges with $a/d = 2.5$: Crack patterns (at ultimate capacity) and crack widths

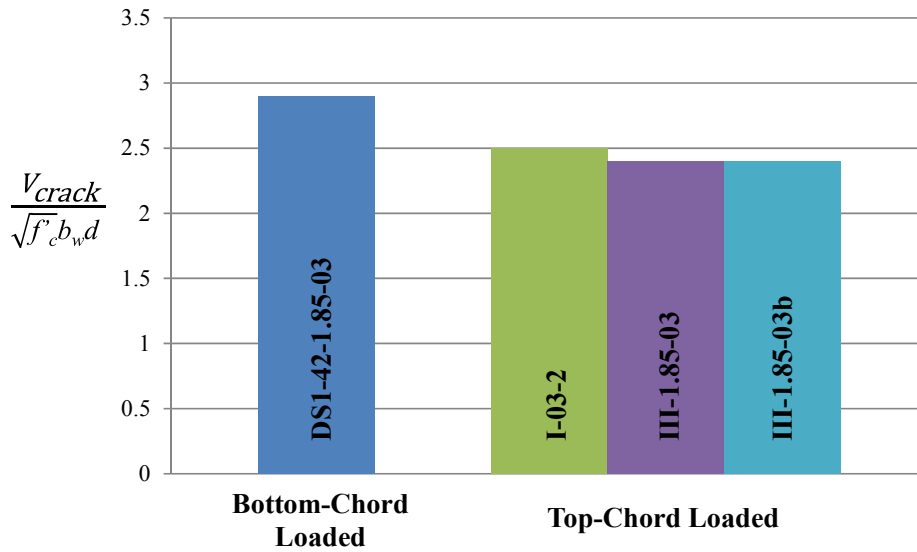
Figure 5-5: First cracking shear force for bottom- and top-chord loaded specimens with $a/d = 1.85$

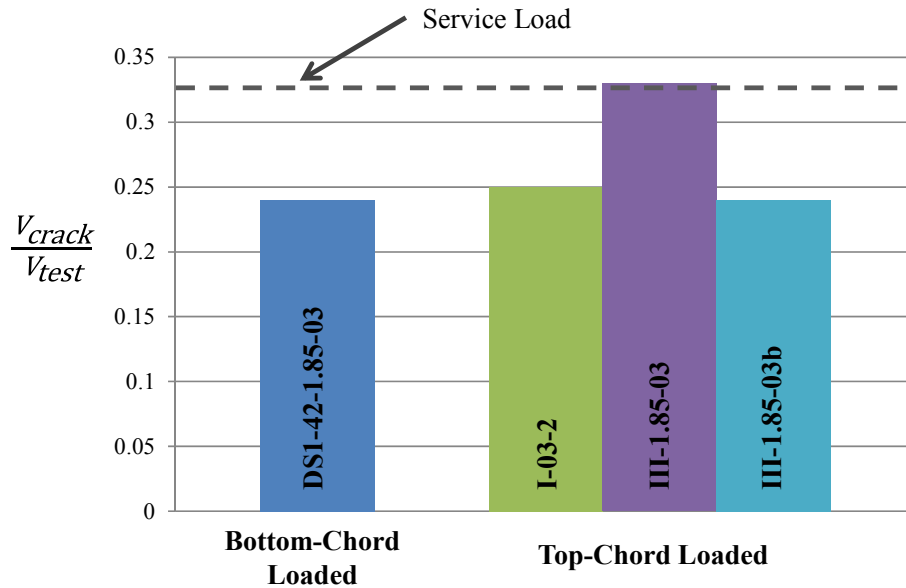
Figure 5-6: Ratio of first cracking shear force to ultimate shear capacity for bottom- and top-chord loaded specimens with $a/d = 1.85$

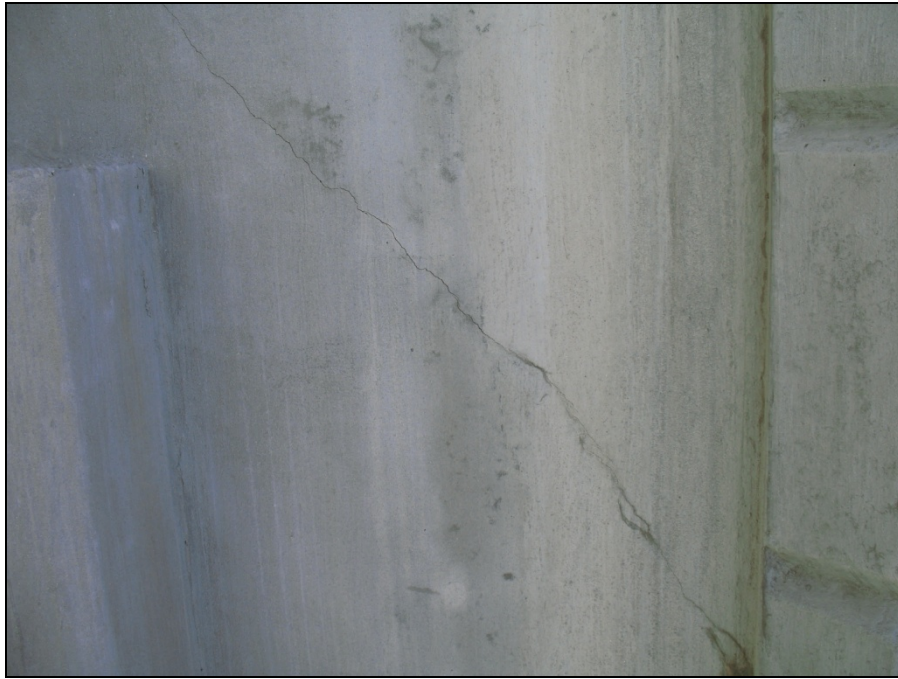
Figure A-6 – Largest shear crack (0.02 inches) (a in Figure A-5)

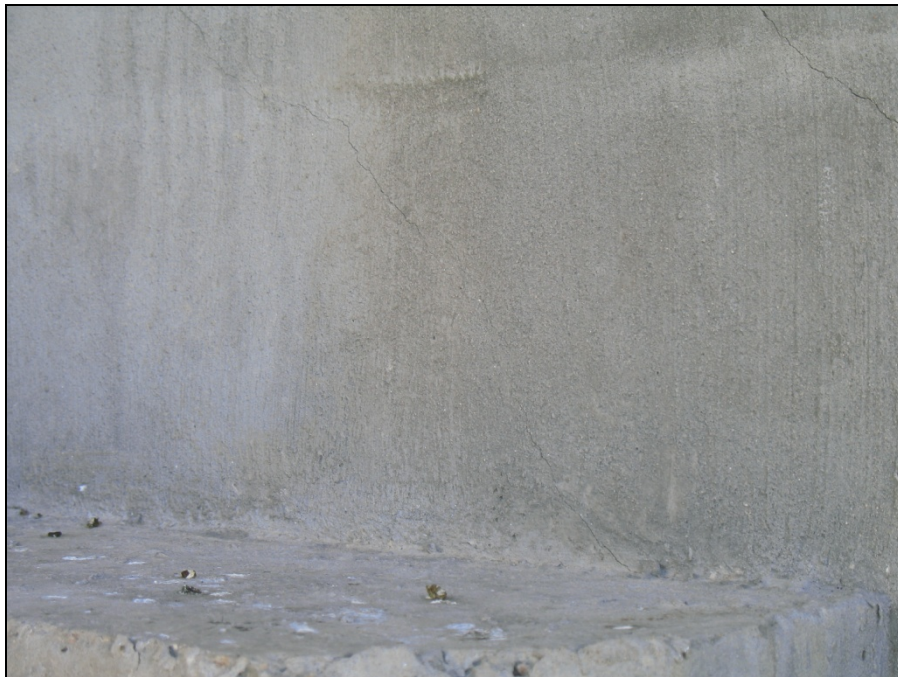
Figure A-7 – Small crack above ledge (b in Figure A-5)

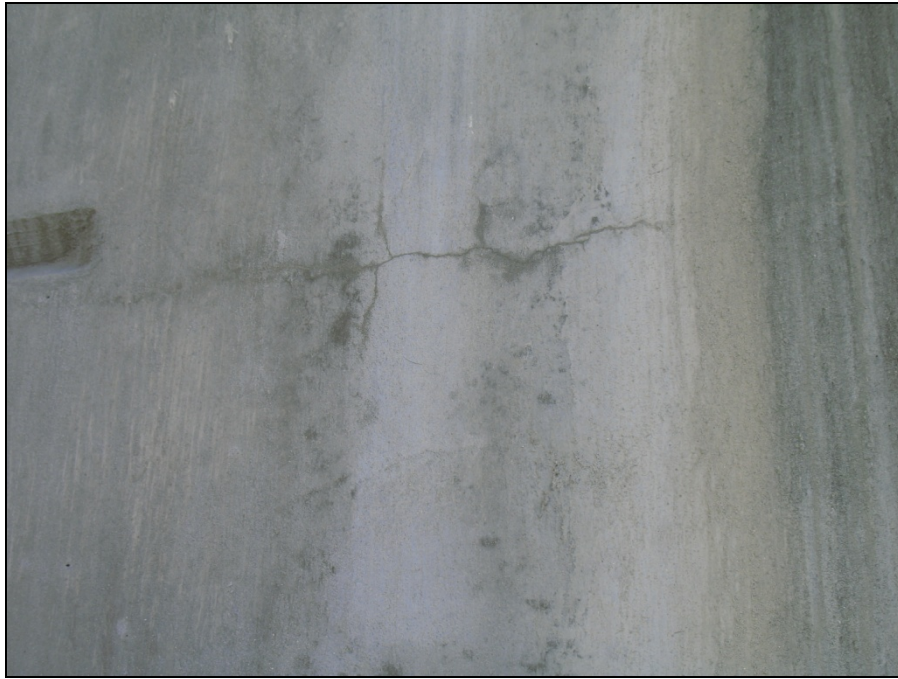
Figure A-8 – Horizontal cracking above shear crack (c in Figure A-5)

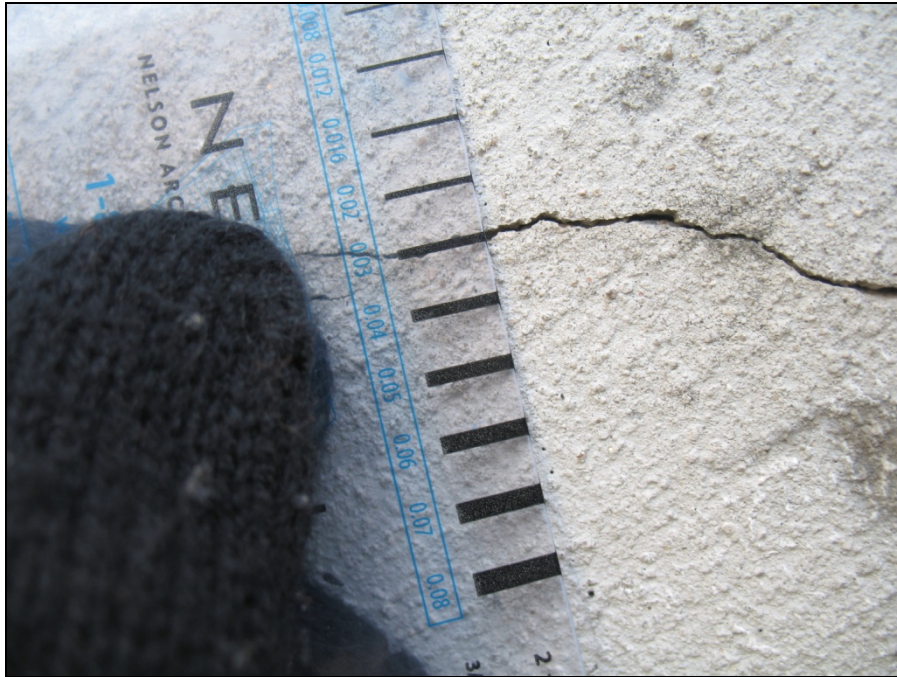
Figure A-18 – Largest shear crack (0.03 inches) (a in Figure A-17)

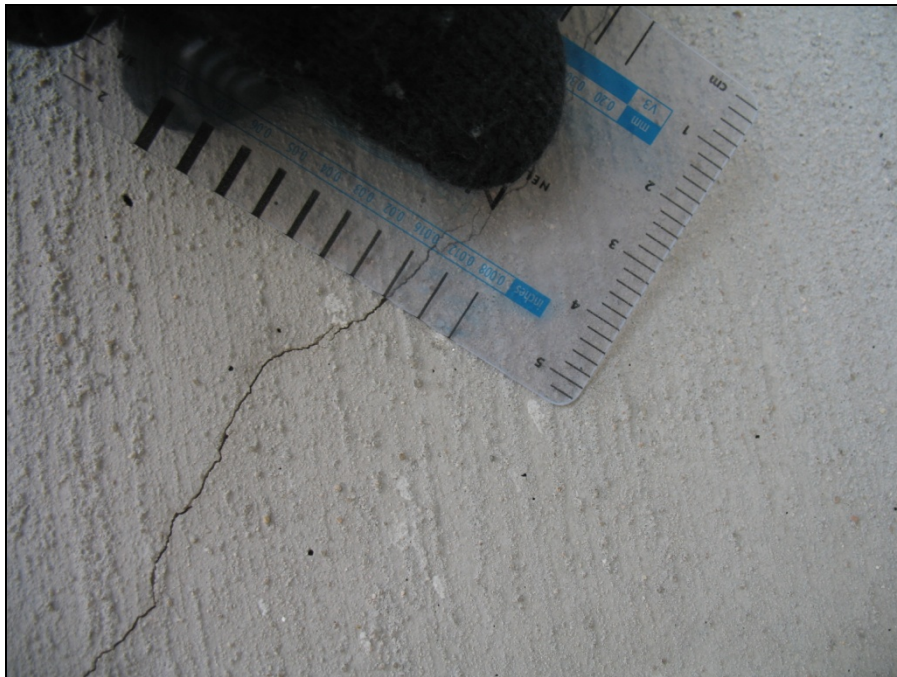
Figure A-19 – Crack above ledge (0.016 inches) (b in Figure A-17)

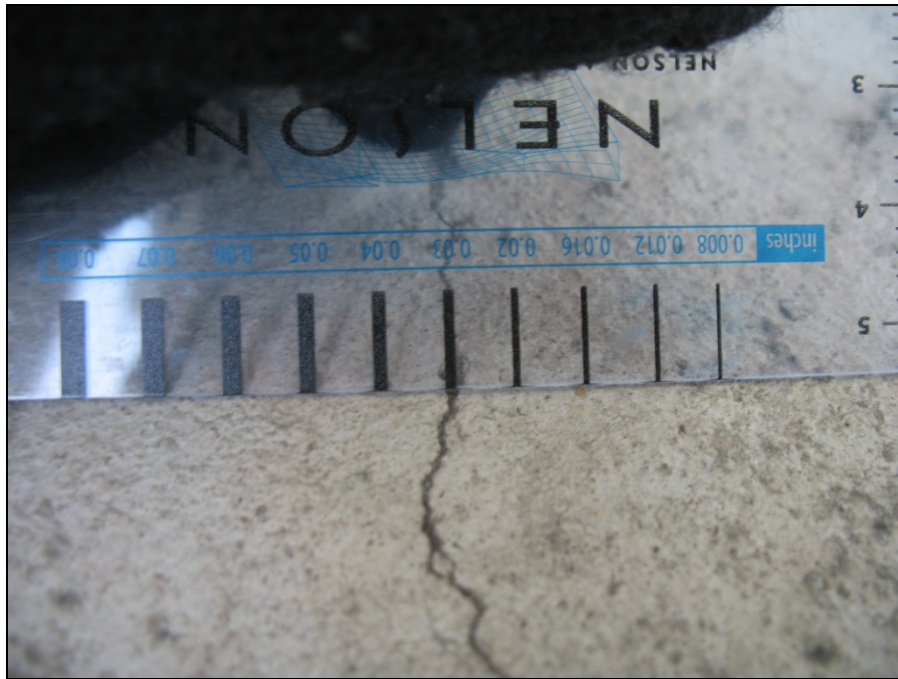
Figure A-20 – Top of ledge at interface (0.03 inches) (c in Figure A-17)

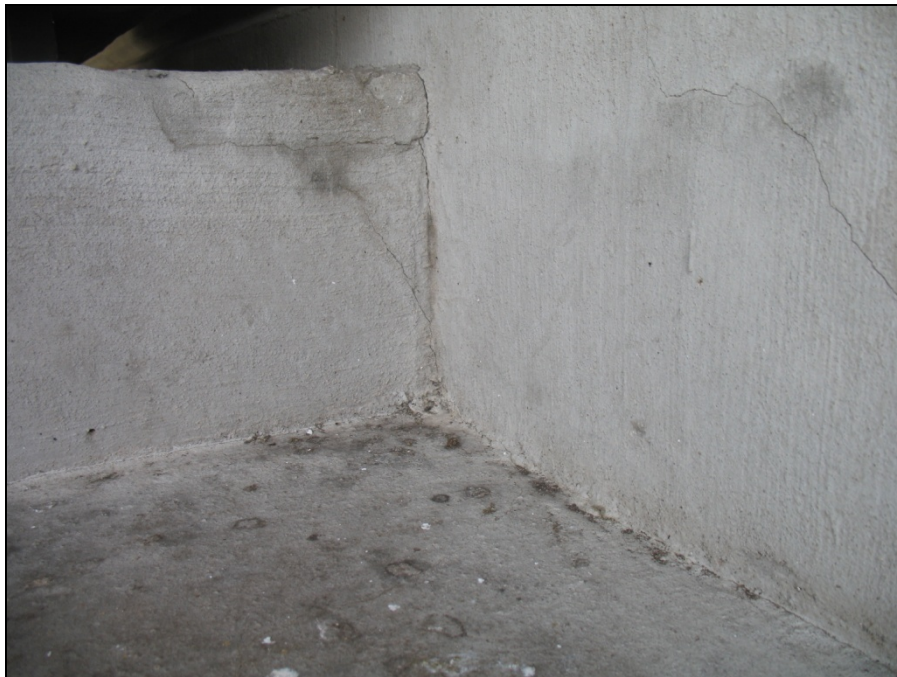
Figure A-23 – Bearing plate-ledge-web interface (b in Figure A-21)

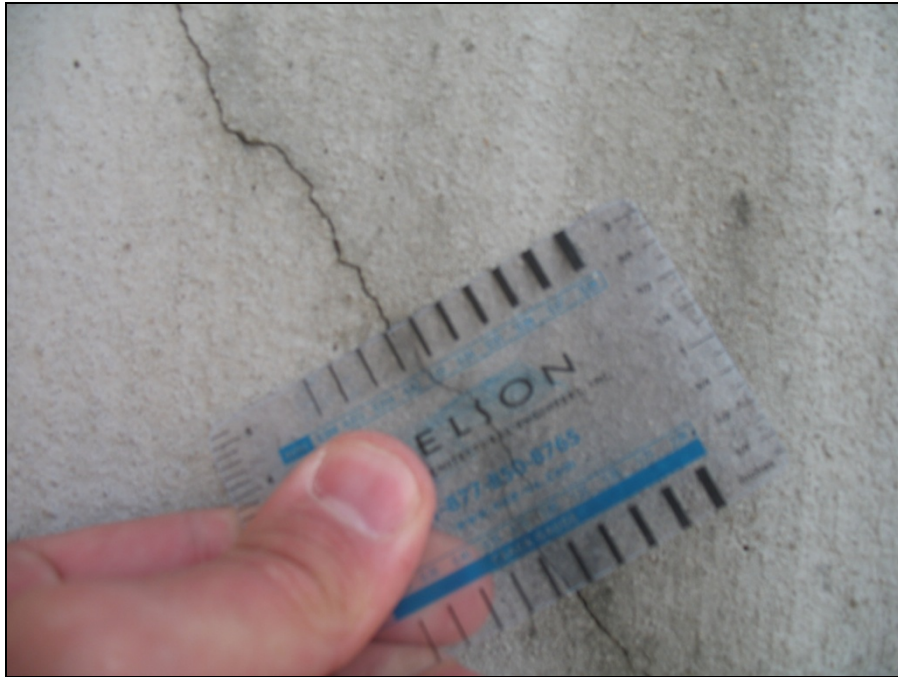
Figure A-24 – Largest shear crack (0.02 inches) (c in Figure A-21)

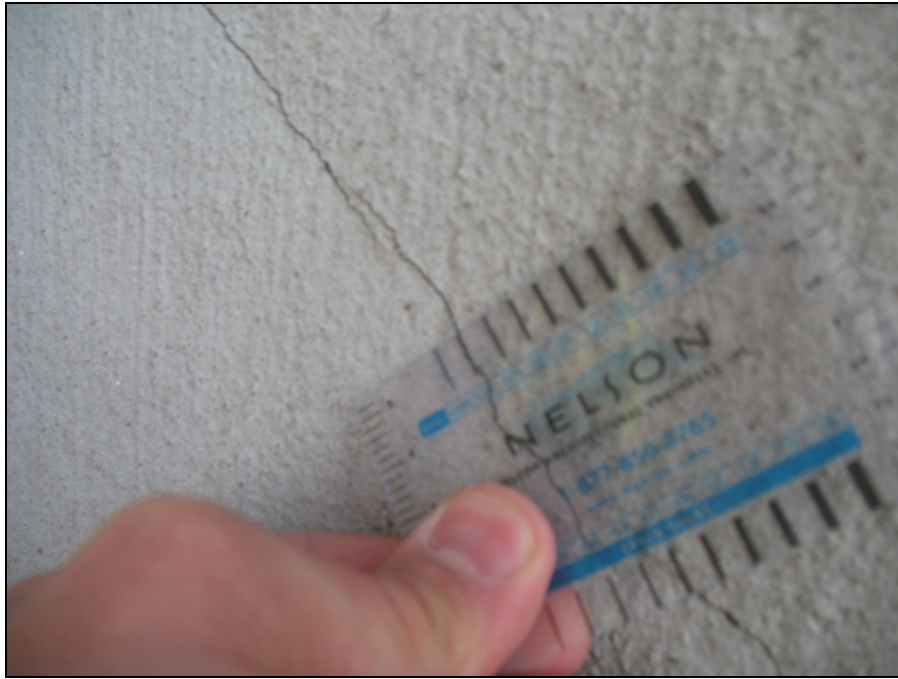
Figure A-26 – Crack above ledge (e in Figure A-21)

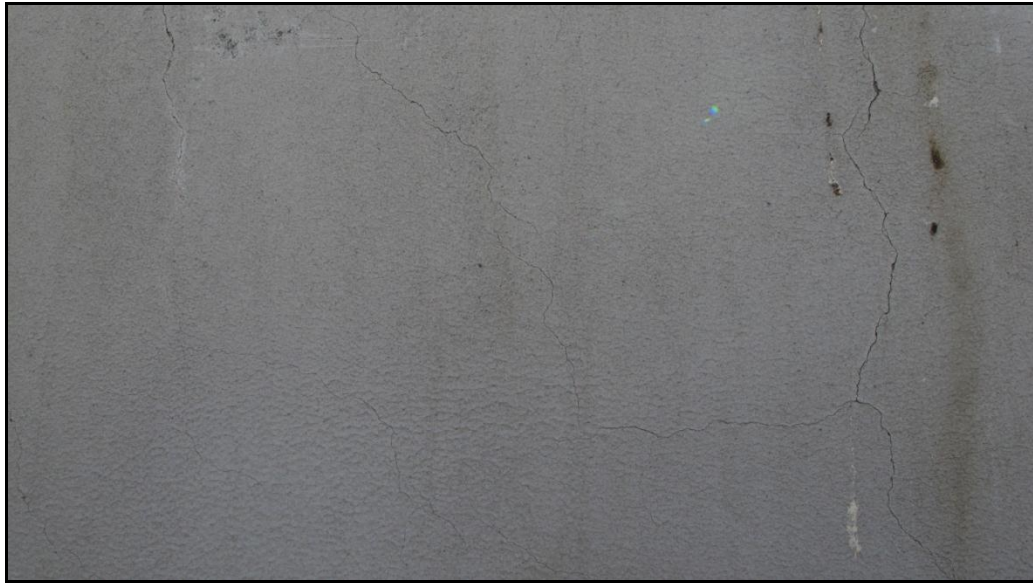
Figure A-43 - Map cracking located in the middle of shear span (d in Figure A-39)

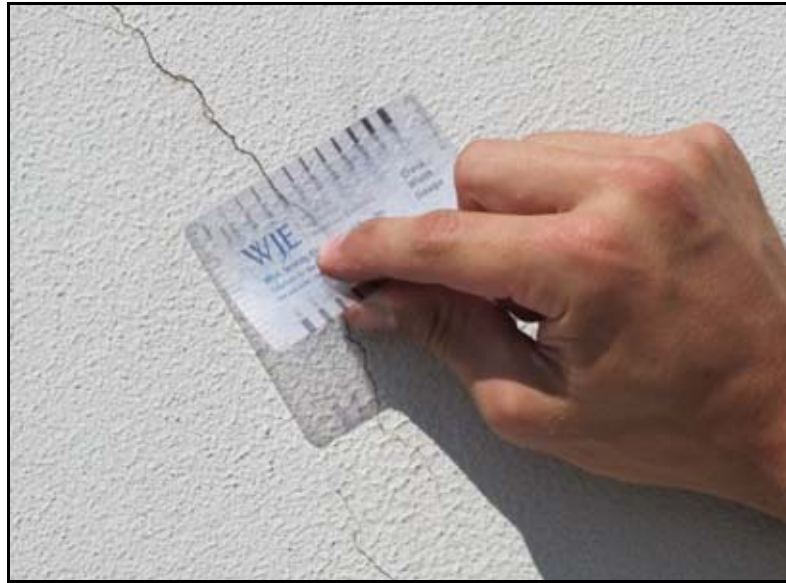
Figure A-46 - Moment crack (0.02 inches) (a in Figure A-45)

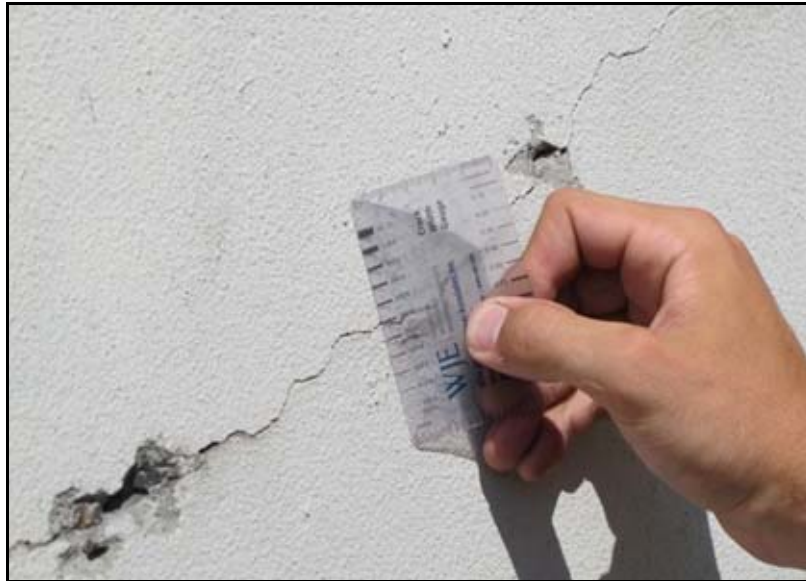
Figure A-48 - Shear crack (0.03 inches) and spalling (c in Figure A-46)

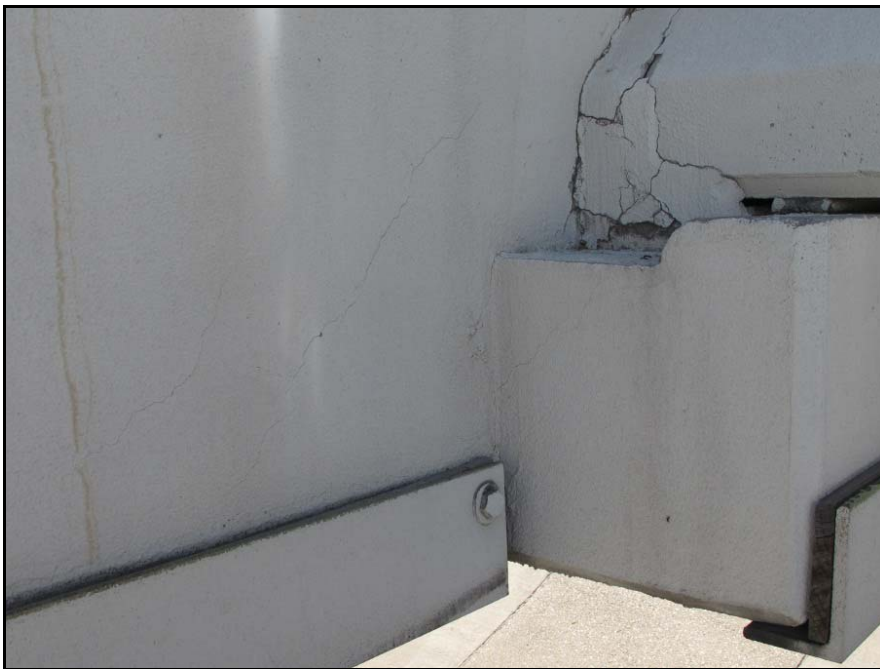
Figure A-52 - Shear crack and web ledge interface crack (a in Figure A-51)

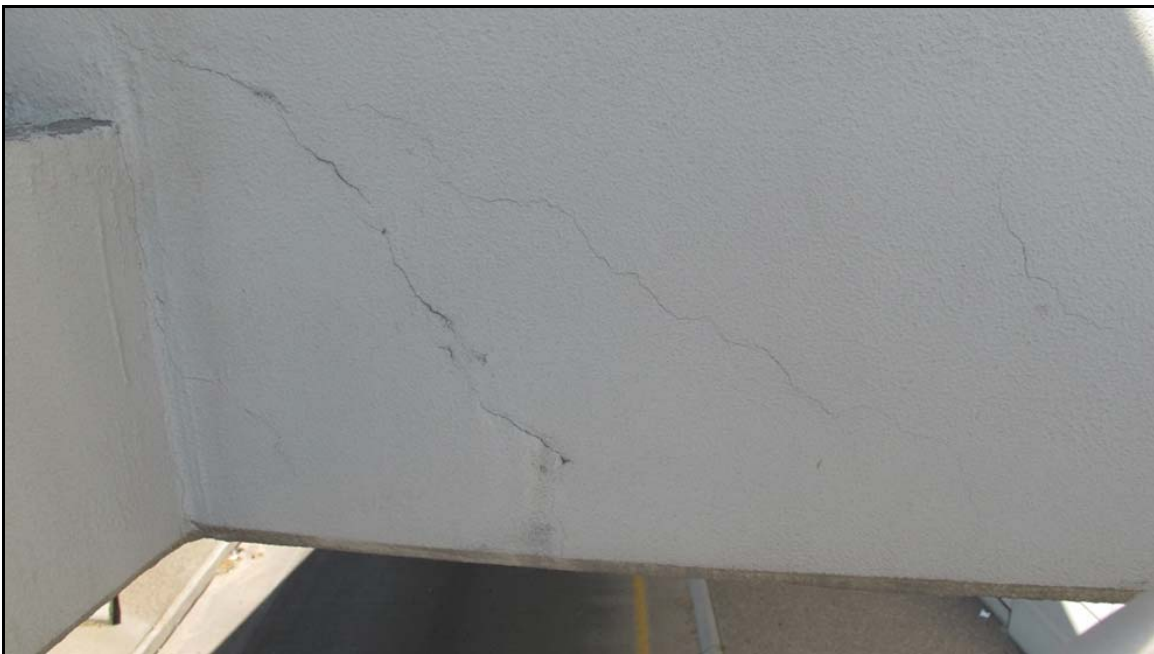
Figure A-54 - Shear crack and web-ledge interface crack (a in Figure A-53)
