**A STUDY OF FRETTING FATIGUE IN POST-TENSIONED  
CONCRETE BEAMS**

THESIS

The University of Texas at Austin

August , 1989

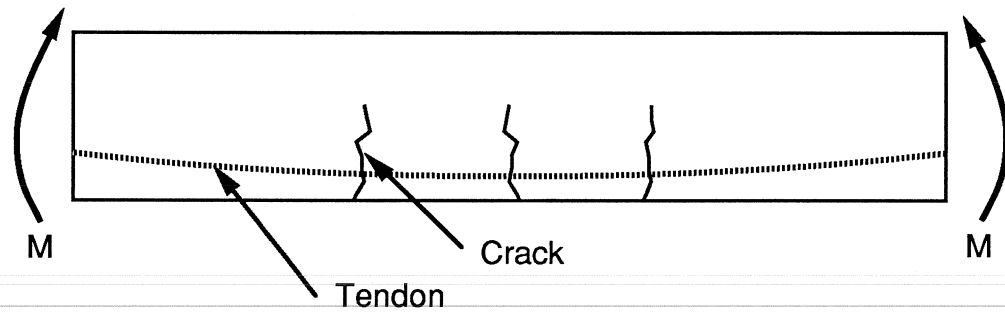
Figure 2.1 Variation of Tendon Stress in Prestressed Concrete Beam Sections  
(from Yates [27])

concrete in the beam remains uncracked [10]. Once the beam is cracked, localized tendon stress concentrations occur at the crack locations as shown in Fig. 2.1. In general, the increased stress range results in faster growth of cracks in the prestressing steel, and reduced life of the specimen. This is shown schematically in Fig. 2.2. The Endurance Limit, which is the maximum stress range for which fatigue does not occur, is also shown in the above figure.

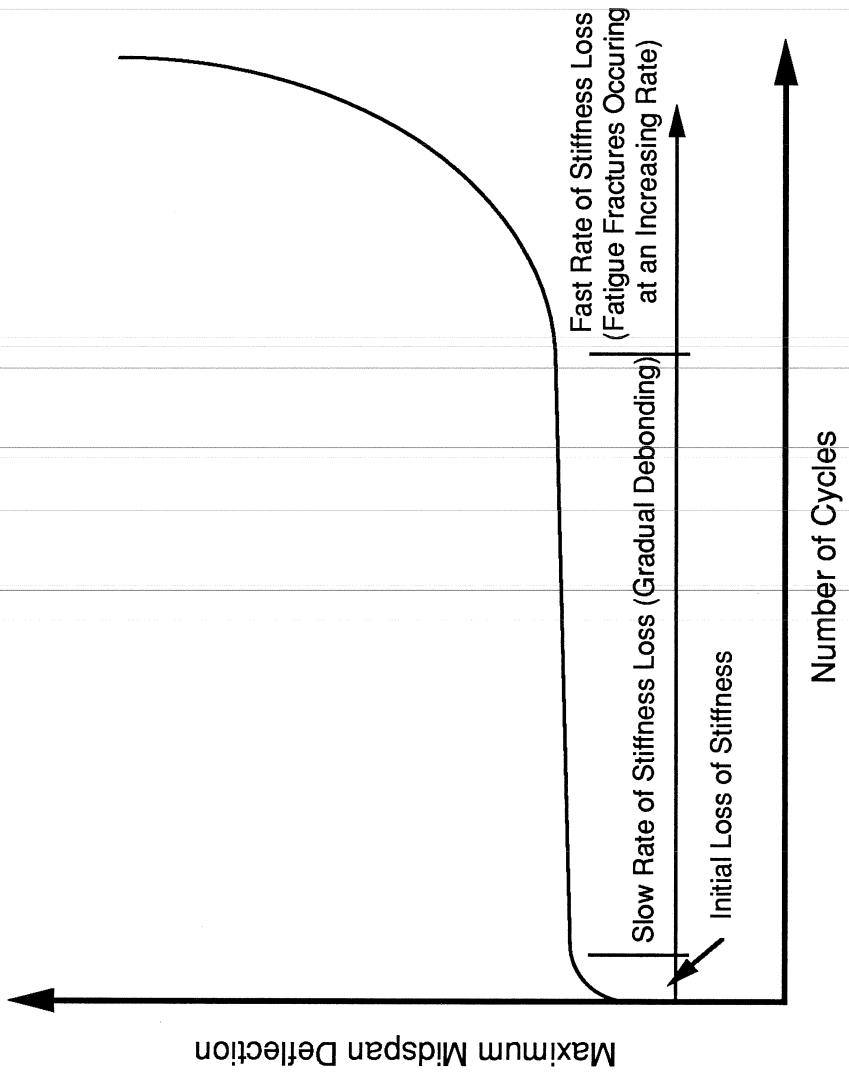
Figure 2.3 Typical Stiffness History

The stiffness history of a prestressed concrete beam that was initially cracked before cyclic loading is shown in Fig. 2.3. The graph is characterized by three distinct regions. The first region corresponds to the initial cracking cycles. Specimen deflections increase due to the formation and propagation of flexural crack, and the bond deterioration between prestressing steel and concrete. The second region corresponds to the load cycles between the initial

cracking cycles and the first wire break. In this region cracks propagate further and bond deterioration continues. As a result, additional deflection (loss of stiffness) occurs. The third region corresponds with the occurrence of wire fractures. The initial wire break is followed by the fracture of additional wires at an increasing rate resulting in a rapid loss of stiffness.

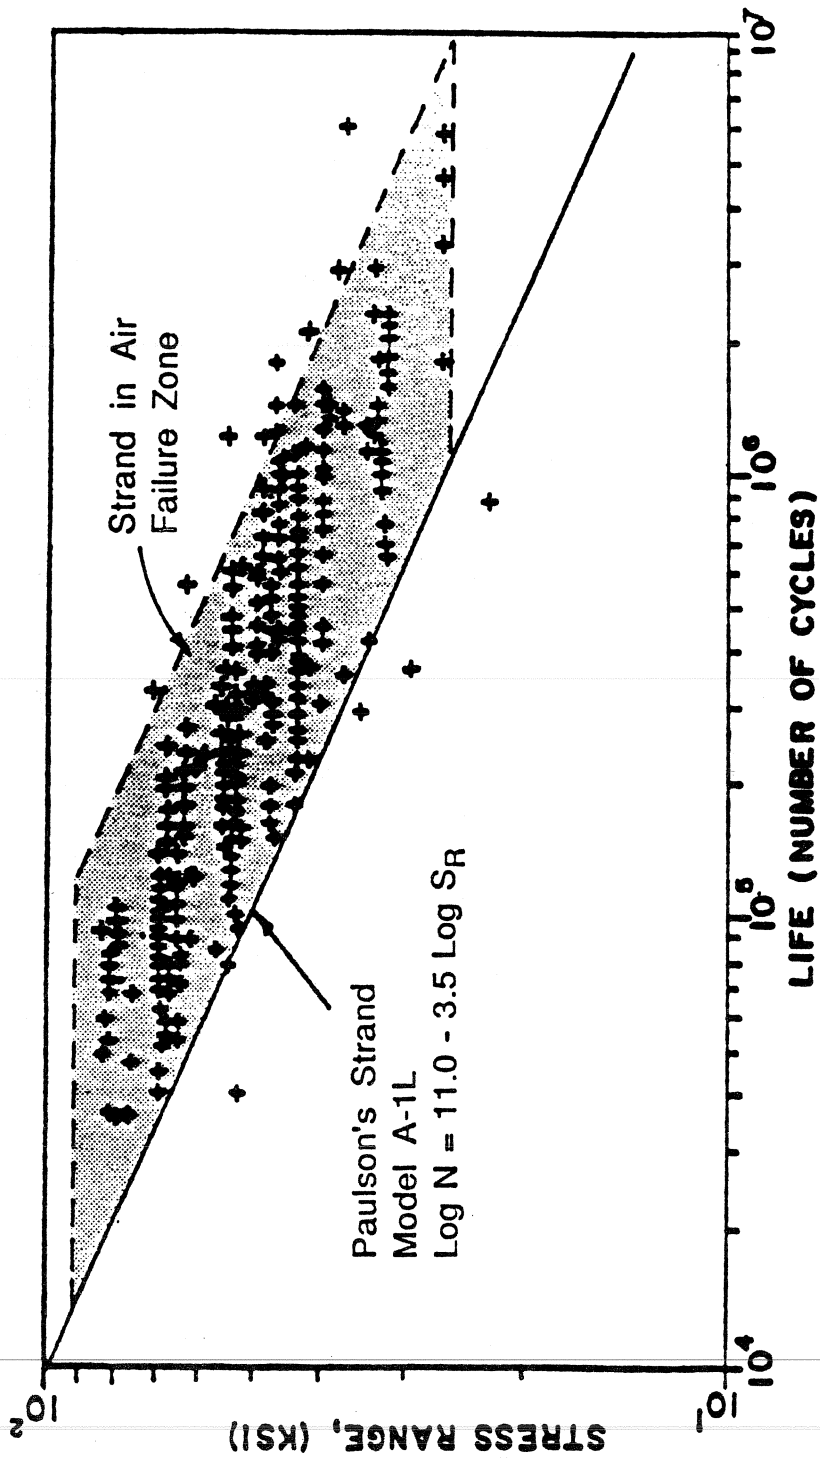
Figure 2.4 Strand In Air Failure Zone (from Paulson [17])

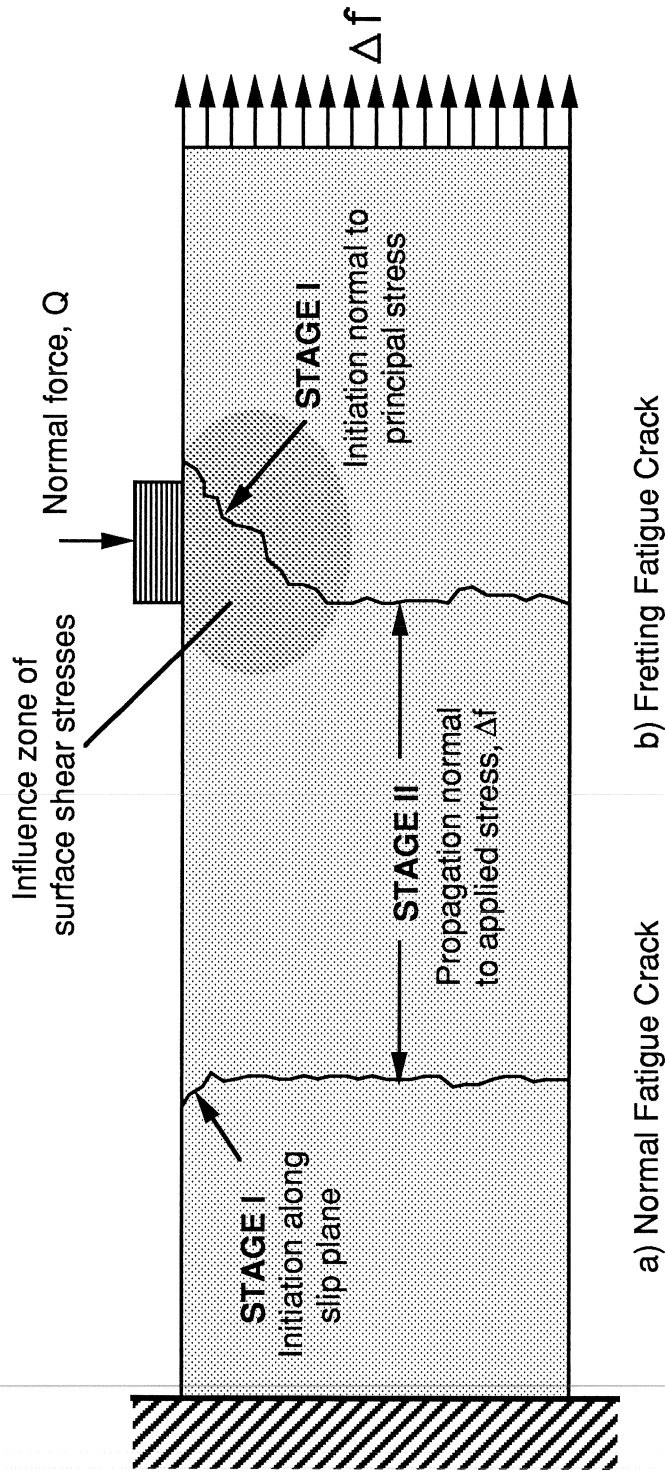
Figure 2.5 Fatigue Crack Characteristics ( from Waterhouse [24] )

Figure 2.5 shows schematically the characteristics of an ordinary fatigue crack and a fretting fatigue crack. Within the zone of surface shear stresses the fretting fatigue crack follows an inclined path corresponding to a plane of principal tension. Beyond the zone where surface shear stresses have an influence, the fretting fatigue crack propagates due to existing tensile stresses in the same way as an ordinary fatigue crack propagates. The existing tensile stresses help in accelerating initiation of fretting fatigue cracks

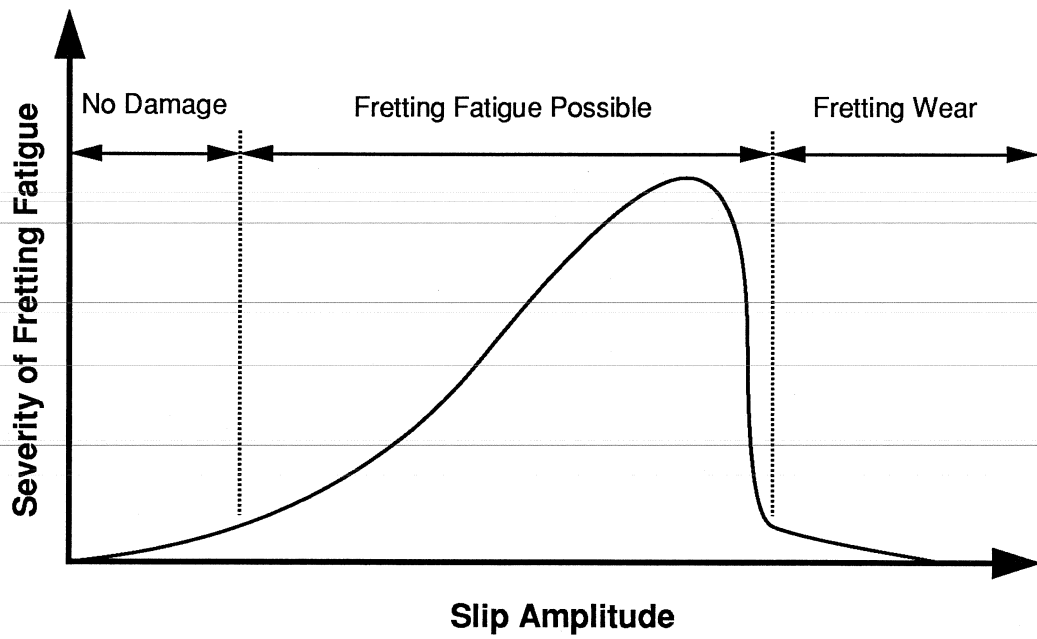
Figure 2.7 Effect of Slip Amplitude on Fretting Fatigue ( from Yates [27] )

The slip amplitude is interrelated with other factors influencing fretting fatigue. However, there is a general trend describing the effect of slip amplitude on fretting fatigue as indicated in previous studies [2,8,9]. This general trend is shown schematically in Fig. 2.7. Krueger [8] suggests that if the slip is small enough, it can be accommodated by elastic deformation, and no fretting fatigue damage will take place. If the slip is large enough to wear away any already existing surface microcracks by abrasion before they propagate, no new cracks will form from fretting, and the result will be normal wear. Between these two extremes, fretting fatigue damage is very probable. Within this region an increase in the slip

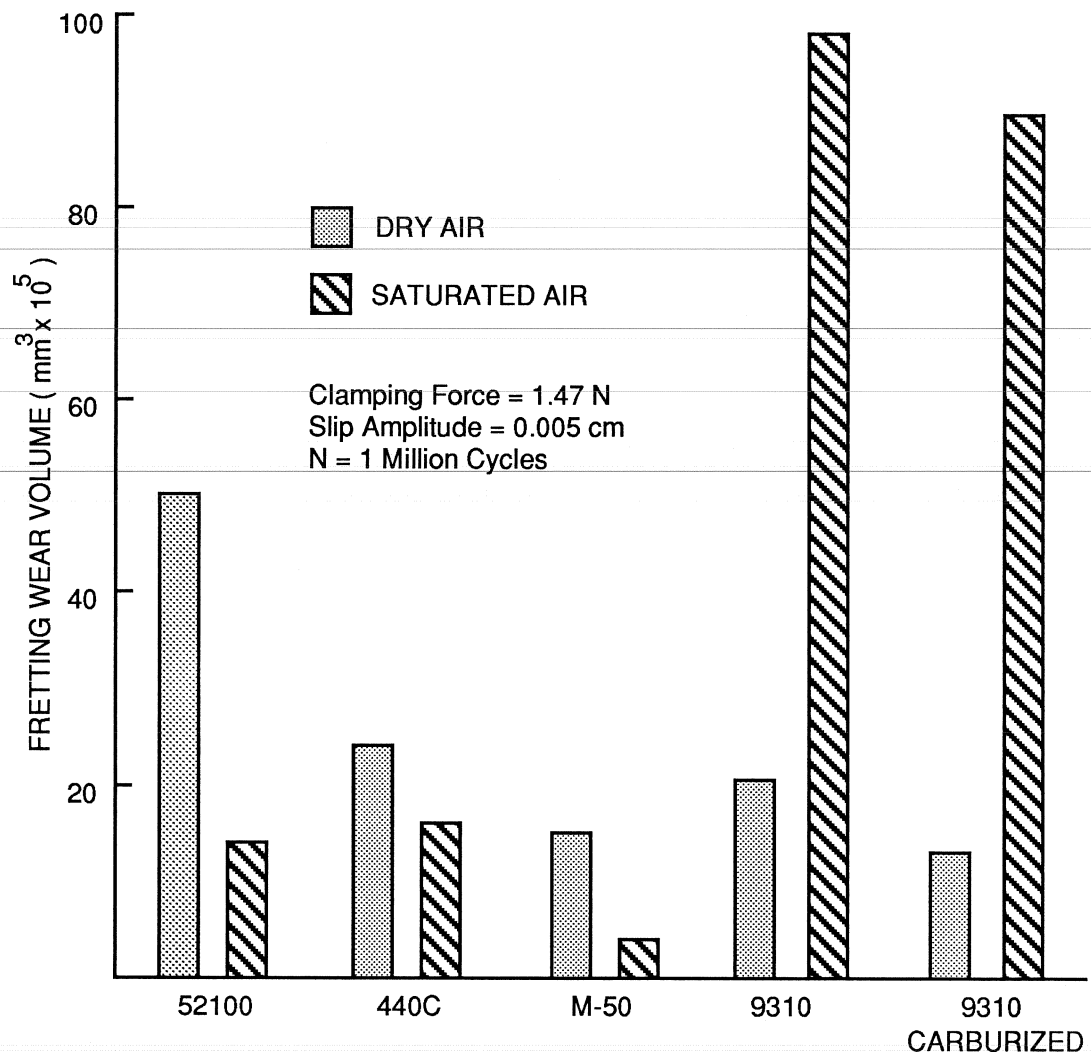
Figure 2.8 Influence of Humidity on Fretting Wear for Several Steels (from Bill [2])

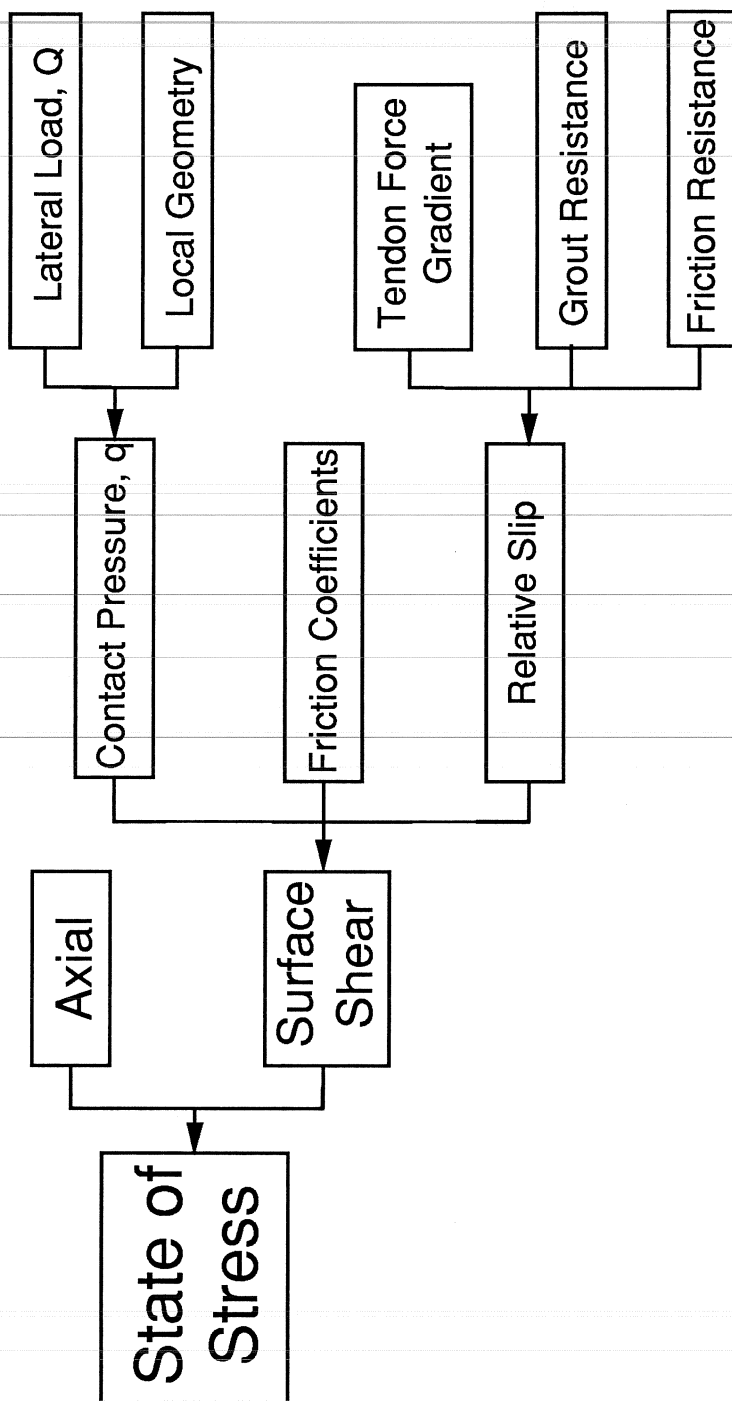
Figure 2.9 Interaction of Local Variables Affecting Fretting Fatigue of a Post-Tensioned Tendon (from Yates [27])

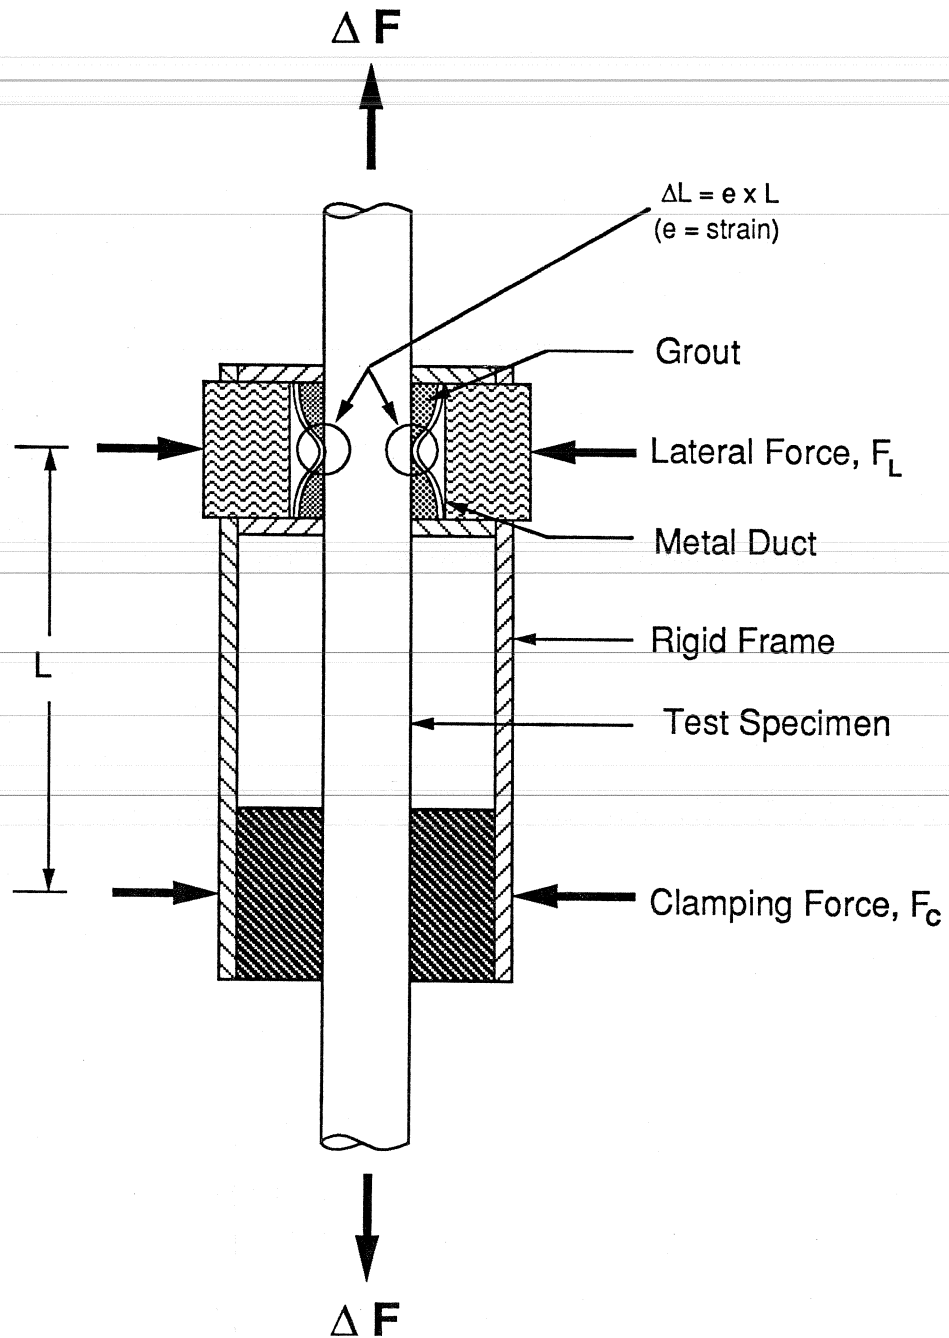
Figure 2.13 Fretting Simulation Apparatus Used by Cordes, Lapp-Emden and Trost [4]

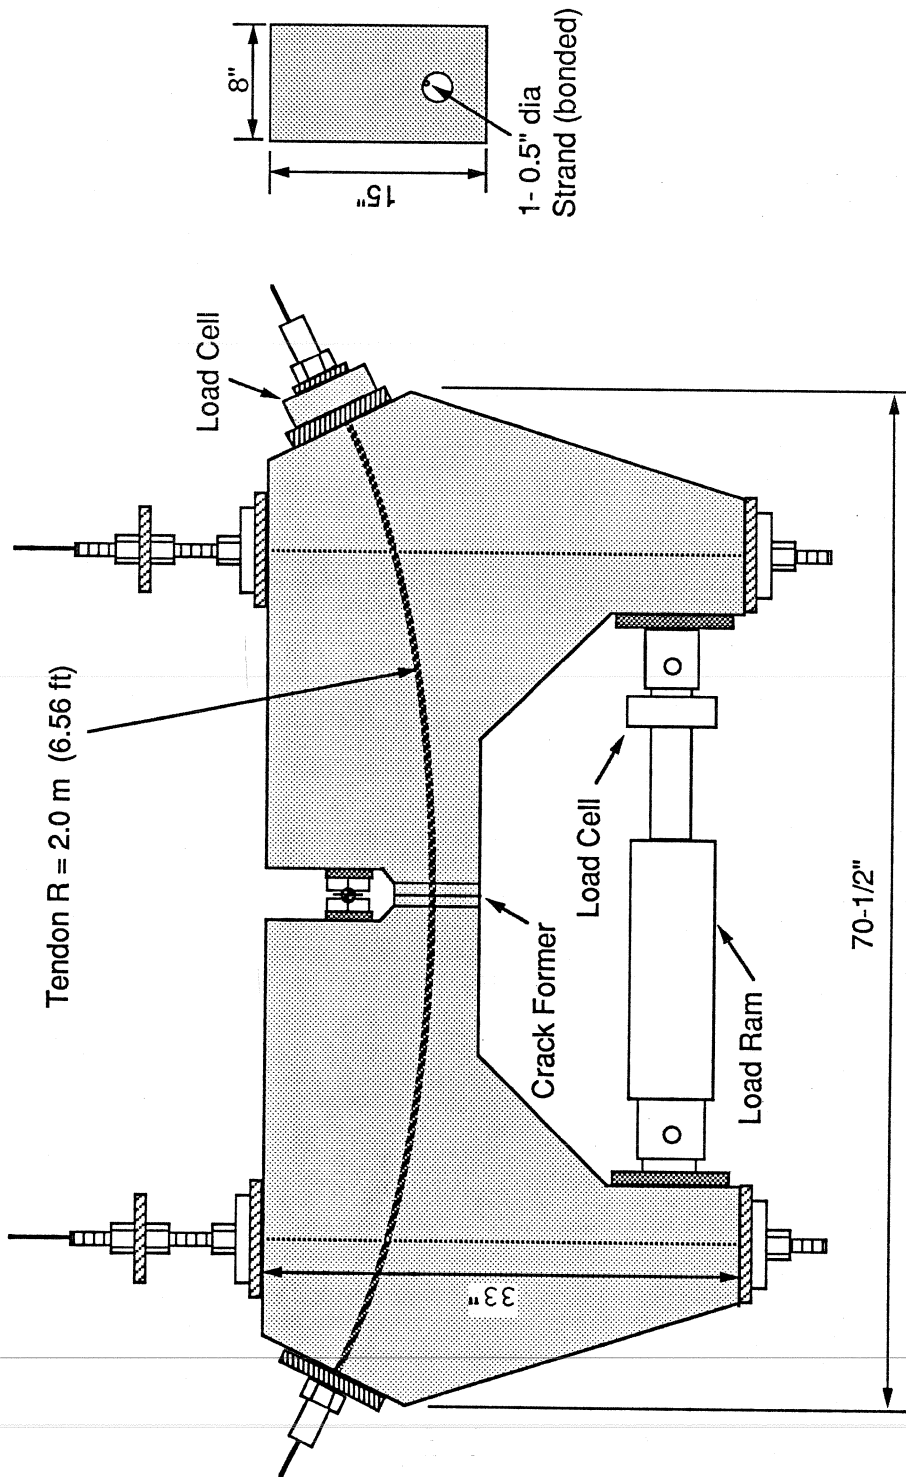
Figure 2.16 Reduced Beams Tested by Yates [27]

The reduced-beam specimens were constructed, post-tensioned, grouted, and tested at FSEL. Each specimen was cracked during the initial static load cycles, and the response to these static loads was recorded. This response was used to determine the flexural decompression load which was used to determine the

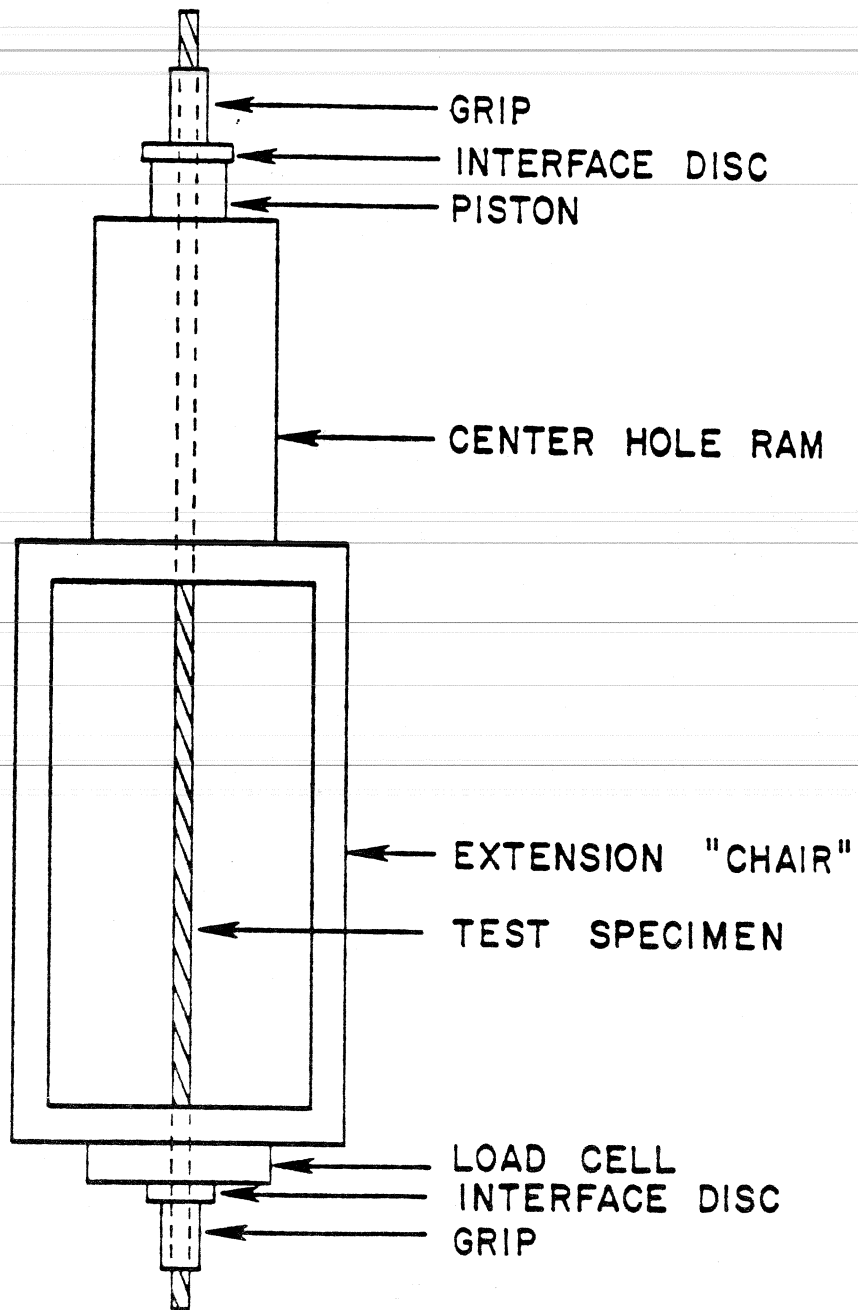
Figure 3.1 Schematic Representation of the Strand Fatigue Test Set-Up (from Paulson [17])

A set of 10 Strand B samples and a set of four Strand C samples were fatigue tested in air by Yates [27] and Wollmann [26], respectively. The fatigue equipment and test set-up are described in detail by Paulson [17]. A simple schematic of the strand fatigue test set-up is shown in Fig. 3.1. The results of the tests are listed in Table 3.1. The results are also plotted in Fig. 3.2, along with Paulson's strand in air failure zone developed based on results of over 700 strand in air fatigue tests [17] and the AASHTO fatigue model. Comparison of the results and the data points in

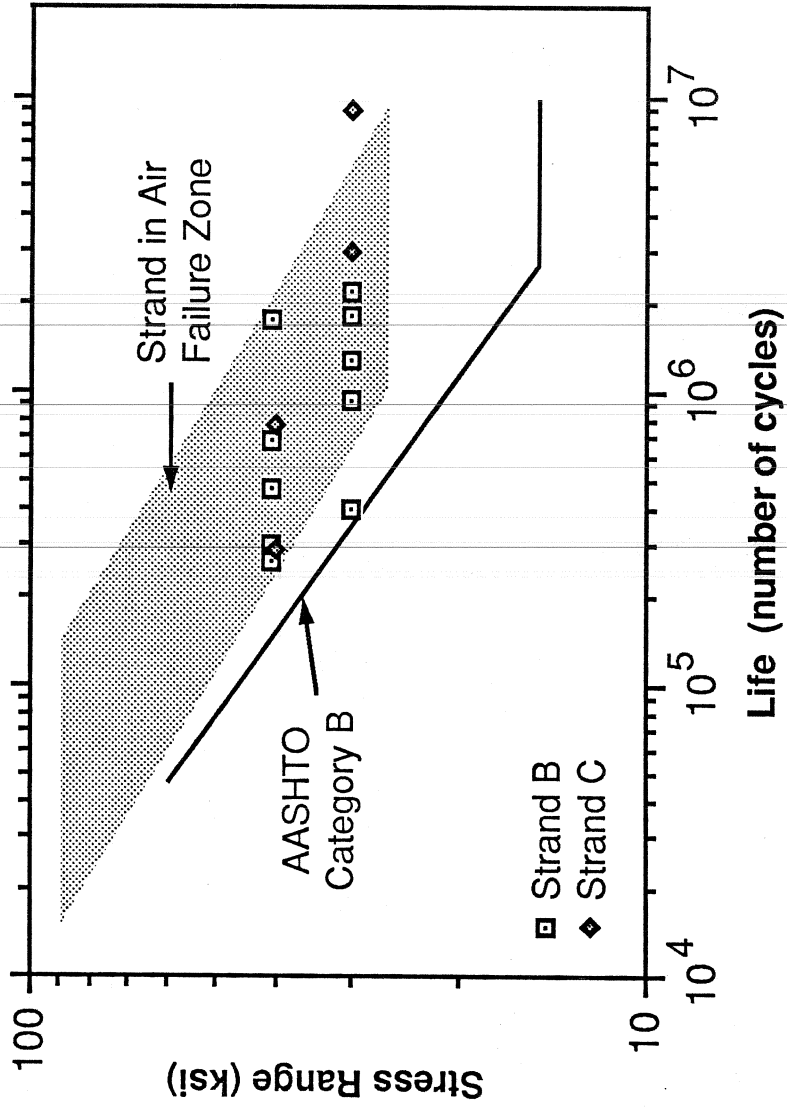
Figure 3.2 Comparison of Strand-In-Air Fatigue Test Results, Paulson's Strand-In-Air Failure Zone and AASHTO Fatigue Model

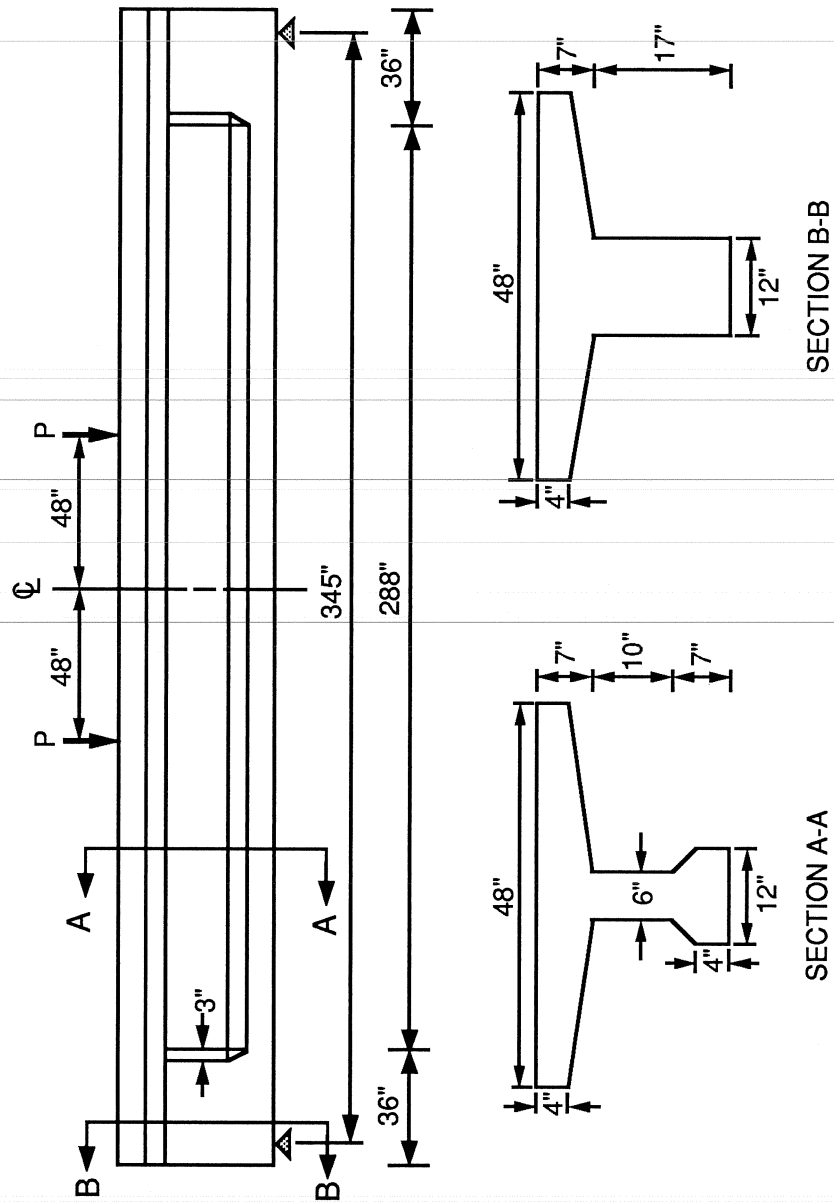
Figure 3.3 Actual Dimensions and Details of Large-Scale Beam

The draped ducts had a radius of curvature of 3.5 m or 11.5 ft for the curved section of the tendon. This curvature is the same as used in post-tensioned beams tested at the Swiss Federal Institute of Technology in Zurich [20] and at the Technical

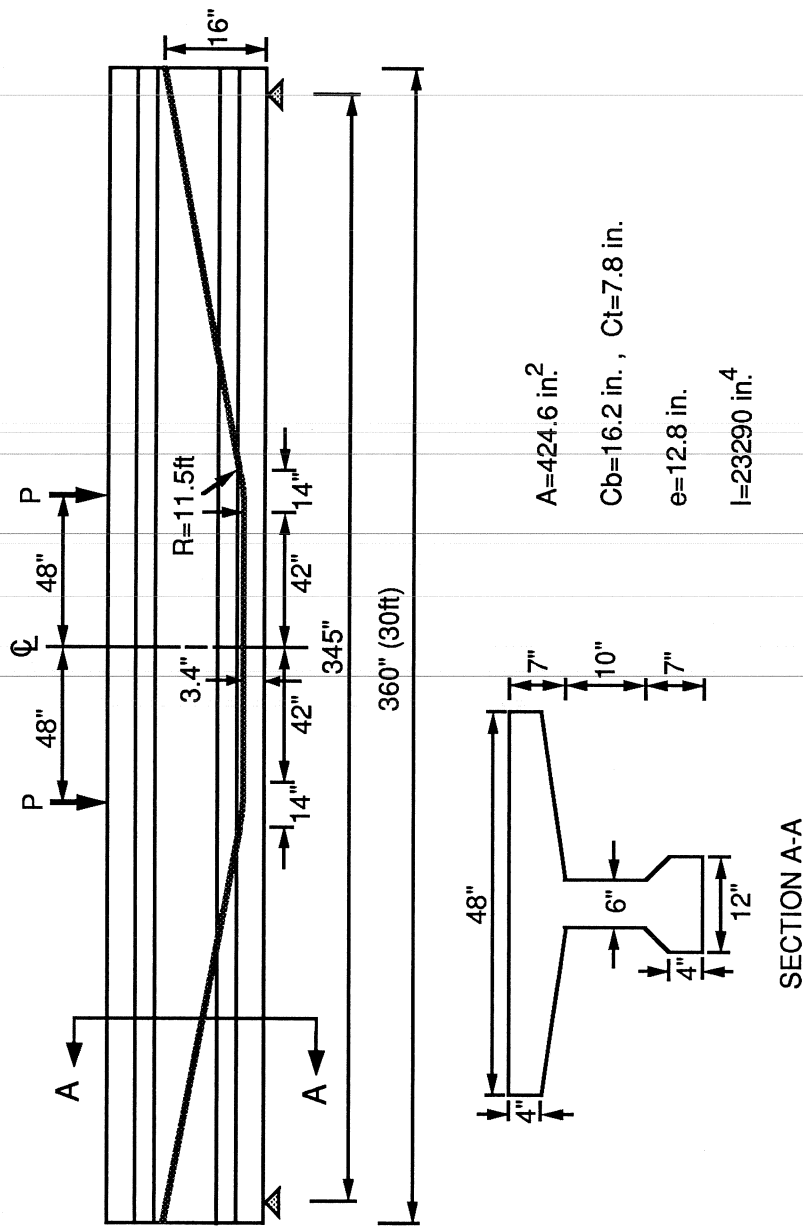
Figure 3.4 Large-Scale Beam with Draped Tendon  
(Non-Prestressed Reinforcement Not Shown)

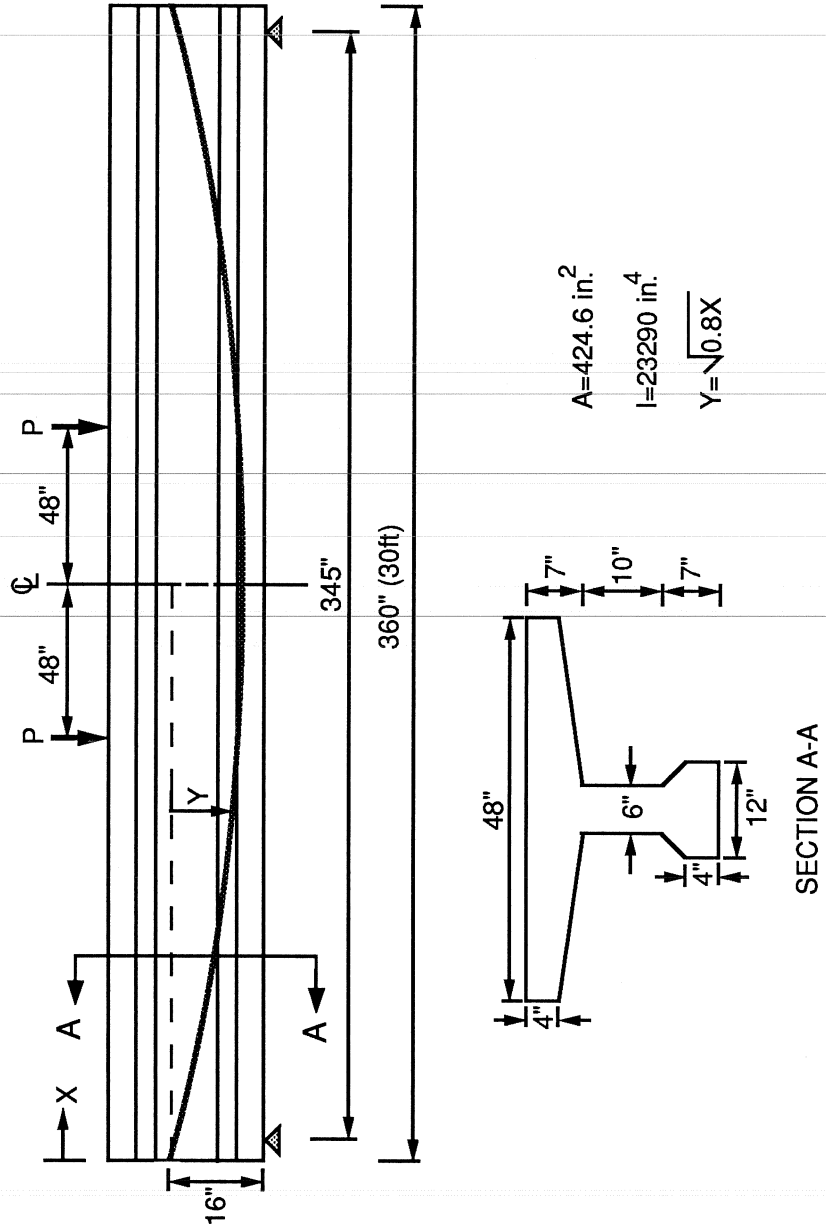
Figure 3.5 Large-Scale Beam with Parabolic Tendon  
(Non-Prestressed Reinforcement Not Shown)

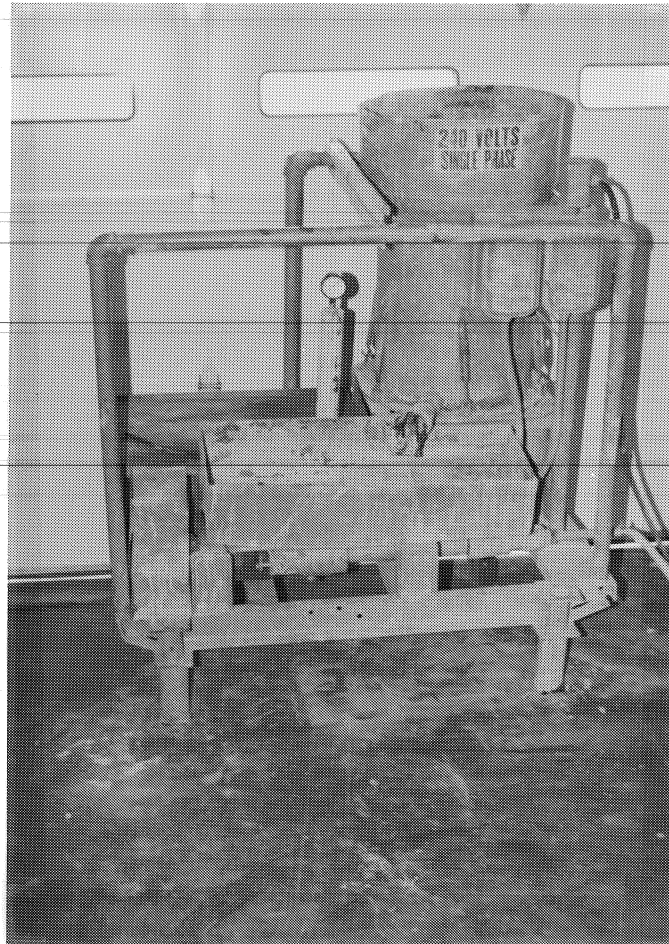
Figure 3.10 Photograph of the Grout Pump

First, silicon caulk was used to seal the unused open hole of the prestressing anchor and any gaps around the prestressing anchor and wedges to prevent grout from leaking outside the duct. This was done immediately after post-tensioning was finished. The following day the grout ingredients (proportions are discussed in Section 3.3.3.6) were placed and mixed for ten minutes in a commercial grout pump. The grout was then pumped into the duct through plastic hoses. A photograph of the grout pump is shown in Fig. 3.10.

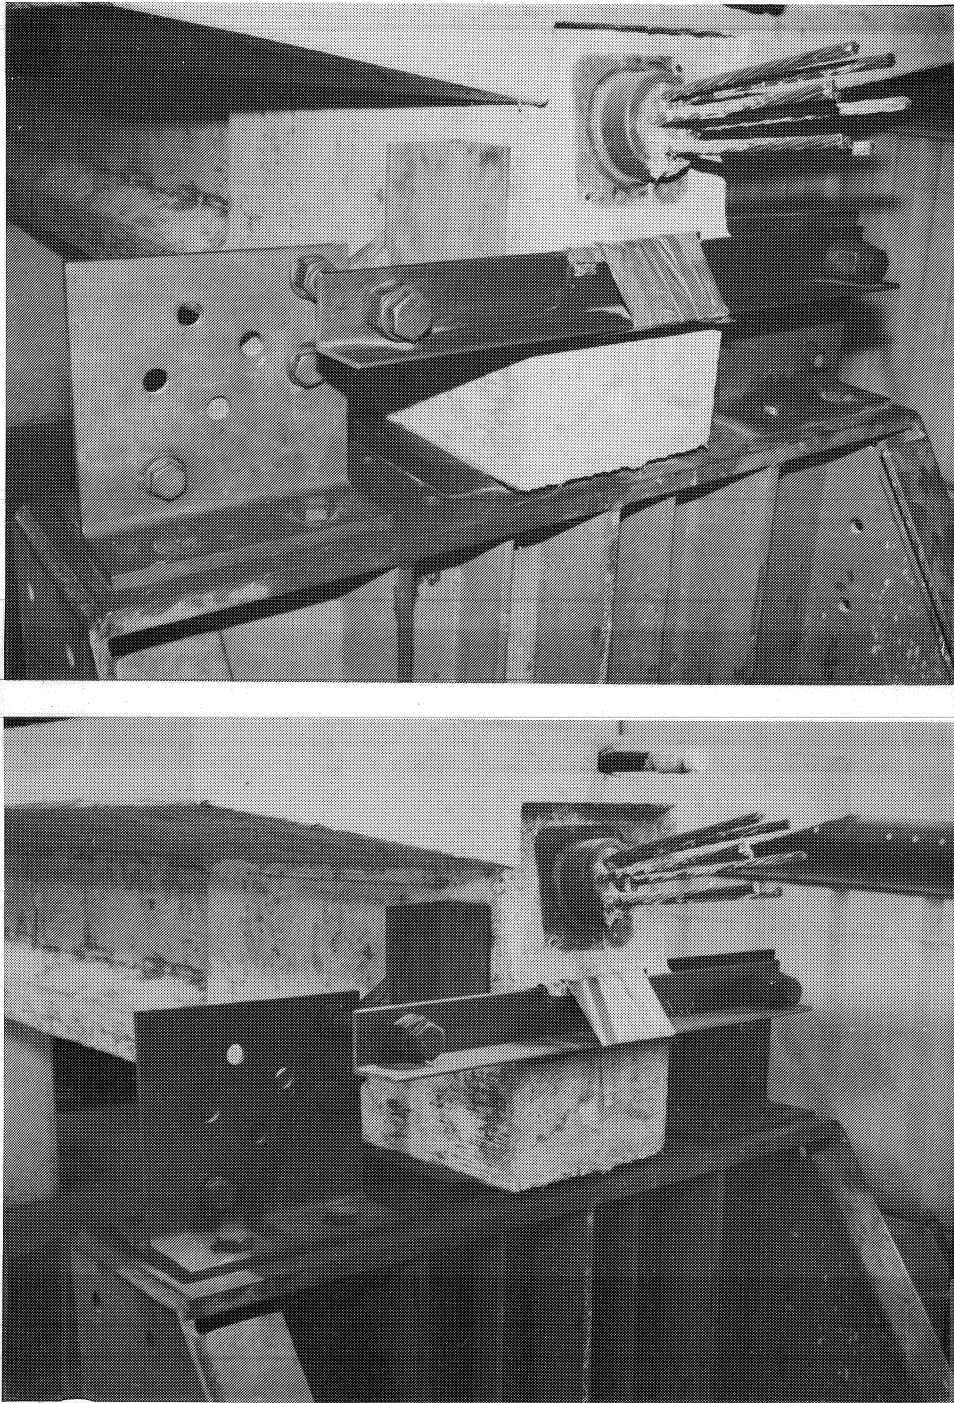
Figure 3.12 Photographs of Steel Pedestals, Neoprene Pads, and End Restraints

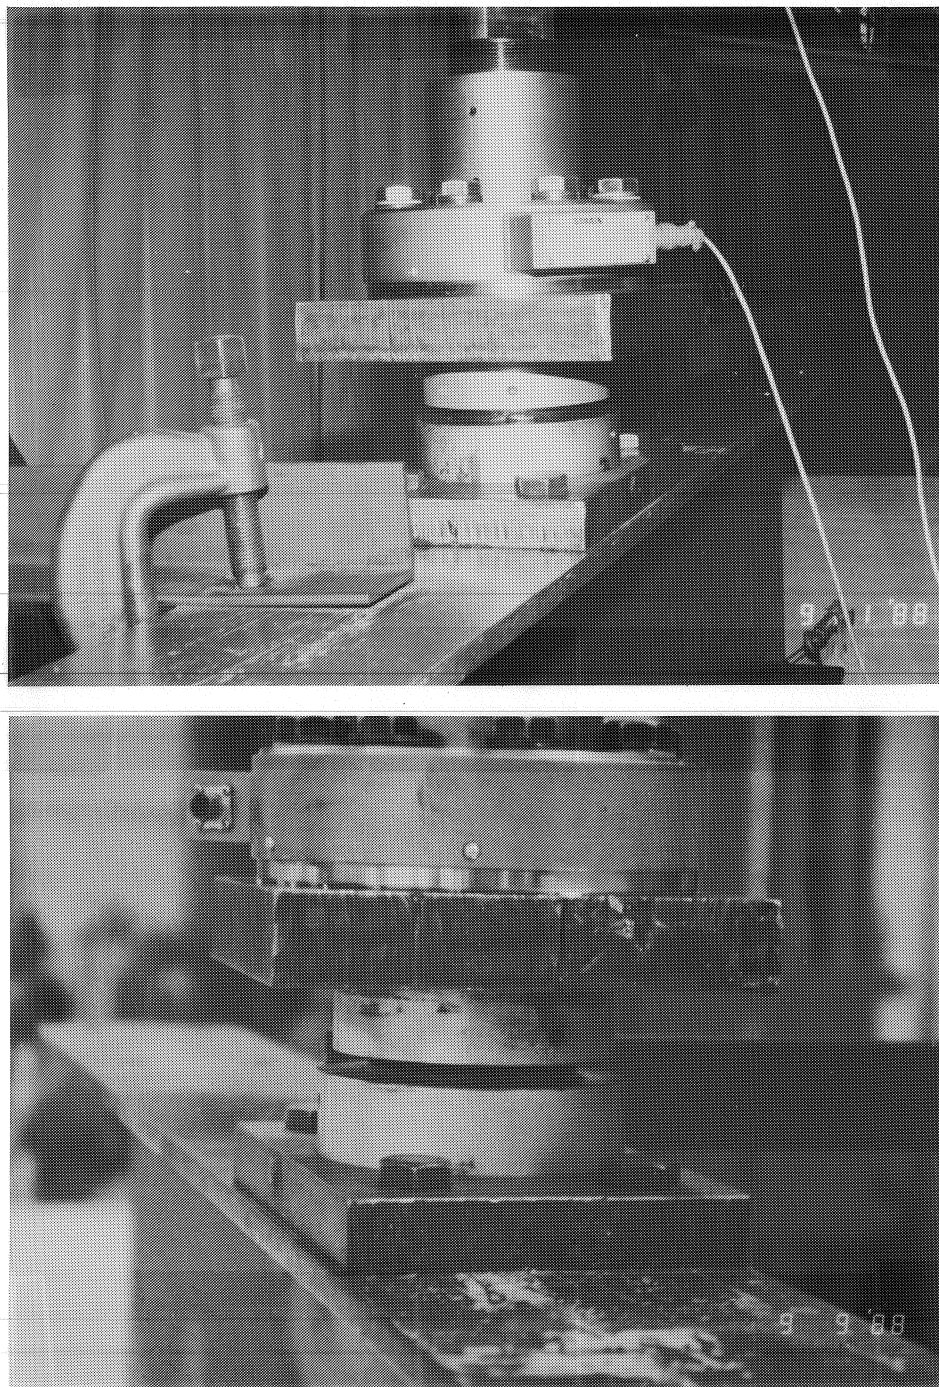
Figure 3.13 Cup and Dish Assembly Between the Ram and Spreader Beam

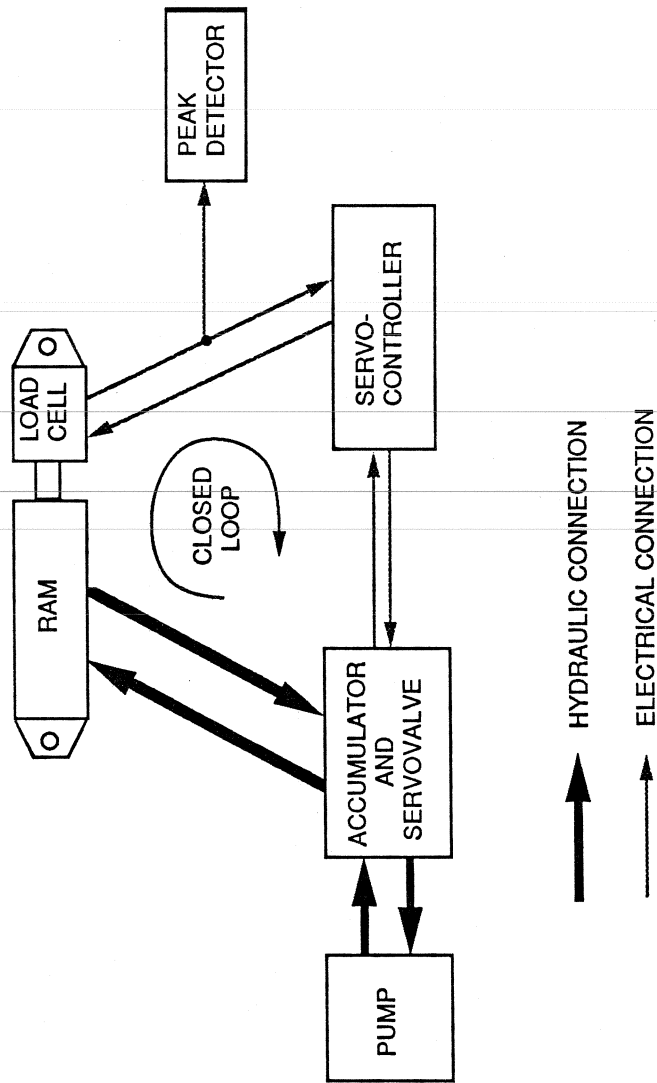
Figure 3.15 Schematic Representation of Closed Loop Servo Control System (from Yates [27])

Load was applied using a Miller 192 kip capacity ram with a 7 in. bore and 12 in. stroke. Flow of oil to the ram was controlled by a Moog A076-104 15 gpm servo-valve installed on top of the ram as shown in Fig. 3.11. Voltage signals which corresponded to load levels were monitored by a Pegasus Hydraulic Servo Controller (Fig. 3.16) and a 100 kip capacity Universal Flat Load Cell attached at the bottom of the ram. These signals (loads) were continuously read and displayed on

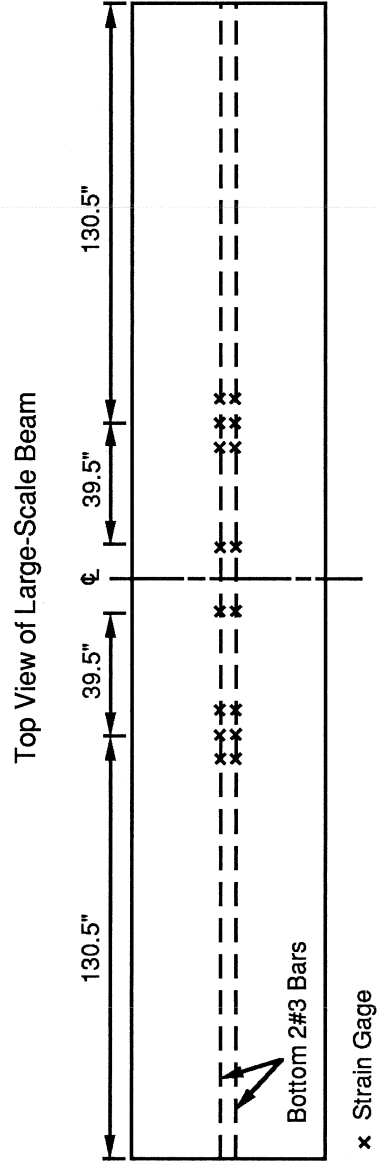
Figure 3.18 Location of Strain Gages on Bottom Passive Reinforcing Bars

Additional instrumentation was used to determine whether any of the bottom-flange passive reinforcing bars had fractured. The two bottom #3 bars were cleaned with sand paper near the ends. An electrical wire was then soldered and clamped onto each sanded location of each bar. The regions of the stirrups which touched the bottom bars were epoxied and covered with plastic material in advance so there was no conductivity between any of the bottom bars and the stirrups or the duct. The two electrical wires connected to each bar were connected to an Ohm meter. If a bar was not broken, the bar's resistance was very close to zero. If it was broken, the electrical resistance was quite high. With this instrumentation, knowledge about the condition of bottom passive reinforcement could be obtained at any time.

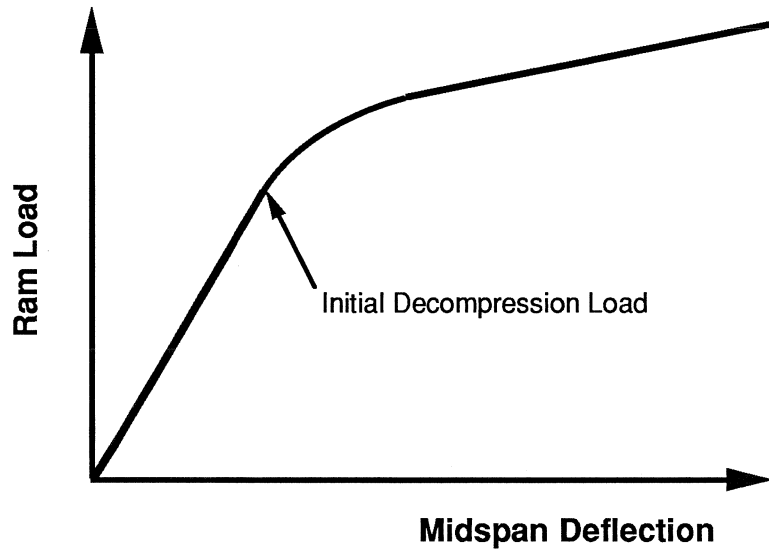
Figure 3.19 Typical Ram Load Vs. Midspan Deflection Curve

Each specimen was initially subjected to a monotonically increasing load until it cracked. Additional loads, which were larger than the initial cracking load by five percent, were applied to fully crack the specimen, increase the number of cracks, and get a more accurate evaluation of the initial stiffness of the specimen. During these initial static cycles, deflection transducers were used to measure the crack widths and the midspan deflection of the specimen. This information was plotted against the ram load using an X-Y plotter. The plots were used to cross-check the cracking load displayed on the peak detector when first cracking occurred, and to evaluate the specimen's decompression load ( $P_0$ ). The decompression load is the ram load at which the concrete bottom fiber stresses were estimated to be zero, or in other words, the load which initiated opening of cracks in the bottom of the specimen. A typical ram load vs. midspan deflection curve is shown in Fig. 3.19 and a typical ram load vs. crack-width curve is shown in Fig. 3.20.

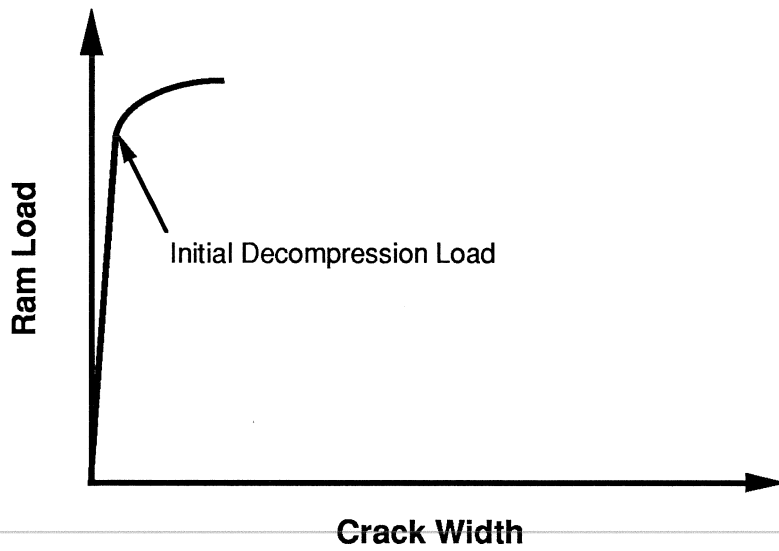
Figure 3.20 Typical Ram Load Vs. Crack-Width Curve

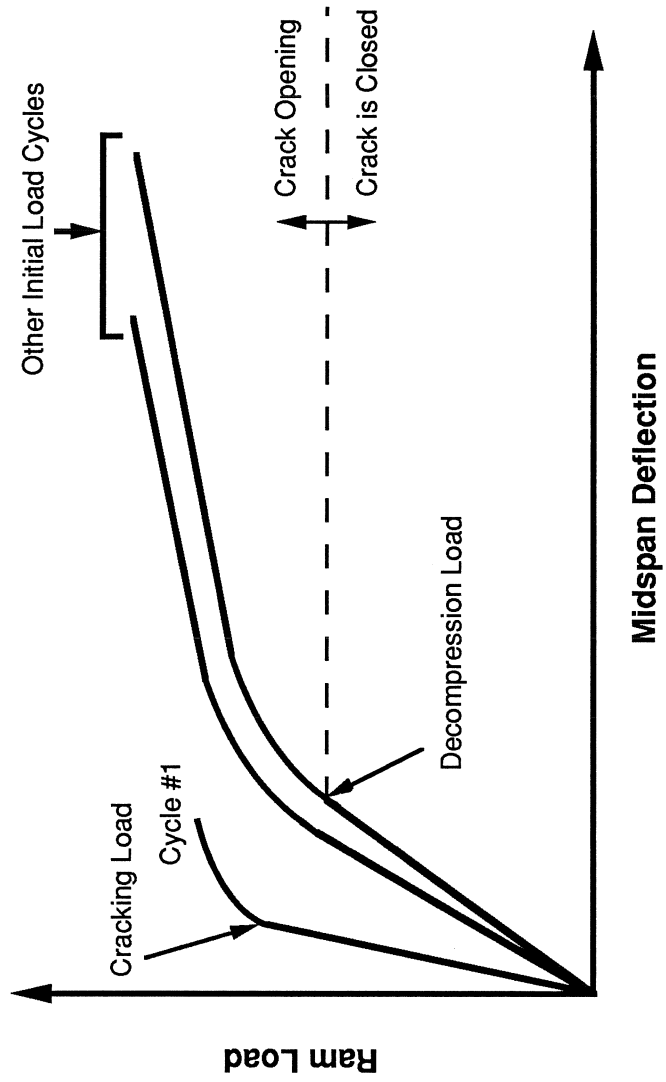
Figure 4.1 Typical Specimen Response to Initial Static Load Cycles

Each specimen was first subjected to initial static load cycles. During the first cycle the load was increased until a flexural crack was formed in the concrete. The load causing formation of the first flexural crack is called the "cracking load". During the initial static load cycles ram load vs. midspan deflection and ram load vs. crack-width curves were plotted. The ram load vs. midspan deflection curve plotted during the first static load cycle was used to confirm the observed cracking load. The response curves plotted during the remainder of the initial static load cycles were used to graphically determine the value of the decompression load. The decompression load corresponds with zero flexural stress at the extreme flexural fibers, and was identified as the transition point between the lower linear portion and the curved portion of the ram load vs. midspan deflection curve shown in Fig. 4.1. An accurate estimation of the decompression load and cracking load for each specimen was very important because they were used in the determination of the effective tendon stress for each specimen. The effective tendon stress was used in
