**A STUDY OF FRETTING FATIGUE IN POST-TENSIONED  
CONCRETE BEAMS**

THESIS

The University of Texas at Austin

August , 1989

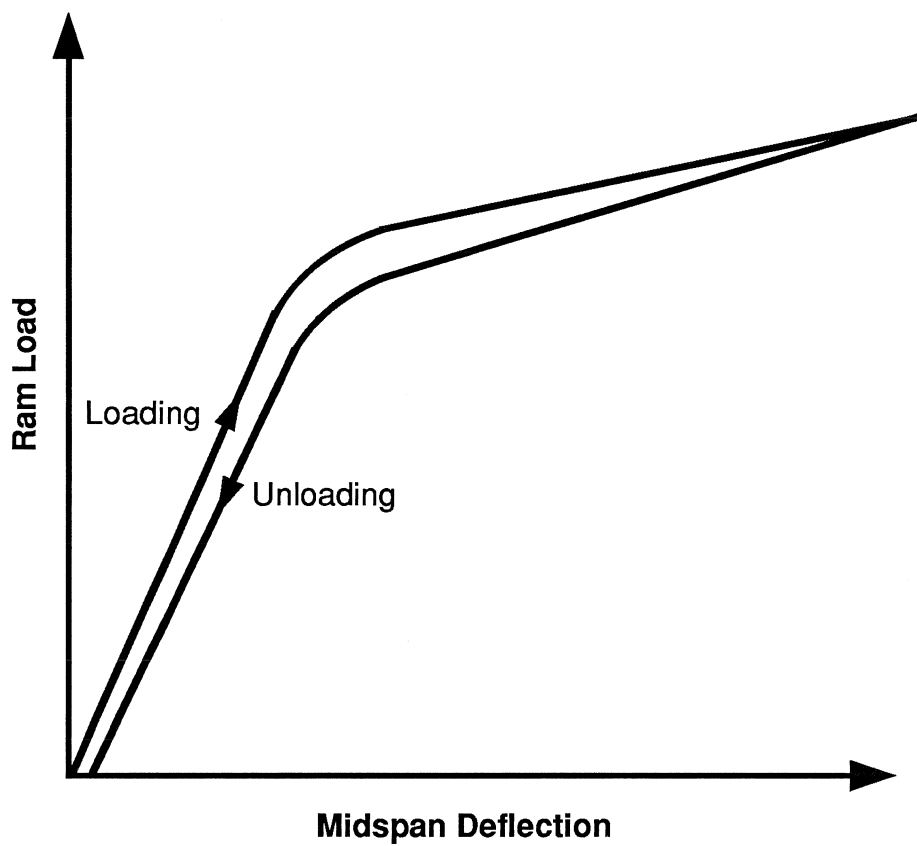
Figure 4.2 Typical Hysteretic Behavior during Static Load Cycles

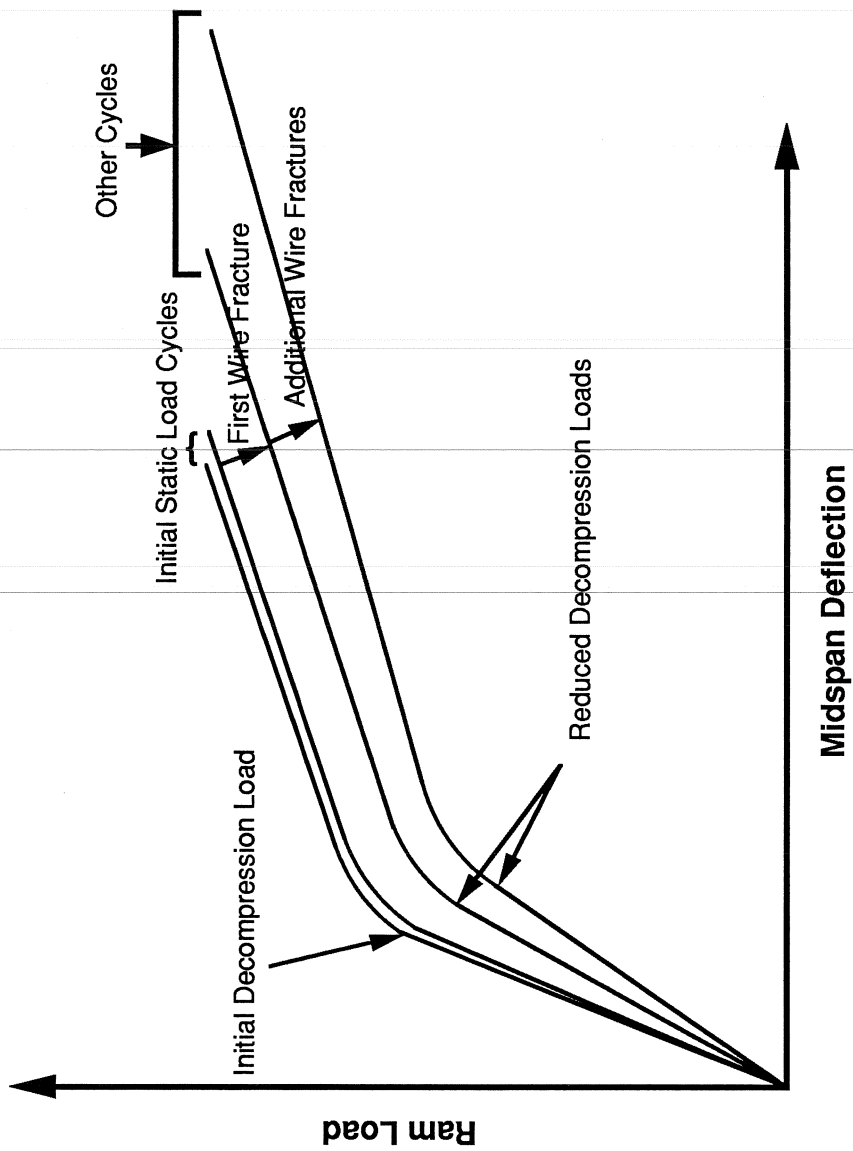
Figure 4.6 Typical Ram Load Vs. Midspan Deflection History

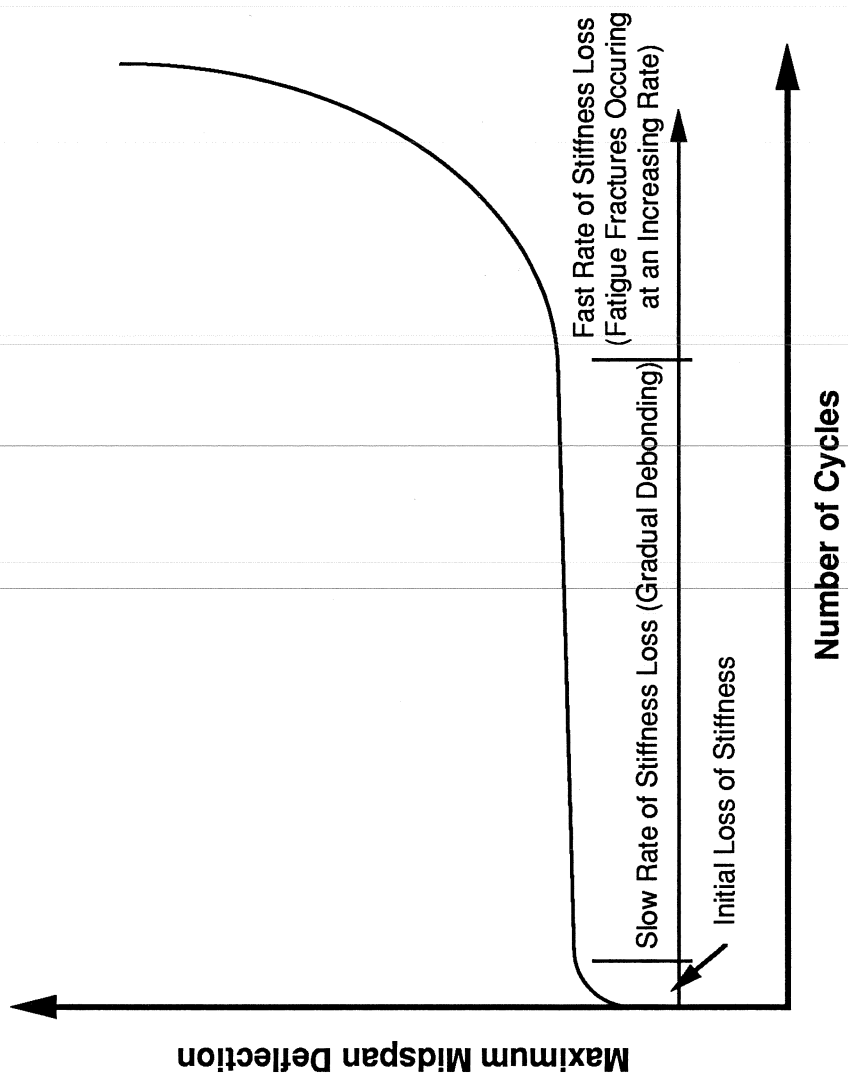
Figure 4.7 Typical Stiffness History

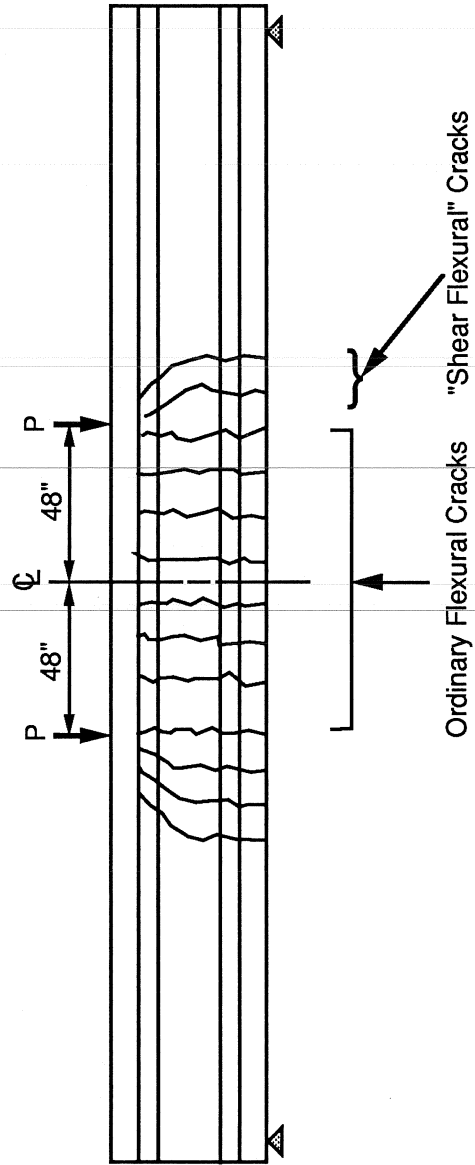
Figure 4.8 Typical Crack Patterns (before Static Flexural Strength Test)

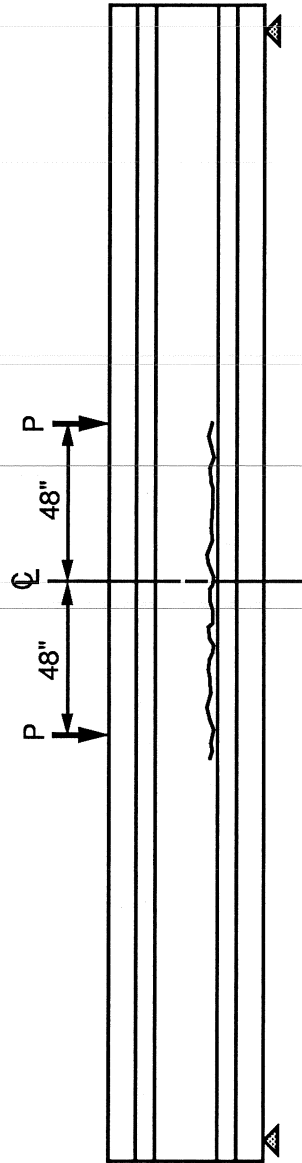
Figure 4.9 Horizontal Crack at Bottom of Web

After completion of the static flexural-strength test, a post-mortem investigation was conducted for each specimen. The bottom-flange concrete between the extreme crack locations or the ends of the drape region (whichever was larger) was chipped away and the duct was removed for further examination. The exterior damage on the duct depended on many factors like the tendon stress range, the contact pressure, and the duct material.

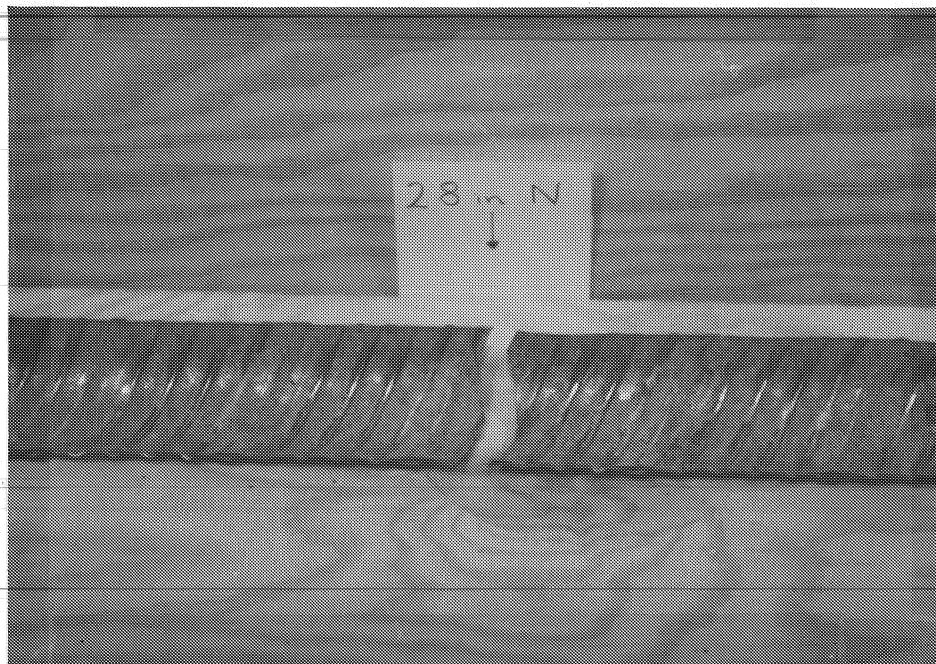
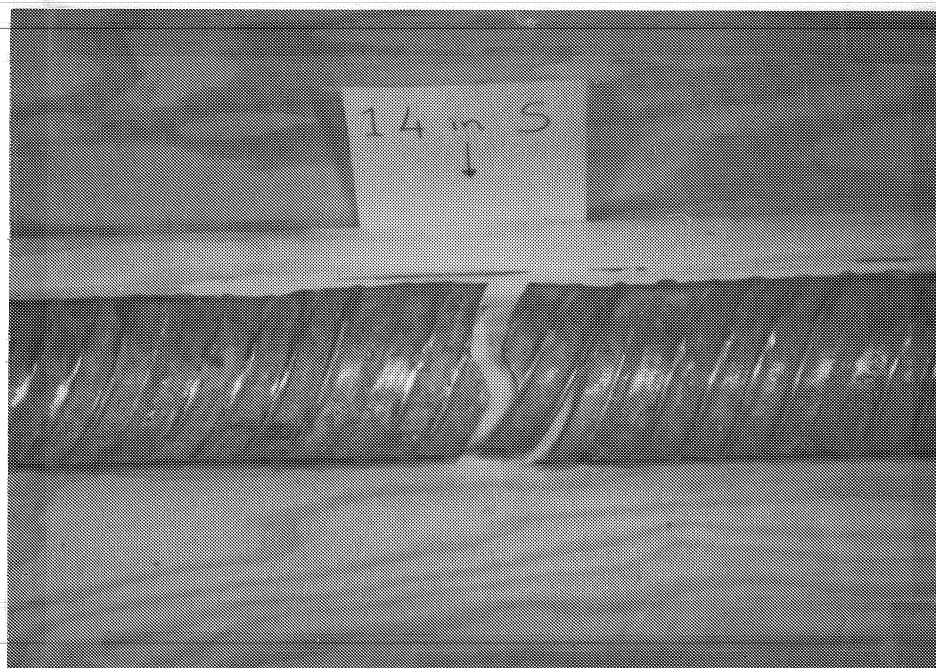
Figure 4.10 Photographs of Fractured Metal Duct

After inspection of the exterior surface of the ducts, they were cut open for further inspection. All ducts had longitudinal indentations at the contact points with the strand caused by the rubbing action between duct and strand, and the lateral pressure. The indentations were more severe in the vicinity of a crack. In the case of metal ducts, the indentations were either corrosion or abrasion signs. Figure 4.11 shows the condition of the inside surface of a metal duct. In the case of plastic ducts, the situation was much different. The indentations at the contact points showed no signs of corrosion or abrasion. The indentations were simply signs of strand rubbing through the plastic. In some cases the strand had rubbed

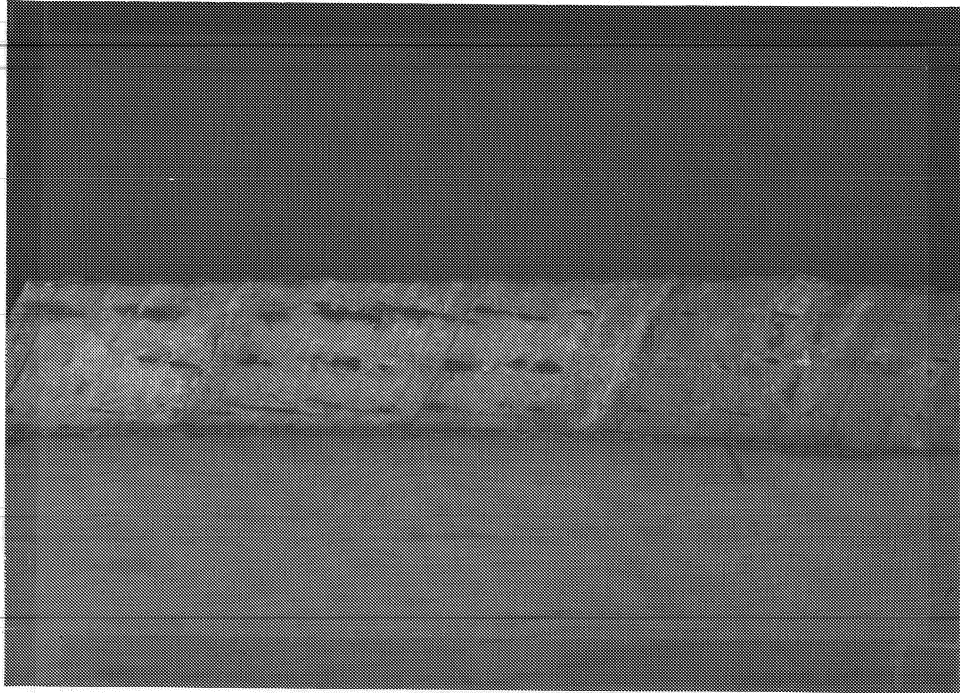
Figure 4.11 Condition of Metal Duct

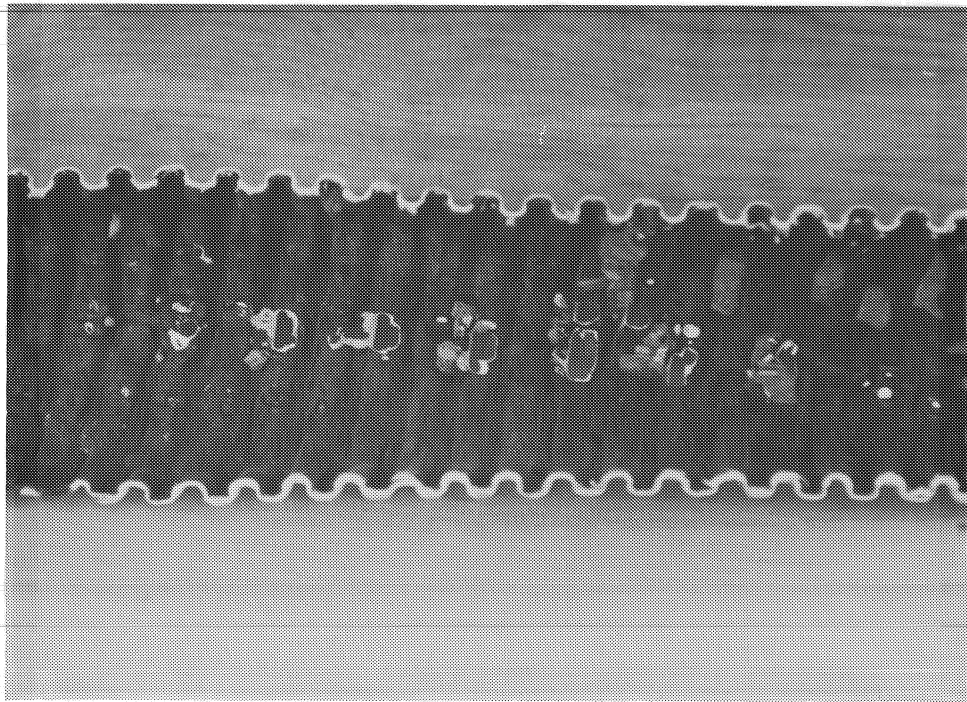
Figure 4.12 Condition of Plastic Duct

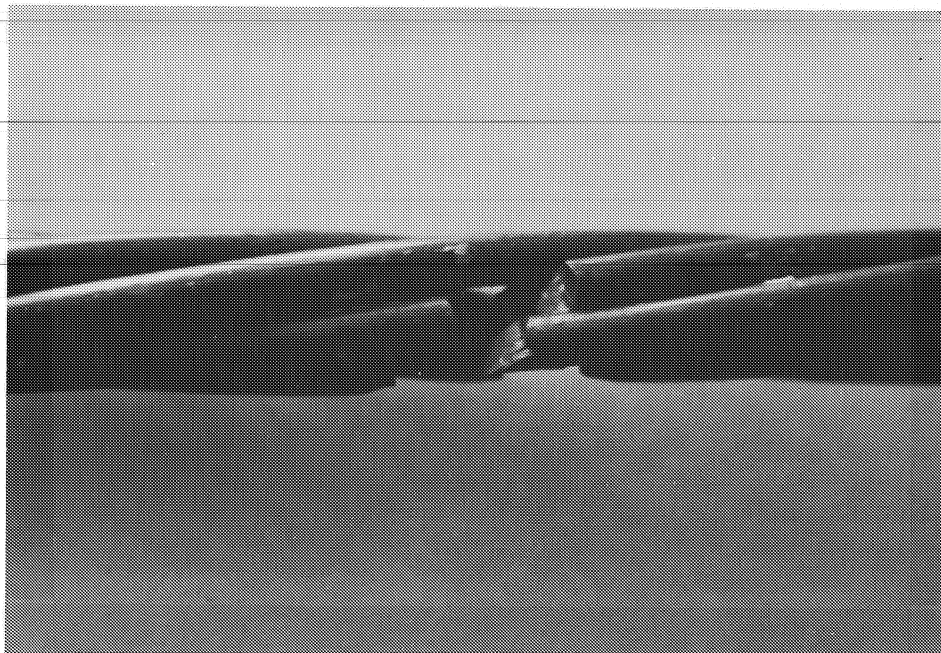
Figure 4.13 Photograph of a Fretting Fatigue Fracture

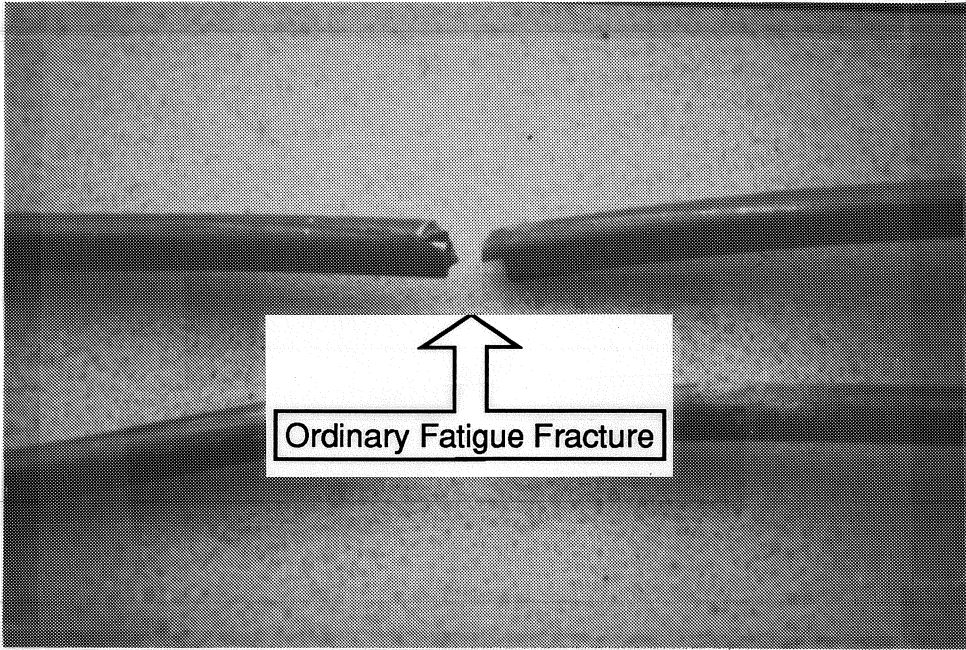
Figure 4.15 Photograph of an Ordinary Fatigue Fracture

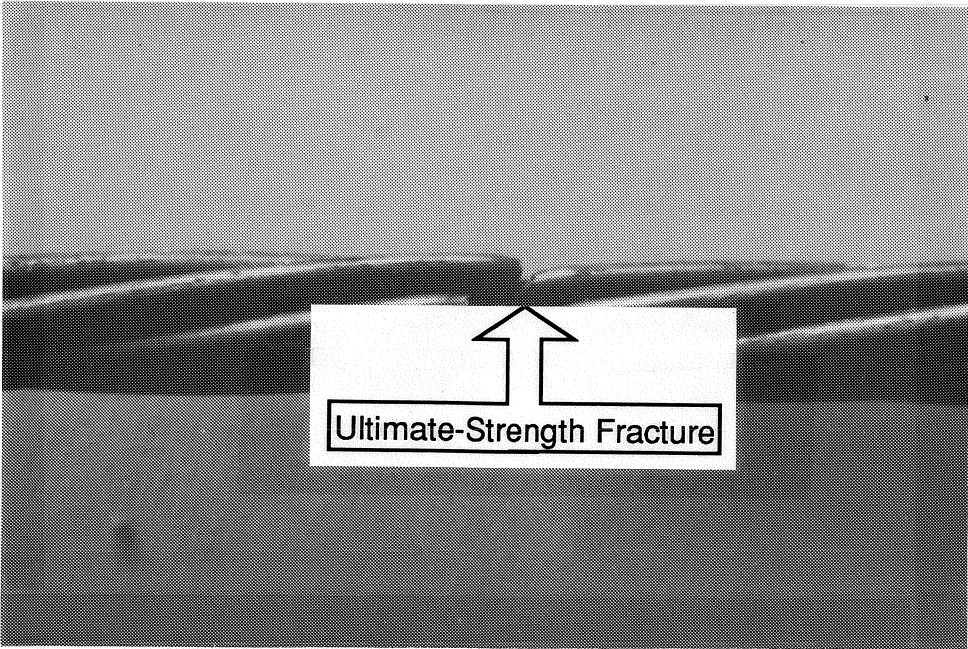
Figure 4.16 Photograph of an Ultimate Strength Fracture

Ultimate-strength fractures of wires are the easiest to identify due to their unique characteristics. They are characterized by necking of the wires as shown in Figures 4.14c and 4.16. The necking of the wires is caused by yielding of the wires. Usually, this type of

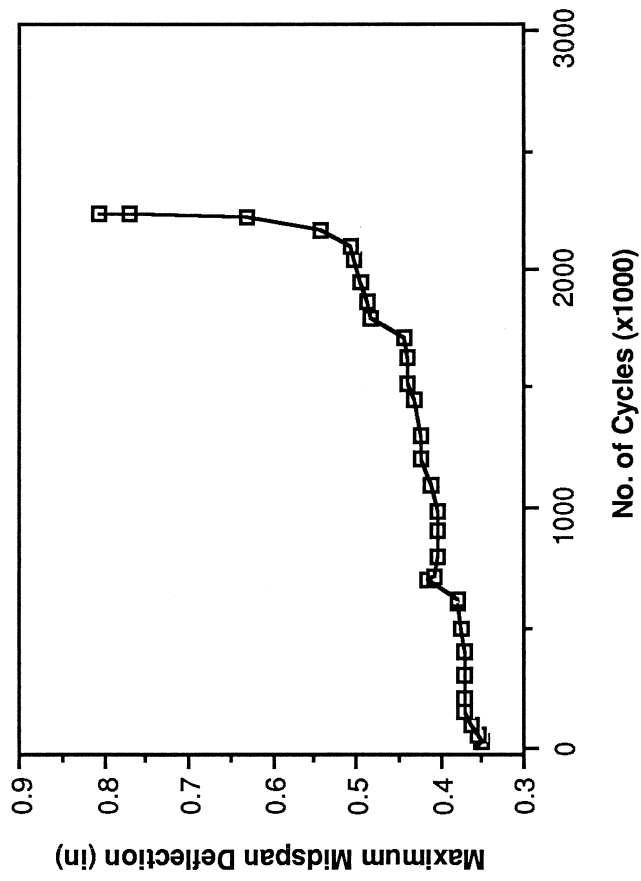
Figure 4.17 Stiffness History of Specimen P-M-1-25

interesting. After initial reductions in stiffness had occurred during the initial static load cycles, the stiffness was stable (decreased at a very slow rate) until 600,000 cycles where a significant reduction in stiffness occurred. This was attributed to a wire fracture. After that, cyclic loading was resumed. Stiffness remained relatively stable for another 1,200,000 cycles until additional wire fractures occurred. At 1,800,000 cycles another wire was fractured causing some more reduction in the specimen's stiffness. After that cycling loading was again resumed. At 2,200,000 cycles and at 2,235,000 cycles, additional wires were fractured causing large and rapid reductions in the specimen's stiffness, indicating that the specimen had exceeded its useful fatigue life. This specimen was the only one in which the first wire fracture did not cause a rapid deterioration in the specimen's stiffness leading to failure. The third wire fracture was the critical one leading to multiple fractures and failure. The stiffness history of the specimen is shown in Fig. 4.17. The fatigue life of the specimen is also listed in Table 4.5 and plotted in Fig. 5.6 along with the fatigue lives of the other specimens.

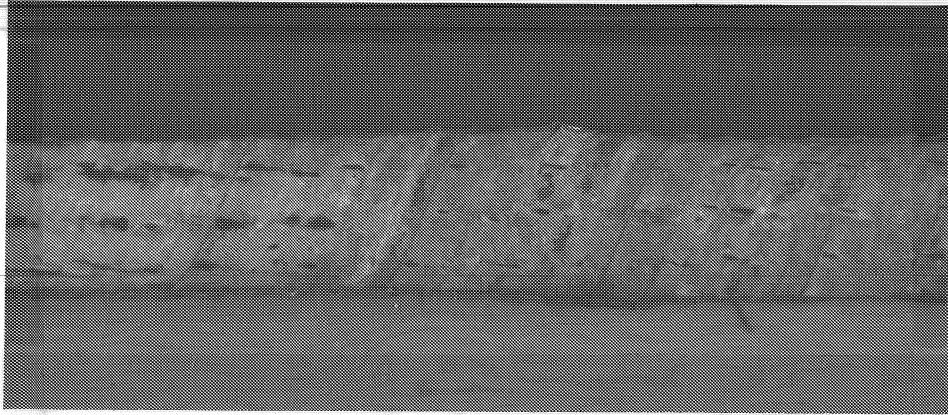
Figure 4.18 Fretting Signs on Metal Duct of Specimen P-M-1-25

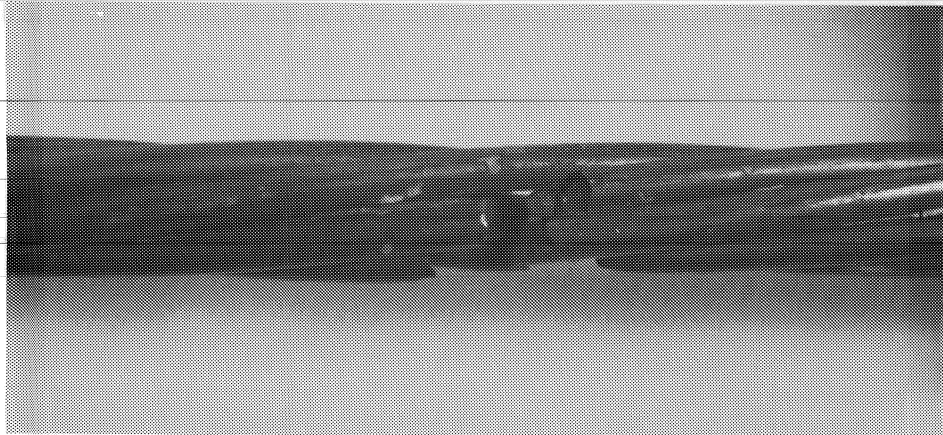
Figure 4.19 Fretting Fractures of Wires of Specimen P-M-1-25

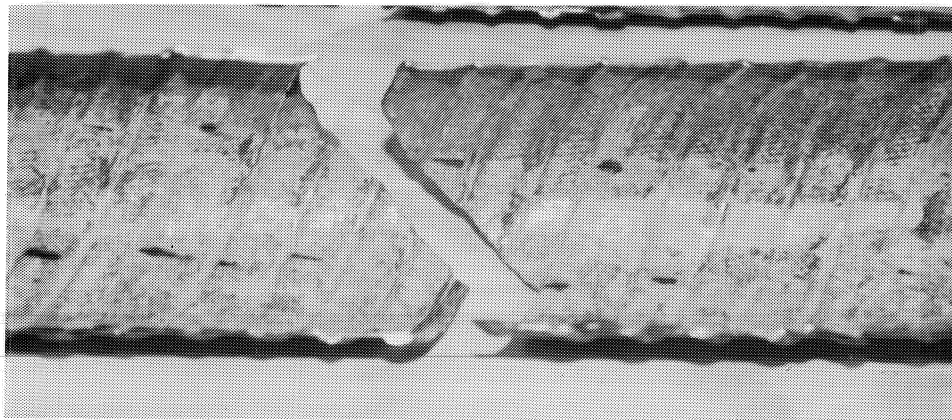
Figure 4.20 Fractured Metal Duct of Specimen P-M-1-25

The metal duct was cracked at many locations primarily in the vicinity of concrete cracks (Fig.4.20). When the concrete cracks were opening during cyclic loading, the metal duct was forced to elongate. In some cases, repeated elongation along with deterioration of

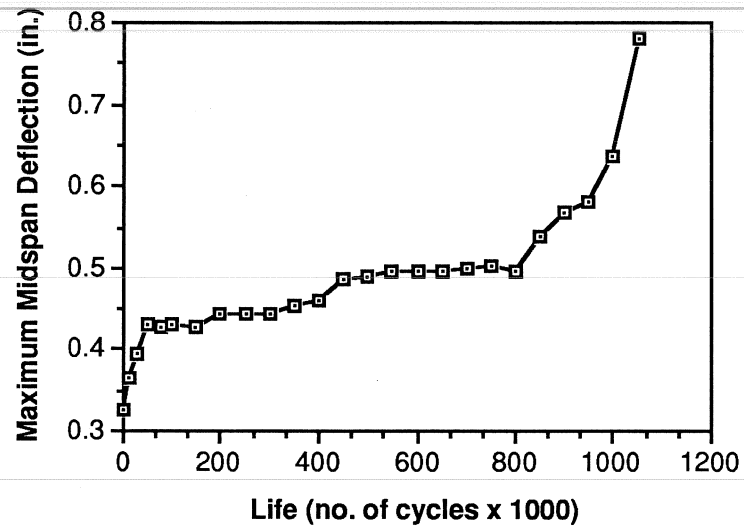
Figure 4.21 Stiffness History of Specimen D-M-2-40

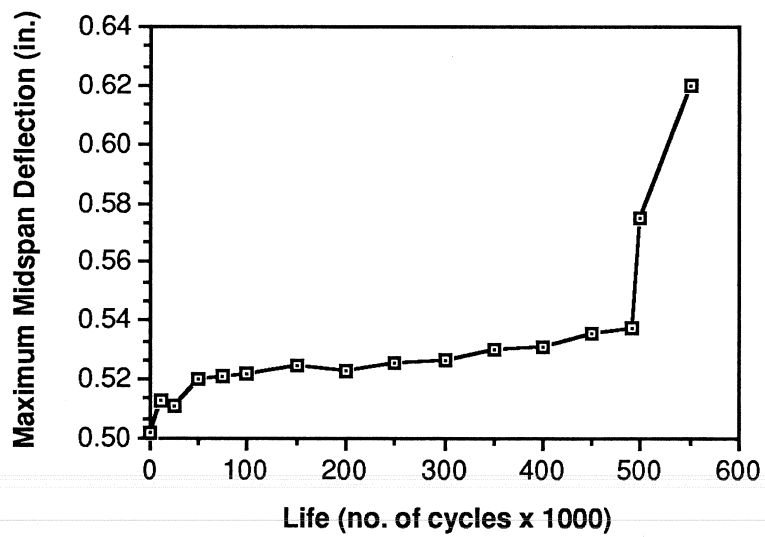
Figure 4.22 Stiffness History of Specimen D-M-3-30

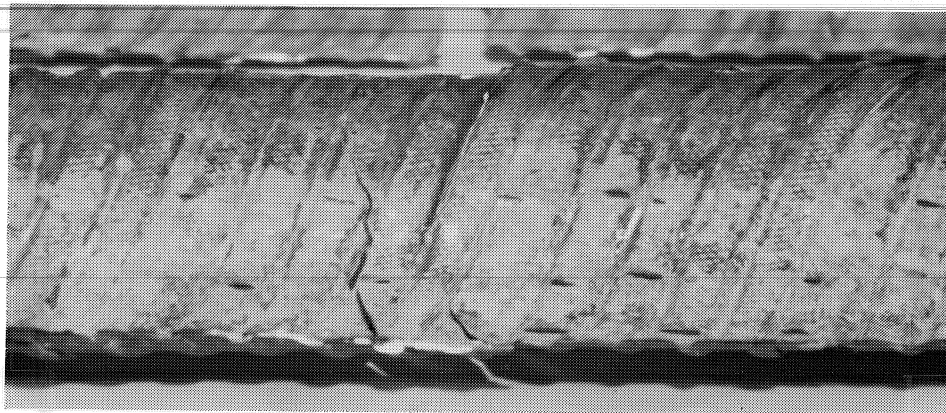
Figure 4.23 Fretting Signs on Metal Duct of a Group DM Specimen

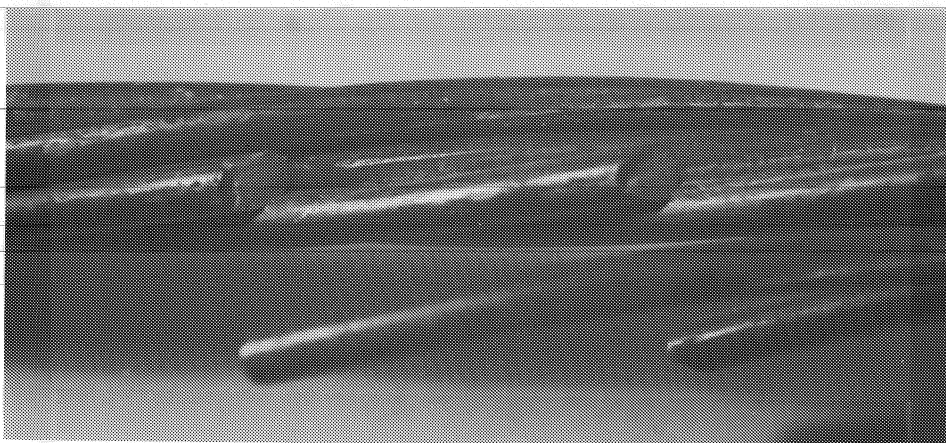
Figure 4.24 Fretting Fractures of Wires of a Group DM Specimen

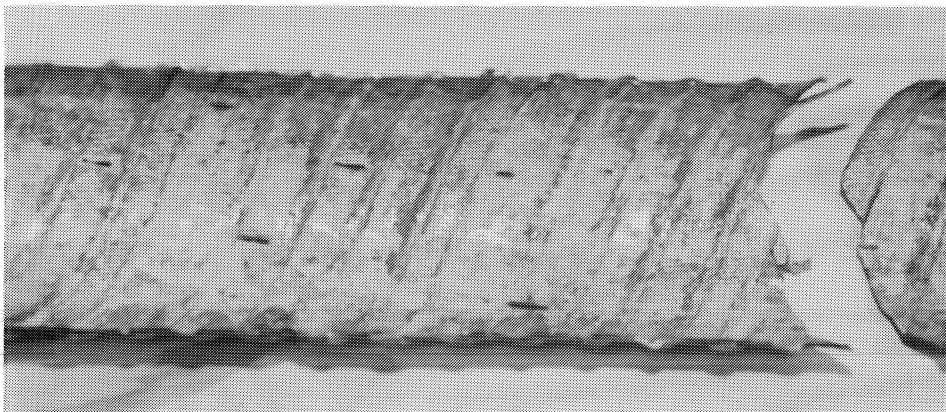
Figure 4.25 Fractured Metal Duct of a Group DM Specimen

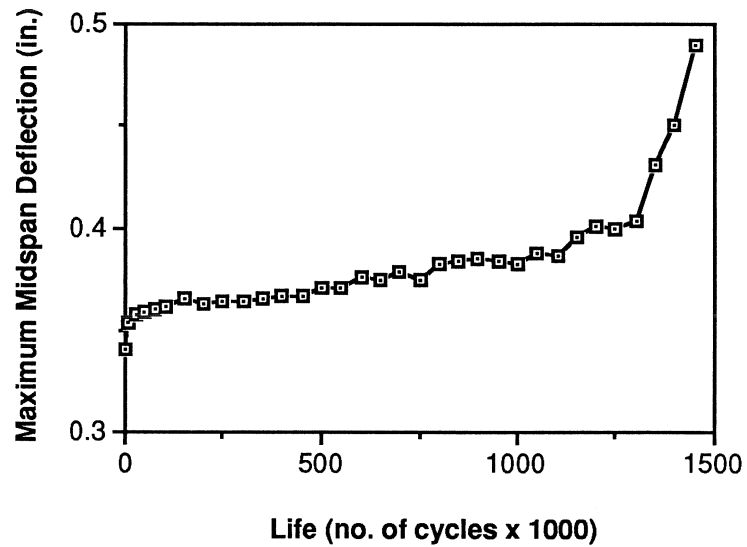
Figure 4.26 Stiffness History of Specimen D-P-4-30

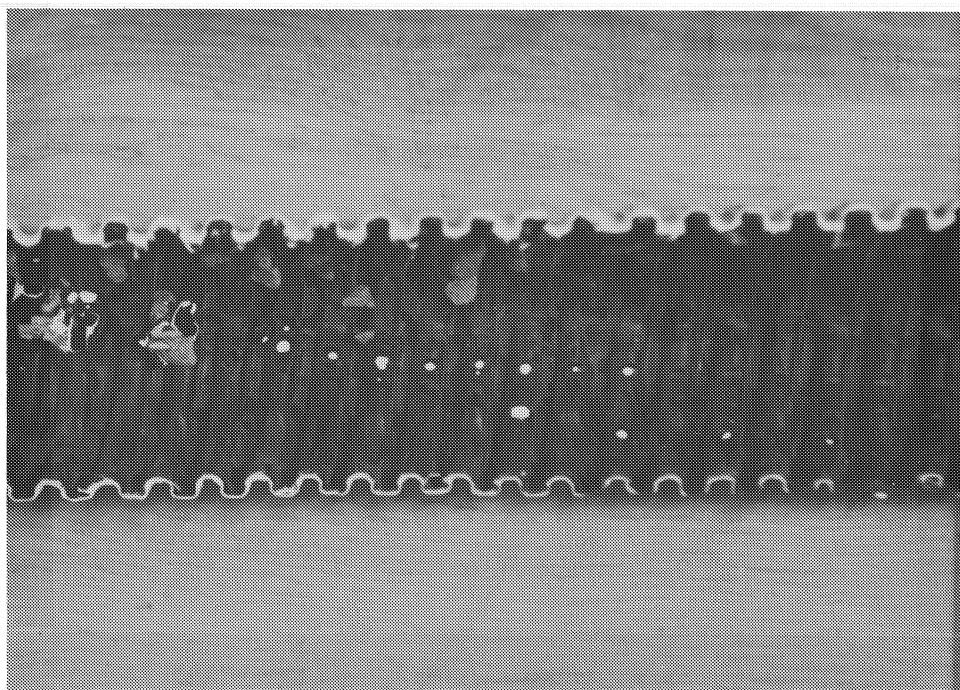
Figure 4.28 Condition of Plastic Duct of a Group DP Specimen

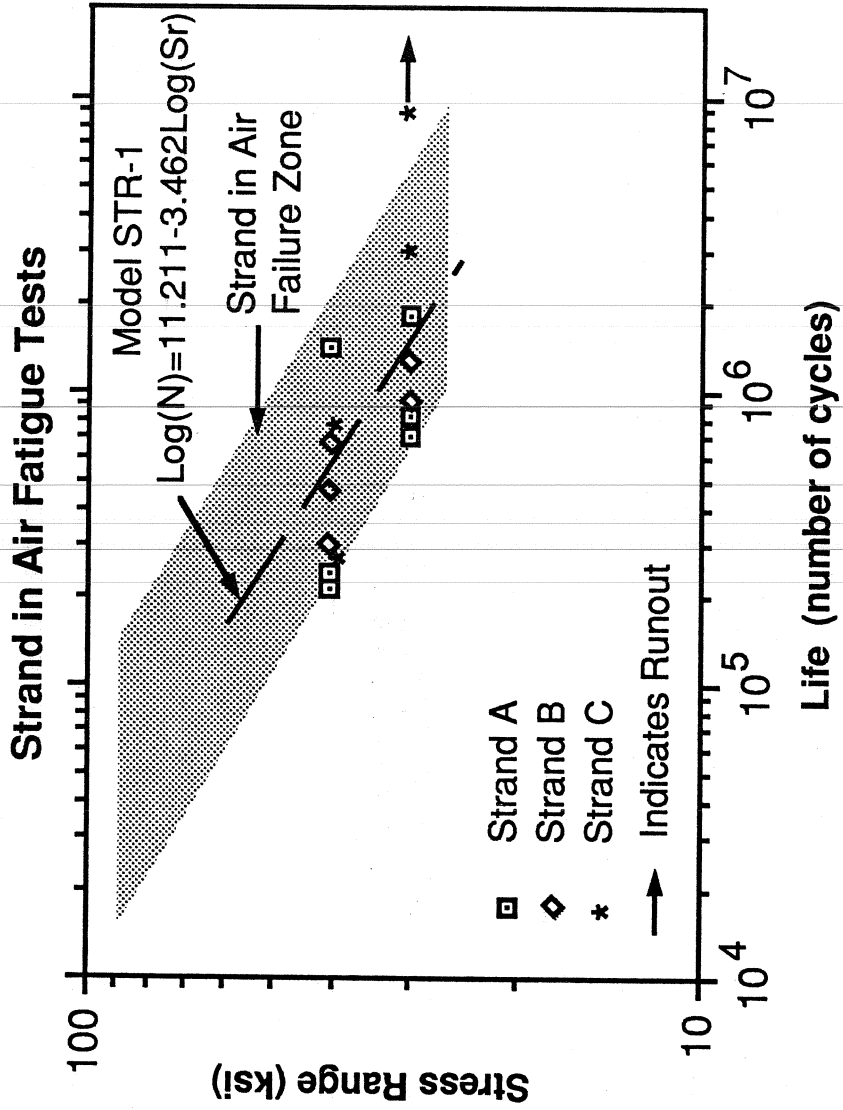
Figure 5.1 Comparison of Strand In Air Fatigue Data and Strand In Air Failure Zone

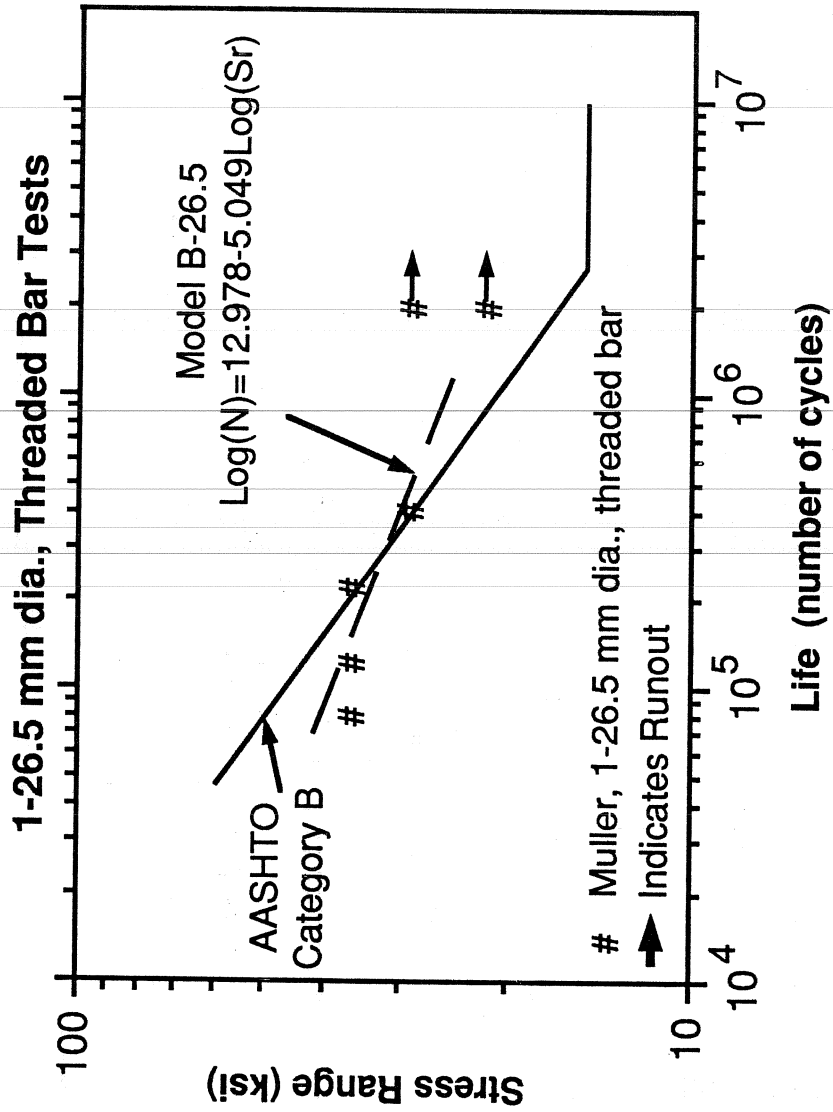
Figure 5.2 Comparison of 1-26.5 mm dia. Threaded Bar Tests with AASHTO Fatigue Model

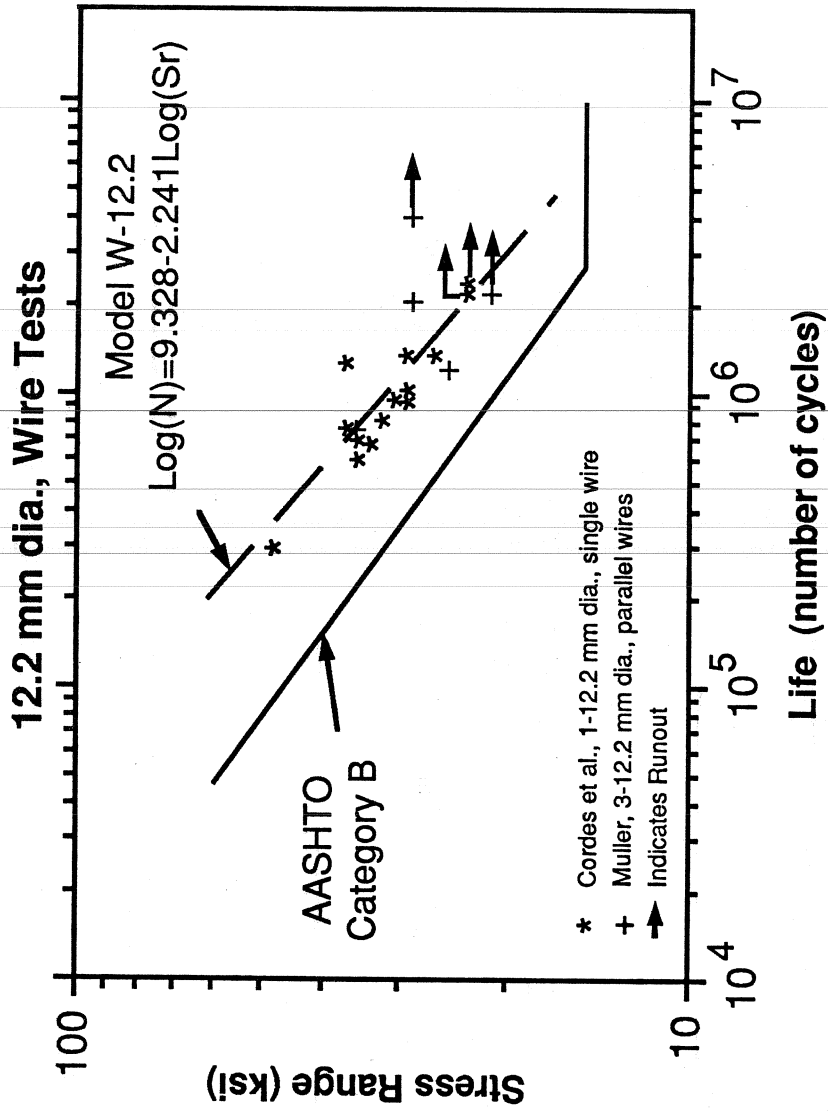
Figure 5.3 Comparison of 12.2 mm dia., Wire Tests with AASHTO Fatigue Model

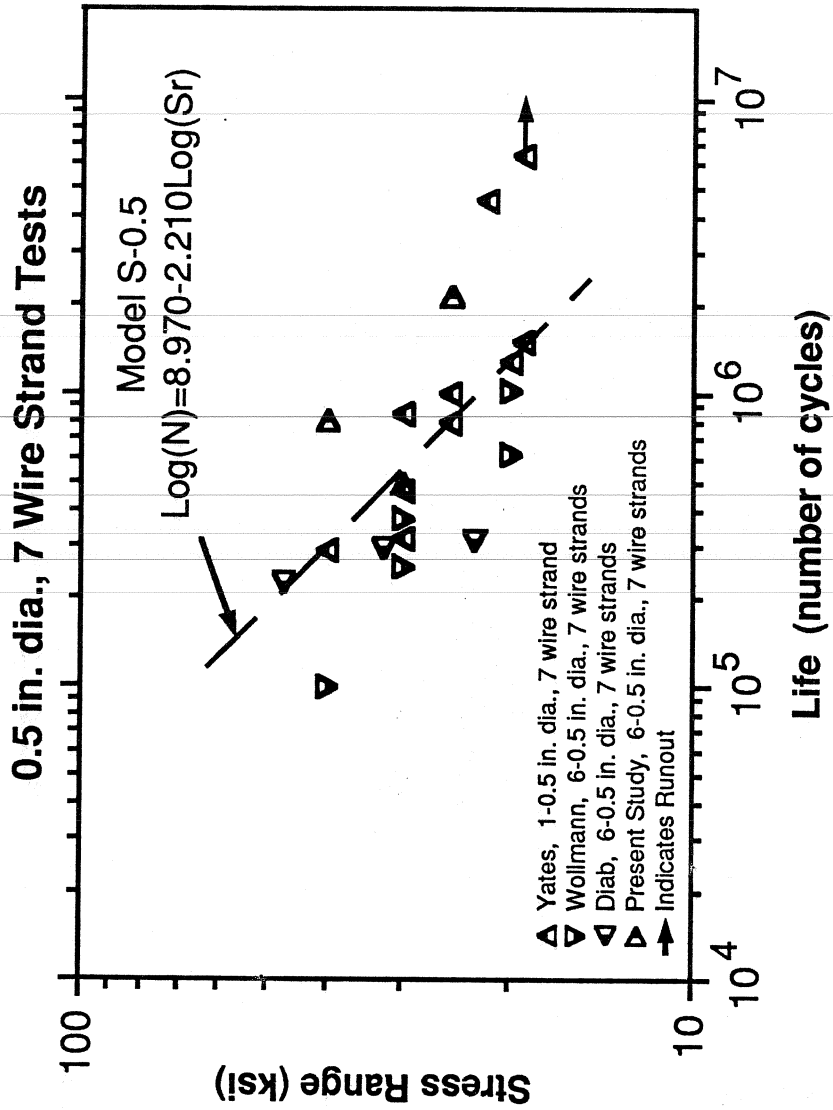
Figure 5.6 Results of 0.5in. dia., 7 Wire Strand Tests

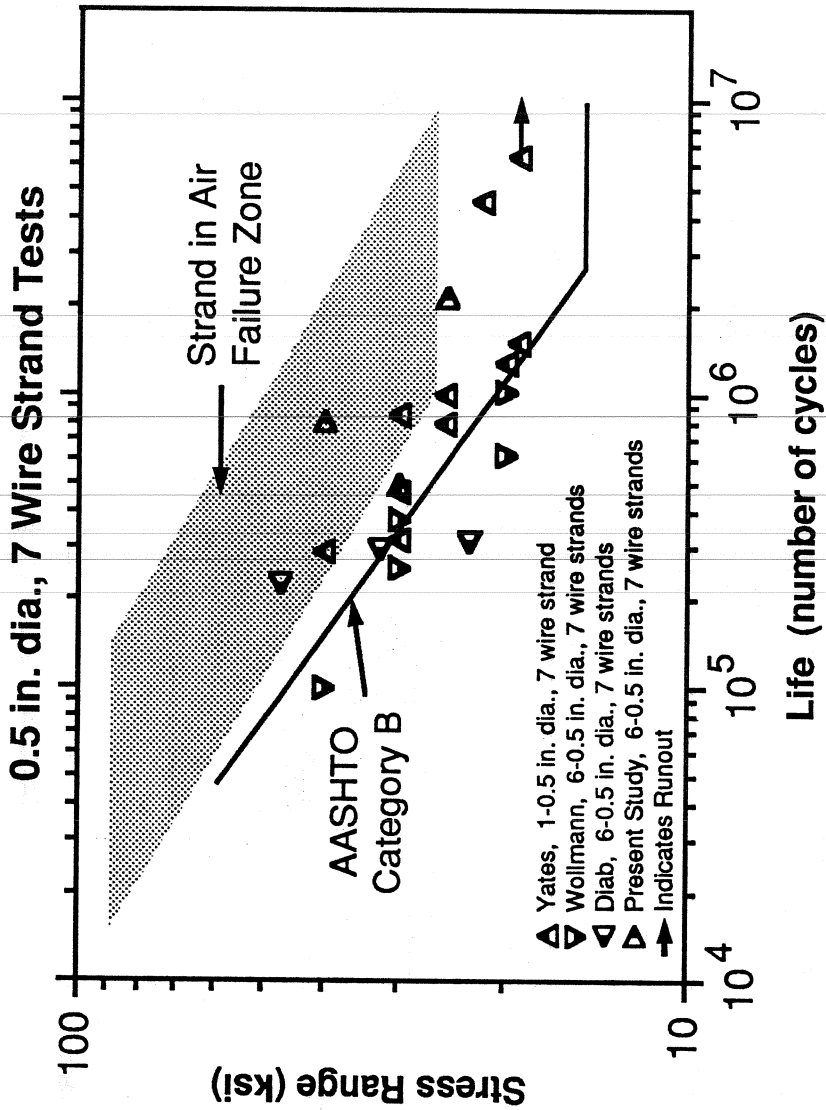
Figure 5.7 Comparison of 0.5in. dia., 7 Wire Strand Tests with Strand In Air Failure Zone and AASHTO Fatigue Model

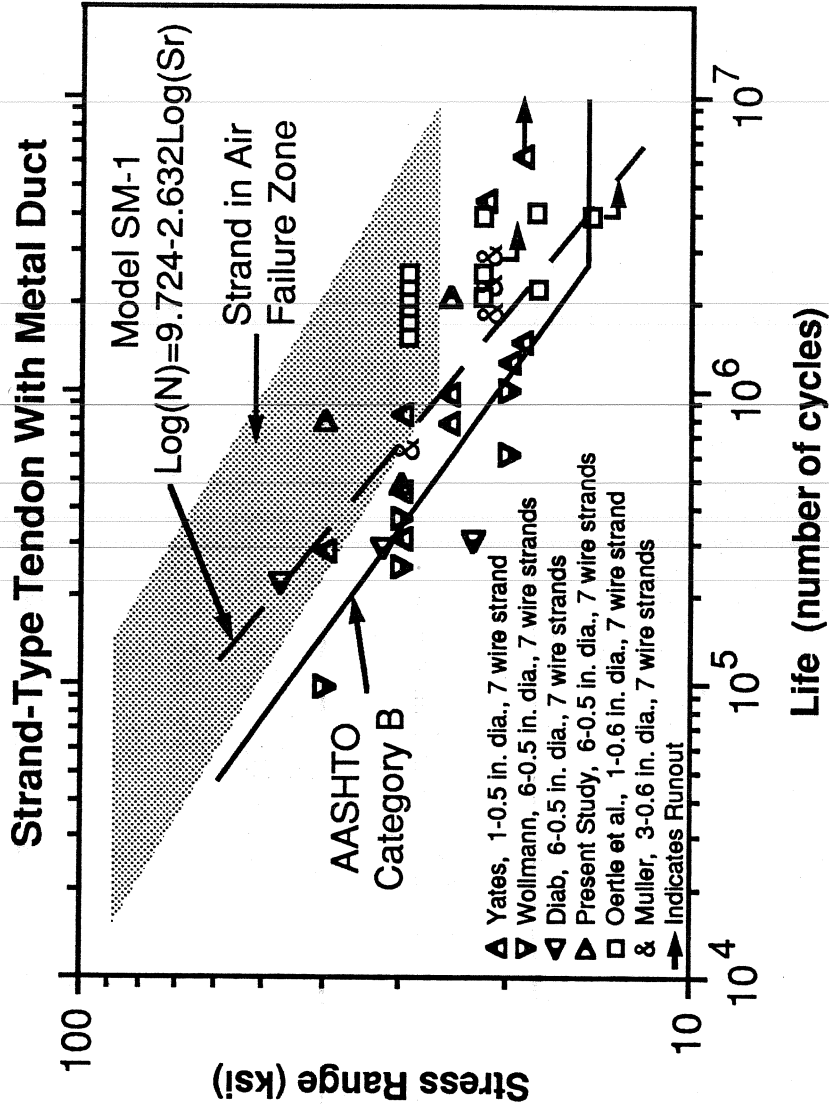
Figure 5.8 Comparison of Tests of Strand-Type Tendon With Metal Duct with Strand In Air Failure Zone and AASHTO Fatigue Model

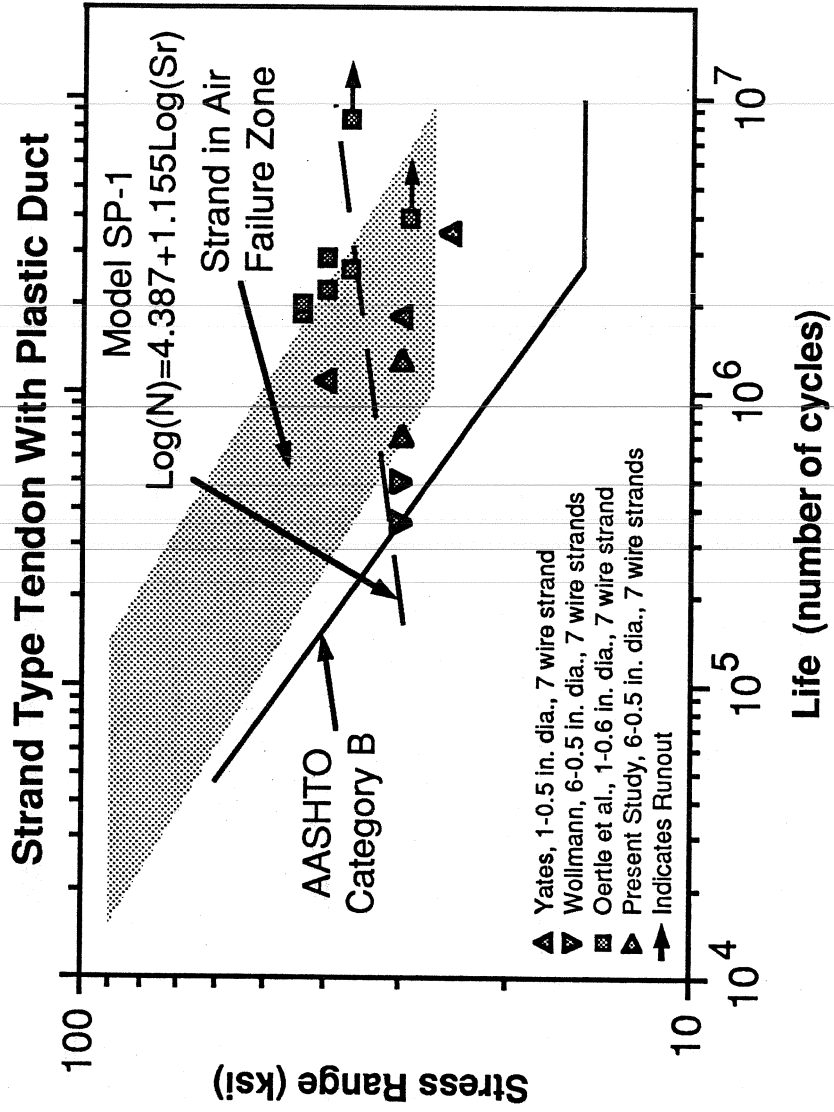
Figure 5.9 Comparison of Tests of Strand-Type Tendon With Plastic Duct with Strand In Air Failure Zone and AASHTO Fatigue Model

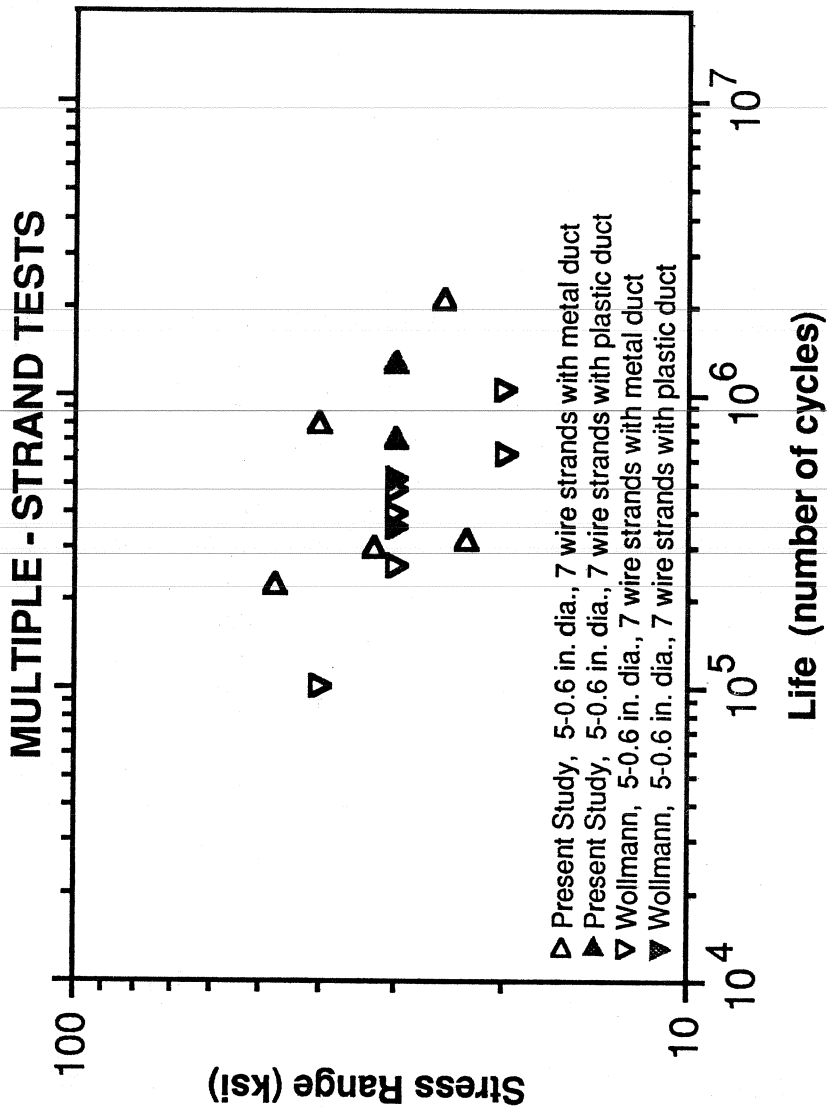
Figure 5.10a Comparison Between Multiple-Strand Tendon Tests for Metal Duct and Plastic Duct

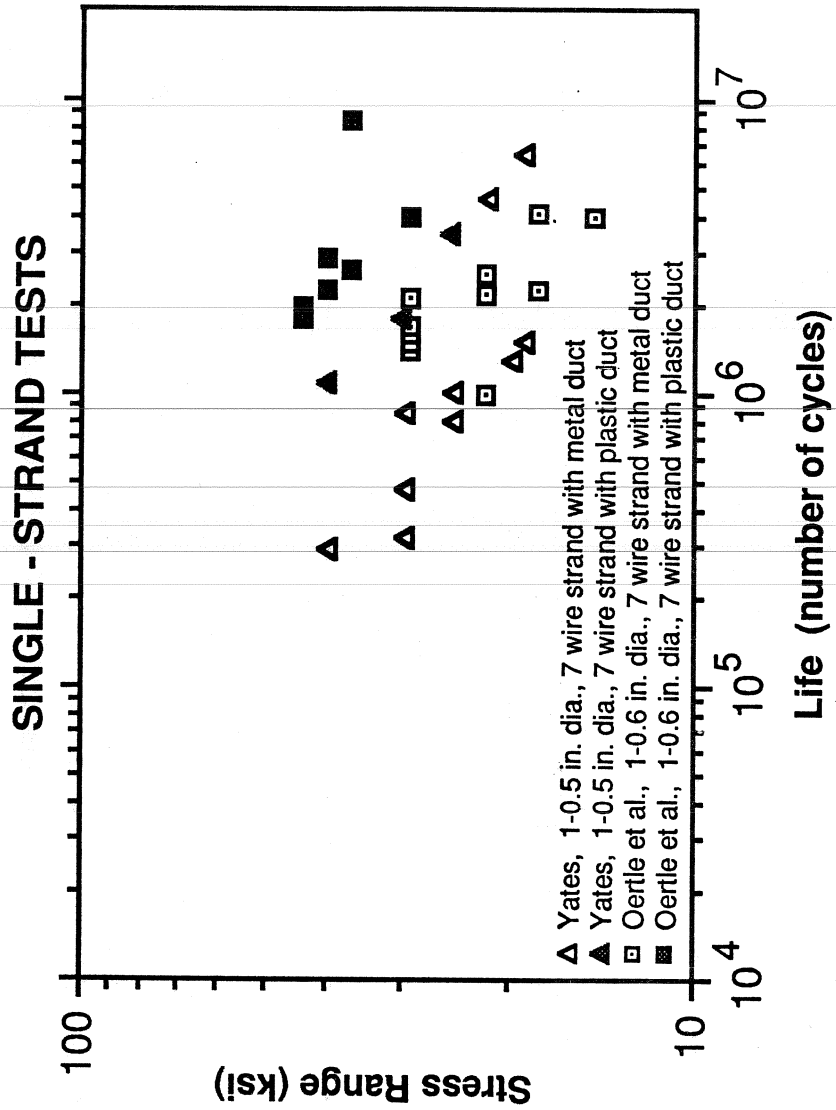
Figure 5.10b Comparison Between Single-Strand Tendon Tests for Metal Duct and Plastic Duct
