**A STUDY OF FRETTING FATIGUE IN POST-TENSIONED  
CONCRETE BEAMS**

THESIS

The University of Texas at Austin

August , 1989

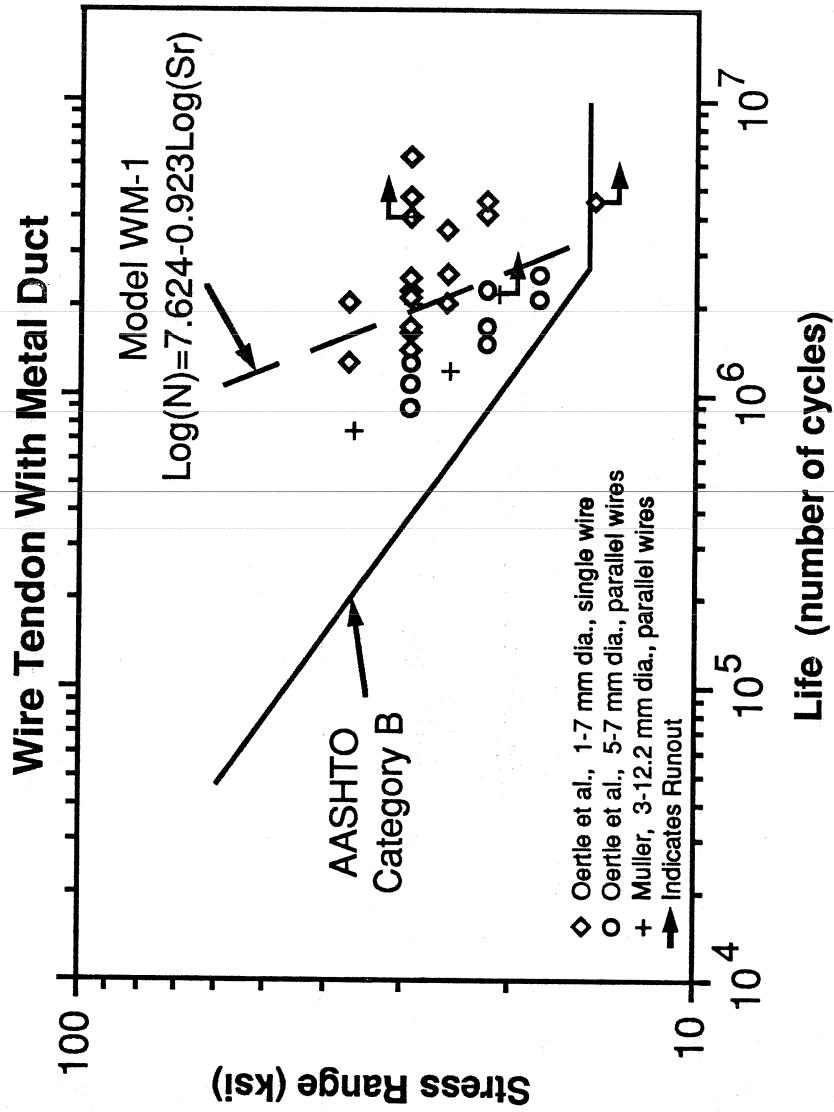
Figure 5.11 Comparison of Test Results from Beams with Wire Tendons and Metal Duct with AASHTO Fatigue Model

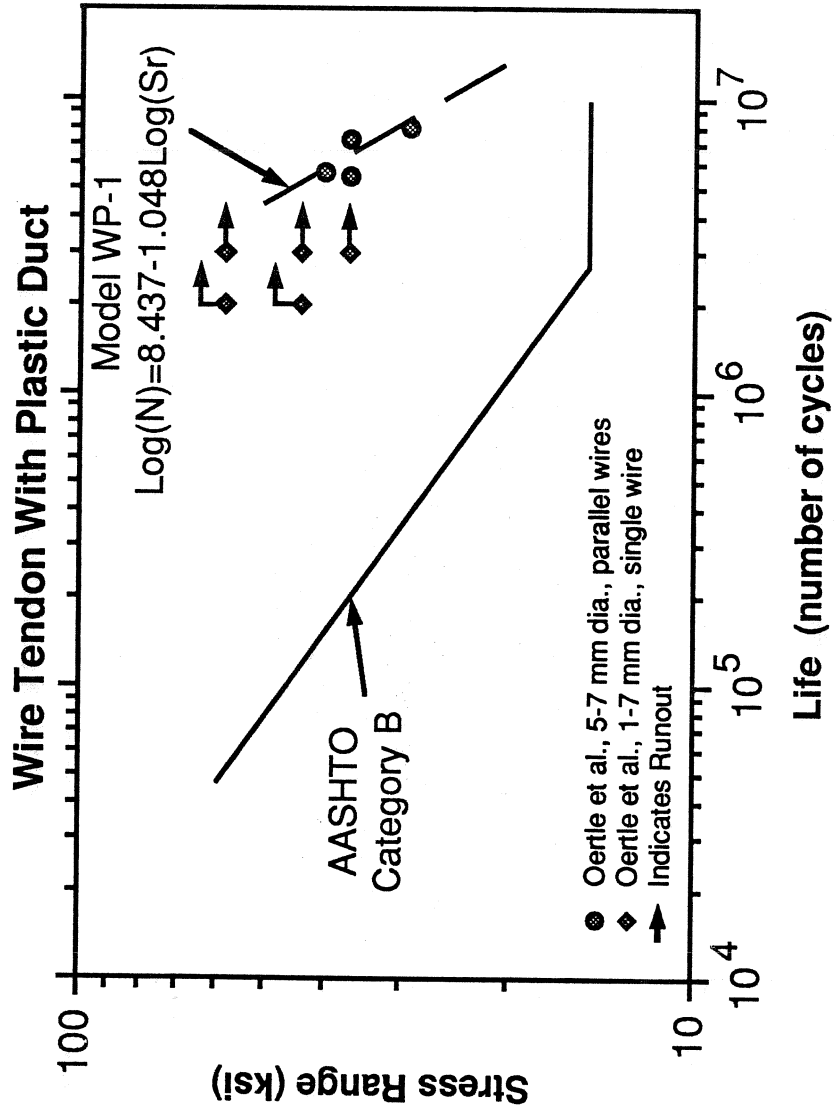
Figure 5.12 Comparison of Test Results from Beams with Wire Tendons and Plastic Duct with AASHTO Fatigue Model

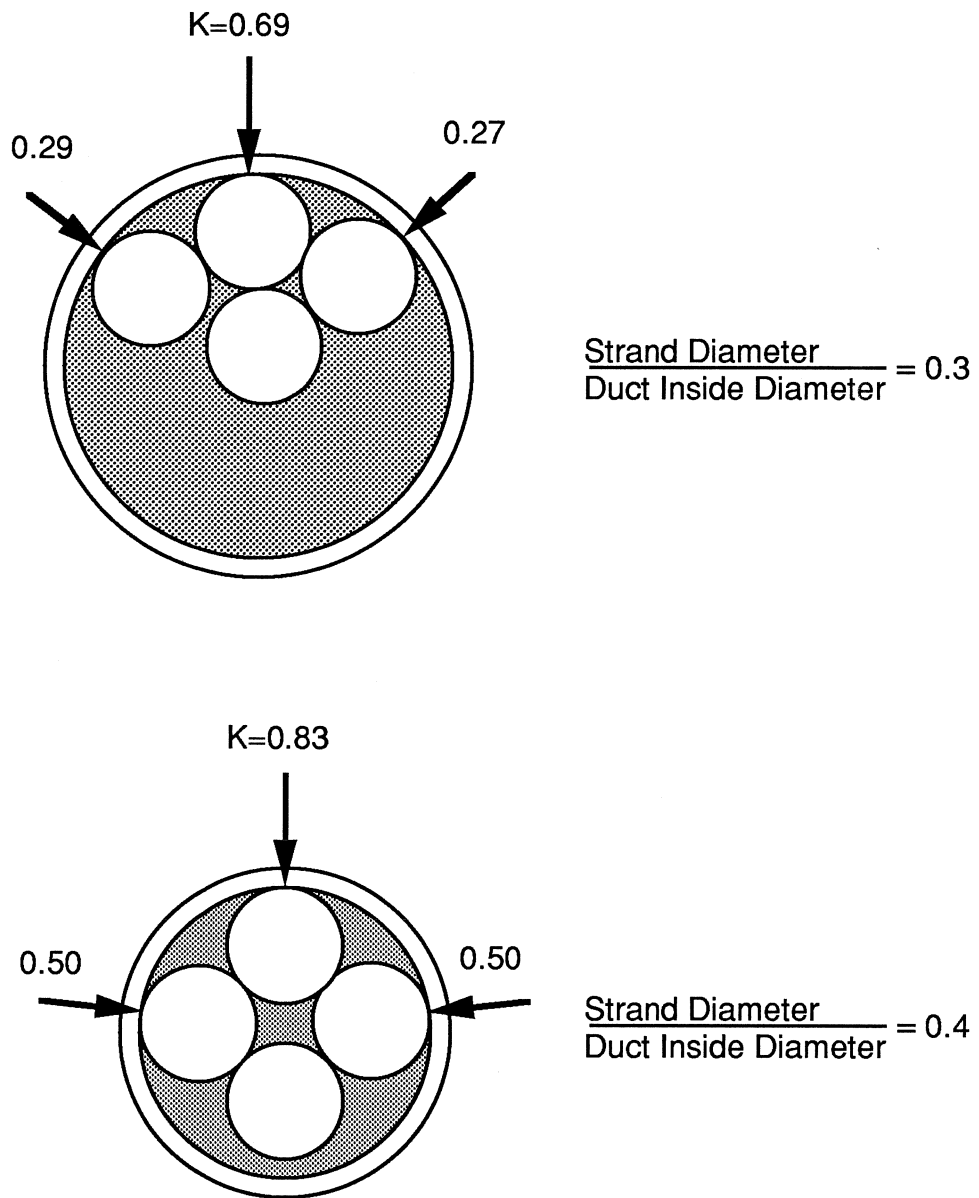
Figure 5.16 Variation of K Factors With Ratio of Strand to Duct Size

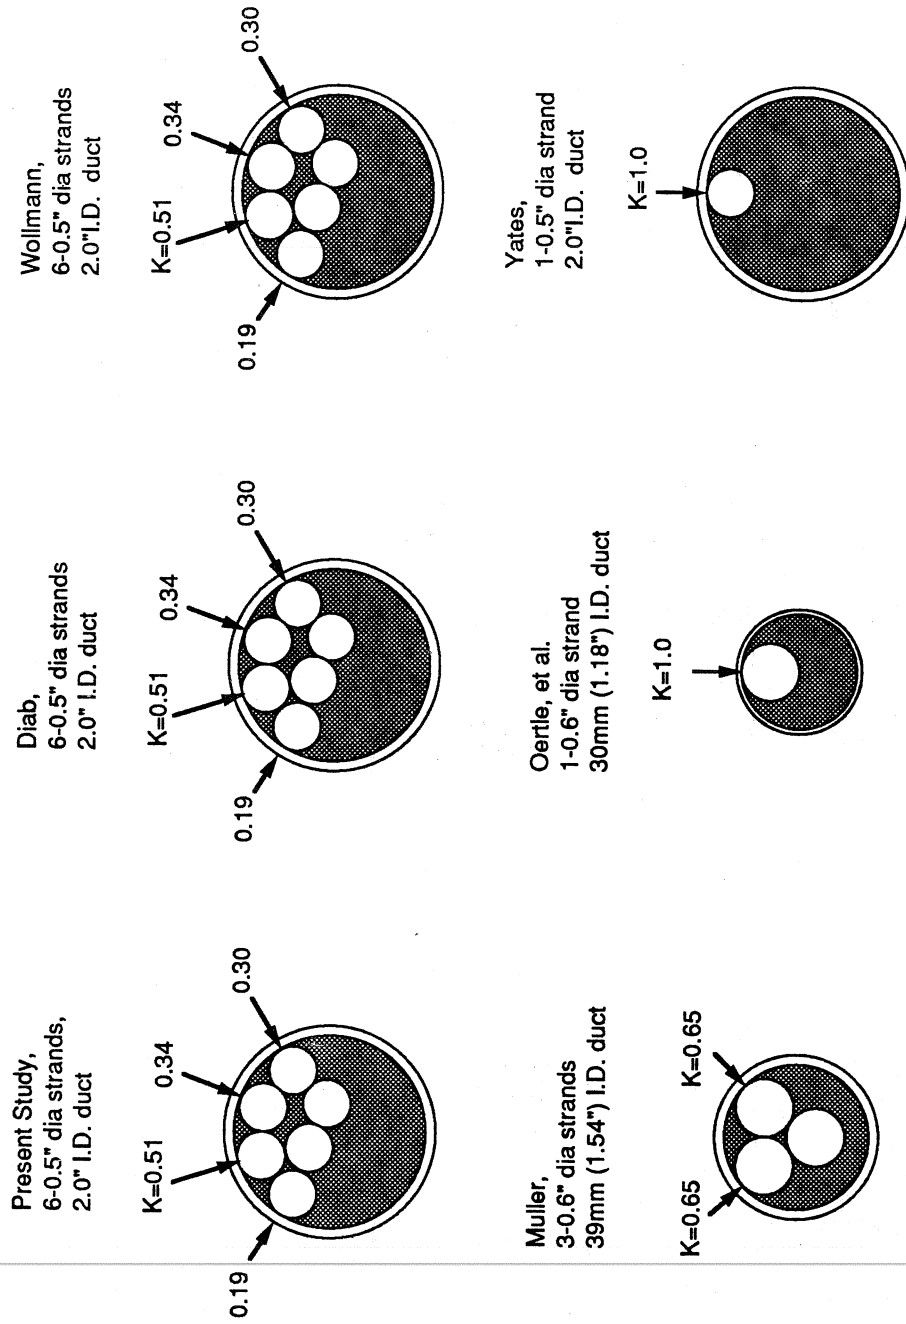
Figure 5.17 K Factors Used for Beams with Strand-Type Tendons

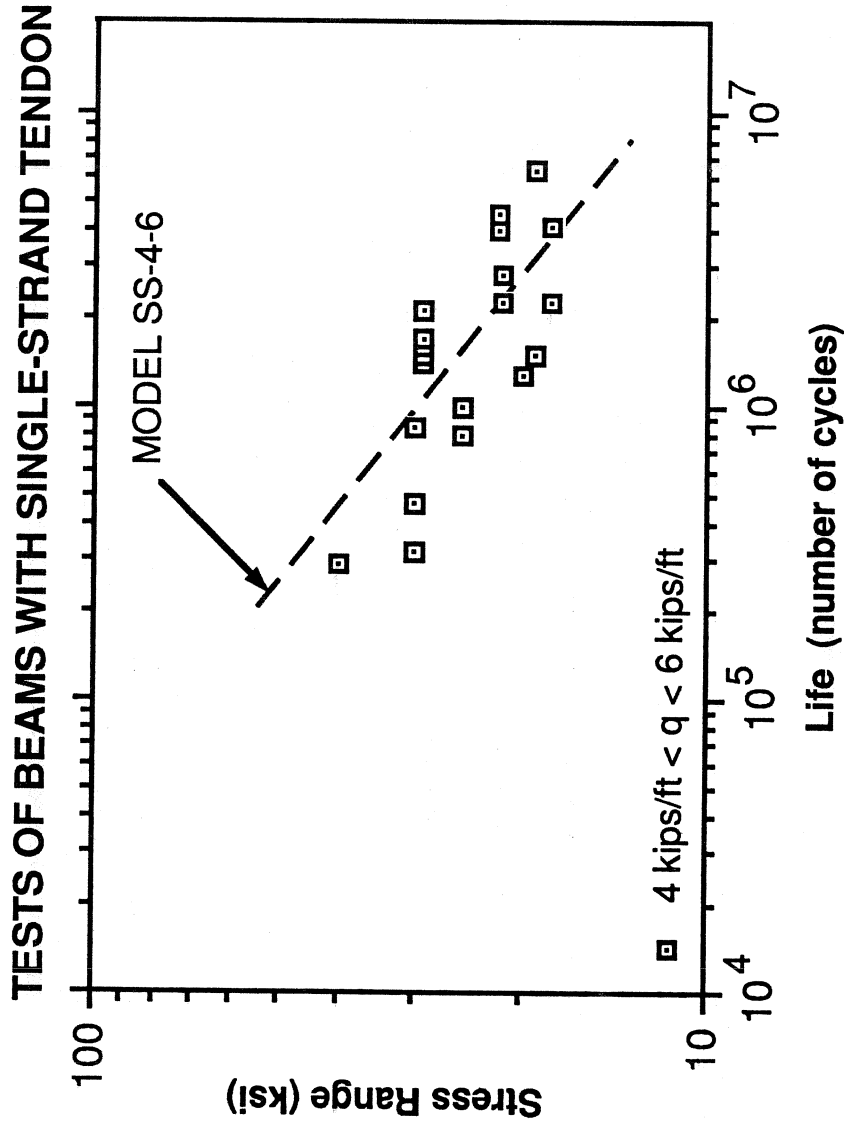
Figure 5.21 Fatigue Life as a Function of Stress Range and Contact Load for Beams with Single-Strand Tendon and Metal Duct

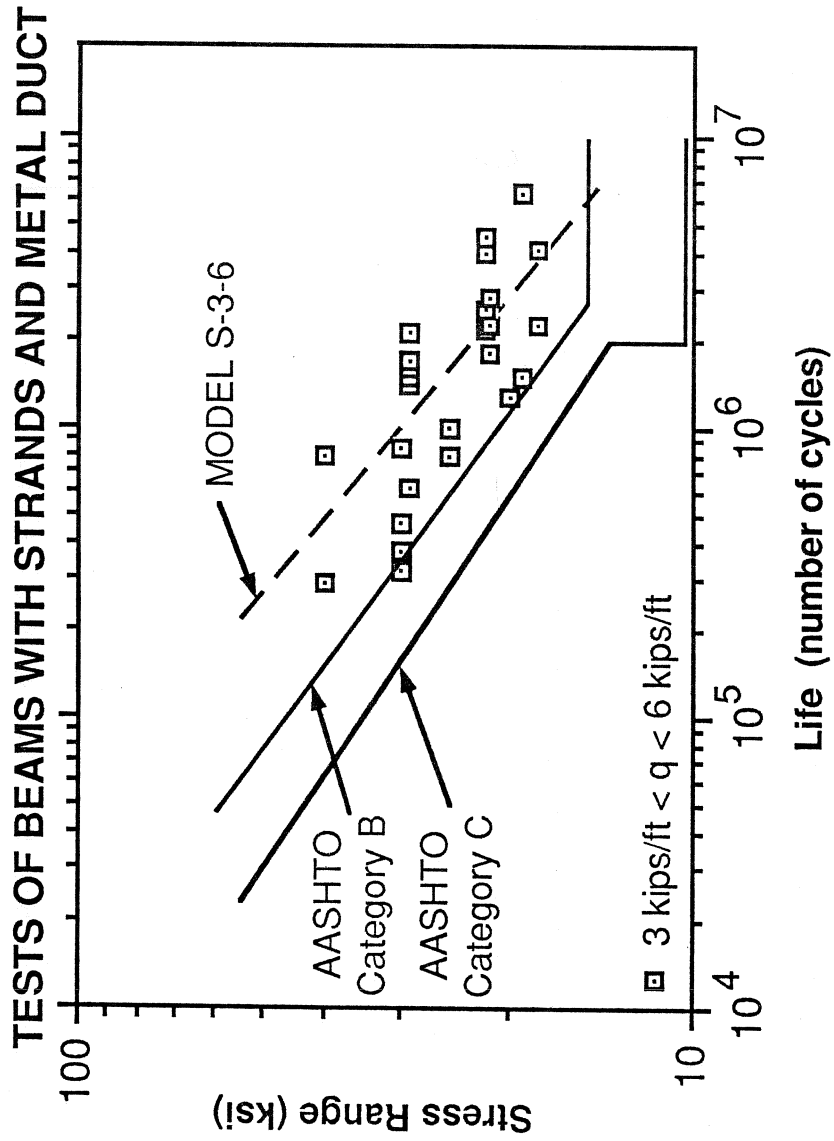
Figure 6.1 Comparison of Model S-3-6 with AASHTO Category B and AASHTO Category C Fatigue Models

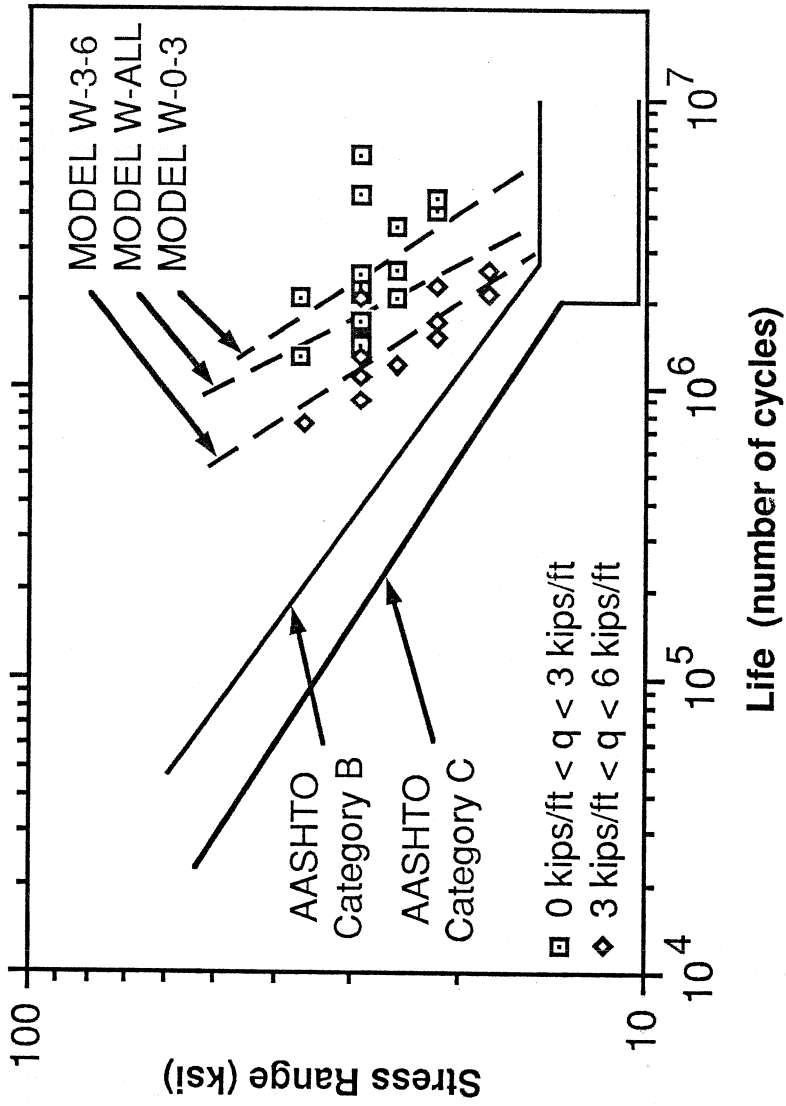
Figure 6.3 Comparison of Models W-0-3, W-3-6 and W-ALL with AASHTO Category B and AASHTO Category C Fatigue Models
