**NON-DESTRUCTIVE EVALUATION OF GRAVITY LOAD
CARRYING CAPACITY AND LATERAL LOAD DAMAGE
OF REINFORCED CONCRETE SLAB-COLUMN
CONNECTIONS**

Dissertation

The University of Texas at Austin

May 2006

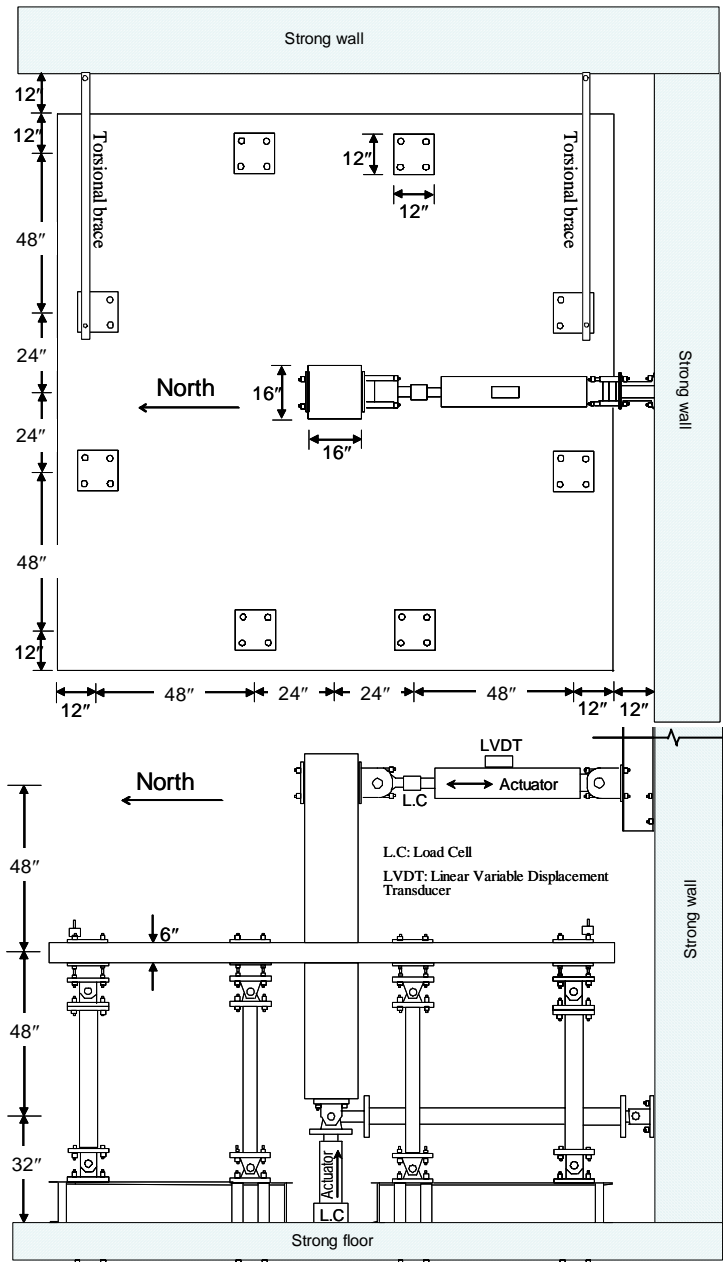
Vertical loading was provided through the ram located under the column. Loads in the ram were gradually increased until punching shear failure was achieved.

Figure 2.11 *Set-up for lateral loading tests*

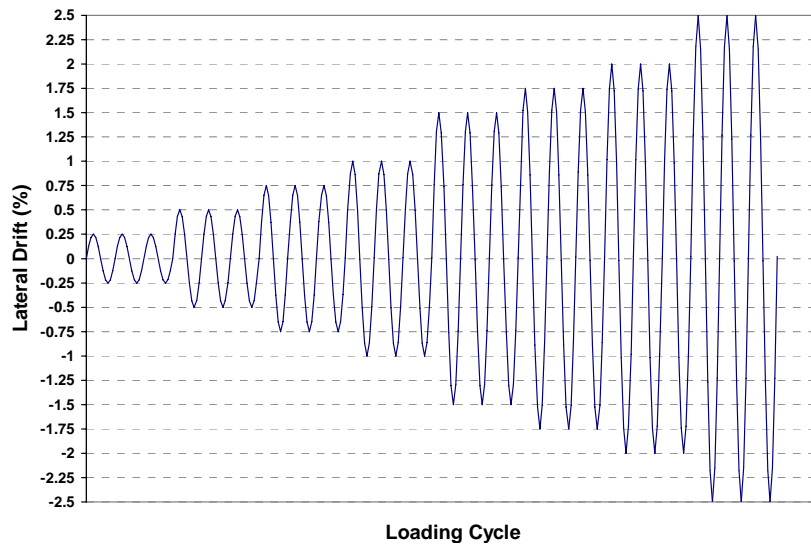
In all lateral loading tests, the column axial load was kept constant to produce a shear force “ V ” on the critical shear perimeter equal to $0.92\sqrt{f'_c}b_o d$, where $b_o = 84$ in. is the critical shear perimeter, $d = 5$ in. is the average depth of the slab reinforcement and f'_c is the concrete compressive strength. V was set equal to dead load plus 25% live load on the prototype structure.

Figure 2.14 Displacement Protocol for specimen L0.5

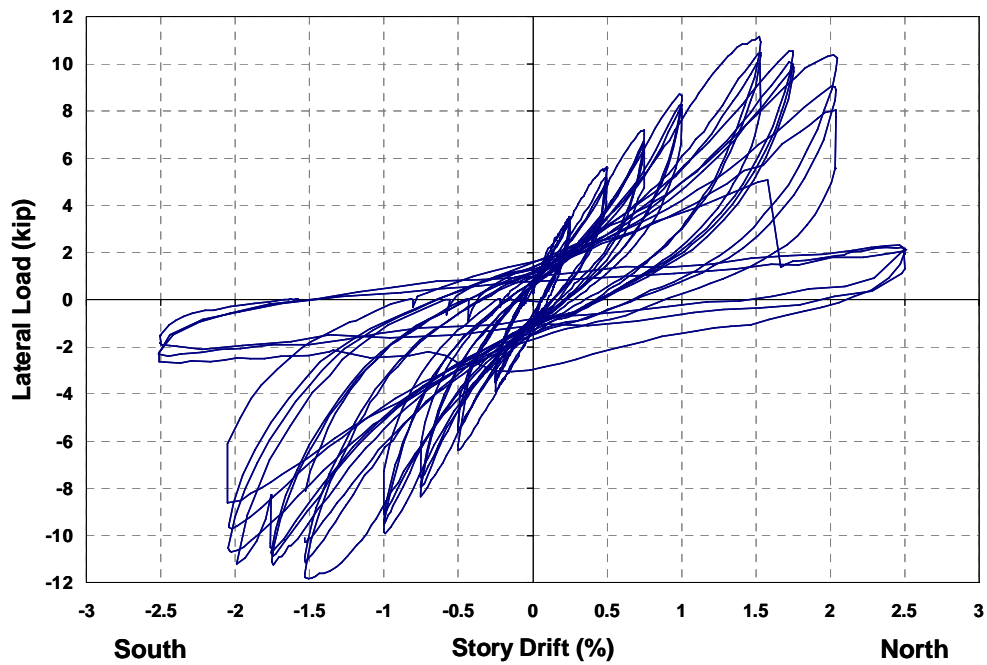
Figure 3.1 Hysteretic loop for specimen L0.5

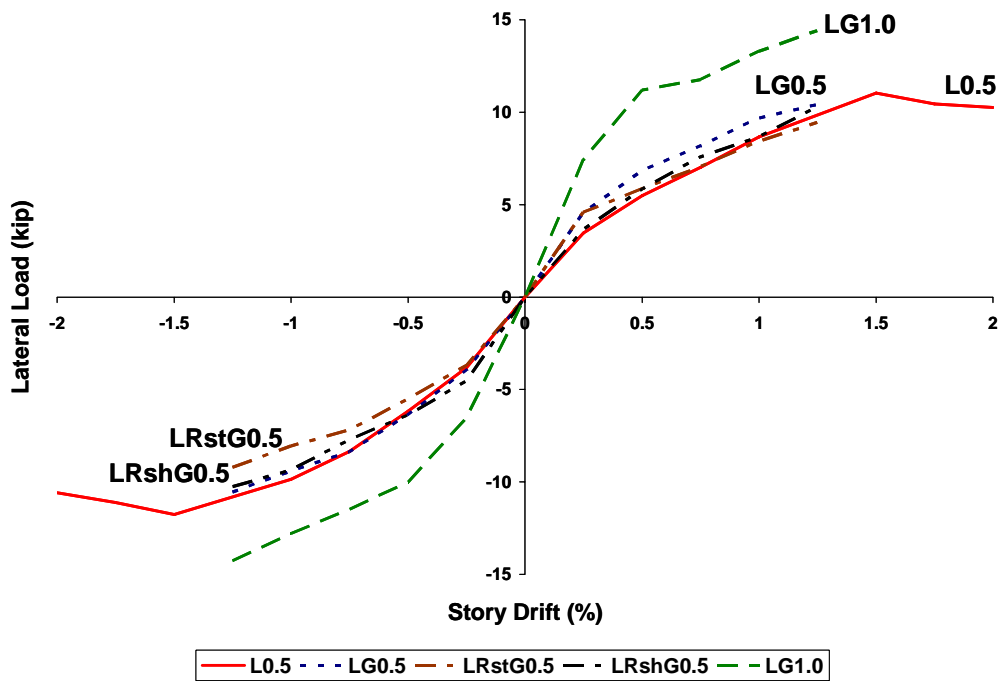
The load-deformation envelope for specimen LG1.0 had a higher capacity than the others because it was fabricated with 1% top reinforcement ratio in the (c+3h) region within the column strip (Figure 2.2), while others had 0.5% reinforcement ratio in the same location.

Figure 3.2 Load – deformation envelopes for all laterally loaded specimens

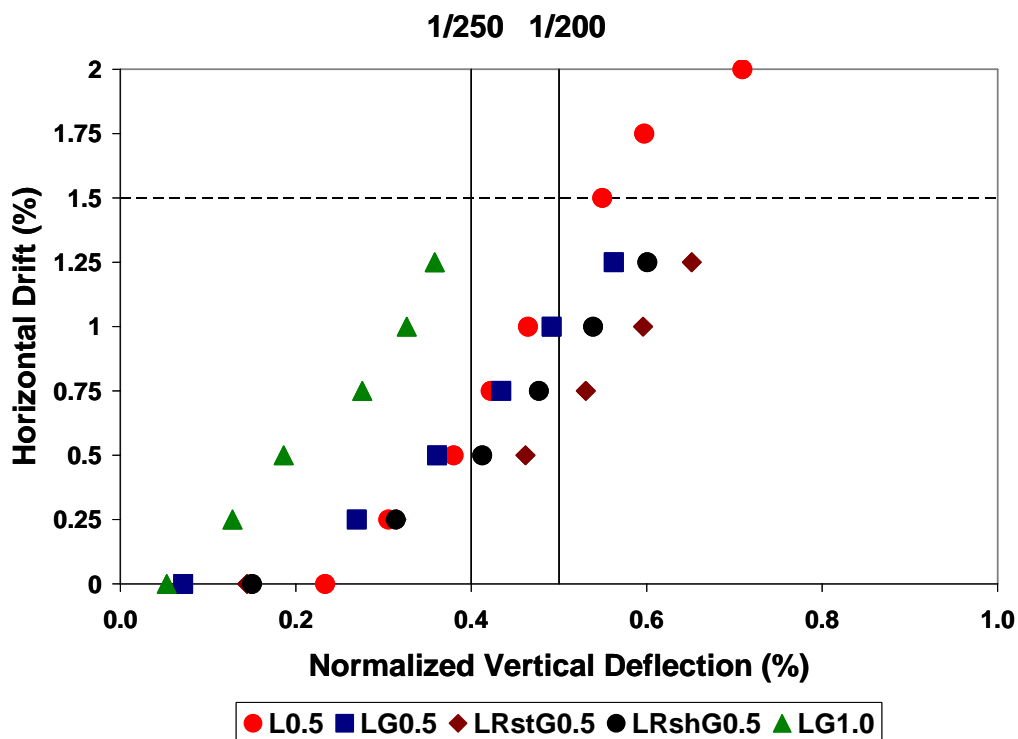
For specimens with 0.5% top reinforcement ratio in the (c +3h) region, a normalized vertical deflection 1/200 can be considered a threshold deflection limit for severe structural damage. At a normalized vertical deflection of 1/200, lateral drifts were below 1.5% and the observed lateral load damage was moderate.

Figure 3.3 Horizontal drift versus normalized vertical Deflection for all laterally loaded specimens

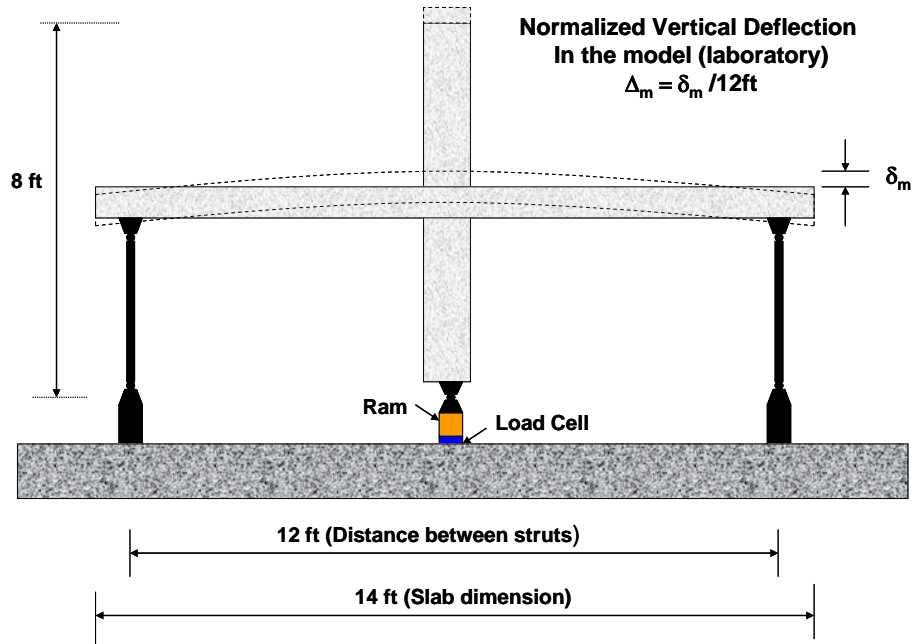
Figure 3.4 *Determination of the Normalized Vertical Deflection of the slab in the model (specimens)*

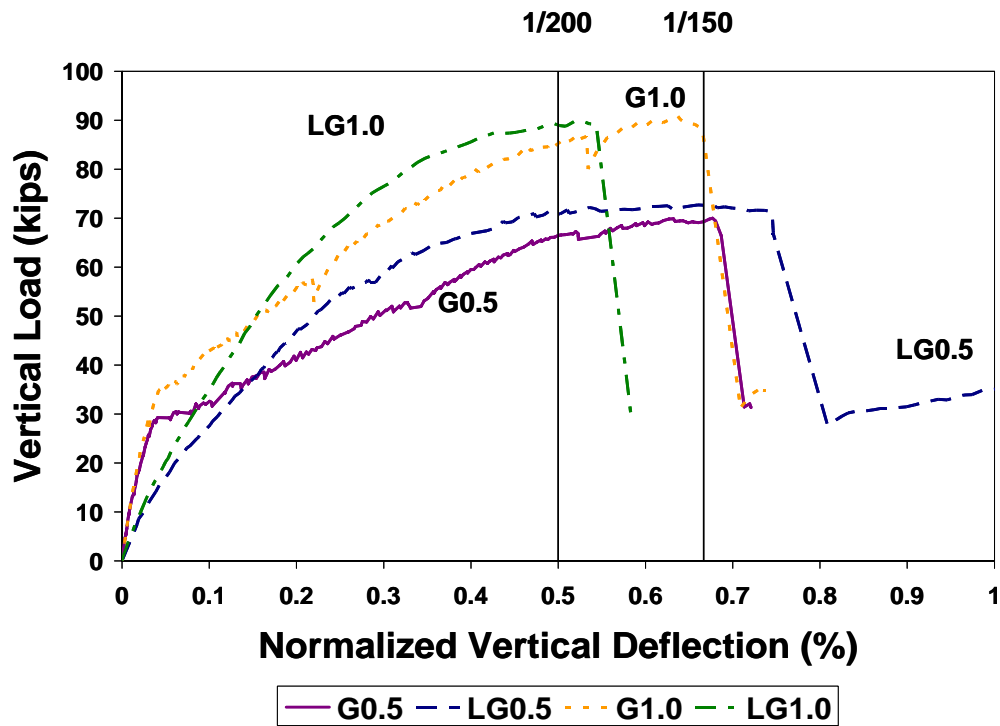
For specimens with 0.5% top reinforcement ratio in the (c+3h) region within the column strip, a normalized vertical deflection 1/150 is considered a threshold deflection limit against punching shear failure.

Figure 3.5 Vertical load versus normalized vertical deflection for non-rehabilitated specimens

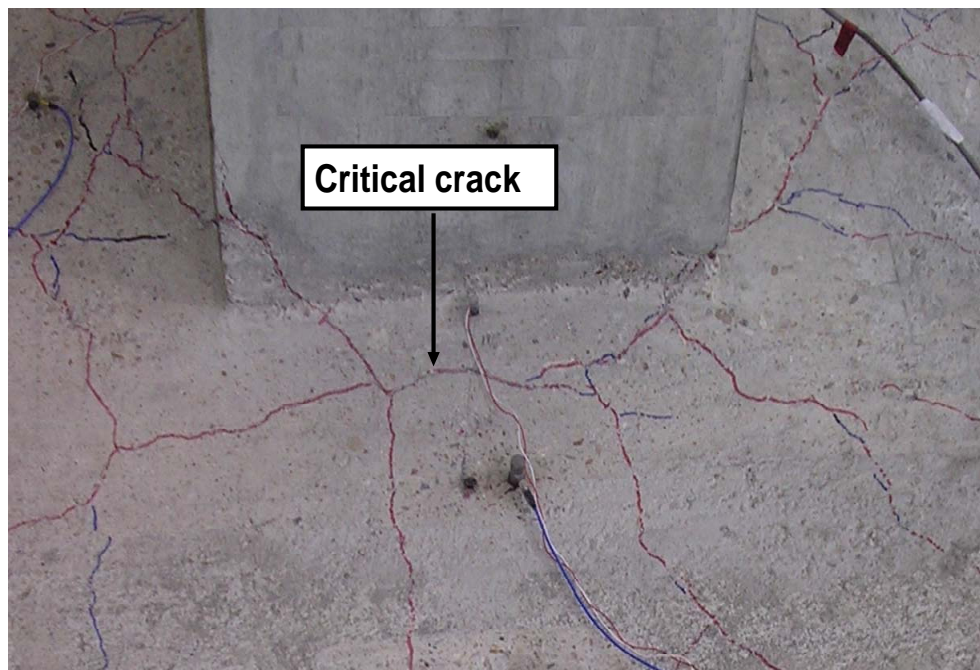
Figure 4.1 *Critical crack in Specimen L0.5 (North axis)*

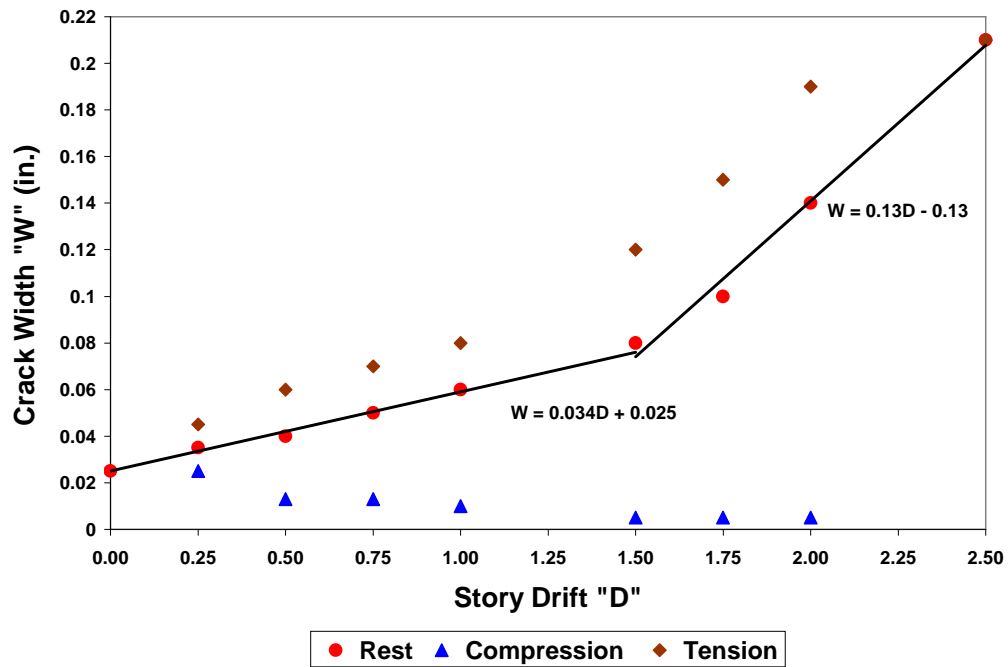
Figure 4.2 Crack width measurements in Specimen L0.5

- i. The control crack width remained constant after 1% drift because the crack at the slab-column interface became active.
- ii. There is a linear correlation between drift level and crack width for lateral drifts from 0 to 1%.

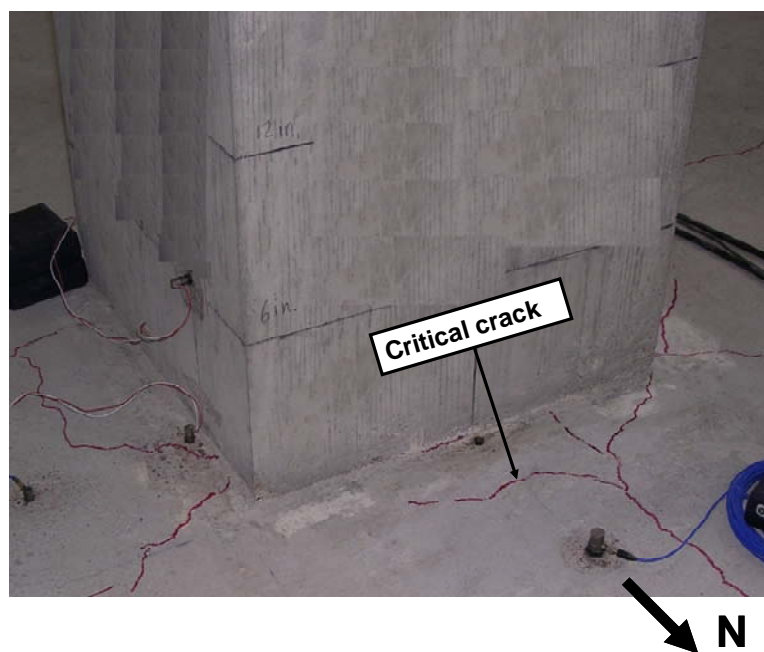
Figure 4.3 Critical crack in Specimen LG0.5 (North axis)

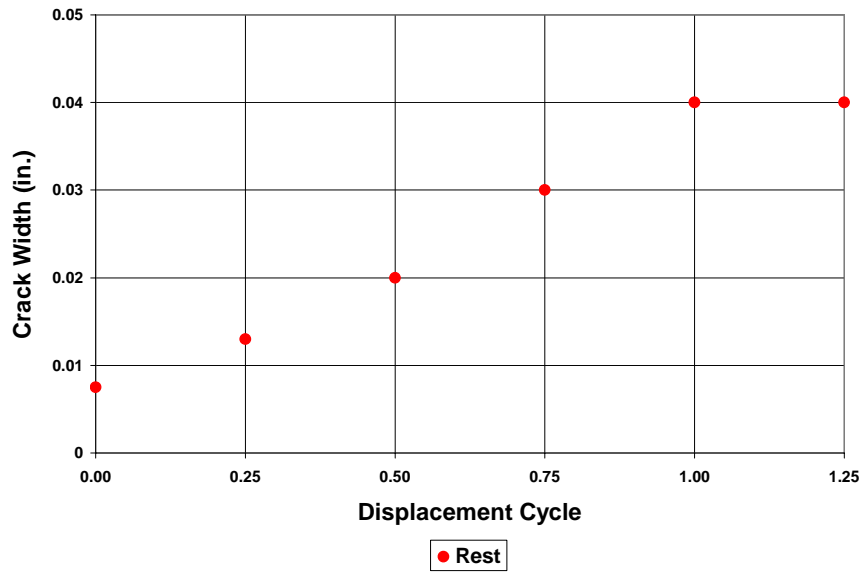
Figure 4.4 Crack width measurements in Specimen LG0.5

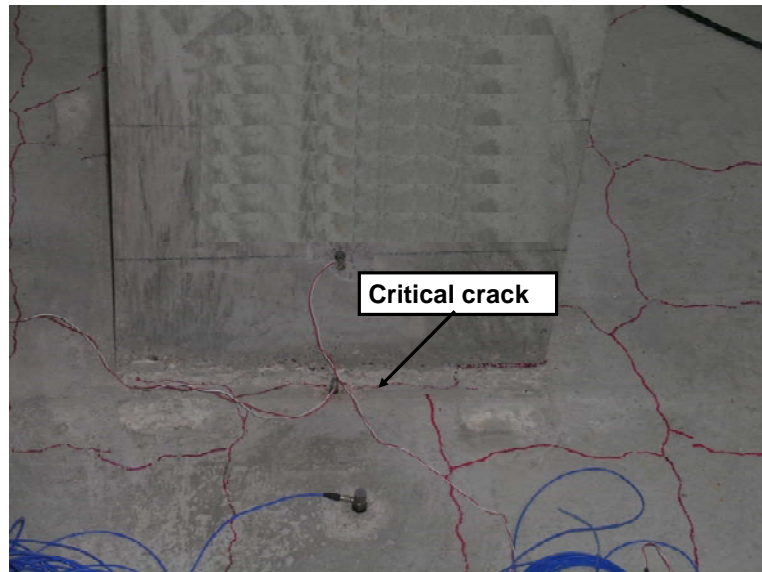
After applying the gravity load, a critical crack was formed at the slab-column interface on the north axis (Figure 4.5) and on the south axis, at 1.5 in. from the column (Figure 4.6). The critical crack on the north axis was not accessible with the crack gauge; therefore crack widths were measured for the critical crack on the south axis. Results are presented in Figure 4.7. Visual observations during testing showed that widths of both, the north and south critical cracks were similar at every lateral drift level. From the results presented in Figure 4.7, it was observed that there is a nearly linear correlation between drift level and crack width.

Figure 4.5 Critical flexural crack in Specimen LR_{ST}G0.5 (North axis)

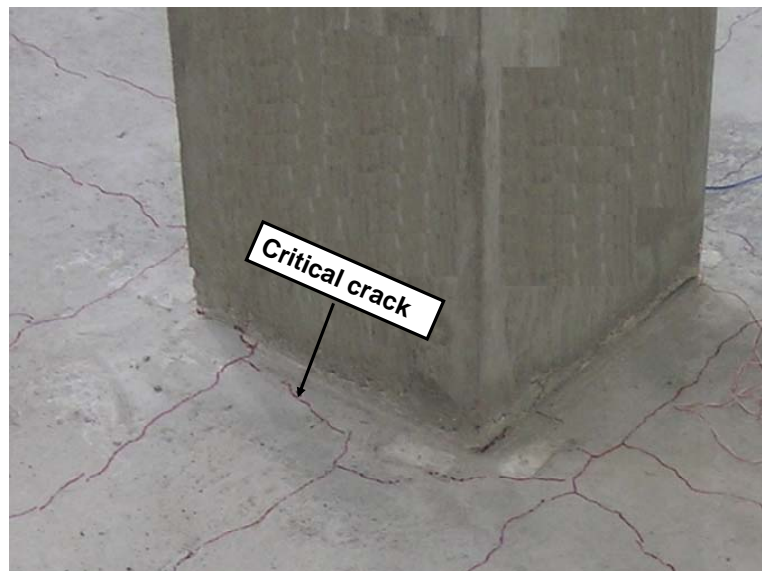
Figure 4.6 Critical crack in Specimen LR_{ST}G0.5 (South axis)

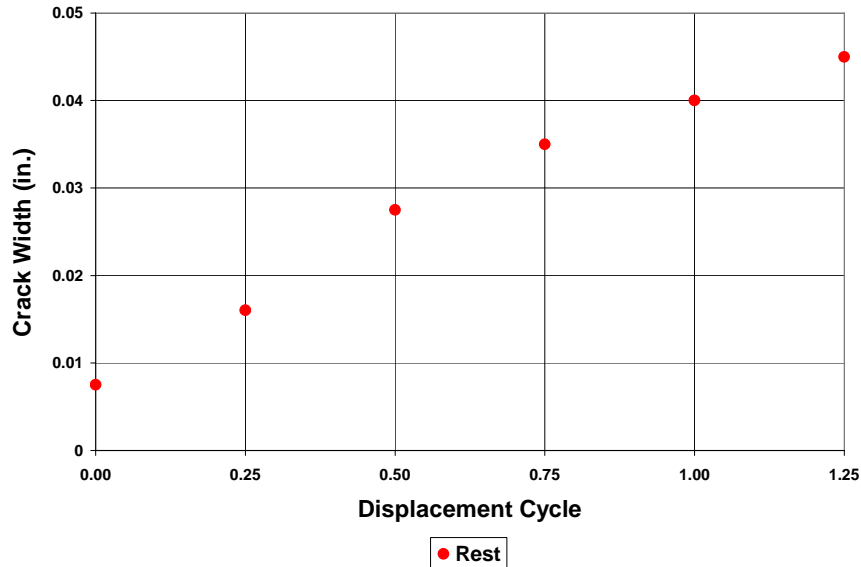
Figure 4.7 Crack width measurements in Specimen LR_{ST}G0.5

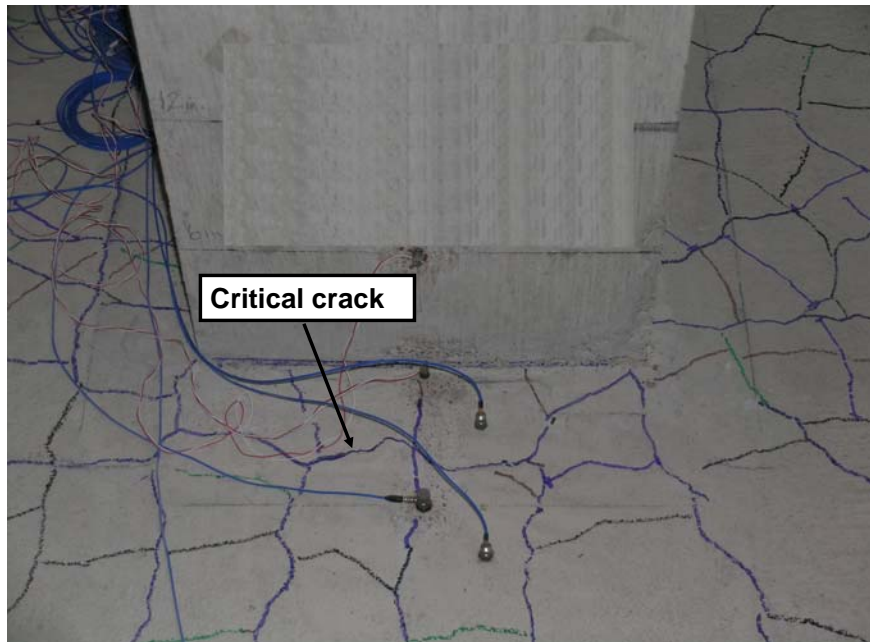
Figure 4.8 Critical crack in Specimen LG1.0 at 1.25% drift (North axis)

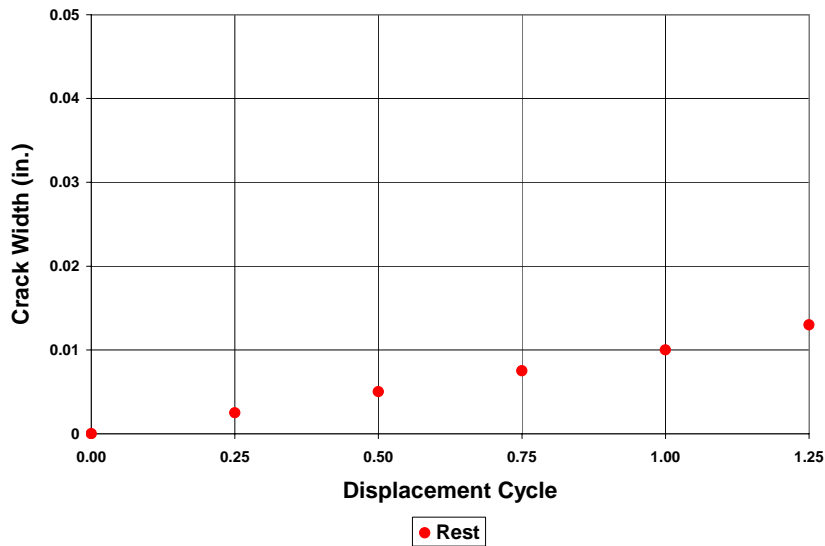
- ii. There is not good agreement between crack widths measured for specimen LG1.0 and specimens L0.5, LG0.5 and LR_{ST}G0.5. Crack widths for specimen LG1.0 are much smaller than those measured for other specimens. That is attributed to the higher top reinforcement ratio (1%) in specimen LG1.0 than the ratio used for other specimens (0.5%). A high reinforcement ratio produces a well distributed pattern of cracks of fairly uniform width. Likewise, a low reinforcement ratio produces a pattern of cracks of variable width.

Figure 4.9 Crack width measurements in Specimen LG1.0

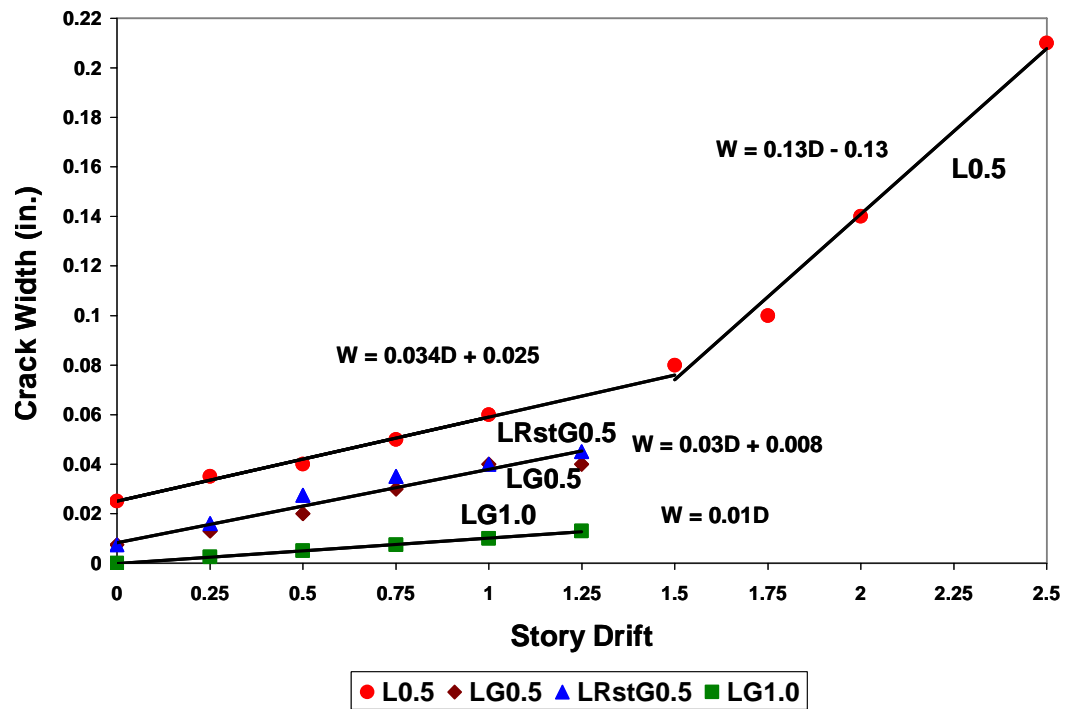
Figure 4.10 Crack widths for all specimens

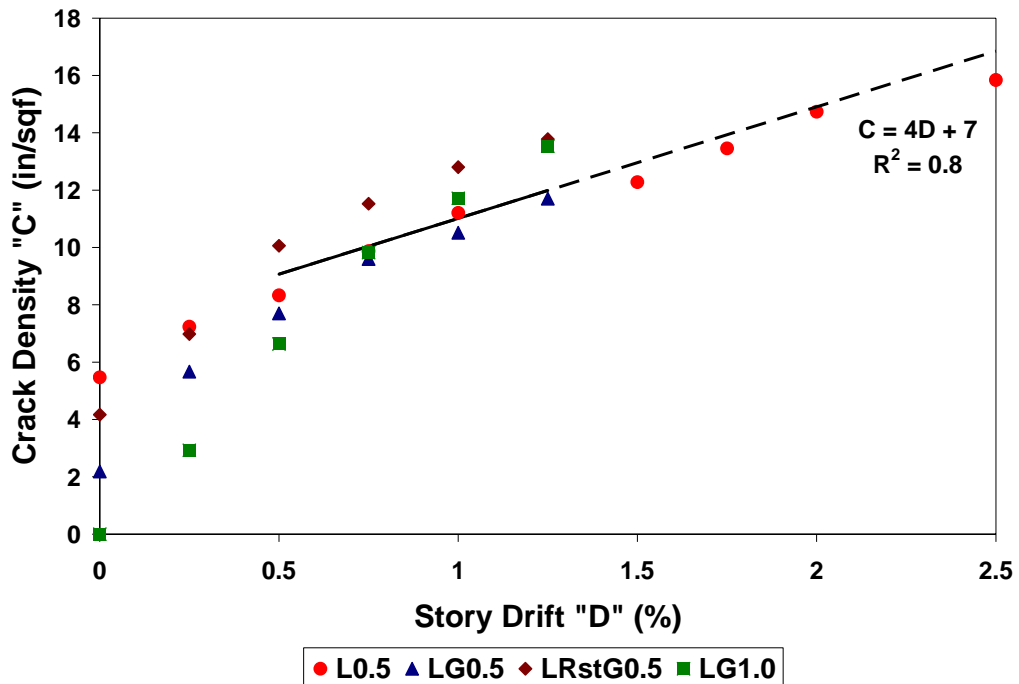
- ii. For drift levels 0.5% and above, there is a good correlation between crack density and story drift. Regardless of the loading history and top reinforcement ratio, data from all specimens converge to a similar trend when story drifts are equal or greater than 0.5%.

Figure 4.41 Relationship between Crack Density and Story Drift

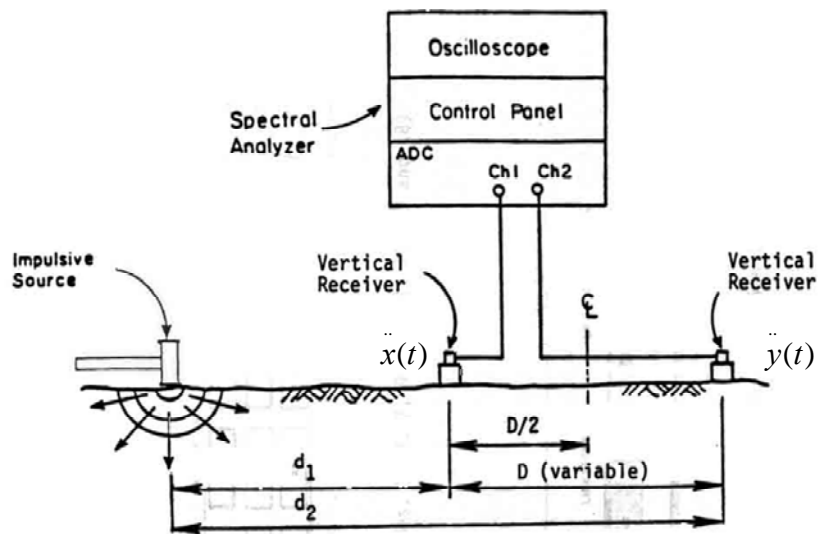
The time history records from the accelerometers $\ddot{x}(t)$ and $\ddot{y}(t)$, located at a distance d_1 and d_2 from the source (Figure 5.1), are transformed into the frequency domain by a FFT procedure to obtain $X(f)$ and $Y(f)$ real functions. $X^*(f)$ and $Y^*(f)$ are the complex conjugates of $X(f)$ and $Y(f)$ respectively.

Figure 5.1 General configuration of SASW testing (Nazarian, et al., 1988).

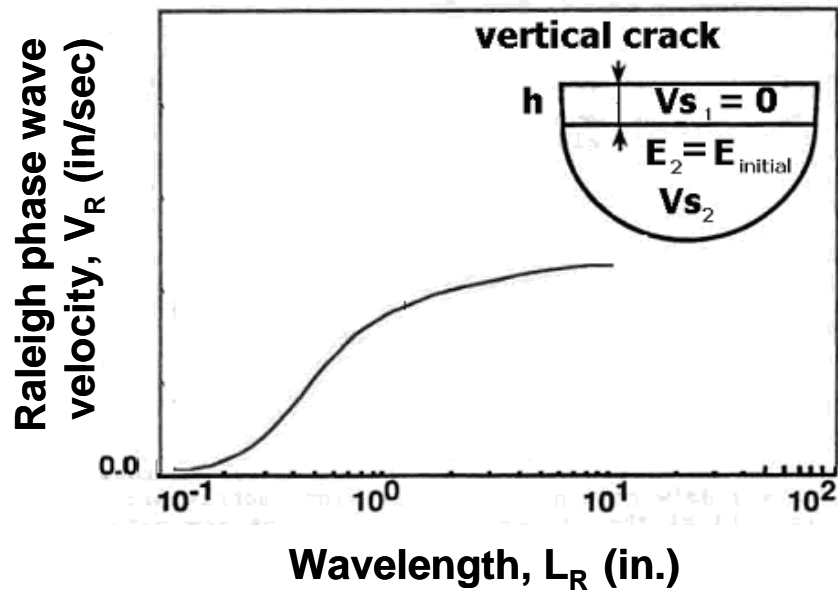
A dispersion curve of Raleigh wave phase velocity (V_R) versus wavelength (L_R) is constructed for all available frequencies. The shape of the dispersion curve is used to locate layer interfaces and discontinuities such as honeycombs, boundaries, etc. For concrete members without discontinuities, the dispersion curve will tend to be a horizontal line, since no significant changes in E and V_R can be measured in a homogeneous and continuous material. An example of a dispersion curve for a two layered material is shown in Figure 5.2. The top layer has an open crack to a depth h and therefore surface wave velocity and equivalent modulus of elasticity are equal to zero to the depth of the crack.

Figure 5.2 Expected dispersion curve for a concrete member with a vertical crack to a depth h (Roesset, J.M., et al, 1990).

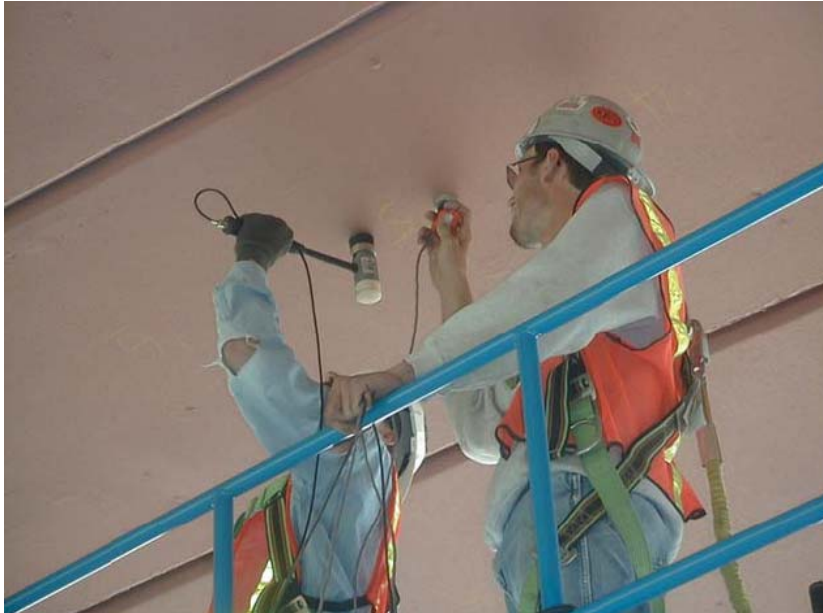
Figure 5.4 Slab Impulse Response Test (Olson, 2004)

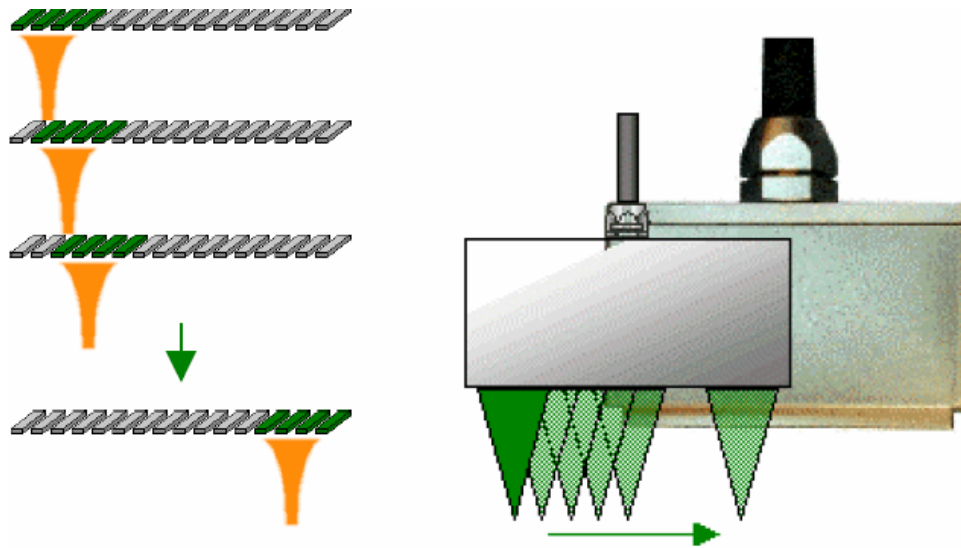
Figure 5.10 View of electronic scanning (Poguet, et al, 2002)

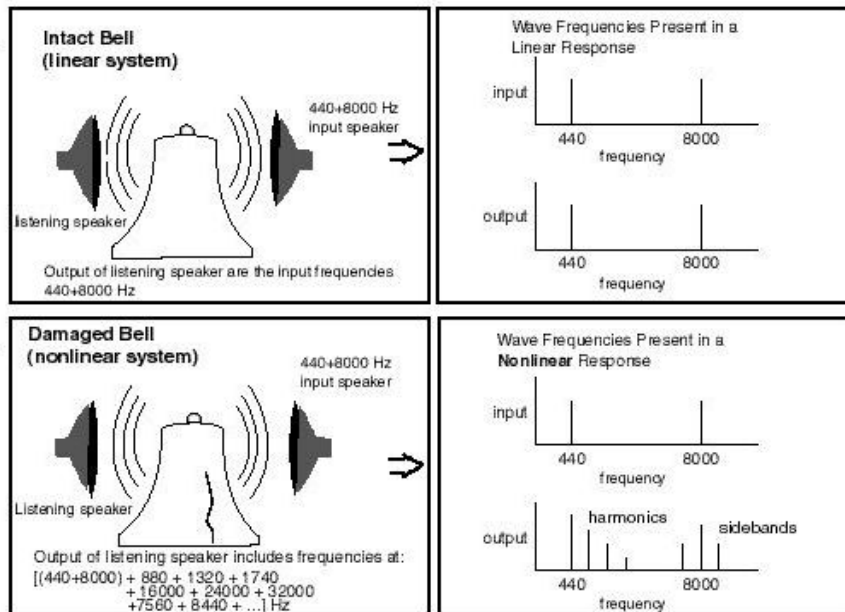
Figure 5.12 Generation of harmonic and sideband frequencies in a nonlinear system (Johnson, 1999)

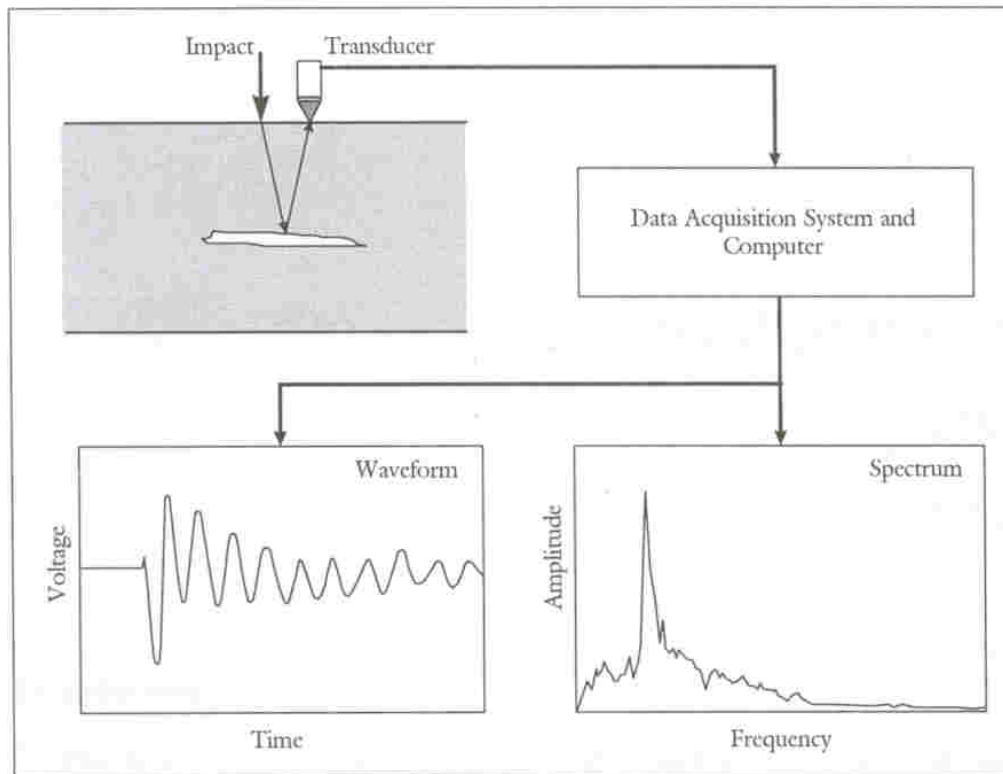
It is the patterns present in the waveforms and spectra (especially the latter) that provide information about the existence and locations of flaws, or the dimensions of the cross-section of the structure where a test is performed, such as the thickness of a pavement. For each of the common geometrical forms encountered in concrete structures (plates; circular and rectangular columns; rectangular, I-, and T-beams; hollow cylinders; etc.), impact-echo tests on a solid structure produce distinctive waveforms and spectra, in which the dominant patterns—especially the number and distribution of peaks in the spectra—are easily recognized. If flaws are present (cracks, voids, delaminations, etc.) these patterns are disrupted and changed, in ways that provide qualitative and quantitative information about the existence and location of the flaws.

Figure 5.14 Outline of the Impact-Echo Method

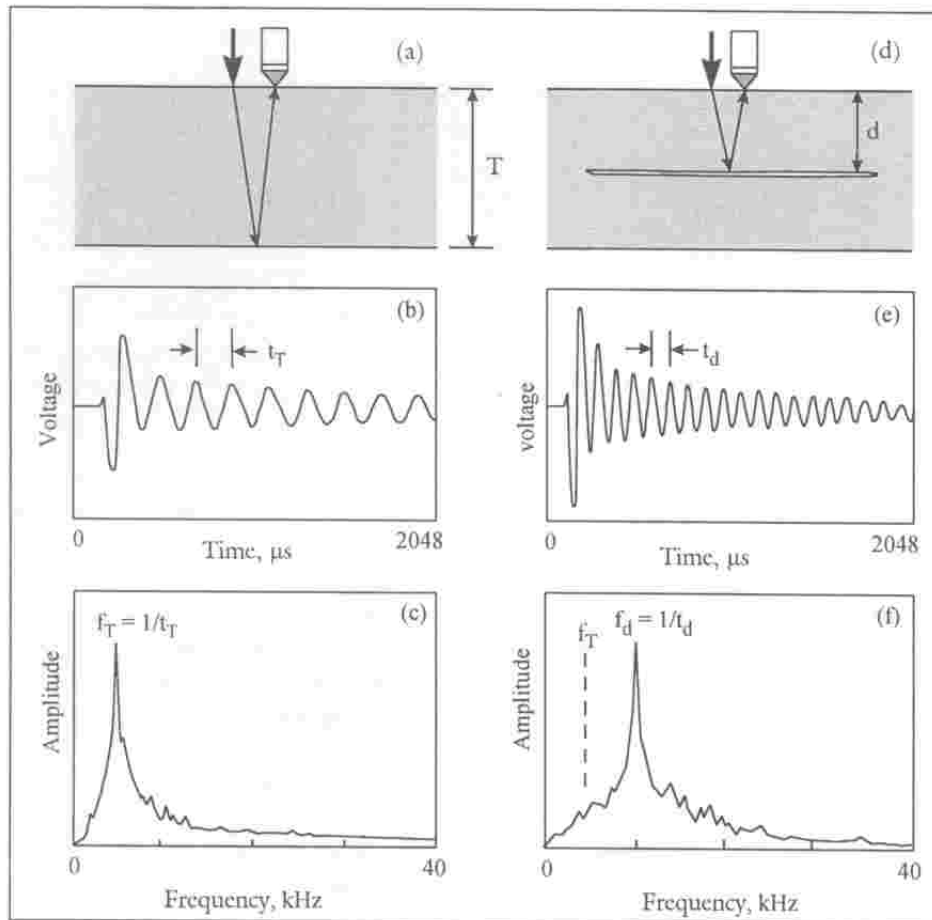
Sansalone M. J. and Streett W. B. (1997) developed a technique to locate areas of delamination in a concrete slab of thickness T . Figure 6.2a through Figure 6.2c show the response for a slab without delamination. As explained in Section 3.5, the period of the thickness mode response is t_T and the thickness mode frequency is $f_T = 1/t_T$. When a delamination occurs inside the slab, at a distance d from the surface, the P-waves are diffracted at the horizontal crack and then propagate back up through the slab producing a response equivalent to a plate of thickness d , resulting in a time-history response of higher frequency. Figure 6.2d through Figure 6.2f show the response of a slab with a concrete delamination.

Figure 6.2 *Impact Echo response of a concrete slab with and without delamination (Sansalone and Streett, 1997).*

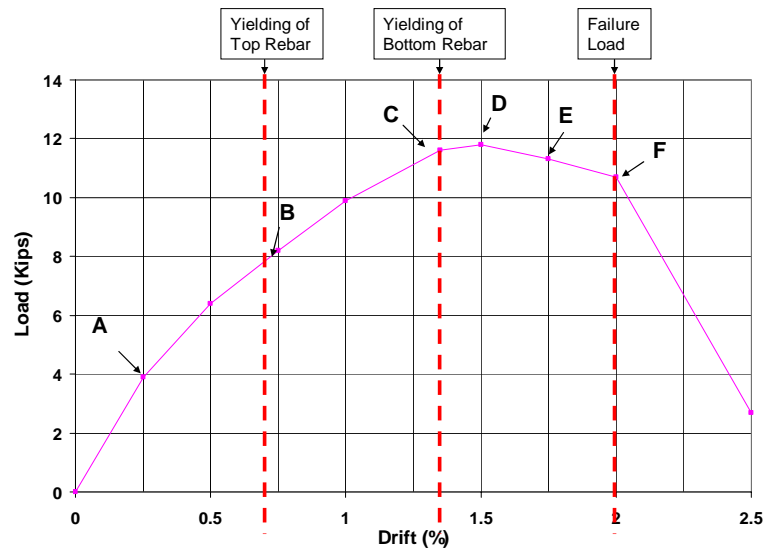
The load-deformation envelope curve for specimen L0.5 is presented in Figure 6.3, where points A through F show relevant stages at which data were collected.

Figure 6.3 Load Deformation Envelope Curve for Specimen L0.5

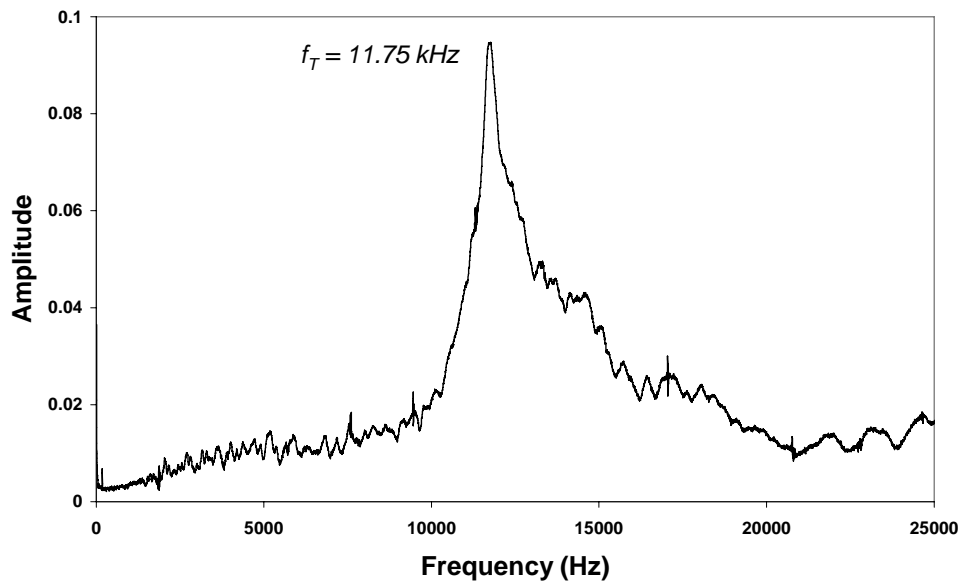
The unconstrained P-wave velocity obtained by using the Impact Echo technique is very close to the value obtained in Appendix B ($V_c = 12,431 \text{ ft/sec}$) by conducting Resonance and Direct Arrival Tests on 6 in. x 12 in. concrete cylinders.

Figure 6.4 *Detection of the Thickness Frequency in Specimen L0.5*

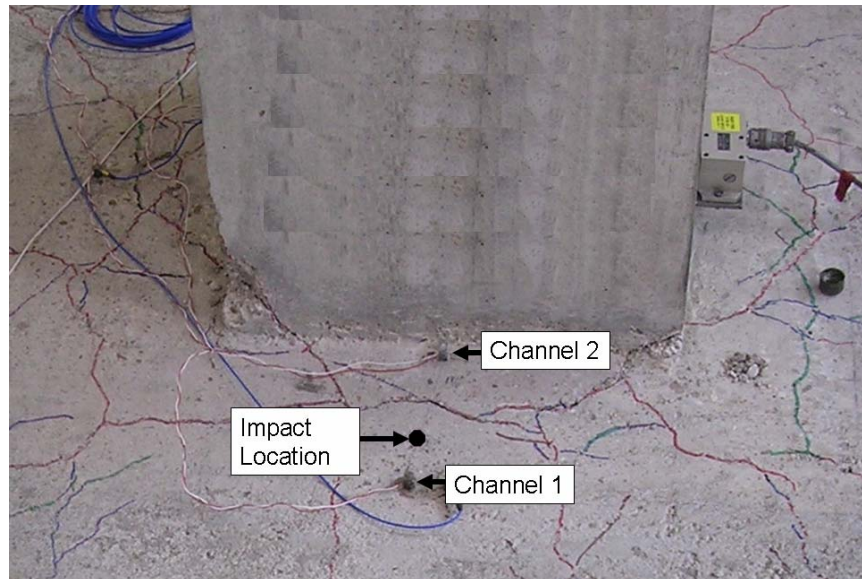
Figure 6.5 *Layout of accelerometers used to measure depth of critical crack in Specimen L0.5 (North Axis)*

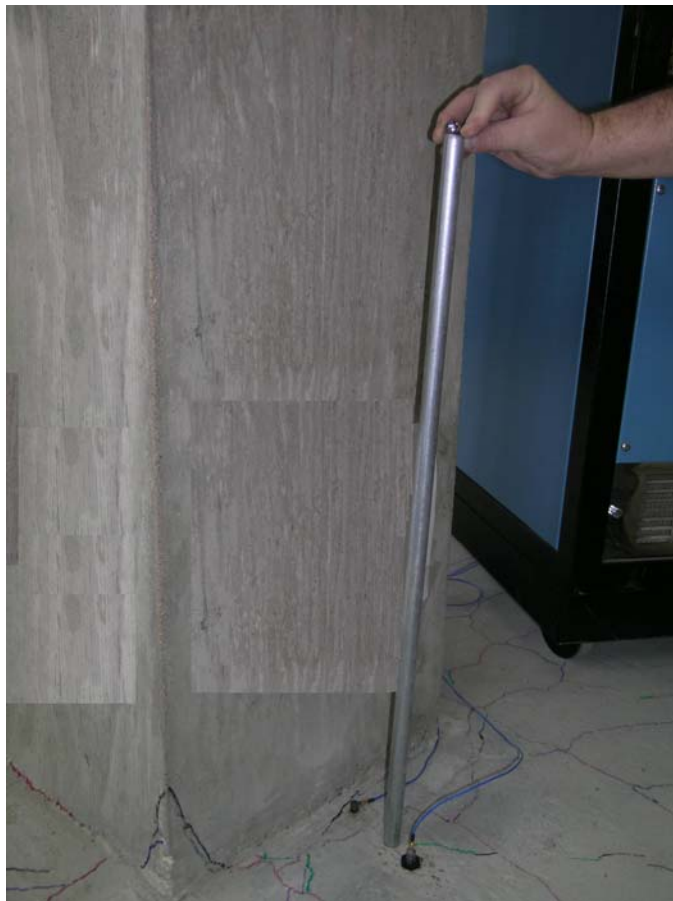
A steel pipe was used to drop the ball at the precise location of impact between sensors (Figure 6.6).

Figure 6.6 *Crack depth measurements using a steel pipe to drop the ball at the precise position of impact*

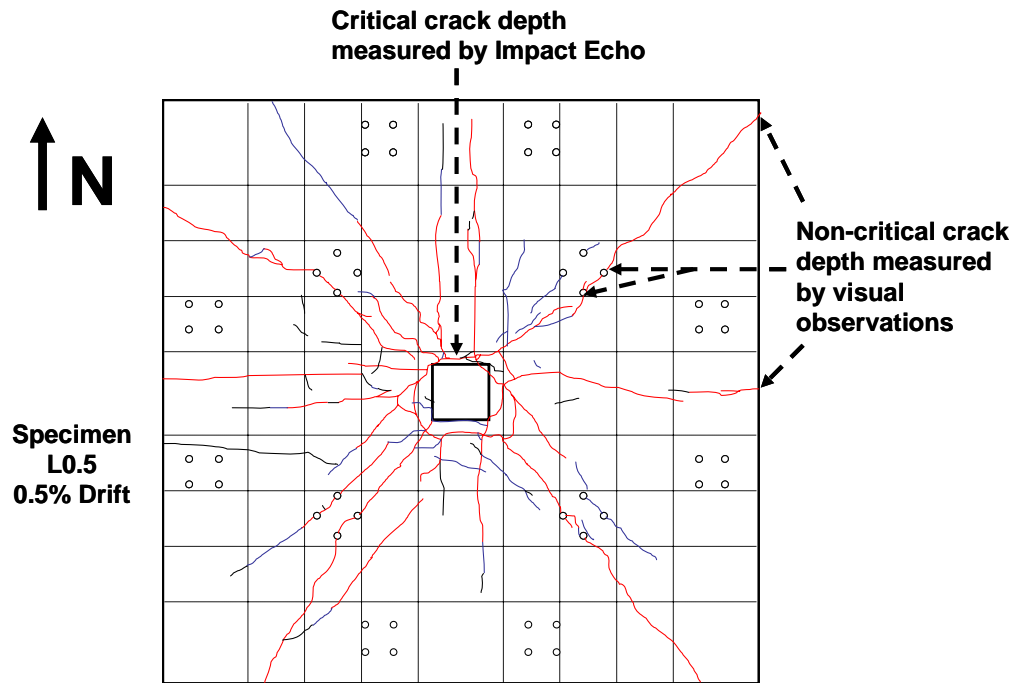
Figure 6.7 *Typical locations where crack depths were measured using the Impact Echo method and visual observations*

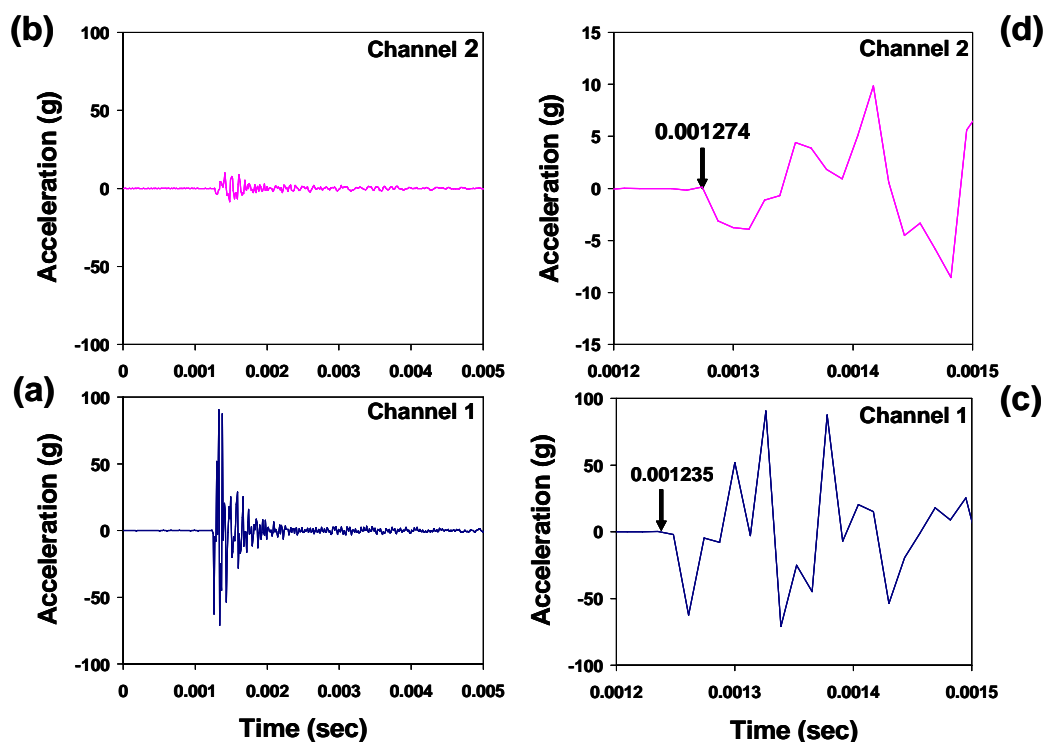
Figure 6.8 Example of the use of time-history records to measure crack depth in specimen L0.5

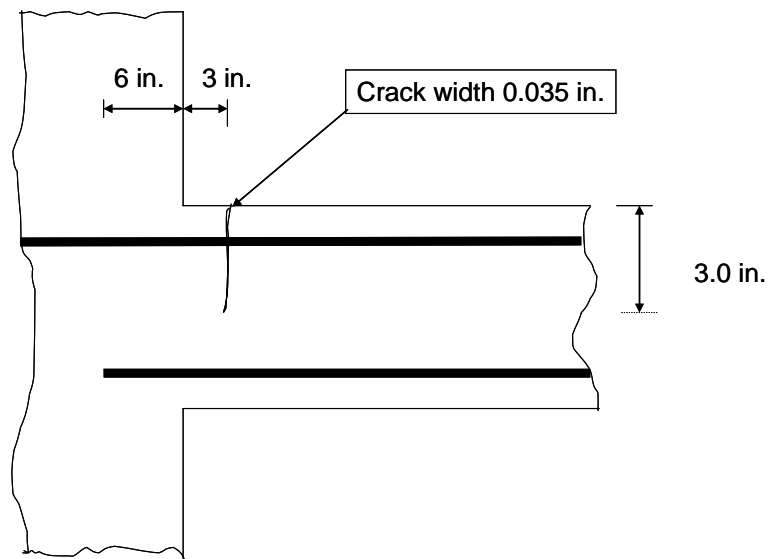
Figure 6.9 Specimen L0.5 at 0.25% Lateral Drift (North Axis)

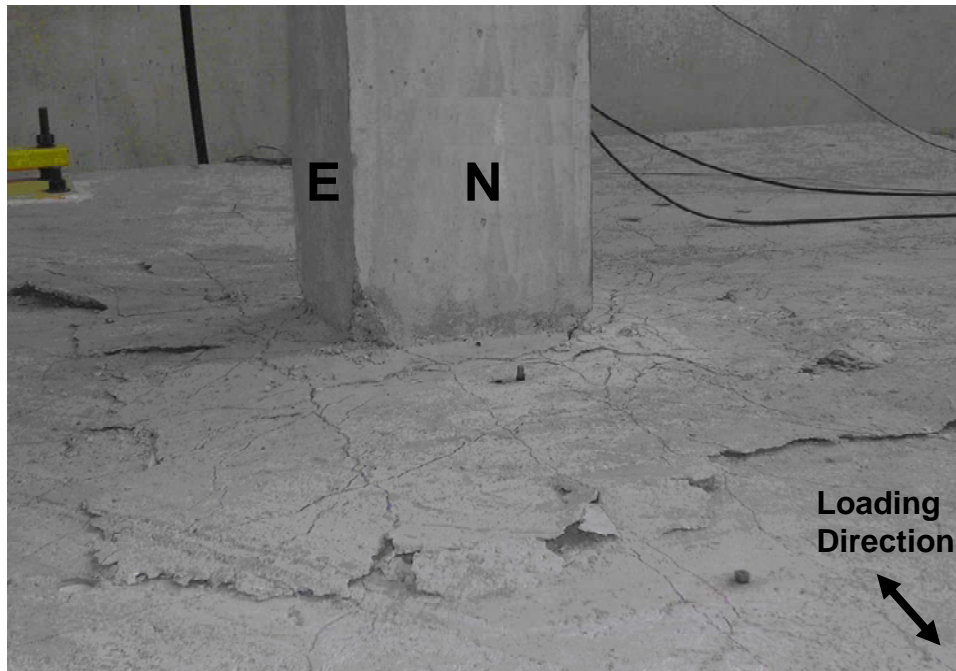
Finally, the specimen failed in shear at 2% drift and the regions of top and bottom delamination spalled (Figure 6.14). The failure mechanism described was observed on the North and South sides of the column where flexural action predominated because the loading was in this direction (North-South). On the East and West sides, the failure surface formed closer to the column and the cracking indicated torsional actions in the slab on those faces of the column. The failed specimen is shown in Figure 6.15.

Figure 6.15 Failure of Specimen L0.5

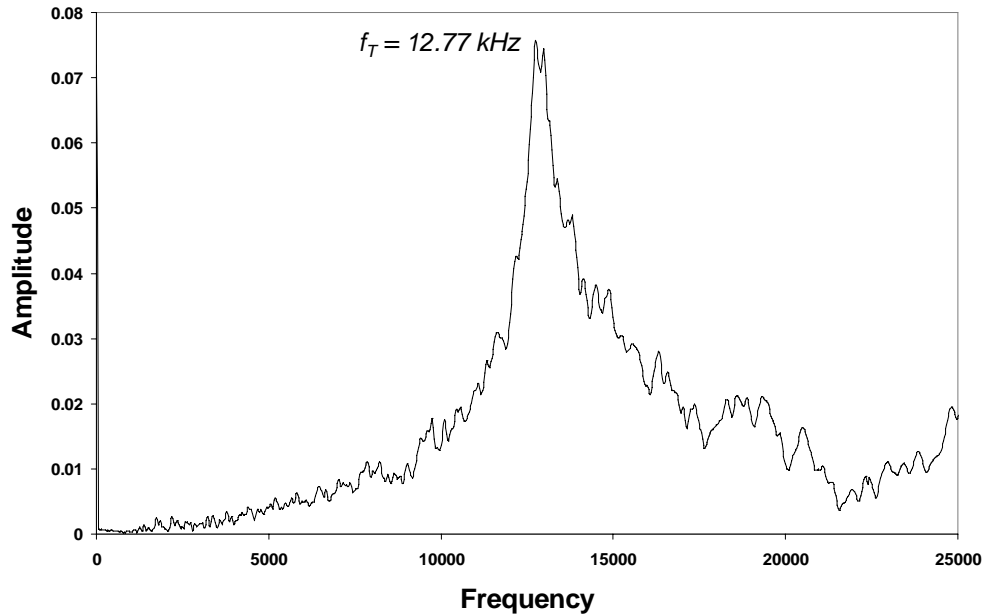
record showing a resonant response was obtained and is presented in Figure 6.16, where the thickness frequency was found to be $f_T = 12.77$ kHz.

Figure 6.16 *Detection of Thickness Frequency in Specimen LR₅₇G0.5*
