**NON-DESTRUCTIVE EVALUATION OF GRAVITY LOAD
CARRYING CAPACITY AND LATERAL LOAD DAMAGE
OF REINFORCED CONCRETE SLAB-COLUMN
CONNECTIONS**

Dissertation

The University of Texas at Austin

May 2006

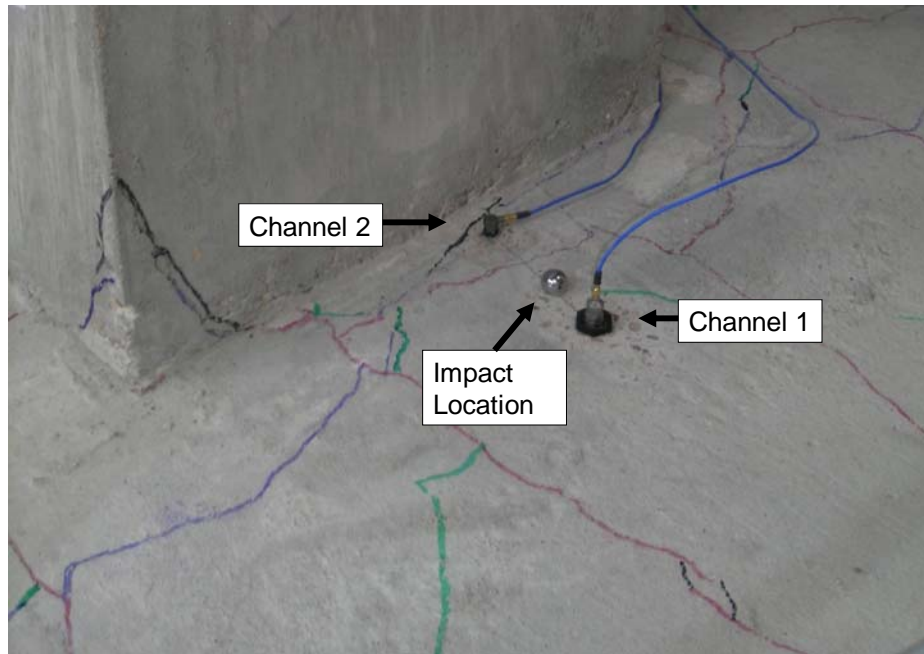
Figure 6.17 Layout of accelerometers used to measure depth of critical crack in Specimen LR_{ST}G0.5 (South Axis)

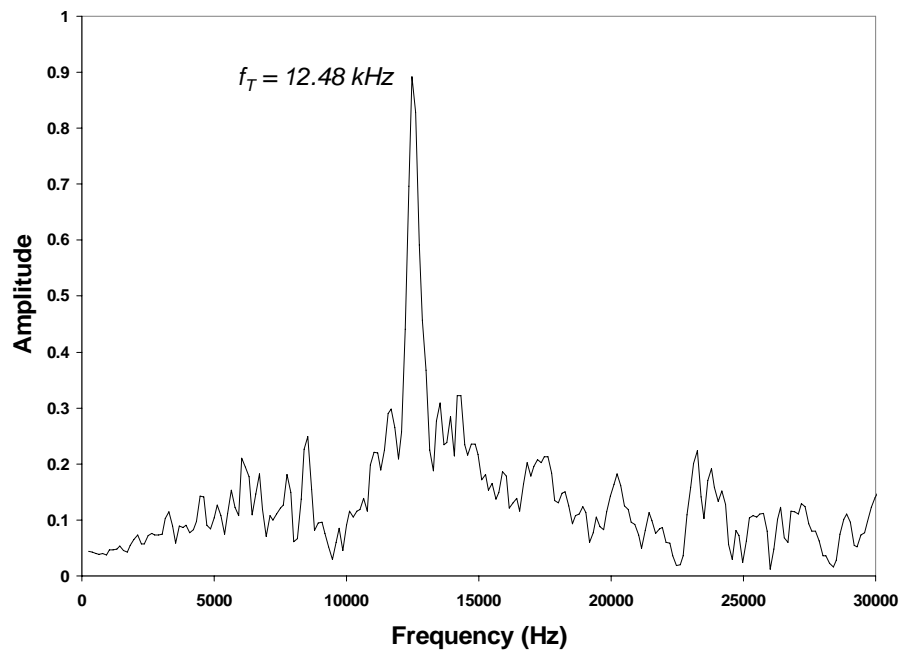
Figure 6.18 *Detection of Thickness Frequency in Specimen LG1.0*

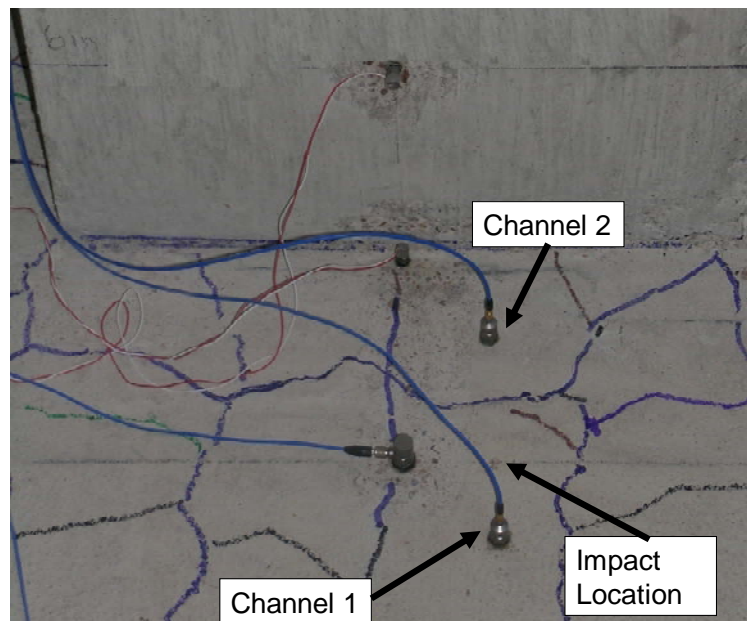
Figure 6.19 *Layout of accelerometers used to measure depth of critical crack in Specimen LG1.0 (North Axis)*

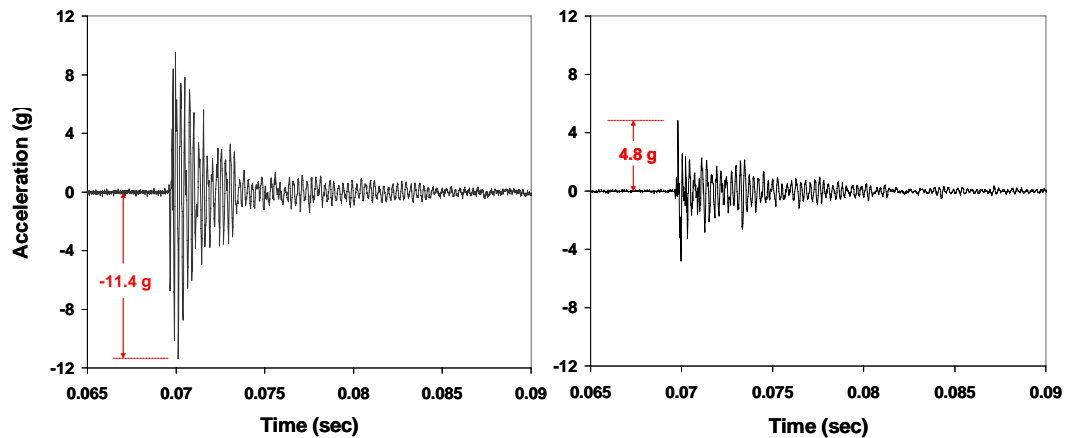
Figure 7.1 Attenuation of acceleration amplitudes in concrete

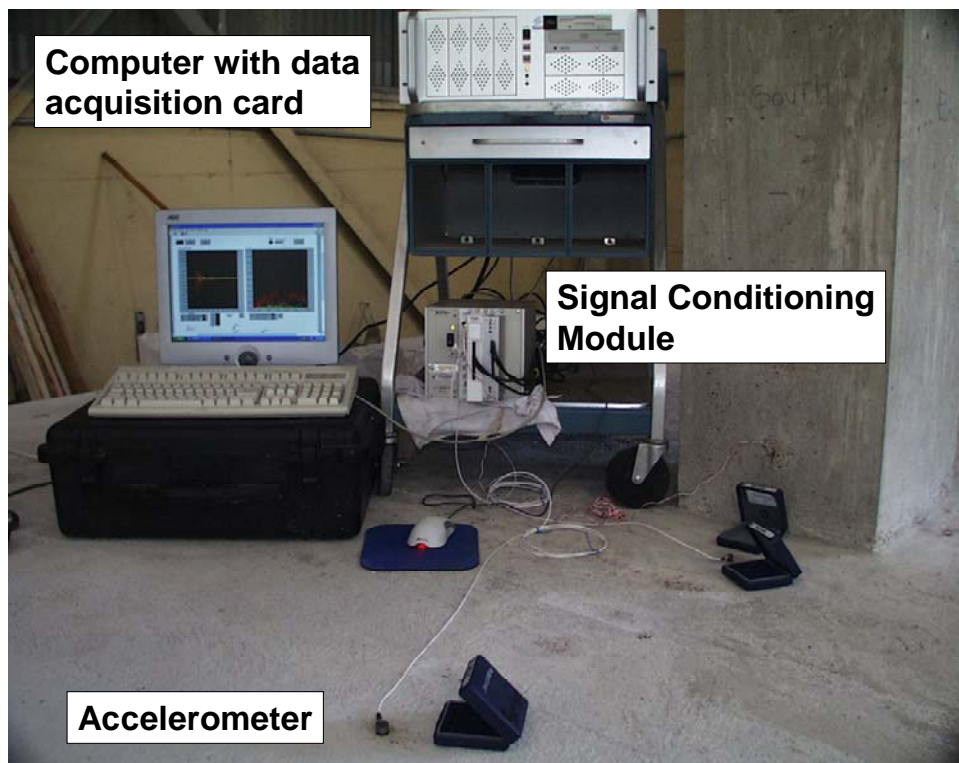
Figure 7.2 Data Acquisition System

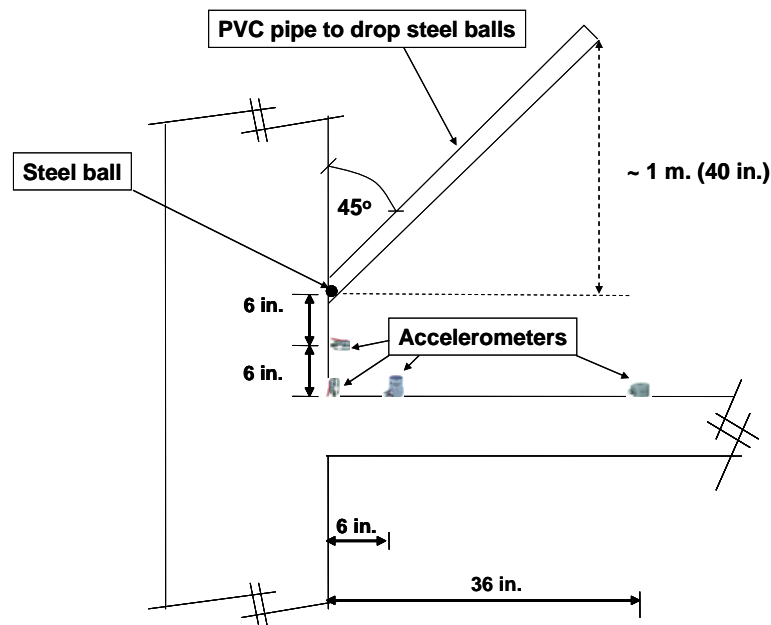
Figure 7.13 *PVC pipe used to drop steel balls on concrete column*

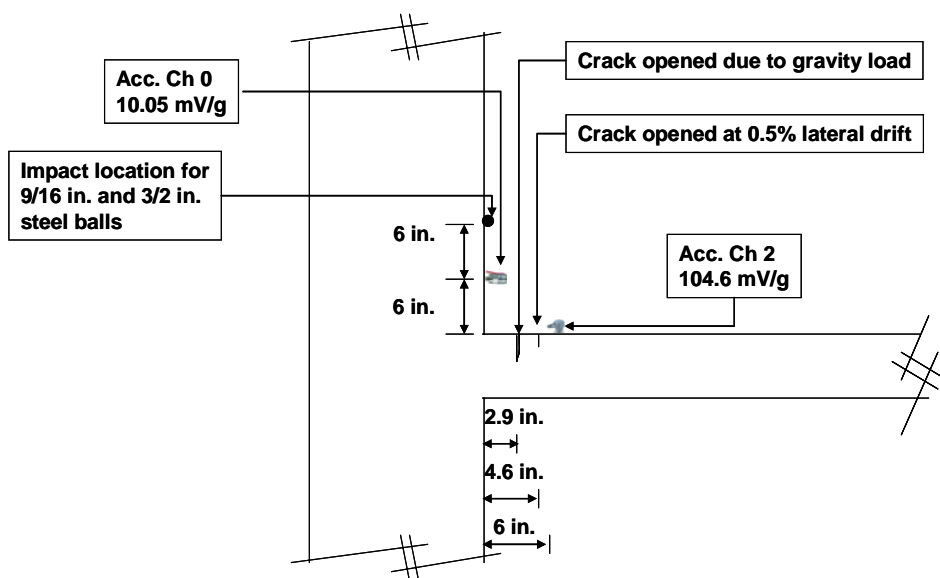
Figure 7.15 SWA tests on Specimen L0.5 along its East Axis

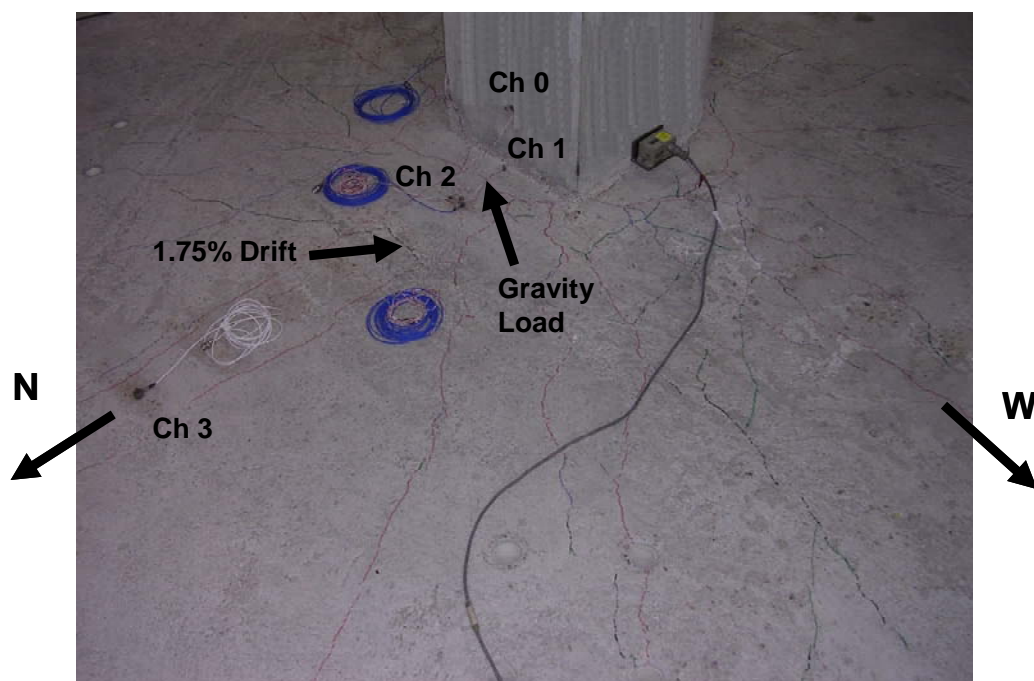
Figure 7.16 Cracking of Specimen L0.5 in the NW quadrant

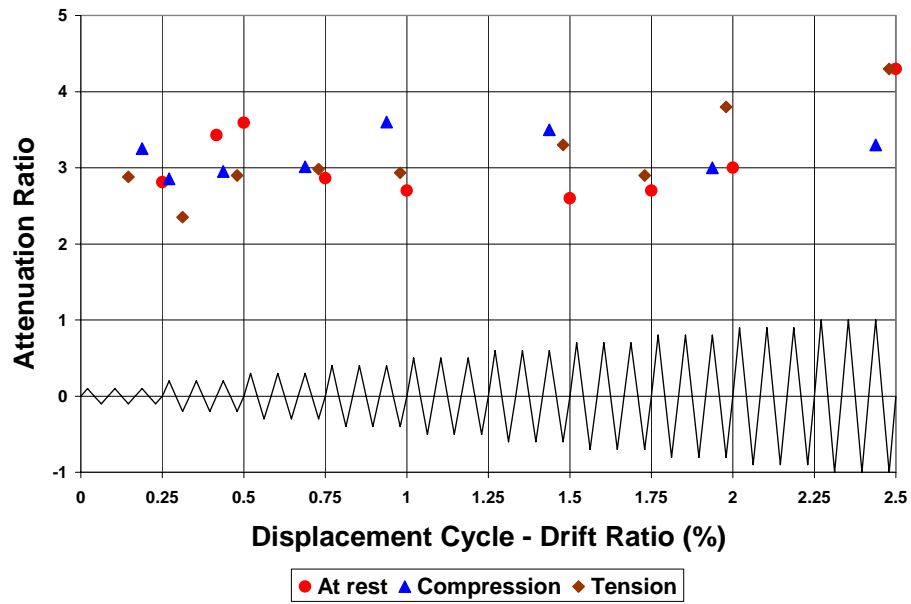
Figure 7.17 Ch0/Ch1 Attenuation Ratios for 9/16 in. ball on North Axis

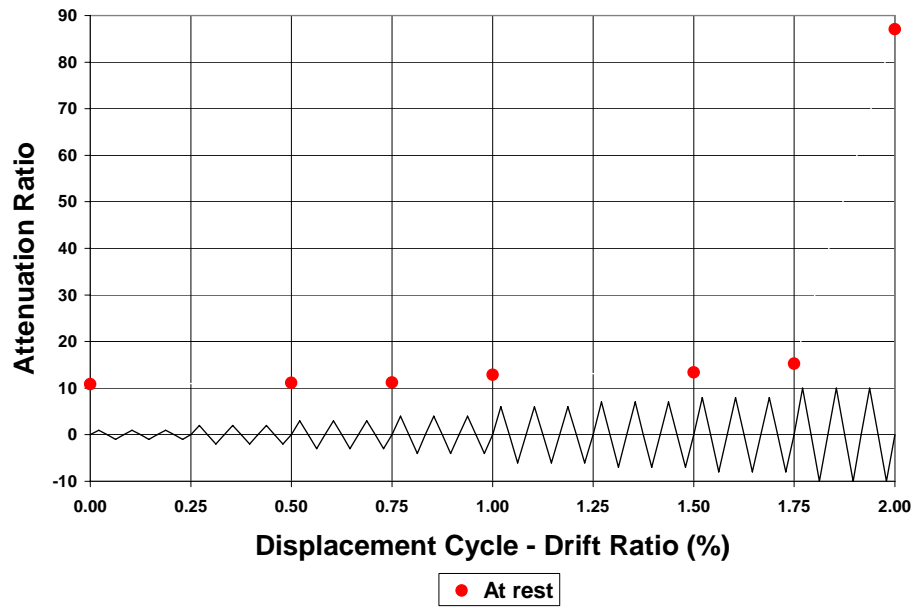
Figure 7.29 Ch0/Ch2 Attenuation Ratios for 9/16 in. ball on East Axis

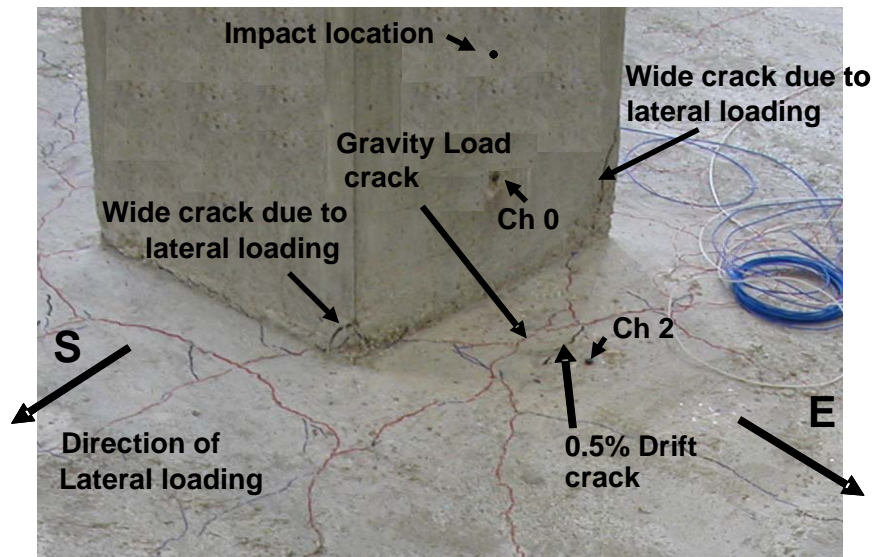
Figure 7.31 Cracking on East Axis of specimen L0.5 at 0.5% drift

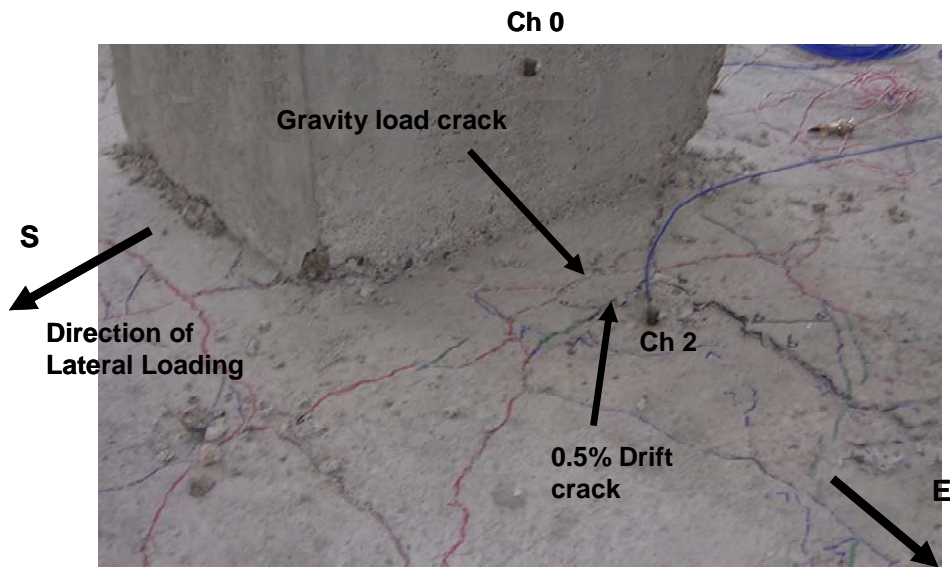
Figure 7.32 Cracking on East Axis of specimen L0.5 at 2% drift

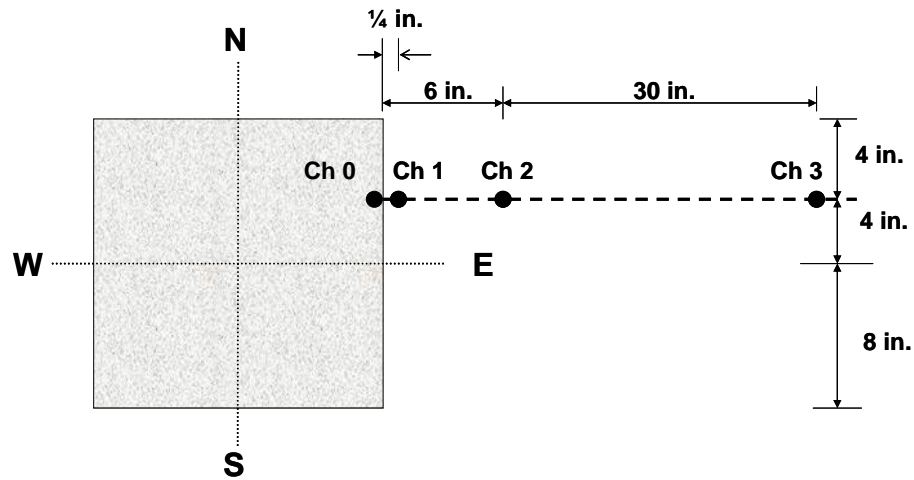
Figure 7.33 Alternative location of sensors for the East axis, in a plane eccentric to column centerline

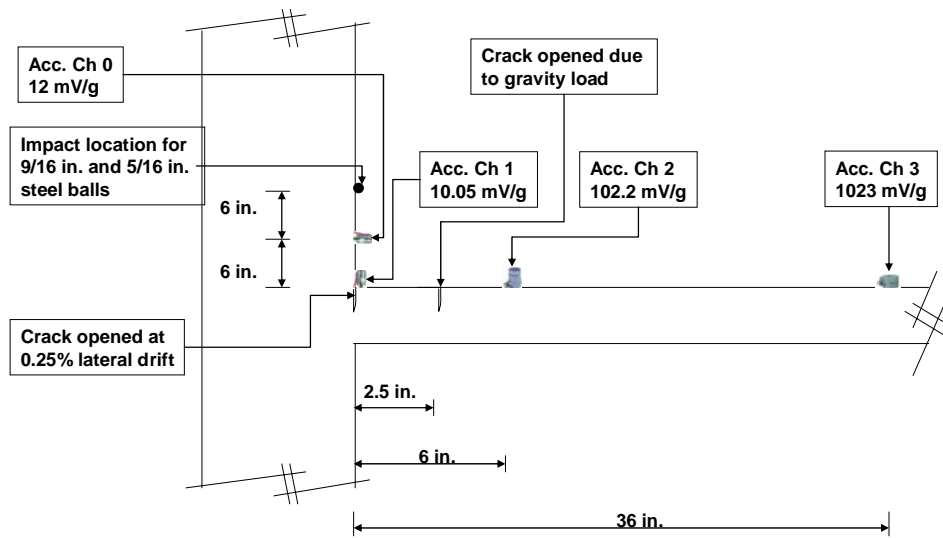
Figure 7.35 SWA tests on specimen LG0.5 along its North axis

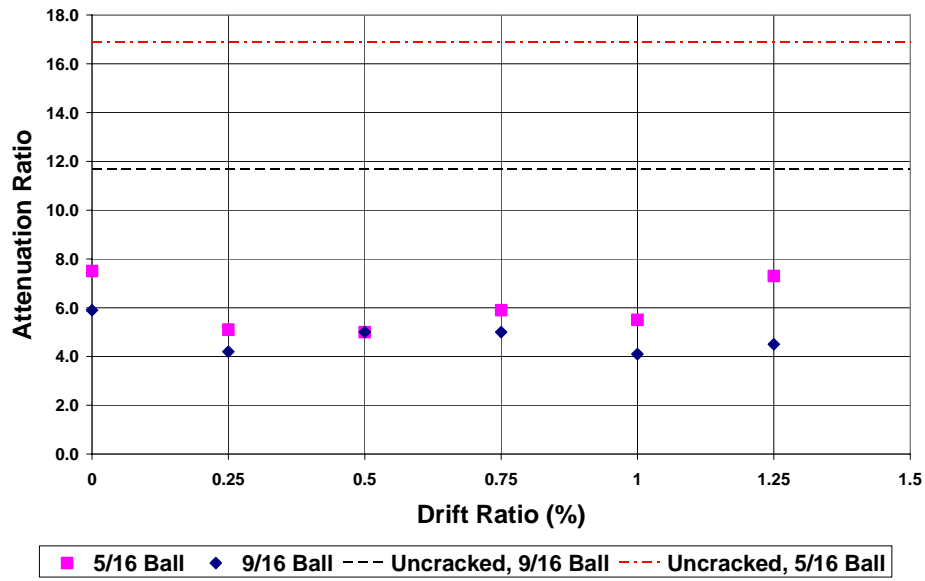
Figure 7.43 Ch0/Ch1 Attenuation Ratios, 9/16 and 5/16 in. balls on East Axis

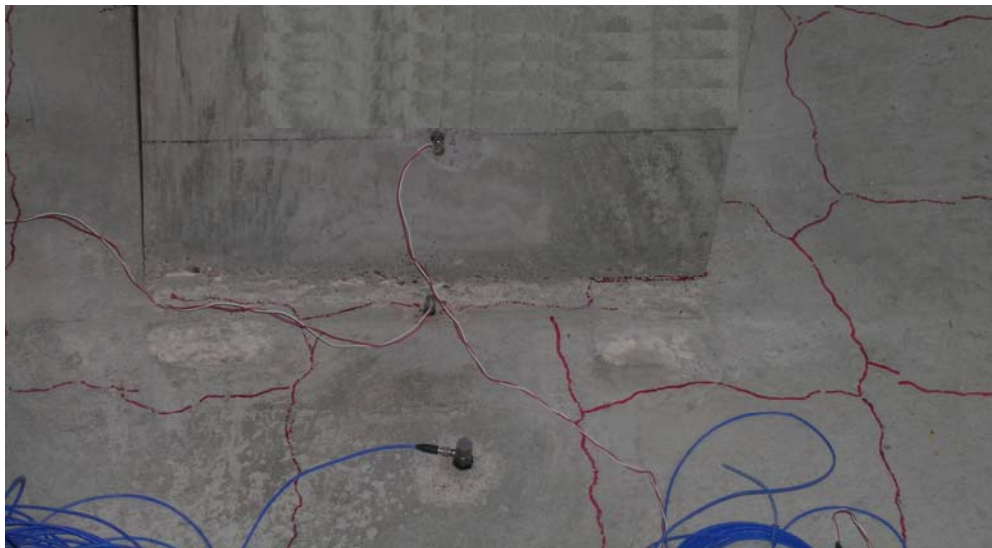
Figure 7.51 Crack at slab-column interface in specimen $LR_{ST}G0.5$

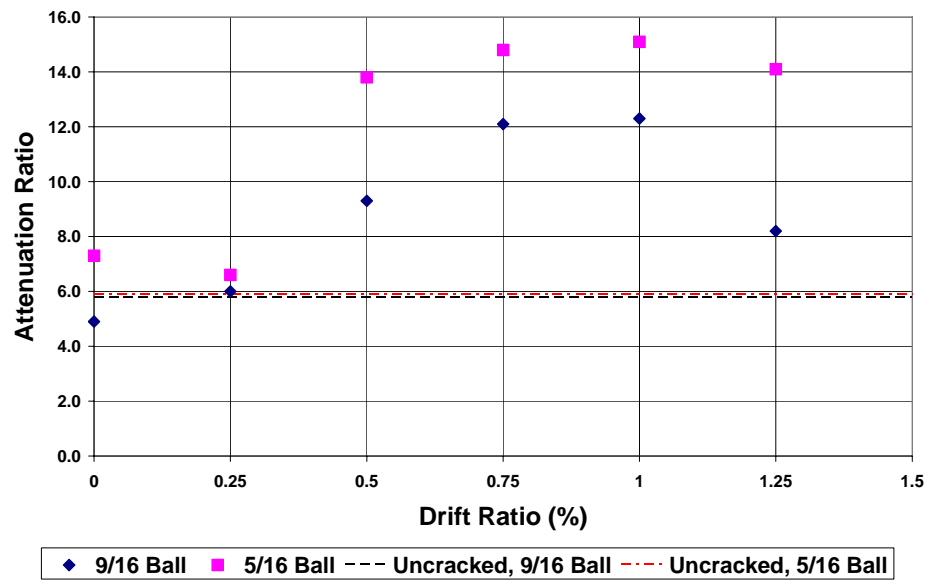
Figure 7.52 Ch0/Ch1 Attenuation Ratios, 9/16 and 5/16 in. balls (North Axis)

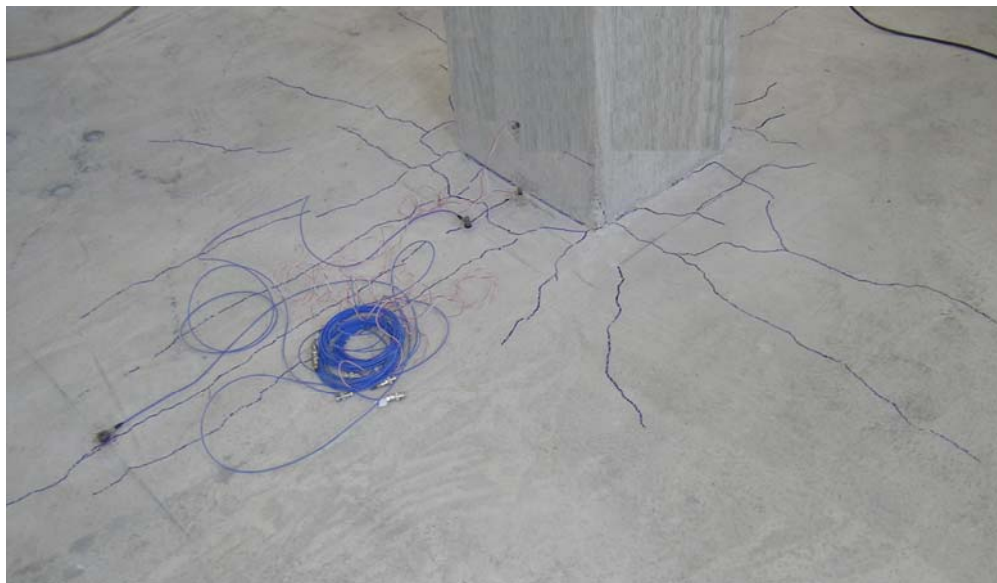
Figure 7.60 Critical crack formed in specimen LG1.0 at 4 in. from column

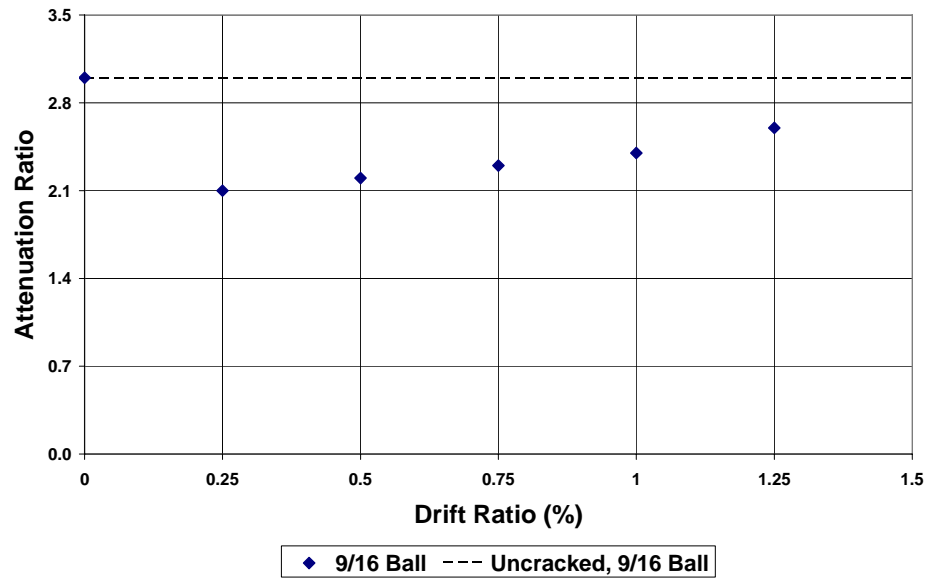
Figure 7.61 Ch0/Ch1 Attenuation Ratios, 9/16 in. ball (North Axis)

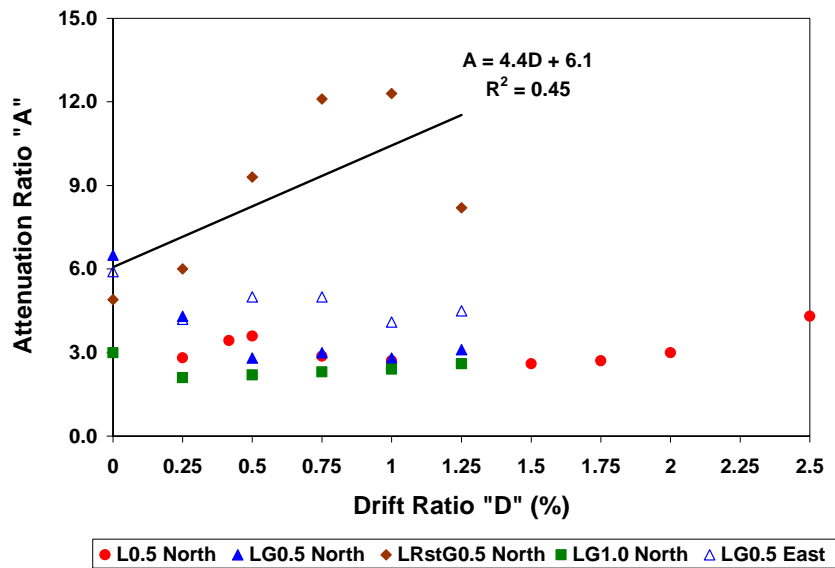
Figure 7.67 Regression lines for Ch0/Ch1 Attenuation Ratios

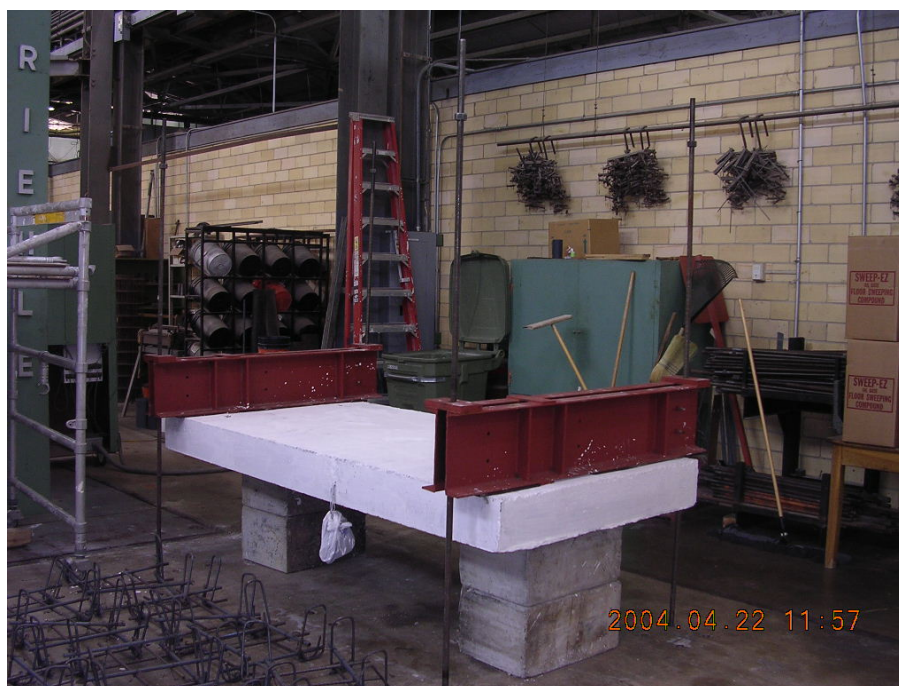
Figure A.1 Reinforced concrete slab for SIR test

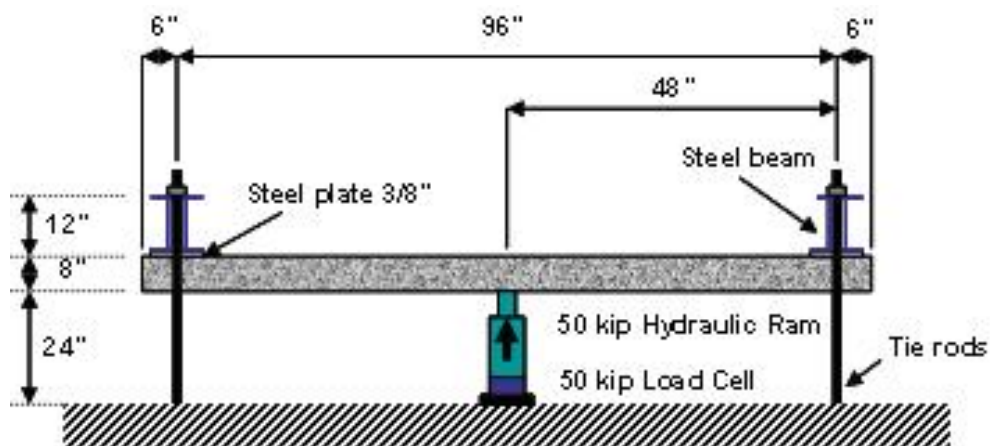
Figure A.5 Simply supported beam loading condition

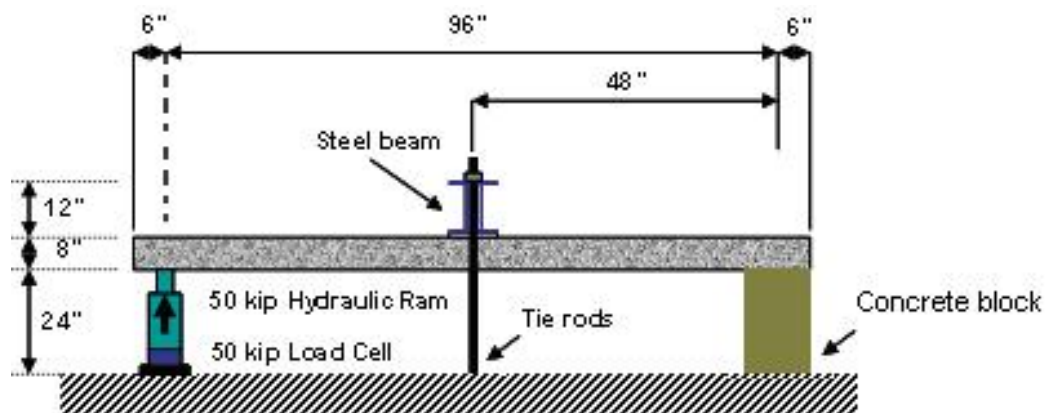
Figure A.6 End loading condition

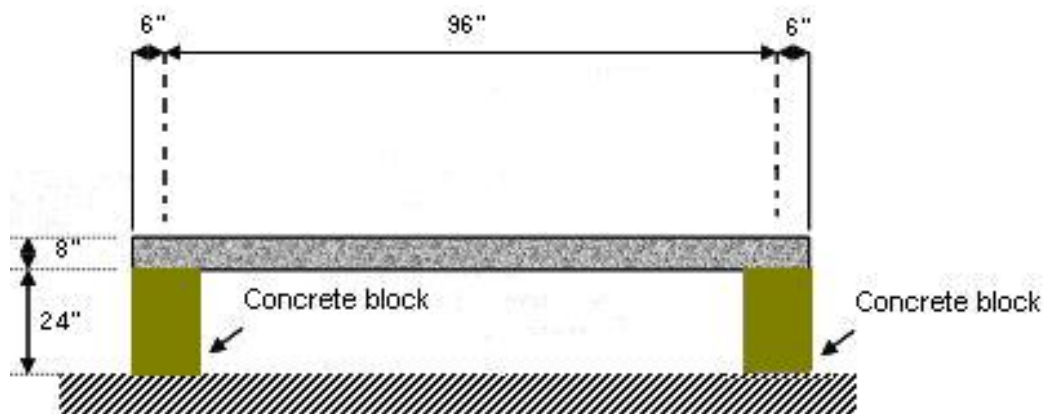
Figure A.7 Support condition for Impulse Response tests conducted at rest

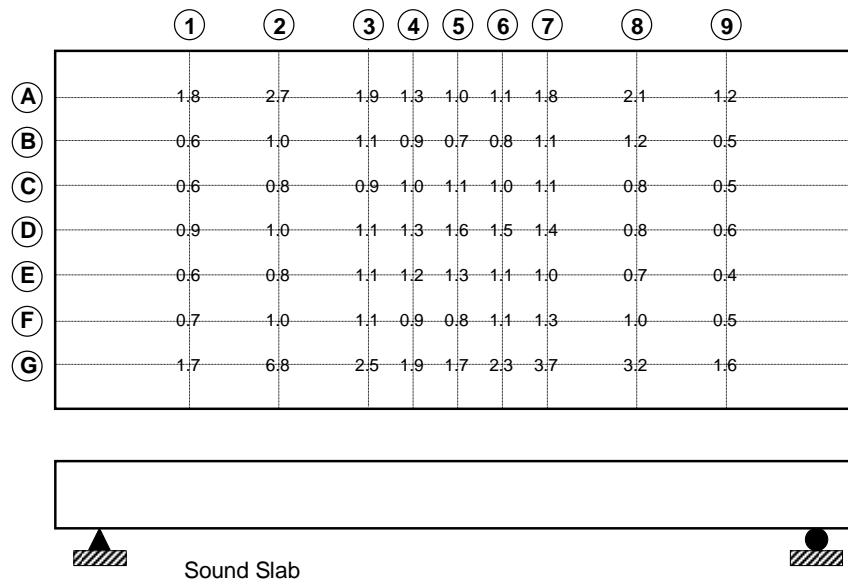
Figure A.10 Average Mobility results for a sound slab at rest, Stage 1

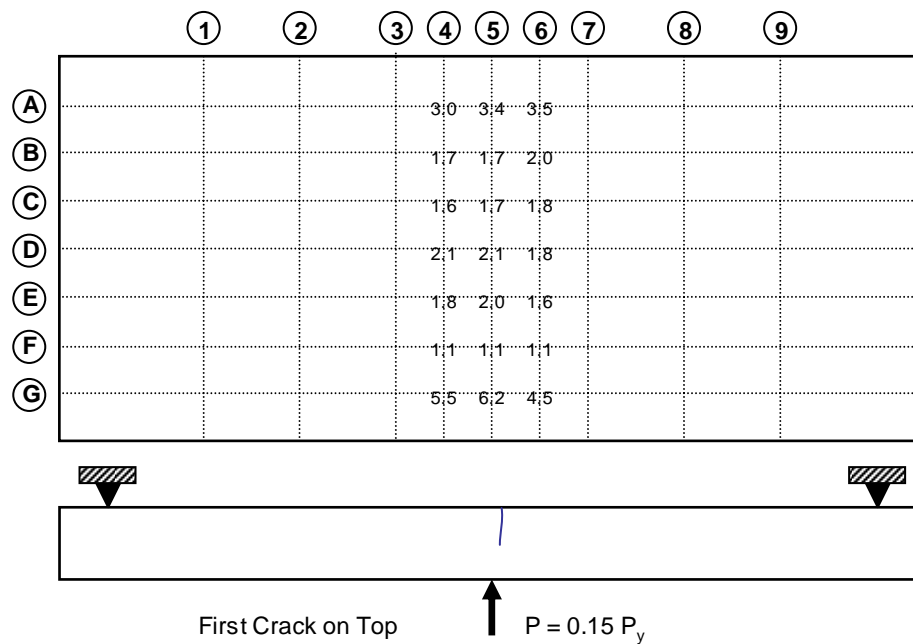
Figure A.11 Average Mobility results for a slab with first crack on top (load $0.15P_y$), Stage 2

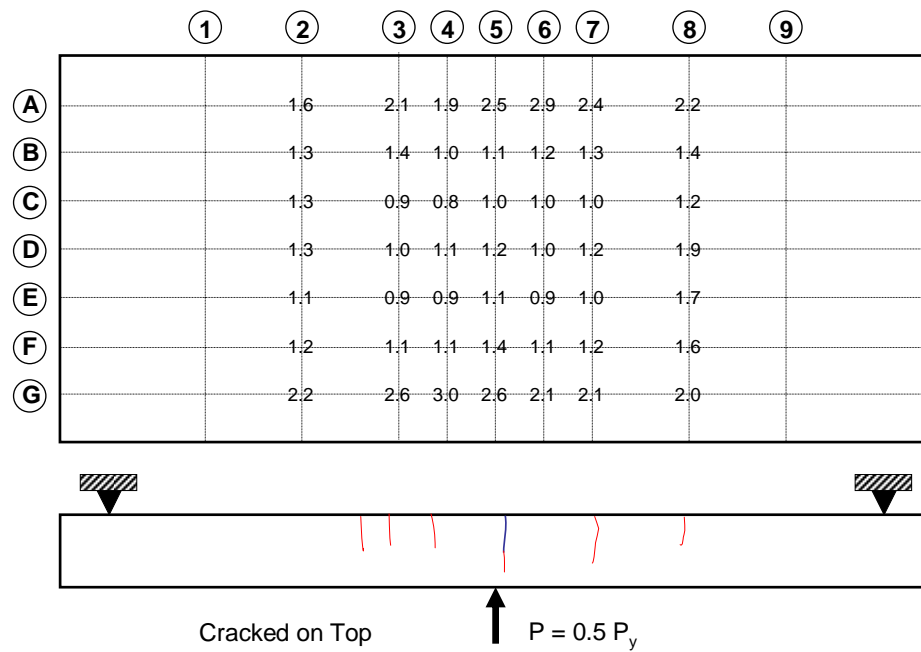
Figure A.12 Average Mobility results for a slab cracked on top (load $0.5P_y$), Stage 3

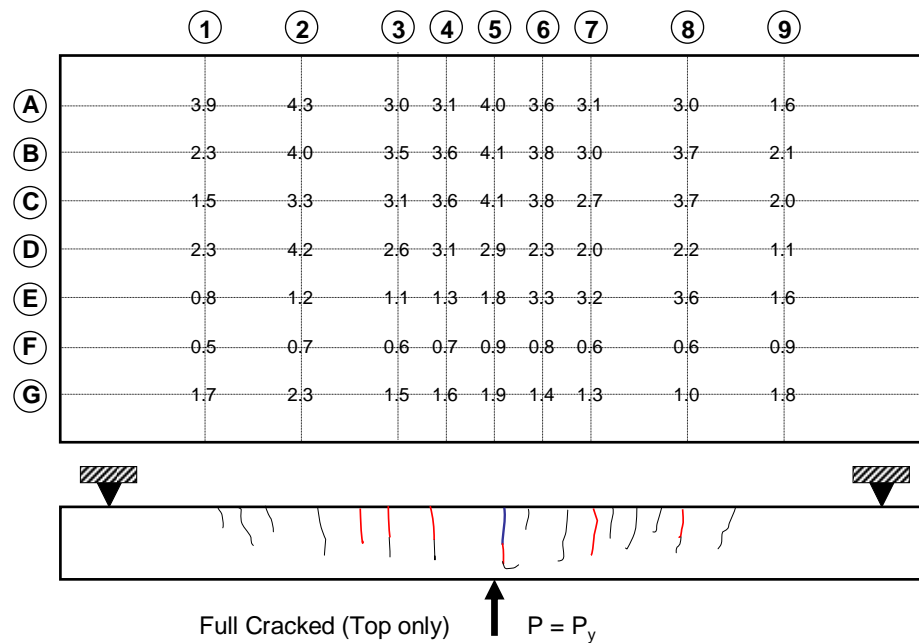
Figure A.13 Average Mobility results for a slab fully cracked on top (load P_y),
Stage 4

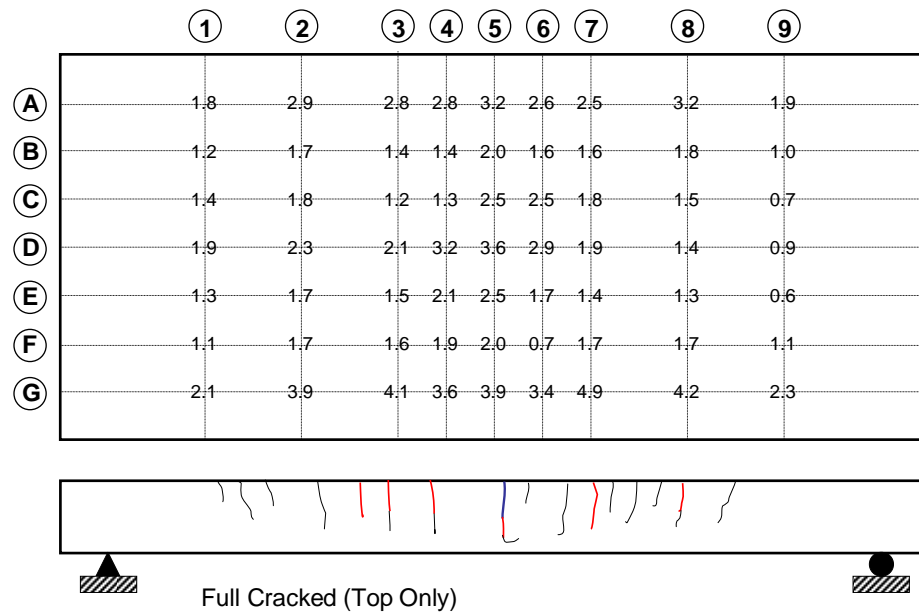
Figure A.14 Average Mobility results for a slab at rest fully cracked on top, Stage 5

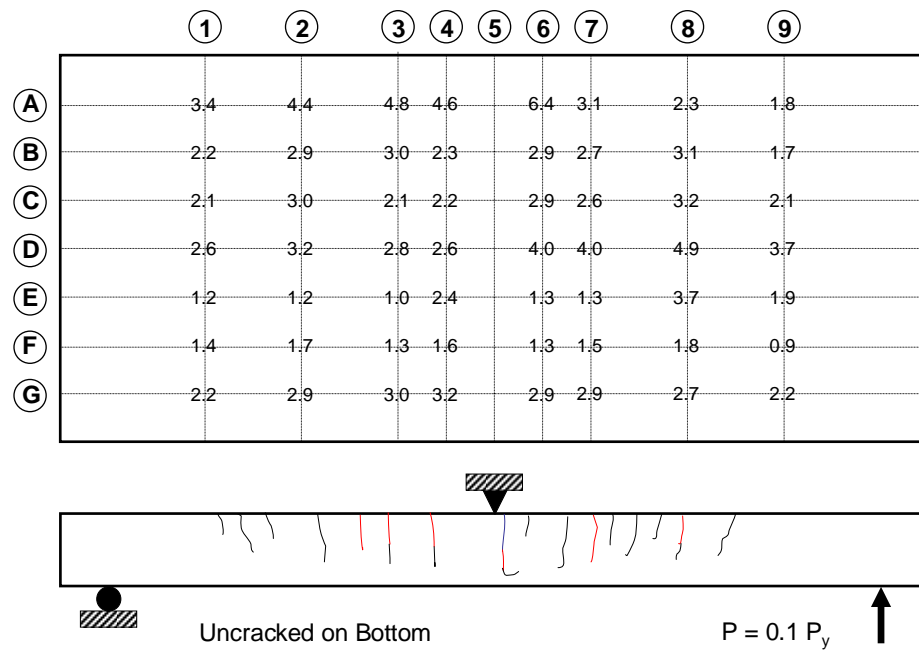
Figure A.15 Average Mobility results for a slab uncracked on bottom and fully cracked on top (load $0.1P_y$), Stage 6

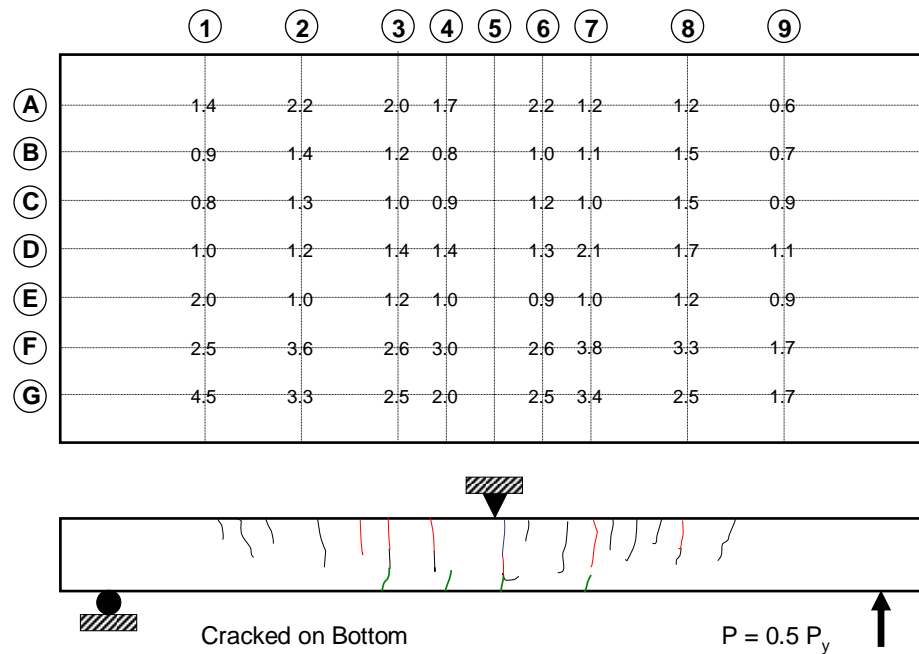
Figure A.16 Average Mobility results for a slab cracked on bottom and fully cracked on top (load $0.5P_y$), Stage 7

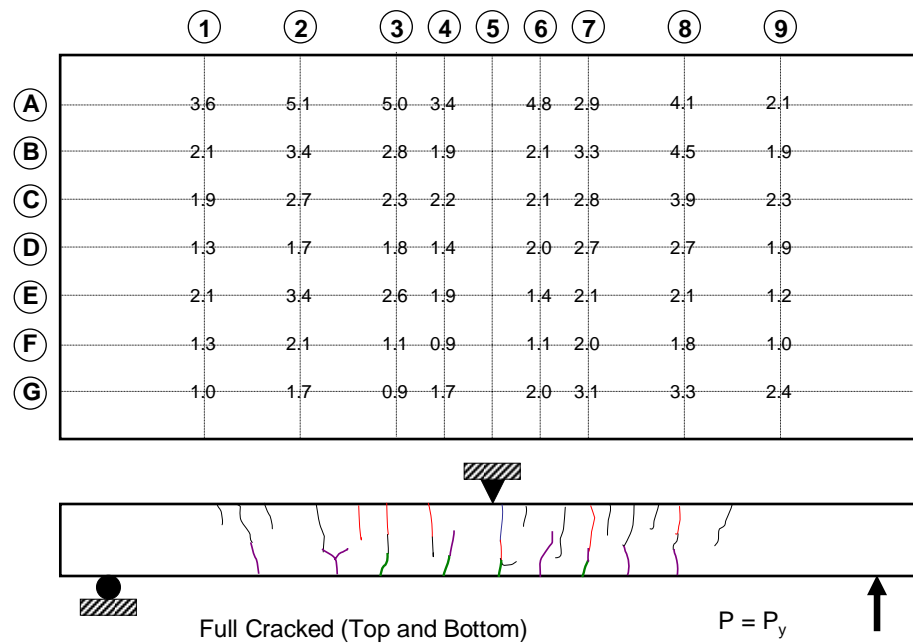
Figure A.17 Average Mobility results for a slab fully cracked on bottom and top (load P_y), Stage 8

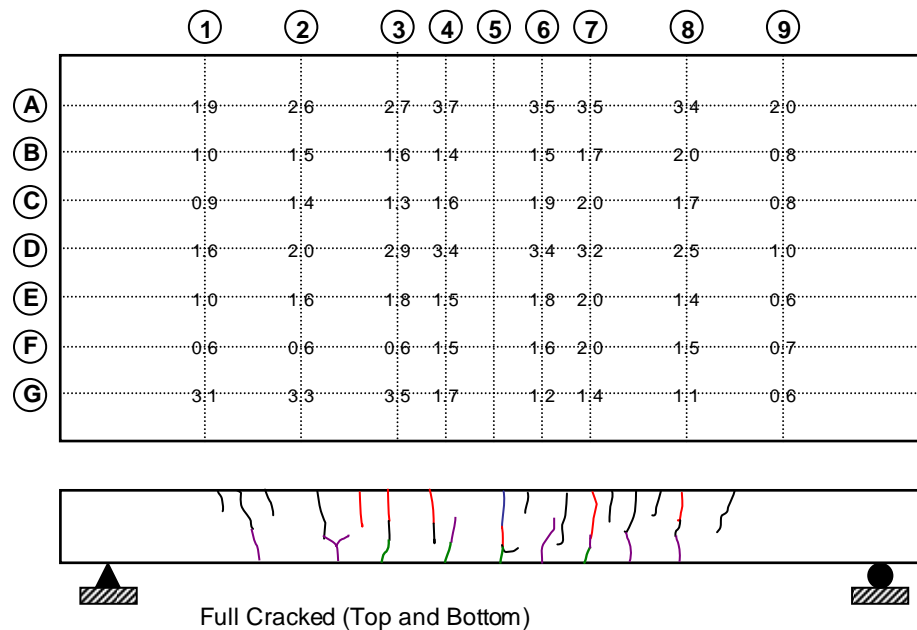
Figure A.18 Average Mobility results for a slab at rest fully cracked on bottom and top, Stage 9
