**Galvanizing Crack Formation at Base Plate to Shaft Welds of High
Mast Illumination Poles**

Thesis

The University of Texas at Austin

August, 2011

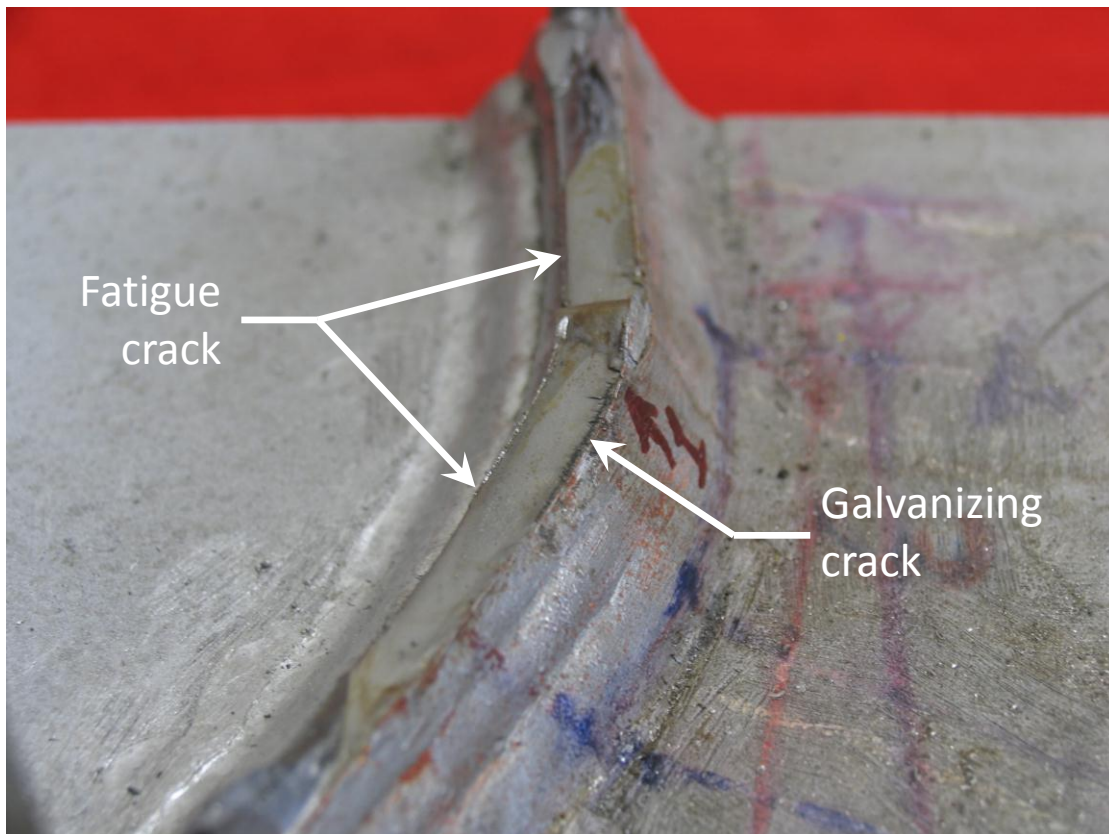
Figure 1-2: Crack at bend from high mast illumination tower after fatigue testing

Seeking answers to these questions led researchers to understand that cracks can form in HMIPs by two separate mechanisms. After focusing research efforts on the fatigue performance of HMIPs, researchers at the University of Texas were aware of the potential for crack growth due to fatigue loads. But studying the fatigue performance of HMIPs also led researchers to become aware of cracks that formed during galvanizing, prior to loading in the field, as shown in Figure 1-2.

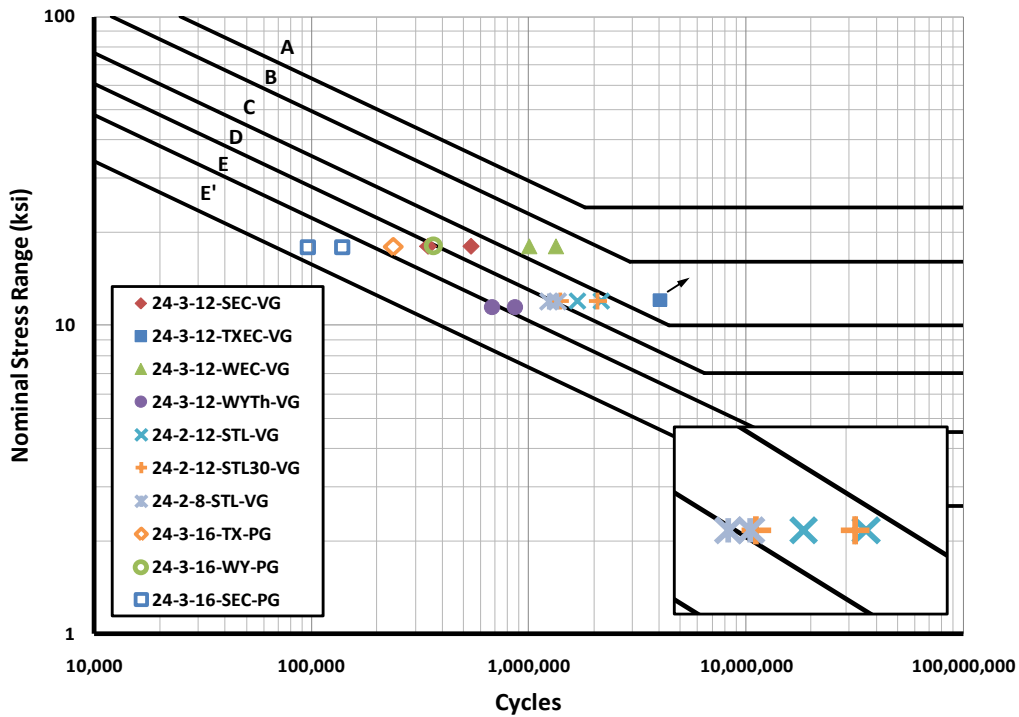
Figure 2-5: S-N plot of fatigue test results for Phase II of Pooled Fund Study (Stam, 2009)

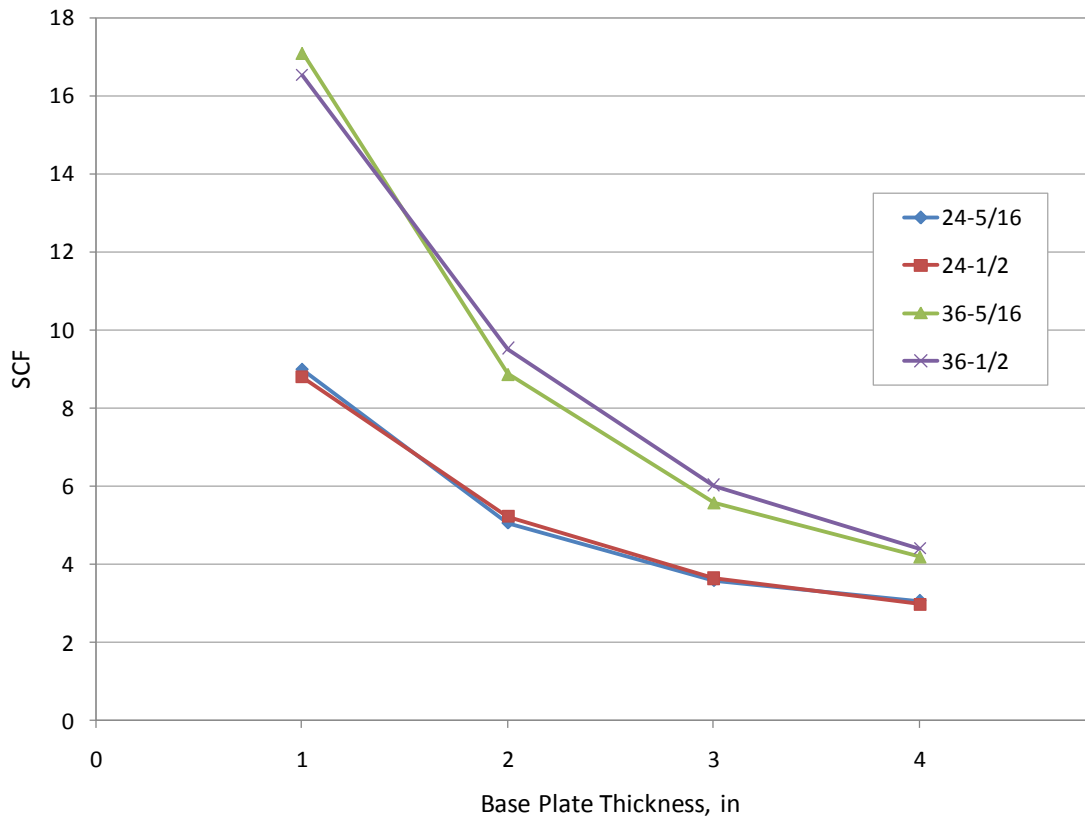
Figure 2-6: SCFs for Socket Details in Wall Thickness and Shaft Diameter Parametric Study (Stam, 2009)

for improving the section modulus than increasing the shaft thickness. At the end of the first two phases of the Pooled Fund Study, the primary conclusion converged on the idea that fatigue life is a function of the SCF, and this SCF can be reduced most effectively by increasing the baseplate thickness, and where necessary, including an external collar.

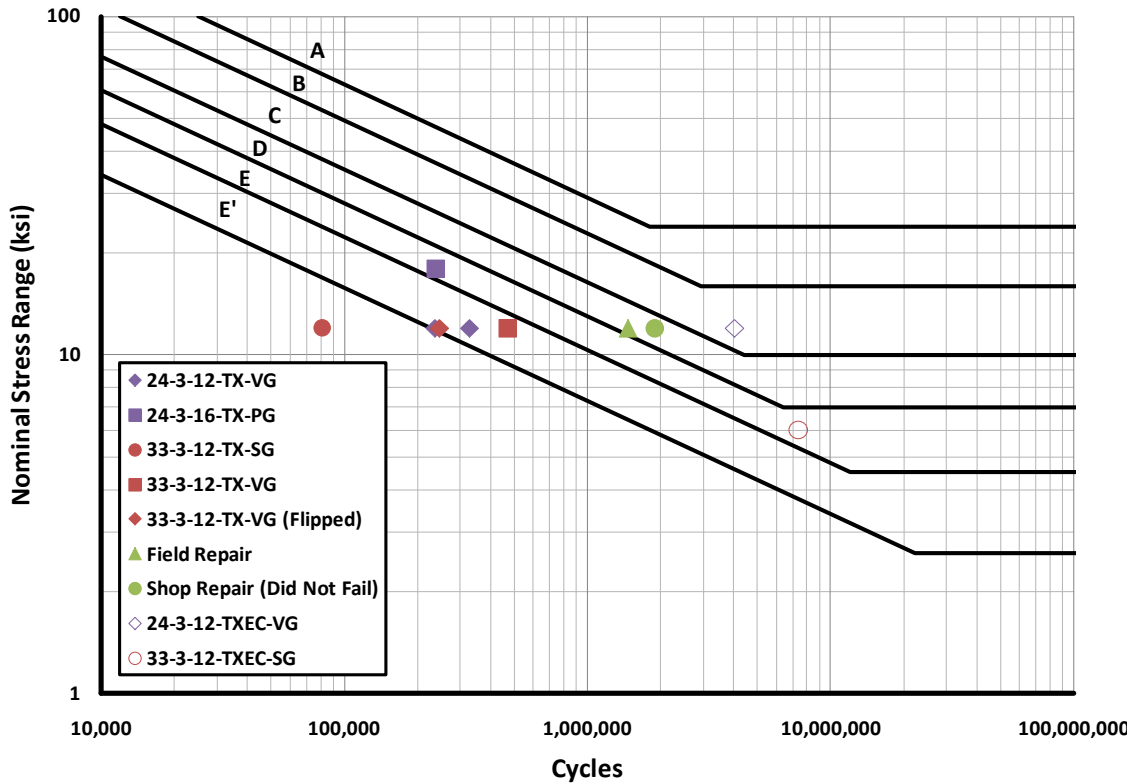
Figure 2-7: Fatigue results from 32.5" test specimens relative to 24" test specimens (Pool, 2010)

Stam (2009) demonstrated that increasing the shaft diameter from 24" to 36" decreases the hotspot stresses at the weld toe and, by deduction, the SCF as well. As Figure 2-7 indicates, the opposite held true when subjected to full scale testing.

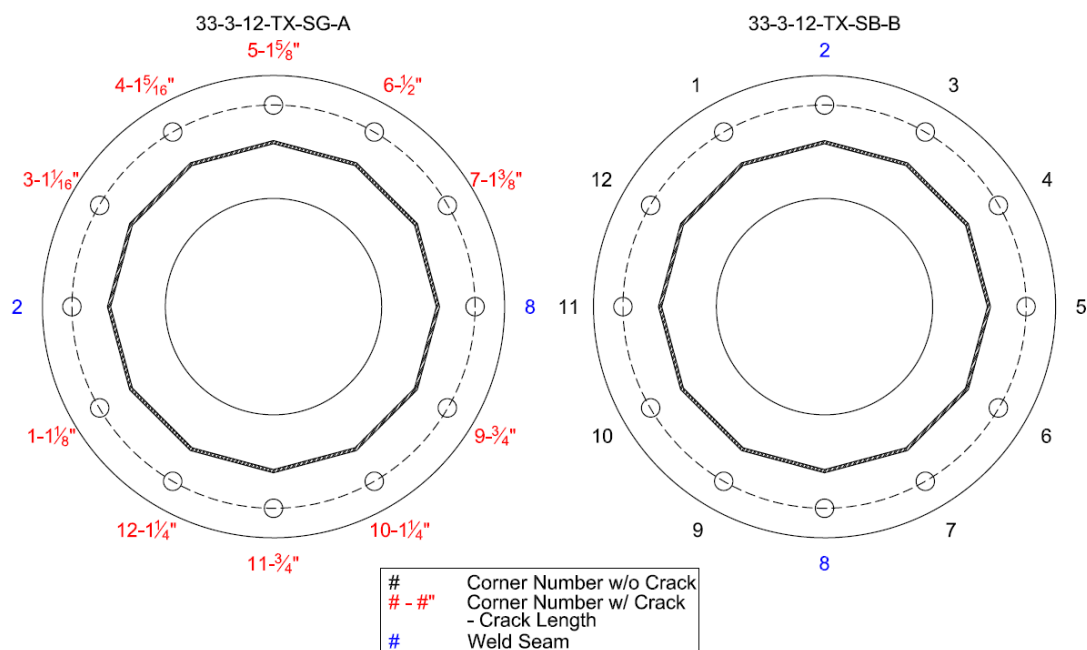
Figure 2-8: Initial Crack Locations and Lengths in Specimens 33-3-12-TX-SG-A and 33-3-12-TX-SB-B (Pool, 2010)

In the next step of the Texas study, Pool was preparing to test a black HMIP specimen back-to-back against a galvanized specimen of the exact design, but a significant difference was noticed prior to testing. The researchers asked Texas Department of Transportation (TxDOT) to use ultra-sonic testing (UT) techniques to inspect the test specimens prior to the fatigue tests. After checking all the bends of each high mast, designated 33-3-12-TX-SG-A and 33-3-12-TX-SB-B, TxDOT determined that the black specimen had no initial defects, whereas the galvanized specimen was riddled with small crack indications at the toe of the full penetration baseplate-to-shaft connection at every location of a cold bend. A schematic drawing of the crack locations on the two pole cross sections is shown in Figure 2-8. The UT evaluations showed that some of the cracks penetrated as much as 1/8" into the 5/16" thick shaft and extended between 1/2" to 1 5/8" on either side of the bend. The fatigue performance of 33-3-12-TX-SG-A suffered accordingly, as demonstrated in Figure 2-7, whereas 33-3-12-TX-SB-B showed no signs of deteriorating fatigue performance at the same number of cycles and stress range (Pool, 2010).

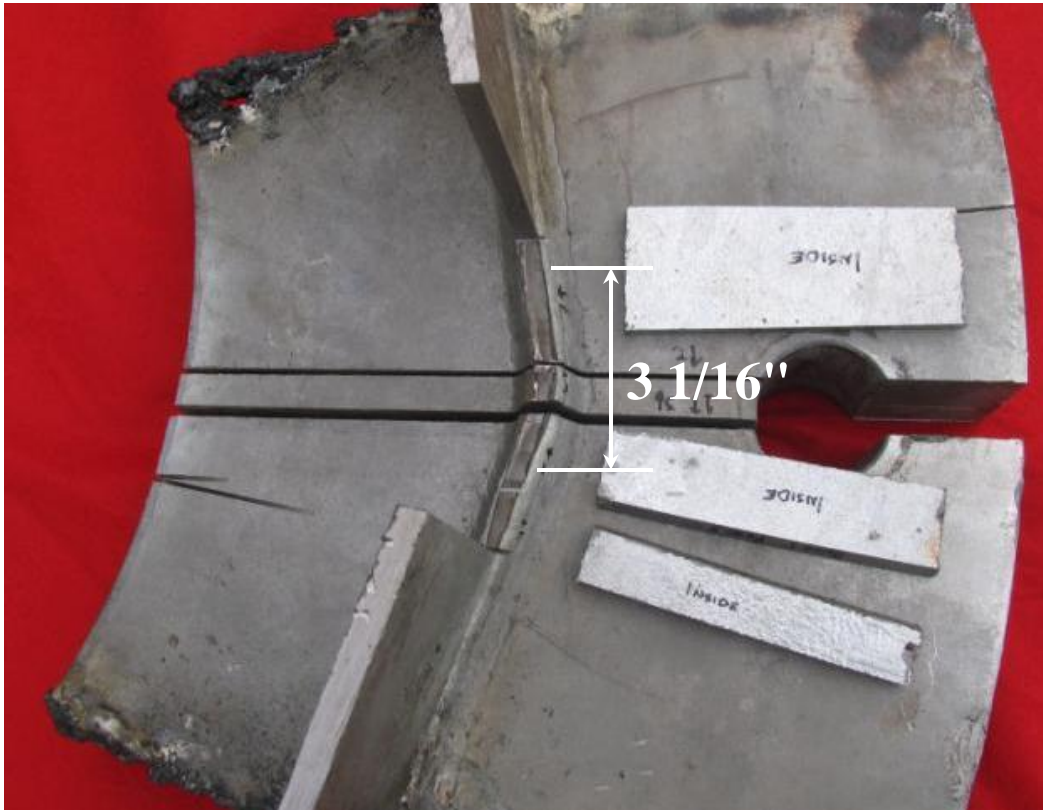
Figure 2-9: View of Bend 5 after sectioning. Length of observed initial crack is labeled (Pool, 2010).

After fatiguing specimen 33-3-12-TX-SG-A to the point of failure, bends containing initial cracks were opened to examine the crack surface for potential clues pertaining to the crack indications noticed by TxDOT and the poor fatigue performance. Photographs of bend 5 are depicted in Figure 2-9 and Figure 2-10. Pool notes that several details of the crack regions provide an indication of the nature of the cracking. The roughened black surface visible in Figure 2-8 is attributed to the initial cracking phenomenon, whereas the smooth, rounded surface is a sign of growth of the crack during the fatigue testing. Also worthy of noting, the roughened black surfaces were present at all opened bend locations where initial ultra-sonic testing indicated the presence of cracks prior to the fatigue tests. The different crack surfaces verified that a significant failure mechanism was introduced prior to fatigue loading and contributed to the earlier-than-expected fatigue failure of the test specimen and connection detail (Pool, 2010).

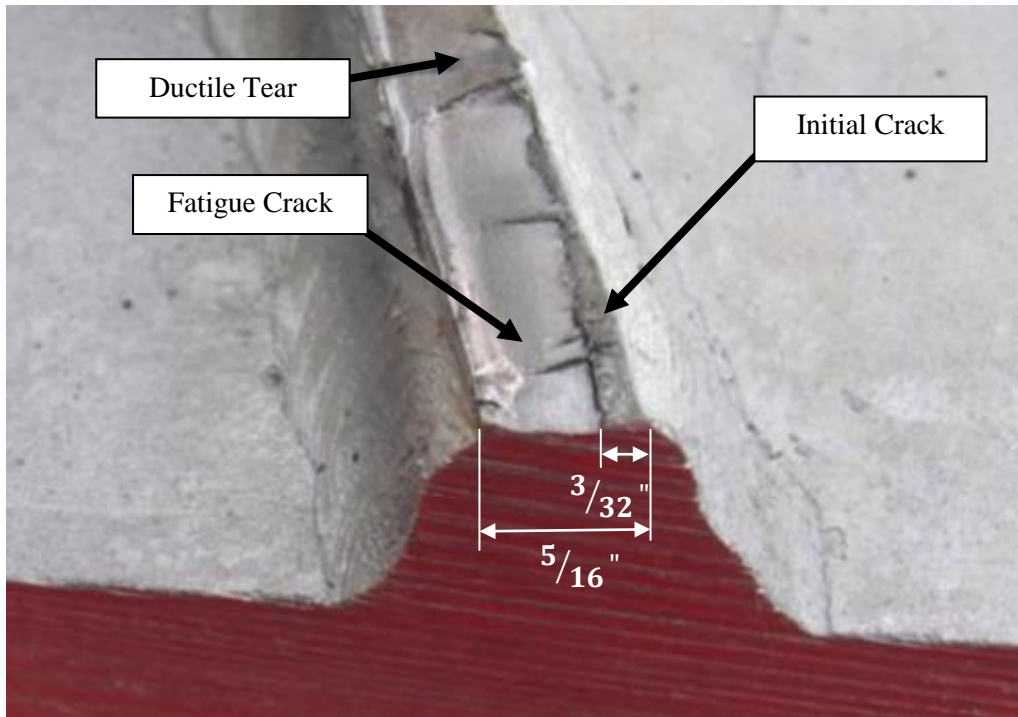
Figure 2-10: Depth of initial crack at weld toe of bend 5 from 33-3-12-TX-SG-A (Pool, 2010)

Though the initial cracks varied in both length and penetration depth into the wall thickness, their presence and subsequent effect on fatigue life were alarming: this was a phenomenon not observed on the 24" diameter specimens tested by Stam (2009). Because TxDOT has several hundred of the 32.625" diameter poles in the field, researchers realized the potential severity of the problem with respect to TxDOT's HMIP inventory. Pool, therefore, spent the remainder of his research investigating the location of initial cracks in 32.625" diameter poles with various shaft to baseplate connection details, how to identify the initial cracks, and the corresponding impact on fatigue life.

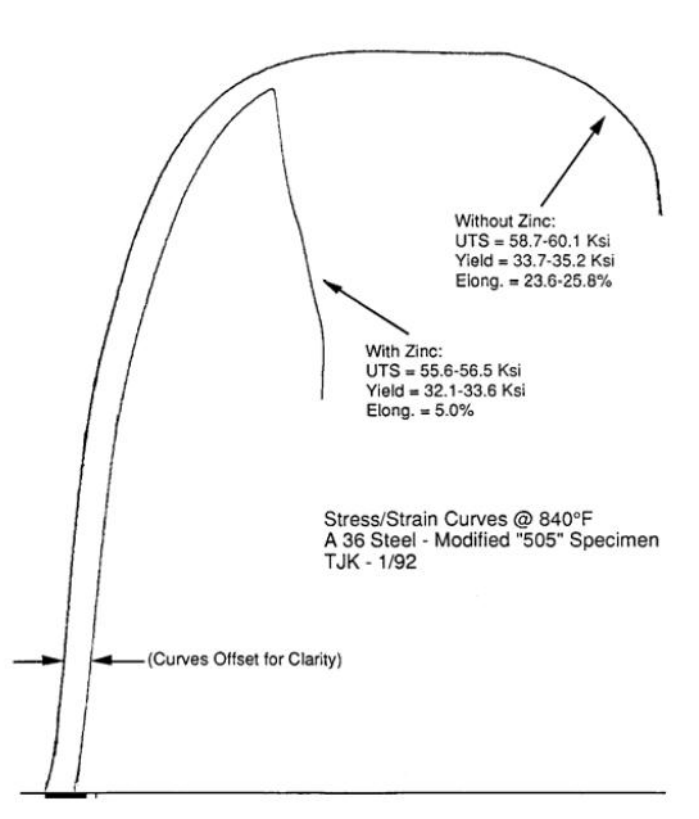
Figure 2-11: Stress strain curve with and without zinc at 840°F (Kinstler, 2006)

Other research completed by Kinstler indicates that steel becomes less ductile while in contact with liquid zinc. Figure 2-11 depicts a tensile test completed in a zinc environment, then in an air environment. Though the curves seem to match up fairly well, the fracture strain of the steel immersed in zinc is significantly lower. Kinstler points out that despite this mechanical phenomenon, which must have also occurred 100 years ago, galvanizing cracks were not reported. However, it is possible that cracks at the toes of base plate to pole shaft welds were not noticed due to their small size and difficulty to identify without use of specific ultra-sonic testing techniques. Nevertheless, it stands to reason that if the problem did not occur when the standard practice was to galvanize with Prime Western Zinc, then the more extreme examples of galvanizing cracks more recently observed must be a result of a change in bath or steel chemistries.

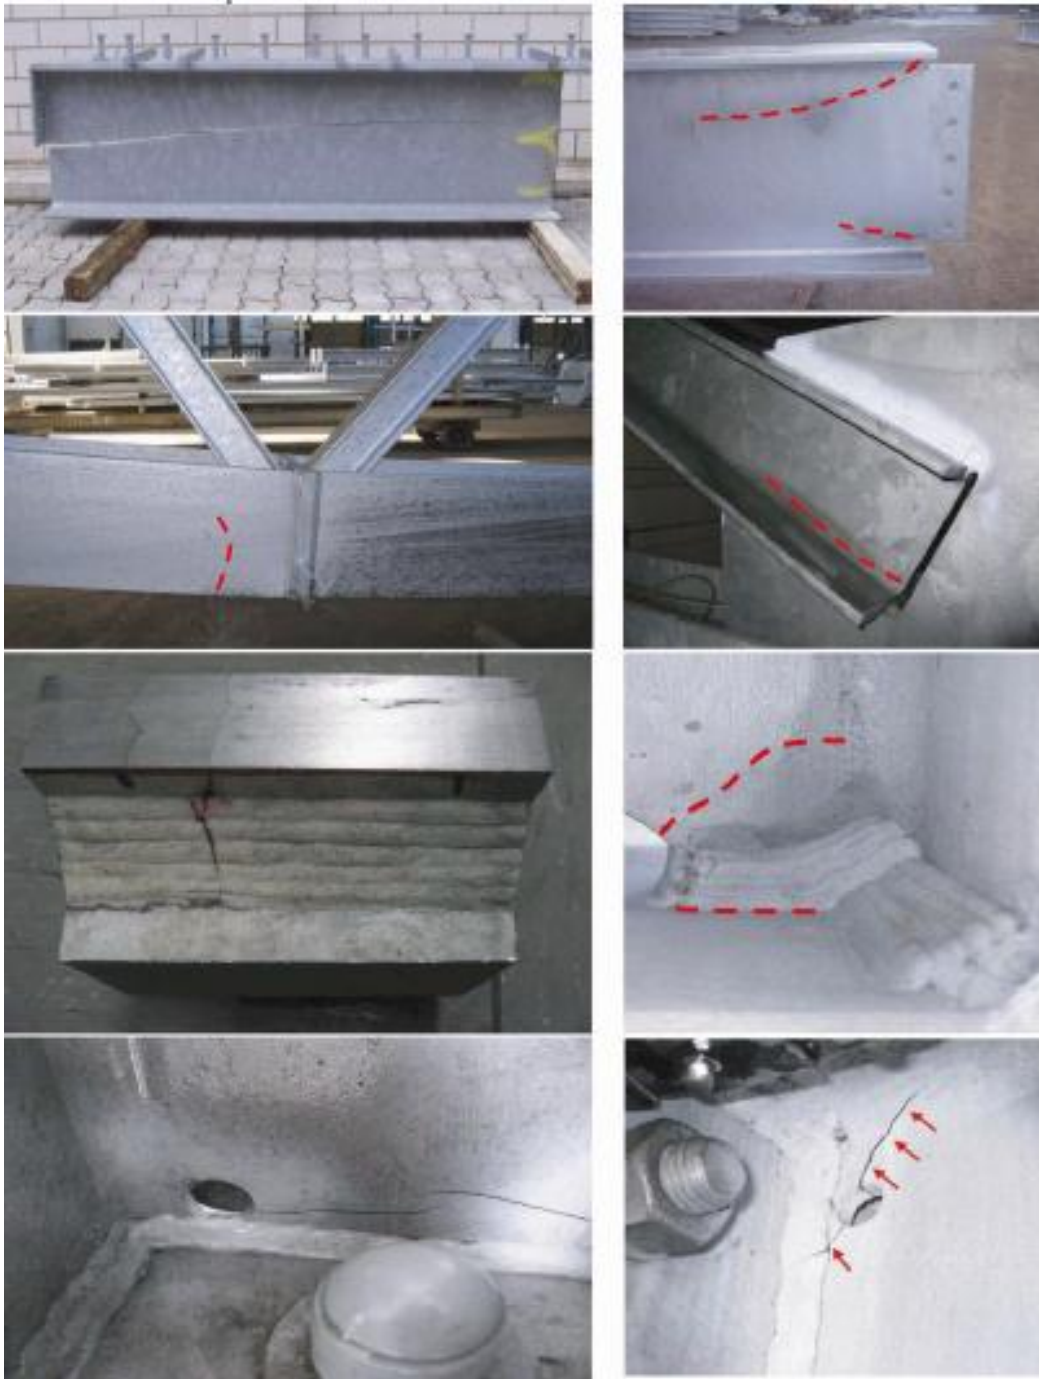
Figure 2-12: Damages observed after zinc coating or after erection of hot-dip-zinc-coated structural components (Feldmann et al., 2010)

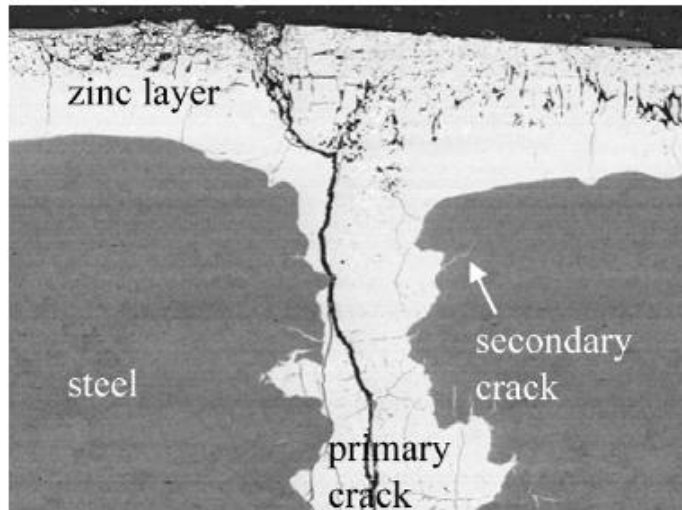
Figure 2-13: Primary crack and secondary crack (200x) (Feldmann et al. 2010)

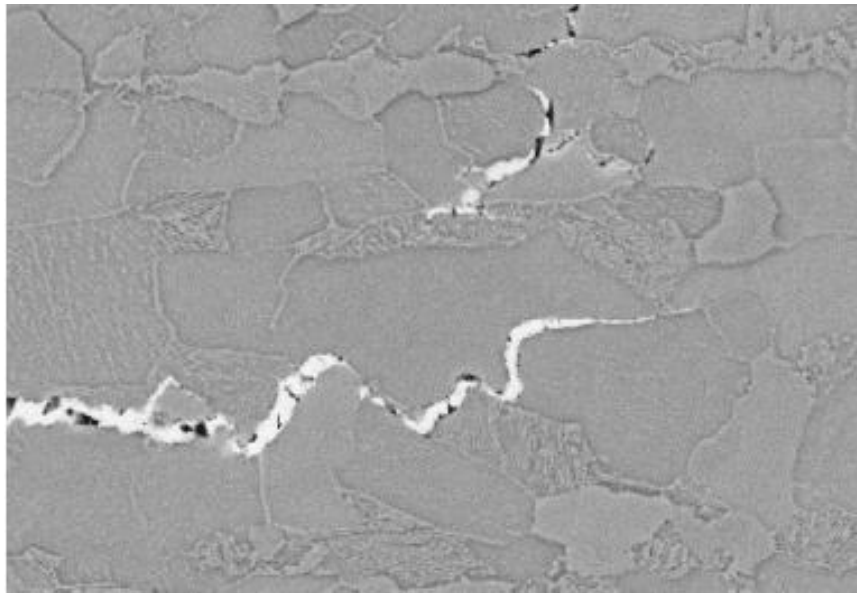
Figure 2-14: Intergranular crack in ferrite-pearlite structure (5000x) (Feldmann et al. 2010)

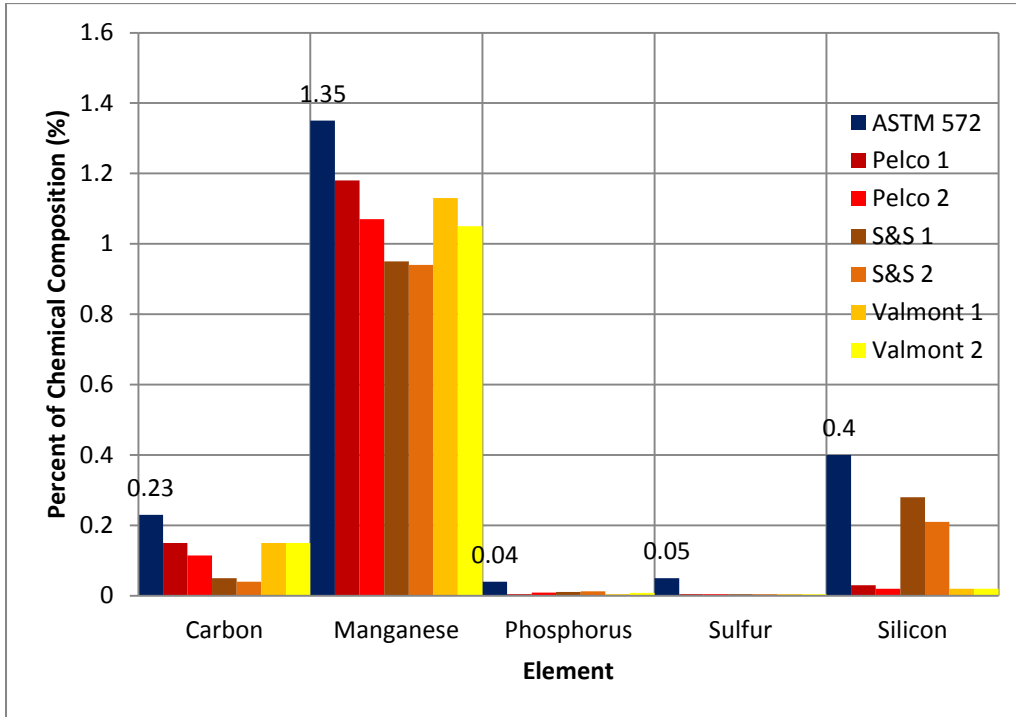
Figure 3-1: Base steel chemistry compositions relative to ASTM 572 specification

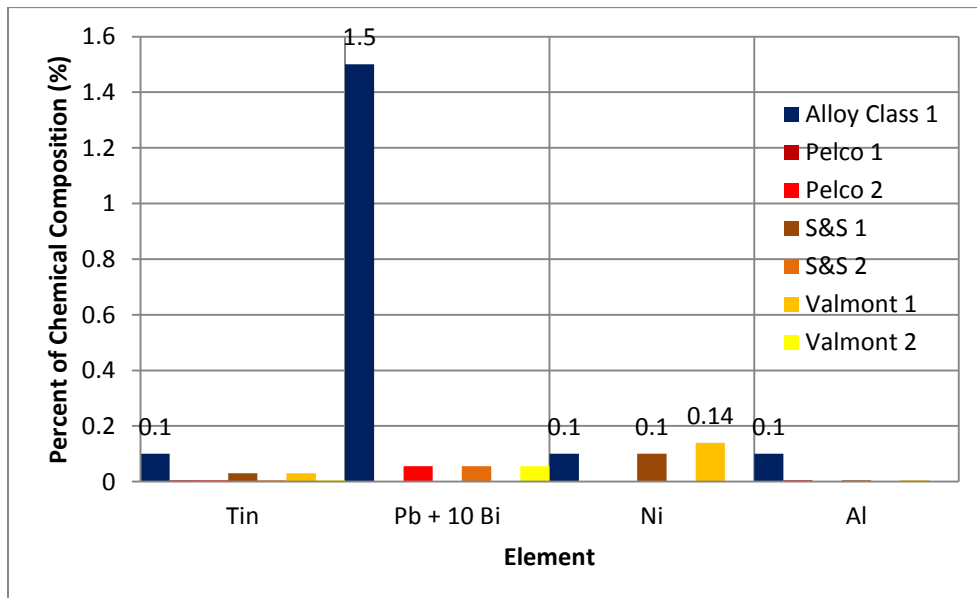
Figure 3-2: Zinc bath chemical compositions relative JRC Scientific and Technical Report Alloy Class 1

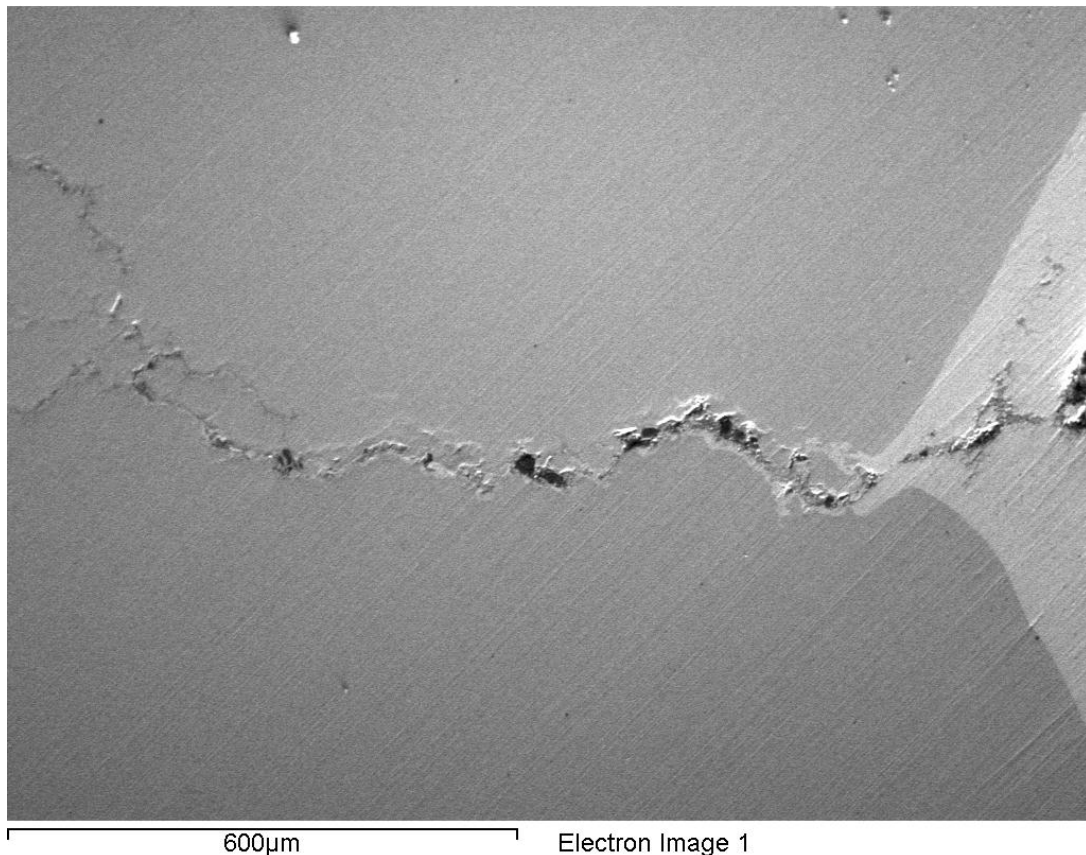
Figure 3-3: Initial crack from bend 10 of 33-3-12-TX-SG-A (Courtesy of TxDOT)

Apart from examining shaft and coating chemistry at shaft locations, researchers were also interested in observing chemistry at the location of an existing initial crack. Images of an initial crack from specimen 33-3-12-TX-SG-A, bend 10 were taken to evaluate localized chemical concentrations. Figure 3-3 shows the initial crack from the outside weld toe of bend 10.

By analyzing the section of the initial crack observed in Figure 3-3, several details stand out. First of all, the crack seems to spread in multiple directions, and seems to follow a more erratic path, perhaps grain boundaries, rather than propagating in a strain line like those seen due to fatigue. Also, there appear to be alloy regions at the surface of the cracks that indicate the penetration of chemicals deeper into the base metal during galvanizing. These beliefs were verified when TxDOT created dot maps to indicate the presence of various elements superimposed on the section of bend 10 as depicted in Figure 3-4, Figure 3-6, and Figure 3-5.

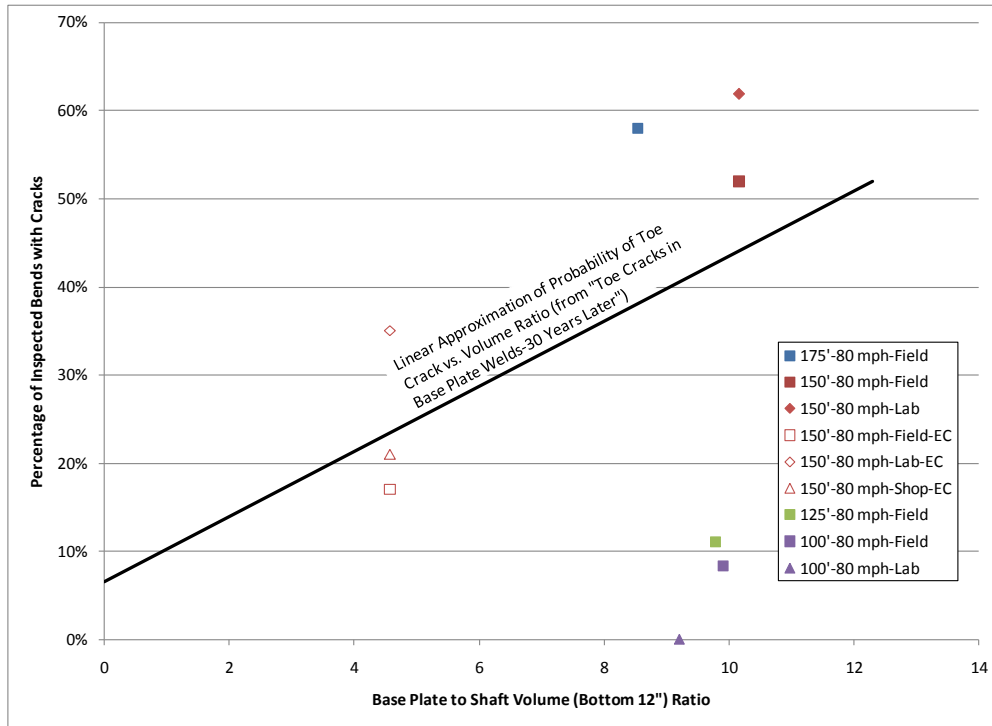
Figure 3-7: Percentage of cracks found compared to ratio of the volume of the base plate to the volume of the shaft (Pool, 2010)

A factor reported in research by Valmont is the volumetric shaft to baseplate ratio. According to the earlier referenced Valmont report, as the thickness of the baseplate increases relative to that of the shaft, the likelihood of developing cracks during galvanizing increases. Pool (2010) addressed this observation in his thesis by presenting the graph shown in Figure 3-7. The line shown on the graph represents the trend indicated by Valmont, and the individual points indicate specific HMIPs which were evaluated for initial cracks by using ultrasonic testing.

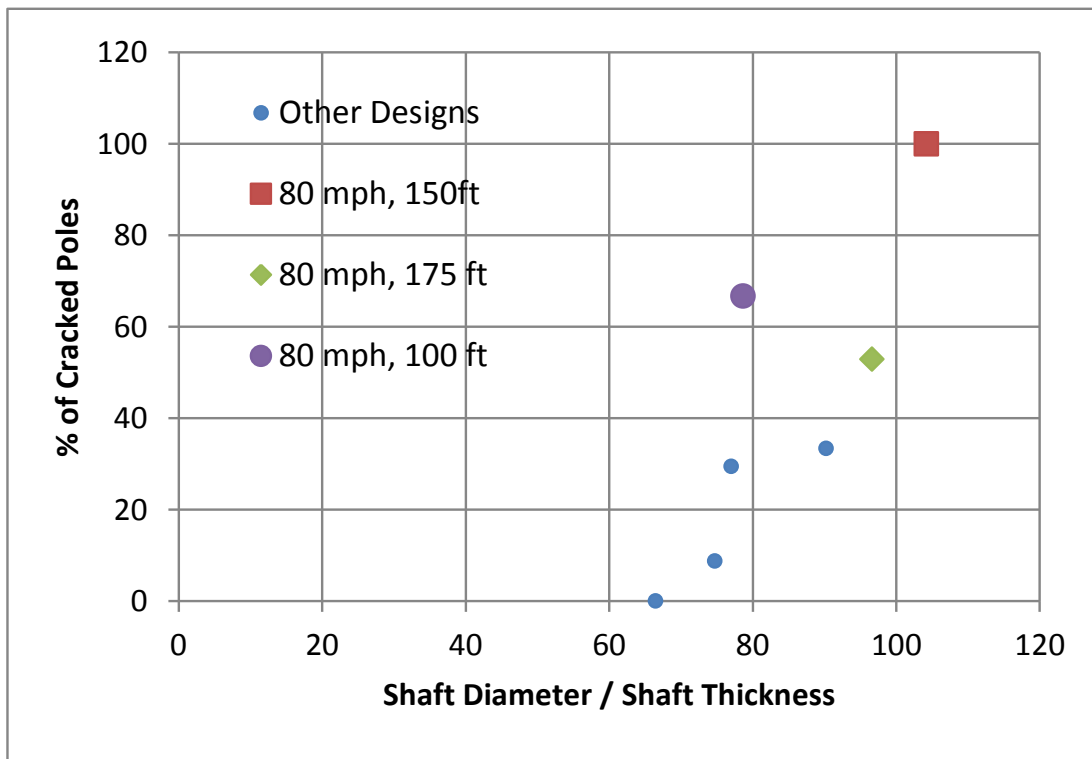
Figure 3-8: Percent of cracked poles of a given TxDOT design relative to shaft diameter to thickness ratio (Figure courtesy of Luca Magenes)

100 ft. tall poles. Figure 3-8 graphically depicts the results from this study. Through this study, a clear correlation appears between shaft diameter to thickness ratios and the development of cracks. It should be noted, however, that every pole evaluated by UT testing by TxDOT had already been installed in the field, and could have been subjected to wind loading for years. Despite the variability in loading and load duration, a direct relationship between the shaft diameter to shaft thickness ratio (d/t ratio) and the likelihood of crack formation in poles that were otherwise thought to be safe clearly exists. Particularly, the study indicates that should the d/t ratio be increased above 66, HMIP designs may be at risk of developing cracks at the toes of the base plate to pole shaft weld.

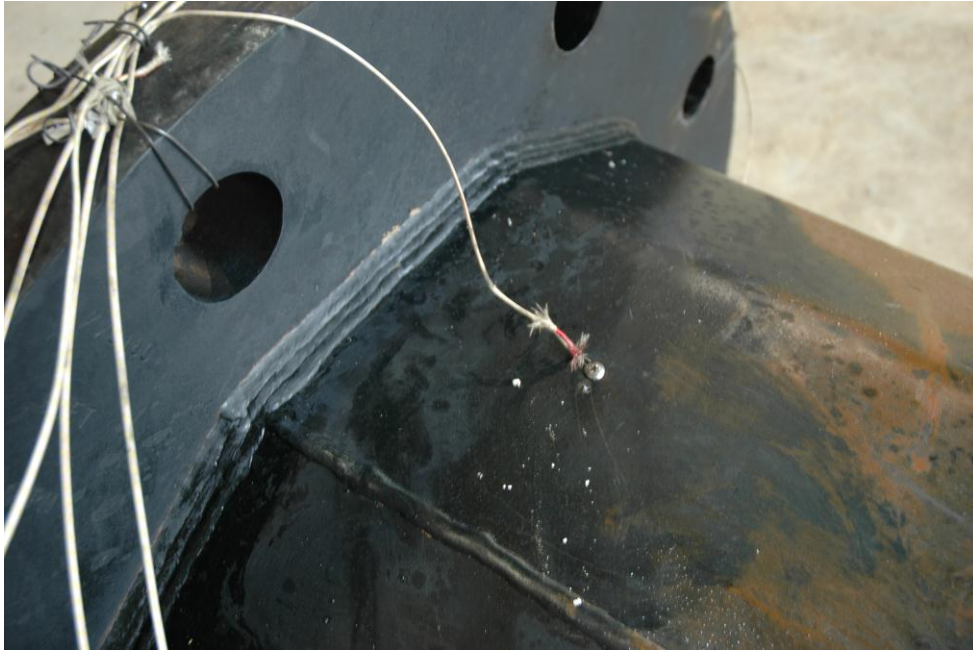
Figure 4-1: Screw thermocouple connection at HMIP shaft location

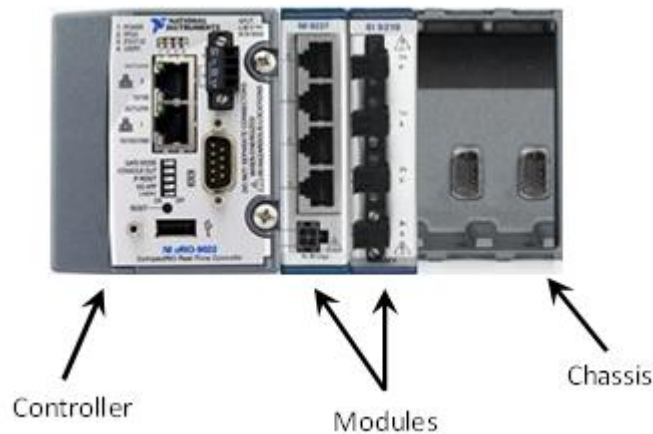
Figure 4-3: CompactRIO component diagram

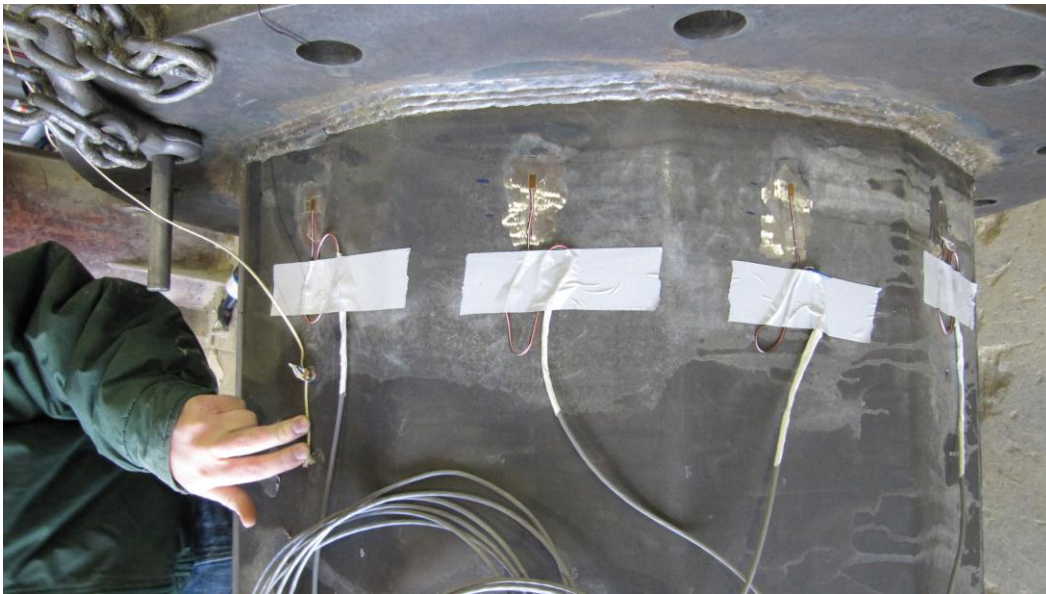
Figure 4-8: Strain gages attached to high mast prior to galvanizing

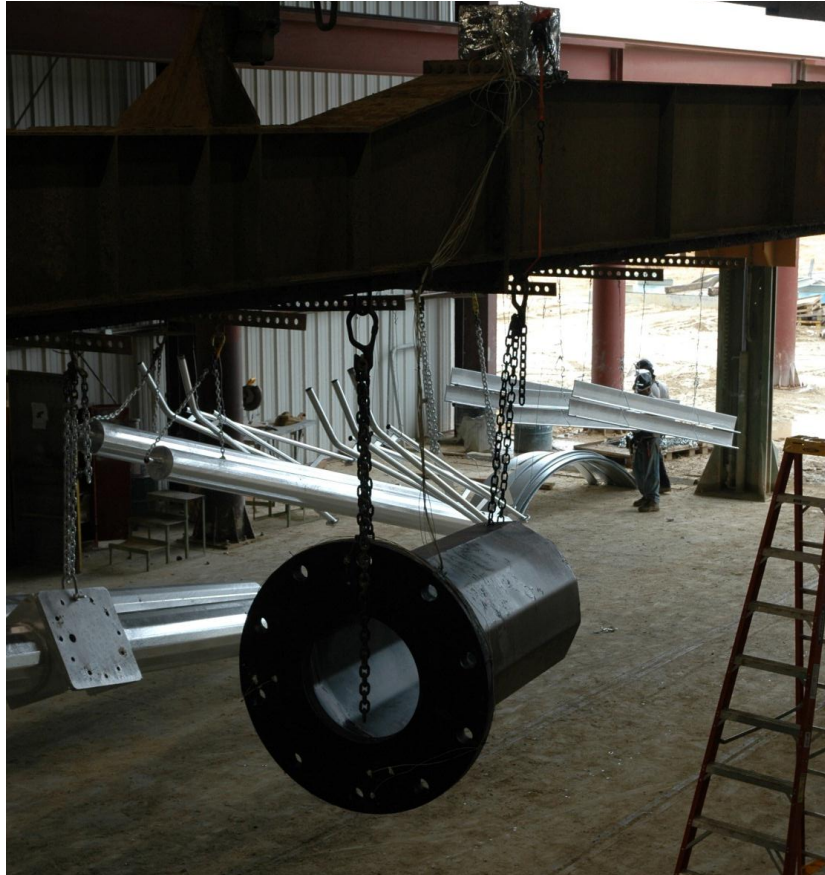
Figure 4-10: Instrumented high mast stub and DAQ box prior to galvanizing

Once activated, the DAQ was sealed inside the DAQ box, and then fastened to the galvanizing rigging as shown in Figure 4-10. The HMIP was then moved to the galvanizing bath. The results of these dipping experiments are recorded and discussed in Chapter 5.

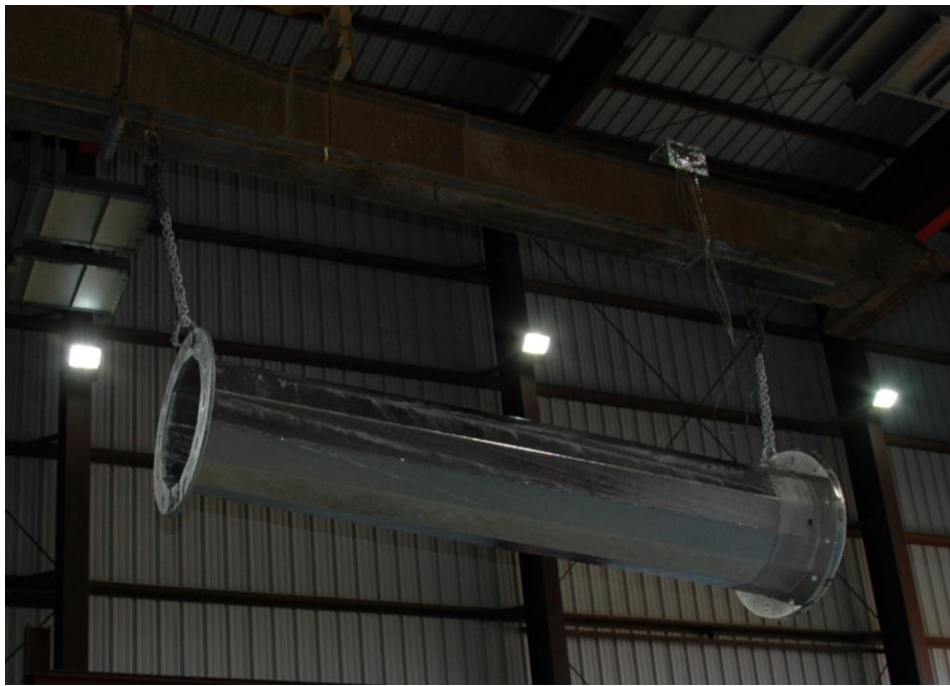
Figure 5-1: Suspended HMIP section with external collar and DAQ box after galvanizing

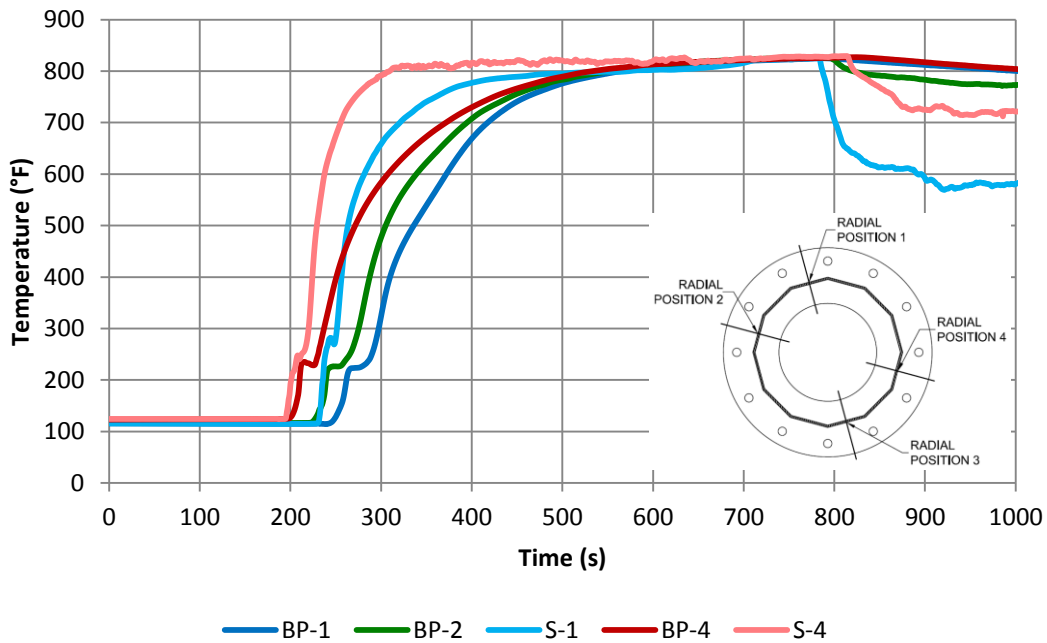
Figure 5-7: Typical thermal results from January 2010 specimen galvanizing trip

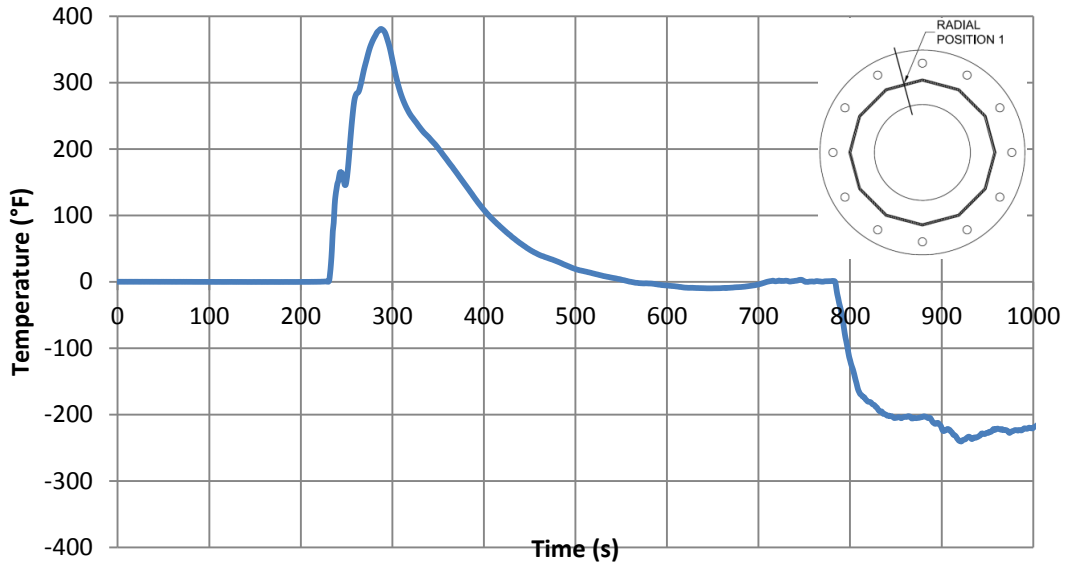
Figure 5-8: Thermal gradient between nodal locations BP-1 and S-1

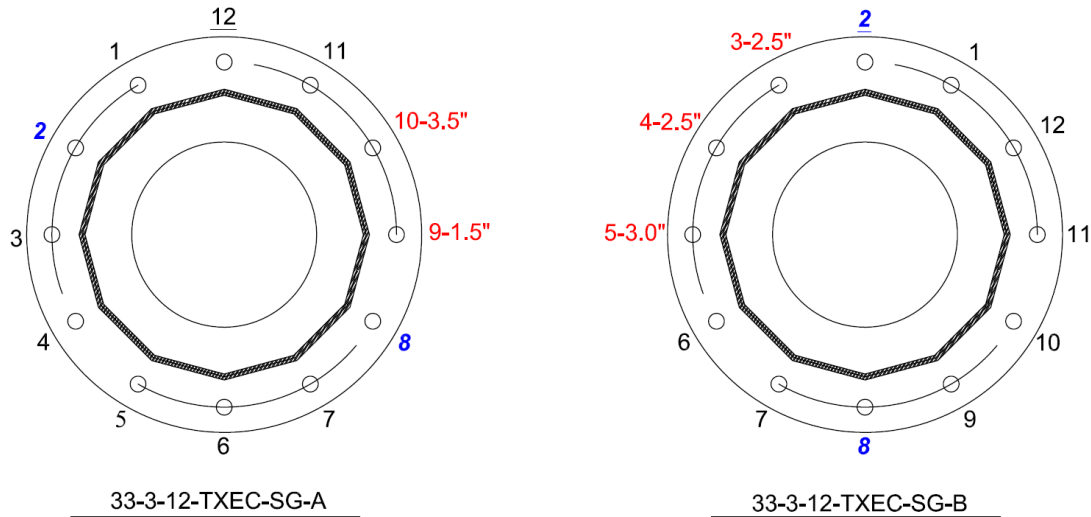
Figure 5-9: Initial crack locations after January 2010 galvanizing. Cracked bends and lengths marked in red.

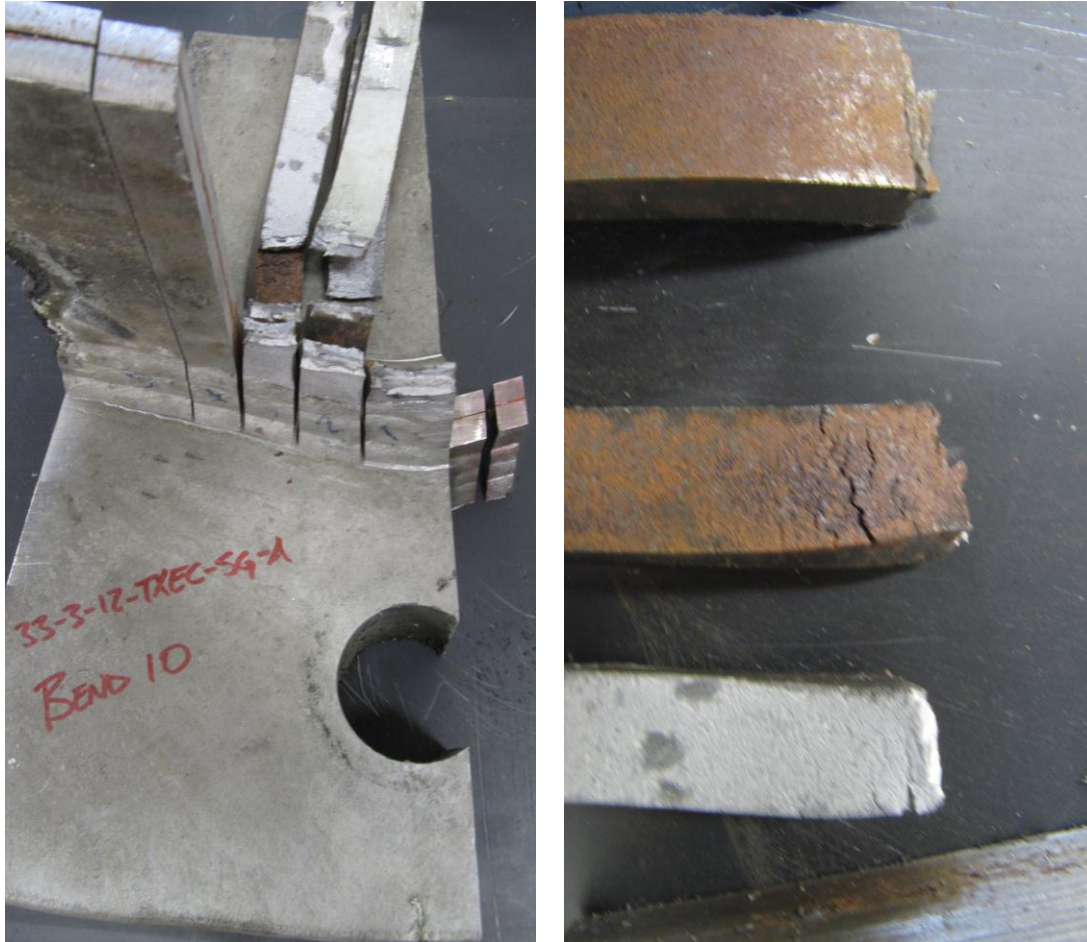
Figure 5-10: Suspected non-ductile cracks due to yielding during destructive testing

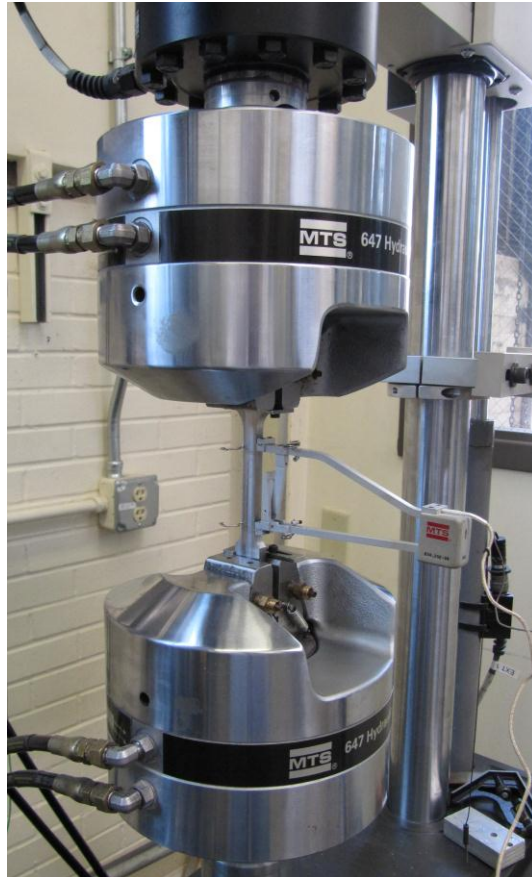
Figure 5-11: Tension coupon being tested in uniaxial tension with universal testing

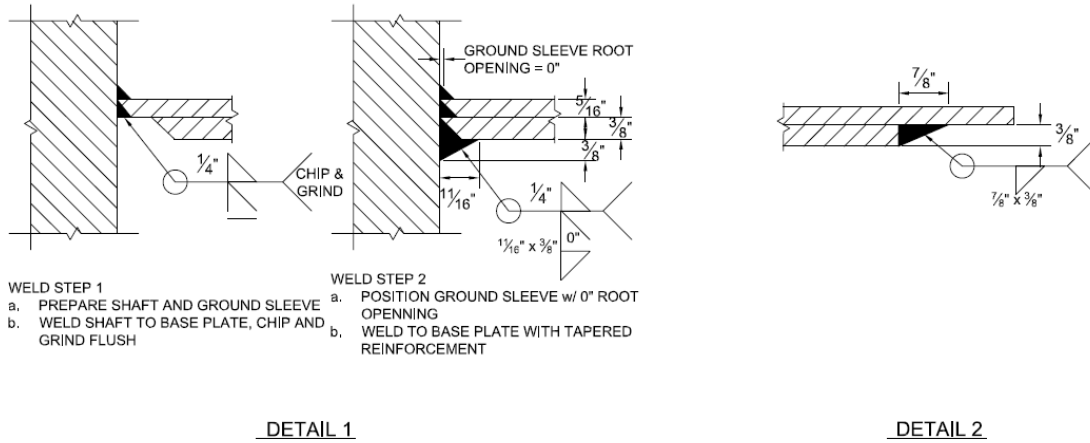
Figure 5-18: Weld details for 33-3-12-TXEC-SG-SA, as called out in Figure 5-14

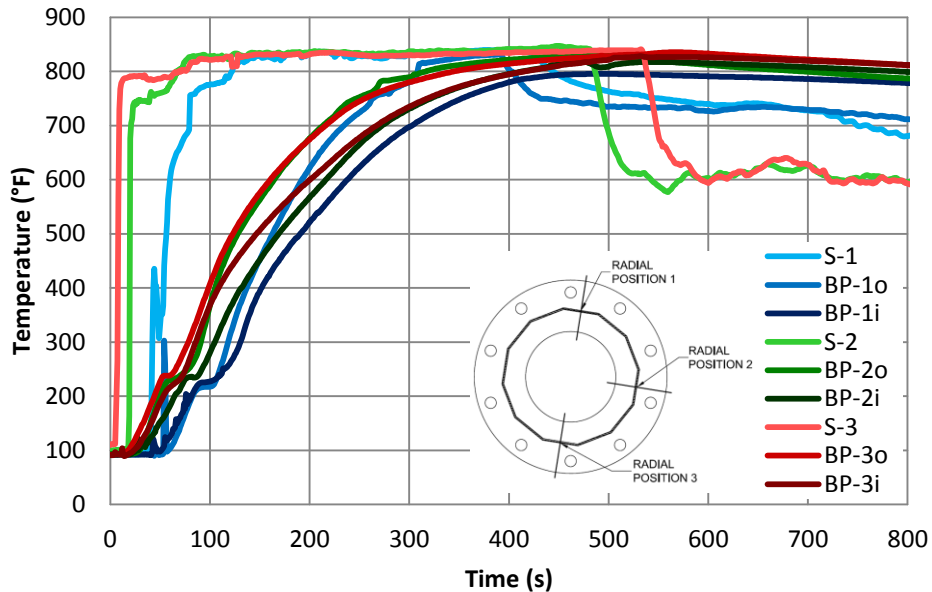
Figure 5-23: Typical thermal results from June 2010 galvanizing trip
